NIST NCSTAR 1-1C

**Federal Building and Fire Safety Investigation of the
World Trade Center Disaster**

Maintenance and Modifications to Structural Systems

September 2005

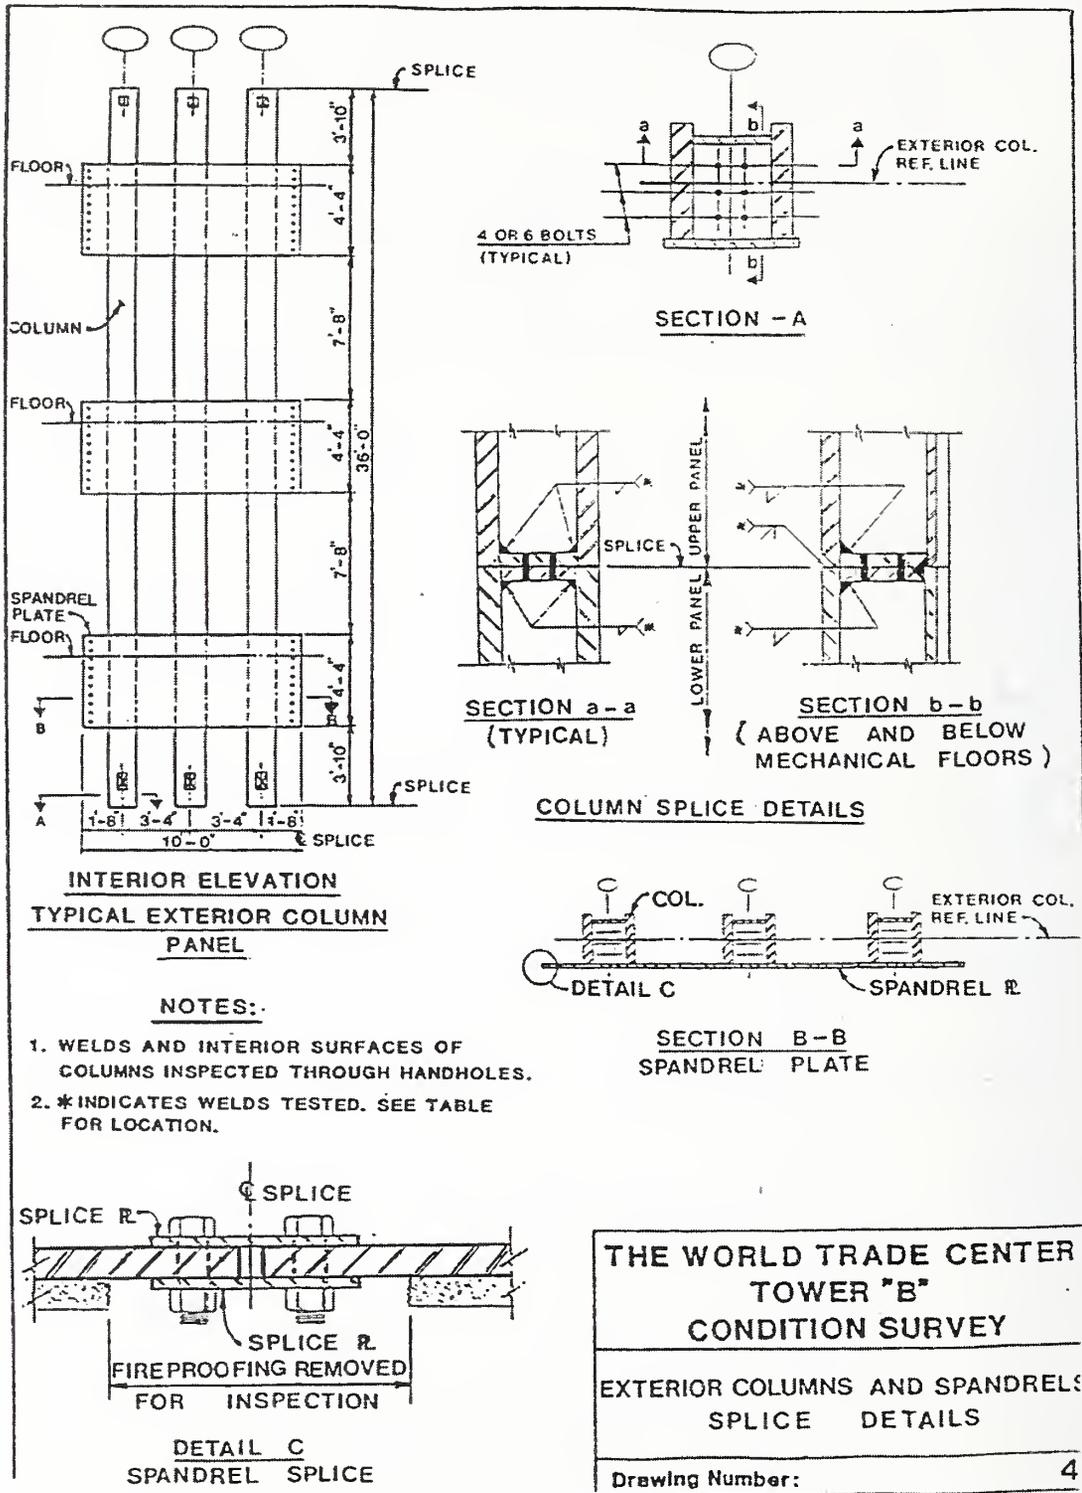
EXTERIOR COLUMNS AND SPANDRELS
SPLICE DETAILS

**THE WORLD TRADE CENTER
TOWER "B"
CONDITION SURVEY**

Recommendations—No priority recommendations for repair were made in the report. It was recommended, however, that a long-term maintenance program be developed and implemented to clean and paint the inside surfaces of the exterior box columns to prevent further corrosion of the structural steel.
