**NBSIR 87-3667**

# The Whittier Narrows Earthquake of October 1, 1987

## A Reconnaissance Report

By H. S. Lew

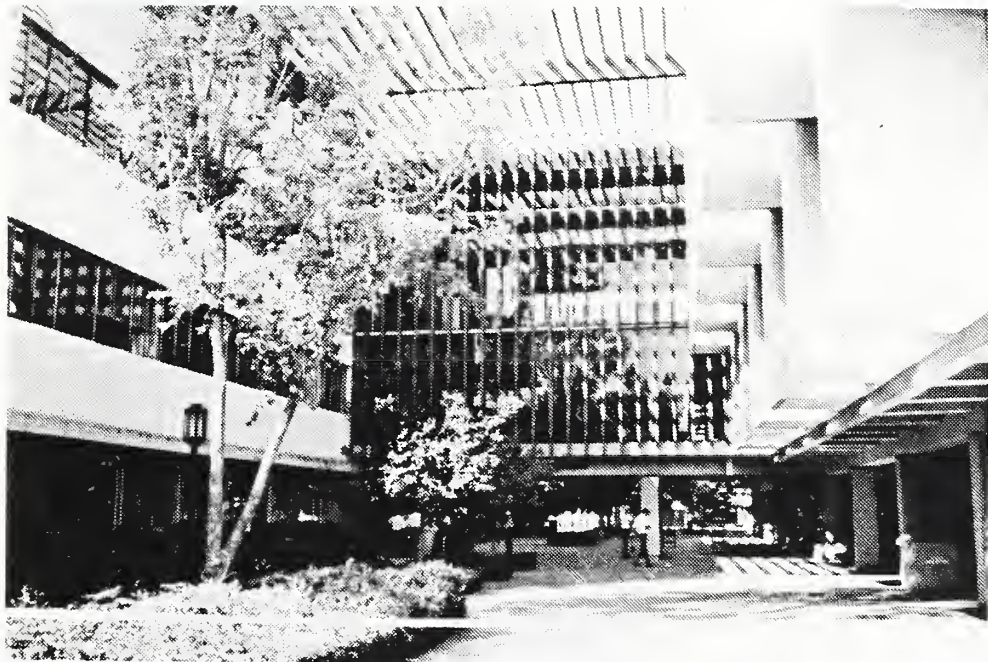
Photo 18 The library building complex on the campus of the California State University in Los Angeles. The two buildings are connected by a structurally-separated walkway structure.
