FIRE ENDURANCE AND HEAT TRANSFER
TESTS OF PREFABRICATED PANELS

NBS REPORT

May 4, 1960

6837

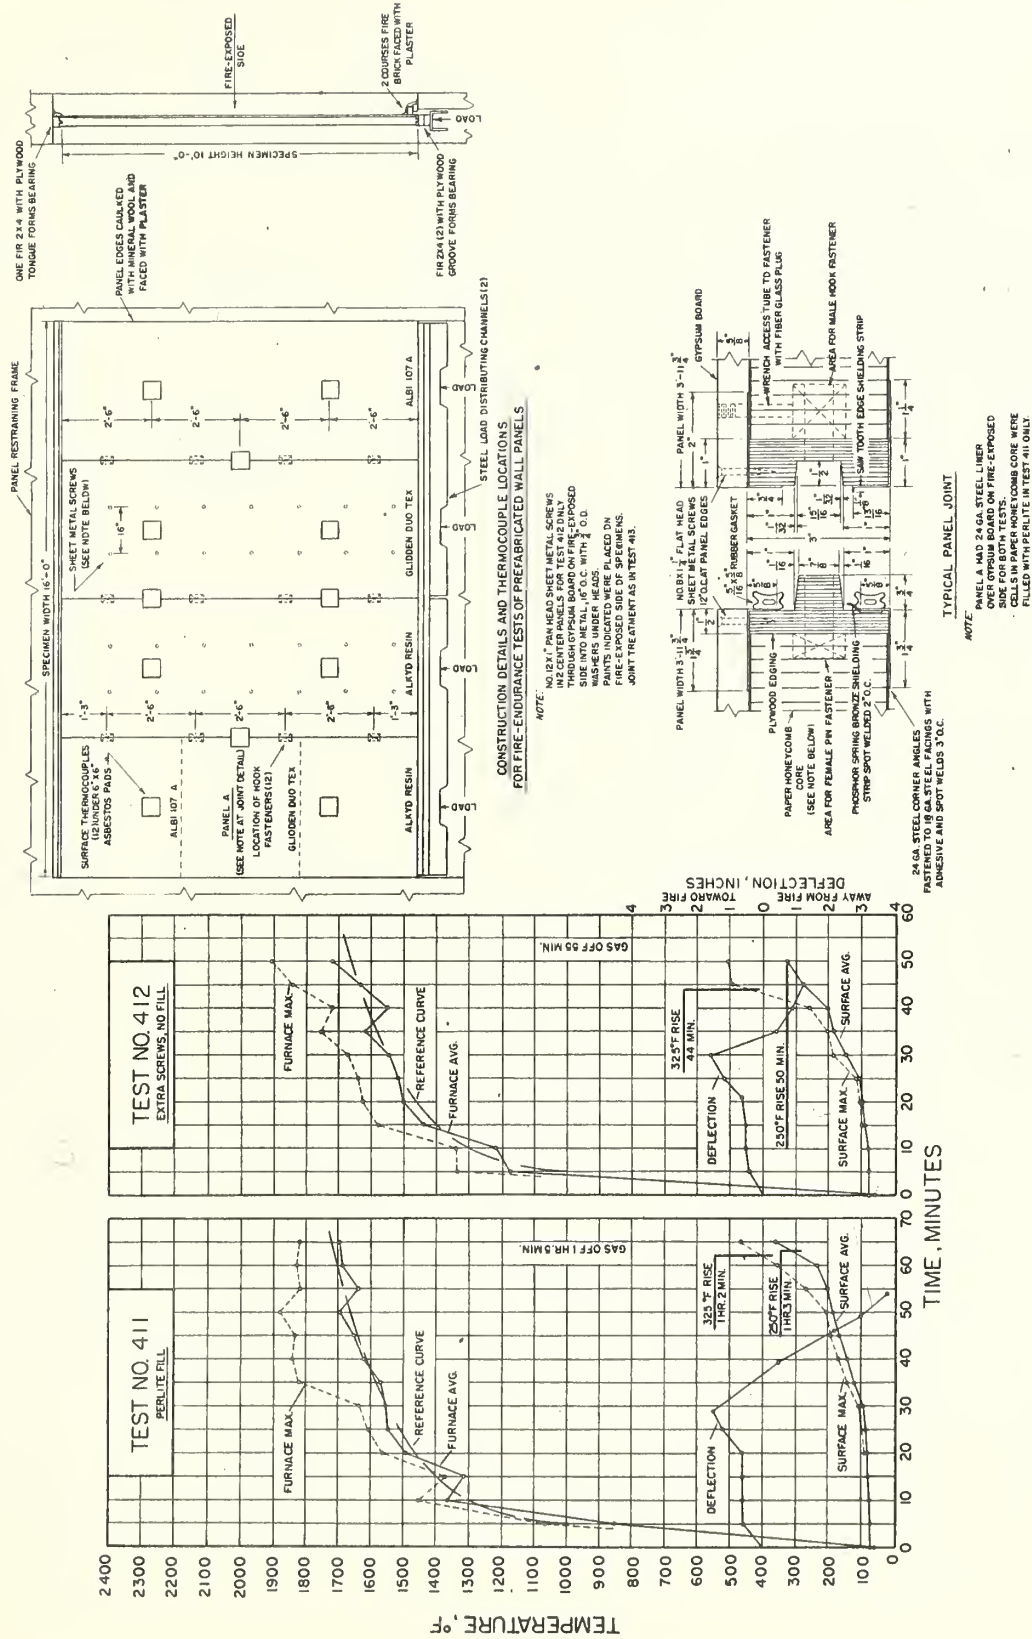
Figure 1. Construction details and data summary for wall tests.

The two wall specimens were identical in all but two features. In the first wall tested, the honeycomb had been filled with a perlite insulation; in the second, the honeycomb was empty. As a result of the behavior observed in the first test, it was decided to provide additional support for the gypsum board on the second specimen. This was done by means of 1-in. long No. 12, 13/32 in. cap head self-tapping sheet metal screws, with 3/4 in. OD washers, driven into holes drilled (No. 28 drill) through the gypsum board and metal skin. The locations of the holes are shown in Figure 1, at the end of this report. These screws were put into only the two center panels of the specimen.

The interior of the specimen continued to burn. The frame and specimen were removed from the furnace and the flames extinguished. Temperature and deflection data are summarized in Figure 1.

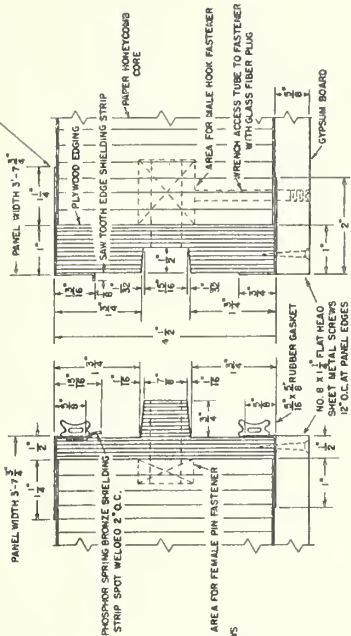
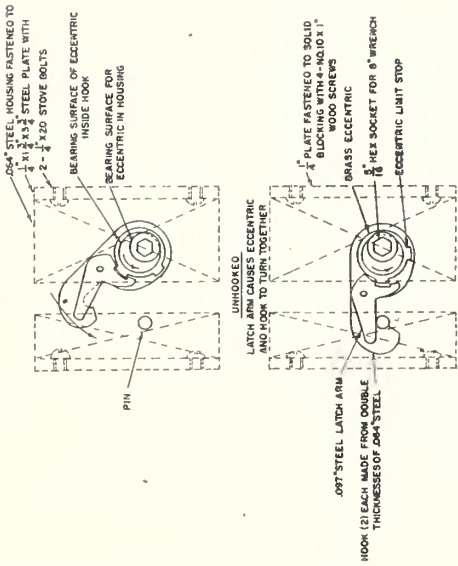
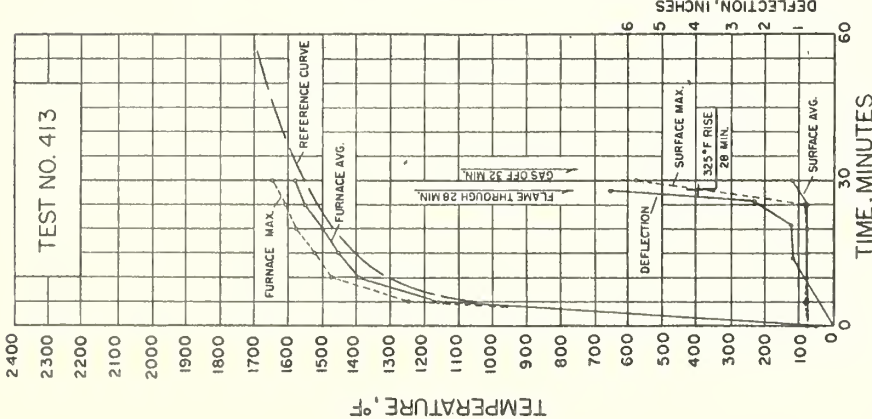
Figure 2. Construction details and data summary for roof test.

The roof specimen was 16 ft long by about 12-1/2 ft wide, made up of three roof panels, marked R2, plus an angle panel, marked R1, for transition from roof to side wall. The roof panels were 16 ft long, 44 in. wide, and 5-3/16 in. thick including 5/8 in. thick gypsum board. The gypsum board was painted with one of three paints. The painted surfaces were stenciled: Albi 107A, Glidden Duo Tex, or Mil-C-15328A. None of the roof panels had a metal liner over the exposed surface of the gypsum board; all the roof panels had perlite fill in the honeycomb. Additional support was provided the gypsum board of one panel by 1 in. long No. 12, 13/32-in. cap head, self-tapping sheet metal screws driven into holes drilled through the gypsum board and metal skin. The screws on one half the panel were used without washers; those on the other half were used with 3/4 in. OD washers. The screws were driven the day before the test and were in addition to those around the peripheries of the pieces of gypsum board (No. 8, 1-1/4 in. long flat head sheet metal screws at 12 in. o.c.). The locations of the screws, and other details, are shown in Figure 2.

heavy flames from its interior issued into the furnace chamber. The test was stopped at 32 min. The specimen continued to burn and a stream of water was used to extinguish the flames. Temperature and deflection data are summarized in Figure 2.
