**NIST-SP 1118 Volume I**

# **Technical Study of the Sofa Super Store Fire - South Carolina, June 18, 2007**

March 2011

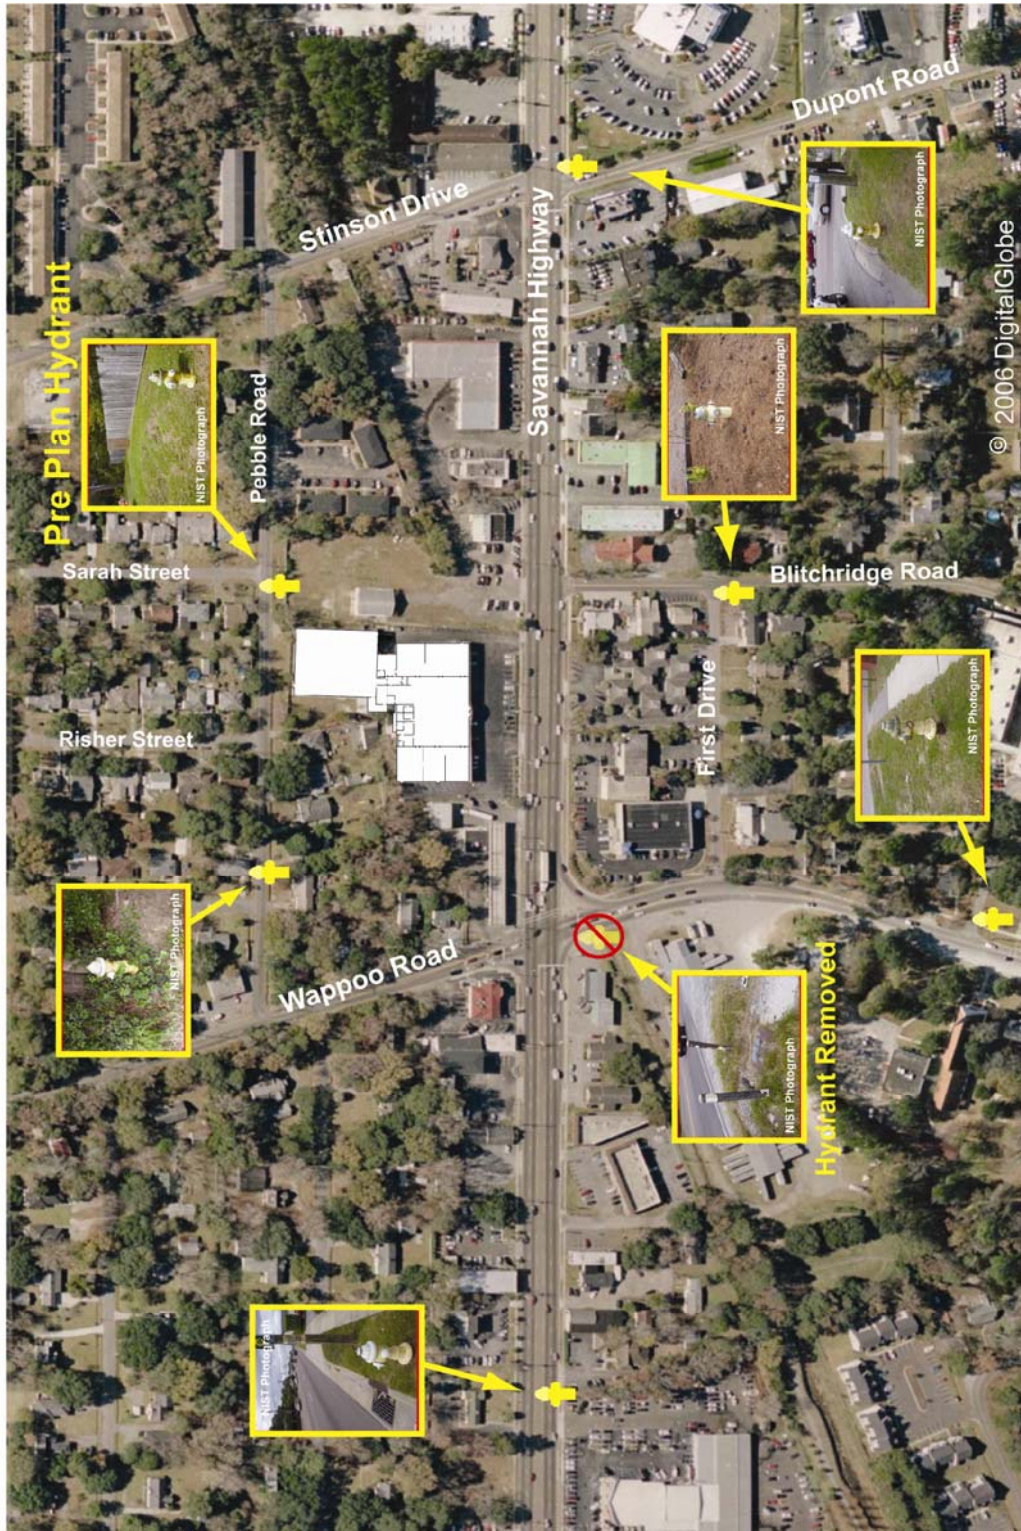
The area in which the Sofa Super Store was located had immediate access to a municipal hydrant system to support fire ground operations. Water hydrants were located along Savannah Highway to the west and east of the store, on Pebble Road behind the store, and at Blitchridge and Wappoo Roads to the north of the store. The location of the six hydrants is shown in Figure 1-17. Each hydrant typically had a pair of 6.4 cm (2.5 in) outlets and a single 10.2 cm (4 in) outlet.

Figure 1-17. Location of fire hydrants near Sofa Super Store. Hydrant identified during pre-plan inspection was on Pebble Road (upper right of figure). Hydrant at corner of Savannah Highway and Wappoo Road had been removed and not replaced (center left of figure). Background image used with permission of DigitalGlobe. Enhancements by NIST.

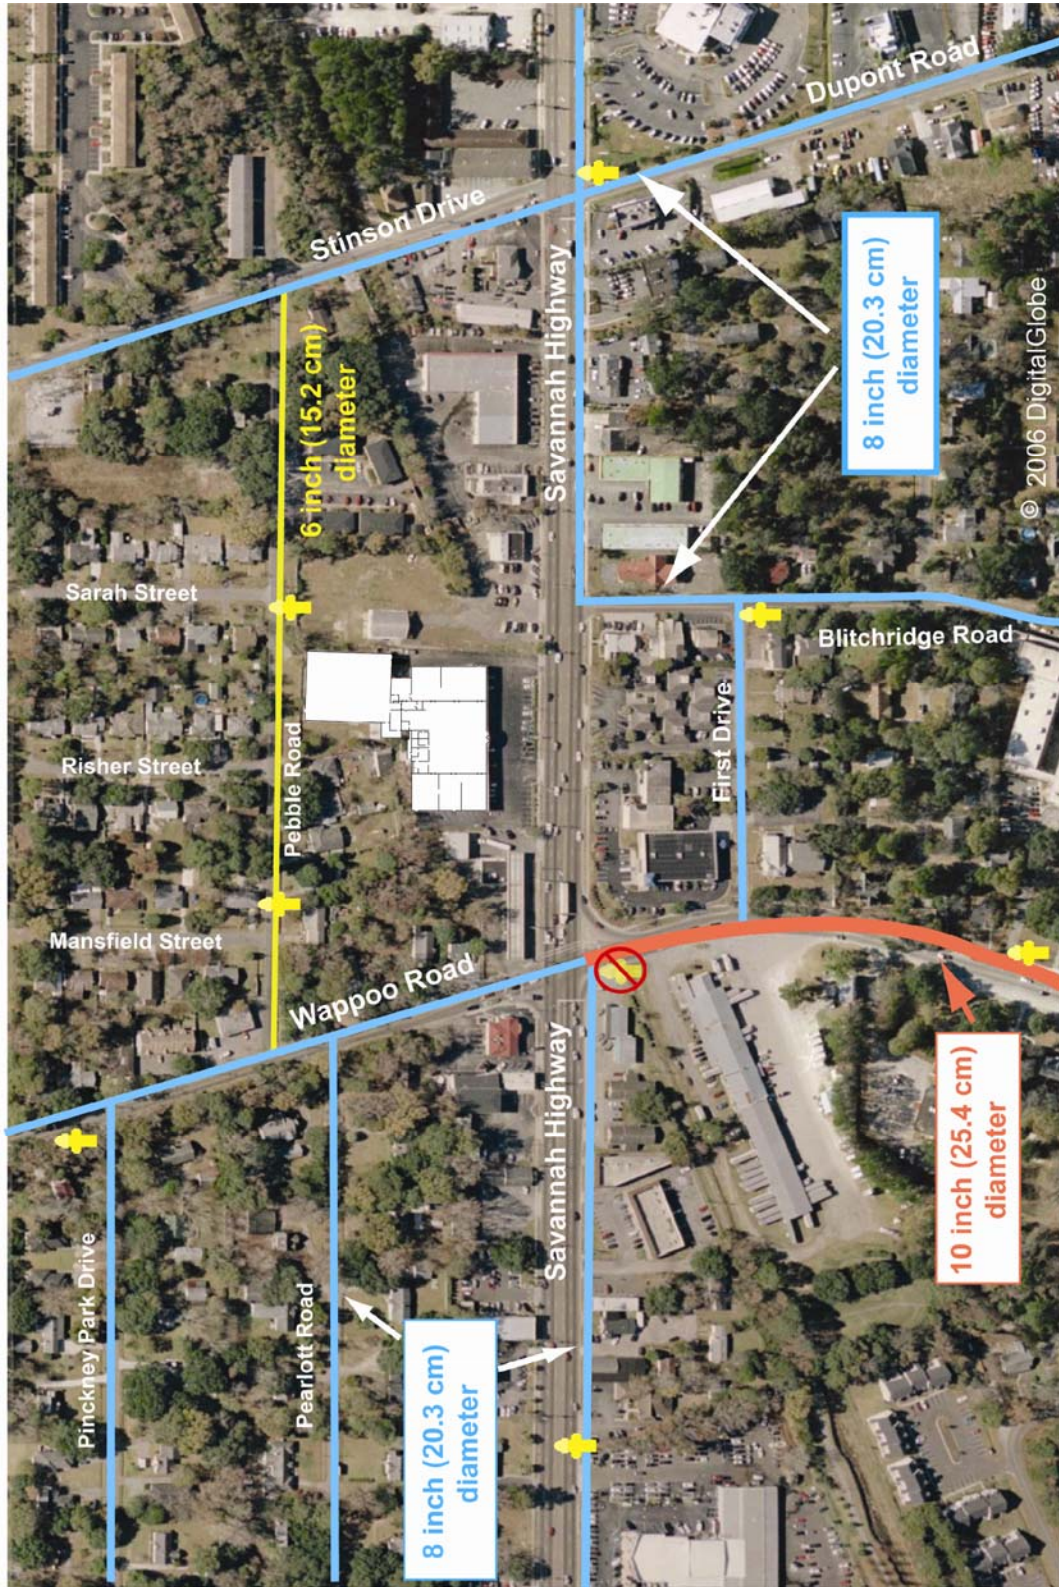
Water supply lines, 20.3 cm (8 in) diameter, were located along Savannah Highway, Stinson Drive, Dupont Road, First Drive, and Blitchridge Road (Figure 1-18). A smaller supply line, 15.2 cm (6 in) diameter, ran south of the warehouse along Pebble Road. On Wappoo Road, the water line was 20.3 cm (8 in) south of Savannah Highway and 25.4 cm (10 in) north of Savannah Highway.

Figure 1-18. Water supply lines near Sofa Super Store. Hydrants behind store on Pebble Road were on 15.2 cm (6 in) diameter lines while hydrants located along Savannah Highway were on 20.3 cm (8 in) diameter lines. Background image used with permission of DigitalGlobe. Enhancements by NIST.

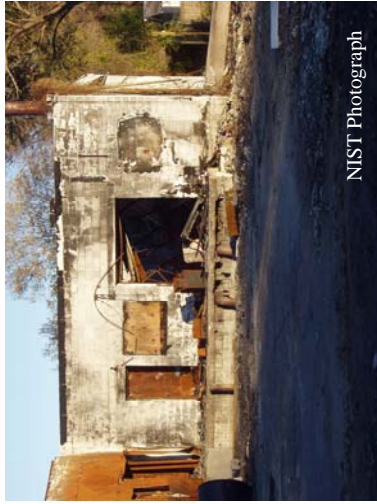
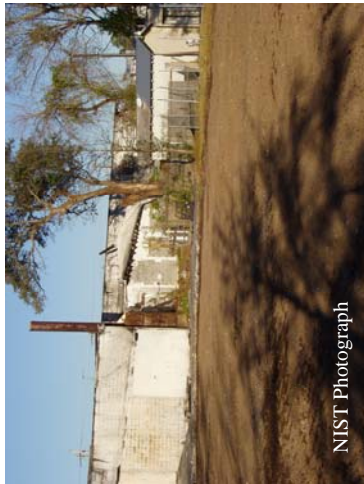
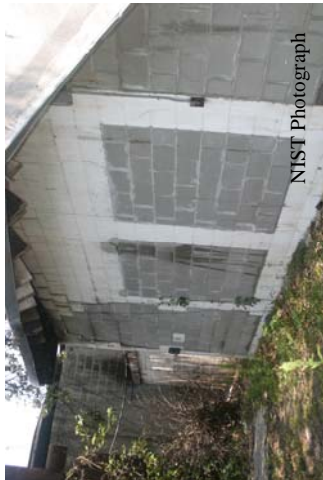
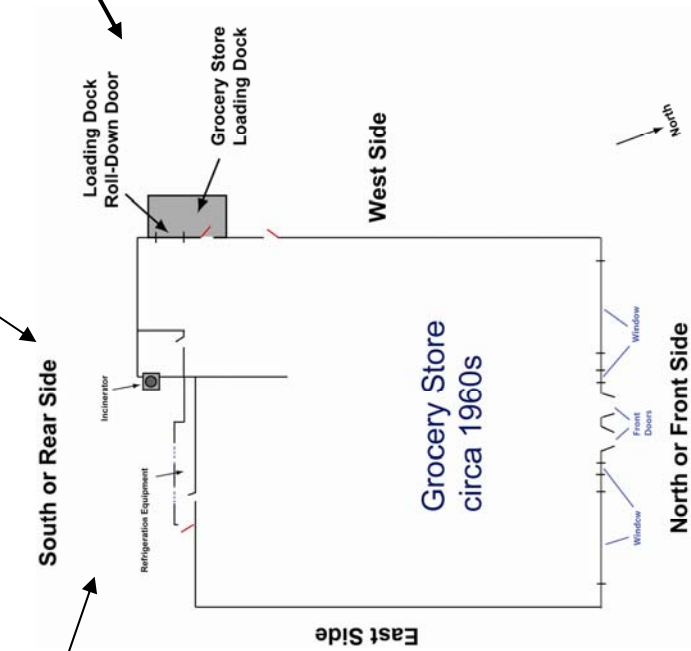
NIST found no building records that identified the original owner, architect, design engineer, or builder of the Sofa Super Store building at 1807 Savannah Highway, Charleston, SC. Anecdotes indicated that the building originally was a Piggly Wiggly Supermarket that was erected in the late 1950s or early 1960s. The roll-down door between the loading dock area and the holding area was consistent with what would have been a loading dock door for the original grocery store. As an exterior door, the roll-down delivery door was not designed as a fire door and did not have a fusible link. The grocery store refrigerator/freezer compressor equipment was located in the enclosed area behind the store (Figure 1-19). The incinerator was also located at the rear of the store and was still visible although no longer operational.

Figure 1-19. Grocery store loading dock, incinerator, and refrigeration equipment areas. Loading dock and incinerator photographs taken after warehouse was torn down and removed from site.

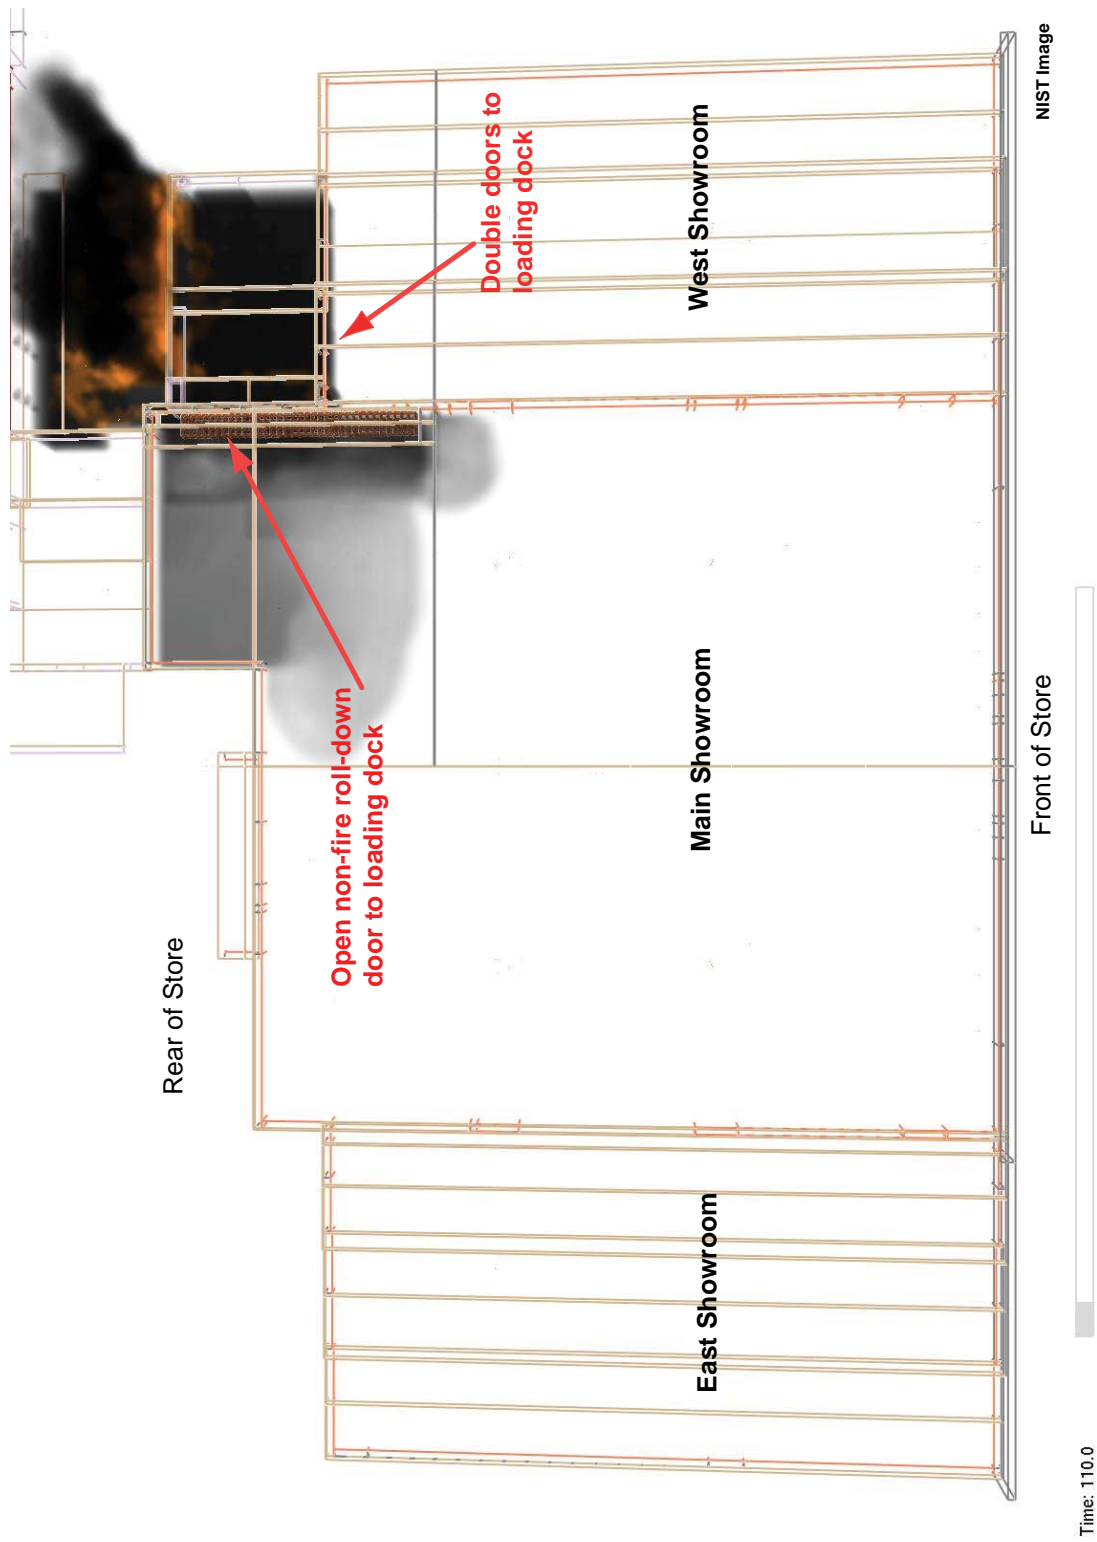
Figure 4-12. Smoke filling in void space above main showroom. Image was rendered 110 s into the simulation.

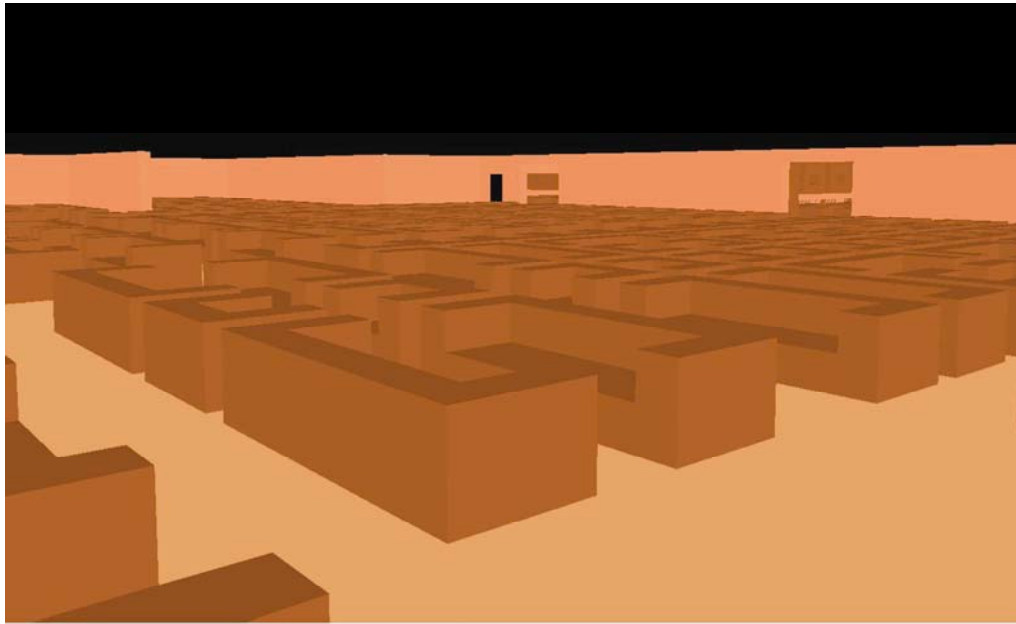
The AC and E-10 captain entered the main showroom and initially observed clear conditions. Figure 4-13 shows an image of the main showroom, from the perspective of a person standing at the front entrance and facing south west, toward the holding area. This image was rendered 80 s into the simulation (7:12:13 p.m.), approximately the time the Assistant Chief entered the showroom and observed clear conditions.

**Figure 4-13.** Image rendered 80 s (7:12:13 p.m.) into the simulation from inside the main showroom, near the entrance. View is toward the south west corner of the main showroom.

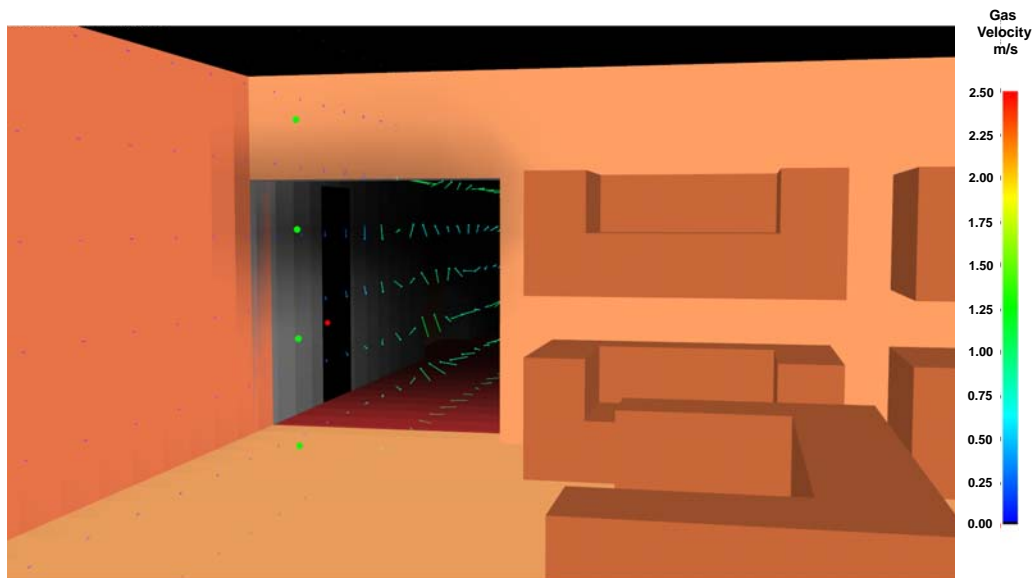
**Figure 4-14.** Image rendered 145 s (7:13:18 p.m.) into the simulation from the west showroom, near the double doors that lead to the loading dock. Arrows indicate direction and relative speed of air moving from the showroom into the loading dock (The relative speed is proportional to the length of the arrow, i.e. longer arrows indicate higher relative speeds and color scale indicates velocity magnitude).

Figure 4-15 shows a rendered image of the double doors from inside the west showroom at 145 s, 1 second after they were opened. The arrows or velocity vectors indicate that the air was flowing from the rear of the west showroom into the loading dock just after the doors were opened.

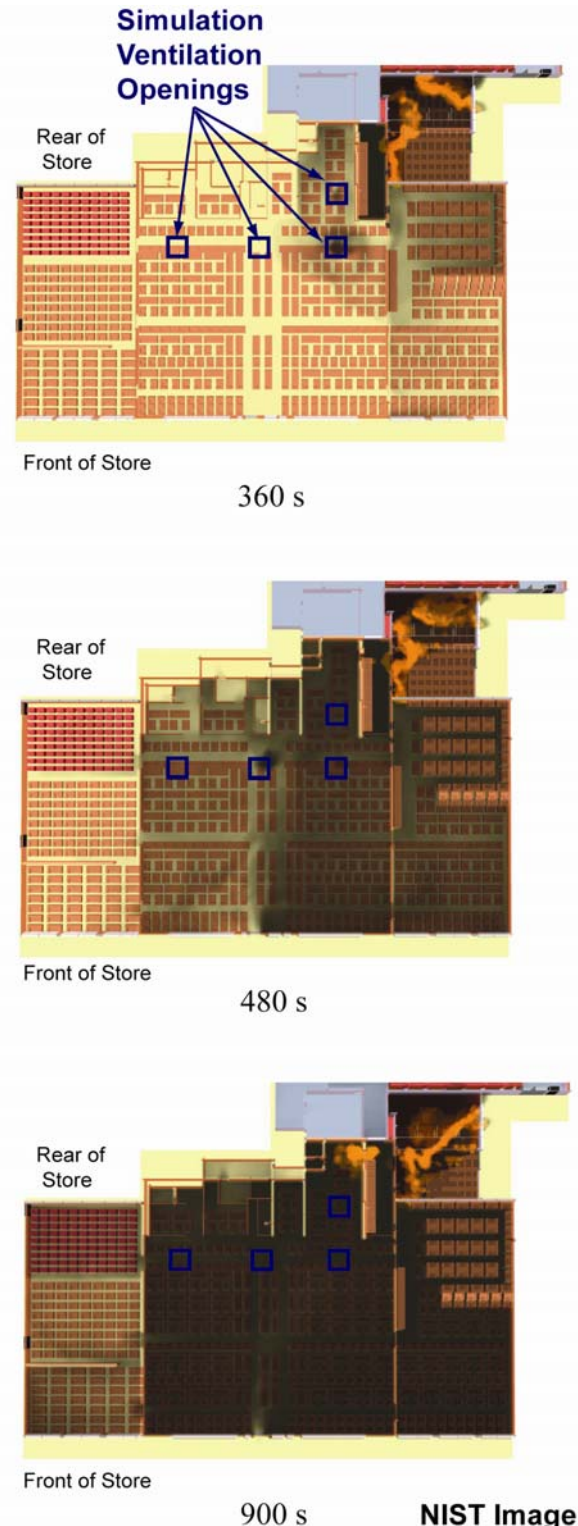
Smoke penetration through the ceiling was modeled by creating an opening in the rear of the main showroom when the adjacent temperature reached 50°C. Figure 4-15 shows the progression of fire and smoke below the ceiling level (2.6 m) throughout the loading dock, holding area and showrooms between 300 s (7:15:53 p.m.) and 900 s (7:25:53 p.m.). The images in this figure have been clipped down to the level of the ceiling in the showrooms.

At 300 s (7:13:53 p.m.) there is light smoke in the rear of the main and west showrooms. Initially, smoke in the west showroom entered through the double doors while the smoke in the main showroom entered through the ceiling. The ventilation openings in the ceiling in the main showroom (blue colored squares in Figure 4-15) opened between 261 s (7:15:14 p.m.) and 976 s (7:27:09 p.m.).

By 600 s (7:20:53 p.m.), the smoke layer had permeated the west and main showrooms, and there was evidence of a “tunneling” as fresh air was being pulled into the front door to supply oxygen. This is consistent with the account of Engineer 6, who entered the structure at approximately 7:24 p.m. (787 s) and reported a tunnel of clear space that extended several feet inside the showroom as fresh air was being pulled through the open door. Beyond this space he reported heavy smoke conditions. By 900 s (7:25:53 p.m.), the fire in the rear of the main showroom had grown to approximately 23 MW.

**NIST Image**  
**Figure 4-15. View of fire and smoke progression from above the showrooms from 300 to 900 s (7:15:53 p.m. to 7:25:53 p.m.). The images are clipped to view conditions below the ceiling.**

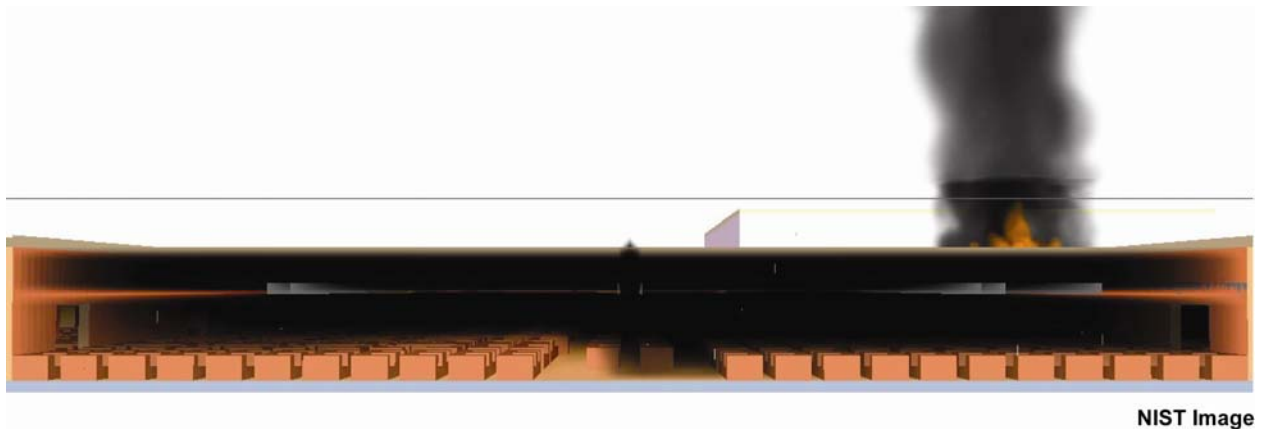
**Figure 4-16. Model rendering of view inside the front of the main showroom at 487 s (7:19:00 p.m.).**

self-contained breathing apparatus (SCBA) face pieces. Figure 4-16 shows an image of the front of the main showroom, with the front wall removed, at 487 s. This image shows that smoke had filled the void space above the ceiling and banked down to the showroom floor. Conditions on the east side, including the area near the entrance, are not as severe. However, as one progresses toward the rear and west, conditions degrade significantly.

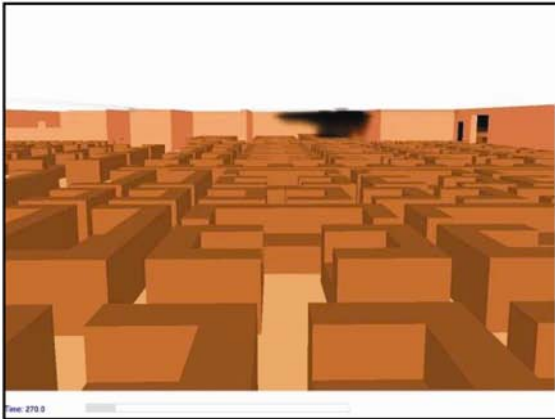
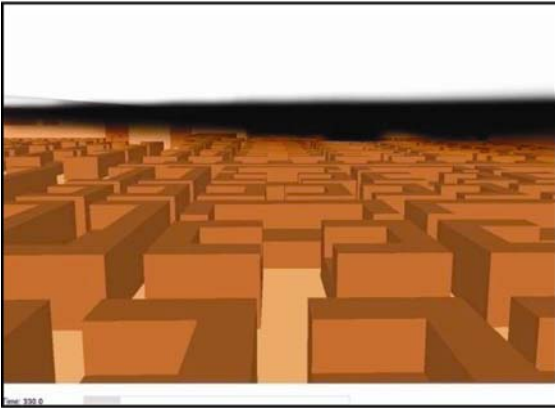
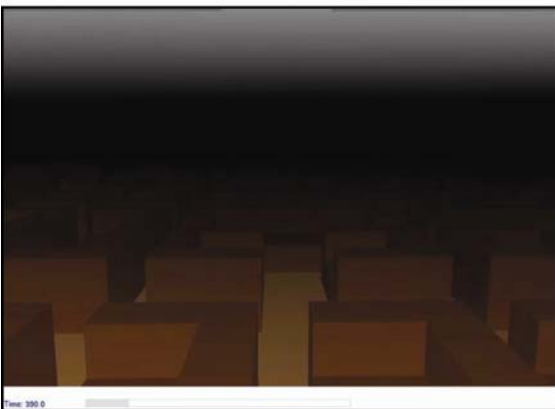
Figures 4-17 and 4-18 show smoke filling in, respectively, the main and west showrooms from the perspective of someone at the front of the room. The sequence in Figure 4-17 begins at 270 s (7:15:23 p.m.), after smoke began penetrating the ceiling. The sequence in Figure 4-18 begins at 270 s (7:15:23 p.m.). In both showrooms, conditions deteriorate considerably within a 120 s span.

**Figure 4-17. Smoke progression inside the west side of the main showroom between 270 s to 390 s (7:15:23 p.m. to 7:17:23 p.m.).**

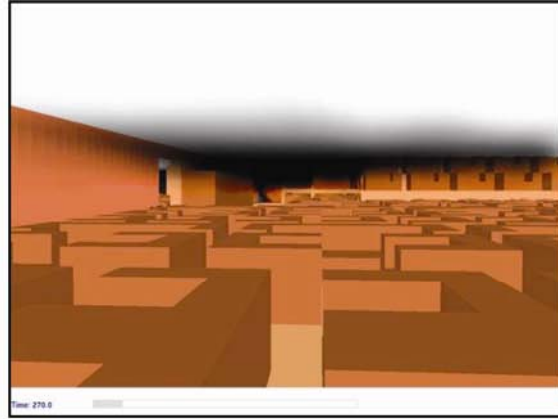
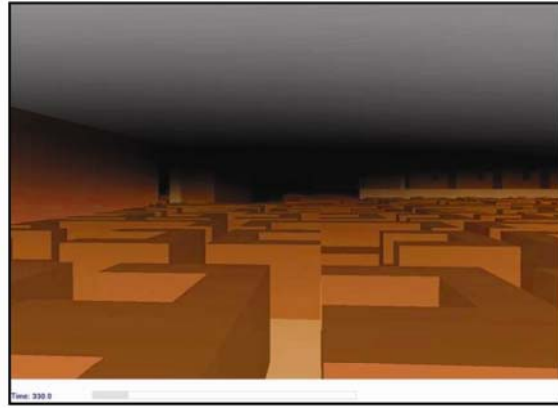
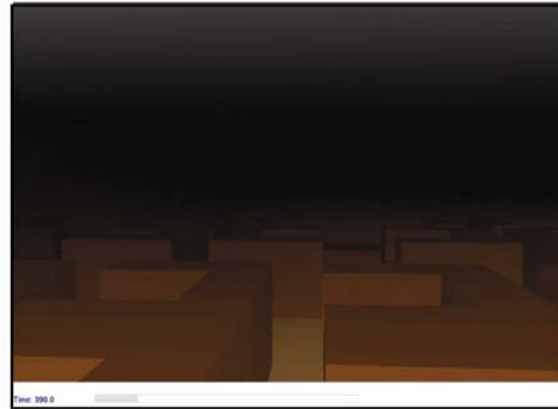
**Figure 4-18. Smoke progression inside the west showroom between 270 s to 390 s (7:15:23 p.m. to 7:17:23 p.m.).**

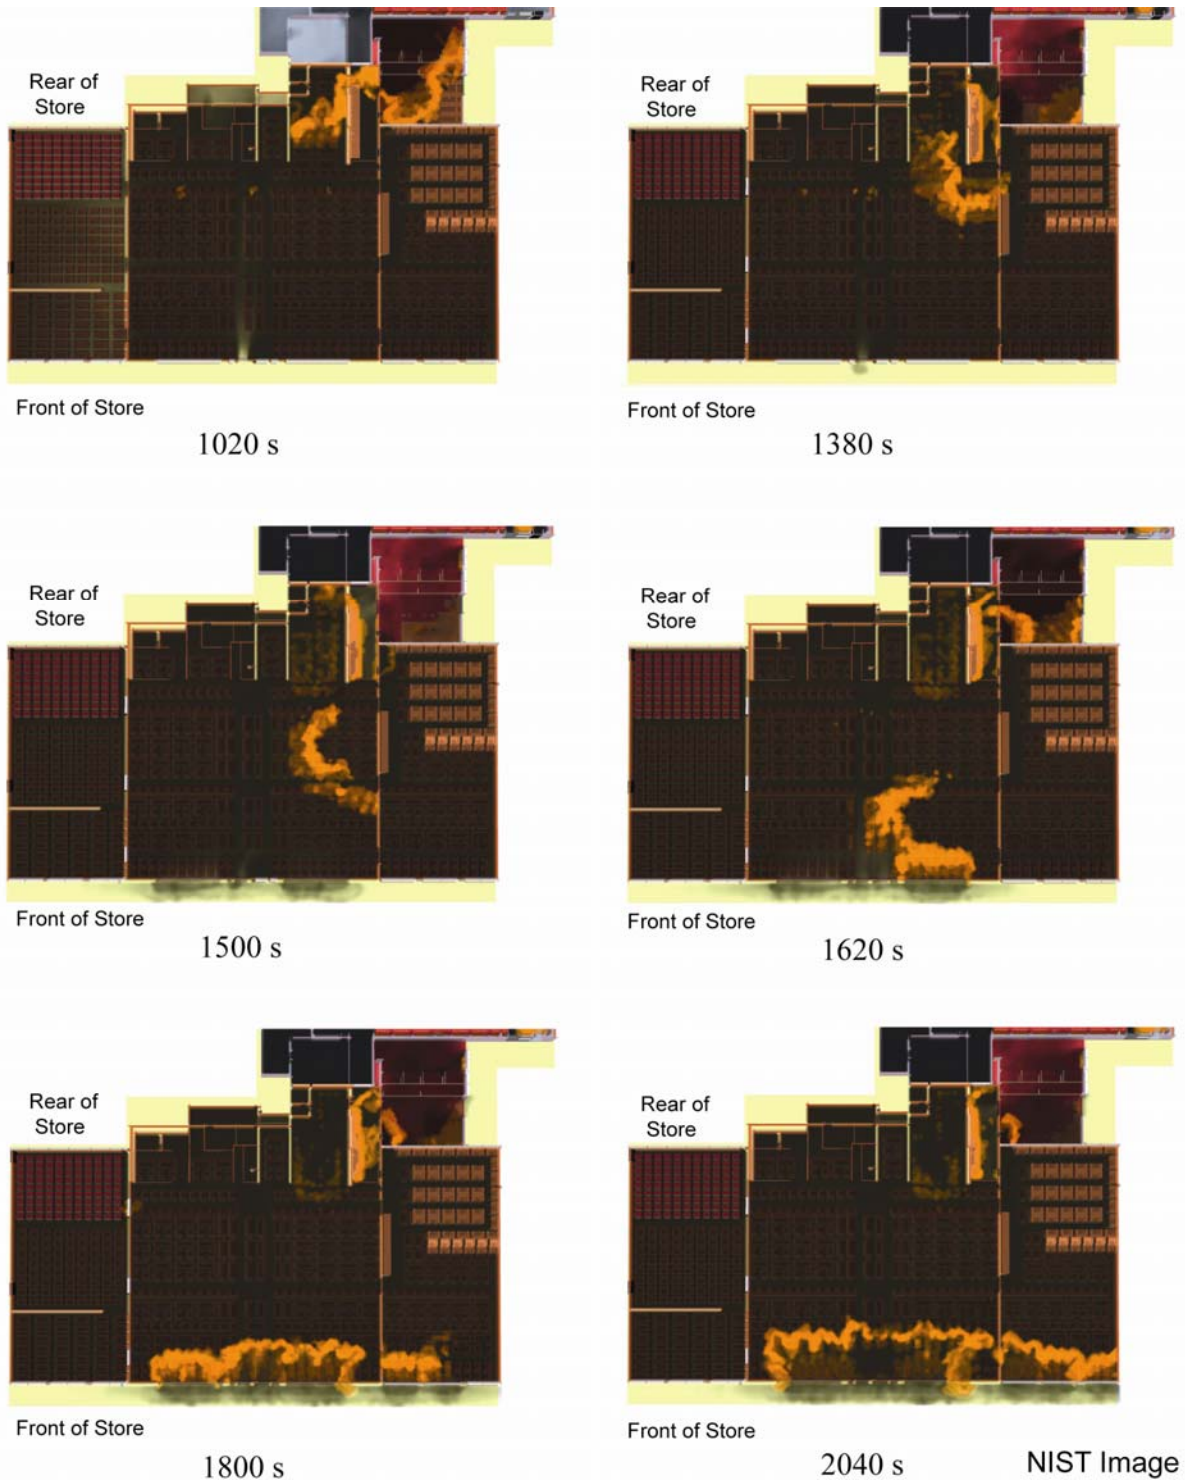
At 1020 s (7:27:53 p.m.), the fire in the main showroom reached about 70 MW and had begun moving forward toward the front of the showroom. Figure 4-19 shows the progression of fire and smoke throughout the loading dock, holding area and showrooms between 1020 and 2040 s. The front windows were vented during the period between 1457 through 1530 s (7:35:10 through 7:36:23). Fire reached the front of the main showroom at approximately 1540 s (7:36:33 p.m.) and spread across the west side of the main showroom by 1590 s (7:37:23 p.m.). By 1680 s (7:38:53 p.m.), the fire had moved into the front of the west showroom. This is consistent with the image in Figure 4-23, where the fire is visible in the west showroom through the window opening.

**Figure 4-19. View of fire (orange color indicates stoichiometric boundary) and smoke progression from above the showrooms from 1020 s to 2040 s (7:27:53 p.m. to 7:44:53 p.m.). The images are clipped to view conditions below the ceiling.**

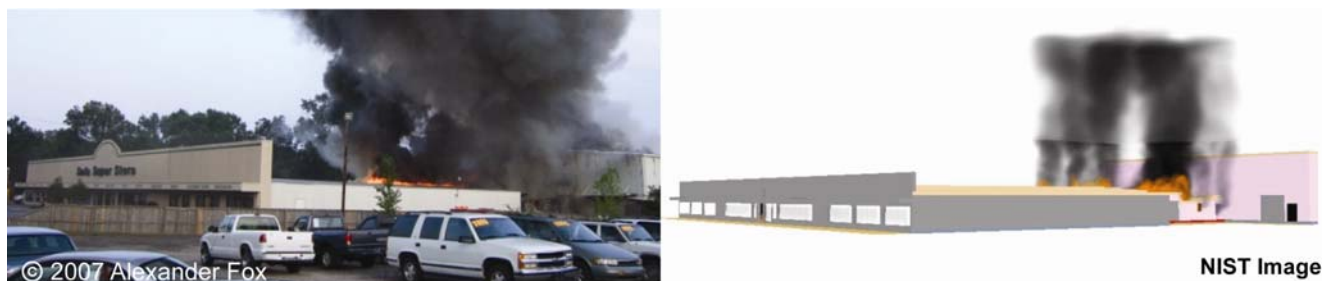
Figures 4-20 through 4-24 show comparisons of the fire and smoke progression with available photos at various times during the critical time between 7:23 p.m. and 7:45 p.m. (740 s through 2040 s). Figure 4-20 shows one of the earliest photos that were obtained of the fire, taken at 7:23:16 p.m. (743 s). At this time the fire was still mainly concentrated in the loading dock and holding area. Although the showrooms were charged with smoke, there was no smoke pushing out the open door at the front of the store. The fire had impinged on the underside of the roof over the holding area and flames were visible from the exterior at the roof level. At 1530s (7:36:23 p.m.), shown in Figure 4-21, the main sections of the front windows had been broken out and smoke was pushing out the front of the main showroom. At this

**Figure 4-20. Comparison between photo and rendered image from the simulation at 743 s (7:23:16p.m.). The view is of the north west corner of the structure.**

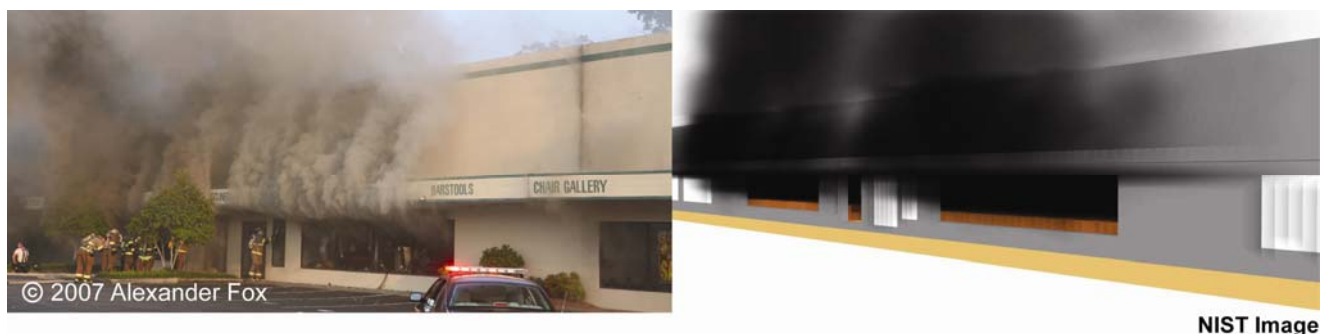
**Figure 4-21. Comparison between photo and rendered image from the simulation at 1530 s (7:36:23 p.m.). The view is of the front of the main showroom.**

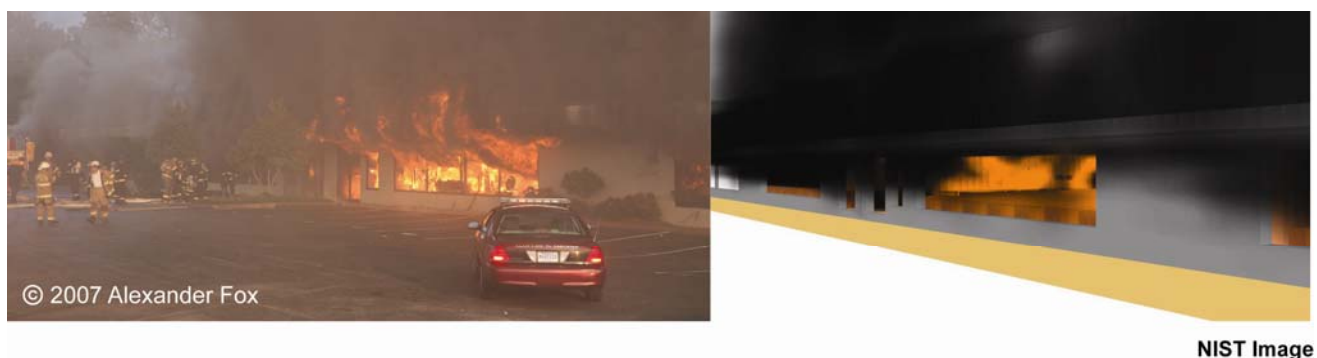
time, flames were not yet visible from the exterior through the front windows. By 1655 s (7:38:28 p.m.), shown in Figure 4-22, fire had reached the front of the main showroom and had stretched across the west side of the main showroom. At 1686 s (7:38:59 p.m.) flames were visible inside the west showroom, Figure 4-23, and the first window in this side had failed. By 1884 s (7:42:17), shown in Figure 4-24, fire had stretched across the front of the west showroom and two of the three windows were broken out.

**Figure 4-22. Comparison between photo and rendered image from the simulation at 1655 s (7:38:28 p.m.). The view is of the front of the main showroom.**

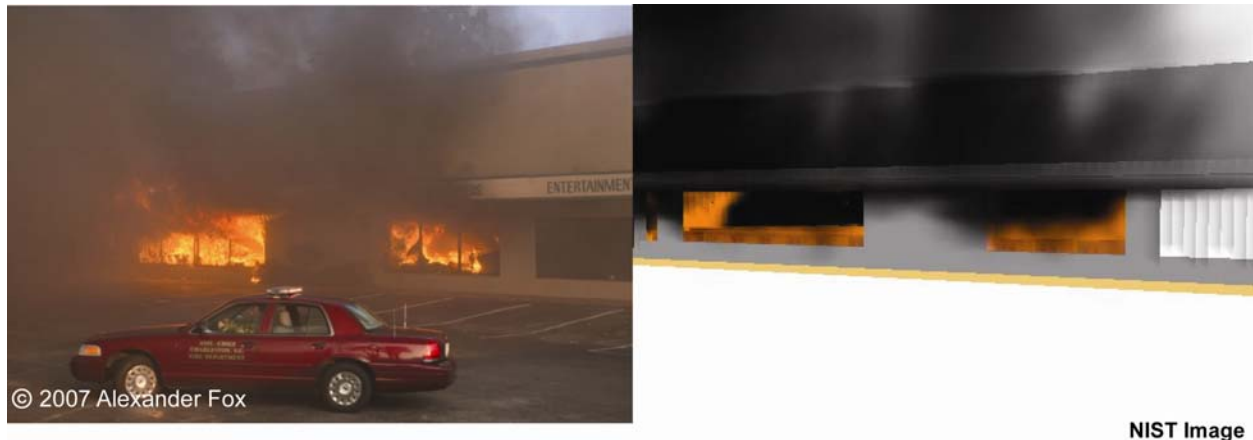
**Figure 4-23. Comparison between photo and rendered image from the simulation at 1686 s (7:38:59 p.m.). The view is of the front of the main and west showrooms.**

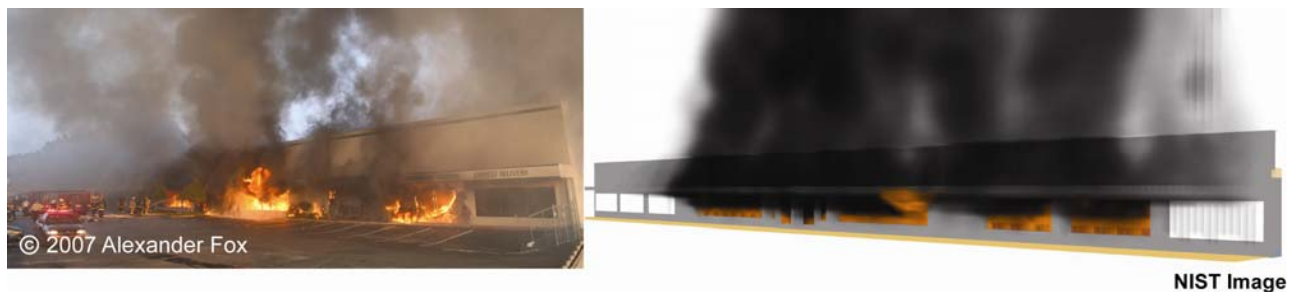
**Figure 4-24. Comparison between photo and rendered image from the simulation at 1884 s (7:42:17 p.m.). The view is of the front of the main and west showrooms.**

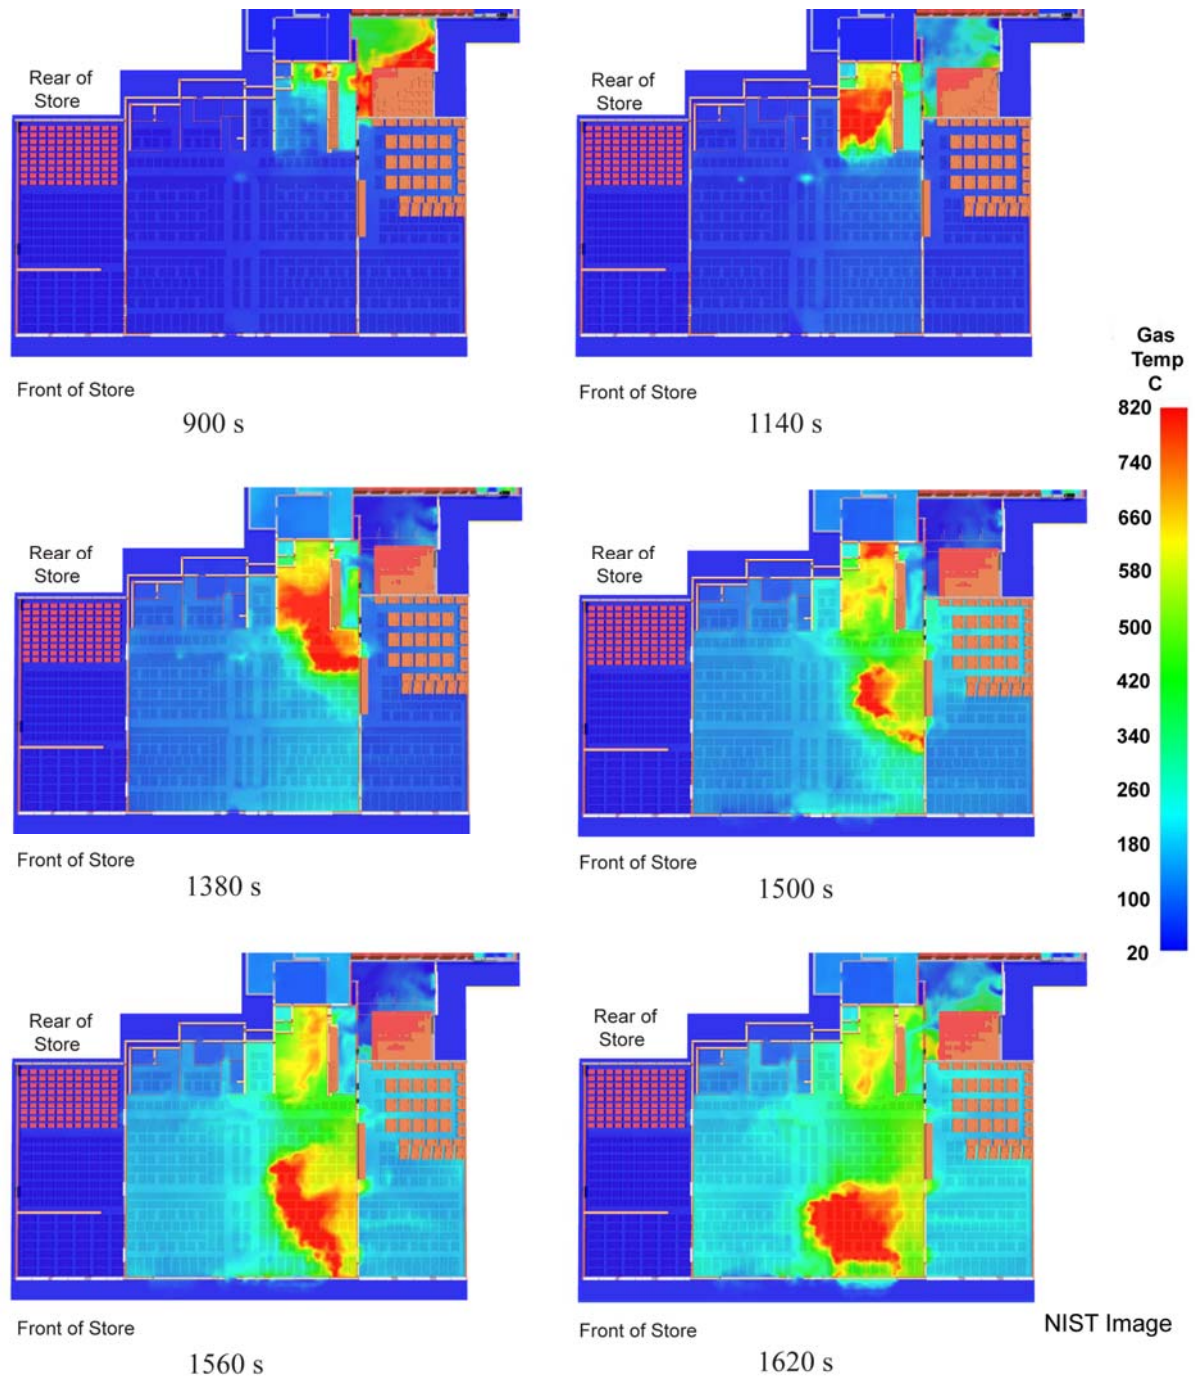
Figure 4-26 shows a series of images with a temperature slice 1.5 m (5 ft) from the floor rendered at a range of times between 900 s through 1620 s (7:25:53 p.m. through 7:37:53 p.m.). These images show the progression of the elevated temperatures from the loading dock, into the holding area, and eventually into the main showroom. Temperatures above 100 °C (approximately indicated by the border between dark blue and light blue) are first observed in the holding area approximately three minutes into the simulation. Note that the double doors separating the west showroom from the loading dock were opened at 144 s, but the temperature in the west showroom remained low even as fire was spreading into the holding area.

Figure 4-26. Temperature slices located 1.5 m (5 ft) above the floor.

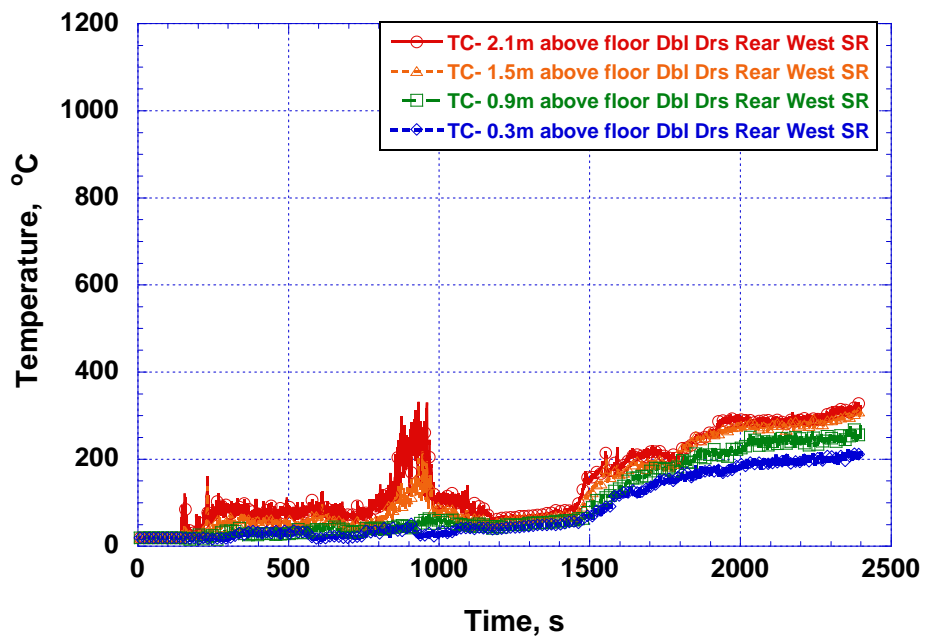
Figure 4-27 shows a chart of temperatures recorded in the west showroom, near the double doors. The data are from sensors located 0.3 m (1 ft), 0.91 m (3 ft), 1.52 m (5 ft), and 2.13 m (7 ft) from the floor. Figure 4-27 shows that temperatures remained below 100 °C through approximately 750 s (7:23:23 p.m.). The fire was positioned near the double doors to the loading dock; however, during the early stages much of the heat was venting through the loading dock roof and later through the main showroom roof. Air was being pulled through the doorway to feed oxygen to the fire in the loading dock and holding area. There was a surge in temperature in the upper layer lasting several minutes caused by fire progression into the showroom. At 900 s (7:25:53 p.m.), a section of the roof above the holding area was removed and this resulted in the subsequent temperature drop. Temperatures dropped below 100 °C, but as the fire increased in the main showroom the temperatures in both showrooms began to rise quickly. A second temperature surge, which began at approximately 1460 s (7:35:13 p.m.), was due to the fire entering the west showroom through the open roll-down door as it moved to the front of the main showroom. It should be noted that the focus of suppression efforts was in this area of the showroom, and that the simulation does not take this into account.

Figure 4-27. Temperatures at different elevations, 0.3 m (1 ft), 0.9 m (3 ft), 1.5 m (5 ft), and 2.1 m (7 ft) in rear of west showroom near double doors.

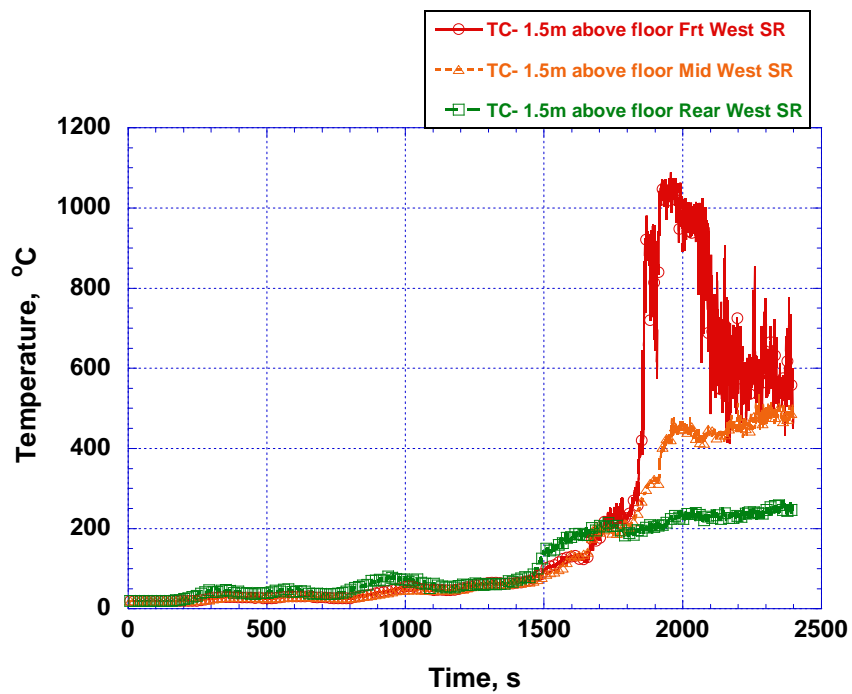
Figures 4-28 through 4-30 show charts of temperatures recorded at the locations throughout the main and west showroom as indicated in Figure 4-25. All data in these charts were recorded 1.5 m (5 ft) above the floor. Figure 4-28 shows temperatures in the west showroom. Temperatures in the west showroom remained relatively low, below 100 °C, until the fire began moving toward the front of the main showroom. The temperature at the rear sensor surpassed 120 °C at 1350 s (7:33:23 p.m.). As the fire in the main showroom continued to move forward, the temperature at the mid and front sensors reached 120 °C at 1400 s (7:34:13 p.m.)

Figure 4-28. West showroom temperatures for 1.5 m (5 ft) above floor.

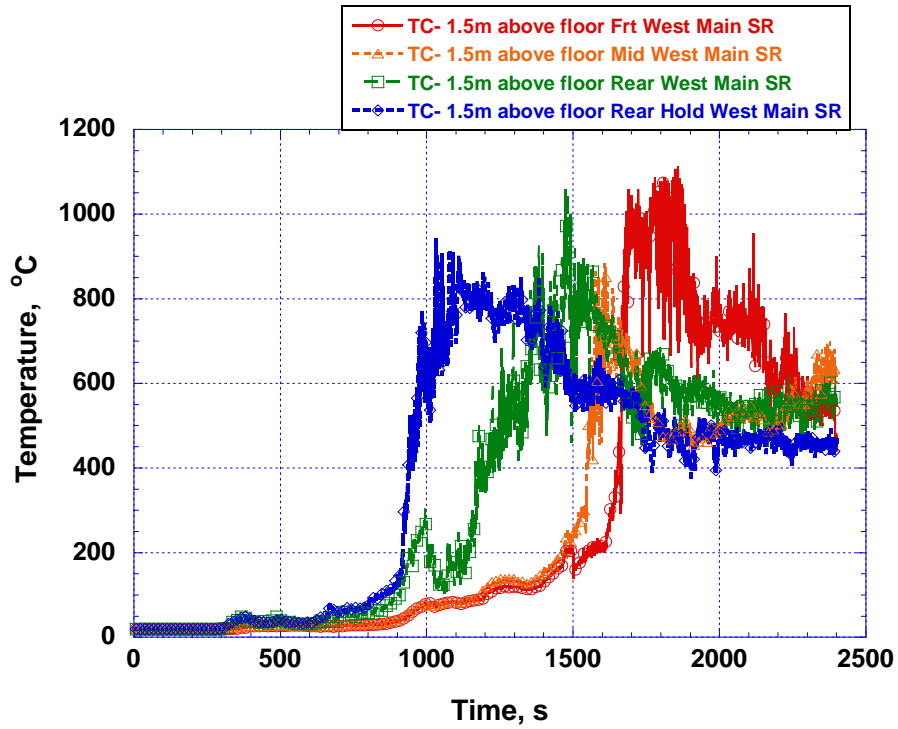
Figure 4-29 shows a temperature chart that displays data from sensors located on the west side of the main showroom. This chart contains a fourth data location, labeled Rear Hold, which was identified in Figure 4-25. Temperatures in the west side of the main showroom became elevated at an earlier point than in the other areas of the showroom because the fire moved across these sensors as it moved to the front of the showroom. The rear holding area location reached 120 °C at 864 s (7:25:17 p.m.); the rear location was roughly 30 s behind, reaching 120 °C at 900 s (7:25:53 p.m.). The mid and front locations reached 120 °C simultaneously at 1250 s (7:31:43 p.m.). Temperatures in the center and east areas of the main showroom showed similar trends.

Figure 4-29. Main showroom (west) temperatures for 1.5 m (5 ft) above floor.

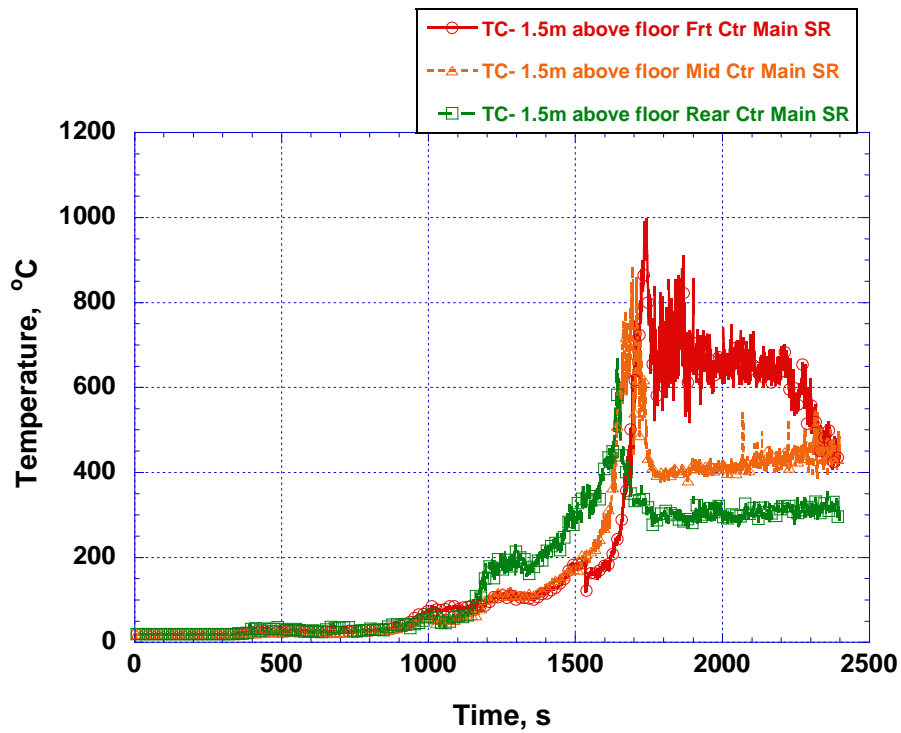
Figure 4-30. Main showroom (center) temperatures for 1.5 m (5 ft) from floor.
