**NIST-SP 1118 Volume I**

# **Technical Study of the Sofa Super Store Fire - South Carolina, June 18, 2007**

March 2011

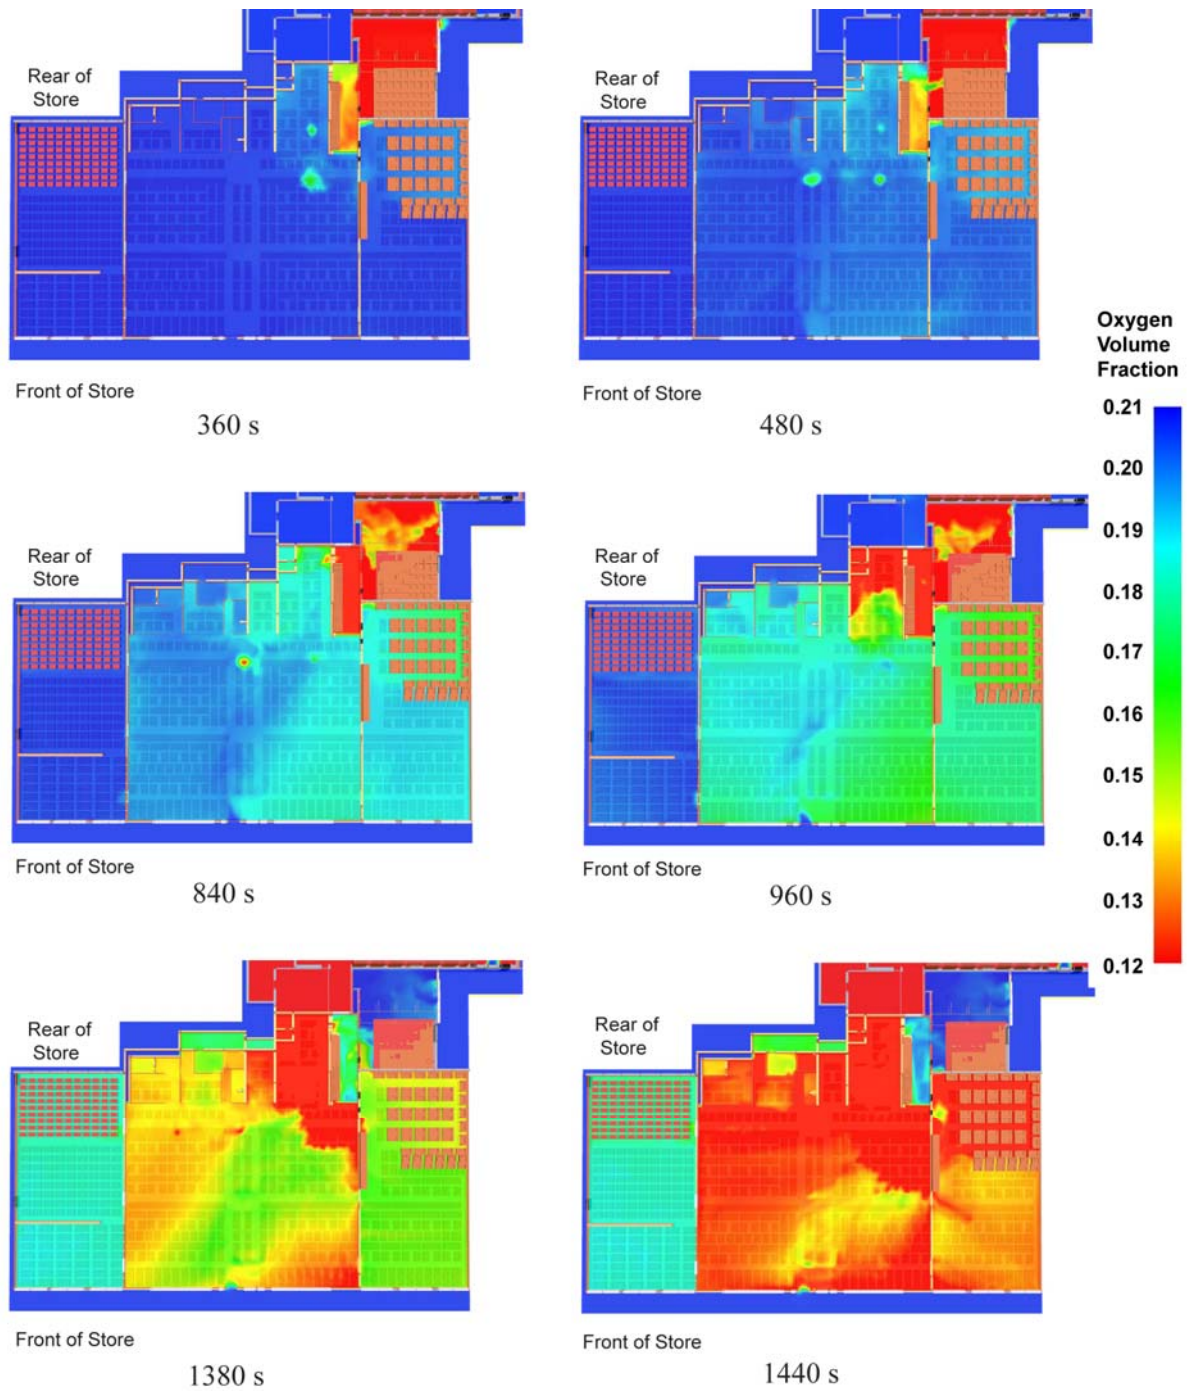
Figure 4-31 shows a series of images with an oxygen slice 1.5 m (5 ft) from the floor rendered at a range of times between 360 s and 1440 s (7:16:53 p.m. through 7:34:53 p.m.).

Figure 4-31. Oxygen volume fractions (slice images) for 1.5 m (5 ft) above the floor.

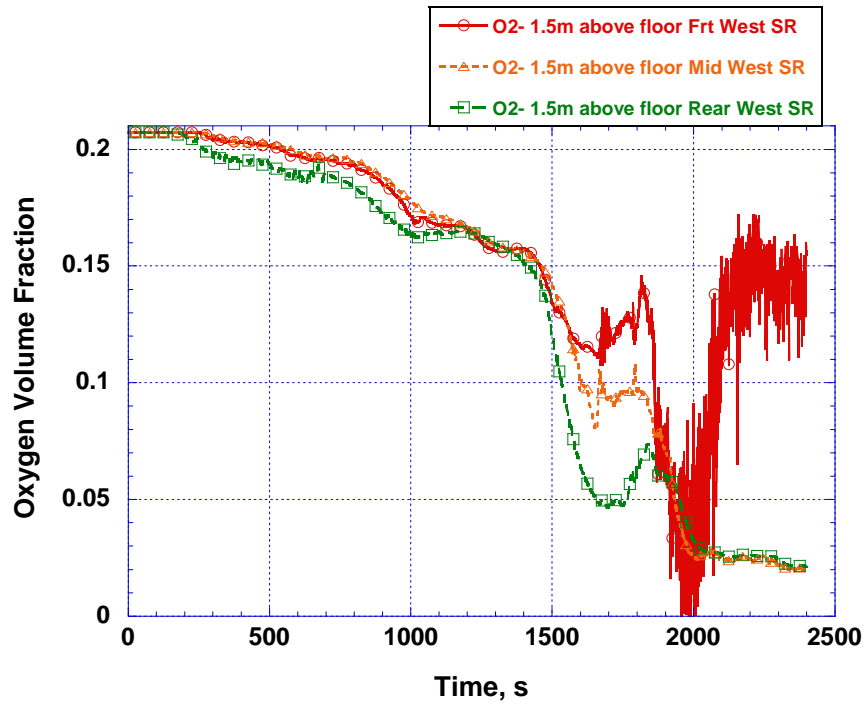
Figures 4-32 through 4-34 show charts of oxygen volume fraction recorded at several locations throughout the main and west showroom. All data in these charts were recorded 1.5 m (5 ft) above the floor. The locations correspond to those used for the temperature results shown in Figures 4-28 through 4-30. The oxygen volume fraction at the sensor in the rear of west showroom fell below 0.12 at 1500 s (7:35:53 p.m.). As the fire in the main showroom continued to move forward, the oxygen at both the mid and front sensors reached 0.12 volume fraction at 1600 s (7:37:33 p.m.).

Figure 4-32. West showroom oxygen volume fractions for 1.5 m (5 ft) above the floor.

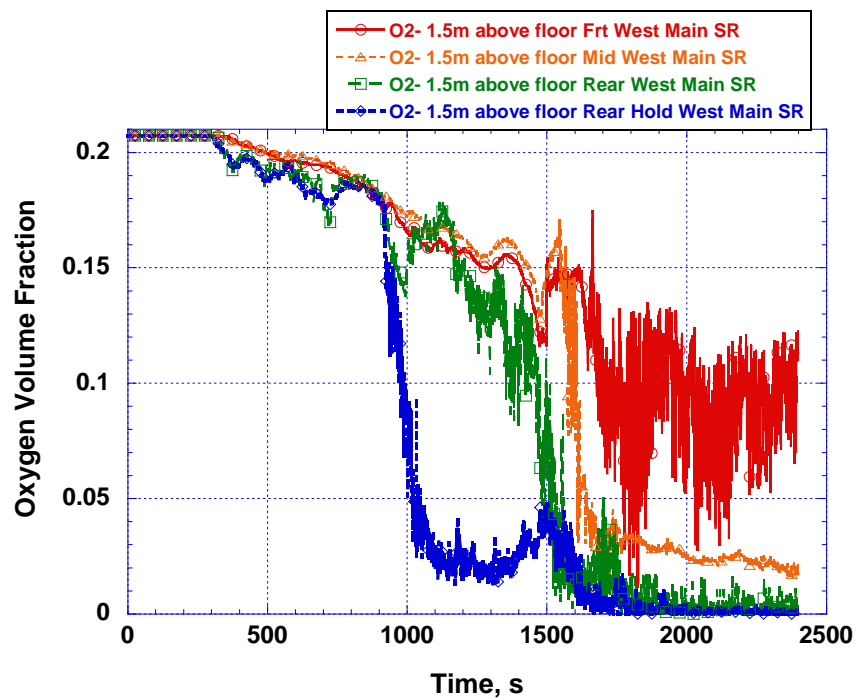
Figure 4-33 shows a chart that displays oxygen data from sensors located on the west side of the main showroom. Oxygen in the west side of the main showroom became depleted at an earlier point than in the other areas of the showroom because this was the path of the fire as it moved to the front of the showroom. The holding area location reached 0.12 volume fraction at 950 s (7:26:43 p.m.); the rear location was roughly six minutes behind, reaching 0.12 volume fraction at 1250 s (7:31:43 p.m.). The mid and front locations initially reached 0.12 volume fraction approximately the same time at 1400 s (7:34:13 p.m.). The mid and front locations then increased up to 0.15 volume fraction as the front windows were broken. Oxygen volume fractions in the center and east areas of the main showroom had similar trends.

Figure 4-33. Main showroom (west) oxygen volume fractions for 1.5 m (5 ft) above the floor.

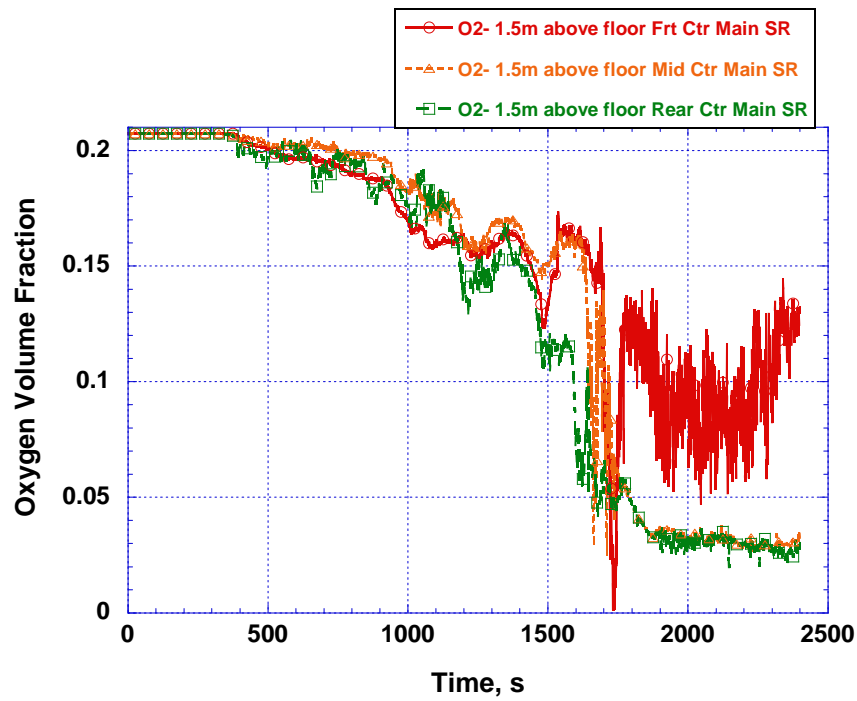
Figure 4-34. Main showroom (center) oxygen volume fractions for 1.5 m (5 ft) above the floor.

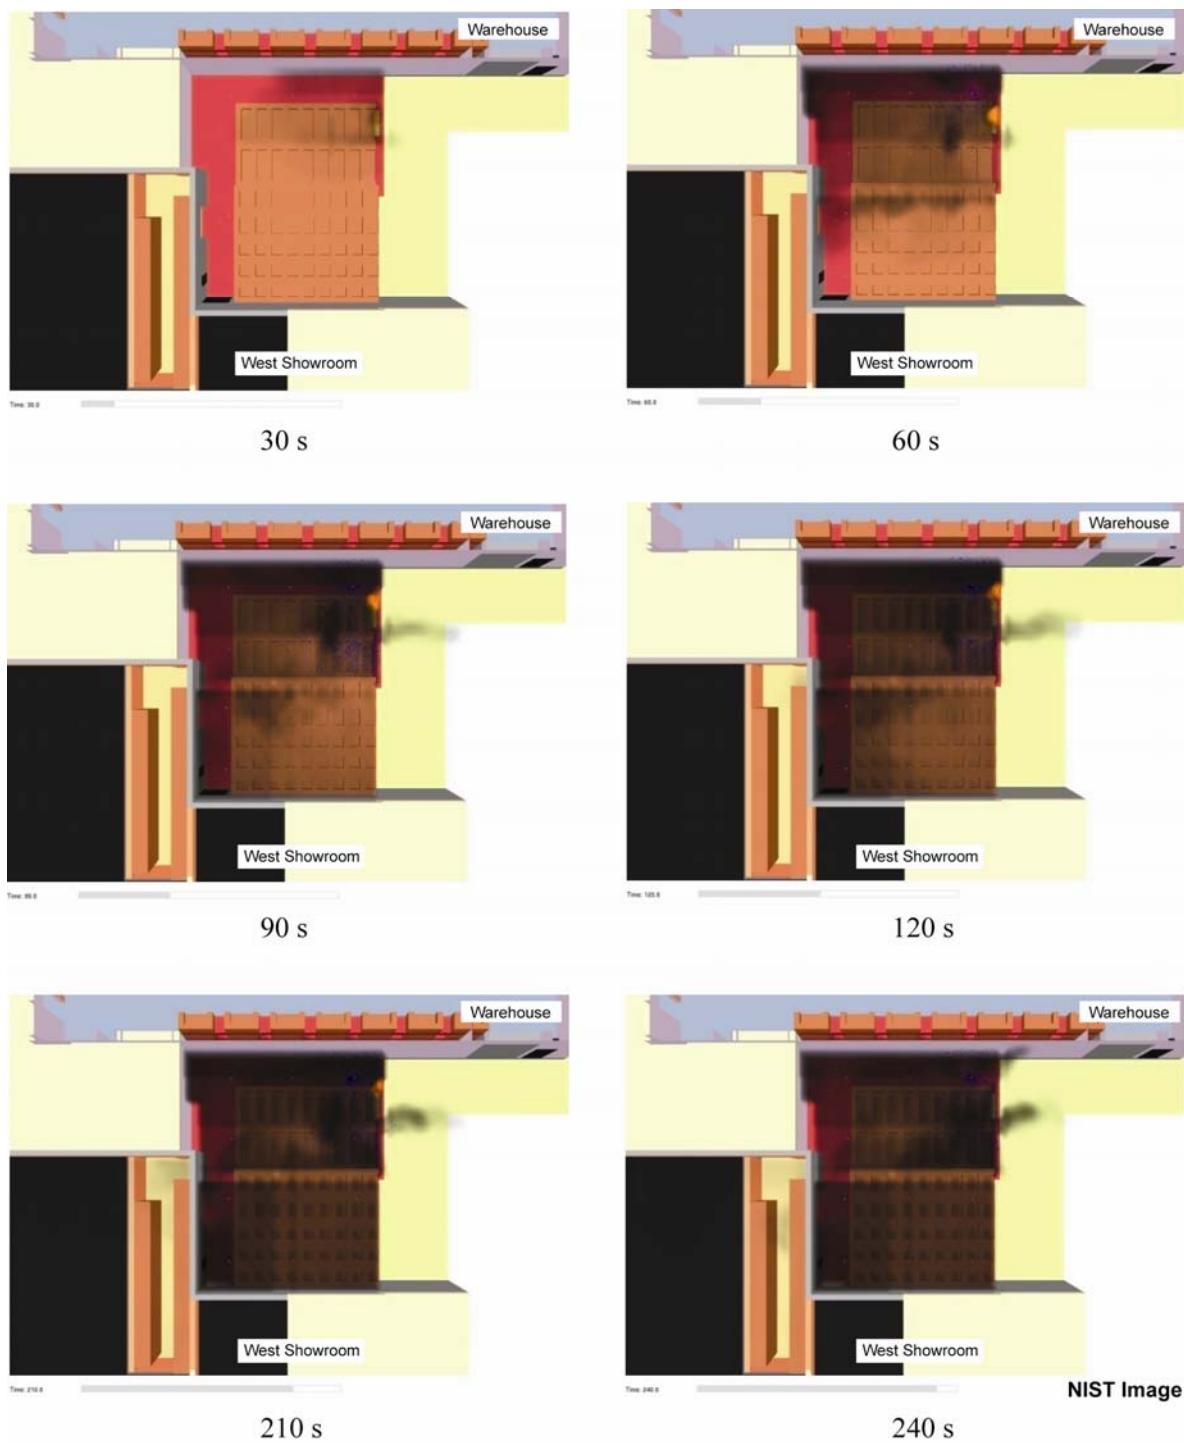
Figure 4-36 shows a series of images indicating the progression of fire and smoke in the loading dock during the sprinklered simulation. These images show an overhead view, centered on the loading dock (the area shaded in red). The north end of the warehouse is shown at the top of the images and the south end of the west showroom is at the bottom. The southwest corner of the main showroom (including the holding area) is shown in the lower left corner. In these images, the roof and walls of the loading dock were made invisible in order to facilitate viewing the loading dock interior. Additionally, the roofs over the main and west showrooms were clipped so that the interior of the holding area was visible. The areas colored black are the showroom ceilings. The west showroom ceiling is only partially revealed because this addition had a sloped roof and only the upper section was clipped away.

The quantity of fire generated smoke increases through the first five images in this sequence, from 30 through 210 s. Smoke spread across the underside of the loading dock roof and began to fill downward. At 210 s, the smoke layer was low enough to begin spilling into the holding area where there is access to the space above the showroom ceiling. By 240 s however, the fire is no longer burning and the smoke is beginning to dissipate.

**Figure 4-36. Fire and smoke progression in the early stages of the sprinklered scenario. Sprinkler 8 was the first to activate, at 50 s, while sprinkler 4 activated at 75 s.**

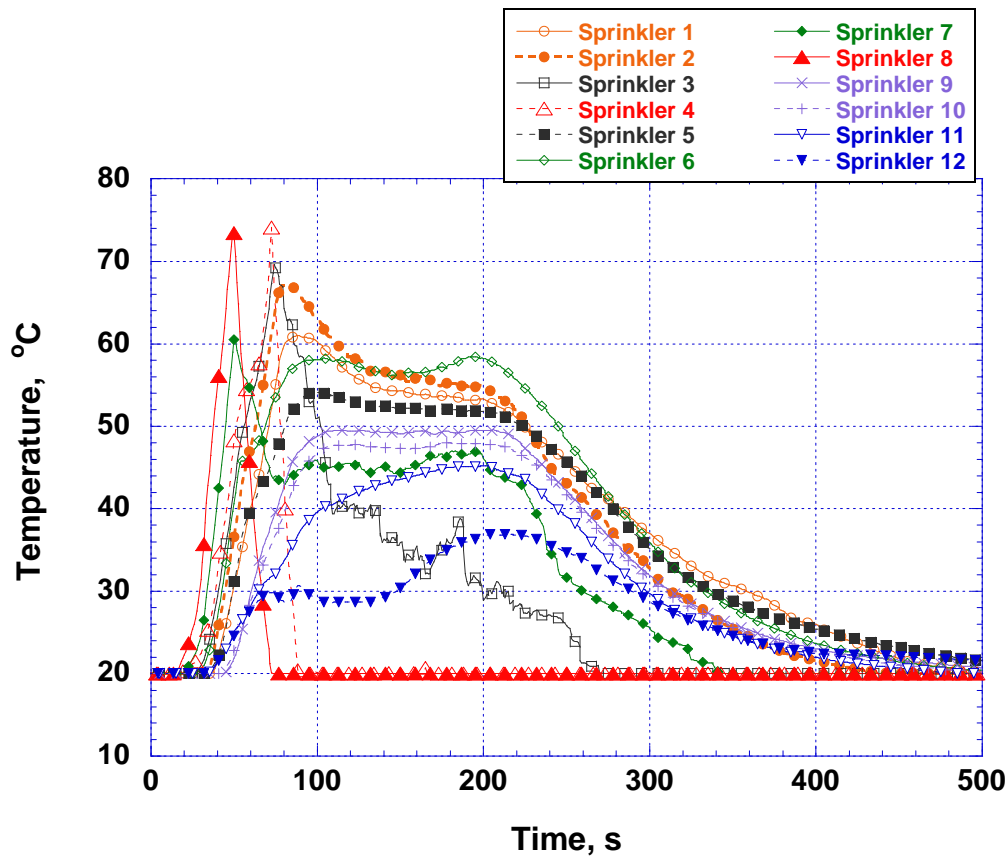
Figure 4-37 shows the sprinkler temperature at each of the sprinkler locations. The graph indicates that the temperature at locations 4 and 8 reached  $74^\circ\text{C}$ , at which point the sprinklers were activated in these locations. Temperatures at locations 1 and 2 peaked in the  $60^\circ\text{C}$  to  $70^\circ\text{C}$  range but never reached the threshold for activation.

**Figure 4-37. Sprinkler temperatures inside the enclosed loading dock.**

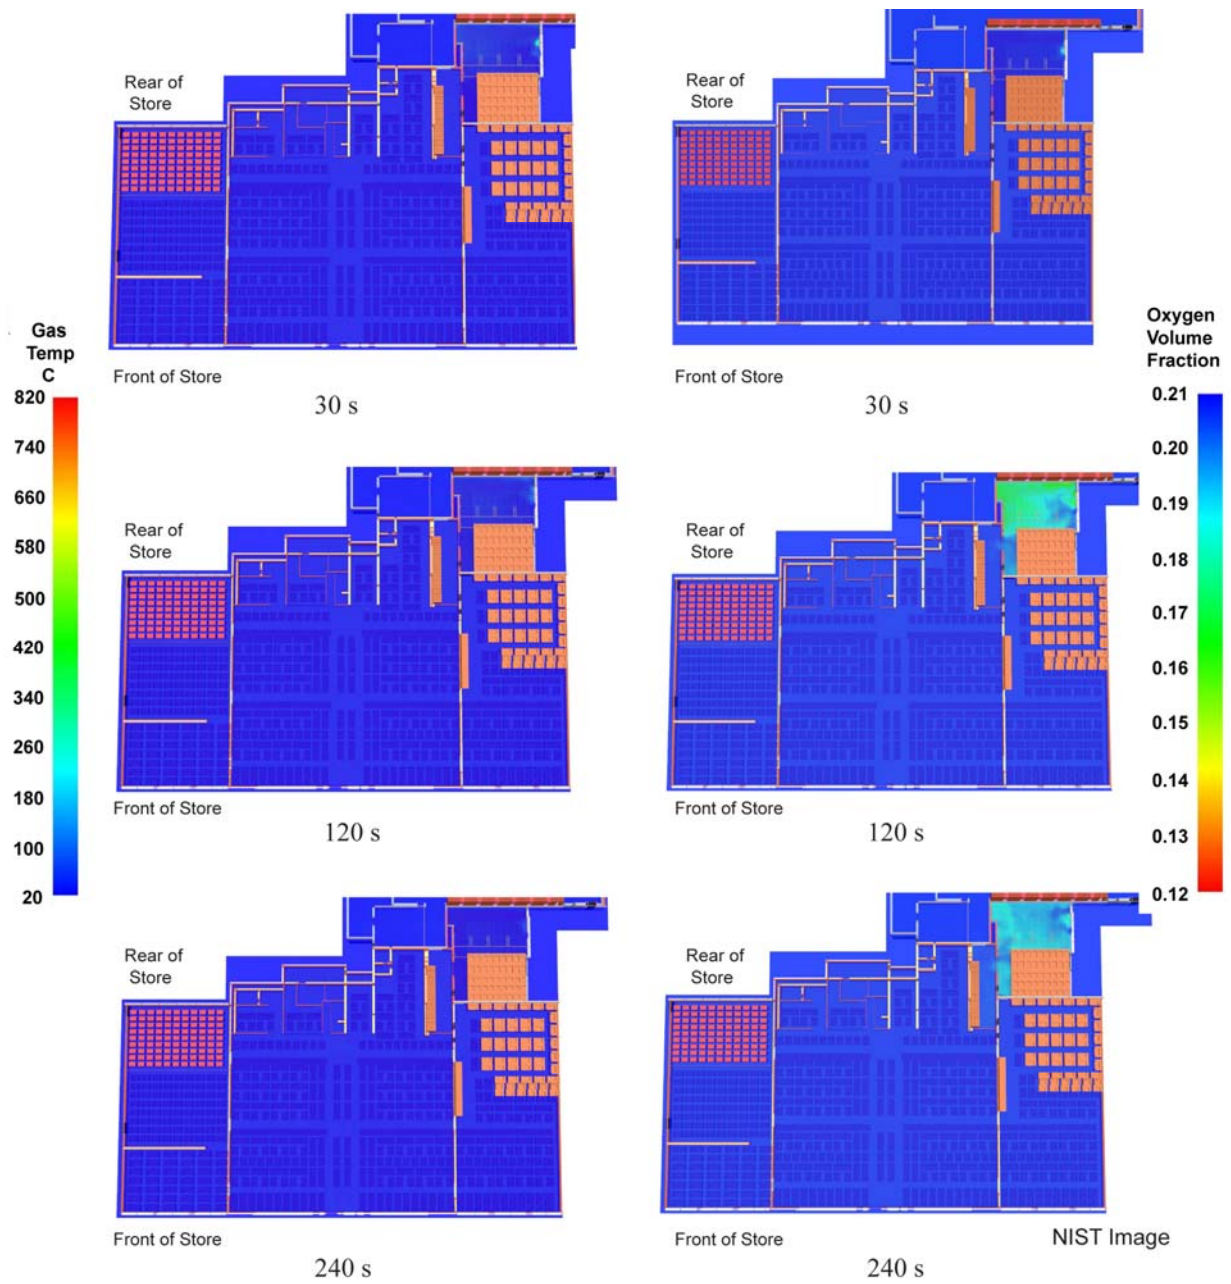
Figure 4-38 shows a series of images with a temperature slice 1.5 m (5 ft) from the floor rendered at a range of times between 30 s through 240 s. Note that the scale on these images is consistent with those in Figure 31. These images show that the area of elevated temperatures is limited to the immediate vicinity of the fire inside the loading dock.

**Figure 4-38. Temperatures 1.5 m (5 ft) above the floor in the sprinklered simulation.**

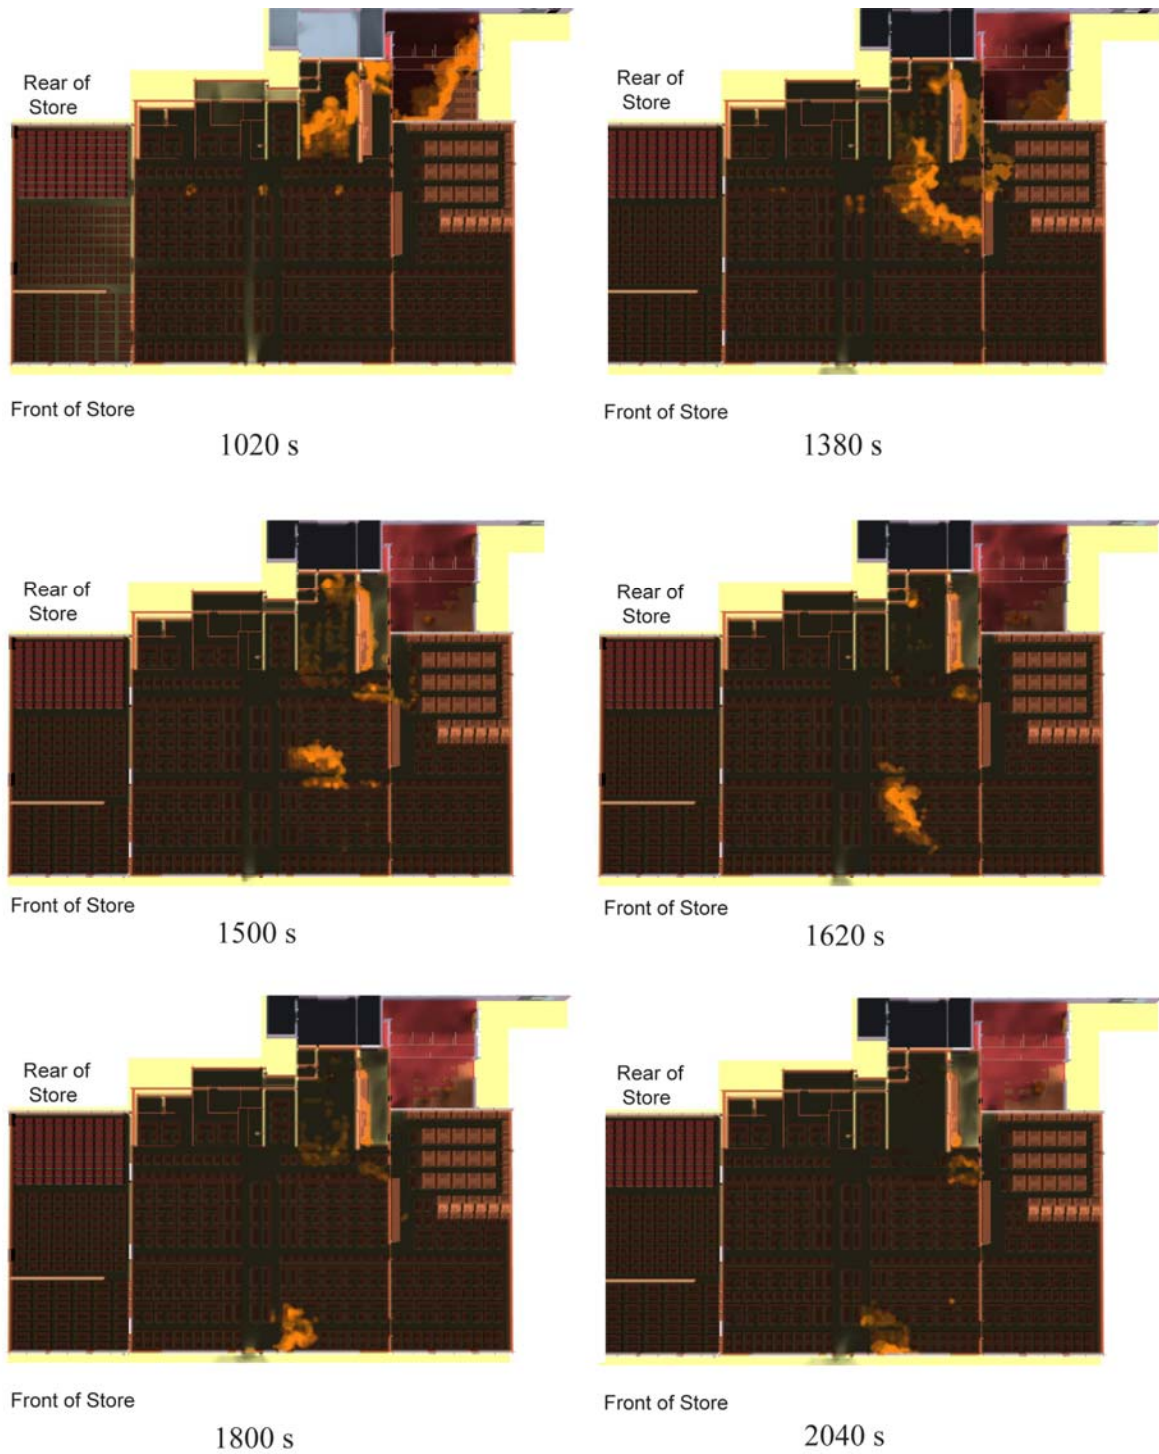
Figure 4-40 shows the progression of fire and smoke throughout the loading dock, holding area and showrooms between 1020 s and 2040 s (7:27:53 p.m. through 7:44:53 p.m.). The first three images in this figure are indistinguishable from the corresponding images in Figure 4-19 (the baseline simulation). The differences appear in the later images – 1500 s and beyond. Compared to Figure 4-19, Figure 4-40 shows far less burning in the northwest quadrant of the main showroom.

**Figure 4-40. Fire and smoke progression in simulation with front windows intact.**

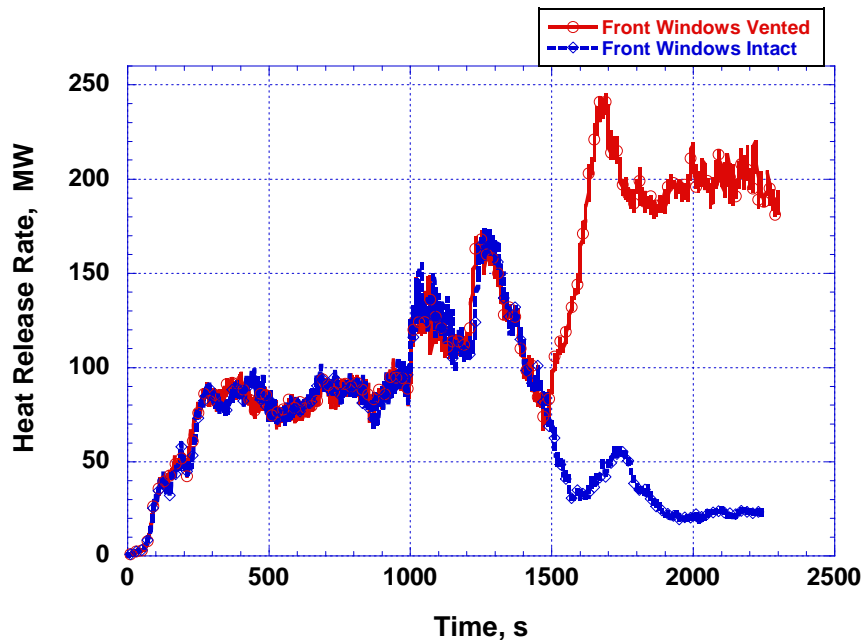
Figure 4-41 shows the change in HRR over time for this scenario and the baseline simulation. In both scenarios, HRR peaked at 120 MW at around 1300 s after which the HRR decreased. This would be consistent with the fire becoming underventilated. The venting of the front windows in the main showroom at 1457 s corresponds with the subsequent rapid increase in HRR for the base case. In the simulation with the windows intact, the HRR did not increase at approximately 1500 s, but continued to decrease until about 1600 s.

**Figure 4-41. Comparison of the heat release rate in the simulations for front windows vented and front windows intact.**

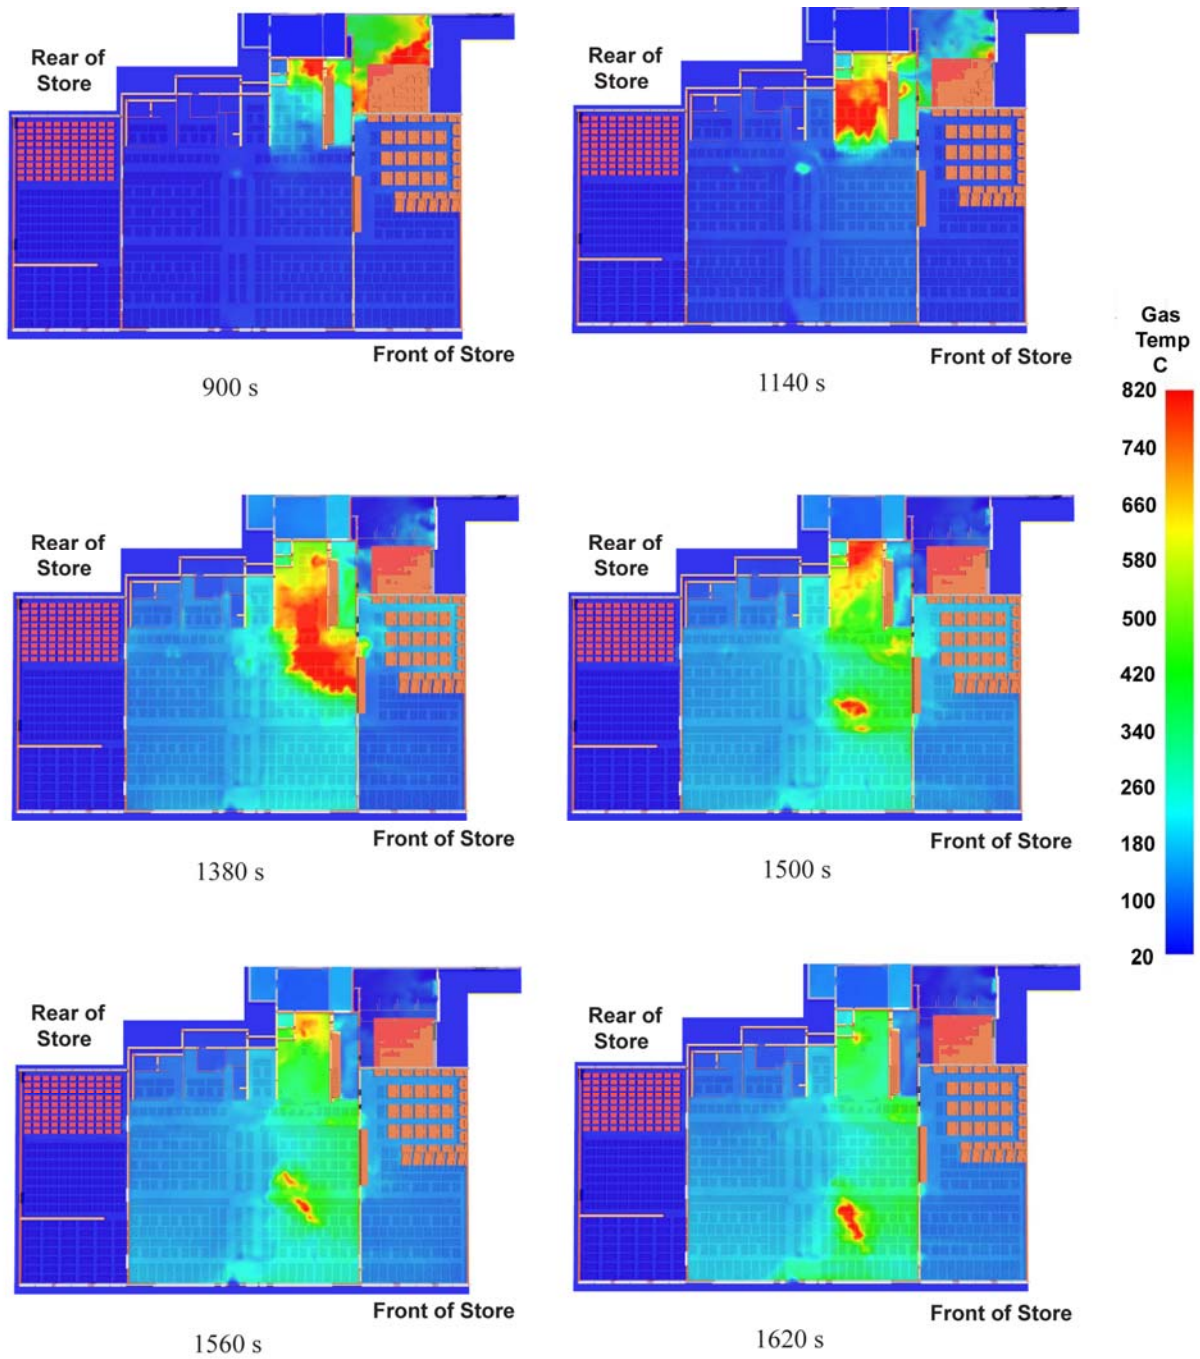
Figure 4-42 shows a series of images with a temperature slice 1.5 m (5 ft) from the floor rendered at a range of times between 900 s through 1620 s (7:25:53 p.m. through 7:37:53 p.m.). The trends in this figure are similar to those seen in Figure 4-28 for the baseline simulation. For the windows intact scenario the high temperature areas, shown in red, diminishes between 1380 s and 1500 s. After 1500 s the simulation displays less red areas in the windows intact case than for the same times in the baseline case (Figure 4-28).

Figure 4-42. Temperature slices located 1.5 m (5 ft) above the floor in simulation with front windows intact.

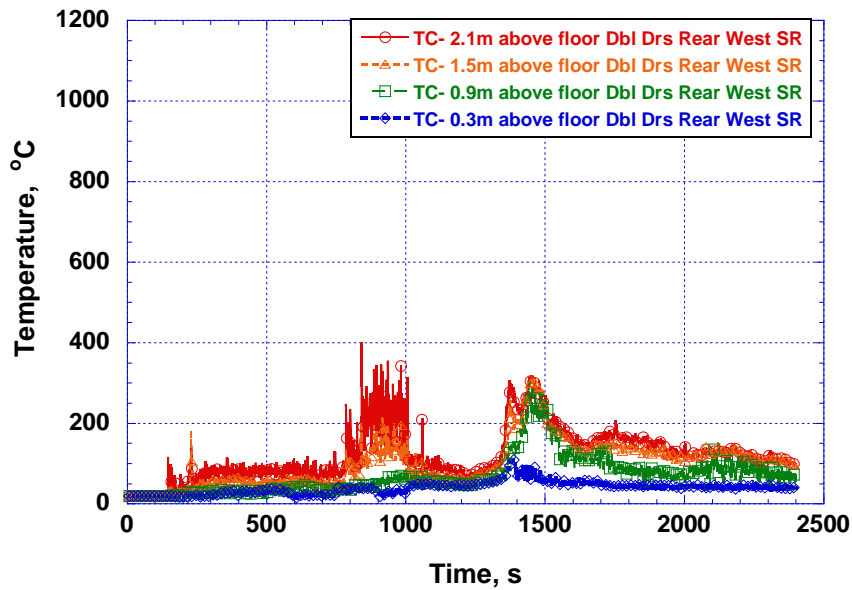
Figures 4-43 through Figure 4-46 show temperature data recorded at the same sensor locations used in Figure 4-25 for the baseline simulation. For comparison purposes, the scale in these figures was kept the same as the corresponding scale in Figure 4-27 through Figure 4-30. After 1500 s, the temperatures were lower in the scenario with the front windows intact as compared to the base case. The temperatures with the windows intact exceeded the 120 °C tenability threshold at each sensor location before the time at which the windows would have been broken out.

Figure 4-43. Temperatures at different elevations, 0.3 m (1 ft), 0.9 m (3 ft), 1.5 m (5 ft), and 2.1 m (7 ft) in rear of west showroom near double doors.

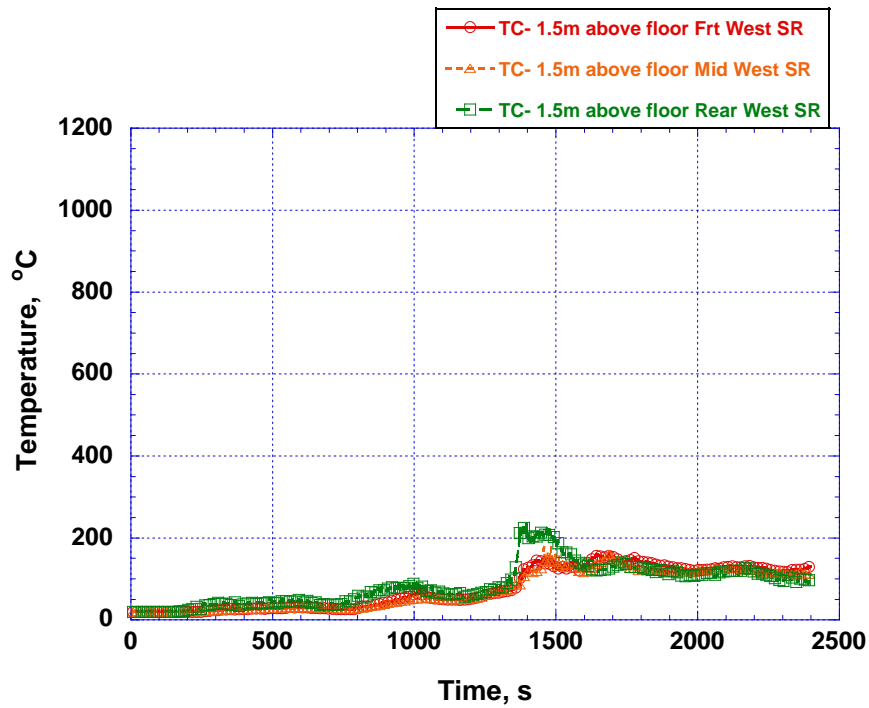
Figure 4-44. West showroom temperatures for 1.5 m (5ft) above the floor.

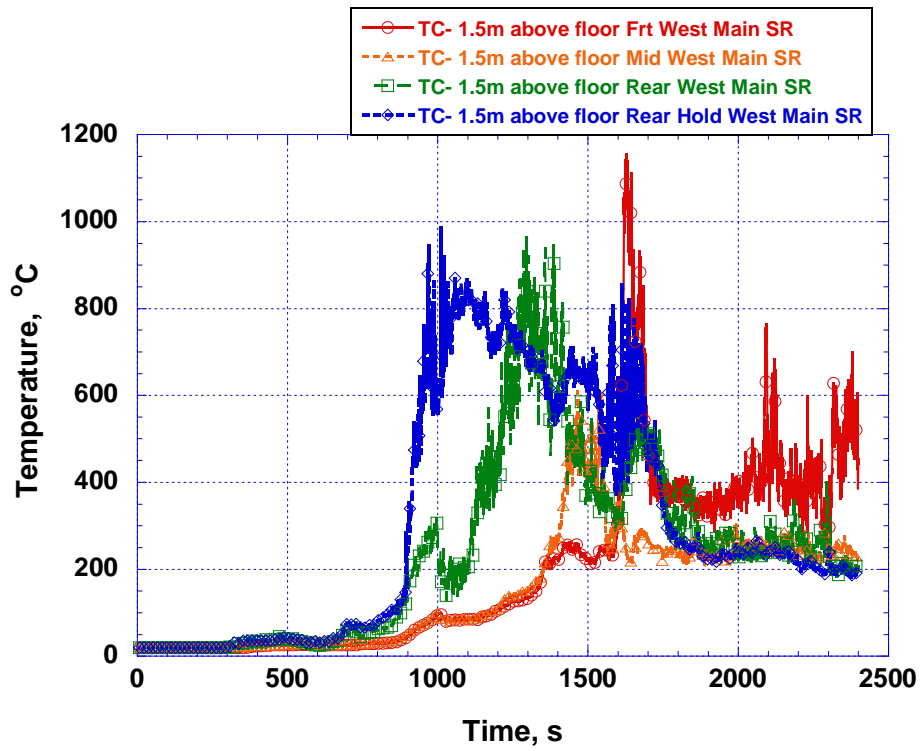
Figure 4-45. Main showroom (west) temperatures for 1.5 m (5 ft) above the floor.

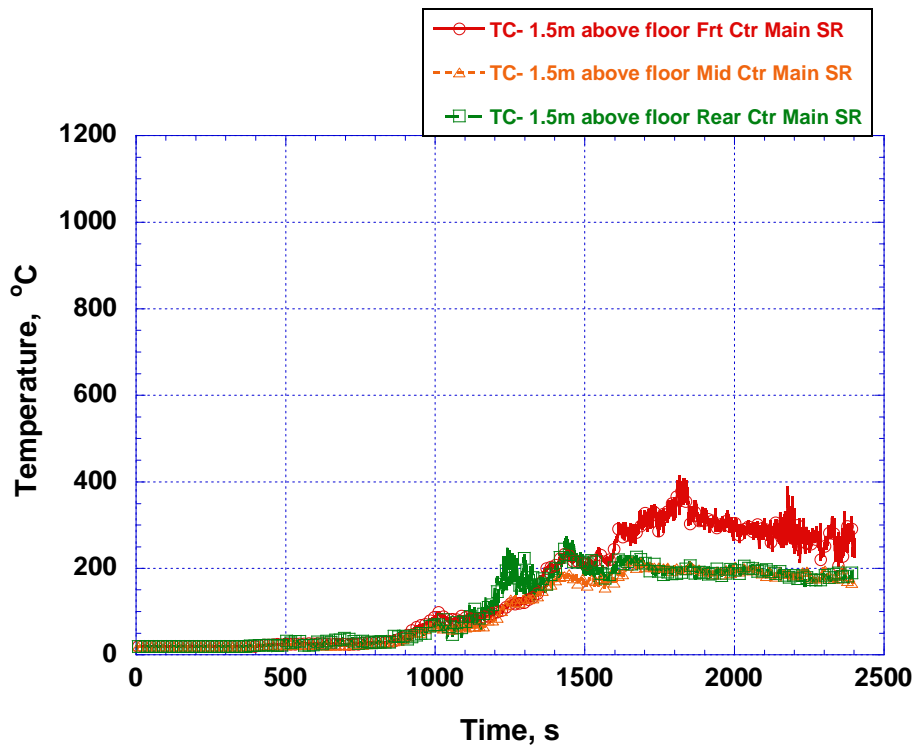
Figure 4-46. Main showroom (center) temperatures for 1.5 m (5 ft) above the floor.

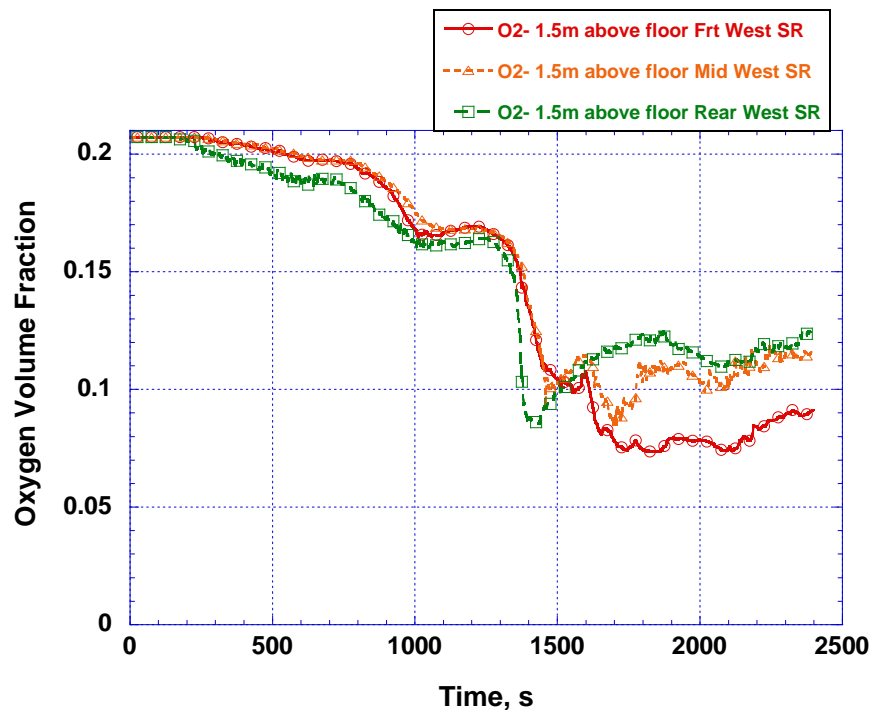
Figures 4-47 through 4-49 show oxygen volume fraction data for the front windows intact case that were recorded at the same sensor locations (Figure 4-25) as the baseline case. For the first 1000 s, the oxygen volume fraction in the west showroom (Figures 4-47 and 4-32) drops to about

Figure 4-47. West showroom oxygen volume fractions for 1.5 m (5 ft) above the floor.

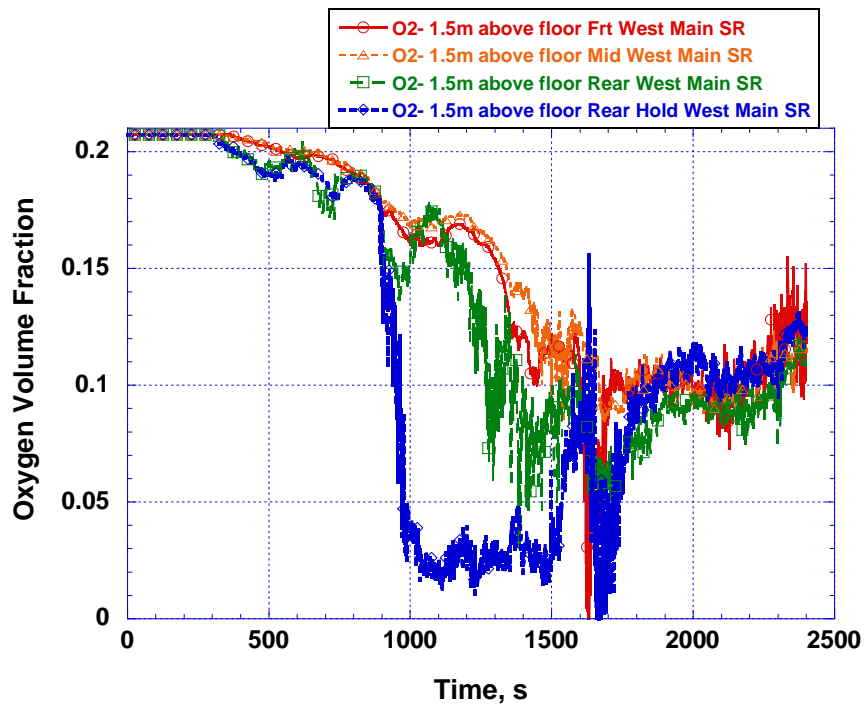
Figure 4-48. West main showroom oxygen volume fractions for 1.5 m (5 ft) above the floor.

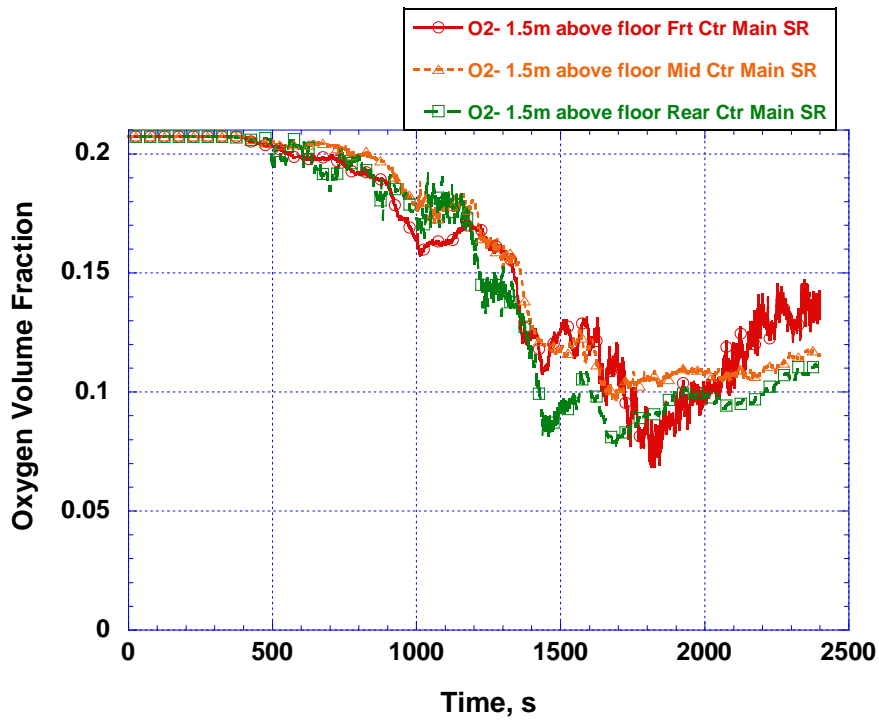
Figure 4-49. Main showroom (center) oxygen volume fractions for 1.5 m (5 ft) above the floor.

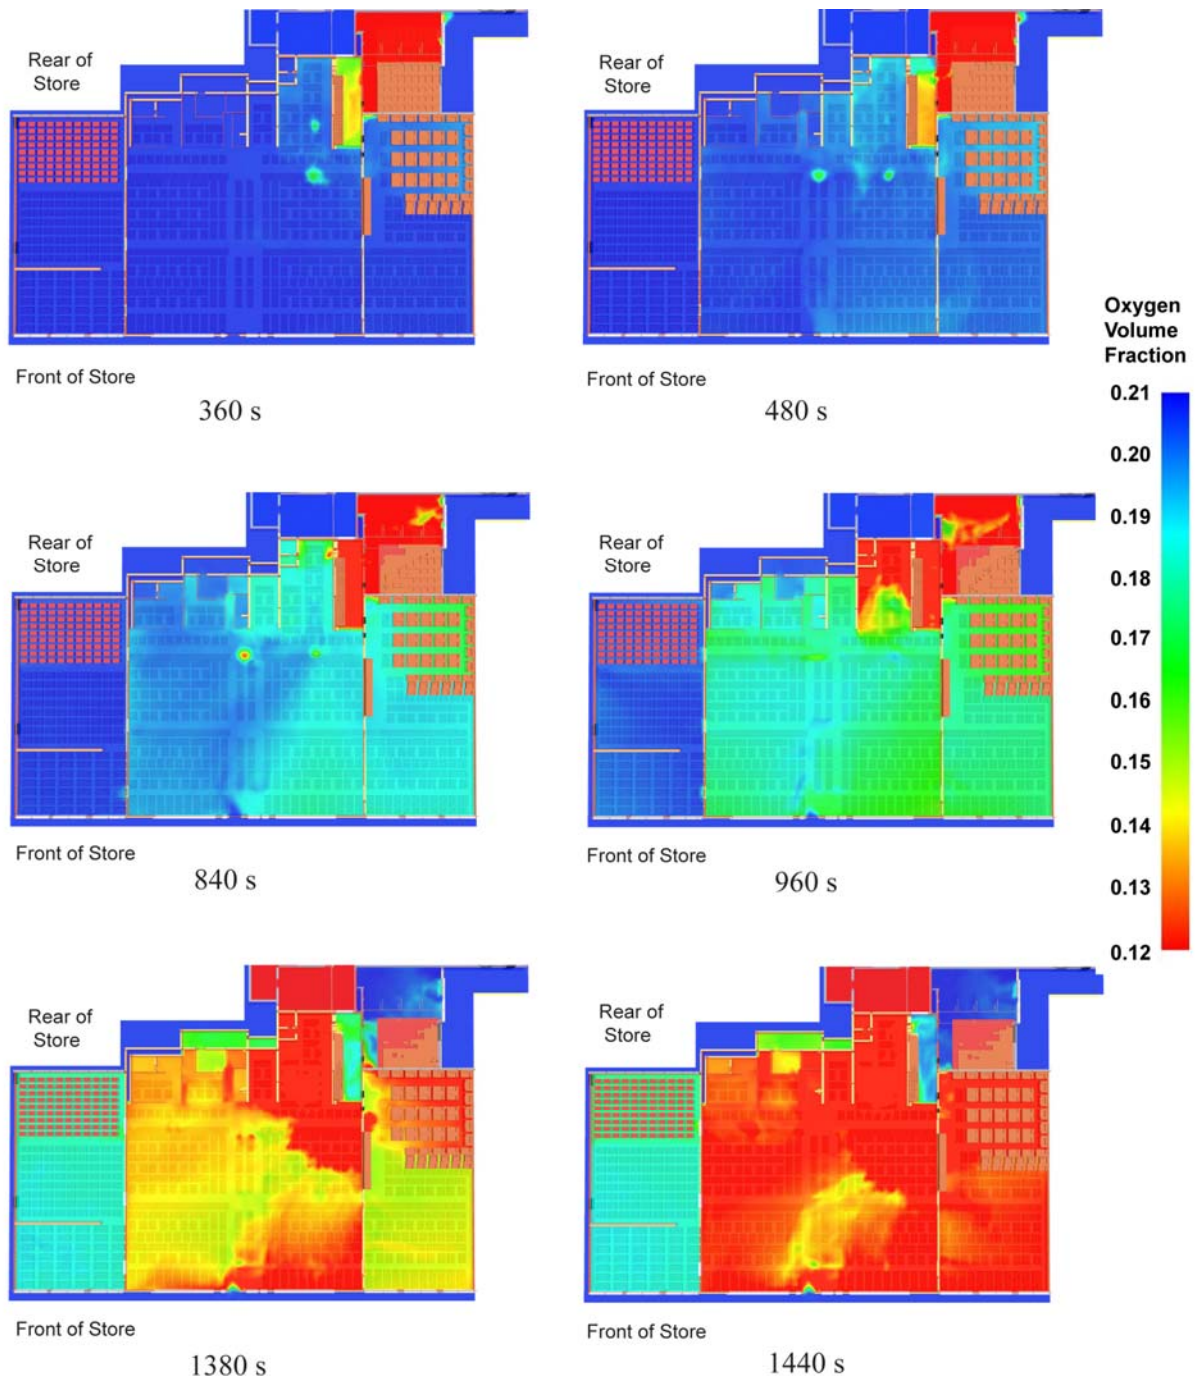
Figure 4-50 shows a series of images with an oxygen slice 1.5 m (5 ft) from the floor rendered at a range of times between 360 s and 1440 s. As was the case with temperature, the conditions in the main and west showrooms become untenable because of oxygen depletion prior to 1440 s (7:34:53 p.m.). While minimum oxygen volume fractions were not as low in the case with the windows intact, they nonetheless dropped below 0.12 (indicated by the red shaded areas in Figure 4-50) in the main and west showrooms.

**Figure 4-50. Oxygen volume fractions (slice images) 1.5 m (5 ft) above the floor in simulation with front windows intact.**
