NIST Special Publication 778

Performance of Structures During the Loma Prieta Earthquake of October 17, 1989

H. S. Lew, Editor

January 1990

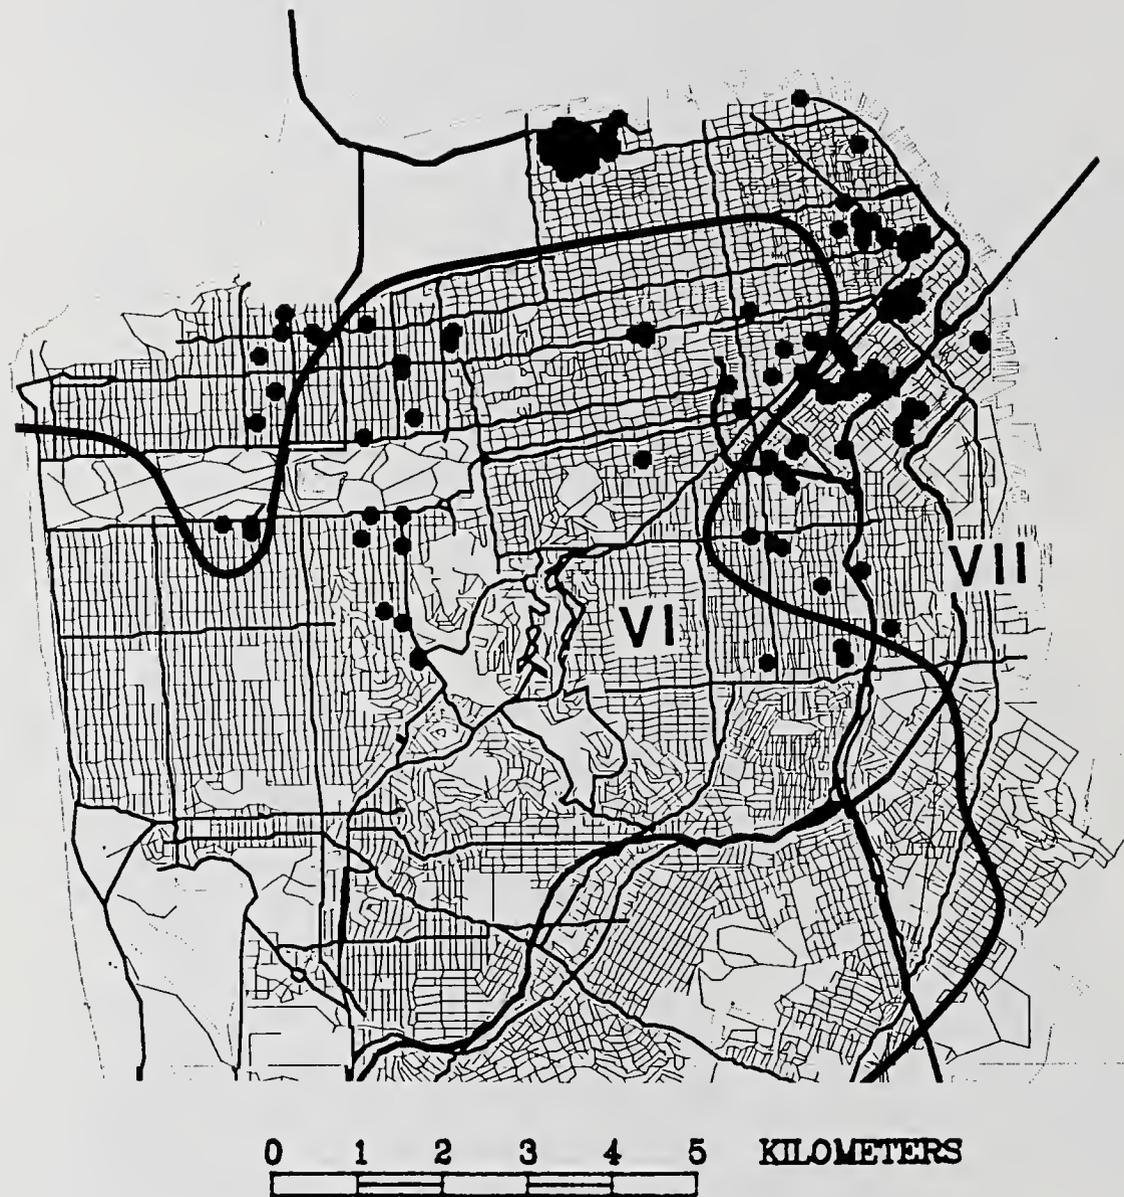
As an example of the wealth of data available, figure 2.4.2 shows some of the safety inspection results available for San Francisco (Lew, 1989). These represent 378 inspected buildings using post-earthquake safety evaluation procedures developed by the Applied Technology Council (ATC, 1989). These are only

Figure 2.4.2 Damage inspections for San Francisco. The figure shows 378 inspections judged as "red" using the ATC postearthquake safety evaluation procedures (ATC, 1989a,1989b). Damage judged sufficiently for a "Red" designation may be caused by either ground shaking, ground failure, or be in a dangerous area. The preliminary intensity contour based on ground shaking effects from figure 2.4.1 is shown for comparison.

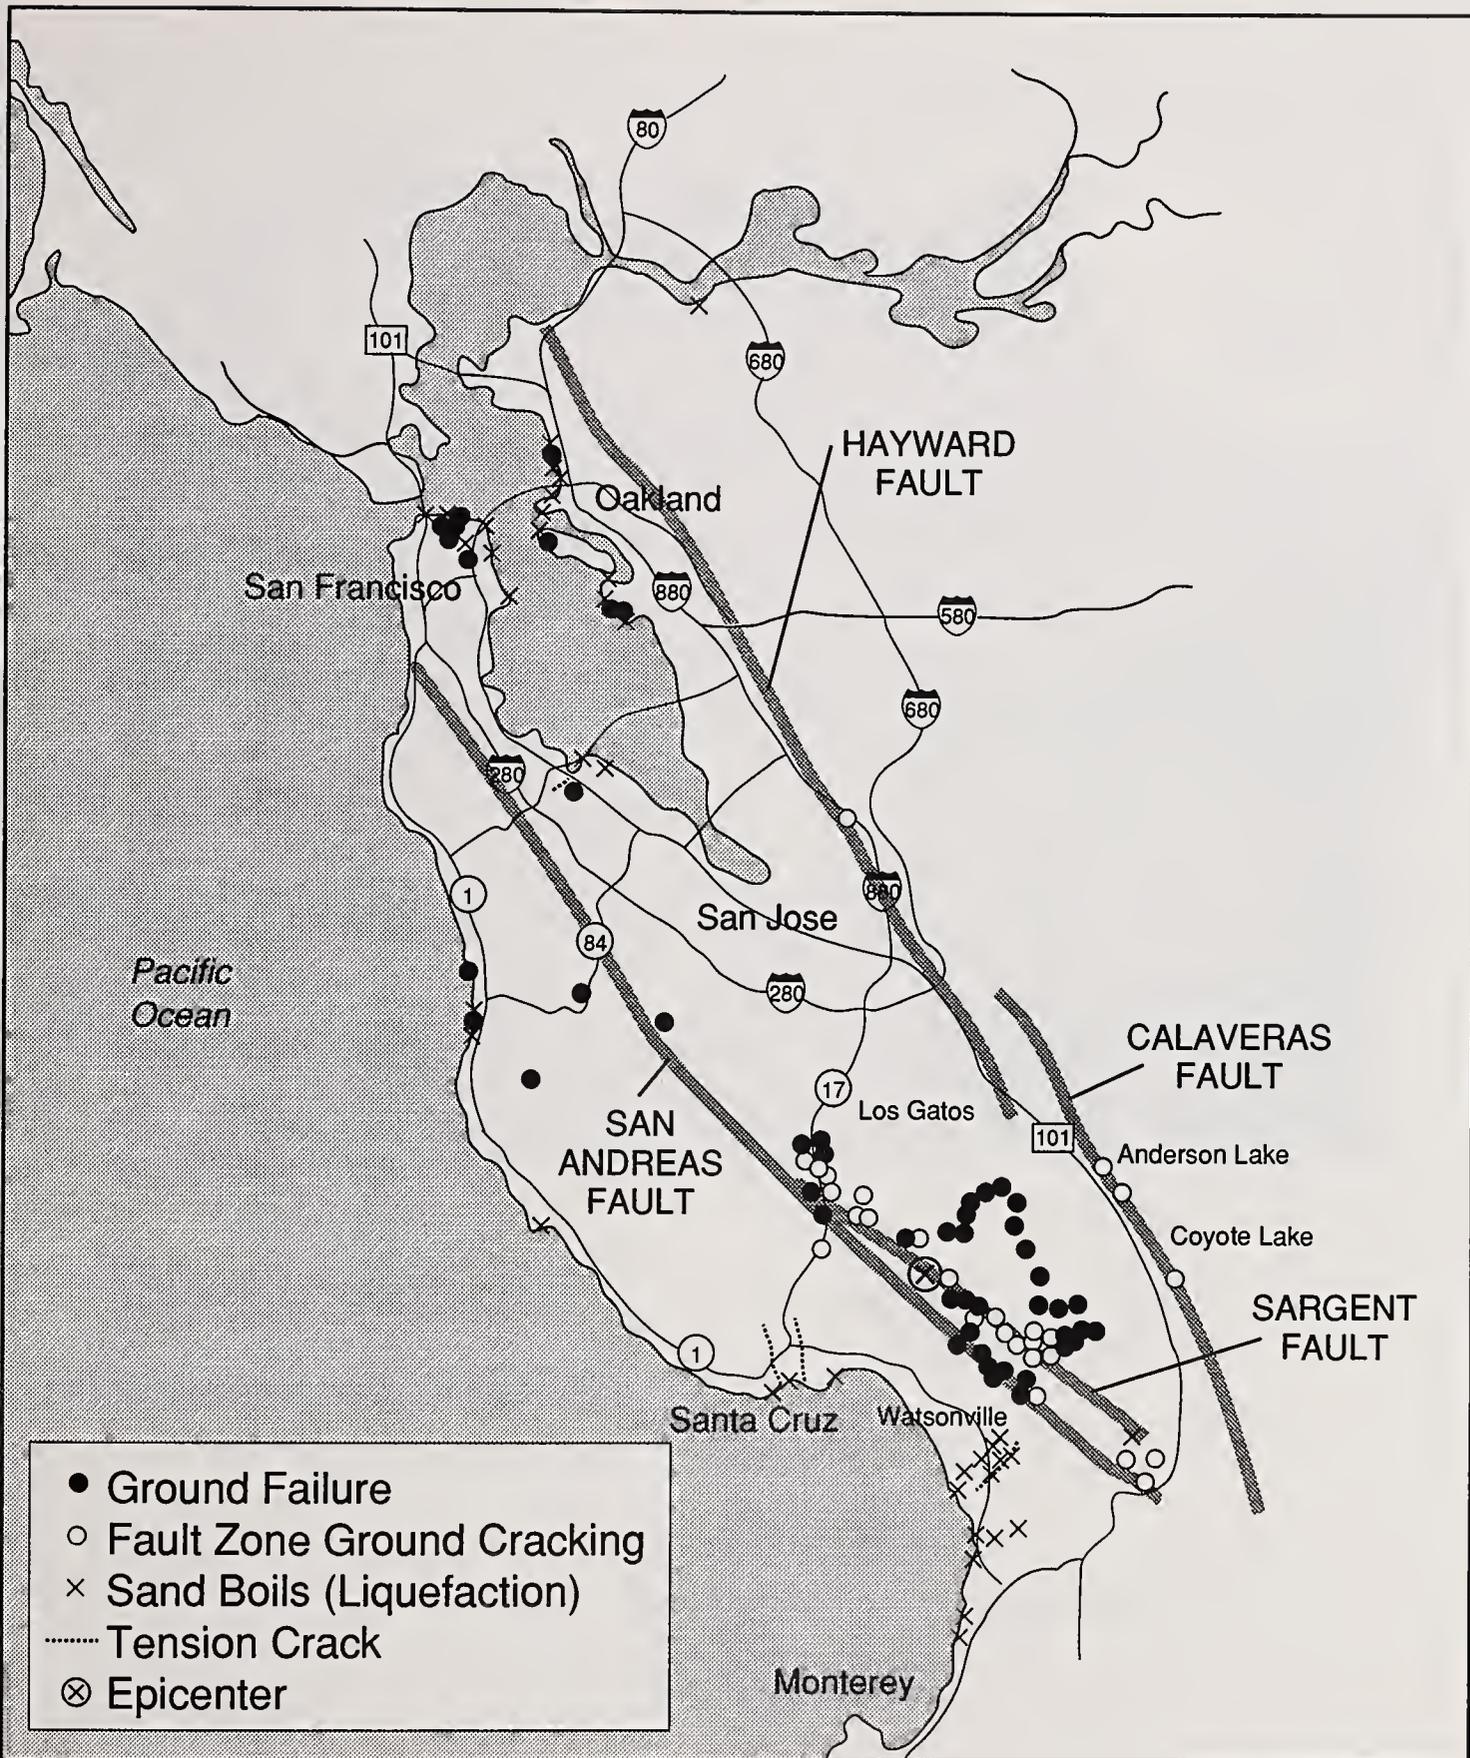
Figure 3.2.1 shows the approximate locations of observed ground failures. Four failure categories are identified: (1) fault zone ground cracking; (2) ground failures; (3) liquefaction; and (4) tension cracks. The observations compiled in the map were recorded by the U.S. Geological Survey in Menlo Park, CA, (prior to October 23, 1989), the University of California at Berkeley (Abolhassan et al., 1989), the U.S. Army Corps of Engineers, and the ICSSC team.

documented by the U.S. Corps of Engineers, and the ICSSC team. The failure categories identified in figure 3.2.1 are not mutually exclusive. For instance tension cracks in embankments may be attributable to a stability failure, in which case they would fall under "ground failures," or to liquefaction.

Figure 3.2.1 Ground failures caused by the Loma Prieta earthquake.

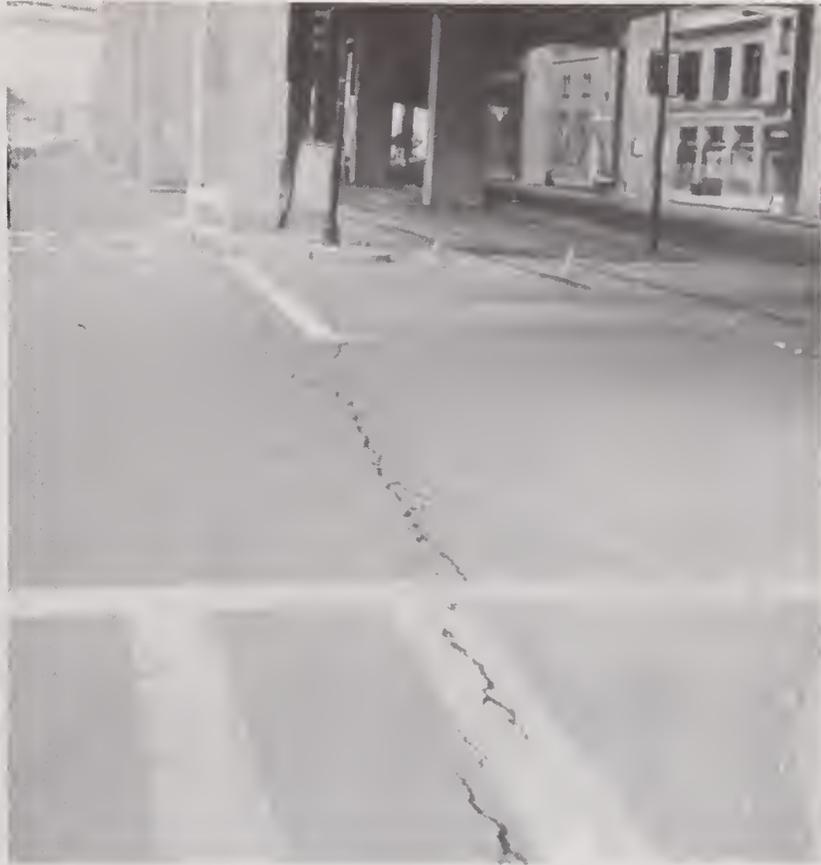
Figure 3.3.5 Tension crack at Mission Street and Embarcadero Freeway.

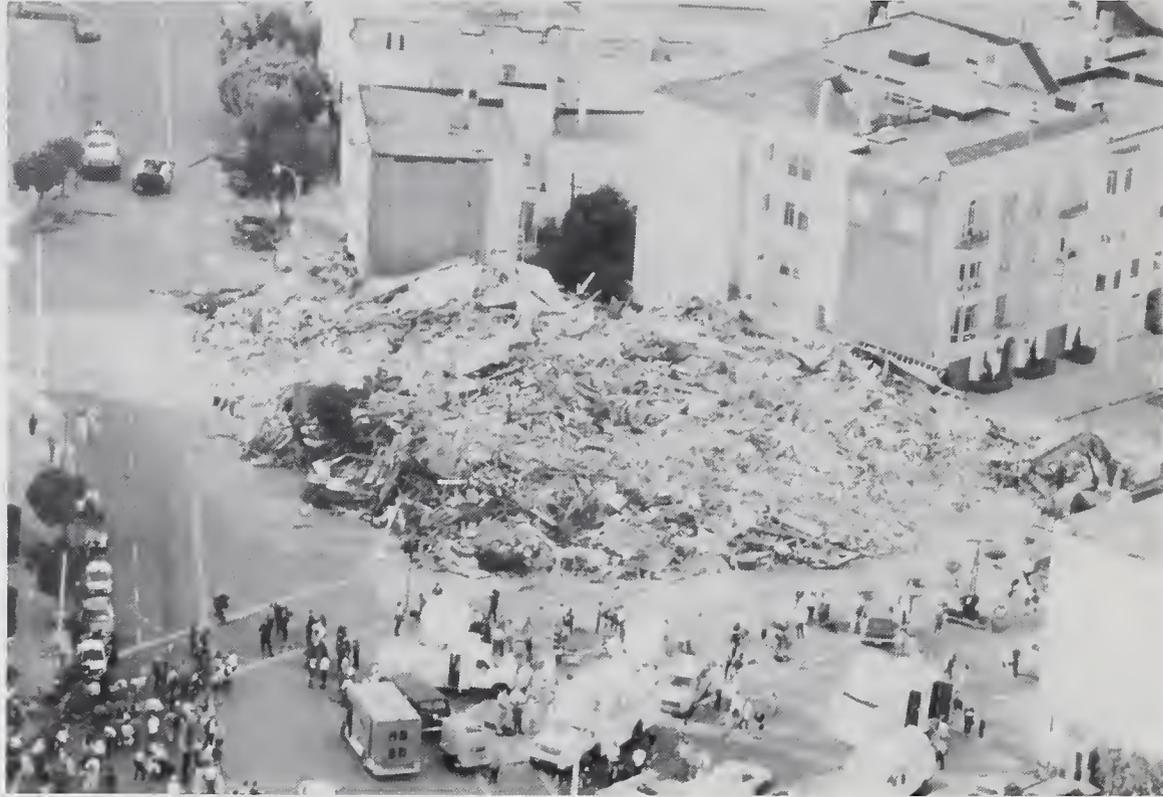
Figure 4.2.4 Aerial view (#2) of demolished building at the intersection of Fillmore St. and Cervantes Blvd.

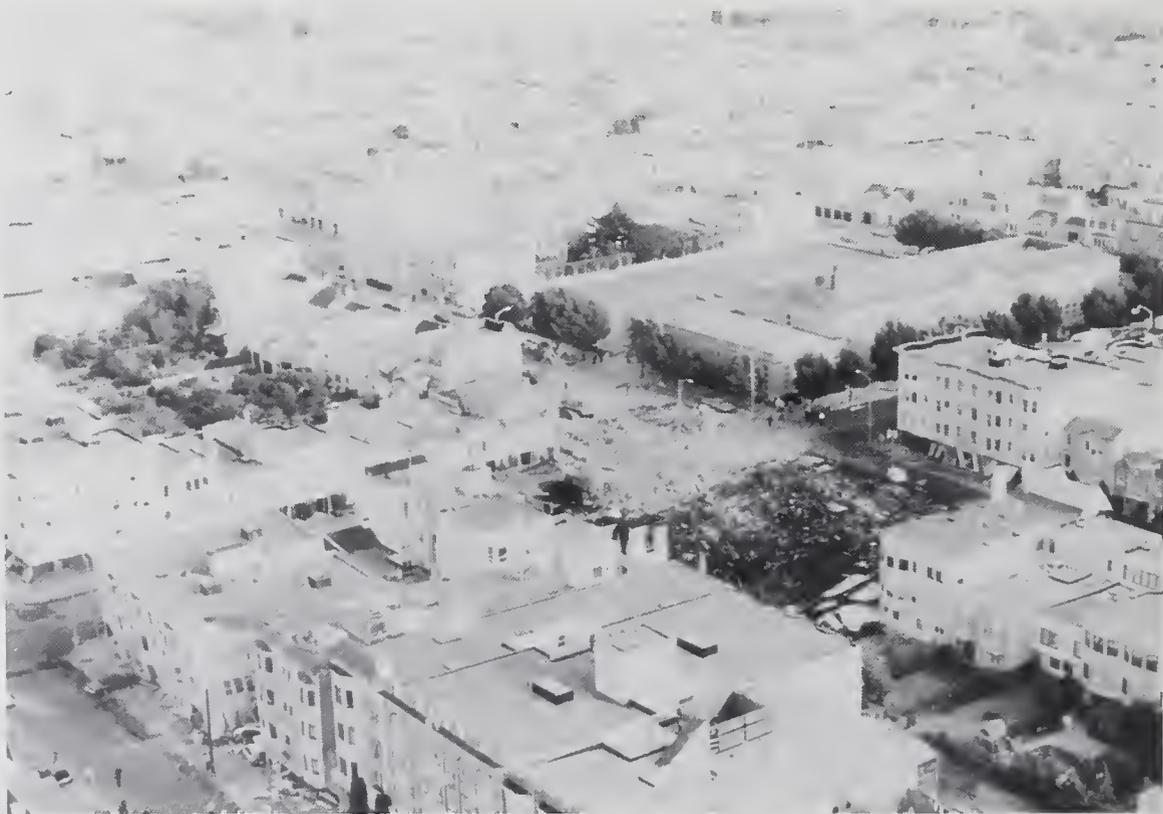
Figure 4.2.5 Aerial view (#3) of portion of the Marina District which suffered extensive damage; dark zone is location of the fire.

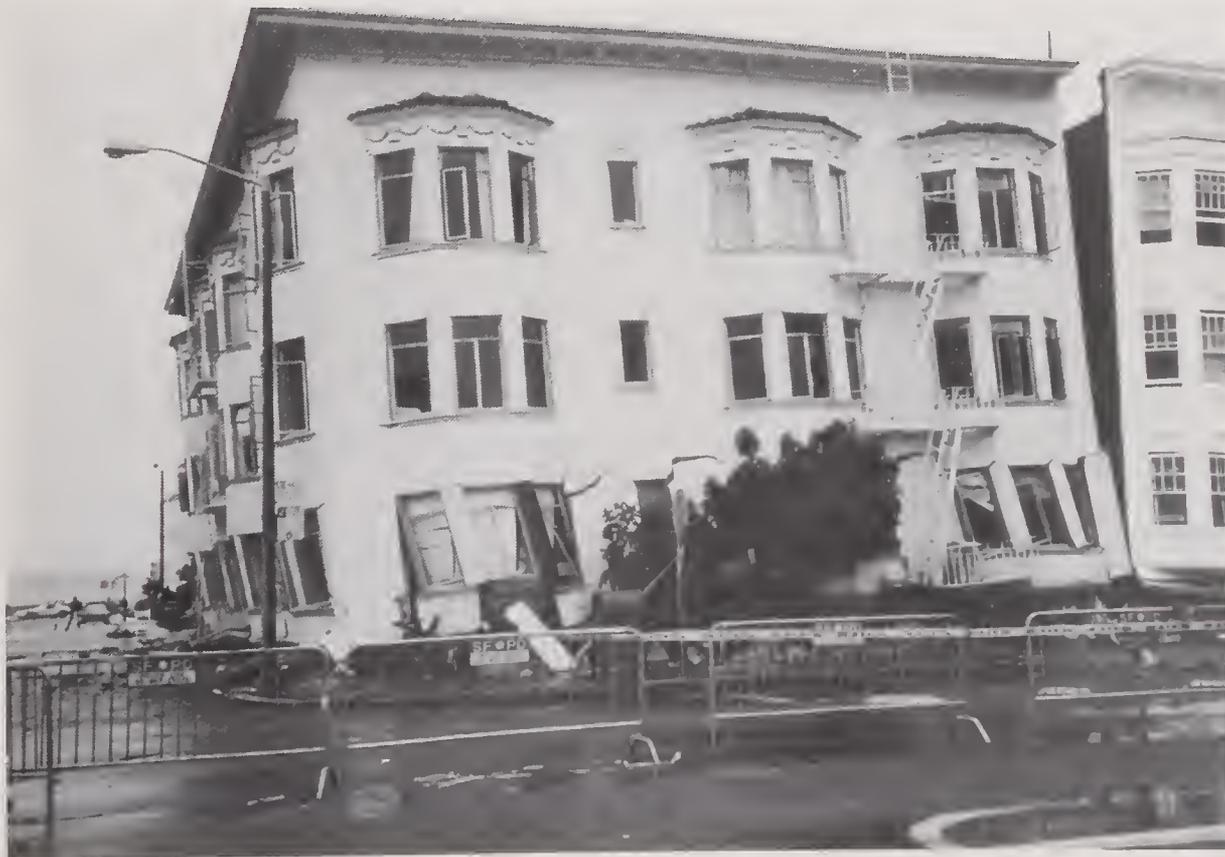
Figure 4.2.7 Two four-story buildings which suffered total collapse of their first stories (location #14).

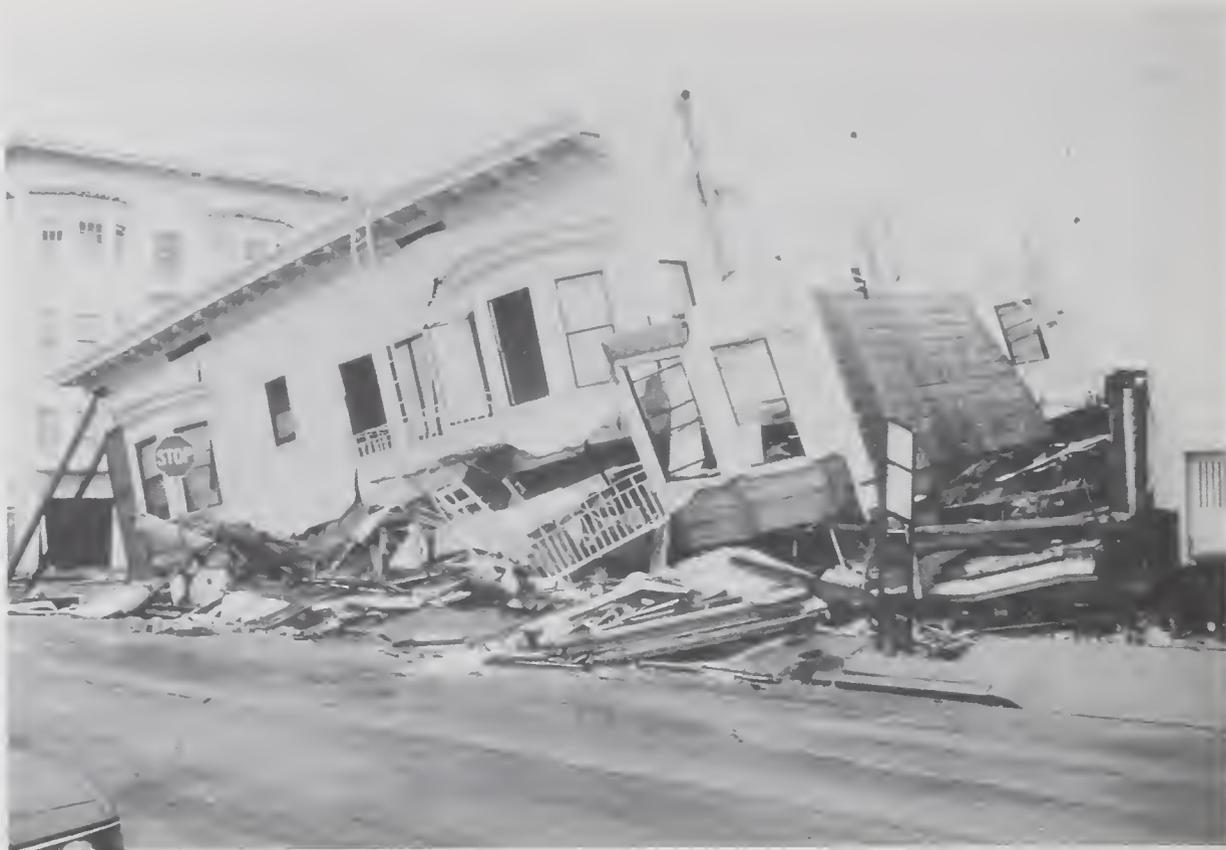
Figure 4.2.8 Four-story building which suffered total collapse of its lower stories (location #3).

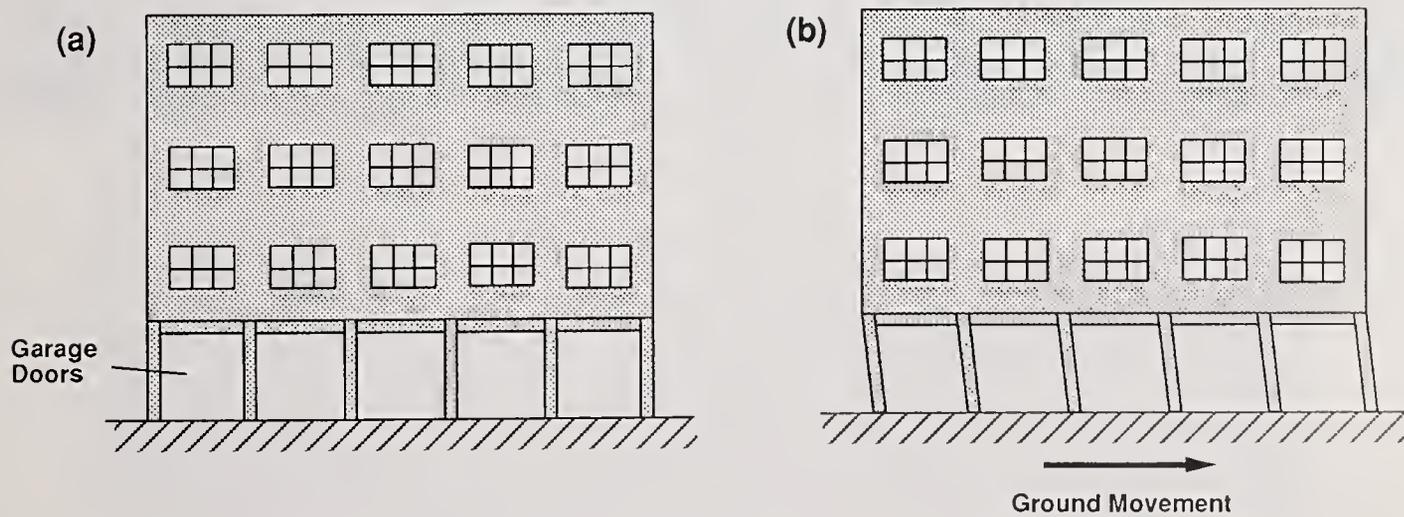
Figure 4.2.15 (a) Schematic elevation view of a four-story building with multiple garages and (b) expected building distortion due to ground motion.

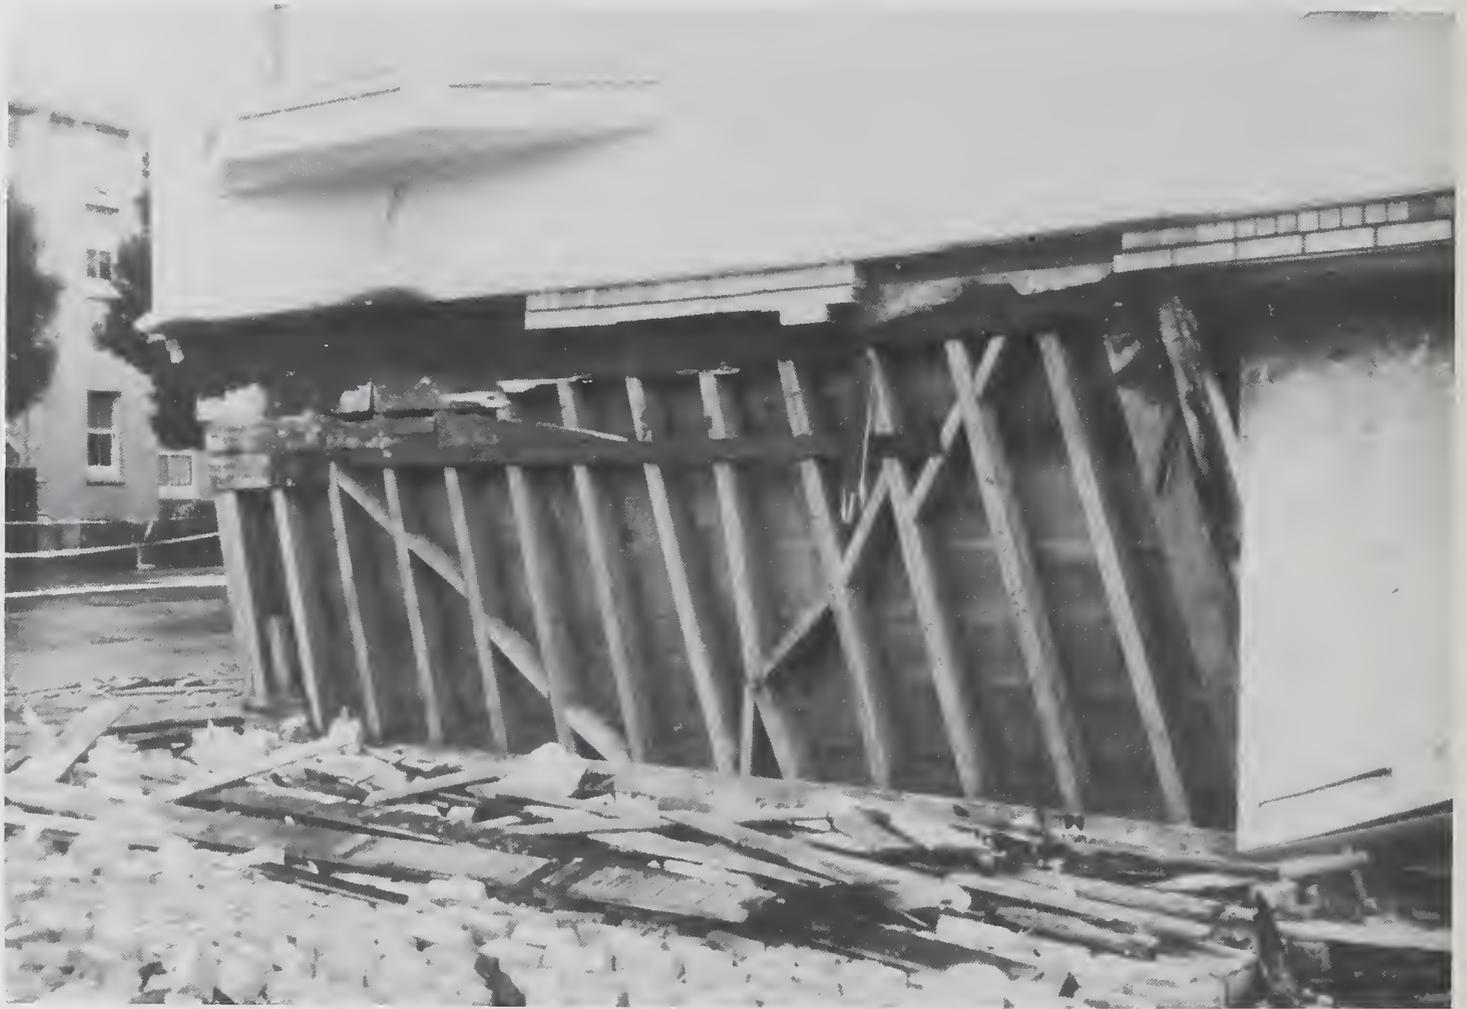
Figure 4.2.16 Detail of ineffective framing system in corner of building at the intersection of Beach and Divisadero Streets (location #5).

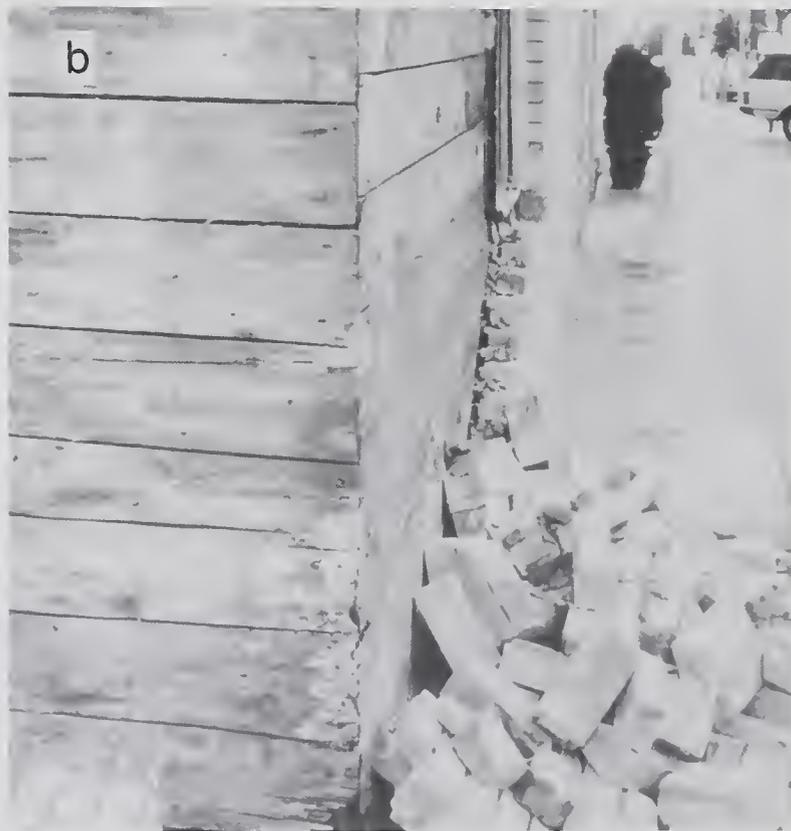
Figure 4.2.19 (a) Example of building with failure of brick masonry facade (location #12) and (b) close-up view of corner showing damaged wood and lack of anchorage to the masonry.

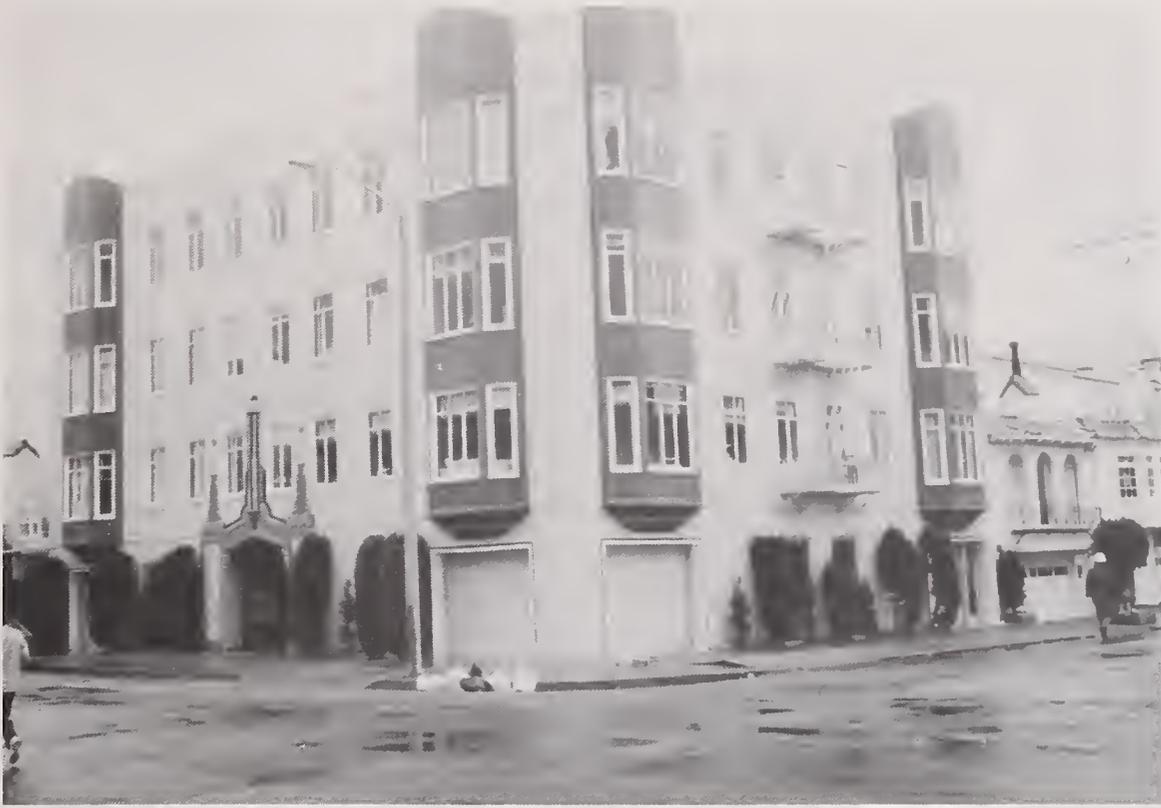
Figure 4.2.20 An undamaged four-story building on the corner of Broderick and Beach Streets (location #7).

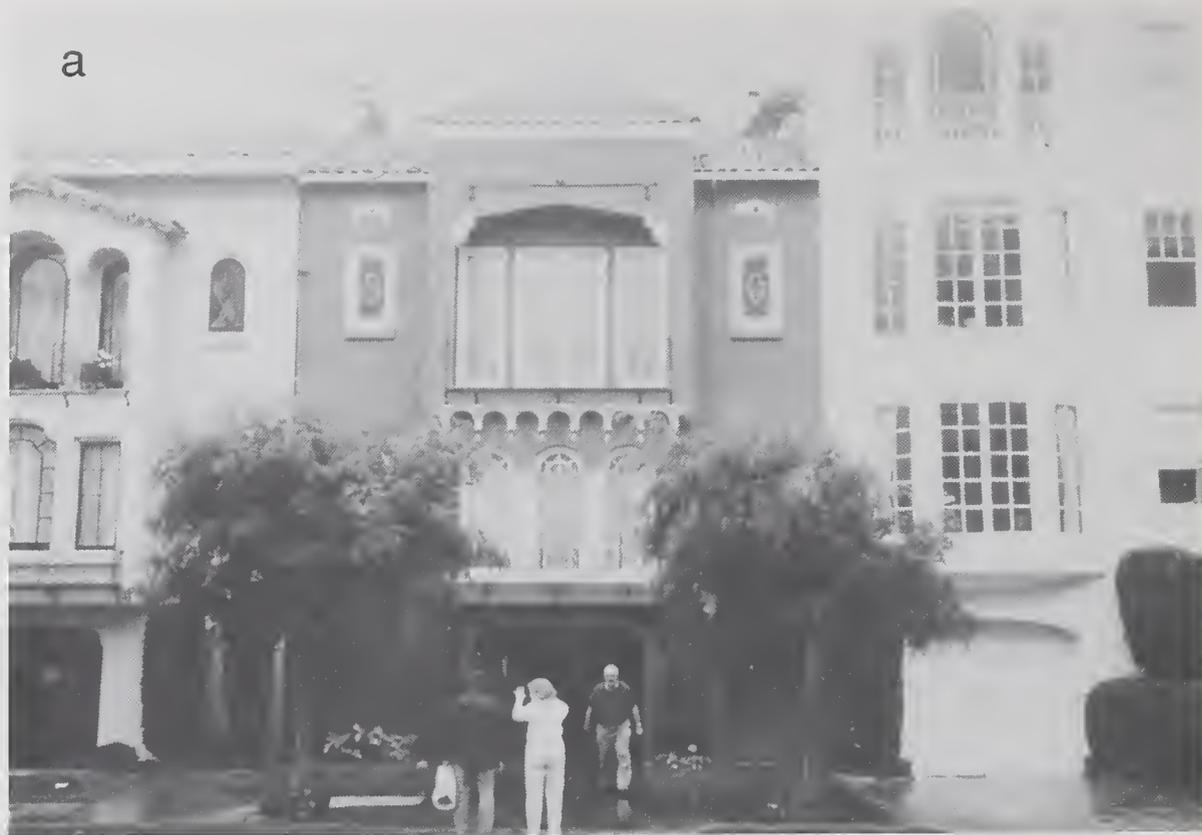
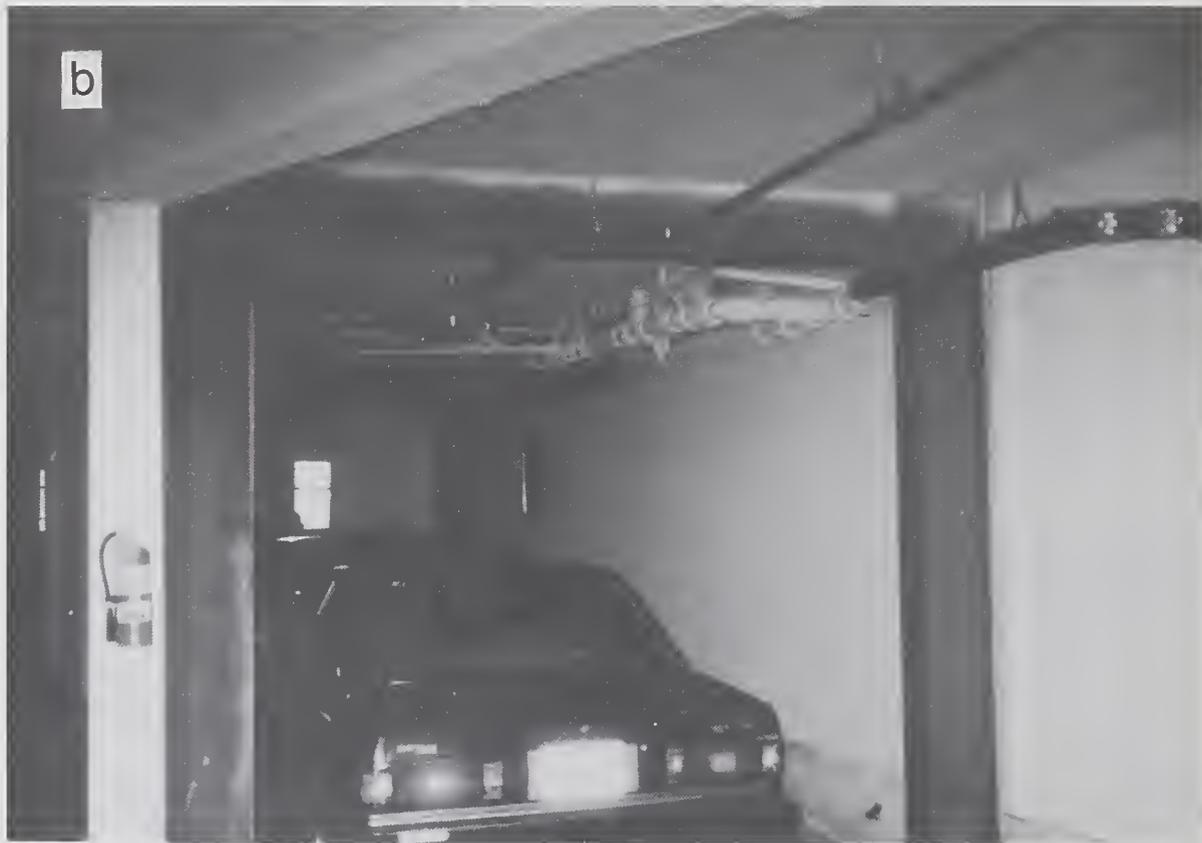
Figure 4.2.22 (a) An undamaged, three-story building (location #8) and (b) view of the moment-resting frame used for retrofitting.

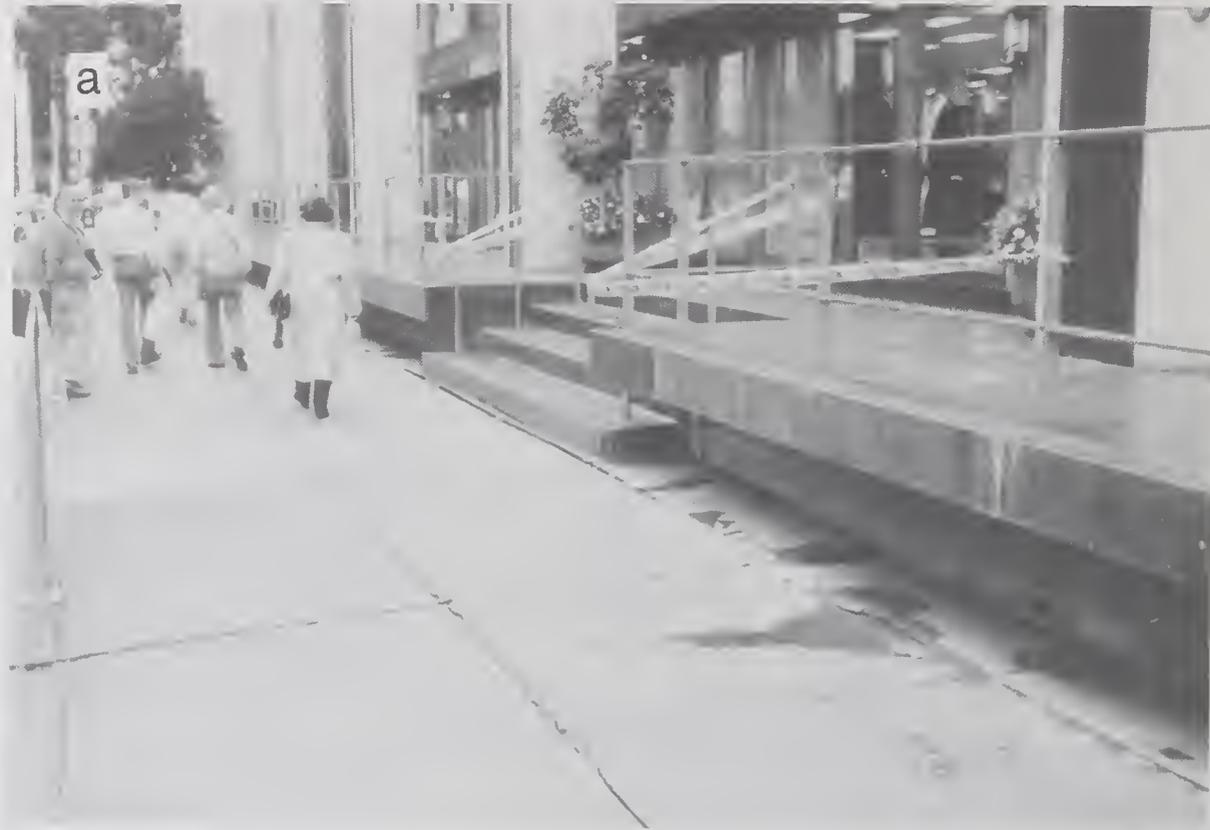
Figure 4.2.26 (a) Sidewalk showing distortions due to differential settlements, and (b) close-up view of intersection of sidewalk with retaining wall showing magnitude of differential movement.

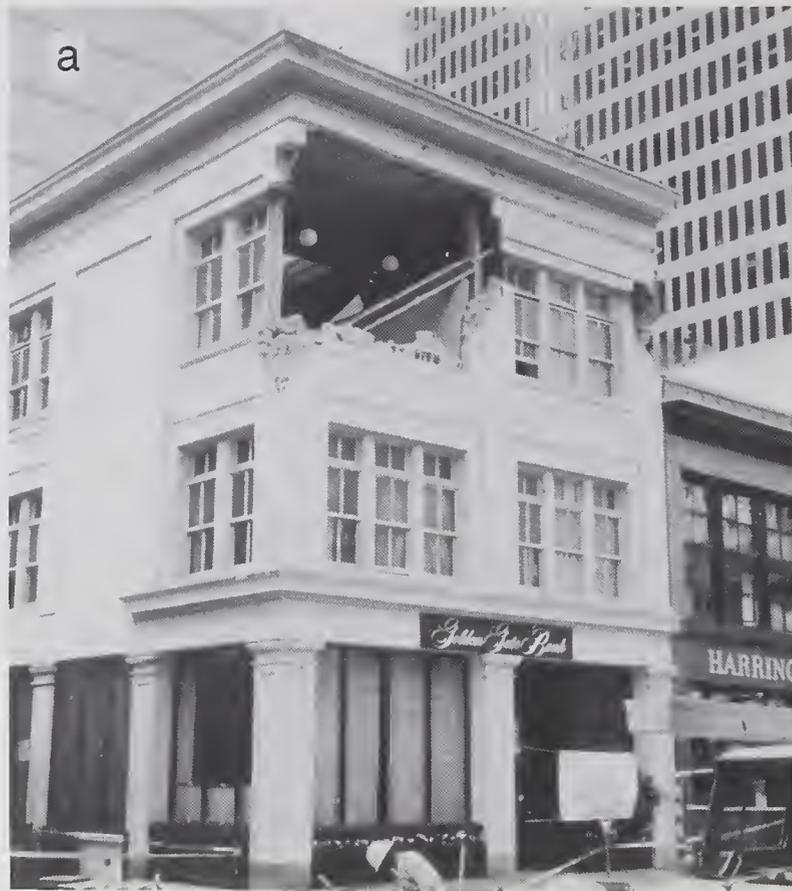
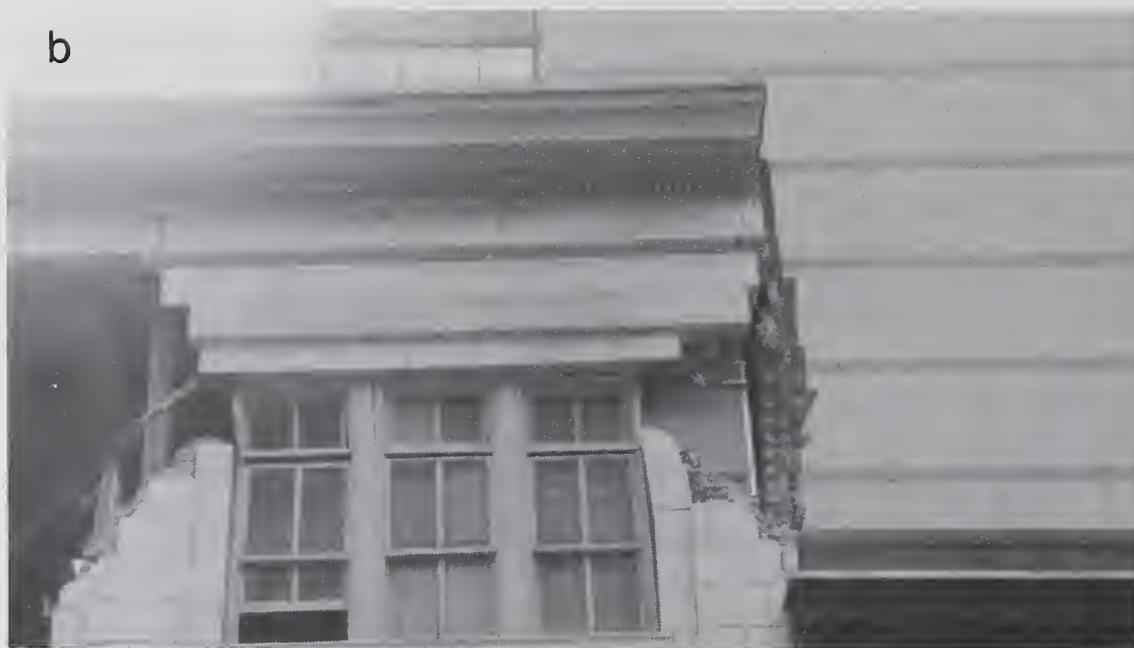
Figure 4.2.28 (a) Damage to the southeastern corner of the Golden State Bank Building; (b) Close-up view of the northeastern corner; damage was likely caused by pounding against the adjacent building.

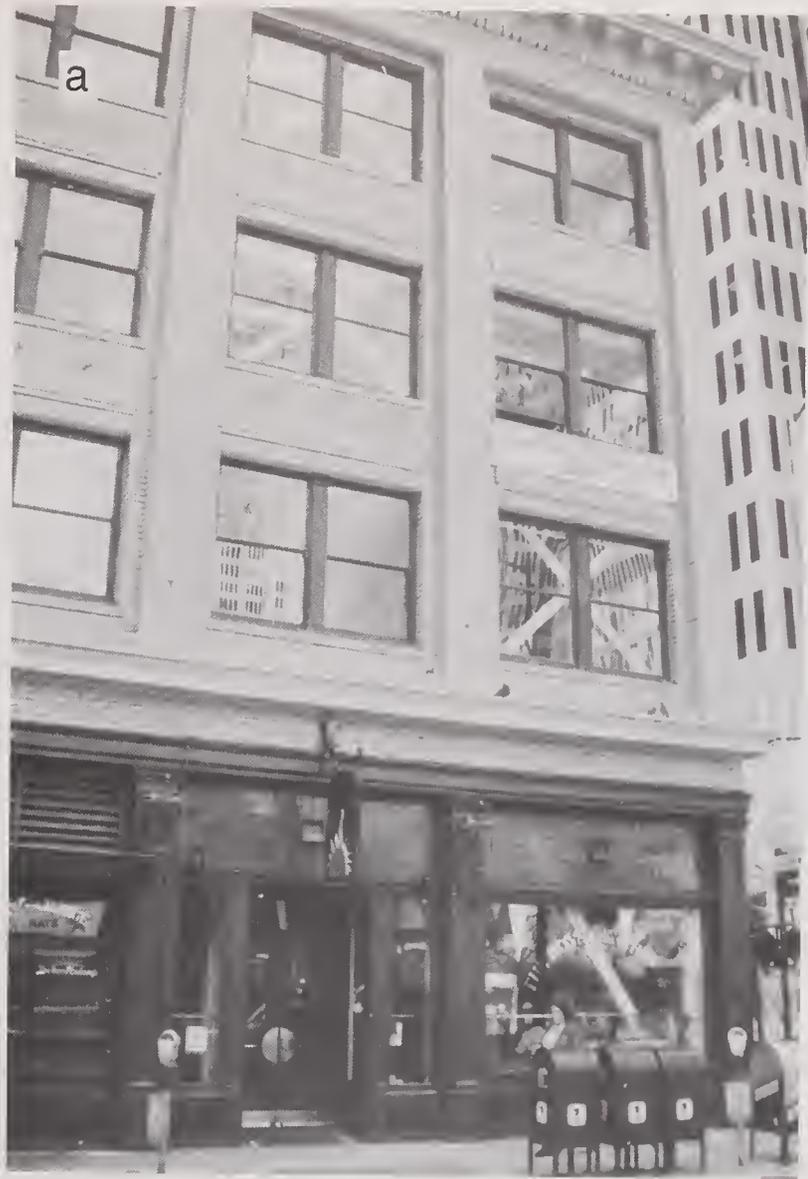
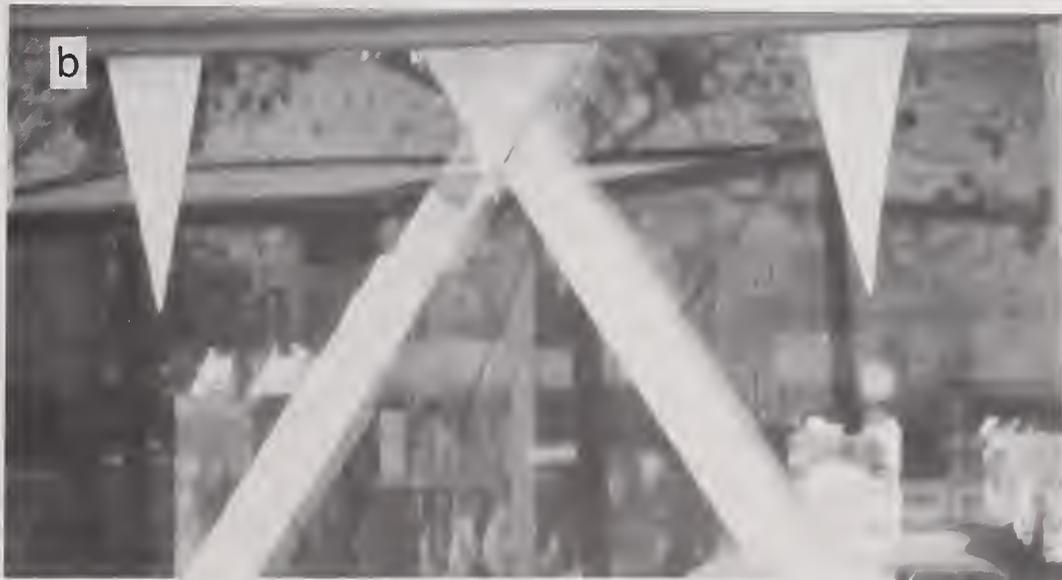
Figure 4.2.29 (a) The historic DeBernardi warehouse building showing the bracing added during seismic retrofitting; (b) close-up view of the bracing showing damage caused by earthquake.

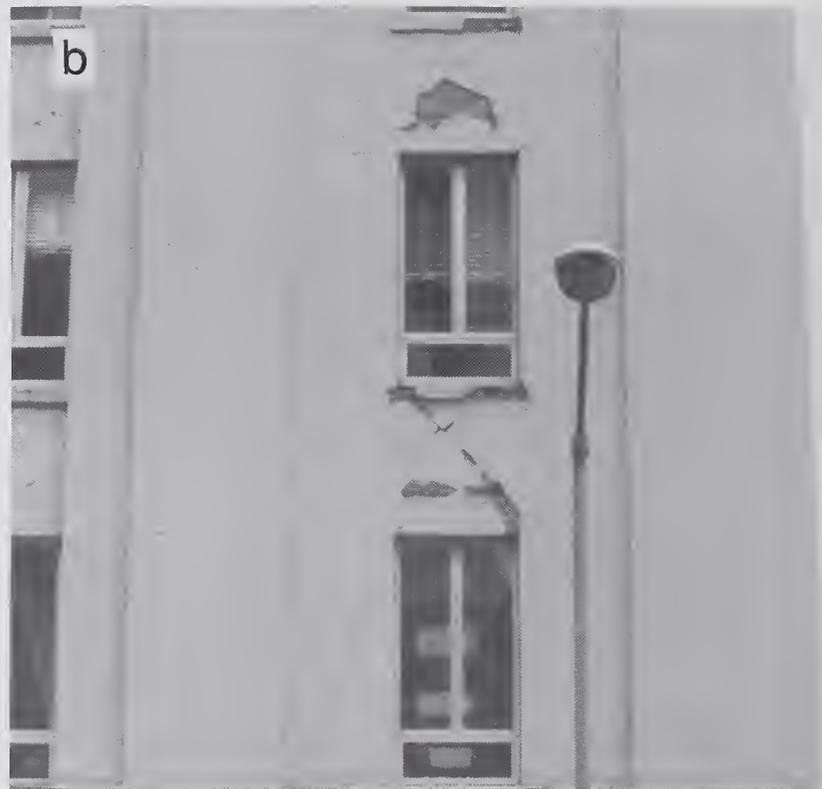
Figure 4.2.33 (a) Reinforced concrete, flat-slab building which sustained severe damage to the exterior walls (location #6); (b) close-up view of damage to spandrels.

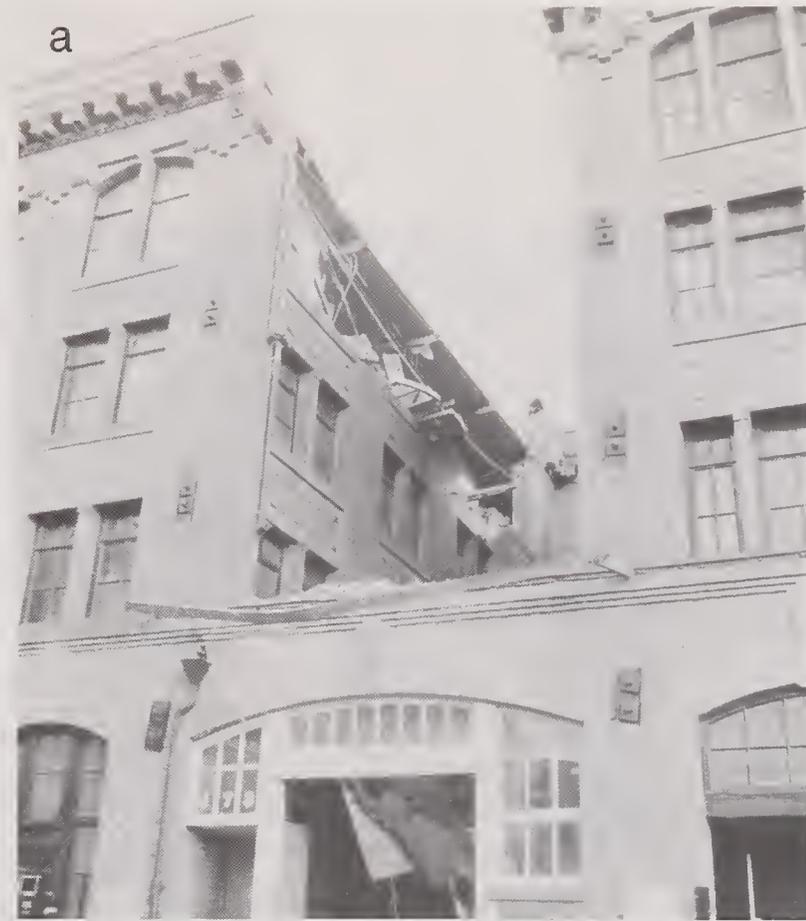
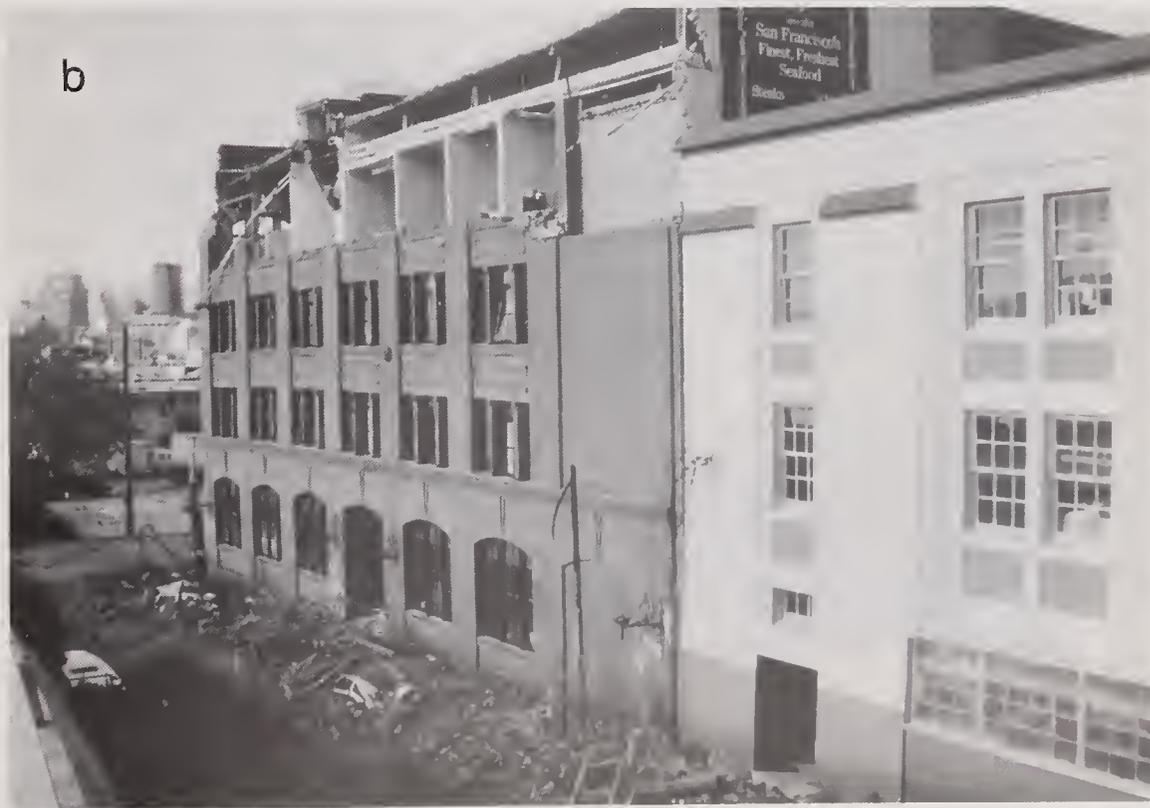
Figure 4.2.34 (a) Damage to upper story of unreinforced masonry building on Bluxome St. (location #8);
(b) damage to the southwestern wall which resulted in the death of six persons.

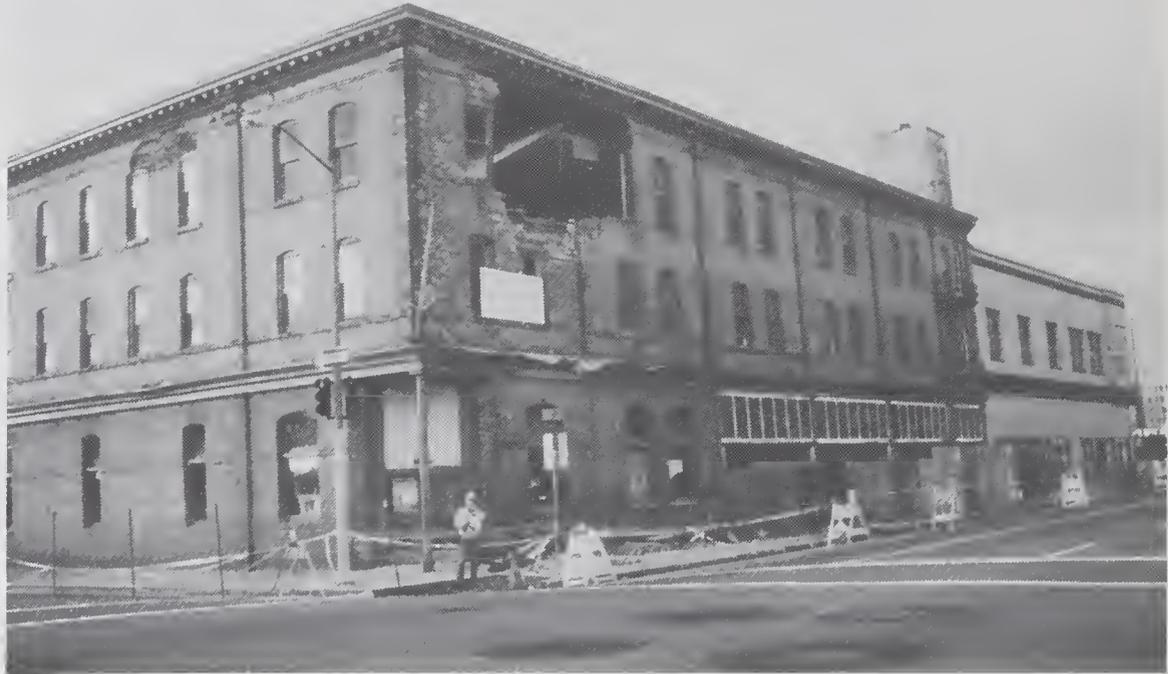
Figure 4.3.4 shows the three-story Clay Building (location #2) which had a serious failure of its unreinforced masonry walls. On the corner opposite to the Clay Building there was a two-story URM

Figure 4.3.4 Damage to the Clay Building, an unreinforced masonry structure (location #2).
