NIST Special Publication 778

Performance of Structures During the Loma Prieta Earthquake of October 17, 1989

H. S. Lew, Editor

January 1990

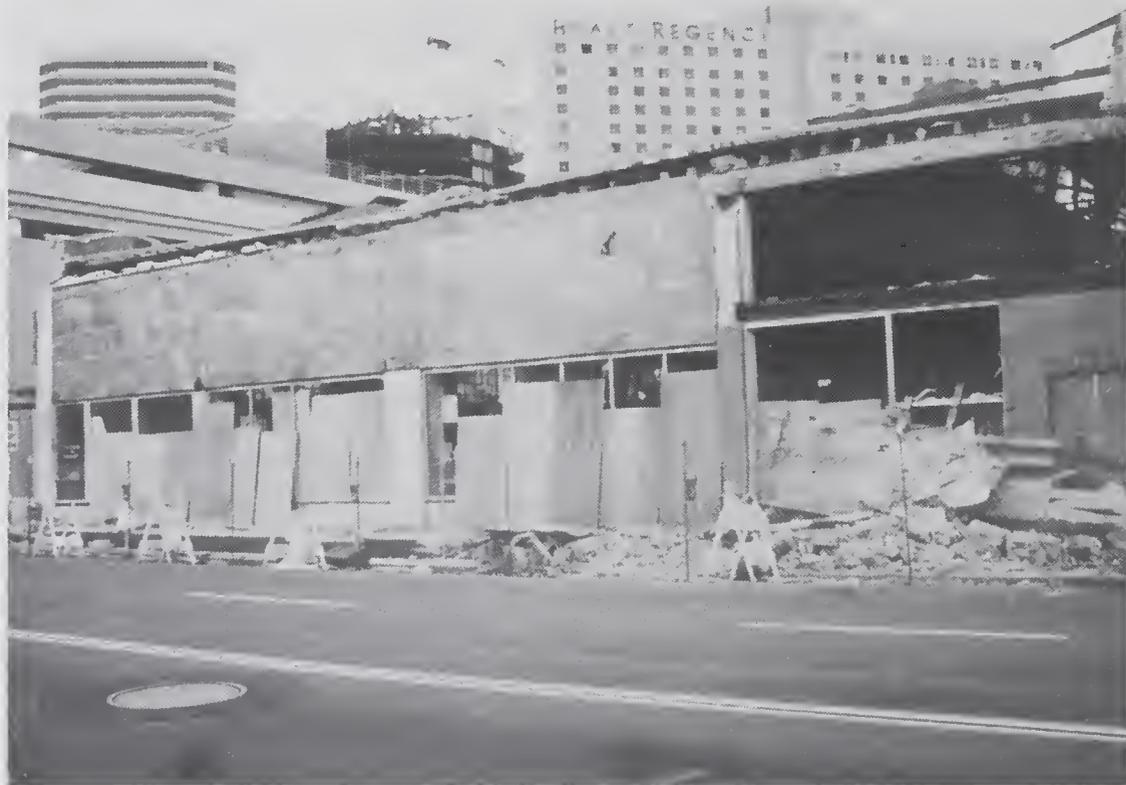
building (location #3) which was apparently built as a produce market in 1917. As is shown in figure 4.3.5, there was failure of the parapet as well as a portion of the infilled wall. The building occupied the entire block, and the eastern portion, which was being renovated, did not appear to have been damaged. Another example of a URM-building failure (location #5) is shown in figure 4.3.6. The collapse of the outer wall crushed three vehicles parked in the adjacent lot. The high-rise steel frame structure, seen in the background of figure 4.3.6, being constructed at 12th Street and Broadway, suffered damage at the top. It was reported⁶ that some steel members and the construction elevator fell to the ground. Fortunately there were only some minor injuries from what could have been a serious accident.

Figure 4.3.5 Extensive damage occurred to a two-story unreinforced masonry building built in 1917 (location #3).

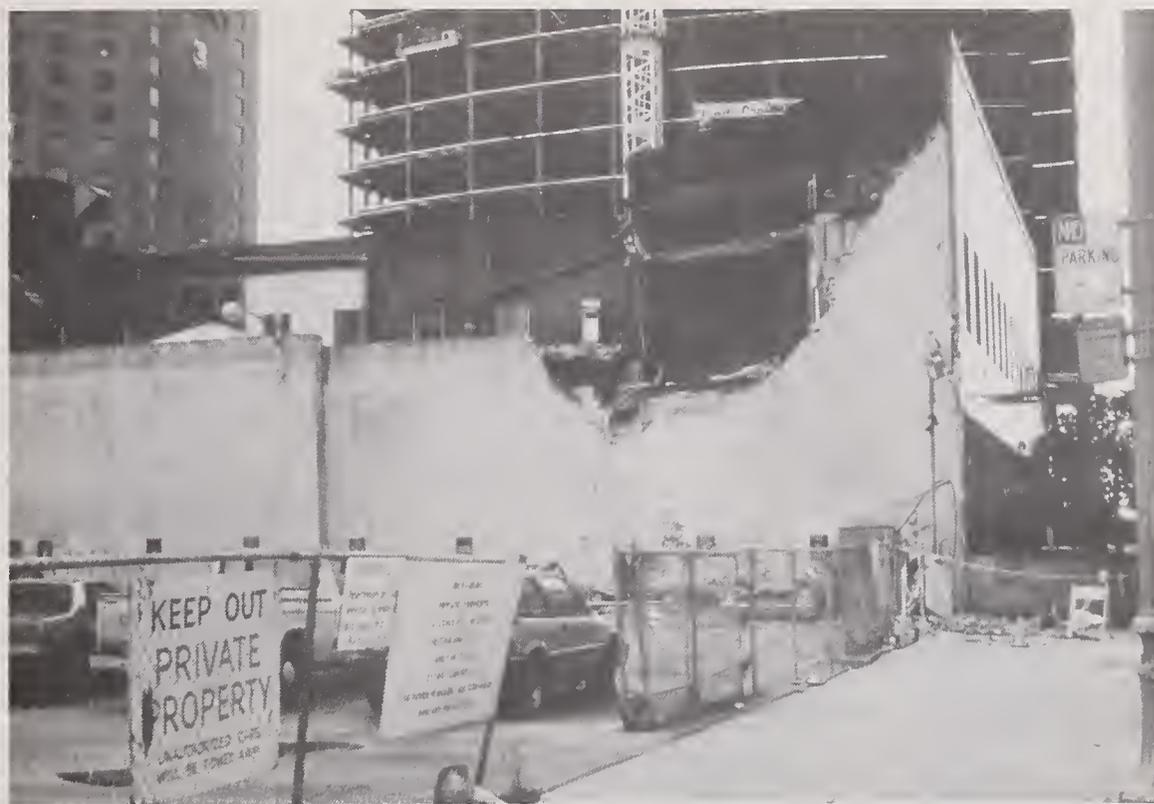
Figure 4.3.6 Collapse of unreinforced masonry wall crushed vehicles in adjacent parking lot (location #5). In background is a steel-framed building under construction which sustained damage.

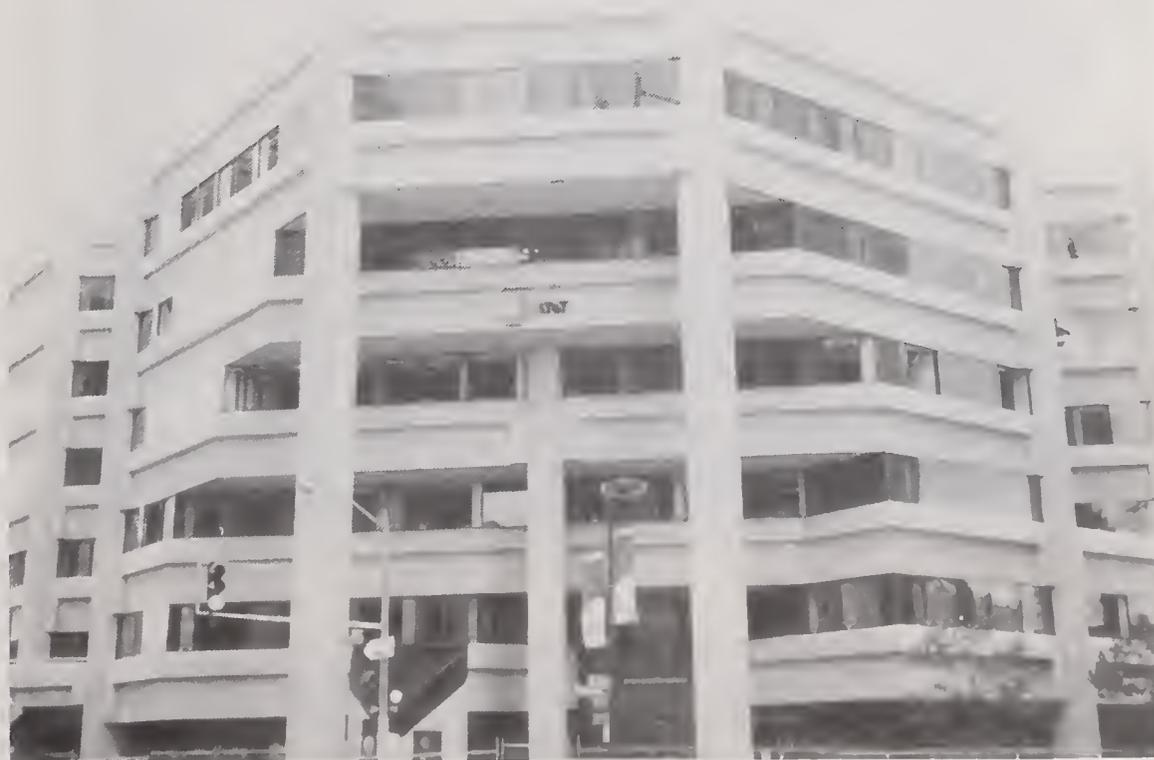
Damage also occurred to some modern buildings. Figure 4.3.7 shows the Trans Pacific Centre at 11th Street and Broadway (location #4). The building had to be evacuated not because of structural damage, but because of ruptured sprinkler lines, broken windows, and fallen ceiling tiles. The 16-story telecommunications building at 20th and Franklin Streets (location #7) suffered damage. The structural system consists of a steel frame with reinforced concrete shear walls. As is shown in figure 4.3.8, extensive damage occurred to the shear walls as well as other concrete structural members.

Figure 4.3.7 Trans Pacific Centre Building which suffered extensive damage due to ruptured water pipes, broken windows, and fallen ceiling tile (location #4).

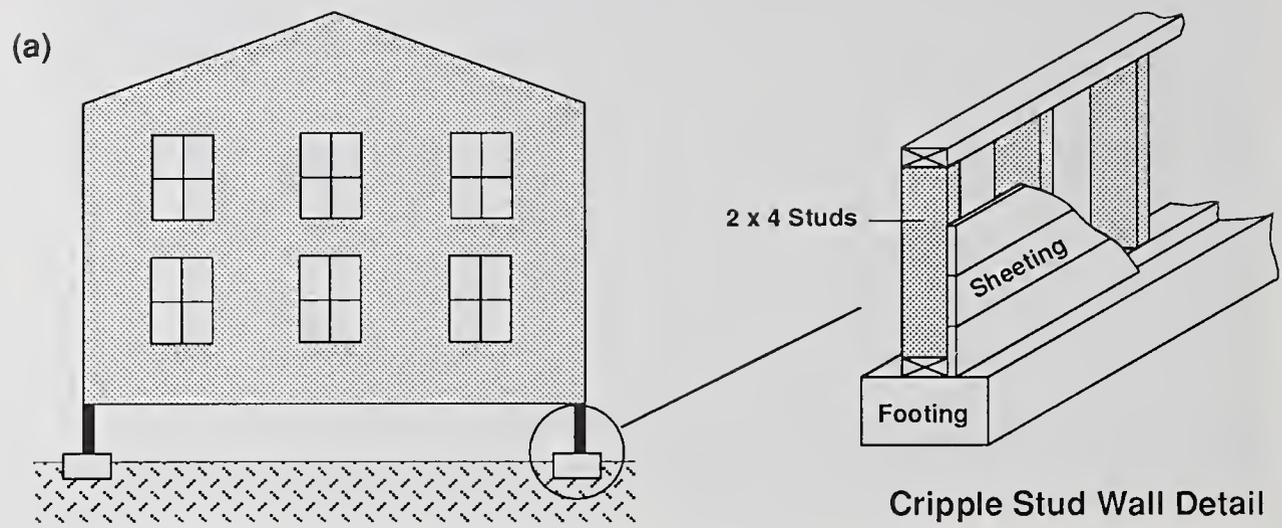
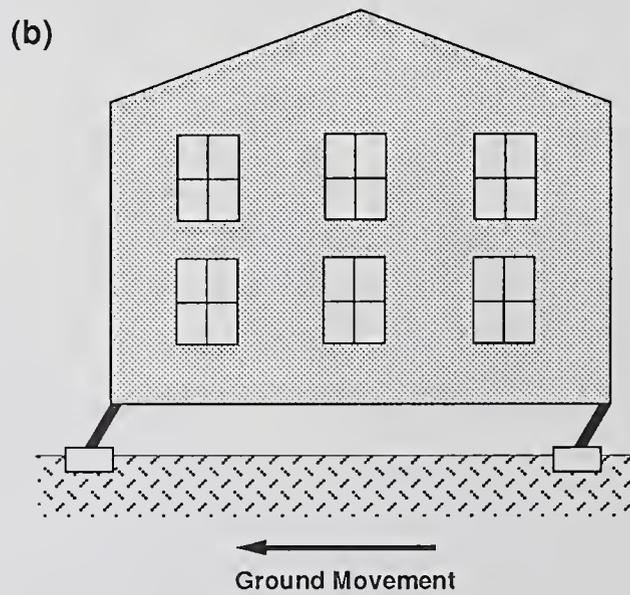
In Los Gatos, about 400 out of 11,000 houses were damaged. Figures 4.4.2 (a) and (b) show examples of damage to wood-framed houses which shifted off of their foundations. The shifting was usually as a result of the failure of the supporting perimeter walls. Figure 4.4.3 illustrates how a house, such as those which failed, is supported. The concrete footings support a short perimeter wall, known as a "cripple stud wall," which supports the frame of the house. The cripple stud walls are typically built using 2-by-4 studs and wooden boards as sheeting. When the ground moved during the earthquake, the cripple stud walls were unable to resist the induced horizontal forces. This caused the walls to sway until they could no longer support the weight of the house. The house crashed to the ground and secondary damage resulted from the impact. The same type of damage was also observed to houses in Watsonville.

Figure 4.4.3 Schematic of failure caused by inadequately braced cripple stud walls: (a) construction of cripple stud wall and (b) failure mechanism.

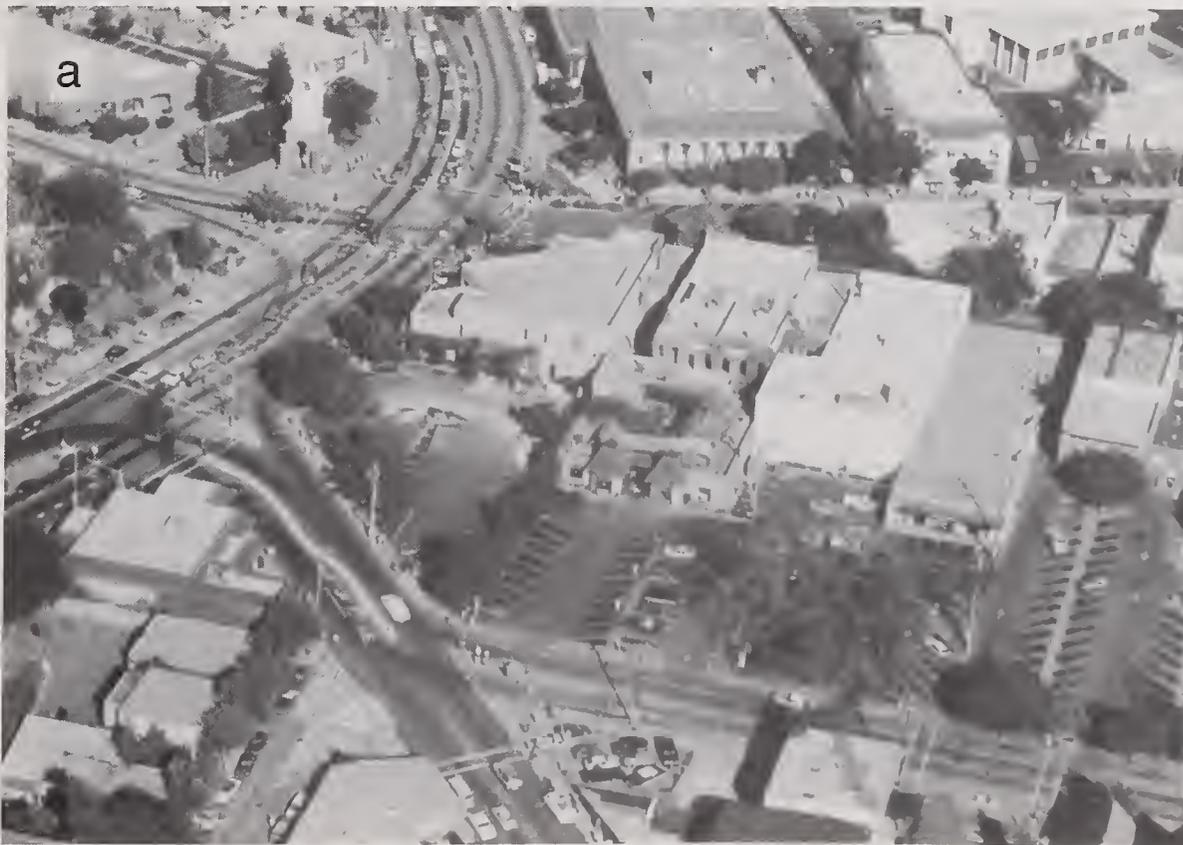
At the center of figure 4.4.8(a) there is a two-story masonry structure at the corner of Pacific Avenue and Water Street (location #1). Figure 4.4.9 shows the appearance of the structure at street level. It was designed about 15 years ago according to the 1973 Uniform Building Code, and it survived without any sign of structural damage. Adjacent to this modern building is an older unreinforced masonry building, which is seen on the left side of figure 4.4.9. Although the facade shows a small amount of damage, the roof of the building collapsed and killed two persons.

Figure 4.4.8 Aerial views of the Pacific Garden Mall: (a) northern portion.

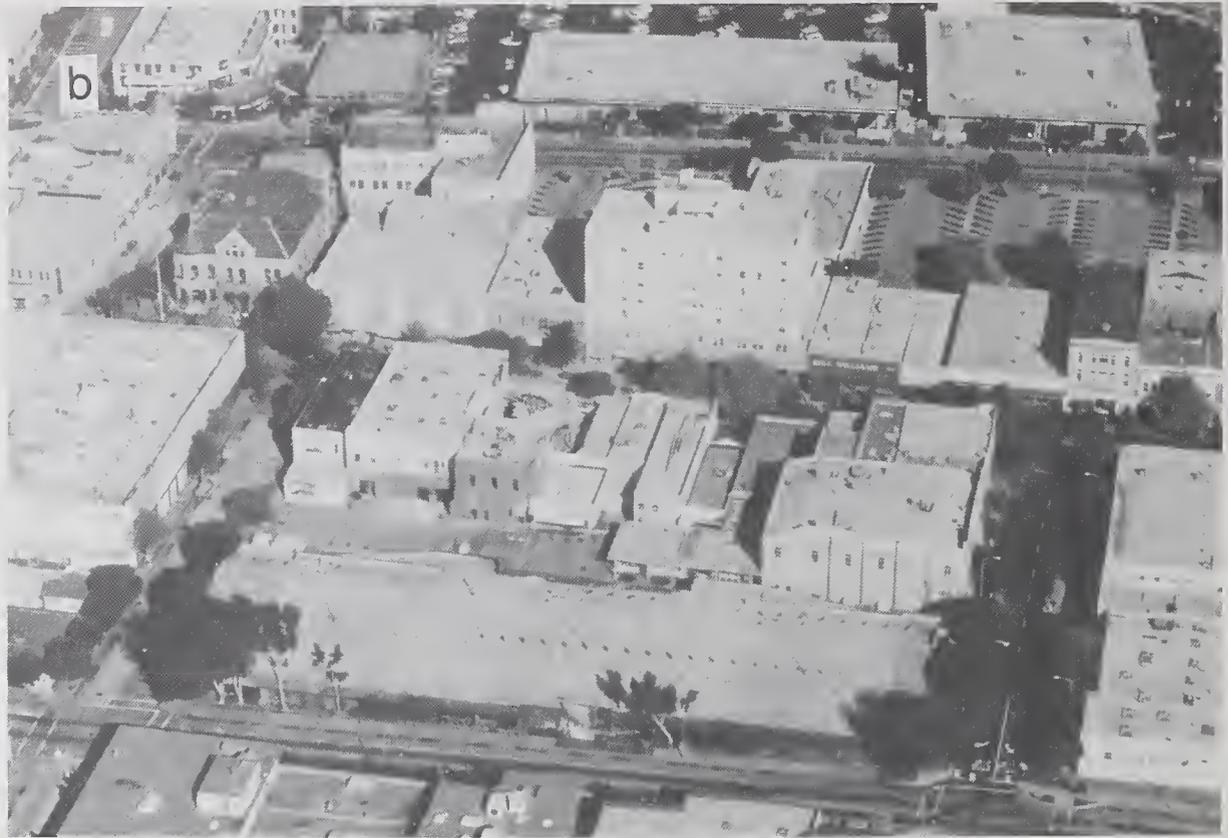
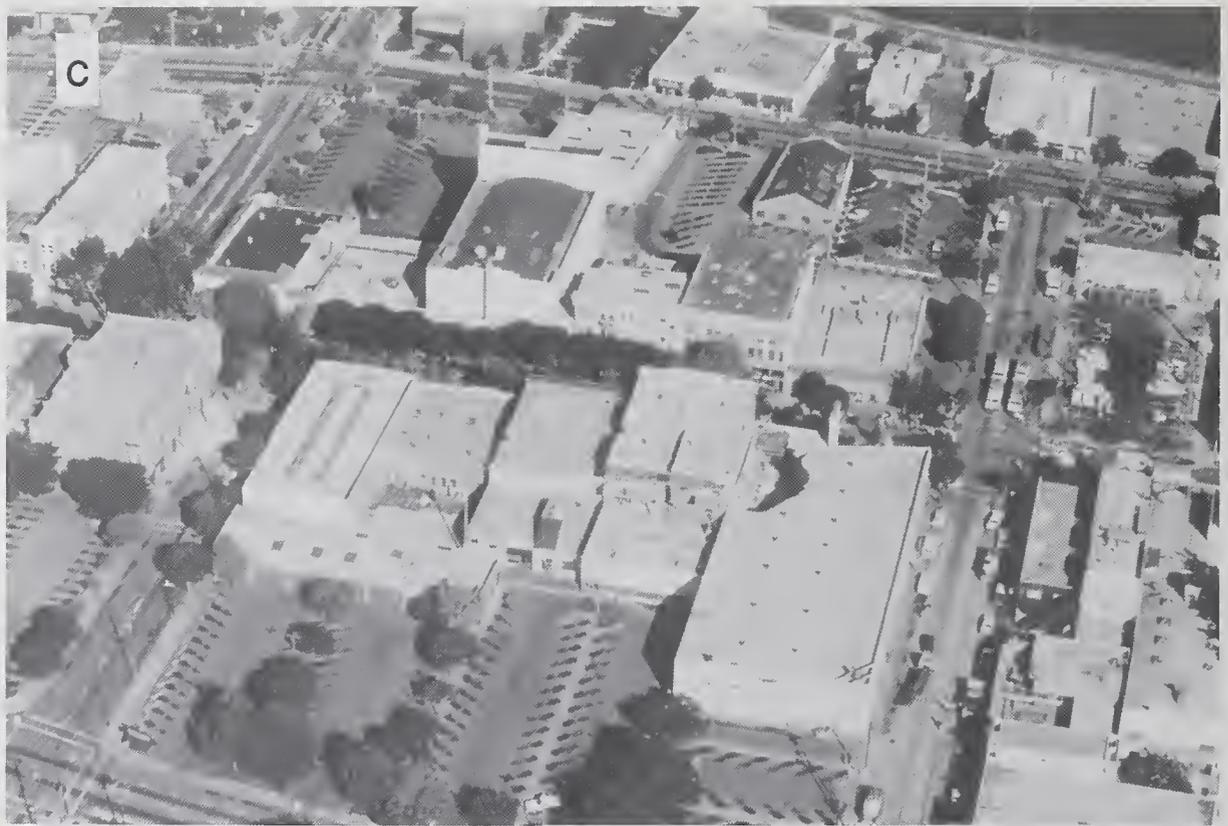
Another roof collapse in the mall caused the death of one person. This failure occurred to the department store on the corner of Pacific Avenue and Cathcart Street, and can be seen in figure 4.4.8(c). The roof failure was caused by the collapse of the top story masonry wall of the adjacent building. This type of damage was observed at several other stores within the mall.

A seven-story building is seen near the center of figure 4.4.8(b) (location #3). This reinforced concrete building, which was reported to have built in the 1920's, was severely damaged. The street level view in

Figure 4.4.8 (Cont'd) Aerial views of the Pacific Garden Mall: (b) central portion, and (c) southern portion.

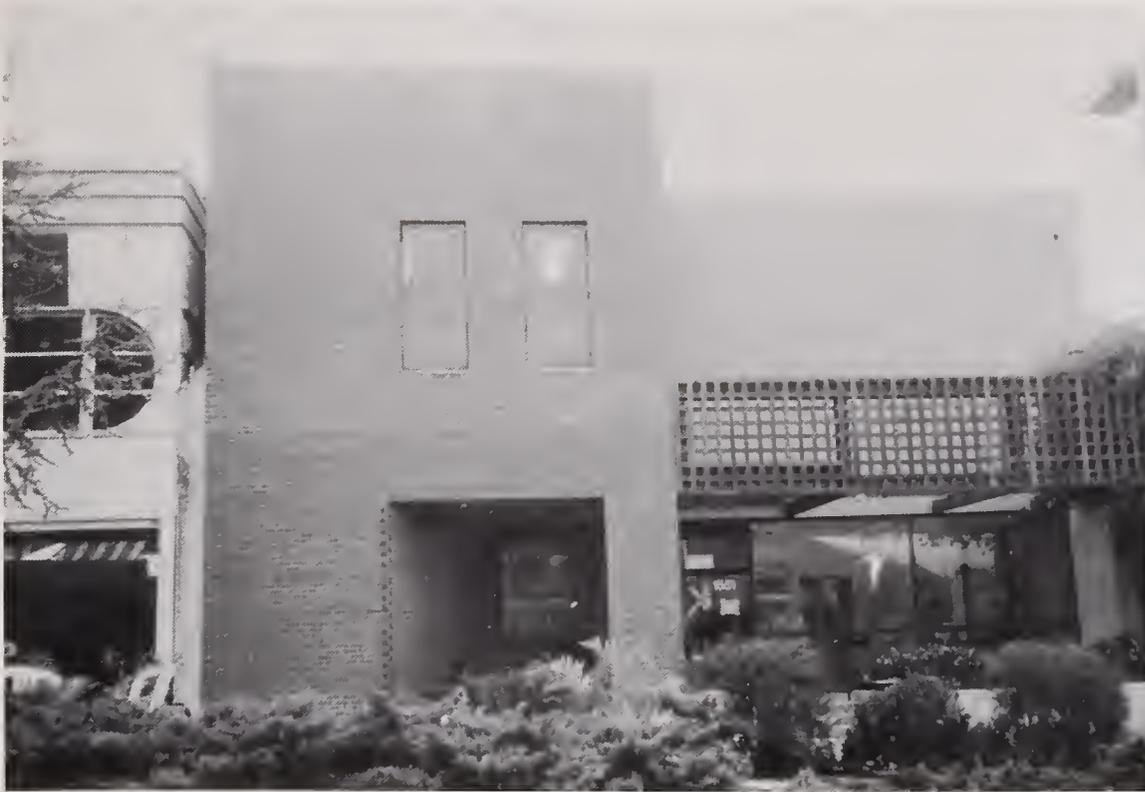
Figure 4.4.9 Modern reinforced masonry structure which was undamaged; building on the left suffered roof failure causing two deaths (location #1).

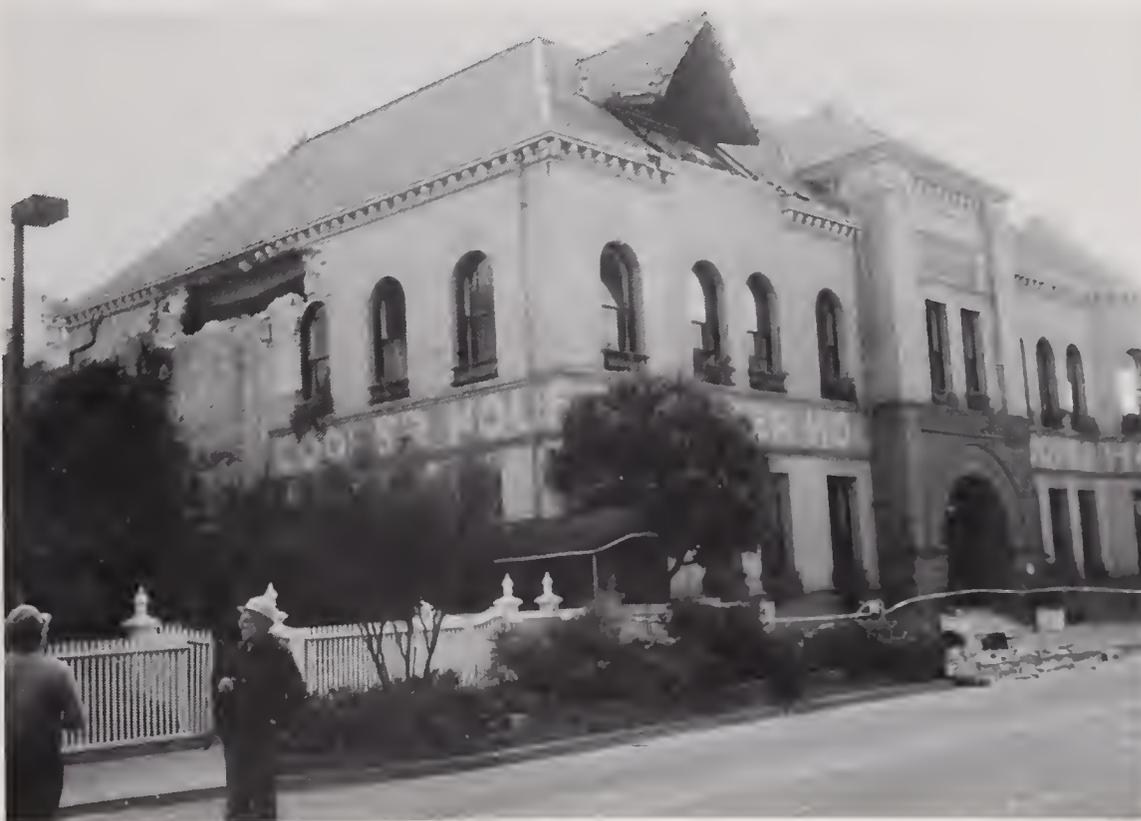
One of the historic structures severely damaged is the Cooper House located on the corner of Pacific Avenue and Cooper Streets (location #2). The unreinforced masonry building was built in the 1880's as the county courthouse. The building was reported to have survived the 1906 San Francisco earthquake⁷, but it was extensively damaged during the Loma Prieta earthquake. As shown in figure 4.4.10, portions of exterior walls collapsed and there were extensive diagonal cracks throughout the exterior walls. The damage was so severe that the building subsequently was demolished.

Figure 4.4.10 Historic Cooper House in Santa Cruz was severely damaged and had to be demolished (location #2).

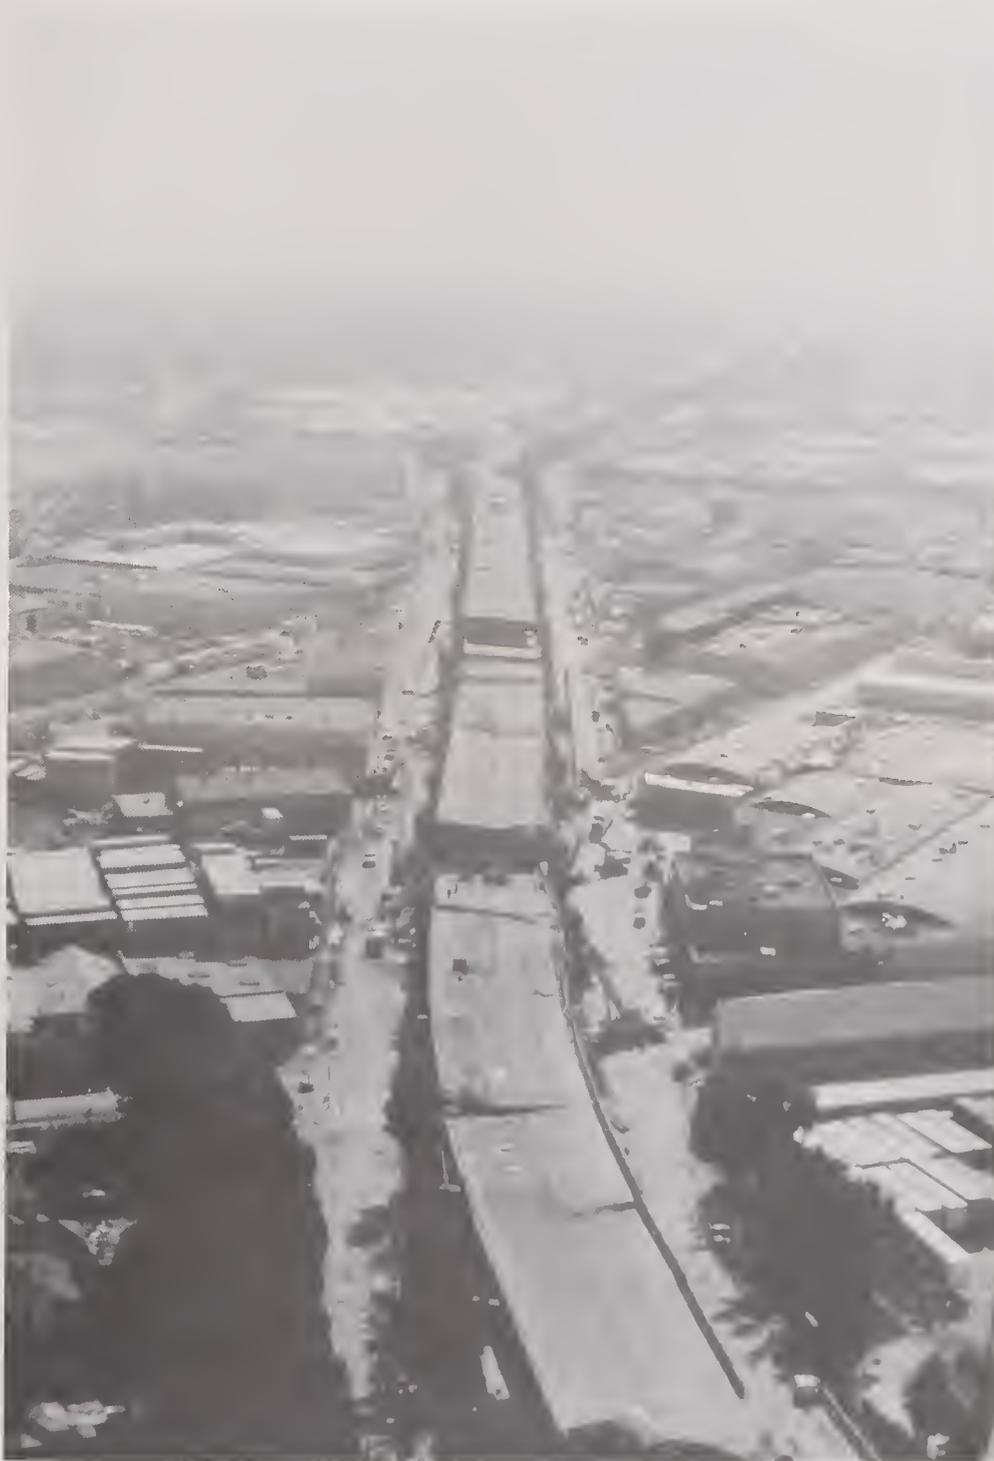
Figure 5.6.9 Aerial photo of Cypress Structure looking south from the northern limit of the collapse at 34th Street in Oakland.

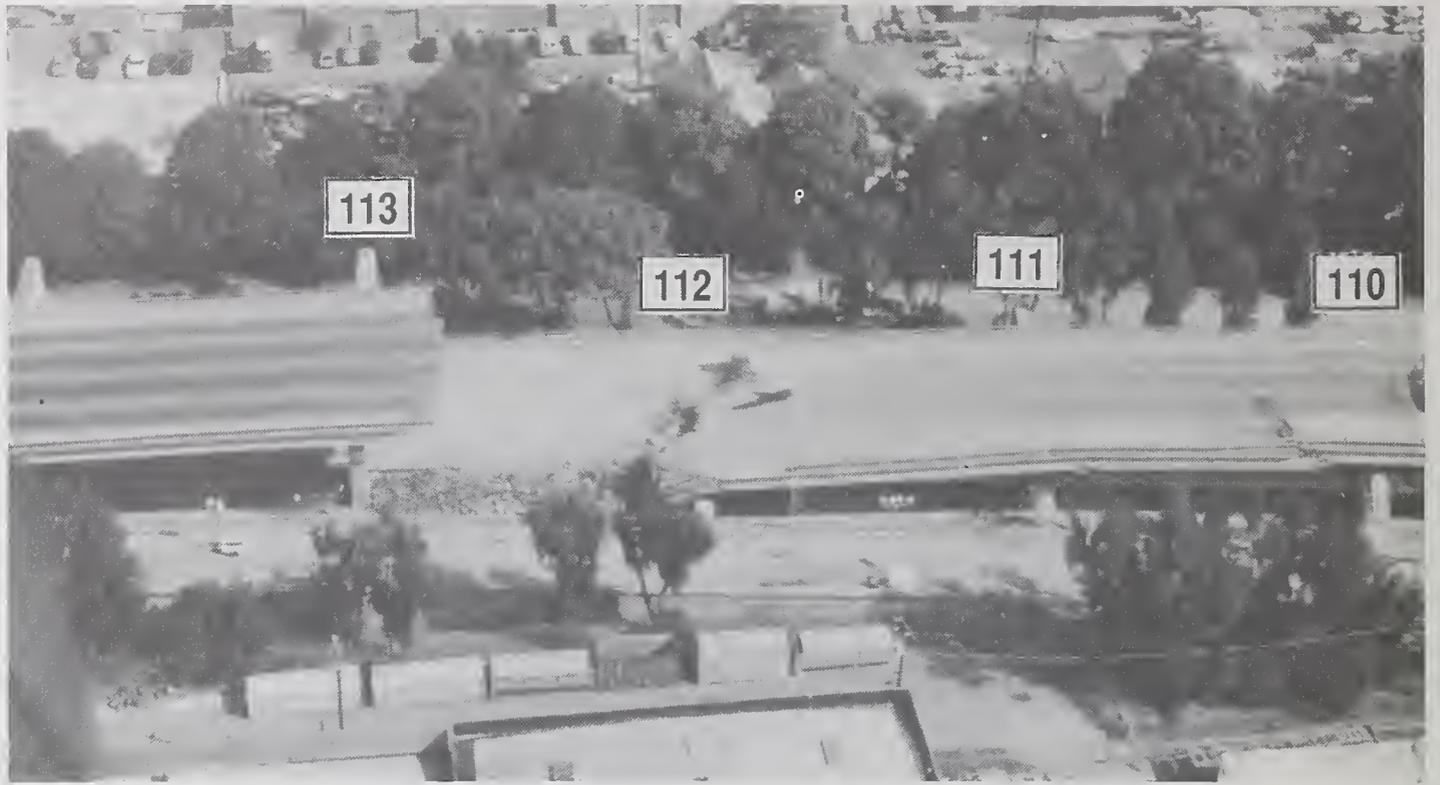
Figure 5.6.10 Aerial photo looking east to the northern limit of the collapsed portion of Cypress Structure between Bents 110-113.

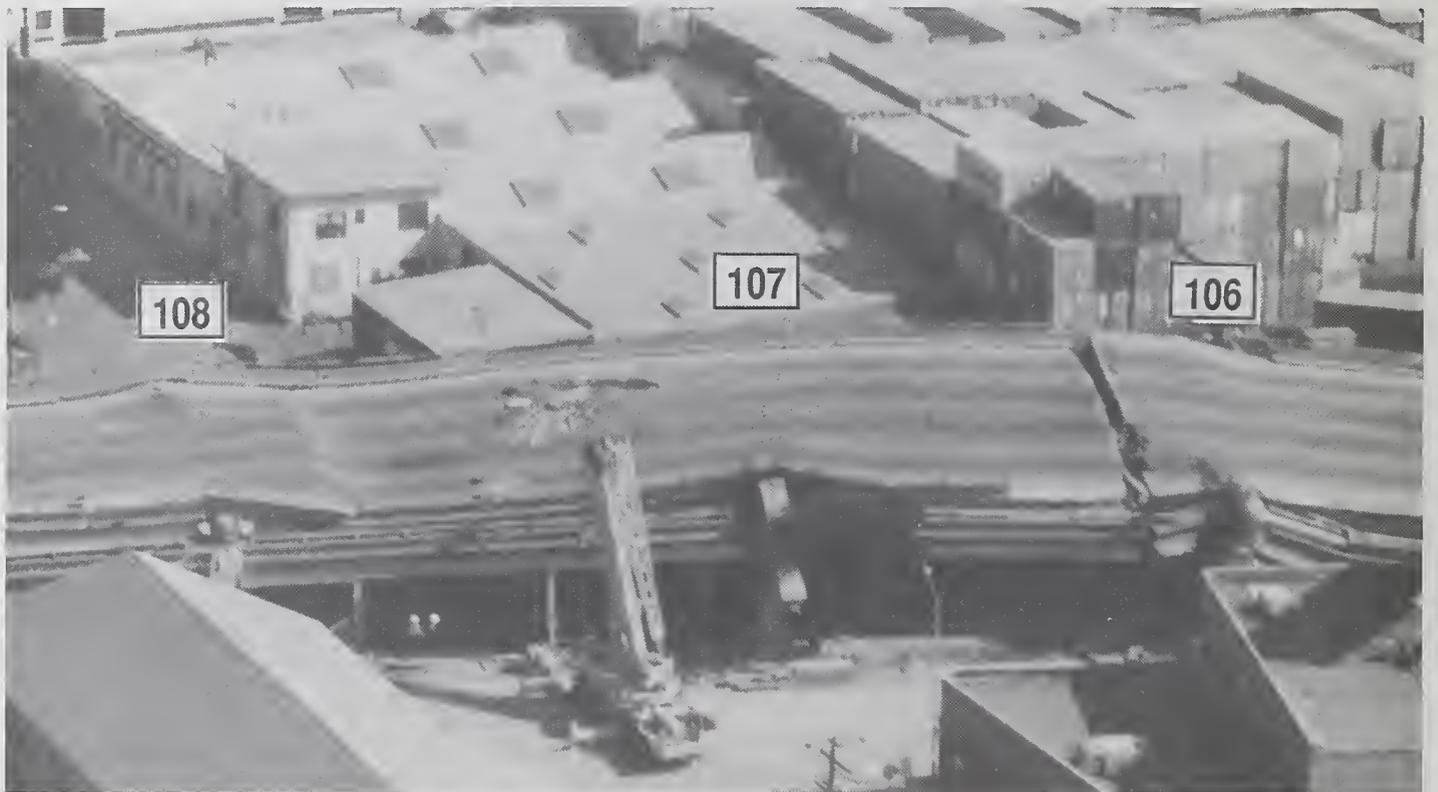
Figure 5.6.11 Aerial photo looking east to the collapsed portion of Cypress Structure between Bents 106-108.

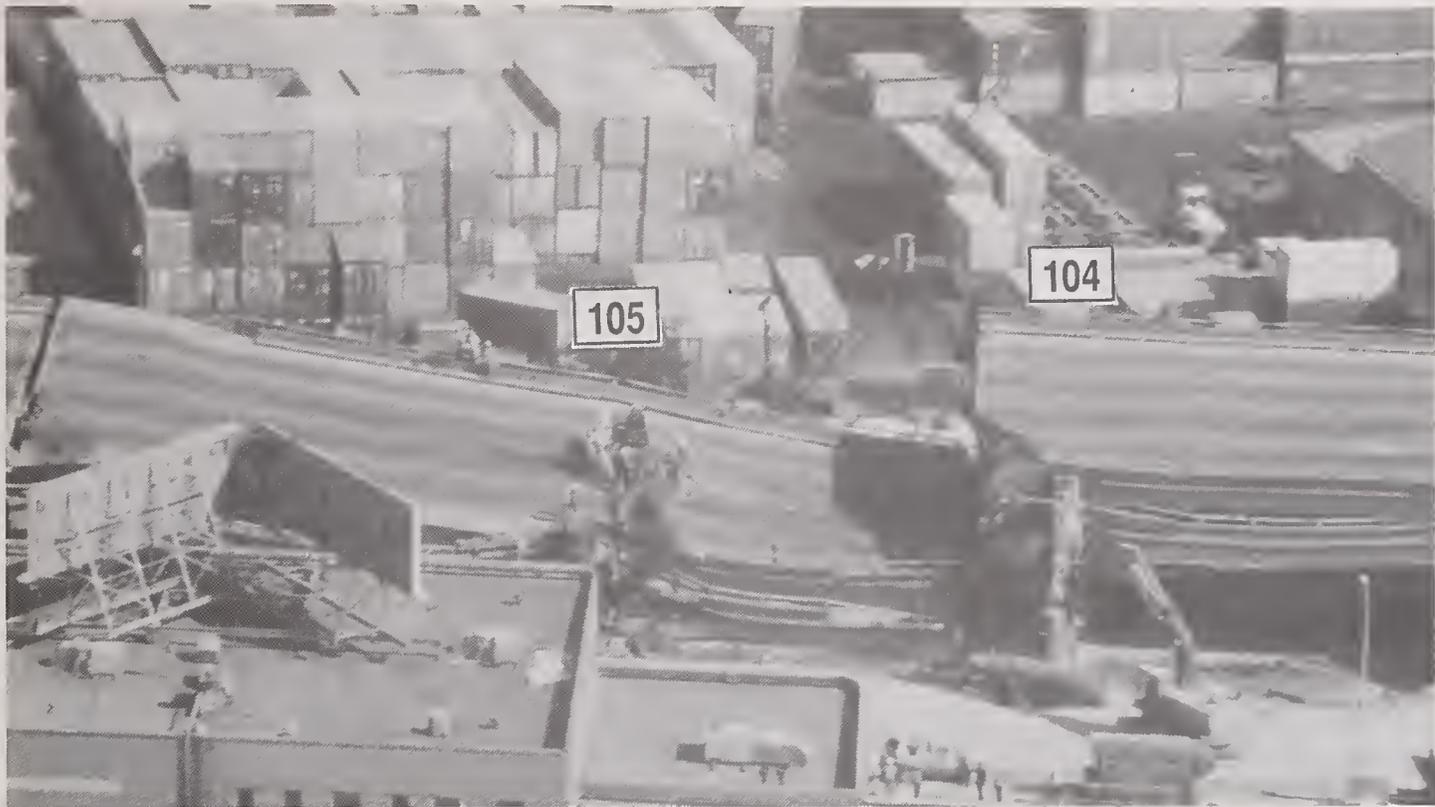
Figure 5.6.12 Aerial photo looking east to the collapsed portion of Cypress Structure between Bents 104-106.

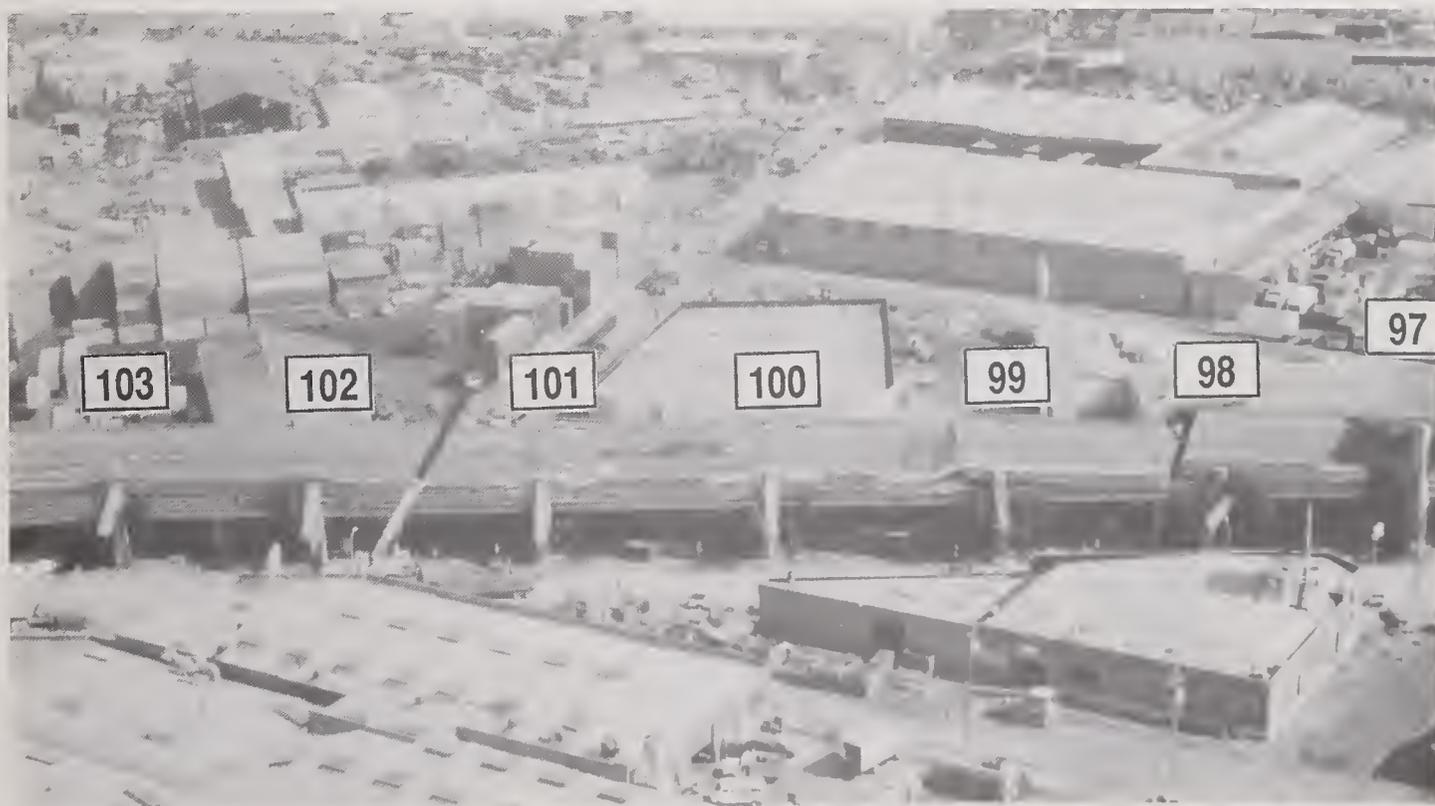
Figure 5.6.13 Aerial photo looking east to the collapsed portion of Cypress Structure between Bents 97-104.

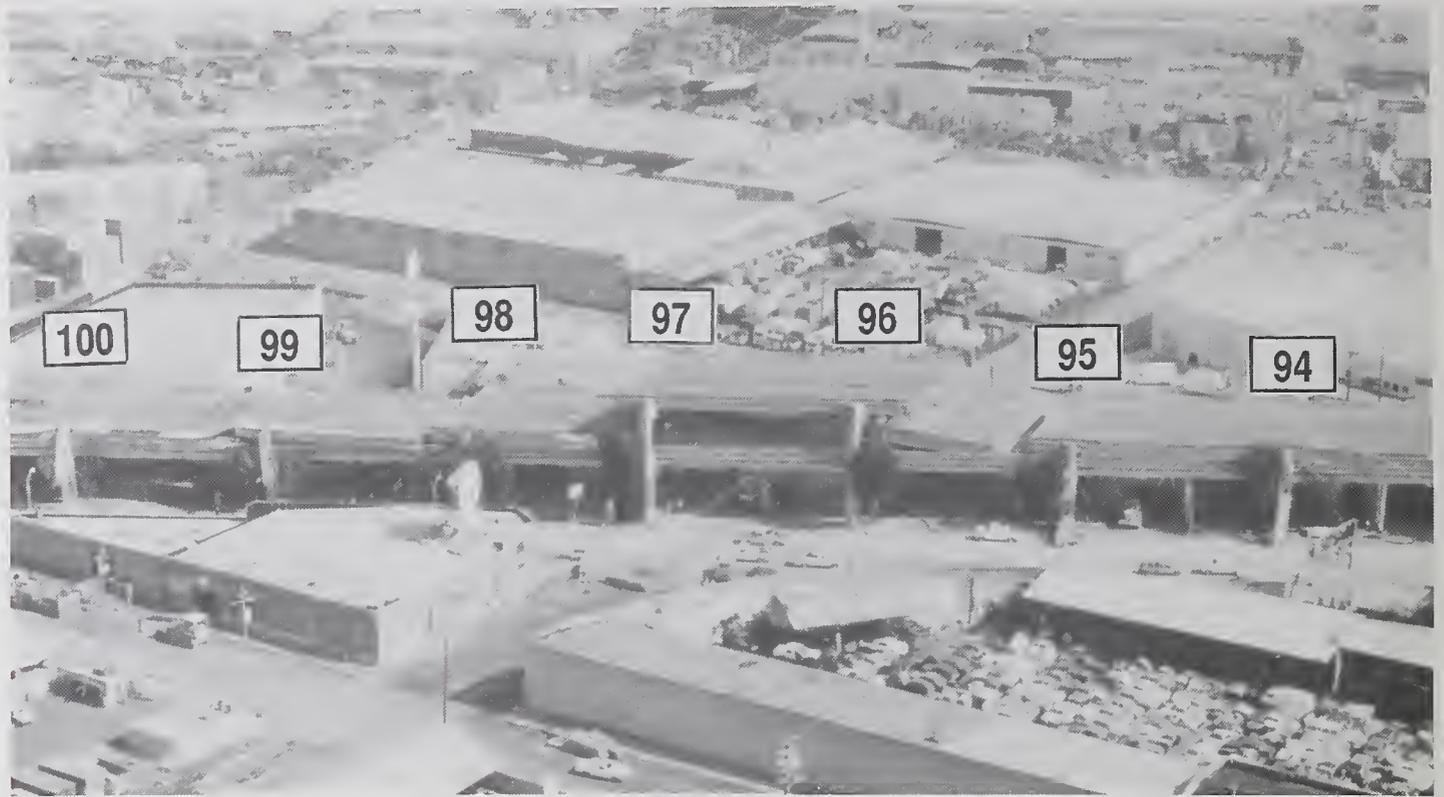
Figure 5.6.14 Aerial photo looking east to the collapsed portion of Cypress Structure between Bents 94-100.

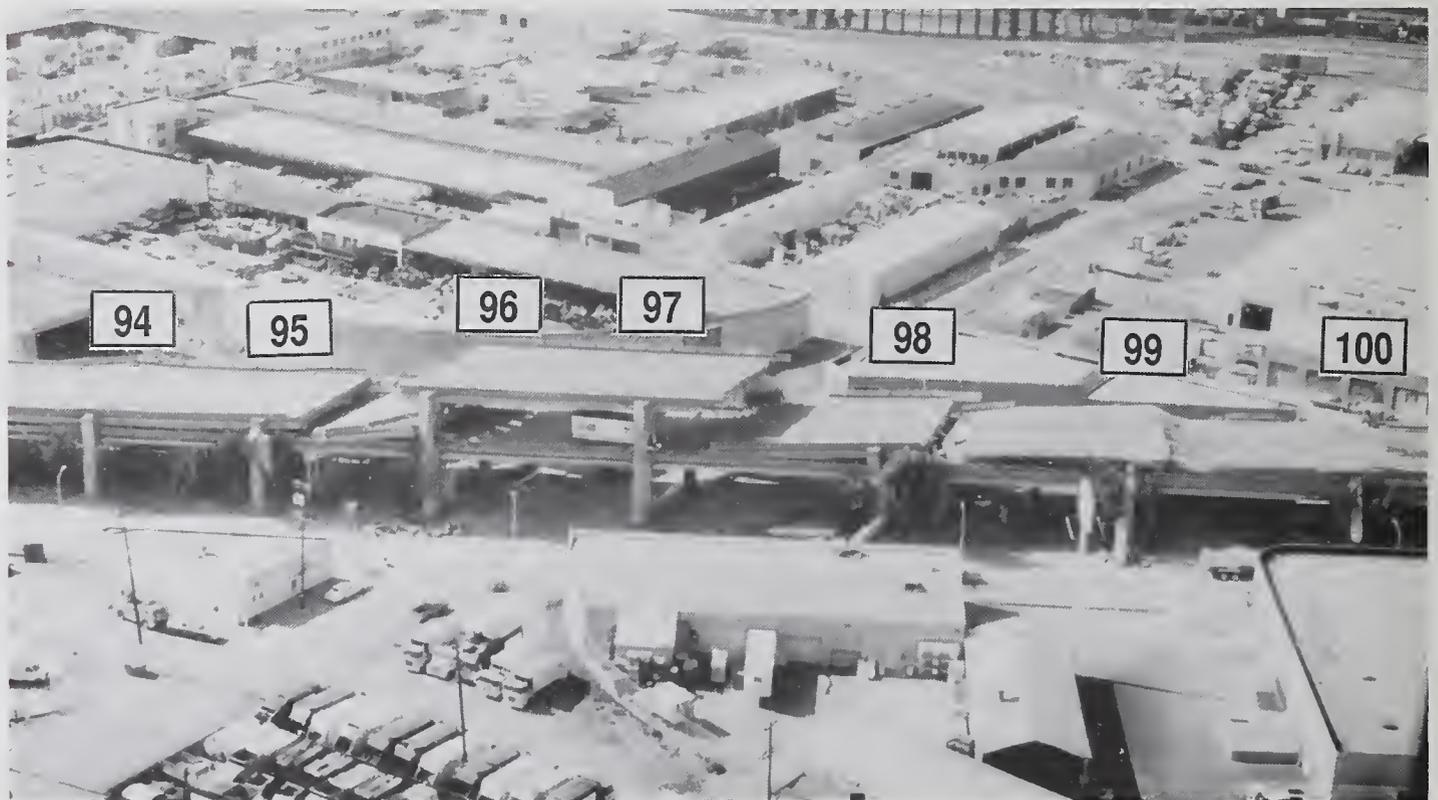
Figure 5.6.15 Aerial photo looking west to the collapsed portion of Cypress Structure between Bents 94-100.

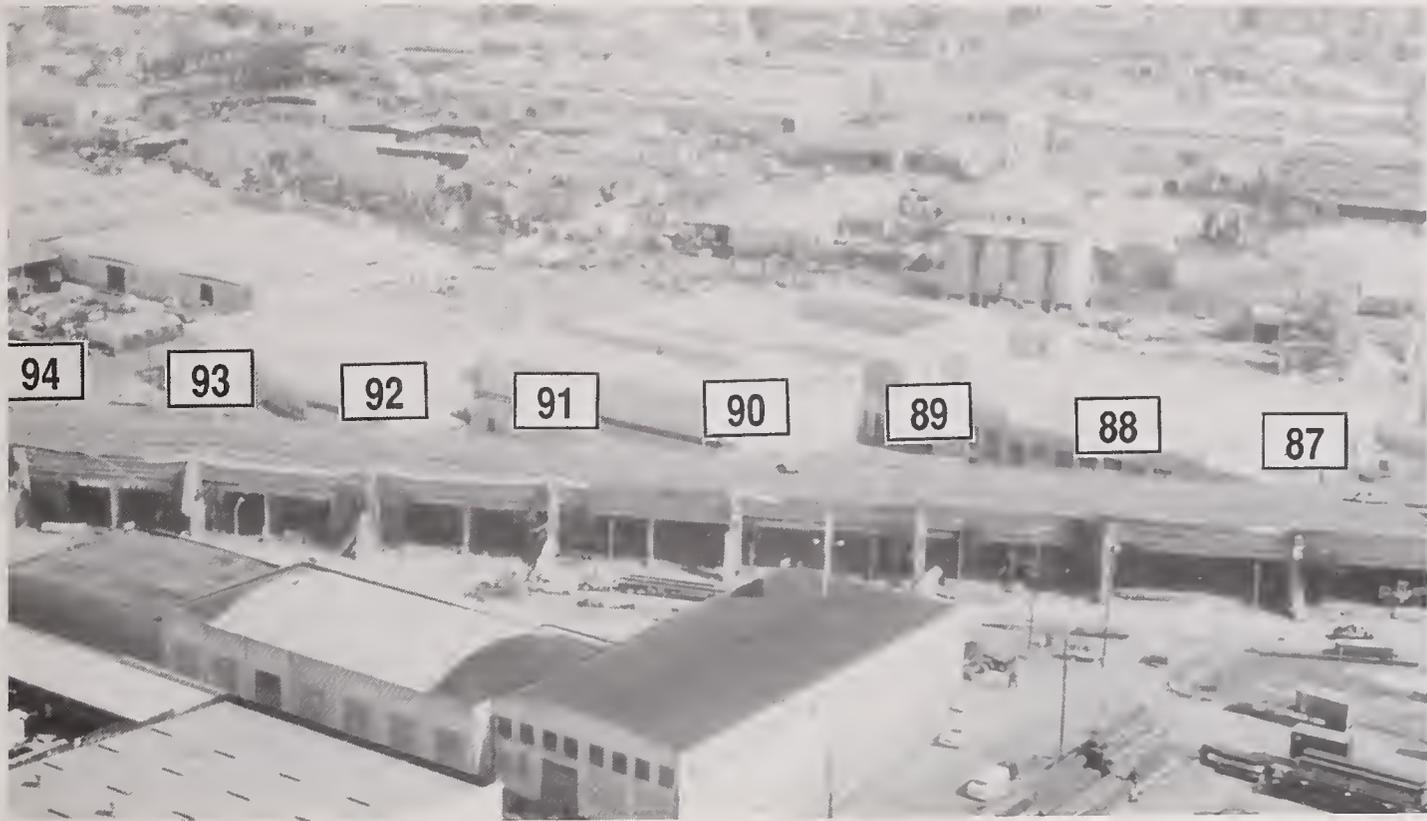
Figure 5.6.16 Aerial photo looking east to the collapsed portion of Cypress Structure between Bents 86-94.

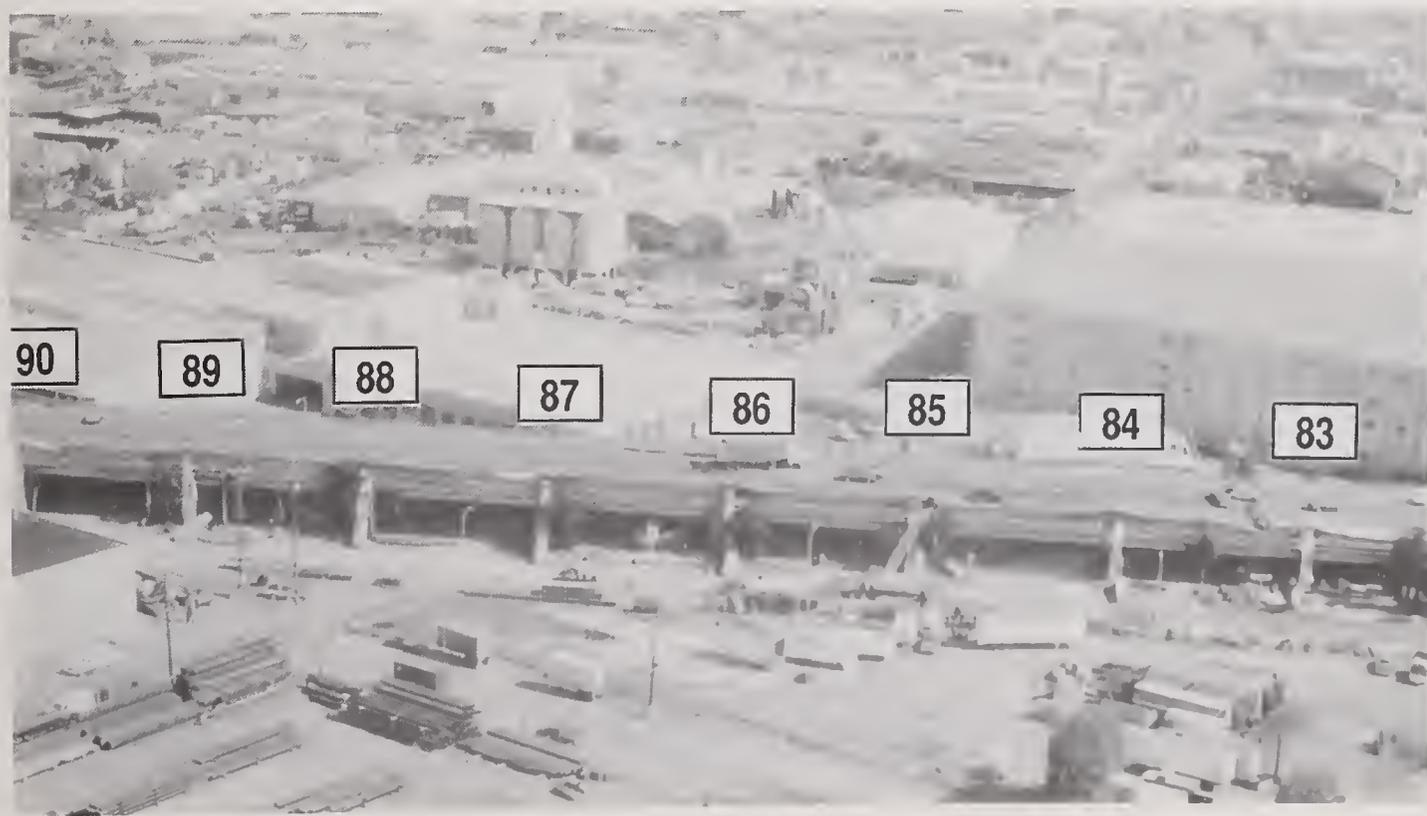
Figure 5.6.17 Aerial photo looking east to the collapsed portion of Cypress Structure between Bents 83-90.

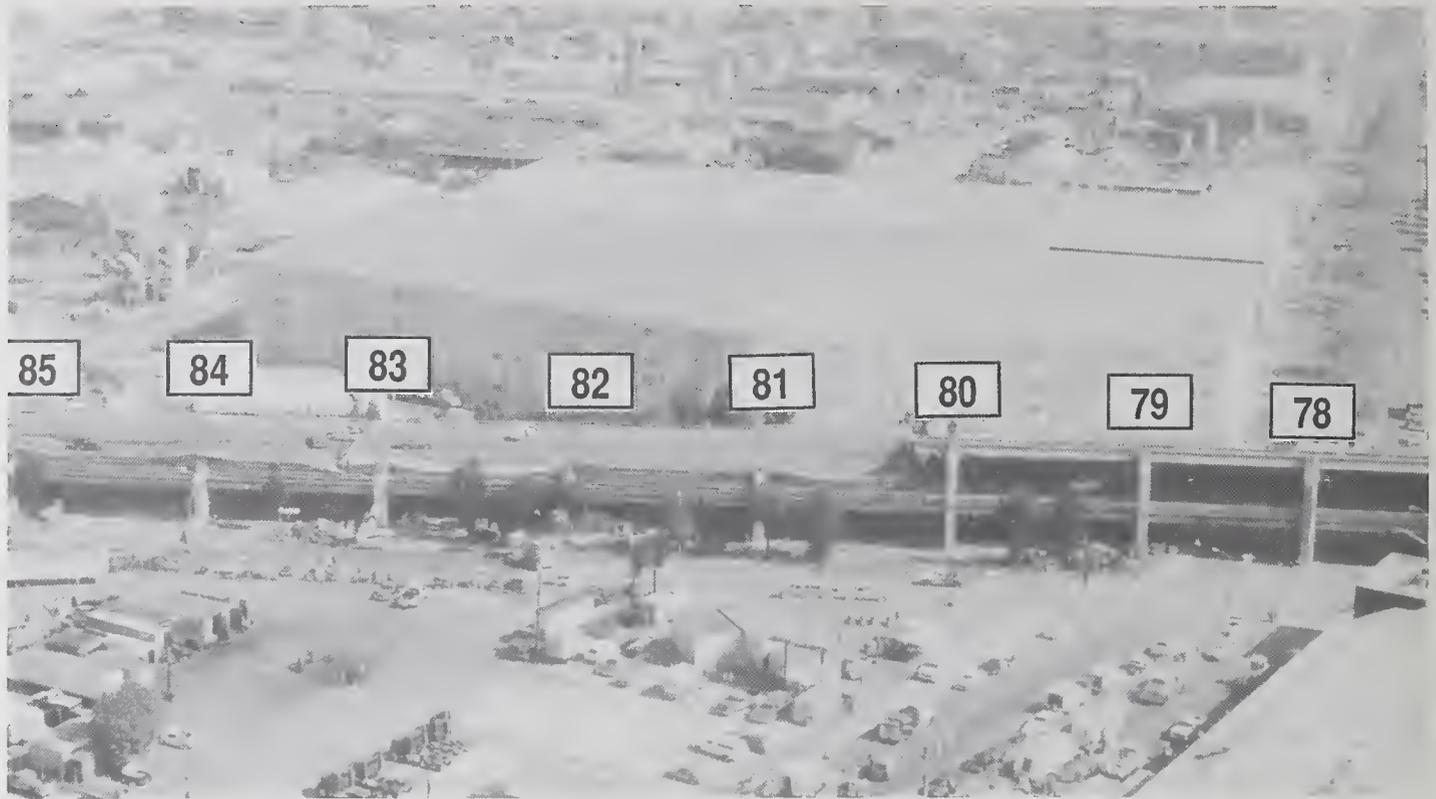
Figure 5.6.18 Aerial photo looking east to the collapsed portion of Cypress Structure between Bents 78-85.
