NIST Special Publication 778

Performance of Structures During the Loma Prieta Earthquake of October 17, 1989

H. S. Lew, Editor

January 1990

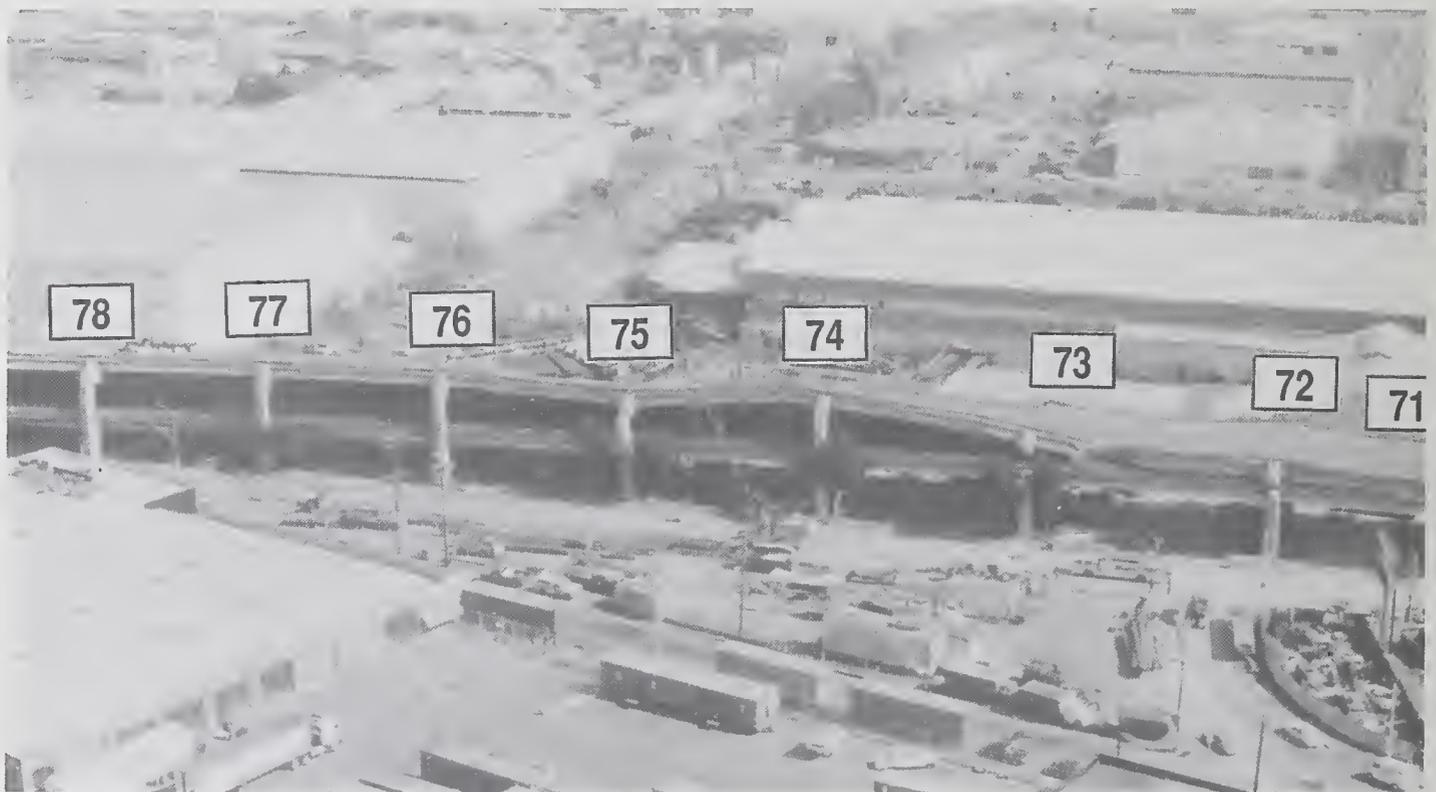
Figure 5.6.19 Aerial photo looking east to the collapsed portion of Cypress Structure between Bents 71-78.

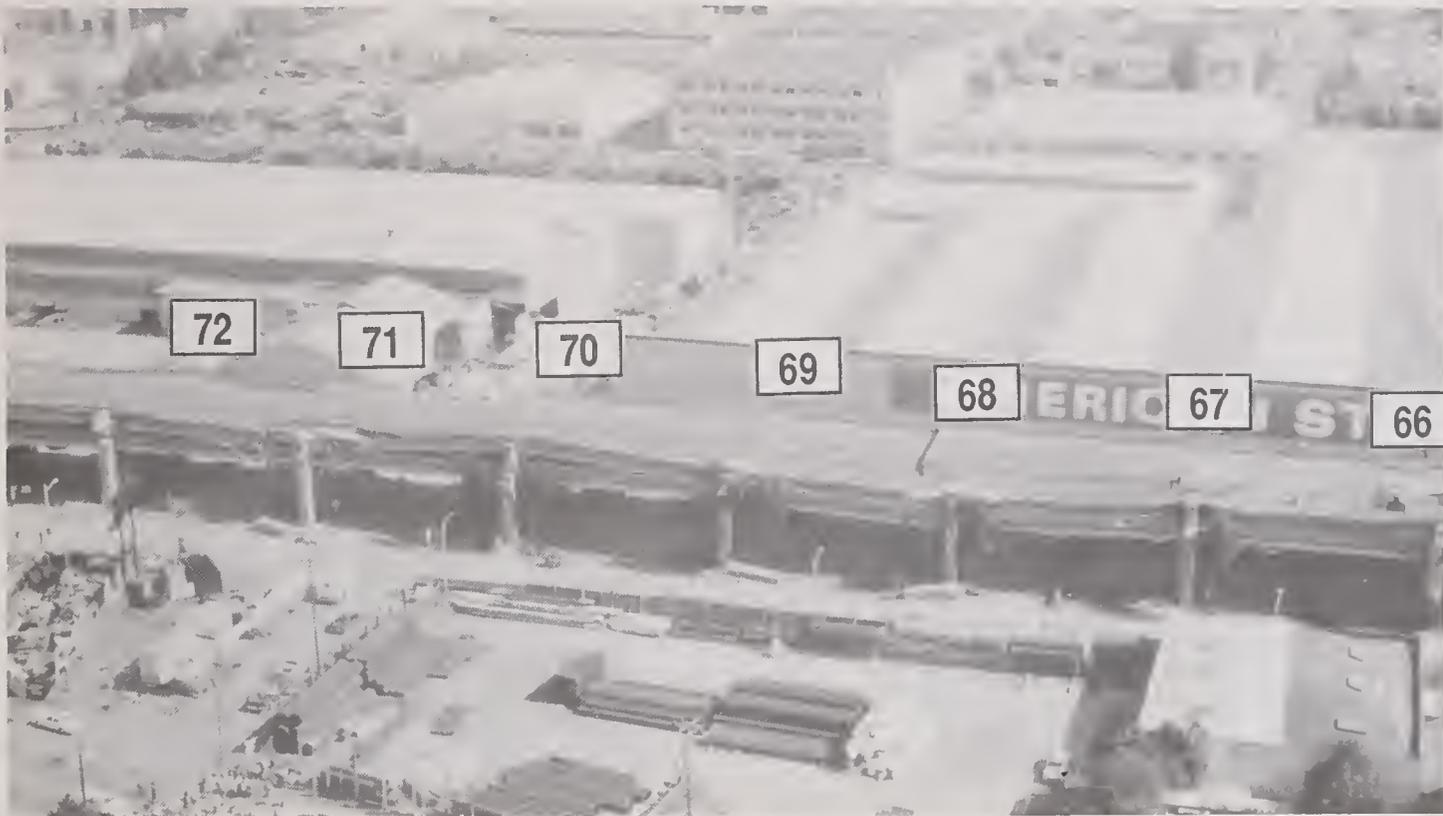
Figure 5.6.20 Aerial photo looking east to the collapsed portion of Cypress Structure between Bents 66-72.

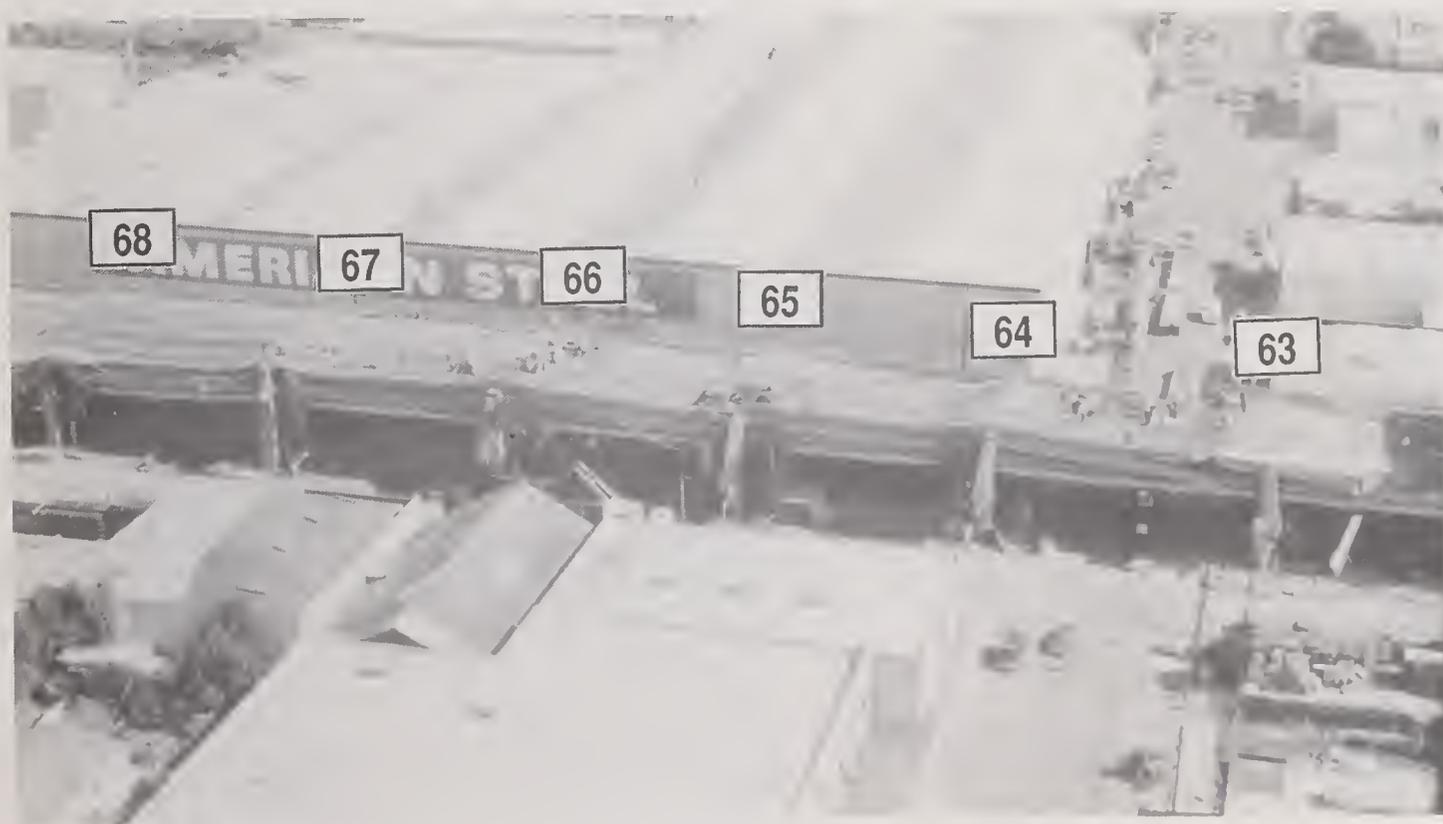
Figure 5.6.21 Aerial photo looking east to the collapsed portion of Cypress Structure between Bents 62-68.

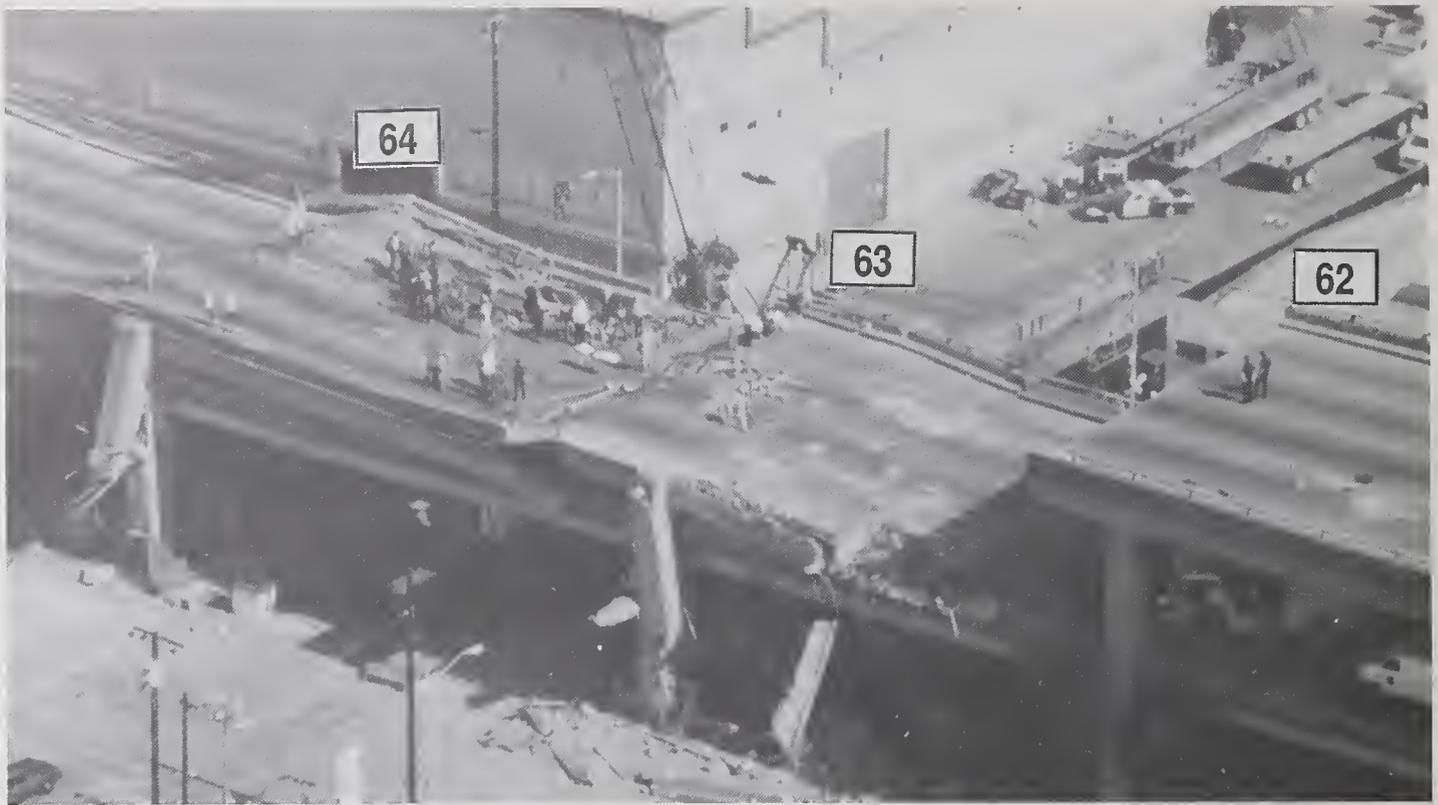
Figure 5.6.22 Aerial photo looking east to the southern limit of the collapsed portion of Cypress Structure between Bents 62-64.

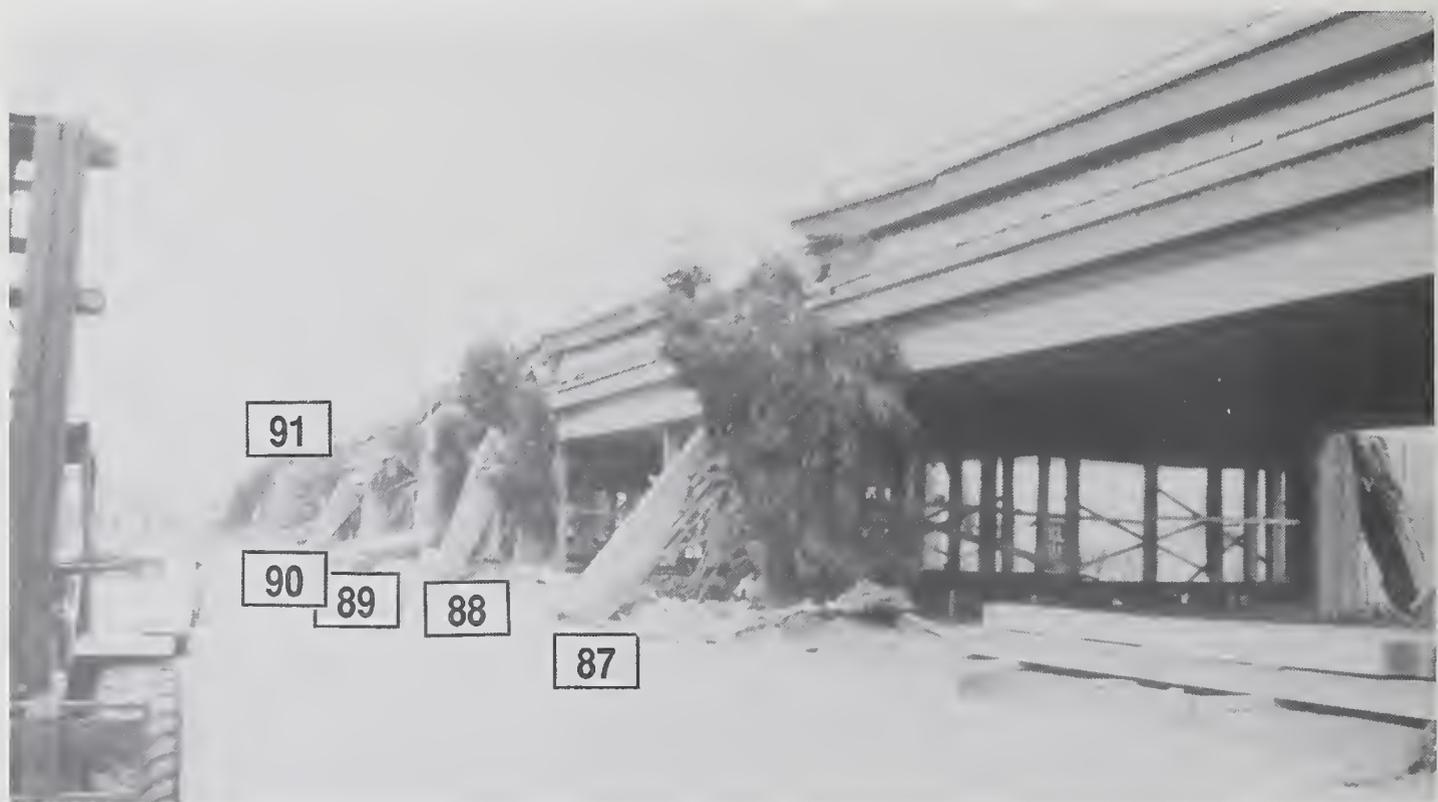
Figure 5.6.23 shows a ground-level view looking northward from Bent 86 on the west side of the expressway. All of the bents visible in this photo were Type 1 which invariably exhibited a symmetrical failure with both upper columns shearing free at their base and being splayed outward as the upper deck fell. The timber posts visible beneath the lower deck were installed by Caltrans under each bent to insure that there was no subsequent settling of the structure during rescue operations. Further evidence that the upper deck fell nearly squarely on the lower deck with no significant sidesway is shown in figure 5.6.24 which is looking northward from atop Bent 80.

Figure 5.6.23 View of the west side of Cypress Structure looking north between Bents 86-92. These were all Type 1 bents which demonstrate the uniformity of the collapse mechanism.

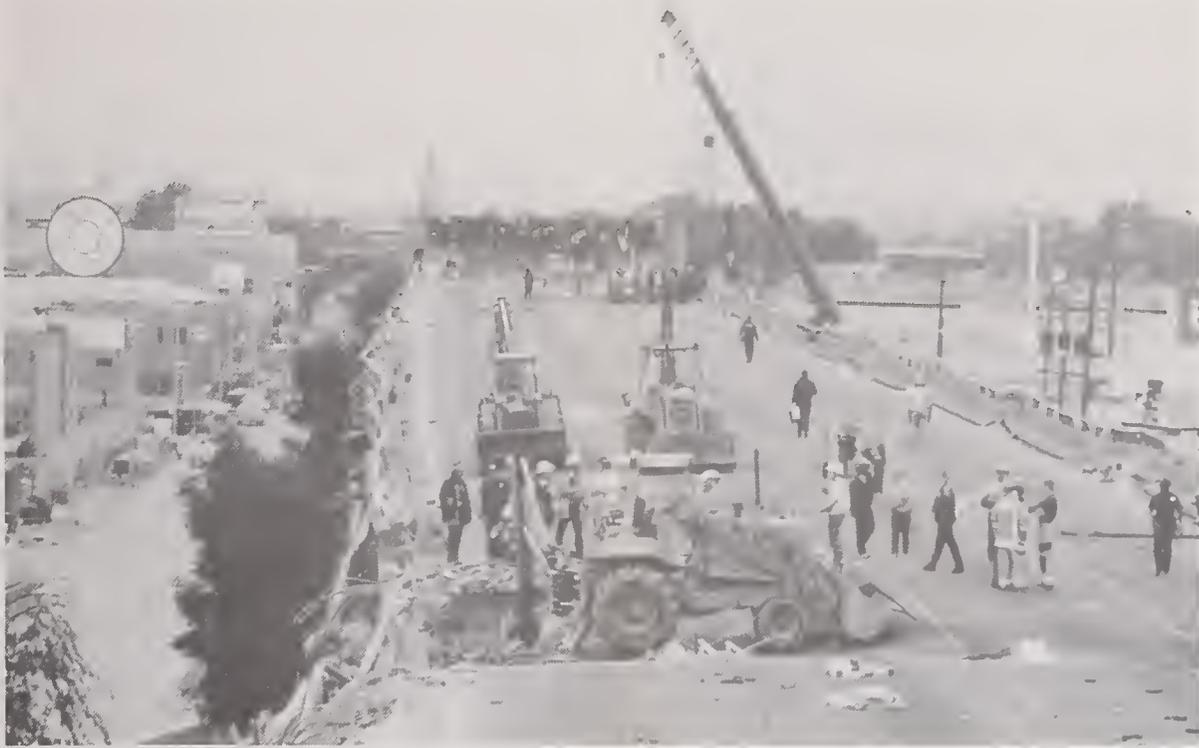
Figure 5.6.24 View of the upper deck of Cypress Structure looking north of Bent 80. This photo illustrates the negligible lateral displacement of the upper deck relative to the lower deck during the collapse.

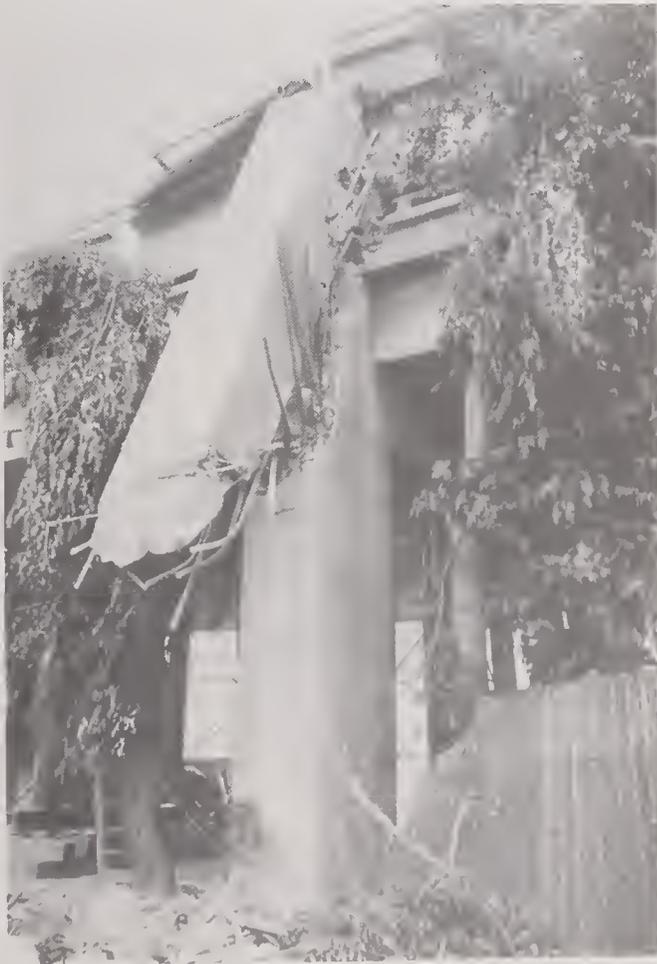
Figure 5.6.25

Figures 5.6.25 through 5.6.28 show four minor variations of Type 1 bent failure. All views are from the west side of the respective bents. At Bent 65 (fig. 5.6.25), it can be seen that the upper column support pedestal is still attached to the base of the column and that an inclined failure plane exists through the failed pedestal. Note that confining reinforcement in the vicinity of the lower girder/column joint is non-existent. As for most Type 1 bent failures, the upper columns remained tenuously attached to the upper bent girder. Bent 85 (fig. 5.6.26) shows a similar situation regarding the upper column support pedestal (beneath the numbers "85" in the figure). Here it is evident that the failure plane for the pedestal ran flush with the curved face formed by the lower bent girder negative moment steel. It is also evident that the seismic loads, in combination with a lack of confining steel in the upper beam/column joint, were sufficient to induce an explosive rupture of concrete at the top of the column, breaking it free from the upper girder steel seen at the top center of the photo. It should be emphasized, and it will become clear in subsequent discussion, that such compressive failures did not initiate the collapse of the bent, despite the lack of lateral confining steel in the upper girder/column joint. At Bent 90, the upper column apparently sheared through the 4-#10 dowel bars at the center of the shear key and was propelled outward

A view of the west side of Bent 65 of Cypress Structure illustrating the predominant failure mode for a Type 1 bent. The upper frame columns sheared through the support pedestal which connected them to the lower frame. In most cases the upper columns remained connected to the upper deck as shown.

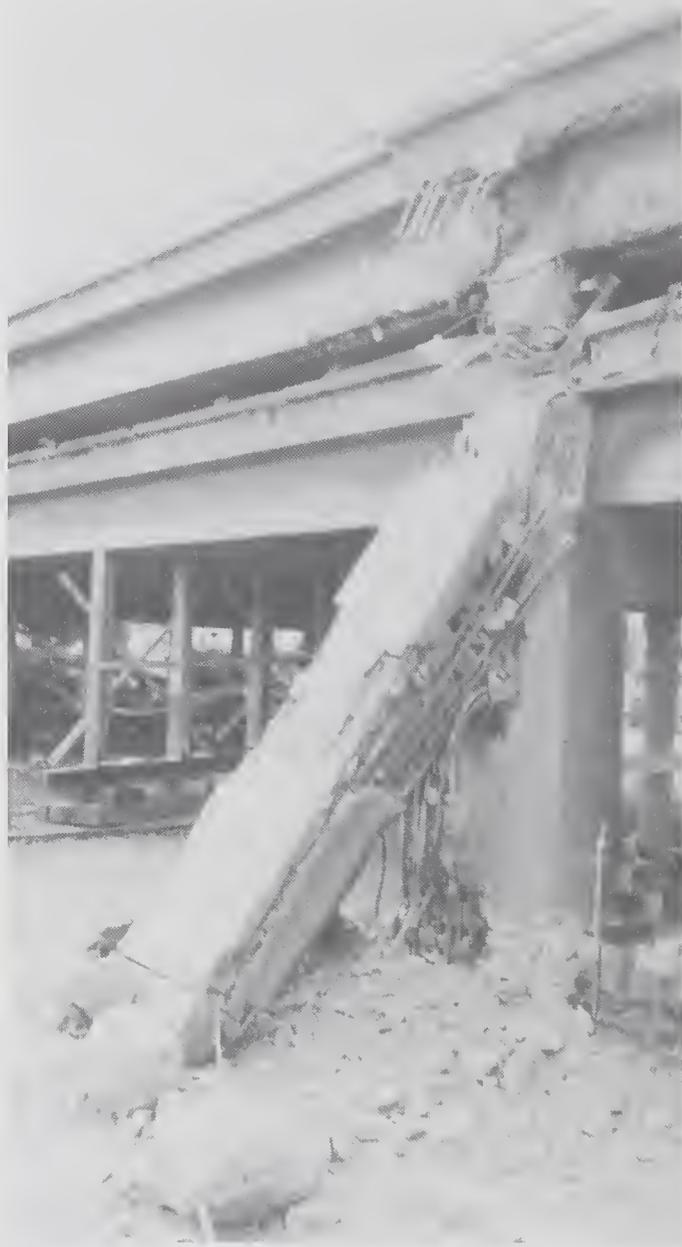
Figure 5.6.26

Failure of the west side of Bent 85. In this particular case a portion of the sheared support pedestal is still attached to the base of the upper column. The top of the column failed explosively and separated from the upper frame girder.

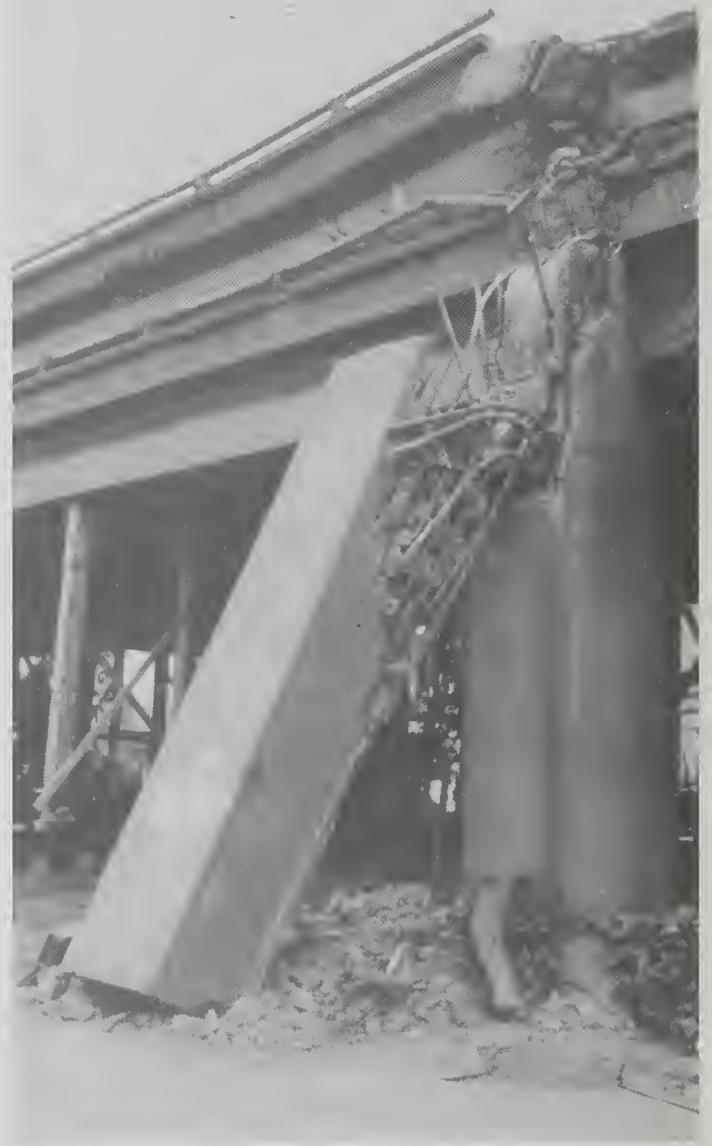
Figure 5.6.27

Failure of the west side of Bent 90. In this case the supporting pedestal for the upper columns was completely disintegrated; only the interior face of axial reinforcement that was present in the pedestal remains imbedded in the lower column. It can be seen that the failure plane followed the face of the curved negative moment steel from the lower frame girder.

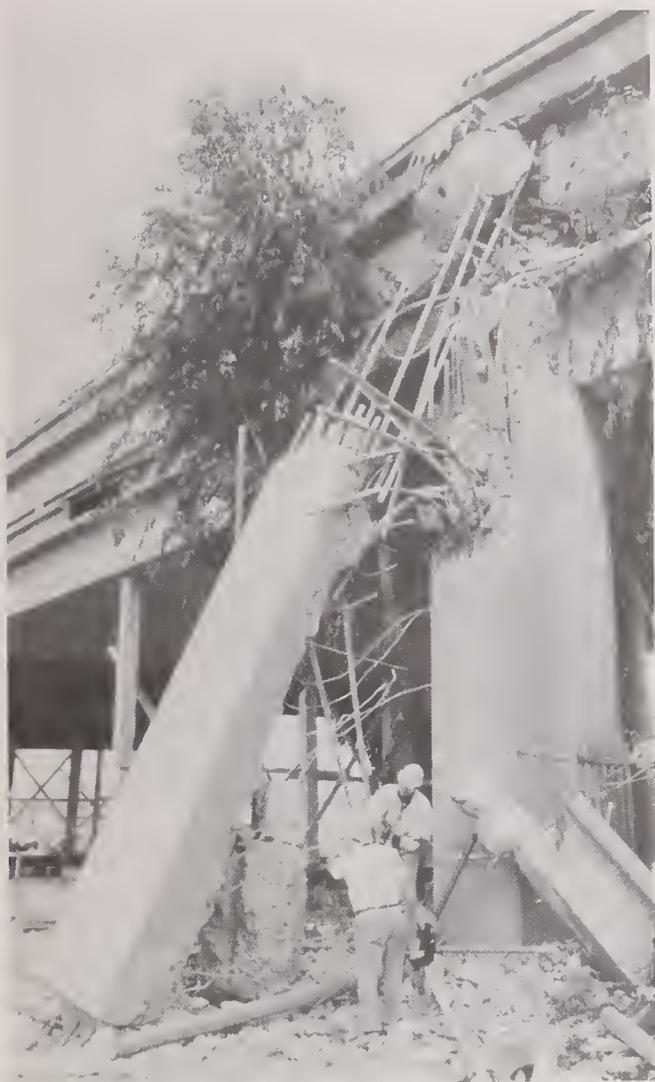
Figure 5.6.28 shows a final variation of a Type 1 bent failure. This particular column, at Bent 94, carried a pipe through its center which drained the upper deck. Given a lack of significant confining reinforcement (note the thin #4 ties which appear as wires compared with the massive #18 axial reinforcement), the presence of this pipe likely served to create the fracture path which split the column.

Failure of the west side of Bent 94. The presence of a central pipe, used to drain the upper deck, permitted a fracture plane to develop through the center of the column. The eastern half of the column disintegrated under compressive load while the western half spalled off.

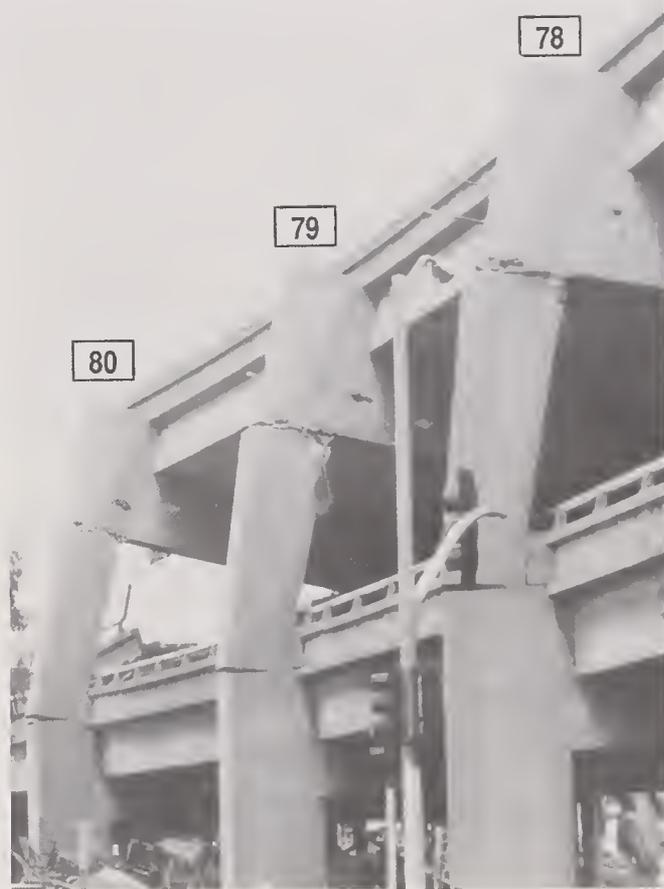
Figure 5.6.29 shows a closeup of a Type 2 bent failure in which the eastern half of a series of three-hinged prestressed bents collapsed, due to shearing failure at the base of the east column, leading to a rigid body rotation of the upper deck about the western, two-hinged columns. As can be seen, the western column shear keys did perform as hinges even under rotations sufficient to cause compressive spalling on the interior face of the columns (fig. 5.6.30). Most of the upper bent girders fractured due to impact-induced bending stresses. This in turn yielded, and subsequently fractured most of the post-tensioning bars which, because they were unbonded, were partially expelled from the girder due to rebound from the release of stored elastic energy, as shown in figure 5.6.31. It is of some significance that Bent 78, the innermost frame in figure 5.6.32, was skewed at an angle of 16 degrees. This difference, although subtle, may be part of the explanation for why this particular section did not fail completely. This performance is to be directly contrasted with Bent 72 (see figs. 5.6.33 and 5.6.34) in which the western two-hinged columns were ejected from the structure. Of particular note in figure 5.6.33 are the bent #10 bars projecting both from the top of the lower bent column as well as the bottom face of the upper bent girder. These represented the only continuous reinforcement through the upper and lower shear keys. Figure 5.6.35 leaves no doubt that lateral confining steel was insufficient to prevent localized fracture of the concrete and the subsequent pullout of these dowels. A closeup of the top of the Bent 71 upper two-hinge column in figure 5.6.35 shows a detail of the still intact shear key, 4-#10 dowel bars, and, in this particular instance, a central drainage pipe. In this case the dowel bars remained intact within the column and pulled out, instead, from the upper girder joint.

A view looking north at the west side of Bents 78-80. These were all Type 2 bents which included prestressing of the upper girders. This particular mode of failure, in which only the east columns of the upper frames failed, is noted as a Type A Failure in subsequent discussions. Type A Failures occurred in Bents 74 through 80 (see figs. 5.6.18 and 5.6.19).

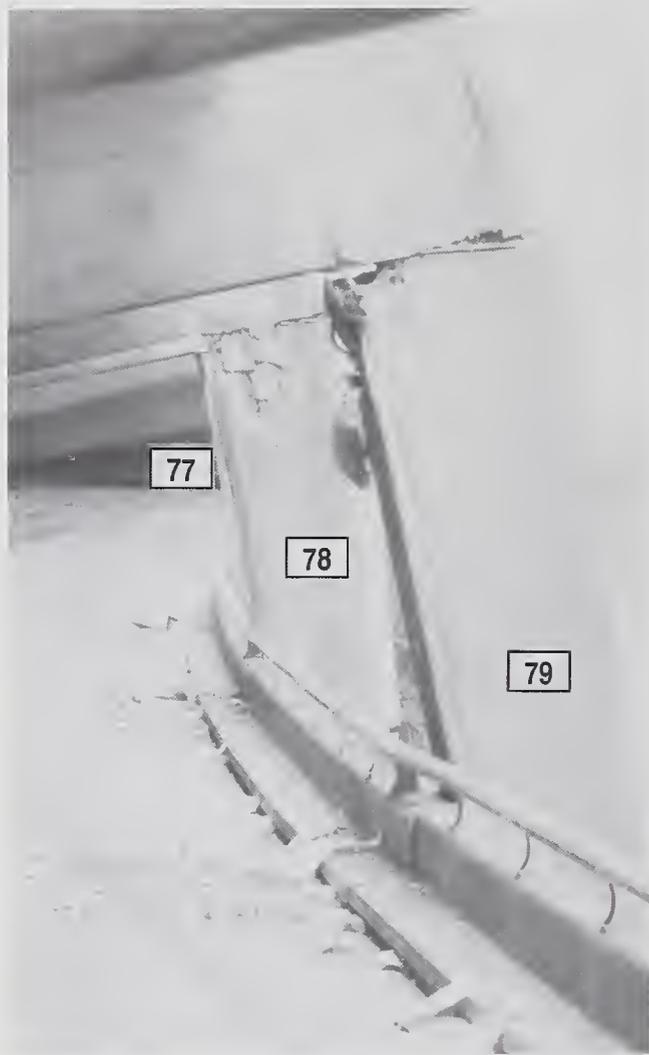
Figure 5.6.30

A close-up view looking south from Bent 80 at the west side of the upper portion of Cypress Structure. Note compression spalling along the interior face of the tops of the columns.

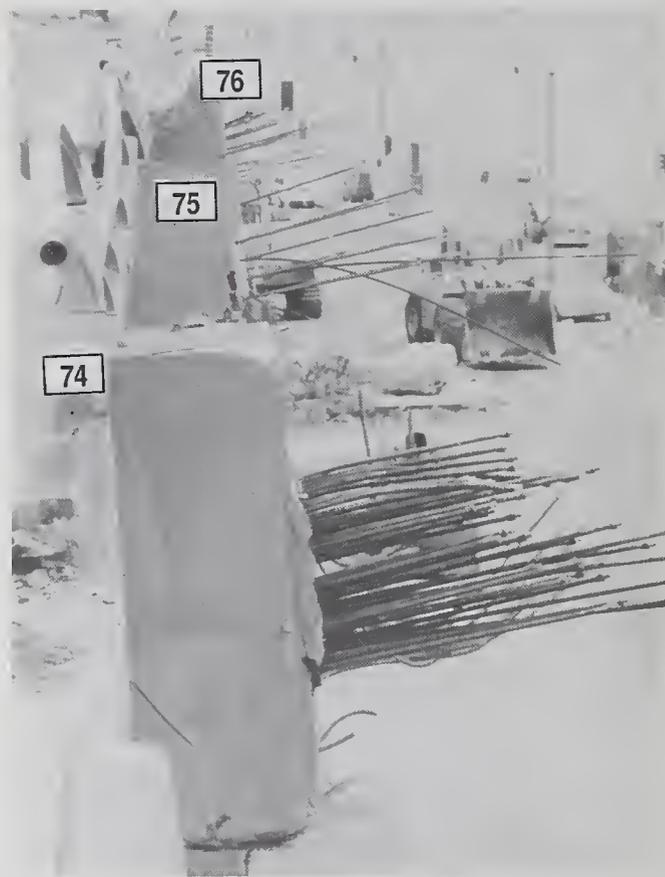
Figure 5.6.31

Due to excessive flexural displacements in the upper frame girder, most of the post-tensioning tendons yielded and then fractured. The tendons were unbonded, to permit extension of the top girder at a later date as part of a planned access ramp. The stored elastic energy drove the tendons from their ducts, as shown here at Bents 74, 75, and 76 on the east side of Cypress Structure.

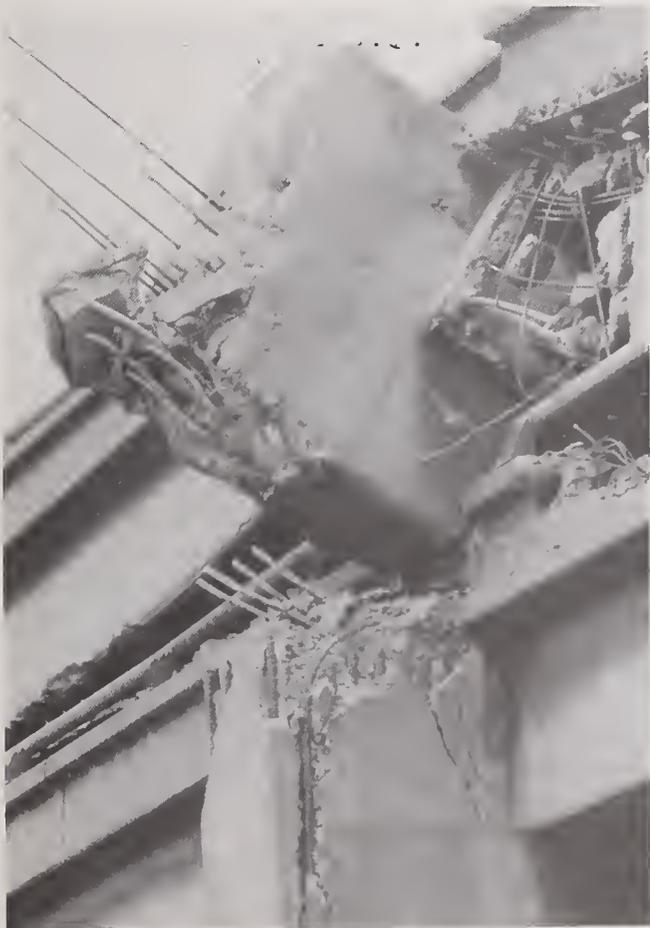
Figure 5.6.33

A close-up of the west side of Bent 72 shows the second, or Type B, variation of failure observed for Type 2 bents. In this case the entire double-hinged upper frame column segment has been ejected from the structure. The 4-#10 bars which passed through the upper and lower shear keys may be seen projecting from the base of the upper girder and the top of the lower column.

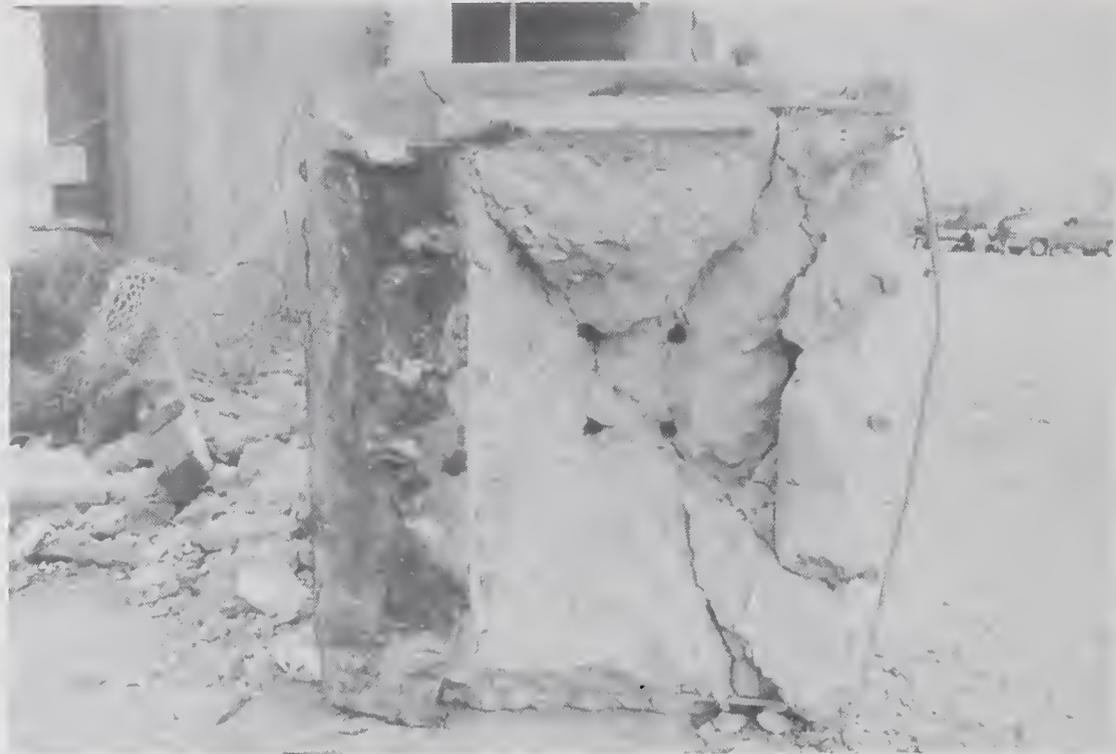
Figure 5.6.34 Detail of the base of the two-hinged column that was ejected from the west side of Bent 72. The 4-#10 dowel bars which passed through the center of the shear key have been pulled free.

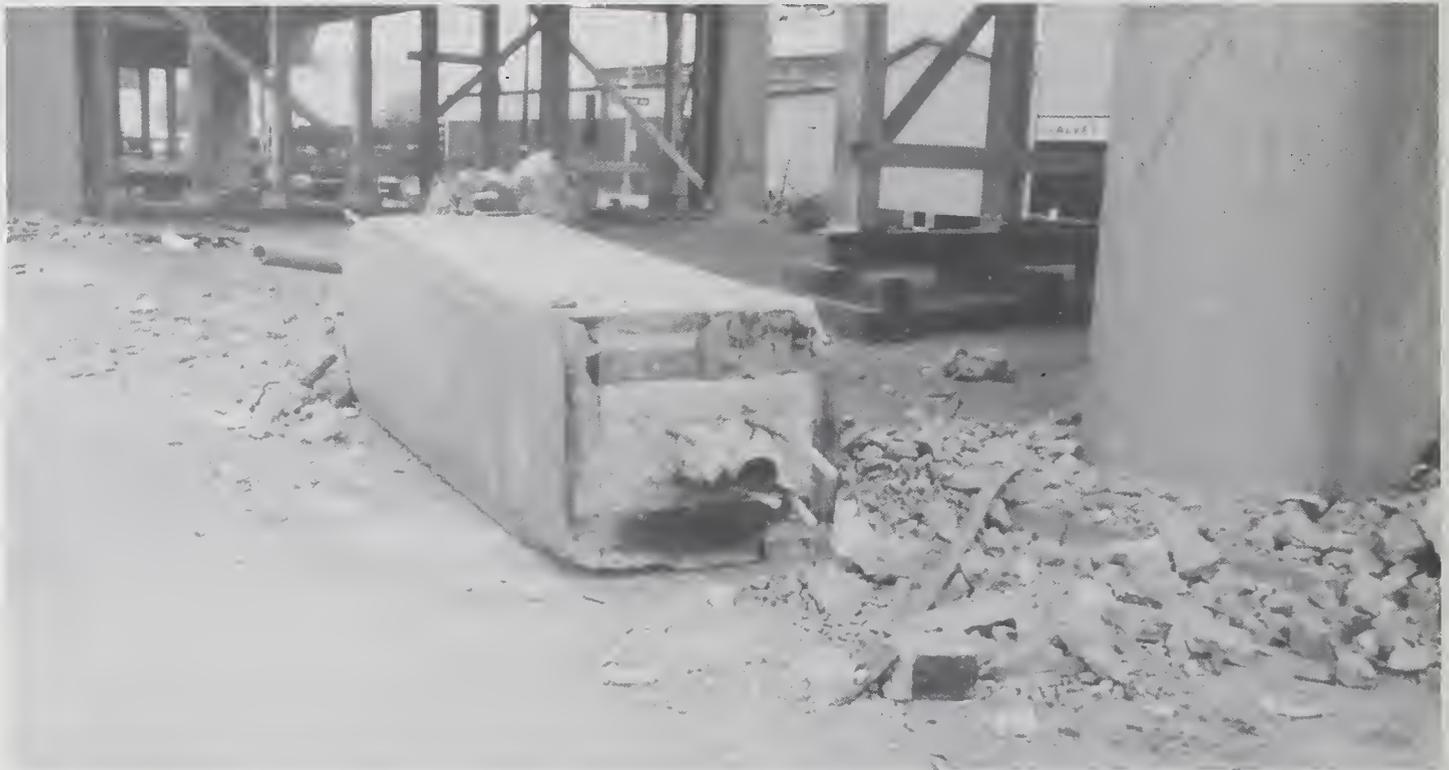
Figure 5.6.35 Detail of the bottom of the two-hinged column that was ejected from the west side of Bent 71 showing central pipe used to drain the upper road deck and the 4-#10 dowel bars used to transfer shear across the hinge.

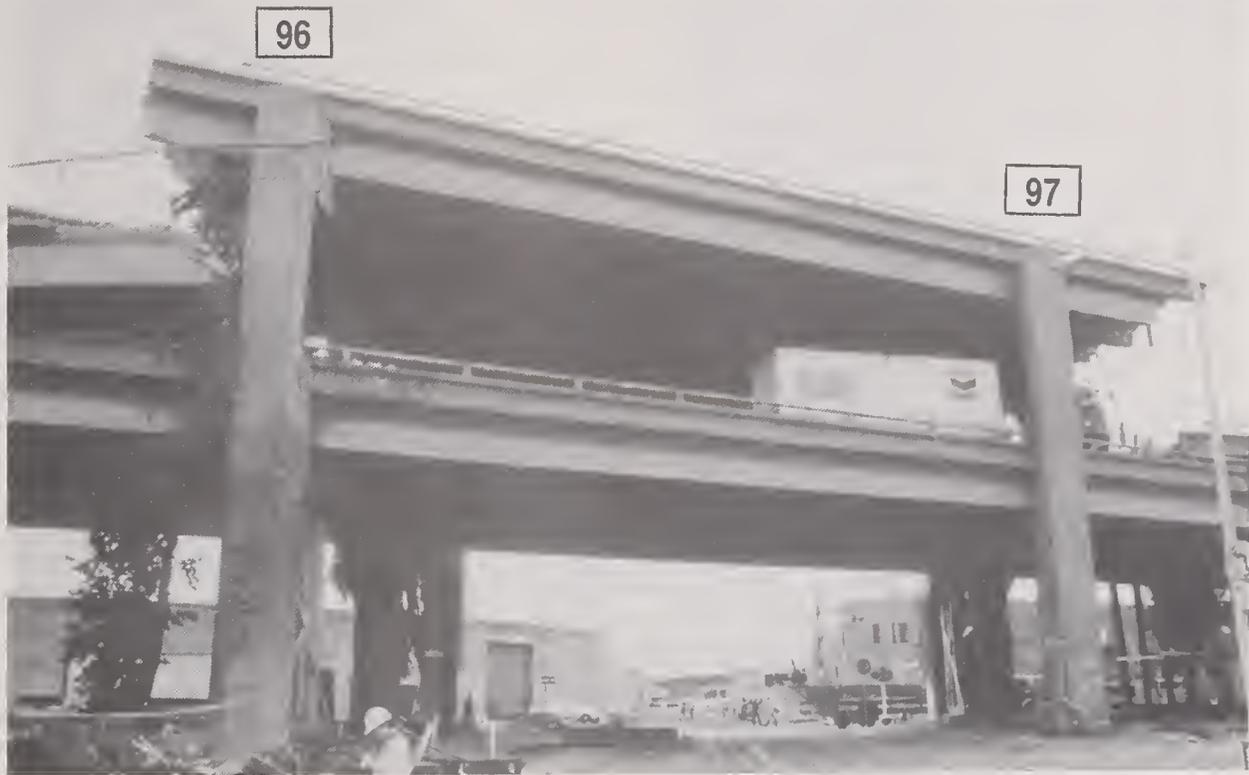
Figures 5.6.36 and 5.6.37 show details of the span between Bents 96 and 97, the only one to remain completely intact between Bents 62 and 113. There are several obvious differences which could account for this. The Type 4 bent, which includes Bents 95-98, contains an additional central column in the lower bent which would serve to limit lateral sway at the first deck level. More importantly, the reinforcing steel at the base of the upper bent columns is continuous with the lower columns, eliminating the pedestal/hinge detail that appears to have contributed to widespread failure in Type 1 bents. Figure 5.6.37 indicates that, despite severe flexurally induced cracking at the lower column/girder joint, the upper and lower

Figure 5.6.36 View looking west towards Bents 96 and 97 which supported the only segment of the upper deck to remain standing between Bents 62 and 113.

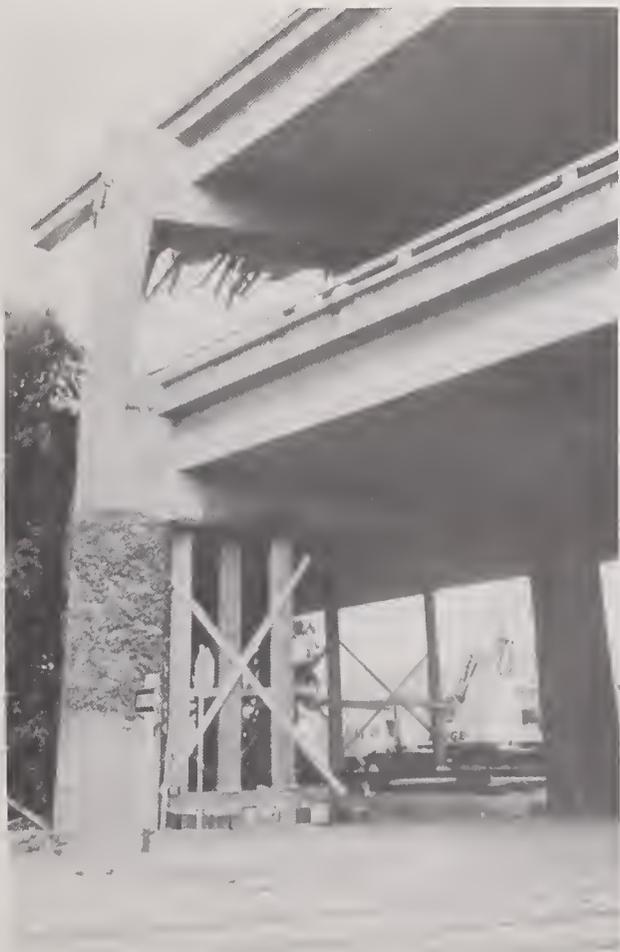
Figure 5.6.37

It is interesting to note that the calculated column shear resistance reported by Priestley et al. (Priestley, 1989) for Type 4 bents (see fig. 5.6.5), when modified to account for the measured compressive strength of the concrete, comes to 398 kips (1770 kN). Accounting for portal frame reaction shear at the column bases for the upper bent, the lateral base acceleration required to achieve failure is 0.38g, i.e., greater than the expected acceleration from the response spectra reported by CDMG (CDMG, 1989b). These frames, as can be seen in figure 5.6.37, suffered significant damage, but remained standing.

Detail of the west side of Bent 97 showing extensive shear cracking at the interior beam/column joint for the lower frame and compression spalling at the upper beam/column joint. Axial reinforcement for the upper frame columns was continuous with the lower frame columns on both east and west sides. This, and the larger cross section, helps to explain why these Type 4 bents did not collapse.

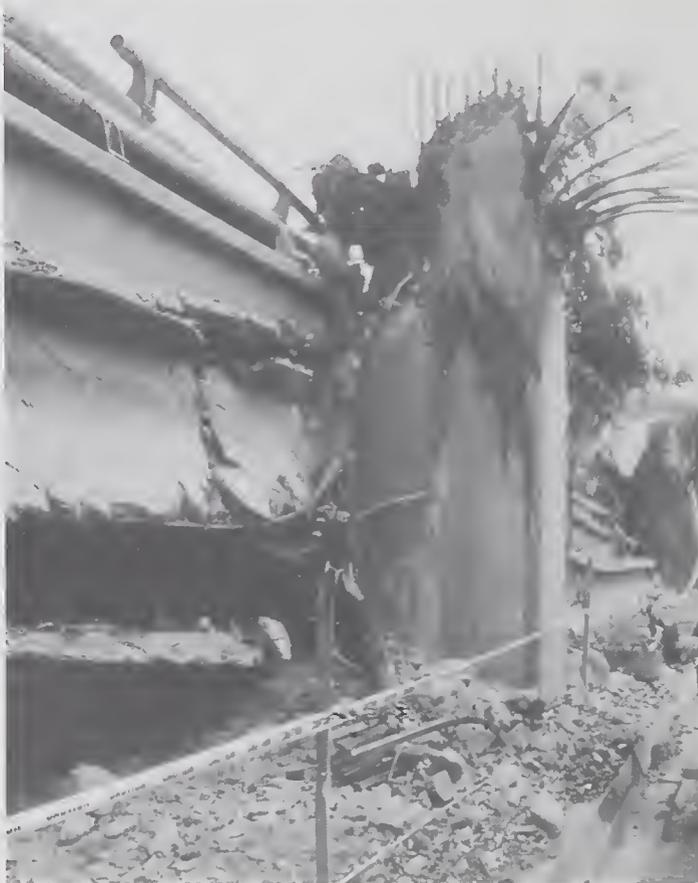
Figure 5.6.39

Close-up of the west side of Bent 105 looking south, illustrating complete shear failure of the lower bent beam/column connection.

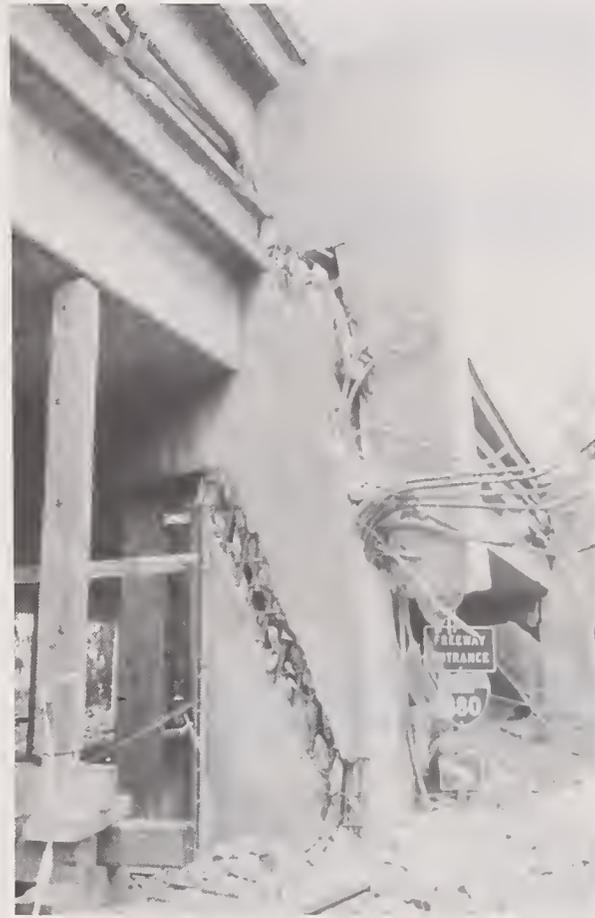
Figure 5.6.40

Close-up view of the east side of Bent 108 looking north. This was the last Type 1 bent prior to the northern limit of the collapse at Bent 113. In addition to the common failure of the pedestal supporting the upper frame column, the column of the lower frame sustained a total shear failure.
