NIST Special Publication 778

Performance of Structures During the Loma Prieta Earthquake of October 17, 1989

H. S. Lew, Editor

January 1990

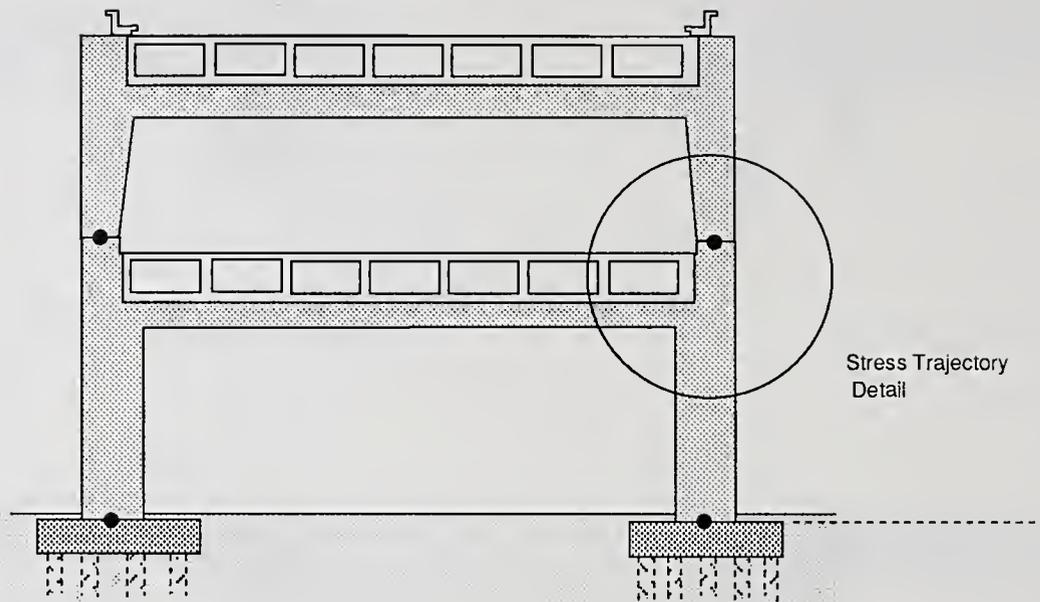
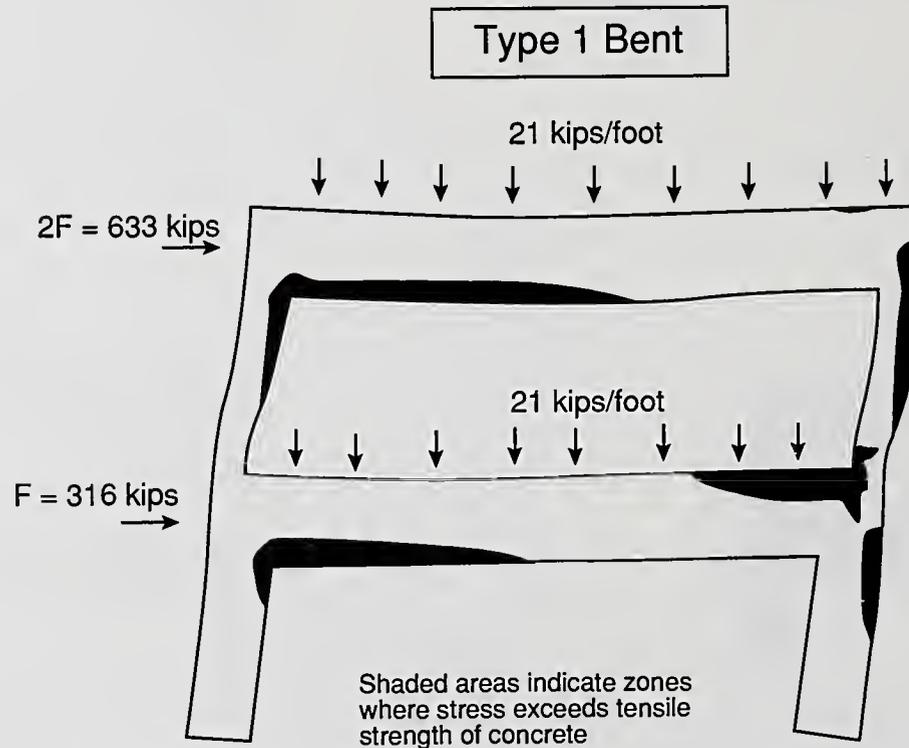
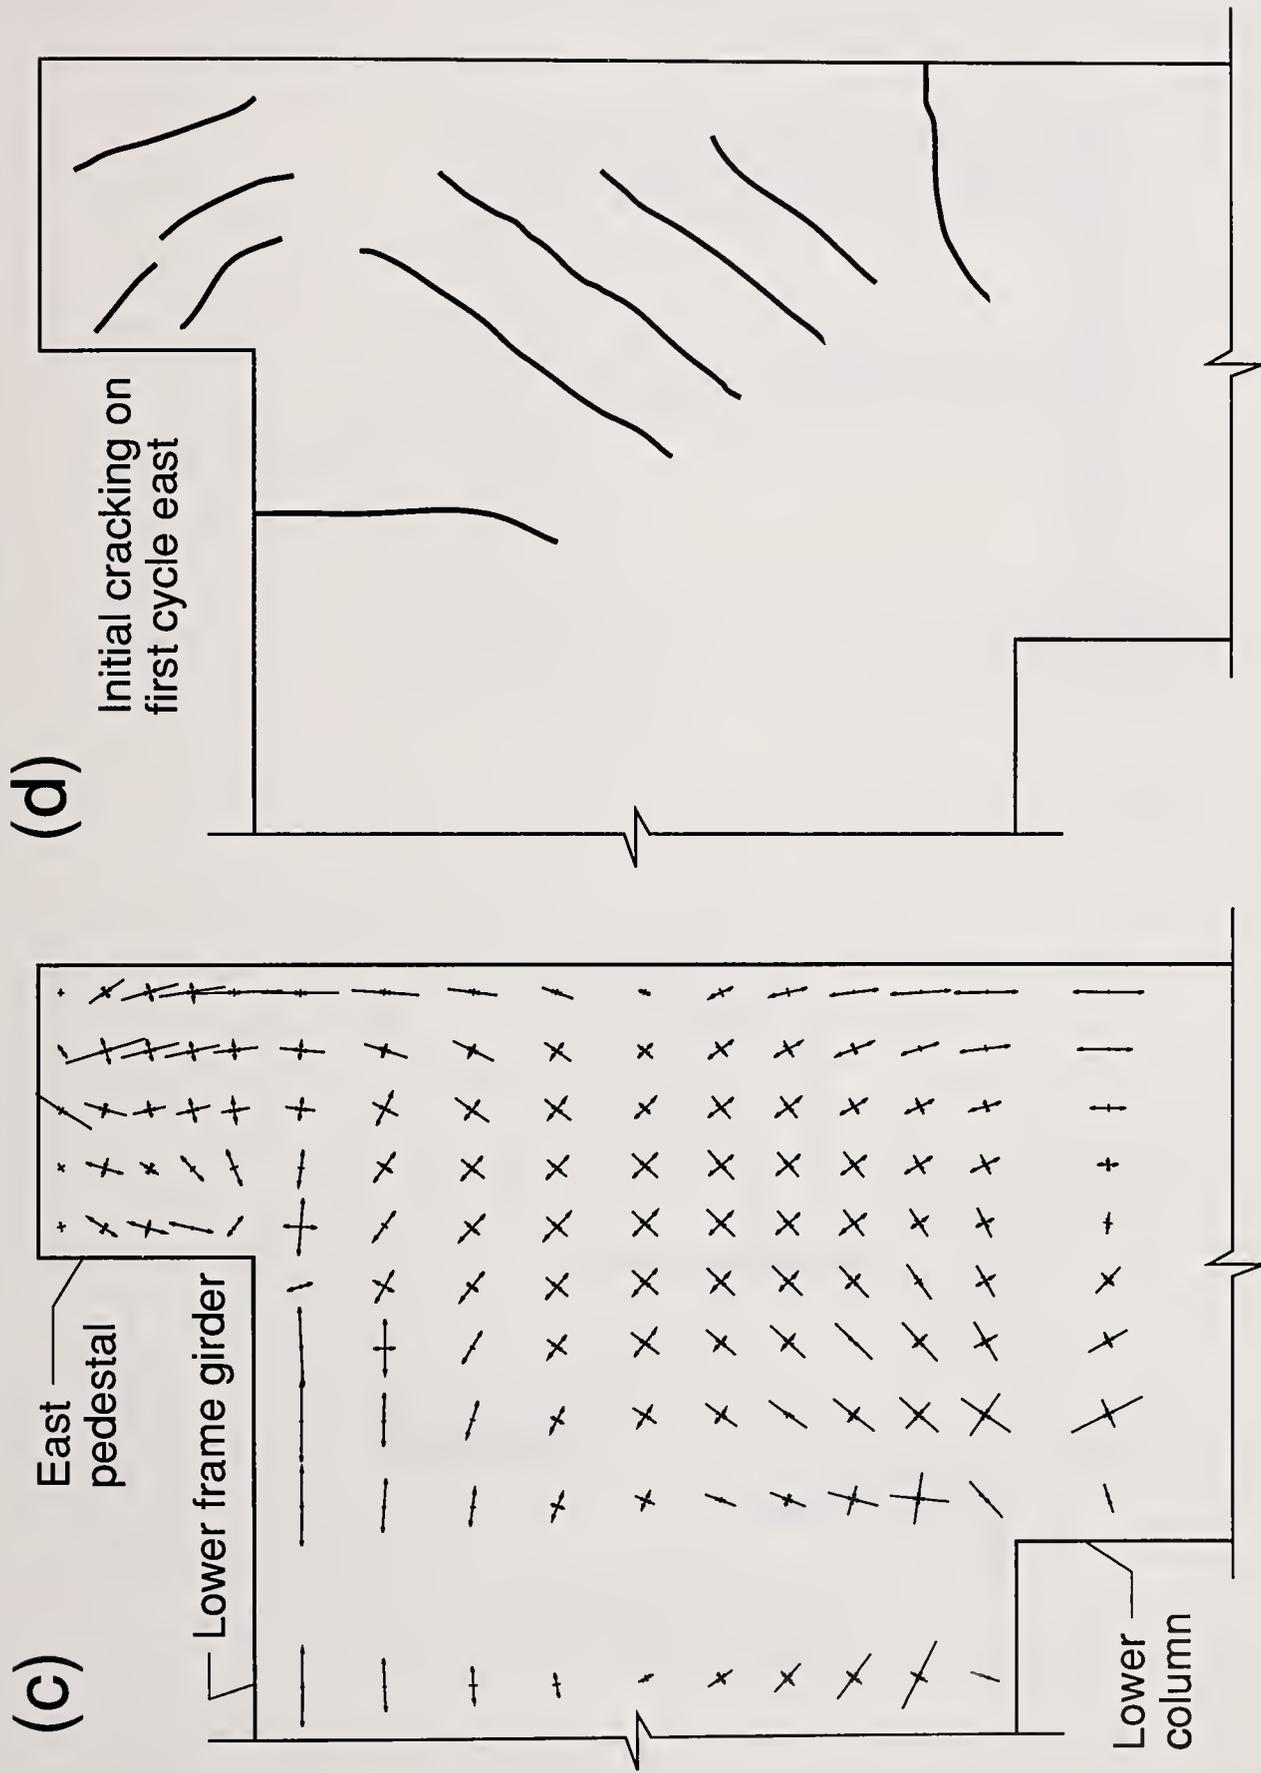
Figure 5.6.44(b) Displaced shape of Type 1 bent under applied loads showing zones of principal tensile stress sufficient to induce cracking.

Figure 5.6.44 (c) Principal stress tensors for pedestal region in Type 1 bent. Scale 0.25 inch = 650 psi (6.3 mm = 4.5 MPa).
 (d) Predicted cracking during first half-cycle of lateral load.

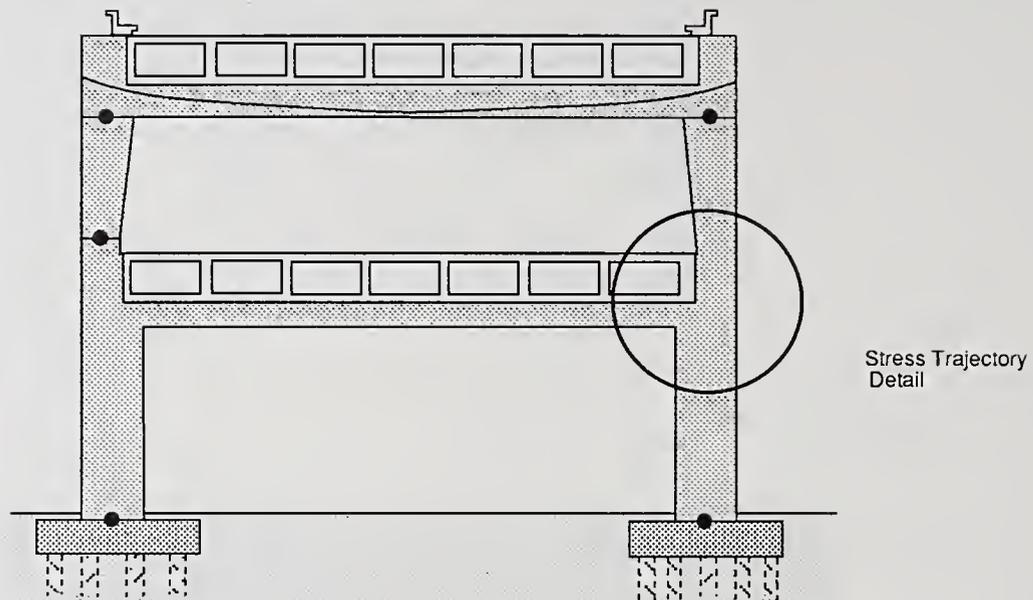
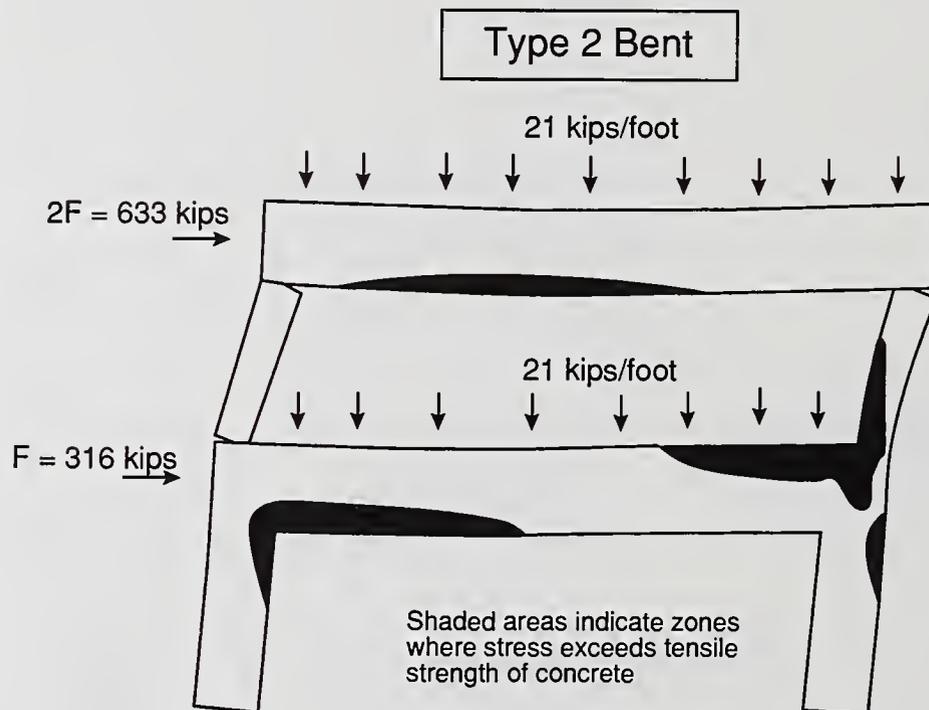
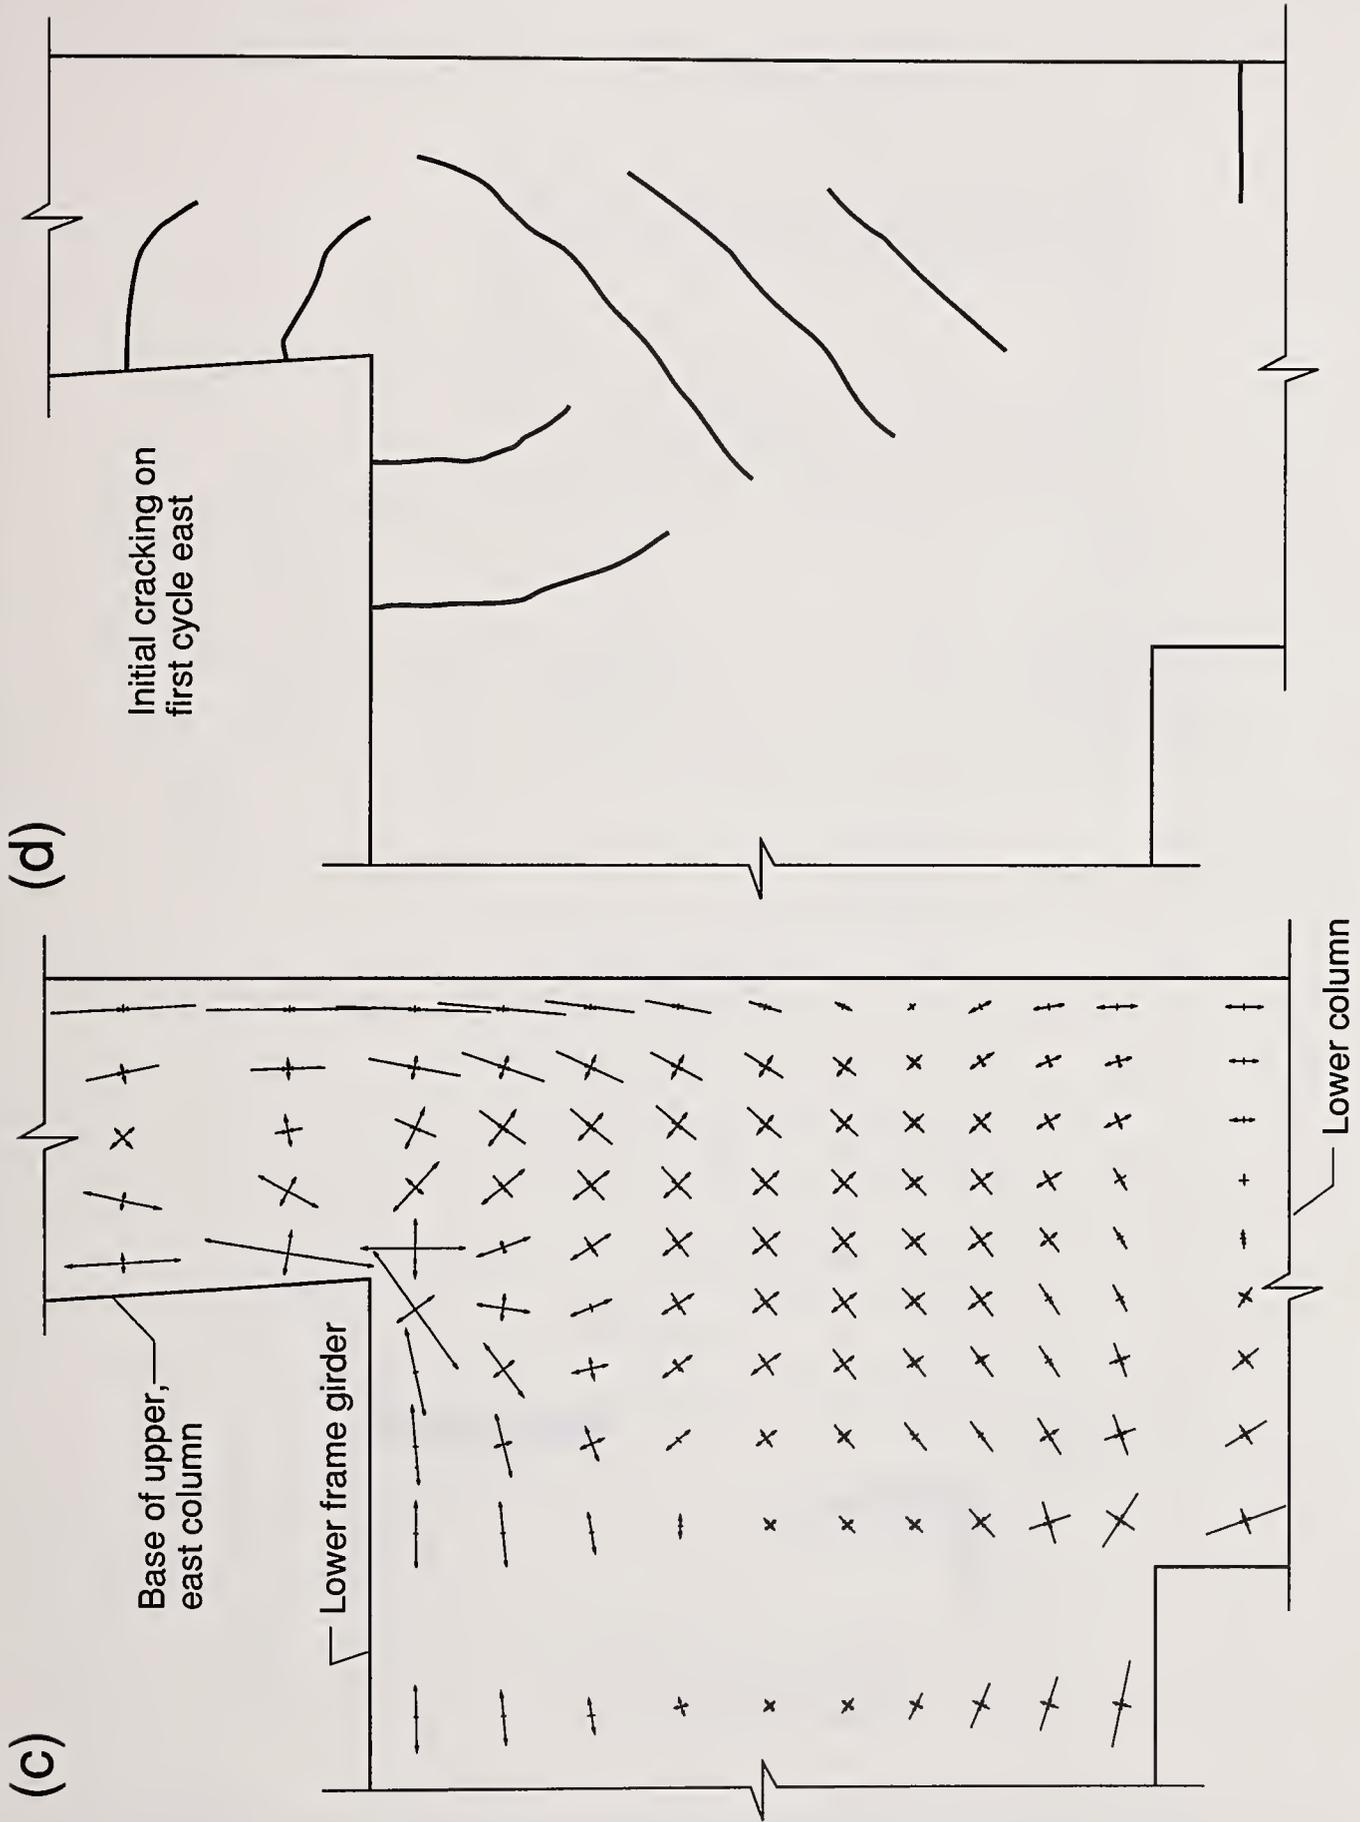
Figure 5.6.45(b) Displaced shape of Type 2 bent under applied loads showing zones of principal tensile stress sufficient to induce cracking.

Figure 5.6.45 (c) Principal stress sensors for pedestal region in Type 2 bent. Scale 0.25 inch = 650 psi (6.3 mm = 4.5 MPa).
 (d) Predicted cracking during first half-cycle of lateral load.

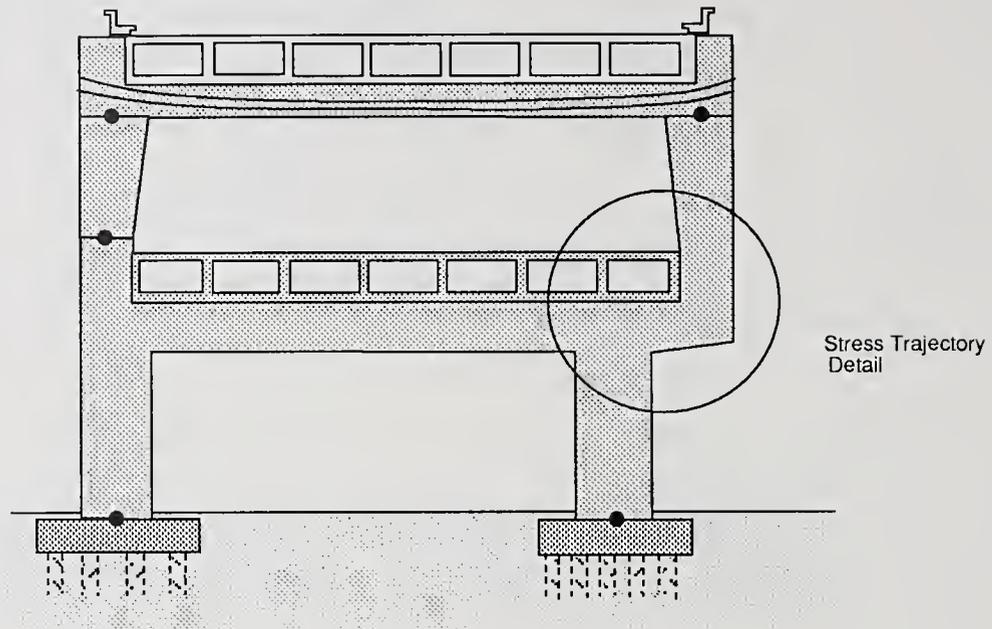
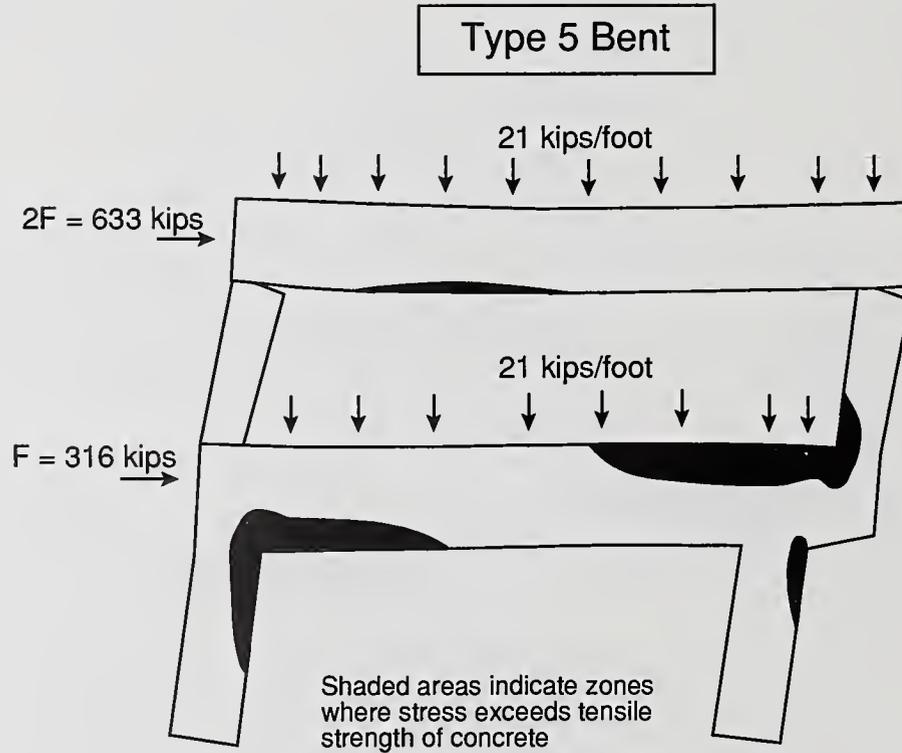
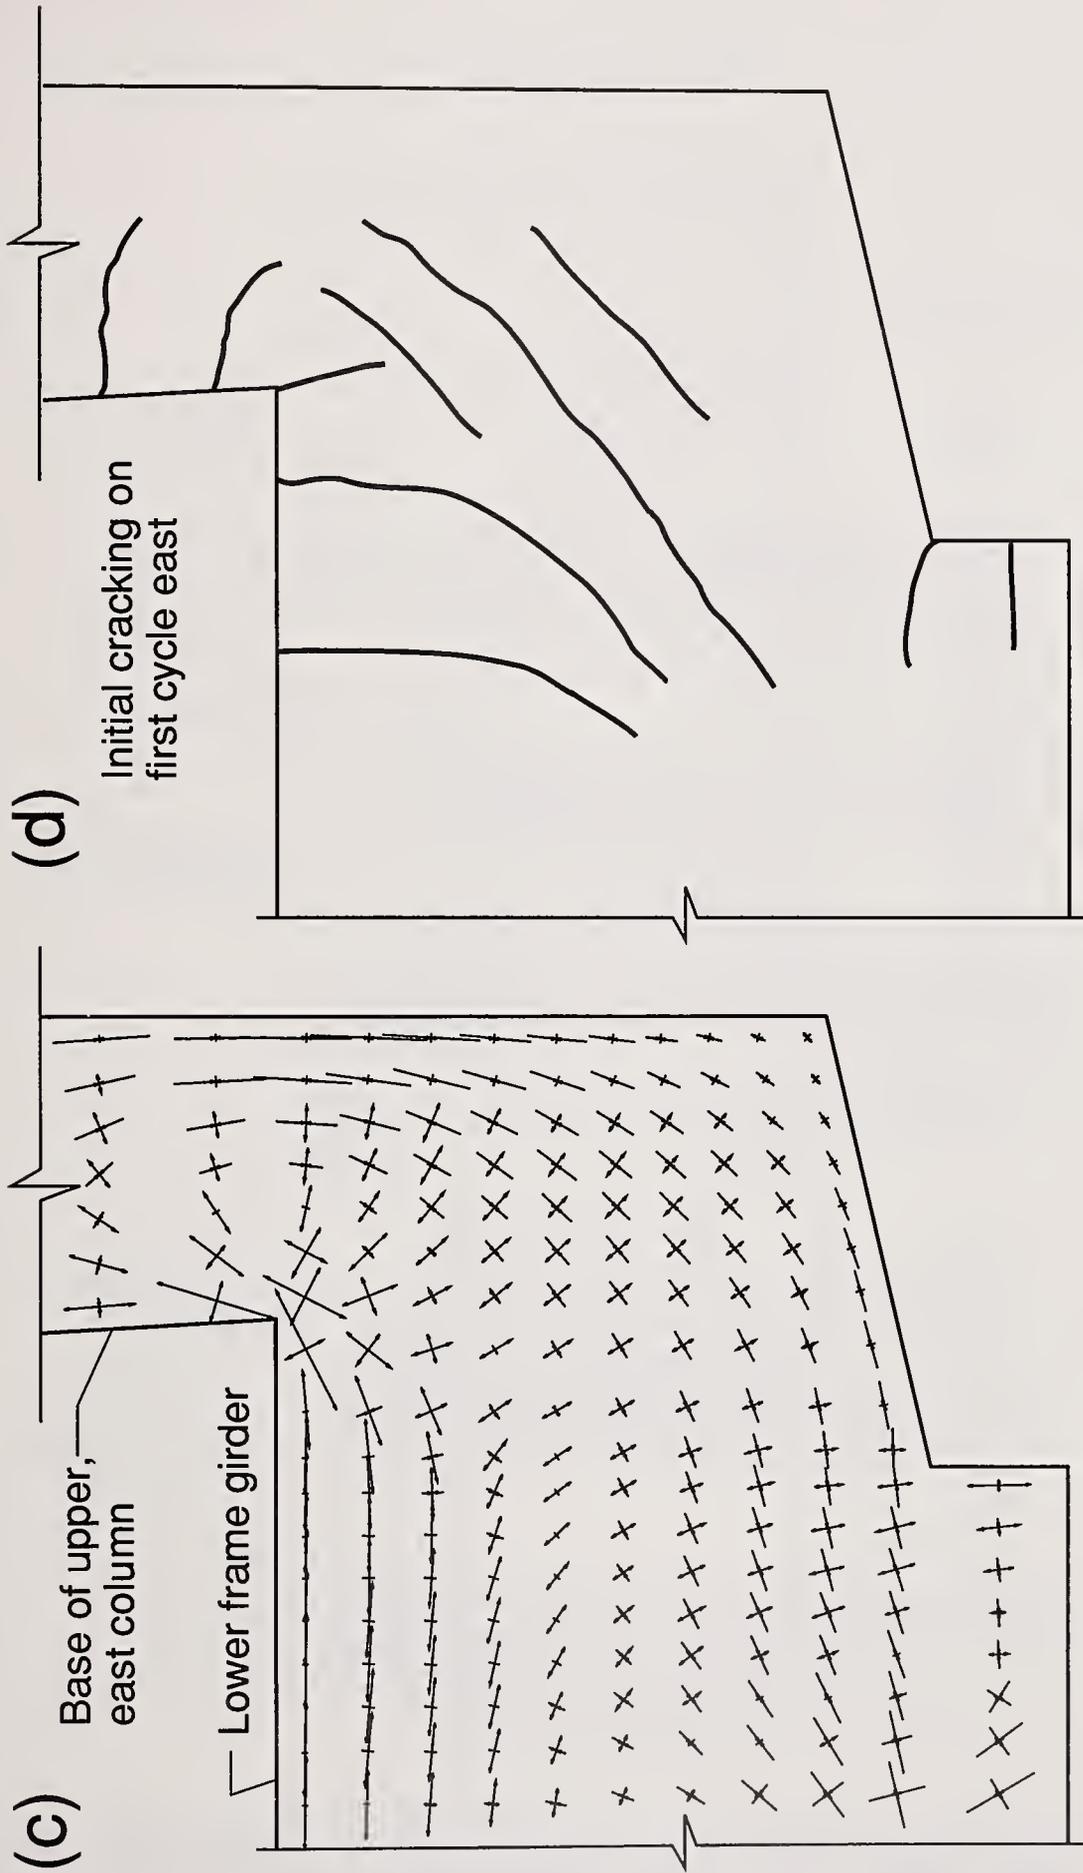
Figure 5.6.46(b) Displaced shape of Type 5 bent under applied loads showing zones of principal tensile stress sufficient to induce cracking.

Figure 5.6.46 (c) Principal stress tensors for pedestal region in Type 5 bent. Scale 0.25 inch = 650 psi (6.3 mm = 4.5 MPa).
(d) Predicted cracking during first half-cycle of lateral load.

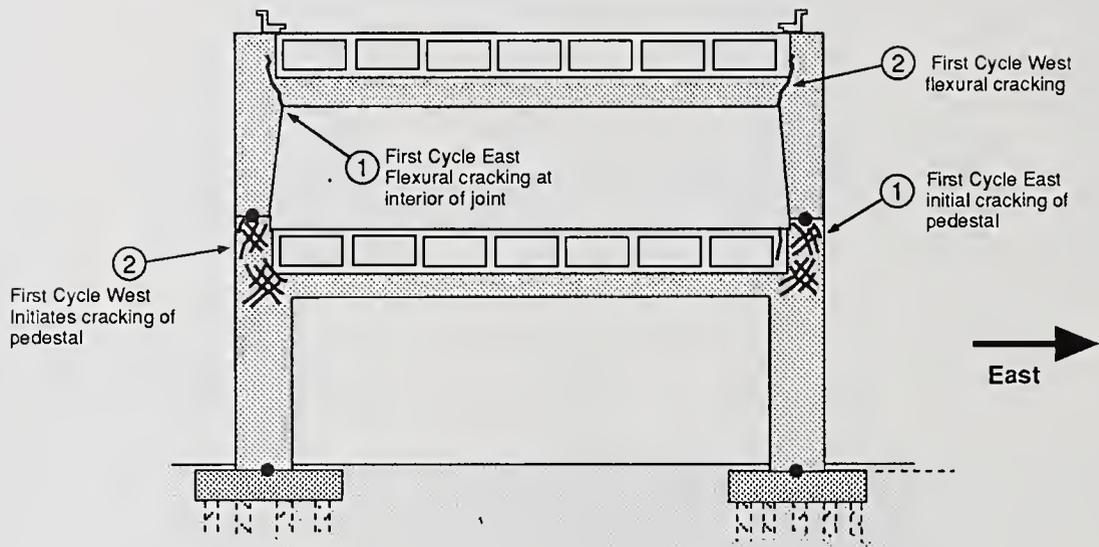
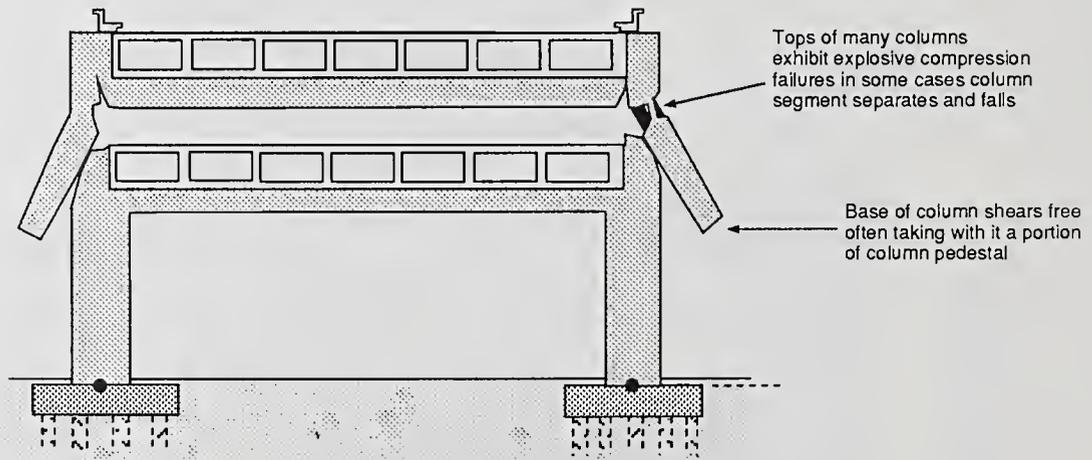
Figure 5.6.47 Top: Anticipated crack initiation sequence for Type 1 bents under lateral loading. Bottom: Observed failure mode for Type 1 bents at Cypress Structure.

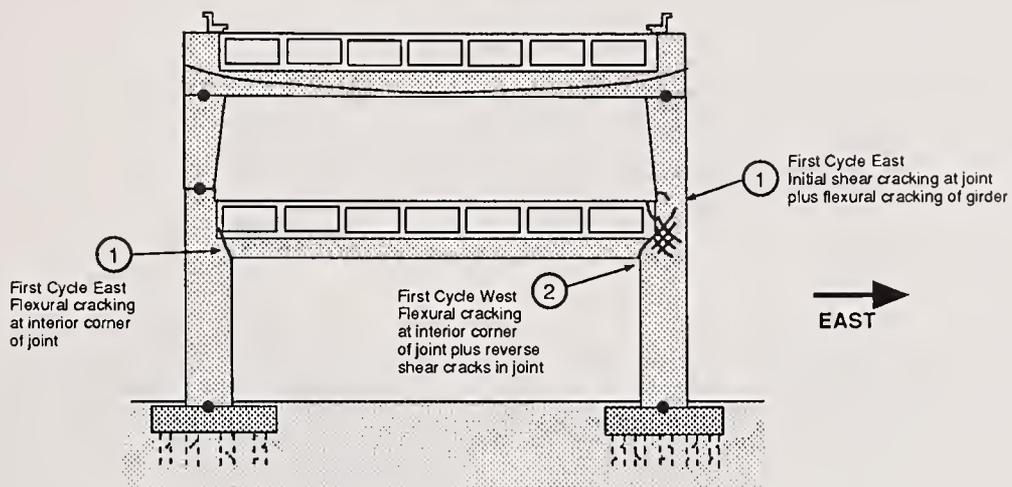
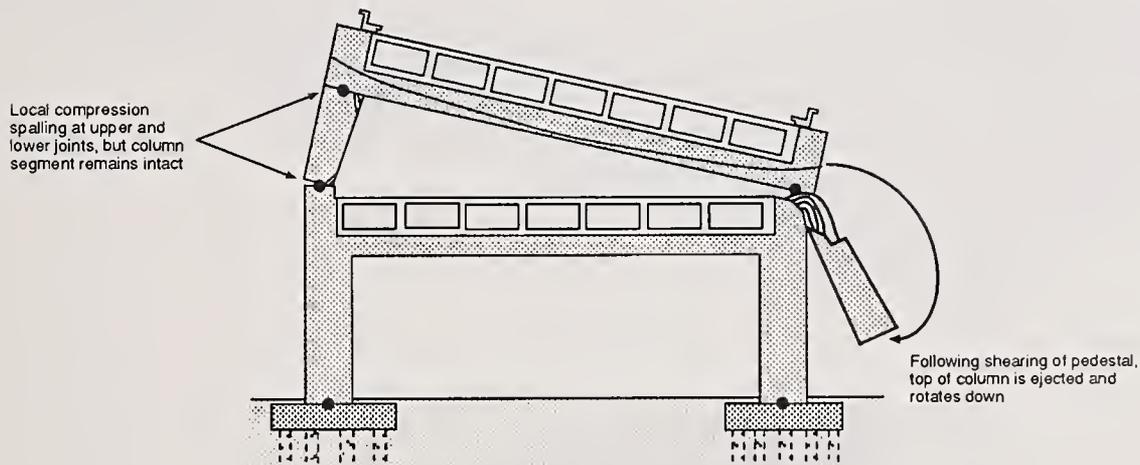
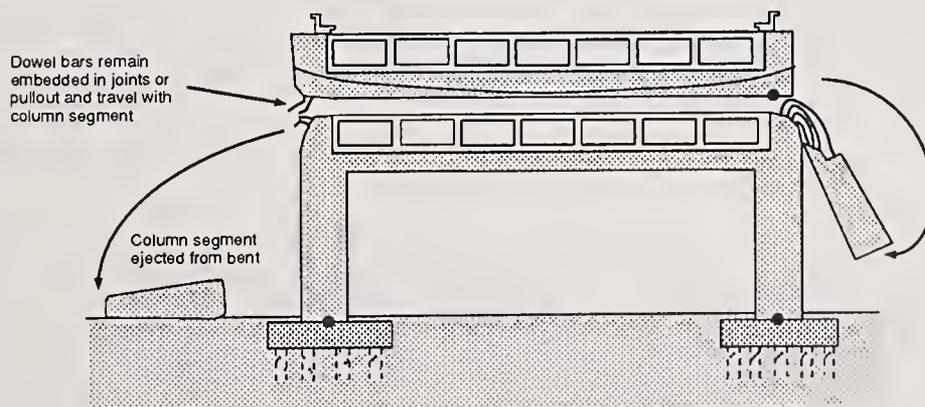
A close-up of the west side of Bent 72 shows the second, or Type B, variation of failure observed for Type 2 bents. In this case the entire double-hinged upper frame column segment has been ejected from the structure. The 4-#10 bars which passed through the upper and lower shear keys may be seen projecting from the base of the upper girder and the top of the lower column.

Figure 5.6.48 Top: Anticipated crack initiation sequence for Type 2 bents under lateral loading. Middle: Observed failure mode "A" for Type 2 bents at Cypress Structure. Bottom: Observed failure mode "B" for Type 2 bents at Cypress Structure.

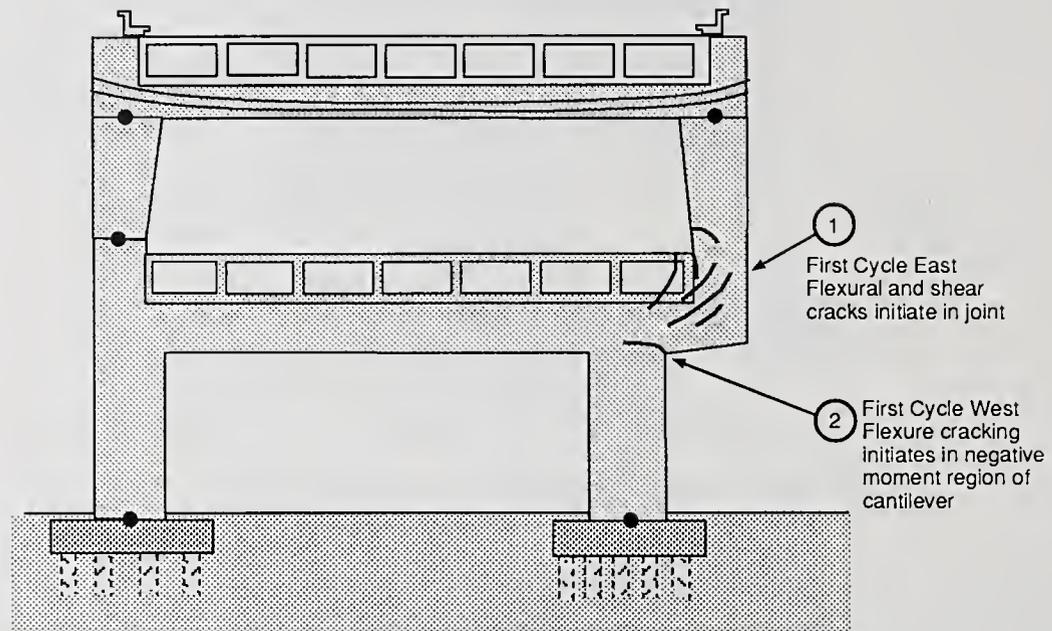
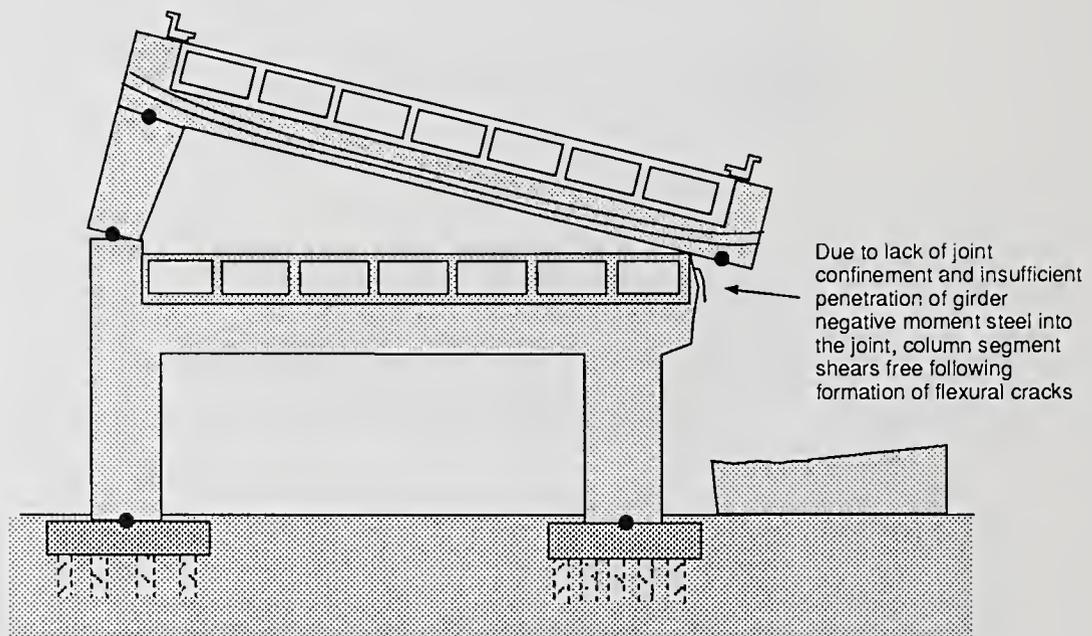
Figure 5.6.49 Top: Anticipated crack initiation sequence for Type 5 bents under lateral loading. Bottom: Observed failure mode for Type 5 bents at Cypress Structure.

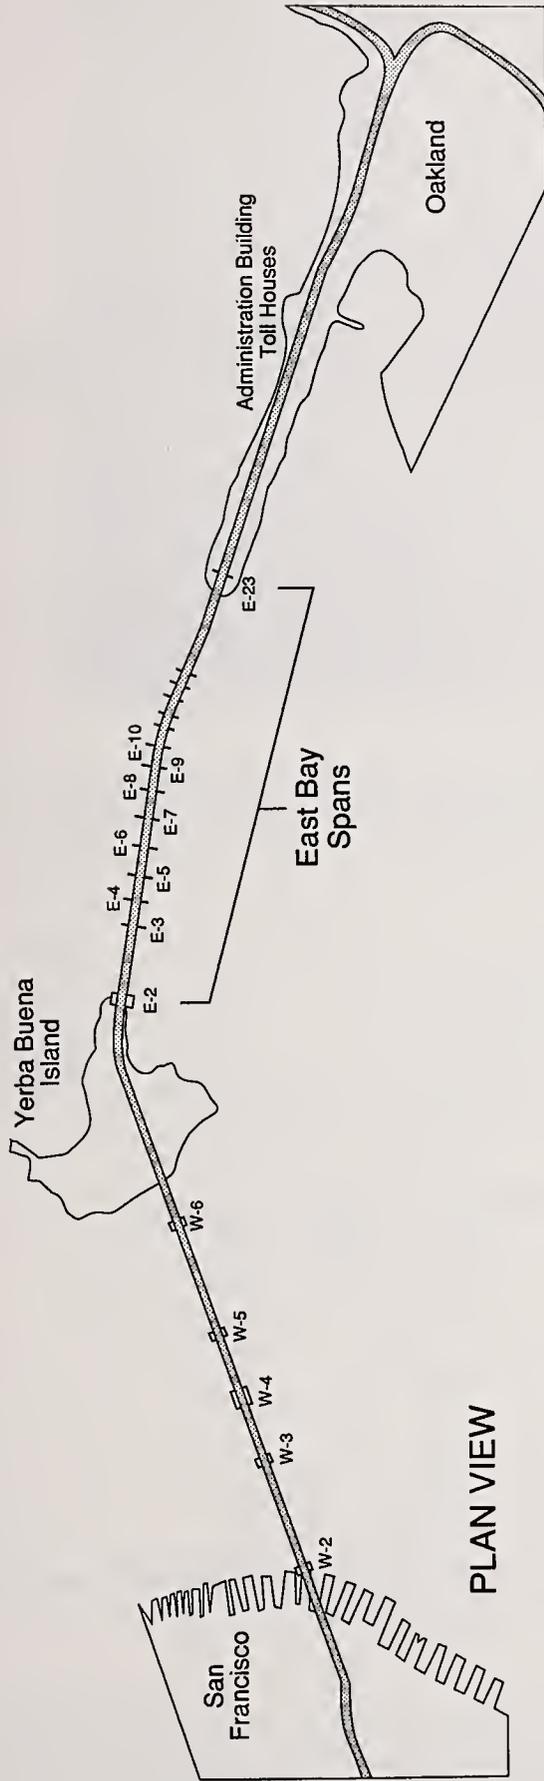
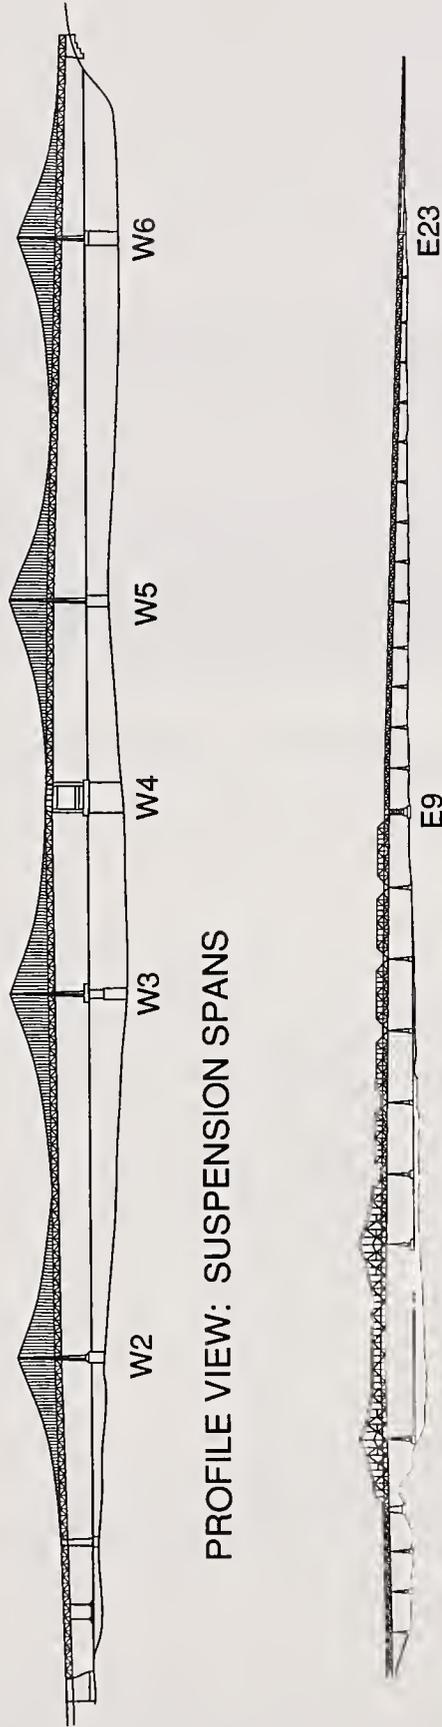
1. Damage to the San Francisco-Oakland Bay Bridge was concentrated within three general areas. These included the collapse of the upper and lower link spans at pier E-9 and the shearing of the truss shoe retainer bolts for span E-9/E-10; the general shearing of truss shoe retainer bolts for spans between piers E-17 and E-23; and the near loss of span E-23/E-24.

Figure 5.7.2 Plan and profile views of the San Francisco-Oakland Bay Bridge. Damage, as well as significant residual displacement of structural elements, was confined to the section between Piers E-9 and E-23 in the east bay spans.

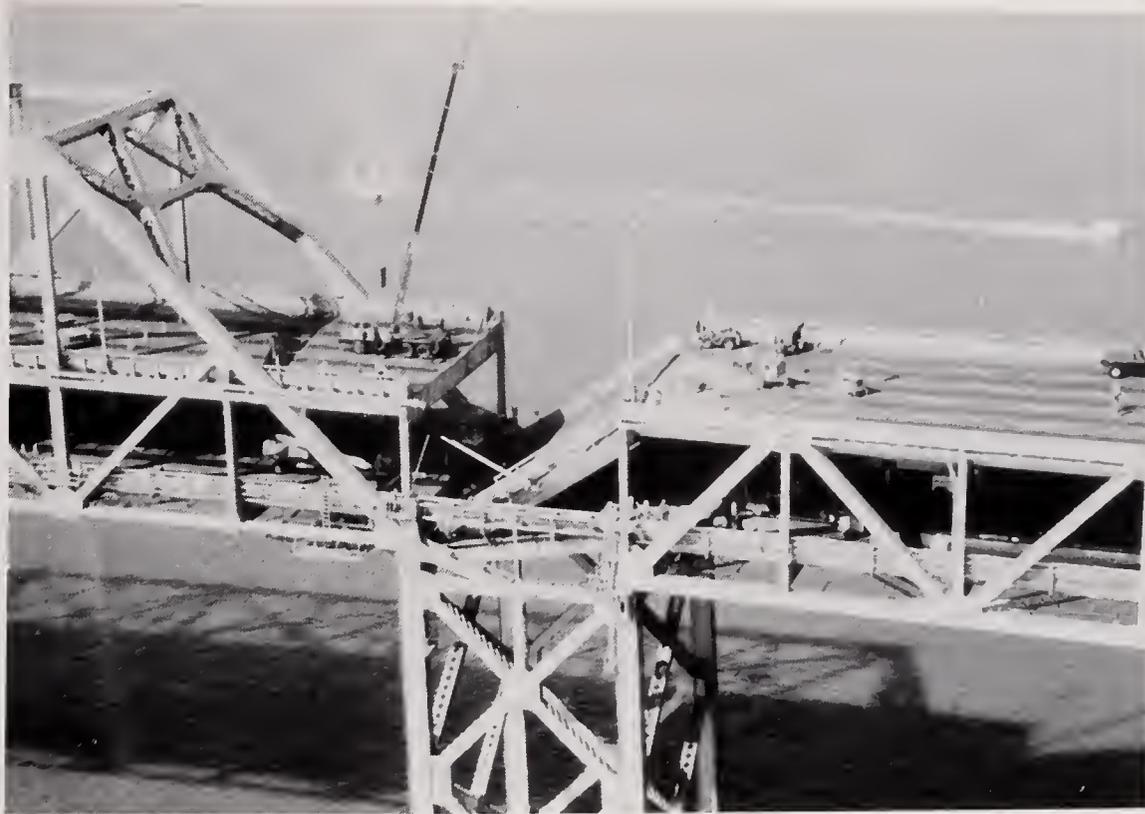
There was no apparent damage as a result of the earthquake to the west bay suspension bridges. First reports of the earthquake via the media, however, showed the dramatic collapse of the 50 foot (15 m) link spans at pier E-9 (see fig. 5.6.4), approximately halfway between Yerba Buena Island and the Oakland landing. Inspection revealed that both the upper and lower decks had simultaneously been pulled off their bearing seats as the truss east of pier E-9 moved, by Caltrans measurements, as much as 10 inches (250 mm) east during the first excursion of motion before returning 5 inches (130 mm) to the west, leaving a residual 5 inch (130 mm) eastward displacement. The western girder seats for the upper and lower bridge decks (see fig. 5.6.6) were simply supported configurations in which the bottom flange of the deck girders sat on a riveted angle bracket while two vertical angle brackets constrained movement of the girder web. The bearing seat was only 6 inches (150 mm) wide, so that when truss E9-E10 moved eastward both top and bottom decks slipped off their respective angle brackets and pivoted downward, landing as shown in figures 5.6.4 and 5.6.5. This mechanism is evident when viewing figures 5.6.7 and 5.6.8 which show closeup photos of the western bearing seats for the lower deck girders and the eastern hinge seat for the upper deck girders, respectively. There is practically no damage visible in figure 5.6.7 to the bearing seats, indicating that the girder flanges had cleared the edge quickly and fell away without any further impacting before the lower deck girders landed on a transformer station mounted on the utility deck on the north side of the bridge. The eastern deck girder supports for the link spans, which were in contrast bolted to the girder, were severely distorted (fig. 5.6.8) and in some cases torn loose. It has been suggested that were it not for the presence of the transformer station both spans would likely have torn

free from the girder restraining bolts and fallen into pier E-9, causing far greater damage⁶. During the fall the upper deck cut through several power and communication lines and additionally severed a water main on the south side, but otherwise the damage was confined to the decks themselves.

Figure 5.7.4 Aerial photo looking north at Pier E-9 on October 19, 1989 showing the collapsed upper and lower 50 foot deck spans.

and that there was some elastic rebound from pier E-10⁷. Within 4 weeks of the quake, Caltrans had replaced the deck girders for the pier E-9 link spans, placed precast concrete panels between them, cast the composite deck, and reopened the bridge for traffic. The 40 1 inch (25 mm) bolts connecting the E-9/E-10 truss shoes to the eastern column tops of pier E-9 were replaced with high strength bolts. Whether this is to the advantage of the bridge during future earthquakes is subject to review. Opinions have been expressed by some⁸ that the shearing of these bolts served as a fuse, isolating pier E-9 from otherwise large lateral loads which could have led to disastrous column buckling.

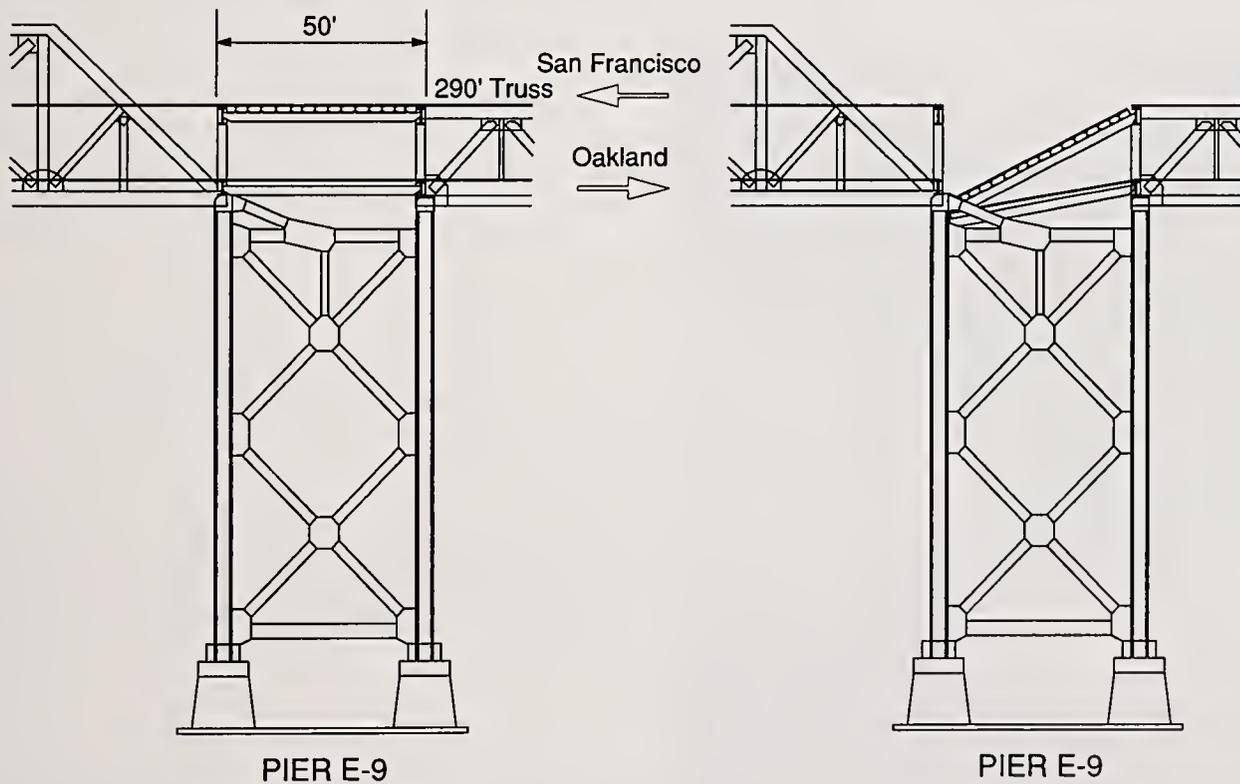
Figure 5.7.5 Schematic detail of Pier E-9 looking north. Evidence indicates that the 290 foot truss segment on the east side of the pier moved eastward, simultaneously unseating both Upper and lower deck segments.

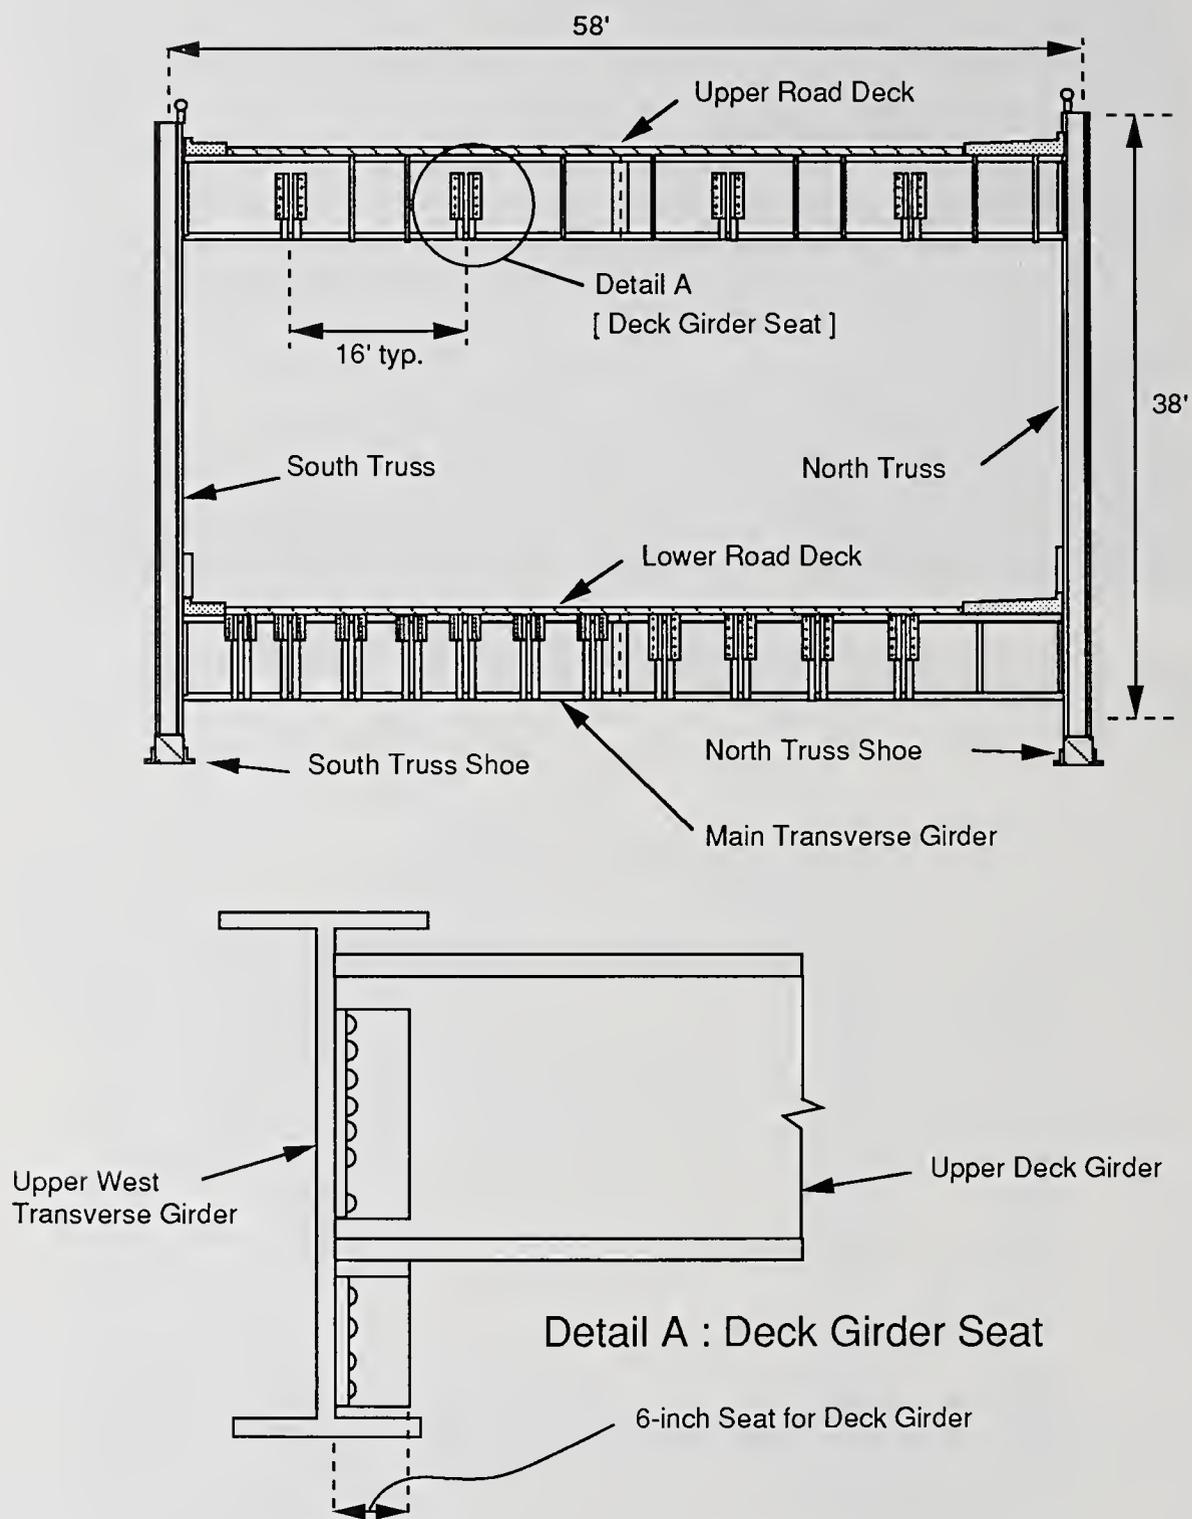
Figure 5.7.6 Cross-sectional detail of the Bay Bridge at Pier E-9, showing upper and lower roadway transverse support girders and longitudinal deck girder seats. The connection of the longitudinal girders to the transverse girders consisted of a simple bearing seat on the west side; The eastern beam seat was bolted.

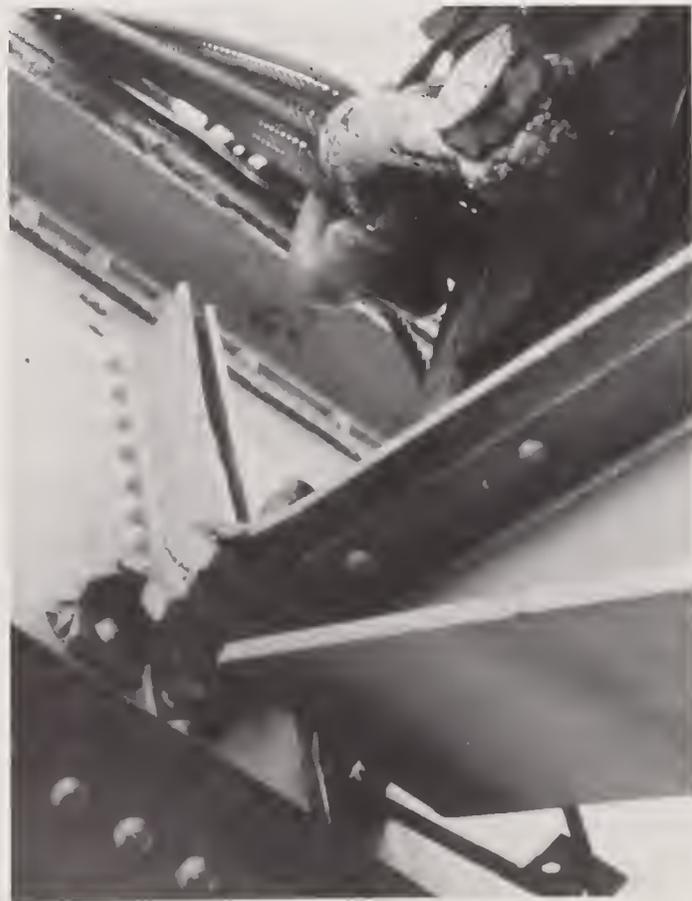
Figure 5.7.8
Close-up of the eastern seat for the upper deck girder showing distortion of bolted beam seat.
