NIST Special Publication 778

Performance of Structures During the Loma Prieta Earthquake of October 17, 1989

H. S. Lew, Editor

January 1990

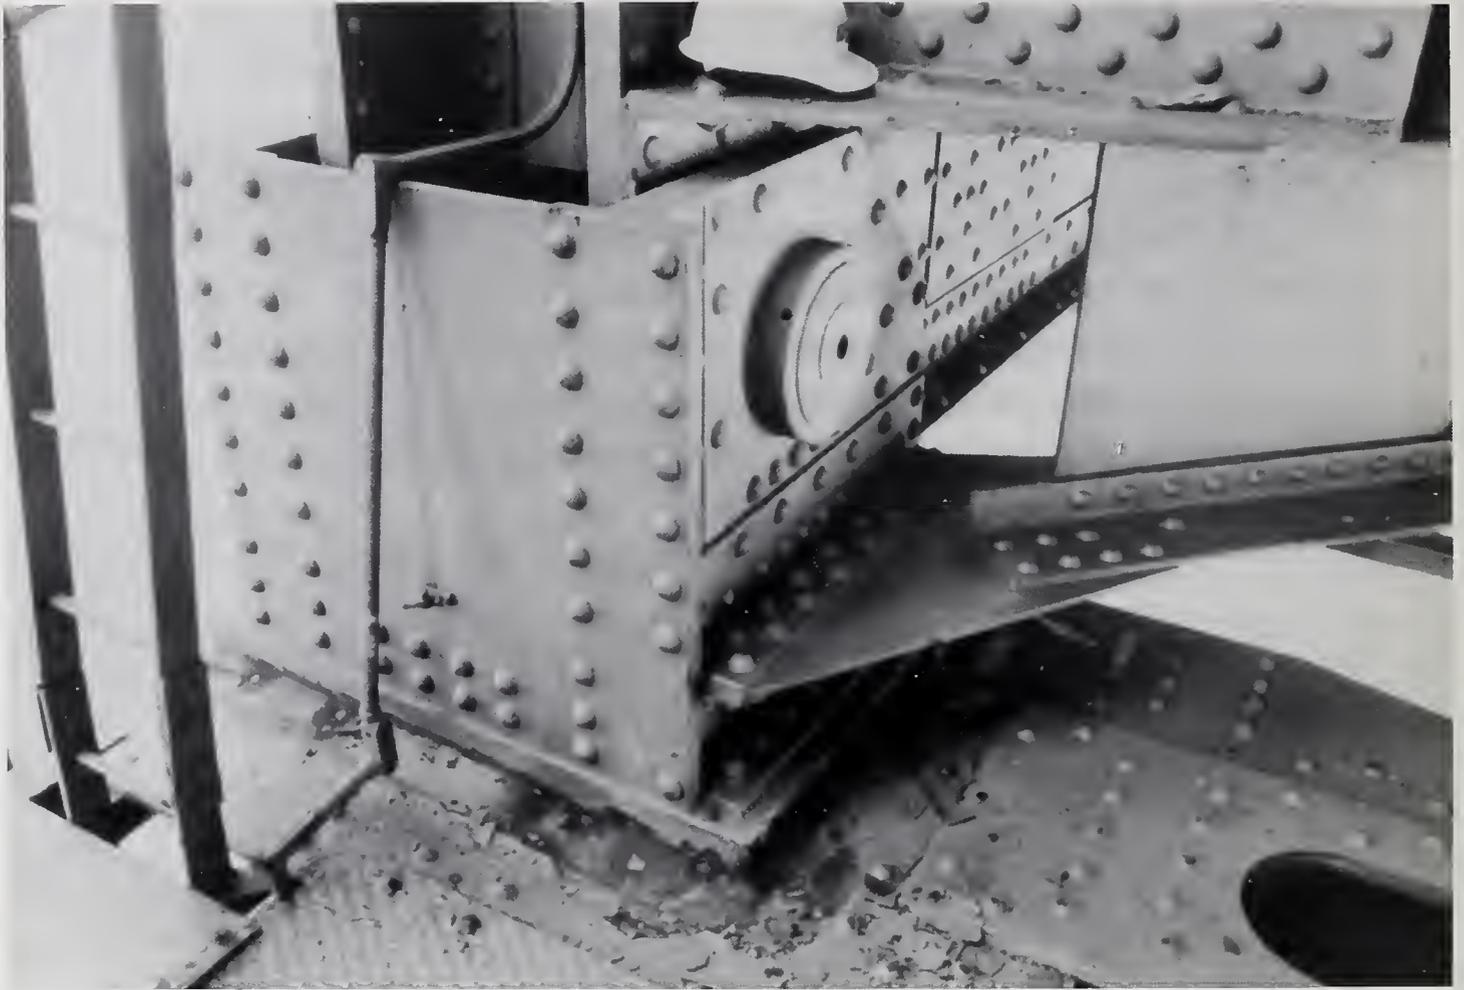
Figure 5.7.9 Close-up of the northeast shoe for the 290 foot truss between Pier E-9 and E-10. During the earthquake this truss moved eastward as much as 10 inches before returning to leave a 5.5-inch residual displacement to the east and 5/8-inch to the north.

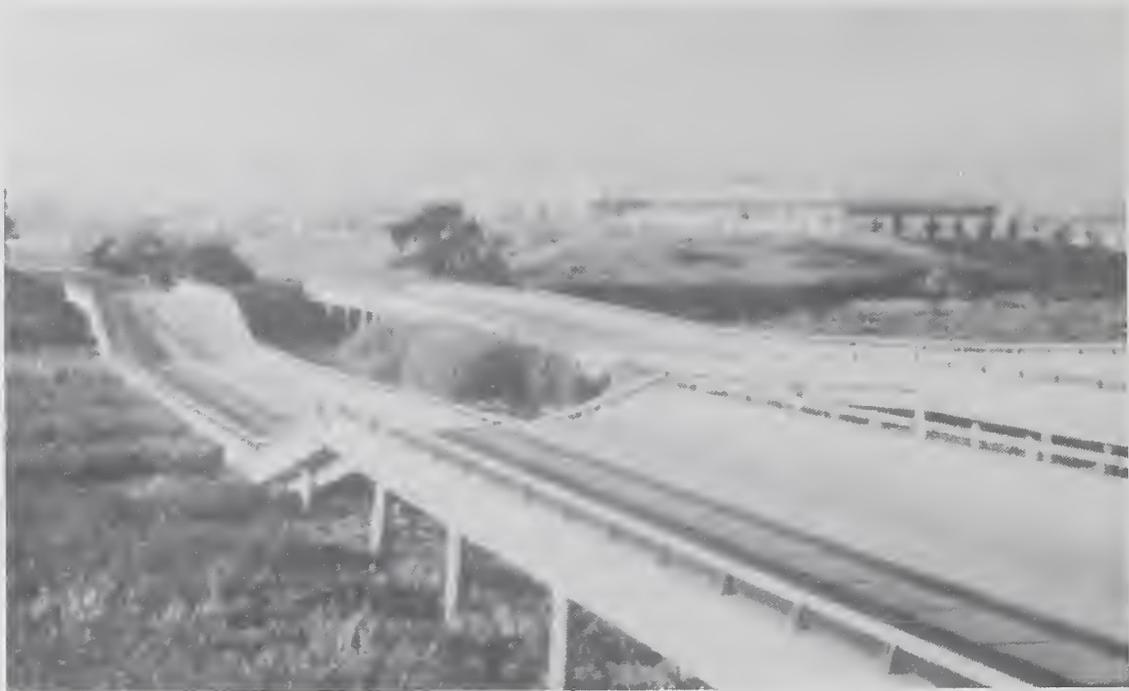
"The hinge restrainers performed well and held the structure together in spite of the large downward movement. Some evidence existed at the site that auto traffic had crossed the bridge during or immediately after the event. The pile extensions under the structure were lightly confined with #3 wire at about 12 inch (305 mm) pitch and failed primarily at the top. Some piles apparently also failed some distance below the ground surface. The soil displacement at the base of several of the piles was in several directions up to a maximum of 18 inches (460 mm). The eastern structure dropped about 5 feet (1.52 m) onto damaged pile extensions. The western structure dropped to the ground surface about 8 to 10 feet below (2.44 to 3.05 m). A few of the piles on the western bridge separated from the bent, displaced, and punched through the deck slab as the superstructure fell to the ground (see fig. 5.8.1)."

Figure 5.8.1 View looking north of State Highway 1 crossing Struve Slough, approximately 1 mile south of Watsonville. Piles on the left bridge separated from the bent, displaced, and punched through the deck slab as the superstructure fell to the ground (photo courtesy EQE Engineering).

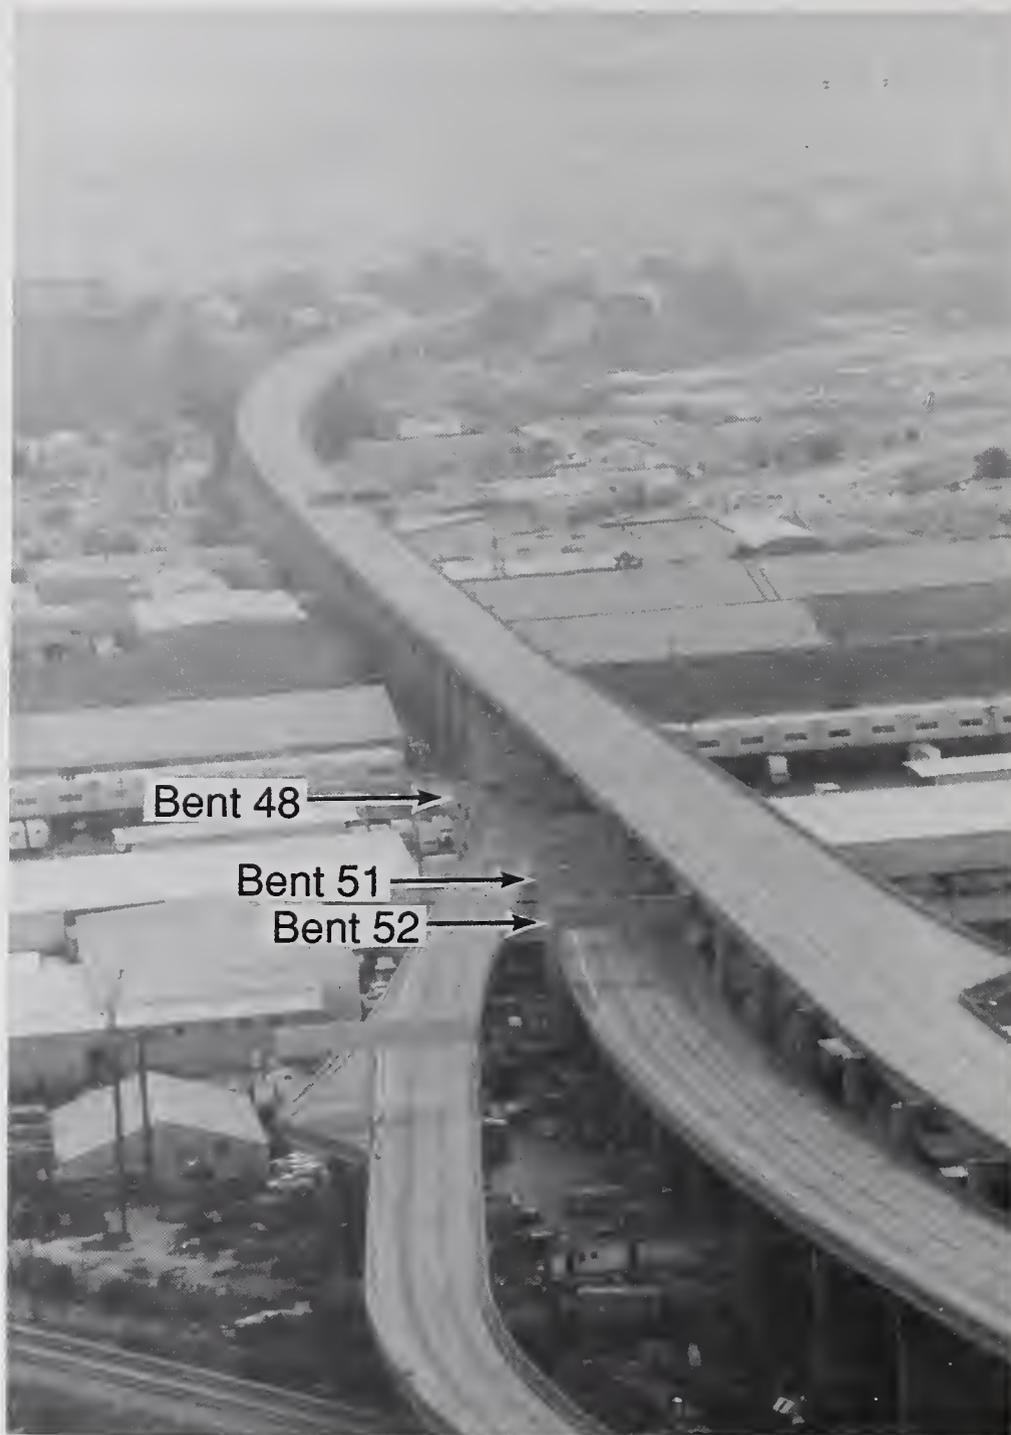
Figure 5.9.2 is an aerial view, looking south, of I-280 south of Army Street. At this location a two-level elevated highway (to the south) transforms into to a single level divided highway (to the north). In addition, there is an exit ramp for the lower level northbound section. Damage was observed at Bent numbers 48, 51, and 52.

Some minor damage occurred due to pounding. It is seen in figure 5.9.2 that where the roadways become side-by-side, the columns supporting the upper roadway are close to the lower roadway. One of these columns which support the upper roadway was damaged due to pounding with the lower roadway, as can be seen in figure 5.9.10.

Figure 5.9.2 Aerial view of I-280 south of Army St., note the transition from a two-level elevated structure to a single-level, divided structure (view is looking south).

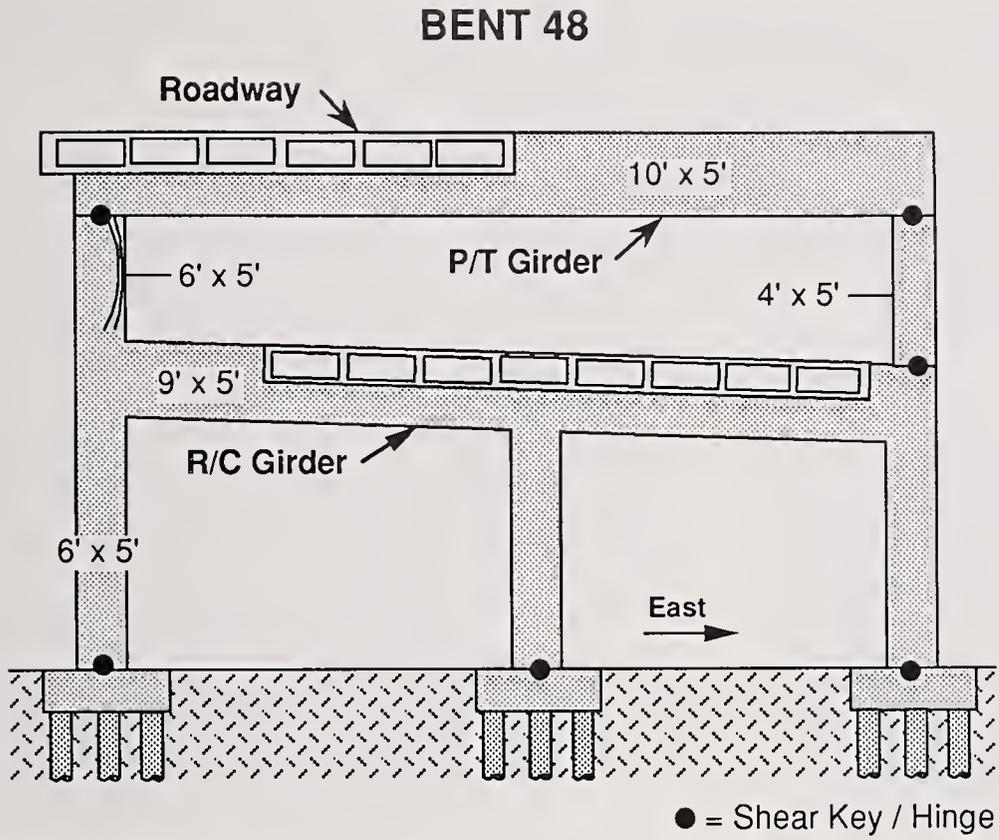
Figure 5.9.3 Schematic elevation view of Bent 48 of I-280 (looking north).

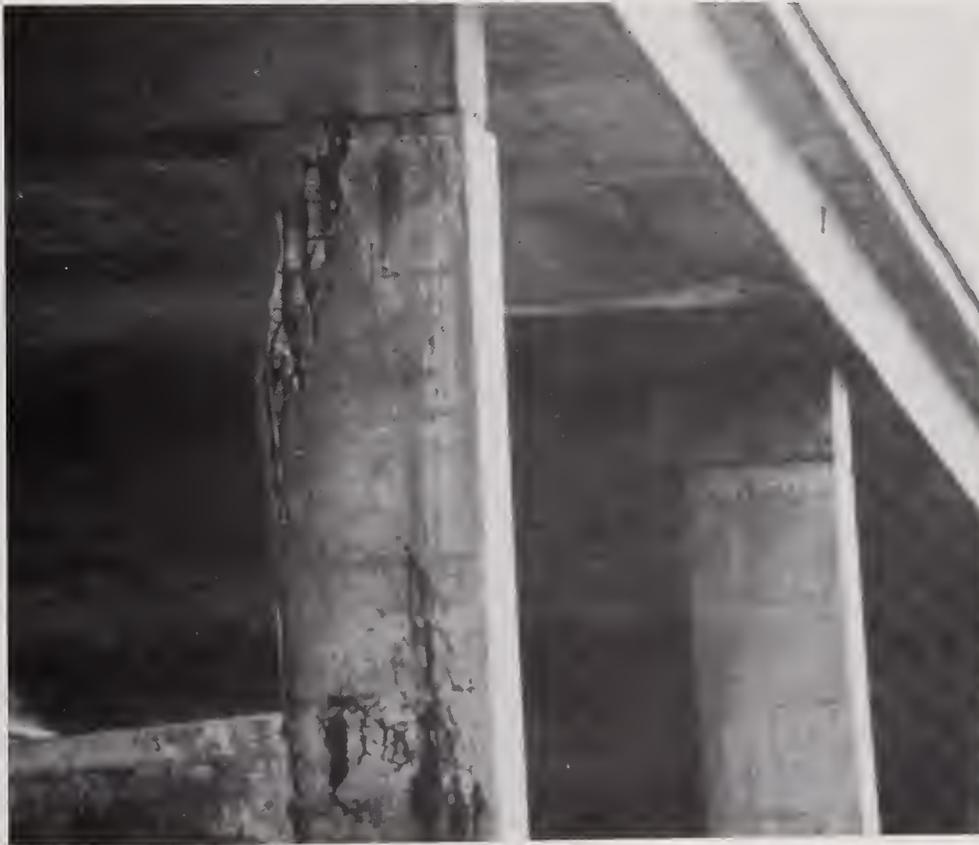
Figure 5.9.4 Damage to west-side column of Bent 48 (looking toward south).

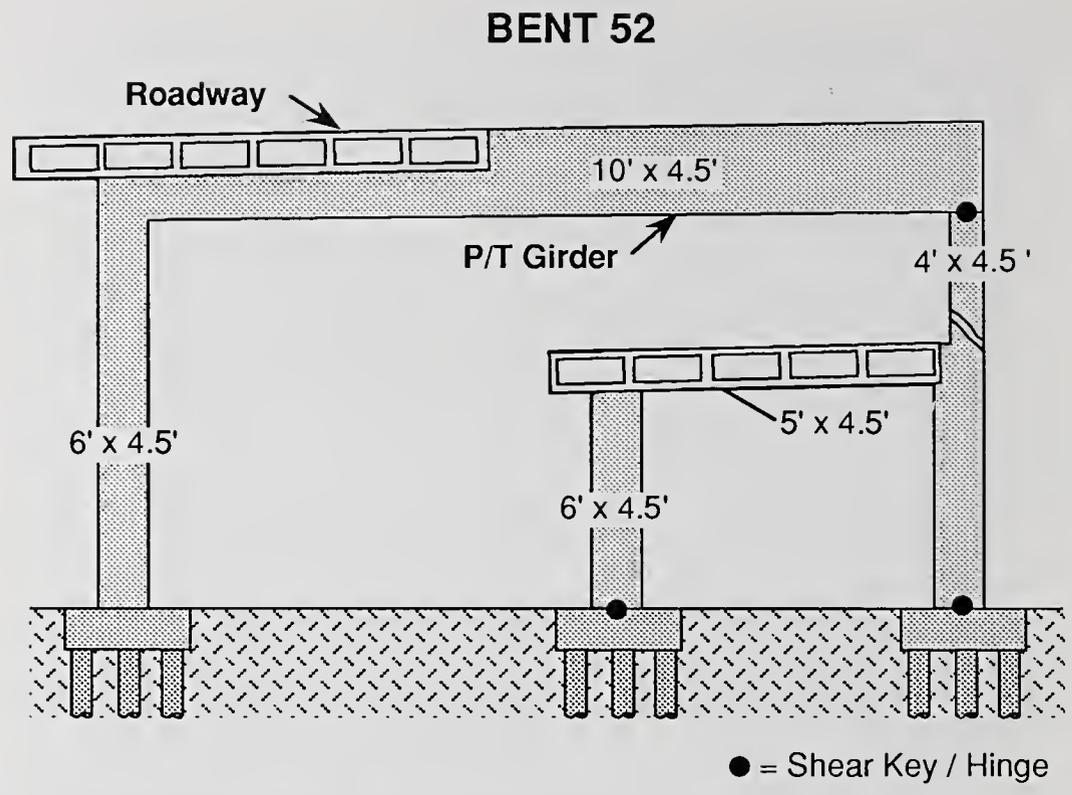
Figure 5.9.5 Schematic elevation view of Bent 52 of I-280 (looking north).

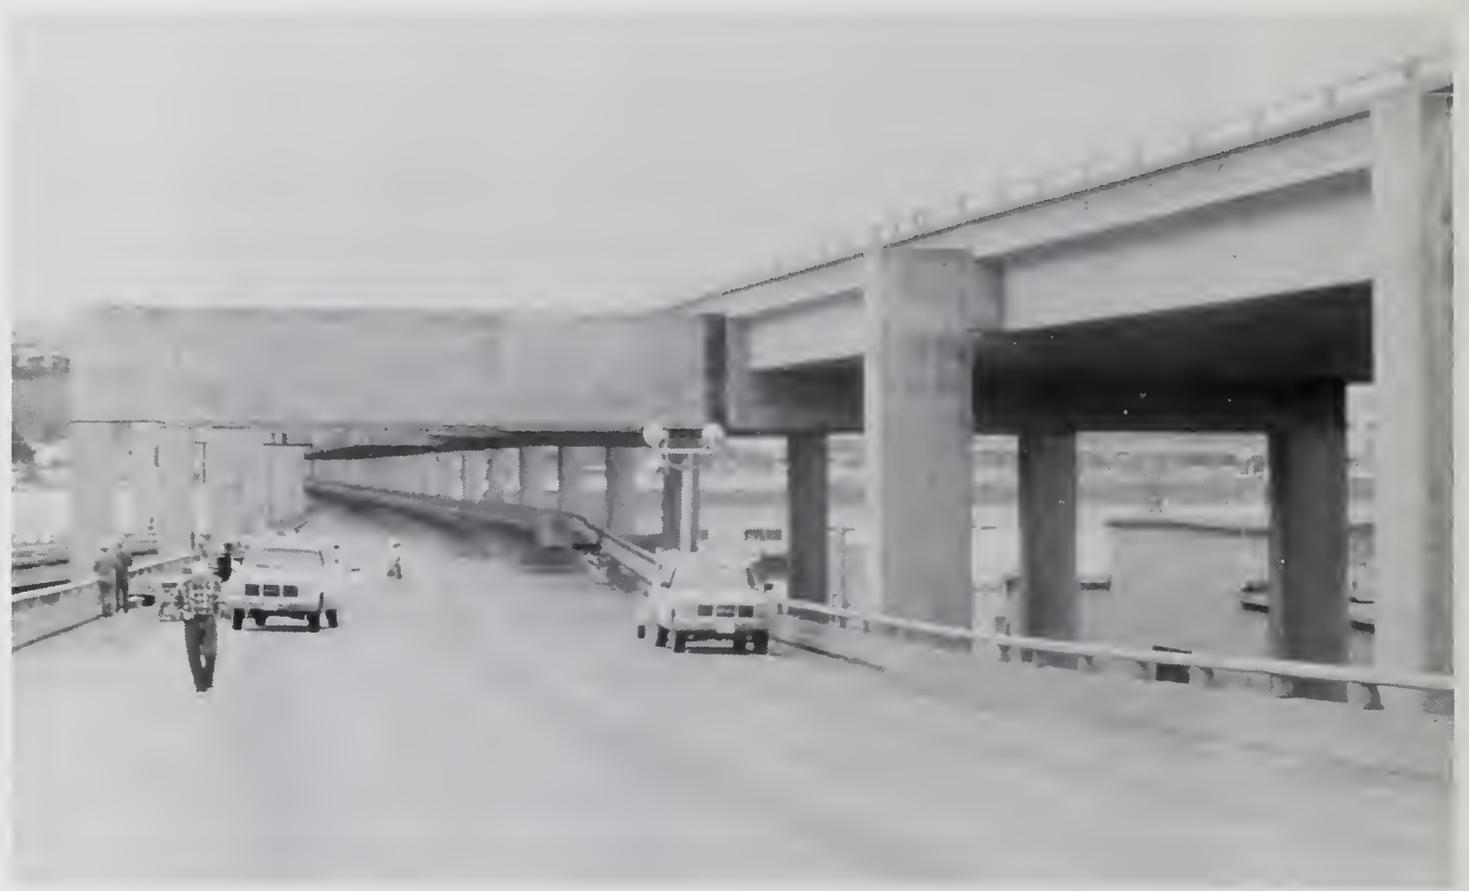
Figure 5.9.6 View looking south on I-280 showing the upper girder of Bent 52.

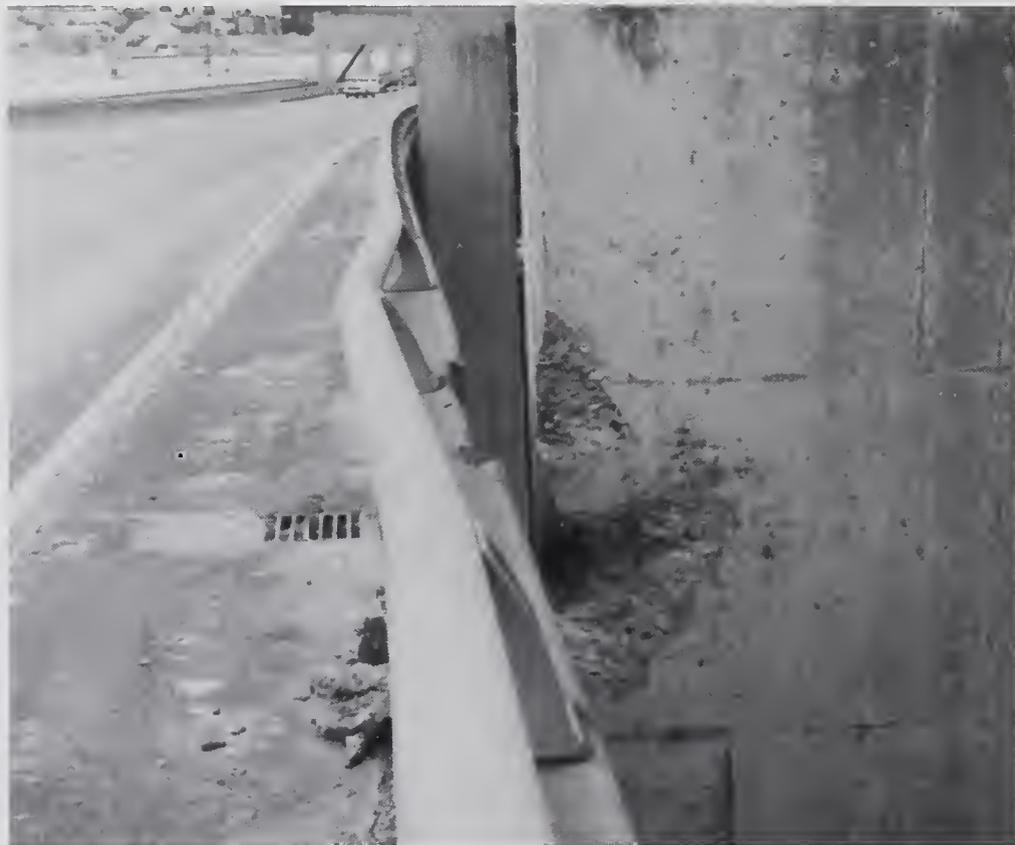
Figure 5.9.10 Pounding damage at I-280 south of Army Street.

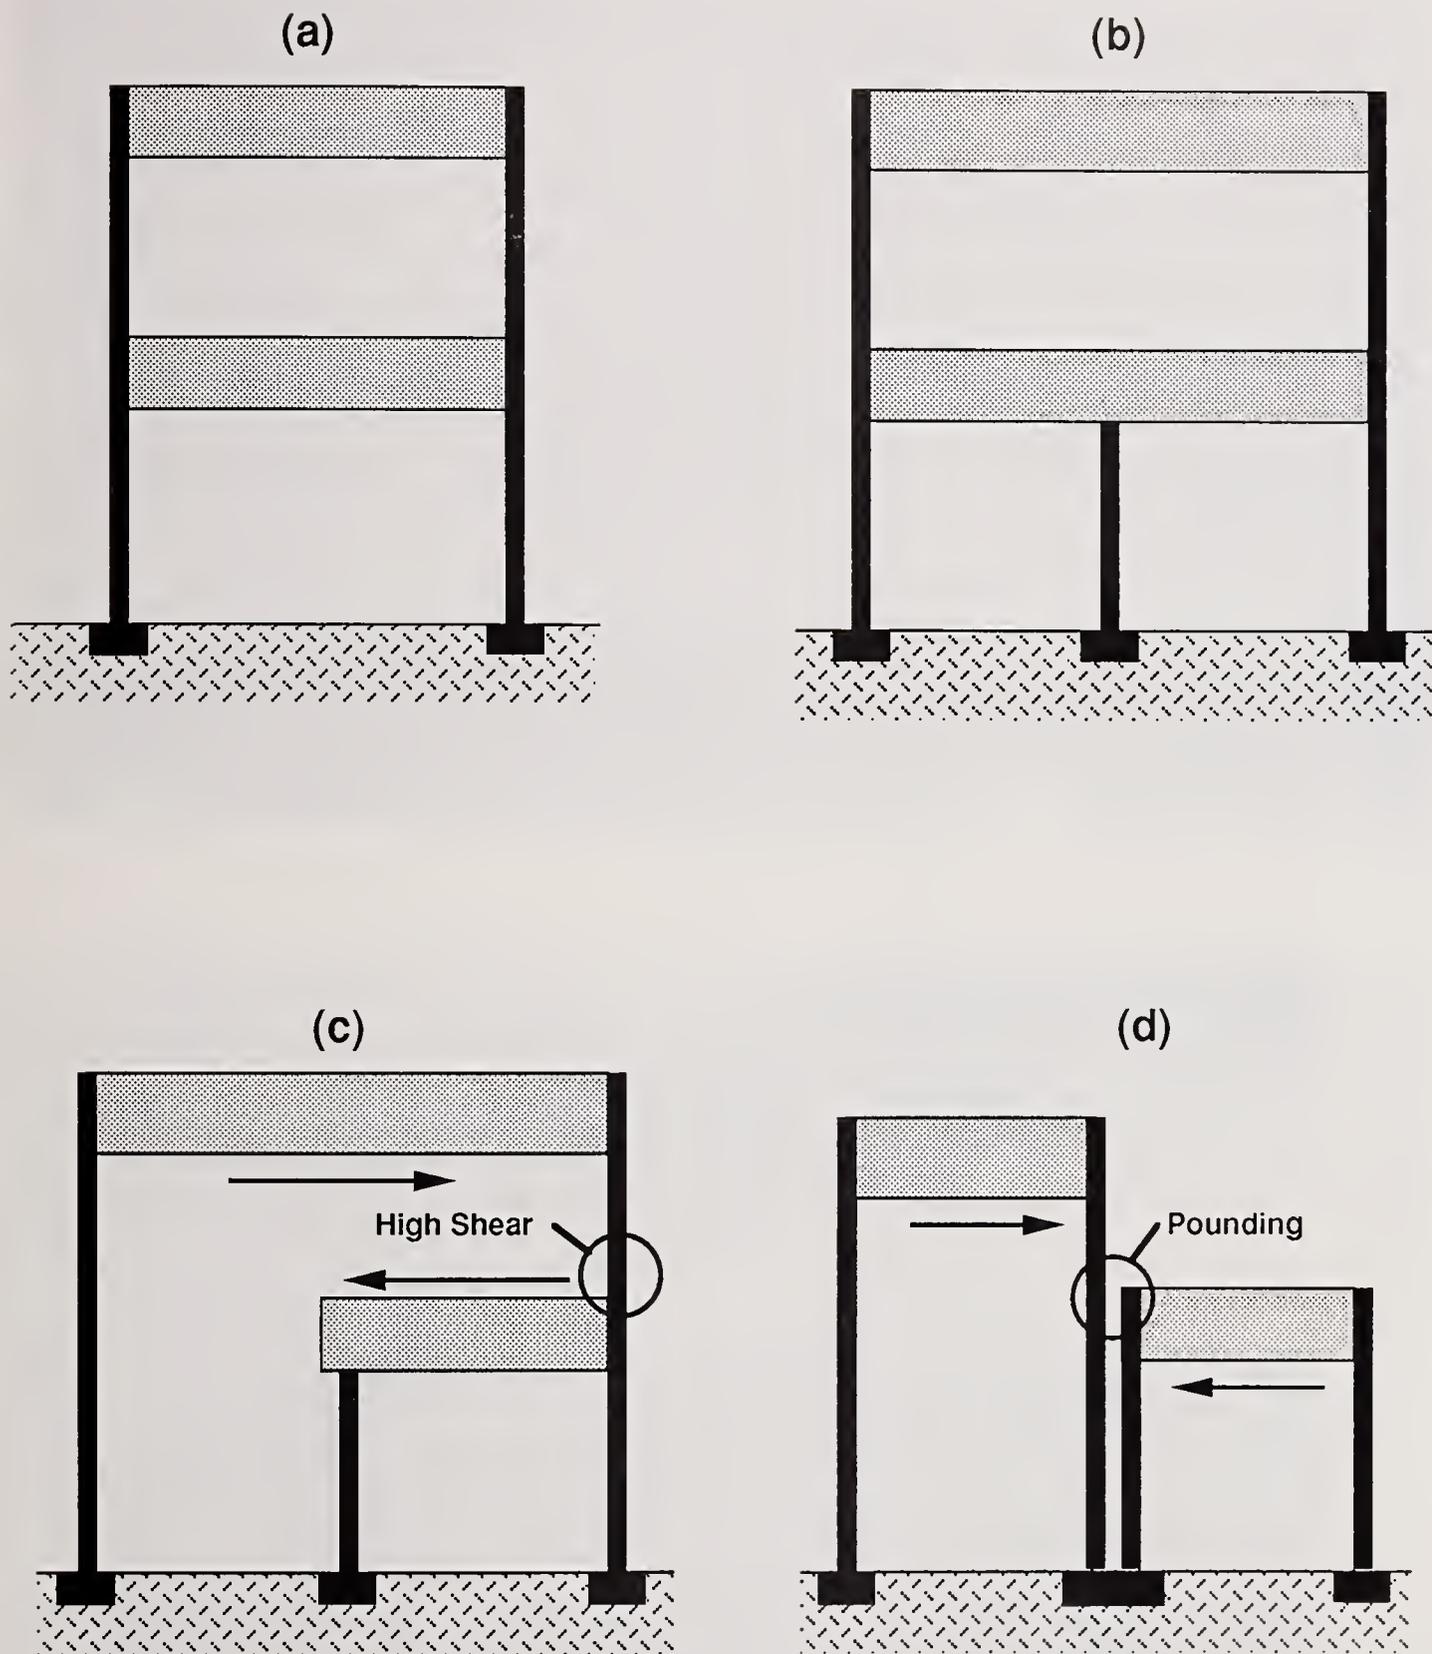
Figure 5.9.11 Schematic illustration of the various structural configurations as I-280 undergoes transition from a two-level to a single-level elevated highway.

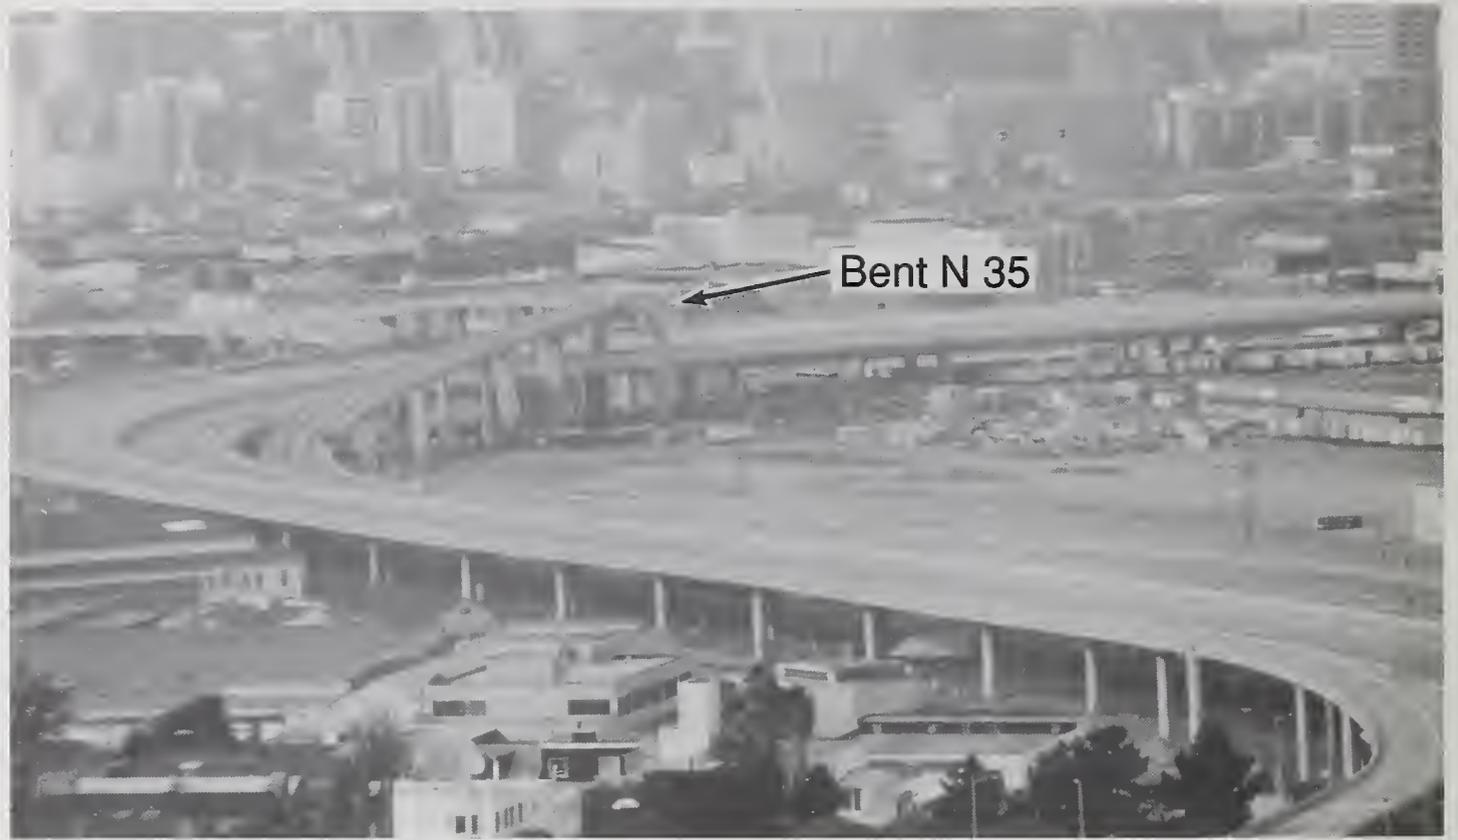
Figure 5.9.12 Aerial view of the Sixth St. exit of I-280.

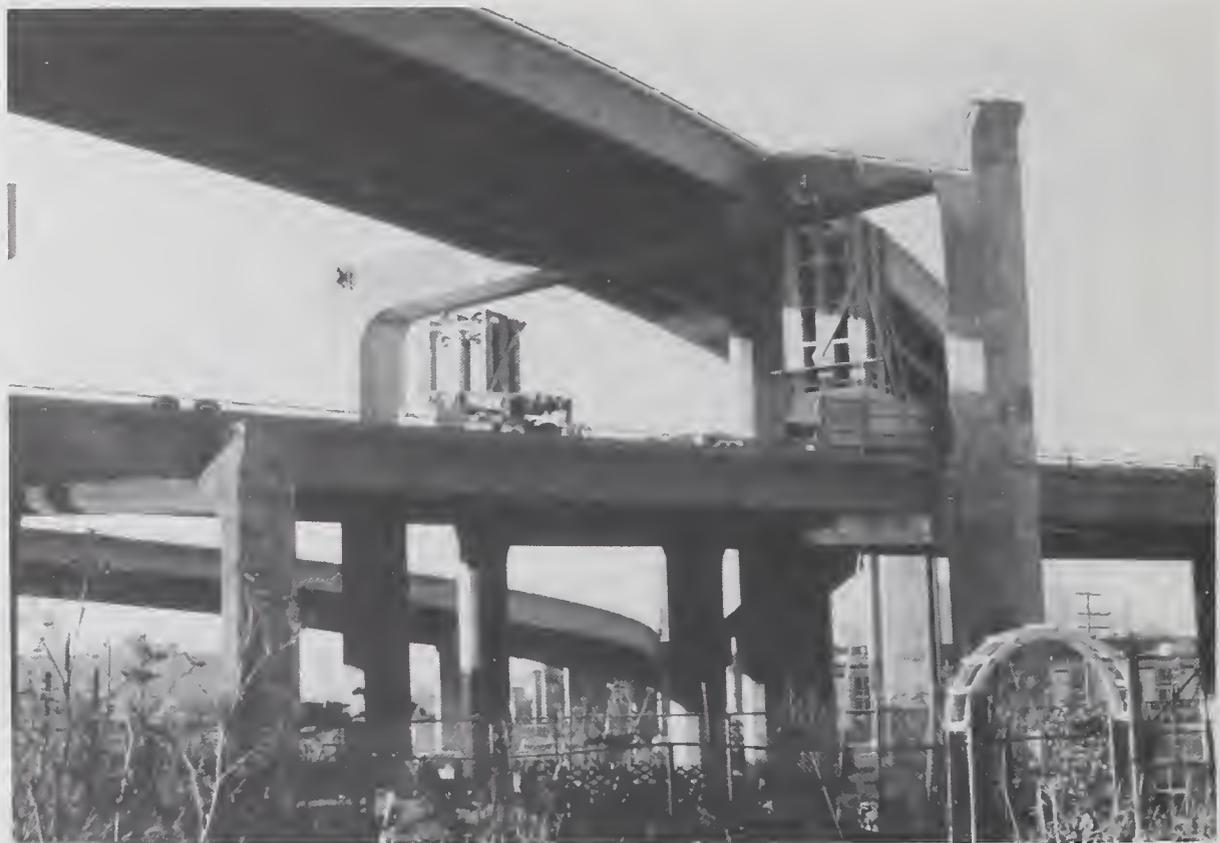
Figure 5.9.13 The Sixth St. exit ramp where it passes over the northbound lanes of I-280. (View is toward west; cribbing was added to provide temporary support.)

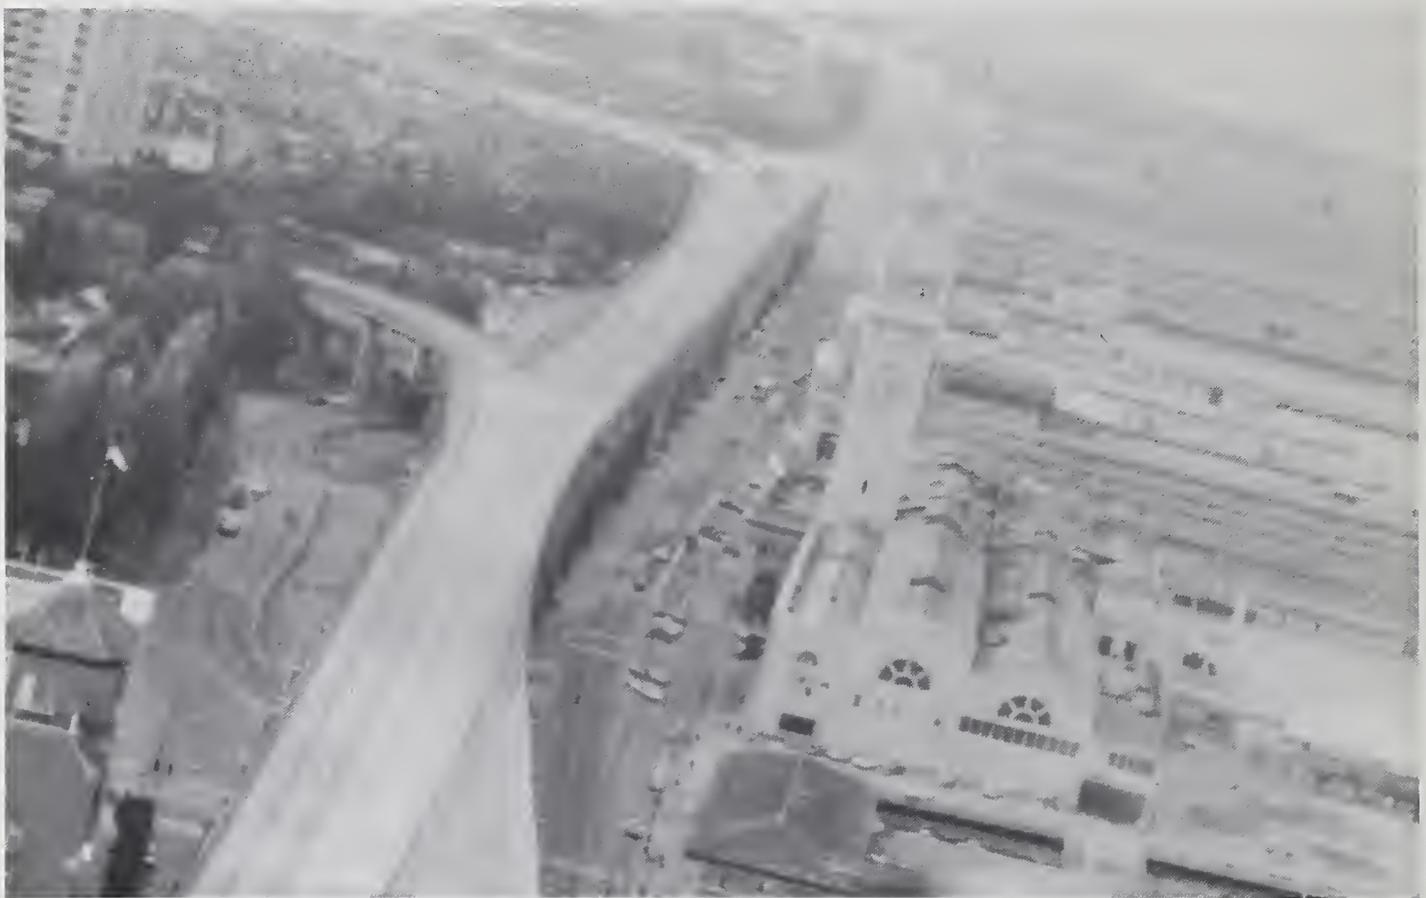
The Embarcadero Freeway (I-480) is a two-level elevated highway which provides the Financial District with access to the San Francisco-Oakland Bay Bridge. According to the as-built drawings supplied by Caltrans, the freeway was designed according to the 1953 AASHO Specifications (AASHO, 1953). Figure 5.10.1 is an aerial view of the portion of I-480 north of Mission Street. The historic Ferry Building is east of the freeway.

Figure 5.10.1 Aerial view of the Embarcadero Freeway north of Mission St.

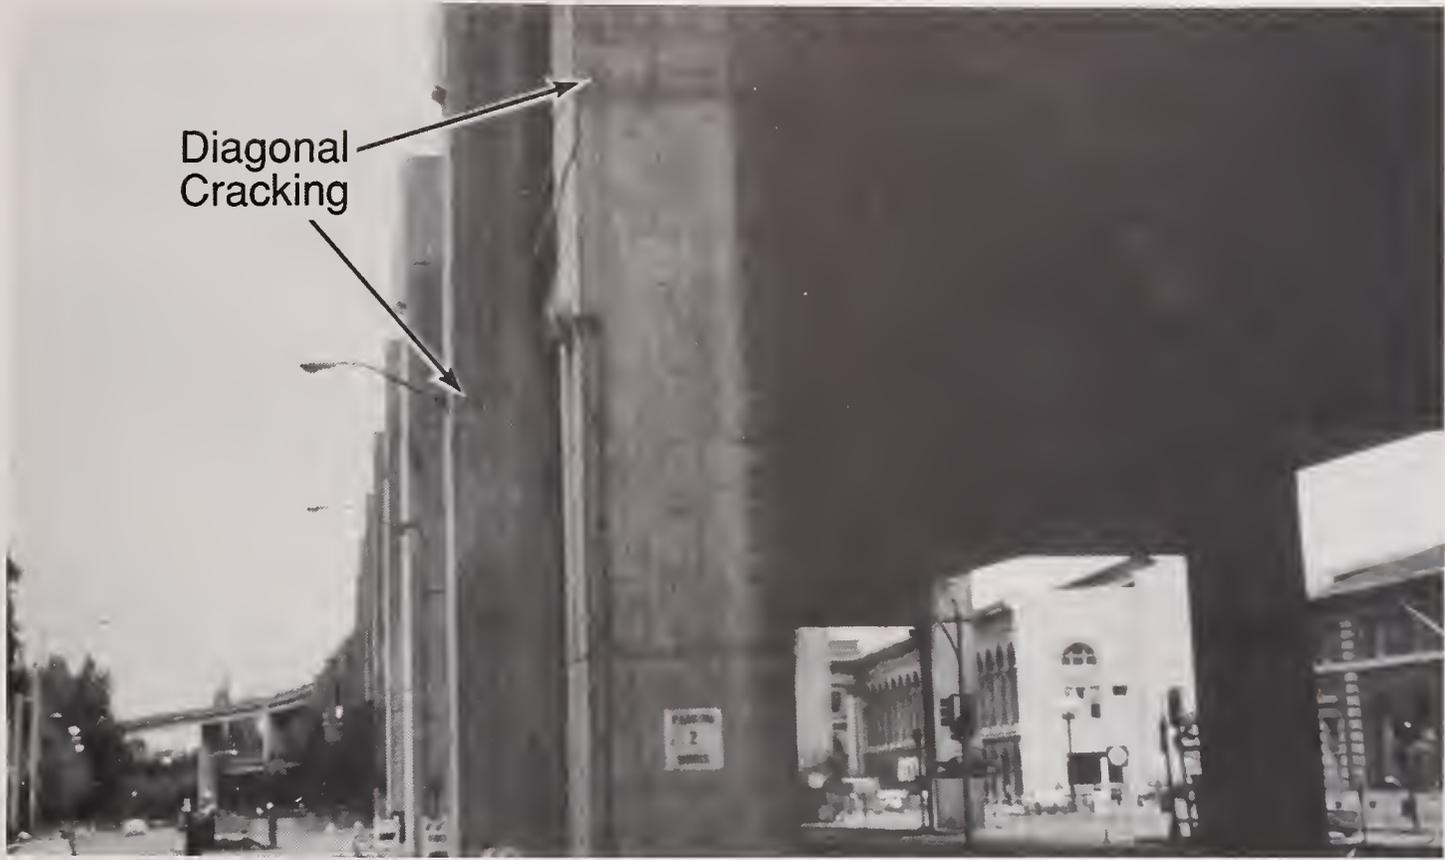
Figure 5.10.2 is a ground-level view looking north along the west side of the freeway; Bent 76 is in the foreground. The vertical metal covers which can be seen at the top girder-column joints protect restraining tendons which were added during the earthquake upgrading in 1972. Figure 5.10.3 is a ground-level view from the east side looking north; Bent 78 is in the foreground. Mission Street is located between Bents 78 and 79 (numbers increase toward the north). The observed damage occurred at the lower girder-column joints in bents located north and south of Mission Street.

Figure 5.10.2 West side of Embarcadero Freeway south of Mission St., Bent 76 is in foreground.

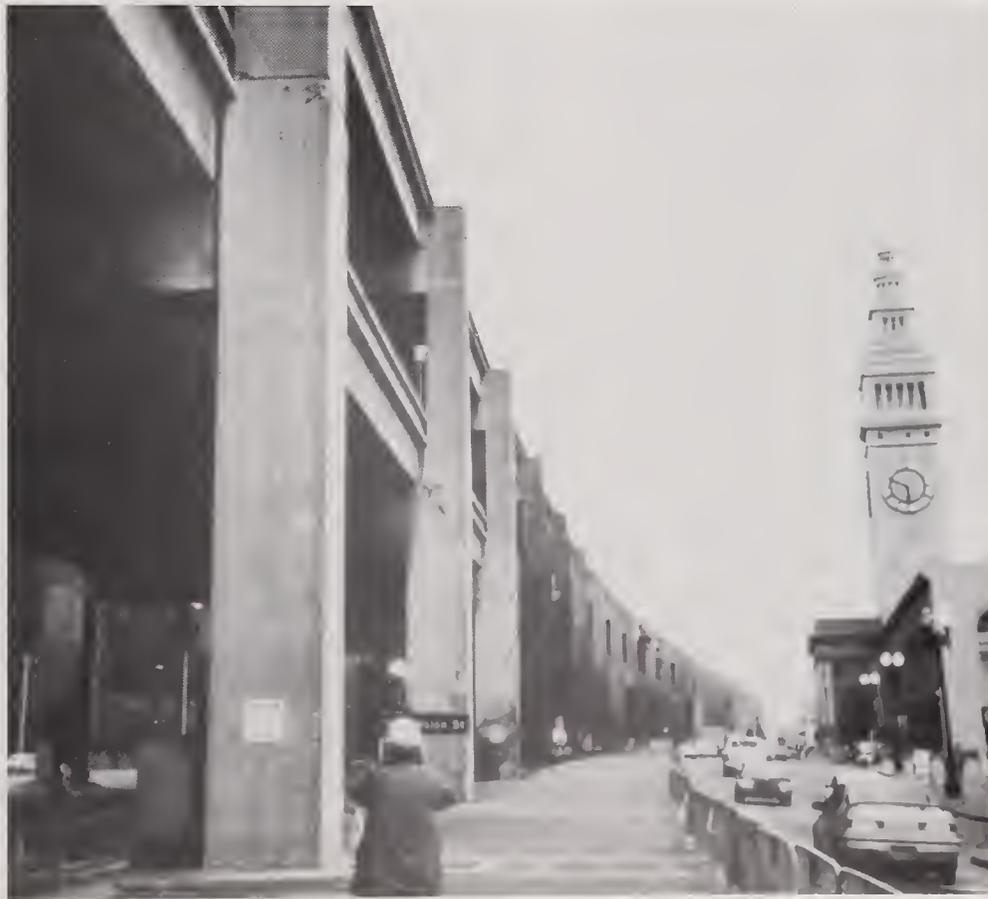
Figure 5.10.3 East side of Embarcadero Freeway at Mission St., Bent 78 is in foreground.

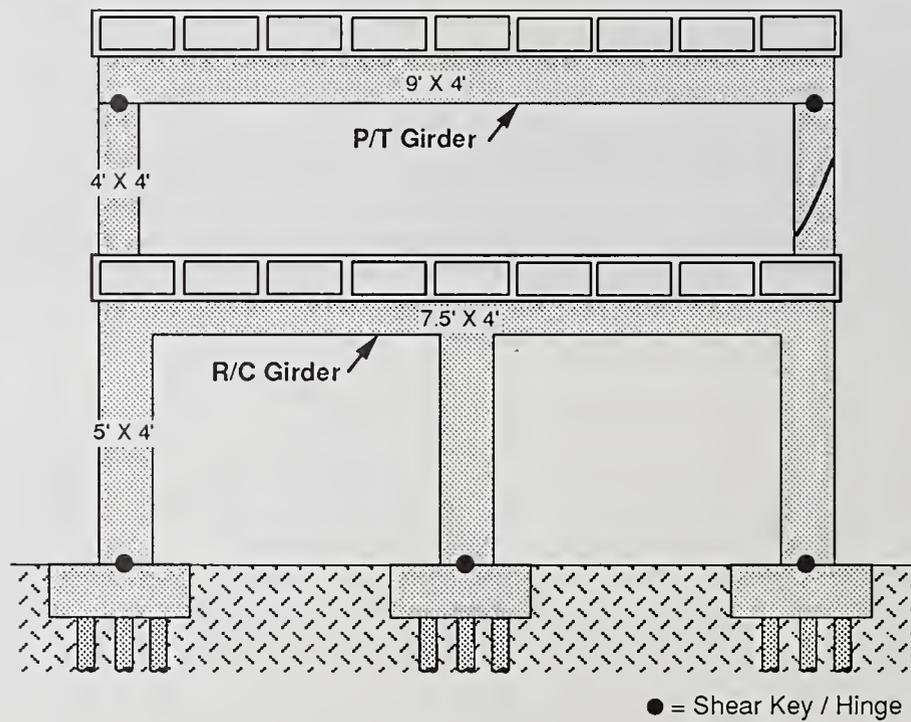
BENT 43

Figure 5.11.3(a) is close-up view of the east-side column of Bent 42. A series of diagonal cracks occurred at the middle of the column, and finer cracks developed at the top of the column inclined in the opposite direction. The more serious damage was observed at Bent 43. As shown in figure 5.11.3(b), extensive diagonal cracking developed just above the roadway.

Figure 5.11.2 Schematic of Bent 43, which had the more severe damage.
