**Federal Building and Fire Safety Investigation of the
World Trade Center Disaster**

**Damage and Failure Modes of
Structural Steel Components**

Stephen W. Banovic
Timothy Foecke

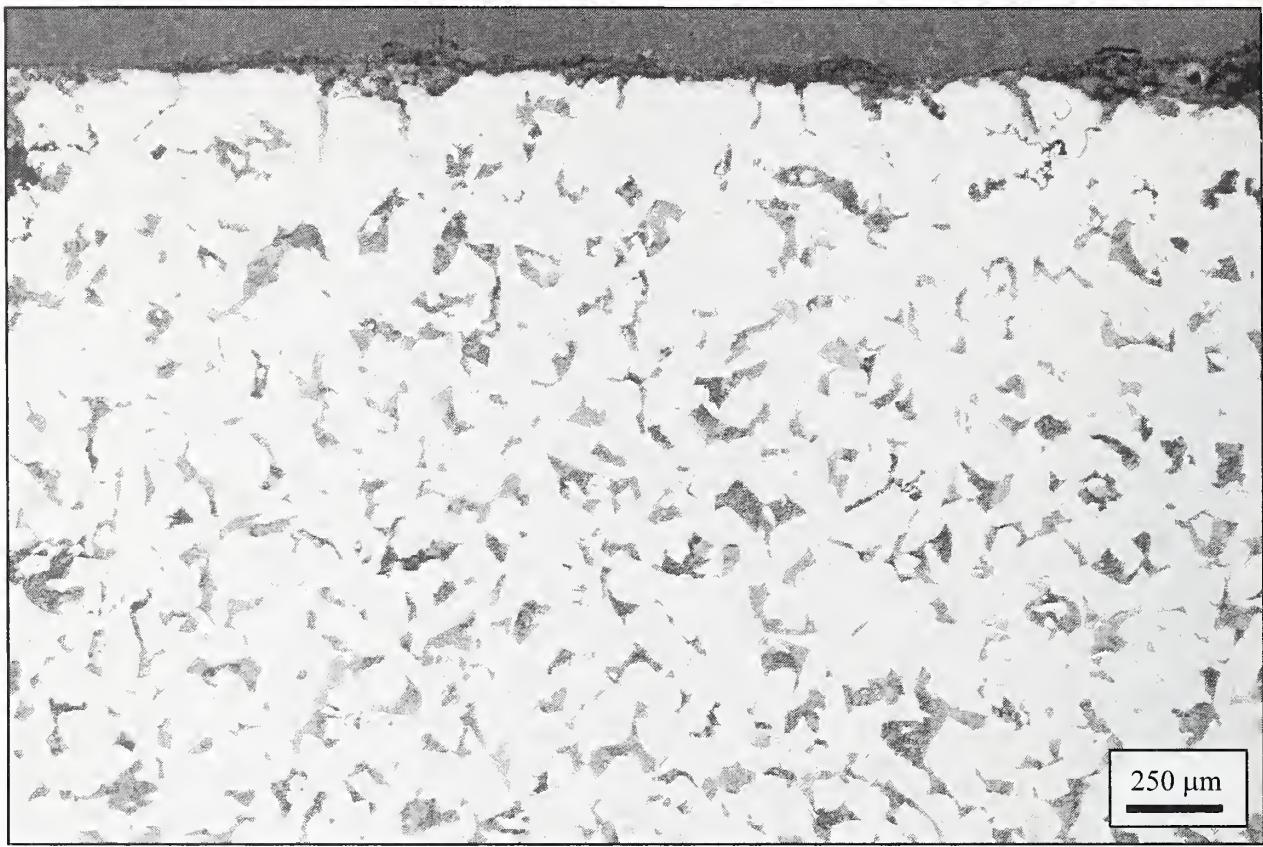
Figure 6–27. Light optical micrograph showing the structure of corrosion scale formed on sample C-115. A decarburization zone was not observed. Two percent nital and 4 percent picral etch.

The corrosion product at the surface of the rod from the reduced section was also investigated. There was some evidence that decarburization did occur near the surface, Fig. 6–27. A close-up of the scale is shown in Fig. 6–28 with four regions of interest noted. The first was the actual corrosion scale itself. Numerous gray-colored and gold-colored phases, when viewed light optically, were present in the scale. Figure 6–28a shows a secondary electron image of this region and the location of EDS analysis. Table 6–3 displays the results of the EDS analysis. From these results, it appears that a mixture of oxide and sulfides were present (points 1-4 and 9-11). These scales were similar to those observed on corroded samples from panel K-16. The second region of interest was the matrix directly surrounding the advancing corrosion product, Fig. 6–28b. This region appeared to be free of any internal oxidation or grain boundaries and, according to EDS analysis (points 5, 8, and 12), contained iron with nickel in solution. Within this region were two other phases; one needle-like and the other with a “feathery” appearance. These two phases can be seen in Fig. 6–28c. Both of these contained iron and nickel, with the nickel concentrations higher than that found in the surrounding matrix (points 6, 7, 13, 16-18). The next region was an internal oxidation region of varying thickness and depth into the sample, also observed in Fig. 6–28c. The final area was the matrix itself.

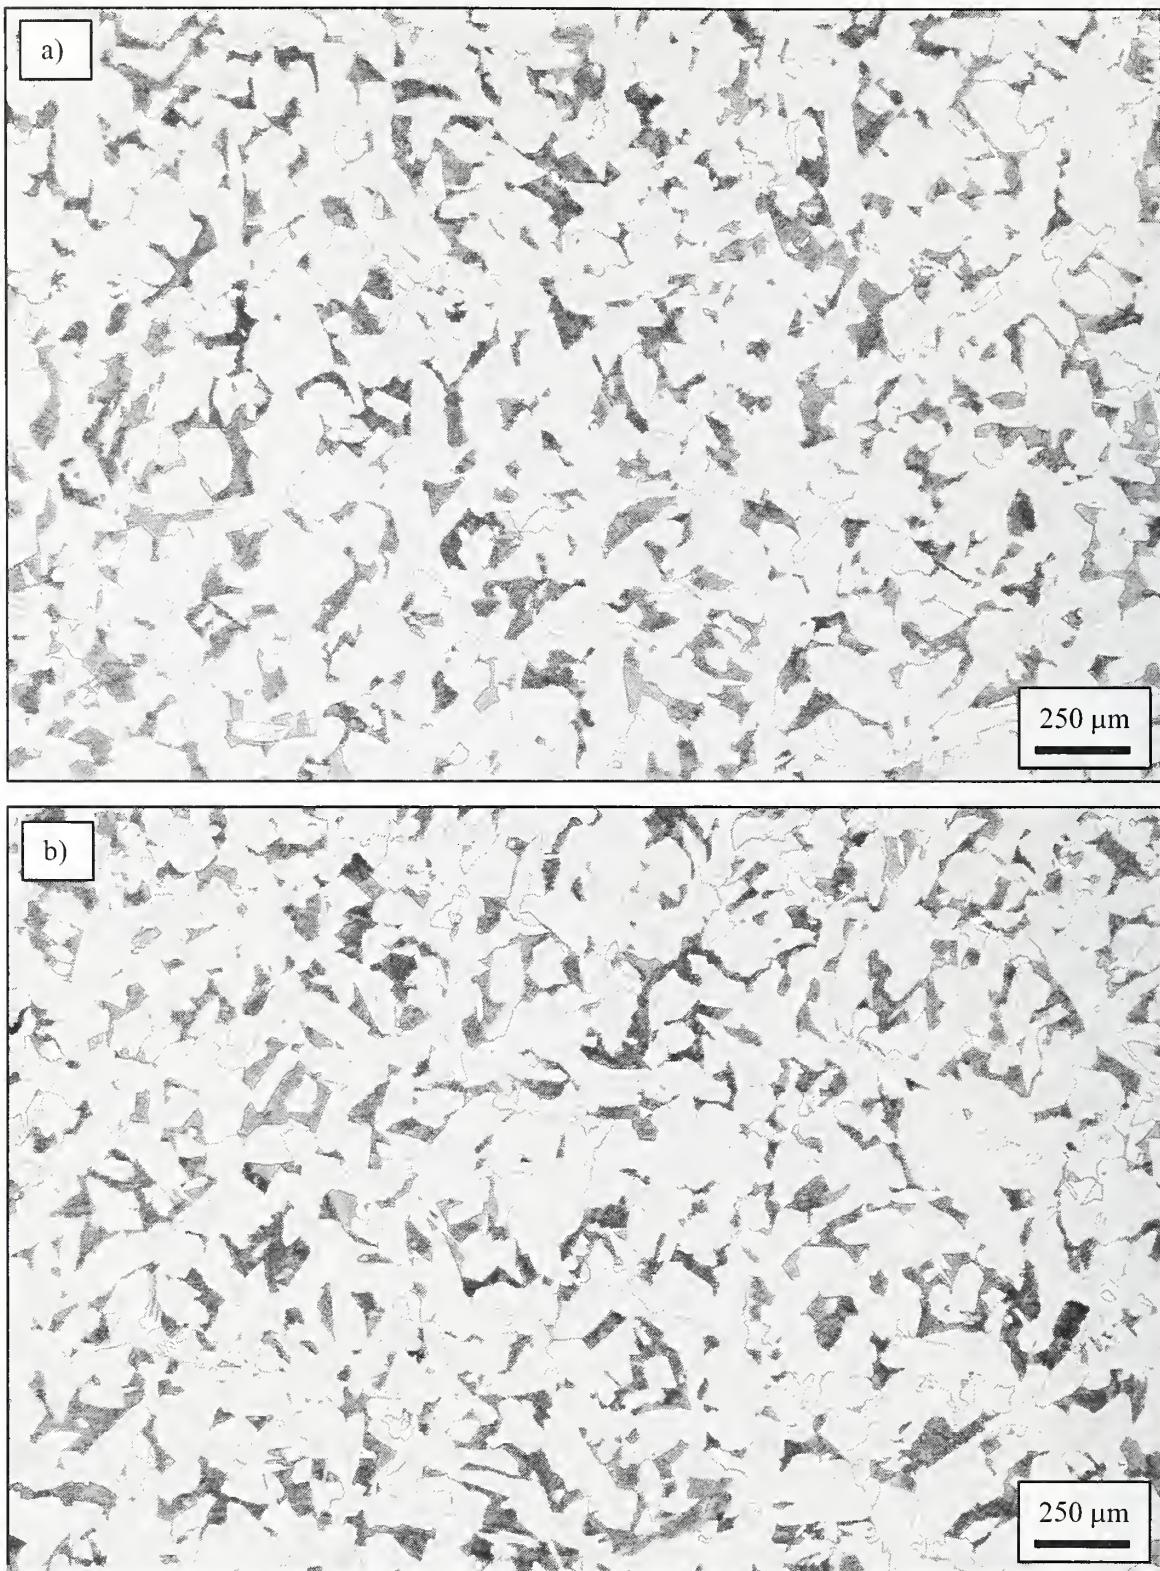
Figure 6-25. Light optical micrographs showing ferrite-pearlite structure of truss rod sample C-115. a) 1 in. section, b) reduced section. Two percent nital and 4 percent picral etch.

Microstructural evaluation of both ends revealed a ferrite-pearlite structure with fairly coarse constituents, Fig. 6–25. The ferrite grains were relatively equiaxed with no banding of the pearlite. Additionally, there were no indications that spheroidization of the pearlite had occurred. In contrast, other (undeformed) rods of A 242 examined revealed a different structure, Fig. 6–26. In addition to the significantly smaller ferrite grain size (and size of pearlite colonies), in general, a Widmanstätten morphology was widely observed throughout the structure. Development of ferrite in this morphology typically occurs when the steel is austenitized at a relatively high temperature, above the A_3 line, and then cools at a relatively fast rate (Samuels 1980). Some banding of the pearlite was locally observed.

Two facts have led to the conclusion that this floor truss rod was heated above the A_3 line: 1) the high ductility displayed by the material under load and 2) the constituents observed in the microstructure were significantly larger than observed for other A 242 rods. Exposure to this high a temperature explains how the extent of deformation observed on the sample was obtained without the concomitant microstructural indications of deformation (e.g., elongated ferrite grains). At these temperatures, and under the applied tensile load, the rod was extremely ductile, which allowed it to thin down to the dimensions observed. Deformation of the microstructure was eliminated through dynamic recrystallization of the austenite grains and upon cooling, no indication of deformation was observable in the microstructure. Additionally, it is likely that (1) this rod was not at high temperature for an extended period of time as a decarburization zone at the surface of the rod was not found or (2) the cooling rate of the rod was such that the carbon was able to uniformly redistribute after exposure. While review of the evidence does not give any indication as to when the temperature excursion and subsequent deformation occurred, it is

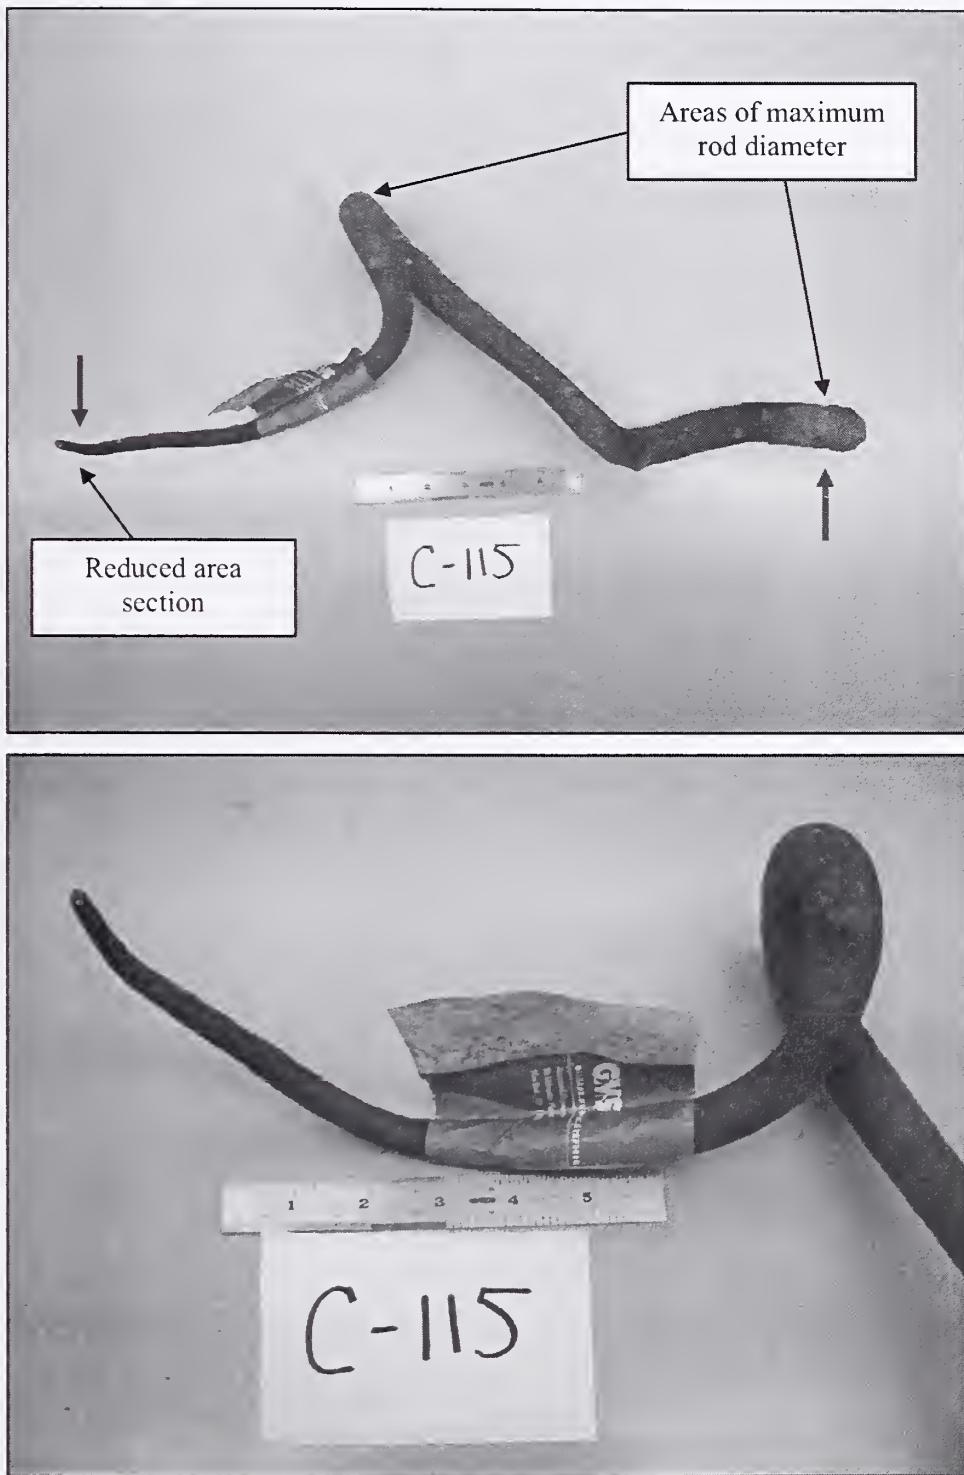
Figure 6–24. Sample C-115, an unidentified floor truss rod that has thinned down. Red arrows indicate areas of sample removal for analysis.

Figure 6–24 indicates the location of samples removed for analysis. One was taken from the significantly reduced area (hereafter referred to as “reduced section”) and the other from the opposite end of the rod where the diameter was slightly greater than 1 in. (hereafter referred to as “1 in. section”). Chemical analysis of the two sections of rod indicated a slight difference in carbon levels (0.16 weight percent for the 1 in. section and 0.18 weight percent for the reduced section). The Mn contents were similar (~0.8 weight percent), with additions of V also observed (0.038 weight percent for the 1 in. section and 0.028 weight percent for the reduced section). Based upon these results, the rod met chemistry specifications for A 242 and most likely had an original diameter of 1.14 in. (NIST NCSTAR 1-3A).

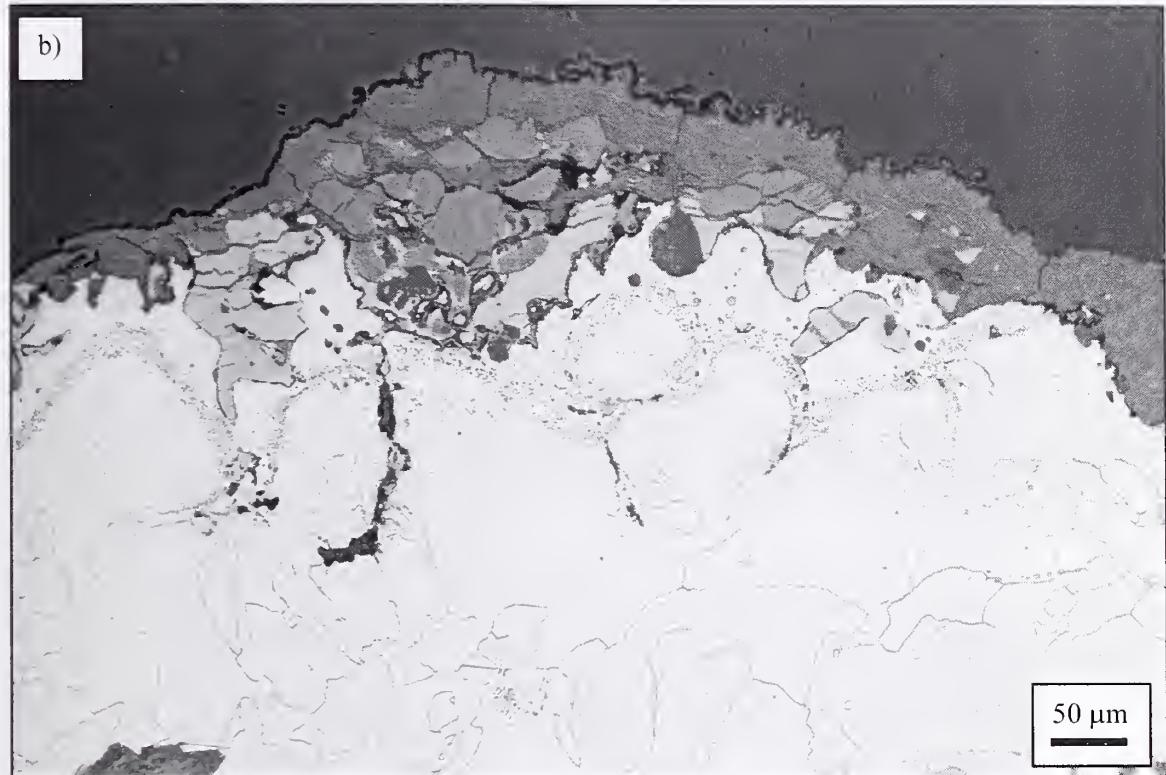
Figure 6–21. b) Light optical micrograph showing the microstructure near the metal-scale interface of the 50 ksi column labeled K-16 near where the corrosion process occurred. As-built location was not known. Two percent nital and 4 percent picral etch (cont.).

The corrosion scales on the outer web can be observed in all three images of Fig. 6-21. Viewed optically, the scales were a complex mixture of varying gray-shaded scales, gold-colored phases, and dark grain boundary precipitates. Table 6-3 shows the results of the EDS probed areas in Fig. 6-21c. Again, the lighter gray phases at the scale-environment interface appeared to be iron oxides. The darker gray phases in the scale interior appeared to be iron oxides containing high levels of Ca, as well as minor quantities of Cl, Si, and S. The bulk gold-colored phases, as well as the majority of phases in the grain boundaries, were iron sulfides. The corrosion scale observed on the un-corroded web (Fig. 6-22a) were found to be all oxides that had a similar morphology to the scales observed on sample K-1 (Figs. 6-16a and 6-19). Further, corroding elements (e.g., S, Cl), as found in the scale observed in the eroded/corroded regions, were not detected.

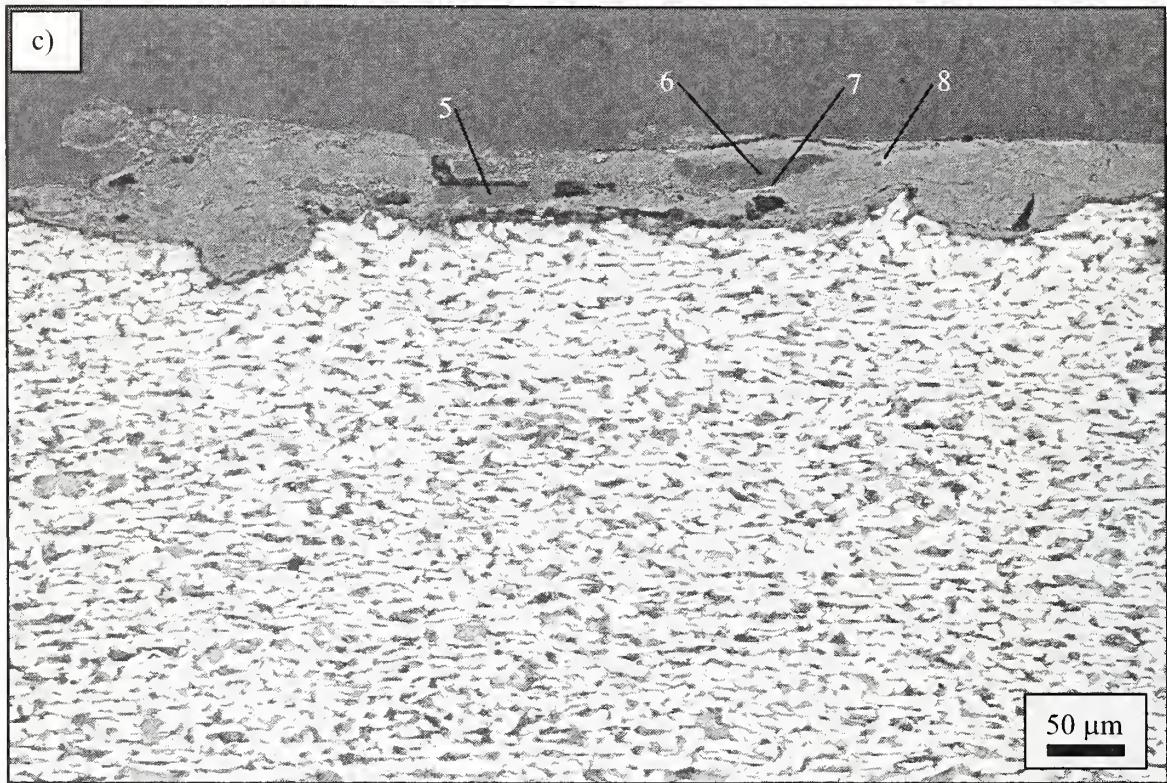
Figure 6–19. Light optical micrographs showing microstructure from flange of column 210 of panel K-1 (A209: 97-100) from the crumpled area above the 98th floor spandrel. c) Characteristic scale formation. Two percent nital and 4 percent picral etch.

An oxide scale was also observed on the sample from the 98th floor region (Figs. 6-16b and 6-19). This scale was somewhat dense and continuous, but non-uniform in thicknesses (ranging on the order of 25 μm to 250 μm). The latter characteristic was a result of localized scale penetration into the flange material, resulting in nodular oxide structures when viewed in cross-section (Fig. 6-19). The scales were composed of gray colored phases of varying shades when examined using a light optical microscope. Energy dispersive spectroscopy (EDS) concluded that the two lighter gray phases contained Fe with traces of Mn (oxygen was not detectable with the system utilized). Table 6-3 displays the qualitative results of the EDS probed areas on Fig. 6-19. In addition to Fe, the darkest gray phase was found to have relatively high amounts of Ca, though it was unclear from where this elemental component originated. Another scale observed was orange in color and found to contain Ti, most likely contributed by the primer paint. When viewed using polarized light, the scale was optically active, resulting in a red-orange shading throughout the scale (Fig. 6-19b).

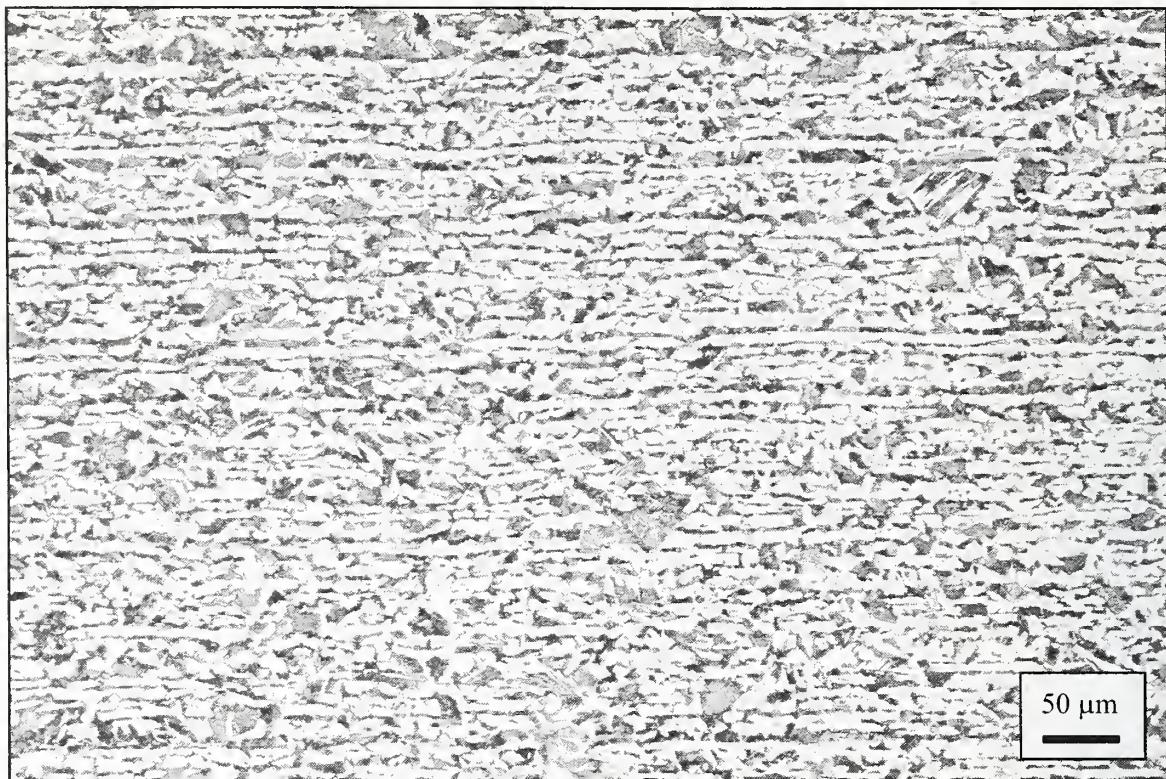
Figure 6–18. Light optical micrograph showing a characteristic microstructure taken at the centerline of a 60 ksi outer web plate. Sample is from panel C-40 (A136: 98-101), column 136 in the 99th floor region of WTC 1. Two percent nital and 4 percent picral etch.

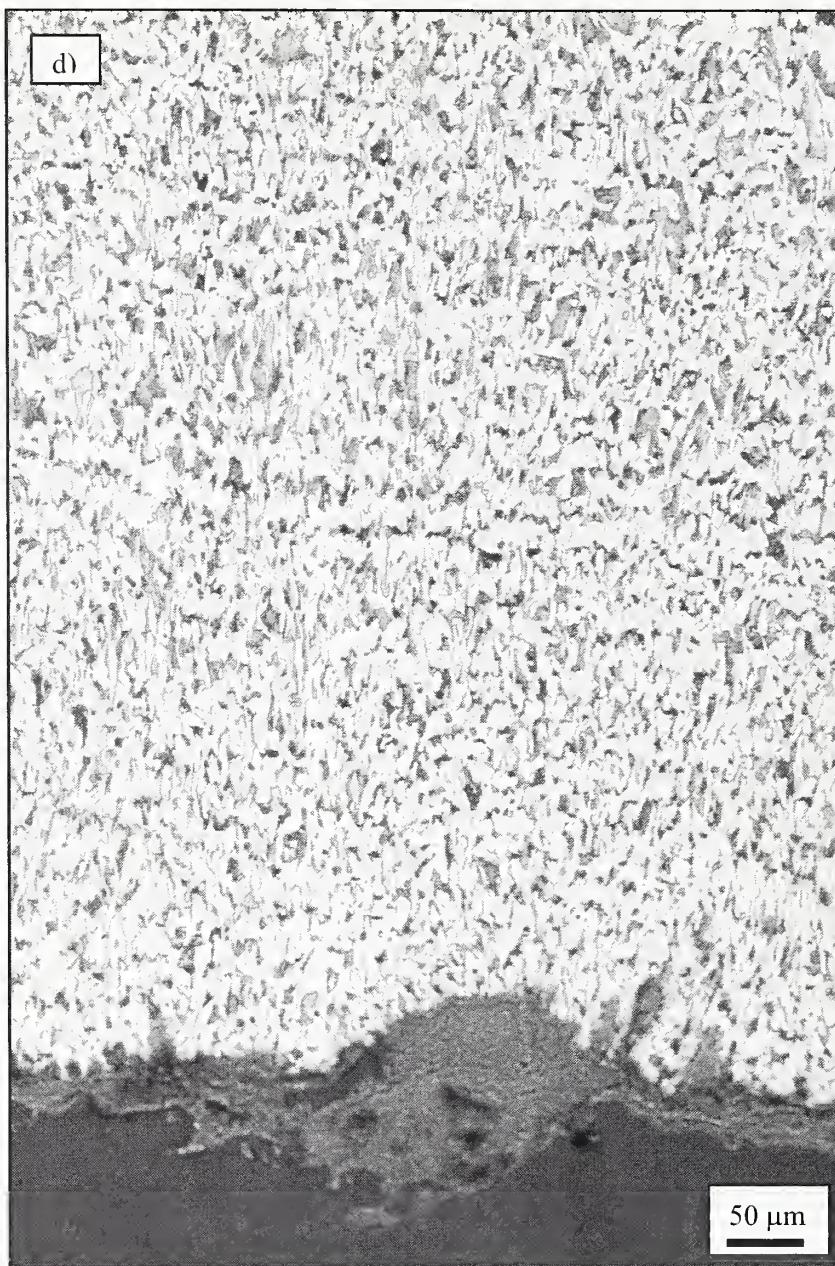
Figure 6–16. Light optical micrographs showing the microstructure from flange of column 210 of panel K-1 (A209: 97-100) from the crumpled area above the 98th floor spandrel. d) inner surface of plate showing compressed constituents of ferrite and pearlite. Two percent nital and 4 percent picral etch.

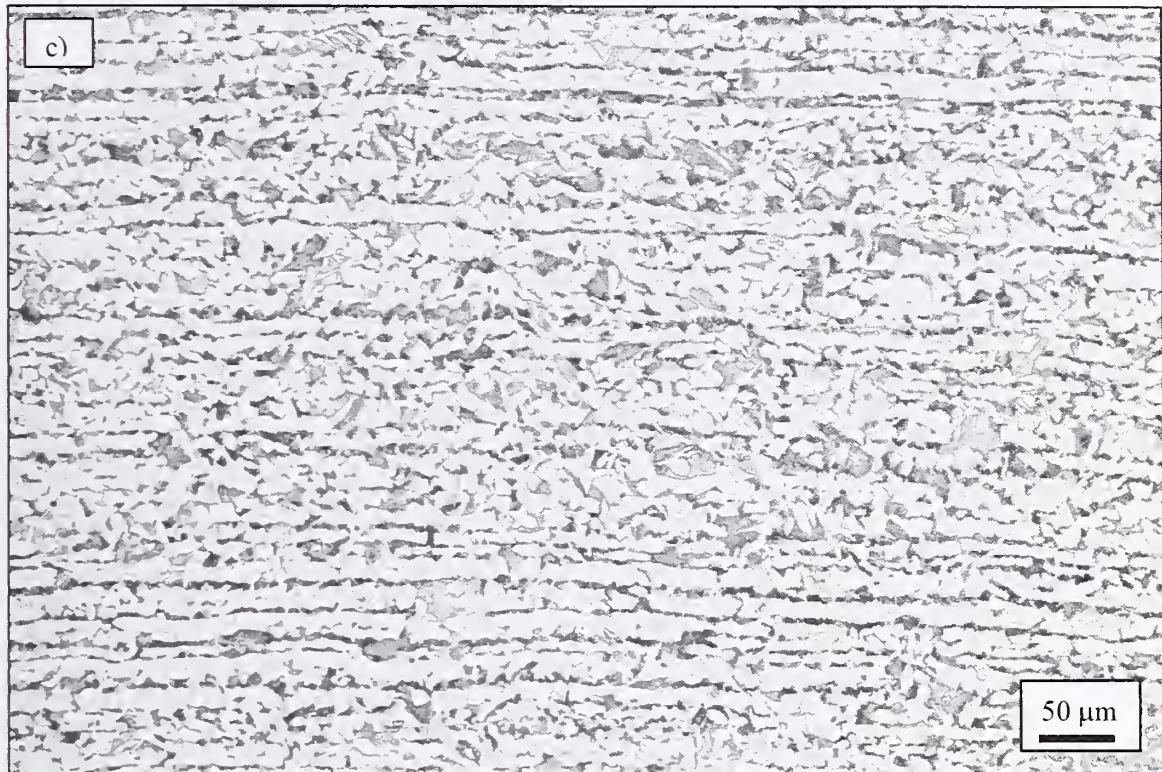
Figure 6-16. Light optical micrographs showing the microstructure from flange of column 210 of panel K-1 (A209: 97-100) from the crumpled area above the 98th floor spandrel. c) centerline of plate showing relatively undeformed grains of blocky ferrite and pearlite colonies. Two percent nital and 4 percent picral etch.

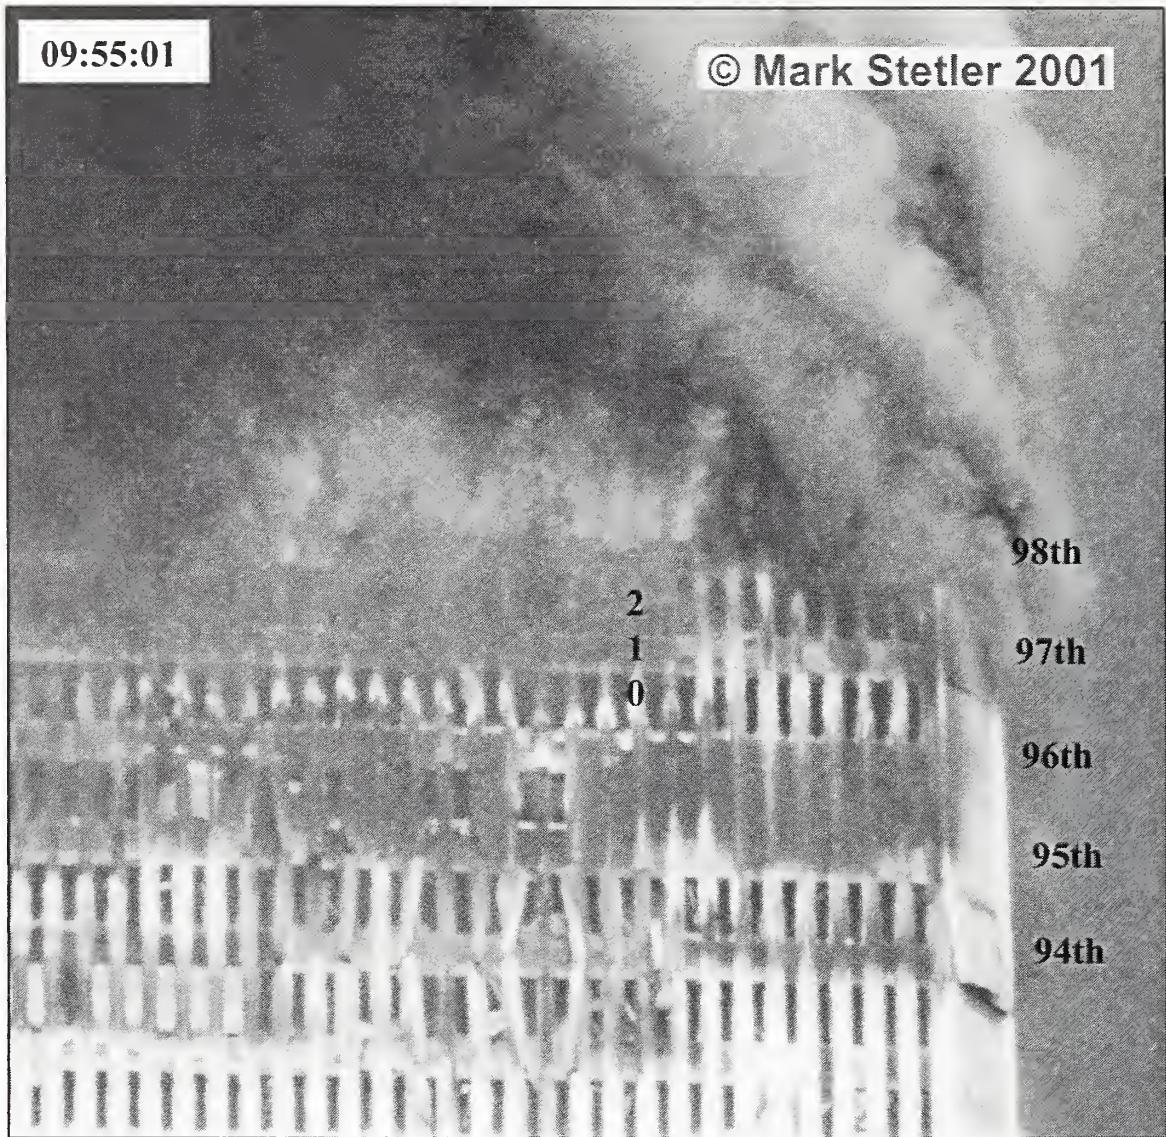
Figure 6-15. Pre-collapse photographs of panel K-1 (A209: 97-100) showing b) external flaming of the panel at time 9:55:01 a.m., 34 min before collapse.

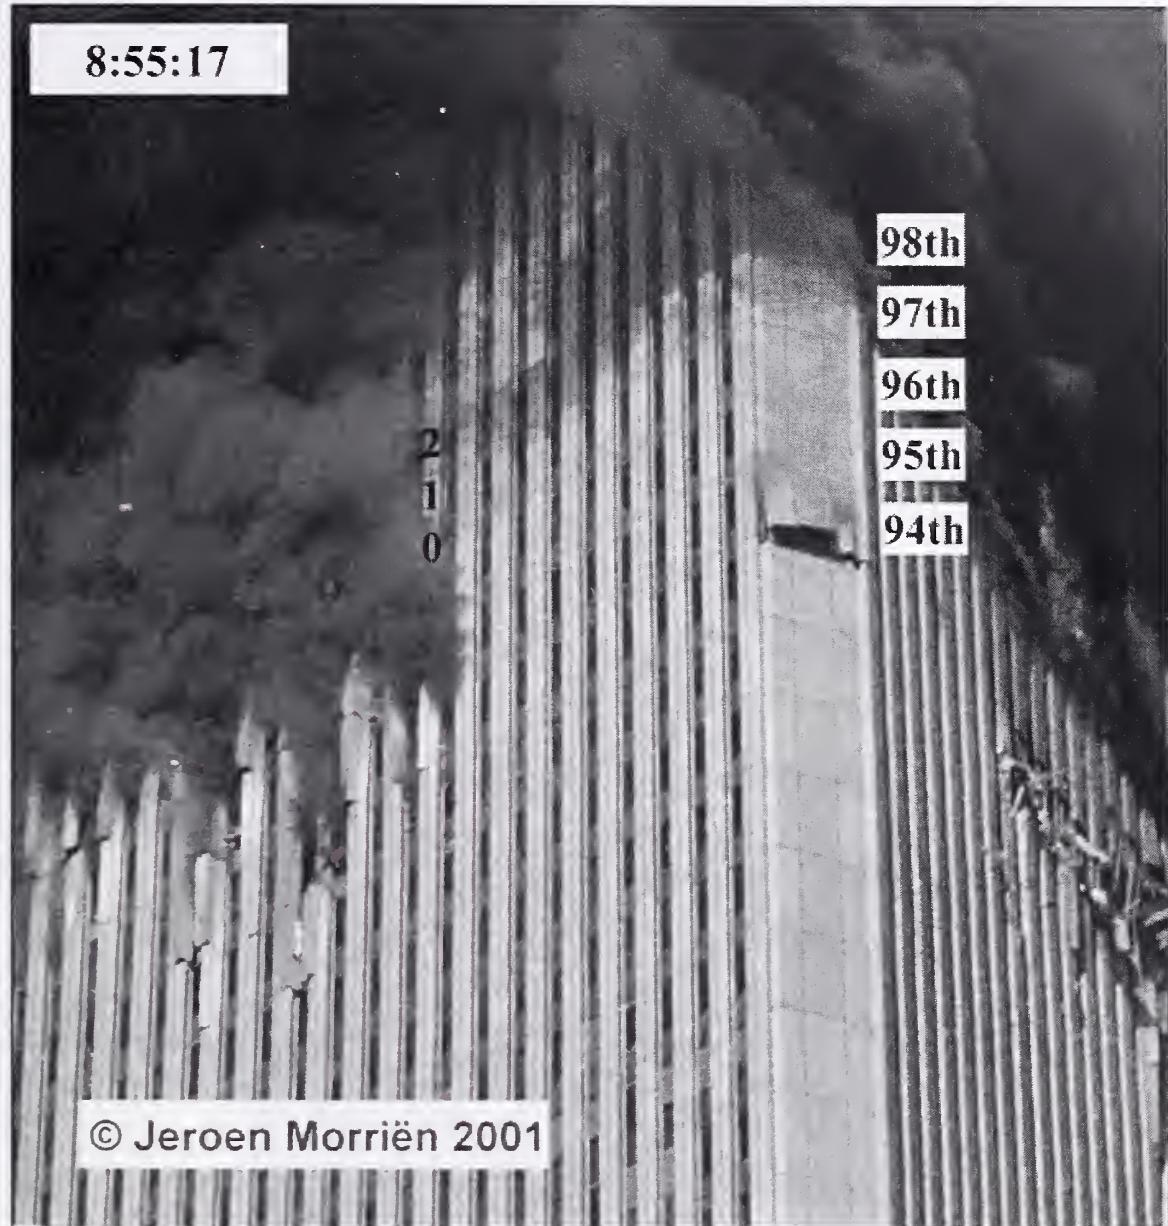
Figure 6–15. Pre-collapse photographs of panel K-1 on the east face of WTC 1 (A209: 97-100) showing a) aluminum façade intact minutes after impact. Column 210 was indicated.

Pre-collapse images indicated that immediately after the impact, there was no disruption in the aluminum façade of this panel (column 210 in the 98th floor region), Fig. 6-15a. This would suggest that the sprayed fire-resistant material of this panel, at least the exterior portion, was still intact at this time. The impact models verified that the sprayed fire-resistant material was most likely intact on this panel (NIST NCSTAR 1-2A). There was no fire or smoke evident from any of the 98th floor windows at this time, though there was external flaming of the 97th floor near the panel. Table 6-2 summarizes the time-fire exposure data obtained from Fig. 2-48m for this area, as well as other essential data related to the analysis of this sample. Significant external flaming was visually observed in the windows adjacent to column 210 on the 98th floor from 9:46 a.m. to 10:22 a.m. The extent of this external flaming can be observed in Fig. 6-15b. However, after 10:22 a.m., photographic evidence suggests that the fire had retreated to within the building and appeared to have completely receded from this area closer to the time of collapse. Smoke inhibits the view of this panel at these later times. However, evidence showed that at 10:17 a.m., the fire had already begun to subside in this area (Fig. 6-15c) and commenced its movement toward the southern face of the building. At times shortly thereafter, external flaming was concentrated at the middle of the west face of the building and toward the southern end of the 98th floor. As stated above, a fair amount of smoke from other locations of the building obscured the view of the panel near the time of collapse. However, at the initiation of collapse, external flaming was observed coming out the windows on the 98th floor near the southeast corner where fire was observed at slightly earlier times. No external flaming was associated with the northeast corner at the moment of collapse. Evidence shows that collapse was initiated on or very near the 98th floor level for WTC 1 (NIST NCSTAR 1-6).

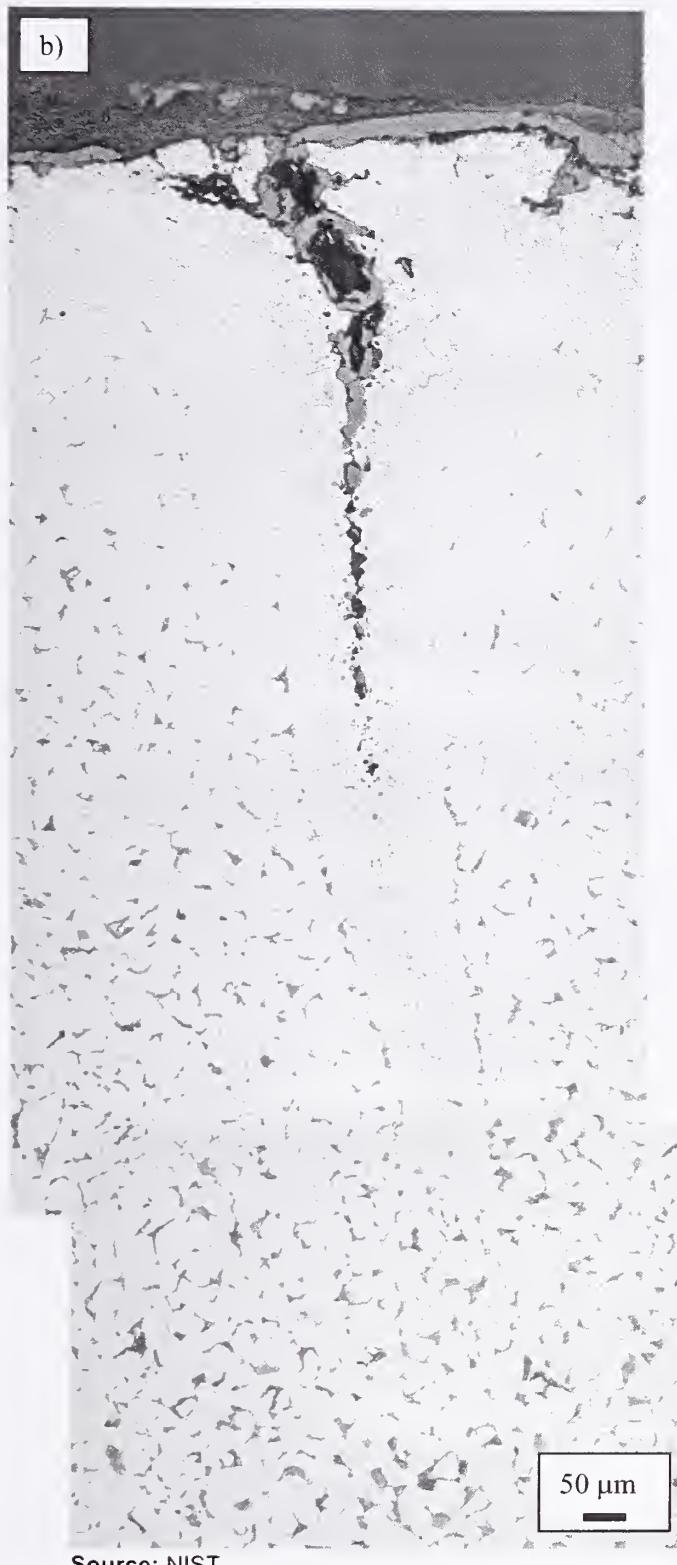
Figure 6–12. Light optical micrographs of the microstructure of a perimeter floor truss seat from the 99th floor of WTC 1, panel N-8 (A142: 97-100). b) penetration of the iron oxide phase with internal oxidation and decarburization fronts possibly due to elevated temperature exposure. Two percent nital and 4 percent picral etch (cont.).

- Results indicated that three of the four seats observed to be exposed to severe pre-collapse fire conditions did not experience significant degradation as a result of the exposure. Results from the seat taken from panel N-8 indicate that this seat may have been exposed to elevated temperatures.

that were not clearly distinguishable, in addition to the overall mottled appearance. Seats for panels C-40, M-2, and N-12 had a thin, non-uniform, and cracked oxide scale. The fourth seat, from panel N-8, had two corrosion features that were unique to this sample. The first was a continuous, uniform, and dense scale of iron oxide (Fig. 6-12a), with the second being internal penetration of the iron oxide phase and decarburization fronts (Fig. 6-12b) surrounding an oxidized crack.

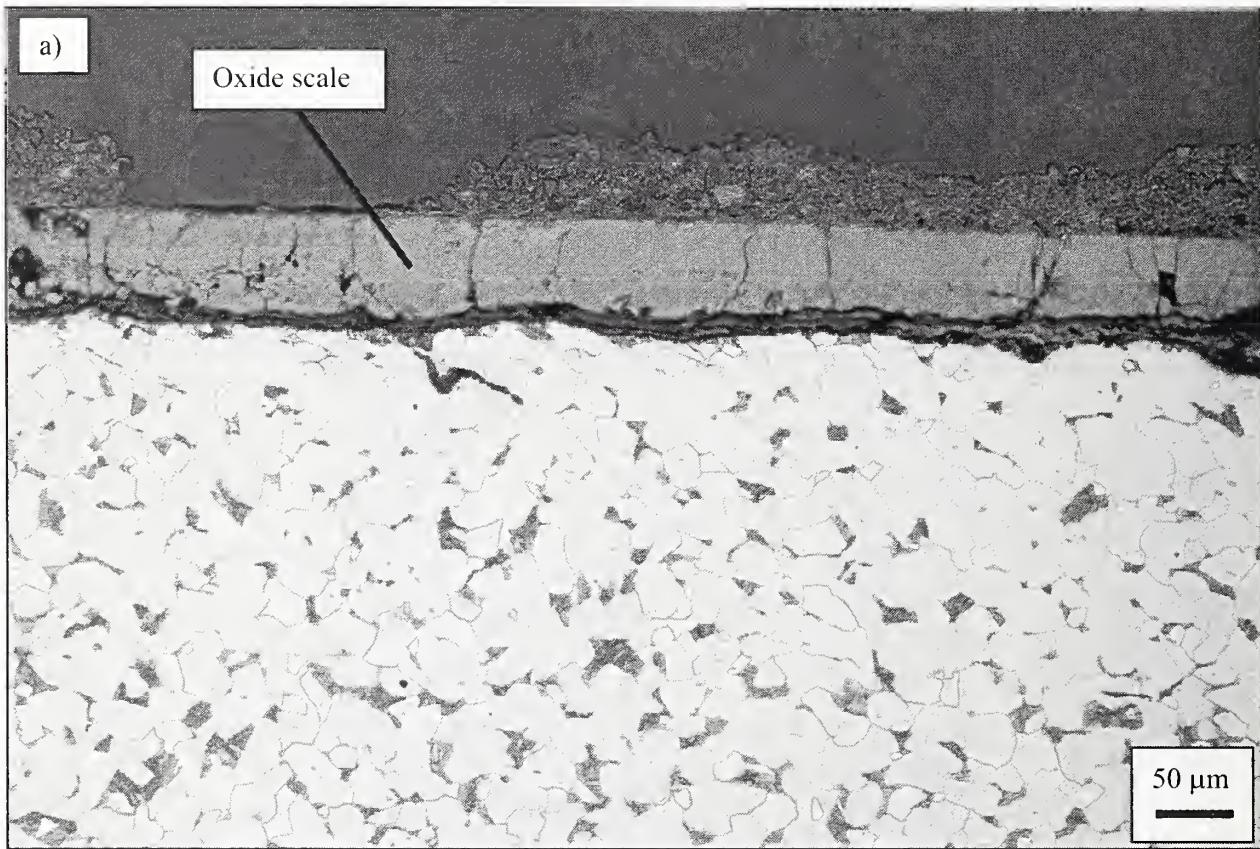
Figure 6-12. Light optical micrographs of the microstructure of a perimeter floor truss seat from the 99th floor of WTC 1, panel N-8 (A142: 97-100). a) Ferrite-pearlite microstructure and developed oxide scale. Two percent nital and 4 percent picral etch.

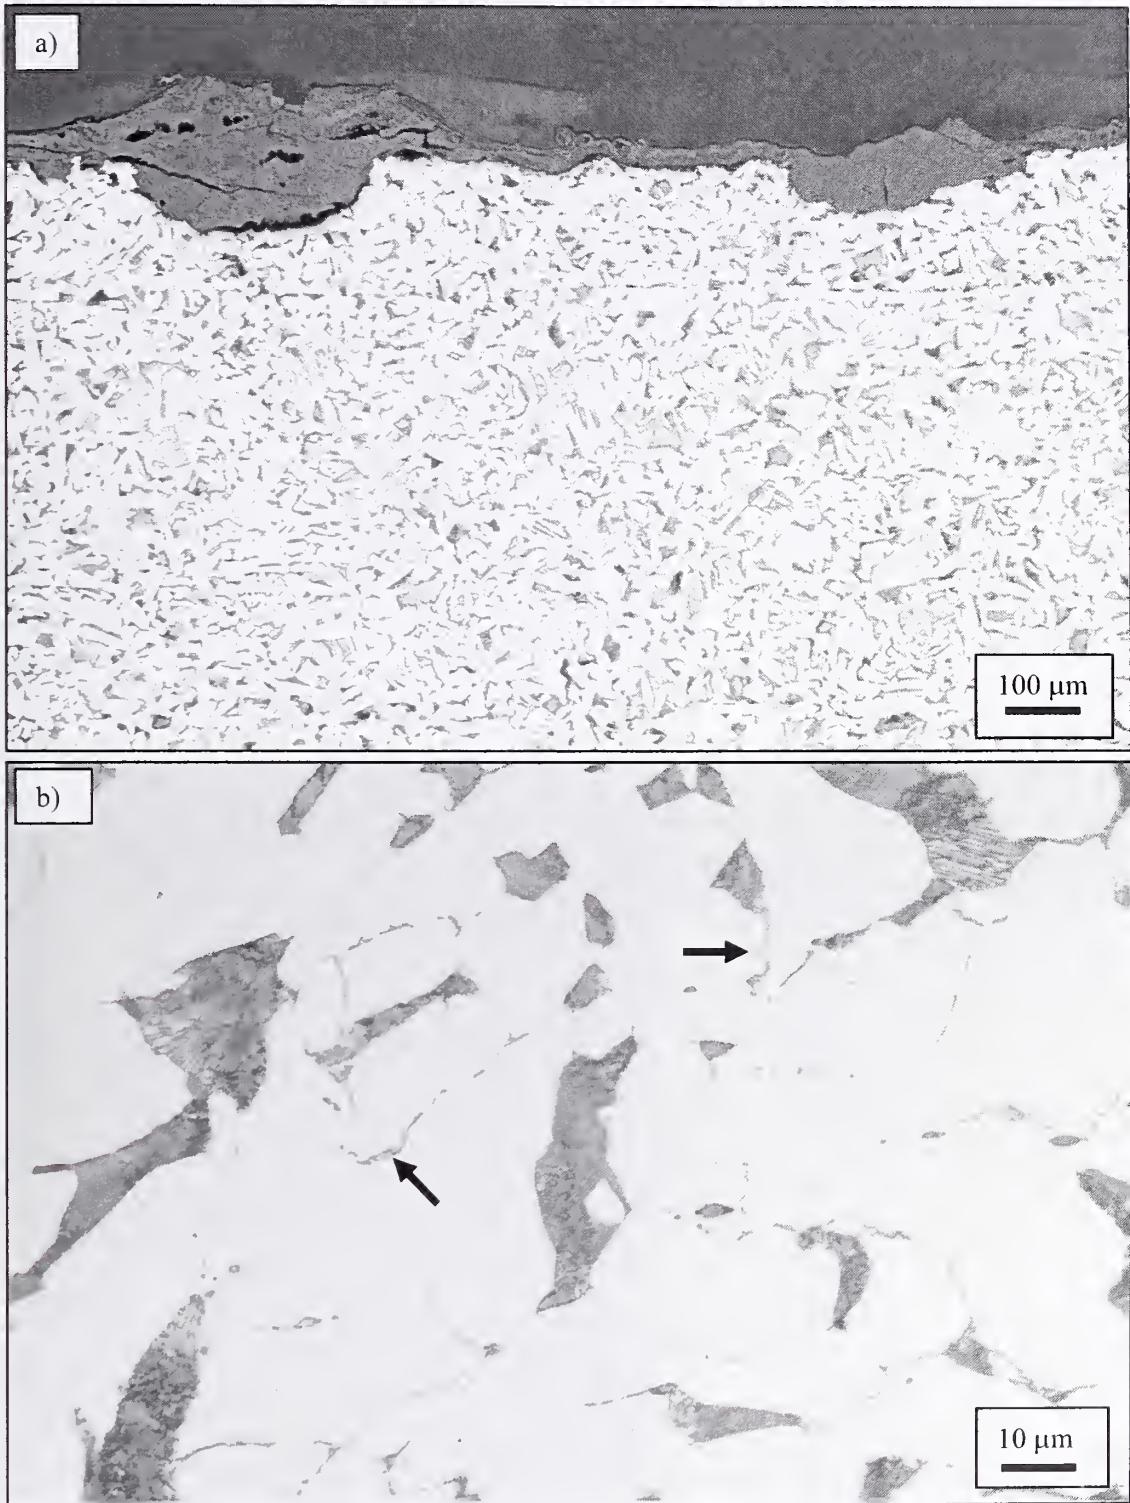
Figure 6–9. Light optical micrographs showing the microstructures from “fire exposed” spandrels. a) Ferrite-pearlite structure and developed oxide scale, b) lamellae were observable in pearlite, carbides (indicated by arrows) decorating ferrite grain boundaries. Both images taken from the 99th floor spandrel of WTC 1, panel M-2 (A130: 96-99). Two percent nital and 4 percent picral etch.

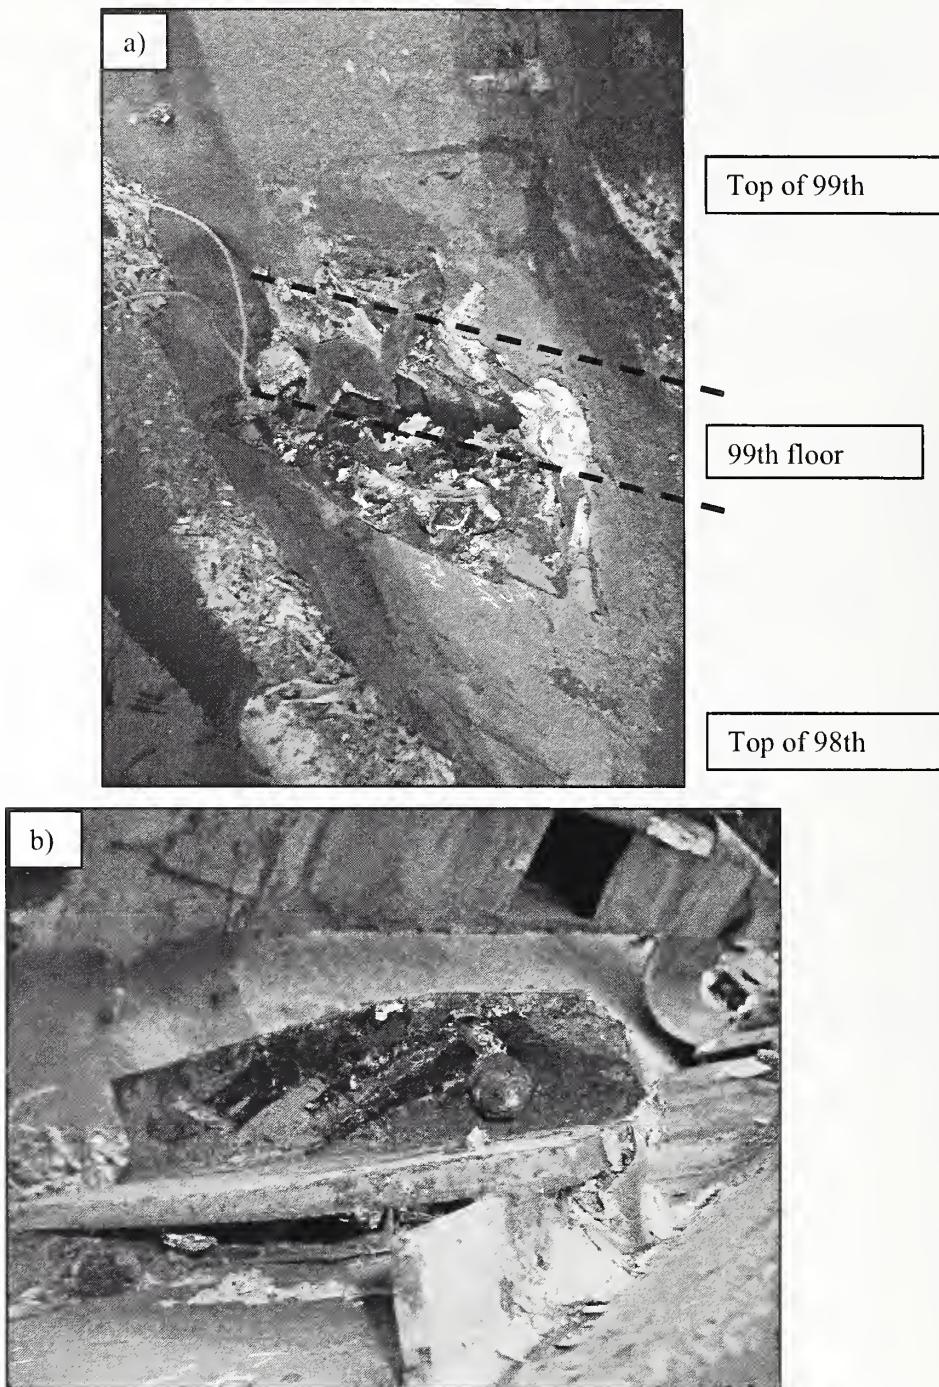
Figure 6-4. Truss seat of the 99th floor on column 143 of WTC 1 from panel N-8 (A142: 97-100). Mud cracking was observed only on the truss seat and standoff plates. a) Top view showing the re-solidified black plastic with imbedded papers, most likely a binder of some type and b) bottom view showing the drip pattern.

- Panel N-8 (A142: 97-100): Located on a seat and its standoff plates, the spandrel was “negative” both above and below floor levels.
- The selected spandrel steels that were identified to have been exposed to severe fire events prior to the collapse of the building did not experience material degradation due to the exposure.

3. Panel N-8, WTC 1, column 143, seat and standoff plates supporting the 99th floor. This seat (Fig. 6-4) was exposed to fire for a minimum of 18 cumulative minutes before collapse. In viewing the seat, it appears that a plastic note paper binder (based upon melted black plastic with imbedded papers) settled and melted on the seat. According to the drip pattern of the binder (Fig. 6-4b), it appears that the panel was in a horizontal position when this occurred. Mud cracking was not observed on the spandrel plate to which the seat was welded. Metallographic analysis of this sample can be found in Sec. 6.3.3.

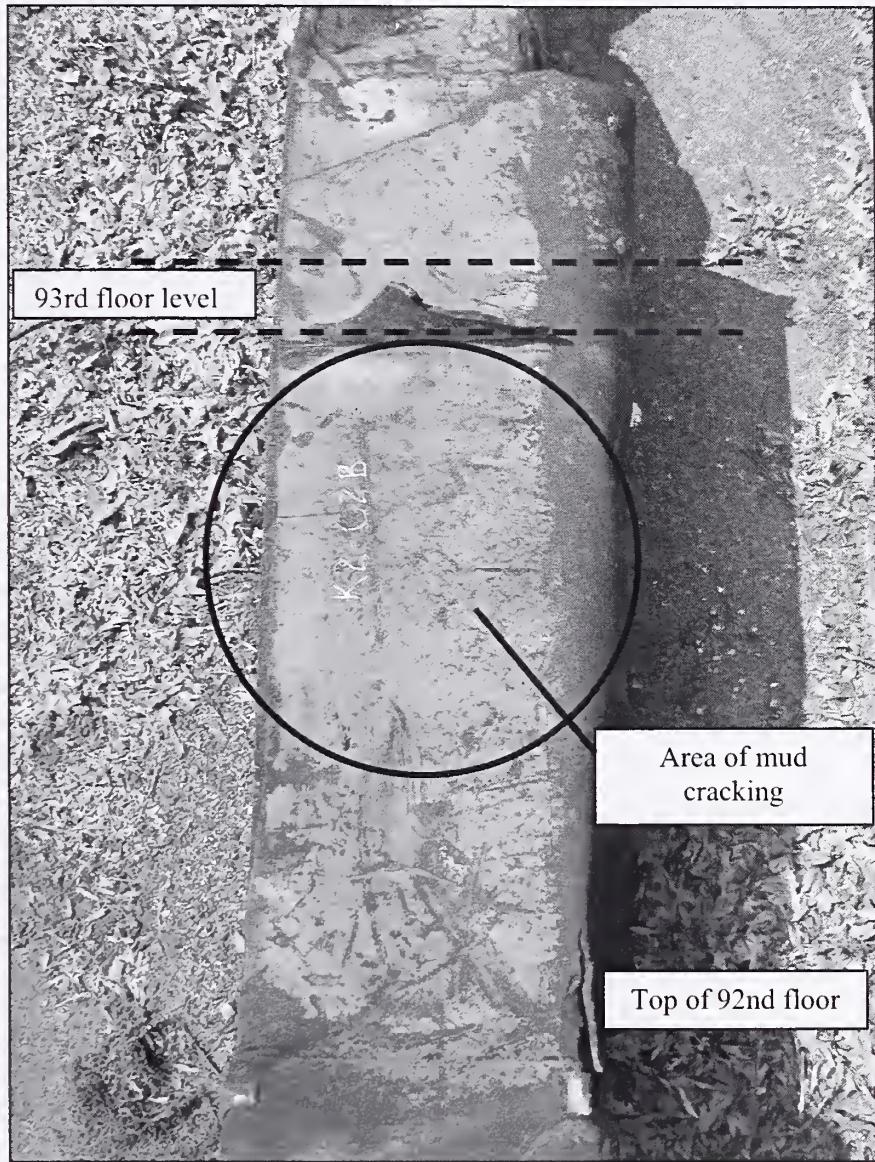
Figure 6–3. Spandrel at the 93rd floor of column 236 of WTC 1 from panel K-2 (A236: 92-95). Mud cracking of the paint occurred below the 93rd floor line. No evidence of mud cracking was observed above the floor line.
