**Federal Building and Fire Safety Investigation of the
World Trade Center Disaster**

**Damage and Failure Modes of
Structural Steel Components**

Stephen W. Banovic
Timothy Foecke

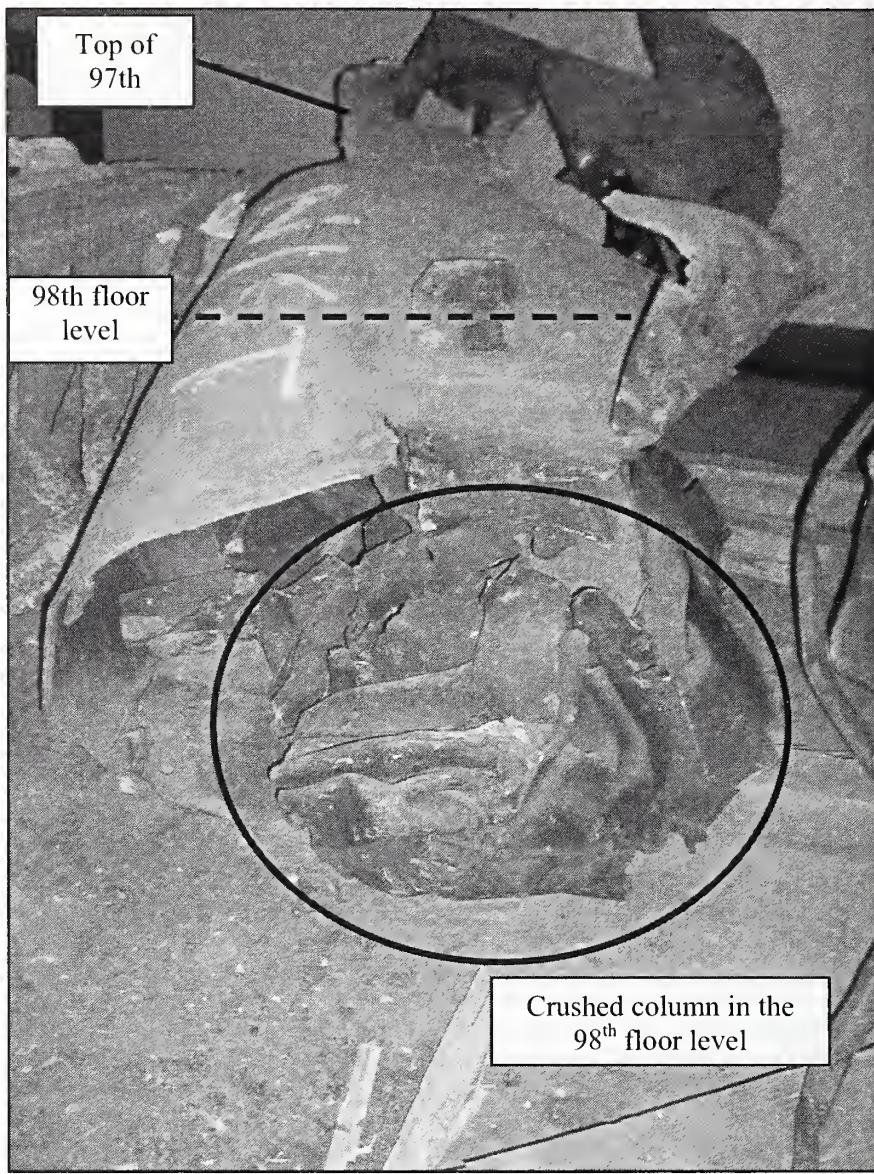
Figure 6–2. Crushed portion of column 210 in the area of the 98th floor of WTC 1 (panel K-1, A209: 97-100). Mud cracking of the paint was observed in crushed portion of this column. The cracking of the paint was a result of either temperature exposure over 250 °C, mechanical deformation, or environmental degradation.

- There were three “positive” findings from the areas analyzed, indicating that mud cracking of the paint occurred.
 - Panel K-1 (A209: 97-100): Located on the flanges of the crushed portion of column (note: the spandrel directly below this area was “negative”),

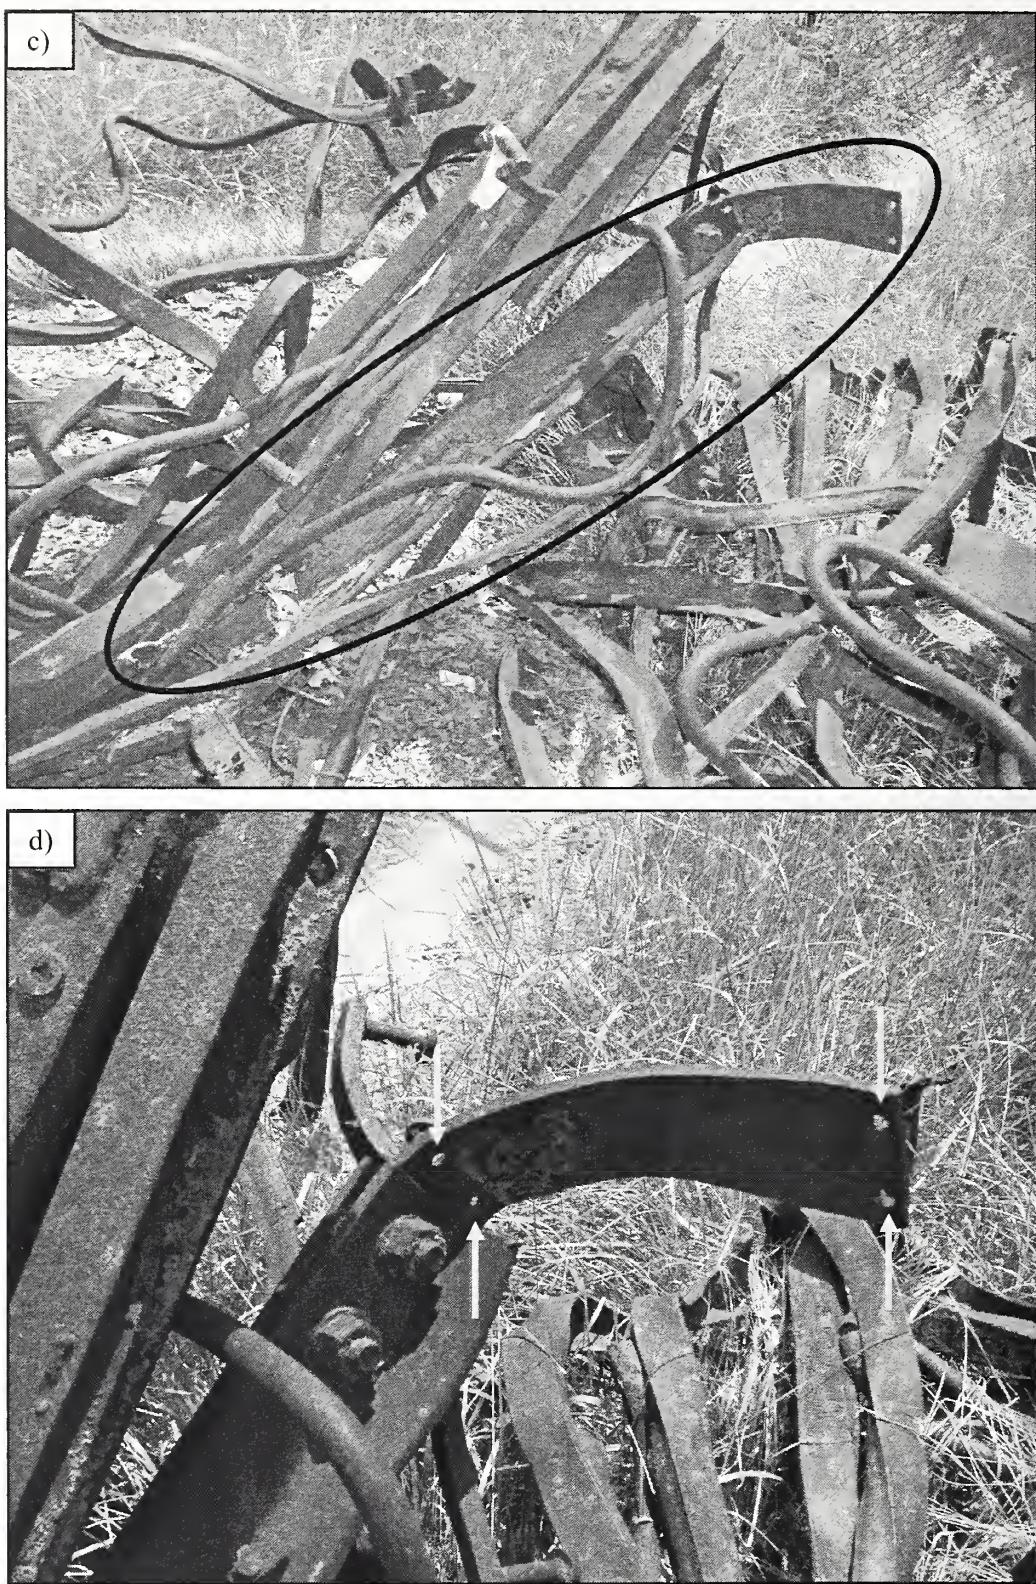
Figure 5–2. Recovered floor truss connectors. c) lower support with attached remnant of viscoelastic damper (as indicated) and d) close-up of remnants of viscoelastic damper showing intact bolt holes (indicating bolt failure) (cont.).

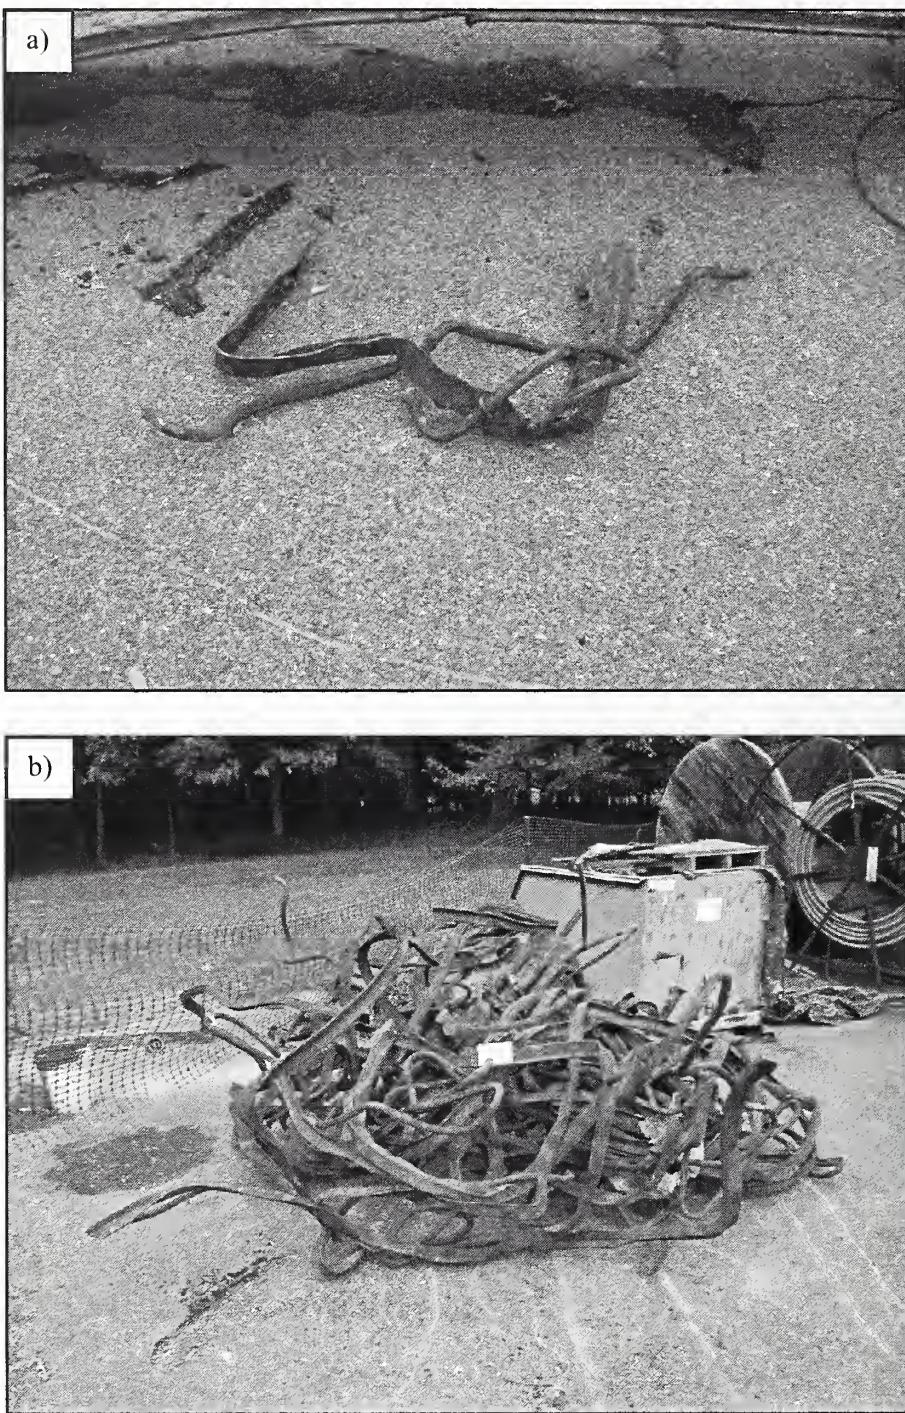
Figure 5-1. Examples of recovered floor truss material. a) Small sections of rod and chord (sample C-53) and b) “balled-up” sections of rod and chord. (C-137f).

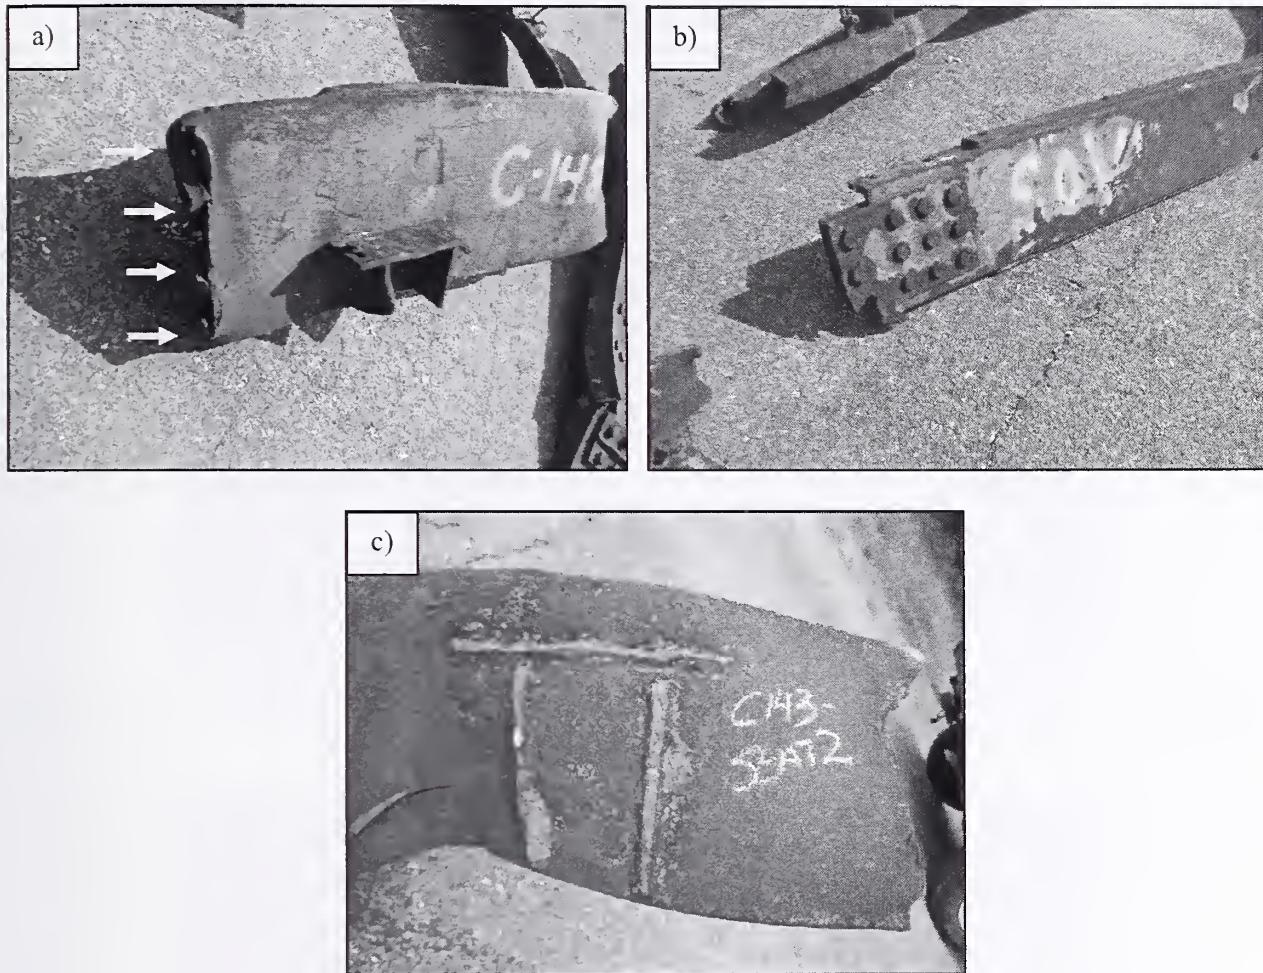
Figure 4–9. Failure modes of core channels. a) Fracture through channel as indicated by arrows, b) failure associated with end connector, and c) seat ripped off at welded connection to channel.

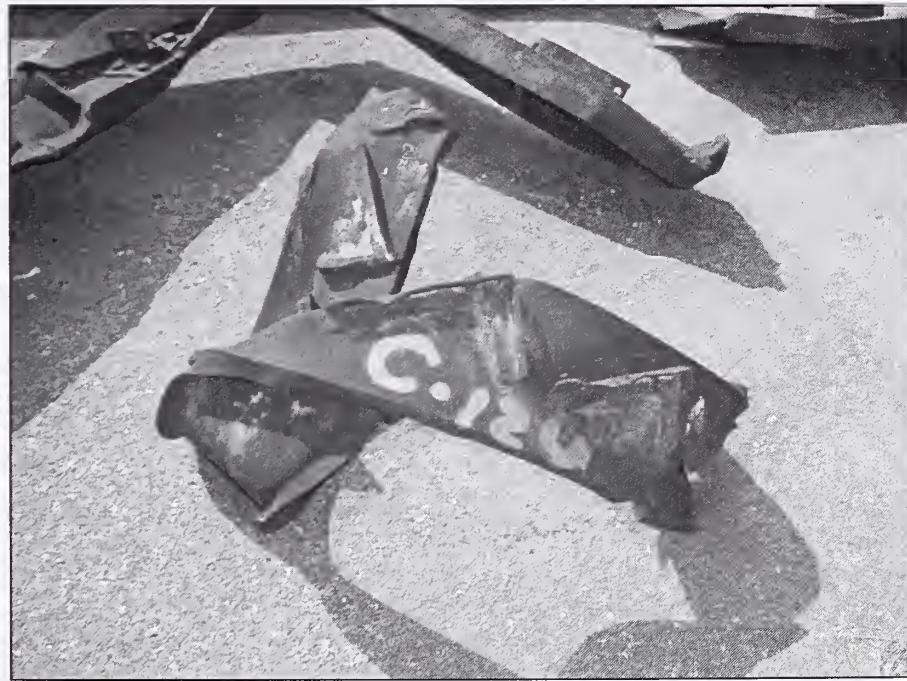
Figure 4–5. Core column HH (605A: 98-101) from the fire floors of WTC 1. a) Failure at both ends and b) separation between flange and web in the 99th floor region.

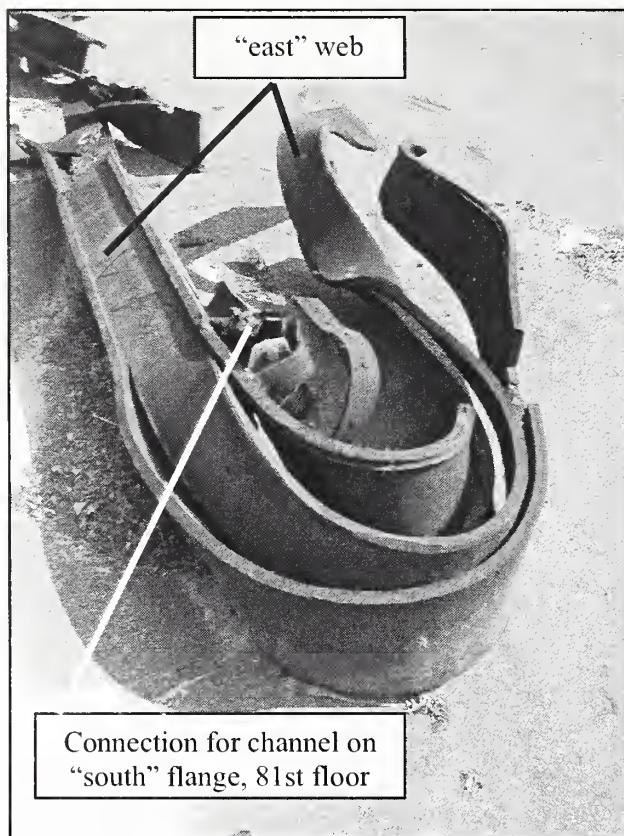
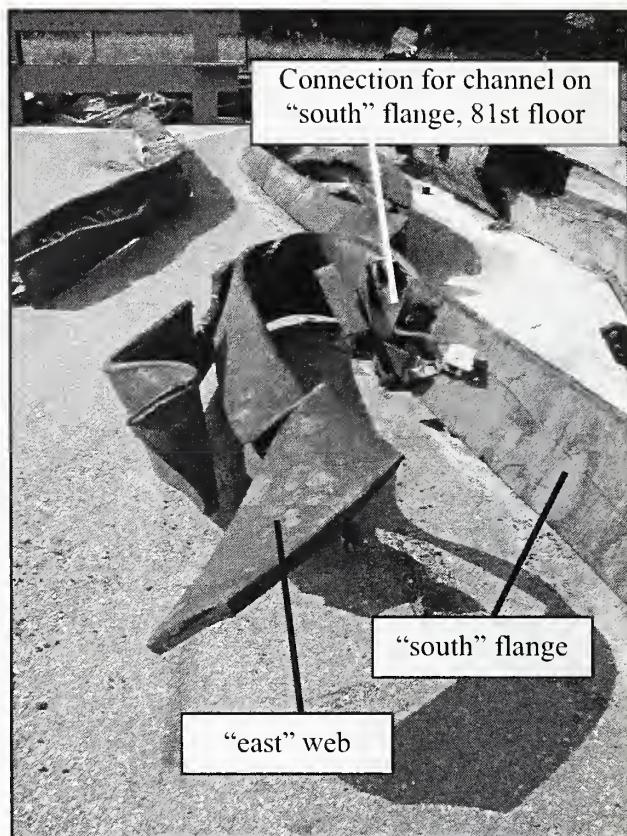
Figure 4–3. Damage associated with core column C-88a (801B: 80-83) from the impact zone of WTC 2.

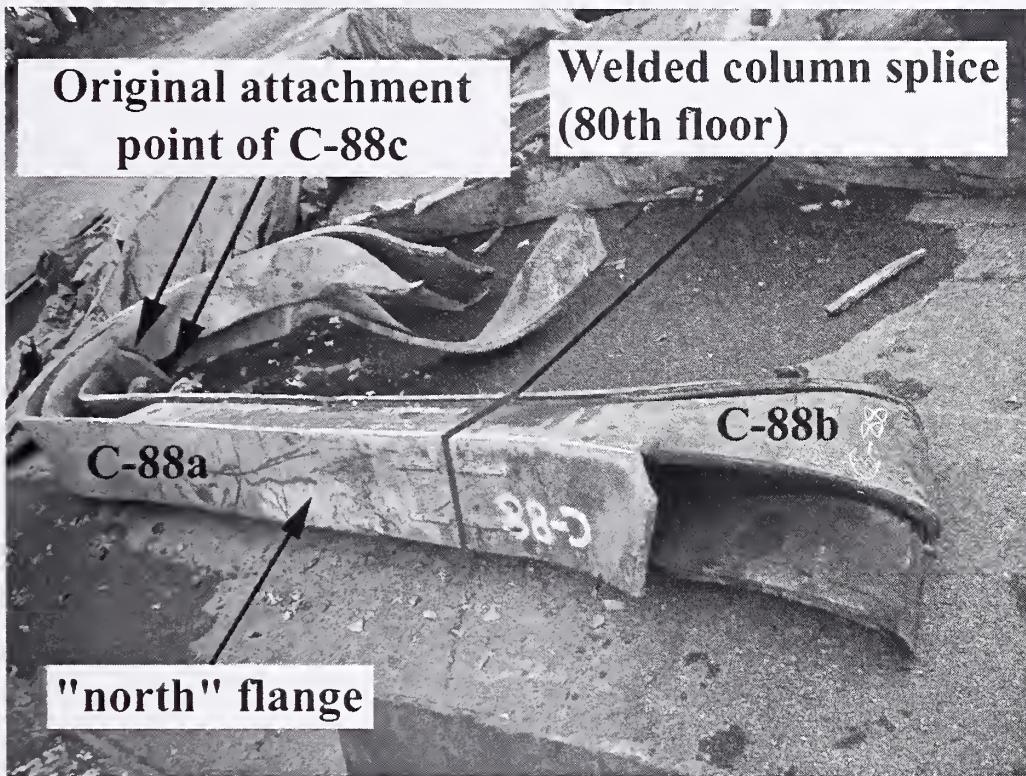
Figure 4–2. Overall view of recovered core columns C-88a (801B: 80-83) and C-88b (801B: 77-80) that were located in the impact zone of WTC 2. The north flange of C-88b may have sustained impact damage. Note that the welded column splice was still intact though the airplane may have struck a portion of this column.

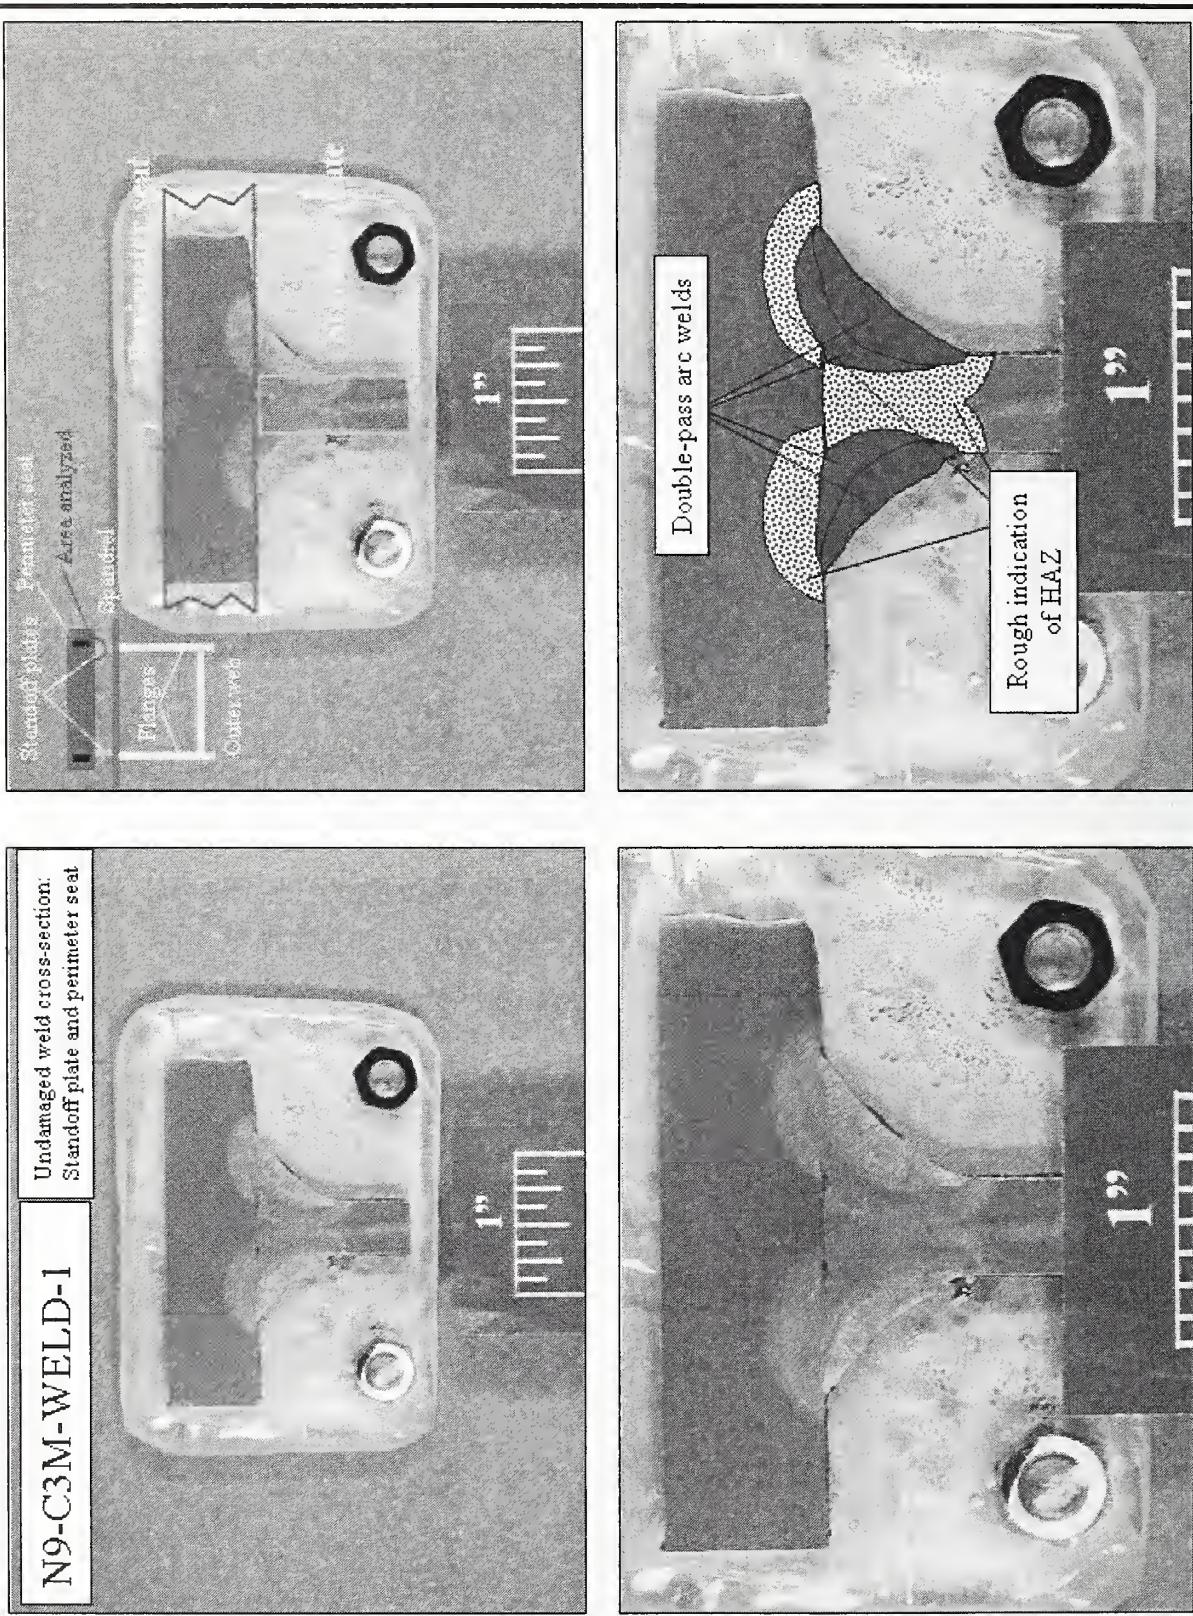
Figure 3-54a. Etched cross-section of intact weld between a standoff plate and truss seat. Sample was from panel N-9 (A154: 101-104, column 153, 103rd floor). Two percent nital and 4 percent picral etch.

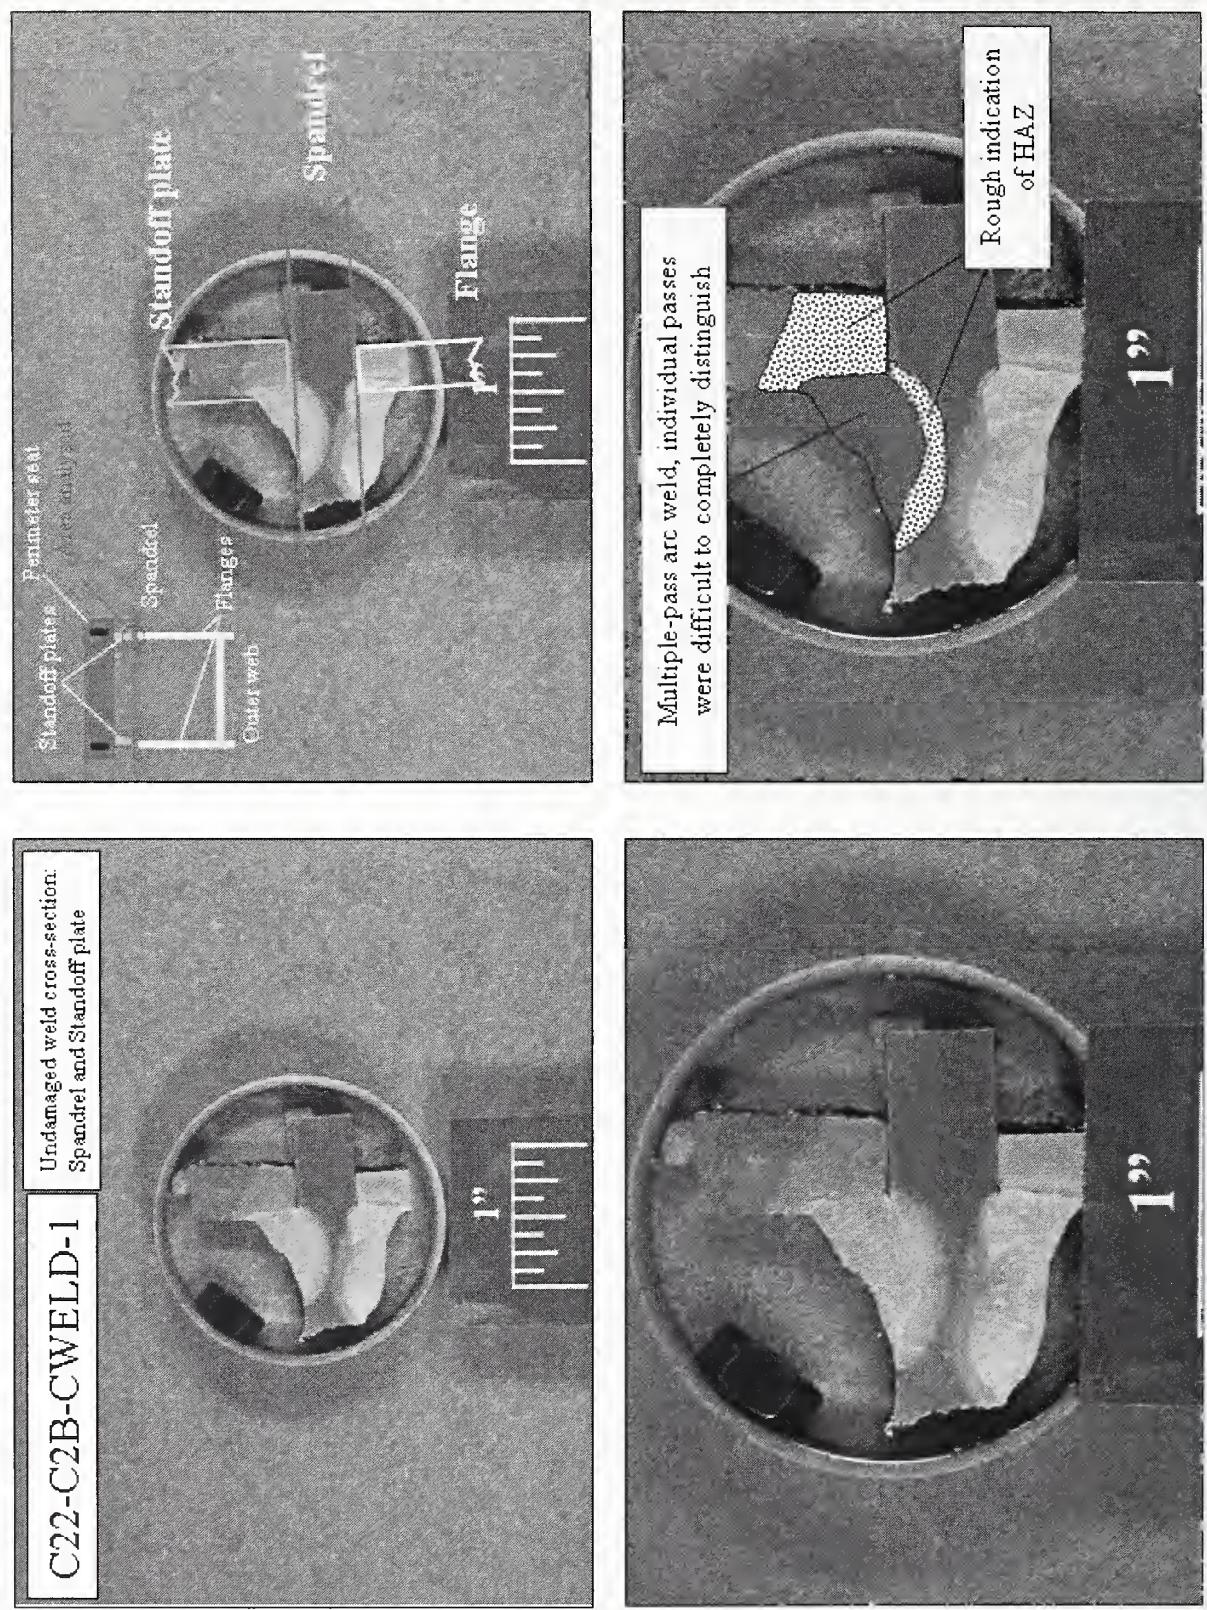
Figure 3-53a. Etched cross-section of intact weld between spandrel plate (65 ksi) and standoff plate (42 ksi). Sample was from panel C-22 (A157: 93-96, column 157, 94th floor). Two percent nital and 4 percent picral etch.

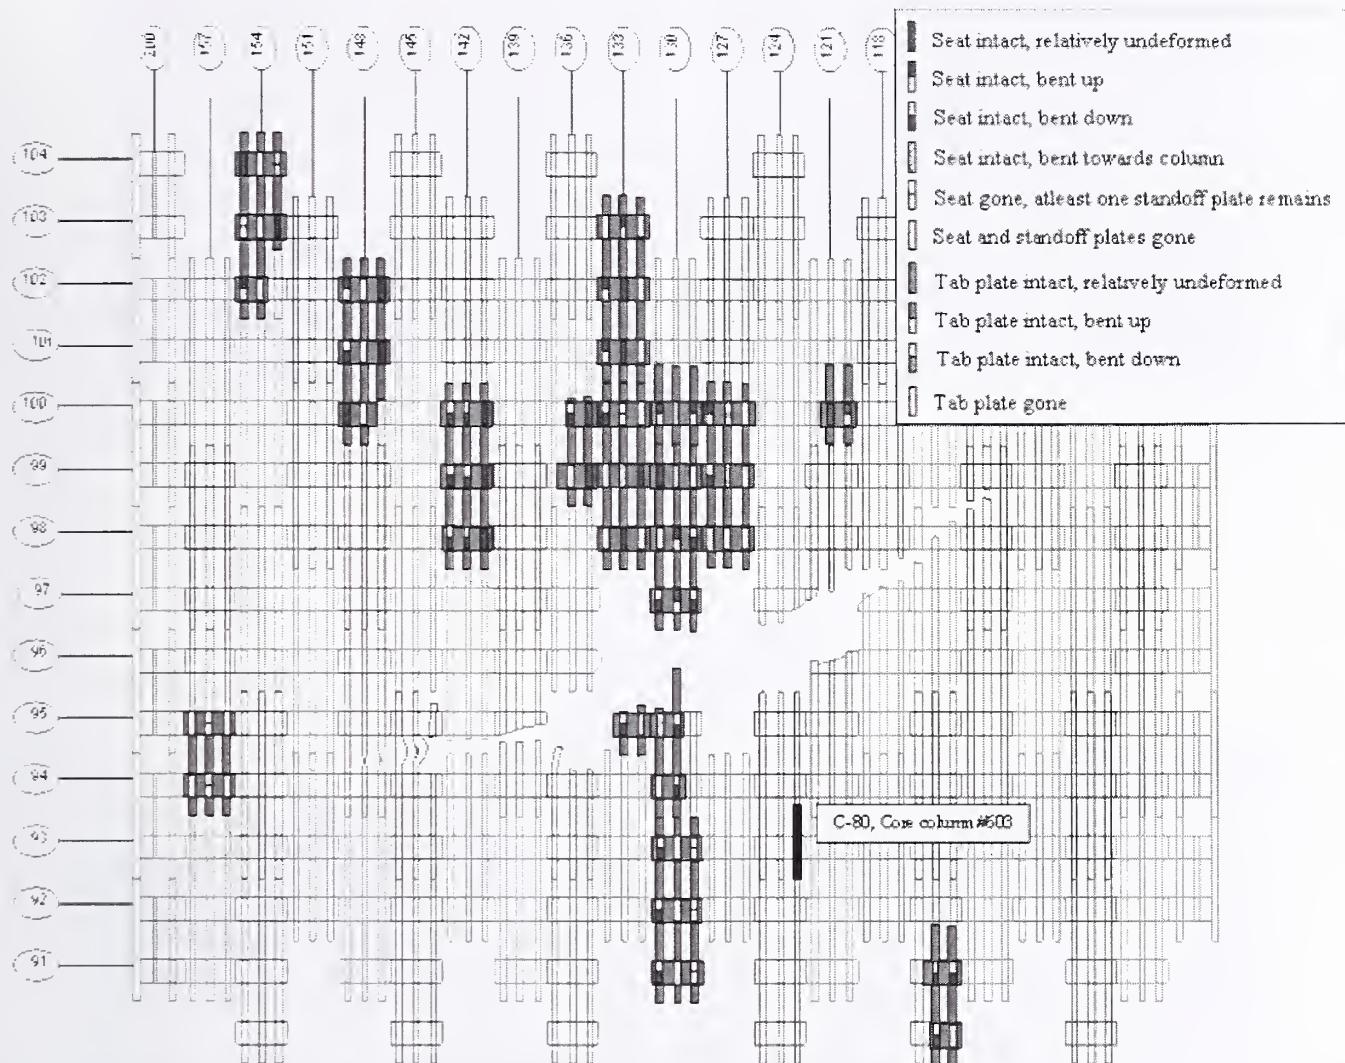
Figure 3-51a. WTC 1, damage diagram overlaid with recovered samples and damage of connectors.

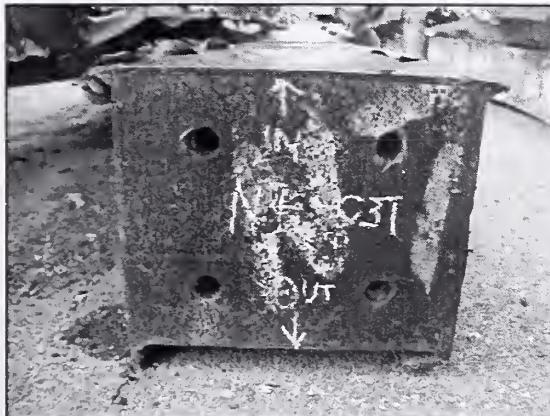
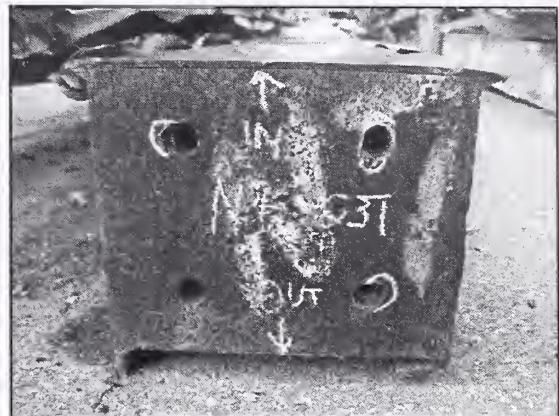
N7-C3T
WTC1
Col 126
Fl 100

Figure 3-49. Photographs of recovered end plate connections from sample N-7 (A127: 97-100). Lower connection failed upon airplane impact, upper connection most likely failed as a result of collapse (cont.).

- **N-7:** N-7 was located just above one of the panels that was pushed inside the envelope of the building upon impact. From photographic evidence, it appears that the panel was still intact. Reviewing the deformation of the bolt holes on the lower endplates (Fig. 3-49) indicated that connections of columns 127 and 128 failed in a similar manner, that being, the connection was pushed in toward the building. Evidence also suggested that the bottom of column 126 broke due to torquing of the column.

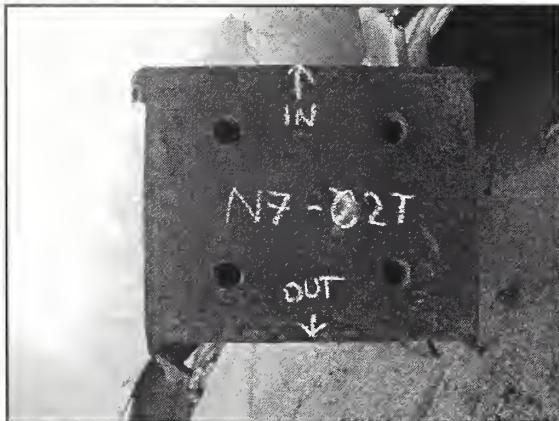
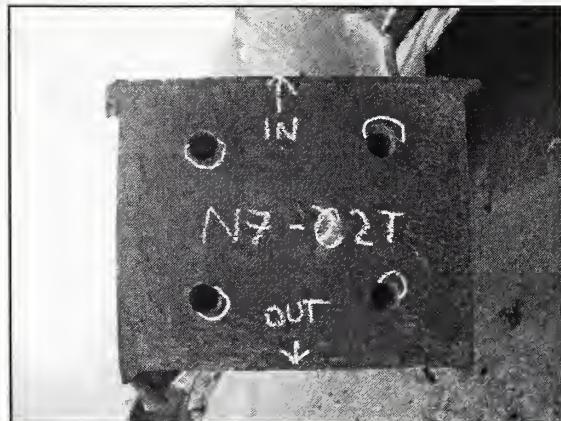
N7-C2T
WTC1
Col 127
Fl 100

Figure 3-49. Photographs of recovered end plate connections from sample N-7 (A127: 97-100). Lower connection failed upon airplane impact, upper connection most likely failed as a result of collapse (cont.).

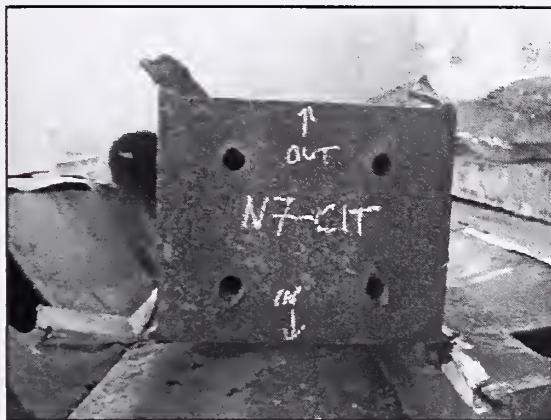
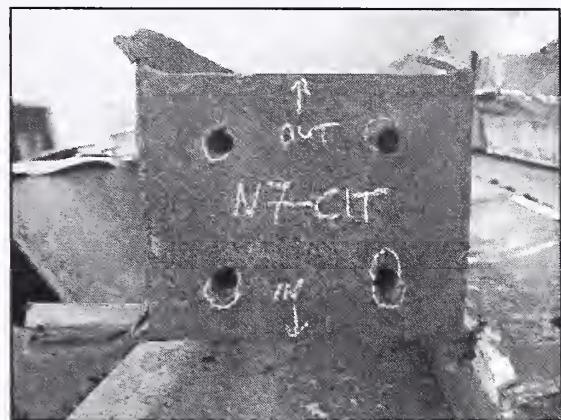
N7-C1T
WTC1
Col 128
Fl 100

Figure 3-49. Photographs of recovered end plate connections from sample N-7 (A127: 97-100). Lower connection failed upon airplane impact, upper connection most likely failed as a result of collapse.

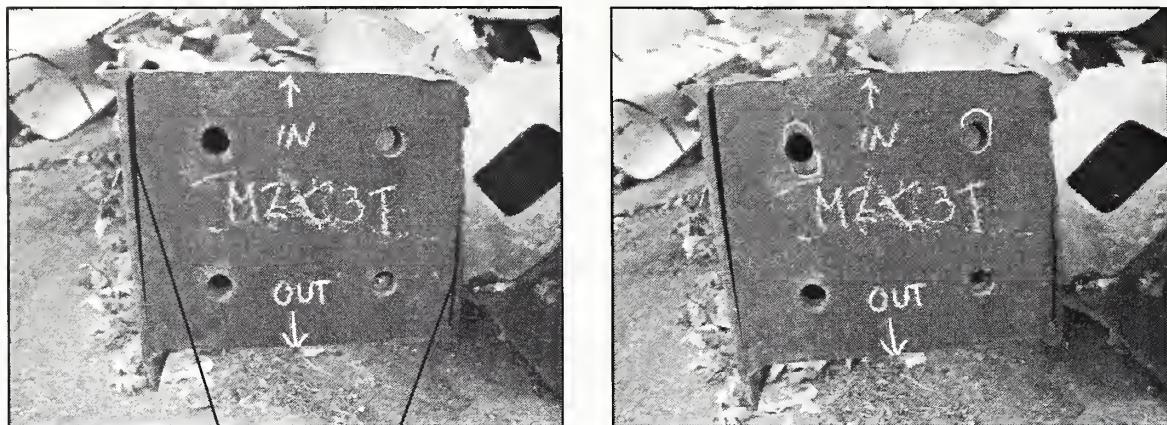
M2-C3T
WTC1
Col 129
Fl 99

Figure 3–48. Photographs of recovered end plate connections from sample M-2 (A127: 97-100). Lower connection failed upon airplane impact, upper connection failed as a result of either airplane impact or collapse (cont.).

- **M-2:** M-2 was the panel located directly above M-27. It appears that the state of the recovered bottom portion of columns 129 and 130 was nearly identical to the condition after the impact, a Type 2b failure where the end plates were ripped completely out of the column, Fig. 3-48. Failure was found to be a mixture of fracture in the base metal (portion of the flange/web still attached to the end plate) and clean separation of the end plate from the flange/web (complete flange/web recovered with internal weld bead visible). Section 3.2.1 discussed the deformation of the flange/web plates associated with this failure. Bolt hole deformation for column 131 indicated that the connection was broken by bending inward of the lower column of the connection. Lastly, while bolt failure was observed for the top of column 129, it was noted that separation existed between the four components of the column and the endplate.

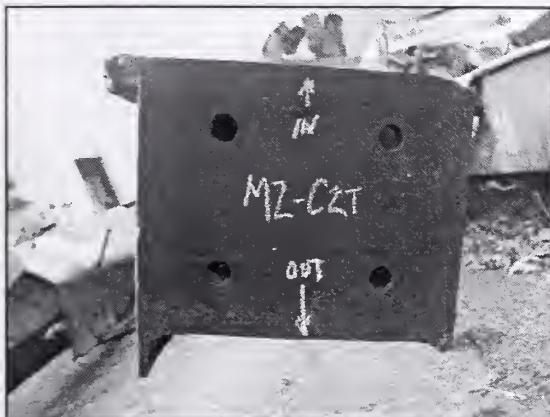
M2-C2T
WTC1
Col 130
Fl 99

No change in bolt
hole shape

Figure 3-48. Photographs of recovered end plate connections from sample M-2 (A127: 97-100). Lower connection failed upon airplane impact, upper connection failed as a result of either airplane impact or collapse (cont.).

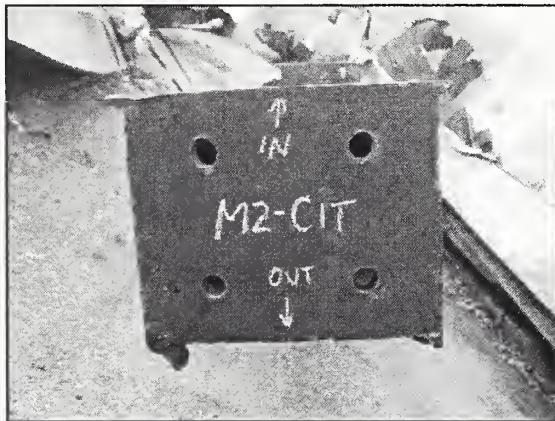
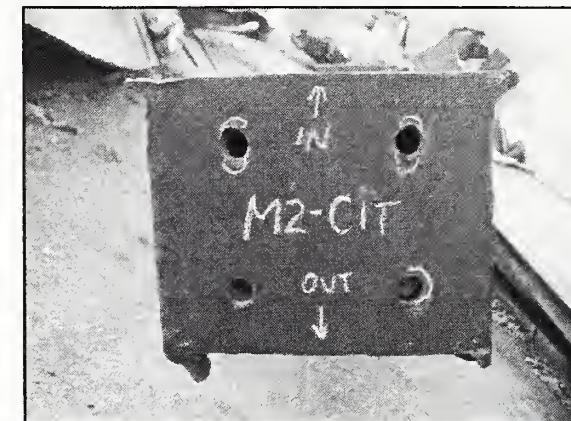
M2-C1T
WTC1
Col 131
Fl 99

Figure 3-48. Photographs of recovered end plate connections from sample M-2 (A127: 97-100). Lower connection failed upon airplane impact, upper connection failed as a result of either airplane impact or collapse.

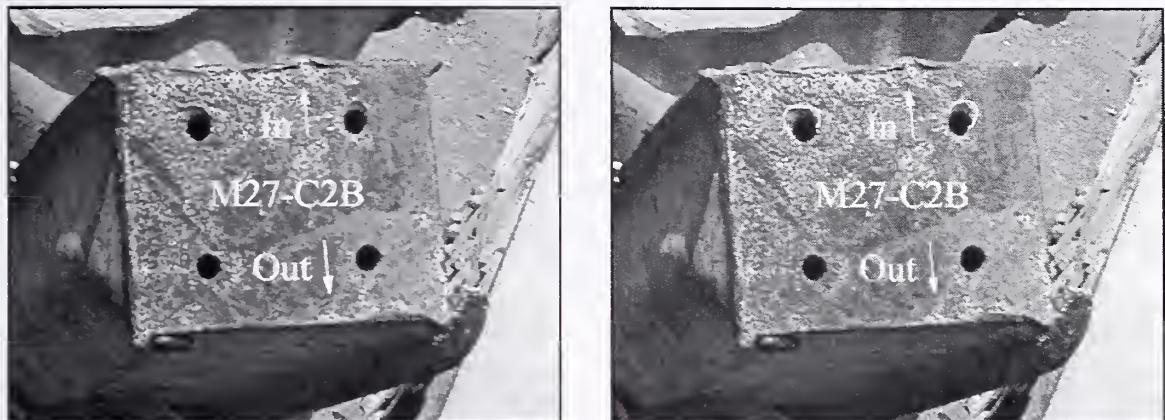
M27-C2B
WTC1
Col 130
Fl 93

Figure 3-47. Photographs of recovered end plate connections from sample M-27 (A130: 93-96). Probable cause of connection failure was collapse (cont.).

- **M-27:** For M-27, only the lower end plates of two columns were available for inspection. From pre-collapse photographs, it appears that the connections between M-27 and the panel directly below it were intact. Therefore, failure occurred upon collapse of the building. From the deformation of the bolt holes, it appears that the connection was broken through inward collapse of the top of the columns. The 1 3/8 in. end plate of column 131 was bent along a diagonal axis, Fig. 3-47; however, failure of the welds was not observed.

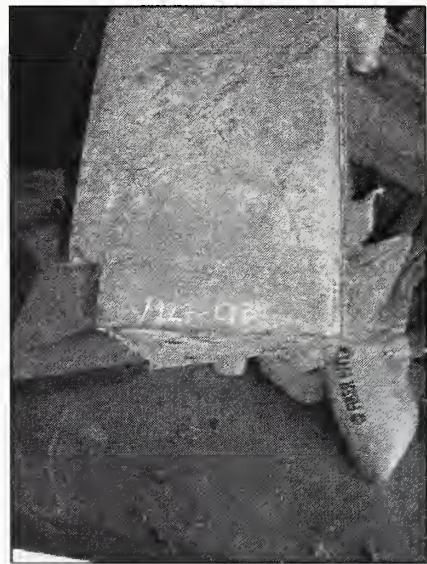
Endplate is bent, no weld failures observed

Figure 3-47. Photographs of recovered end plate connections from sample M-27 (A130: 93-96). Probable cause of connection failure was collapse.

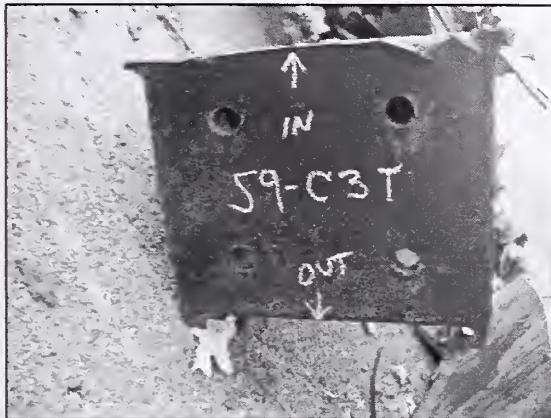
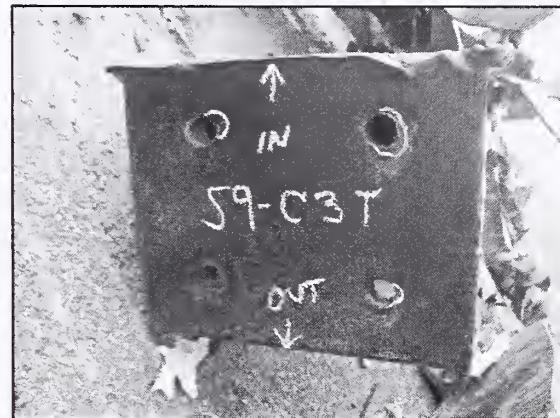
S9-C3T
WTC1
Col 132
Fl 100

Figure 3-46. Photographs of recovered end plate connections from sample S-9 (A127: 97-100). Lower connection failed upon airplane impact, upper connection failed as a result of either airplane impact or collapse (cont.).

- **S-9:** After the impact, it was observed that S-9 was still in its original position. The panel below S-9 (sample M-30) had broken away at the end plate connections due to Type 1 failures. This was correlated with the inspected bottom endplates of S-9, Fig. 3-46. A peculiar feature on this panel though, was the appearance of more damage to the bolt holes of the upper connections than those at the lower. The upper end plates have failed in the same manner (Type 1) but with significantly more deformation to the bolt holes; whether this occurred upon impact or during the collapse could not be determined. The limited deformation of the bolt holes associated with the lower connection would be consistent with a brittle failure mode of the bolts upon airplane impact. The bolts at the top of the panel would have been more slowly loaded in tension as the panel was pushed into the building, and likely did not immediately fail but deformed the holes as they stretched.

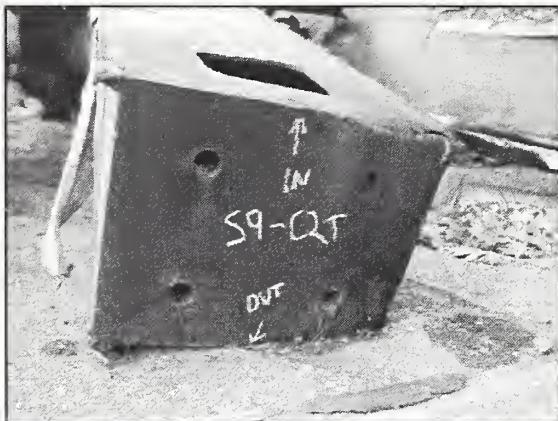
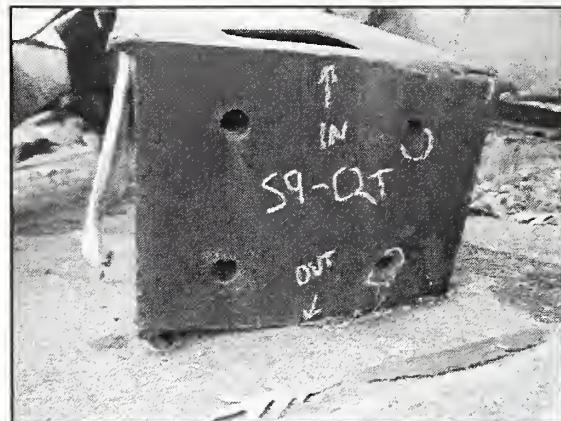
S9-C2T
WTC1
Col 133
Fl 100

Figure 3–46. Photographs of recovered end plate connections from sample S-9 (A127: 97-100). Lower connection failed upon airplane impact, upper connection failed as a result of either airplane impact or collapse (cont.).

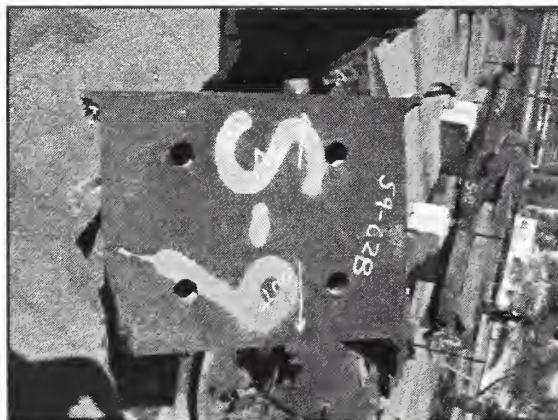
S9-C2B
WTC1
Col 133
Fl 97

No change in bolt
hole shape

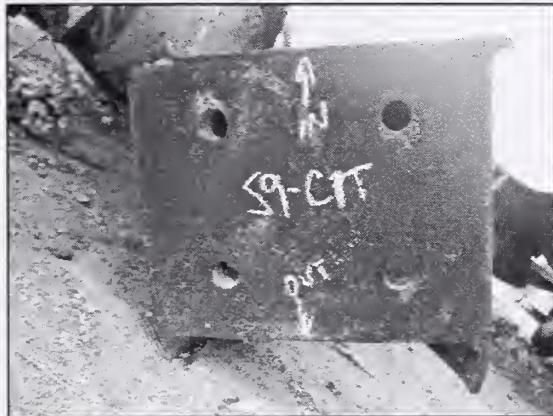
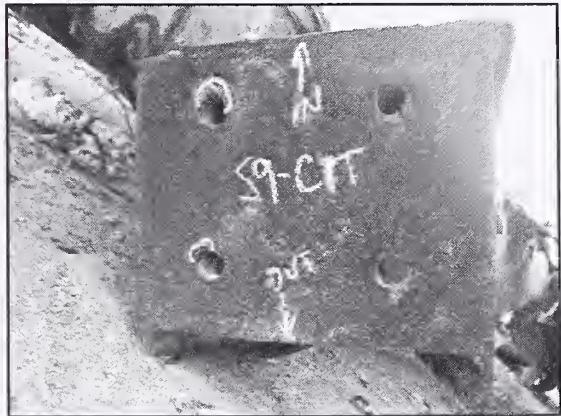
S9-C1T
WTC1
Col 134
Fl 100

Figure 3-46. Photographs of recovered end plate connections from sample S-9 (A127: 97-100). Lower connection failed upon airplane impact, upper connection failed as a result of either airplane impact or collapse.

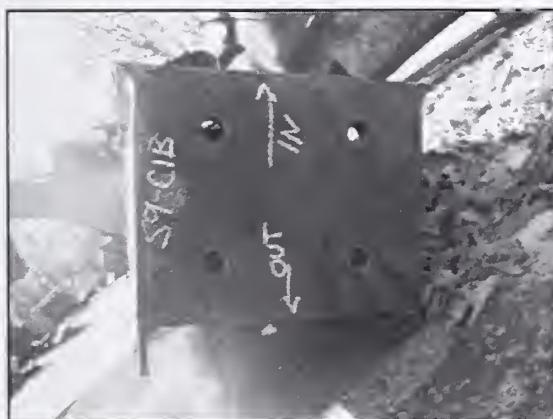
S9-C1B
WTC1
Col 134
Fl 97

No change in bolt
hole shape

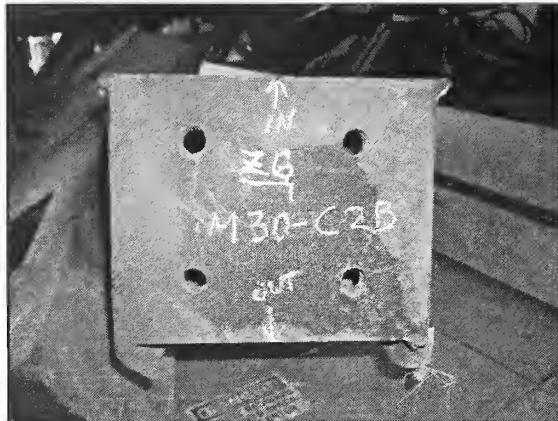
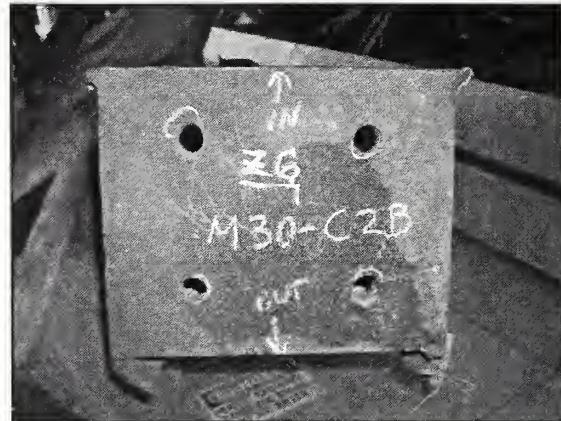
M30-C2B
WTC1
Col 133
Fl 94

Figure 3-45. Photographs of recovered end plate connections from sample M-30 (A133: 94-97). Both connection failures were due to airplane impact.

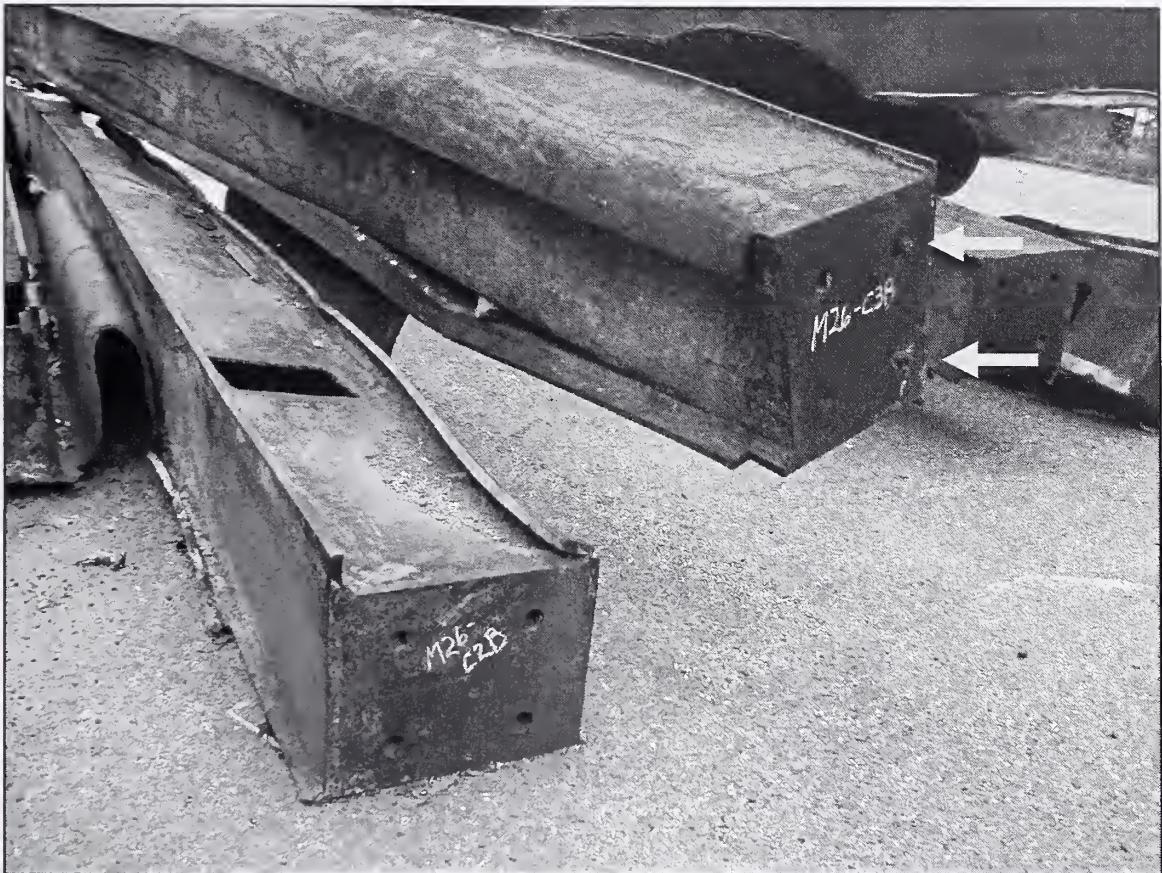
Figure 3–42. Photographic example of Type 1 failure mode for end plate connections, bolt failure. Column on right (M26-C3B) has two failed bolts remaining (arrows). Sample shown is M-26 (A130: 90-93). Damage of this type may be due to any one of the extreme loading events.

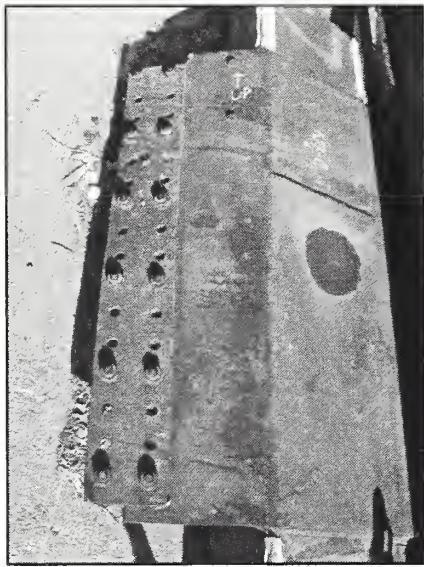
N7-C3T
Column 126, 100th floor

Spandrel Detail: 101
Failure mode: Type 1b
Orientation of image: From inside building looking out.
Probable cause of damage: Collapse

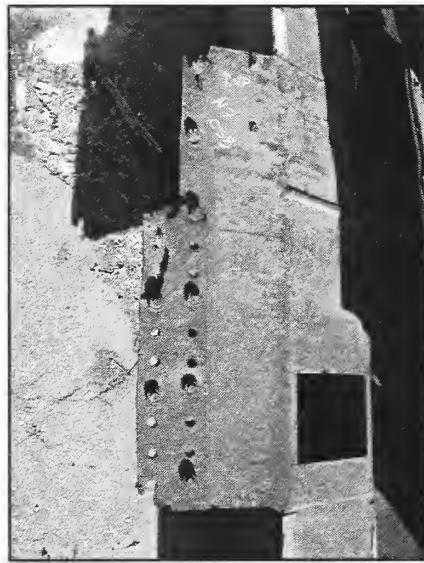
N7-C3M
Column 126, 99th floor

Spandrel Detail: 101
Failure mode: Type 1c
Orientation of image: From inside building looking out.
Probable cause of damage: Collapse

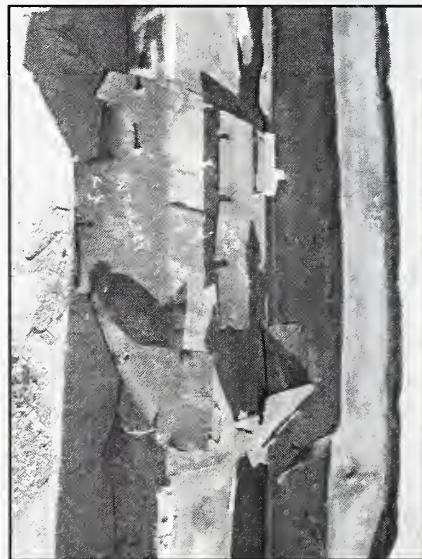
N7-C3B
Column 126, 98th floor

Spandrel Detail: 101
Failure mode: Type 3
Orientation of image: From inside building looking out.
Probable cause of damage: Impact or collapse

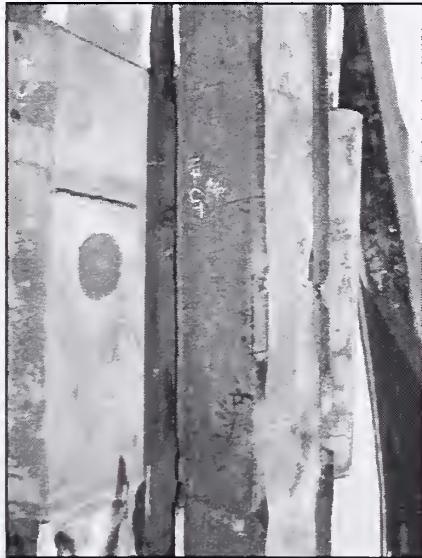
N7-C1T

Failure mode: Type 4a

Probable cause of damage: Collapse
