**Federal Building and Fire Safety Investigation of the
World Trade Center Disaster**

**Damage and Failure Modes of
Structural Steel Components**

Stephen W. Banovic
Timothy Foecke

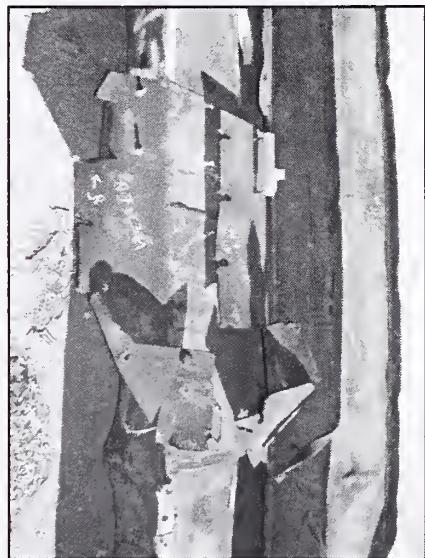
N7-C1M

Failure mode: Type 1c

Probable cause of damage: Collapse

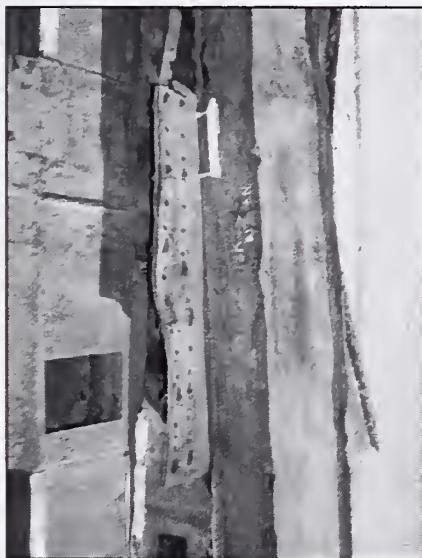
N7-C1B

Failure mode: Type 1b

Probable cause of damage: Impact or collapse

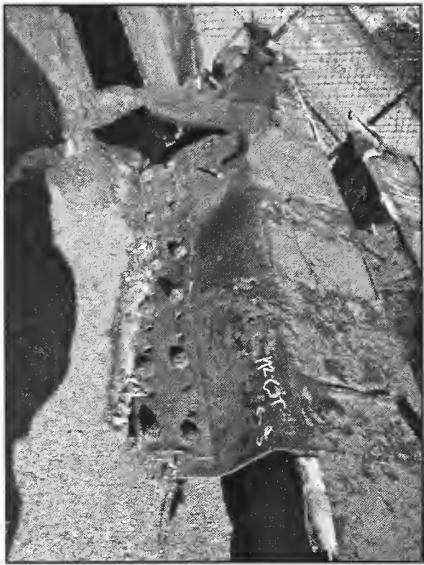
M2-C3T
Column 129, 99th floor

Spandrel Detail: 101
Failure mode: Type 1b
Orientation of image: From inside building looking out.
Probable cause of damage: Collapse

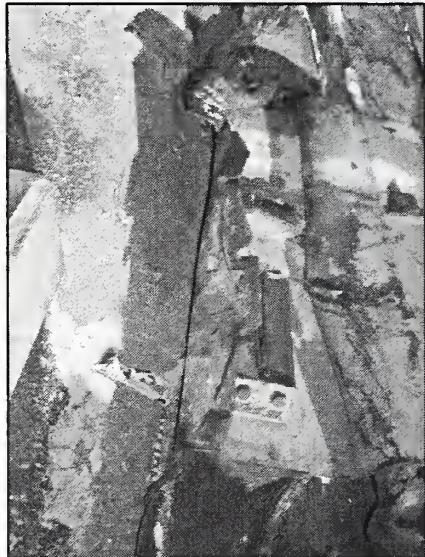
M2-C3M
Column 129, 98th floor

Spandrel Detail: 101
Failure mode: Type 1a
Orientation of image: From inside building looking out.
Probable cause of damage: Impact or collapse

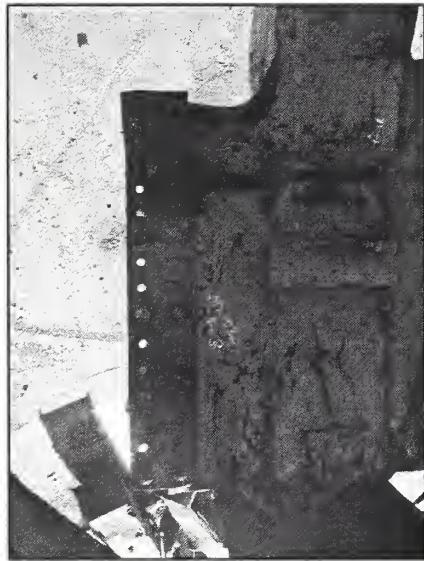
M2-C3B
Column 129, 97th floor

Spandrel Detail: 101
Failure mode: Type 1b
Orientation of image: From inside building looking out.
Probable cause of damage: Impact

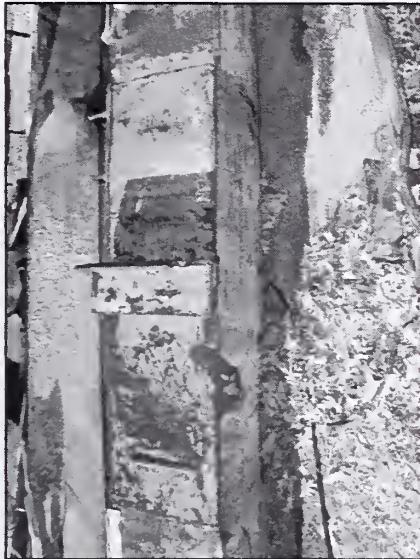
M2-C1T

Failure mode: Type 4a

Probable cause of damage: Collapse

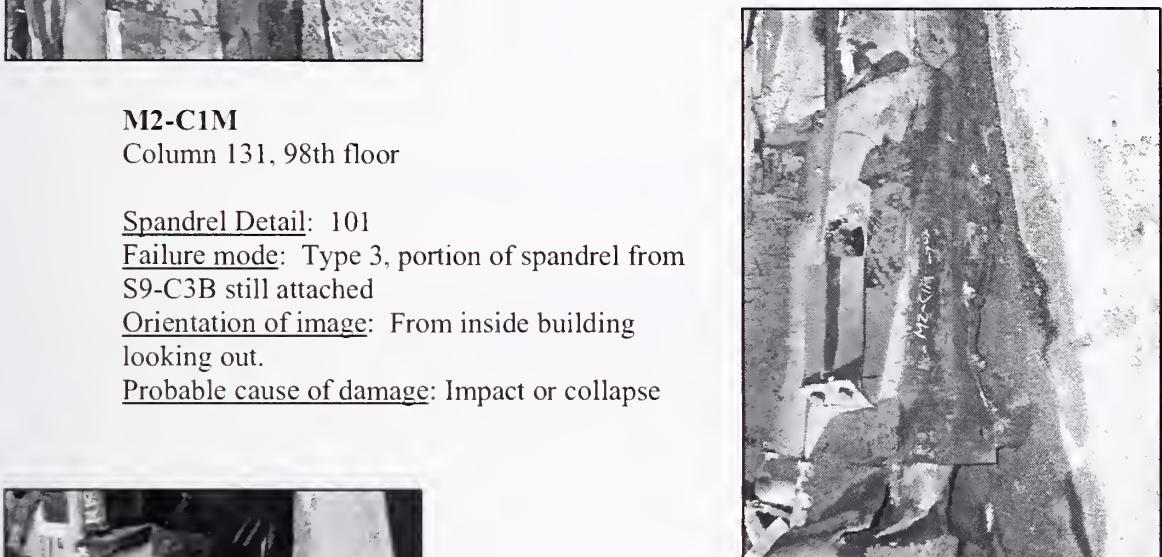
M2-C1M

Failure mode: Type 3, portion of spandrel from S9-C3B still attached

Probable cause of damage: Impact or collapse

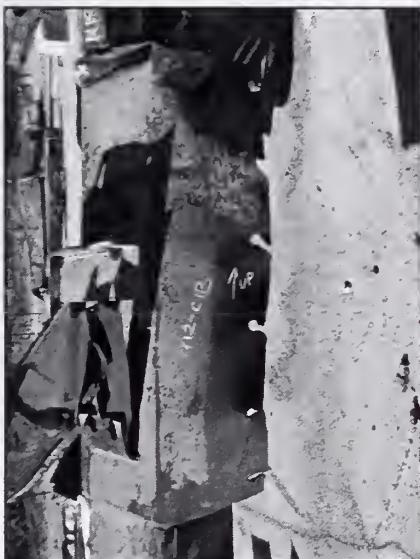
M2-C1B

Failure mode: Type 1a

Probable cause of damage: Impact

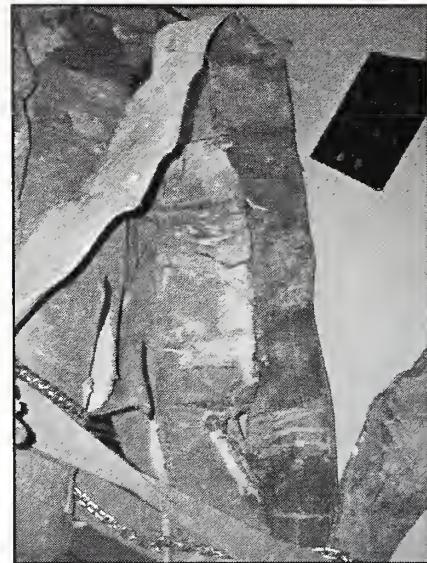
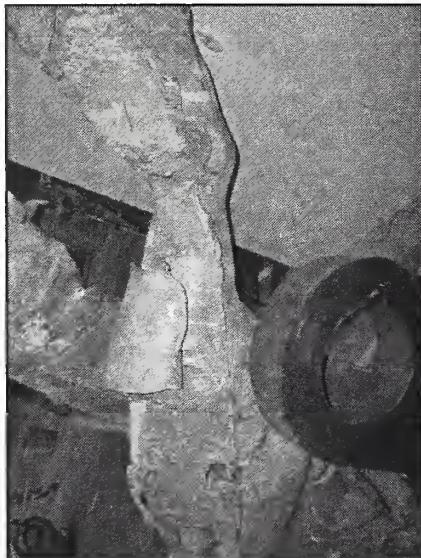
Spandrel Detail: 101
Failure mode: Type 4a
Orientation of image: From inside building looking out.
Probable cause of damage: Collapse

Spandrel Detail: 102
Failure mode: Type 4a
Orientation of image: From inside building looking out.
Probable cause of damage: Impact or collapse

Figure 3–39. Photographs of recovered spandrel connections from sample M-27 (A130: 93-96).

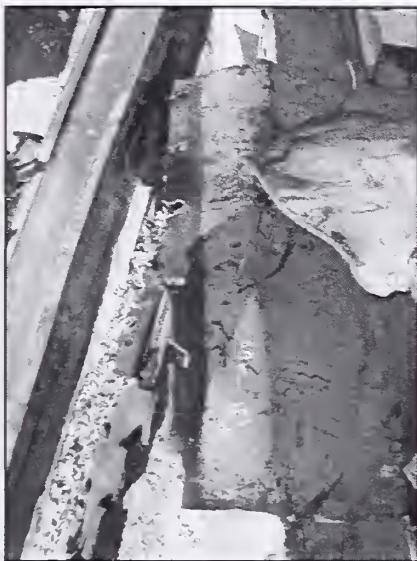
S9-C3T
Column 132, 100th floor

Spandrel Detail: 101
Failure mode: Type 1a
Orientation of image: From inside building looking out.
Probable cause of damage: Collapse

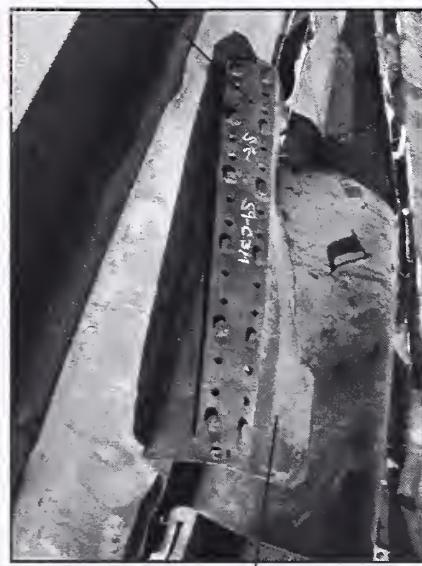
S9-C3B
Column 132, 98th floor

Spandrel Detail: 101
Failure mode: Type 3
Orientation of image: From outside building looking in.
Probable cause of damage: Impact or collapse

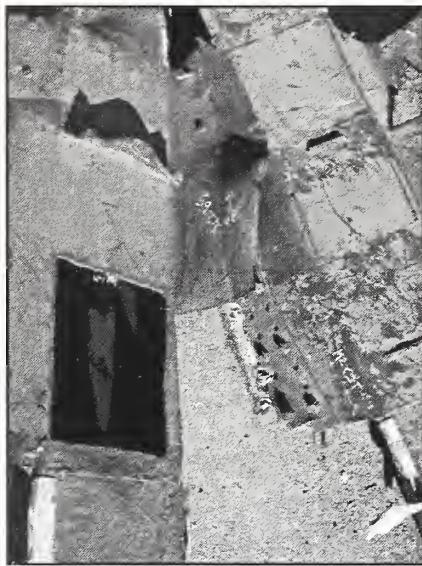
S9-C1T
Column 134, 100th floor

Failure mode: Type 3

Probable cause of damage: Collapse

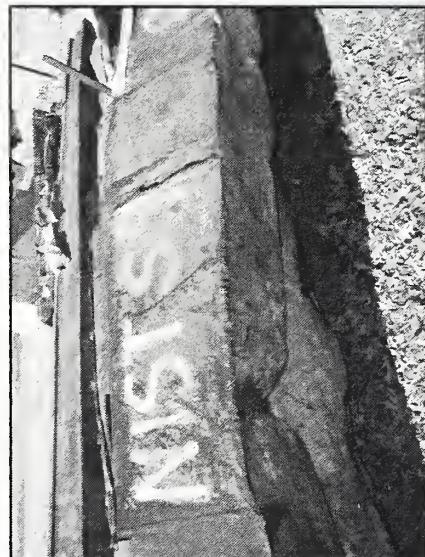
S9-C1M
Column 134, 99th floor

Failure mode: Type 4a

Probable cause of damage: Collapse

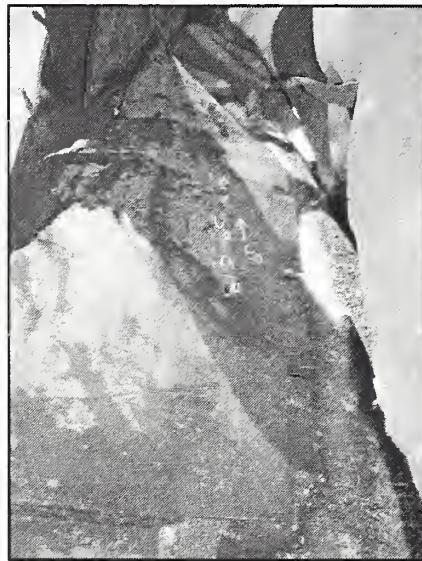
S9-C1B
Column 134, 98th floor

Failure mode: Type 1a

Probable cause of damage: Impact or Collapse

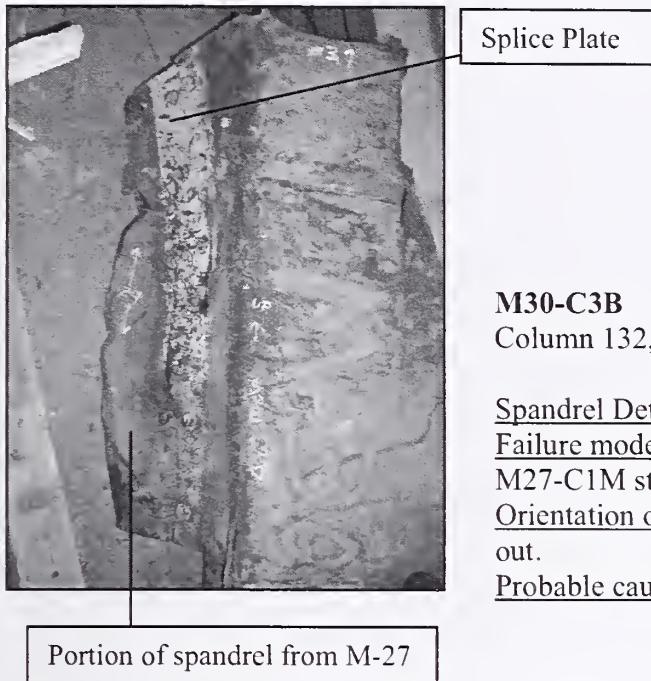
M30-C3B
Column 132, 95th floor

Spandrel Detail: 101
Failure mode: Type 4b, portion of spandrel from M27-C1M still attached.
Orientation of image: From inside building looking out.
Probable cause of damage: collapse

Figure 3–37. Photographs of the recovered spandrel connections from M-30 (A133: 94-97).

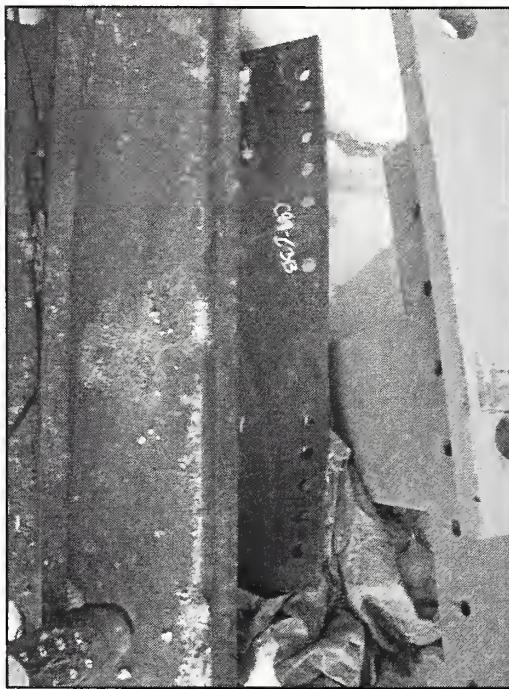
Figure 3–36. Photographic example of Type 5 failure mode for spandrel connections, bolt failure resulting in intact holes in spandrel or splice plate (observed from outside the building looking in) from C-89 (B215: 12-15). Damage of this type may be due to any one of the extreme loading events.

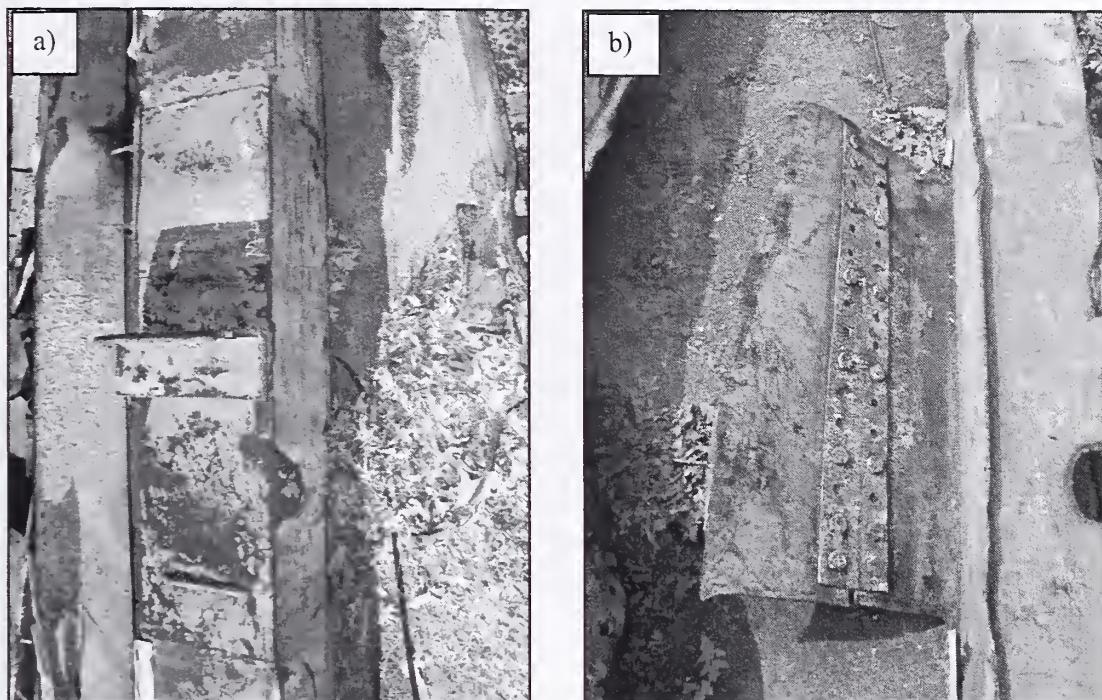
Figure 3–35. Photographic examples of Type 4 failure mode for spandrel connections. a) Type 4a, vertical fracture of observed spandrel plate (observed from inside the building looking out) from M-2 (A130: 96-99) and b) Type 4b, vertical fracture of the neighboring spandrel plate resulting in the observed spandrel connection retaining both the splice plate and portion of spandrel from neighboring panel (observed from outside the building looking in) from C-25 (A206: 89-92). Damage of this type may be due to any one of the extreme loading events.

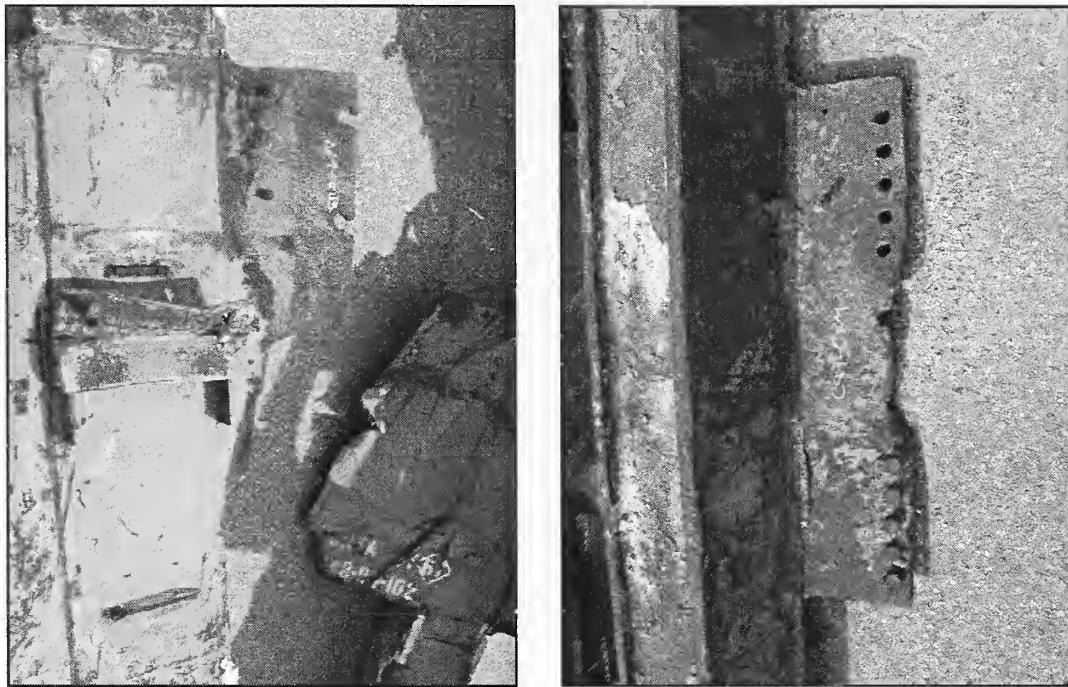
Figure 3–34. Photographic examples of Type 3 failure mode for spandrel connections, mixed mode. Left image orientation was from the inside of the buildings looking out from N-9 (A154: 101-104), right image orientation was from the outside of the building looking in from C-89 (B215: 12-15). Damage of this type may be due to any one of the extreme loading events.

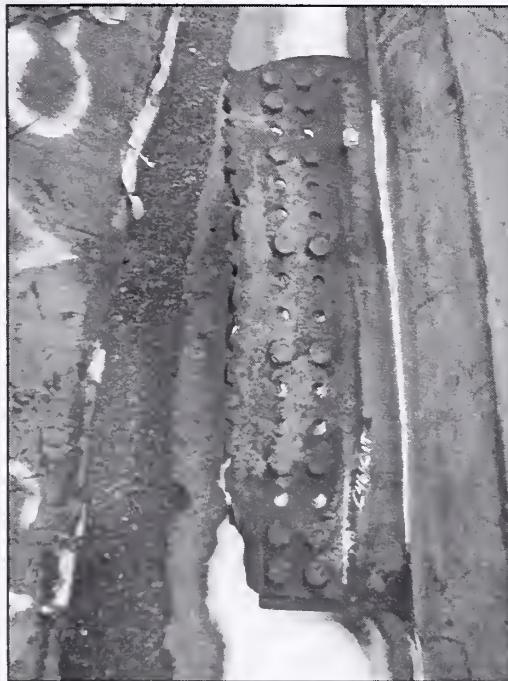
Figure 3–33. Photographic example of Type 2 failure mode for spandrel connections, bolt tear out in splice plate from C-46 (B157: 68-71). Orientation was from the outside of the building looking in. Damage of this type may be due to any one of the extreme loading events.

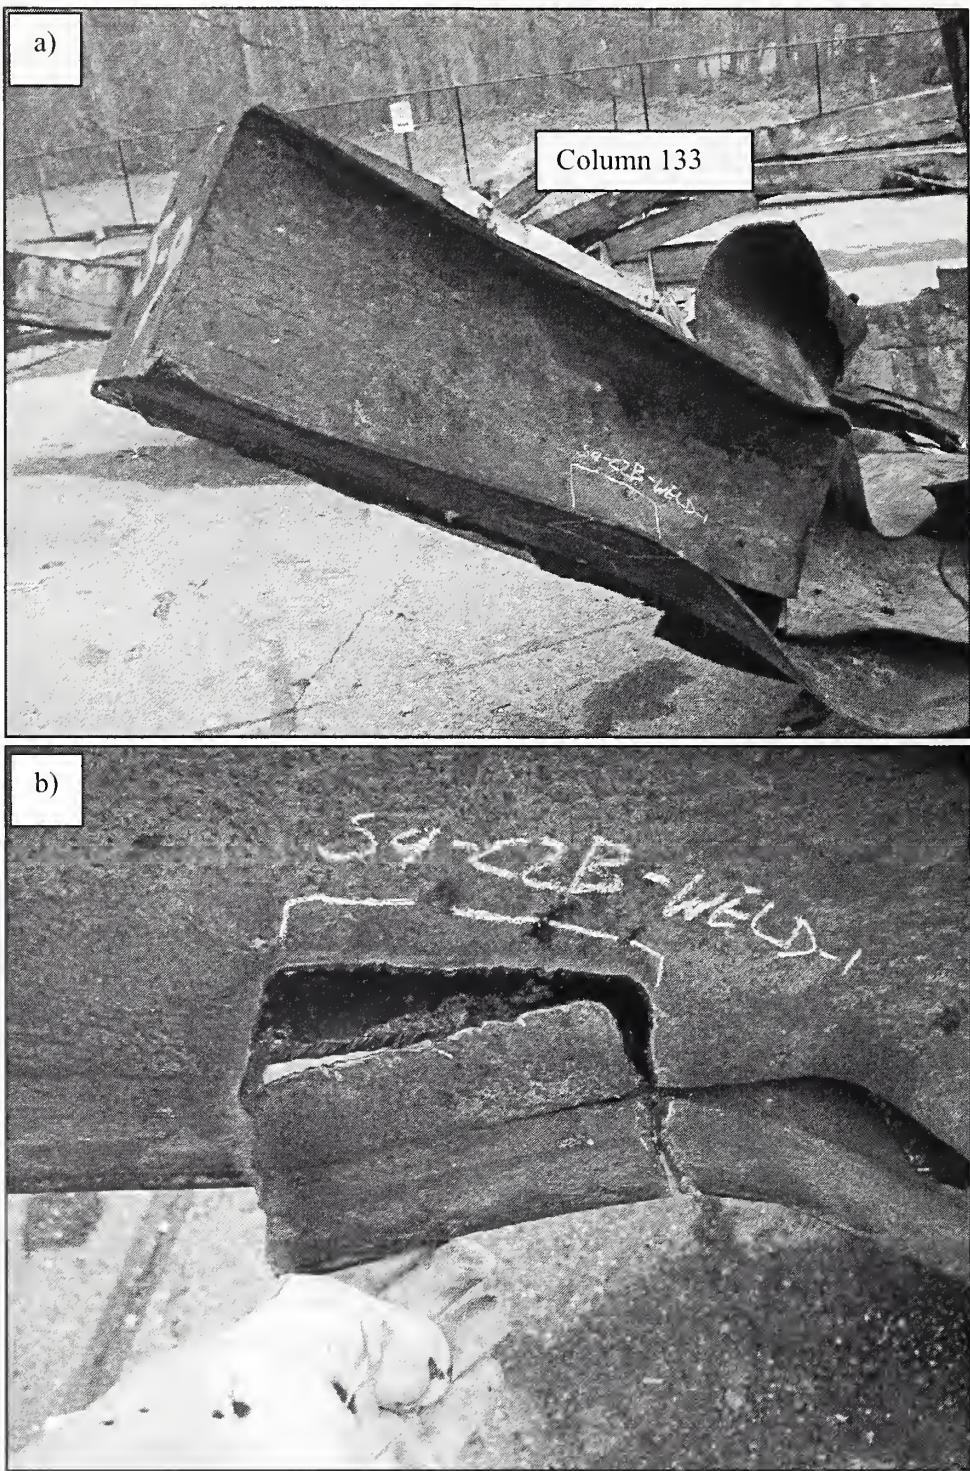
Figure 3-24. Weld fracture sample S9-C2B-Weld-1 (A133: 97-100, column 133), images taken a) prior to sample removal and b) after flame cutting. Panel S-9 was struck by the vertical tail assembly of the airplane.

A third fractured weld sample was removed for investigation of crack propagation through the material. This sample was from the 96th floor level of column 133 (specified minimum yield strength of 55 ksi) on panel S-9. This panel was struck directly by the plane, in particular, the tail section. The lower portion of column 133 was found to be intact and in relatively good condition near the splice connection; however, just below the 97th floor spandrel, the column had a similarly splayed appearance as that observed for panel M-2 (Fig. 3-24a). The removal of the sample was such that the crack tip could be investigated, Fig. 3-24b. Inspection with the naked eye revealed that the crack propagated in the outer web plate along the weld bead, Fig. 3-25.

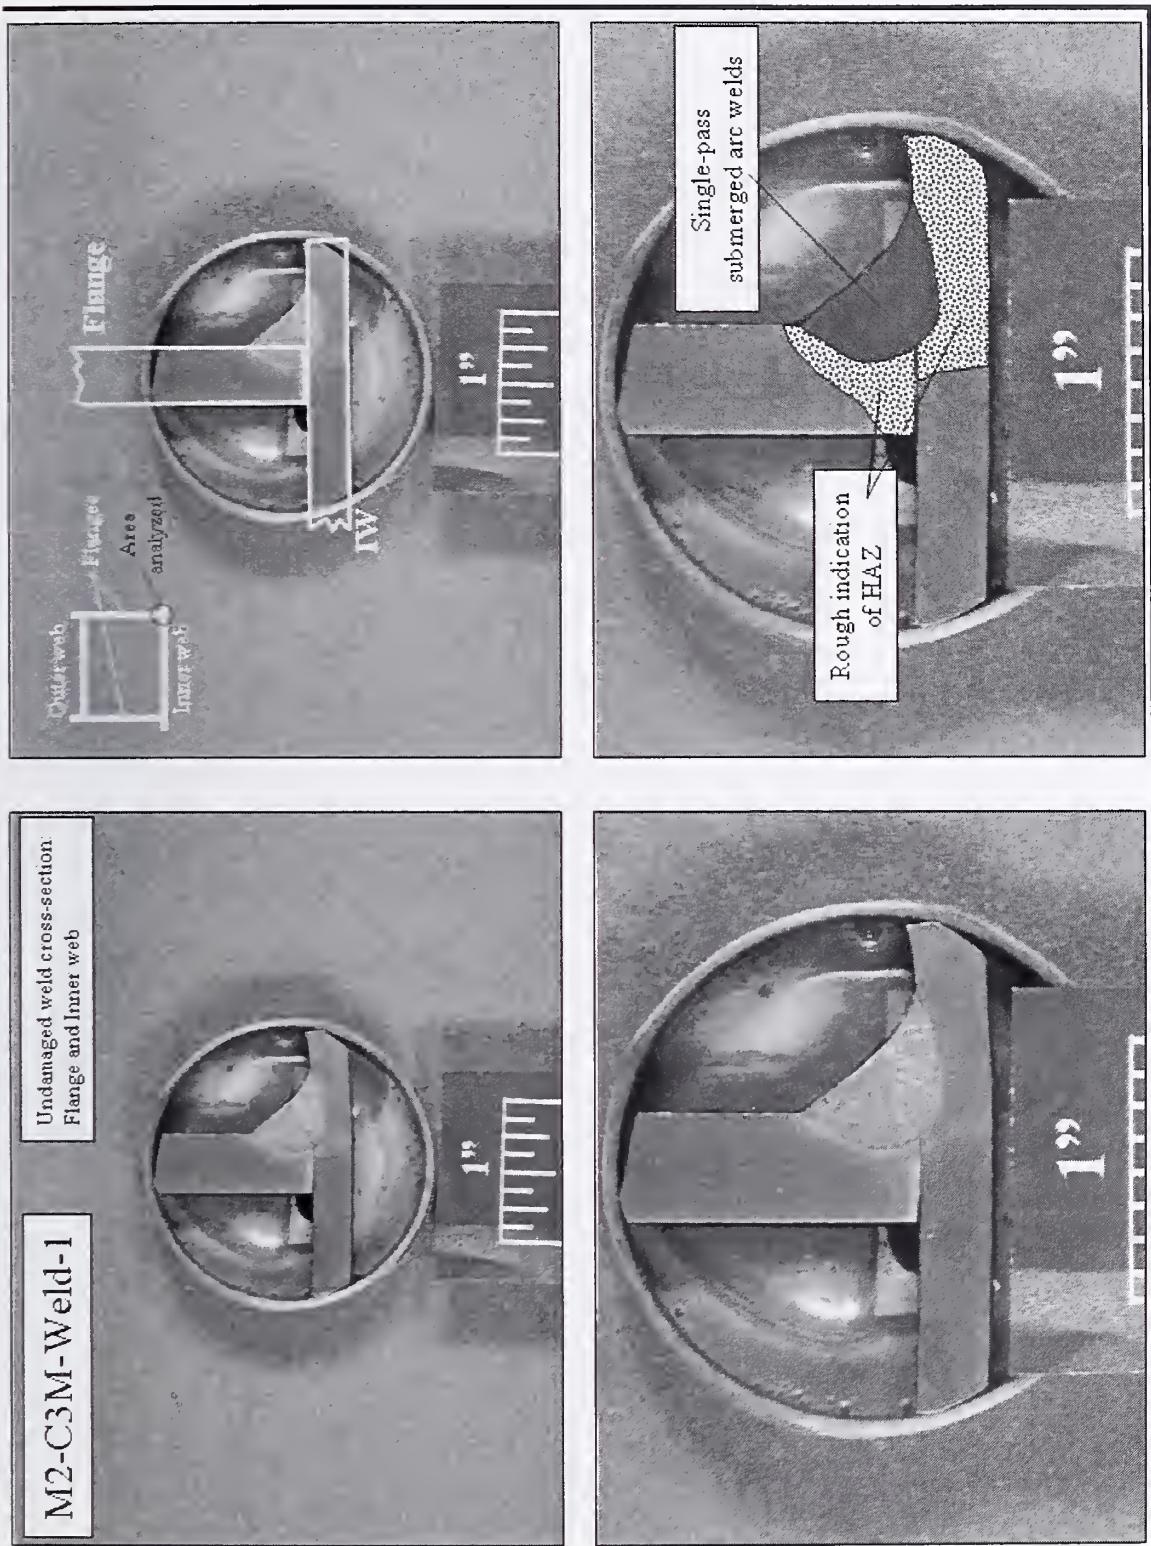
Figure 3-23. Polished and etched cross-section of intact weld between inner web and flange (same as shown in Fig. 3-21c and 3-21d). The sample was removed from an undamaged portion of column of panel M-2 (A130: 96-99, column 129) that was directly hit by the plane. Note the geometry of the HAZ in the inner web base plate. Two percent nital and 4 percent picral etch.

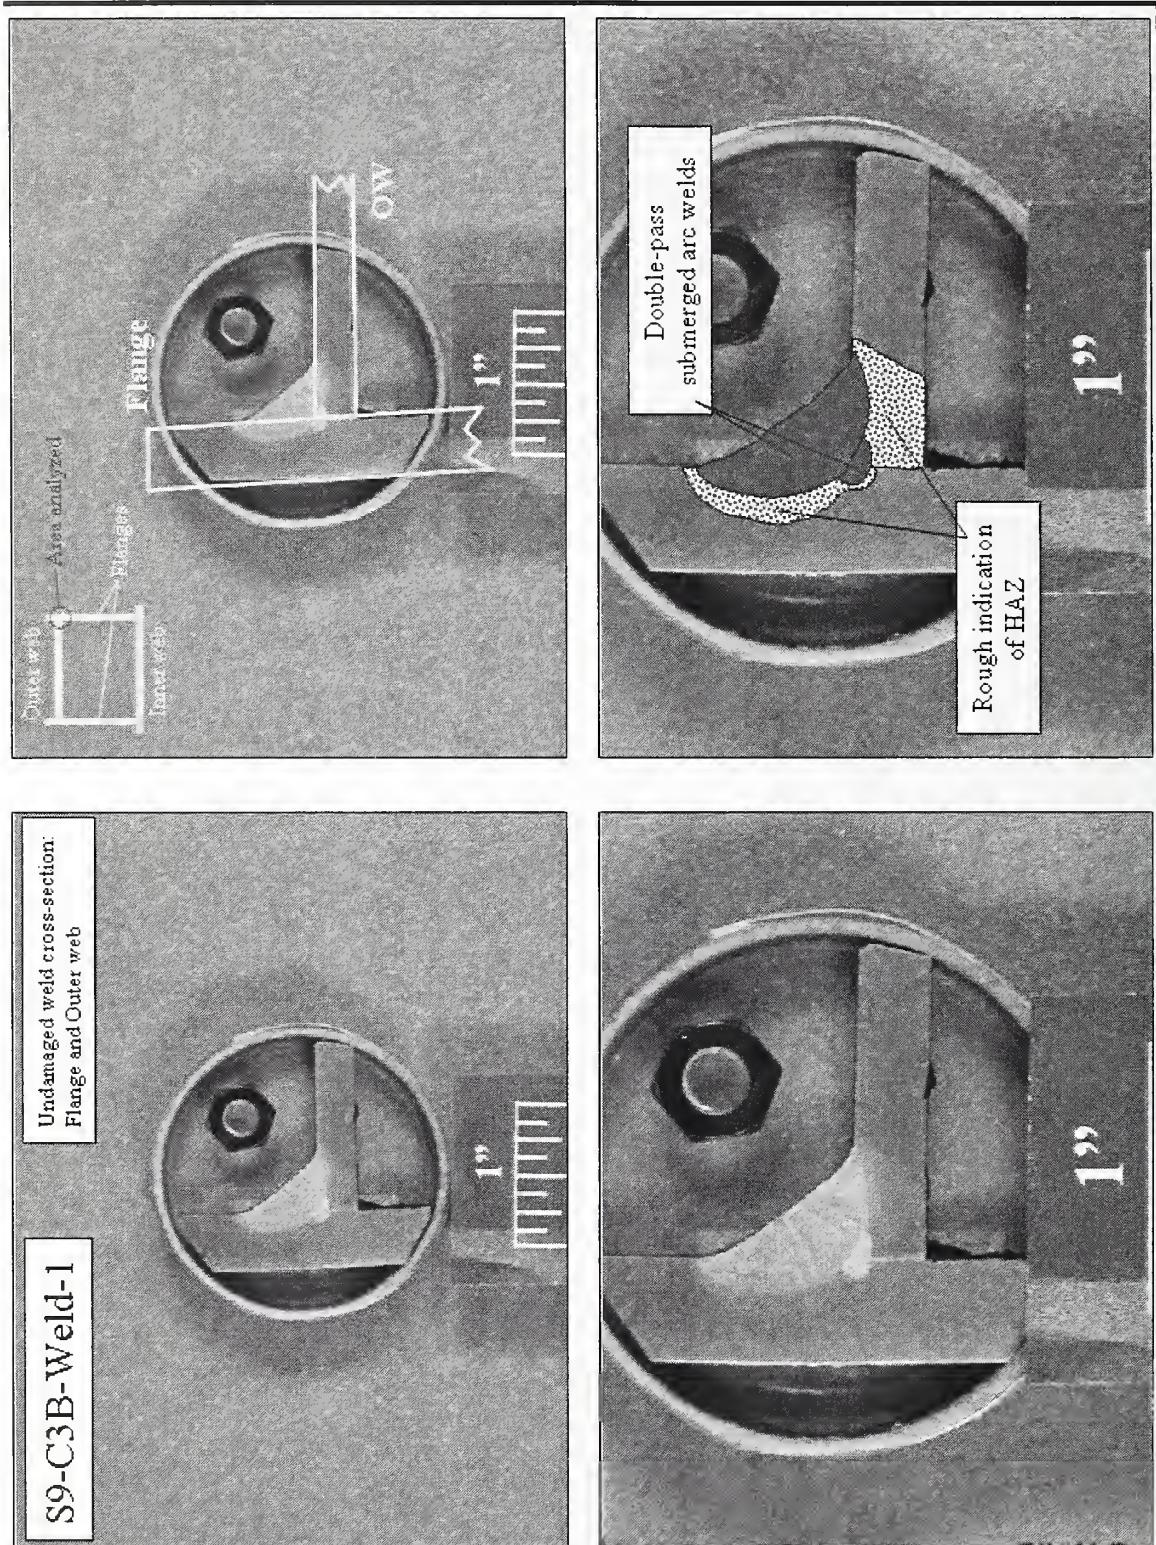
Figure 3-22. Polished and etched cross-sections of intact weld between outer web and flange (same as shown in Fig. 3-21a and 3-21b). The sample was removed from an undamaged portion of column of panel S-9 (A133: 97-100, column 132) that was directly hit by the plane. Note the geometry of the HAZ in the outer web base plate. Two percent nital and 4 percent picral etch.

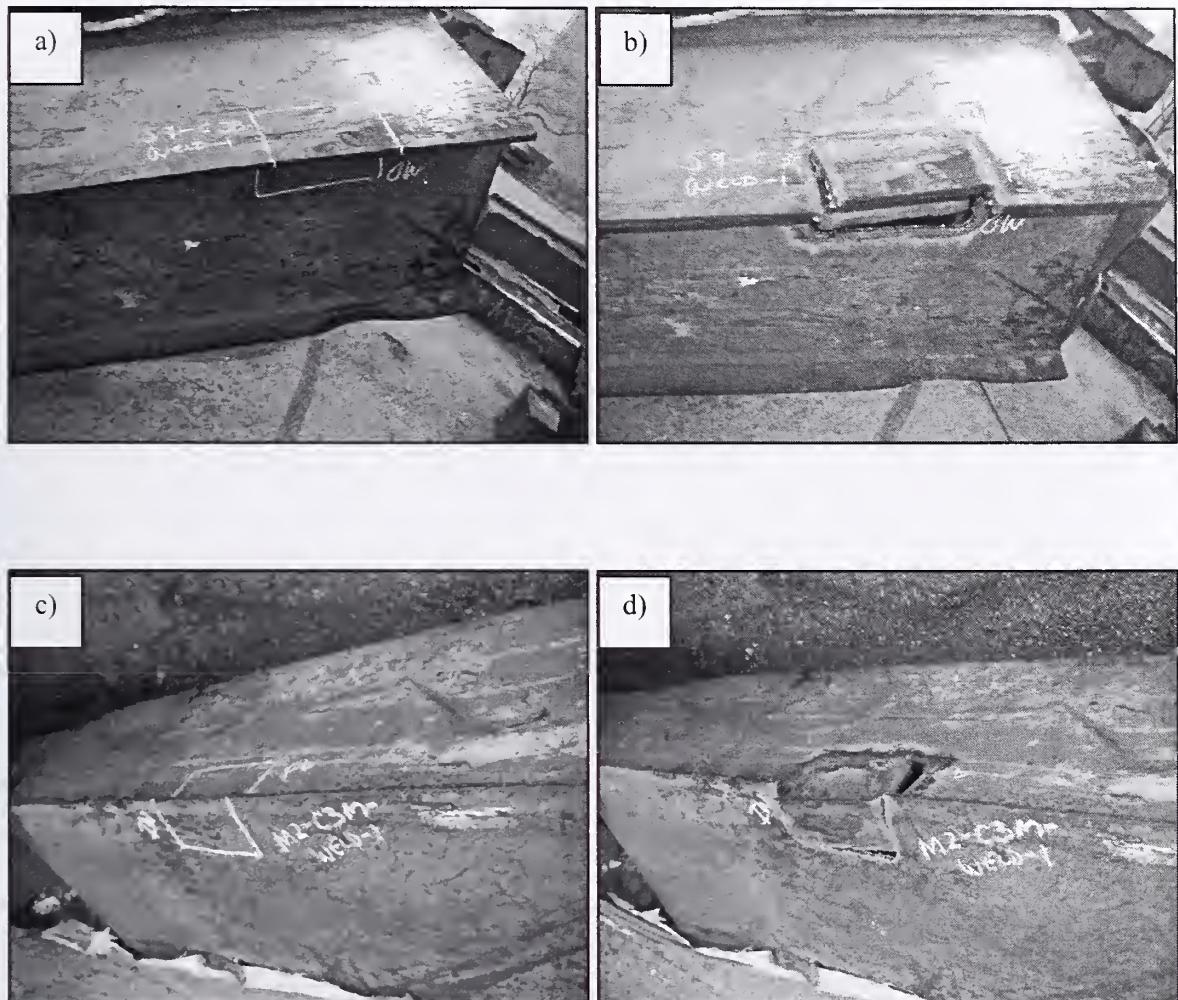
Figure 3-21. Removal of undamaged weld samples. a) Uncut sample labeled S9-C3B-Weld-1 (A133: 97-100, column 132) of a welded joint between a flange and outer web, b) cut sample, c) uncut sample labeled M2-C3M-Weld-1 (A130: 96-99, column 129) of a welded joint between a flange and inner web, and d) cut sample.

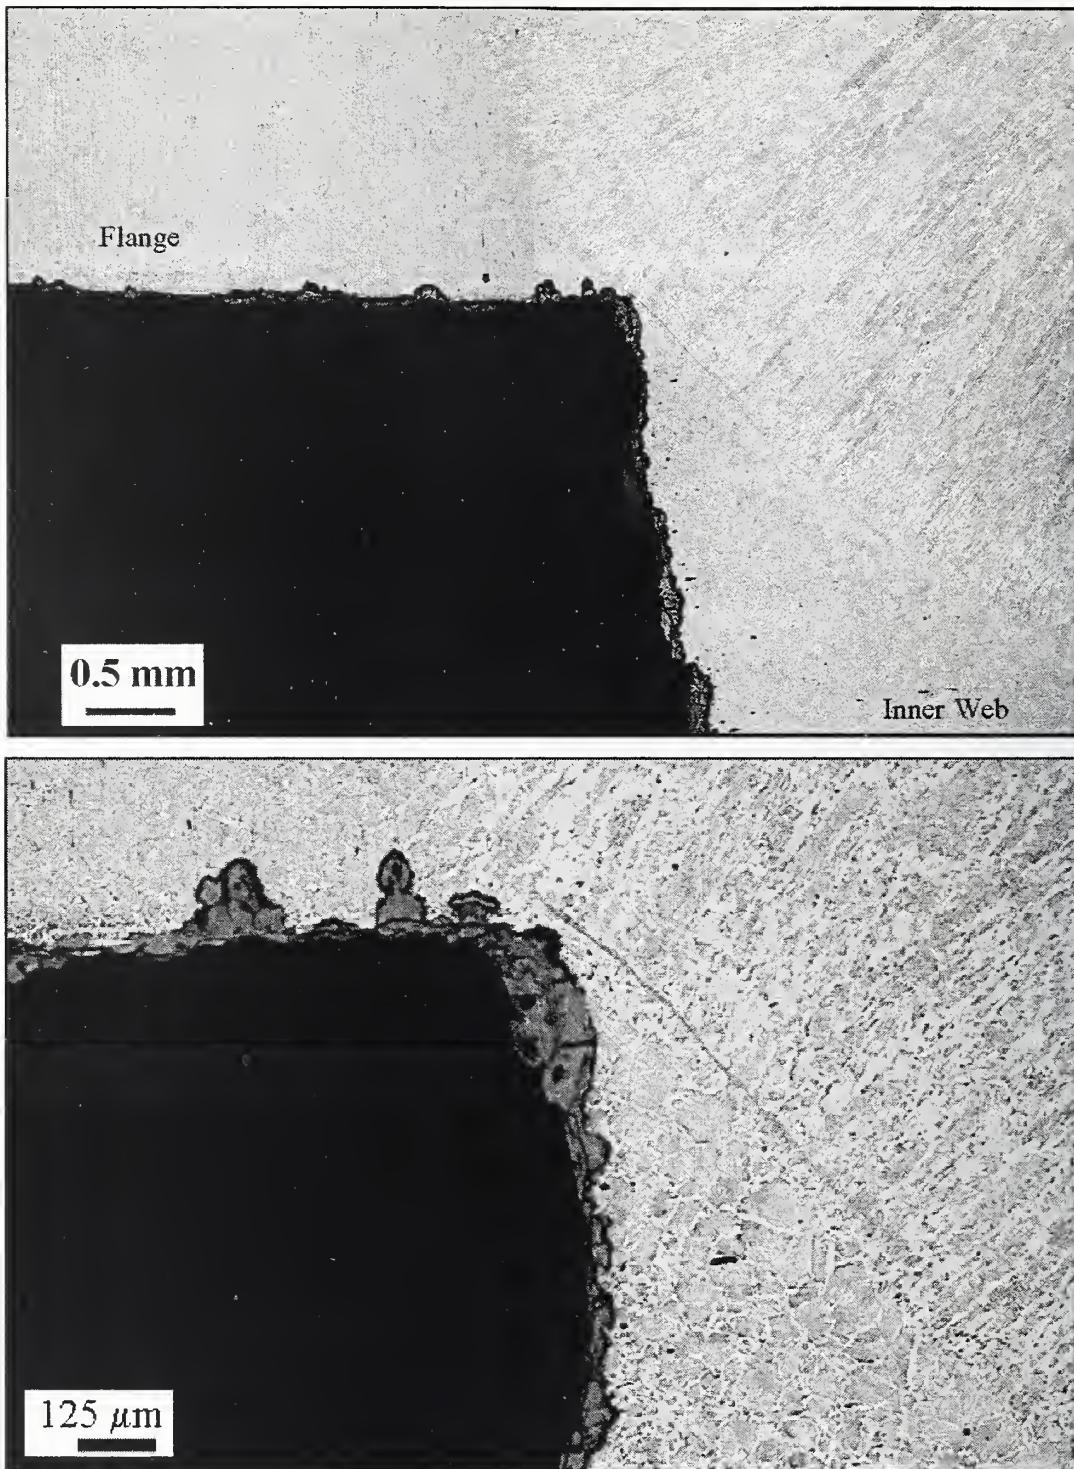
Figure 3–20. Light optical micrograph showing fracture of the inner web (from Fig. 3–18) initiating near the fusion line in the HAZ of the plate. Two percent nital and 4 percent picral etch. (A130: 96-99, column 129).

Macroscopic investigation of the cross-section revealed that fracture did occur in the inner web plate, Fig. 3-19. The flange and single-pass submerged arc weld were also seen. However, a few, small steps were noticeable on the fracture surface in cross-section (lower left image of Fig. 3-19). Similar to the first case discussed above, the direction of high rate impact with the joint geometry dictated that the initiation site for fracture of the inner web was associated with the stress concentrator in this area where the flange and web meet but were not metallurgically joined. It appears that the tearing initiated at the location where the weld bead intersected the surface of the inner web and then propagated through the HAZ. Microscopic investigation revealed that tearing of the inner web occurred at the juncture between the weld bead and the surface of the inner web and was restricted to the HAZ of the plate, Fig. 3-20.

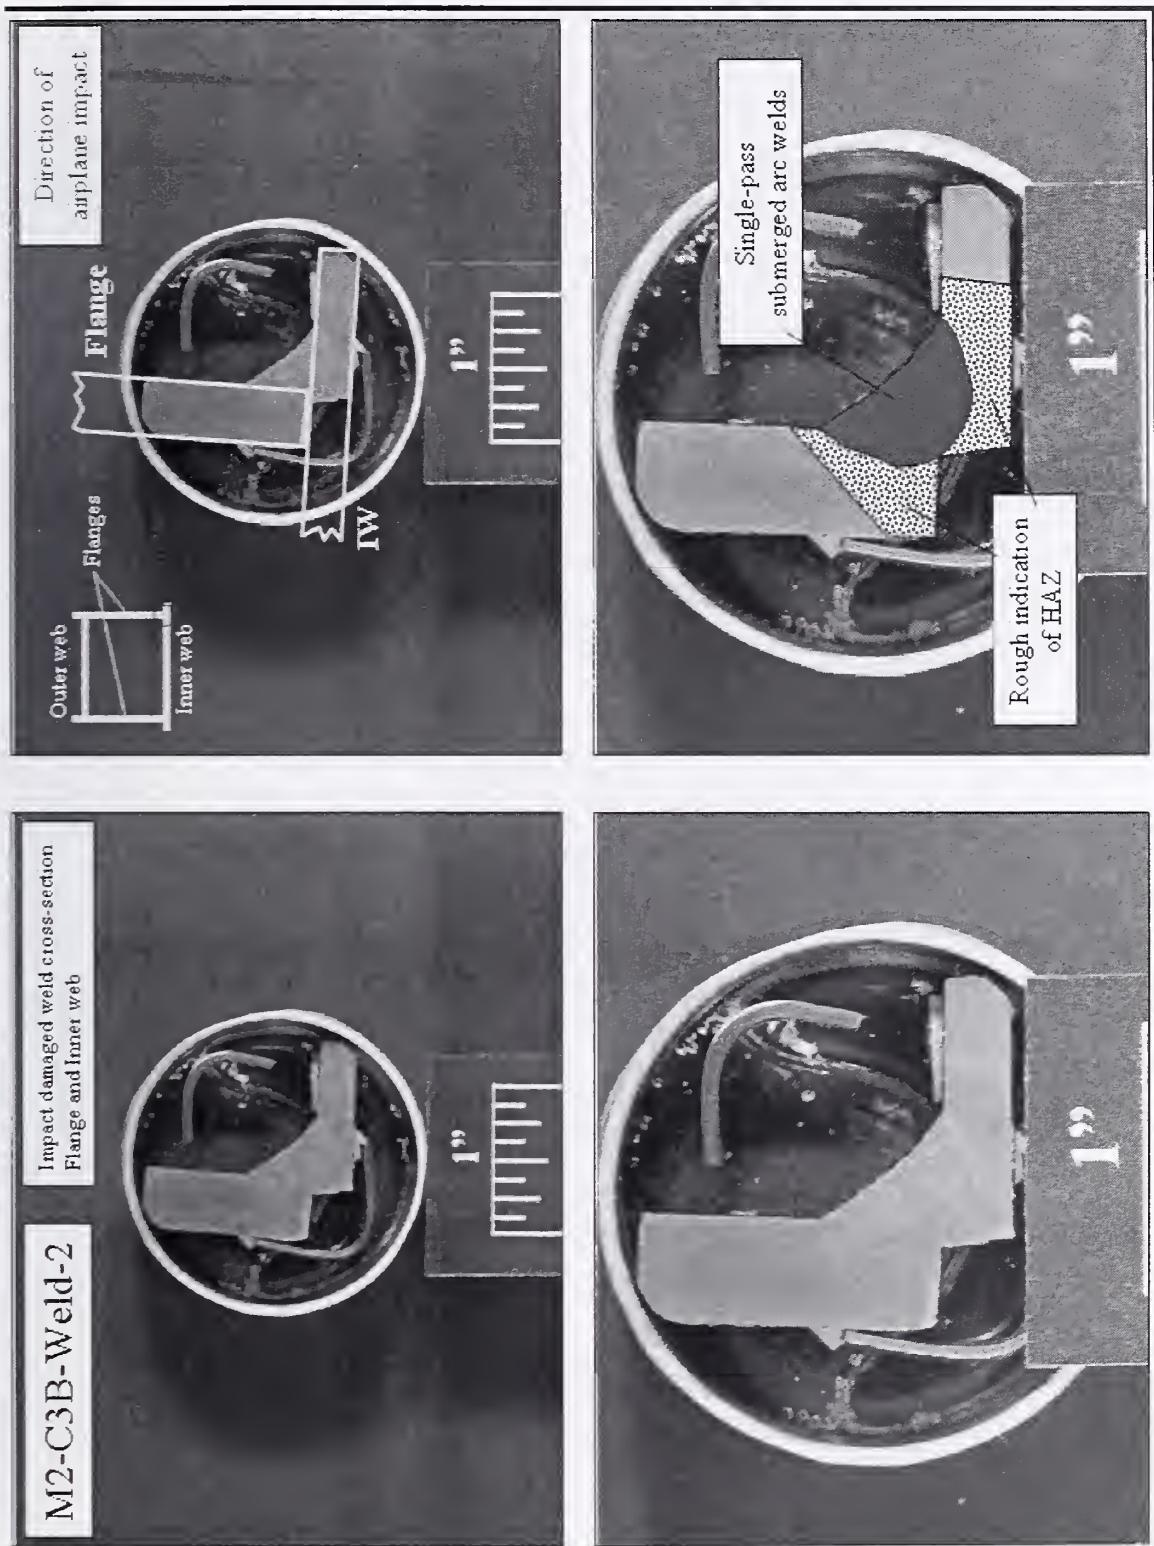
Figure 3-19. Polished and etched cross-section of fracture near weld between inner web and flange as seen in Fig. 3-18. Sample was from panel M-2 (A130: 96-99, column 129) that was directly hit by the plane. Fracture occurred in inner web plate; weld was intact. Two percent nital and 4 percent picral etch.

Once again, the fracture associated with this WTC weld joint was not attributed to either poor material quality of the inner web or the weld joint configuration. Instead, the direction of the high impact loading of the plate in combination with the diminished properties of the HAZ of a rolled plate was believed to have led to this type of fracture. There was a difference between the two macroscopic angles of fracture; the first case having a “woody” appearance and the second case having a “flatter” fracture surface. This was most likely related to the geometry of the HAZ of the weld itself. To clarify this point, two additional cross-sections were prepared of welds that had not experienced fracture, Fig. 3-21. The first example was taken of a joint between the flange and outer web. Figure 3-22 shows the geometry of the HAZ in the outer web plate. The HAZ was angled similarly to the fracture surface observed in the first weld fracture sample. Likewise, Fig. 3-23 shows the HAZ geometry from the second example, that between a flange and an inner web. Similar to the fracture surface of the second weld fracture examined, the angle of the HAZ front had a significantly higher slope with respect to the rolling plane of the inner web. Clearly, the macroscopic angle of fracture of both plates was a result of diminished properties in the HAZ near the weld, with the difference between the HAZ geometries most likely a combination of the welding parameters and the joint geometry. Further, no microscopic information could again be obtained to define the microscopic mode of fracture.

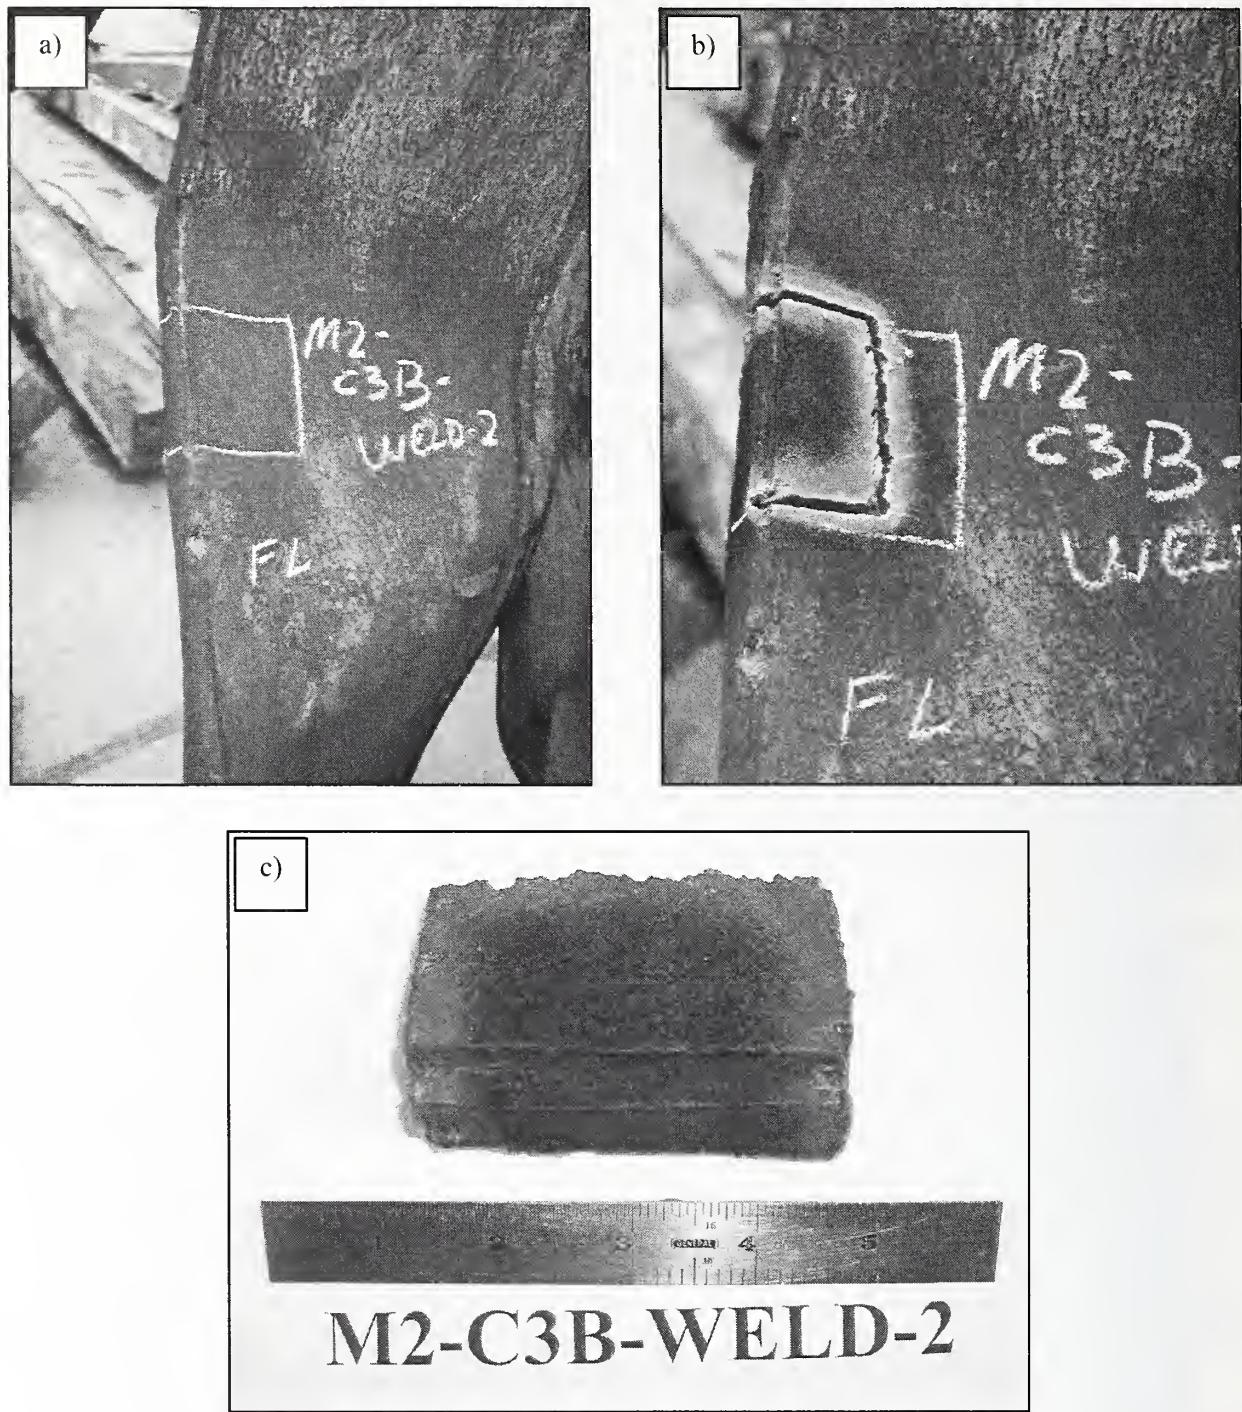
Figure 3-18. Example of fracture near weld of a perimeter column, sample M2-C3B-Weld-2 (A130: 96-99, column 129), images taken a) prior to sample removal, b) after flame cutting, and c) in the laboratory. Fracture was a result of airplane impact.

end near the same lower stiffener plate of the 97th floor level spandrel. Unlike the fracture between the outer web and flange, the inner web fracture surface was relatively flat with no readily observable features to the naked eye, Fig. 3-18c. Again, significant corrosion product had consumed the fracture surface; thus, further analysis would prove to be unproductive.

The second sample removed was a fracture taken between the flange and the inner web of the same column and roughly in the same location, Fig. 3-18. The damage characteristics were quite different from the first case examined. From observations made in the field, it appeared that fracture occurred in the inner web plate near the weld bead. Initial fracture was again assumed to start near the lower end plate of the column upon impact (when end plate was ripped out) and then ran vertically “up” the column toward the 97th floor level spandrel. The inner web was then severed at the lower stiffener plate of the 97th floor level spandrel. The vertical fracture in question between the inner web and flange was found to

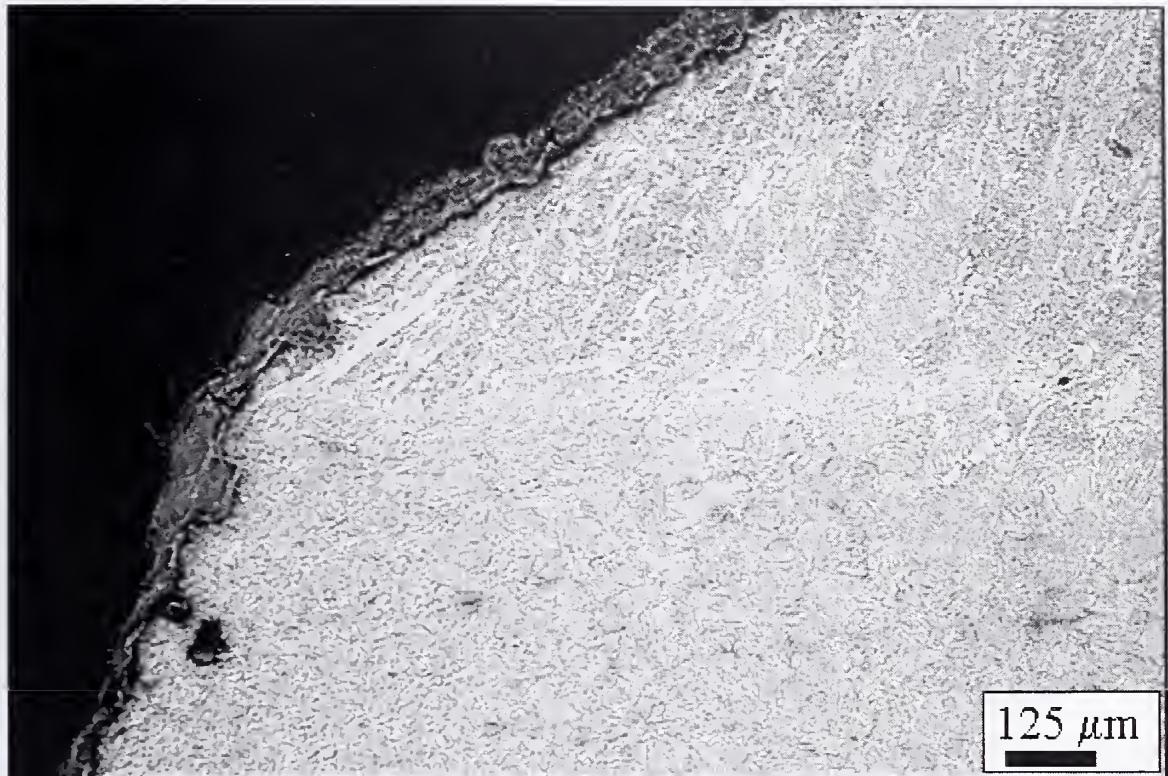
Figure 3–17. Light optical micrograph b) at higher magnification (red box in [a]) showing initiation of fracture at the toe of the weld and traveling through the HAZ of the plate. Two percent nital and 4 percent picral etch. (A130: 96-99, column 129)
