**Federal Building and Fire Safety Investigation of the
World Trade Center Disaster**

**Damage and Failure Modes of
Structural Steel Components**

Stephen W. Banovic
Timothy Foecke

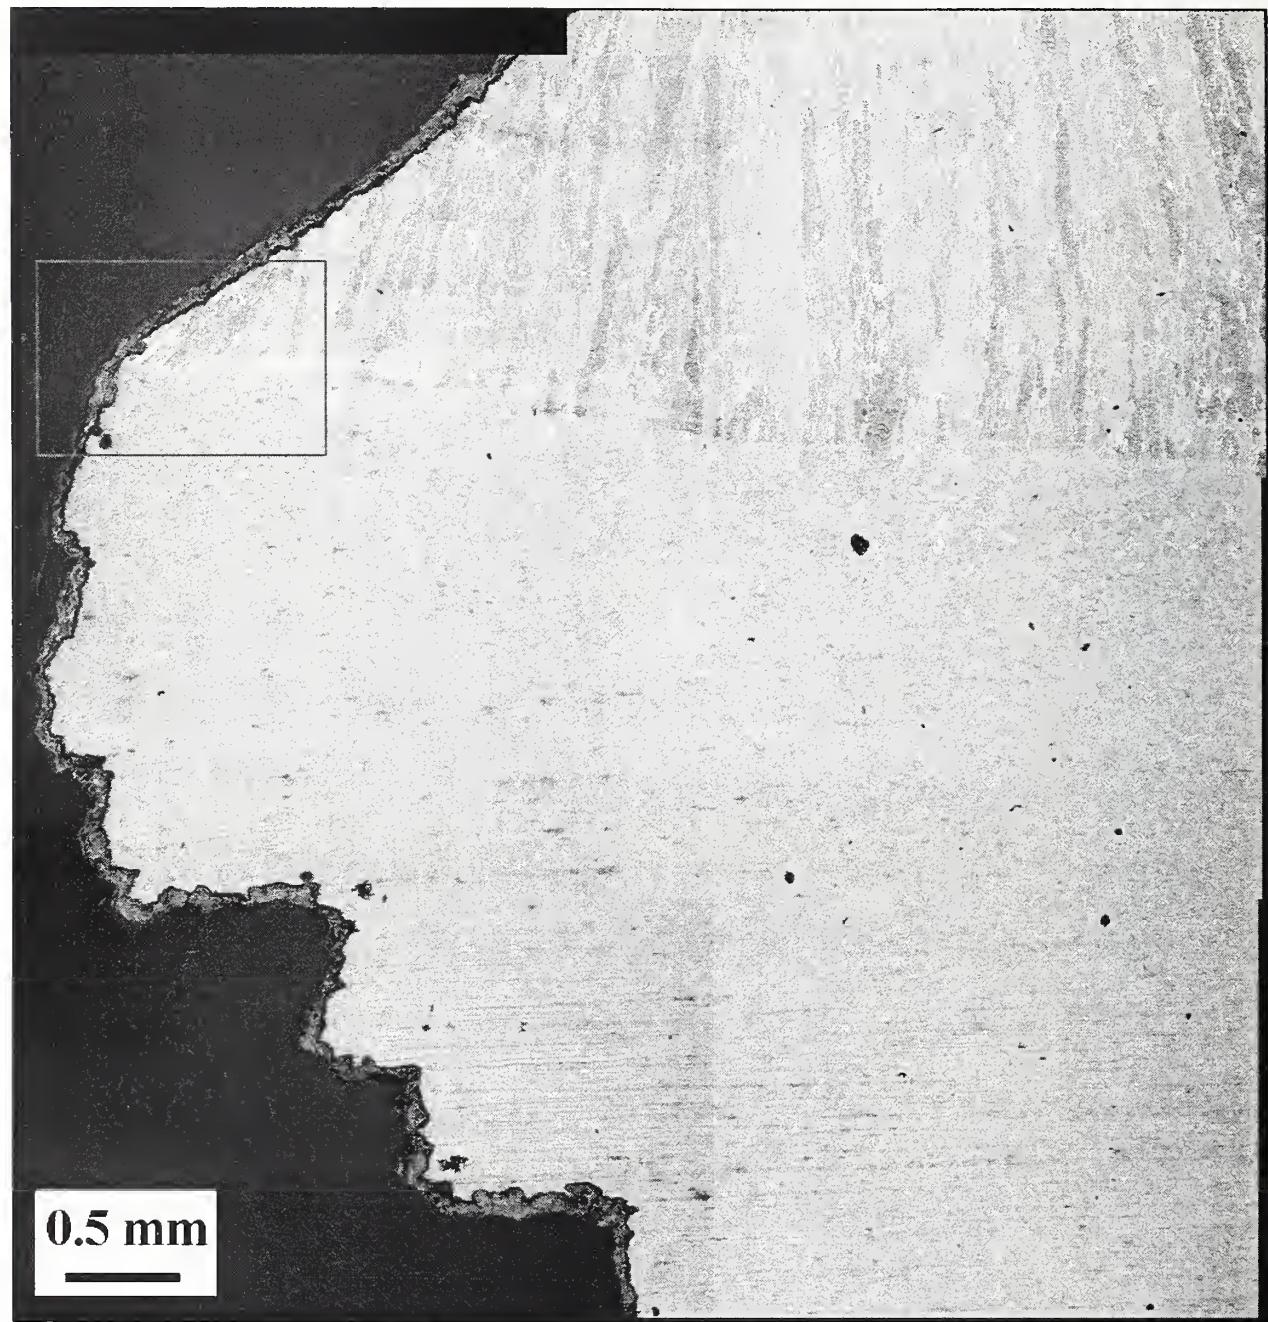
Figure 3-17. Light optical micrograph a) showing fracture of the outer web plate as a result of airplane impact (seen in Fig. 3-14). Fracture initiated at the toe of the weld and traveled through the HAZ of the plate. Two percent nital and 4 percent picral etch. (panel M-2, A130: 96-99, column 129)

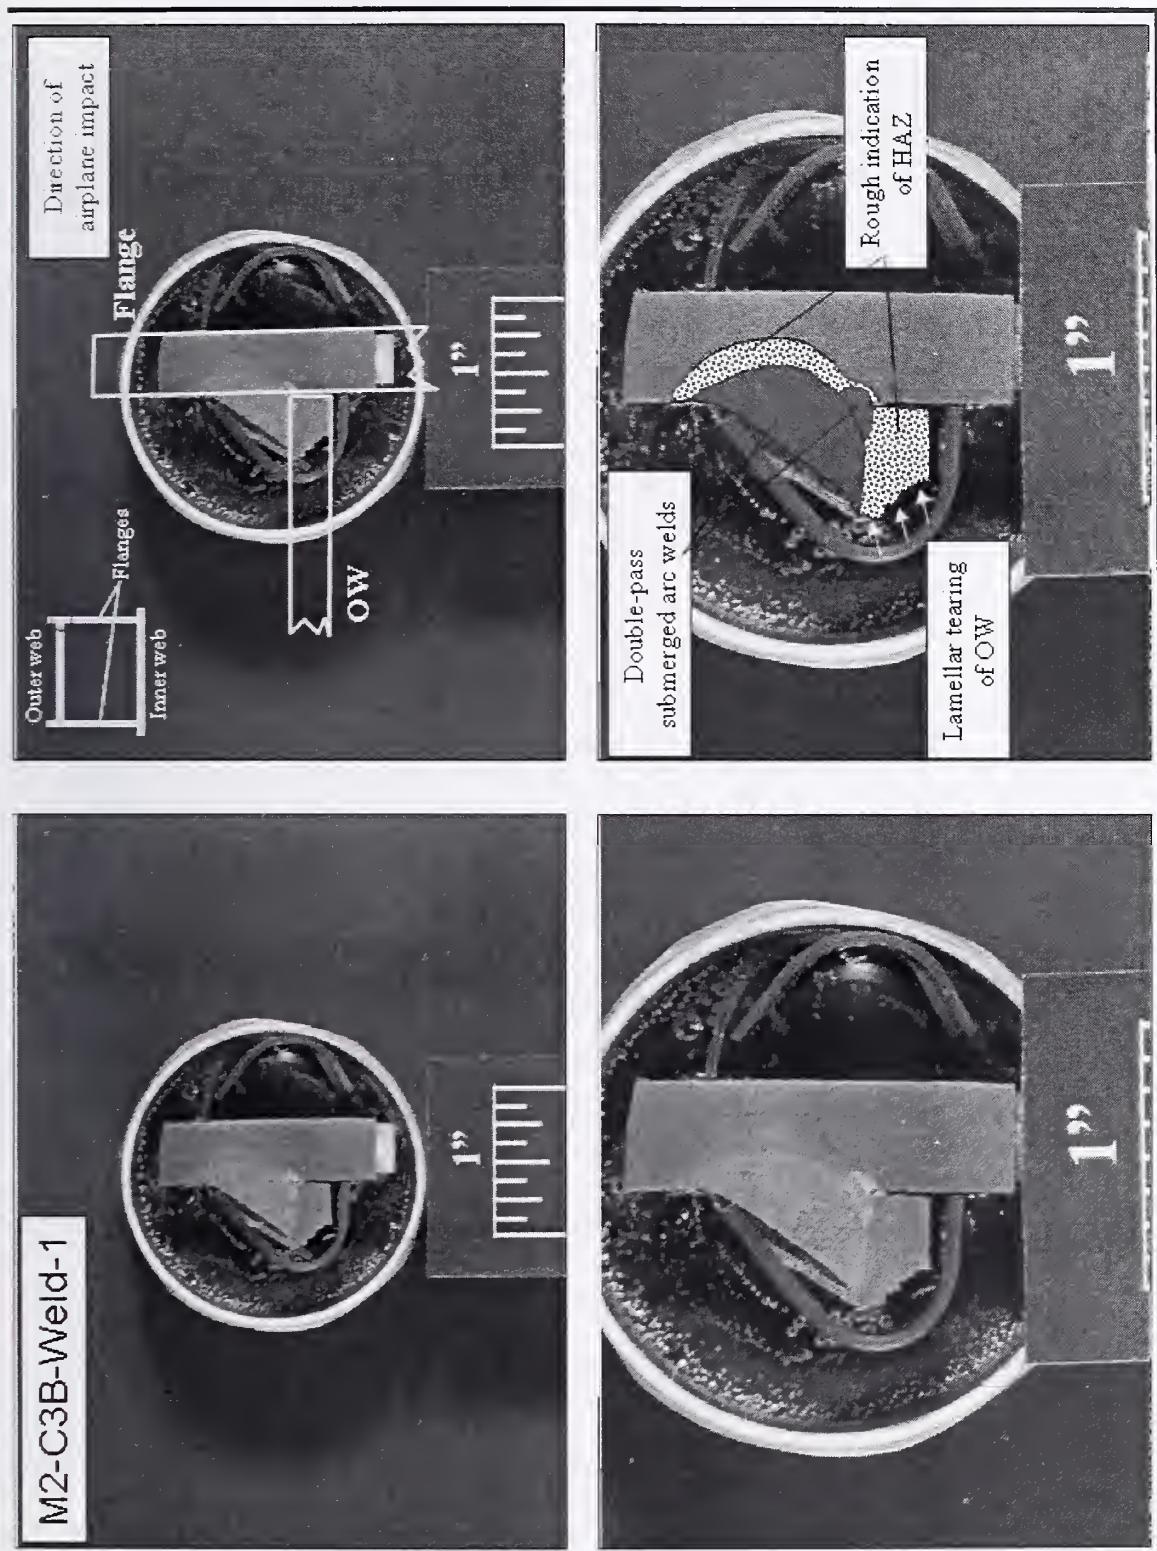
Figure 3-16. Polished and etched cross-section of fracture near weld between outer web and flange as seen in Fig. 3-14. Sample was from panel M-2 (A130: 96-99, column 129) that was directly hit by the plane. Fracture occurred in web plate; weld was intact. Two percent nital and 4 percent picral etch.

Macroscopic investigation of the cross-section revealed that fracture did occur in the outer web plate; a portion of this plate was still visible after metallographic preparation and etching procedures, Fig. 3-16. The flange and double-pass submerged arc welds were also seen. The weld was sound with no visible flaws observed. Typically, these joints were over-welded, meaning that a 3/8 in. or 1/2 in. weld may have been deposited where only a 5/16 in. bead was specified. A slight gap existed between the plates for the outer web and flange; this was not uncommon for most weld cross-sections evaluated between these two column components. The outer face of the fracture surface was associated with the toe or root of the weld. The cross-section of the failed plate revealed a jagged, stepped fracture surface with the steps parallel and perpendicular to the rolling plane of the plate. Microscopic investigation further revealed that tearing of the outer web initiated at the toe of the weld and that the crack propagated through the HAZ of the plate, Fig. 3-17. The HAZ is a common weld feature consisting of microstructurally altered, unmelted base metal adjacent to the weld bead. It is a direct result of the heat input required for

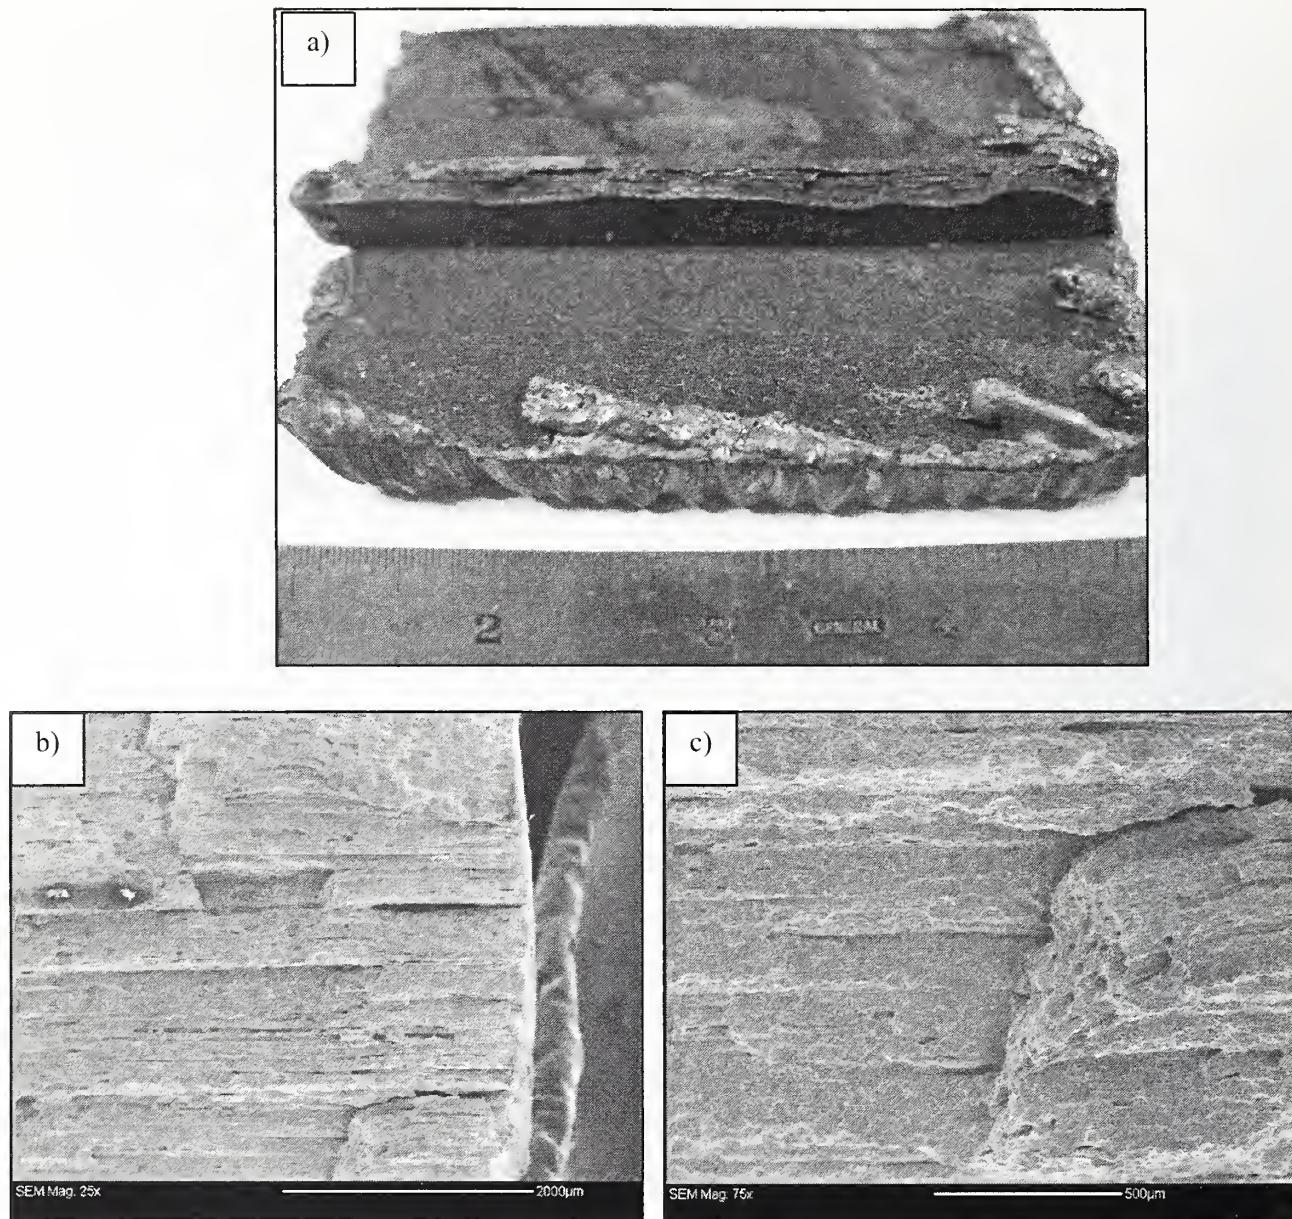
Figure 3-15. Fracture surface for sample M2-C3B-Weld-1 (A130: 96-99, column 129) shown in Fig. 3-14. Fracture features of outer web have “lamellar tearing” type fracture characteristics. a) Light micrograph, b) and c) scanning electron micrographs.

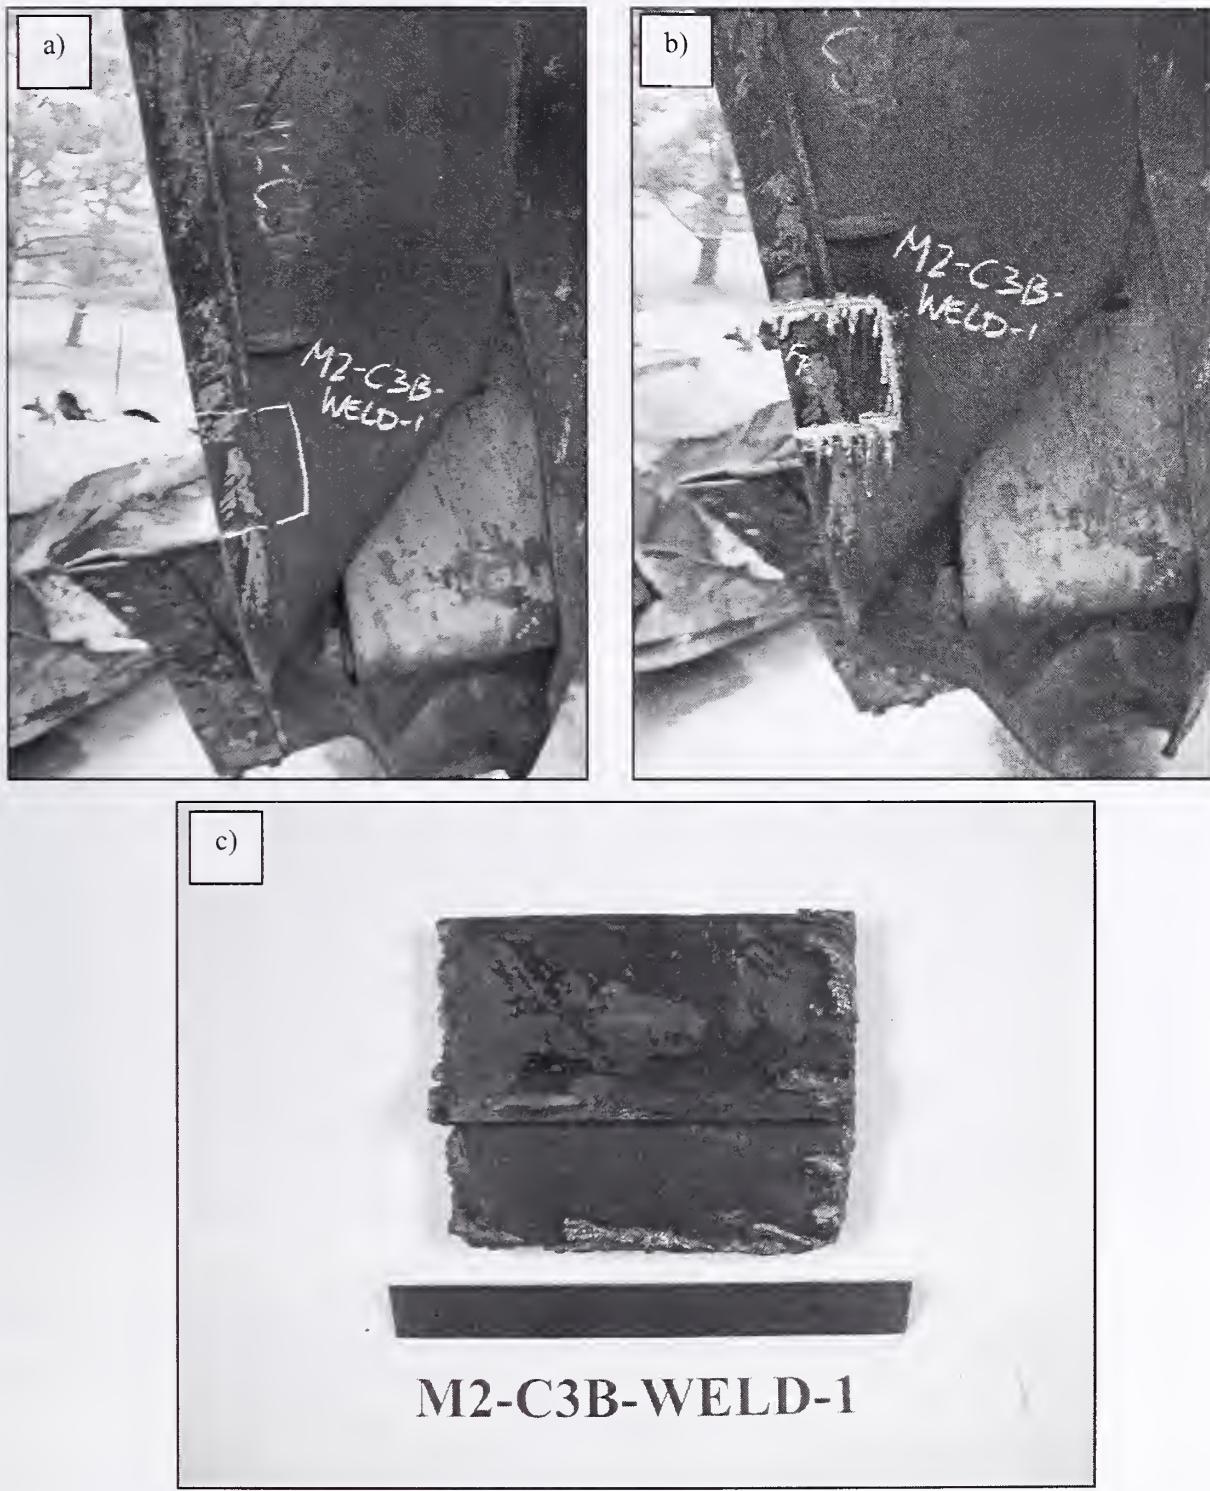
Figure 3-14. Example of fracture near weld of a perimeter column as a result of airplane impact, sample M2-C3B-Weld-1 (A130: 96-99, column 129), images taken a) prior to sample removal, b) after flame cutting, and c) in the laboratory.

The first example was a fracture taken between the flange and the outer web, Fig. 3-14. From observations made in the field, the fracture appeared to have occurred in the outer web plate near the weld bead. It was assumed that fracture was initiated near the lower end plate of the column upon impact (when end plate was ripped out) and then ran vertically "up" the column toward the 97th floor level spandrel. The outer web was still connected to the column, but was pushed inward towards the center of the building; the inner web had been severed near the lower stiffener plate of the 97th floor level spandrel. The vertical fracture in question between the outer web and flange was found to stop short of the same lower stiffener plate of the 97th floor level spandrel. Viewing the fracture surface of the outer web plate with the naked eye, it was observed to have a fibrous and/or "woody" appearance, Fig. 3-15a. Closer examination showed that the fracture surface was stepped, Fig. 3-15b and 3-15c. Due to prior exposure to the elements of weather, the fracture surface was corroded to the point that no further information could be obtained from it.

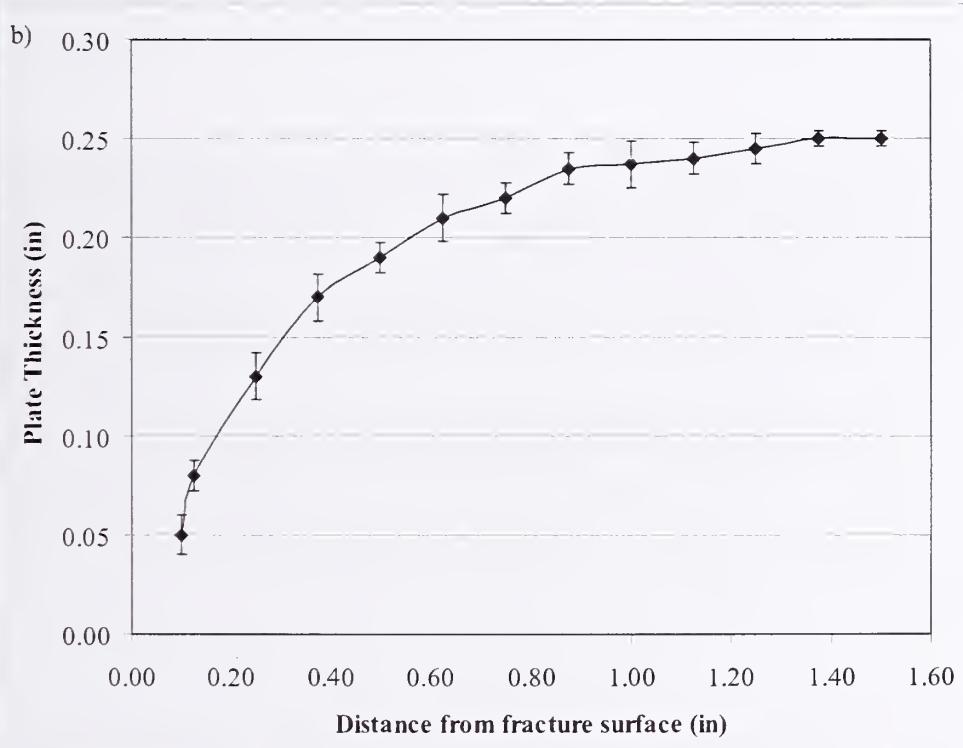
Figure 3–12. Thinning of outer web from column 130 of panel M-2 (A130: 96-99). Tensile failure of the plate was a result of airplane impact into WTC 1. a) photograph showing thinning, b) graph indicating plate thinning near fracture surface.

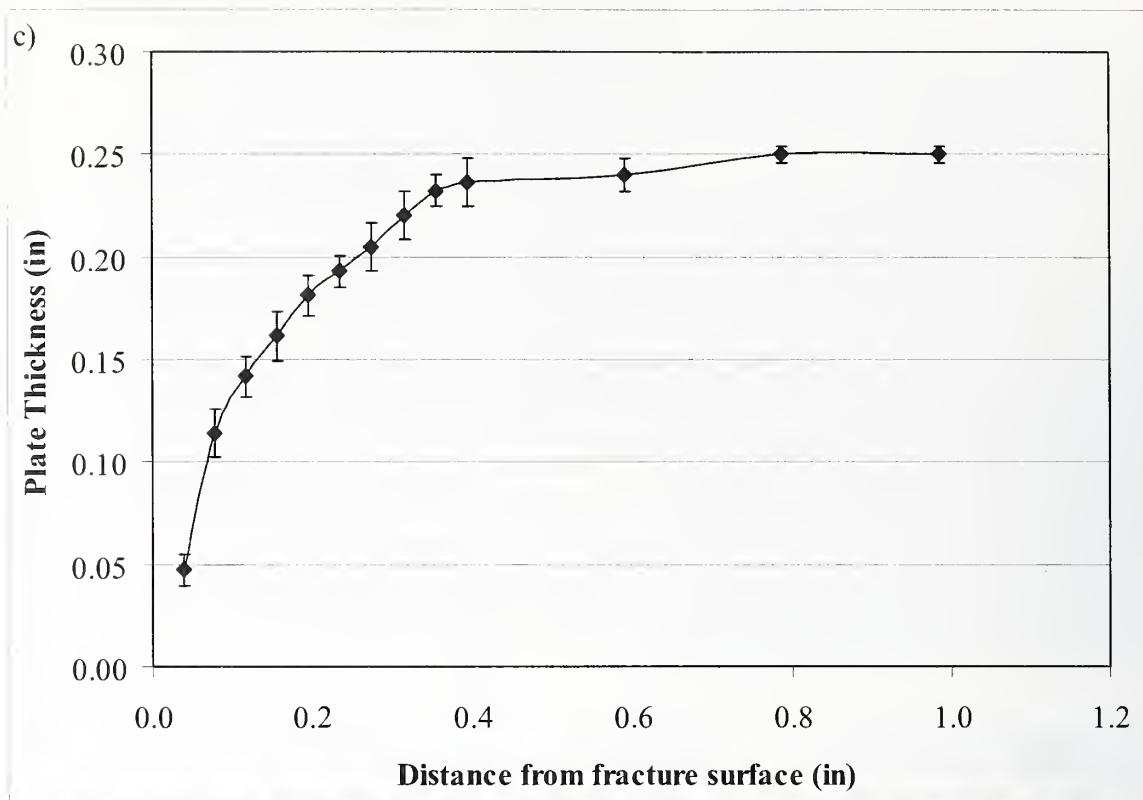
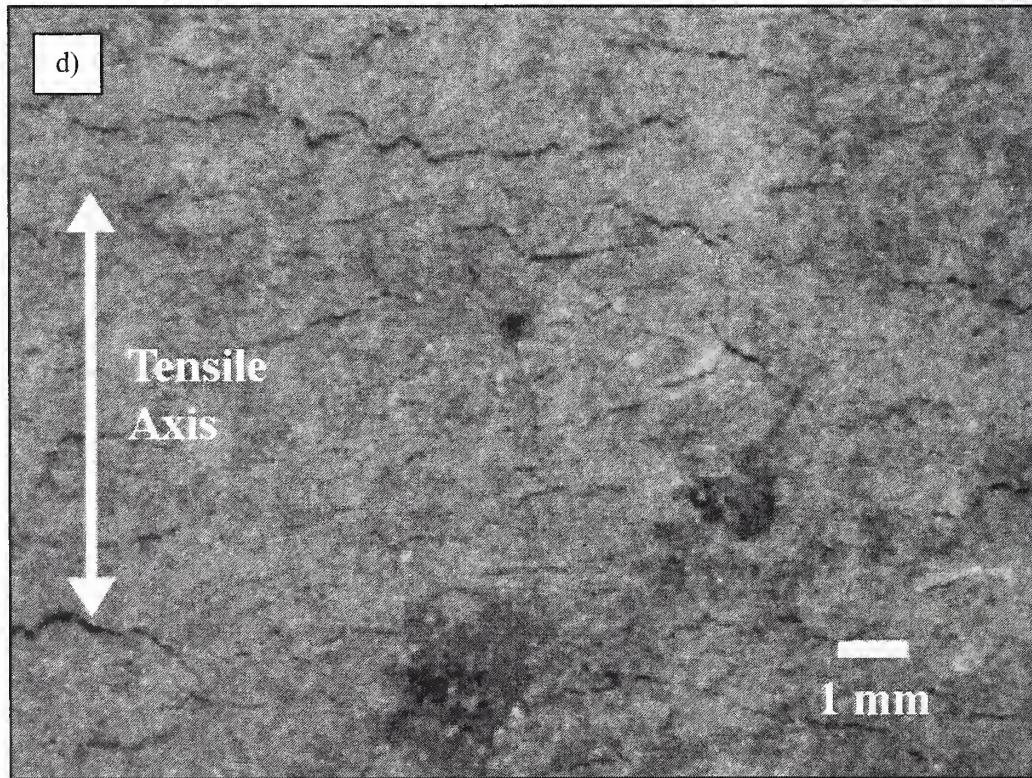
Figure 3-11. Analysis of fractured plate from sample S-9 (A133: 97-100), outer web of column 132. c) graph indicating plate thinning near fracture surface, d) image showing paint cracking as a result of tensile loading of the plate.

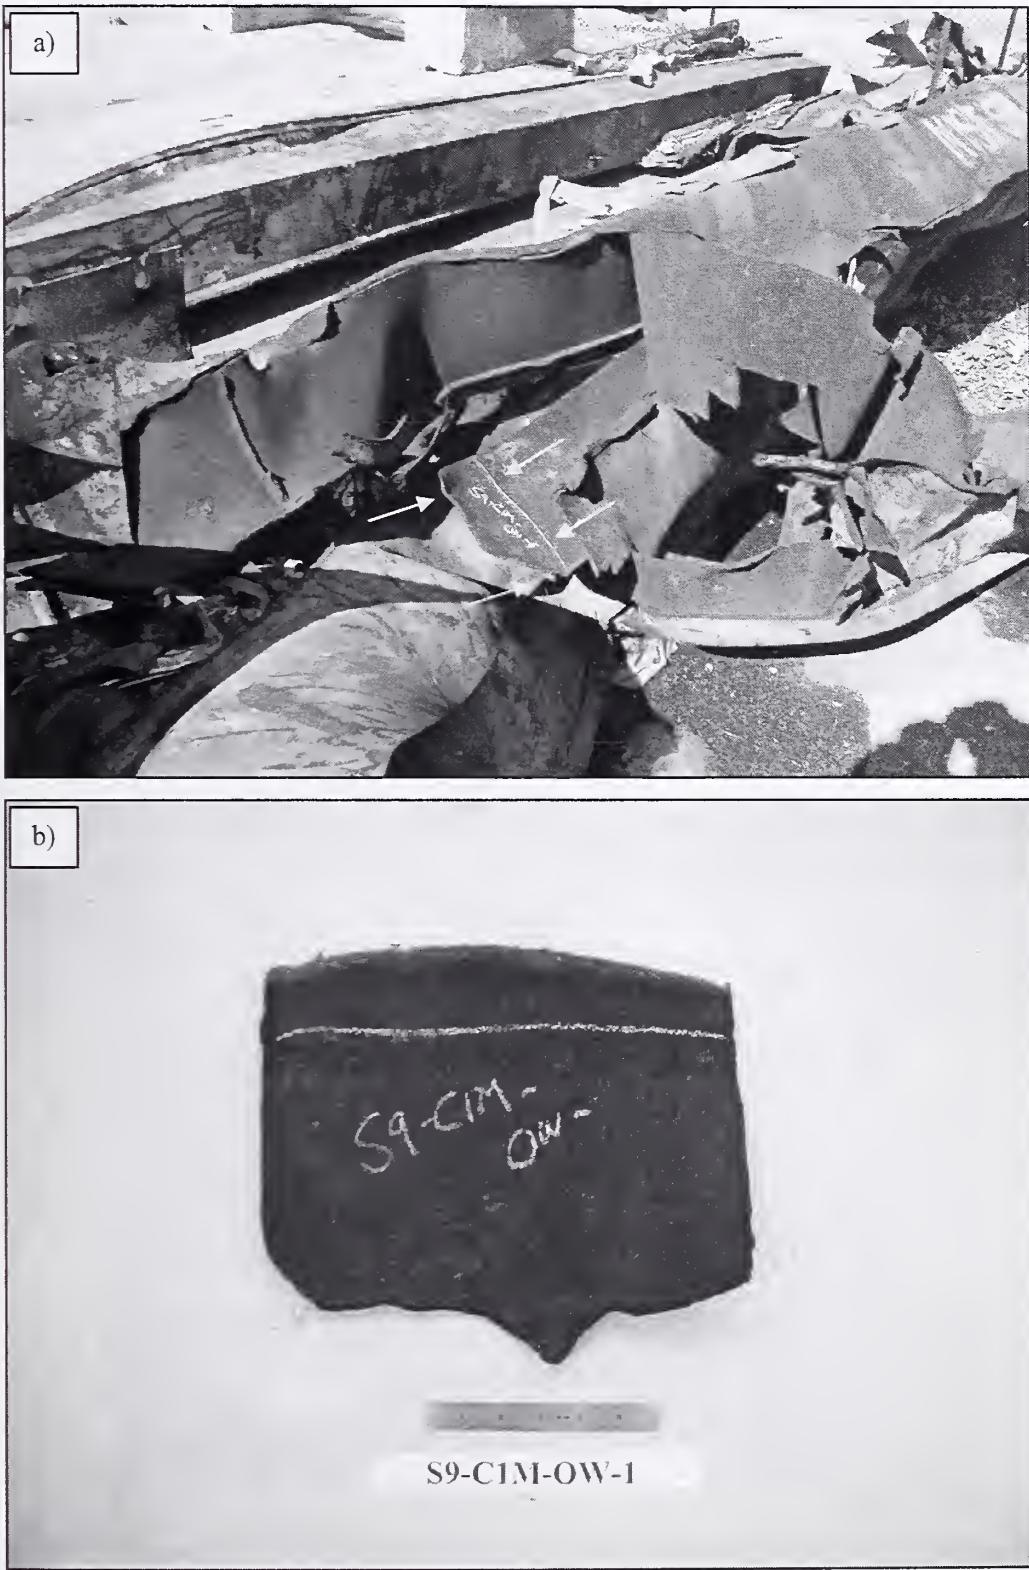
Figure 3-11. Analysis of fractured plate from sample S-9 (A133: 97-100), outer web of column 132. This panel from WTC 1 was struck by the vertical tail assembly. a) Location of sample removed, b) laboratory image showing sample removed.

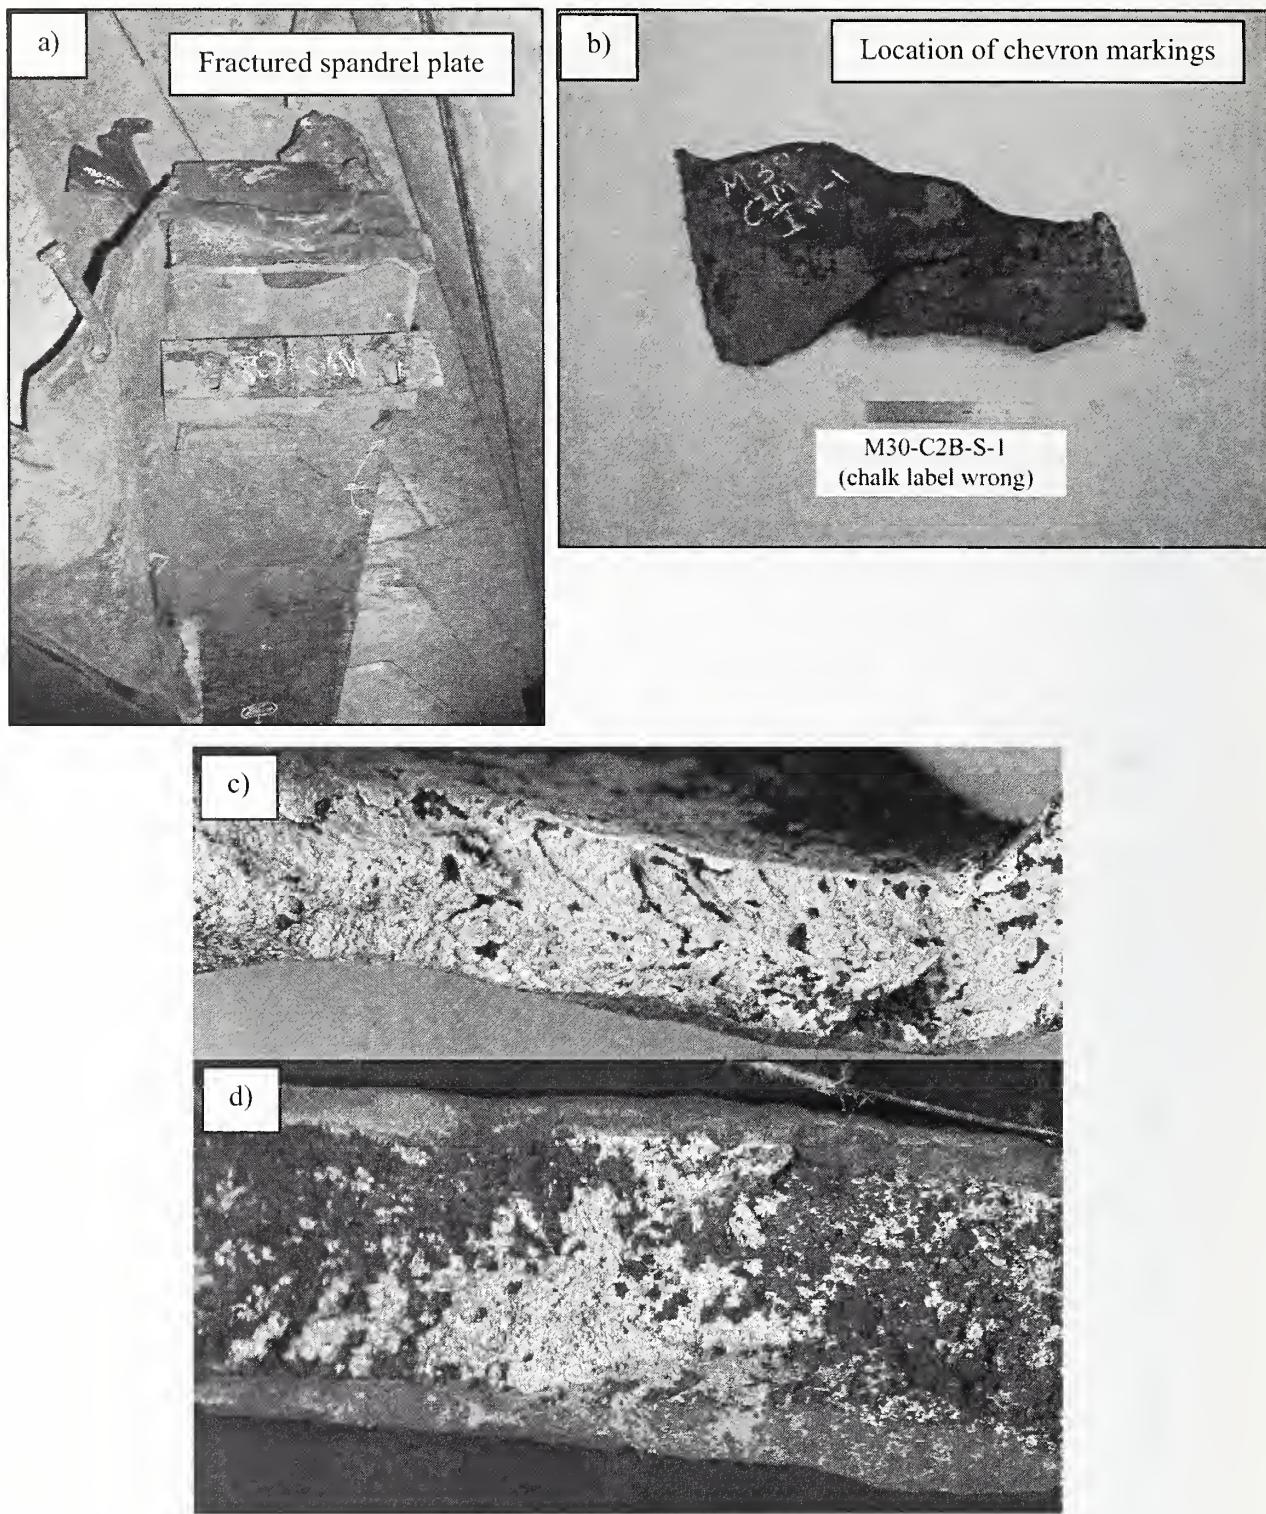
Figure 3–10. Fracture surface of sample M-30 (A133: 94-97), spandrel plate of column 133. Fracture was due to airplane impact of WTC 1. a) Location of sample removed, b) laboratory image showing sample removed, c) fracture shows chevrons running along the length of the crack path, and d) red highlighted area showing the location of small shear lips.

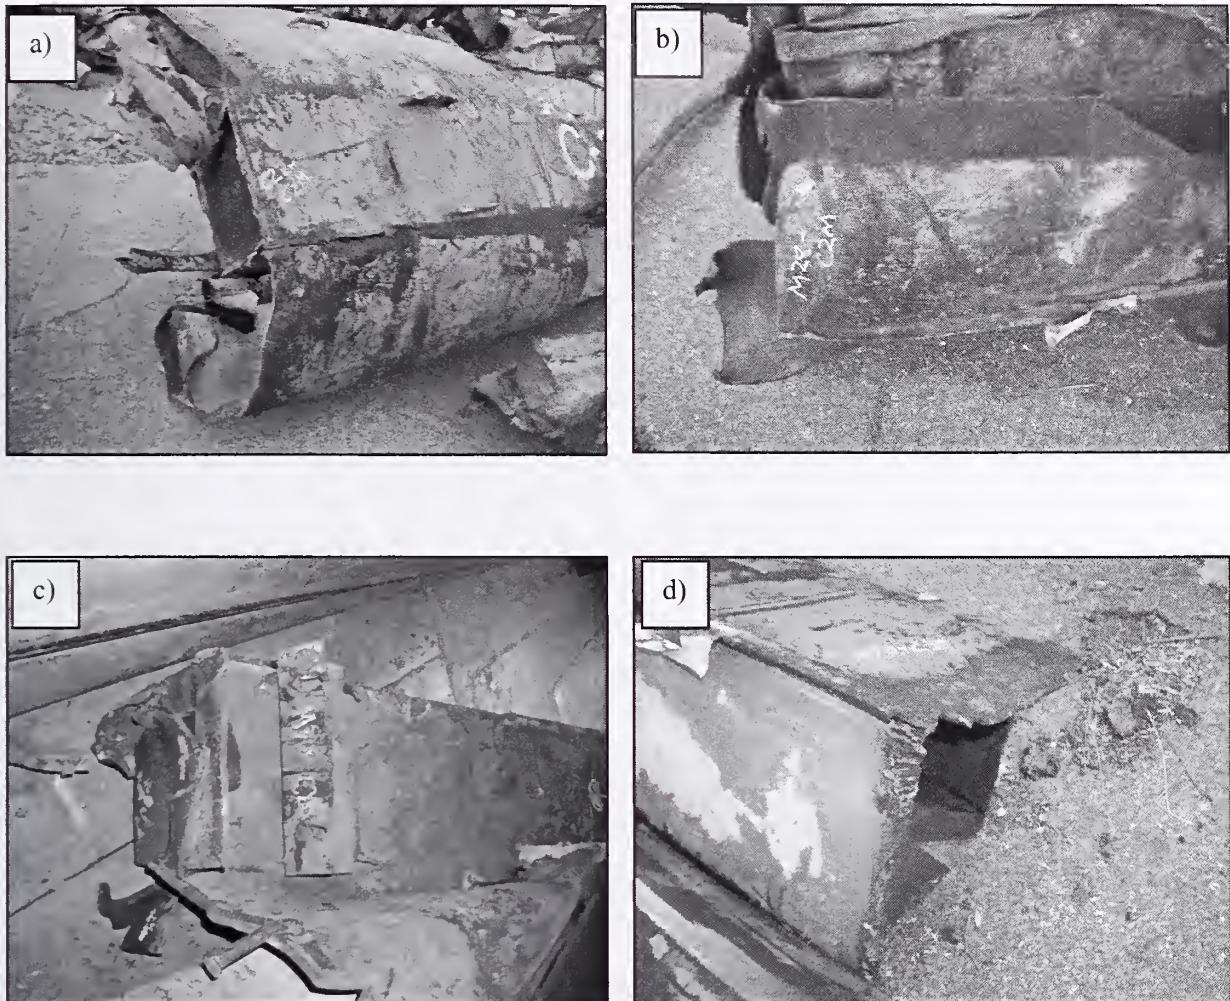
Figure 3-9. Photographic examples of Type 3 damage feature for exterior panel columns, severing of columns. a) Type 3a, sever associated with stiffener or diaphragm plate from C-22 (A157: 93-96), b) Type 3b, sever occurred away from stiffener or diaphragm plate from M-28 (B345: 98-101), c) Type 3c, sever occurred at concrete slab of floor from M-30 (A133: 94-97), and d) end was flame cut during recovery from N-10 (A115: 89-92).

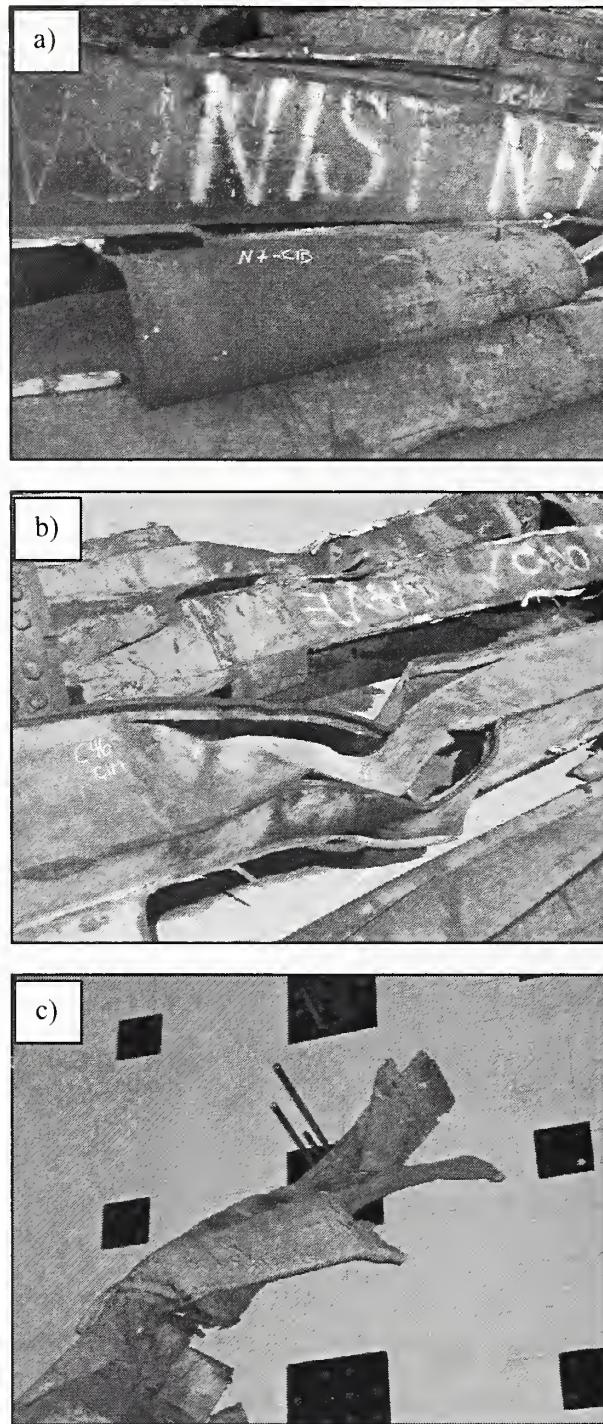
Figure 3–8. Photographic examples of Type 2 damage feature for exterior panel columns, fracture in base plate near fillet welds. a) Type 2a, localized fracture from N-7 (A127: 97-100), b) Type 2b, extensive fracture from C-46 (B157: 68-71), and c) Type 2c, extensive fracture resulting in “splaying” of column from M-27 (A130: 93-96).

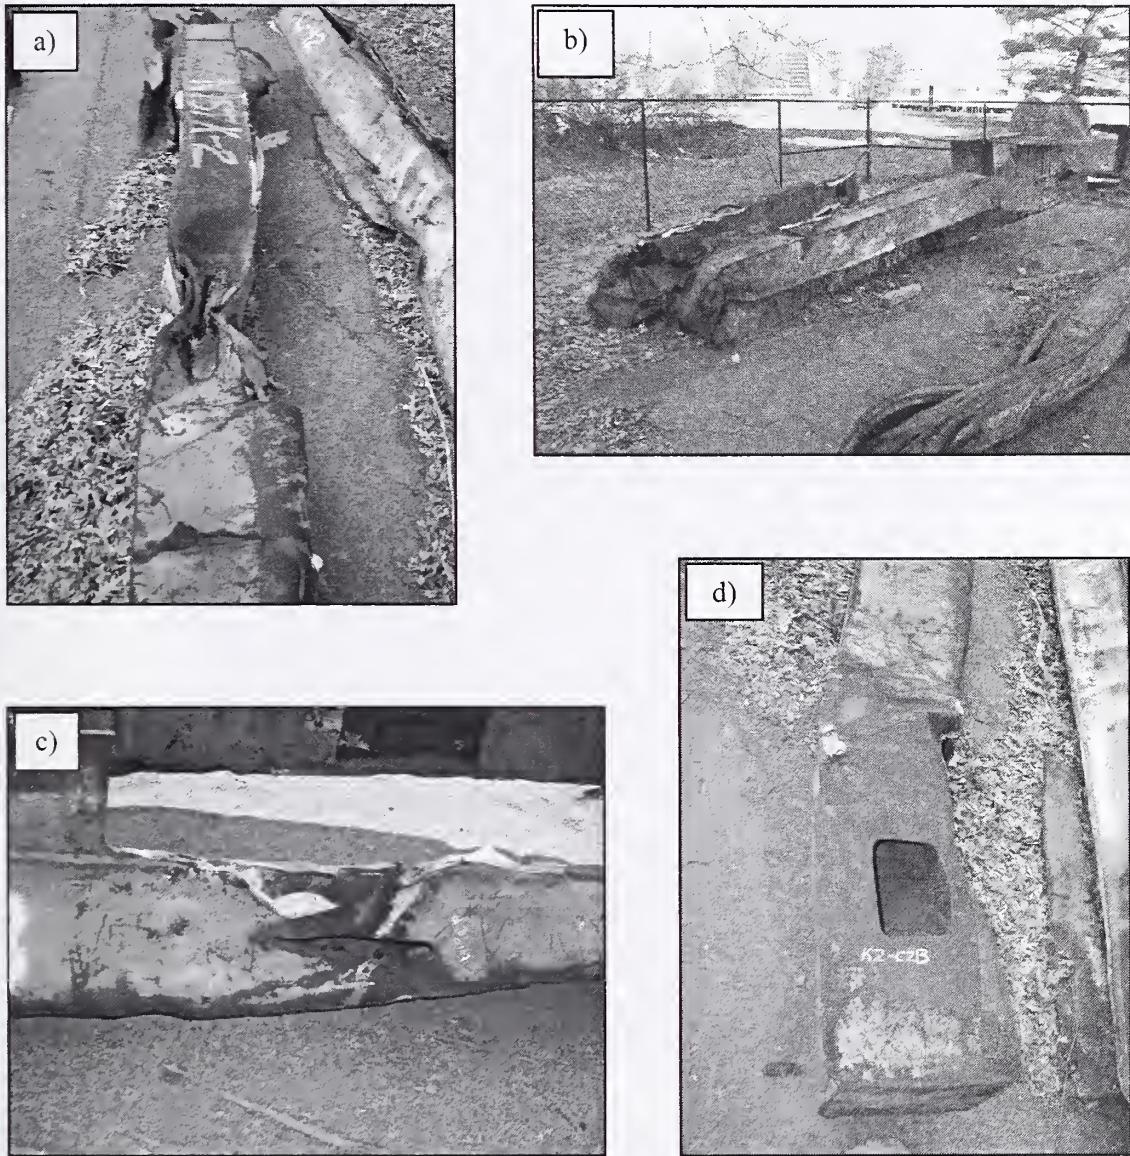
Figure 3–7. Photographic examples of Type 1 damage feature for exterior panel columns, gross physical distortion of flanges and webs. a) Type 1a, crushed columns from K-2 (A236: 92-95), b) Type 1a, crushed column from N-12 (A206: 92-95), c) Type 1b, punctured column from N-8 (A142: 97-100), and d) Type 1c, buckling of column from K-2.

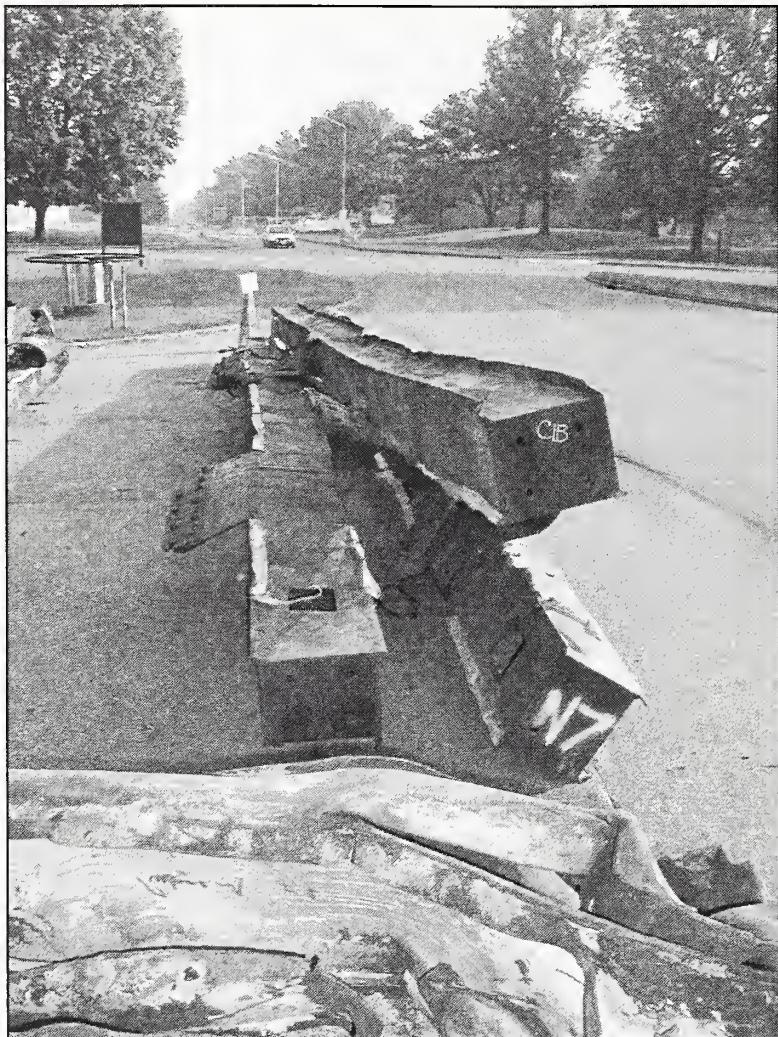
Figure 3–6. Overall image of sample N-7 (A127: 97-100). Panel was in relatively good shape besides being folded inward about an axis parallel to the length of the columns with the outer web of the columns facing outward. This was believed to have happened during the collapse or recovery efforts. The three columns were relatively intact with limited damage.

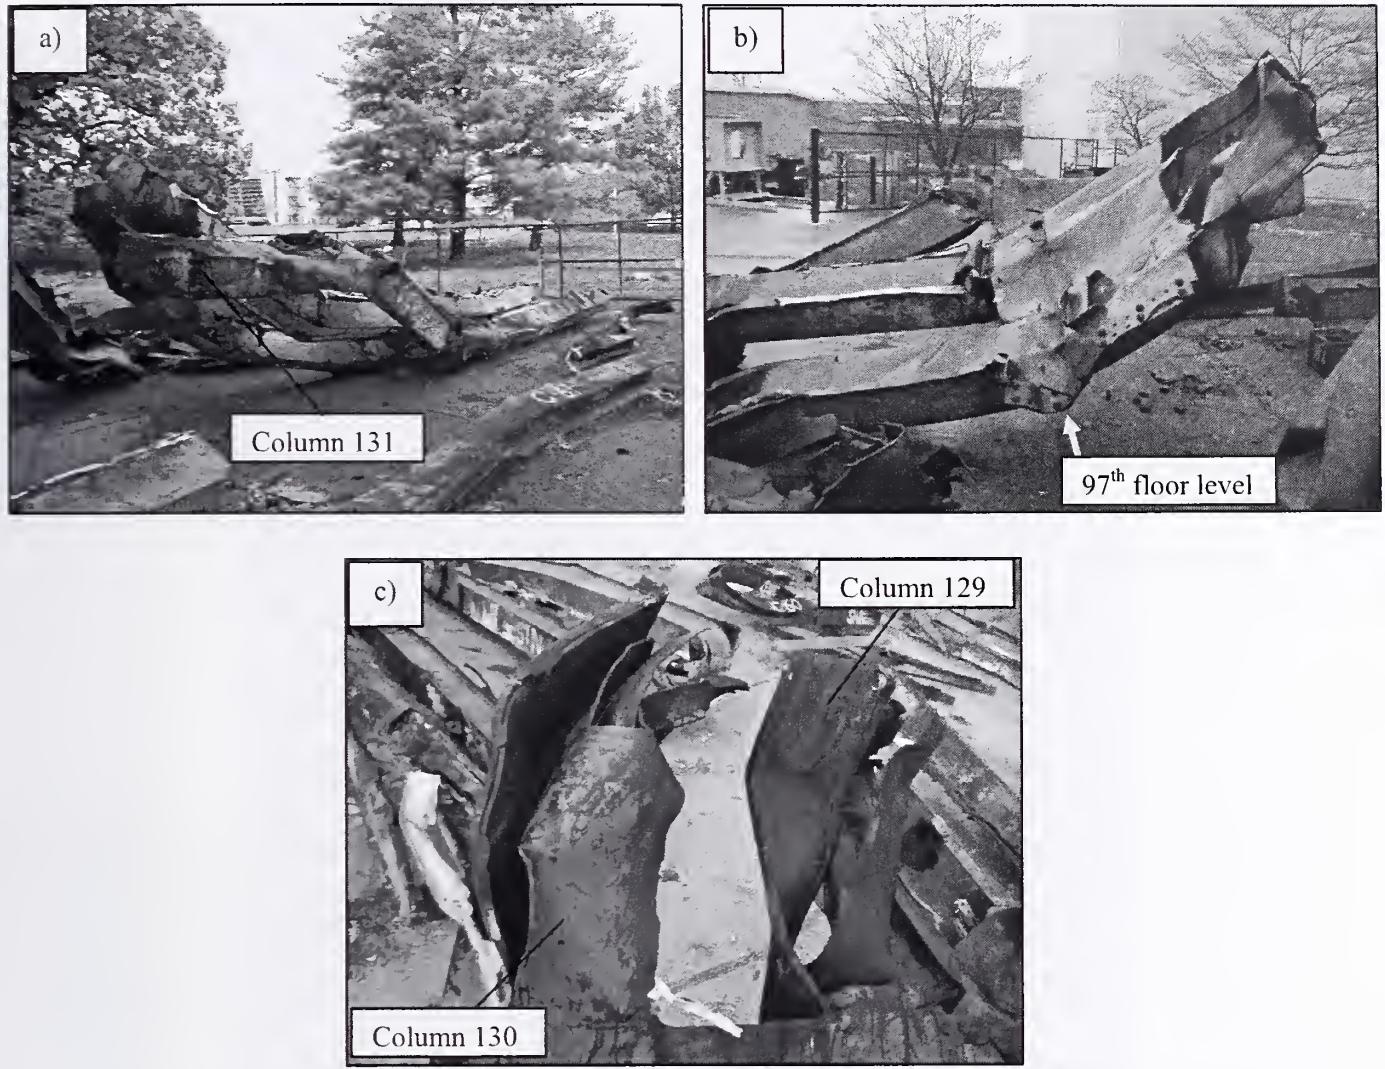
Figure 3-5. Panel M-2 (A130: 94-97). This panel was from the north face of WTC 1. The lower portion of the panel was struck by the fuselage of the airplane. General shape of panel is due to airplane impact and bending about the 97th floor slab. a) Overall view, bottom of panel is on the left-hand side of the picture and the outside of the panel is facing down, b) major bend in panel located at the 97th floor level, and c) splayed bottoms of columns 129 and 130.

- **M-2:** This panel, directly above M-27, was struck by the upper part of the fuselage and the vertical stabilizer of the tail. From the photographic images, it appears that the condition of this panel after recovery was remarkably similar to its condition prior to the collapse, Fig. 3-5a. Therefore, the damage observed was assumed to be a result of the impact. Inward bending of the columns was observed at numerous locations on the panel. A lower bend was directly associated with the concrete slab of the 97th floor level, Fig. 3-5b. The floor appears to have acted as a fulcrum point over which the columns and lower portion of the spandrel were bent inside the building envelope. Also, for columns 129 and 130, the lower end plates were found to be ripped off with the two columns having the splayed appearance, Fig. 3-5c. The end plate for column 131 was still intact and the lower portion of the column was relatively

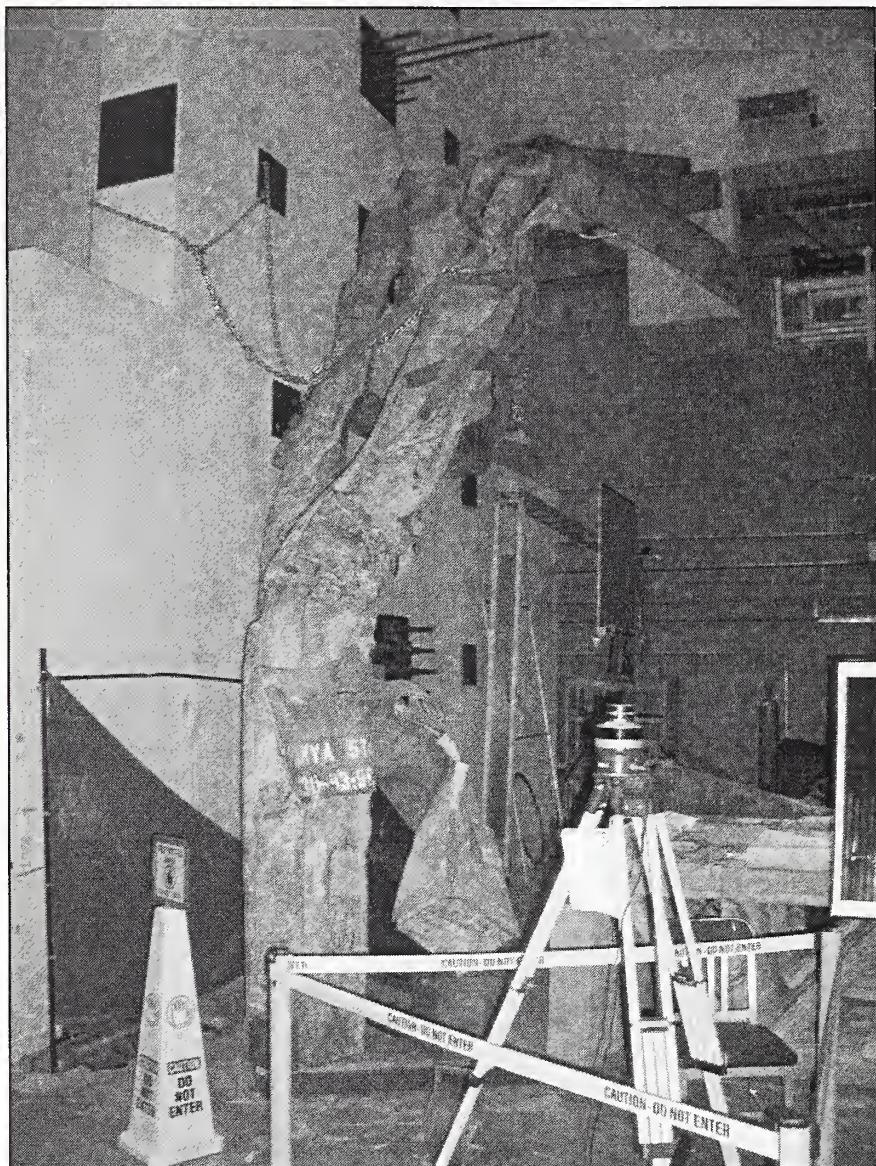
Figure 3-4. Overall view of panel M-27 (A130: 93-96). This panel was from the north face of WTC 1 and struck directly by the nose and fuselage of the plane.

- **M-27:** This panel was hit directly by the nose and fuselage of the plane. The photographic evidence shows that the portion below the 95th floor spandrel still appeared to be intact while the portion above this had been bent inward. The top portions of the two recovered columns (Fig. 3-4), numbers 130 and 131, were in general disarray, with portions above the 96th floor level missing. These columns also had a splayed appearance with the four individual plates making up each column deformed along their entire length. The only connection between the two columns was located at the 95th floor level as the 94th floor spandrel, while still joined to column 131, was detached from column 130.
