**Federal Building and Fire Safety Investigation of the
World Trade Center Disaster**

**Damage and Failure Modes of
Structural Steel Components**

Stephen W. Banovic
Timothy Foecke

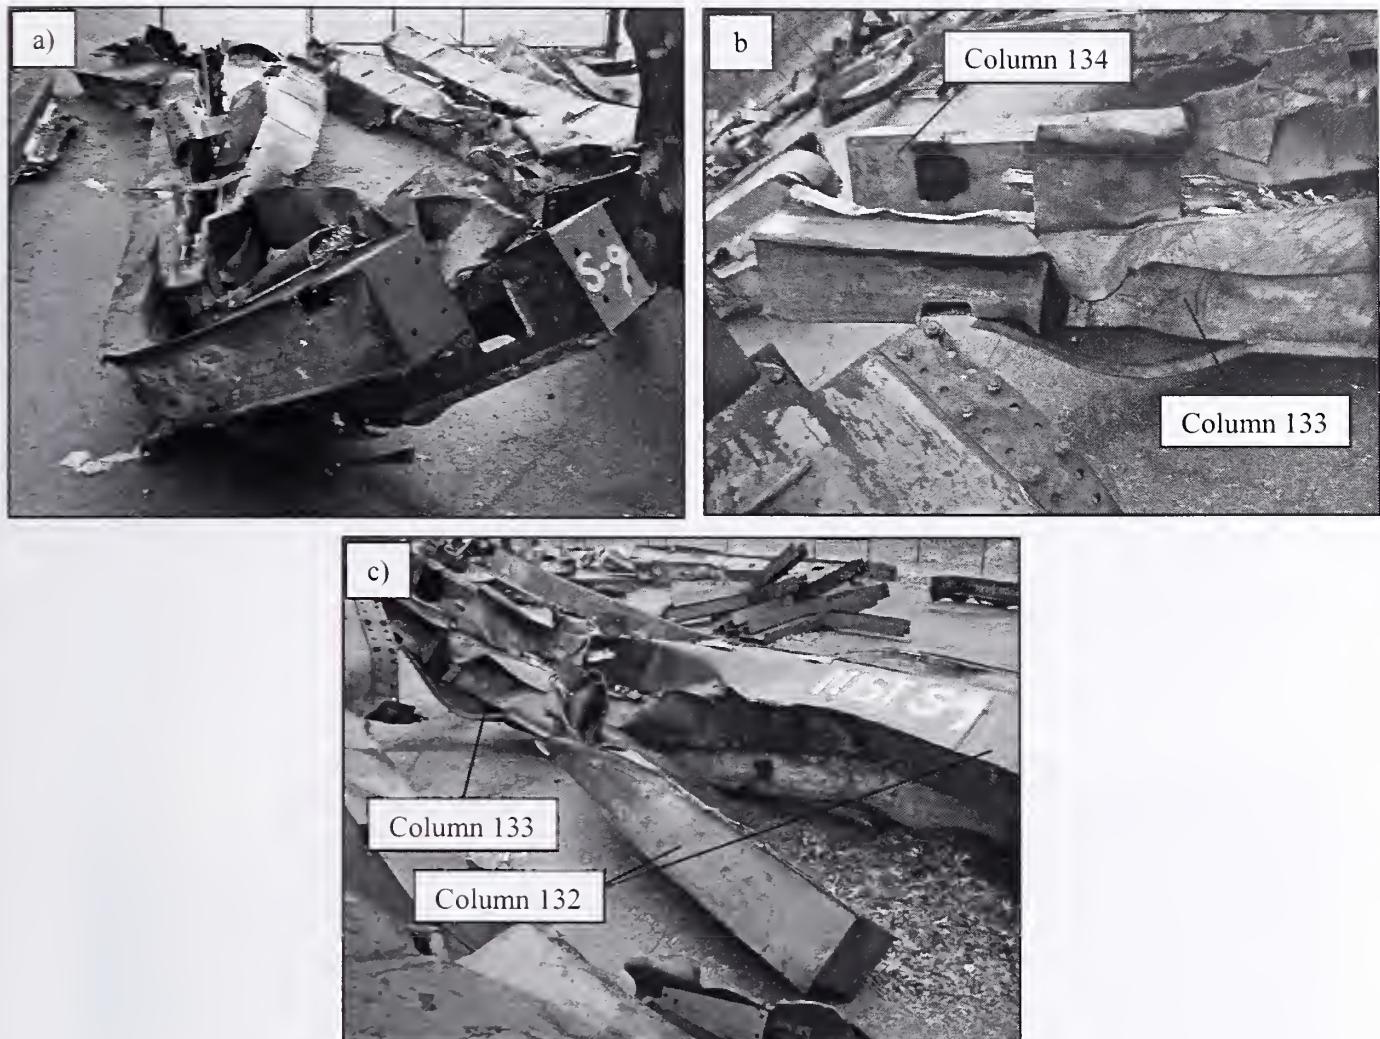
Figure 3-3. a) Overall image of panel S-9 (A133: 97-100) and b) lower portion of panel showing possible damage from airplane impact, bottoms of columns 133 and 134 shown, and c) column 132 that sustained a fair amount of damage.

- **S-9:** Column 132 sustained the most damage at and just above the 98th floor spandrel (Fig. 3-2c). The column was bent nearly 180 degrees just above the 98th floor spandrel, with the spandrel plate completely detached from the column. The portion of the column near the spandrel had fracture near all four welds associated with the box column, thus, resulting in a splayed appearance. Additionally, the outer web was completely severed and slightly bent inward. As this may have been a result of the airplane impact, the sample was removed for analysis (Fig. 3-11a and 3-11b). The fracture surface was badly corroded and exhibited evidence of being damaged by contact with other steel samples or pavement at some point. However, it was possible to observe some macroscopic fracture details. The fracture surface was oriented at 45 degrees with respect to the surface of the plate and oscillated between plus and minus 45 degrees at several points as the crack propagated across the plate. The edge of the fracture surface at one time was quite sharp, and significant thinning of the plate was observed within 0.5 in. of the fracture surface (Fig. 3-11c) indicating significant ductility during crack propagation. In addition, more than 10 in. from the fracture surface, the paint coating was fractured in a particular way as to indicate tensile loading of the surface (Fig. 3-11d). Although this might have been caused by localized bending, the plate at this point was nearly flat, and it was quite possible that these cracks indicate elastic/plastic stretch below a level that was measurable at these locations. This would indicate considerable energy absorption during failure of these plates as well. The additional massive damage to the remainder of the panel not observed prior to the collapse may be related to events occurring during the collapse of the building or as a result of the recovery efforts. Analysis of a weld fracture from column 133 can be found below in Sec. 3.2.3.

- **S-9:** This panel was located directly above M-30. From photographic evidence, it seems that the vertical tail section of the plane hit the lower portion of the columns, damaging the aluminum façade. It is unknown how much damage occurred to the underlying columns themselves as smoke obscured most views of the panel. However, the aluminum façade above the 98th floor level did not appear disrupted, indicating that the panel may not have been significantly displaced upon impact. The recovered panel (Fig. 3-3a) contained all three columns, though the panel was badly damaged (Fig. 3-3b). The columns below the 98th floor spandrel were bent in various directions. Column 132 sustained the most damage at and just above the 98th floor spandrel. The column was bent nearly 180 degrees just above the 98th floor spandrel with the spandrel completely detached from the column (Fig. 3-3c). The portion of the column near the spandrel had a “splayed” appearance as the four individual plates comprising the box column were no longer joined. Additionally, the outer web was completely severed and slightly bent inward. This damage may have been a result of the aircraft impact. Some damage was also noted on the lower portions of columns 133 and 134, though it is unknown whether this was caused by the impact.

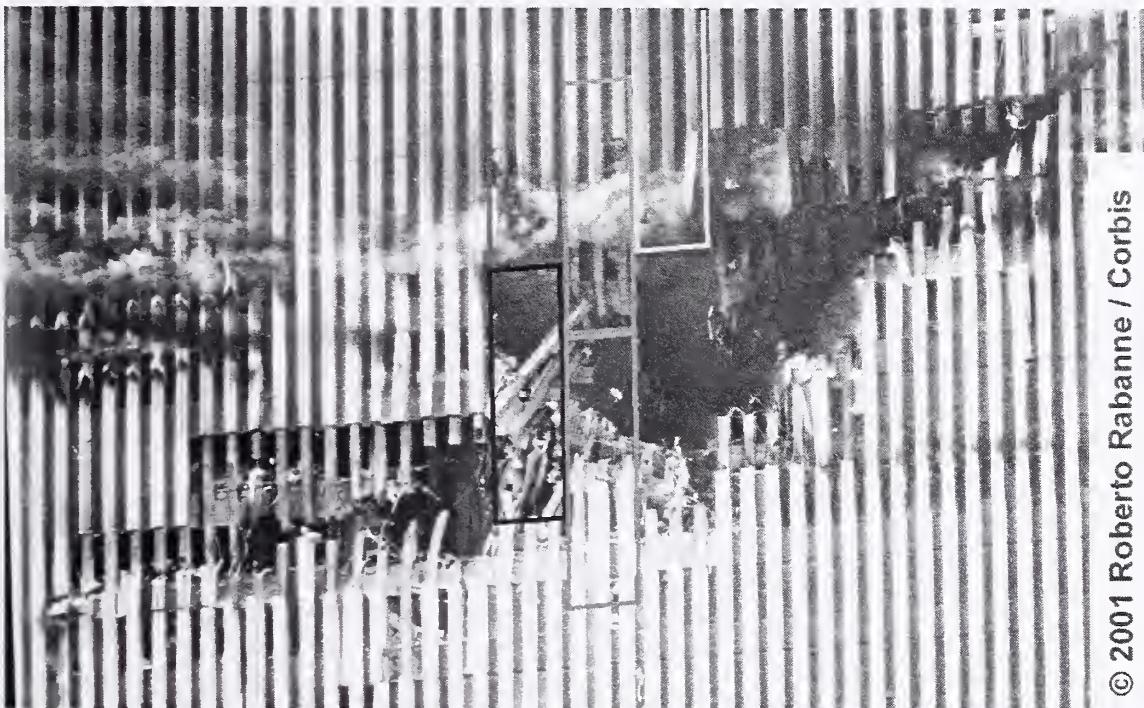
Figure 3–1. Image showing impact damage to the north face of WTC 1. The as-built location of the five recovered panels from the impact zone were highlighted: S-9 (pink), M-30 (blue), M-2 (orange), M-27 (green), and N-7 (yellow).

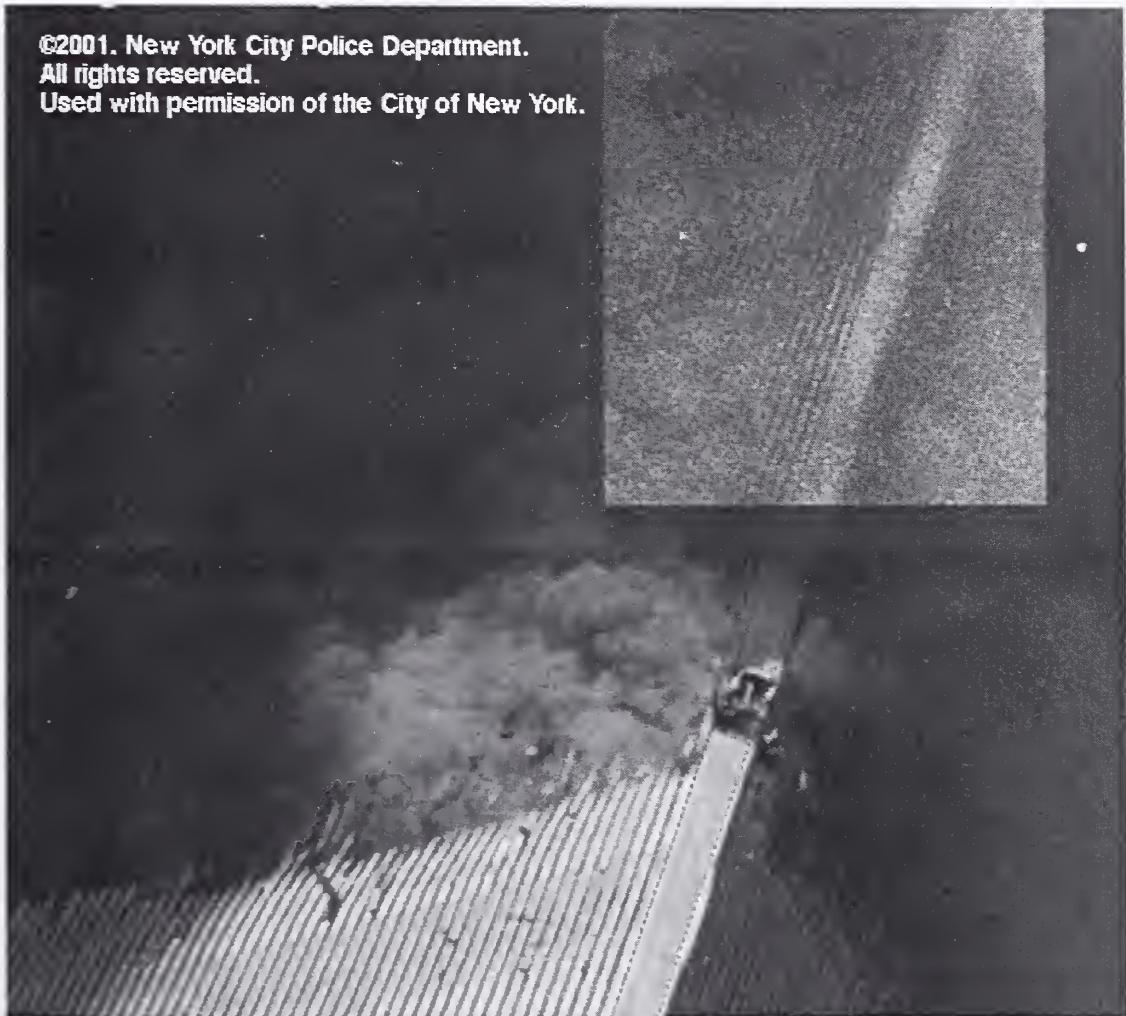
Figure 2–46. Image of the NE corner of WTC 2, several seconds before collapse. The corner shows no distortion of the type in the previous figure. This would imply that the distortion accompanied the collapse and did not precede it. The region in the upper right is enhanced for visibility.

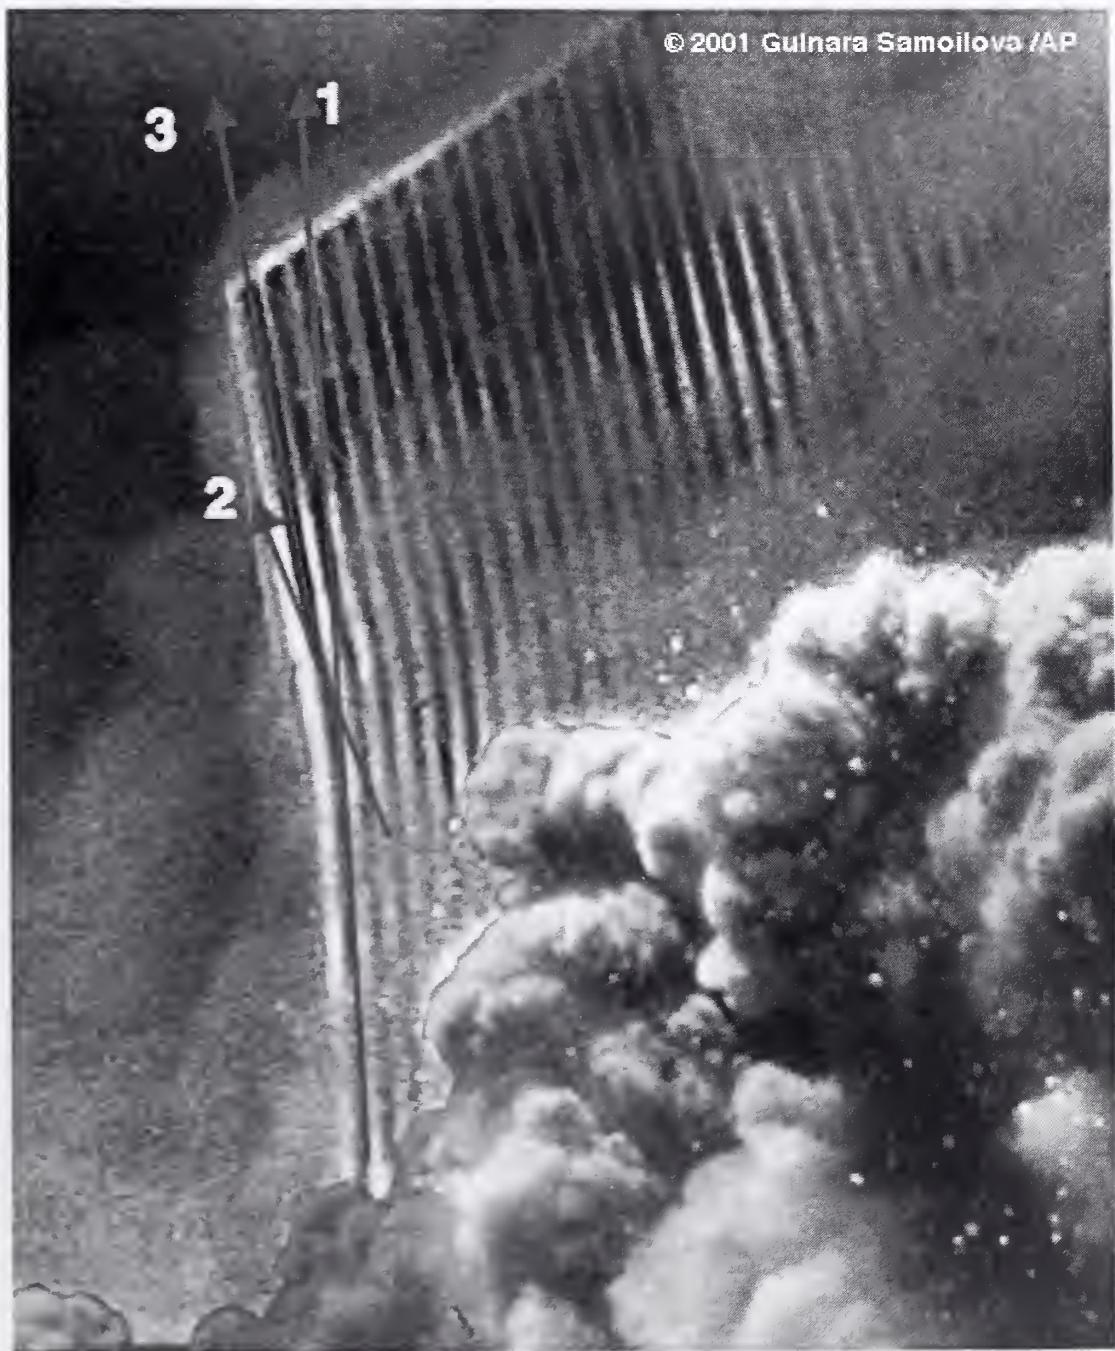
Figure 2–44. An enhanced close-up of the kink area in the previous figure (SE corner, WTC 2), with overlaid lines to highlight the details of the kink geometry. The edge of the building (1) bends an angle to another direction (2), then bends back somewhat toward the original direction (3).

A more detailed analysis of the geometry has been made of this distortion, shown in Fig. 2-44. The kink was in fact a double-kink, and the directions of the axes of bending are shown in the figure. It is likely that this distortion formed by the sideways shift of loads transmitted via the hat truss and rigid, beam-framed floors of floors 107 to 110, and a more detailed structural analysis can be found in McAllister et al. (2005). Examination of the right side of the image, after considerable image processing, shows that the edge of the building has bent, but shows no sharp discontinuity. Thus, the sharp kink had not propagated across the face of the building (Fig. 2-45). An image taken approximately 2 s before collapse (Fig. 2-46) shows no bending, so the kink must have developed at either the moment of collapse initiation or during the earliest moments of the collapse process.

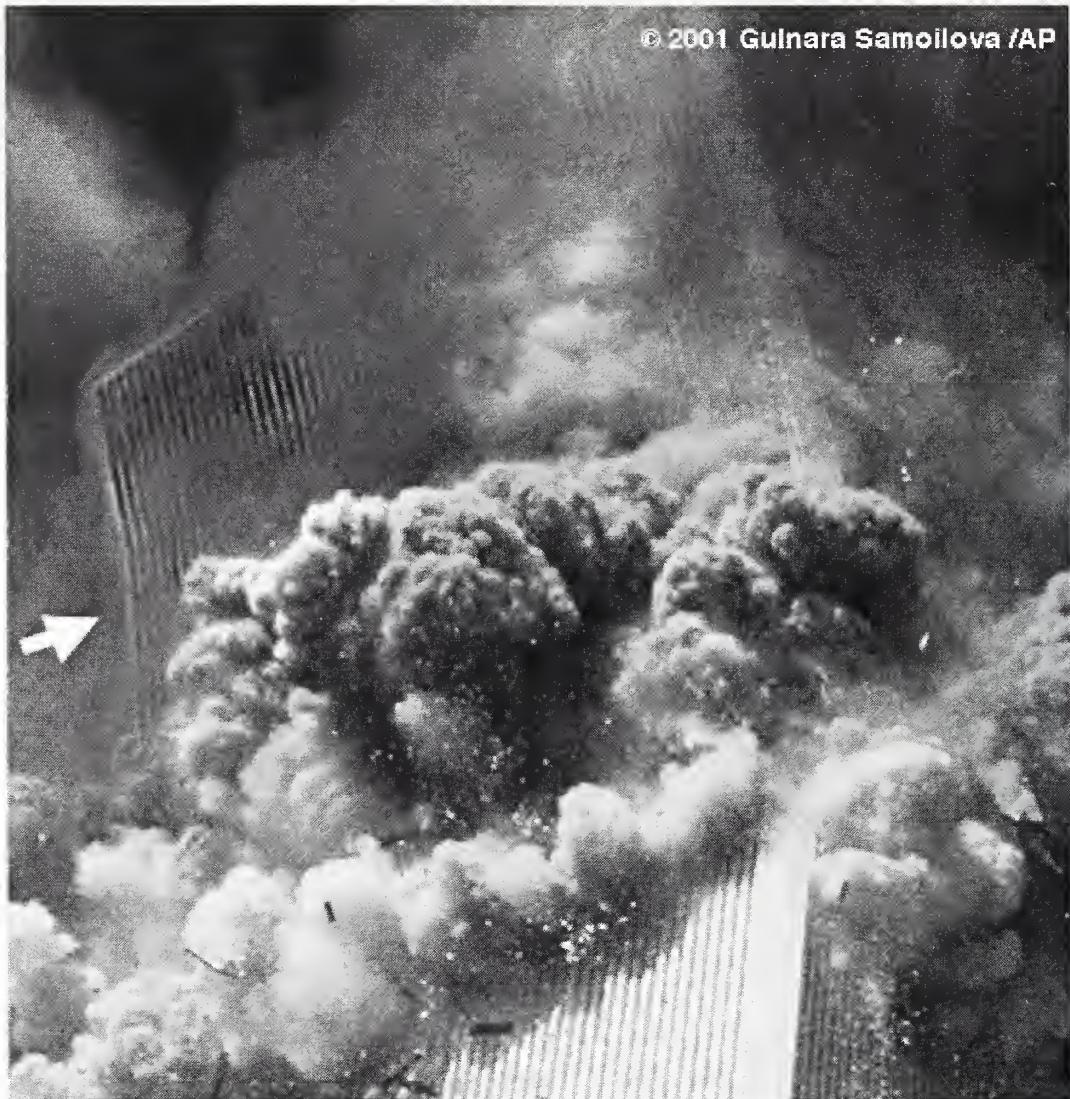
Figure 2–43. Image showing initial seconds of collapse of WTC 2 viewed from the ENE, and kink in the SE edge of the building near the 106th floor (arrow).

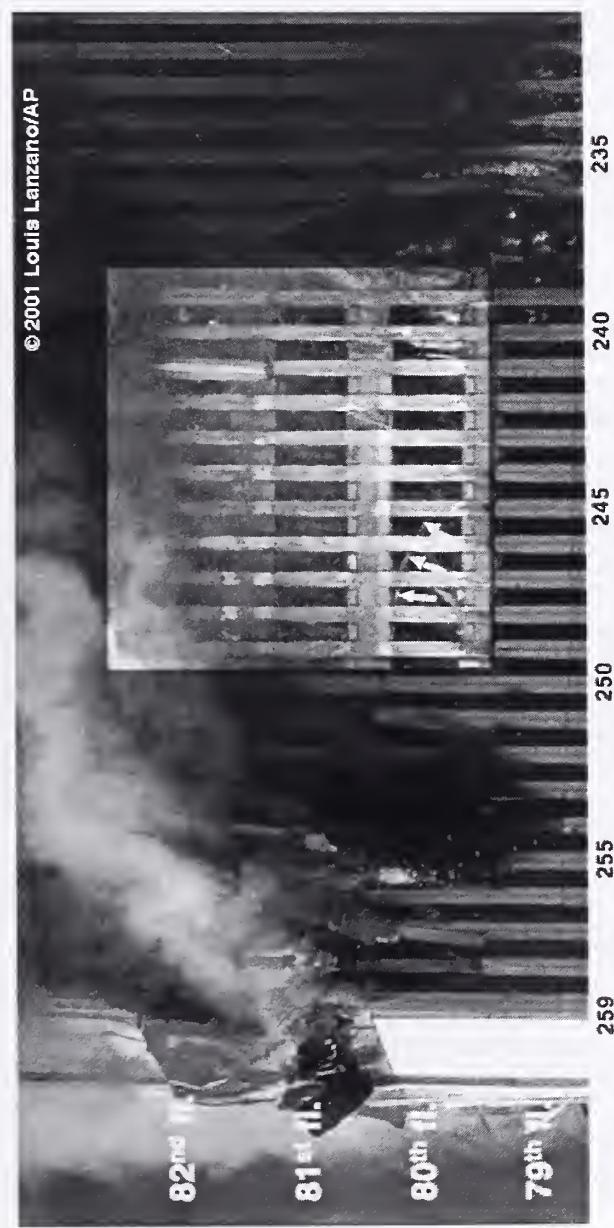
Figure 2–42. Image of dropped floor on north face of WTC 2. The slab of the 81st floor has dropped into the office space of the 80th floor.

A number of photographs of the north face of WTC 2 in the region of the 80th floor appeared to show floor slabs that had fallen from their original positions. The thickness and color of the feature indicated by arrows in the images were consistent with that of the concrete slab of the floor assembly (NIST NCSTAR 1-6C). The floor slab in Fig. 2-41 appeared in the windows bounded by columns 241 and 248 on the 80th floor, and in Fig. 2-42 bounded by columns 245 and 248 on the 80th floor. The timestamps for these two images were (pending) and (pending) respectively, so the floor slabs appear to have moved over time.

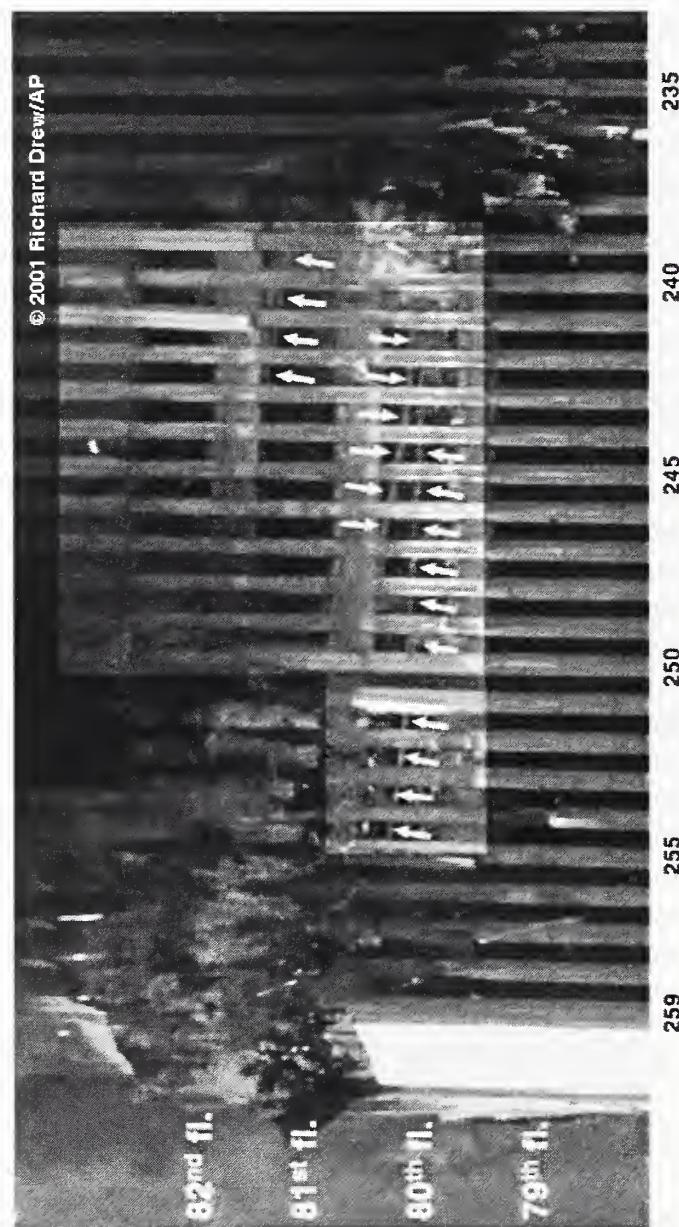
Figure 2-41. Image of dropped floors on north face of WTC 2.

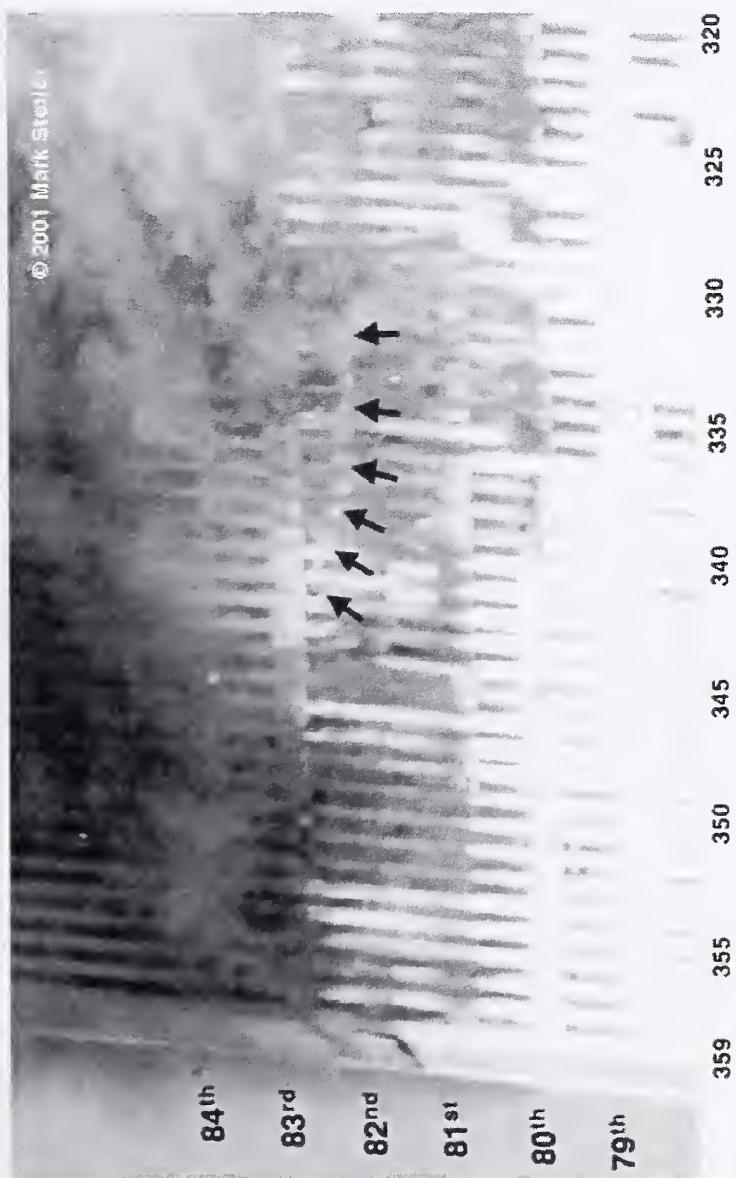
Figure 2–40. Image of dropped floor on east face of WTC 2. The slab of the 83rd floor has partially collapsed onto the 82nd floor.

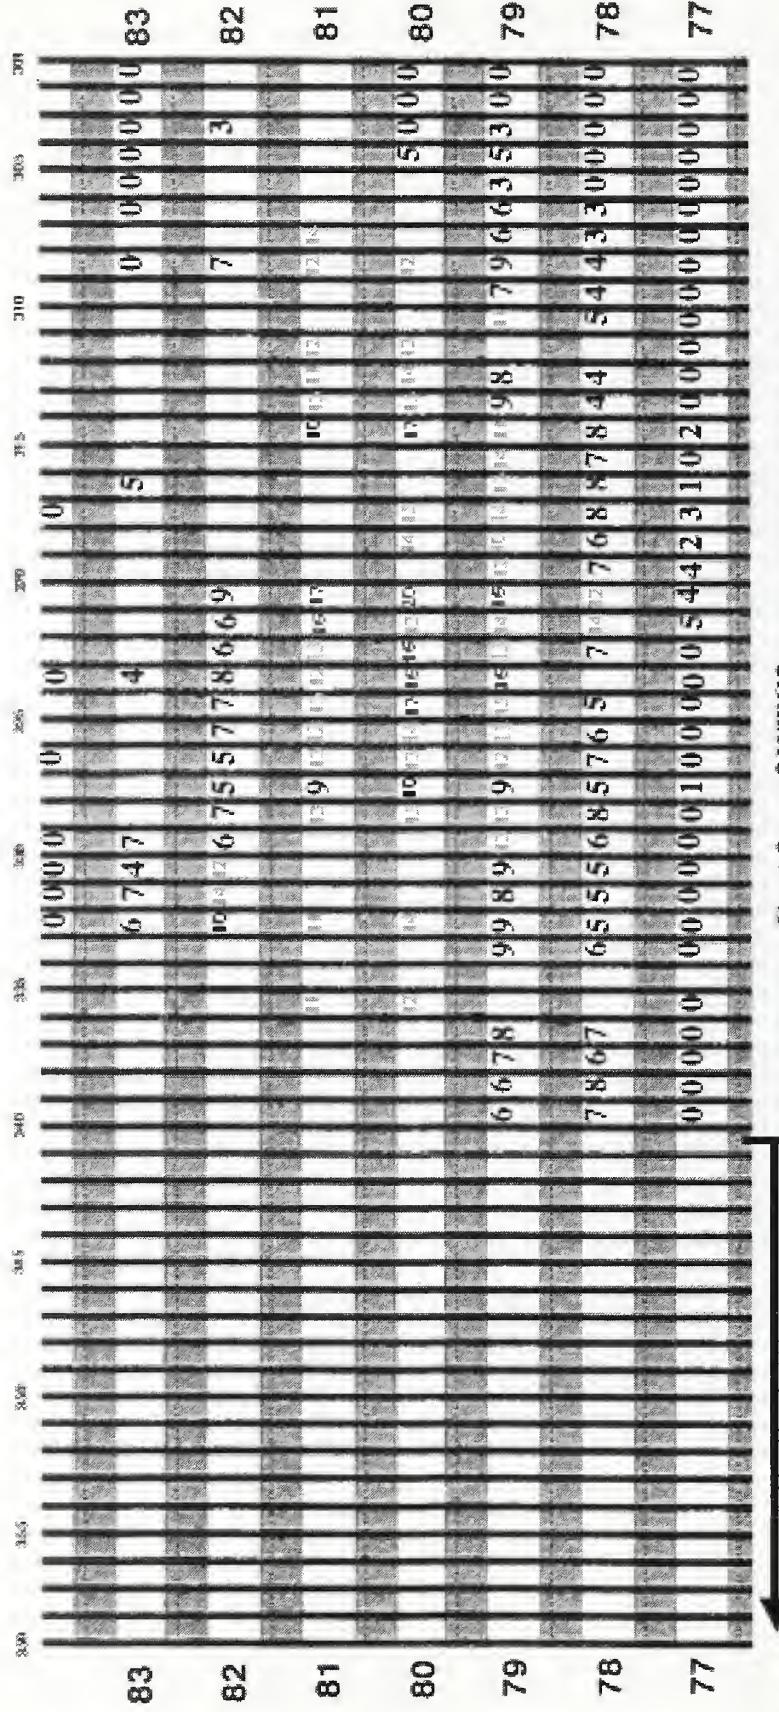
Figure 2-39. Map of pull in displacements of the east outer face of WTC 2 inward shortly before collapse. Each measurement refers to the upper left corner of the window within which the number resides. Measurements are in inches. The colors refer to groups of 5 inch displacements (0-5: black, 6-10: blue, 11-15: orange, 16-20: red) for easier visualization. This data was combined from two images taken by the same photographer at nearly the same location 10 s apart, and it is assumed that the inward deflection did not change appreciably during this time.

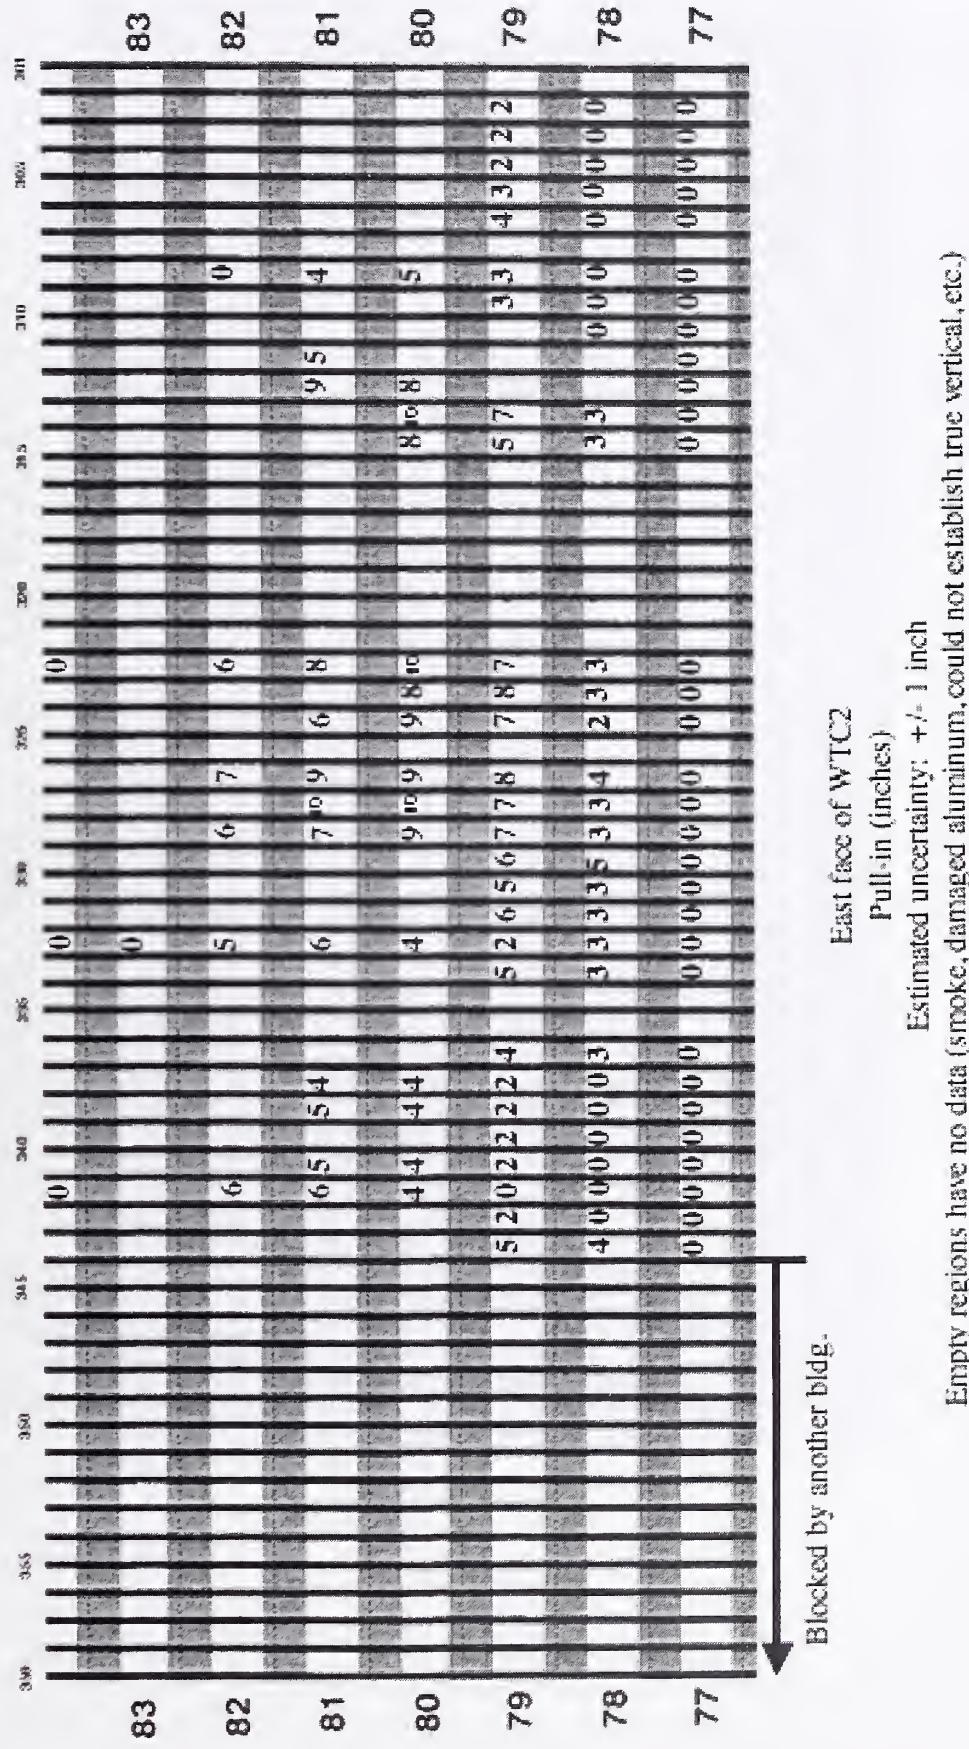
Figure 2-38. Map of inward displacements of the east outer face of WTC 2 inward at time 9:21:29 a.m. Each measurement refers to the upper left corner of the window within which the number resides. Measurements are in inches. The colors refer to groups of 5 inch displacements (0-5: black, 6-10: blue) for easier visualization.

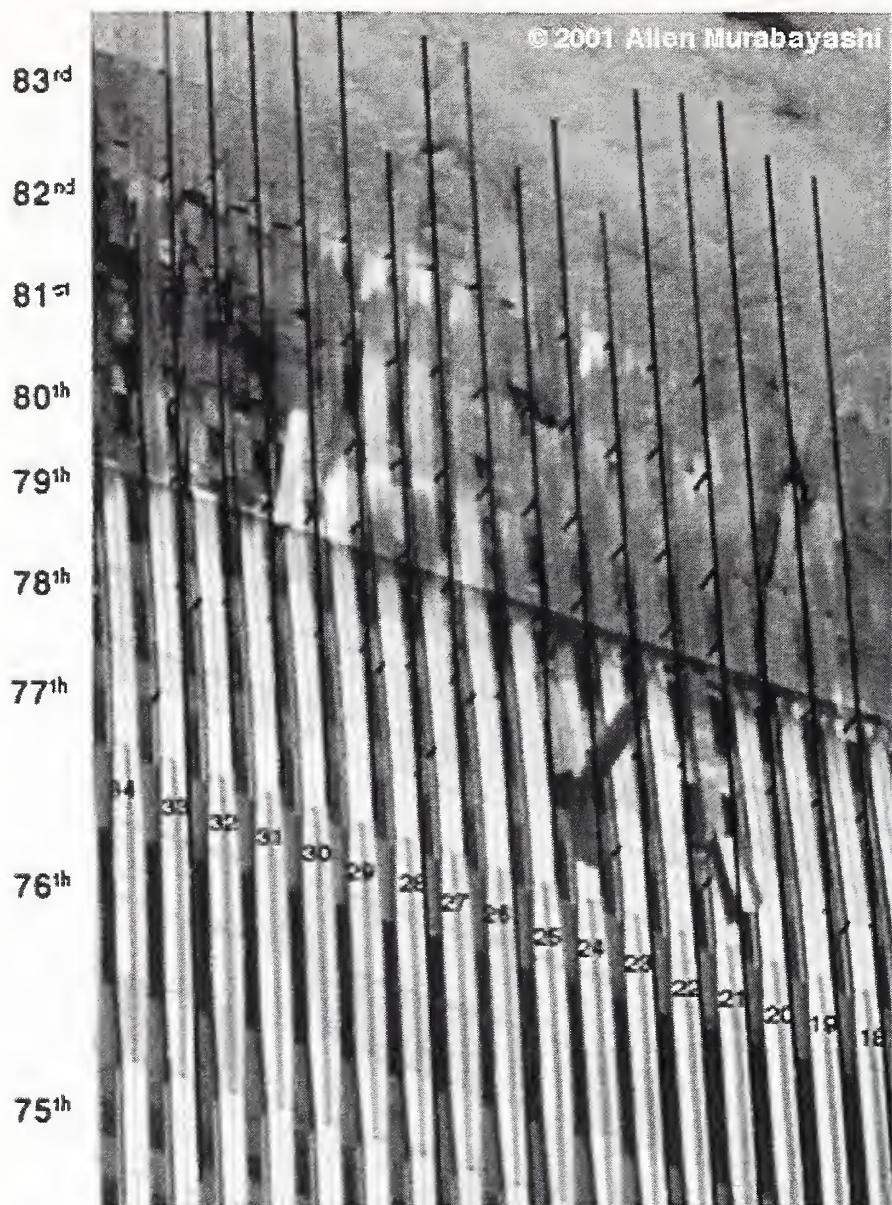
Figure 2-37. East face of WTC 2 at time 9:53:04 showing a larger amount of pull in. The vertical black lines were drawn to establish the original line of the exterior wall columns, and the shorter line segments were drawn at the same angle as the nearest observable joint in the exterior aluminum panels to establish the inward bowing distance. For actual column numbers, add a "3" to the front of the two-digit designations in the image.

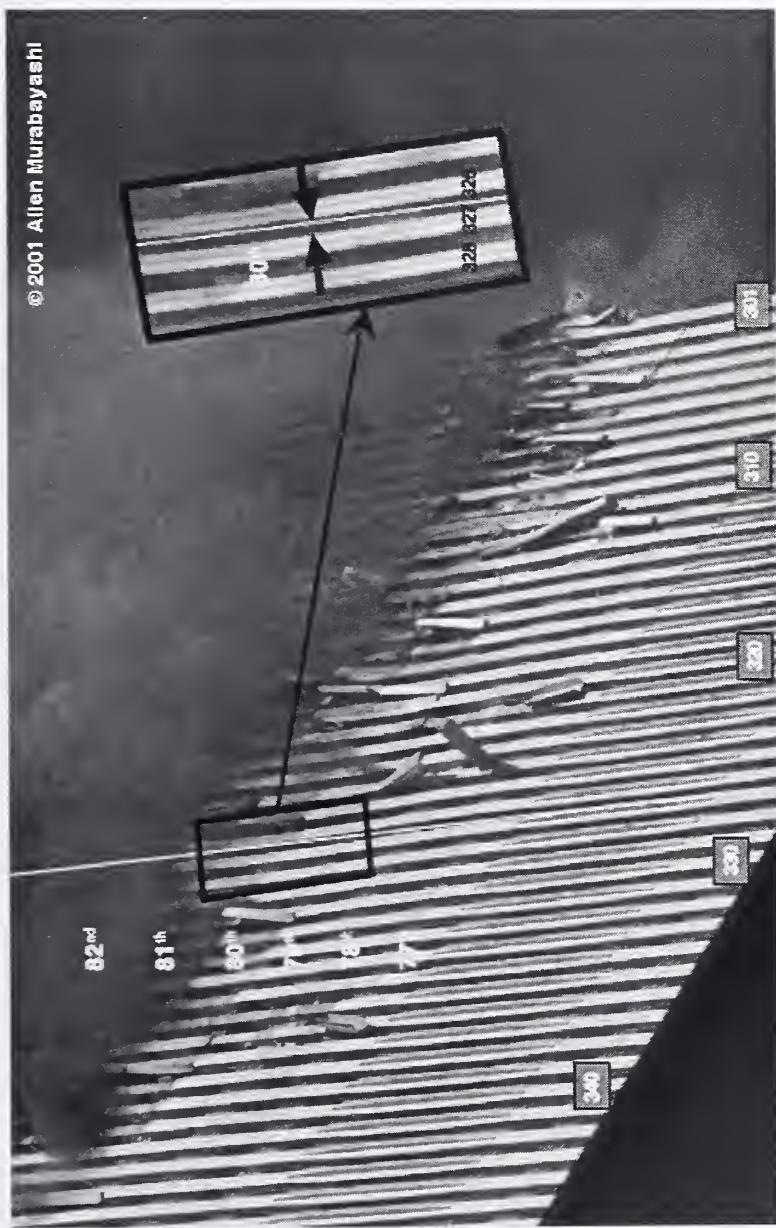
Figure 2-36. East face of WTC 2 at time 9:21:29, showing a small degree of inward deflection of the outer wall.

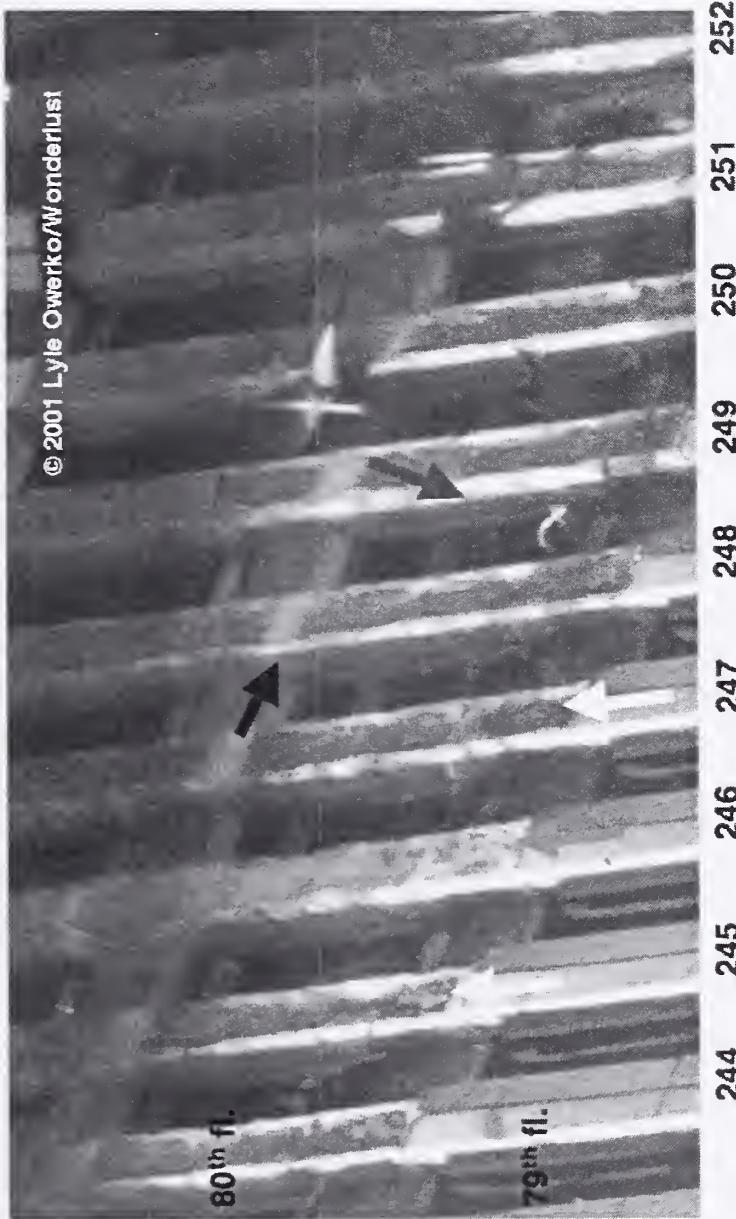
Figure 2-34. Image of missing sprayed fire-resistant material on flanges of exterior columns of N face of WTC 2. Sprayed fire-resistant material has come off, revealing red Tnemec paint of the column (red arrows). This image also shows how the outer web regions have been partially or completely denuded of sprayed fire-resistant material. Damage is evidenced by shading by sunlight - compare green (undamaged sprayed fire-resistant material) and white (damaged sprayed fire-resistant material) arrows. Blue arrow indicates same type of white coated area of sprayed fire-resistant material as previous figure that adhered when material above and below was dislodged.

Additional images taken of the region at higher resolution (Fig. 2-34) showed more subtle details about the SFRM damage. The arrows indicate where the SFRM has been dislodged completely from the

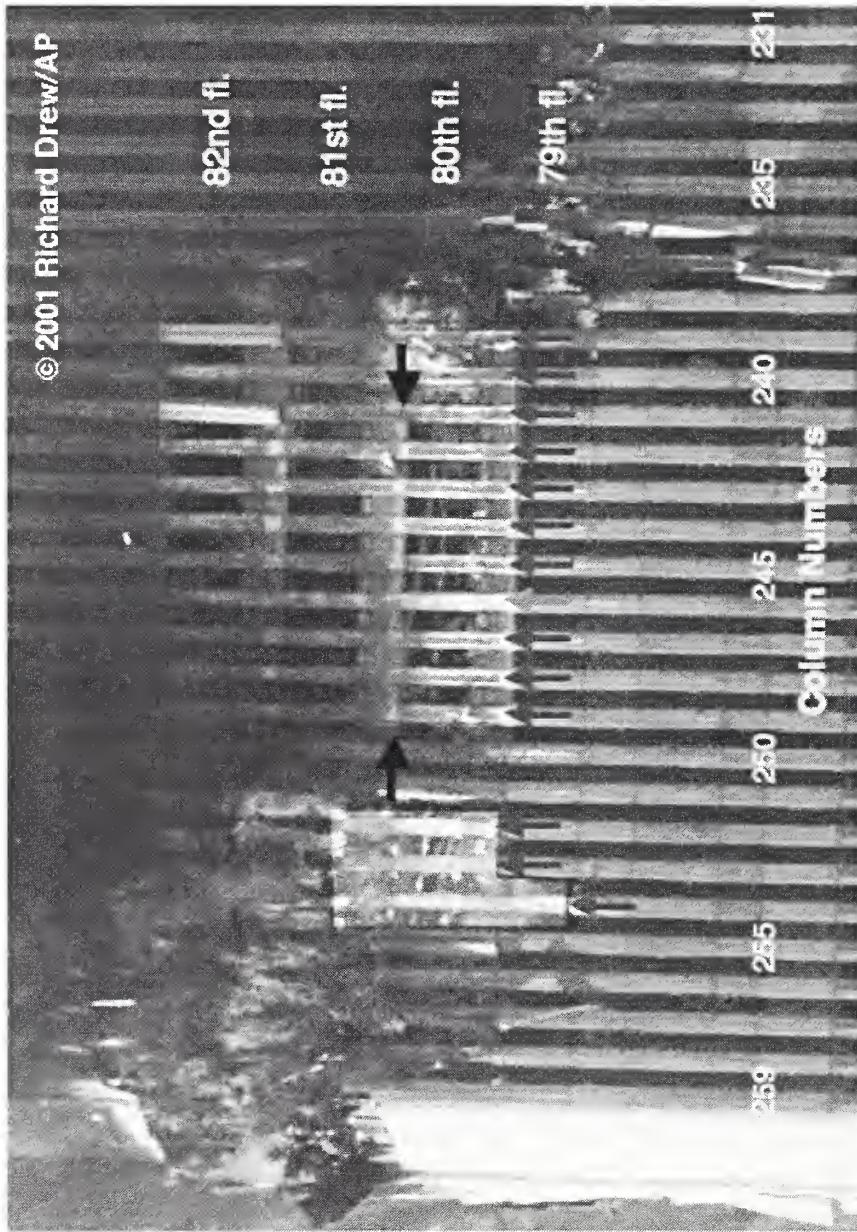
Figure 2-33. Image showing missing façade and sprayed fire-resistant material on N face of WTC 2. Two regions have had contrast and gamma adjusted to enhance visibility of the features. Red arrows indicate columns with missing or damaged sprayed fire-resistant material. Missing or damaged sprayed fire-resistant material determinations were made from this and several other photos taken at different times and angles. Blue arrows indicate white features where some sort of coating has preserved the sprayed fire-resistant material in place.

A region of the north face of WTC 2 spanning columns 230 through 259 and the 79th through 82nd floors had the exterior aluminum panels and SFRM damaged or removed due to debris impact from within the building. In particular, a rectangular region consisting of columns 239 through 249 on floors 79 through 81 were found to be completely free of aluminum panels, and the best observations of SFRM damage were in this region as well. Figure 2-33 shows the region of interest. Red arrows indicate where the SFRM was dislodged from the outer web between the protruding tips of the flanges. This determination was made using this image and other higher resolution images (see forthcoming figures). The appearance of white linear features on the edge of the columns, at this angle of solar illumination, shows the absence of at least some, if not most, SFRM from the center region of the outer web of the column. In contrast, column 246 (green arrow) shows bright contrast across the entire face, and this and other photos confirm that the SFRM was nearly intact along this column for the entire exposed three floors, despite the fact that the aluminum facade had been dislodged.

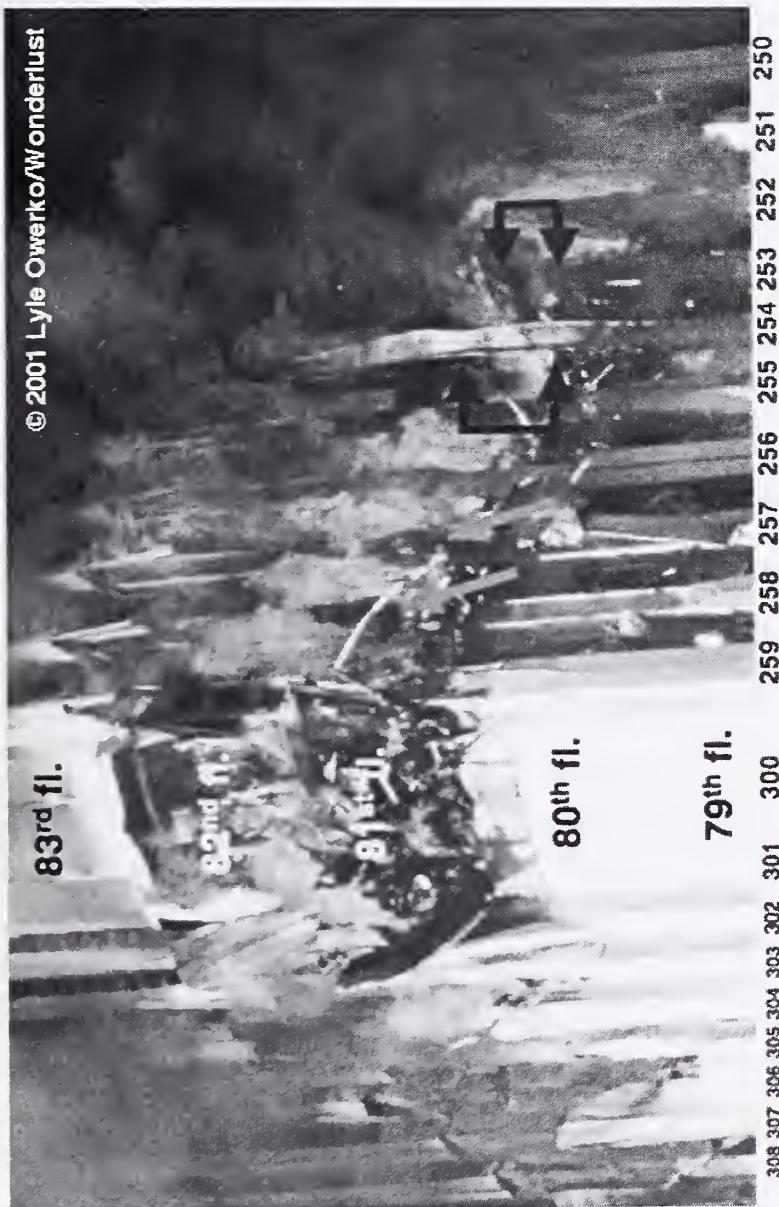
Figure 2-32. Image showing damage to columns on N face of WTC 2 near NE corner due to internal impact by debris. Broken vertical column bolted connections (green arrows) are visible, along with an intact outer web on column 254 (red arrows) and missing column sections (blue arrows).

On the right side of the image in Fig. 2-31 is the north face of WTC 2. It was believed that a large component of a landing gear exited the building on this face near the northeast corner in the region of the 80th floor. On Fig. 2-32, the arrows indicate where the columns have been cut (regions of missing column denoted by blue arrows) or where a bolted connection has broken and bent the column ends outward slightly (green arrows). The bolted connections were broken at the 81st floor in columns 257 and 258. The entire column was cut through at columns number 254 and 255, also at the 81st floor. Once these exterior columns had been severed, they were no longer load bearing.

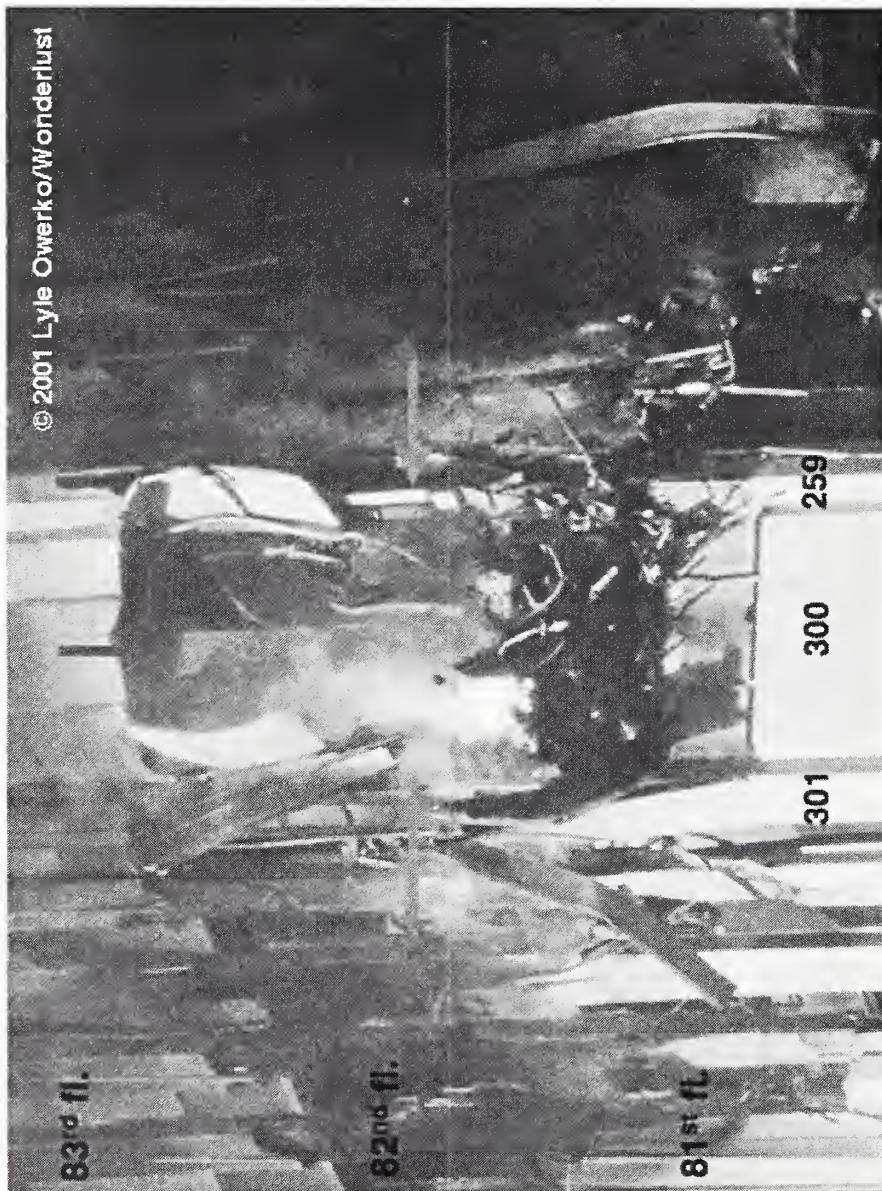
Figure 2-31. Image showing damage to NE corner of WTC 2 at 81st floor. The red arrow indicates an intact column 300 at the 82nd floor. Other photographs confirm that the spandrel connecting column 300 to columns 259 and 301 is also intact (location indicated by green arrows).

Several images taken from different angles and with different smoke and lighting configurations were examined to characterize the damage. Fig. 2-31 is a view of the northeast corner of WTC 2 centered on approximately the 82nd floor. The 81st floor, where the engine exited, was piled full of burning debris. The corners of the buildings were designed such that every other floor had a column in this space, an example of which can be seen above the hole, indicated by the arrow. The plans of the building show that the 81st floor was one without a column, consistent with the image, so that the exiting engine did not remove one as it exited the hole. Also, examination of this and two other images showed that the columns that border the hole to the left and right appear undamaged, so that the engine appears to have not damaged the building structurally as it exited.

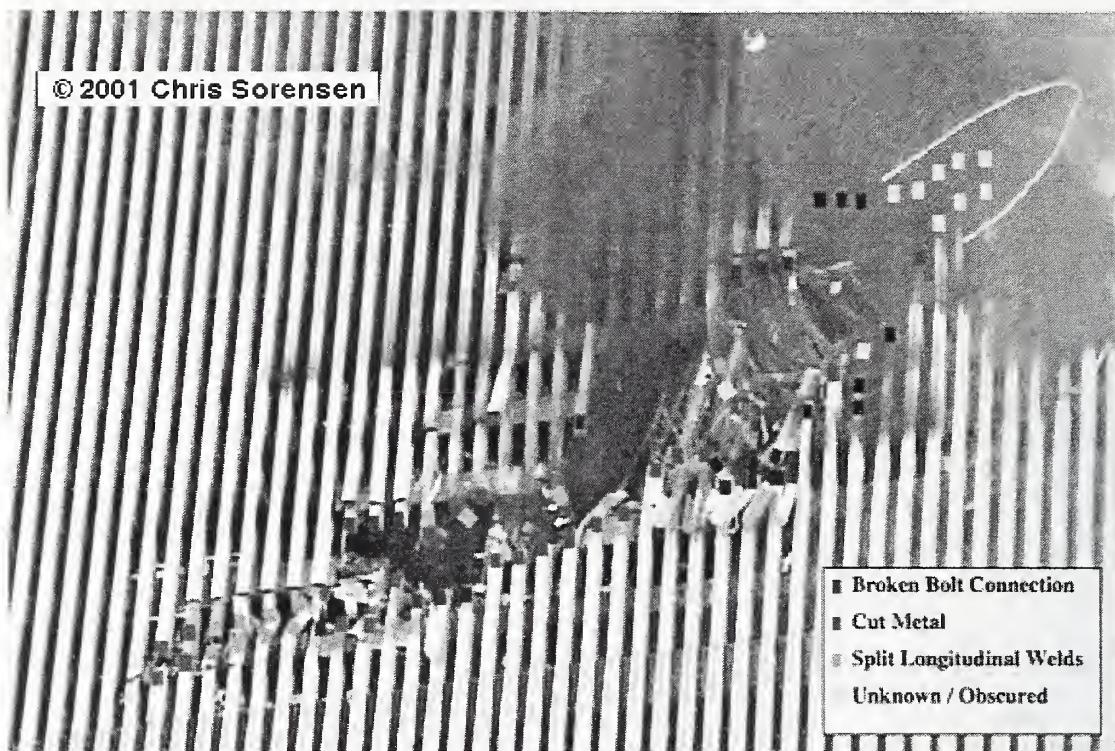
Figure 2-29. Image from Fig. 2-28 with indications of location and type of localized damage. Red designates cut metal components, blue indicates broken vertical column connection bolts, green indicates locations of failure of longitudinal welds in the box columns, and yellow shows regions that could not be identified from any photographic evidence.

In the next image (Fig. 2-29), colored rectangles were added to identify any observable failure modes in the exterior columns, whether at the ends or at some location along their length. The specific failure modes identified are described in the figure caption. Blue rectangles indicate where the bolted connections between two vertically adjacent exterior wall panels have failed. In many instances, this was indicated by a trio of truncated columns at the same vertical location that corresponded with a known column connection. Rectangles shaded red indicate where there was a high likelihood of failure of the steel of the columns via tearing or cracking, not located at a vertical column connection. The number of longitudinal weld splits, designated by green rectangles, that could be seen was very limited due to image resolution. There were several broken exterior column connection failures that could not be definitely identified, and these are colored in yellow. In addition, the region encompassing the starboard wing tip damage area, outlined roughly in yellow, was unobservable in all available photographs and video footage, due to the large and persistent volume of smoke being emitted from those floors.
