**Federal Building and Fire Safety Investigation of the
World Trade Center Disaster**

**Damage and Failure Modes of
Structural Steel Components**

Stephen W. Banovic
Timothy Foecke

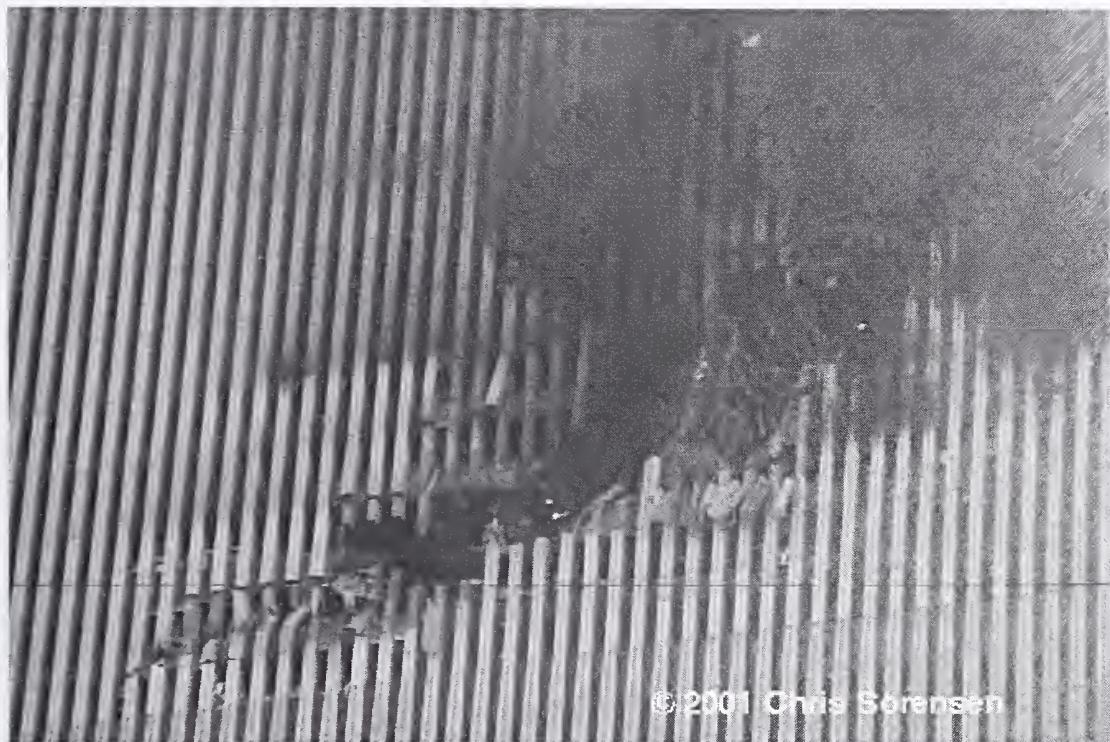
Figure 2-27. Un-enhanced frame from “Sorensen 4 at 1-44-21.jpg” showing the impact hole in the south face of WTC 2.

Figure. 2-27 shows a clear view of the damaged south face. The image was adjusted for contrast, and the levels were changed to bring out the most features and to correct for the general blue cast (Fig. 2-28). Small local regions were adjusted in a manner similar to Fig. 2-8, but the resolution of the image was too low for any new features to be revealed using this method. Fitting of an outline of a 767 to this image was found to be extremely difficult, as the angle of impact of the aircraft with the wall and the angle from which the image was taken with respect to the building face were not well known, and distorting the outline of the plane to match the damage did not produce acceptable results.

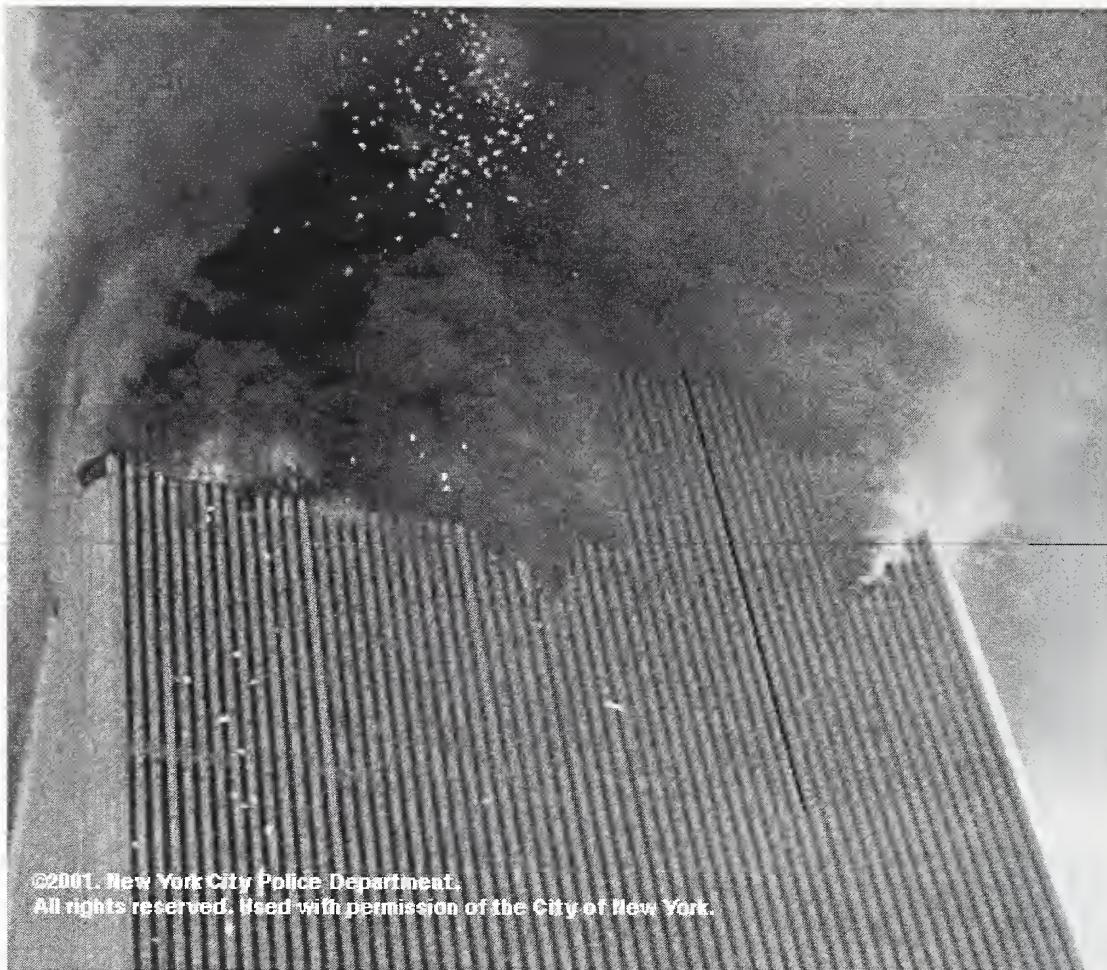
Figure 2–26. South face of WTC 1 58 min after (9:25 a.m.), showing no bowing in the outer columns.

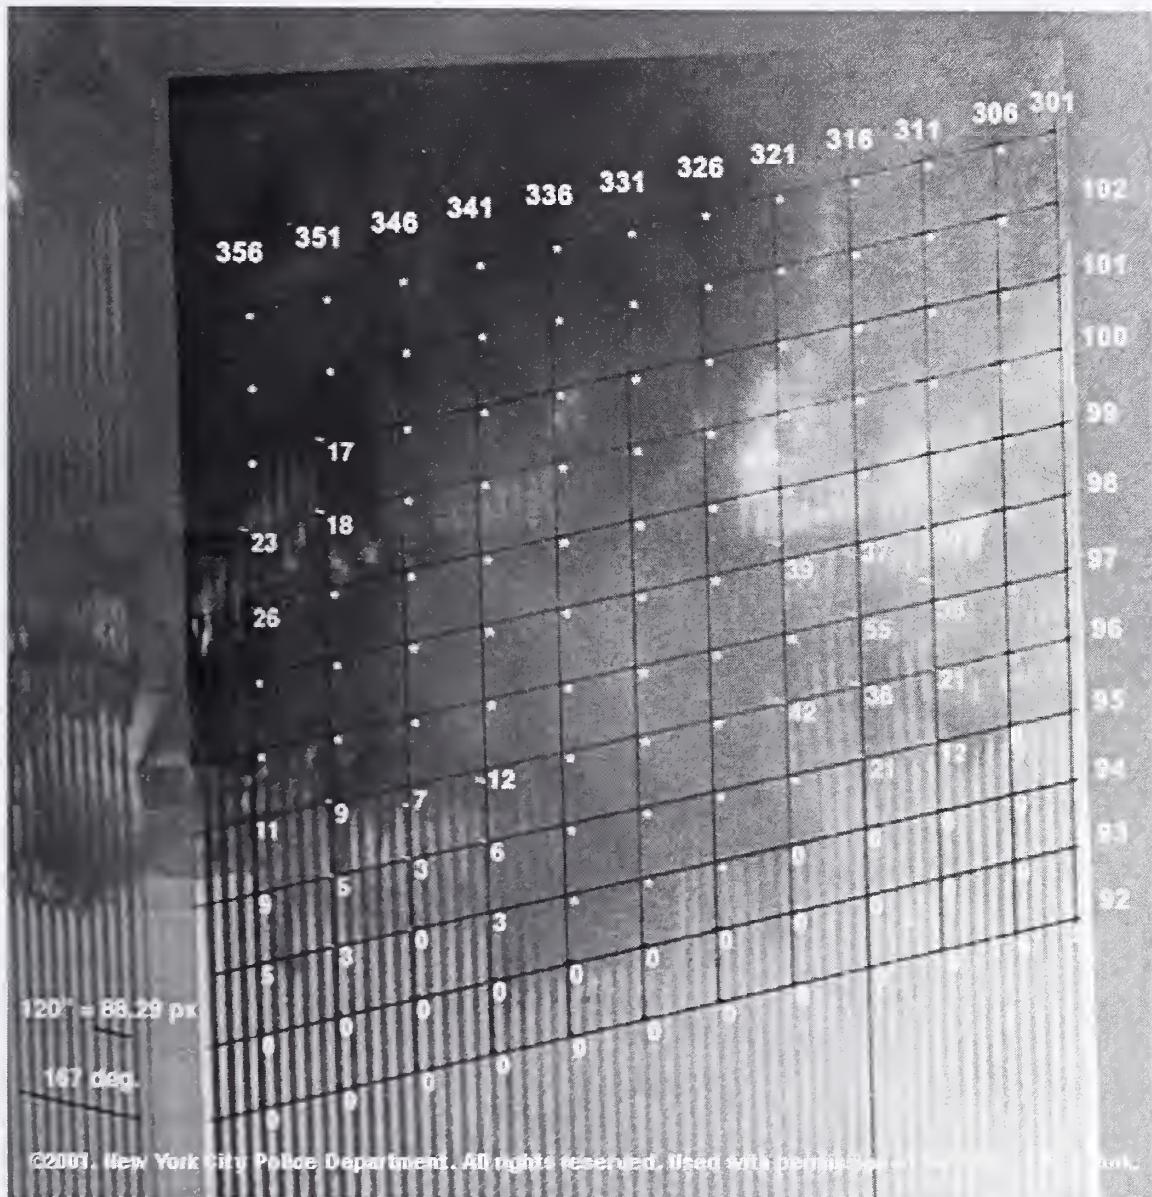
Figure 2–25. Image of pull in of south face of WTC 1 at 10:23 a.m. showing considerable displacements of the outer columns into the building. The faint white vertical features are the aluminum façade of the exterior. Maximum visible inward displacement of the columns is 55 ± 6 in. Poor resolution of the image leads to large uncertainties in the measurements, and a large fraction of the south face of the building is obscured by smoke.

This measurement was performed on an image taken from a NYPD helicopter at approximately 10:23 a.m., several minutes before the collapse of WTC 1. The image is shown in nearly its entirety in Fig. 2-24, and the analysis is shown in Fig. 2-25. Due to the limited resolution of the digital camera that took the image, as well as artifacts introduced into the image by the JPEG compression routine, the resolution of these measurements are estimated to be ± 6 in. This resolution limitation and the presence of such a large region obscured by smoke required that the aforementioned measurement procedure be modified slightly. Instead of establishing the vertical true lines using undeformed sections above and below the region of interest, the large area visible below this area was utilized by establishing the true line along 20 floors below the damaged region. This was extended along the same line through the smoke filled region. In addition, as the seam of the aluminum façade panels was not visible, the distance the columns were deformed into the building perpendicular to the south face was established by measuring angles and distances on the west face at the southwest corner of the building (see Fig. 2-25, lower left). This established the angle (167 degrees from right horizontal) and base magnitude (120 ft per 88 pixels) of the inward bowing vector. The foreshortening of the south face due to perspective was calculated and applied to the distances measured on the south face, and increased the measurements by a maximum of approximately 15 percent over the physical distance measured on the image. Note that later analysis of the inward bowing of the east face of WTC 2 did not require this correction, due to a more normal orientation of the photographer's view of the building.

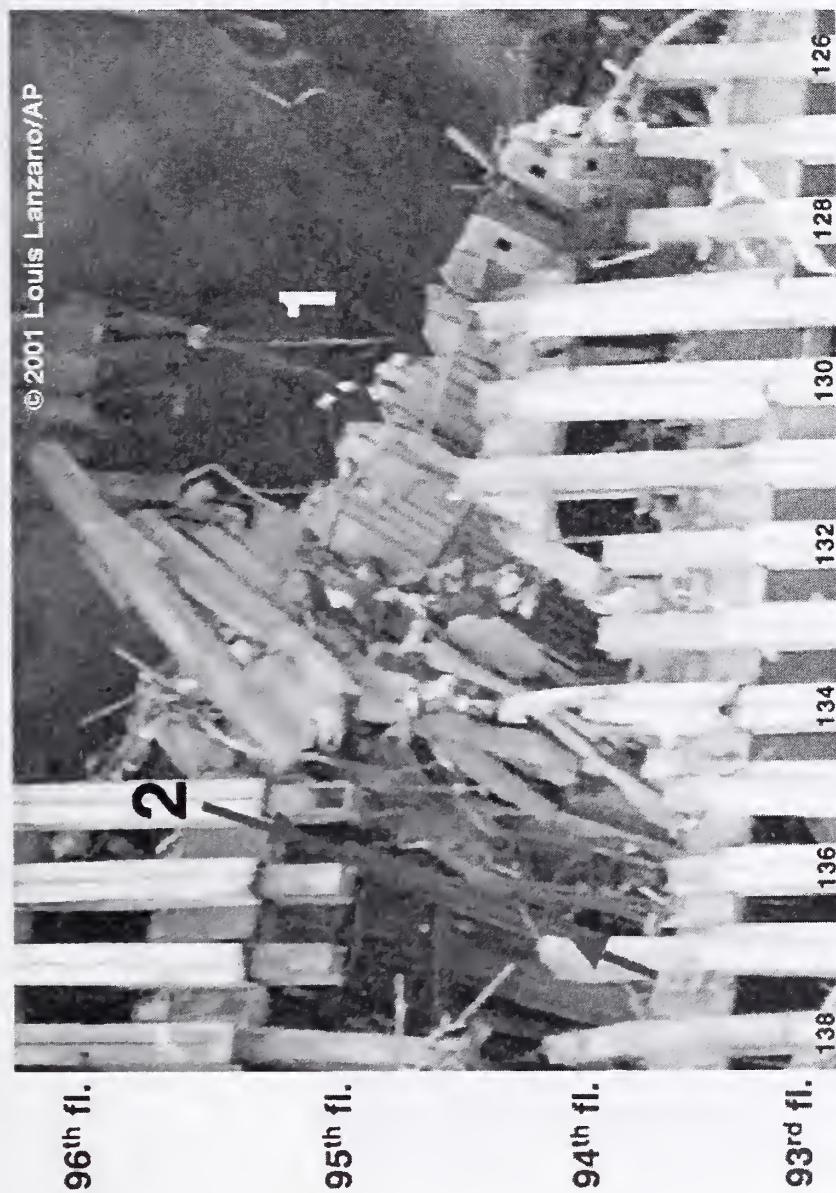
Figure 2–23. Image showing missing sprayed fire-resistant material on floor trusses that fell into impact hole on north face of WTC 1. The arrows labeled “1” are three trusses where you can see the lower or upper chords, and can distinguish the line that separates the two angle iron components. The arrows labeled “2” lie at either end of a lower chord of a truss that fell farther inside the building, and is made up of 4 angle irons (a double truss). The red paint color being visible and the fact that the line between the angle iron can be seen indicated that the sprayed fire-resistant material was displaced.

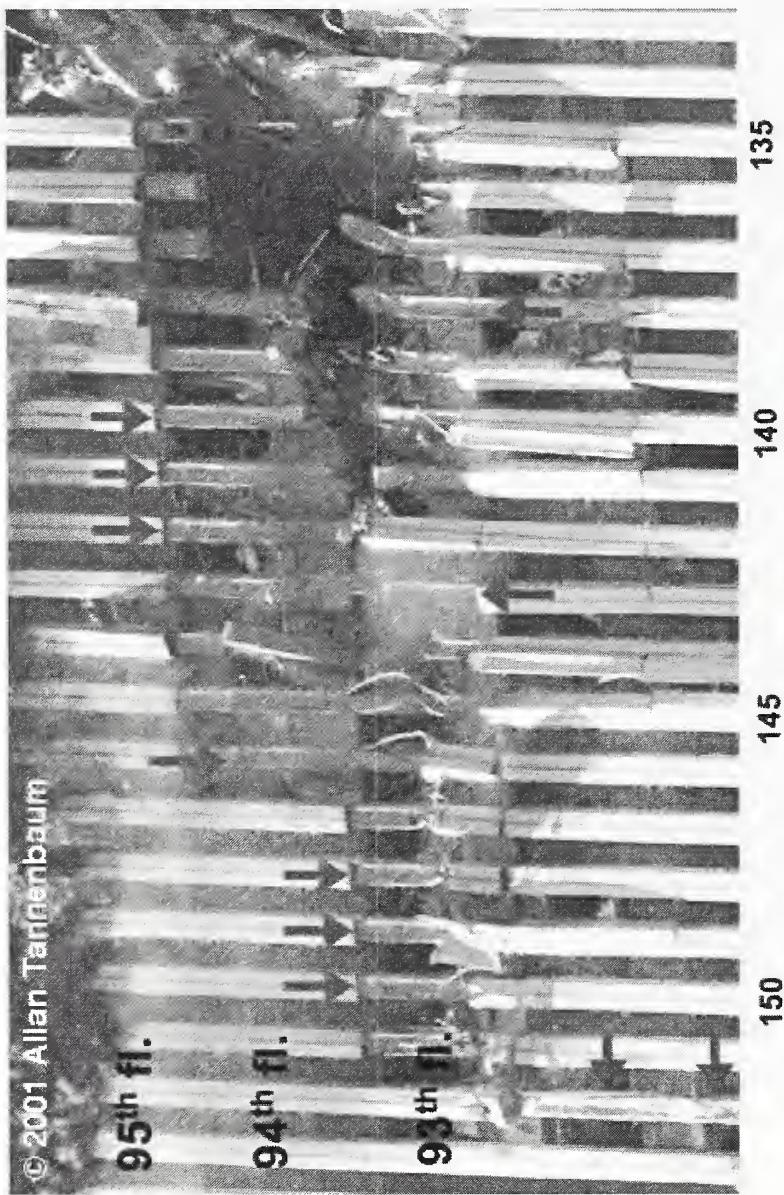
Figure 2-22. Port side of impact hole in north face of WTC 1 showing missing sprayed fire-resistant material. The red arrows indicate a few of the many instances of missing sprayed fire-resistant material around the impact hole. The region roughly approximated as the area where the aluminum panels were dislodged has been digitally enhanced for clarity.

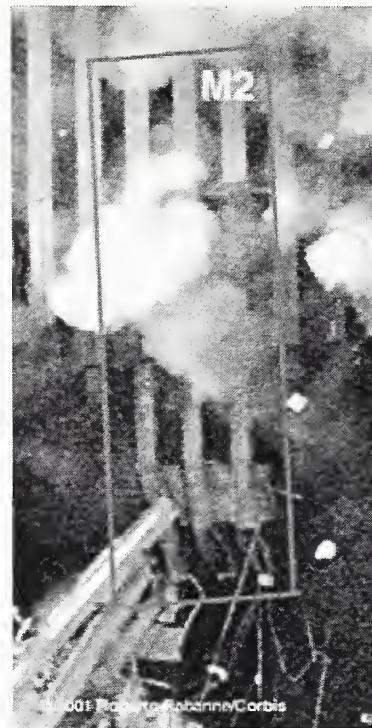
Figure 2-17. Close-up of pre-collapse condition of panel M-2 (A130: 96-99).

- **M-2:** (location A133: 96-99) Panel M-2 was originally immediately above panel M-27, (Fig. 2-17). The lower end was hit directly by the fuselage of the aircraft. The bottom of each of the box columns of the panel showed failure of the vertical column connection bolts, as well as extensive splitting of the longitudinal welds of the box from the end plate to the first spandrel. The bottom end of the panel was pushed several feet into the building. The right end of the lower spandrel remained, and its length implied failure of the middle of the connection with the adjoining panel. The left end of this spandrel was not visible. In all photographs, smoke obscured the bolted vertical connection at the top of the panel.

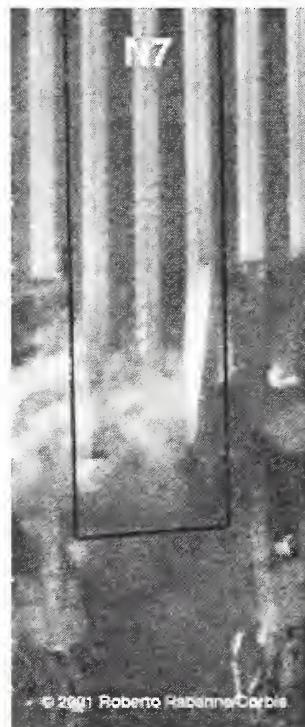
Figure 2-18. Close-up of pre-collapse condition of panel N-7 (A127: 97-100).

- **N-7:** (location A127: 97-100) This panel (Fig. 2-18) was above the impact hole, to the right of and above panel M-2. The vertical column connections in the 97th floor level of columns 126, 127, and 128 broke at the bolts. The panel appeared otherwise relatively undamaged after the plane impact.

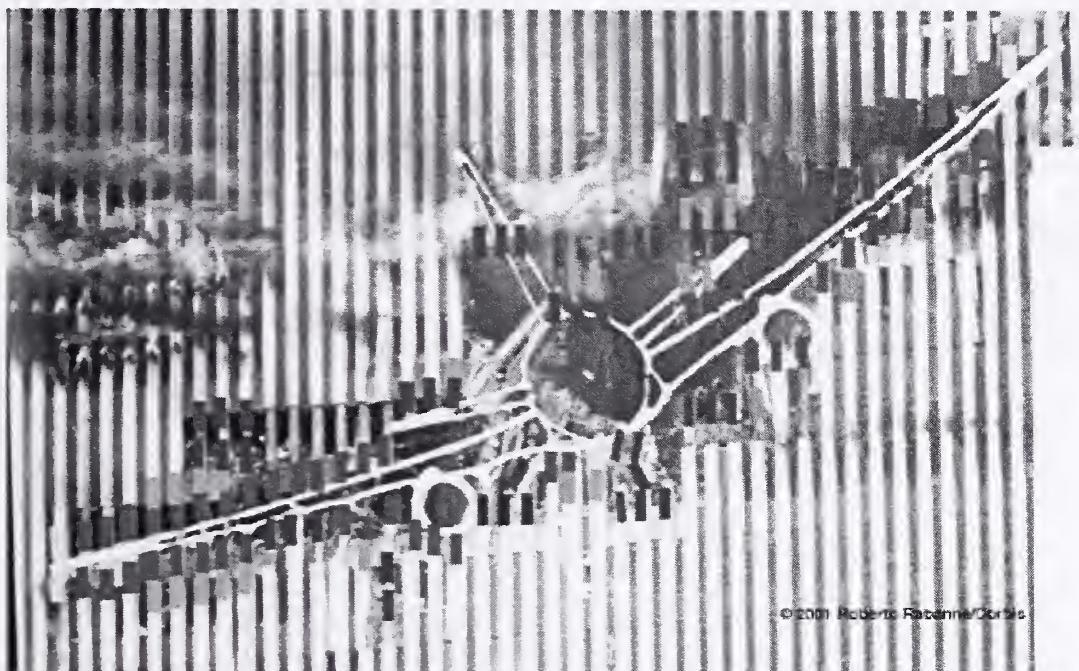
Figure 2–11. Image from Fig. 2–10 with indications of location and type of localized damage. Red designates cut metal components; blue, broken vertical column connection bolts; green, locations of failure of longitudinal welds in the box columns; and yellow shows regions that could not be identified from any photographic evidence.

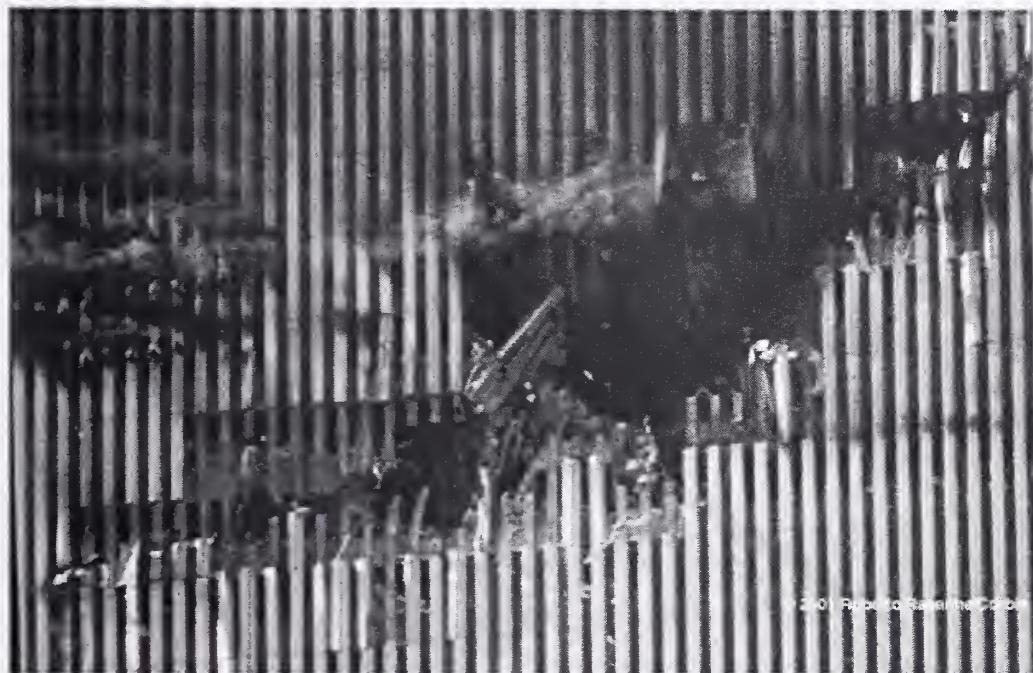
Figure 2–7. Unenhanced image Corbis_NRM161282 showing the impact hole in the north face of WTC 1.

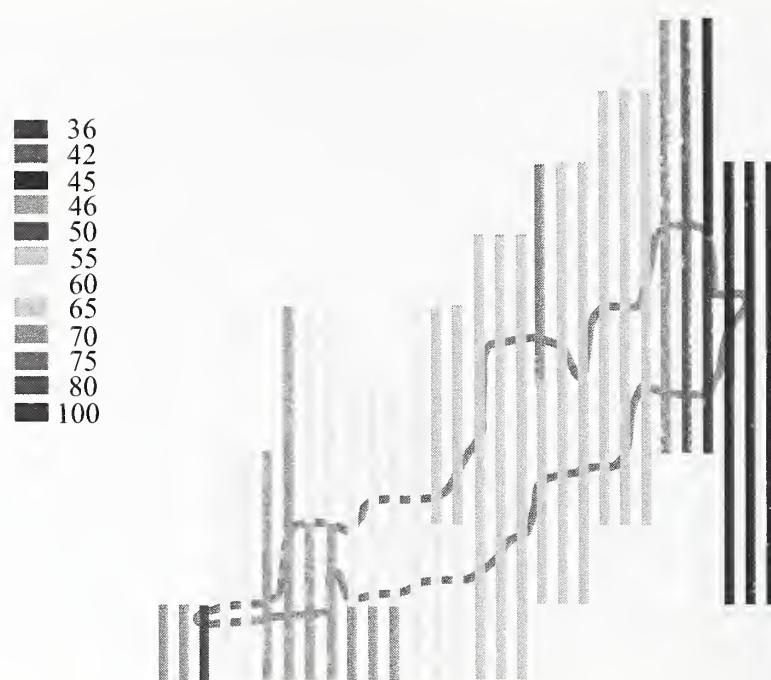
Figure 2-5b. The specified minimum yield strength of the exterior columns for WTC 2 shown in (a).

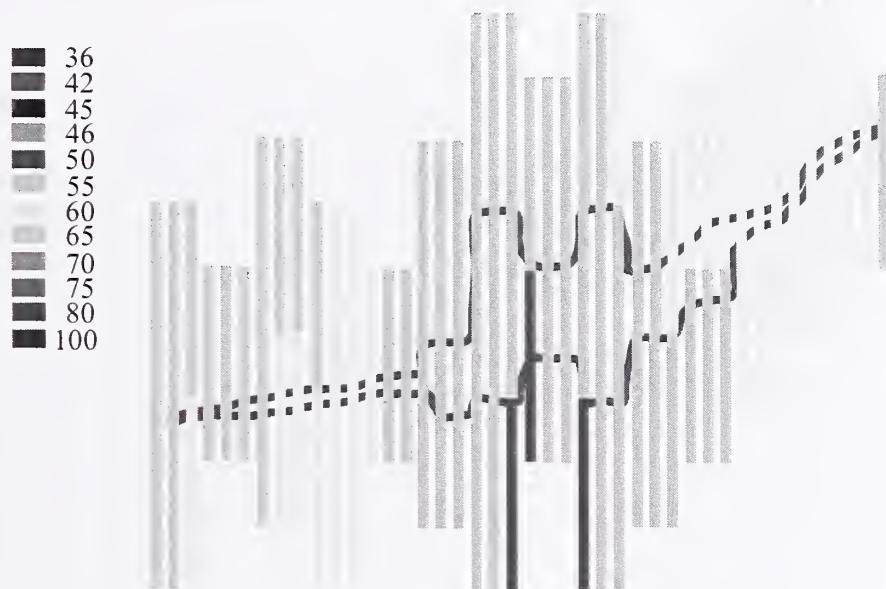
Figure 2–2b. The specified minimum yield strength of the exterior columns for WTC 1 shown in (a).

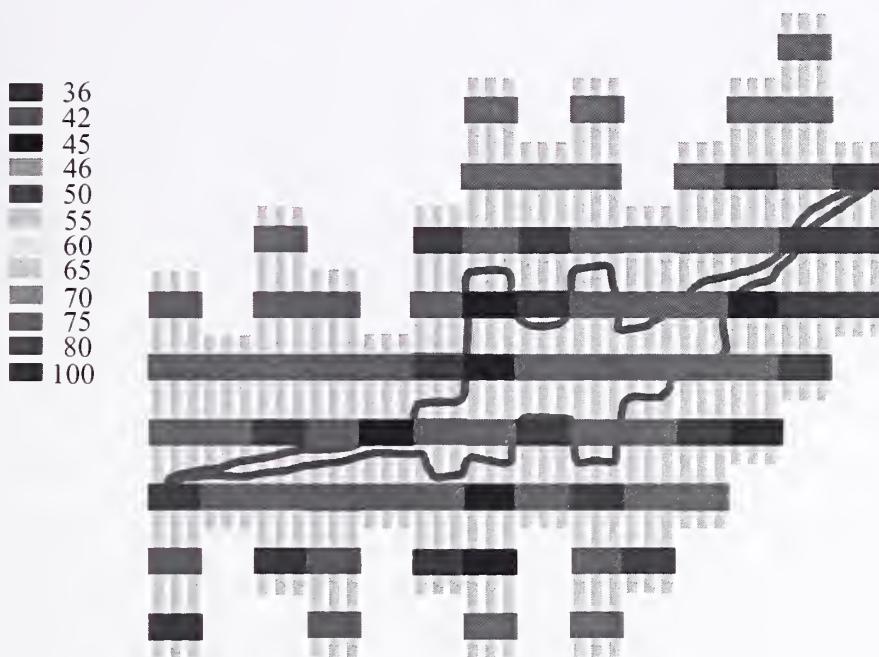
Figure 2–3. Pictorial display showing the required minimum yield strength of the spandrels on the north face of WTC 1 around the airplane impact region.

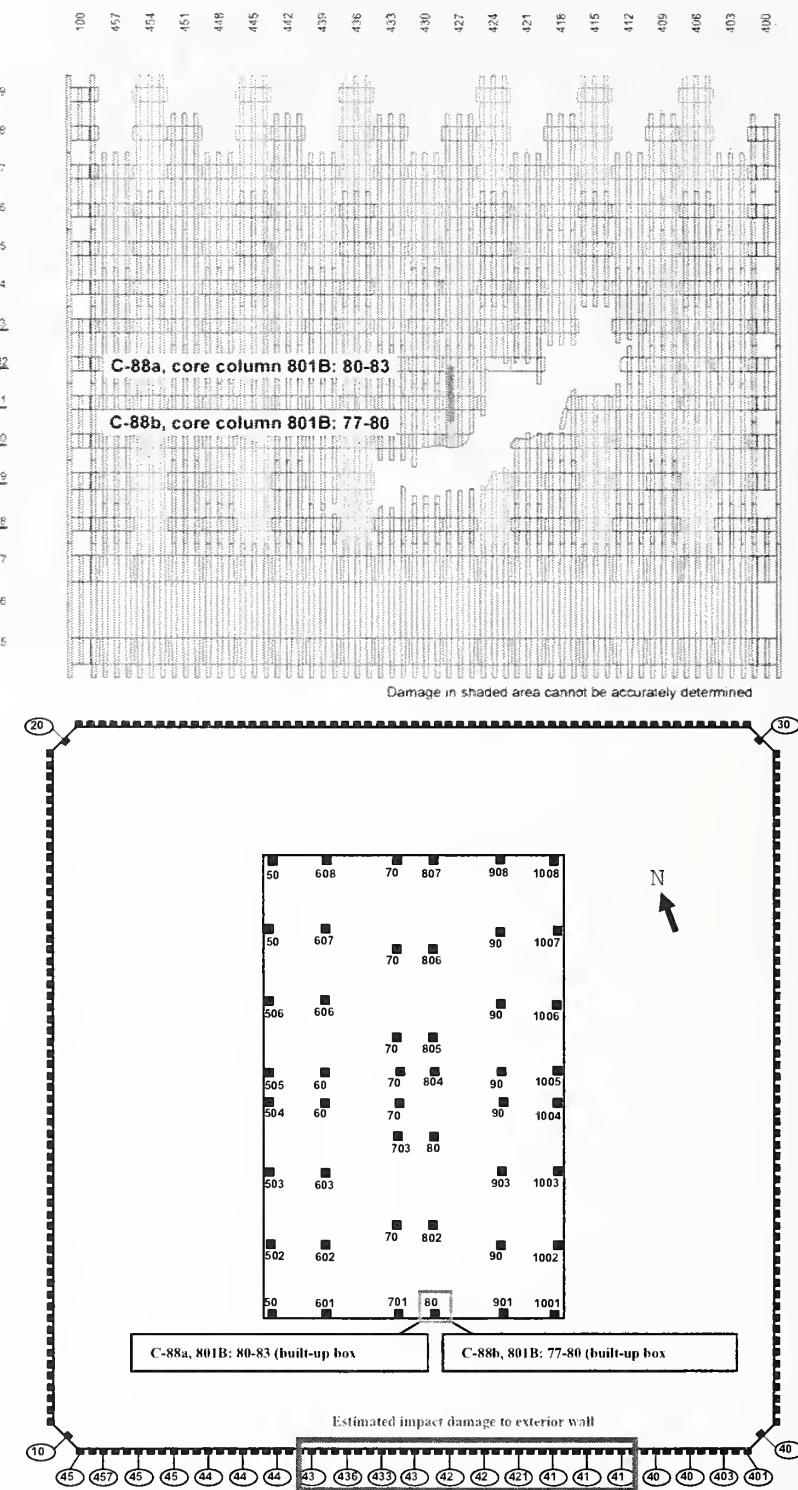
Four core columns were identified as having as-built locations in the vicinity of the impacts. As seen in Fig. 1-7, two columns were from WTC 1, C-80 (603A: 92-95) and HH (605A: 98-101), and from Fig. 1-8, two were from WTC 2, C-88a (801B: 80-83) and C-88b (801B: 77-80). As stated above, the internal damage caused by the impact and subsequent travel of the higher density airframe components through the buildings could not be visually established prior to the collapse. Therefore, determination of which event caused the observed damage also was not firmly resolved from the available evidence. The following section presents computer model results of impact damage of these four core columns.

Figure 1–8. Impact damage location and recovered structural elements from WTC 2. Visual evidence of pre-collapse fires was observed on floors highlighted in red.

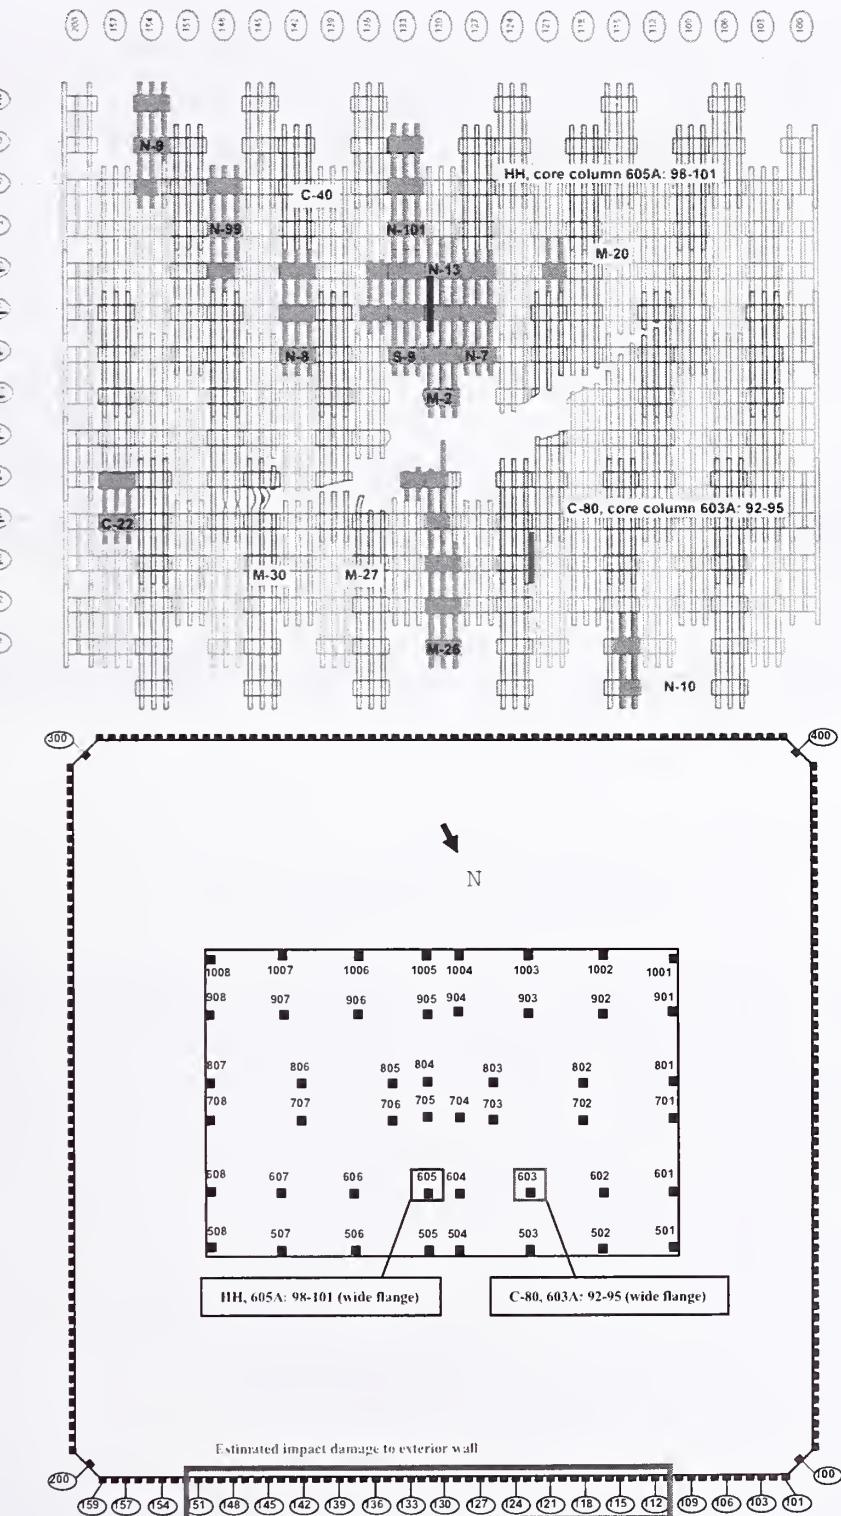
Figure 1–7. Impact damage location and recovered structural elements from WTC 1. Visual evidence of pre-collapse fires was observed on floors highlighted in red.
