NBS BUILDING SCIENCE SERIES 165

# Engineering Aspects of the September 19, 1985 Mexico Earthquake

Following the September 19, 1985 Mexico earthquake, a team consisting of four engineers and one seismologist from the National Bureau of Standards (NBS) and the United States Geological Survey (USGS) was dispatched to Mexico City to provide technical advice to the US rescue effort and to assess structural damage. This report is primarily based on data gathered by the team, but it also contains a compilation of other available information. The report addresses the origin and characteristics of the observed ground motion, the ability of buildings designed in accordance with present and proposed seismic design provisions to resist this type of ground motion, and observed data on structural and foundation failures.

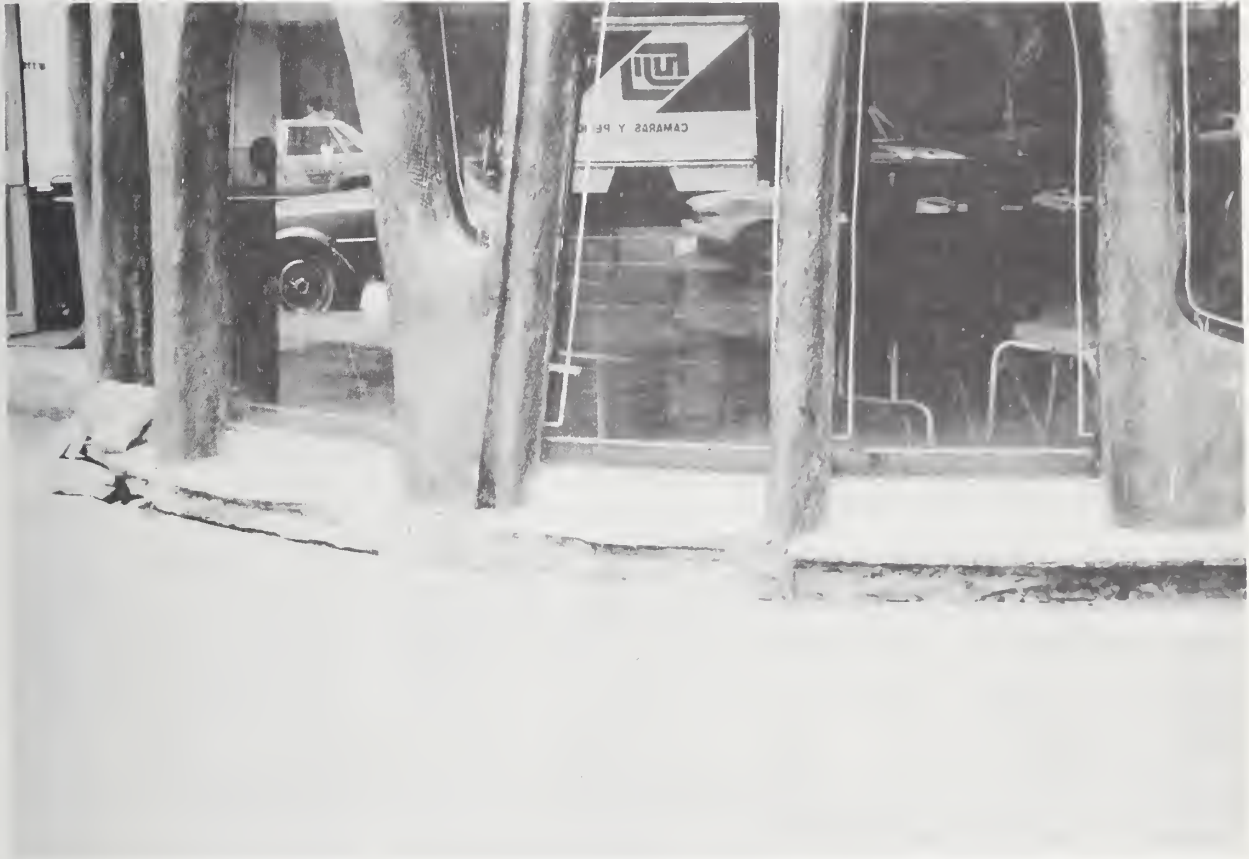
Figure 4.4. Differential displacement between sidewalk and building at the west corner of Versailles and Reforma.

Thus, it is reasoned that the phenomena observed in figures 4.1 through 4.4 are the result of a relaxation in the negative friction forces acting on the piles. This relaxation is the result of loss of shear strength. The loss of shear strength occurred because the clays are sensitive (refer to figure 3.9) and was caused by shear deformations associated with the relative motion between the piles and the surrounding soil. From available data [8] it is estimated that between 85 and 88 percent of the shear strength can be lost. This loss of shear strength does not necessarily lead to an overall foundation failure (it did not cause such a failure in the buildings shown in figures 20 to 23), particularly, since it also results in the relaxation of negative friction forces which the pile had to resist, but it is an important limit state, which should be considered in the design of earthquake-resistant structures founded on sensitive clays.

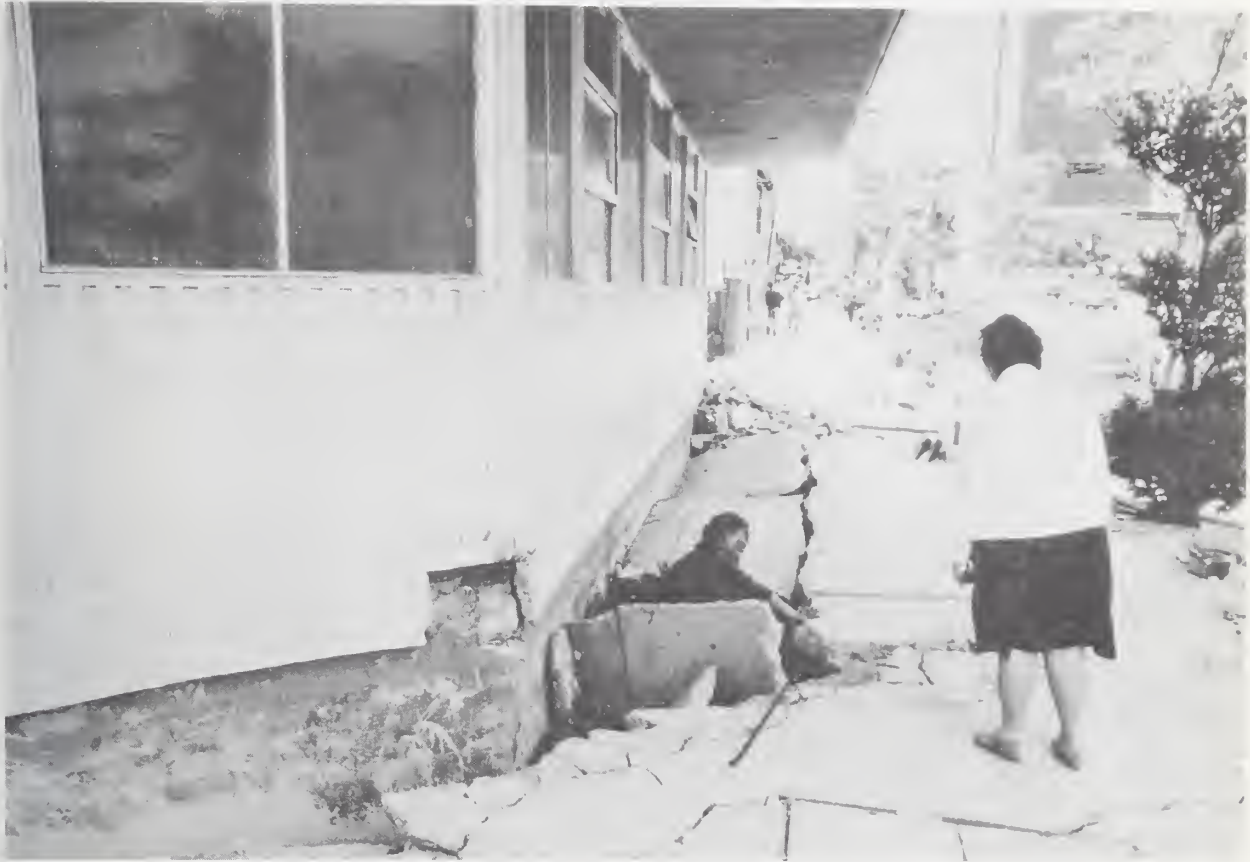
Figure 4.5 shows a tilted ten-story building in the southwest corner of the intersection of Lazaro Cardenas and Fernando. Relative displacements between the building and the sidewalk to the north are shown in figure 4.6, and figure 4.7 shows damage caused to adjacent two-story buildings by the tilting structure. This building is in the vicinity of the severely damaged Communications Center (SCT) where several buildings collapsed. Figure 4.8 shows another tilted building in the same general area in the northwest corner of the intersection of Xola and University. This ten-story building also suffered severe structural and cladding damage. Figure 4.9 shows two- and three-story buildings a short distance to the south on University and opposite the severely damaged Communications Center which apparently did not suffer damage. Likewise, many two-story residential buildings on University to the north of Xola, where two multi-story reinforced concrete buildings (one of them post-tensioned) collapsed, also appeared undamaged.

Figure 4.6. Relative displacement between sidewalk and tilted building at Lazaro Cardenas and Fernando.

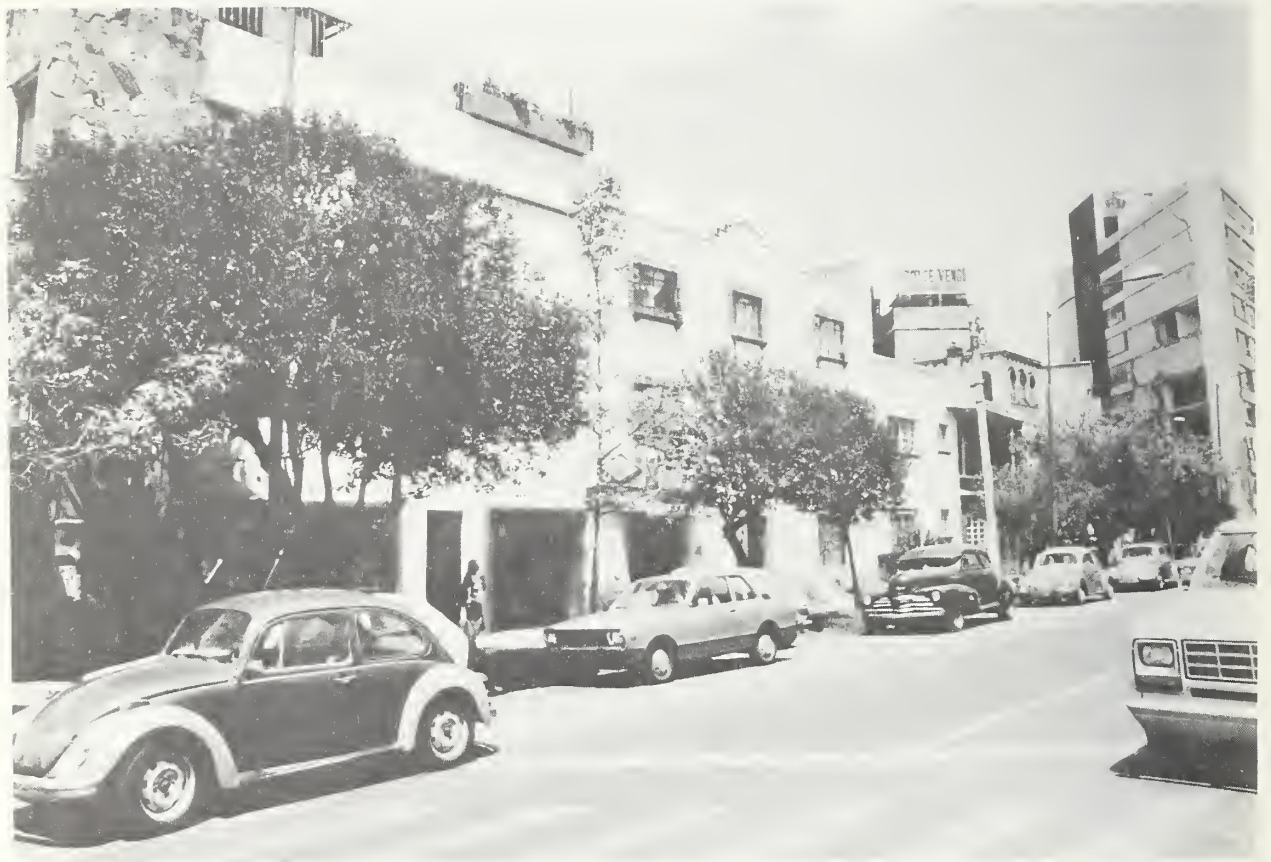
Figure 4.9. Undamaged two and three story buildings on University Boulevard opposite the severely damaged Communications Center.

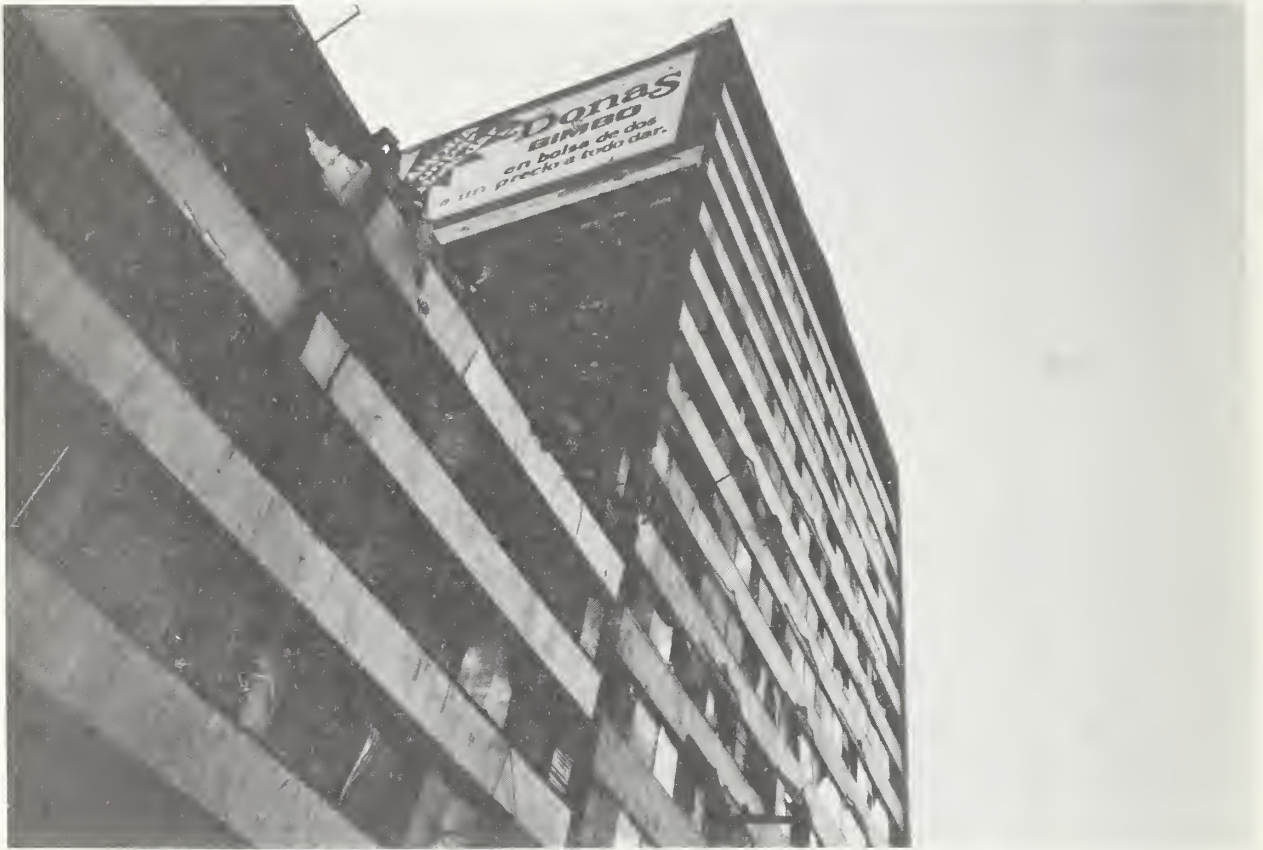
Many buildings were damaged as a result of distortions caused by differential foundation settlements. An example is shown in figures 4.14 and 4.15. The far corner (SW) of the building shown in figure 4.14 which is located on the south side of Teresa De Mier just to the east of Medico Militar settled more than the other corners. This differential settlement resulted in a warping distortion which can be seen in the wall shown in figure 4.15.

Figure 4.15. Warped wall on the north side of building on Teresa de Mier.

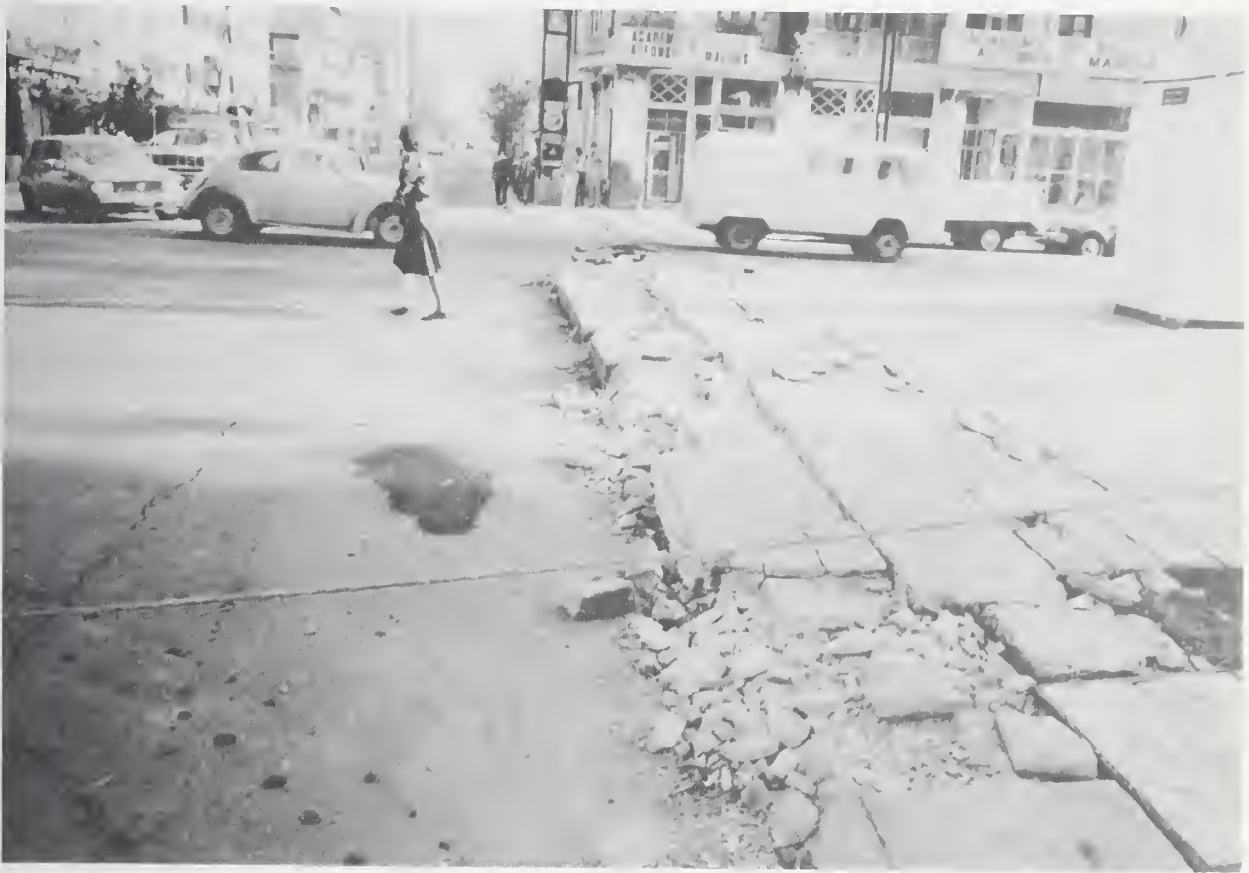
Figure 4.16. Soil disturbance over utility line at the intersection of Monterrey and Obregon.

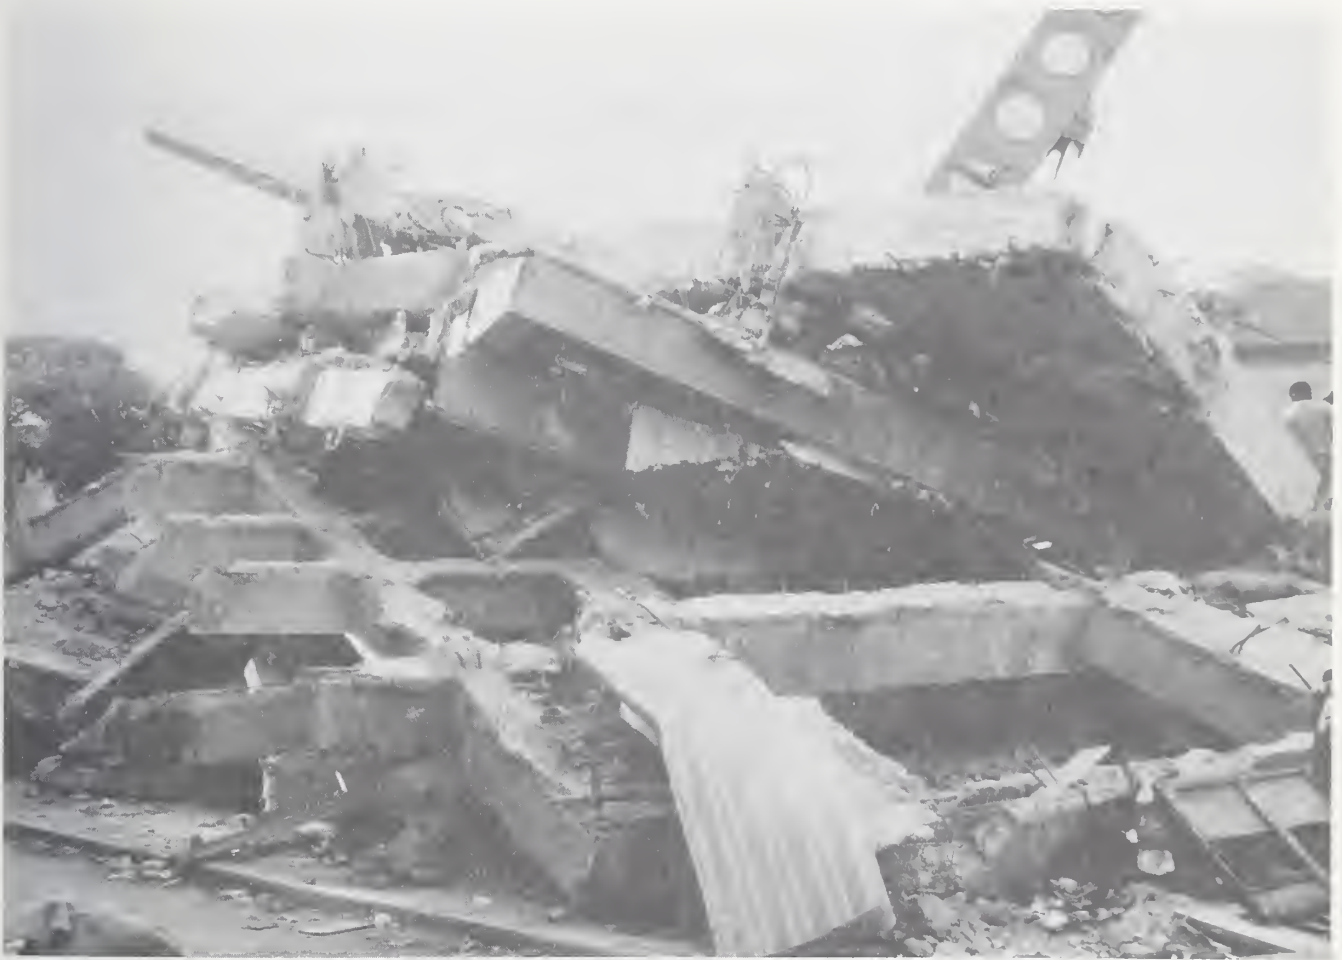
Figure 5.5. Debris from the collapsed Mexico General Hospital.

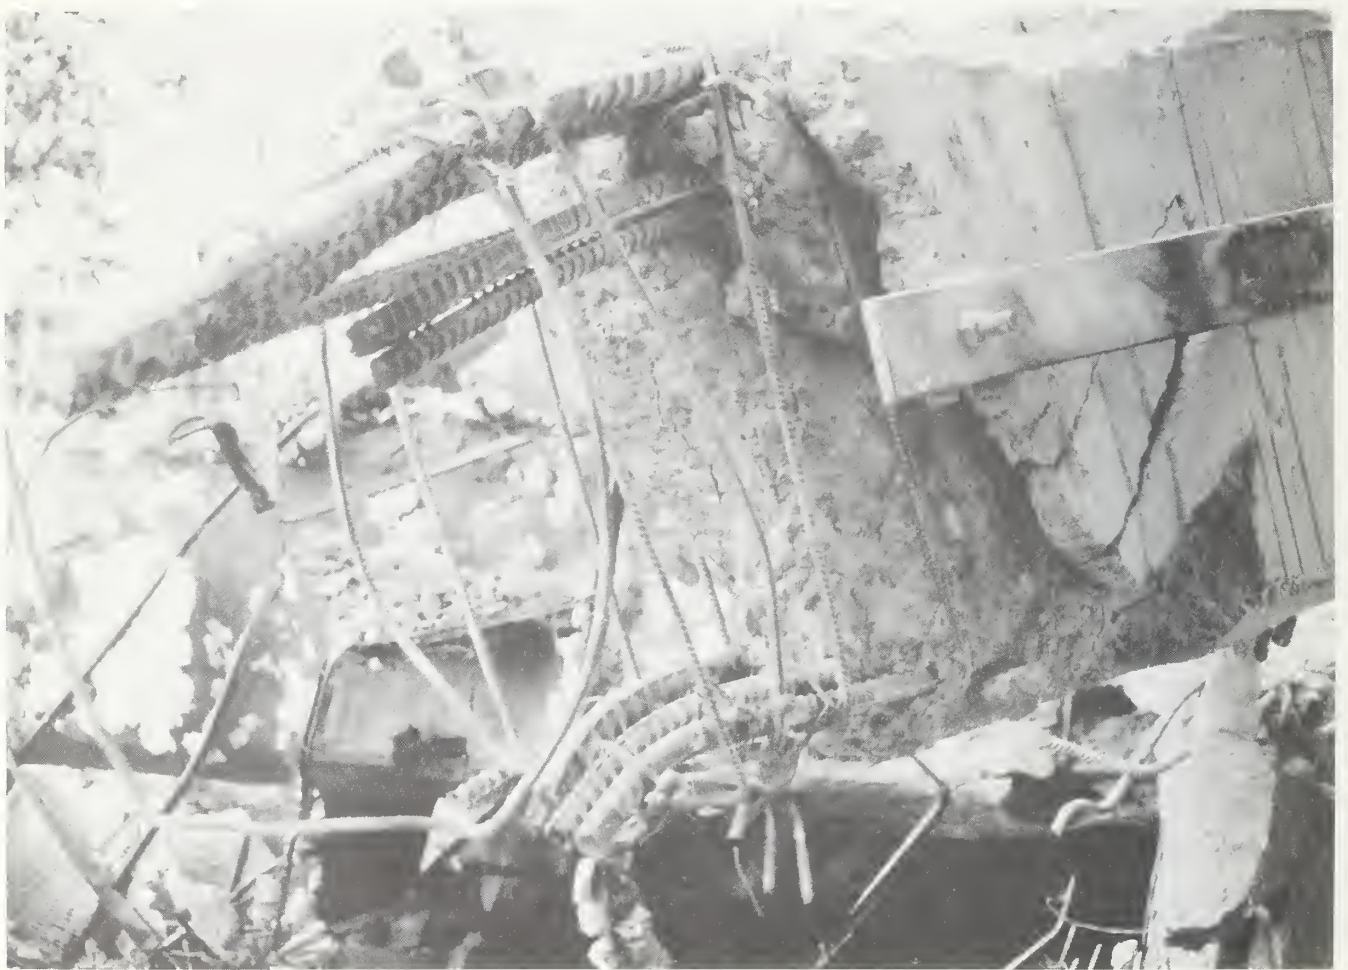
Figure 5.6 shows a close-up view of one of the edge columns. These were typically 14-in (30cm) deep by 12-in (25cm) wide. Closed stirrup confinement consisted of approximately #2 bars (visual evaluation) at 4-6-in (10-15cm) spacing. Following

Figure 5.6. Edge column of collapsed General Hospital.

current Mexico City building code specifications of 1976 [19], the required diameter of these stirrups, given the same spacing, should have been on the order of a #5 bar, which is five times the cross sectional area of steel that was provided.. However, this same code restricts the maximum hoop spacing to 2-3/4-in (7cm). The General Hospital structures were built prior to the adoption of the 1976 code. Of particular interest was the performance of the new parking garage (upper center, figure 5.4) also a frame type structure. In contrast to the personnel building, however, the corners of this building contained reinforced concrete shear walls (see figure 5.7) which safely withstood the lateral forces during the quake. Figure 5.8 shows hairline cracks near beam column connections of the parking garage building.

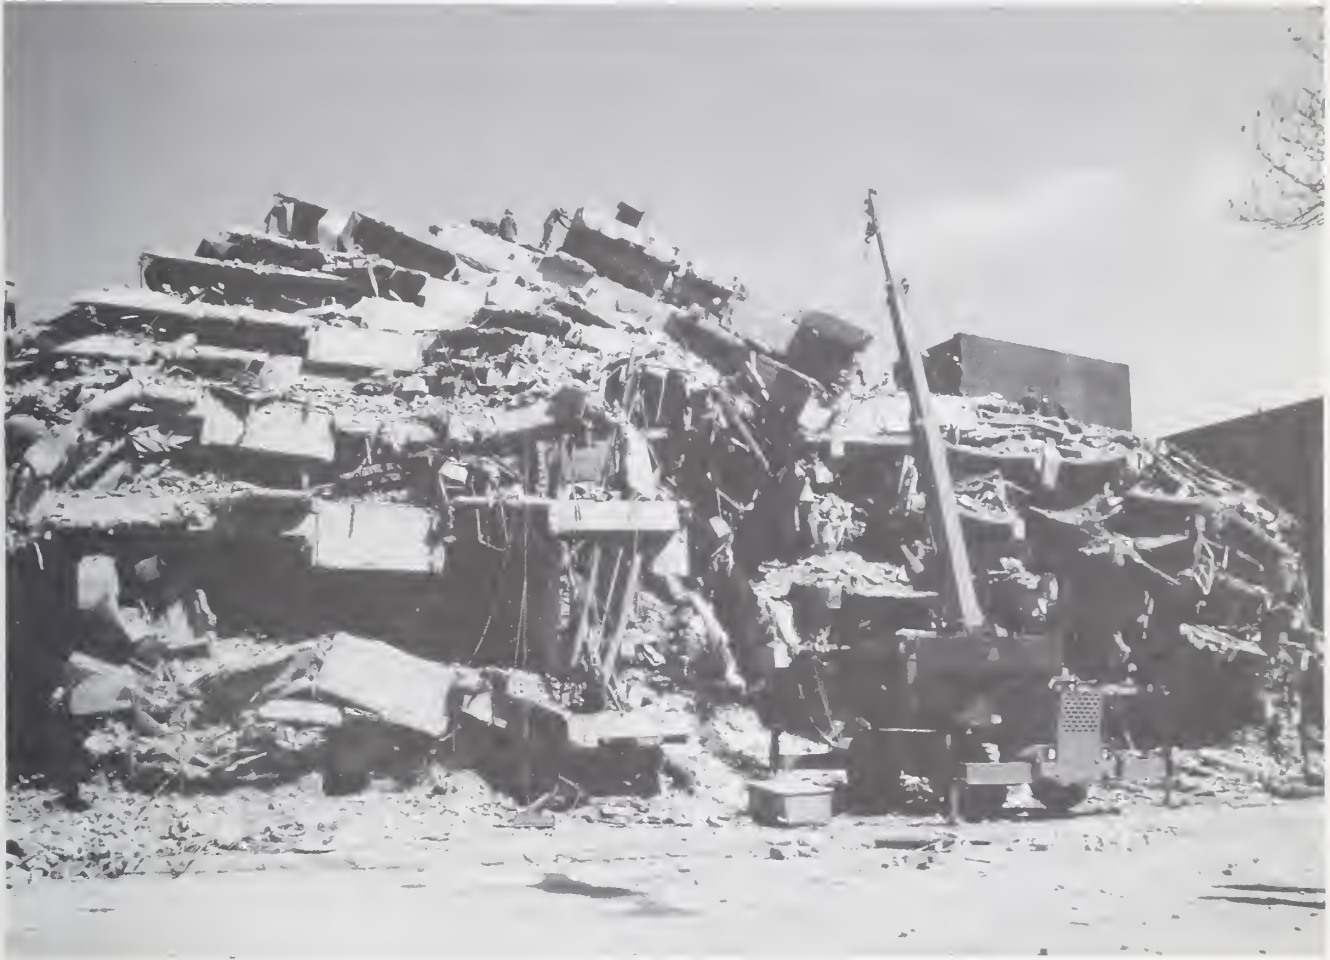
Yet in another hospital building, the Maternity wing of the Juarez Hospital, eight blocks south of the Presidential Palace, 400 medical personnel and patients, notably infants, were trapped. This nine story reinforced concrete frame structure collapsed towards the east also (figures 5.9 and 5.10) exhibiting localized failures at the beam to column joints of each floor. A close-up of various joint details (figure 5.11), indicates that the columns were generally well-proportioned to resist gravity loads. However, figure 5.11 and 5.13 clearly shows minimal to nonexistent confinement through the joints. Furthermore, many joints had longitudinal bar splices at these same critical moment locations. These factors probably contributed to joint failures after a relatively small number of cyclic load reversals.

Figure 5.10. View of collapsed maternity wing of the Juarez Hospital looking east.

continued to retrieve survivors as late as ten days after the earthquake by tunneling through the debris between the floor slabs (see figure 5.10).

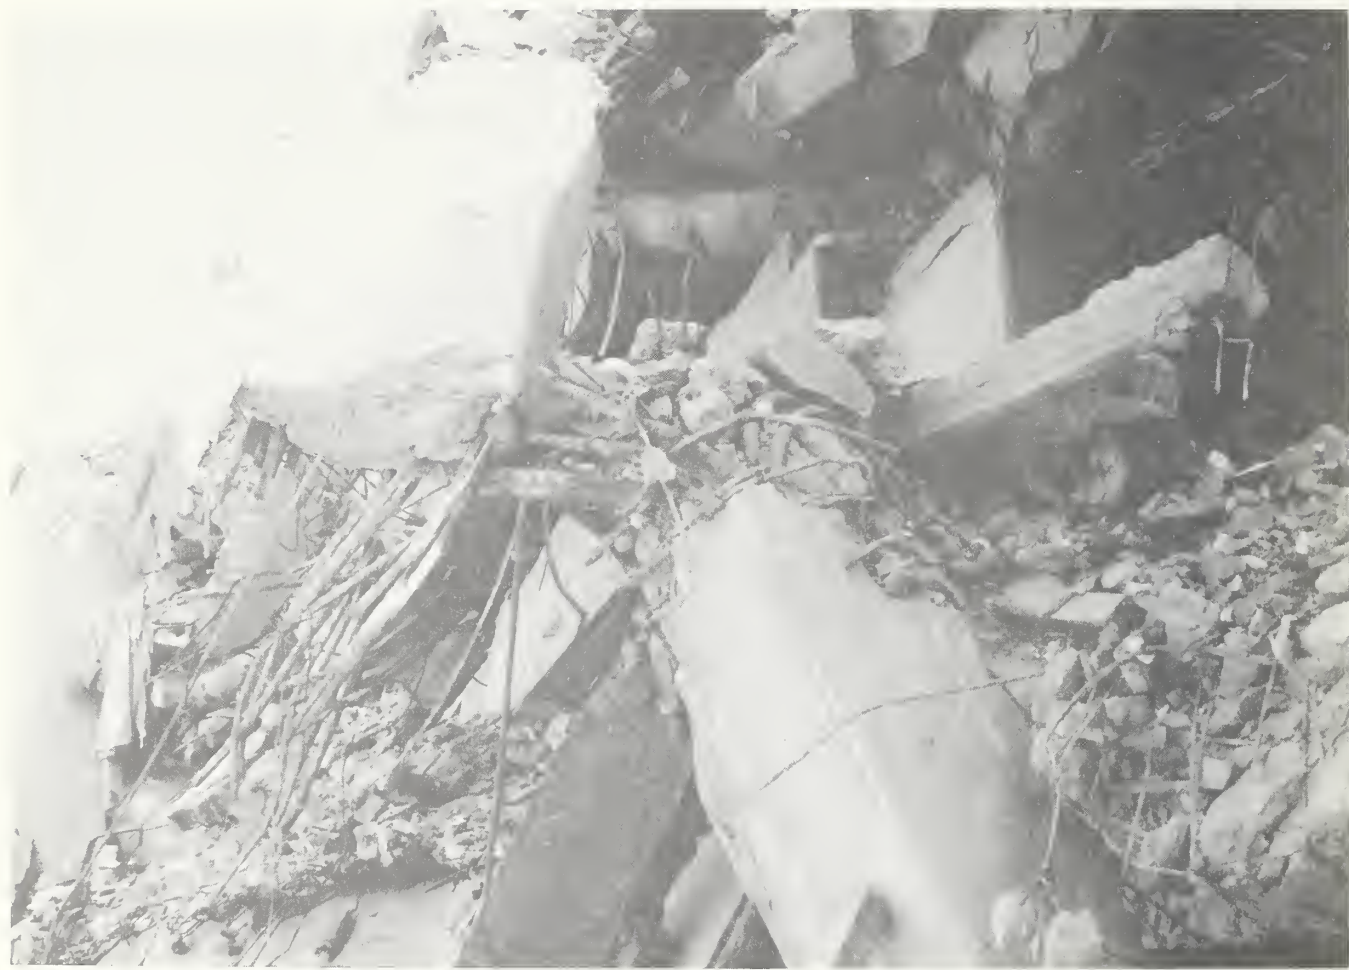
The lack of such confinement, and the presence of splices in such critically underconfined joints -- which could lead to a loss of vertical load bearing continuity as soon as the bond strength is lost following core breakup -- directly contributed to the failure of the Juarez Hospital. This particular structure received considerable media attention as rescue personnel

Figure 5.11. Close up joint details of collapsed Juarez Hospital indicating lack of sufficient confining reinforcement in the vicinity of the joint.

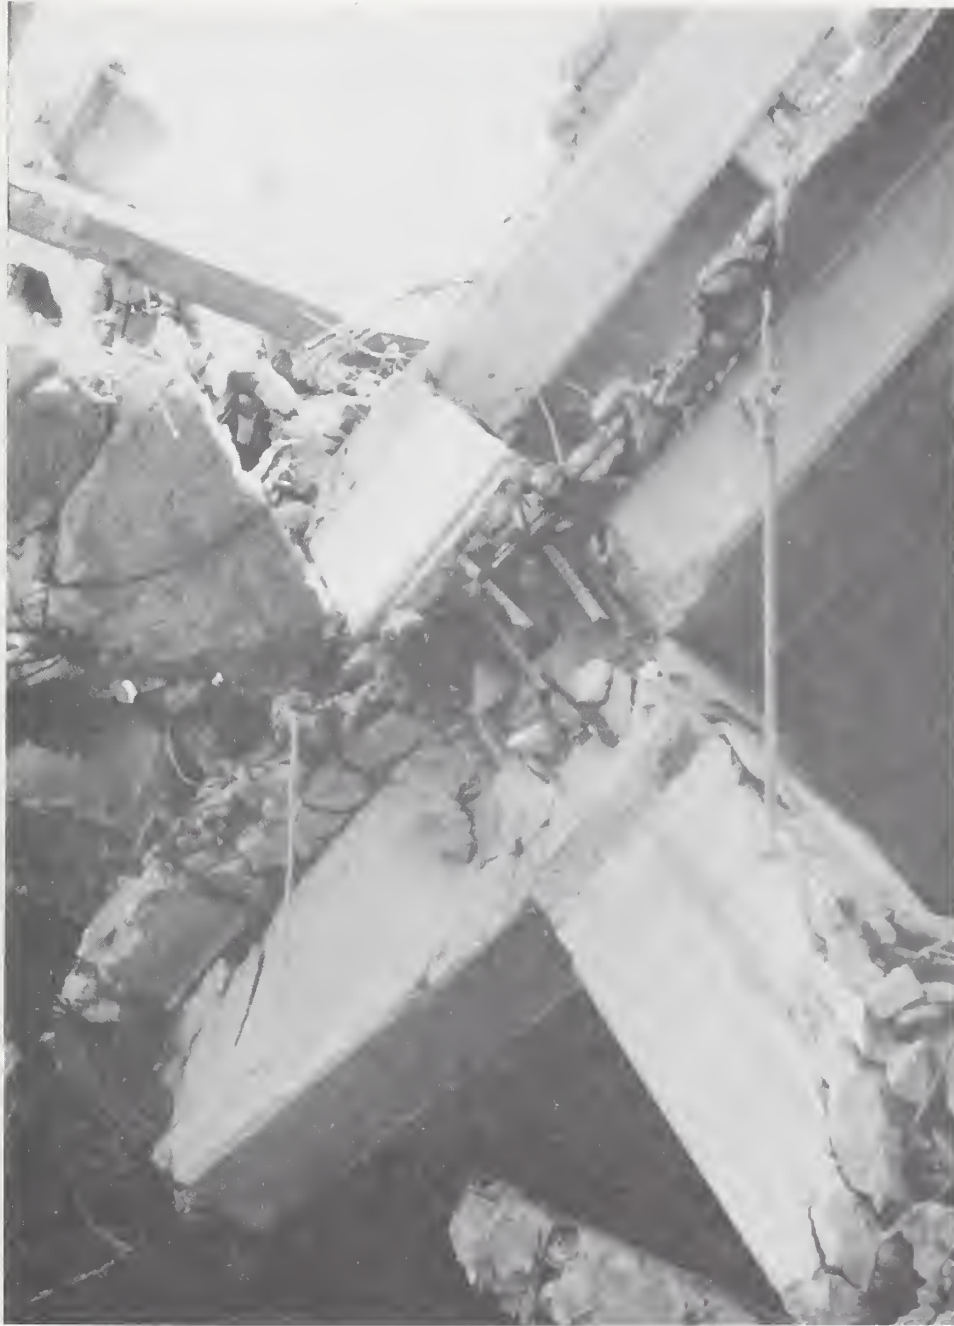
Figure 5.12. Joint details of collapsed Juarez Hospital indicating adverse effect of a splice.

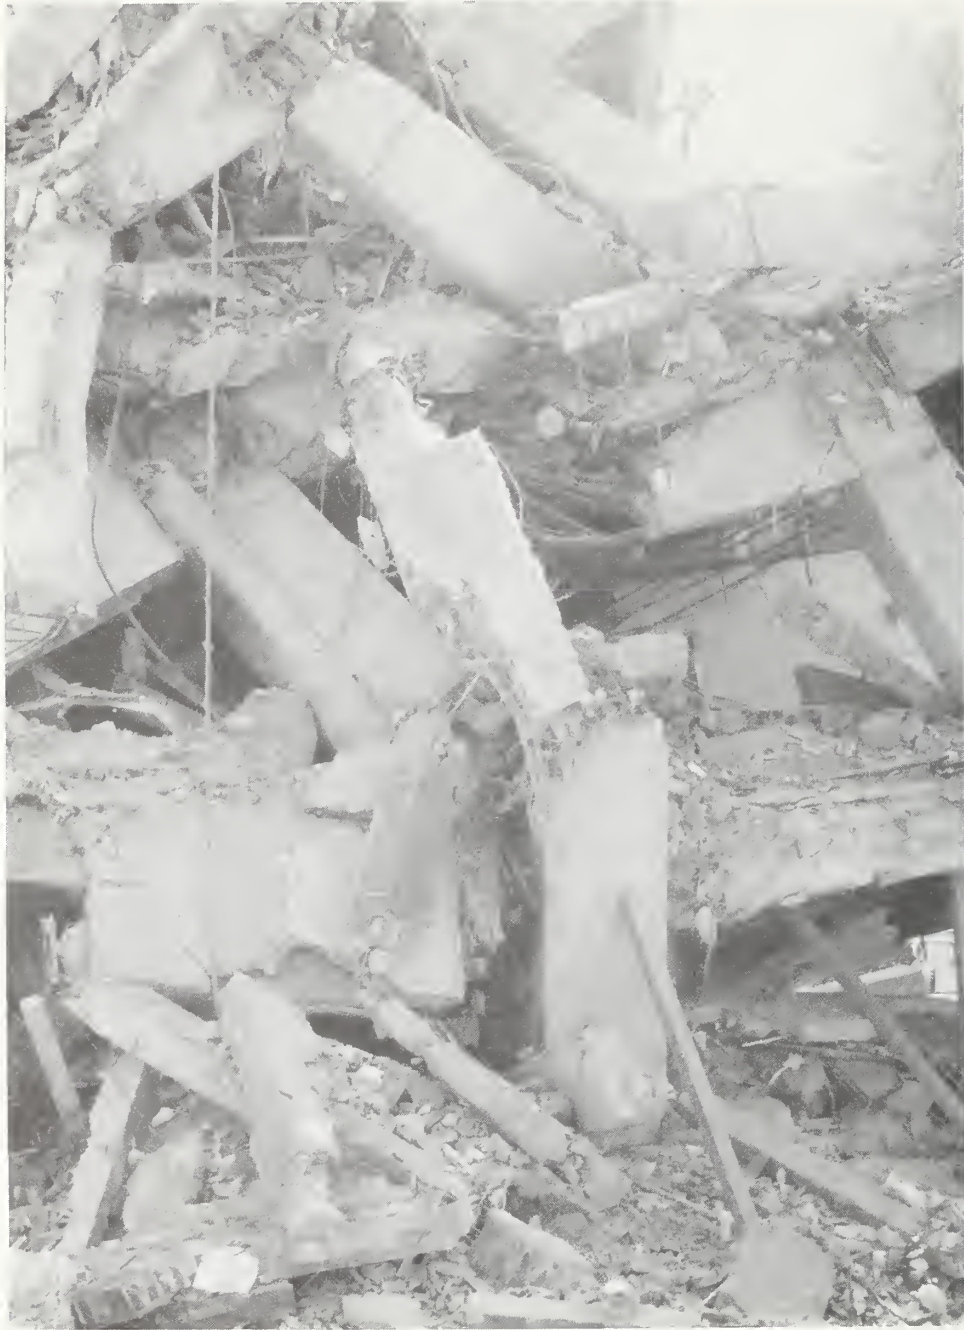
Figure 5.13. View looking south at Juarez Hospital showing how column hinging permitted rotation of successive floors toward the east.

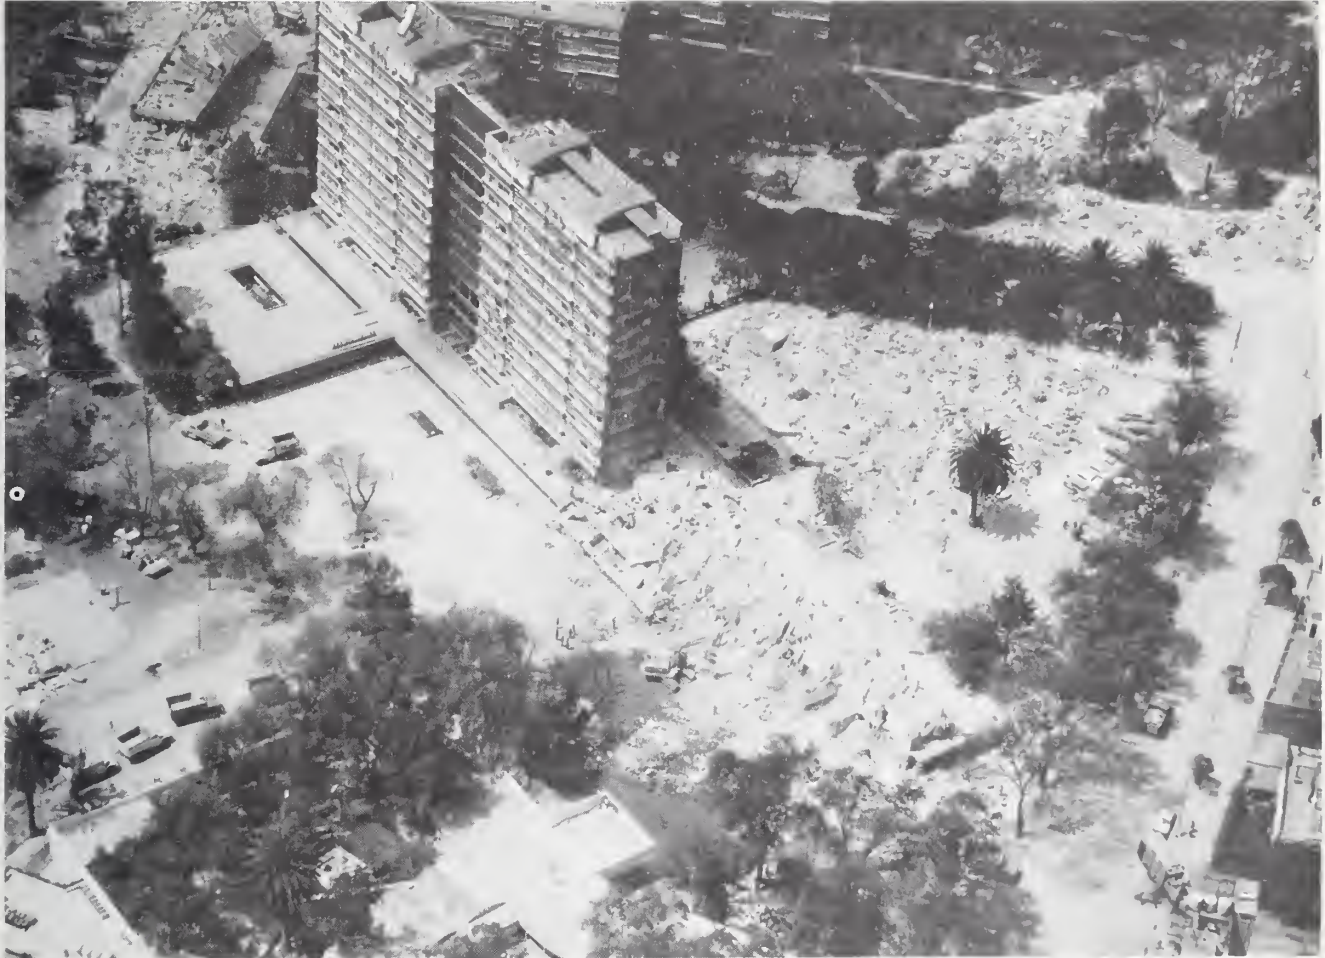
The southern two-thirds of the thirteen-story complex, separated by a construction joint from the rest of the structure, remained standing but tilted out of plumb and was considered unstable (see figure 5.15). This was one of the first structures to be

Figure 5.15. The southern two B towers of the Juarez Apartment complex which remained standing.

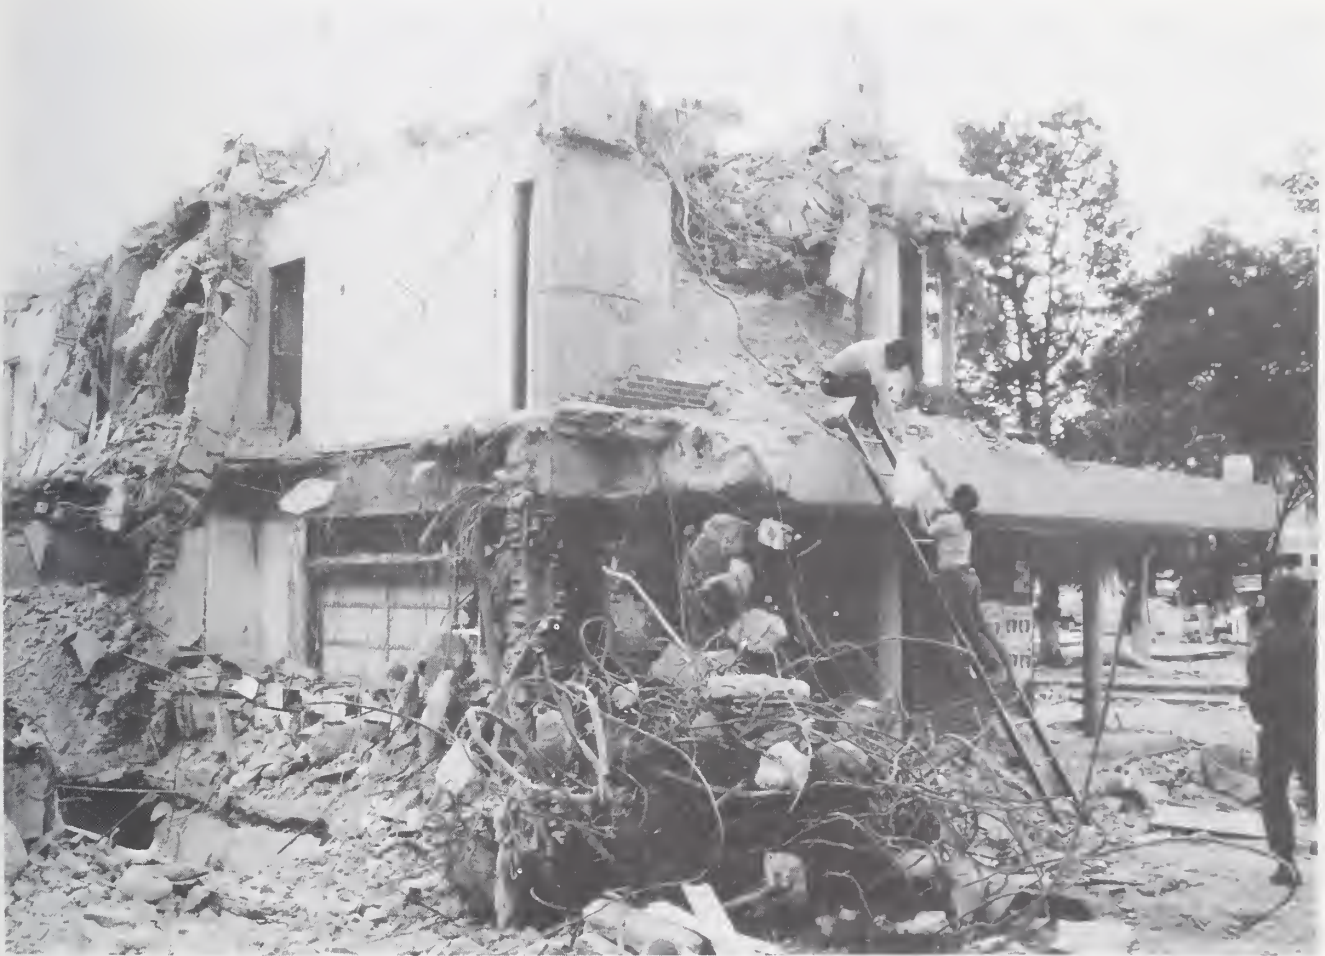
dynamited approximately three weeks following the quake. Figure 5.16 shows a close-up of the first two stories of this structure following removal of debris. It can be seen that the column width was increased in the east-west direction in an effort to stiffen the resistance of the structure in the narrow direction. Nonetheless, based on the debris pattern following the collapse, it appeared that failure of this building was initiated by hinging of the columns in the east-west direction. It is likely that the presence of the thin connecting walkway (see aerial photo, figure 5.15) with the neighboring two towers to the south permitted sufficient independence for each tower to oscillate individually in the east-west direction. This explains why the northern tower was able to collapse without affecting the two southern towers.

Figure 5.16. First two stories of Juarez apartment structure.

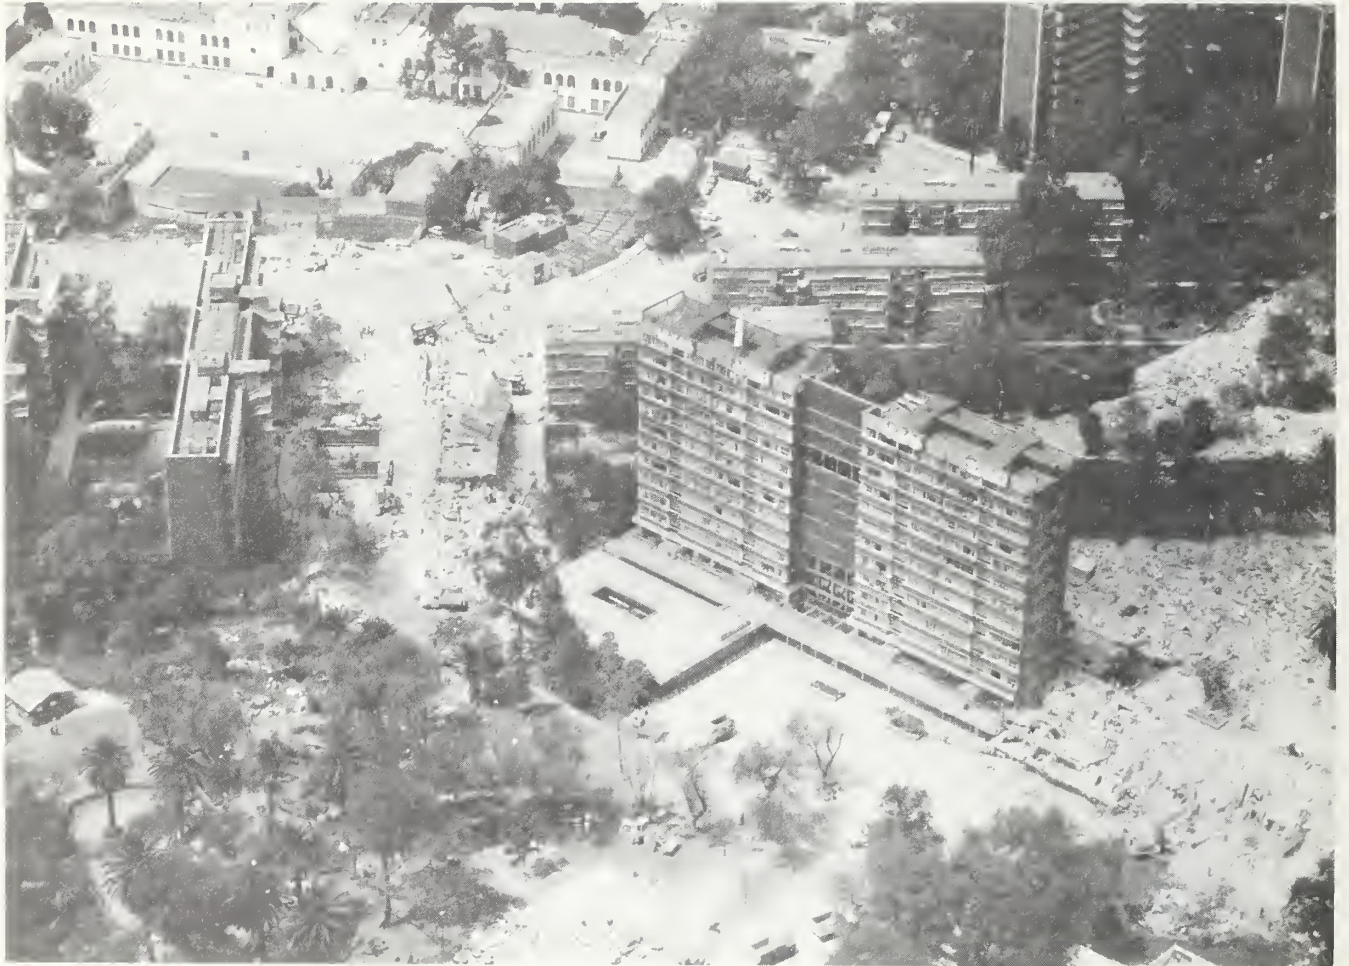
Figure 5.17 shows an aerial view of the collapsed eight-story apartment immediately to the south of the thirteen story complex. This structure was similar in many respects to the one described above, with the notable exception that the aforementioned four lane highway ran directly underneath the center of the building. The reinforced concrete tunnel structure and road foundations may have stiffened the overall foundation, and hence increased the efficiency with which ground accelerations were transmitted to the frame. Each member in this group of four buildings was cast as a continuous unit with no obvious construction joints that might otherwise cause separate portions of the building to act independently under seismic loading. Figure 5.18 shows the "pancake" nature of the collapse, indicating hinging in columns during the earthquake. The skewed stacking of the slabs towards the east indicates that ultimate failure likely occurred during an eastward excursion. Figures 5.19 and 5.20 show views of this same structure looking north-east and east, respectively. The exterior stair tower, which experienced a shear failure in the support pylon at the first story, can be seen on the left side of

Figure 5.17. Aerial view of collapsed eight story apartment building.

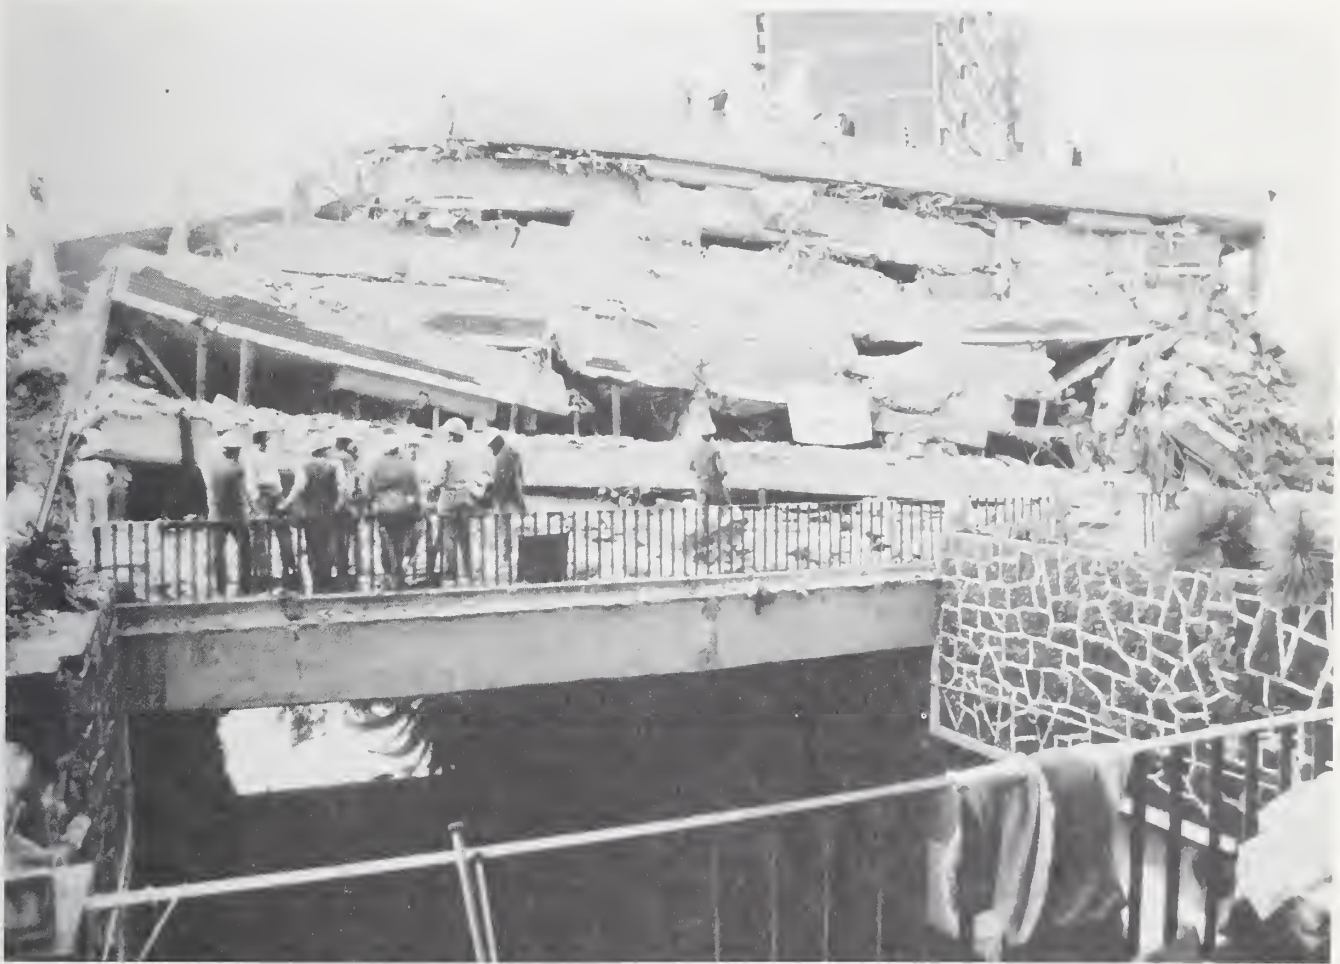
Figure 5.18. Pancake type collapse of eight story apartment.

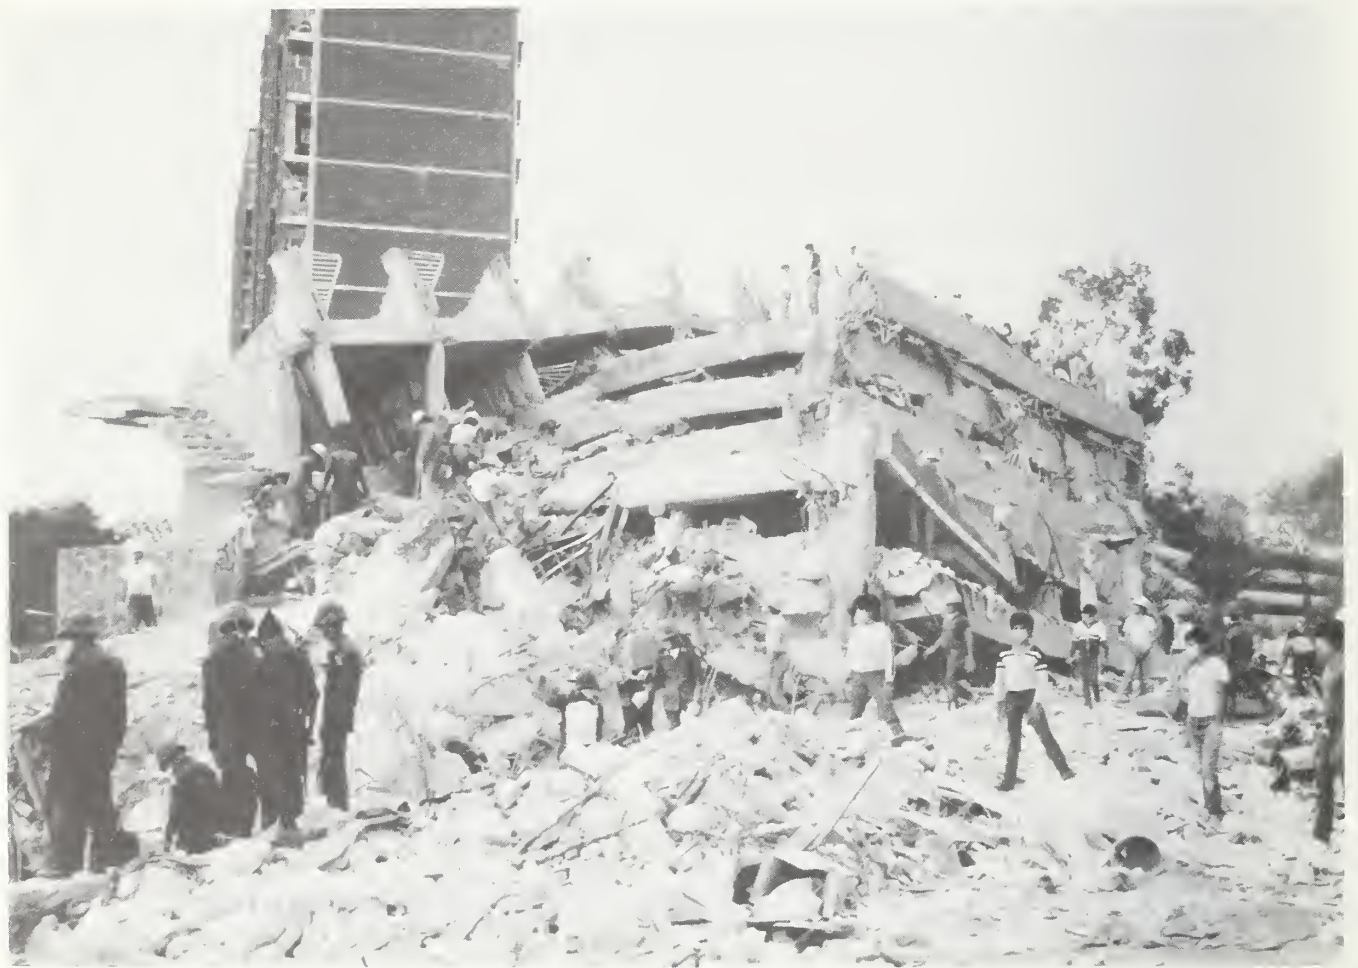
Figure 5.19. View of collapsed apartment looking northeast.
