NBS BUILDING SCIENCE SERIES 165

# Engineering Aspects of the September 19, 1985 Mexico Earthquake

Following the September 19, 1985 Mexico earthquake, a team consisting of four engineers and one seismologist from the National Bureau of Standards (NBS) and the United States Geological Survey (USGS) was dispatched to Mexico City to provide technical advice to the US rescue effort and to assess structural damage. This report is primarily based on data gathered by the team, but it also contains a compilation of other available information. The report addresses the origin and characteristics of the observed ground motion, the ability of buildings designed in accordance with present and proposed seismic design provisions to resist this type of ground motion, and observed data on structural and foundation failures.

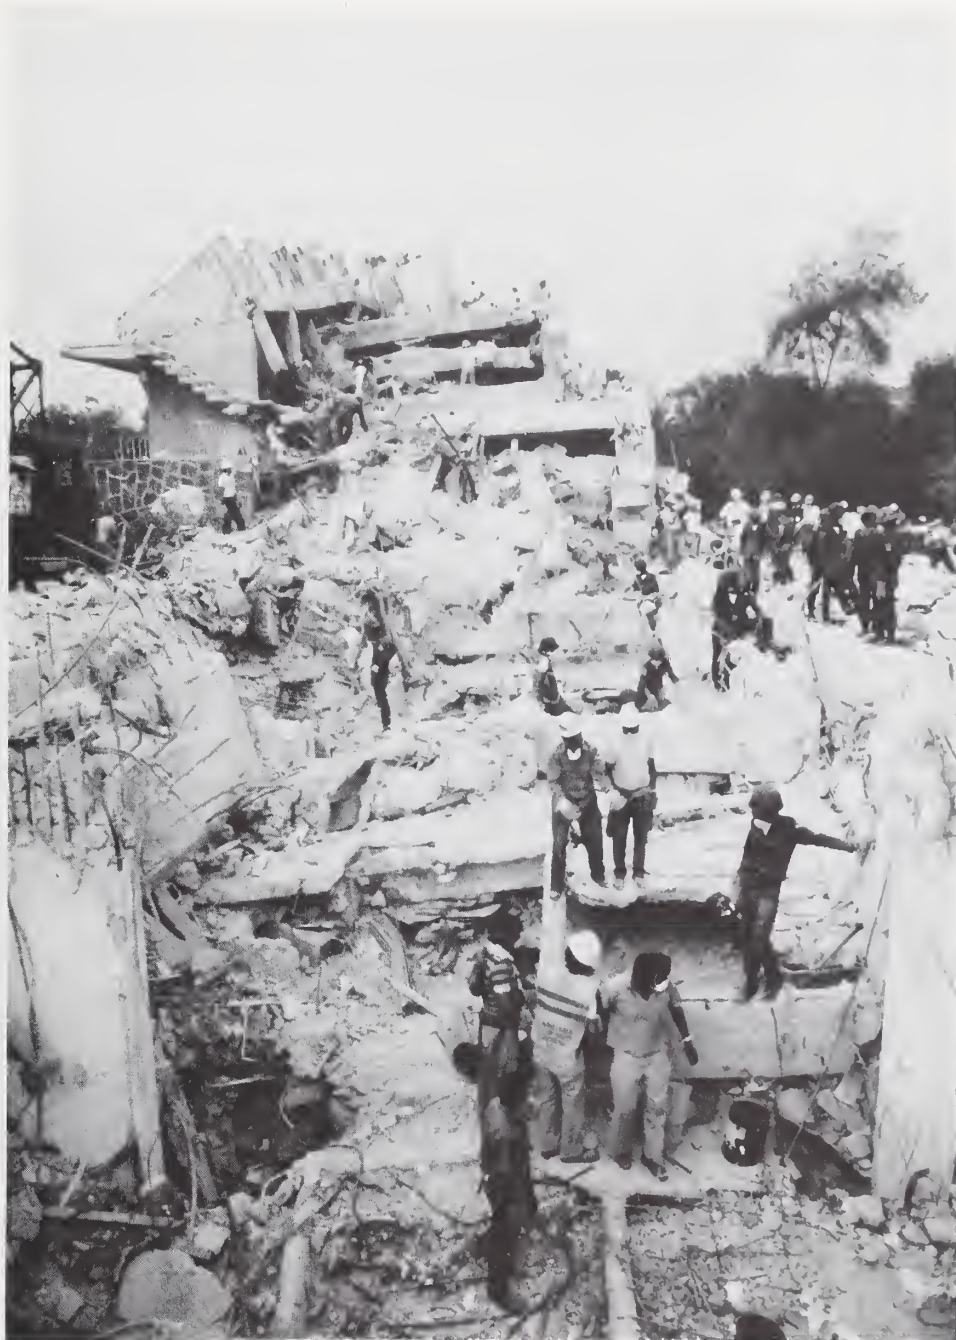
Figure 5.20. View of collapsed apartment structure looking east.

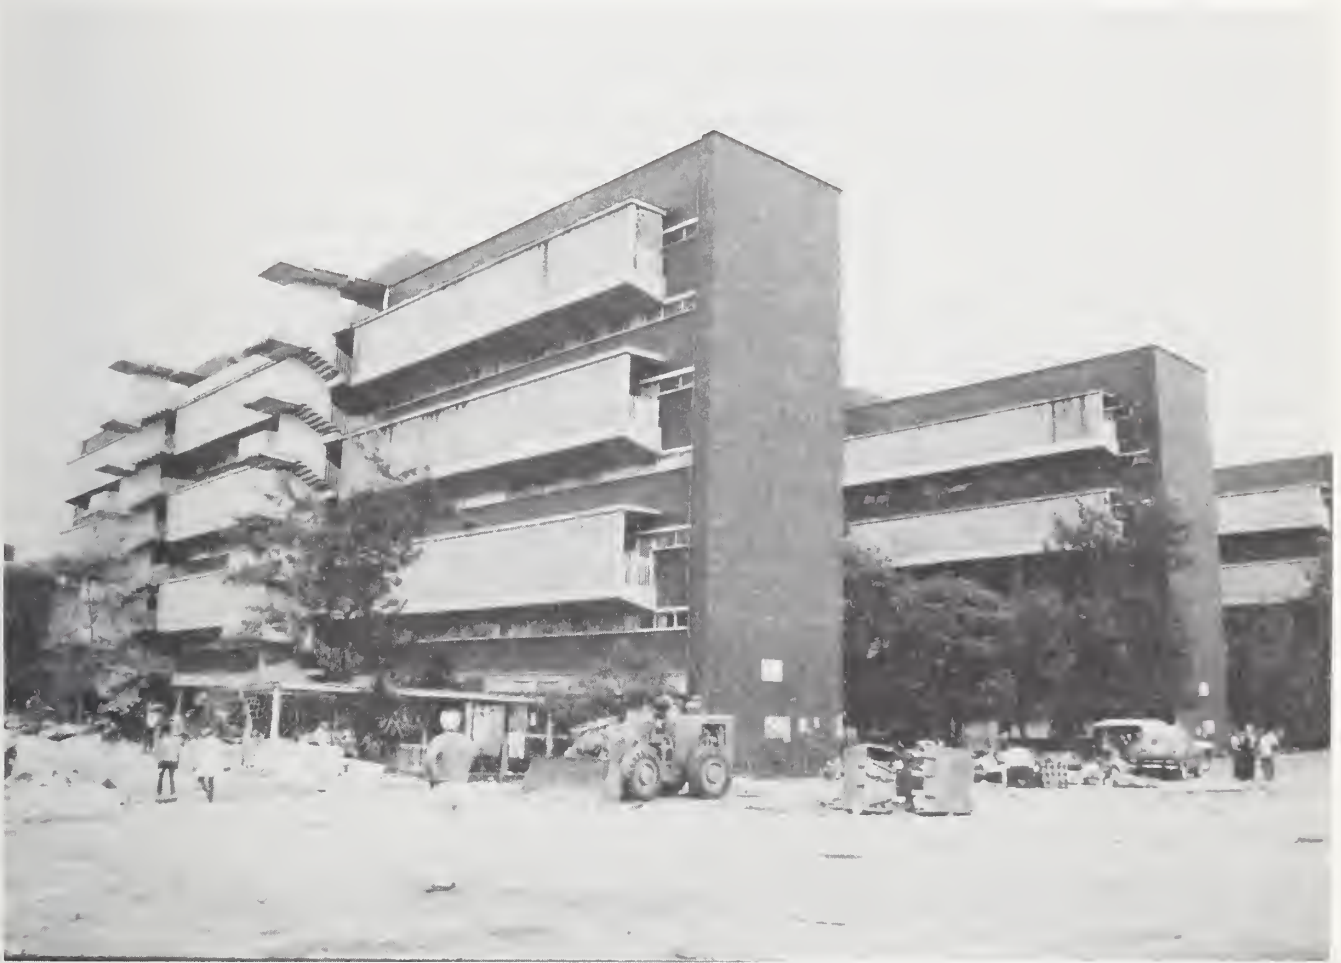
It is of particular interest to know why this particular building collapsed, while its three sister structures (figure 5.21) immediately to the south, did not. Part of the reason may be local variations in the soil consolidation, or perhaps differential-settlement induced stresses, as mentioned in Section 5.2.

Figure 5.21. Undamaged apartment building near identical structure which collapsed.

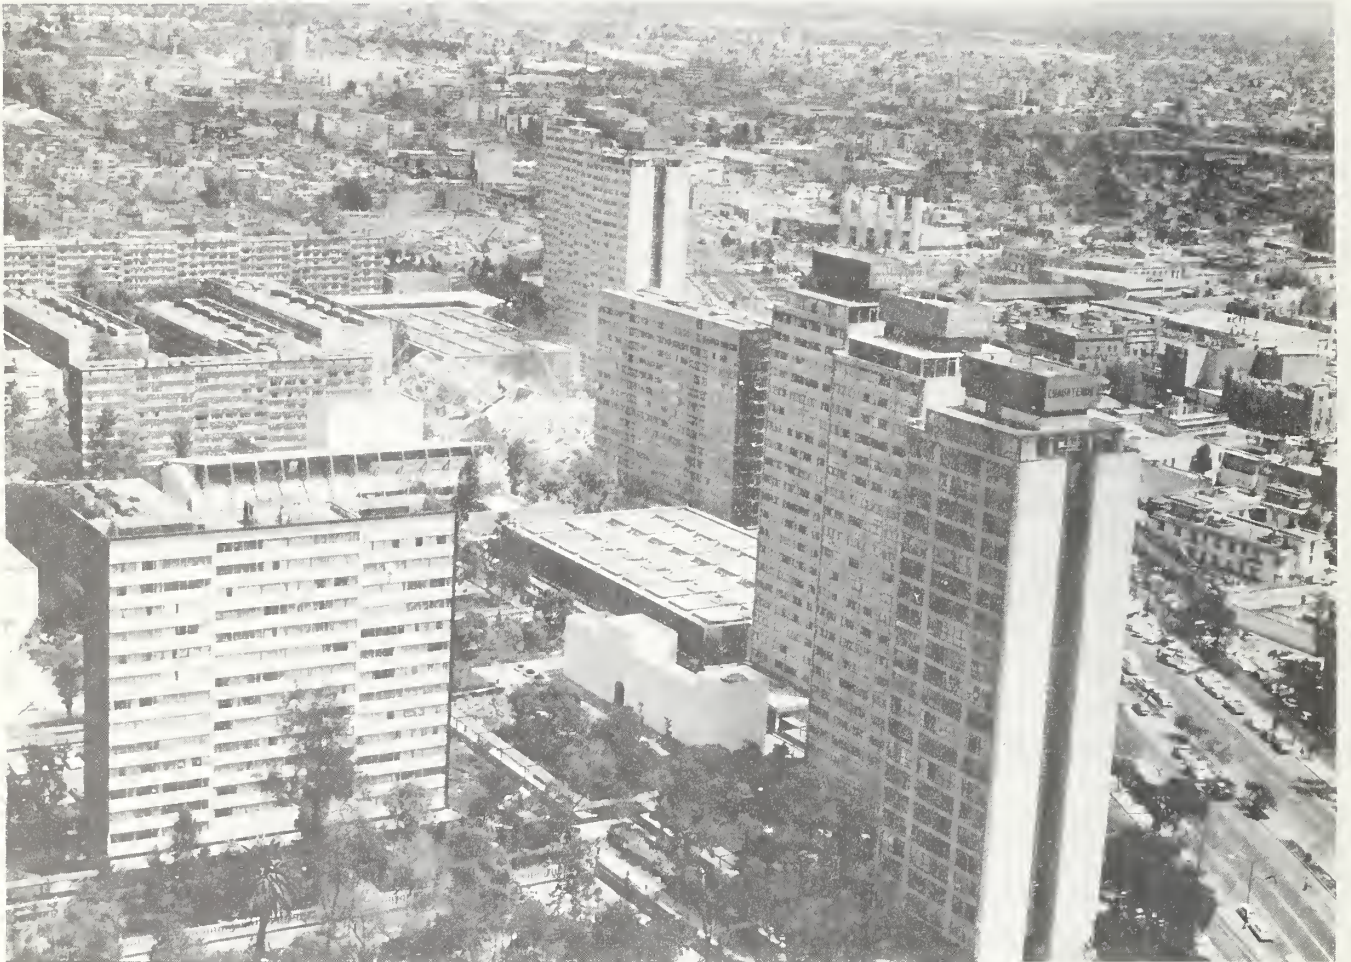
Taller concrete structures with flat plates, such as apartment buildings over five stories, were particularly susceptible to earthquake damage. The 14-story Nuevo Leon building was part of the Tlaltelalco housing project (figure 5.27) near the intersection of Guerrero and Flores-Magon, approximately 2km north of the area most heavily damaged by the quake. This structure consisted of three independent wings separated by construction joints. The two northernmost wings, each containing

Figure 5.27. The Tlaltelalco Apartment Complex. Nuevo Leon building is located at center of photo. Aerial view looking northeast.

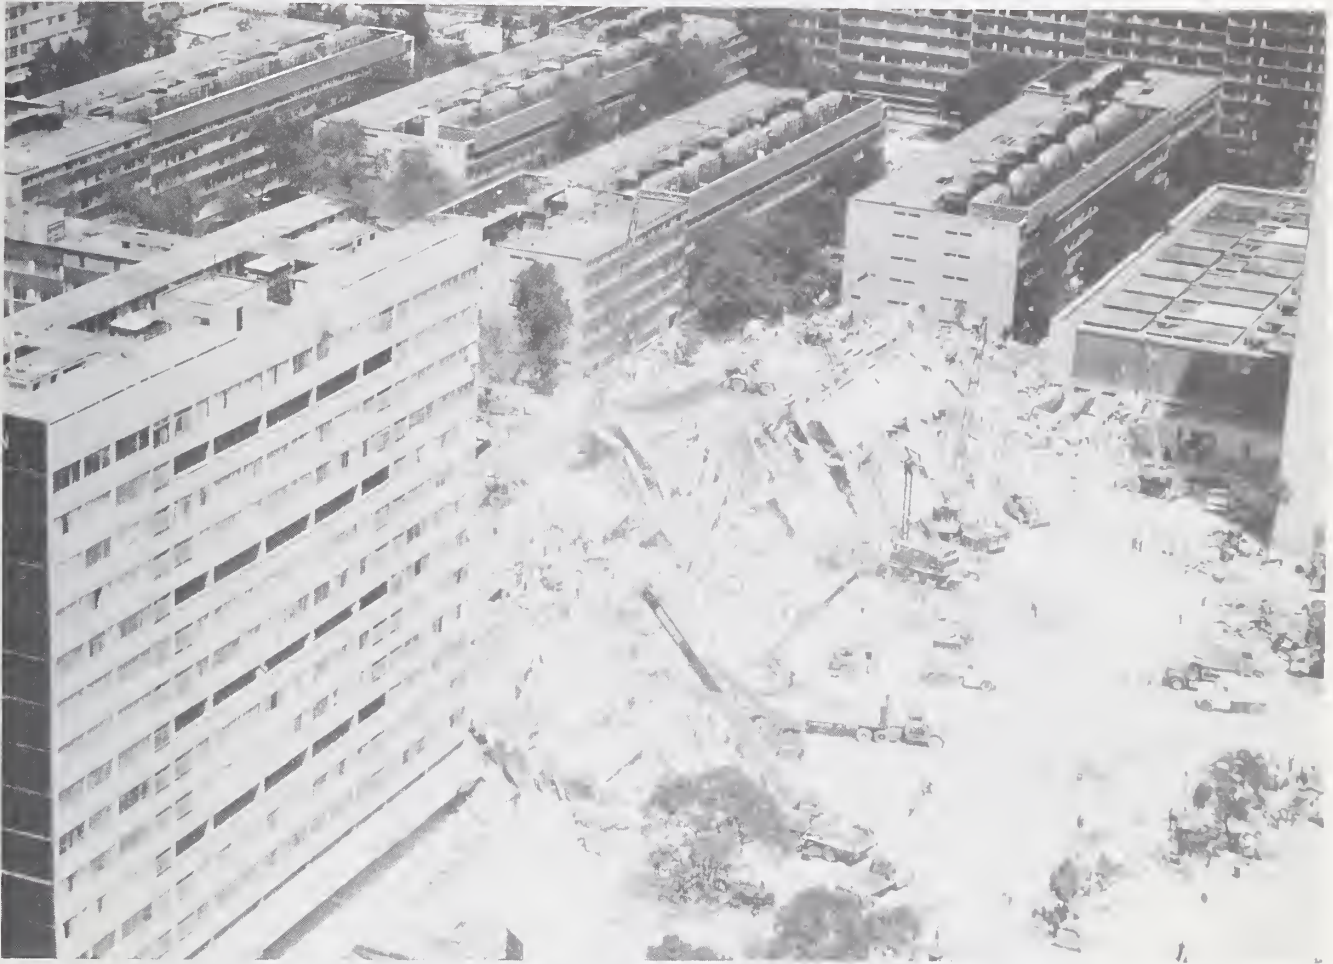
196 apartments (see figs. 5.28 and 5.29), apparently collapsed due to overturning when a failure was initiated on the east side of the structure near the foundation level. Supporting columns were then sheared or pulled from the ground on the west side of the structure (figure 5.30), leading to the toppling of the building towards the east.

Figure 5.28. Aerial view looking northwest of the Nuevo Leon Apartment Complex.

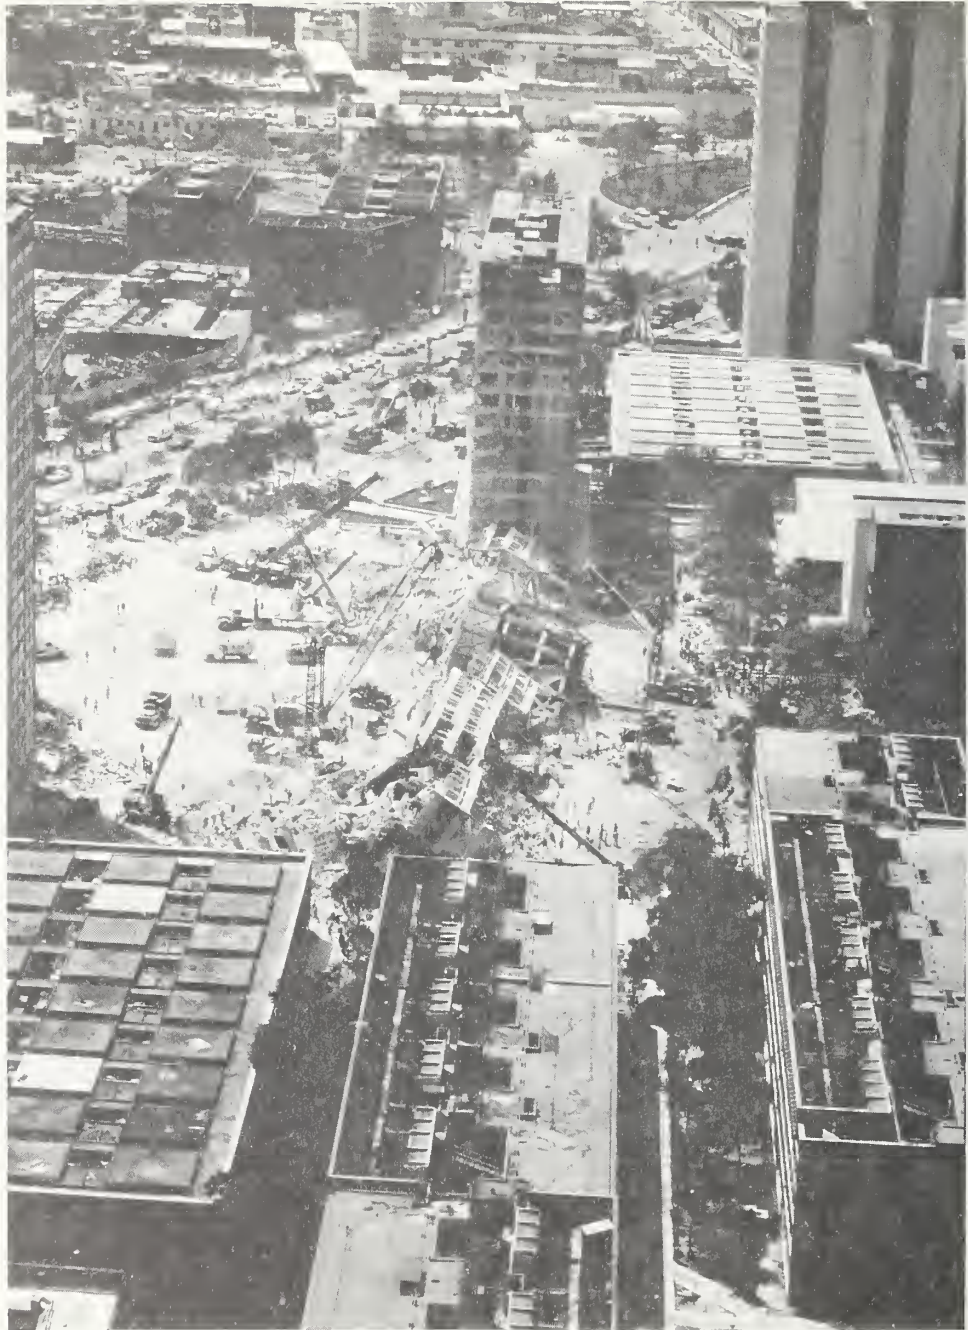
Figure 5.29. Aerial view looking south of the Nuevo Leon Apartment Complex.

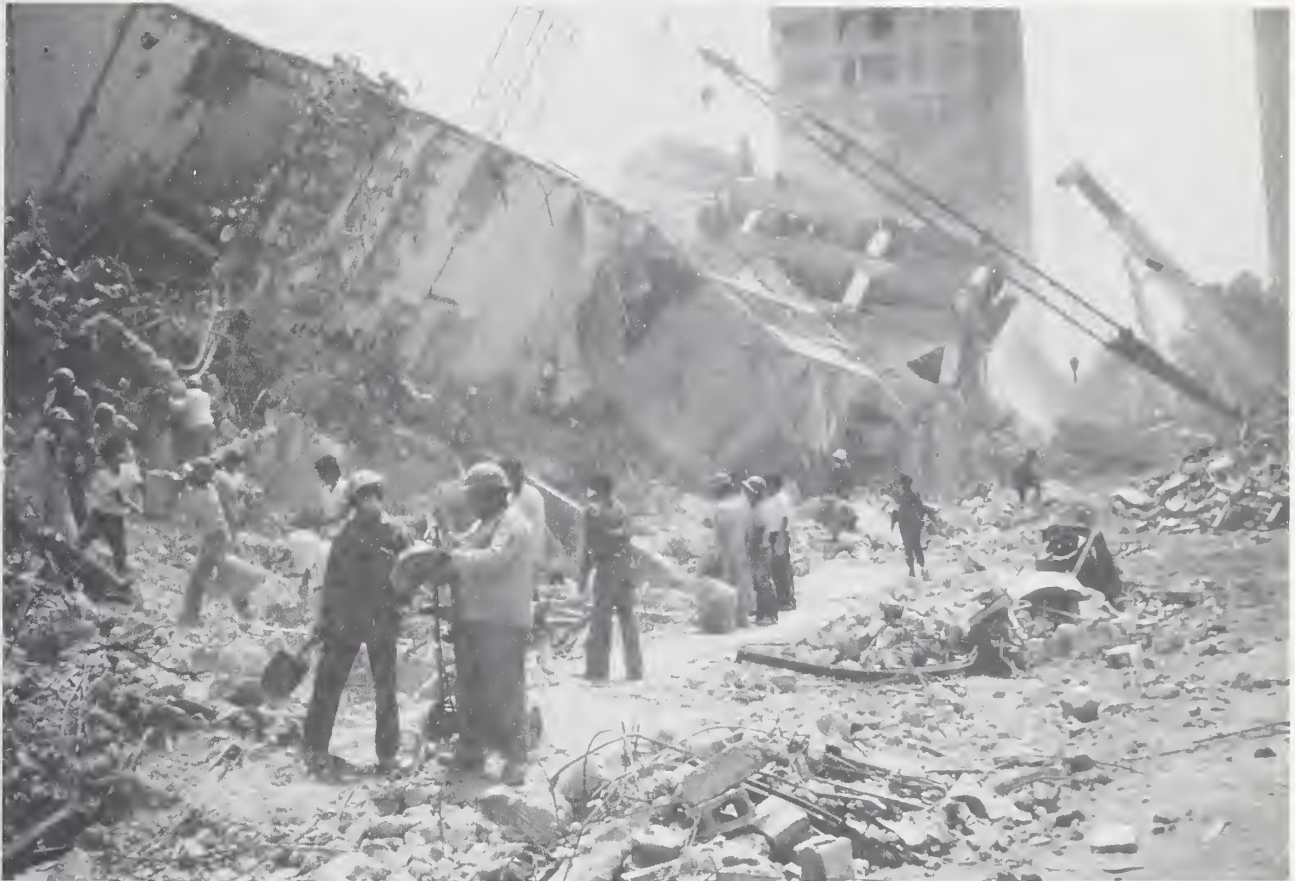
Although the floor levels behaved as flat slabs, they were in fact a special variety of waffle slab. This can be verified by inspection of figure 5.30 which shows the presence of porous blocks used to form the slab, revealed after the ceiling plaster spalled off during the final impact. Figure 5.31 shows the presence of regularly spaced reinforced concrete x-bracing as well as masonry infill walls which would have served to resist lateral forces during the earthquake. Figure 5.32, in fact, shows four structures identical to the Nuevo Leon building in the same vicinity which performed better during the quake.

Figure 5.30. West side of the collapsed Nuevo Leon Apartment Complex.

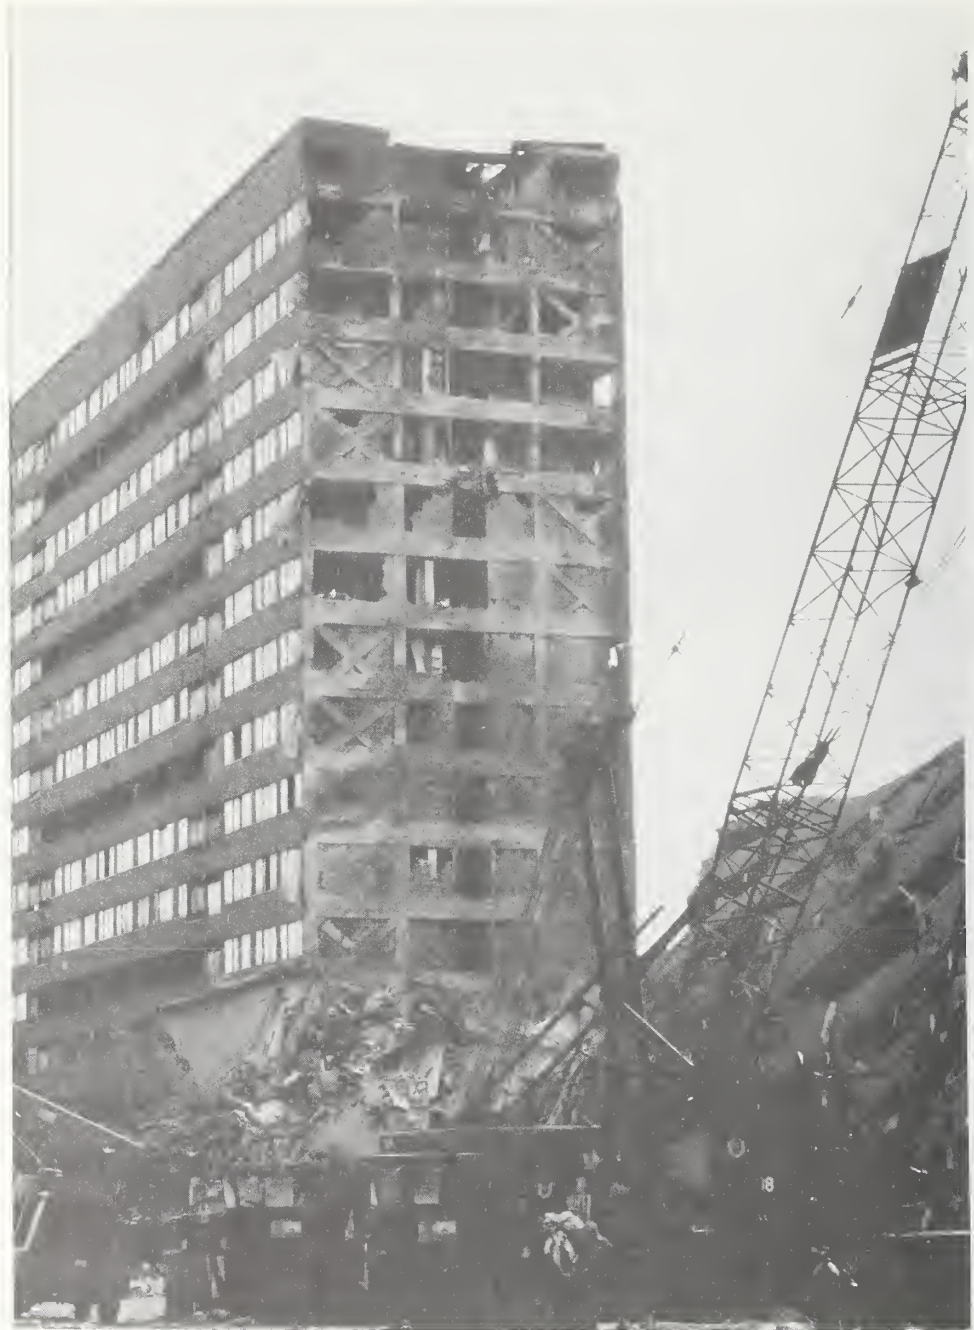
Following the 1979 Petatlan event, residents complained of noticeable settlements. Subsequently, some foundations, notably that of the Nuevo Leon building, were underpinned. The resulting difference in foundations may have contributed to the collapse: the stiffening of the foundation on the east side of the building led to an asymmetrical response condition whereby the east side columns would have been subjected to relatively greater lateral forces. Figure 5.33 shows failures that have occurred in the short column line on the east side of the remaining southern apartment tower, particularly on the level used as a passageway between blocks.

Figure 5.31. Concrete X-braces in remaining tower of Nuevo Leon Apartment Complex.

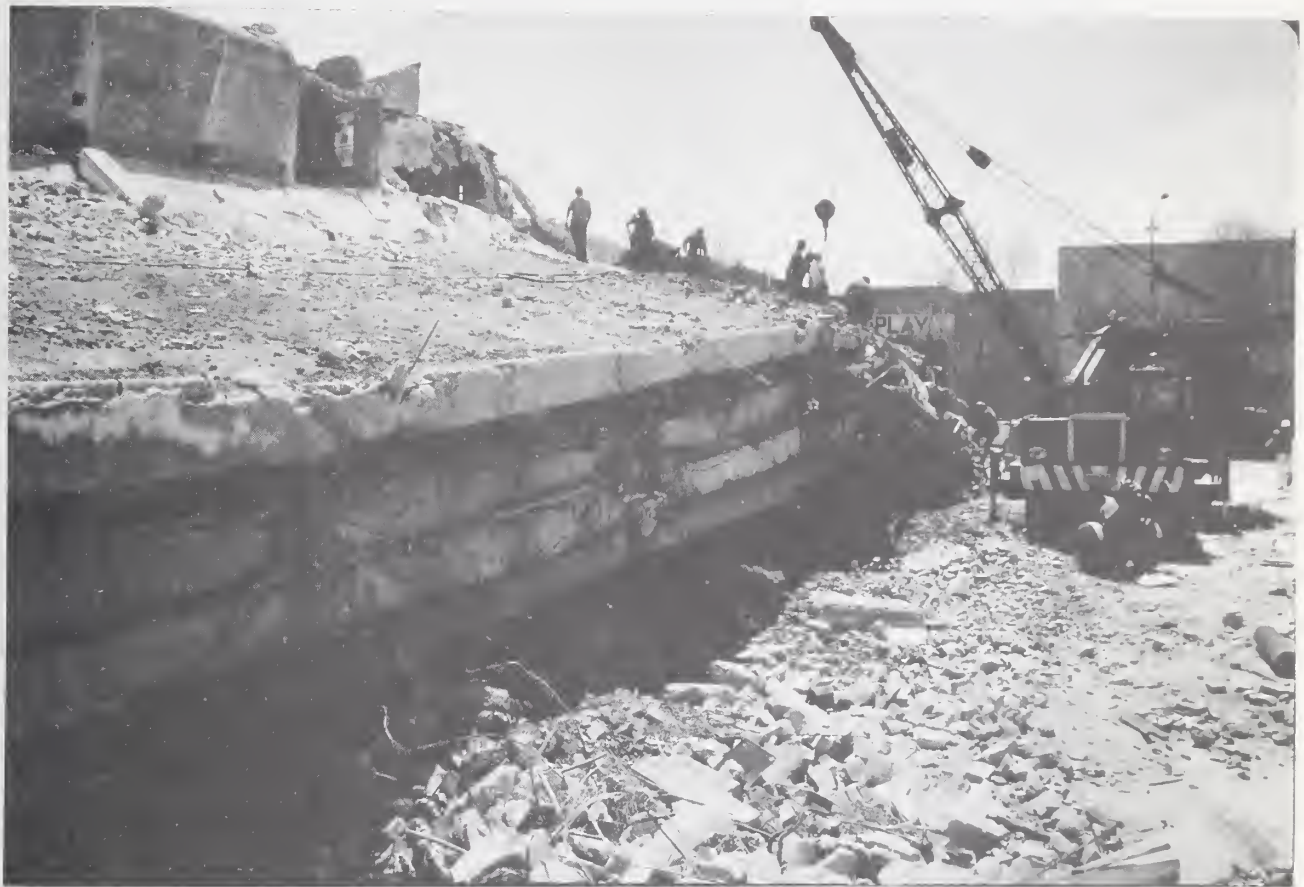
This asymmetry in column loading may have induced a failure of the first story east column line in the two northern structures, due to the relatively lower stiffness associated with the first floor lobby. Shearing of the columns would then occur either at underconfined joints or at the story mid-heights between the x-bracing. That the x-bracing proved effective is demonstrated by the relatively intact nature of large sections of the structure after failure. This is to be contrasted with figures 5.34 and 5.35 which show an office structure near the corner of Neva and Barragan streets, similar in many respects to the Noeva Leon building, with the exception of the lack of reinforced concrete x-bracing. The pancaking phenomenon is clearly evident.

Figure 5.35. Collapsed office building near the corner of Neva and Barragan Streets.

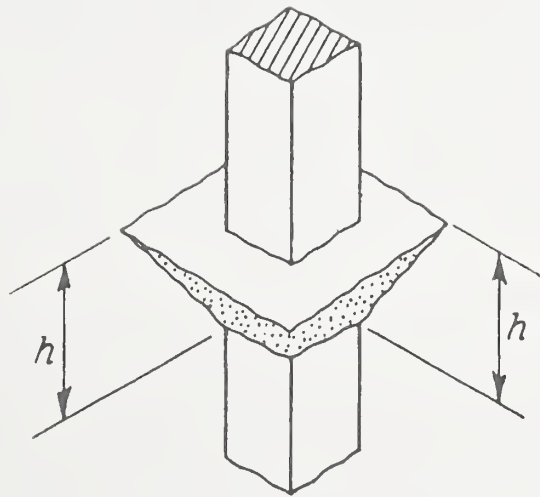
A typical example of flat plate structural failure is shown in figure 5.36, of the ten story Bancomer Building at the corner of Ave. Mier and 20 de Noviembre. This building was constructed recently, after the 1976 design code changes. In many cases the use of thin slabs precluded the placement of sufficient shear reinforcement in the vicinity of the slab-to-column junction. Under the reversed cyclic loading imposed by the earthquake, punching shear failures initiated a vertical progressive collapse, leaving the columns standing. Such failures were also seen at several other collapse sites involving flat plate construction. With the exception of projecting reinforcement at approximately 4 meter intervals, the columns appear bare in figure 5.36. Closer inspection showed that the floor plates slid down the columns, one on top of the other. The classical "shear cone" failure, shown in figure 5.37, is not visible here because the upper floors successively sheared off these cones from the top side as they fell.

Figure 5.37. Shear cone resulting from punching shear failure. Ref. [24].

relatively low ductility at the slab-to-column junction which could have been improved through the use of special shear head reinforcement, as was mentioned in section 5.4.1 above, b) the popularity of this form of construction -- due to its economy -- following the 1976 design changes, giving rise to a larger percentage of structures in the 6-15 story range.

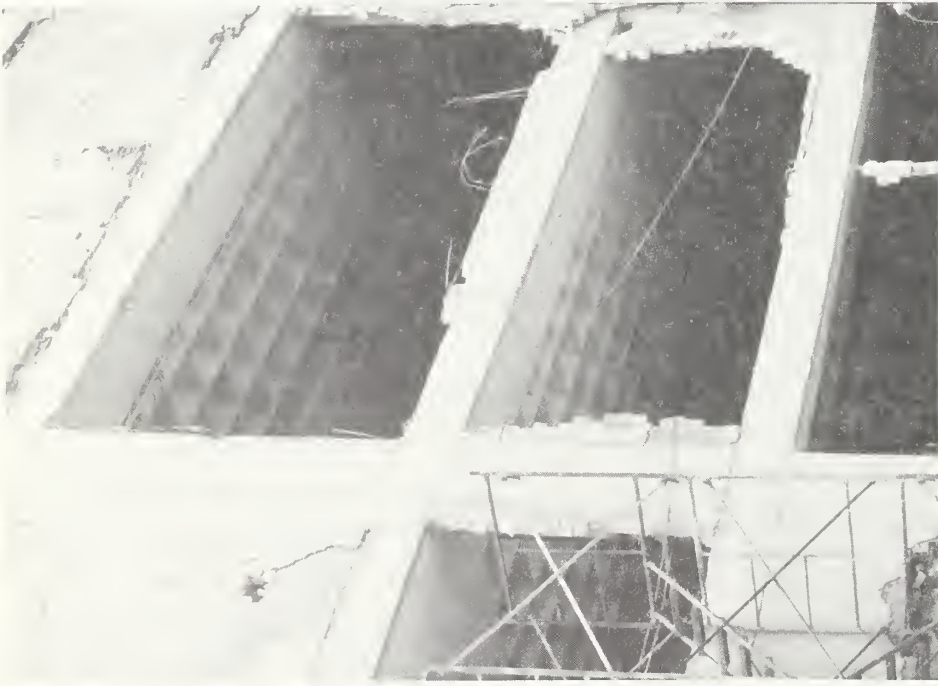
In many cases, the extent of damage to this type of structure was determined by the presence or absence of masonry exterior infill shear walls, as demonstrated in figures 5.38 a and b. The infill walls shown in figure 5.38a failed, and in the process absorbed a

substantial amount of energy prior to buckling outward. On the other hand, the Banco Vencen building near the corner of Ave. Trujano and Hidalgo (figure 5.38 b) was under construction and masonry walls were in the process of being added to some of the upper floors, but were not complete enough to prevent column shear failures from occurring along the entire eastern side of the frame at the third story. Those portions of the building where the infill walls had been completed remained standing. A typical example of a failure of a waffle-slab structure with flexible columns was the 10-story apartment building at the corner of Ave. Dinamarca and Chapultepec shown in figures 5.39 a and b.

(a) Waffle slab building in which masonry infill walls absorbed much of the earthquake energy.

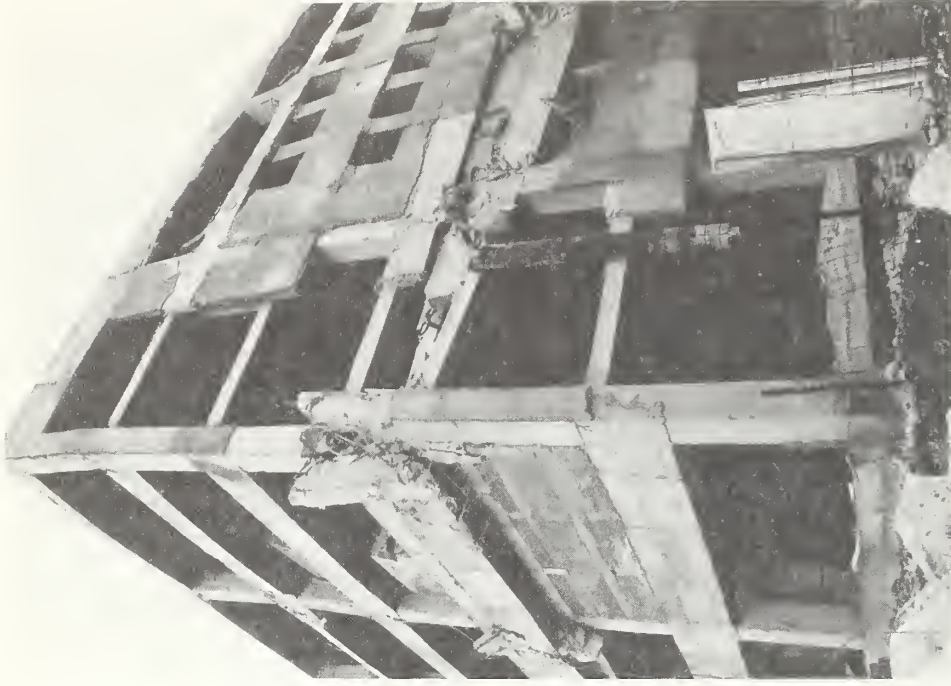
(b) Collapsed waffle slab building which was under construction.

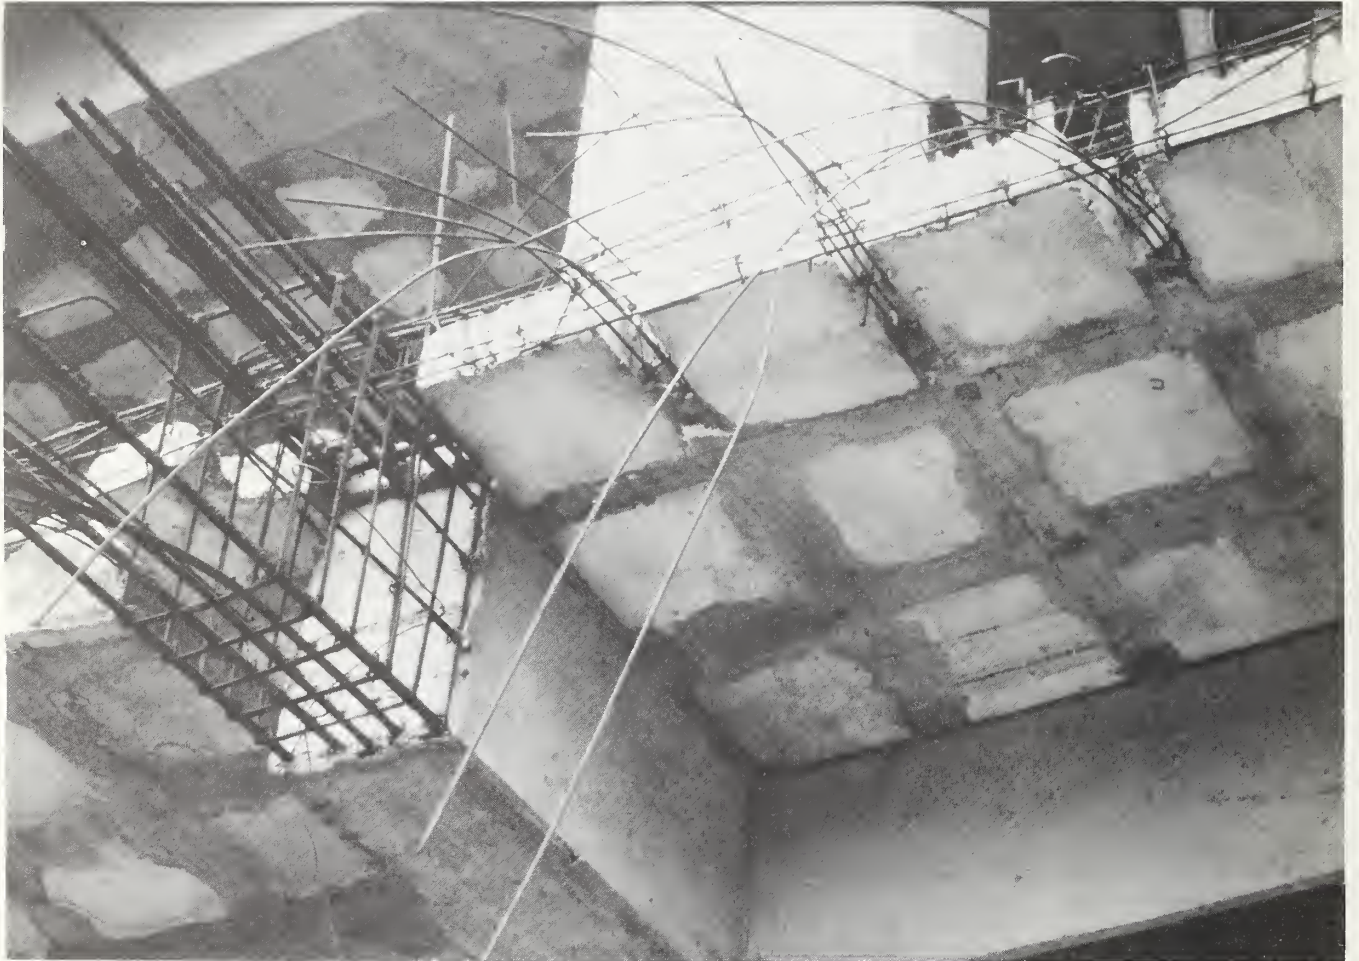
Two unusual variations in waffle slab construction bear mentioning, as they proved to be particularly poor performers during this earthquake. Figure 5.40 shows a new parking garage north of the U.S. Embassy on Ave. Reforma under construction, using rectangular cinder blocks in place of the traditional metal pan forms. The rationale behind this technique was to use readily available, inexpensive cinder block to form the blockout, thereby avoiding the expense of an inventory of metal pan forms while also leaving a smooth ceiling surface for finishing. These cinder blocks are spaced similarly to their metal counterparts, but are left in the structure permanently. Because they are cast into the slab the cinder blocks add to the mass of each floor level.

Figure 5.40. Parking garage under construction on Reforma, north of the U.S. Embassy.

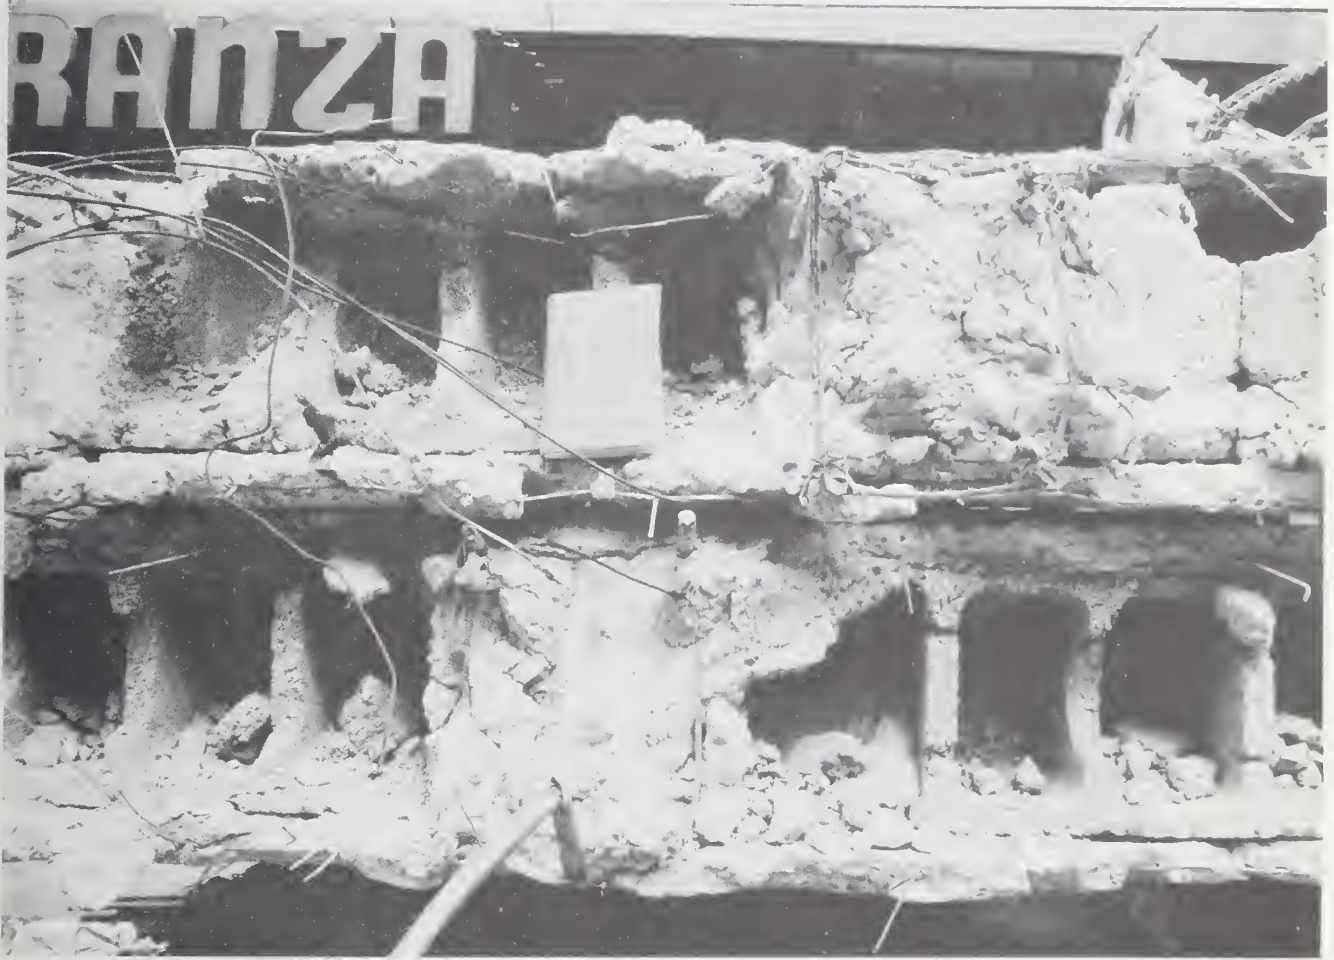
Yet another variation of this form of construction employed standard hollow cinder building block, as shown in figures 5.41. This type of slab was particularly prone to bond failure during reversed cyclic loading, leading to the "floor drop out" phenomenon shown in figures 5.42 and 5.43. In most cases, these same structures contained minimal slab reinforcement placed with

Figure 5.41. Waffle slab construction incorporating concrete block.

negligible cover. As the building underwent successive cycles of lateral loading, the bottom (tensile) cover concrete spalled off, leaving the tension reinforcement exposed in a grid-like pattern. With further shaking the cinder blocks simply began falling out, eventually leading either to the "floor drop out" phenomenon if sufficient shear reinforcement was present to resist a punching shear failure or, more likely, a progressive punching shear failure (see figure 5.43) similar to that observed in flat plate construction. It was apparent from the extensive and specific damage that special design procedures should be developed for this method of construction in future design codes.

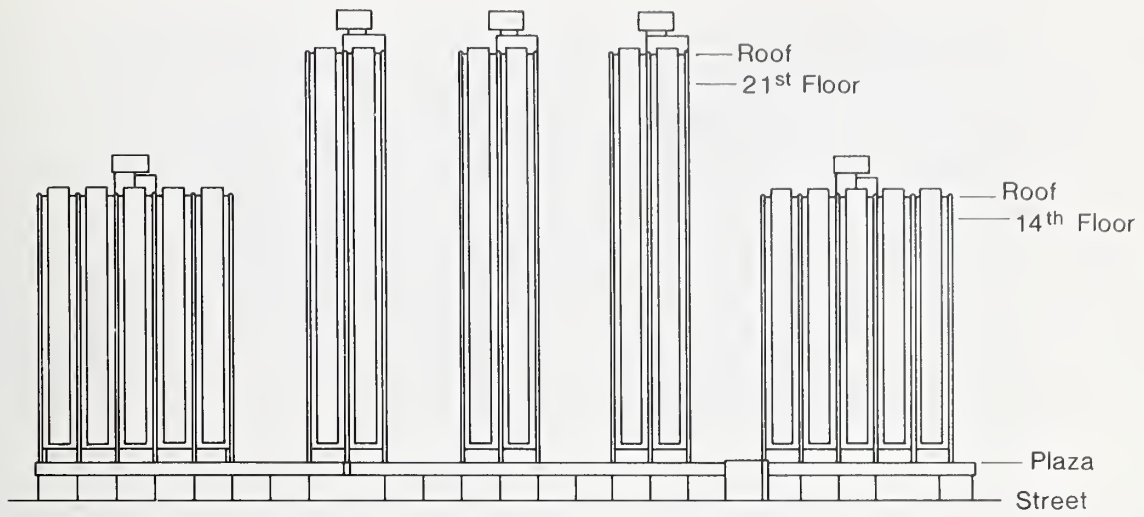
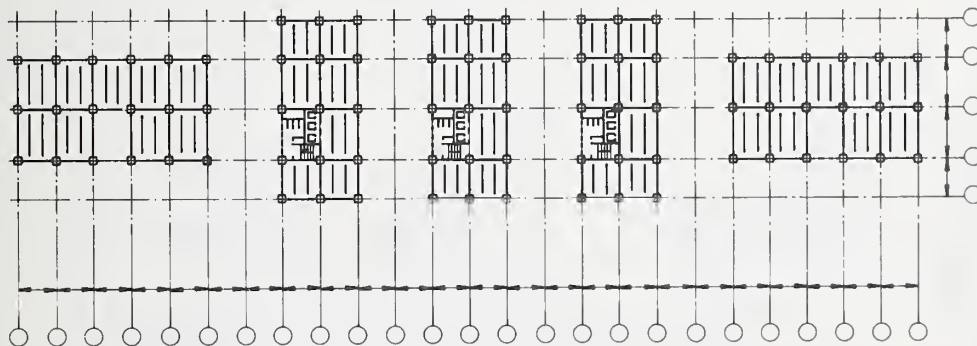
Figure 5.45 Plan and elevation of Pino Suarez Office Complex.

From the plan view of the complex presented in figure 5.45, it is seen that the lateral bracing surrounding the elevator shaft of each tower created an eccentric center of stiffness, thus resulting in torsional vulnerability. This was confirmed through a simplified three dimensional computer model (figure 5.51). The first mode of vibration in the narrow direction was scaled to match the known period of 2 seconds, since precise element stiffnesses and masses were not available at the time of the analysis. The same scale factor was used in making a best-estimate of the periods for the higher order modes in the real structure. The first mode in the wide direction had a calculated period of 1.17 seconds and a distinct twisting component; and the pure torsional mode had a calculated period of 0.64 seconds, sufficiently long to have been excited by the September 19 earthquake. Column axial and bending forces would have been generated in the structure due to components from each of these modes of vibration and, during certain phases, these forces would be additive on certain structural elements, producing loads in excess of those that would be indicated from two dimensional dynamic analyses commonly employed in structural design.

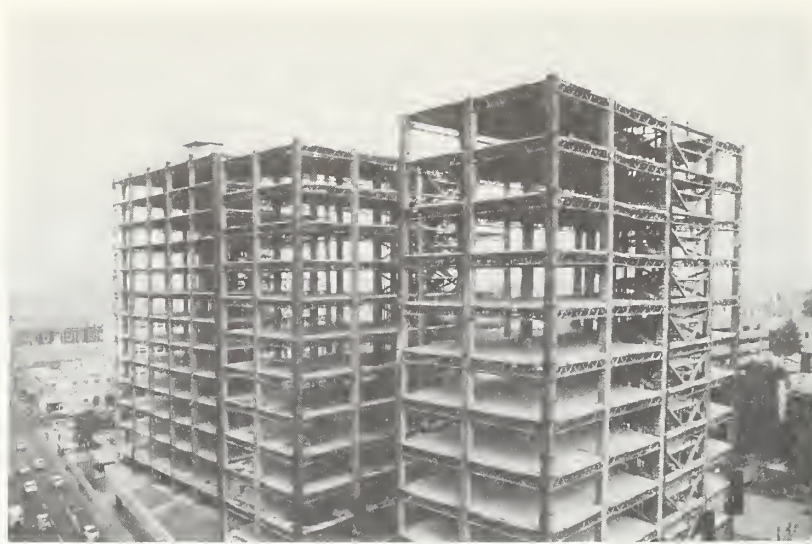
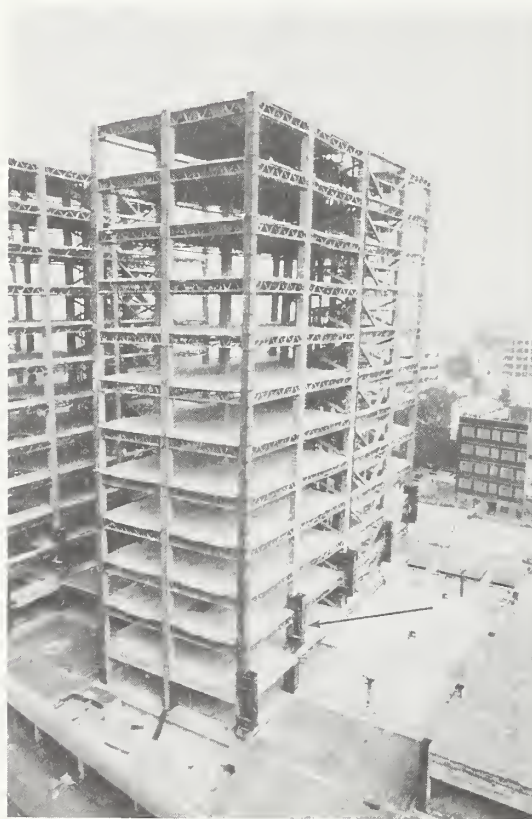
Figure 5.47. Remaining Pino Suarez structures shown during July 1986.

(a) Remaining three Pino Suarez towers.

(b) Central 23-story tower (reduced to 14 stories) at Pino Suarez.  
Note "C" clamps at bottom right.

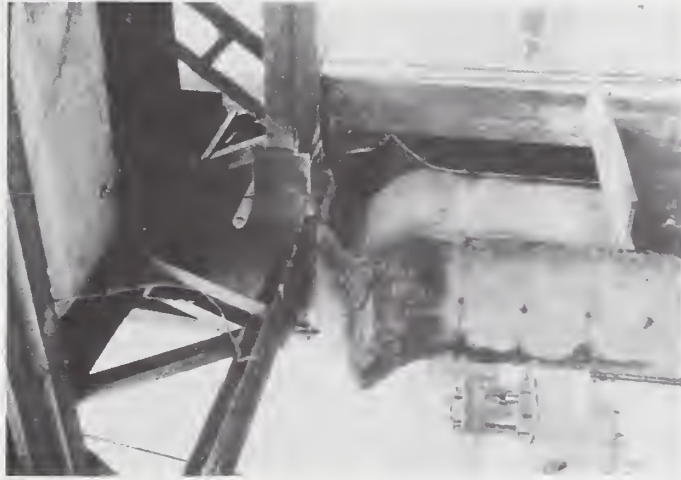
Figure 5.50. Box column buckling and truss beam to column connection details at Pino Suarez Complex.

(a) Detail of the moment resisting connection of truss beam to column. (courtesy Dr. R. Hanson)

(b) Buckled column on south side of center 23-story tower. (courtesy E. Martinez Romero)

buckled (see figure 5.50) indicating that they were not able to dissipate energy through inelastic action in the manner of typical rolled beam sections. This in turn had two adverse effects: primary ductility demand was transferred to the columns (for which they were not designed) and large lateral deflections gave rise to large P-delta effects, all of which served to overstress the southern, stiffer, column line. Eventually, local plate buckling -- amplified by weld tears at the plate joints -- occurred in the most highly stressed columns along the south face near the top of the common mezzanine.

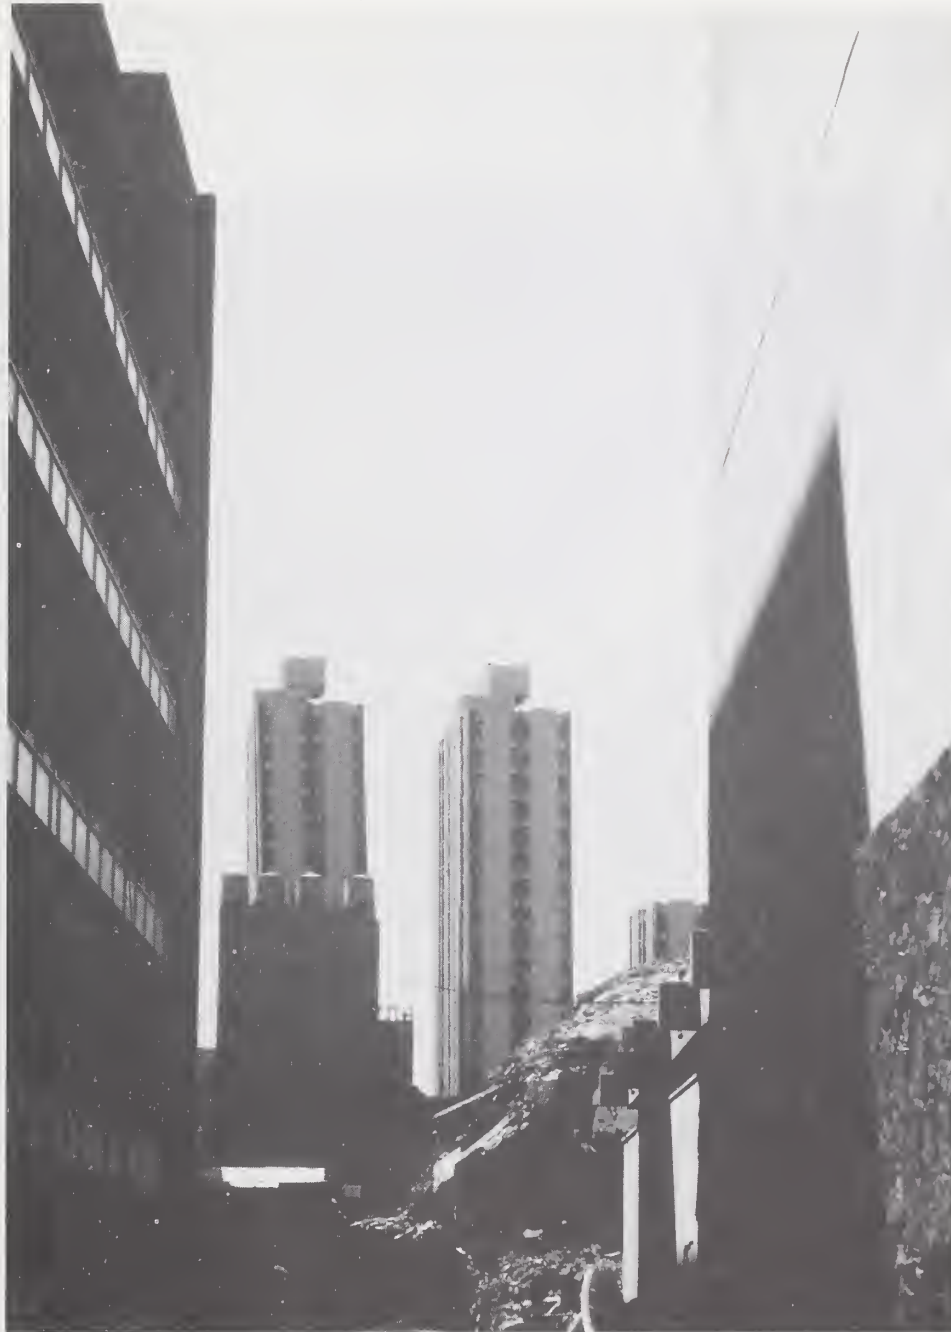
Buckling of columns, and deformations caused by other actions, induced substantial tilt towards the south, as can be seen in figure 5.52. It is highly probable that this situation existed in all three of the 23 story towers prior to the ultimate collapse of the southern-most tower. To complete the collapse mechanism, however, an additional failure was required. Figure 5.53 indicates that the final straw was likely a series of tensile fractures in the box-columns on the north side of the frame, presumably at a joint line near the second story. Lacking this crucial moment resisting element (viewing the structure as a whole) the tower was free to rotate southward, further crushing the southern column line in the process, and eventually impacting on its neighboring 14 story building. Both buildings were subsequently destroyed, leaving the two collapsed buildings in the configuration previously shown in figure 5.44.

Figure 5.52. Tilted central 23-story tower at Pino Suarez Complex. Southern side of structure is to left side.

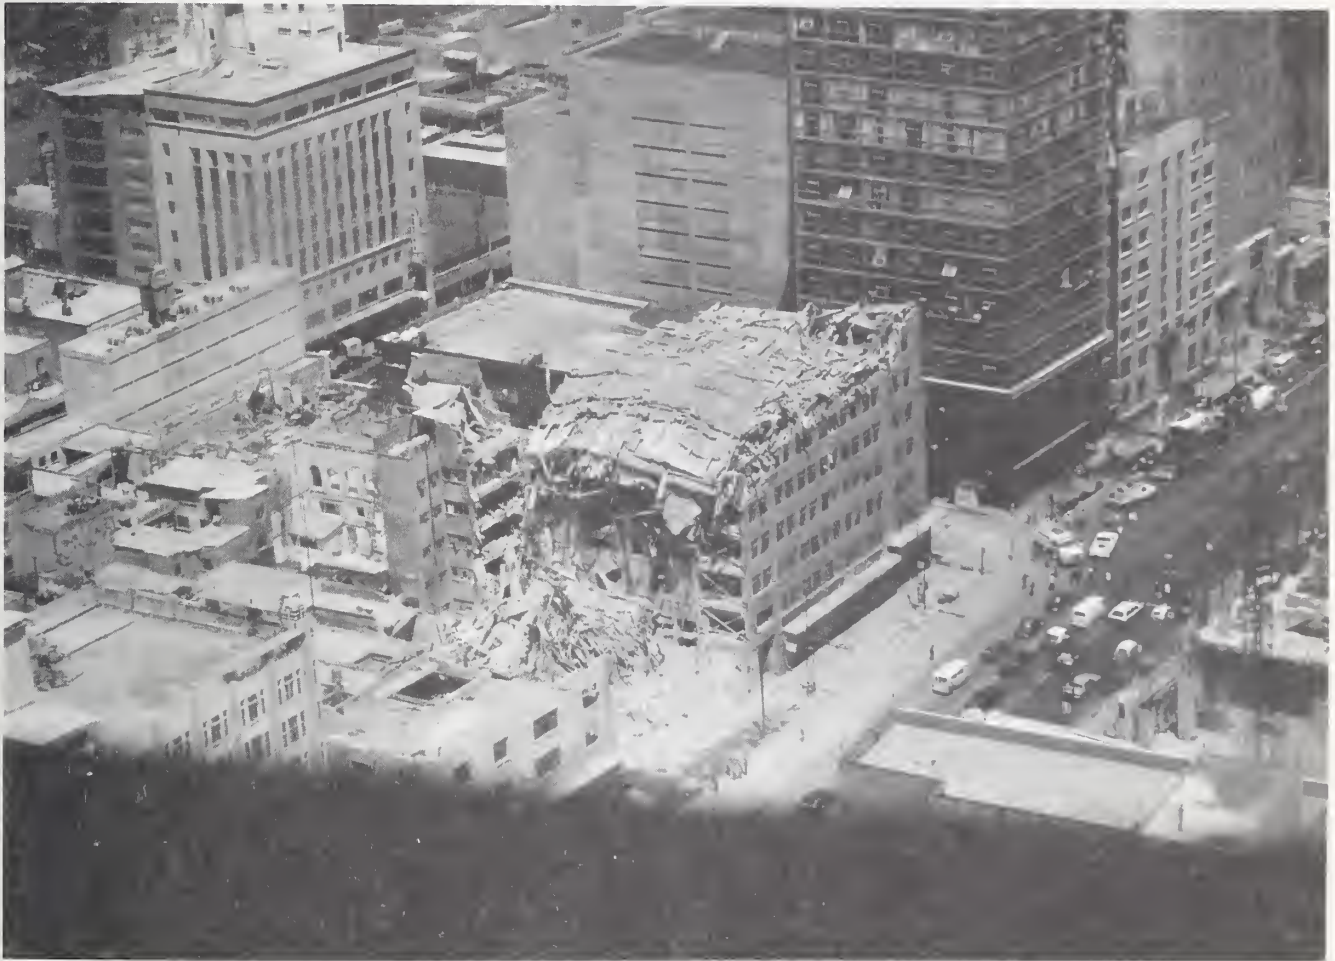
Figure 5.54. Aerial view of the Atlas Building, a typical steel frame structure constructed during the 1940's.

Other steel frame structures performed quite differently from the Pino Suarez Buildings, depending on their location, elevation, and proximity to adjacent buildings. One such example is the Atlas Building (figure 5.54), a 14-story concrete-encased steel frame structure constructed during the 1940's and located just south of Alameda Park on Avenida Lazaro Cardenas. During the 1957 quake this building suffered significant damage to moment-resisting knee braces (steel angles) and was later retrofitted with the diagonal cross bracing visible in figure 5.54.

During the 1985 earthquake the upper seven stories of the building collapsed. The front of the adjacent seven story structure was also destroyed by falling debris from the Atlas building. In the case of the Atlas Building, field evidence indicated that pounding was the principal cause of collapse of the upper floors.
