NBS BUILDING SCIENCE SERIES 165

# Engineering Aspects of the September 19, 1985 Mexico Earthquake

Following the September 19, 1985 Mexico earthquake, a team consisting of four engineers and one seismologist from the National Bureau of Standards (NBS) and the United States Geological Survey (USGS) was dispatched to Mexico City to provide technical advice to the US rescue effort and to assess structural damage. This report is primarily based on data gathered by the team, but it also contains a compilation of other available information. The report addresses the origin and characteristics of the observed ground motion, the ability of buildings designed in accordance with present and proposed seismic design provisions to resist this type of ground motion, and observed data on structural and foundation failures.

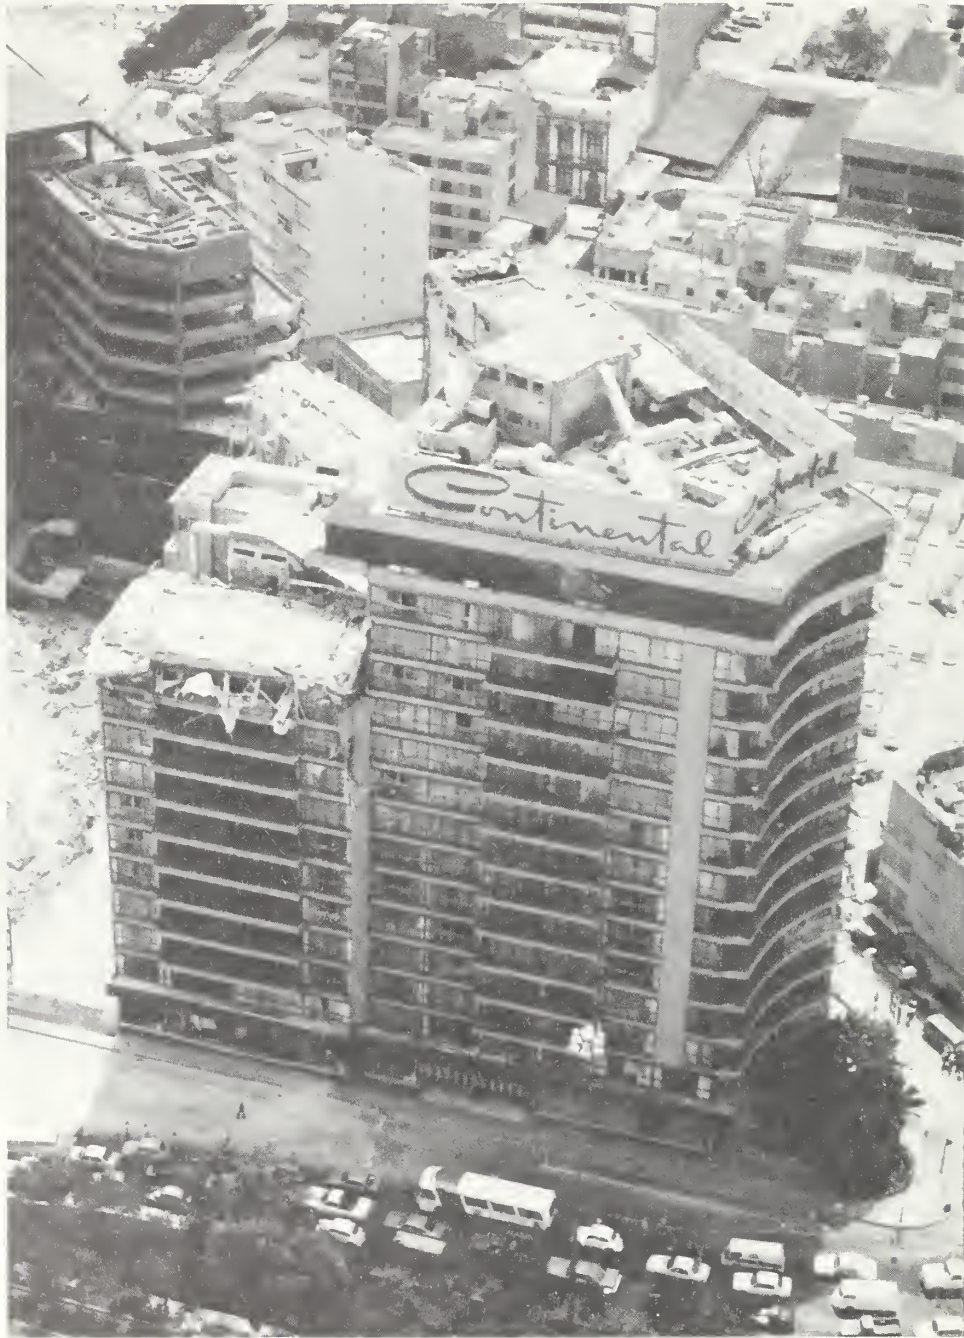
One variant on the pounding problem occurred where expansion joints existed within a structure and where it was possible for the separated substructures to vibrate independently, but where an insufficient "seismic gap" was provided to prevent pounding. An example of this type of failure was the Hotel Continental on Avenida Reforma. The building was V-shaped in plan, largely because of its street corner location, with two independent wings forming the "V" (see figure 5.60). The wing sections, each as tall as the main structure, apparently vibrated out of phase with the stiffer primary building and eventually suffered column failures due to pounding. This, in turn, led to the collapse shown in figure 5.61. Adequate separation between the wings of the building may have prevented such a failure.

Figure 5.60. Aerial view showing "V" shape of Continental Hotel on Paseo de la Reforma.

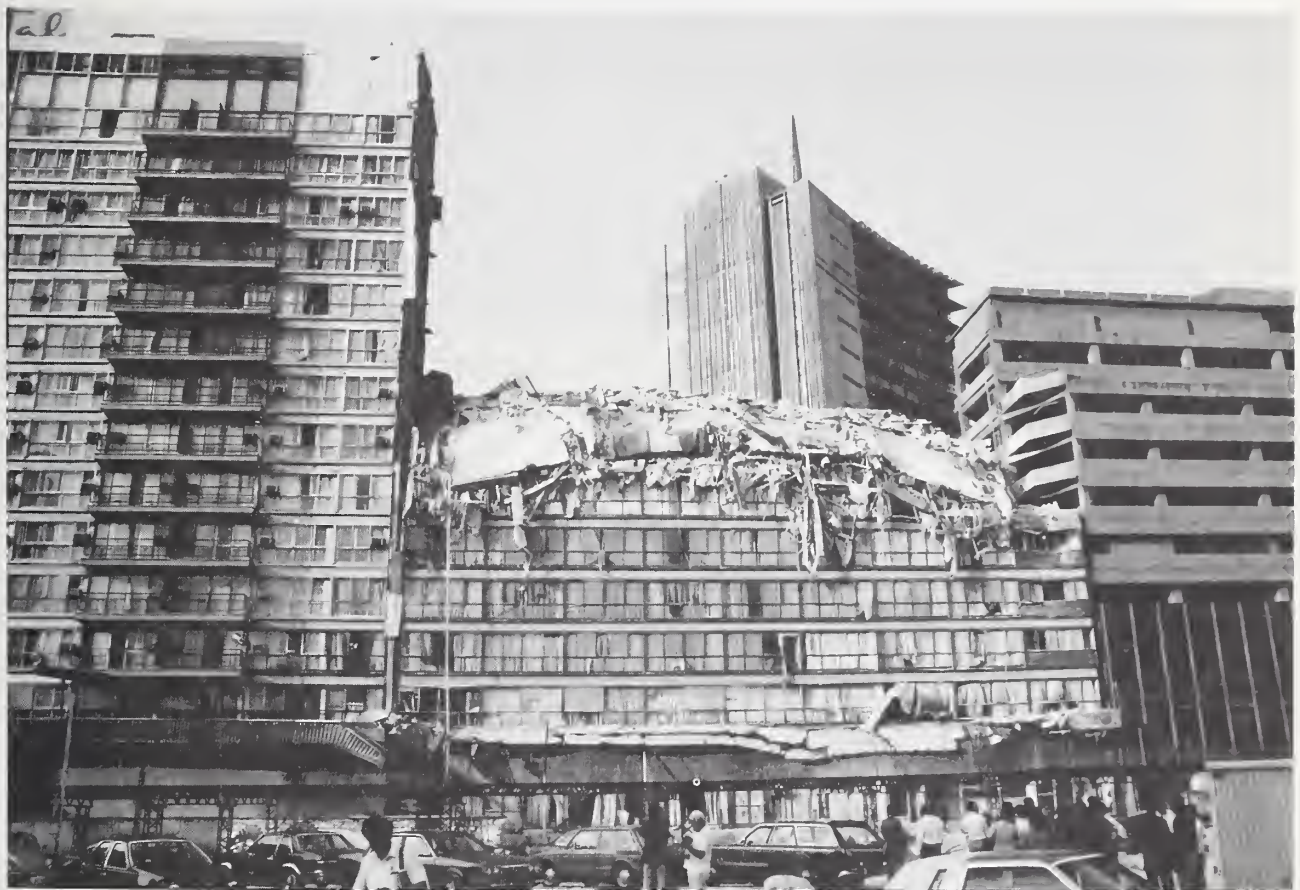
Figure 5.61. View looking north of collapsed southern wing of the Continental Hotel on Paseo de la Reforma. The entire complex was subsequently dynamited.

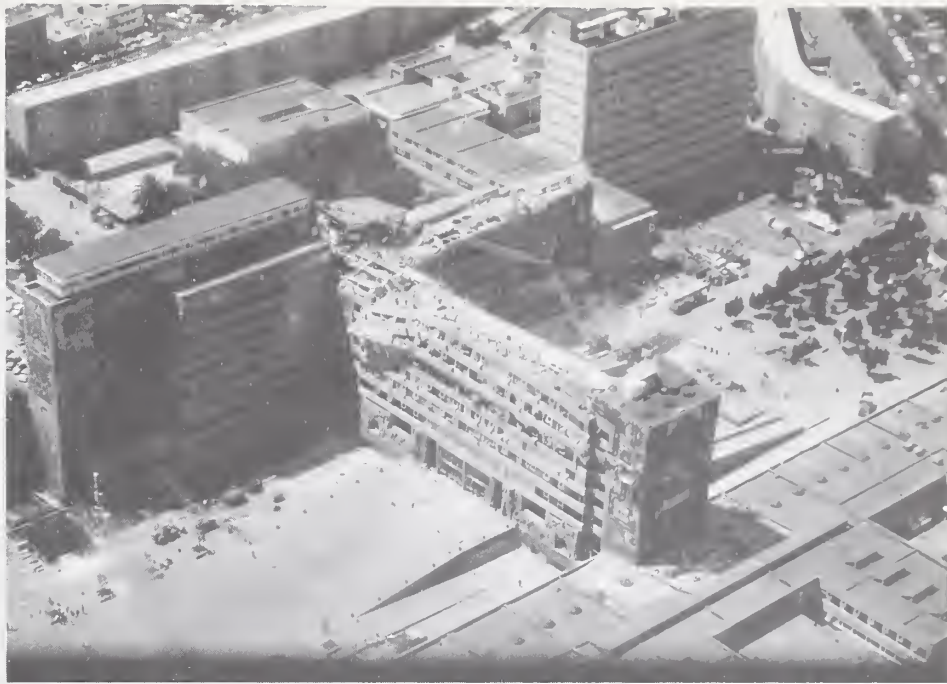
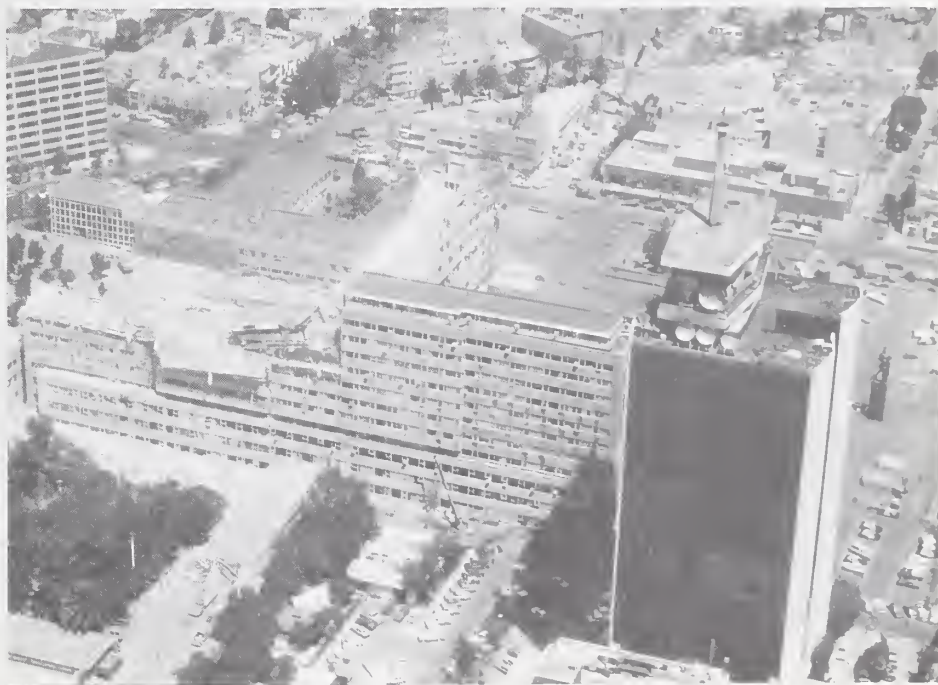
Figure 5.62. Aerial view of SCT Communications Complex.

An example in which building configuration appeared to have led to torsional response during the Mexico Earthquake is illustrated by the 12-story SCT (Secretaria de Comunicaciones y Telegrafos) complex (figure 5.62) on Ave. Lazaro Cardenas, approximately two kilometers south of the central historic portion of the city. The earthquake precipitated a progressive collapse which started near the top of the building at the inside northwest (re-entrant) corner as shown in figure 5.63. The collapse was probably triggered by failure of one of the upper columns (which are often of smaller cross-section and lighter-weight concrete in Mexico City) and then propagated by means of corner column failures along the north face of the west wing and the west face of the north wing of the T as can be seen in figure 5.64. The resulting progressive slab collapse was arrested at the 8th floor, where the 7th floor columns were sufficient to resist the impact load from the collapsing upper stories.

Later discussions with Mexican engineers [36] indicated the presence of a vertical expansion joint between each of the wings, which partly explains why the damage did not progress into the eastern wing of the structure. This would have permitted independent vibration to take place in the various sections of the building leading inevitably to collisions between the various components (i.e., pounding). In either case, T-shaped section or construction joint with insufficient separation to prevent drift interaction, the brunt of the damage would have been sustained at the same junction location. The complex is undergoing renovation and the height was reduced to a uniform 5 stories as of September 1986. The nearby SCT tower sustained negligible damage and offices were in use shortly after the earthquake.

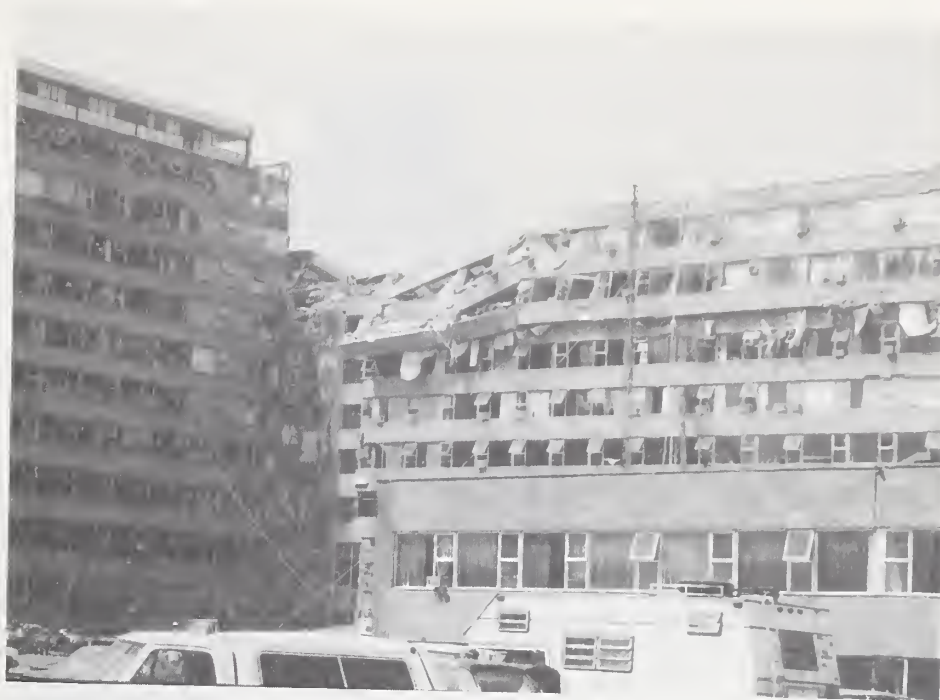
Figure 5.63. Northwest re-entrant corner of SCT Communications Building showing likely initiation point of collapse.

that large shearing forces would have been generated at the re-entrant corners leading to the initiation of the collapse.

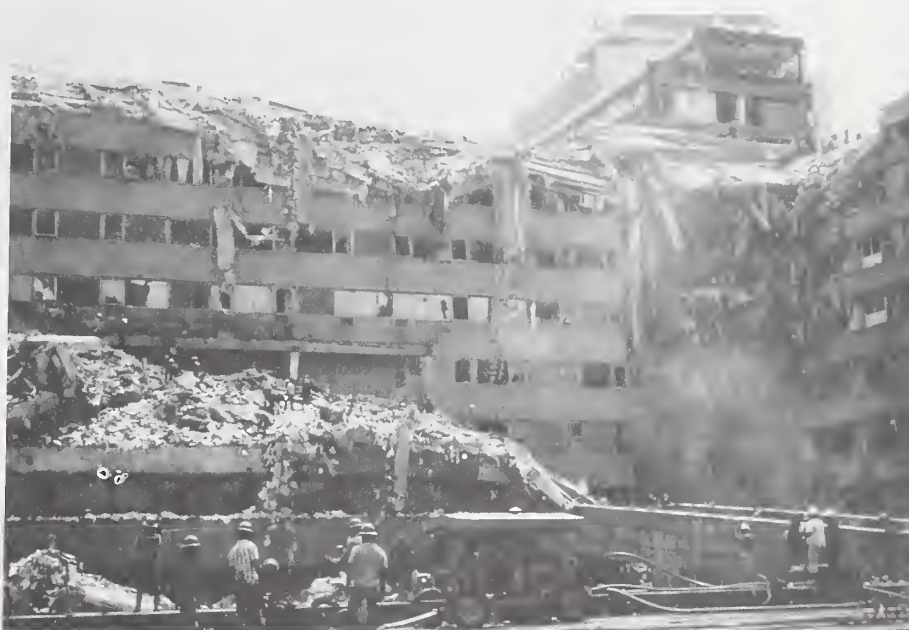
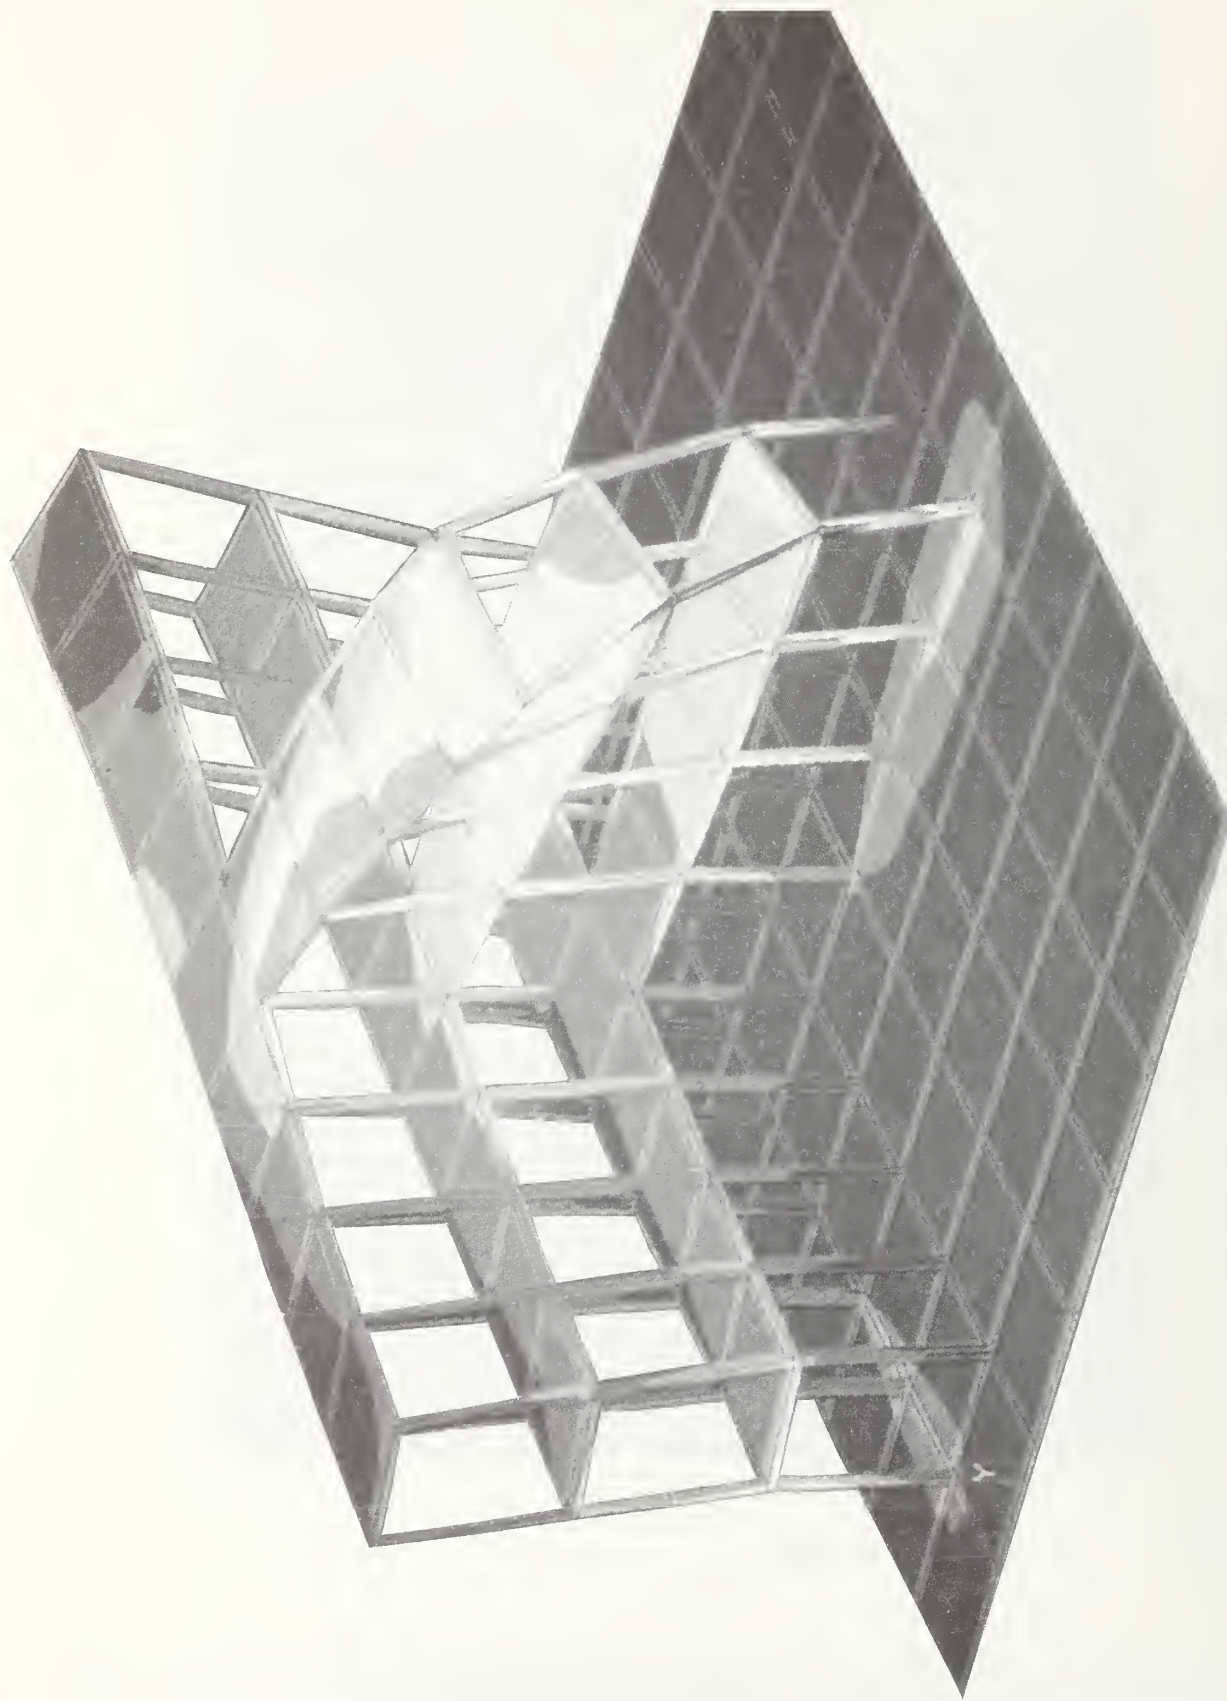
Figure 5.64. SCT Communications Building showing extent of progressive collapse.

(a) East side of SCT Building.

(b) West side of SCT Building.

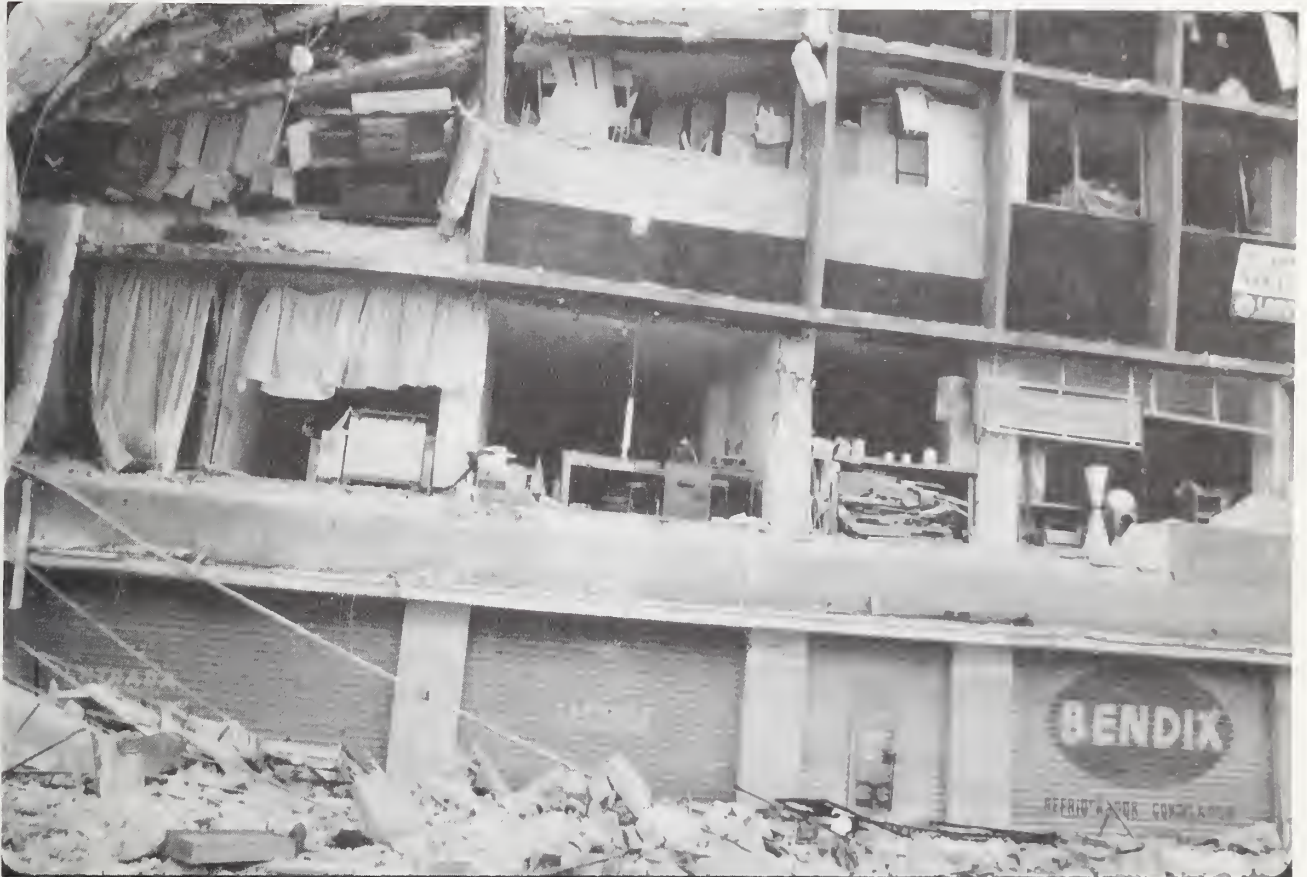
Figure 5.69. Commercial building showing large changes in column stiffness in upper stories.

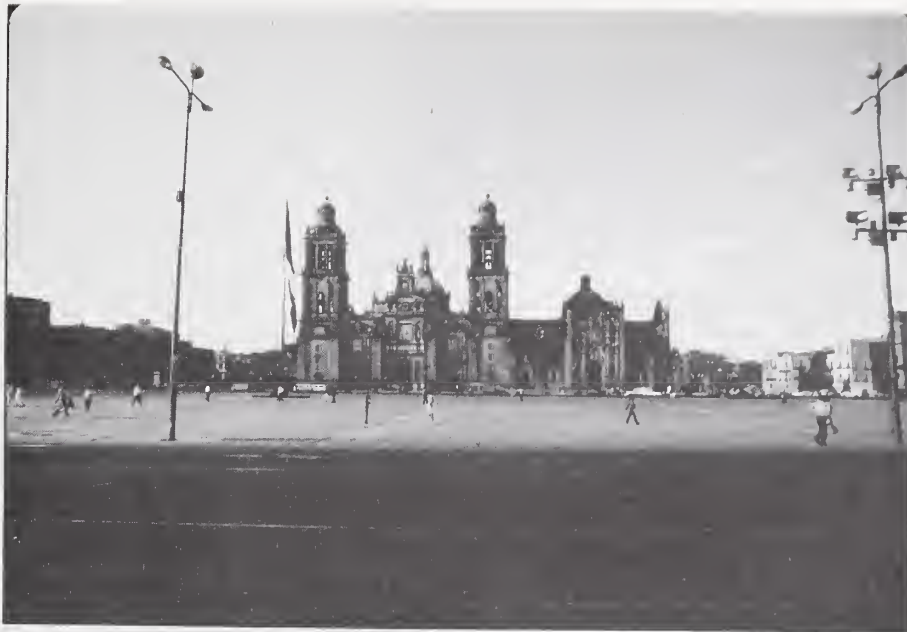
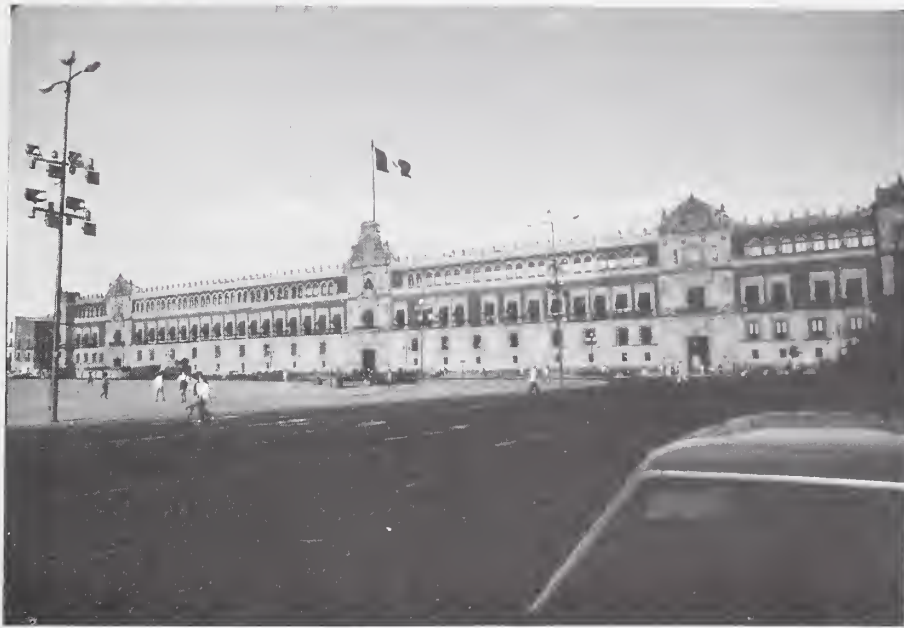
Some of the most effective "survivors" in terms of structural performance during the 1985 earthquake were the historic stone masonry churches and colonial office buildings (see figure 5.70). These buildings have withstood numerous previous earthquakes. In terms of structural behavior the endurance of these buildings may be attributable primarily to their exceptional stiffness. Since the height of these buildings is limited, these structures in general have short fundamental periods of vibration. Therefore, in the lakebed of Mexico City, these structures were out of the range of the spectral peaks of the earthquakes. Furthermore, over the years, powerful earthquakes removed the less earthquake resistant structures.

Figure 5.70. Colonial stone masonry structures (National Palace and Cathedral) have short natural periods of vibration and performed well in the earthquake.

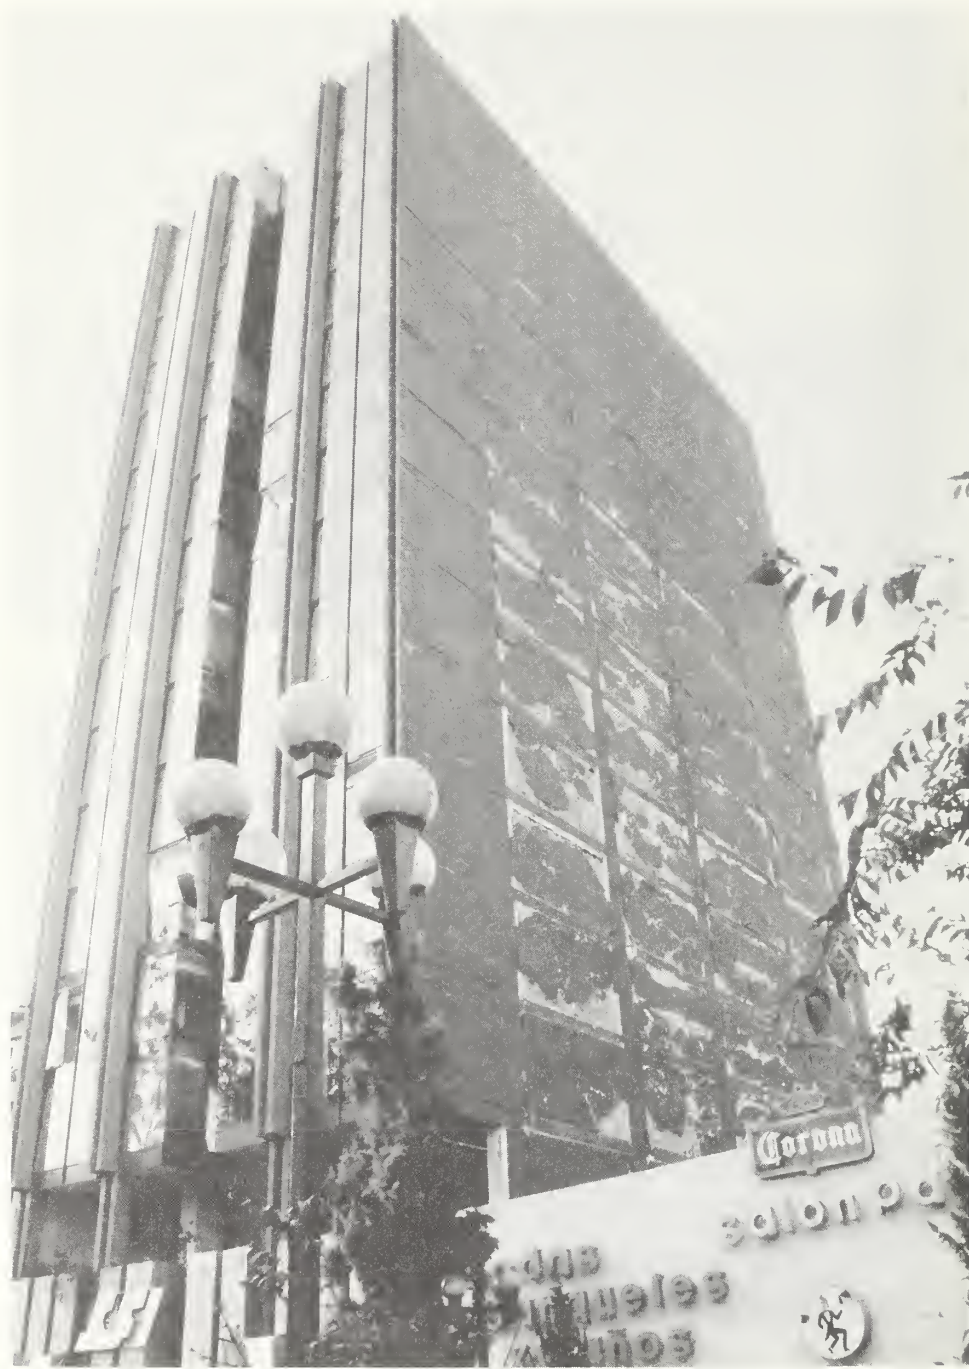
Figure 5.71. Typical high-rise reinforced concrete building with masonry infill walls.
