NIST NCSTAR 1

Federal Building and Fire Safety Investigation
of the World Trade Center Disaster

Final Report on the **Collapse of the World Trade Center Towers**

September 2005

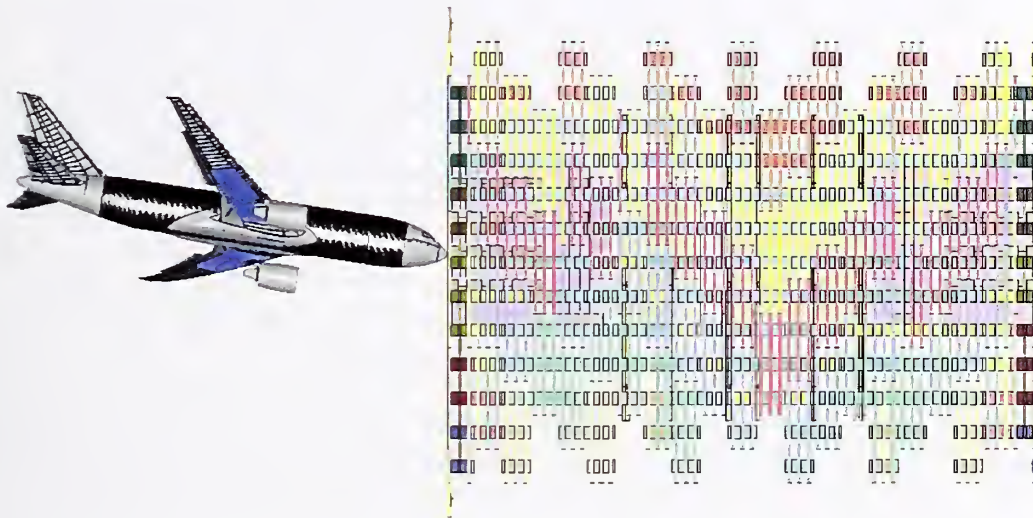
At 8:46:30 a.m. EDT, five hijackers flew American Airlines Flight 11 (AA 11) with 11 crew and 76 passengers into the north face of WTC 1 (Figure 2–1).

Figure 2–1. Simulated impact of American Airlines Flight 11 with WTC 1.

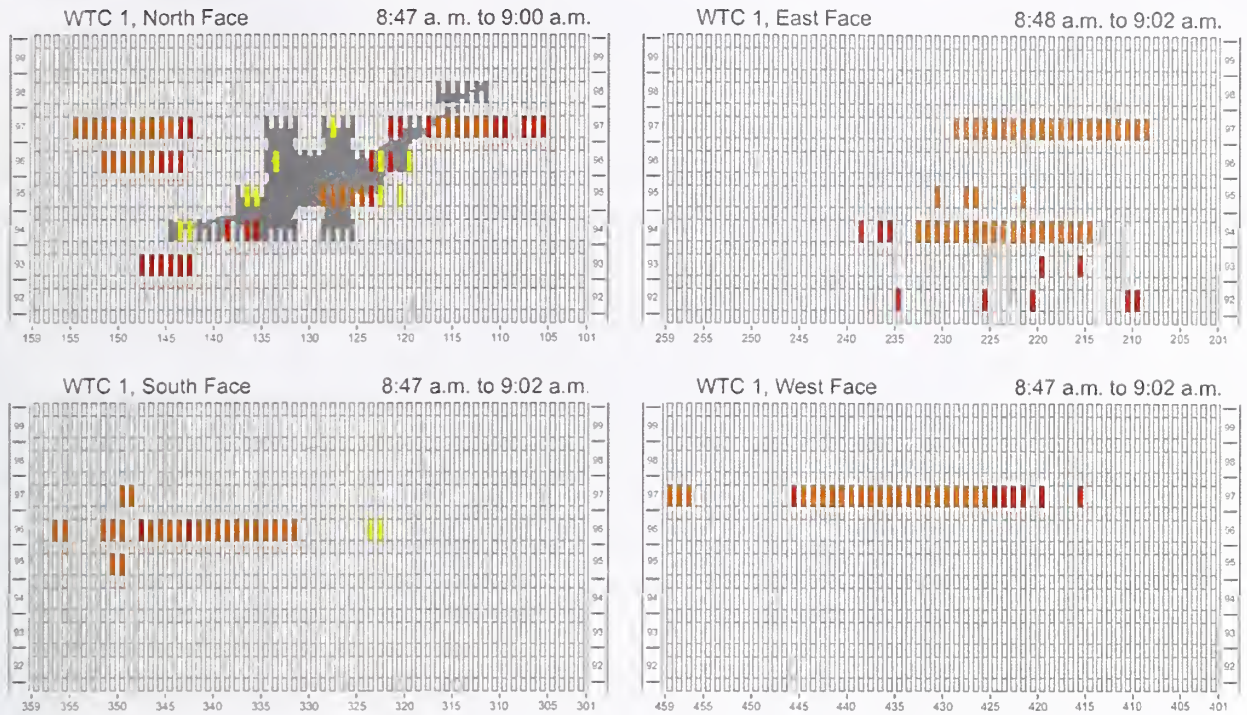
Note: Color coding—white, no fire; yellow, spot fire; red, fire visible inside; orange, external flaming.

Figure 2-5. Representation of exterior views of the fires on the four faces of WTC 1 from 8:47 a.m. to about 9:02 a.m.

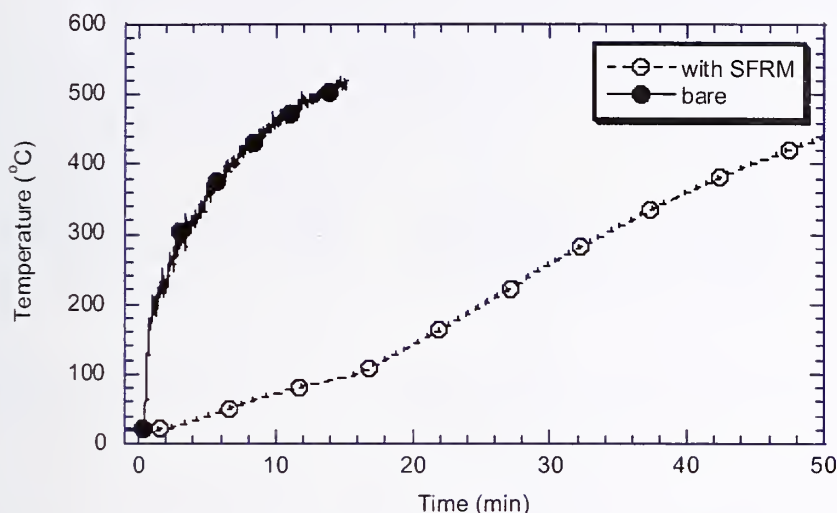
The perimeter columns, floors, and core columns were immersed in these hot gases and began to weaken. Where the insulation was dislodged, the temperature of the steel rose rapidly, in contrast to steel members where insulation was intact (Figure 2–8). The heaviest core columns with damaged insulation heated slowly, as the absorbed heat was dissipated through their massive cross sections. The temperatures of the lighter columns and the floor slabs rose more quickly, and those of the stripped trusses even more so.

Figure 2–8. Steel surface temperatures on the bottom chords of fire-exposed trusses, uninsulated and insulated with ¾ in. of BLAZE-SHIELD DC/F.

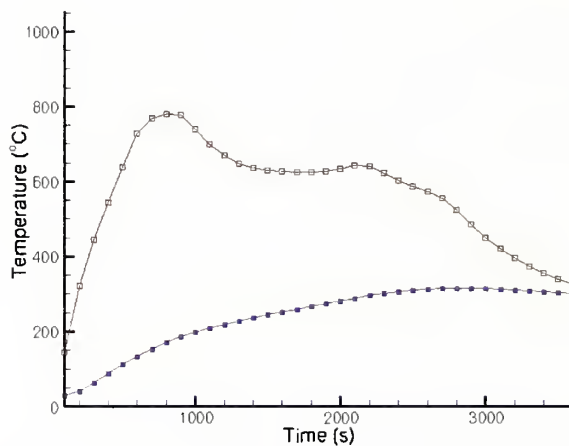
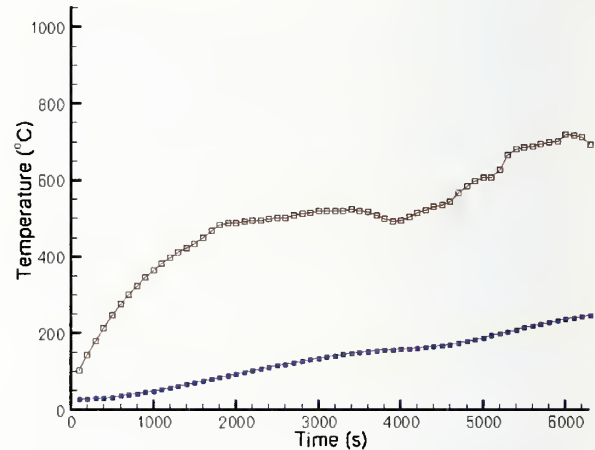
Figure 2-10. Simulated temperatures of two adjacent trusses (left) and two adjacent perimeter columns (right) exposed to the fires in WTC 1.

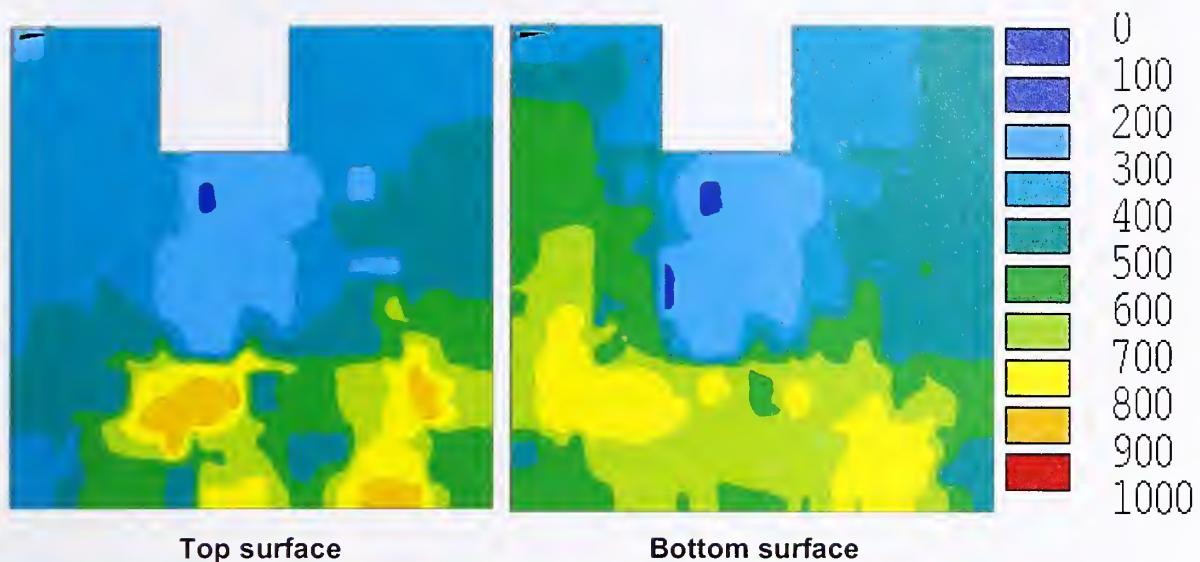
Simultaneously, the fires were creating another problem for the tower. The floors of the 93rd through the 97th stories were being heated both by the hot gases from below and by thermal radiation from the fires on the floor above (Figure 2-11). On the south side of the building, where the fires were heating the long-span trusses whose SFRM had been dislodged, the floors began to sag. In so doing, they began pulling inward on their connections to the south face and to the core columns. Pull-in forces due to the sagging floors did not fail the floor connections in most areas.

Figure 2-11. Temperature contours (°C) on the top and bottom faces of the concrete slab (96th floor, WTC 1) at 100 min after impact. A portion of the concrete slab on the north face (top) was damaged by the impact of the aircraft.

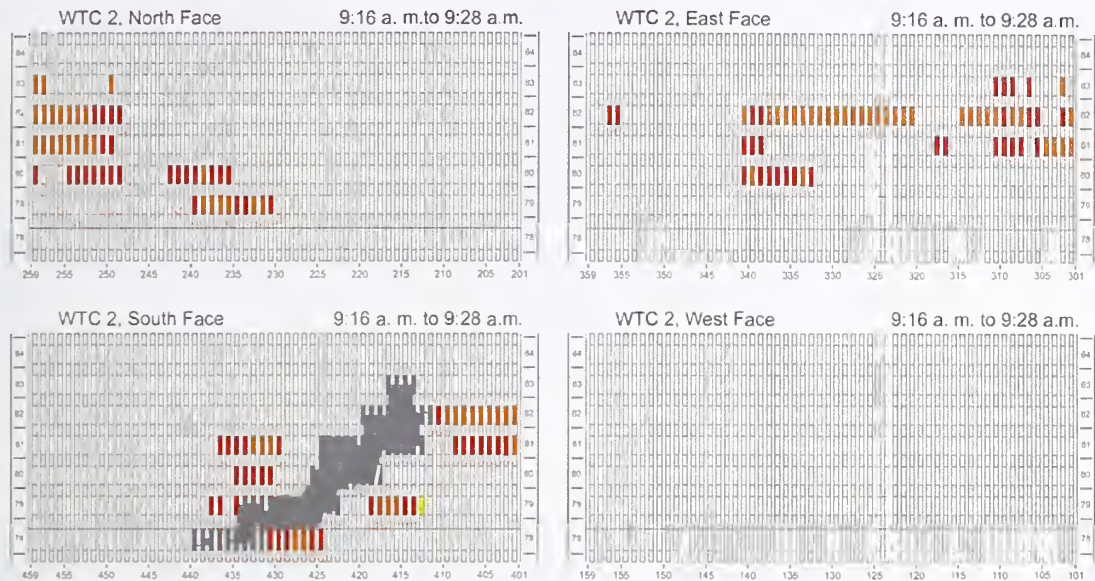
For the next half hour, small fires were burning in and near the aircraft impact cavity on the south side of the building. There were vigorous fires on the east side of the 80th through 83rd floors (Figure 3–4), especially on the northeast end of the 81st and 82nd floors, where the aircraft had bulldozed the office desks and chairs and added its own combustibles. In addition to the ample supply of fuel, these fires had access to plenty of air, as numerous windows on the east face had been blown out by the impact or fireball. They would continue to burn as long as the building stood.

Figure 3–4. Representation of exterior views of the fires on the four faces of WTC 2 at about 9:20 a.m.

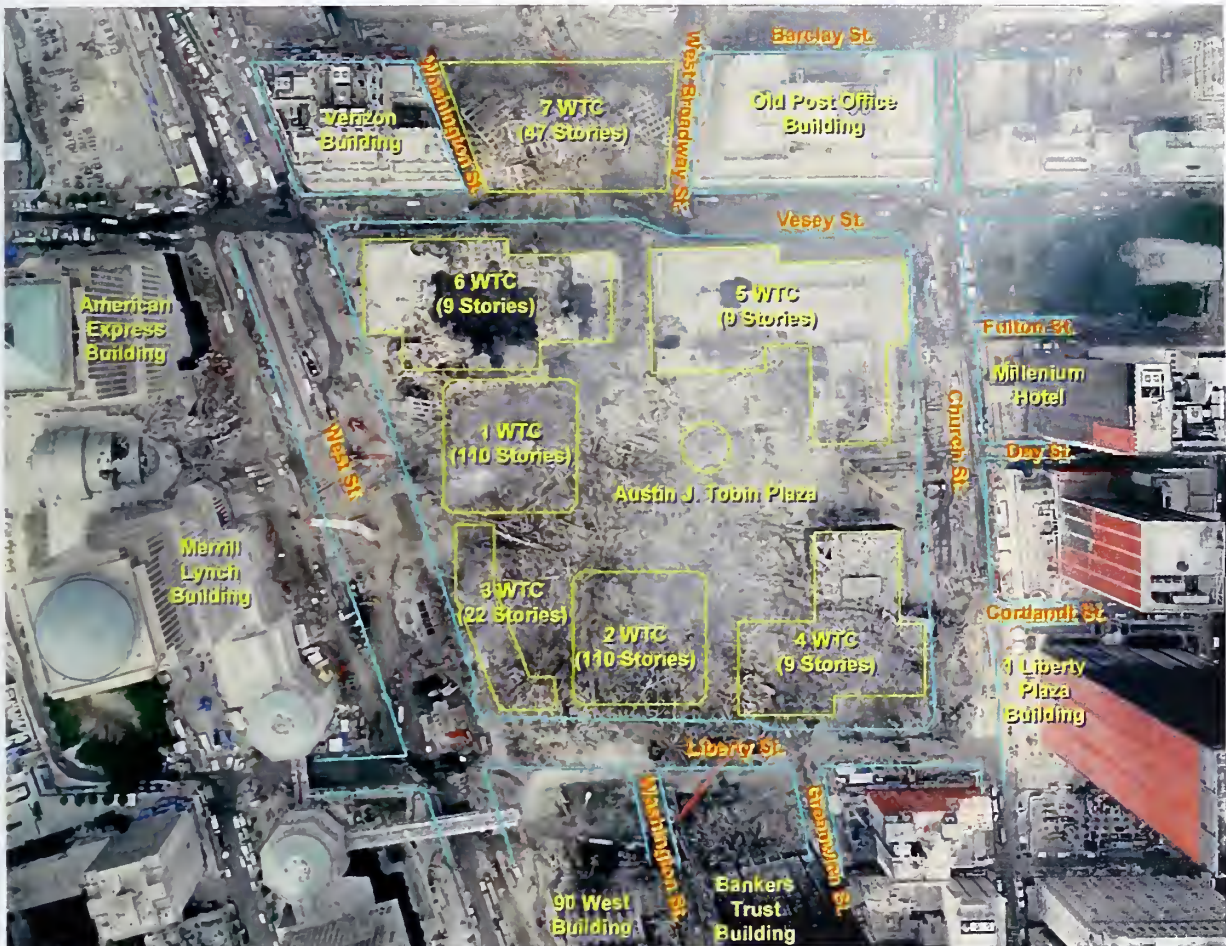
By sunset on September 11, 2001, all seven buildings on the World Trade Center (WTC) site lay in ruins (Figure 4-1). Table 4-1 compiles the likely locations of the decedents.

Figure 4-1. The WTC site on September 17, 2001.

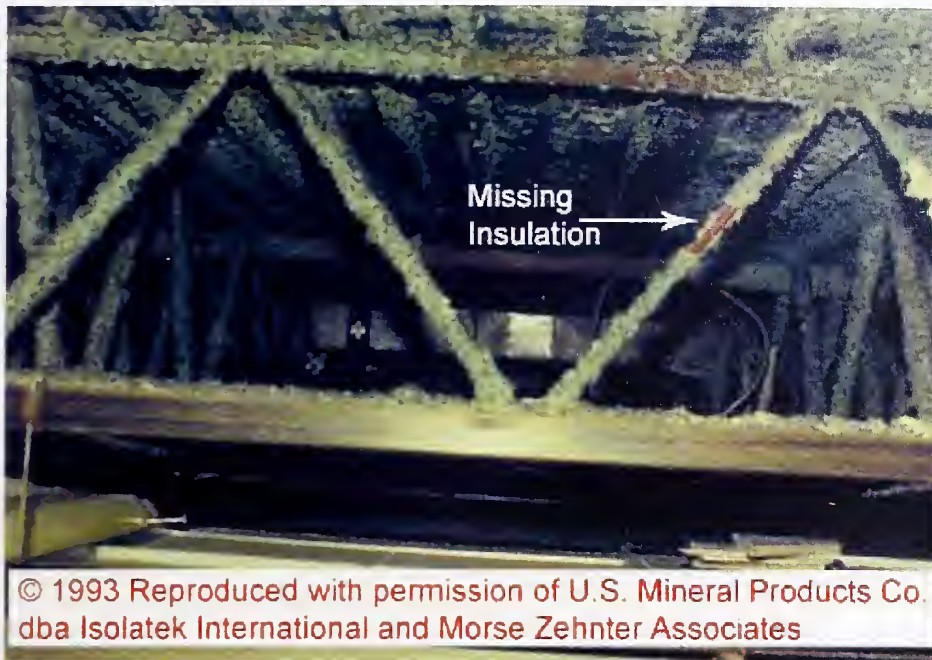
In 1994, The Port Authority measured the SFRM thickness on trusses on floors 23 and 24 of WTC 1. In all, average thicknesses were reported for 32 locations, and the overall average thickness was found to be 0.74 in. NIST performed a further evaluation of the SFRM thickness using photographs taken in the 1990s of floor trusses on (non-upgraded) floors 22, 23, and 27 of WTC 1 (Figure 5–5). By measuring dimensions on the photographs, NIST estimated the insulation thicknesses on the diagonal web members of trusses. (The thickness of chord member insulation could not be measured.) The average thickness and standard deviation of web members was 0.6 in. ± 0.3 in. on the main trusses, 0.4 in. ± 0.25 in. on the bridging trusses, and 0.4 in. ± 0.2 in. on the diagonal struts. These numbers indicated that there were areas where the coating thickness was less than the specified 0.5 in.

Figure 5–5. Irregularity of coating thickness and gaps in coverage on SFRM-coated bridging trusses.

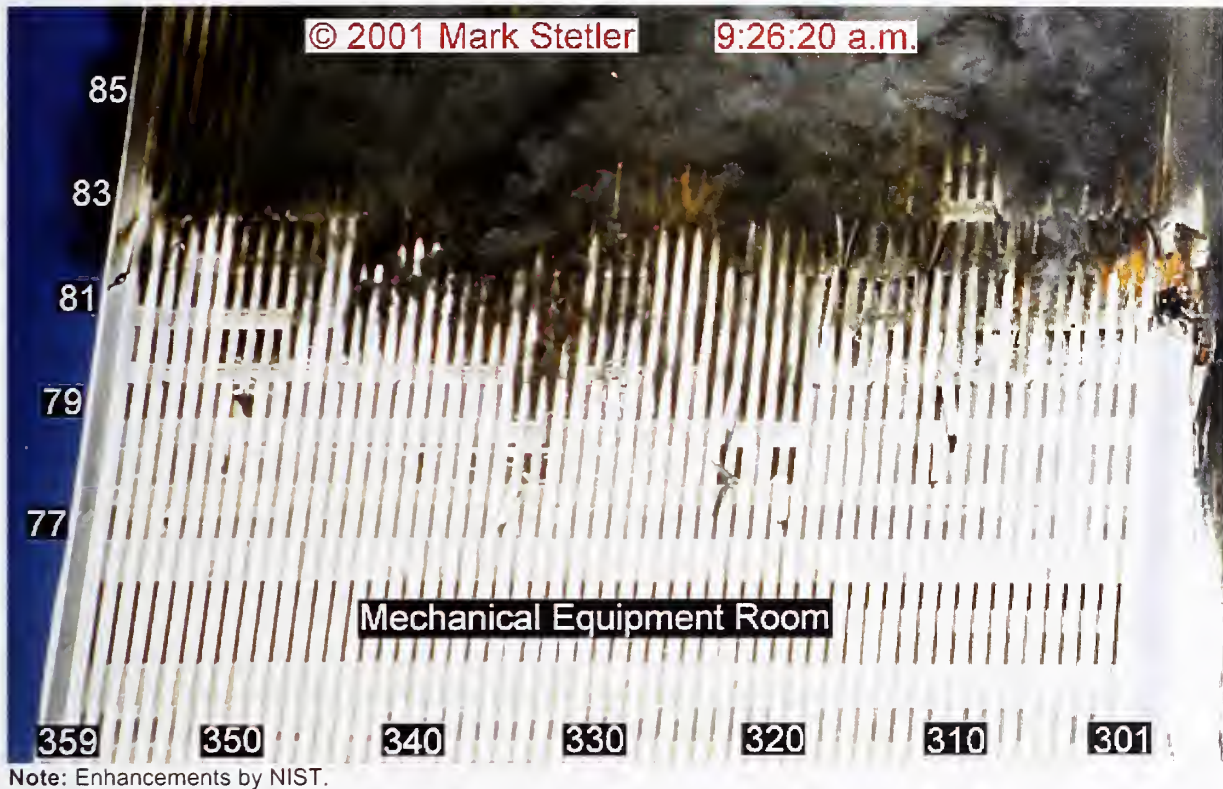
As an example of information that was extracted, Figure 6–1 shows an enhanced image of the east face of WTC 2. Figure 6–2 expands a section of interest. The amount of detail available is evident. For instance, large piles of debris are present on the north side of the tower on the 80th and 81st floors, and locations where fires are visible or where missing windows are easily identified. Many details of each frame were important in tracking the evolution of the fires and the damage to the buildings.

Figure 6–1. 9:26:20 a.m. showing the east face of WTC 2.

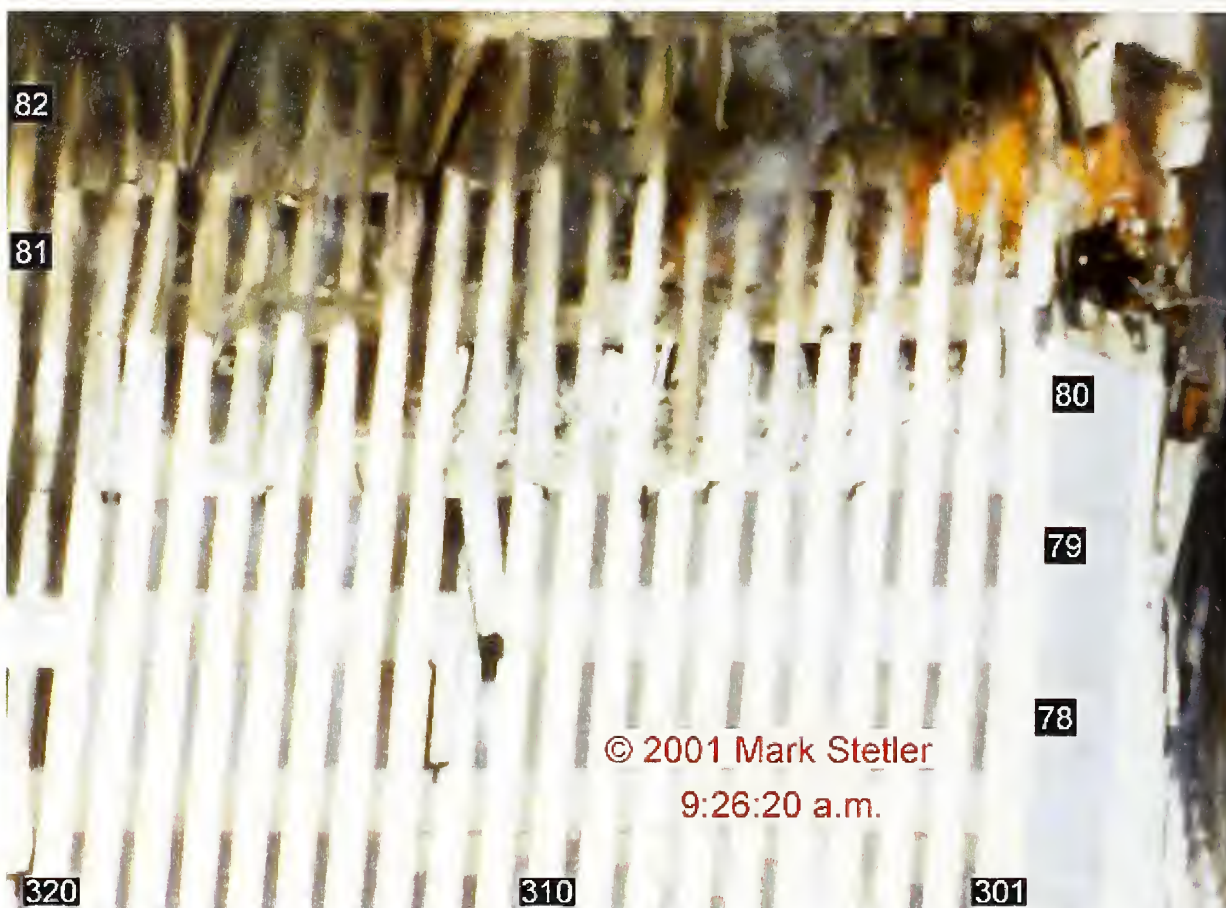
Figure 6–2. Close-up of section of Figure 6–1.

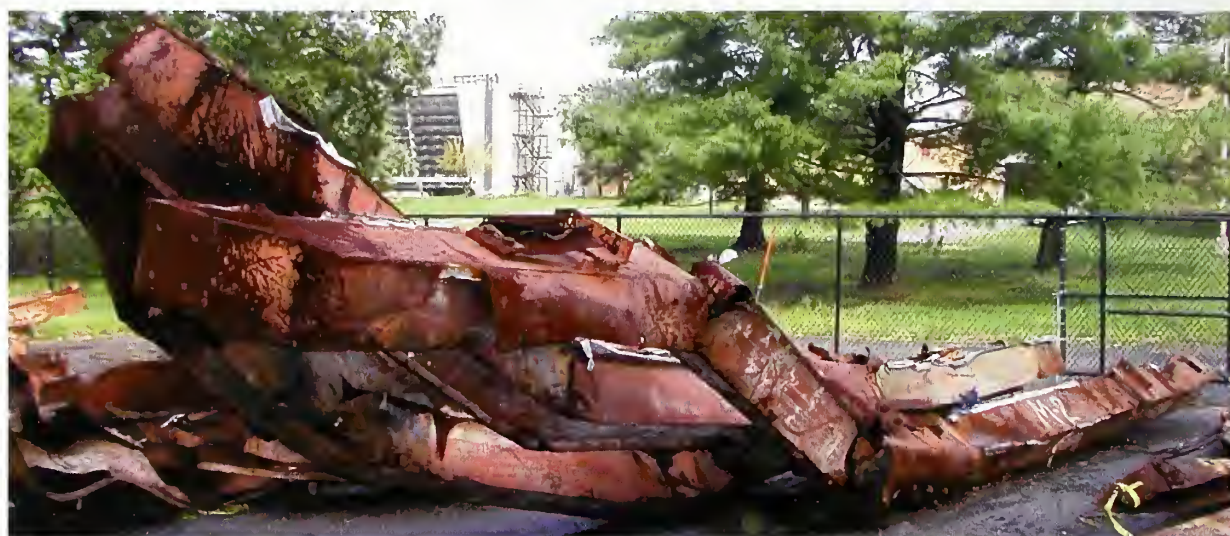
Figure 6-4. WTC 1 exterior panel hit by the fuselage of the aircraft.

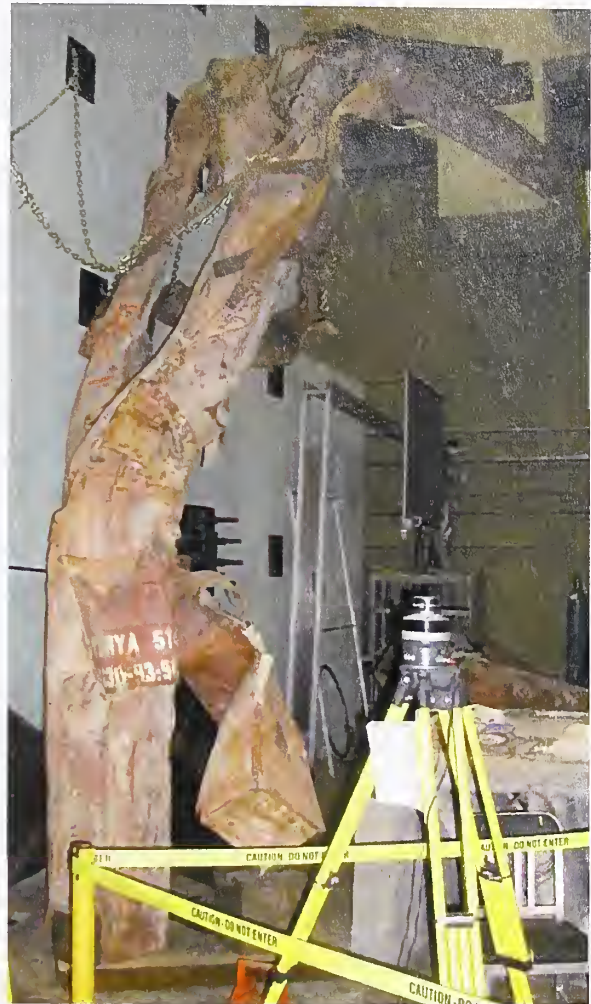
Figure 6–5. WTC 1 exterior panel hit by the nose of the aircraft.

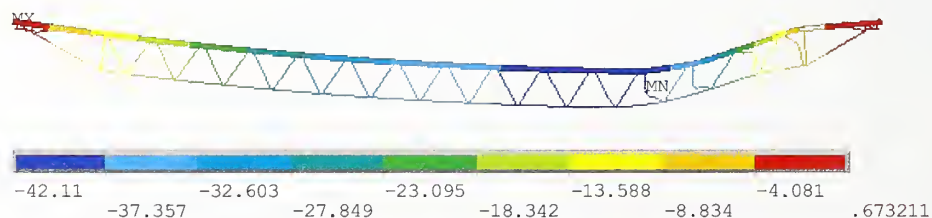
Figure 6–11. Vertical displacement at 700 °C.

- Single composite truss and concrete slab section. A floor section was modeled to investigate failure modes and sequences of failures under combined gravity and thermal loads. The floor section was heated to 700 °C (with a linear thermal gradient through the slab thickness from 700 °C to 300 °C at the top surface of the slab) over a period of 30 min. Initially the thermal expansion of the floor pushed the columns outward, but with increased temperatures, the floor sagged and the columns were pulled inward. Knuckle failure was found to occur mainly at the ends of the trusses and had little effect on the deflection of the floor system. Figure 6–11 shows that the diagonals at the core (right) end of the truss buckled and caused an increase in the floor system deflection, ultimately reaching approximately 42 in. Two possible failure modes were identified for the floor-truss section: sagging of the floor and loss of truss seat support.

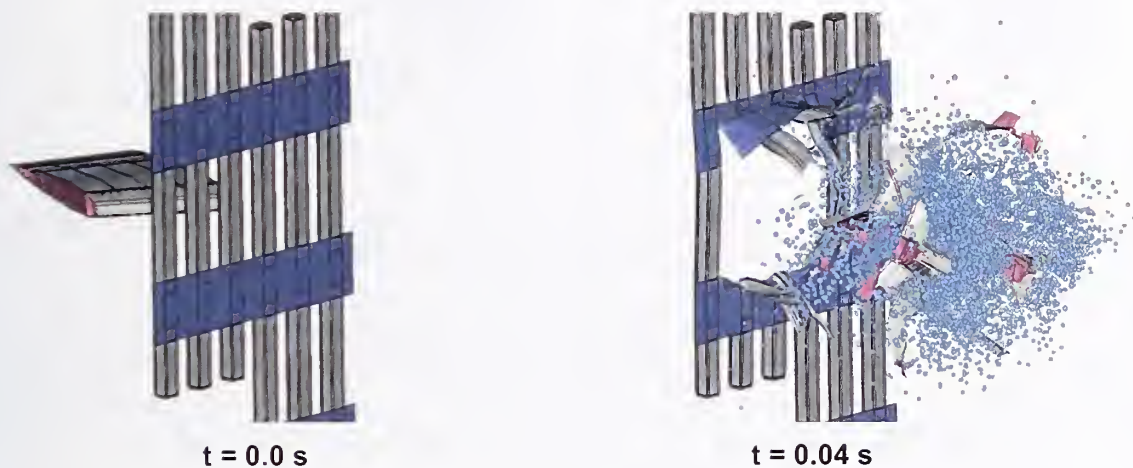
Figure 6–16. Calculated impact on an exterior wall by a fuel-laden wing section.

Figure 6–16 shows two frames from the last of these analyses, with the wing segment entering from the left, being fragmented as it penetrates the exterior columns, and spraying jet fuel downstream.

- Moving at 500 mph, an engine broke any exterior column it hit. If the engine missed the floor slab, the majority of the engine core remained intact and had enough residual momentum to sever a core column upon direct impact.
- The impact of the inner half of an empty wing significantly damaged exterior columns but did not result in their complete failure. Impact of the same wing section, but filled with fuel, did result in failure of the exterior columns.

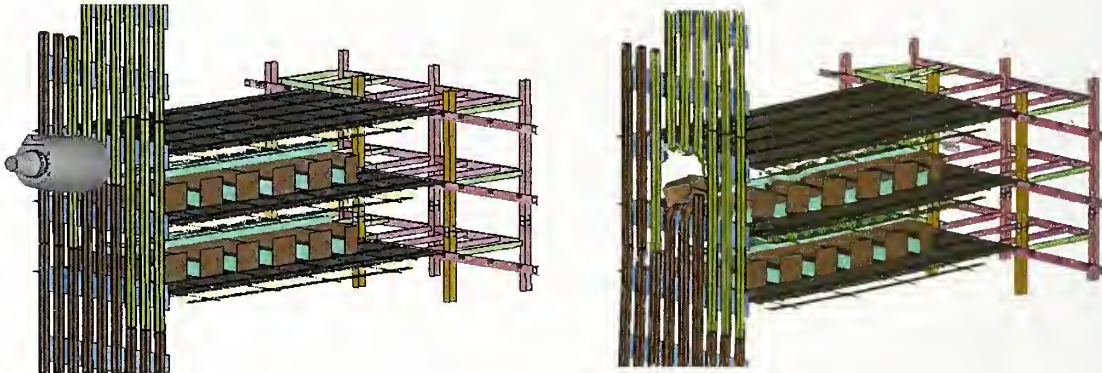
Figure 6–17. Response of a tower subassembly model to engine impact.

- The mass of the concrete floor slab and nonstructural contents had a greater effect on the engine deceleration and subsequent damage than did the concrete strength.
- Variation of the failure criteria of the welds in the exterior columns did not result in any noticeable difference in the damage pattern or the energy absorbed by the exterior panels.

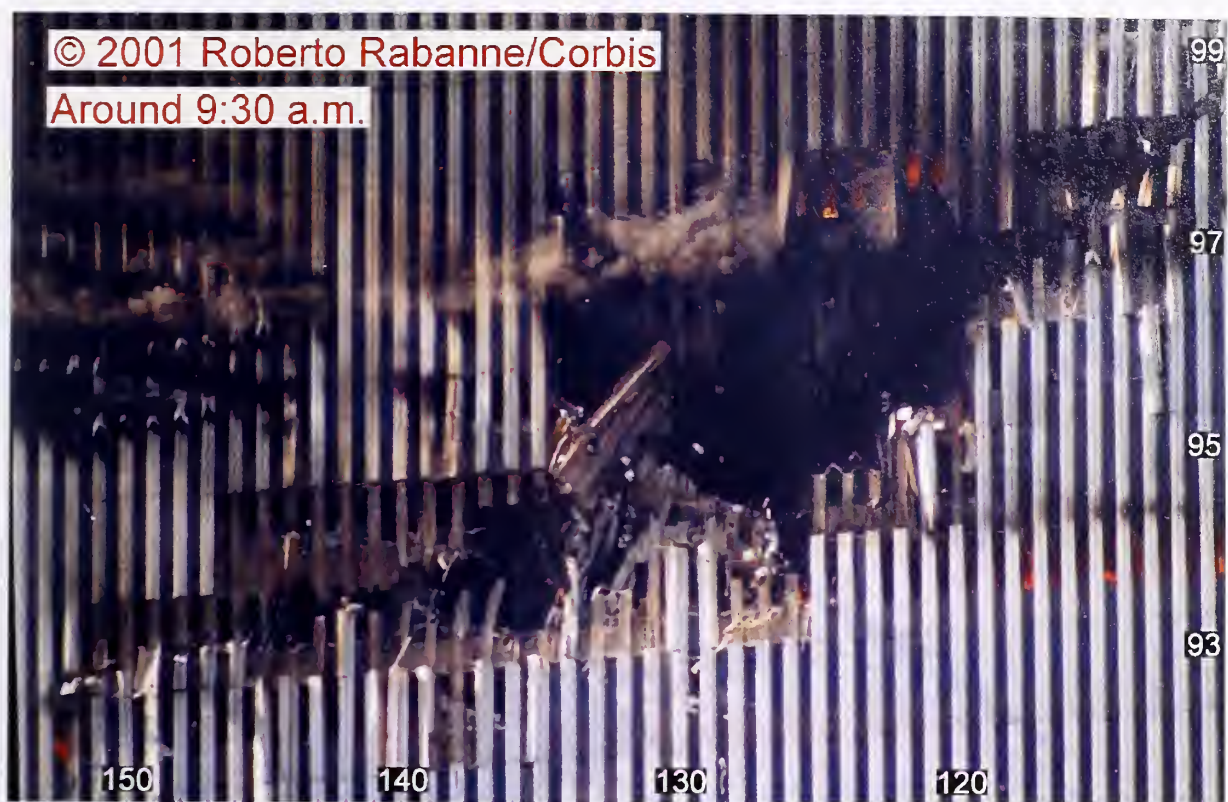
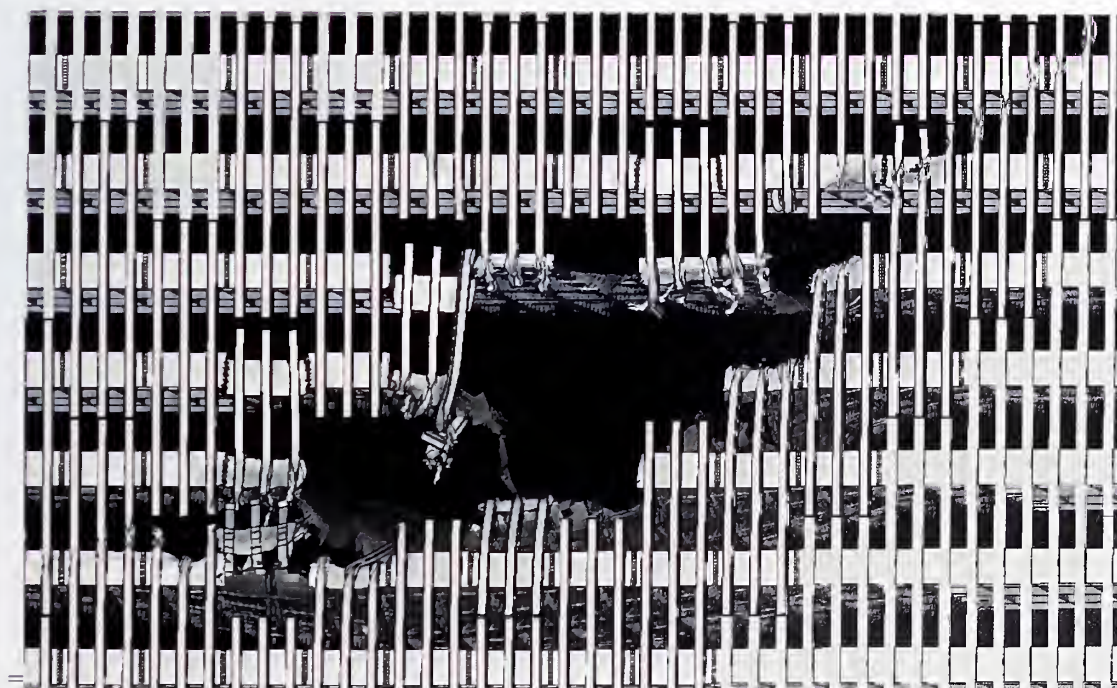
Assessment of the aircraft impact simulations of exterior damage to the towers involved comparing the predicted perimeter wall damage near the impact zone with post-impact photographs of the walls. Figure 6–26 shows a photograph of the north face of WTC 1 after impact and the results of the Case A simulation. The calculated silhouettes capture both the position and shape of the actual damage.

Figure 6–26. Observed and Case A calculated damage to the north face of WTC 1.

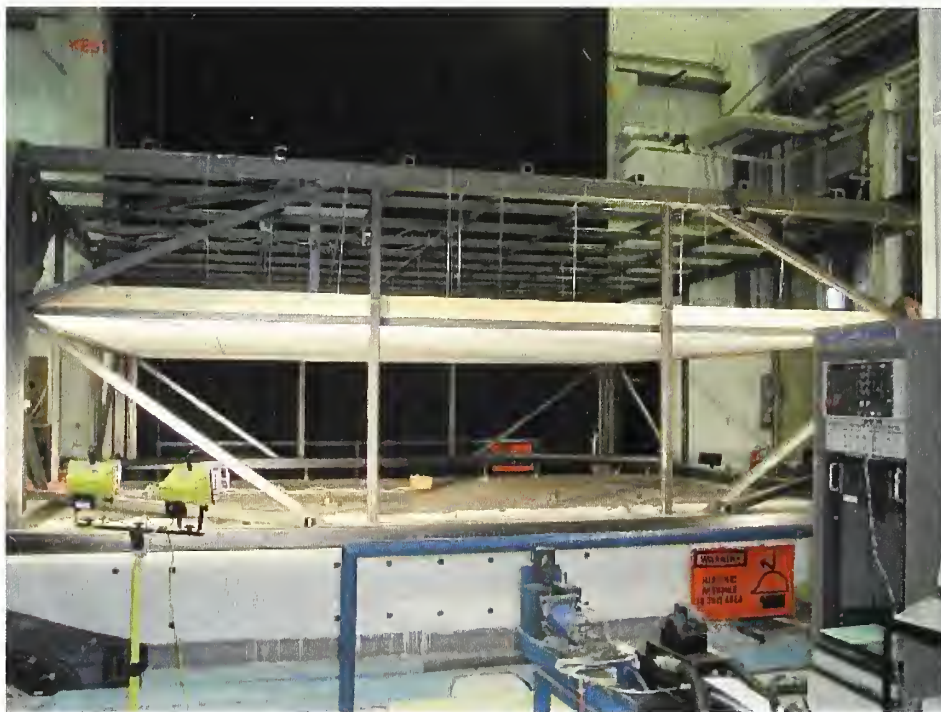
Figure 6–29. Ceiling tile system mounted on the shaking table.

The aircraft impact modeling did not include the ceiling tile systems. To estimate whether the tiles would survive the aircraft impact, the University at Buffalo, under contract to NIST, conducted tests of WTC-like ceiling tile systems using their shake table (Figure 6–29) and impulses related to those induced by the aircraft impact on the towers. The data indicated that accelerations of approximately 5g would most likely result in substantial displacement of ceiling tiles. Given the estimated impact accelerations of approximately 100g, NIST assumed that the ceiling tiles in the impact and fire zones were fully dislodged. This was consistent with the multiple reports of severely damaged ceilings (Chapter 7).

An intact ceiling tile system could have provided the floor trusses with approximately 10 min to 15 min of thermal protection from ceiling air temperatures near 1,000 °C. These temperatures would quickly heat steel without thermal insulation to temperatures for reduction of the strength of structural steels.

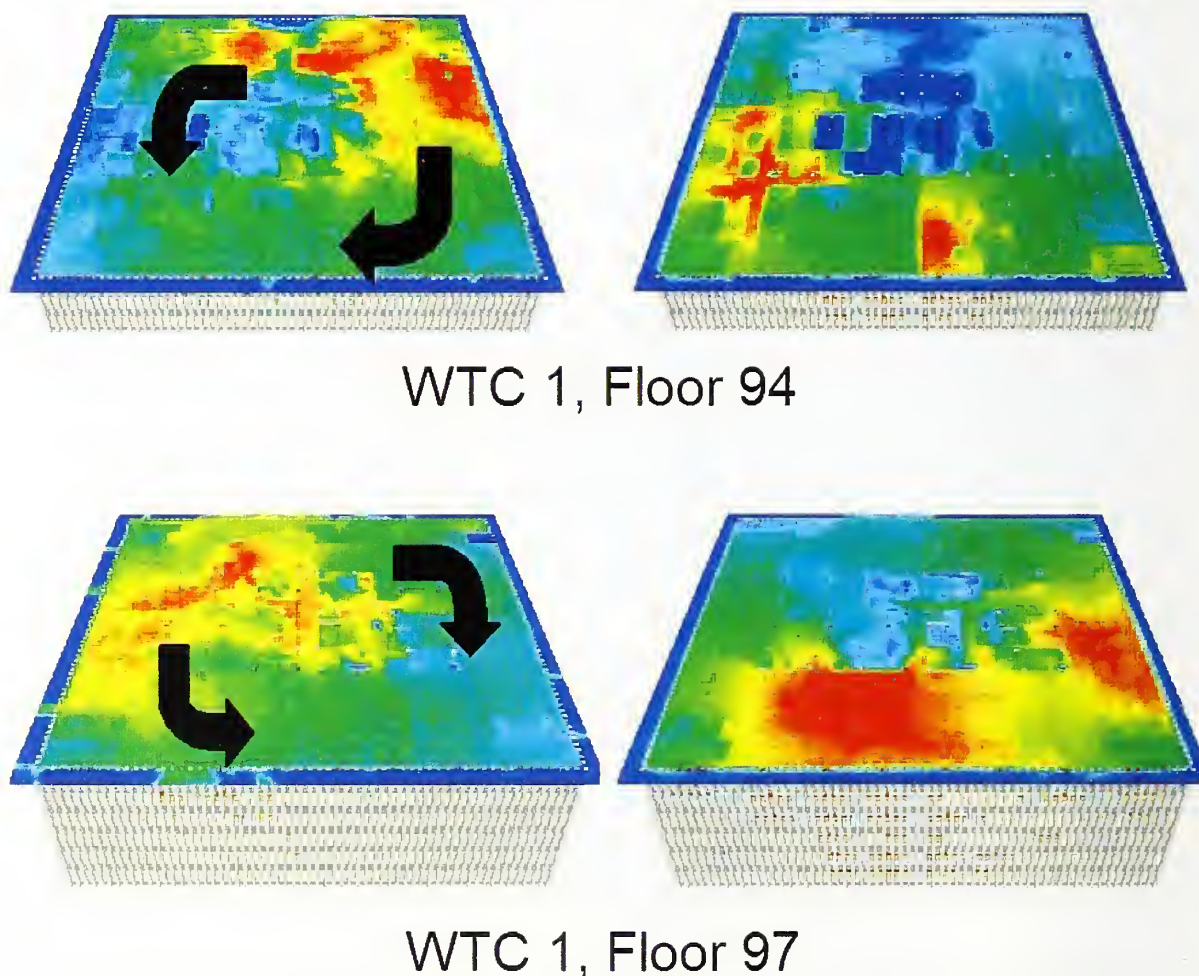
Figure 6–37. Direction of simulated fire movement on floors 94 and 97 of WTC 1.

Much of the fire activity was initially in the vicinity of the impact area in the north part of the building. As a result of the orientation of the impacting aircraft and its fuel tanks, the early fires on the 92nd through 94th floors tended toward the east side of the north face, while the early fires on the 97th through 99th floors tended toward the west side of the north face. The fires on all the floors spread along the east and west sides and were concentrated in the south part of the building at the time of collapse, as depicted in Figure 6–37.

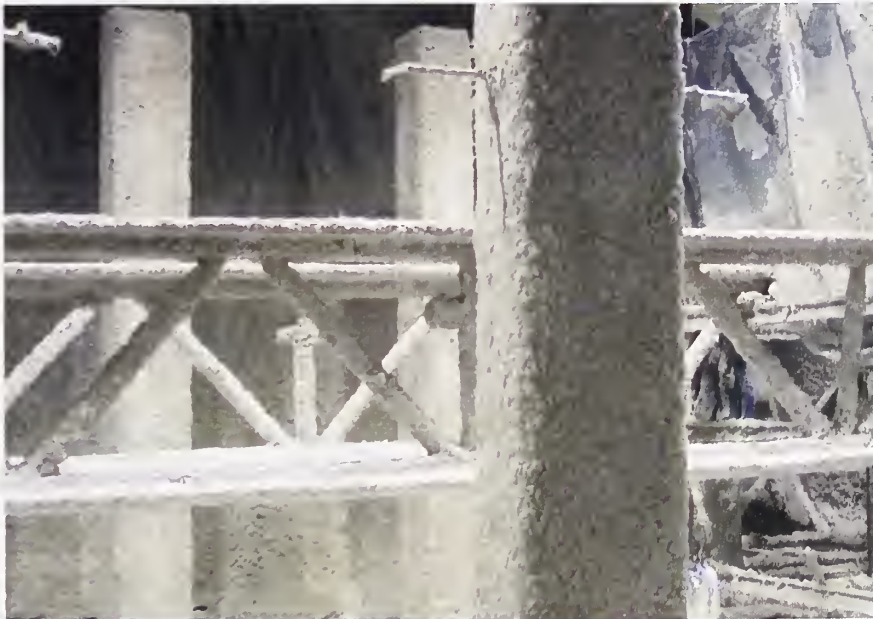
Figure 6–42. SFRM-coated steel components prior to a test.

experienced applicator, who took considerable care to apply an even coating of the specified thickness. As such, the insulated test subjects represent a best case in terms of thickness and uniformity. Figure 6–42 shows some of the coated components.

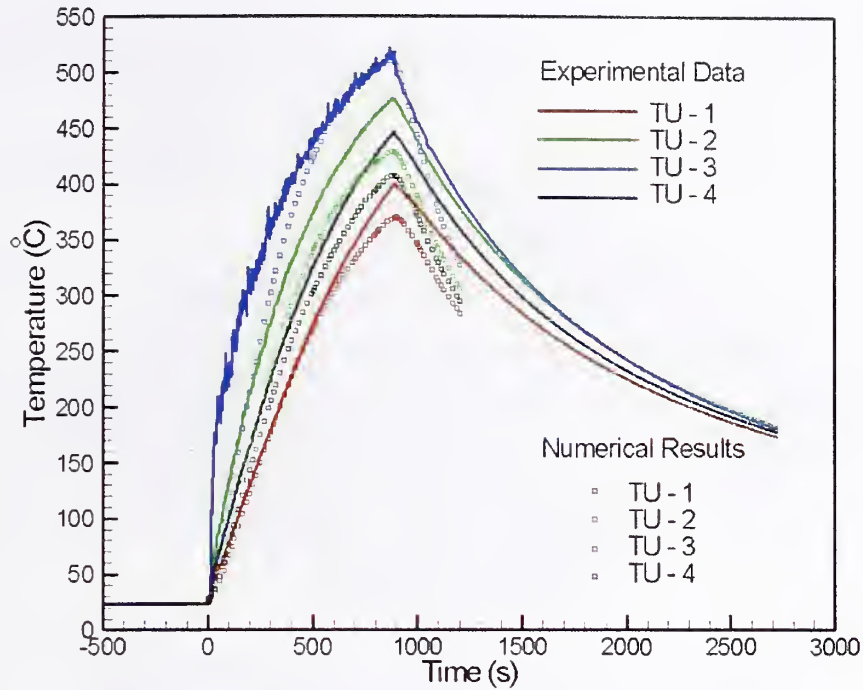
Figure 6-44. Comparison of numerical simulations with measurements for the steel surface temperature at four locations on the top chord of a bare truss.

Figure 6–44 compares the measured and predicted temperatures on the steel surface of the top chord of a bare truss. Figure 6–45 is the analogous plot of the measured and predicted temperatures on the steel surface of the top chord of a truss insulated with 3/4 in. of BLAZE-SHIELD DC/F. Similar curves were generated for each of the steel pieces, bare and insulated.

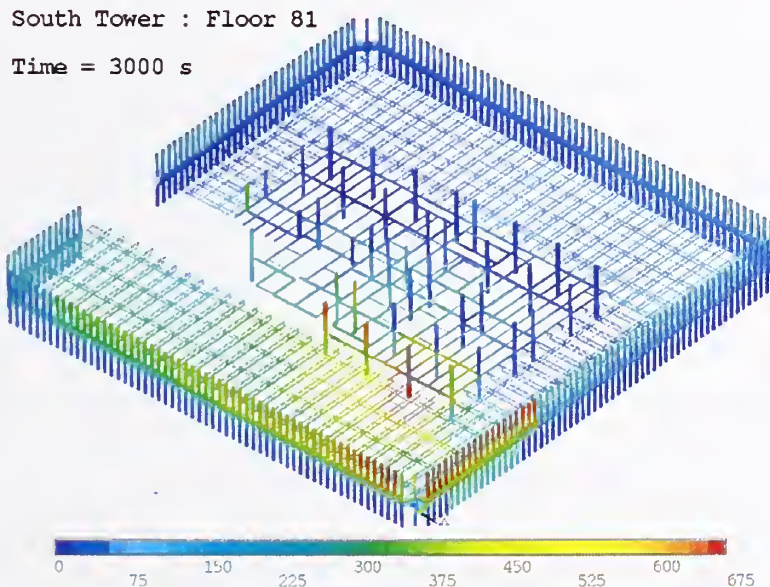
Figure 6–47. Temperatures (°C) on the columns and trusses of the 81st floor of WTC 2 at 3,000 s after aircraft impact, Case D.

For ease of visualization, two graphic representations were developed. Figure 6–46 shows an example of the temperature map for the 96th floor of WTC 1. Severed columns and broken floor segments are not shown. Figure 6–47 shows a similar map for the 81st floor of WTC 2.

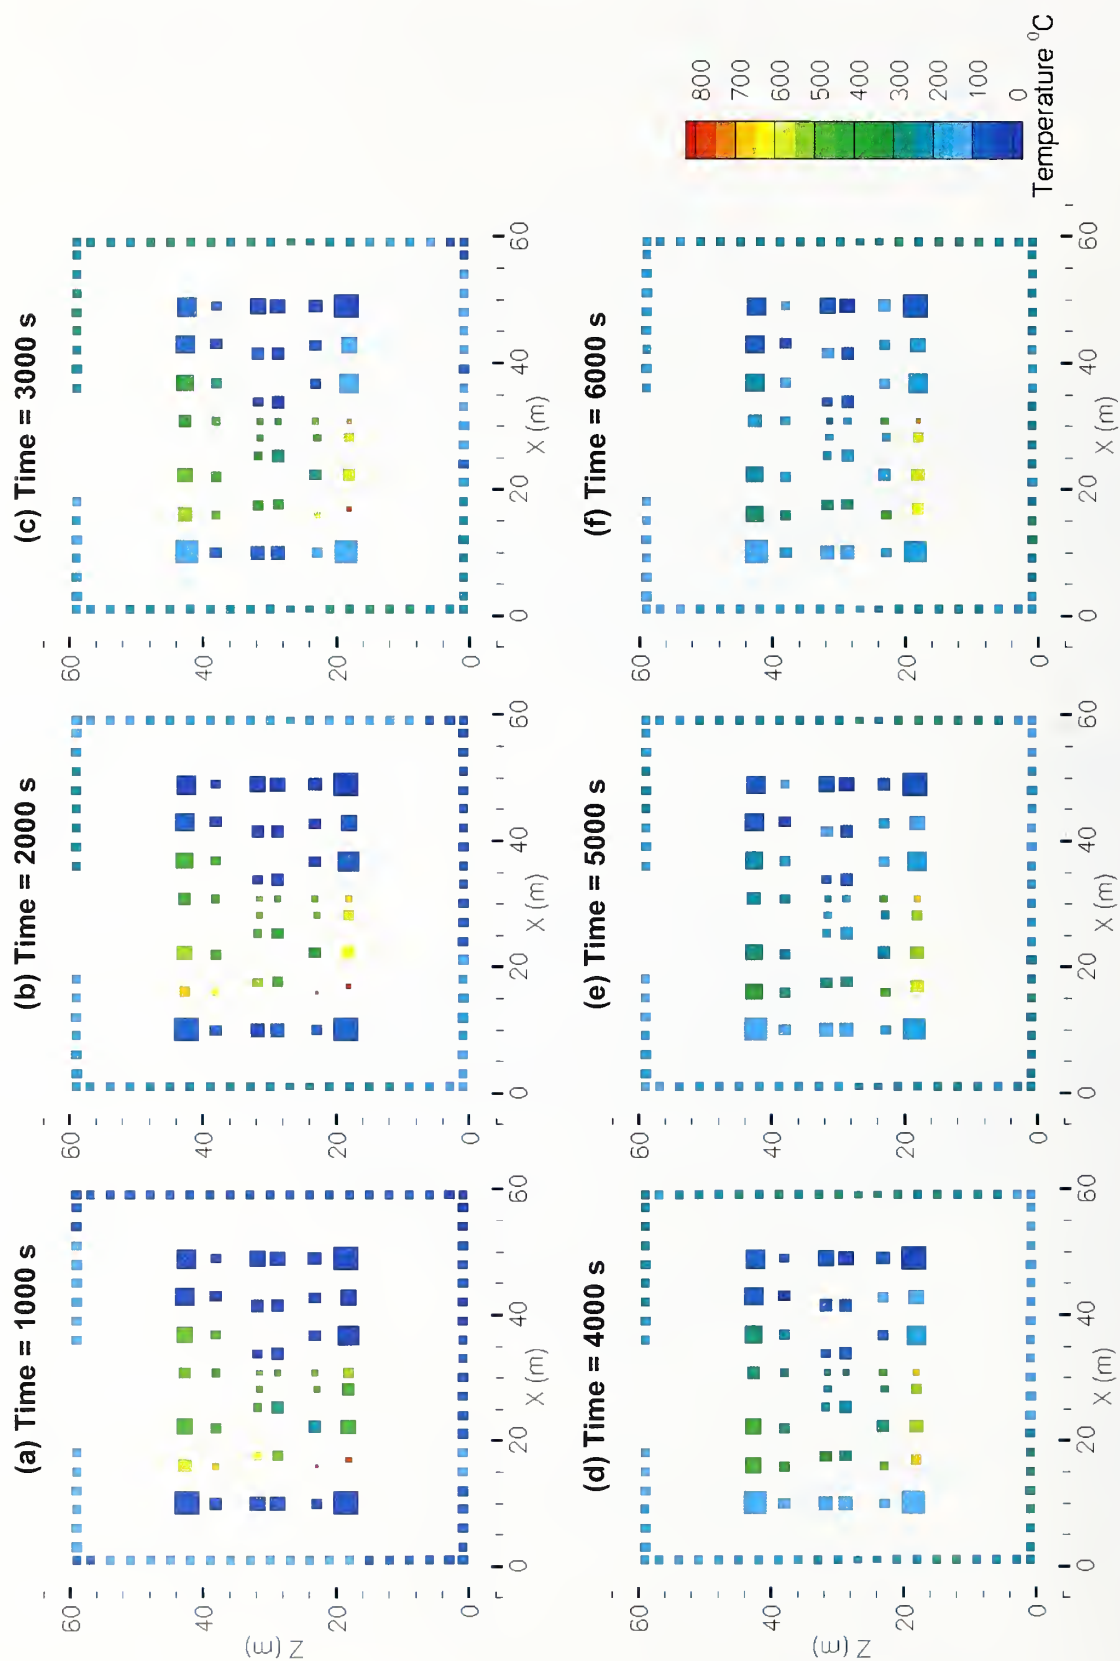
Figure 6-48. Frames from animation of the thermal response of columns on the 96th floor of WTC 1, Case A.

A third visualization tool was animation of the evolving temperatures of the columns. Frames from an example, again of the 96th floor of WTC 1, Case A, are shown in Figure 6–48. The size of the square representing a column represents its yield strength. Columns may have been heated when the fire was nearby and then cooled after the local combustibles were consumed.

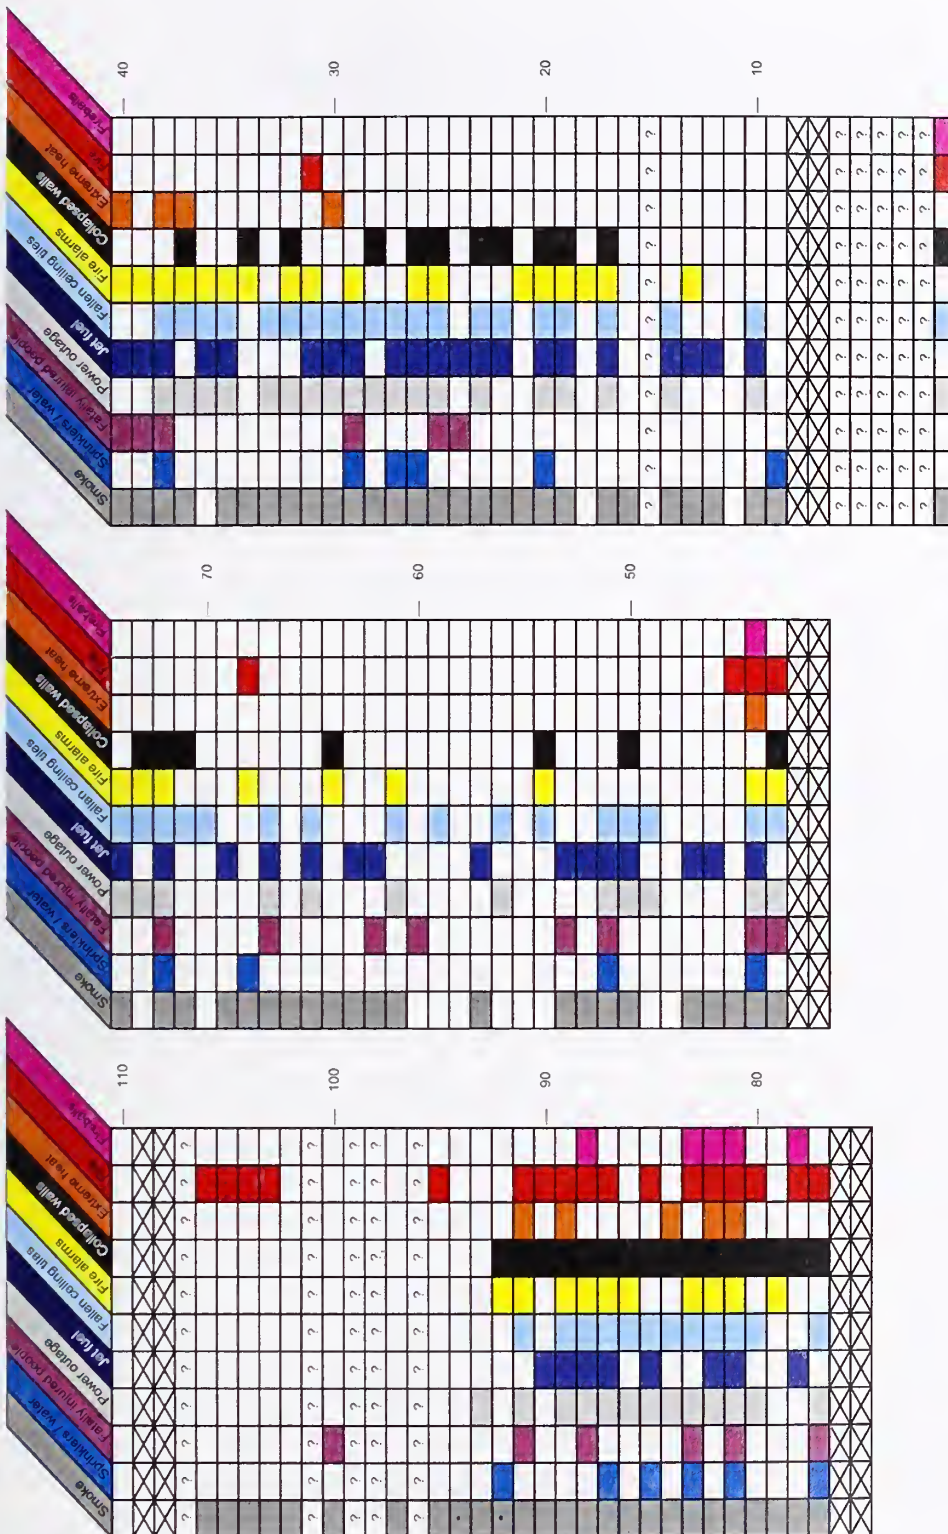
Figure 7-3. Observations of building damage after initial awareness but before beginning evacuation in WTC 1.

- Occupants throughout the building observed various types of impact indicators throughout the building, including wall, partition, and ceiling damage and fire and smoke conditions. The filled-in squares in Figure 7–3 indicate the floors on which the different observations were reported.
