# *H. L. Hunley*

## Recovery Operations

A Collaborative Project of:  
Naval History and Heritage Command,  
South Carolina Hunley Commission,  
and  
Friends of the Hunley

Naval History and Heritage Command  
Washington, D.C.  
2016

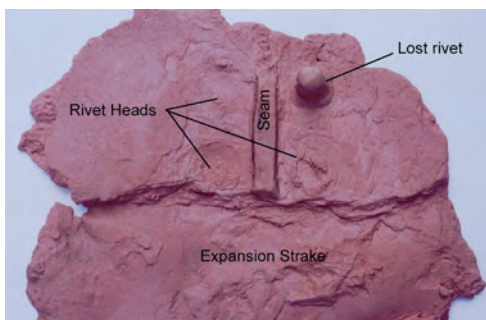
Figure 8.2. Dental putty mold of the seam between two hull plates and the expansion strake. A missing rivet is also represented by the positive impression in the upper right. (Photo by David L. Conlin, NPS)

In total, 21 rivet heads were exposed, which were found to be in variable condition. Many could be examined only from the dental putty mold, because they were flush with the metal plate surface and could not be detected by touch (Figure 8.2). The rivet heads had a diameter of approximately 1.063 in. (2.7 cm) and were spaced 2 to 2.25 in. (5.0–5.5 cm) apart, center to center. There appeared to be no difference in the size and spacing of the seam rivets as compared to the strake rivets. All of the exposed rivet heads were lightly corroded, in the form of pitting and metal loss. Two heads were completely corroded away, leaving just a

portion of the rivet shaft surviving. Archaeologists retrieved one degraded shaft using a small flat-head screwdriver and a pair of tweezers. They later sent this rivet to Dr. William Weins at the University of Nebraska, Lincoln, who analyzed it and found it to consist entirely of corrosion products, with no metal remaining (Weins and Makinson 2000). The diameter of the rivet hole exposed was 1.5 cm (0.6 in.).

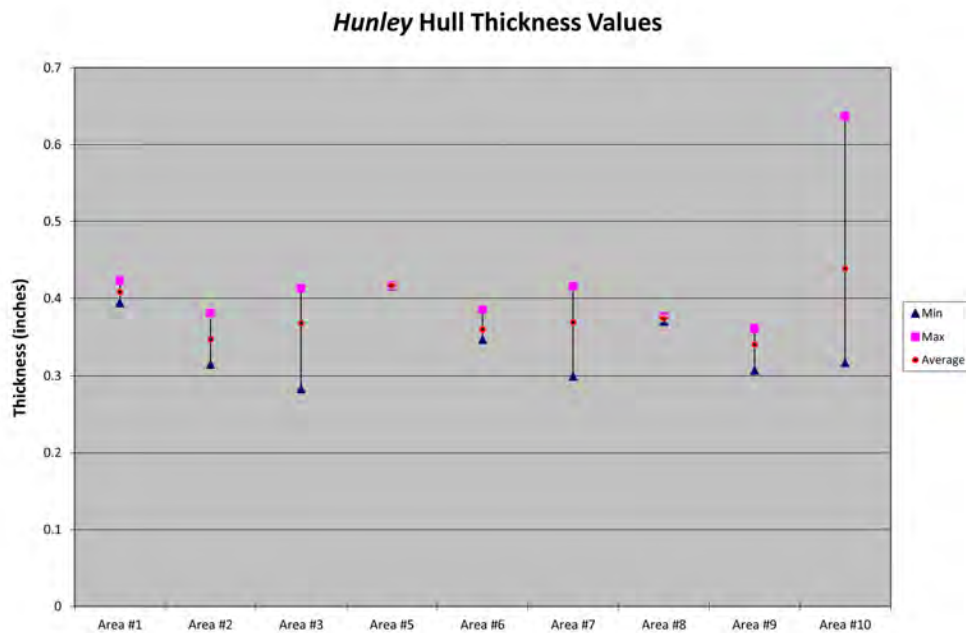
Figure 8.4. Ultrasonic thickness values from nine of the ten test areas on Hunley's hull. Data from Area 4 was not useable. (Graphs by David L. Conlin, NPS)

The mean measurements (in inches) from each area are listed in Table 8.1. These values correspond to  $\frac{3}{8}$  in. (9.53 mm) rolled iron boilerplate. The smaller thickness values may have been due to loss of metal through corrosion, and the larger values may reflect corrosion product buildup or the presence of additional metal such as a backing plate.

Following the ultrasonic measurements, the deconcreted portions of the hull metal surface were covered with an epoxy product, Ameron Devco Devclad 182 Splash Zone Barrier Coating, to prevent prolonged exposure to the oxygenated seawater, which would accelerate corrosion. The product proved difficult to use for this specific application. The epoxy did not readily adhere to the metal surface, requiring divers to pile sandbags over each patch until it hardened.

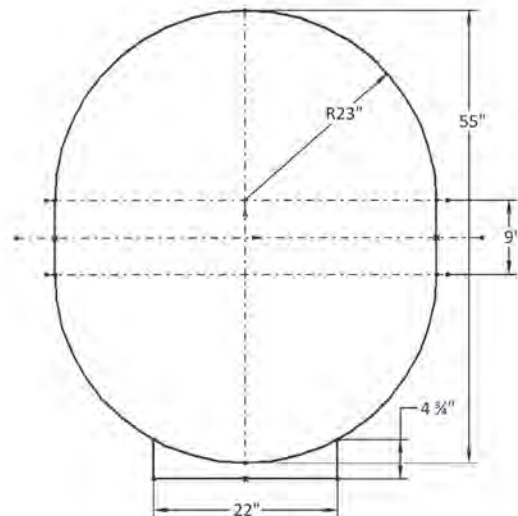
Figure 9.1. Cross section of hull based on measurements taken at the site in 1996. (OII 2000a:31)

As the geometric shape of an object is an essential factor in finite element analysis, a cross section was developed based on measurements taken during the 1996 survey (Figure 9.1). Described as “obround,” the main body of the hull has two parallel sides with a semi-circular top and bottom (OII 2000a:28). Hull thickness data was gathered during the preliminary fieldwork in November 1999 (see Chapter 8). The hull was made of wrought-iron plate, which varied somewhat in thickness, but a minimum average thickness was calculated at 0.340 in. (8.636 mm) for use in the model (OII 2000a:29).

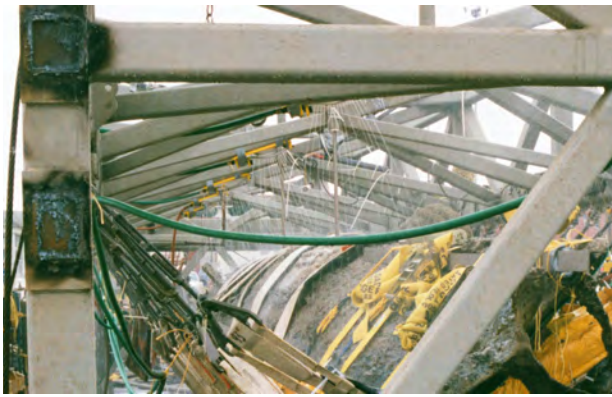
Figure 9.4. The soaker system designed to keep the hull wet during transport utilized ordinary sprinklers and pumped seawater. At left are the burn marks left from removing the bearing seats. (Photo by Rand Pixa, courtesy of FOTH)

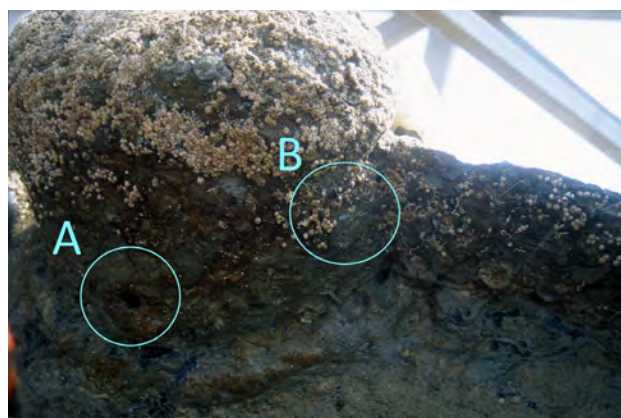
The glass from all but one of the deadlights was not fully concreted and was visible to divers upon the submarine's discovery. Most of the viewports in the conning towers were only partially concreted over, although those on top of the hatches and one on the forward conning tower were completely covered (Figure 12.15).

Figure 12.15. The viewport (A) on the starboard side of the forward conning tower was partially exposed, while the forward viewport (B) was completely covered over. Remains of star coral colonies are densely packed over the top of the hatch. (Courtesy of FOTH).

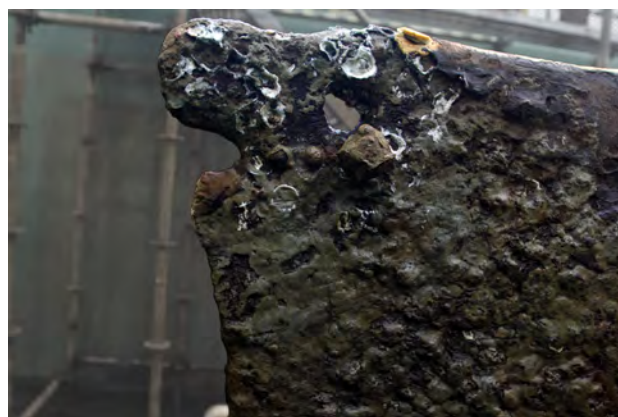
Large areas of the hull were also covered with marine growth, the most distinctive being the white remains of colonies of star coral (*Astrangia danae*) and the horse oyster (*Ostrea equestris*) (Murphy 1998:150–51). The upper areas preserved more evidence of colonies growing on the hull itself, while the lower areas, in the region of the Pleistocene mud layer, were covered in a thick shell/mud conglomerate. A few areas were relatively smooth with minimal shell coverage, such as portions of the bow casting (Figure 12.16). This apparent lack of colonization may be the result of high energy water flow during the period prior to the vessel's burial (see Chapter 13).

Figure 12.16. Horse oyster shells can be seen at the top of the port side of the bow casting, but the area below has been worn smooth by hydrodynamic forces. (Photo by H. G. Brown, NHHC).

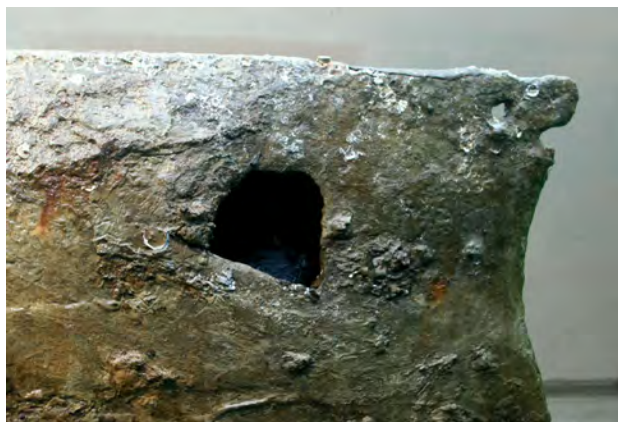
The other two holes are located along the starboard side, one near the bow, one near the stern, both in the vicinity of the boundary between the cast-iron ends and the wrought-iron plates. These appear to have developed after the submarine had settled into its final position, as a result of a complex interaction of erosion and corrosion processes (see Chapter 13). The bow hole

is trapezoidal in shape, measuring 27.4 cm (10.79 in.) at its widest point and 26.6 cm (10.47 in.) high (Figure 12.18). It begins 26.5 cm (10.43 in.) from the top of the hull, and 57.7 cm (22.72 in.) aft of the surviving edge of the bow casting.

Figure 12.18. Hole in bow, along boundary between wrought- and cast-iron components. Deterioration of the leading edge of the casting is also visible at right. (Photo by H. G. Brown, NHHHC).

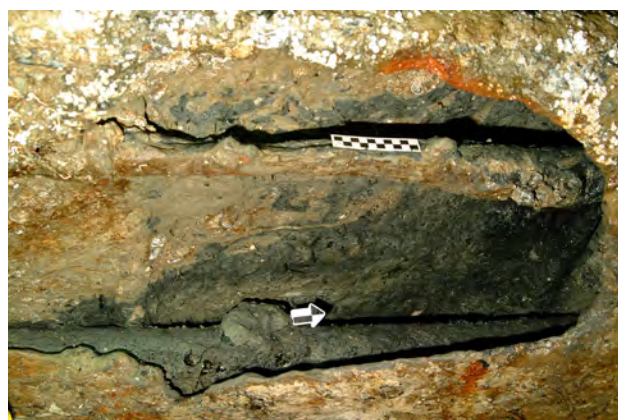
The stern hole is somewhat ovoid in shape, beginning 3 cm (1.18 in.) down from the top of the vessel and 32 cm (12.60 in.) forward of the after edge of the stern casting (Figure 12.19). It measures approximately 90 cm (35.43 in.) at its widest point with a maximum vertical expanse of 50 cm (19.69 in.). It crosses the boundary between the stern casting and the aftermost starboard top quarter plate. The steering rod can be seen through the upper third of the opening, running horizontally along the vessel's centerline.

Figure 12.19. The largest hole was at the stern near the top, crossing the boundary between the wrought- and cast-iron components, causing the loss of several rivets and exposing the steering rod. (Courtesy of FOTH)

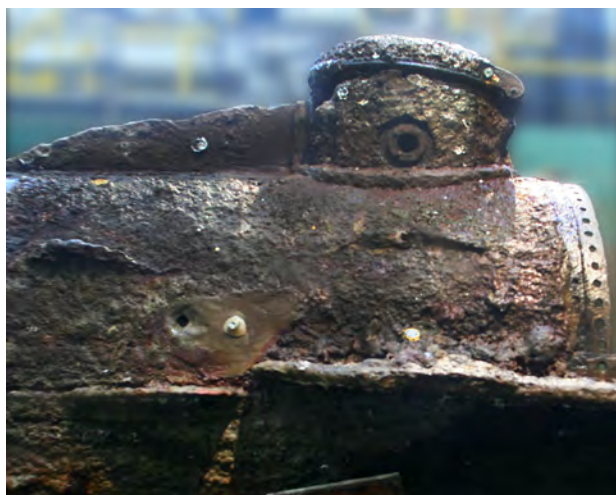
Another anomaly is the arrangement of the diving planes. Designed to move in parallel to each other, maintaining the same angle of inclination, the planes are now out of sync with one another. The starboard diving plane is positioned exactly along the vessel's horizontal axis, in line with the skeg. The port diving plane, however, is inclined slightly upward, its forward edge approximately 3 cm (1.18 in.) above its skeg, yet it does not appear bent (Figure 12.21). It is possible the port plane was snagged by a passing anchor at some point, or that the prolonged pressure from the ebb current on the exposed plane gradually pushed it up in relation to the starboard plane, which was protected by being planted in the Pleistocene mud layer. Further research, after deconcretion is complete, may shed light on the cause for this apparent discrepancy.

Figure 12.21. The port side diving plane is in a slightly raised position. (Photo by H. G. Brown, NHHHC).

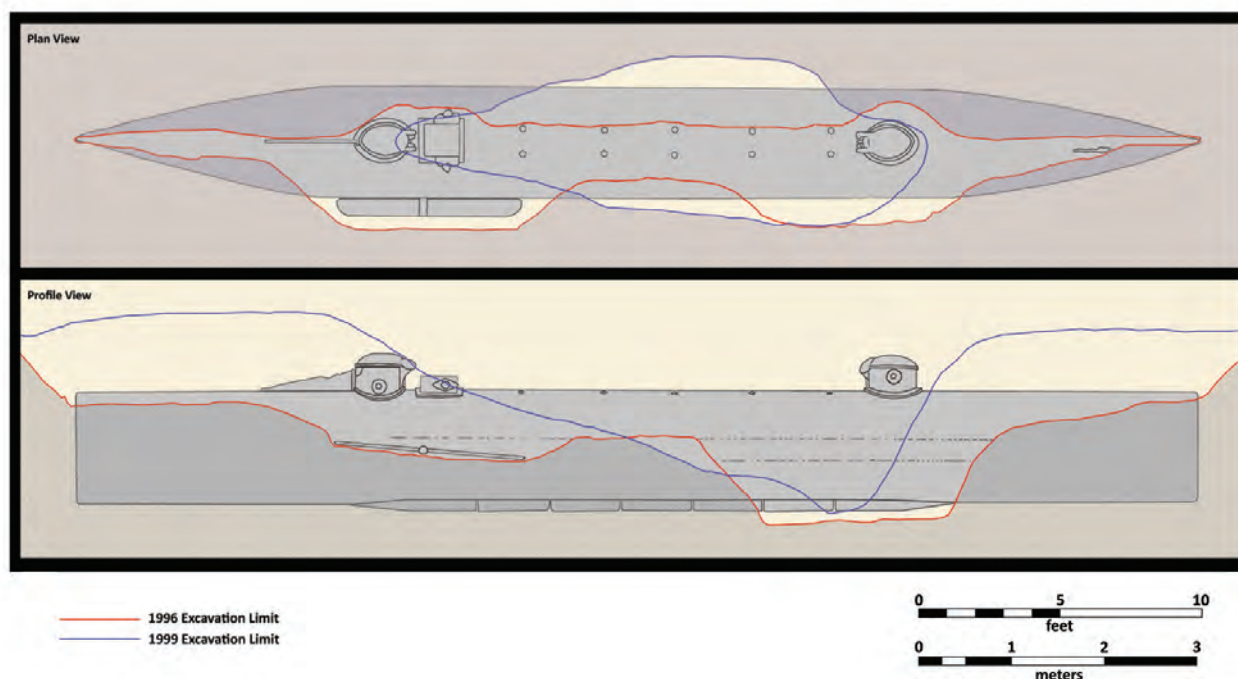
The largest factor affecting the site was the excavation itself. Based on records from the submarine's initial discovery in 1995 (Hall 1995), the site investigation in 1996 (Murphy 1998) and HAT's site visit in 1999, the sediment directly above the hull was disturbed in order to identify and assess the vessel (Figure 13.5). The full length of the top was exposed in 1996 along with the port side down the level of the diving plane, except one section near the aft conning tower that went down to the keel. The dredged material was not screened. Care was taken to minimize dredging around the bow and stern, where it was believed the most fragile elements would be found, and along the starboard side for fear of undercutting the support keeping the hull in position (Murphy 1998:17). In 1999, excavators attempted to stay within the previously disturbed area, but did need to expose a roughly 2 m (6.56 ft.) length along the starboard side to acquire vital engineering data for the recovery (see Chapter 8). Overall, the loss of context was kept as minimal as possible, and the matrix around the lower levels of the submarine remained intact except for the small section of keel port side. Despite the extent of prior disturbance, trends in the sediment matrix were still discernable.

Figure 13.5. Areas of sediment disturbed during the initial assessments of H. L. Hunley. (Diagram by H. G. Brown, NHHC)
