U.S. Fire Administration/Technical Report Series

Seven Fatality Fire at Remote Wilderness Lodge

Grand Marais, Minnesota

USFA-TR-055/July 1991

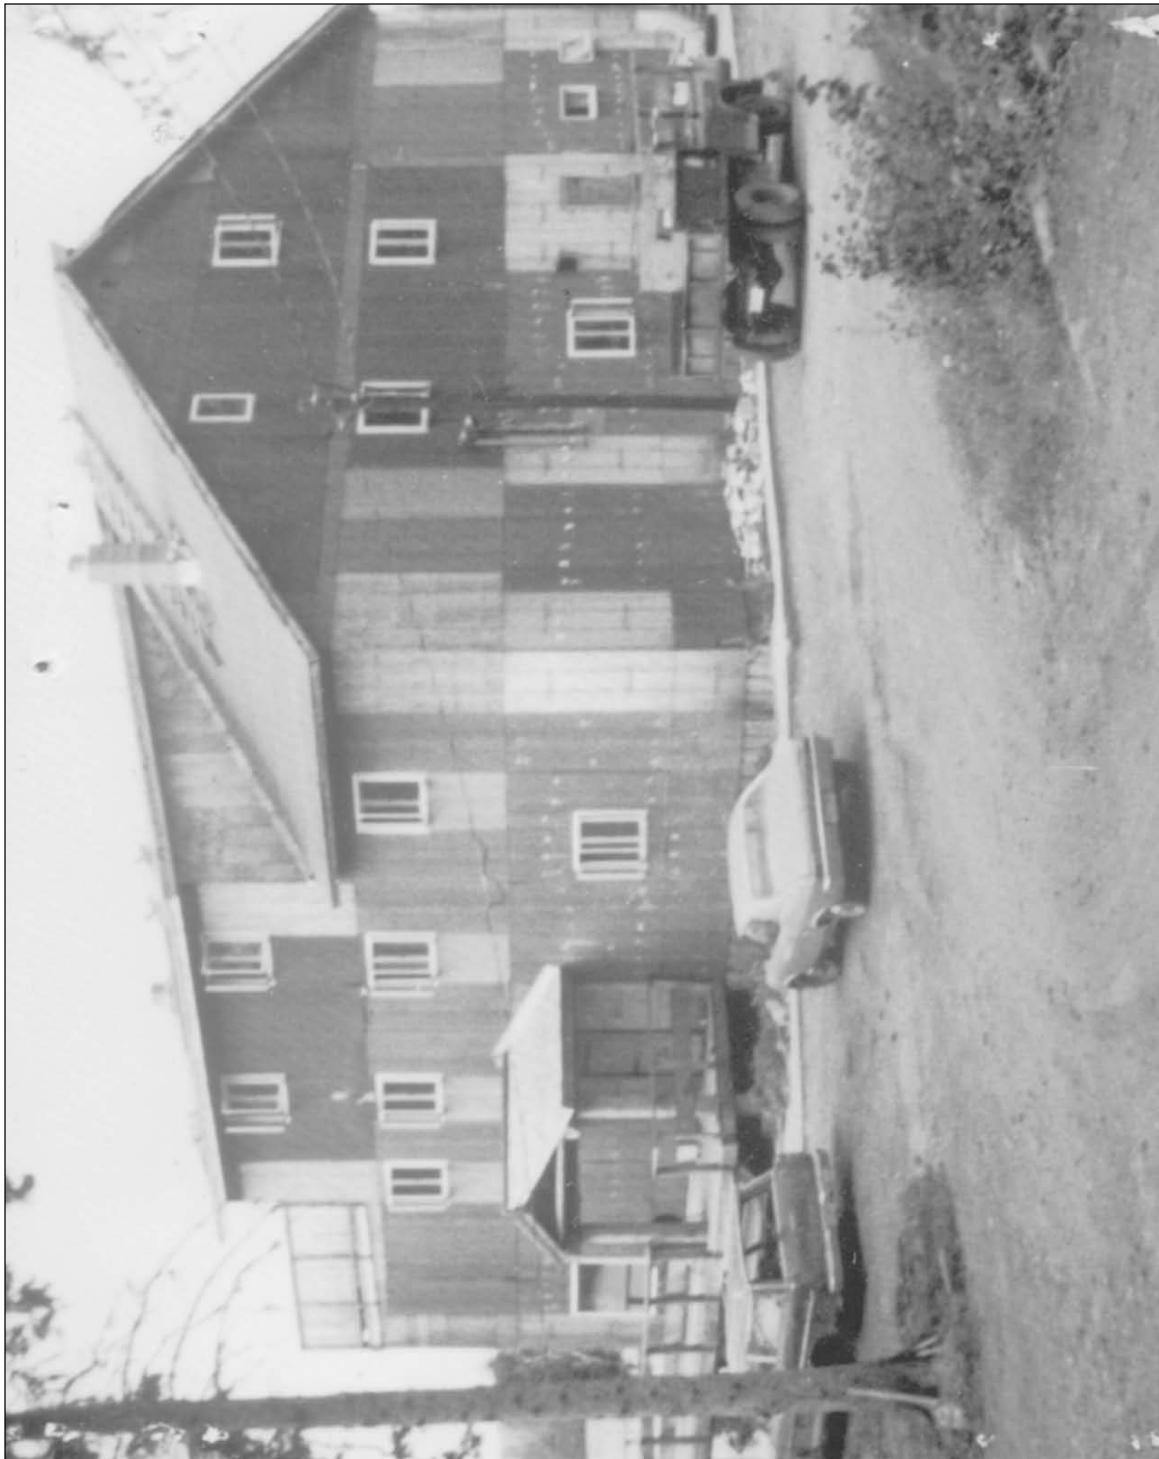
Photo provided by the Minnesota State Fire Marshal
Windigo Lodge under construction. Poplar Lake can be seen in background at left.

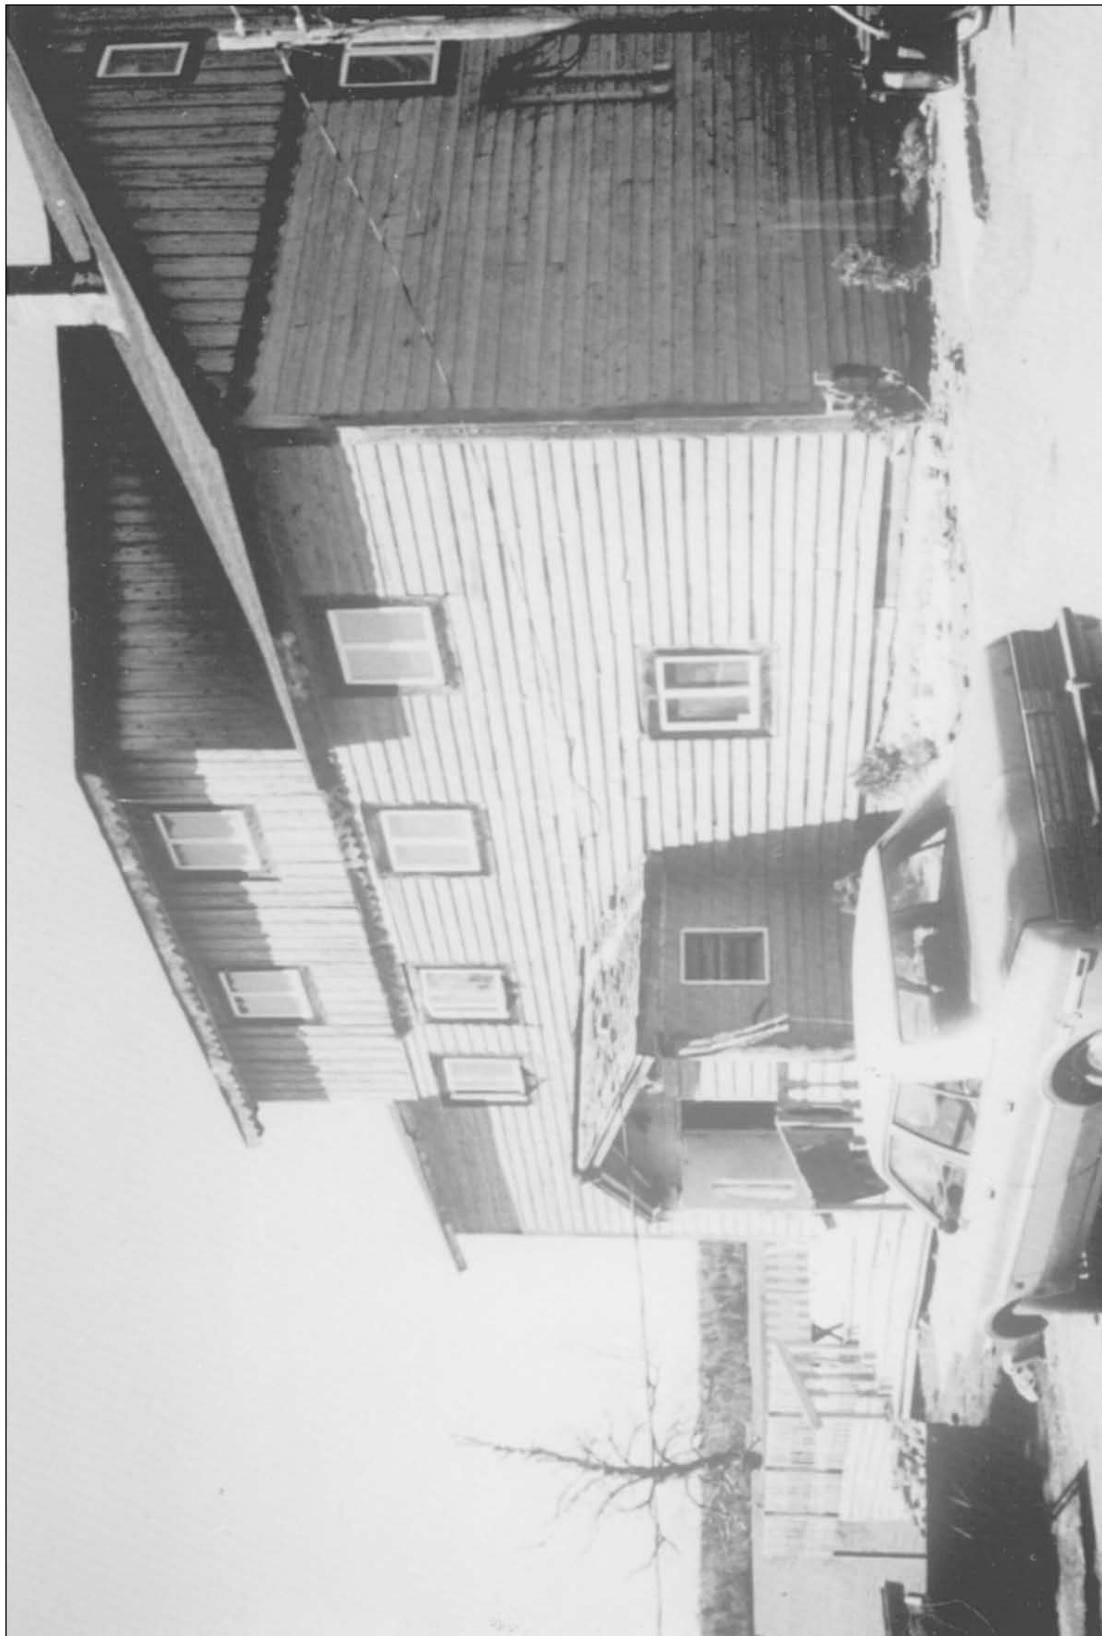
East side of lodge.

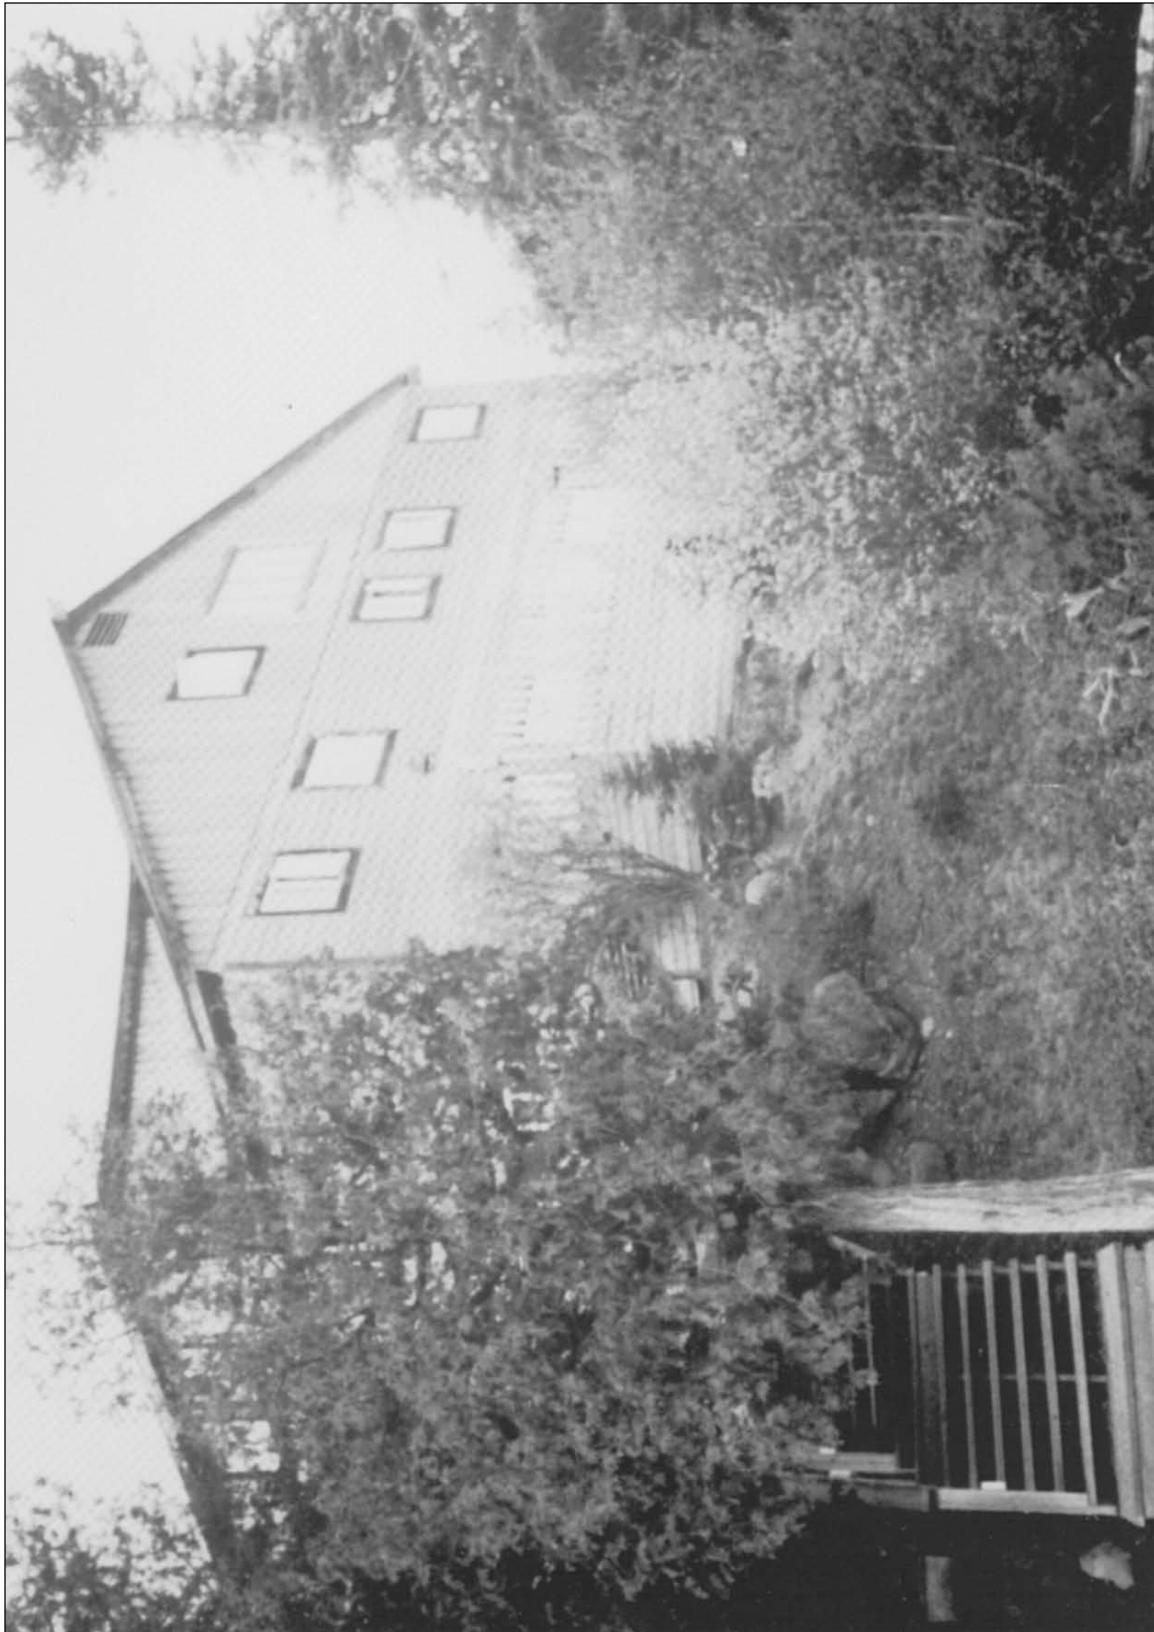
Photo provided by the Minnesota State Fire Marshal
Lake (south) side of lodge showing deck and stairway from basement walkout down to shoreline.
