U.S. Fire Administration/Technical Report Series

# Twelve-Fatality Hotel Arson

Reno, Nevada

USFA-TR-164/May 2008

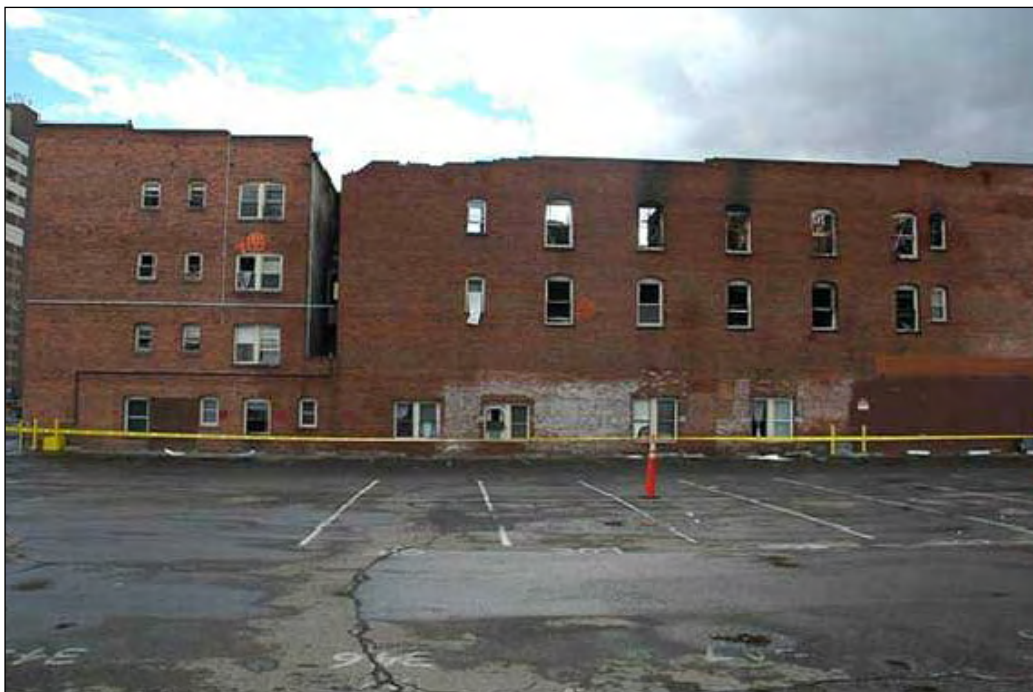
**Figure 2. Offset Between the Annex and North Wing.**

The north and south wings of the hotel were three stories in height, and the Annex was four stories. The Annex was attached to the east end of the north wing at ground level, and above the first floor only by narrow enclosed staircases, which can be seen in the following photo between the Annex and north wing. The height difference between the north wing and Annex created a slight offset of approximately 3 to 4 feet between floors of the Annex and north wing. Figure 2 shows the offset in height between the Annex and north wing.

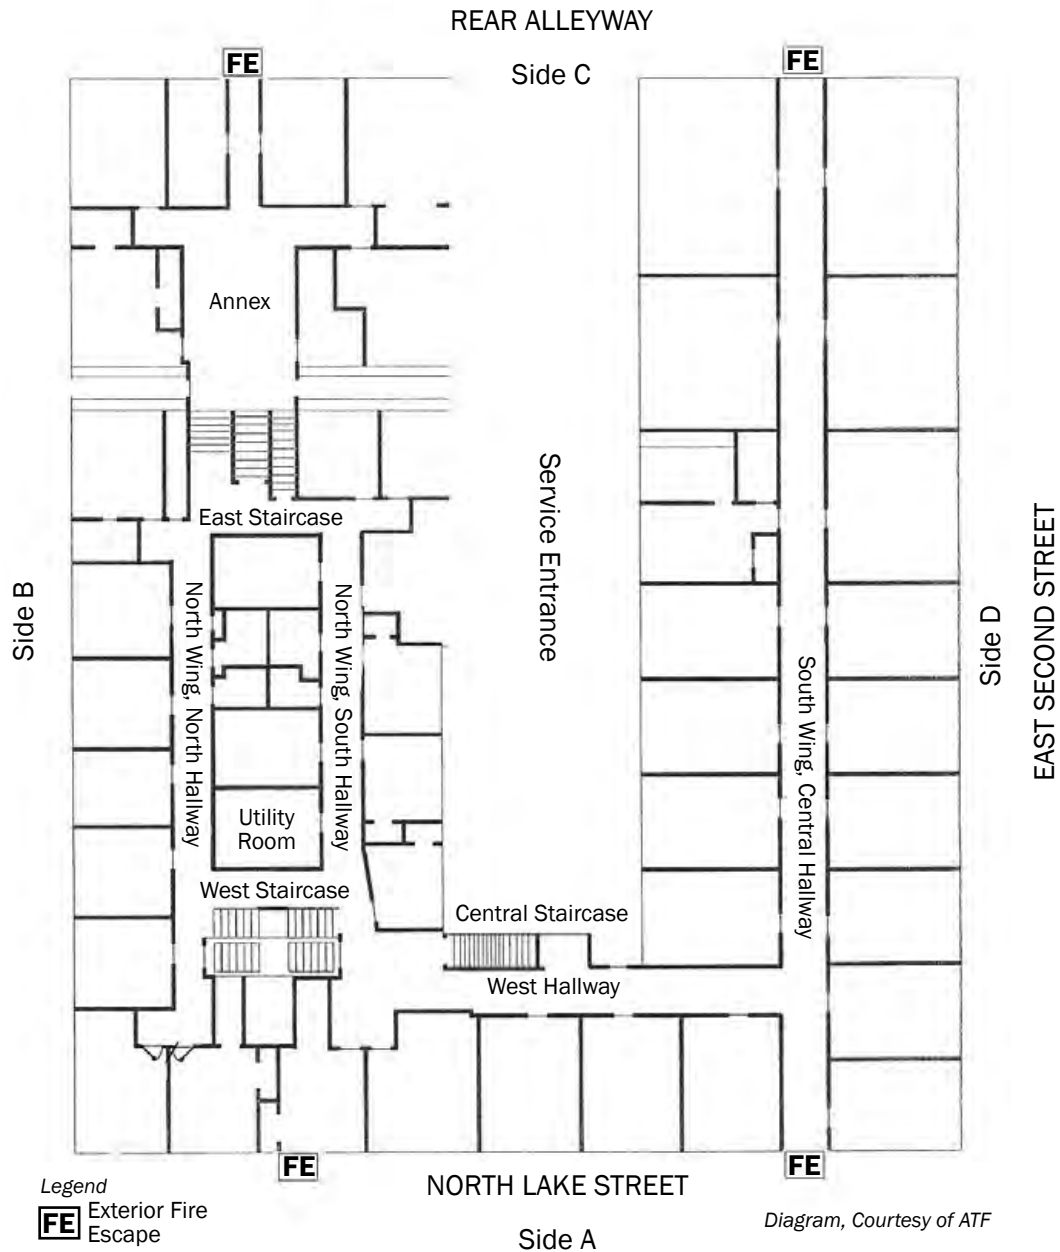
**Figure 4. Basic Floor Plan of Annex and Hotel.**

The second and third floors of the north wing were similar in layout, with two parallel hallways terminating at stairwells at either end. The western staircase was the only stairway in the hotel that led directly to the exterior of the building through the main entrance on Side A of the hotel. A third central staircase was located at midway of the west hallway between the north and south wings. This staircase accessed the residential rooms on the second and third floors of the south wing. A single central hallway provided access to all rooms in the south wing. Figure 4 shows the basic floor plan of the second through fourth floors of the Annex and north and south wings.

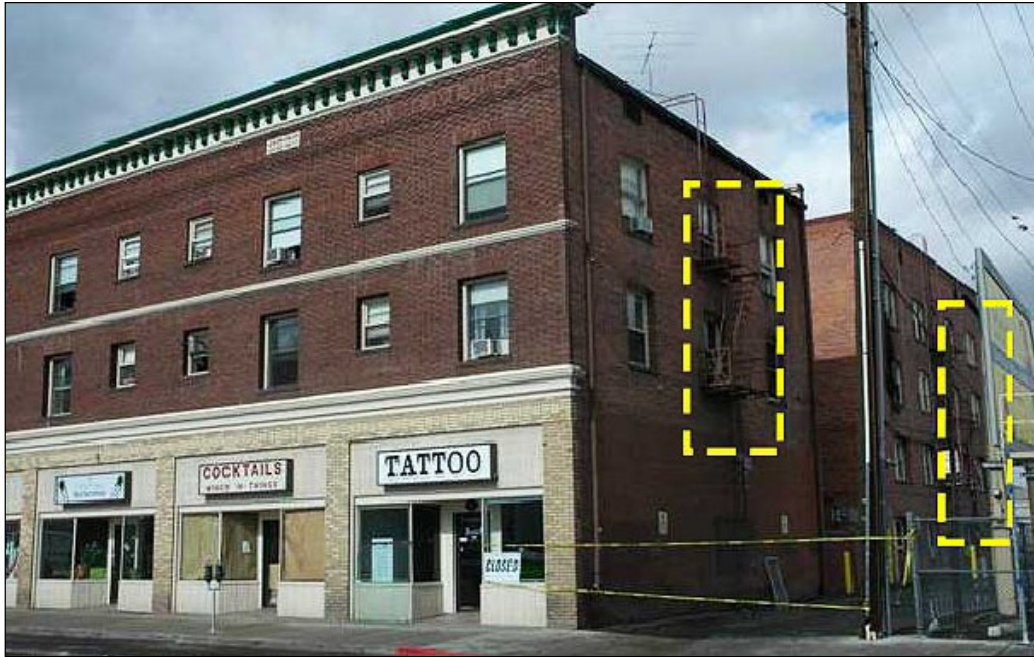
**Figure 6. Rear Fire Escapes.**

The hotel had four exterior fire escapes. Two were located on the front (Side A) of the hotel at the west end of the north and south wings, and two at the rear of the building that serviced the south wing and Annex. The north and south wing fire escapes serviced the second and third floors of the hotel. The fire escape at the rear of the Annex serviced the second through the fourth floors of the Annex. **The only access to the fire escapes was through the interior hallways.** During the fire, the interior conditions deteriorated so rapidly that the interior hallways and stairwells quickly became untenable and residents who failed to exit the building immediately could not get to the fire escapes

and to safety. Figure 5 and Figure 6 show the location of the exterior fire escape on the front and rear of the hotel.

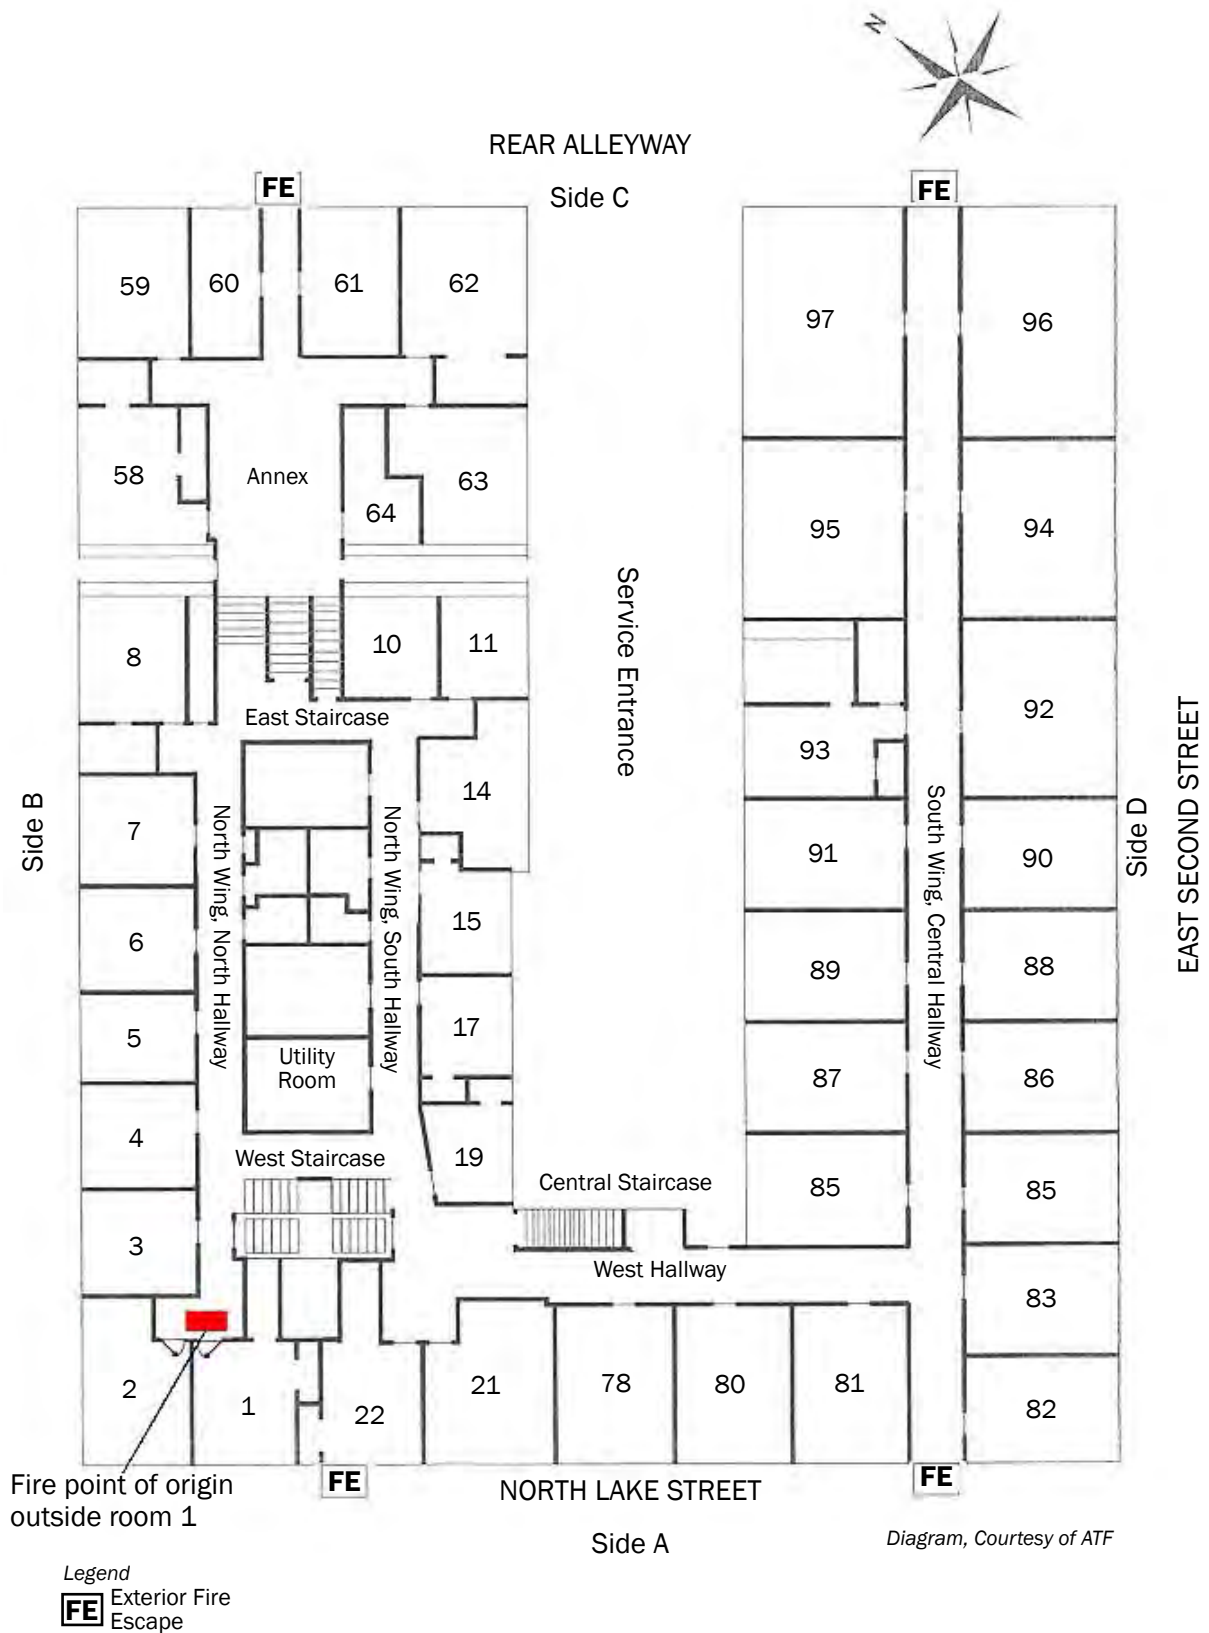
Figure 7. Fire Zone 8.

The system first alerted to the fire at 9:59 p.m. when a smoke detector in Zone 8 activated. This zone covered the entire second floor of both the north and south wings. Fire investigators determined the fire started on the second floor of the north wing. In less than 2 minutes detectors in Zones 3, 4, and 5 activated as well, which is a good indication of how fast the smoke and heat were spreading. Figure 7 shows the second floor area encompassing Zone 8 in which the first smoke detector alerted. Table 2, which follows, shows the time sequence of smoke detector and alarm activations the evening of the fire.
