# UNITED STATES COAST GUARD

## REPORT OF INVESTIGATION INTO THE FIRE ONBOARD THE CARNIVAL SPLENDOR WHICH OCCURRED IN THE PACIFIC OCEAN OFF THE COAST OF MEXICO ON NOVEMBER 8, 2010, WHICH RESULTED IN COMPLETE LOSS OF POWER

MISLE INCIDENT INVESTIGATION ACTIVITY NUMBER: 3897765

16732  
July 15, 2013

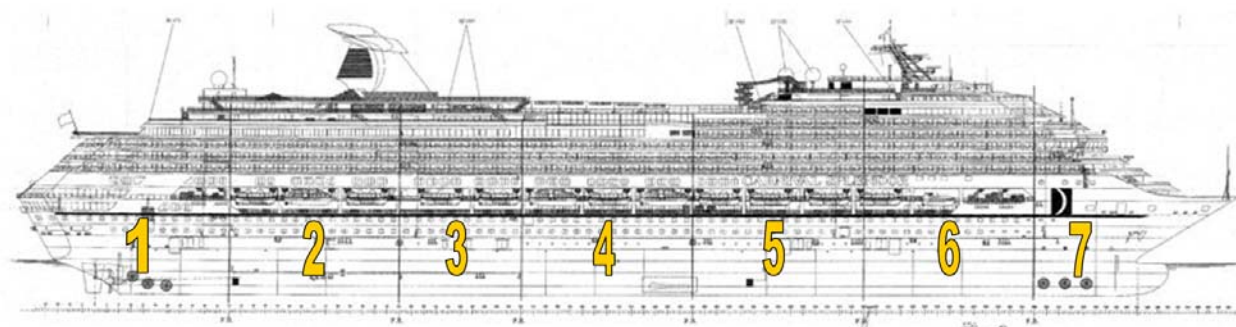
The Carnival Splendor is divided into seven fire zones numbered one through seven, aft to forward and separated by the dark vertical lines in the figure below. The aft engine room is located in fire zone two.

**Figure 2 - Profile view of vessel showing location of Fire Zones**

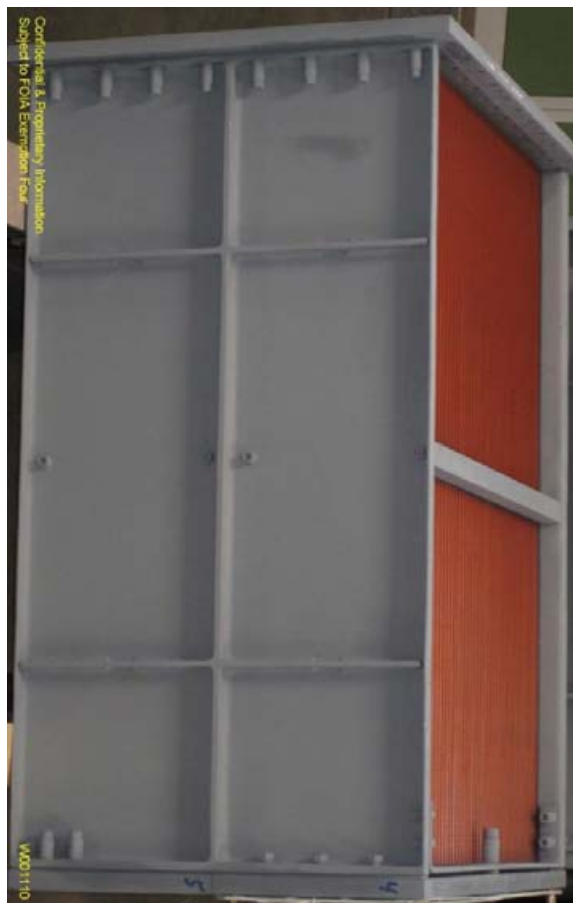
Onboard the Carnival Splendor as recently as July 12, 2010, the B bank of DG5 was discovered to have a severely corroded, destroyed and leaking air cooler heat exchanger. The cause of the corrosion was suspected to be: 1) failed drainage of the condensate formed on the outside of the tubes and away from the heat exchanger, 2) a leaking heat exchanger tube, and 3) backflow from other operating engines when the engine is secured or during temporary exposure from other leakages such as when the exhaust gas boiler flooded back to the engine during refilling. Photograph 7 shows the bottom of the heat exchanger having rusted away almost a complete steel 27 plate between its frames. Photograph 8 shows the plate of a new heat exchanger having slightly different construction.

**Photograph 8 - New heat exchanger for comparison.**  
Photo provided by Wartsila

After the July 2010 incident, check valves were installed in the piping for DG 4, DG 5 and DG 6. During the investigation, a number of Carnival employees stated that fluids and moisture from operating engines would back flow into the air coolers of engines that were secured due to the design of the piping system and absence of check valves. The back flow was due to the fact that they shared a common line leading to the tank and lacked check valves.

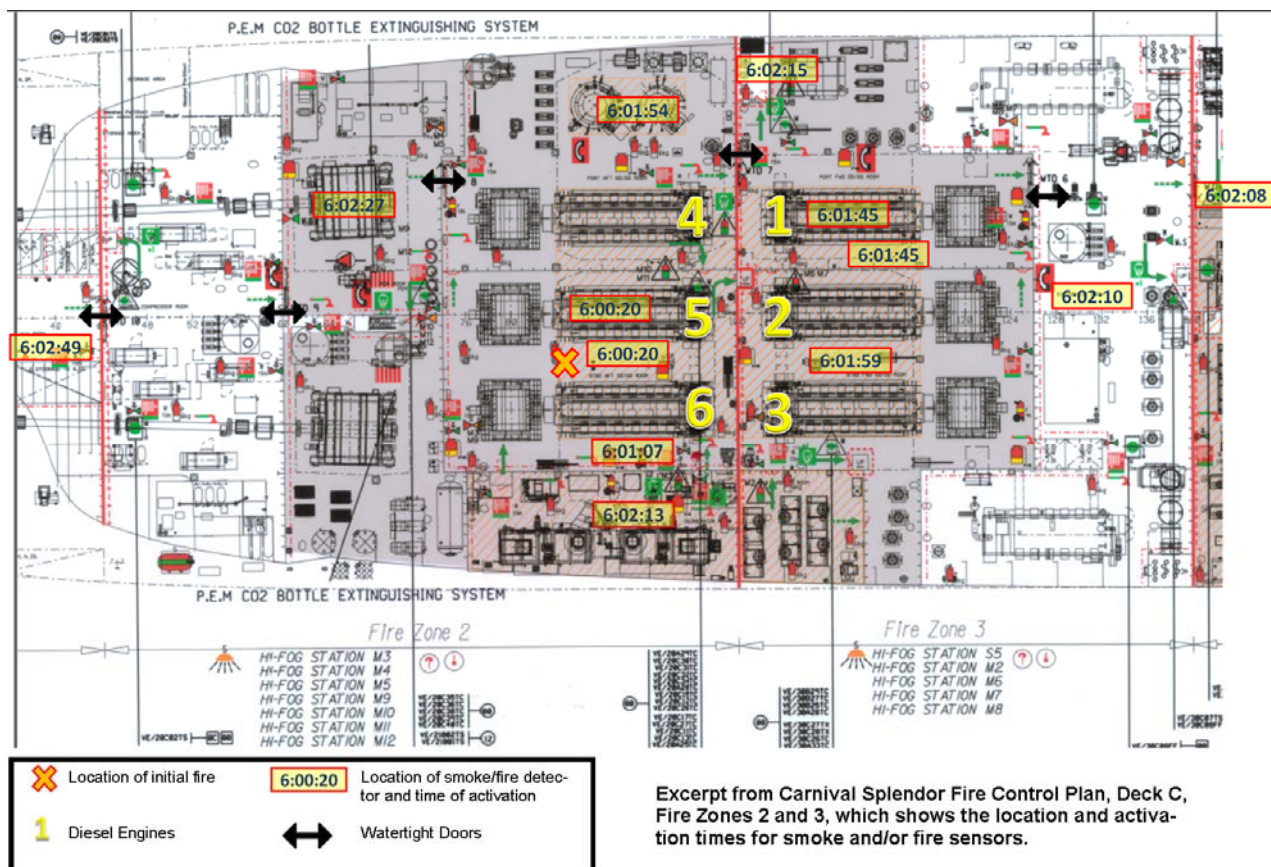
Figure 1 shows the location of the fire as well as the sequential activation of the fire/smoke sensors. Within 2 minutes, the smoke traveled beyond fire zones 2 and 3. As a result, the Hi-Fog local protection system was activated in machinery spaces outside of the affected area.

As a result of the intervention by the bridge watch officer, the activation of the Hi-Fog local protection system for DG 5 and 6 was delayed by approximately 15 minutes. By the time the Hi-Fog system was activated, the fire had spread to the cable runs over DG 5 and 6. Since the Hi-Fog system was designed for local protection, the nozzles were positioned below the cables runs and the Hi-Fog system was not effective in suppressing or extinguishing the fire in the cable runs.

Figure 1 - Excerpt from the Carnival Splendor Fire Control Plan showing Deck C, Fire Zones 2 and 3 Plan annotated by USCG
