# HISTORIC STRUCTURE REPORT The Wright Cycle Company Building

(HS - 01)

Dayton Aviation Heritage National Historical Park  
Dayton, Ohio

March 31, 1999  
Final Submission

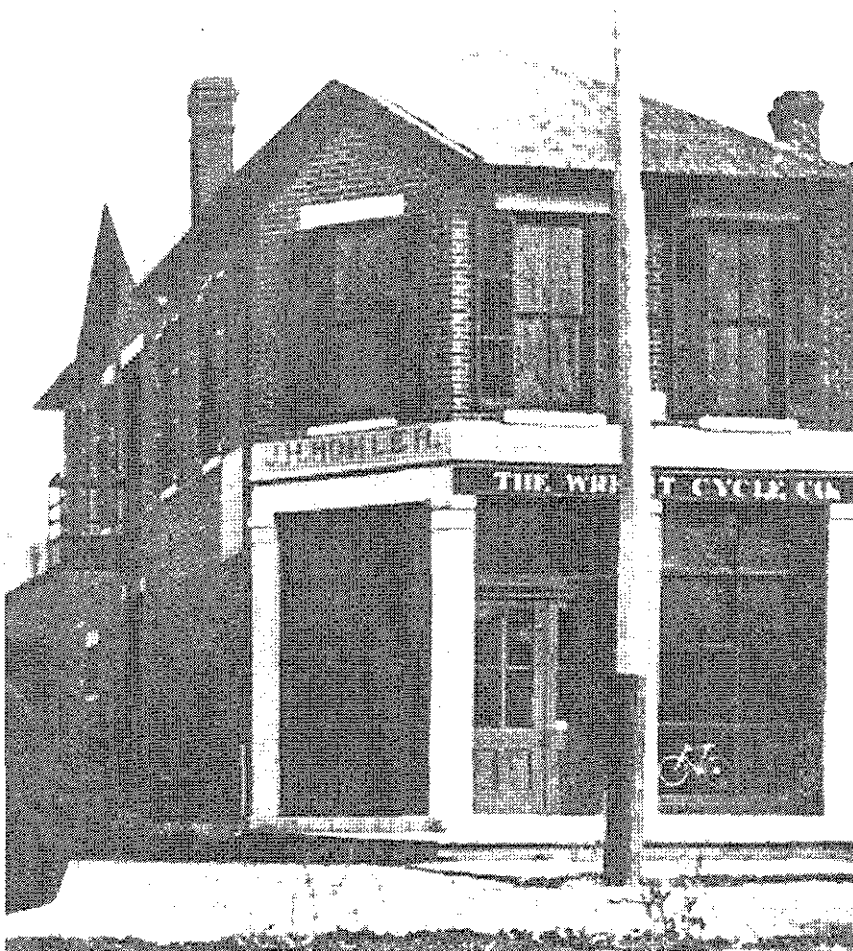
*Figure 1 This is a detail, showing The Wright Cycle Company building in 1896, from a photo of Charles Webbert's niece taken by Lura Hoover. The original photograph is in a private collection. (Wright State University, Archives and Special Collection)*

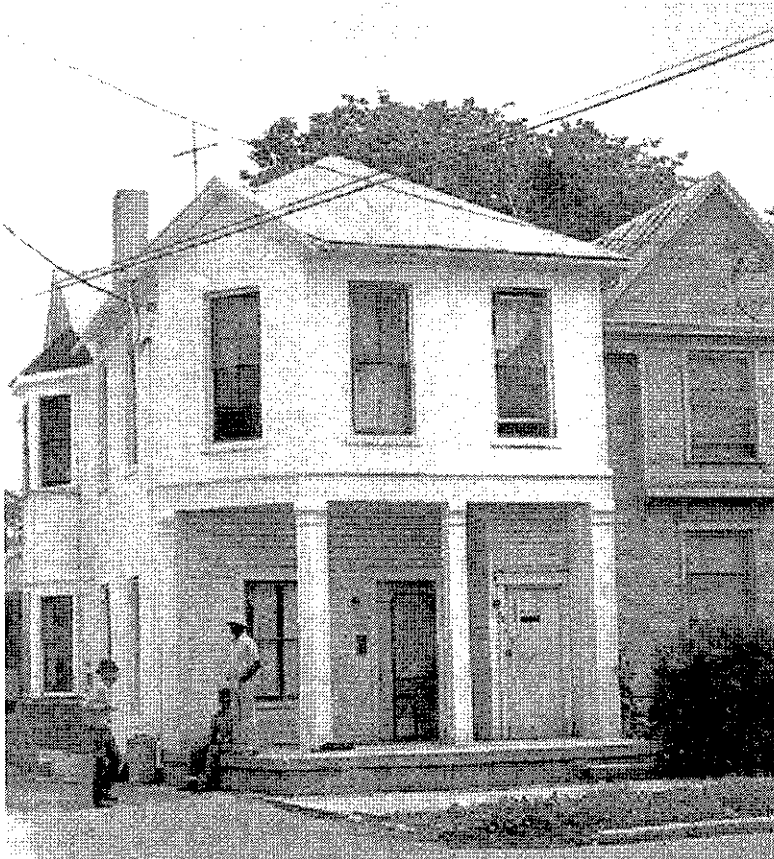
In this photo, Figure 3, the changes to the first floor are more visible. The north window is a double-hung, one-over-one sash. At the center bay is an entrance with a wood paneled door and wooden screen door, complete with a wall-mounted porch lamp and mail box. At the southern end, at the bump-out, is another entrance with another wall-mounted porch lamp and the address numbers "24." The wood trim is the same for both of these entrances and the one window. Along the west elevation, there is a concrete porch that includes the chamfered corner, with two steps down in front of the southern entrance. Above, on the second floor, the windows appear to be original, though the shutters are missing. Only the bottom sash of the southernmost window appears to have been replaced with a single-pane sash.

The brick chimney on the north elevation is still in place although it is missing its corbelled detailing. The second chimney visible in the photo belongs to the adjacent house to the south. The shingles at the roof appear to have been replaced with rolled roofing membrane over the main body of the building, and dark shingles are visible over the bay window. The exterior stairway to the basement can be seen at the north elevation. Almost every surface of the building has been painted white.

**Figure 3** View of The Wright Cycle Company building in 1982. (Aviation Trail, Inc.)

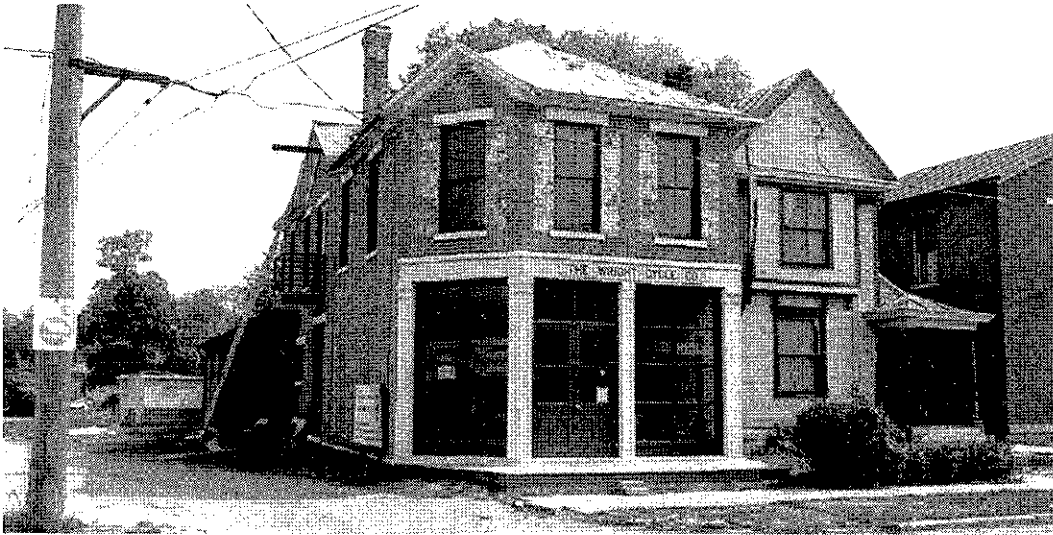
**Figure 4** View of The Wright Cycle Company building in 1986 with most of the restoration work completed. Photo courtesy of Aviation Trail, Inc.

This photo (Figure 4) shows the north and west elevations of 22 South Williams Street, with a chamfered north-west corner. For the most part, these elevations appear to have been restored to the image in the 1896 close-up photo (Figure 1), but there are some slight differences in their appearances. These inconsistencies are as follows:

- The replacement shutters only have two divisions, while the original shutters were divided into three sections, as evidenced in the 1896 photo.
- The small square window on the north elevation at the first floor is not in the same location as the window in the 1896 photo. Originally, the window was centered between the two second floor windows above it.

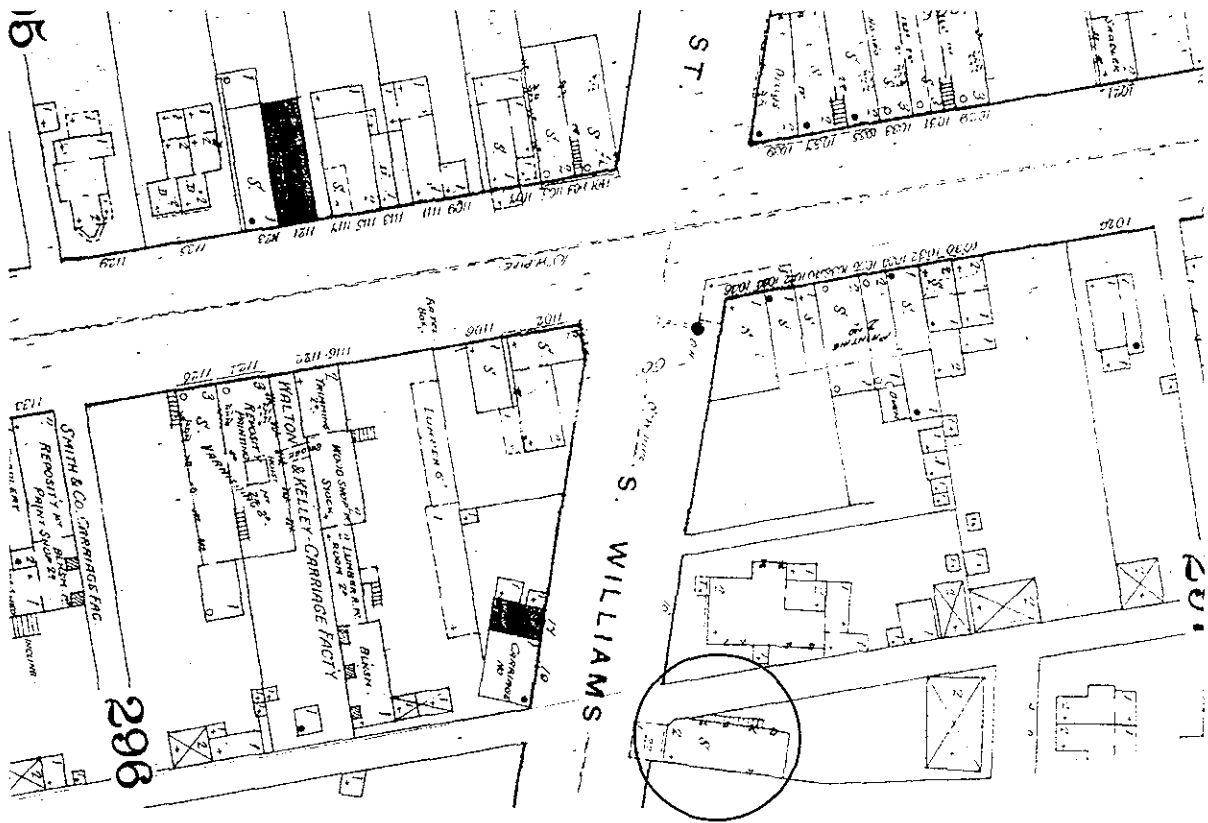
Figure 5 Sanborn Insurance Map, 1887. (The Sanborn Perris Map Co., Ltd., New York, New York)

Figure 5. Drawn shortly after the Wright building was constructed in 1886, this map shows the original outline of the building (circled). There is an exterior stair on the north side, no additions at the back, and the northwest corner is beveled. A porch or unknown structure extends from the west elevation into the street. The lot to the immediate south is empty.

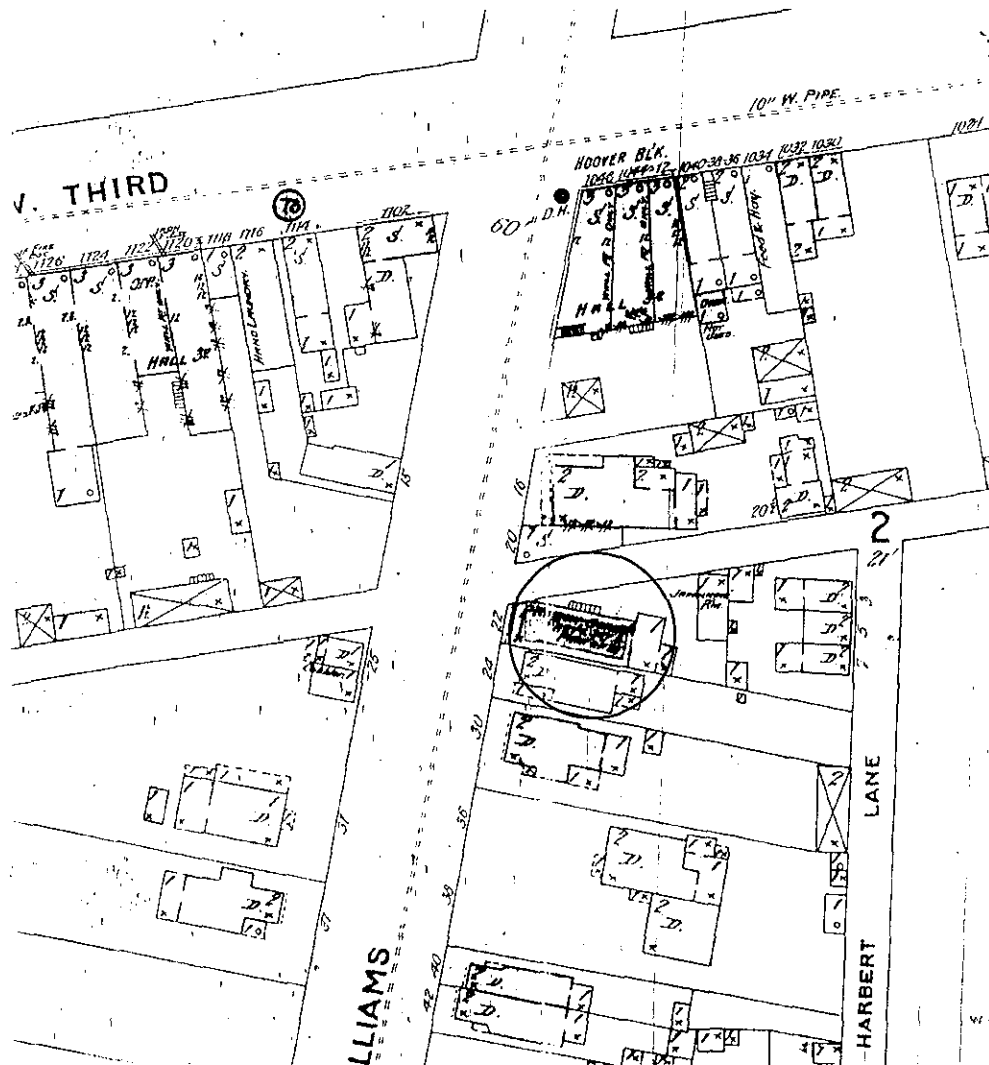
Figure 6. By 1897, the front extension had been removed. Two additions were constructed at the back of the building. The text within the body of 22 Williams Street reads "Window Screen Fcty 1st & part of 2nd," indicating the building was still used for manufacturing. The map includes the two houses to the south of 22 Williams Street, No. 24 and No. 30, which are also part of the current West Third Street Historic District.

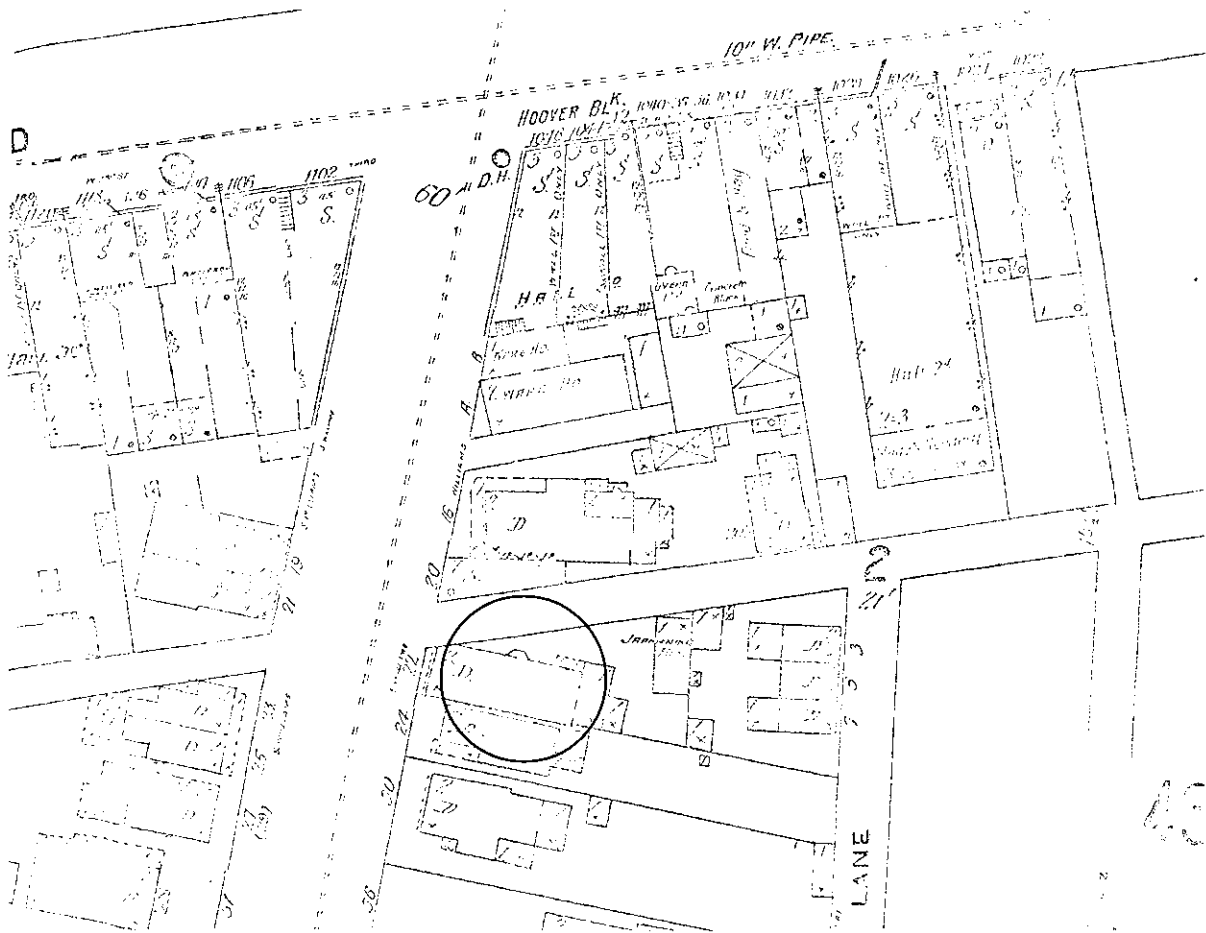
Figure 7 Sanborn Insurance Map, 1911. (The Sanborn Perris Map Co., Ltd., New York, New York)

Figure 7. Changes to the Wright building (circled) indicated on this map include the removal of the north exterior stair and the addition of a bay window to the same elevation. A porch has been added at the northeast corner. On the west side of South Williams Street, the houses at 23-25 and 27 South Williams Street are in place. These houses are also part of the current West Third Street Historic District. The duplex at 23-25 replaced an earlier, smaller structure shown on the 1897 Sanborn map. The occupancy designation of "D" within the building outline indicates a dwelling. Generally, the Sanborn Maps use "dwelling" specifically to mean a single-family residence.

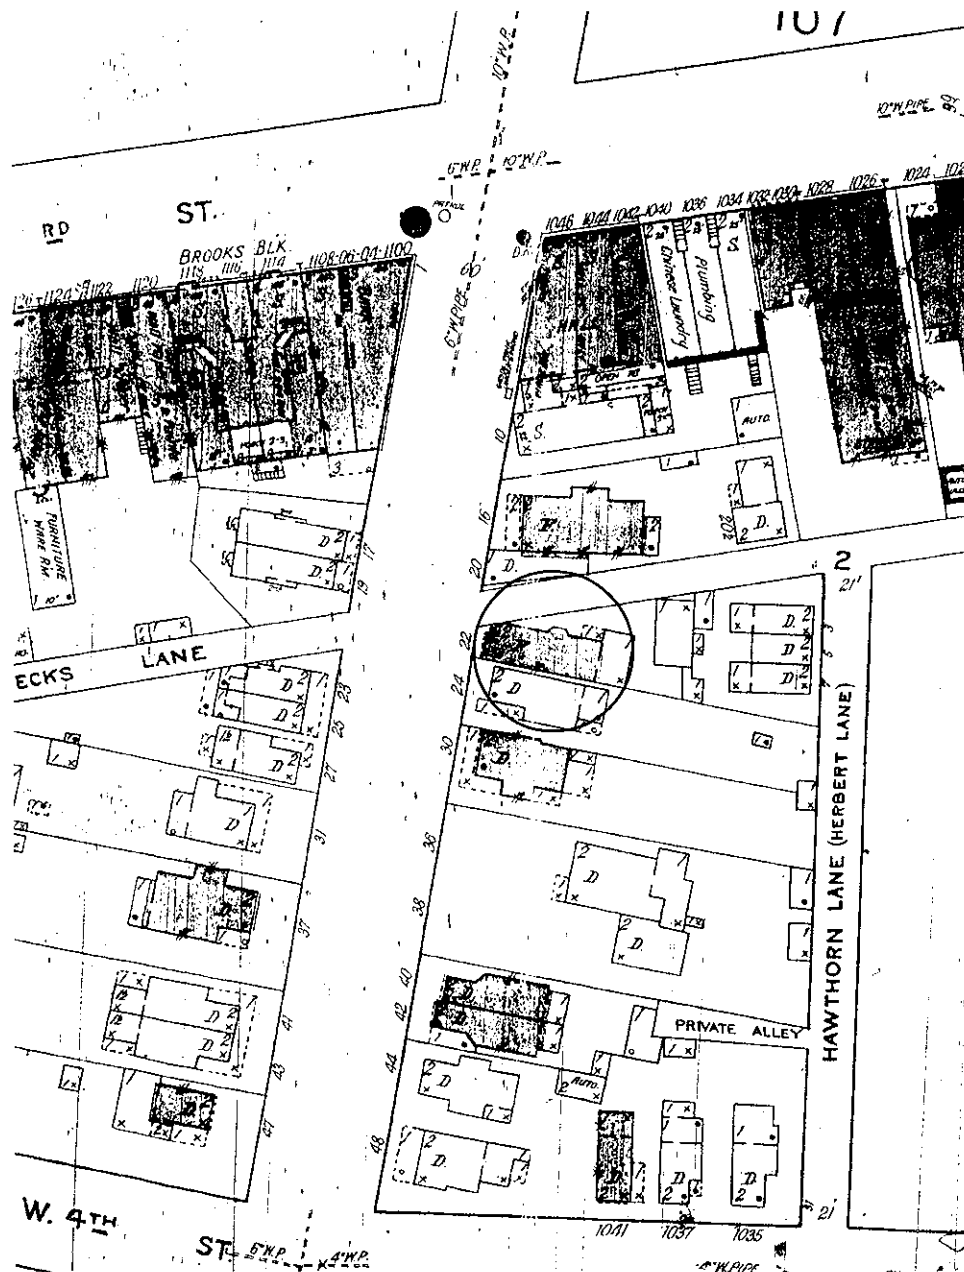
Figure 8 Sanborn Insurance Map, 1918. (The Sanborn Perris Map Co., Ltd., New York, New York)

Figure 8. Changes to the Wright building (circled) indicated on this map include the removal of the north exterior stair and the addition of a bay window to the same elevation. The smaller of the two previous additions has been removed from the back. The occupancy designation has been changed to "F", which in the Sanborn code represents "flats": a single family dwelling at each floor of the building. A dashed line at the west end of the building indicates that the storefront windows have been converted to a porch by this time. The original storefront has been removed, with the columns remaining as freestanding supports for the upper story. The new first floor facade is now recessed into the body of the building, bringing it in line with the house to the south.

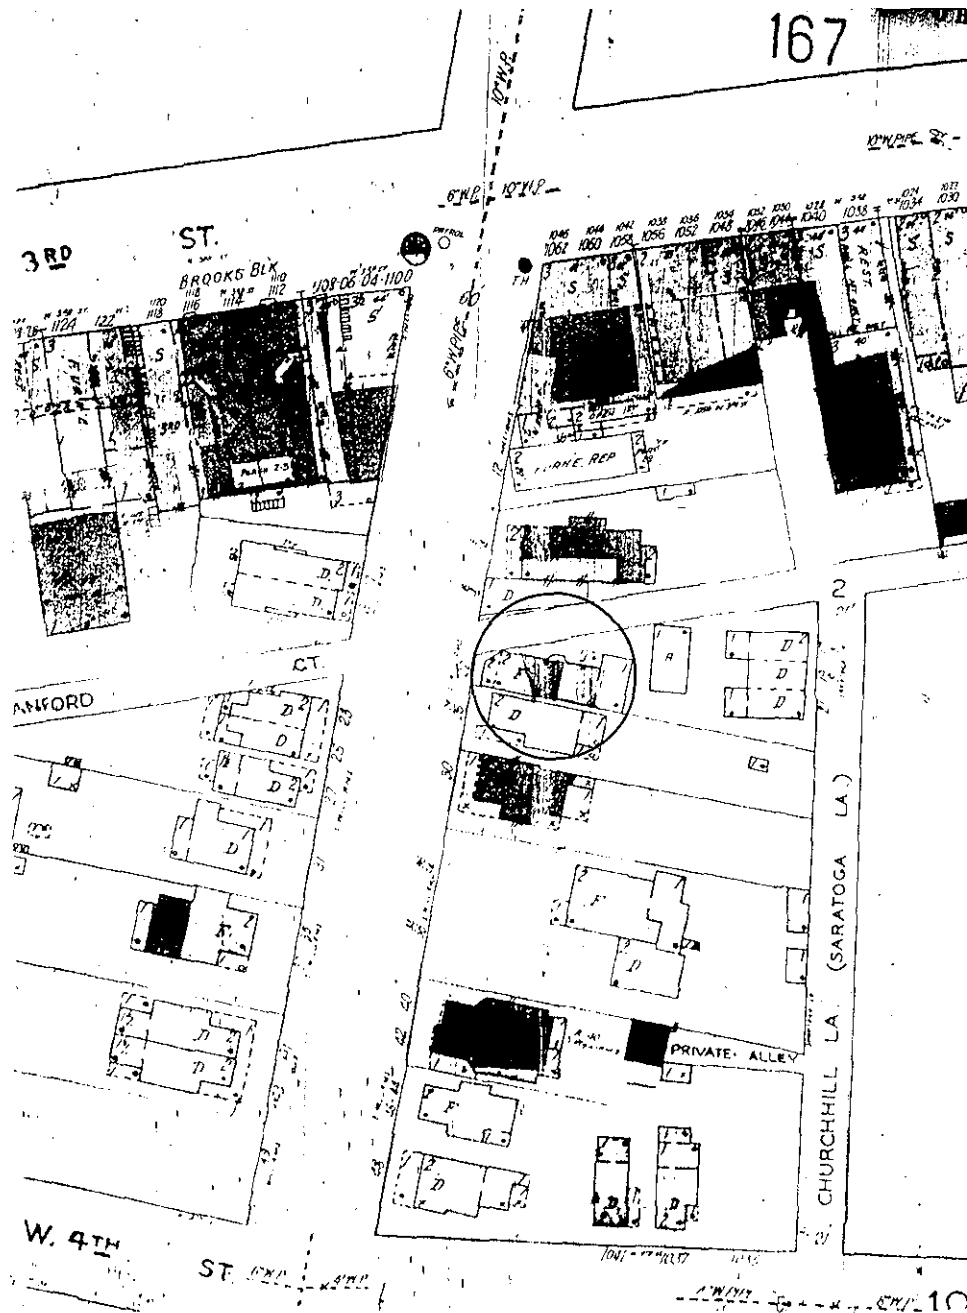
Figure 9 Sanborn Insurance Map, 1936. (The Sanborn Perris Map Co., Ltd., New York, New York)

Figure 9. The general outline of the Wright building (circled) remains unchanged, and the occupancy type is still listed as "flats." The only change appears to be in the roofing material: composition shingles have replaced the wood on the main building and the rear additions.

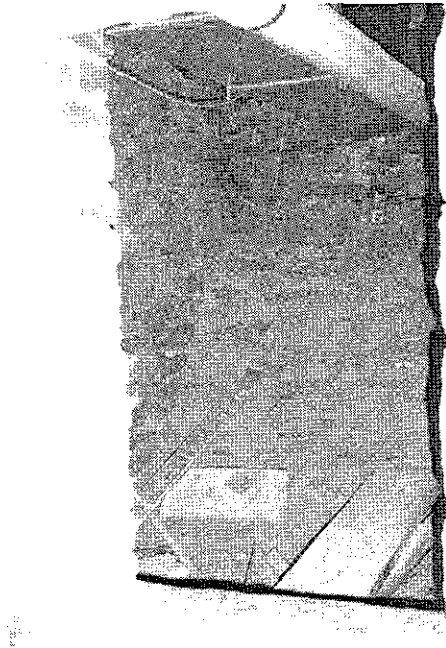
The basement is constructed of original stone rubble walls. The walls at the northwest corner are chamfered, reflecting the above-ground building configuration. At the east wall is an additional, partially excavated, 4'x6' area with masonry walls and a sloped, unfinished floor. This was an exterior stair to the basement (Figure 1) which was probably closed off when the rear addition was constructed prior to 1896. The basement floor is a concrete slab. On the floor north of the stair opening is a semicircular concrete pad which is believed to be original. This may have served as a stove or furnace base.

*Figure 1: The cavity of the former exterior basement stair.*
