# GUIDELINES FOR REHABILITATING HISTORIC COVERED BRIDGES

**Edited by Christopher H. Marston and Thomas A. Vitanza**

National Park Service, Historic American Engineering Record  
National Park Service, Historic Preservation Training Center  
Federal Highway Administration, Turner-Fairbank Highway Research Center

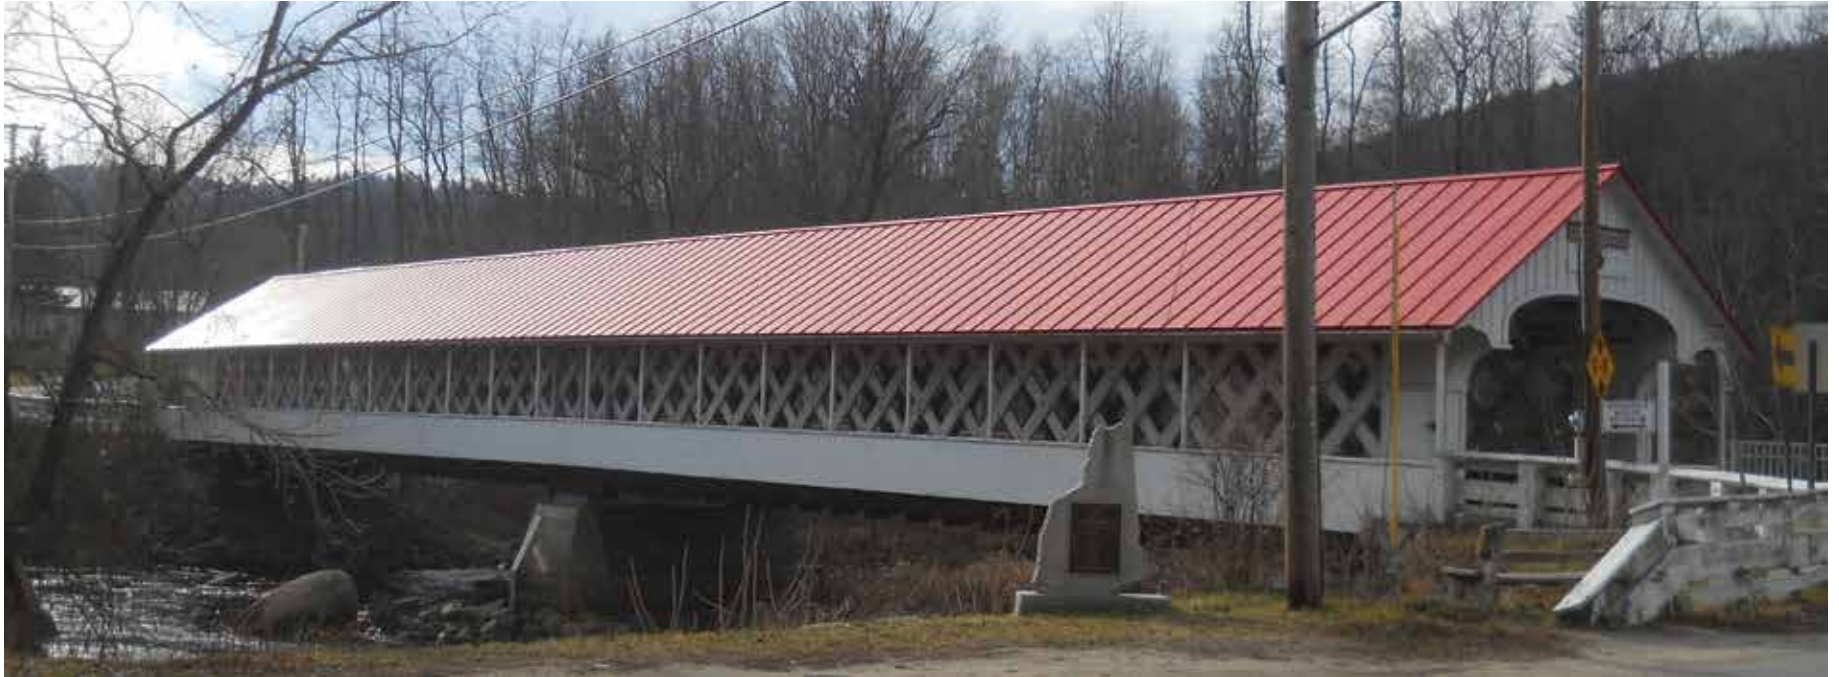
**Figure C1.1** Upstream elevation of Ashuelot Covered Bridge. Sean T. James, 2012.

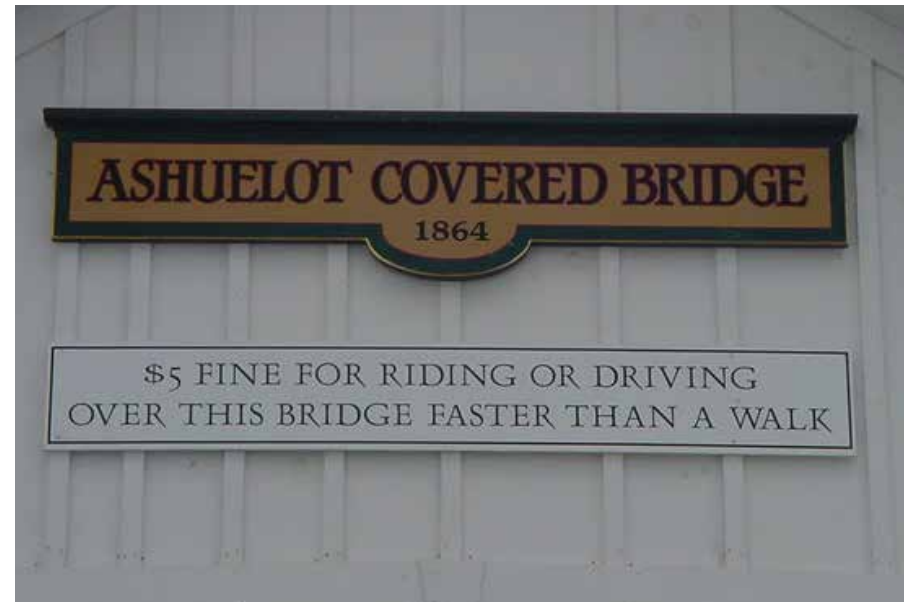
**Figure C1.4** Reconstructed signs. Sean T. James, 2001.

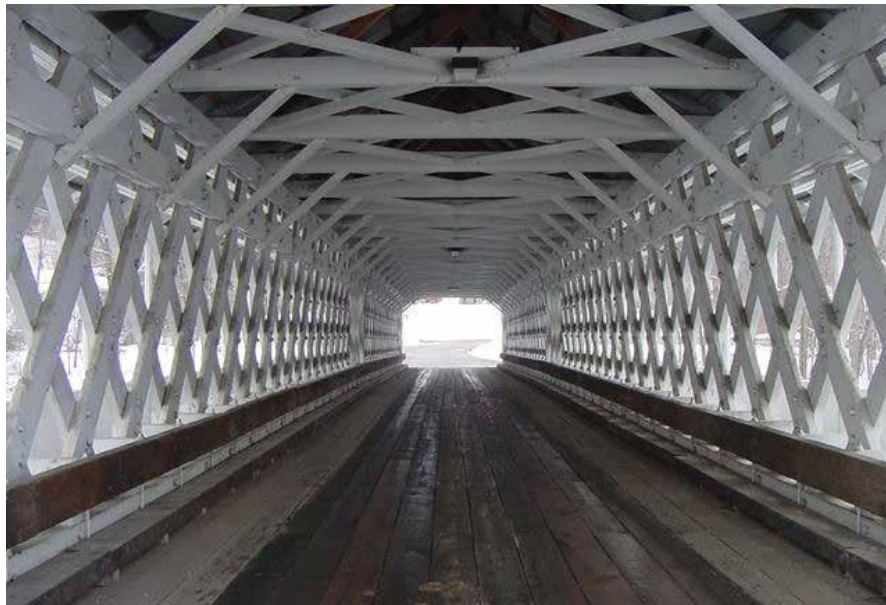
**Figure C1.5** Interior view of trusses, deck and unpainted 4" x 12" bridge guardrail. Sean T. James, 1998.

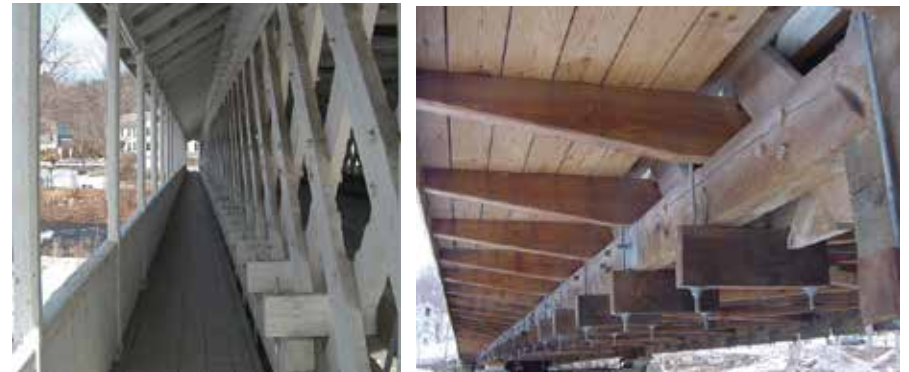
**Figure C1.6** Exterior sidewalk showing bolster blocks and rod clamp system on right; original 4" x 5" molded handrail on left. Scott Wagner, 2005.

**Figure C1.7** Lower guardrail support. Note tapered long floorbeams supporting 3" decking for sidewalk. Sean T. James, 1998.

spaced 1'-4" o.c. Full sawn 4" x 12"s with a higher grade (select structural) were substituted for the 3 1/2"x11 1/4", and the spacing between floor beams was increased to 2'-0". Physical evidence was found to support the change in floor beam spacing. By returning the floor system to its original configuration, material costs were reduced and dead load decreased. The existing Douglas fir floor beams were repurposed as the guardrail supports and clamps depicted in figures 5-7.

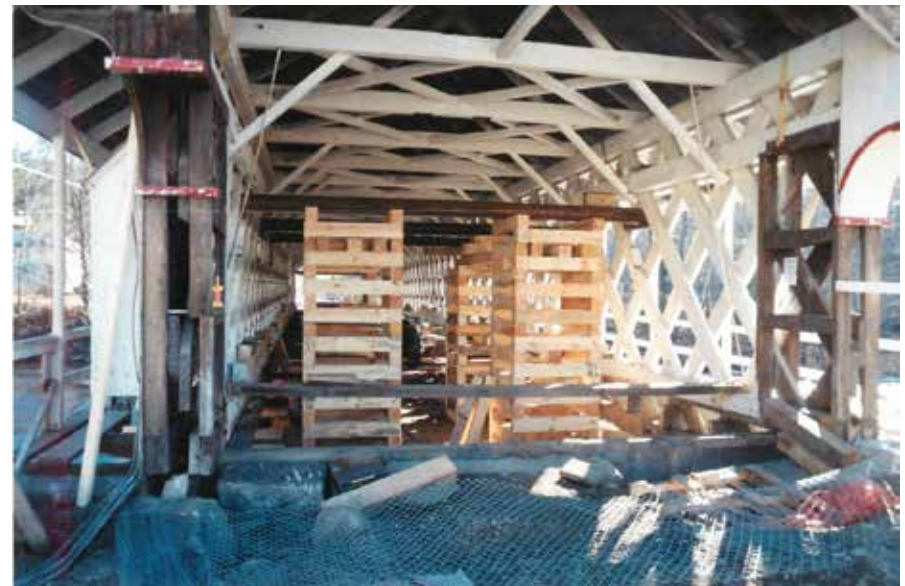
**Figure C1.9** Interior shoring. Sean T. James, 1998.

Once the temporary shoring was in place, the crew replaced truss lattice and chord members with select structural grade Douglas fir members that matched the dimensions of the existing truss members. The replacement members were held in place and new holes drilled for the treenail connections. B&B turned all

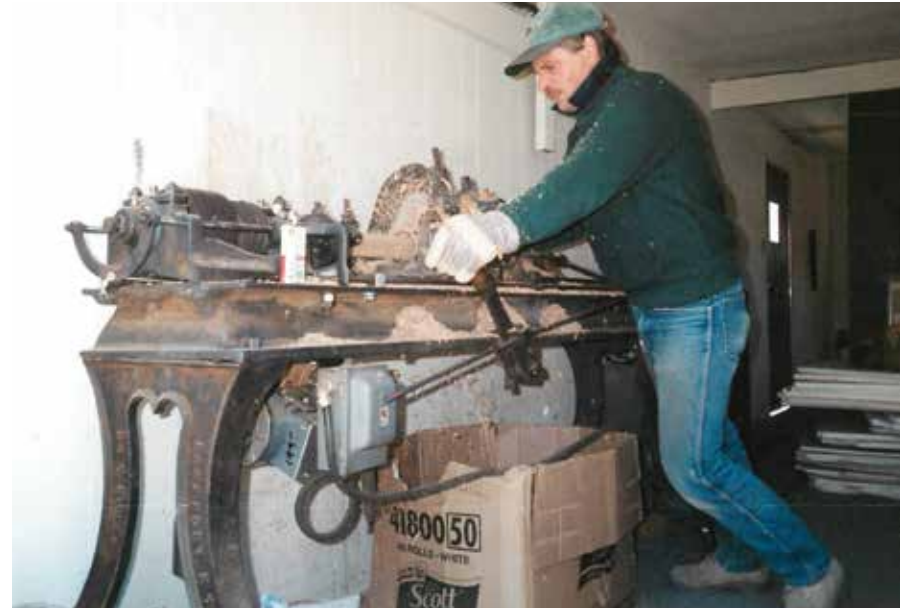
**Figure C1.11** Tim Andrews fabricating replacement treenails on his Trevor treenail lathe. Sean T. James, 1998.

treenails for the project on site using specialized machinery. During construction twenty-three additional lattice members were discovered to have splits at their ends (relish) above or below their chord connections. These twenty-three members were retained and repaired by installing  $\frac{1}{2}$ " x 14" carriage bolts and epoxy and wood Dutchmen at their split ends.

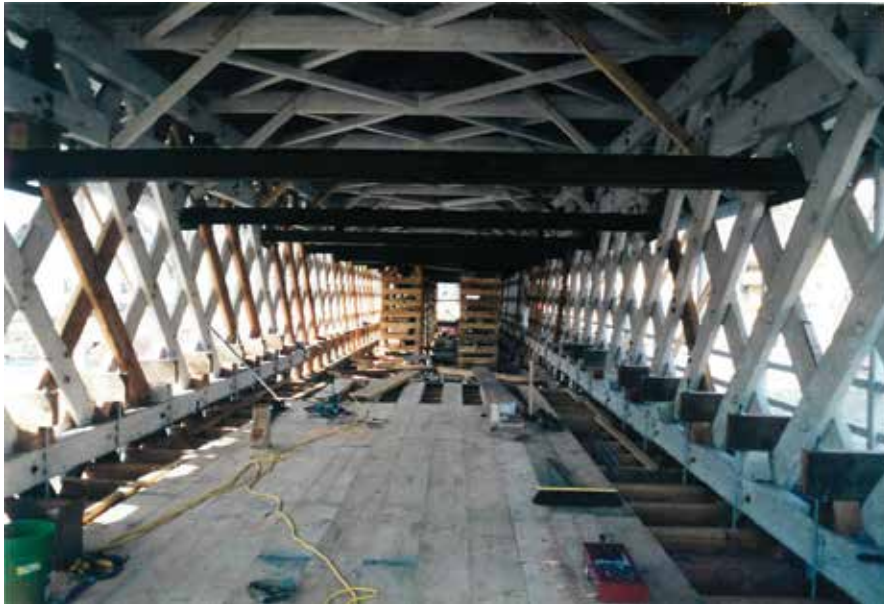
**Figure C1.12** Installation of floor beams and decking; note steel needle beams supporting the top chord, spaced at every third lattice opening, 1998. Sean T. James, 1998.

been repaired, the bridge was returned to its bearings on new bolster beams and spacer blocks. The next portions of the bridge to be completed were the lower lateral bracing, floor beams, and decking. The new members were installed from one end of the bridge to the other, which allowed for easy removal of the temporary shoring along the new bridge deck.

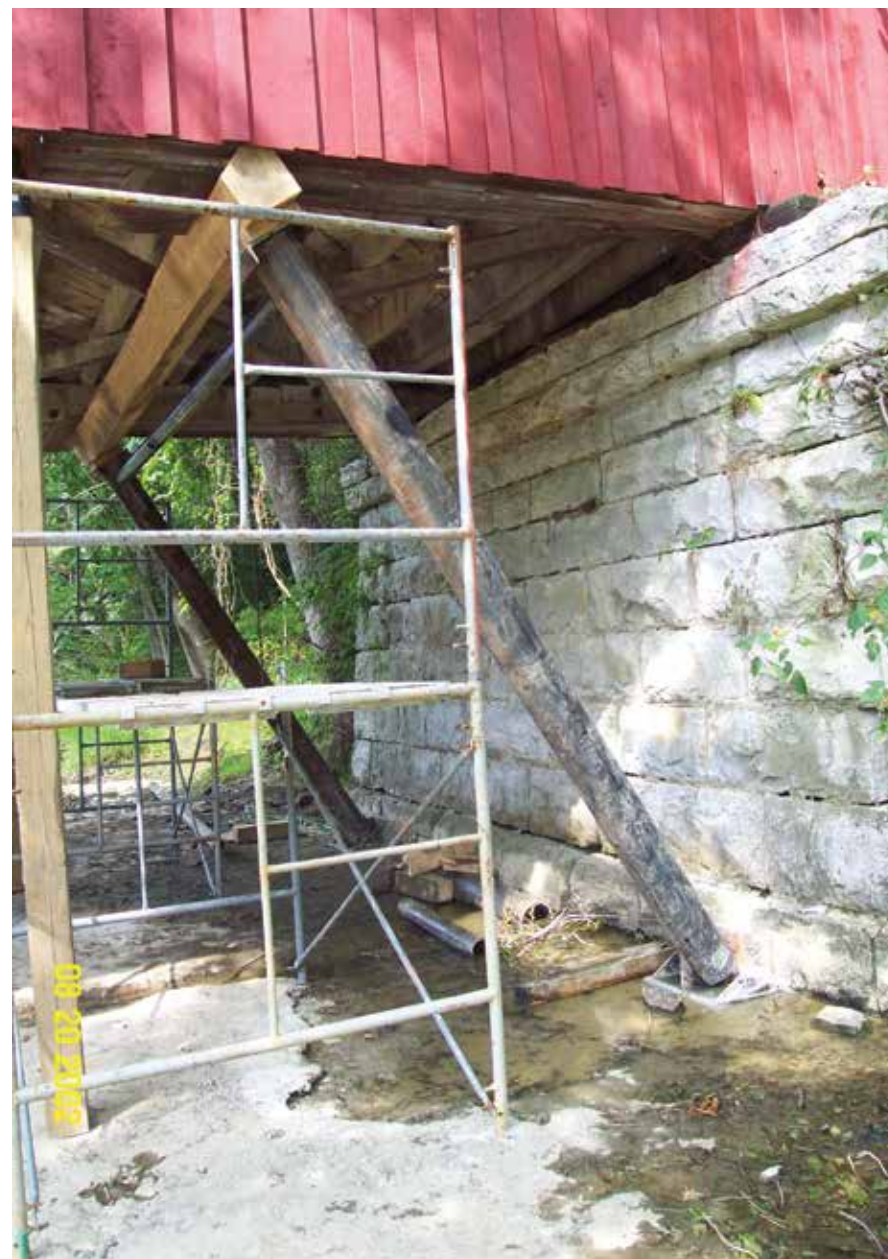
With rehabilitation design underway in 2002, inspectors noticed the sag at one corner of the bridge had increased pronouncedly. Investigation revealed that the lower chord was breaking near the abutment, leaving the bridge in imminent danger of collapse. The bridge was immediately closed to park visitors. Barker Engineering quickly prepared plans for emergency stabilization. IDNR hired F.E. Gates Co. of Indianapolis for the work through an accelerated bidding process.

**Figure C2.4** Temporary shoring installation. J. A. Barker Engineering, August 2002.

F.E. Gates installed the temporary shoring in August 2002. First the crew lifted the bridge back to approximately level with hydraulic jacks. They then placed a heavy timber under each end of the bridge, one panel away from the abutments in the angles between the lower chords and the protruding bottom ends of tension diagonals. Steel pipe supports anchored into the bedrock at the base of the abutments held the timbers. The jacks were then removed. The work was accomplished without fasteners or alterations of any kind in the original bridge materials. The contract price was \$25,540.

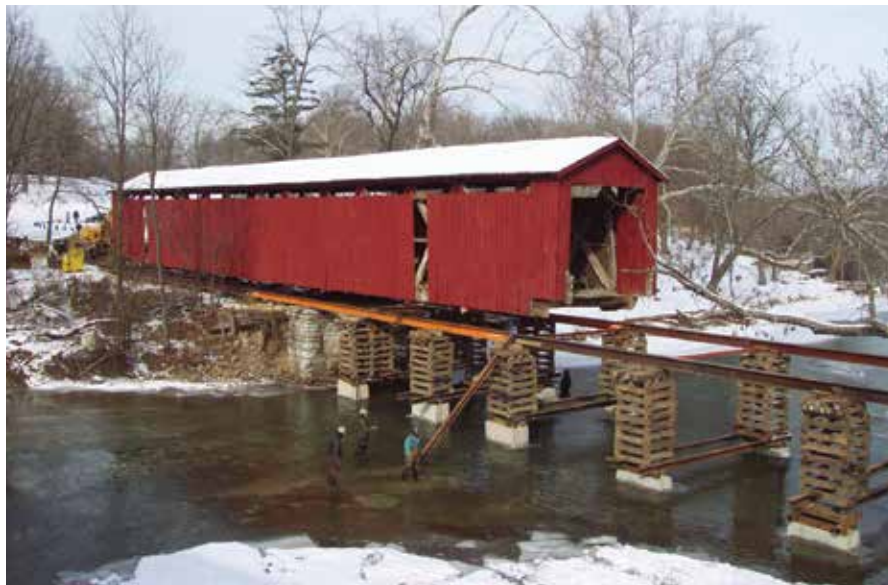
**Figure C2.5** Moving bridge off the river. J. A. Barker Engineering, January 2003.

IDNR feared that the shoring could be knocked out by the large trees and other debris that is often swept down Mill Creek during floods. Consequently they decided to move the bridge off the river pending the rehabilitation project. Dillabaugh, Inc., of Crown Point, Indiana, performed the move in January 2003. This, too, was done without any destruction of original fabric in the superstructure, aside from some of the west approach embankment. Moving the bridge onto shore facilitated the rehabilitation that followed, somewhat offsetting its \$66,000 cost.

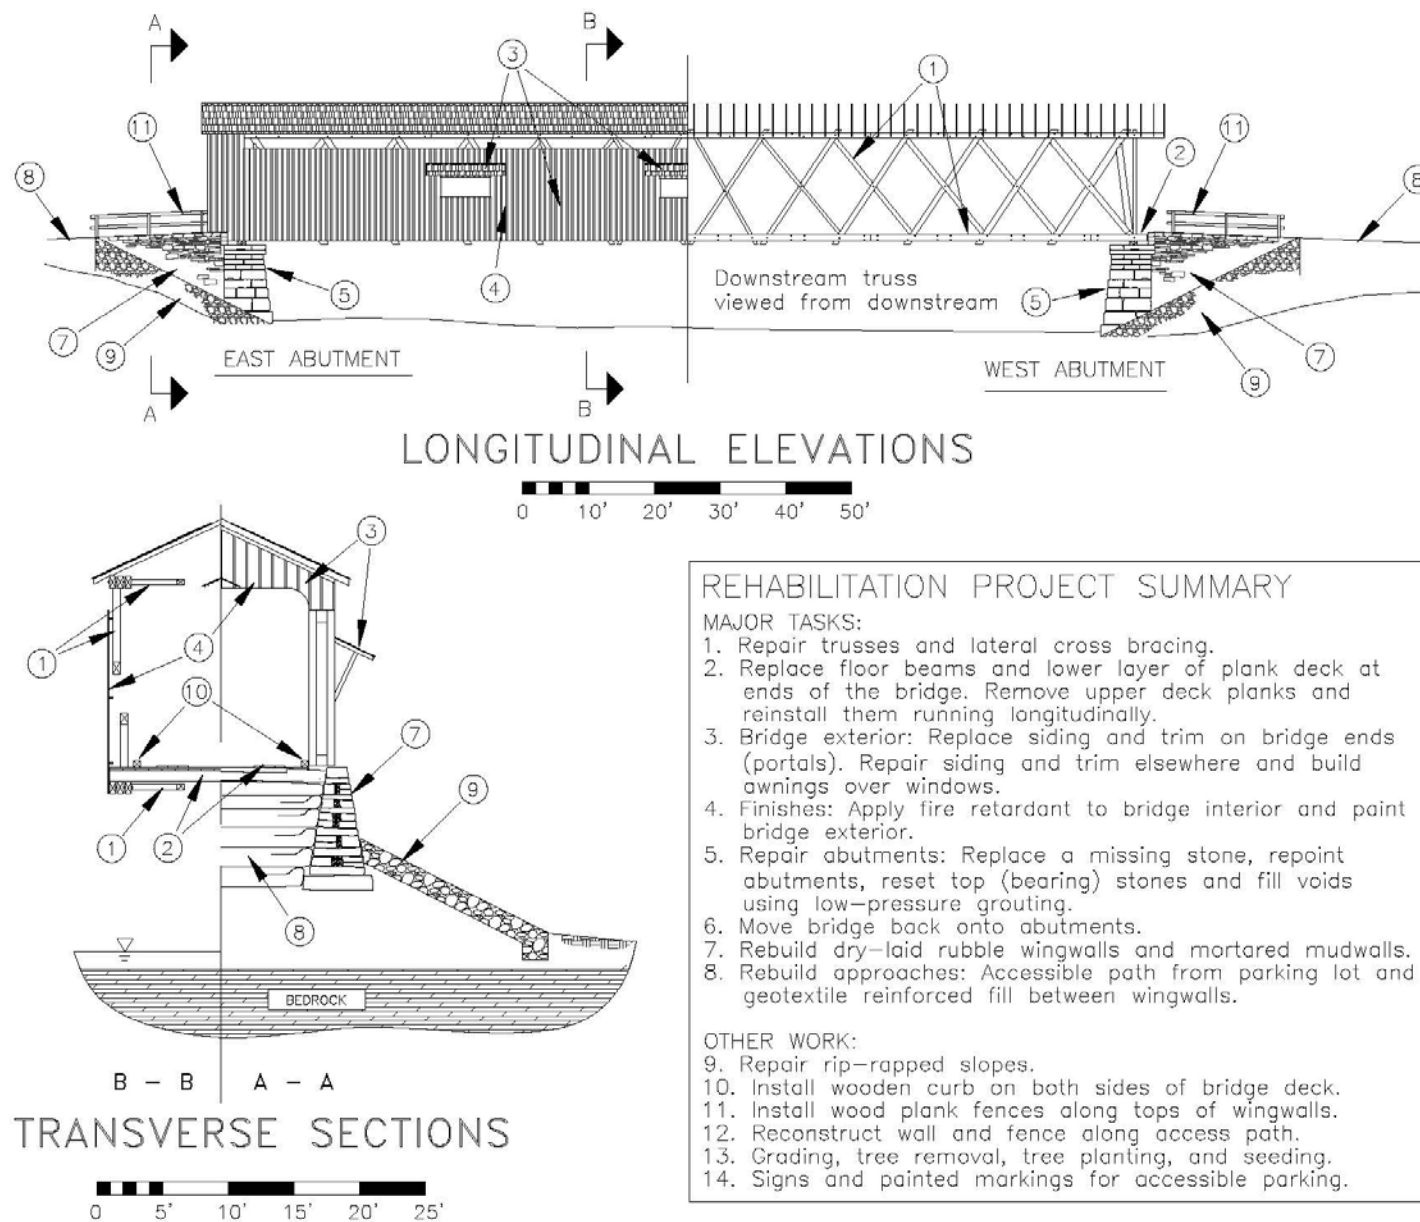
**Figure C2.6** Cataract Falls Covered Bridge Elevations, Sections, and Rehabilitation Summary. Drawings adapted from project plans by Matthew Reckard, November 2012.

Where a compression member was rotten only at one end, that end was generally cut off and a new end spliced on with a bolted, glued lap joint, unlike the tension members that were replaced in full. This was done on four upper chord timbers, one compression diagonal, and six (of eight) truss end posts.

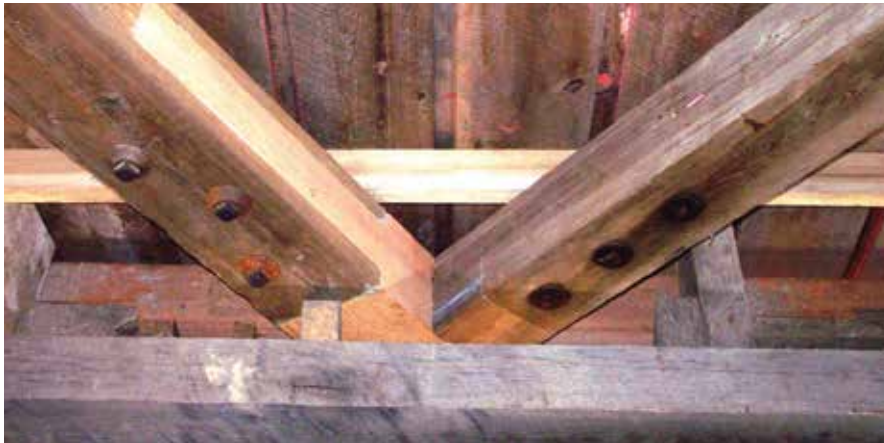
**Figure C2.7** Timber repairs using new Douglas fir (left) were conspicuous. Those using salvage from original timbers (right) were nearly invisible. The Douglas fir repairs, having weathered a few years, are now less noticeable. J. A. Barker Engineering, 2004.

The contract specifications required that, where practical, truss timber repairs be made from wood salvaged from other original timbers that were being replaced. This was desirable for historic reasons (replacing old growth eastern white pine with like material) and aesthetic ones (wood grain and patina in the two pieces would closely match), plus it minimized the chance that shrinkage would cause separation and weaken the joint.

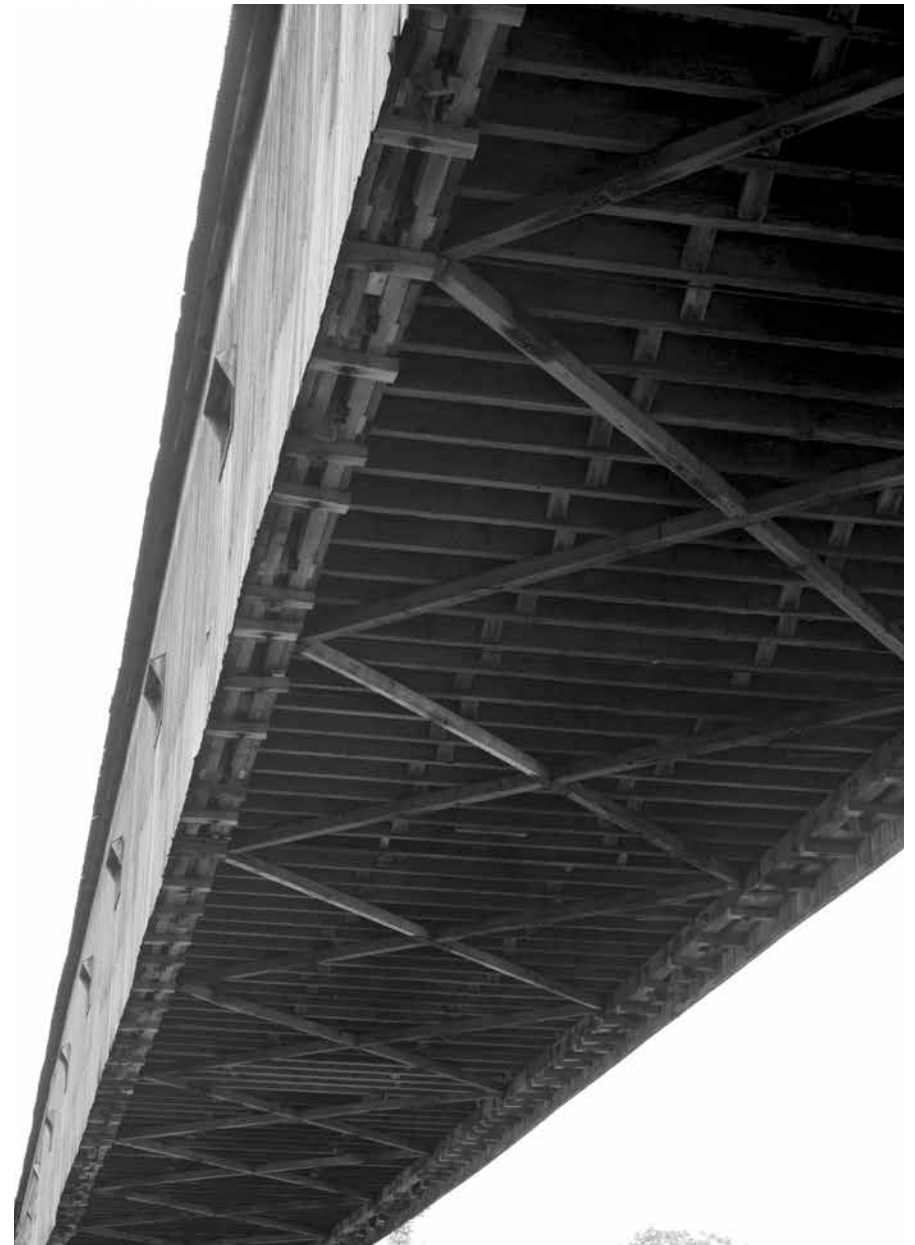
**Figure C3.2** View inside bridge showing notched lattice truss, prior to being closed. HAER NH-8-10, Jet Lowe, 1984.

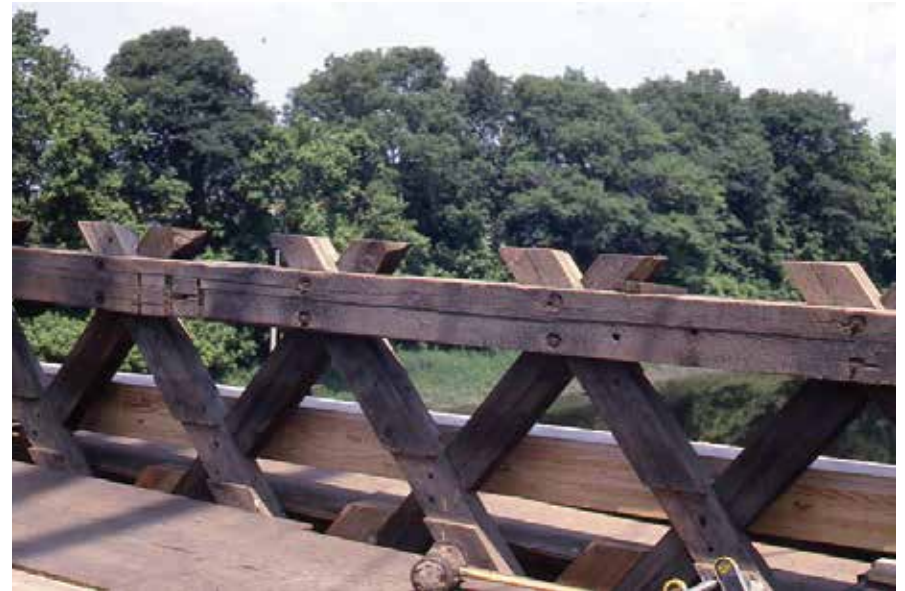
**Figure C3.4** Above central pier, showing removal of Chord 3. James L. Garvin, June 1989.

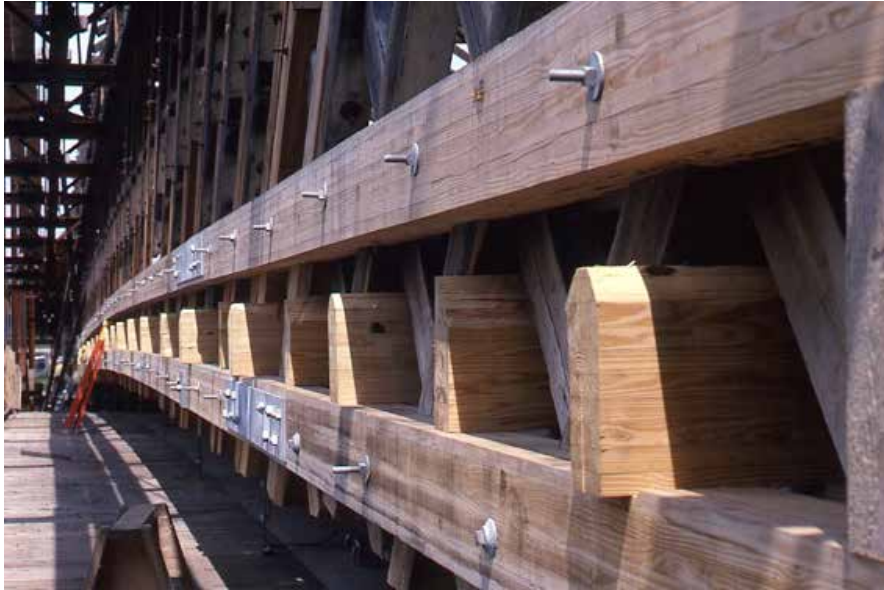
**Figure C3.6** Glulam lower chords and floor beams, showing butt joints with TECO plate system. James L. Garvin, June 1989.

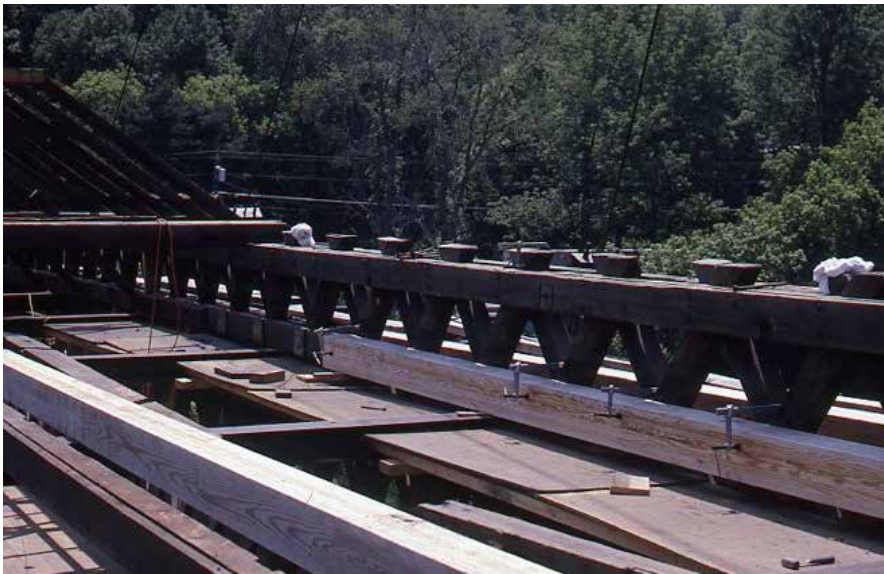
**Figure C3.7** Original upper chords with glulam replacement chord. James L. Garvin, June 1989.

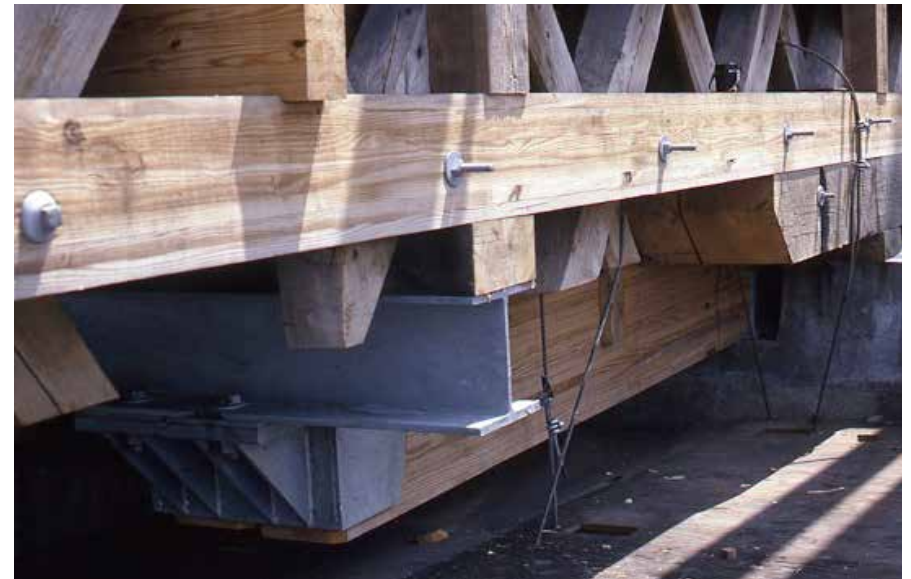
**Figure C3.8** White oak bed timber and glulam bolster beam in new concrete footing, supporting truss. James L. Garvin, June 1989.

The bridge's foundation supports were also improved to better serve the truss. The existing bed timbers were pairs of a mix of original and newer timbers cantilevered 7'. New white oak pieces of the same 10" x 16" x 14' size replaced the bed timbers as necessary. Glulam timber members of 11" x 35" were then placed inside of these, tied to a concrete footing. These cantilevered out 13', further shortening the bridge span. The bolster beams are inactive except under extreme live loading when the bridge deflects to place a load on this supplemental support system. Double-cantilevered glulam bolster beams support the bridge at the center pier.

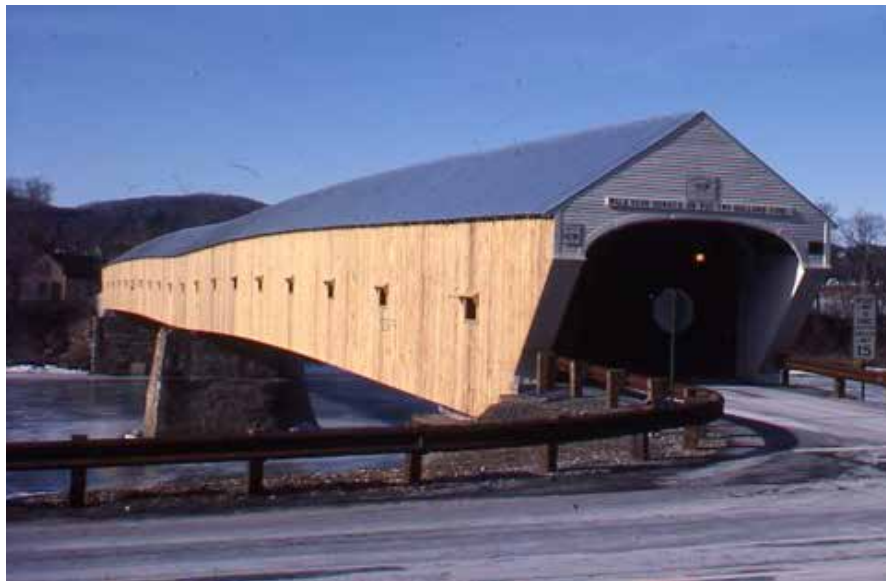
**Figure C3.9** Completed rehabilitation. James L. Garvin, March 1990.

Additional tasks completed during the 1988-89 rehabilitation project included the installation of a new 4" Douglas fir deck, new glulam deck joists, pine siding, spruce rafters, and a galvanized-metal roof.<sup>14</sup> The deck, siding, and roof had all been replaced before.

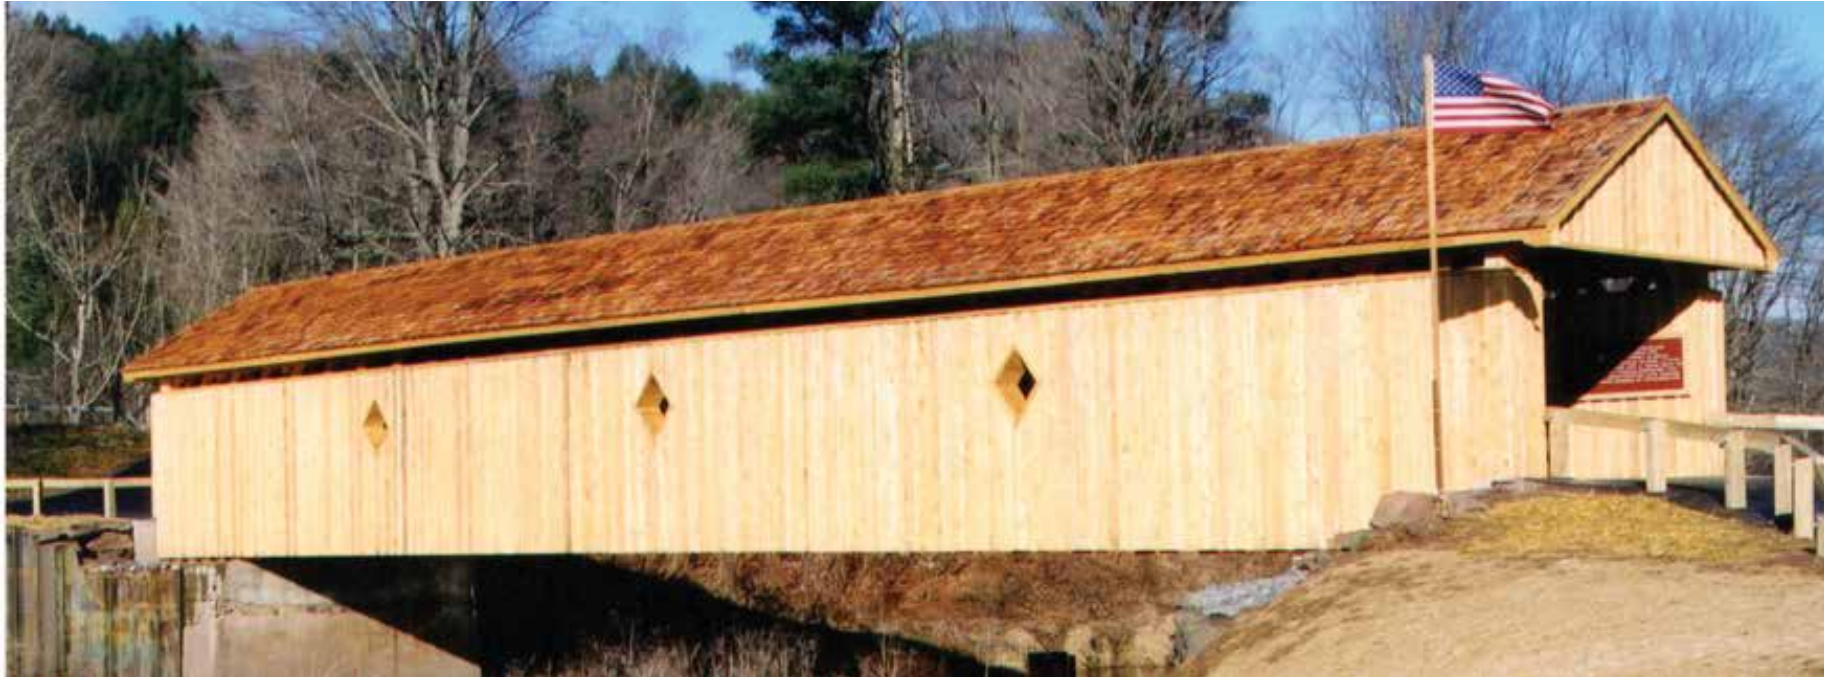
**Figure C4.1** Fitch's Covered Bridge after completion with new diamond openings. Note timber railing system at left at north approach. Phillip C. Pierce, 2002.

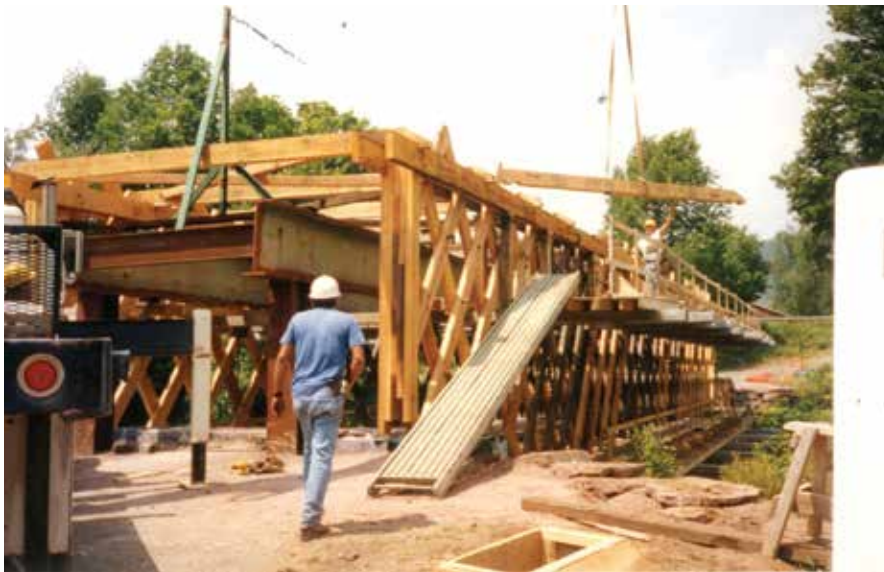
A number of factors contributed to the need for another rehabilitation in 2001. The metal roof had begun leaking, resulting in deterioration of the roof boards, rafters, and top chord elements. The installation of metal gusset plates at each bottom chord corner caused interior condensation and reduced drying through evaporation, which caused the timber to rot. The relatively short (20') bottom chord elements installed in 1976 did not distribute sufficient chord forces to the lattice and adjacent chords since there were few intersections of treenail connections. Town lattice trusses that have survived the longest without major rehabilitation more commonly utilize longer chord elements of 32' or 36'. Finally, powder post beetles had infested many of the treenails, weakening them.

**Figure C4.3** Prior to the start of the 2001 rehabilitation, a steel falsework system with adjustable work platforms was installed. This photograph shows the falsework and the installation of new tie beams. Delaware County Department of Public Works (DCDPW).

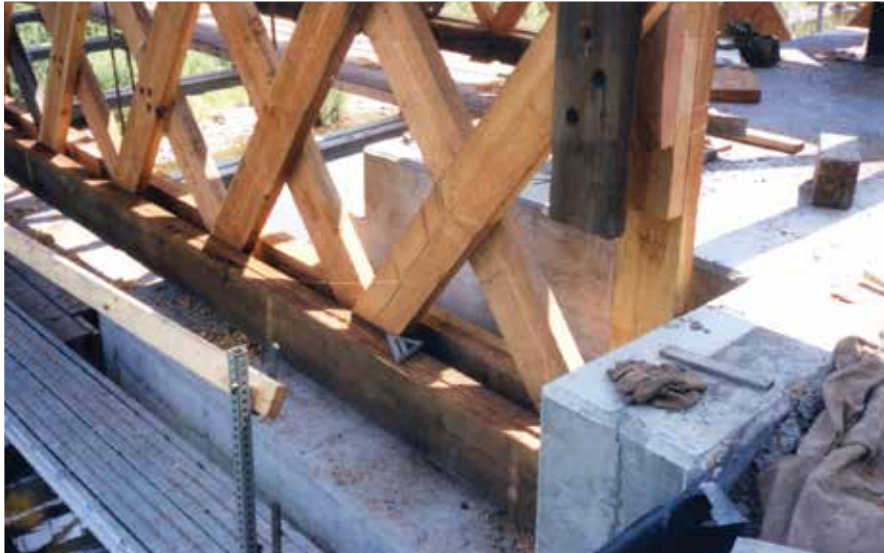
**Figure C4.4** New concrete caps with pockets for longer trusses were installed on the abutments. DCDPW.

The tops of the abutments were reconstructed to provide a longer bearing area to support the trusses, and this also allowed the use of traditional (and original) parallel lattice elements throughout the length of the bridge. The ends of

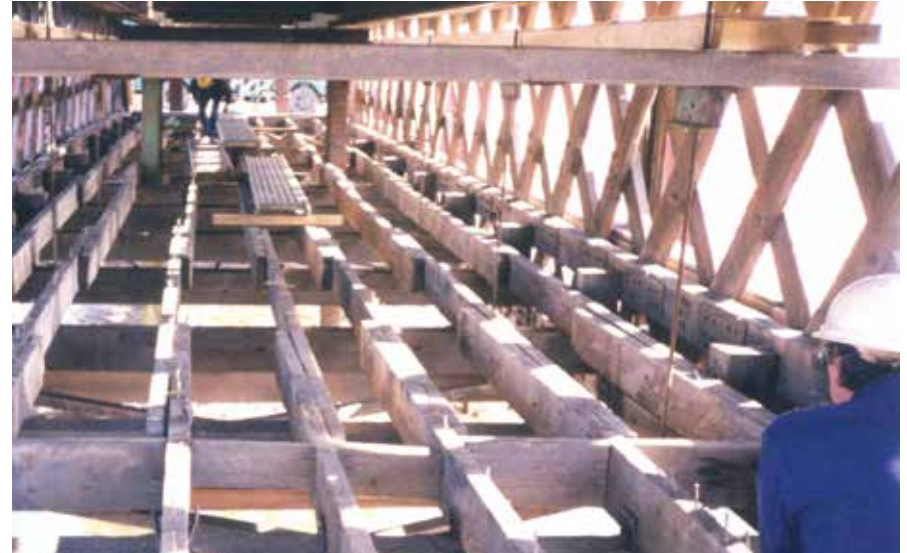
**Figure C4.5** The 1976 floor system has been partially removed. The near edge of the floor is the transverse nail laminated decking. The longitudinal stringers are obviously not uniformly spaced. DCDPW.

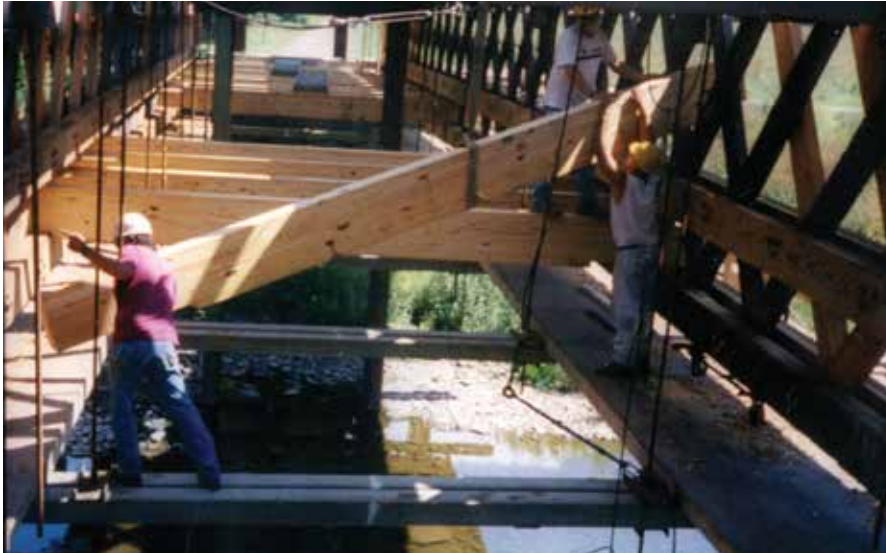
**Figure C4.6** New transverse glulam floor beams were carefully threaded through the lattice opening-satop the lower bottom chord. DCDPW.

The bottoms of the floor beams were dapped 2" for their support atop all four of the bottom chord truss elements. Transverse metal tie rods were installed to pull the floor beam daps tight against the inside edge of the bottom chord elements, thereby providing a strong horizontal diaphragm system to resist lateral loads.

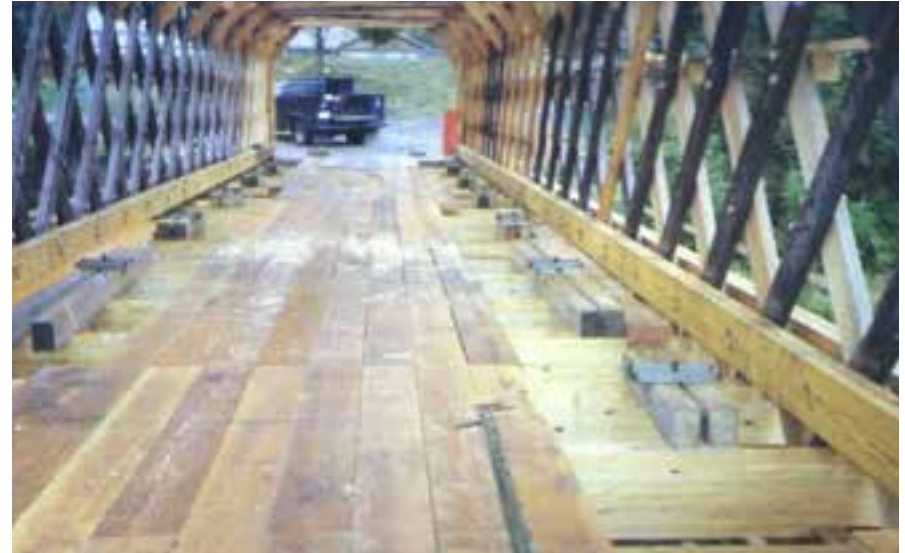
**Figure C4.7** Staggered longitudinal deck planks have been installed; these were then covered with hardwood running planks. Note the darker lattice elements, which are original. DCDPW.

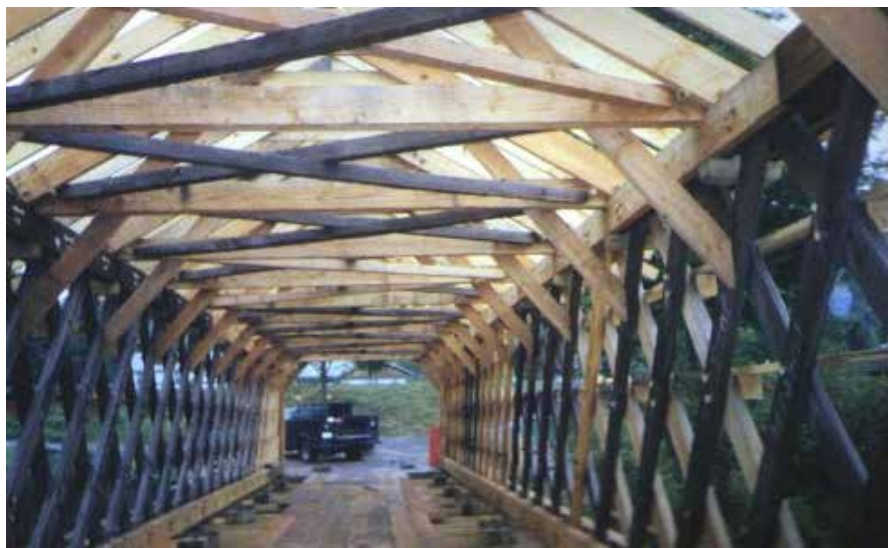
**Figure C4.8** Most of the original upper lateral members were retained, but the tie beams and knee-braces were replaced with stronger components. Traditional wooden peg connectors and matching timber wedges were used, similar to those in the original construction. The darker upper lateral members are original. DCDPW.

The elimination of the external bracing for the top of the bridge was compensated for by installing an especially strong internal knee brace system. The existing 6" x 10" tie beams were spaced 20' apart with 5" x 5" X lateral bracing elements connected to the tie beams with traditional mortise and tenon joinery, held tightly by timber folding wedges. In keeping with rehabilitation work performed at the two other county covered bridges, a 3" x 12" principal rafter was installed beside and notched into the side of the tie beam. It provided a strong connection to the 4" x 8" replacement knee braces. A 5" x 10" collar tie at mid-height of the principal rafter provided the necessary fill thickness and additional transverse strength. Common rafters of 2" x 8" spaced 2' apart supported 2" x 4" rough-cut No. 2 Southern pine nailers. The replacement roofing was ½" thick by 24" long, random-width, premium-grade red cedar shingles, planed on one side.

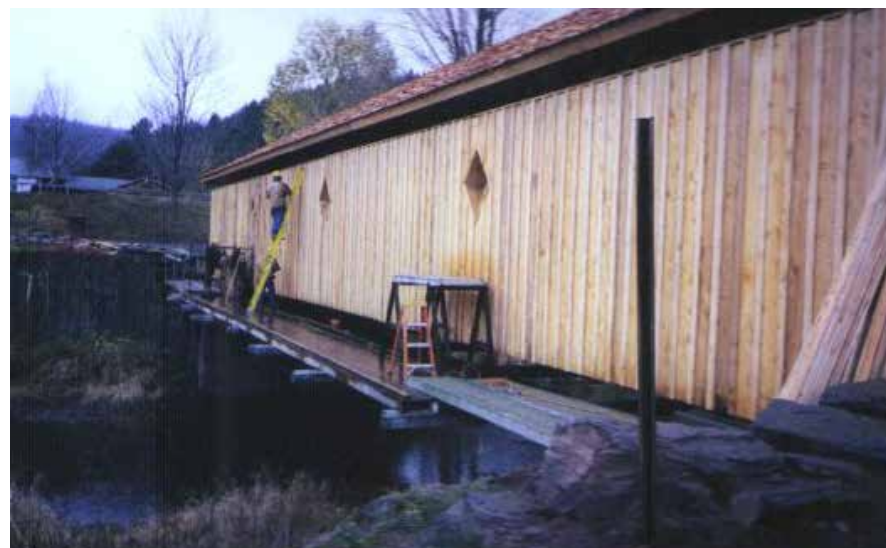
**Figure C4.9** Siding being replaced with rough-cut 1" x 12" hemlock with battens. DCDPW.

The replacement 1"-thick hemlock siding featured the use of nailers as spacers to hold the siding outboard of the metal tie rods beneath the floor and to provide ample ventilation around the bottom chord. Careful siding details around the three windows on each side of the bridge protected the truss elements from wind-borne rain. As in the previous siding, battens were installed to prevent rain penetration through shrinkage gaps between siding boards.

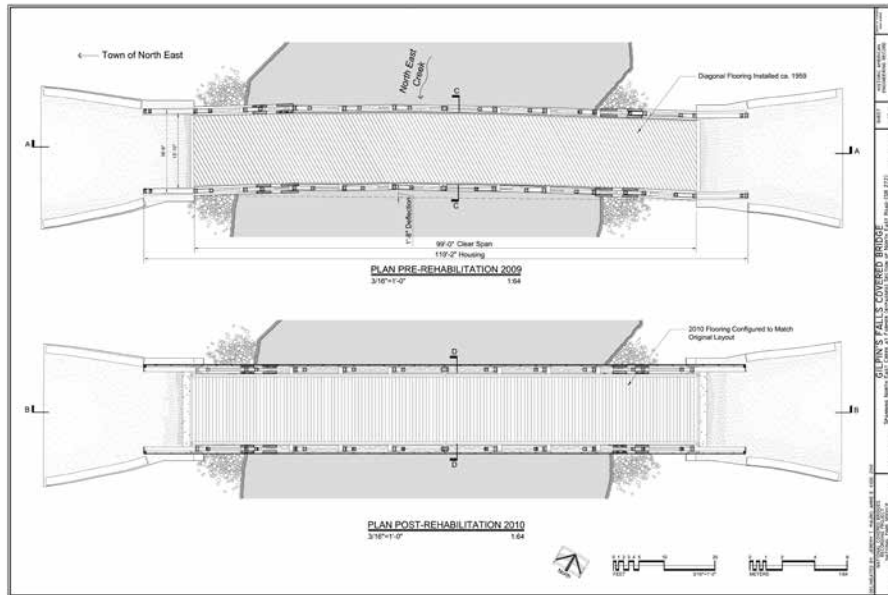
**Figure C5.2** Upper drawing shows upstream deflection of bridge prior to being straightened during rehabilitation. HAER MD-174, sheet 2, Jeremy Mauro and Anne E. Kidd, 2010.

Before the 2009 work began it was generally agreed the bridge was nearing structural failure and in danger of collapse. The bridge was considerably out of alignment in plan, elevation, and cross-section. It sagged 12 ½" at mid-span, was racked (twisted along its length), and bowed 1'-8" upstream. The lower chords had stretched lengthwise causing shear keys to fail and had failed completely at the northeast corner. The arches had buckled and deformed. The timbers embedded into the face of each abutment (removed in 2009) were rotten and crushed by the ends of the arches.

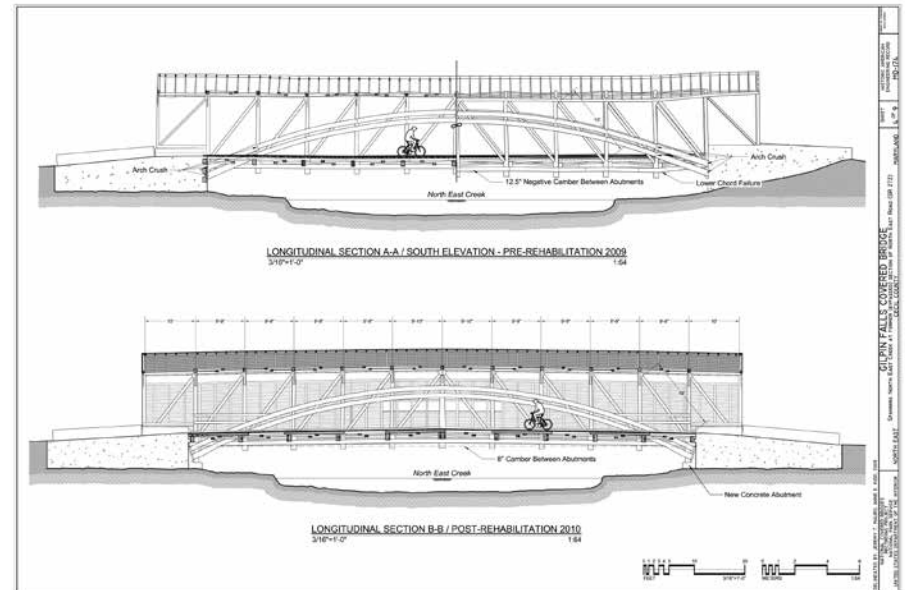
**Figure C5.3** Upper drawing shows negative camber prior to rehabilitation. Lower section documents the positive camber resulting from the rehabilitation. HAER MD-174, sheet 4, Jeremy Mauro and Anne E. Kidd, 2010.

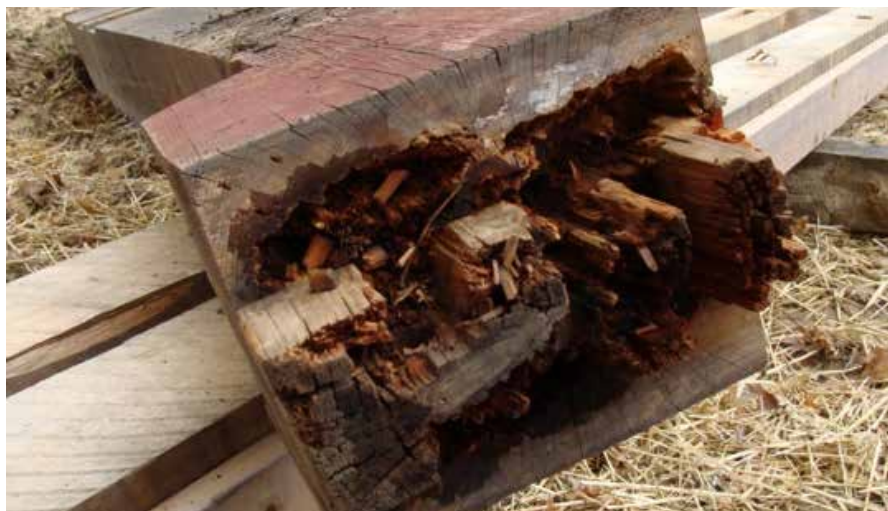
Before work began, it was estimated that 20 percent of the truss timbers needed to be replaced, but after disassembly it became evident that the percentage was far higher. Water damage and insect damage in the joints had hollowed out many of the timbers beyond repair (as seen in Figure C5.5). The connection between each post haunch and the diagonal was particularly deteriorated. Further investigation showed that the entire upper chord, collar ties, upper lateral braces, floor beams, and lower lateral braces were compromised beyond repair. Water penetrating the roof system had resulted in the complete decay of the upper chord at every post connection. The collar ties and lateral braces,

**Figure C5.5** This photo of the top of a post shows the typical condition of truss members between joints. Timothy Andrews, 2009.

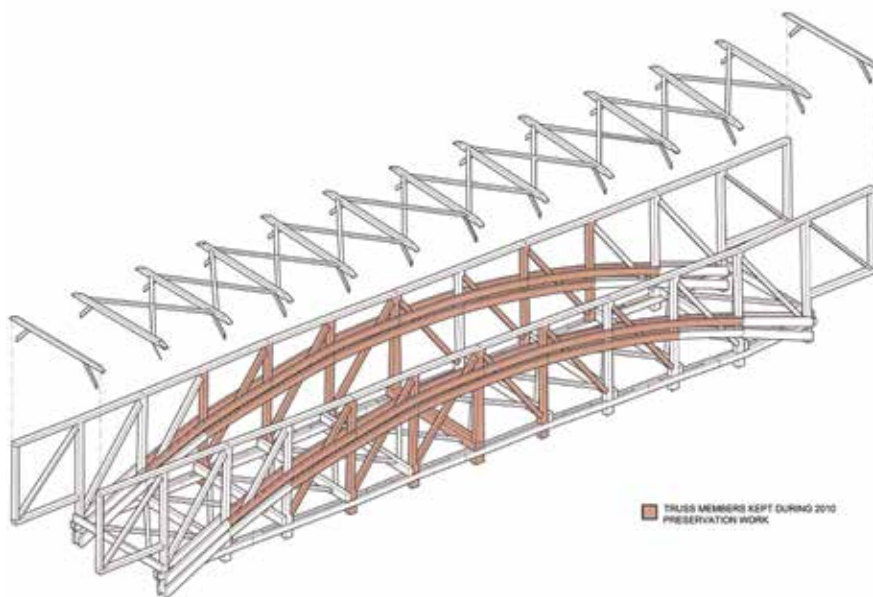
**Figure C5.6** Illustration showing original truss members that were retained during the rehabilitation. The hatched sections of the truss indicate the historic fabric that was saved. All other material was replaced in-kind. Adapted from HAER MD-174, sheet 8, Jeremy Mauro, 2010.
