# GUIDELINES FOR REHABILITATING HISTORIC COVERED BRIDGES

**Edited by Christopher H. Marston and Thomas A. Vitanza**

National Park Service, Historic American Engineering Record  
National Park Service, Historic Preservation Training Center  
Federal Highway Administration, Turner-Fairbank Highway Research Center

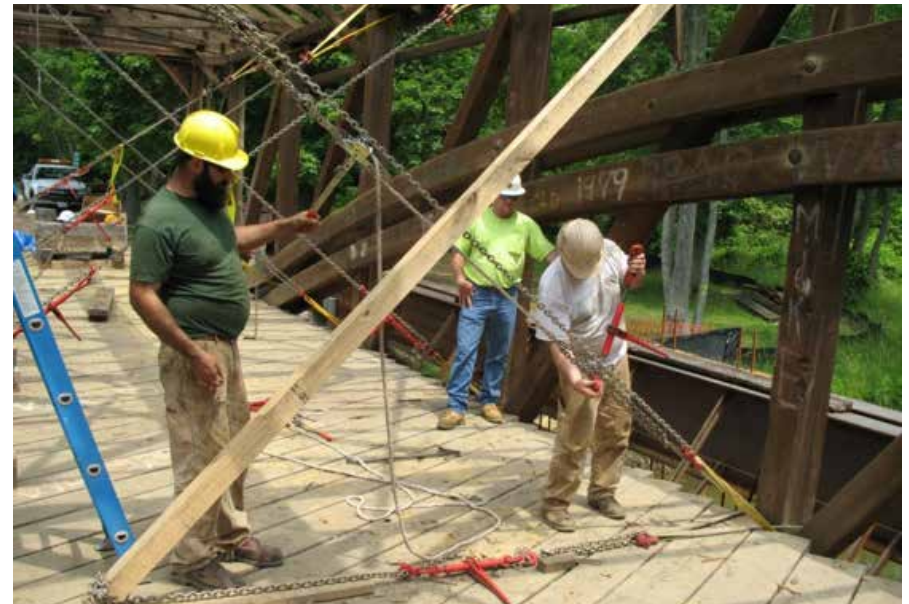
**Figure C5.7** Cross chains installed to straighten the bridge in plan. Also note the deck planks are laid diagonally. The diagonal configuration was not original, and they were returned to a perpendicular arrangement later in the project. Jeremy Mauro, 2009.

With the temporary platform in place, bridgewright Timothy Andrews of Barns & Bridges of New England and timber framers Will Truax and Jeremy Woodliff began to stabilize and re-align the bridge. The first step of this process was to cross brace the structure diagonally through its interior using chains and jacking the lower chord at panel points. The cross bracing lessened the lateral stresses

while the jack supports relieved the abutments and truss of carrying the load of the bridge. By relieving tension from the truss and tightening the cross chains at specific points, it was possible to straighten the bridge laterally. After removing the lateral bow, a second alignment technique called longitudinal clamping was initiated. Four threaded 1"-diameter rods were positioned in pairs running the entire length of both lower chords and threaded through wood blocks placed near the bottom of each post. The rods acted as temporary lower chords and were tensioned by turning nuts set against the wood blocks. This technique of longitudinal clamping both "gathered back" gaps created by failures in the bottom chord and fixed the position of each post. The next step involved stacking numerous 6" x 7" x 4' timbers into tall temporary crib towers, or falsework, that raised the height of the upper chord. These supports carried and controlled the upper part of the truss and helped return the bridge to positive camber. Finally, a series of eight 4" x 4"s, post-tensioned with chains attached to the steel bridge, acted as temporary outriggers by buttressing the bridge posts and holding them securely in a vertical position.

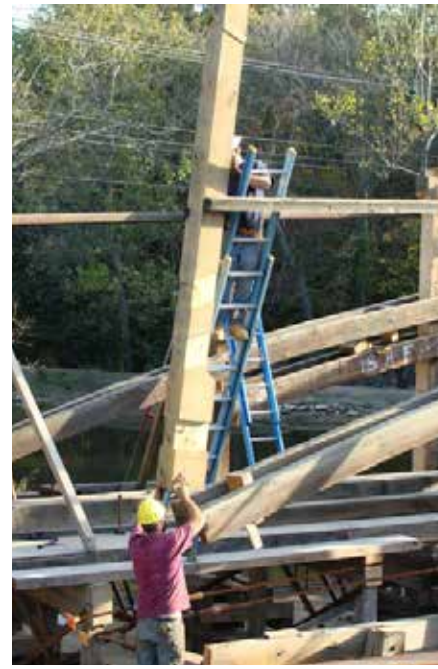
**Figure C5.8** Tim Andrews (top) and Jeremy Woodliff (below) guide a new end post into position. A crane, not shown in the photo, is lowering the post. Tim Andrews, 2009.

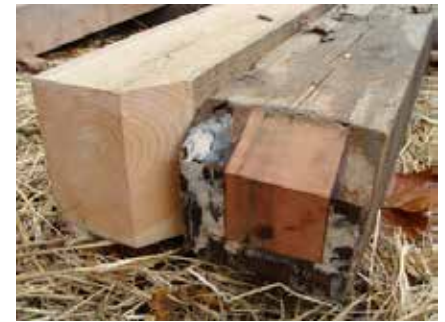
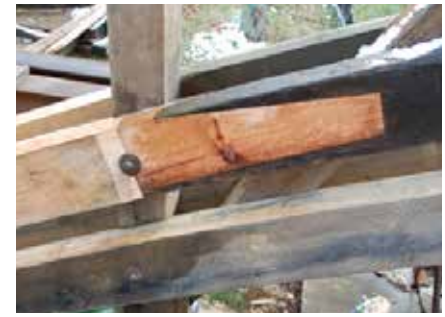
**Figure C5.9 and Figure C5.10** Historic fabric was repaired rather than replaced whenever possible. The photo on the left shows a repair to the end of a diagonal brace. The photo on the right shows a Dutchman repair to the arch. Epoxy was used only to fill non-structural holes and gaps. Left: Tim Andrews, 2009; right: Jeremy Mauro, 2009.

historic timber. These included removing sections of deterioration and attaching new pieces of wood using a traditional Dutchman type joint. Epoxy was used to reinforce rotted end-grain where necessary. For many of the timbers no reasonable repair remedies could be found to restore the structural integrity, so these members were replaced in-kind.

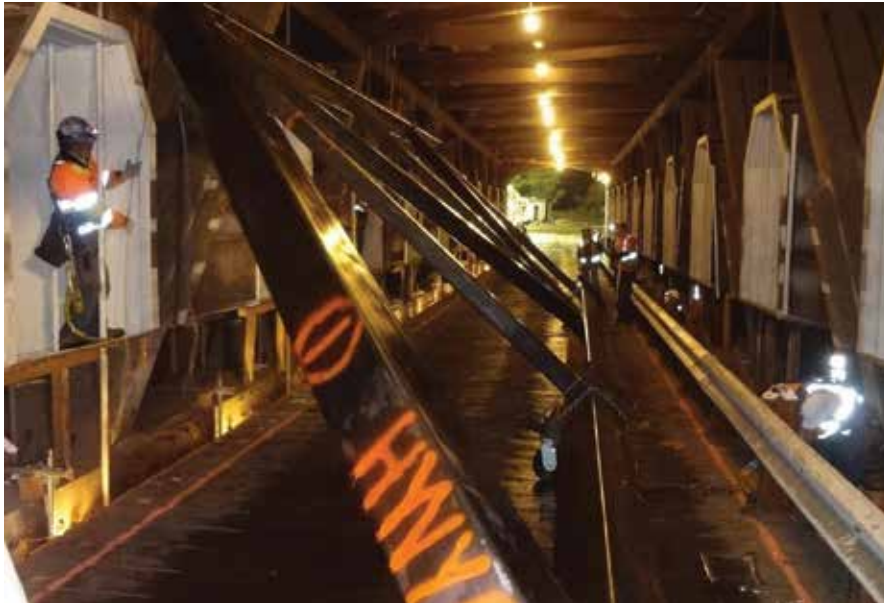
**Figure C6.5** Installation of first temporary steel truss during night closure, 2013.

Keeping the bridge in operation during the rehabilitation was a key element of the project. The design solution of installing temporary tube-steel trusses allowed the existing truss elements to be raised prior to the installation of the post-tensioning system, without any permanent physical or visual effects. All modifications and repairs to the bridge were designed in compliance with the

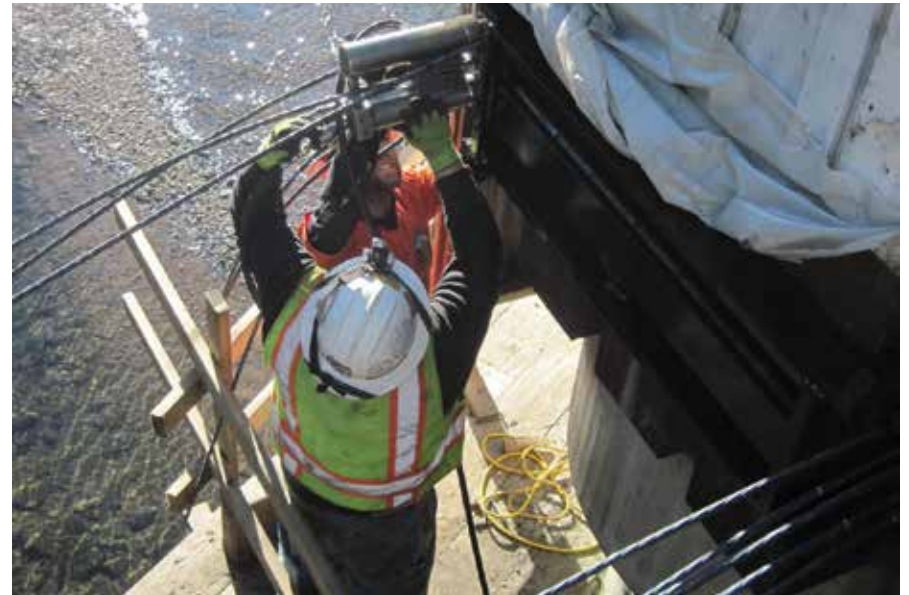
**Figure C6.8** Jacking the PT strand, 2013.

Although Goodpasture Covered Bridge was originally designed to carry only a 20,000-pound live load, it was sufficiently robust that only the bottom chords proved inadequate to carry legal loads. By strengthening the bottom chords, weight restrictions could be removed. However, replacing chord members would not be possible without closing the bridge for an extended period of time. Therefore, an alternate load path had to be provided to relieve the bottom chords. The selected approach was to post-tension with high-strength steel strand. However, the geometry of the truss had to be corrected before any compression was applied to the bottom chords or the repair would have magnified the sag.

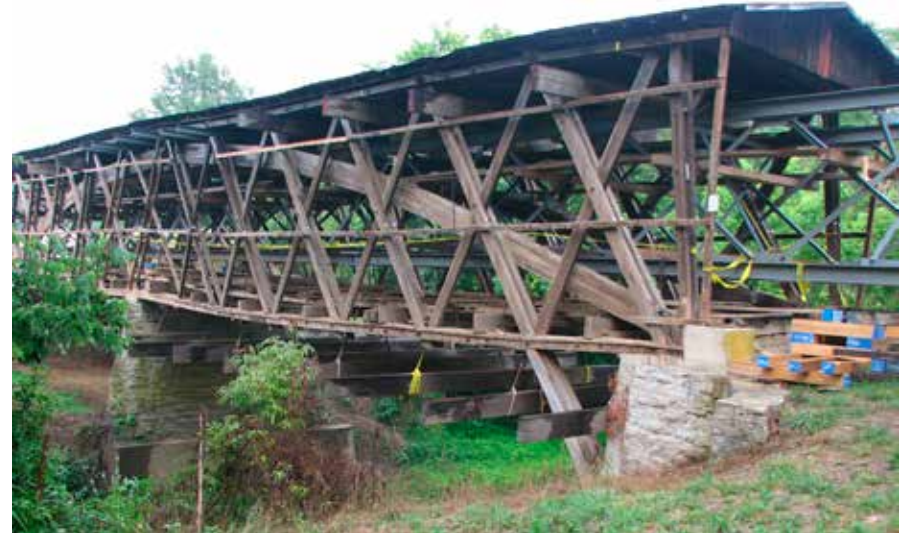
The steel truss was also utilized for staging and for jacking camber back into the bridge. At the time of the restoration, Johnson Creek Covered Bridge had negative camber of 21". The roof reflected the same 21" of negative camber on the downstream side, and the bottom chord was completely separated. The

**Figure C7.5** View of shoring system, with steel truss through bridge, with horizontal needle beams supporting the top chord. Note negative camber, which measured up to 21." William Caswell, 2007.

upstream side showed a little less loss of camber because the bottom chord was supported somewhat by the pier installed during a prior restoration.

A steel truss, the first of its kind to be used in covered bridge restoration, was designed to shore the bridge while clear spanning the creek. Needle beams (temporary members) were installed on the steel truss to support the wooden top chord throughout the restoration. The truss span reached well beyond the abutments. The steel truss maintained the alignment of the bridge throughout the restoration process.

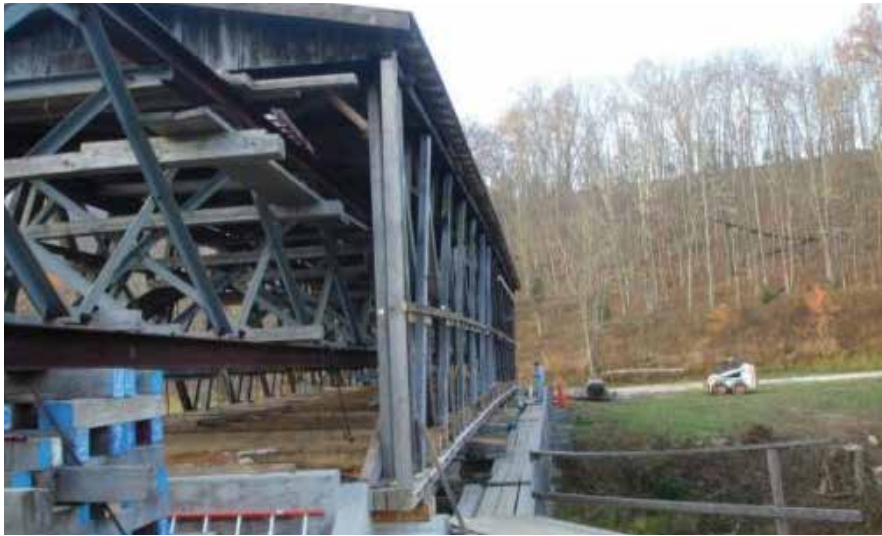
**Figure C7.6** View of bridge after camber was restored to 9". William Caswell, 2008.

The jacking process was started at the maximum camber point and then gradually to each cribbing station until positive camber was restored to 9". During the jacking process, some prior repair work to the bottom chords was removed to allow the bridge to come back to its original configuration.

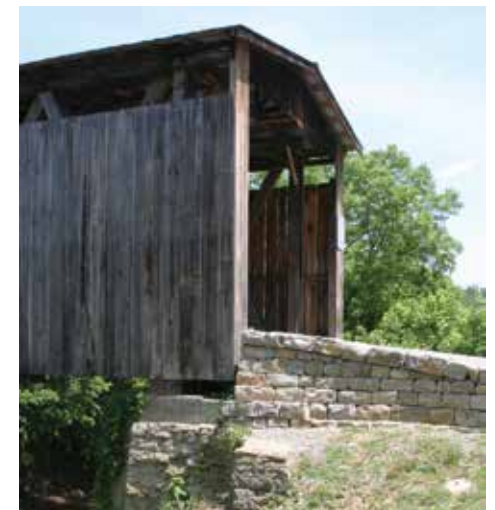
**Figure C7.10** Dry-laid stone approach wall offset from the original dry-laid stone abutment. The approach wall was installed after bridge was raised 18" for flood prevention. Jen Spangler Williamson, 2010.

Concrete had been poured around the ends of the chords and arches, probably to hold the bridge in place. However, the moisture trapped in the concrete caused these critical ends to rot. The concrete was removed, and new thrust blocks for the arches were poured. The arch ends now rest on the concrete. The county also poured a new slab and approach wall to keep the dirt and moisture away from the bridge. The Dry Stone Conservancy replaced the wing walls with dry-laid stone.

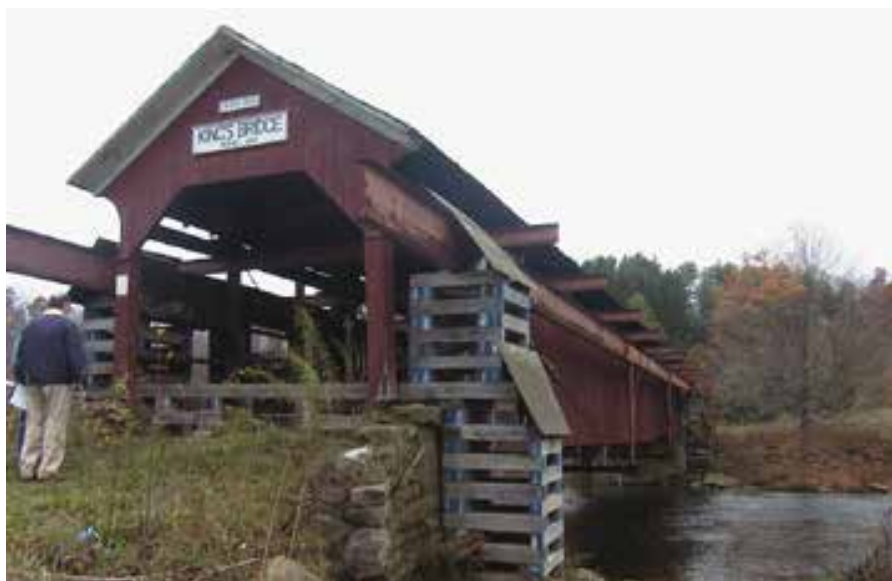
**Figure C8.2.** Bridge before rehabilitation with stabilization falsework in place at east portal. SCLA.

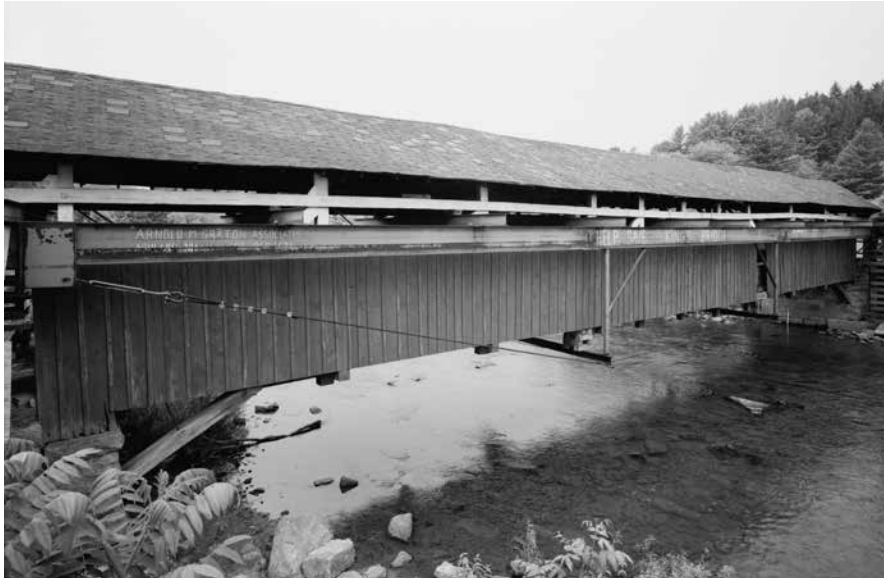
**Figure C8.8** Stabilization of the bridge, showing tension cables tied to steel I-beams. HAER PA-638-3, Jet Lowe, 2005.

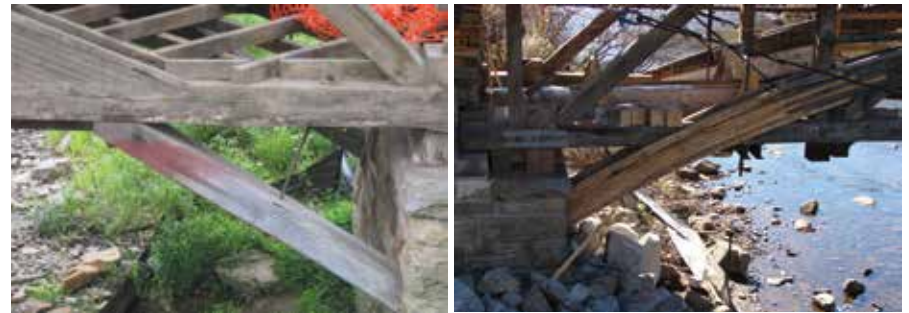
**Figure C8.9** Arch tied to chord and strut below to abutment. SCLA.

**Figure C8.10** Laminated arch extended to reinforced abutment. SCLA.

The arches were extended below the lower chords by adding in-kind laminations to the existing nail-laminated arches. The cross section area of the arch was removed from the corresponding section of each lower chord member to allow the new arch extension to bypass the chord unfastened.

While the bridge was elevated for rehabilitation, the new arch extensions were installed and scribed to meet the new seats carved in the stone abutments before the bridge was lowered into place. The ends of the timbers were treated with wood preservative and elastomeric pads were used as compressive and thermal insulators between the stone and wood at the bearings. The new arch extensions were intended to remedy the damage to the trusses caused by the previous tied arch geometry. The deformed arch sections were separated, reshaped, and re-laminated in place. Repairs were also made by extending the laminations past the lower chords by dapping (notching) a portion of the

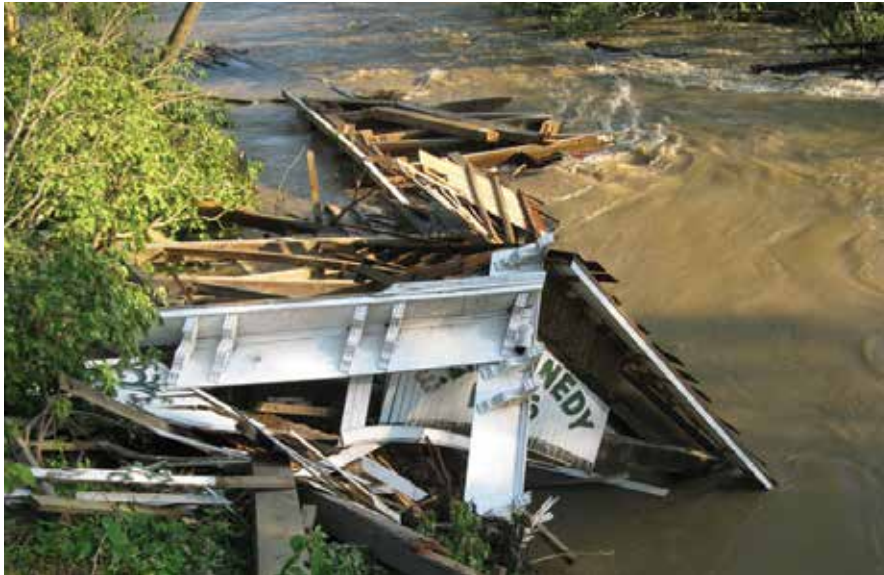
**Figure C9.5** View of Moscow Bridge after the 2008 tornado. Part of the east portal remains, but the river washed away most of the span. Ed Derringer, 2008.

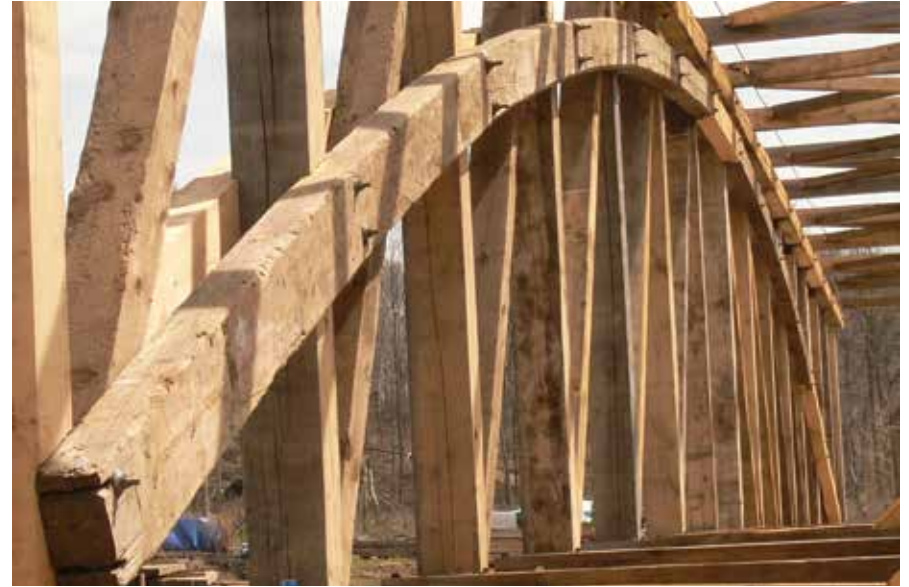
**Figure C9.10** Slightly darker color and "battle scarred" surface distinguish 1886 timbers from those cut in 2009. Tony Dillon, 2010.

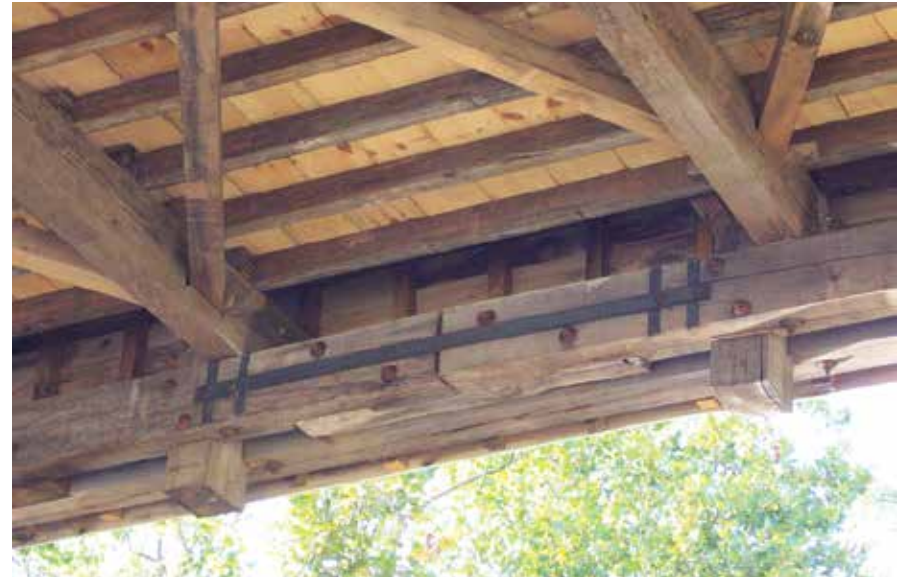
**Figure C9.13** Steel strap and inlays reinforce a lower chord splice in the rebuilt bridge. James Barker, VS Engineering, Inc., 2014.

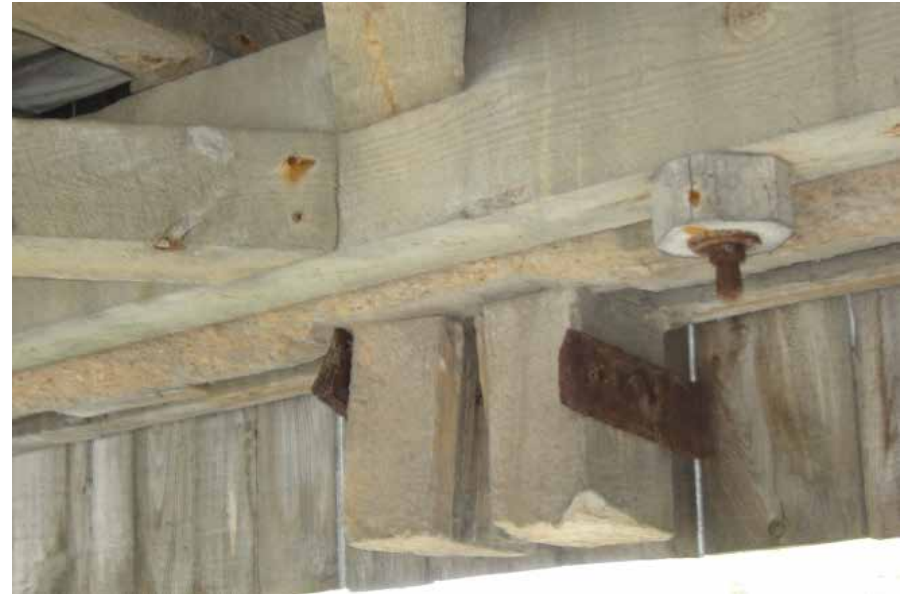
The truss vertical members are approximately 8 ½" x 10" through the middle section and shouldered on the top and bottom to receive the truss vertical members. During previous rehabilitations, timber shoulders were added and bolted at some of the verticals. The verticals were tenoned into the top chord and several of these connections had failed prior to the rehabilitation. In the lower ends of the verticals the timber is notched to a thickness that varies from 2 ½" to 4 ½".

**Figure C10.7** Typical split tail end of verticals at Node N12 (north truss). Josif Bicja, August 2007.

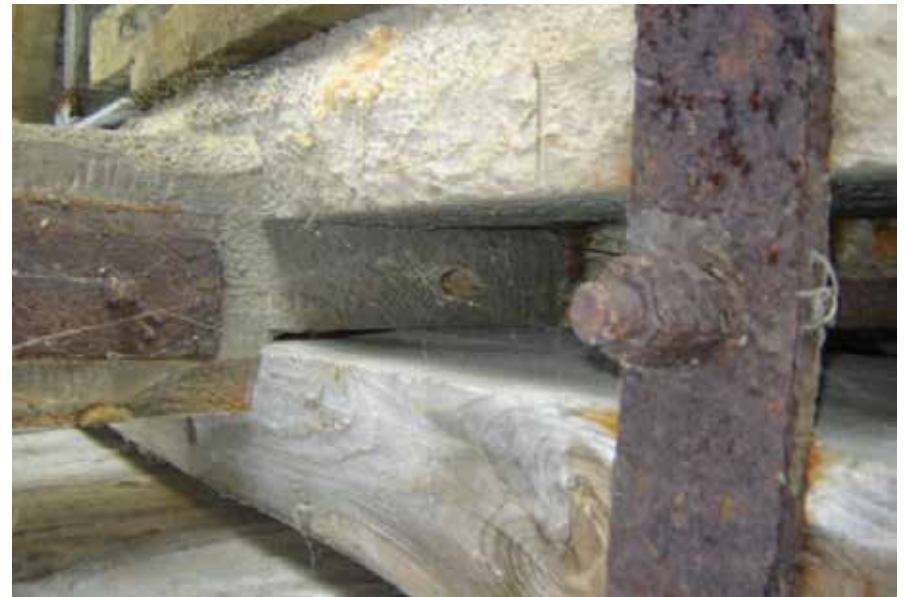
**Figure C10.8** Notched end of vertical at connection with bottom chord at Node N4 (north truss).

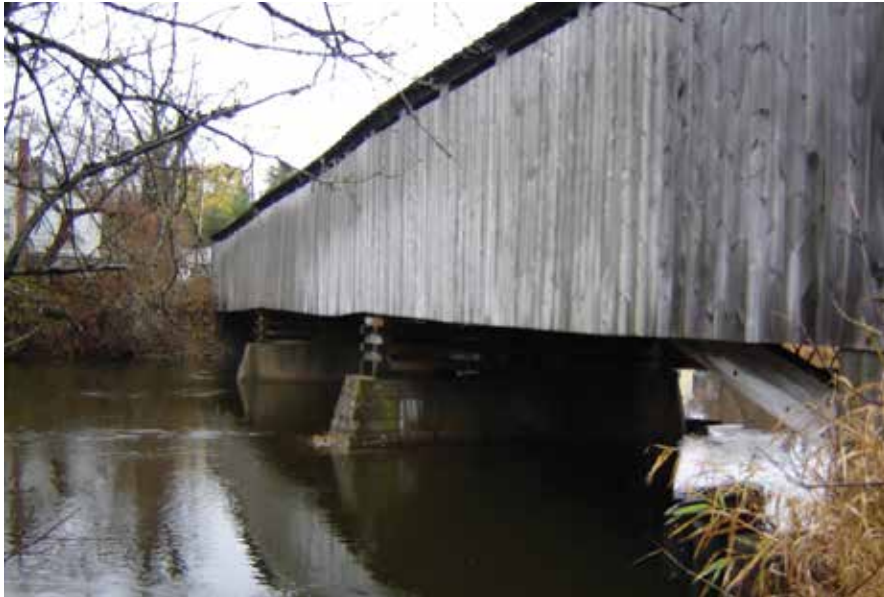
Before the rehabilitation, the sag of the bridge was a maximum of approximately 6” on the eastern span. The trusses were bearing on bedding timber and the timber cribbing that rested on the two piers. Several butt splices of the old bottom chords over the piers had dislodged vertically due to insufficient through bolting and high applied forces and moments.

**Figure C10.9** Downstream elevation, looking east. Note sag in east and center span. Sean T. James, November 2006.

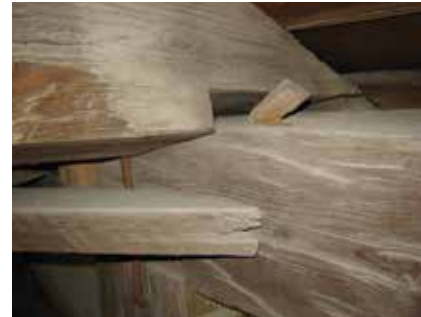
**Figure C10.10** Twisted cross beam and bracing to top chord connection near Node N14.

on top of the top chord members. At these locations the cross beam had been "stapled" with  $\frac{1}{4}$ "-square steel rods. In the majority of these cross beams, the downward forces from the trusses had caused twisting due to eccentric connections of the steel rods.

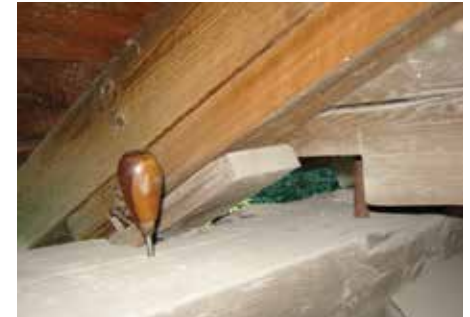
The upper lateral bracing consists of 4" x 4" knee braces and 7" x 8" cross beams bearing on the top faces of the top chords of the north and south trusses and notched at the truss vertical members of the interior truss. There are transverse steel tie rods and wooden sway braces between the cross beams and the vertical truss members. The 4" x 4" knee braces connect the tops and bottoms of the cross beams with a mortise and tenon connection to the truss vertical members of the interior truss. Due to the sag of the existing trusses, a gap of up to 2  $\frac{1}{2}$ " had opened up in approximately nine cross beams bearing

**Figure C10.11** 2  $\frac{1}{2}$ " gap between cross beam and top chord of exterior truss at Node N19. Josif Bicja, July 2007.

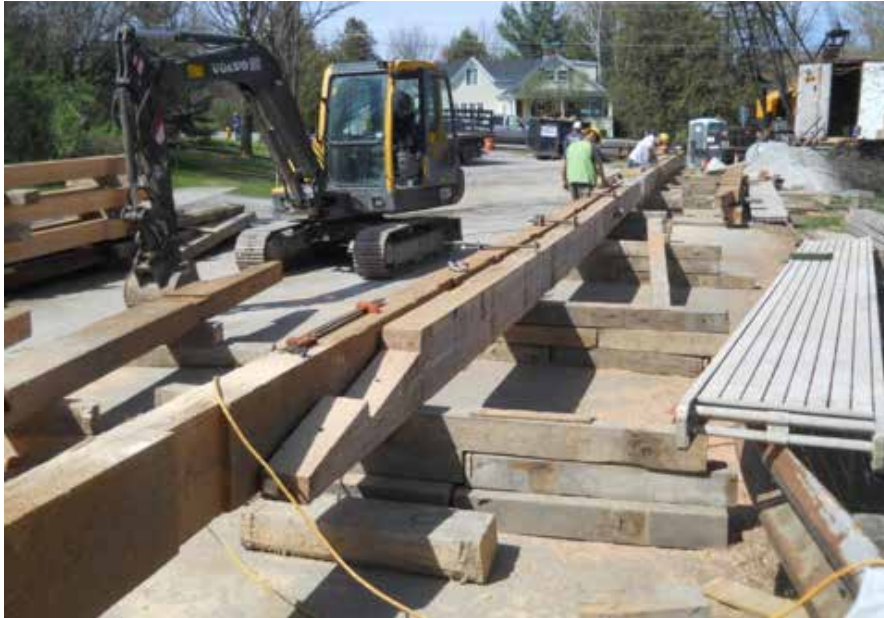
**Figure C10.17** New bottom chord with scarfed joints. Josif Bicja, April 2012.

The existing bottom chord laminae were not notched to receive and lock in place the lower ends of the verticals as explained above. Many attempts to repair the bottom chord had been made, but it was still showing signs of distress prior to the rehabilitation. The poor craftsmanship of the connections of the truss vertical members to the bottom chord significantly reduced the notched timber thickness, which is much needed to prevent the shearing off of the lower ends of the verticals. Two 7" x 14" pressure-treated timbers on the north and south trusses replaced the entire bottom chord, while the interior truss consisted of two 8" x 14" pressure-treated timbers. New bottom chord laminae consisted of scarfed joints.

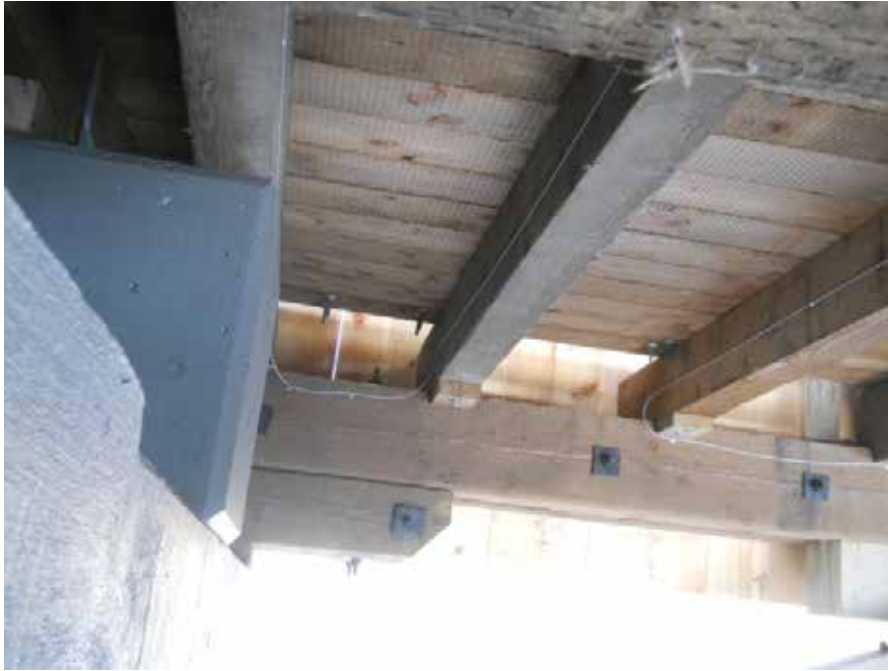
**Figure C10.22** Newly grouted and sealed concrete abutment supporting the new lower chord, consisting of two 7" x 14" pressure-treated timbers. Josif Bicja, July 2012.
