552-554 BROADWAY
New York, New York

Preservation Tech Notes

HISTORIC GLASS NUMBER 2

Repair and Rehabilitation of Historic Sidewalk Vault Lights

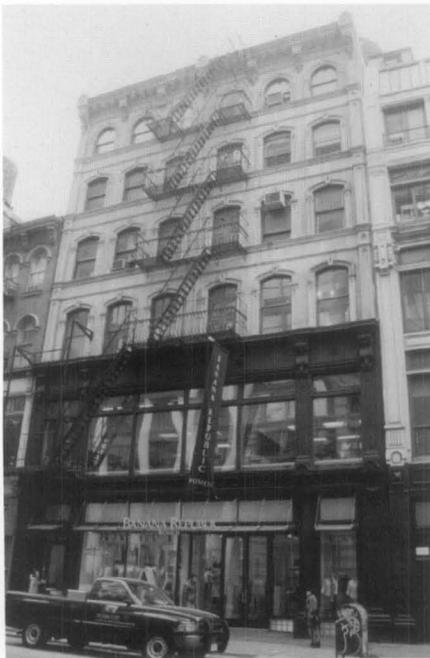
Located in New York City within the SoHo Cast-Iron Historic District, 552-554 Broadway is a six-story loft building detailed with Italianate ornamentation on the upper floors (see figure 1). Designed by the architect John B. Snook and originally constructed in 1855 as two separate buildings, 552 and 554 Broadway were joined internally and unified in 1897 with a new two-story, cast-iron storefront and sidewalk vault installation. It is likely that the building's basement was used historically for a combination of light manufacturing and storage.

Figure 1. A cast-iron storefront was added to 552-554 Broadway in 1897. The storefront included a fifty-four foot long assembly of cast-iron vault lights set in the sidewalk. Glass lenses in the panels allowed light to enter the basement area, increasing rentable space for the building owner.

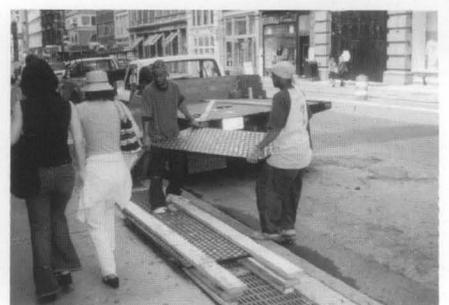
Figure 11. Just prior to installation, each panel was lifted by hand from the back of a truck and stacked on the sidewalk.

Following fabrication, the new panels were shipped to the contractor who set the new glass lenses and transported them to New York City for installation alongside the repaired panels (see figure 11).
