Mason-Willis-Dixon House
Portsmouth Village
Cape Lookout National Seashore

Historic Structure Report

December 2015

JOSEPH K. OPPERMAN-ARCHITECT, P.A.

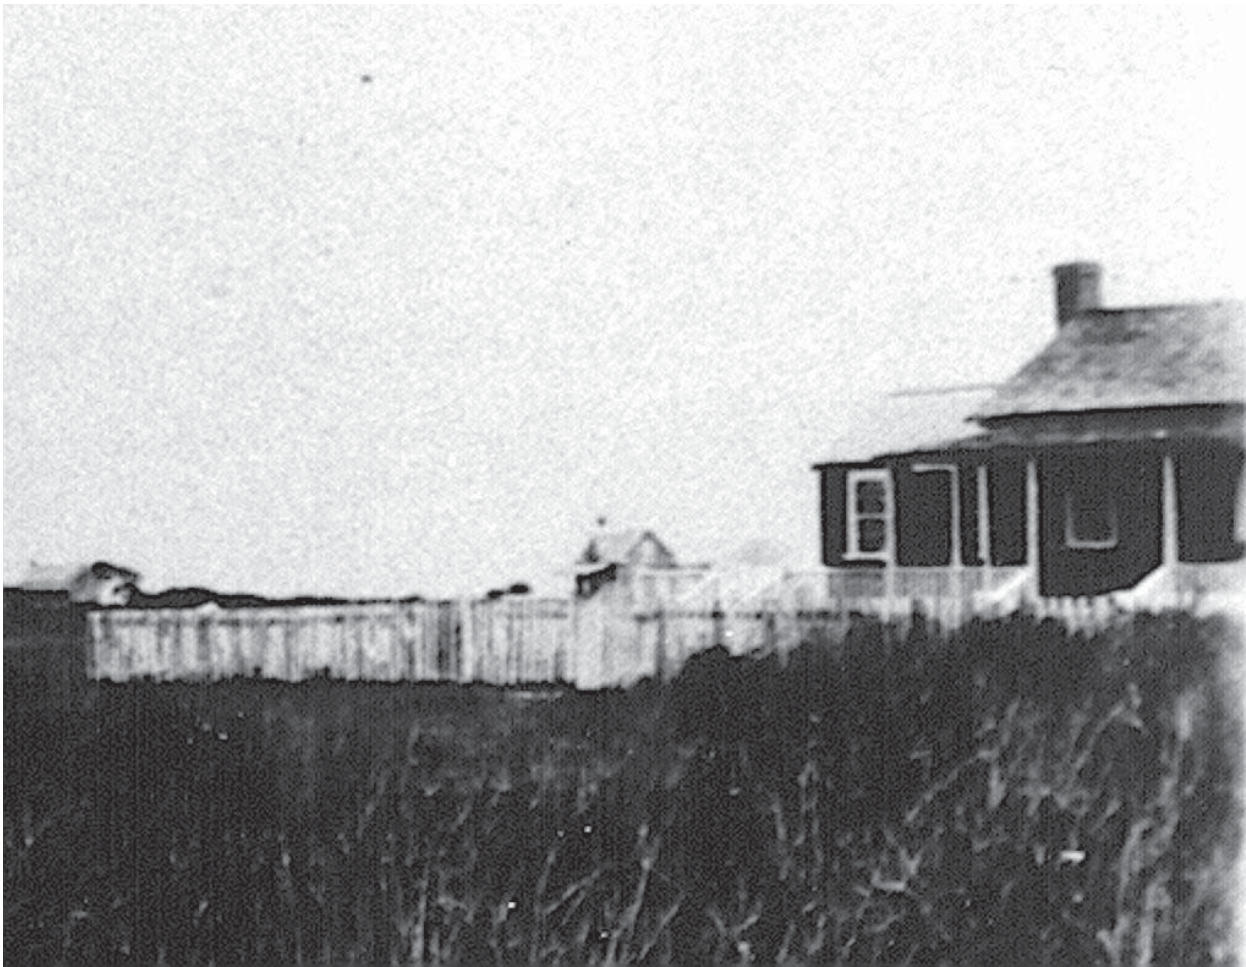
Figure 15. Undated photograph showing the house before the changes of the 1920s. An attached porch fronts the main block, and the west wing is in place. Land to the west is vacant where houses would be added in the 1930s. (Dorothy Byrum Bedwell Coll.)

An early, though undated photograph provides valuable information about the house on the property in the latter years of Willis ownership (*Fig. 15*). It shows a one-story, side-gabled house with an attached front porch, probably shed-roofed

The new eaves at front and rear were deep, in the Craftsman style. Dixon also extended the sides of the new roof to create deep eaves, and added false knee braces to ornament the gable ends. The new eave extension at the chimney is evident in comparison with the early Willis photograph (*Fig. 15*).

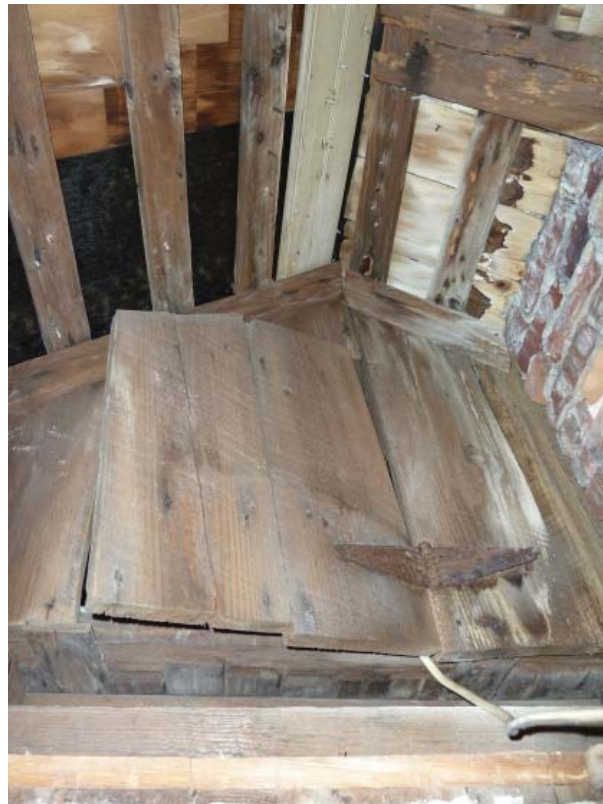
Figure 18. Vertical-board siding of the exterior of the original main block, covered when the west wing was brought up and attached. Shown is a door cut into the siding to lead from attic of wing to attic of main block. (2014 photograph)

The photograph of the house before Dixon’s remodeling and several taken after completion help to determine the history of the house, but are most valuable when coupled with physical investigation of the building. We know from the early photograph (*Fig. 15*) that the west wing was in place before Dixon’s changes. Measurements and inspection of construction materials and techniques suggest that the wing is an early structure, brought up and attached after the initial main block was built. The method of attachment and the vertical-board siding of the main block’s original exterior are visible in the attic of the wing (*Fig. 18*).

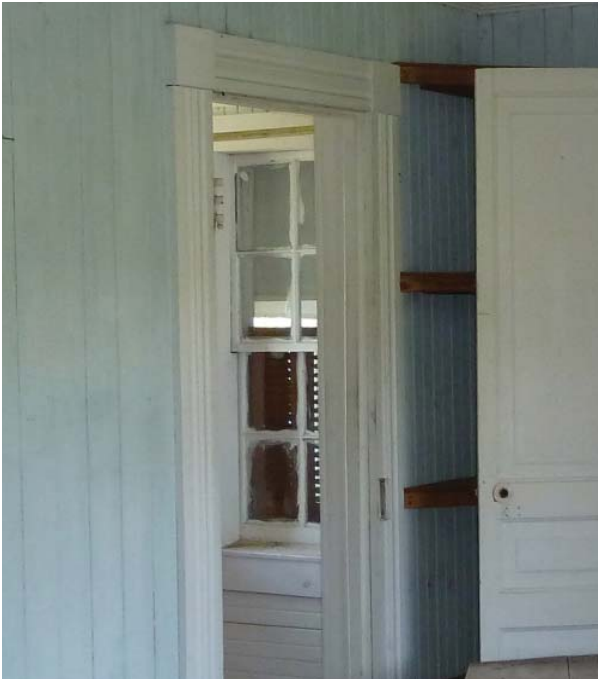
Figure 19. Doorway from north wing to added northeast entrance room, now a storage room. Originally an exterior doorway, it retains the Victorian trim found in the wing. (2013 photograph)

Though not visible in the early photograph, a second wing extending north from the back of the house is also an early structure, of a similar period as the west wing and maybe older. It retains Victorian trim on doors and windows typical of the late nineteenth or very early twentieth century (*Fig. 19*). Structural evidence indicates that it too was attached after the initial main block was built and before Dixon’s project.

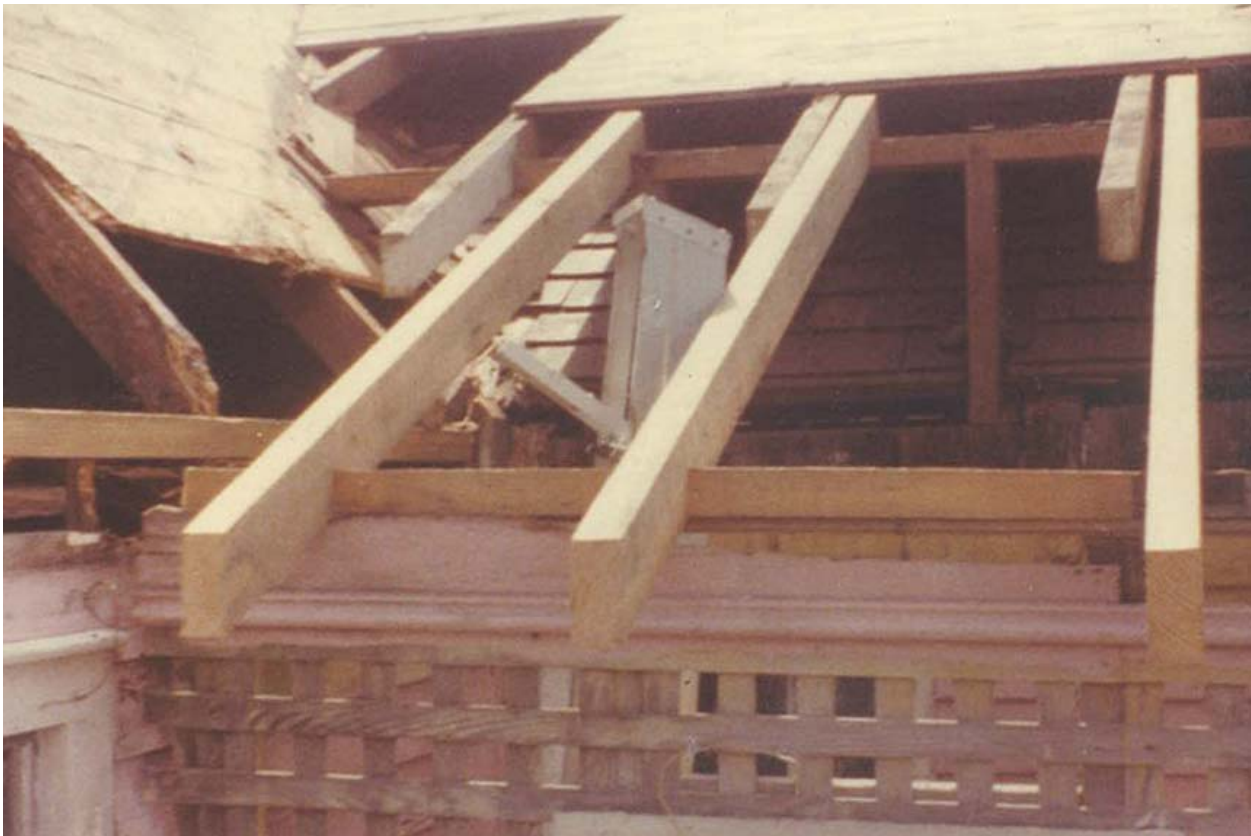
Figure 20. 1979 view showing the rear slope of the Willis roof beneath the higher, longer slope of Harry Dixon's new roof, and the lattice room beneath. The sistered rafters are part of the 1979 repairs. (CALO Polaroid album)

To give the appearance of a symmetrical roof, he built a new, longer back slope above the old, extending it north several feet beyond the existing back wall of the main block. A photograph taken in 1979 during repairs shows the Willis roof visible beneath Dixon's new rear roof (*Fig. 20*). The Willis roof ended at the former rear wall; Dixon's higher roof extended to the back wall of the new lattice room (west) and the new entrance room (east, now the storage room).

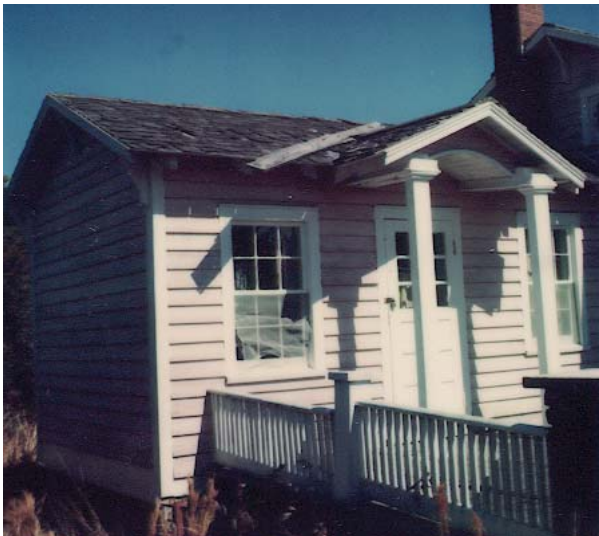
Figure 31. West wing and stepped railing in 1977. (CALO Coll. f80)

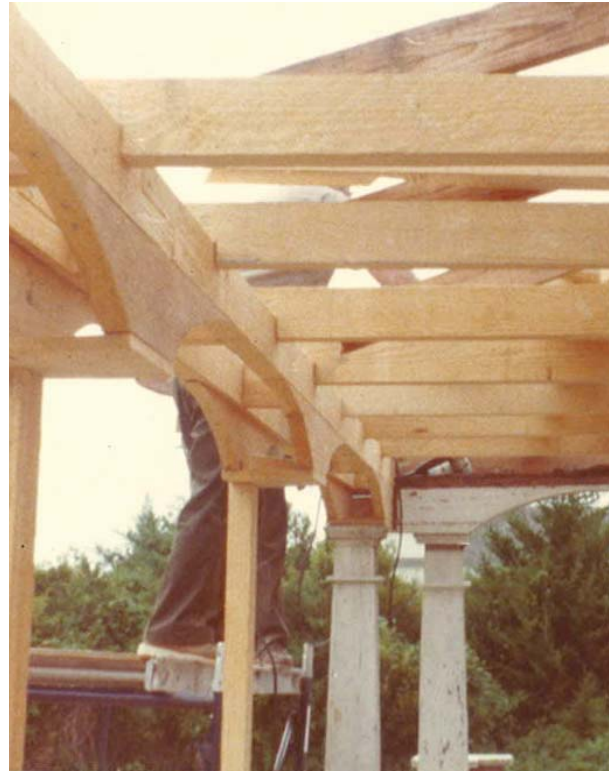
In June and July, an NPS crew replaced most wood features of the porch and deck, which suffered from the more extensive rot and termite damage (*Figs. 32-36*). The subframe of both was replaced and new floorboards installed. The rafters of Harry Dixon's engaged roof extension were replaced, and a new ceiling installed. Also replaced were the two center box columns and all arches, which photographs show were severely damaged by termites. The 1928 tripled corner posts were able to be retained, and the posts and portions of the west portico were also replaced. Some railings were reused and most others replaced, and

Figure 35. Replacing porch roof framing, 1979. (CALO Polaroid album)

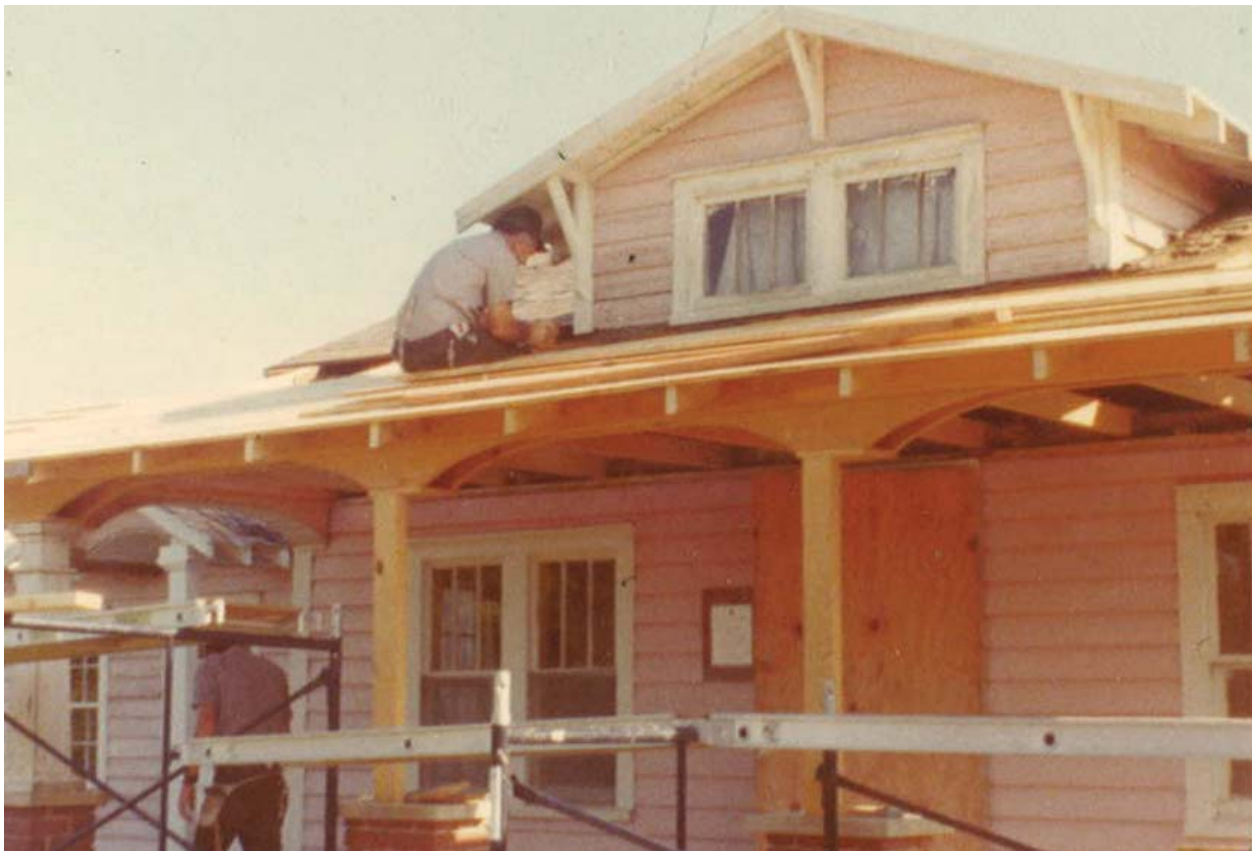
Figure 36. Replacing porch roof, arches, posts, 1979. (CALO Polaroid album)

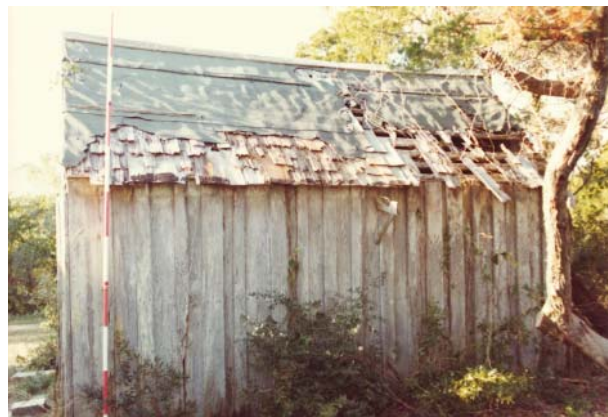
Figure 40. East side of shed before work, 1979. (CALO Coll. f290)

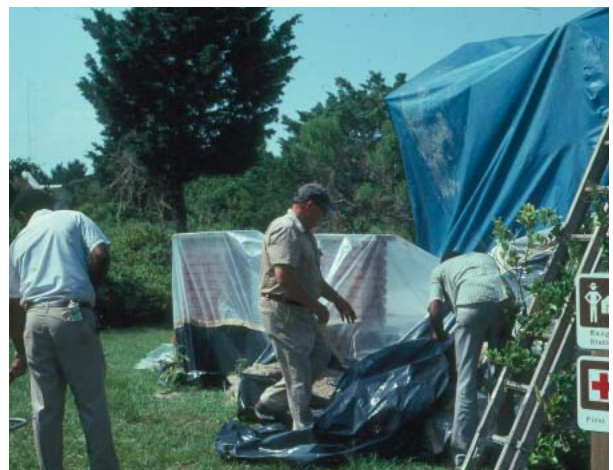
In 1981 the house was fully wrapped and fumigated to combat infestation of insects (Fig. 44).

Figure 44. West wing and deck piers wrapped for fumigation project, July 1981. Ranger station sign in front of house. (CALO acc. 05537)

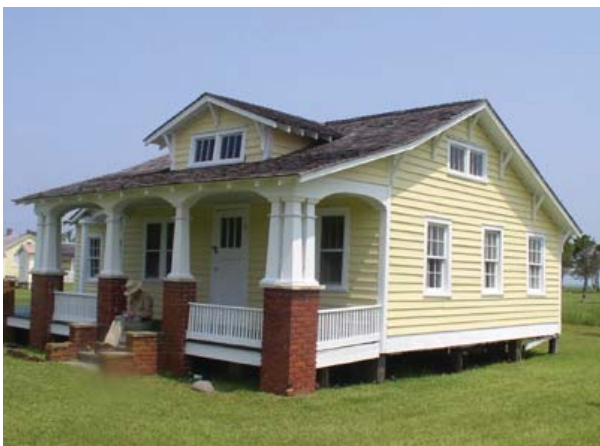
In 2005 a NPS crew spent two years of concentrated work repairing the buildings of Portsmouth. The next year an NPS survey assessed the house in good condition. Photographs allow a comparison of the condition in 1977 and thirty years later (*Figs. 45-46*). In contrast, by 2007 the shed was noted in the 2007 Cultural Landscape Report as being dilapidated and in need of repair, with large portions of the siding missing.⁸⁶ Later that year the shed was rebuilt. Ricky Daniels of Cedar Island signed the interior west wall, documenting that he “rebuilt this old shack.”

Figure 46. Front and east elevations in 2007. (NPS List of Classified Structures [LCS])

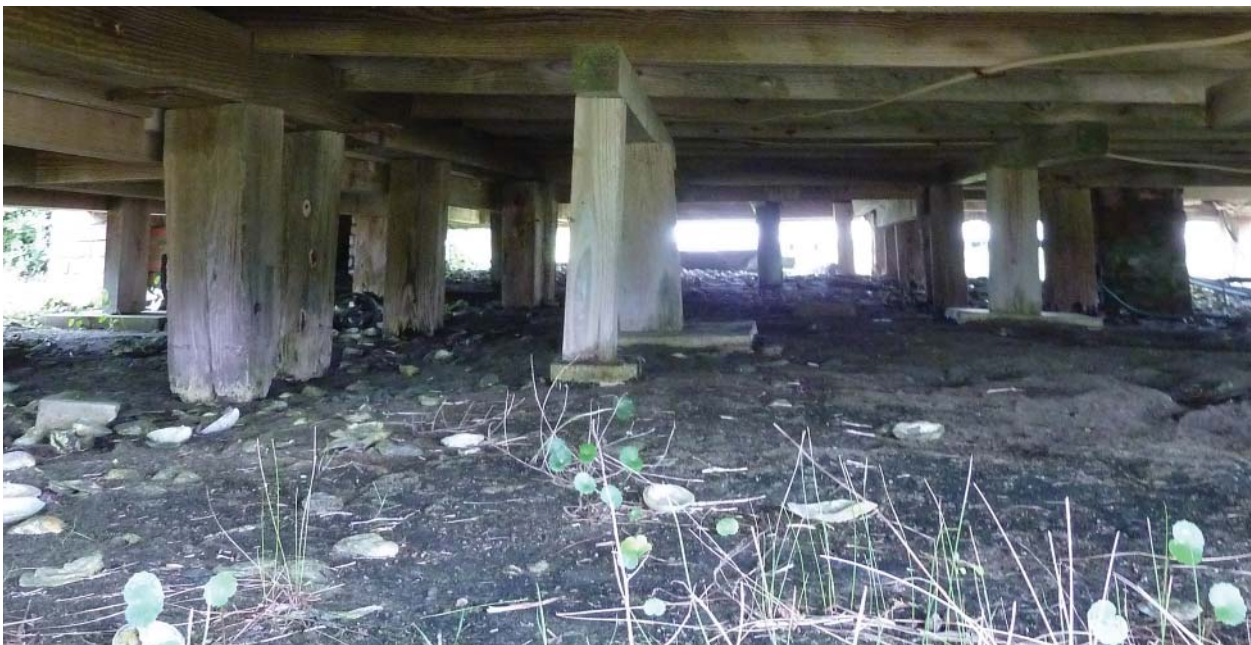
Figure 55. Looking north under west side of front porch and main block, showing historic wood posts at left.

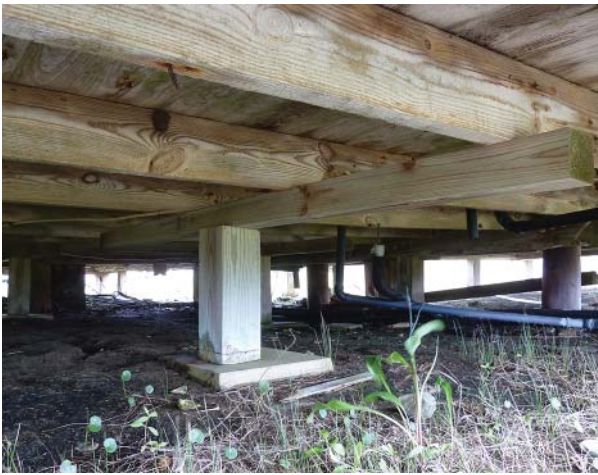
Figure 57. Added supports on west side of main block.

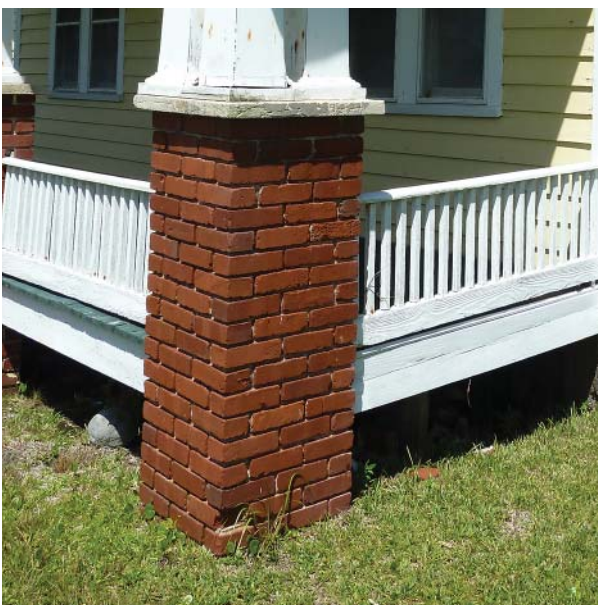
Figure 59. L-shaped pier at southeast corner of front porch.

At the corners of the front porch and at the outside corner of the deck, piers are L-shaped, generally 1'-9" by 1'-9" in plan. Square piers on each side of the two sets of front steps are 1'-5" by 1'-4" in plan.

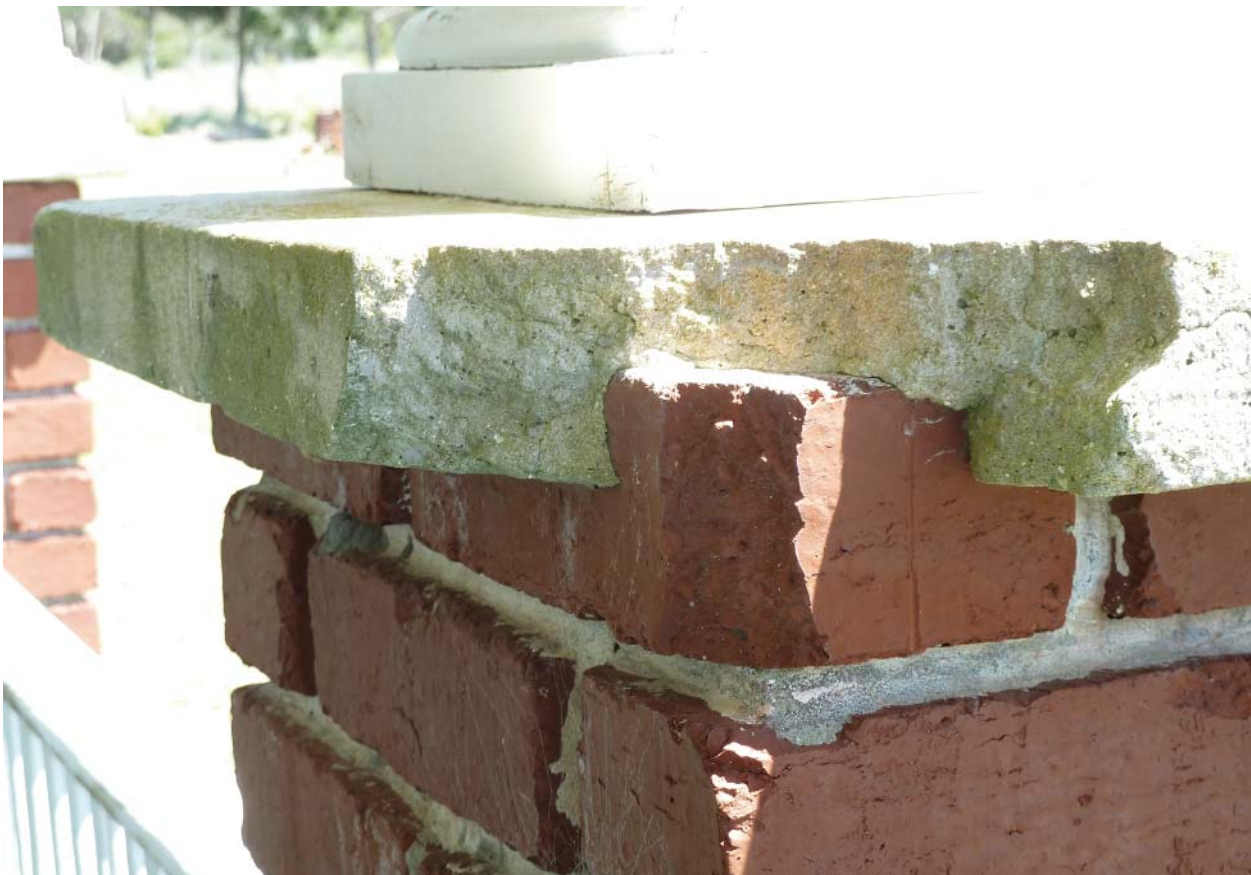
Figure 61. Typical materials in brick piers.

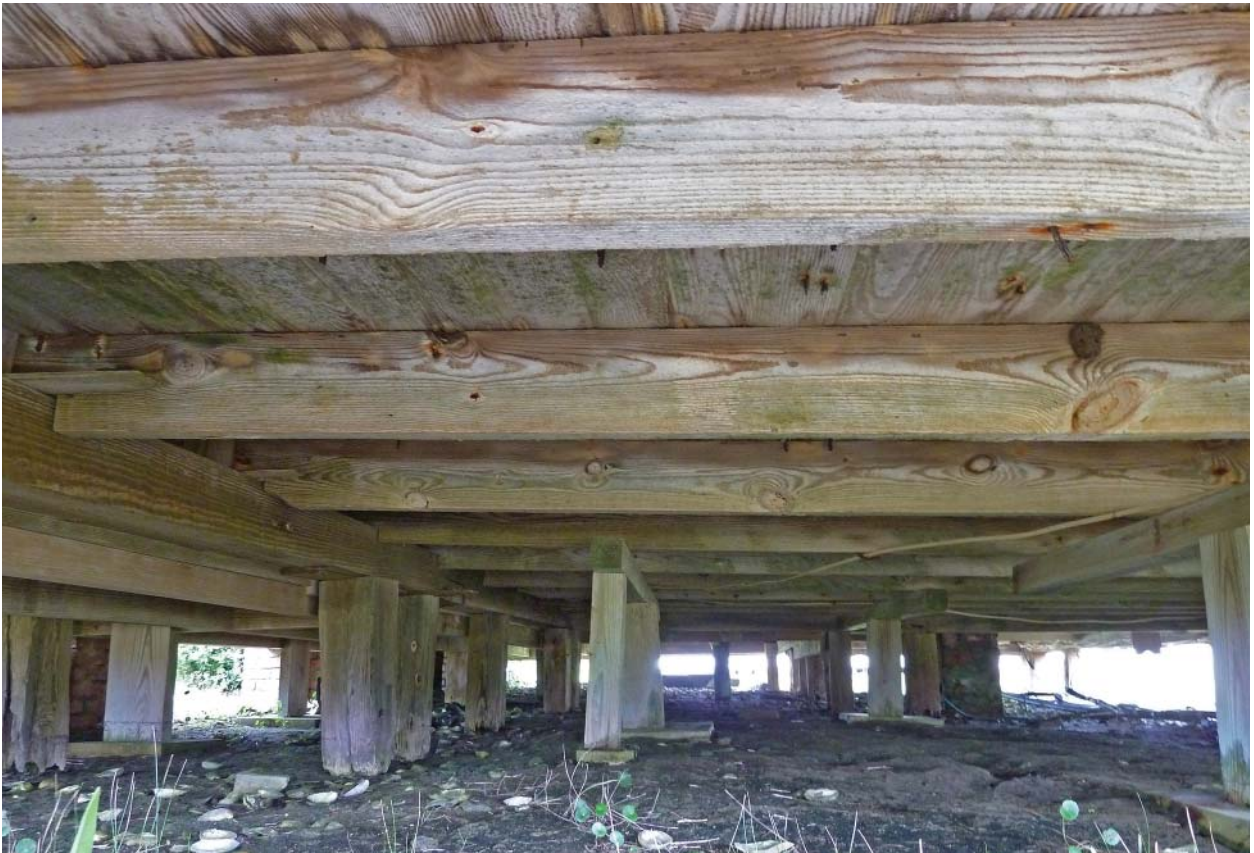
Figure 64. Looking north showing floor framing for the front porch in the foreground.

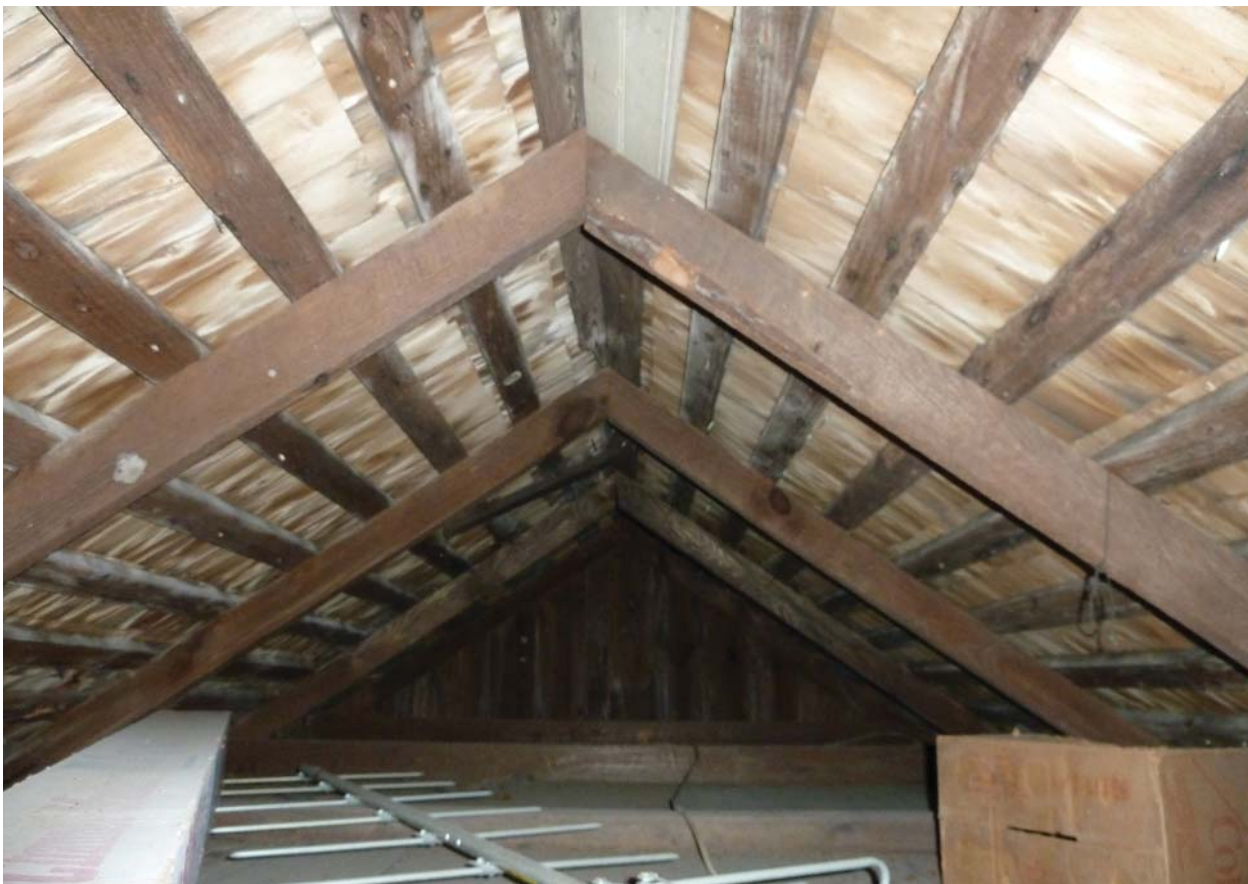
The wood framing appears to be in generally fair condition, and ridge lines remain straight and floors level. Insect damage can be observed in some of the sills, and there is likely to be hidden damage elsewhere in the building. The house is, like many others of the period, under-structured by modern standards, especially in terms of spacing

Figure 65. Looking west in attic of kitchen wing.

between the various framing members, but there is no apparent systemic failure. However, the nails used in framing have inevitably corroded in the damp, salty environment, making the building more subject to wind damage and other stresses.

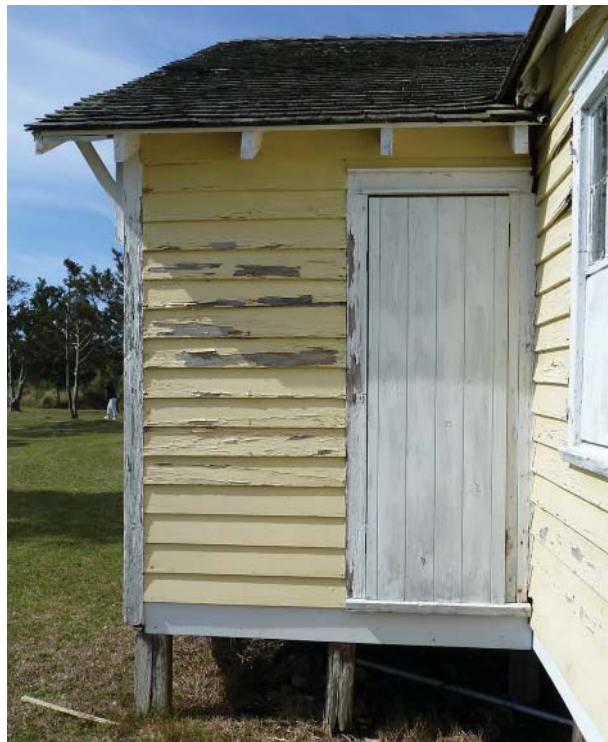
Figure 71. Back door, opening to Room 104.

deteriorated with severe damage to the bottom rail. The door to Room 104 is new but has no exterior hardware and no steps to the ground.

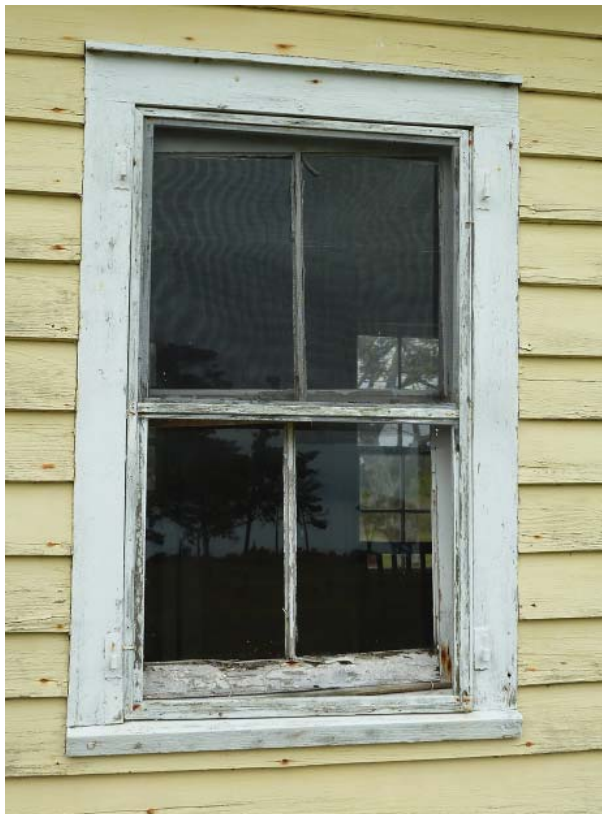
Figure 75. Two-over-two window on the north side of the kitchen wing, the earliest intact window in the house.

Sash are missing from the windows on the east and north sides of the north wing but most of the rest are in fair condition. Painted finishes are in poor condition with peeling paint and staining from rusting nails. Glazing of windows is in poor condition. Many of the wood-framed screens are missing and those that remain are in poor condition.

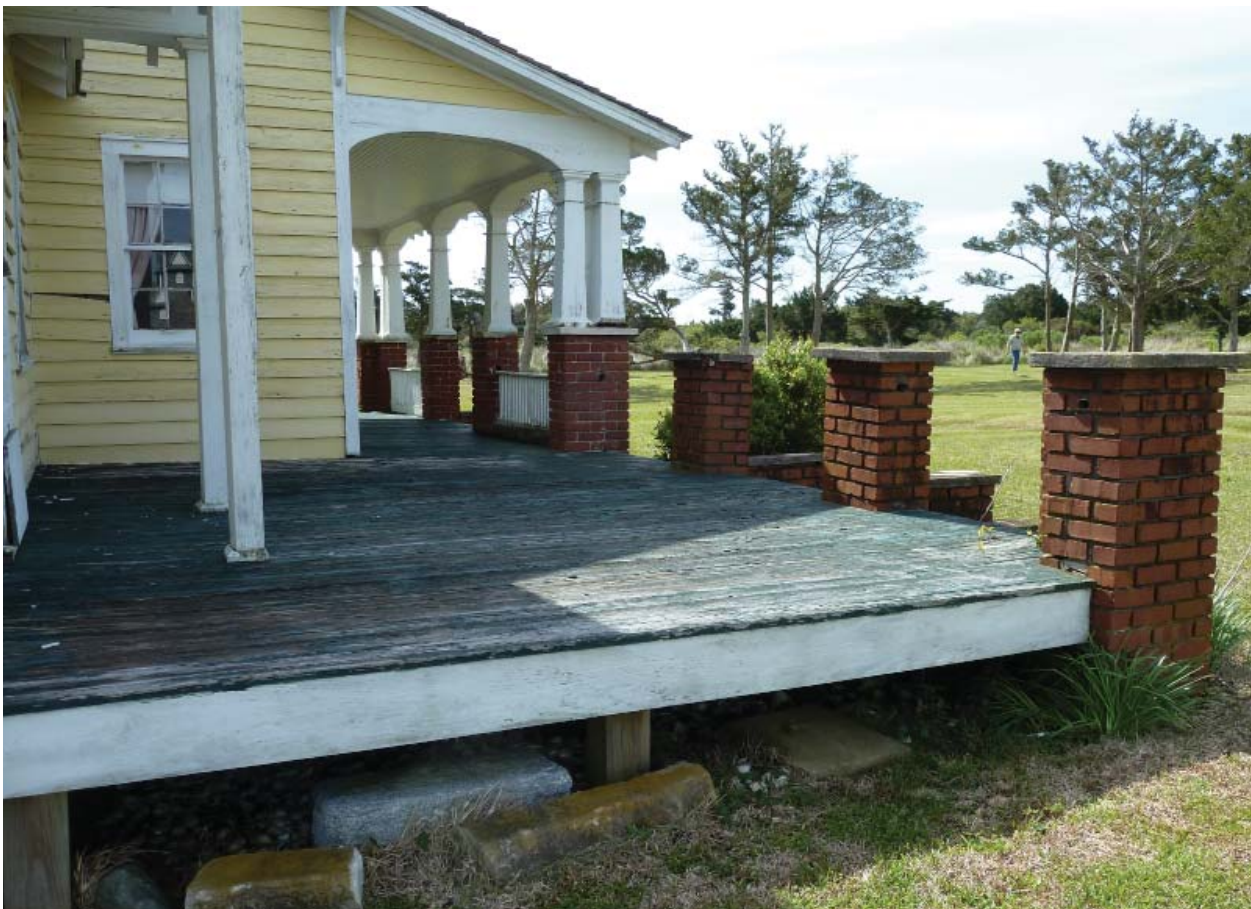
Figure 86. Deck and piers added by Harry Dixon along with the front porch ca. 1928.

The painted finish on the deck flooring is badly worn as is the paint on the plinths and lower half of the posts.

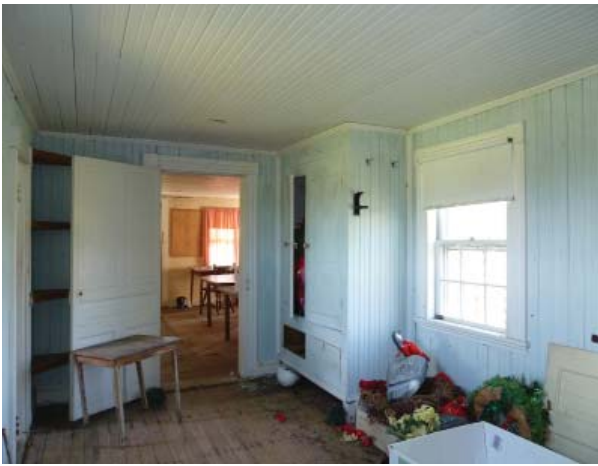
Figure 109. View into Room 101 from Room 105.

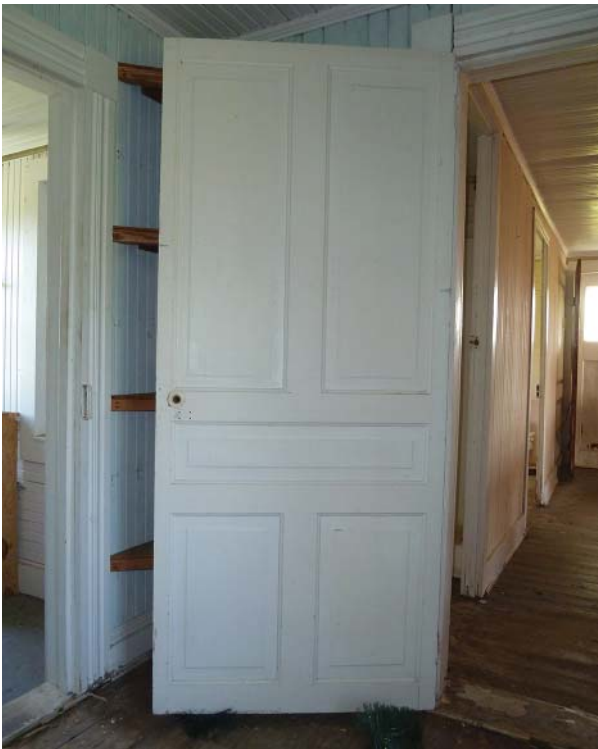
Figure 110. Five-panel door between Rooms 101 and 105.

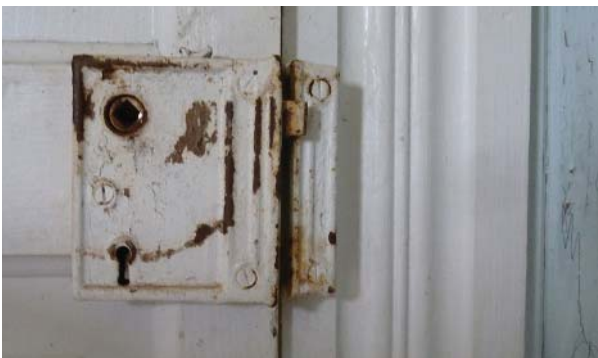
Figure 111. Rim lock on door between Rooms 105 and 101.

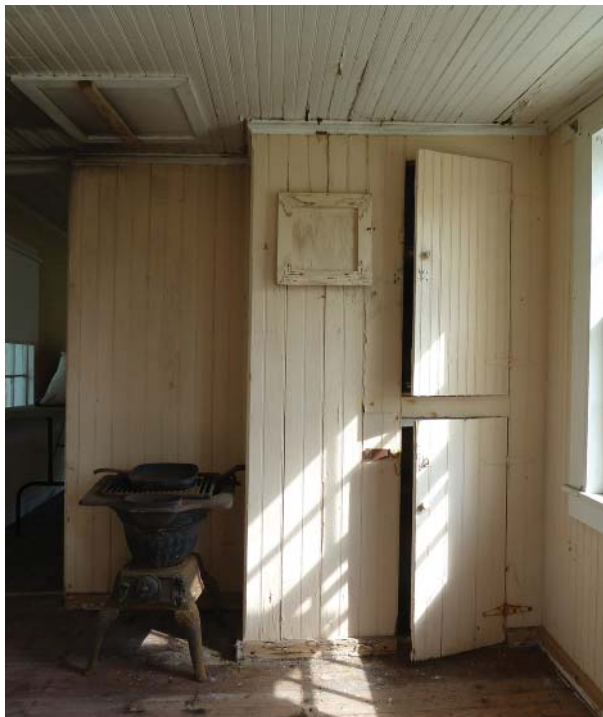
Figure 113. Looking east in Room 106, showing floor-to-ceiling pantry closet.

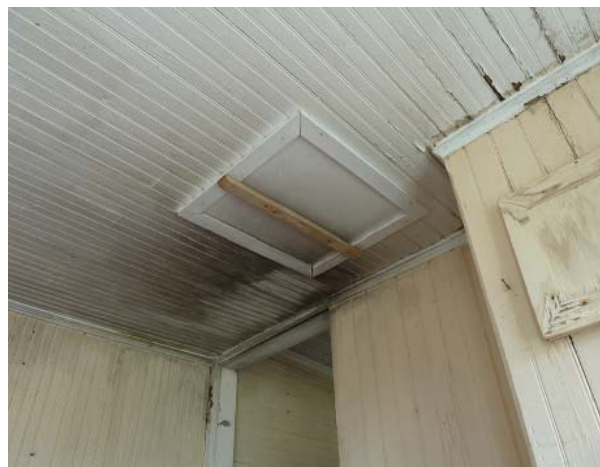
Figure 114. Attic hatch in northeast corner of Room 106.

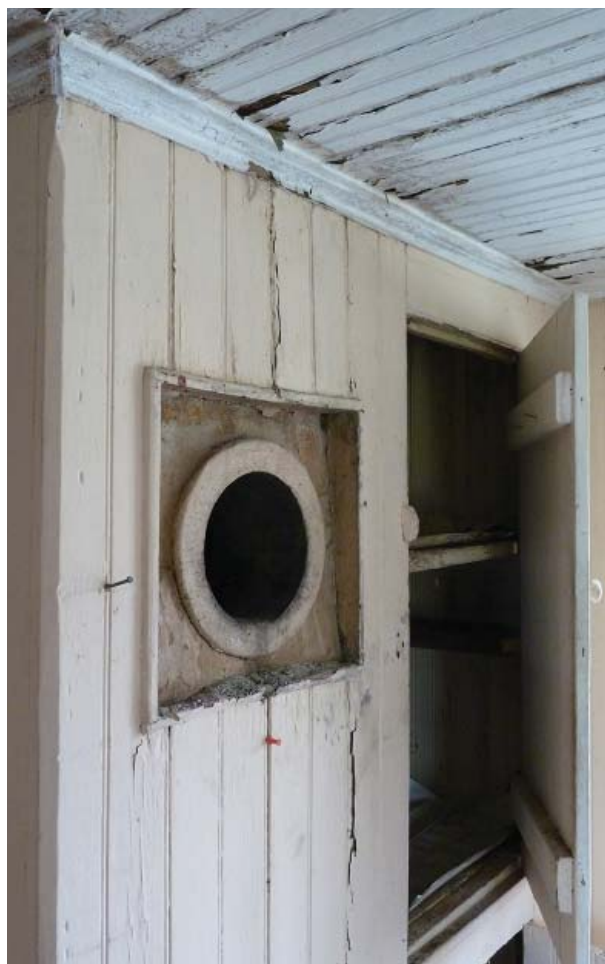
Figure 118. Stove flue and upper door of pantry closet.

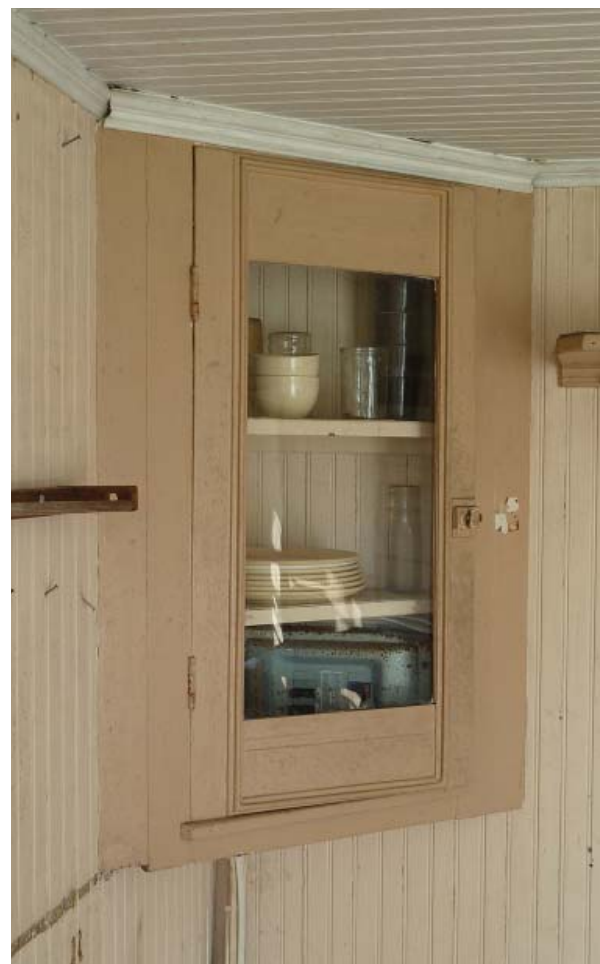
Figure 119. Northwest corner cupboard. The electrical circuit breaker is on the bottom shelf of this cabinet.

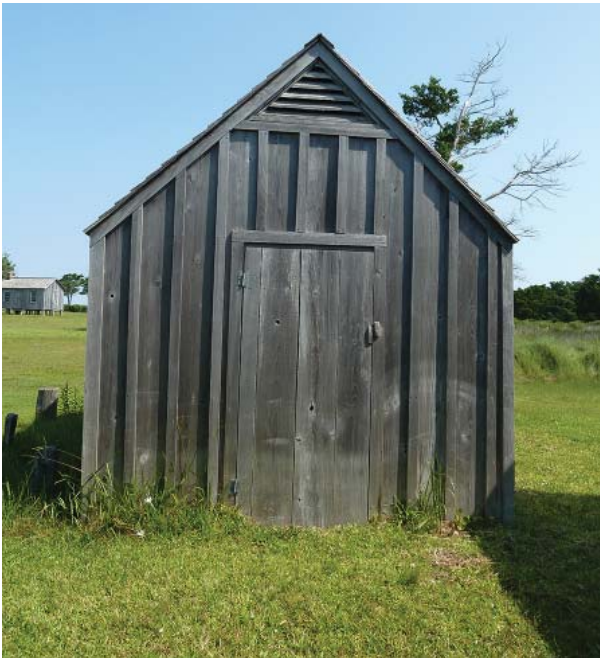
Figure 121. South elevation of shed.

The parts of the shed that are visible are in good condition. Considering the building's proximity to the ground, deterioration of the sills and floor joists is probably ongoing.

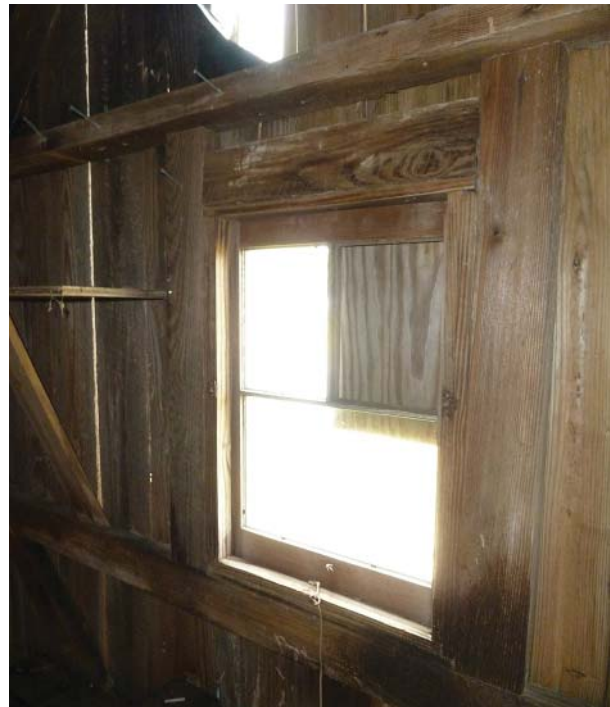
Figure 124. Window at north shed wall.

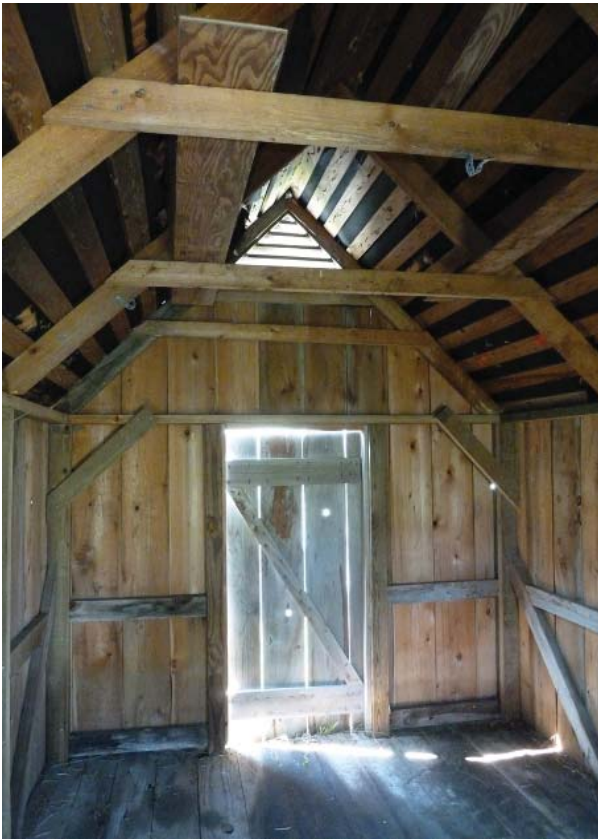
Figure 125. Looking south inside shed.

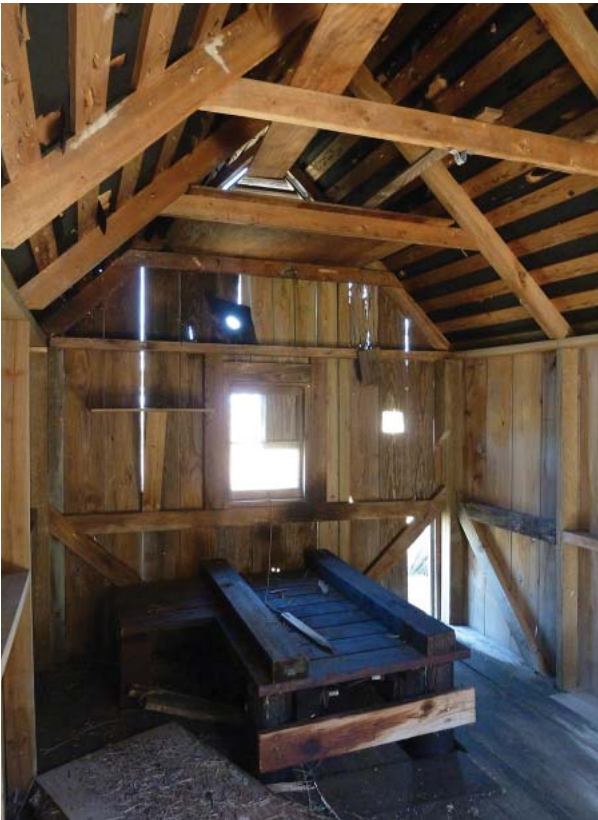
Figure 126. Looking north inside shed.

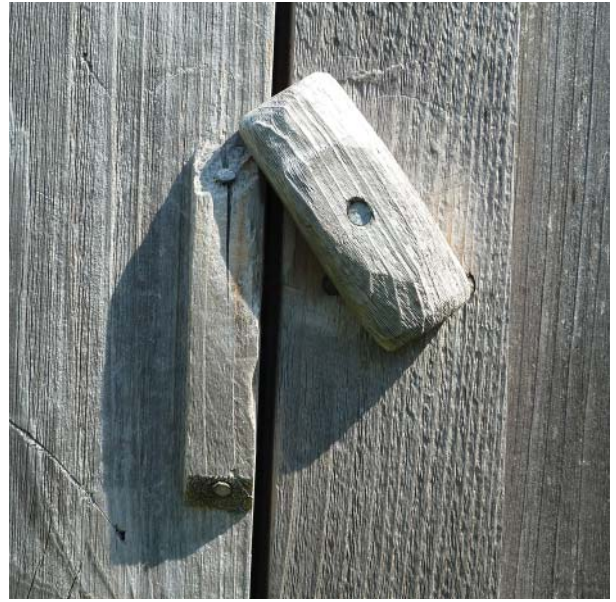
Figure 127. Pivot latch on shed door.

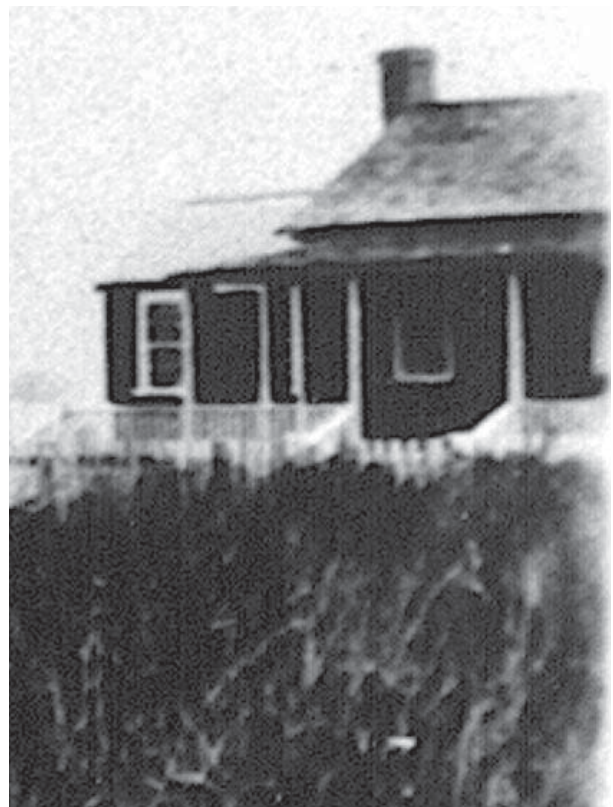
Figure 130. Undated photograph showing the house before the changes of the 1920s. An attached porch fronts the main block, and the west wing is in place. Land to the west is vacant where houses would be added in the 1930s. (Dorothy Byrum Bedwell Coll.)
