Mason-Willis-Dixon House
Portsmouth Village
Cape Lookout National Seashore

Historic Structure Report

December 2015

JOSEPH K. OPPERMAN-ARCHITECT, P.A.

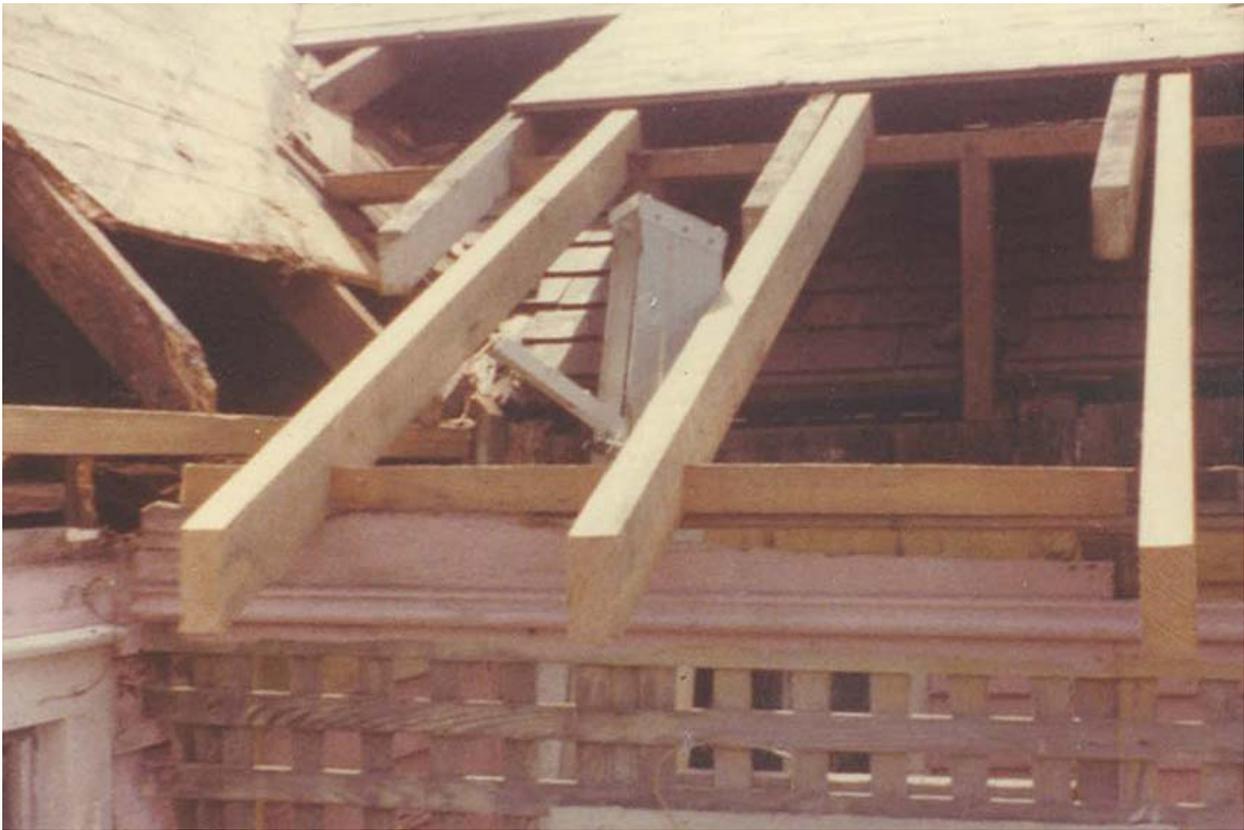
Figure 20. 1979 view showing the rear slope of the Willis roof beneath the higher, longer slope of Harry Dixon's new roof, and the lattice room beneath. The sistered rafters are part of the 1979 repairs. (CALO Polaroid album)

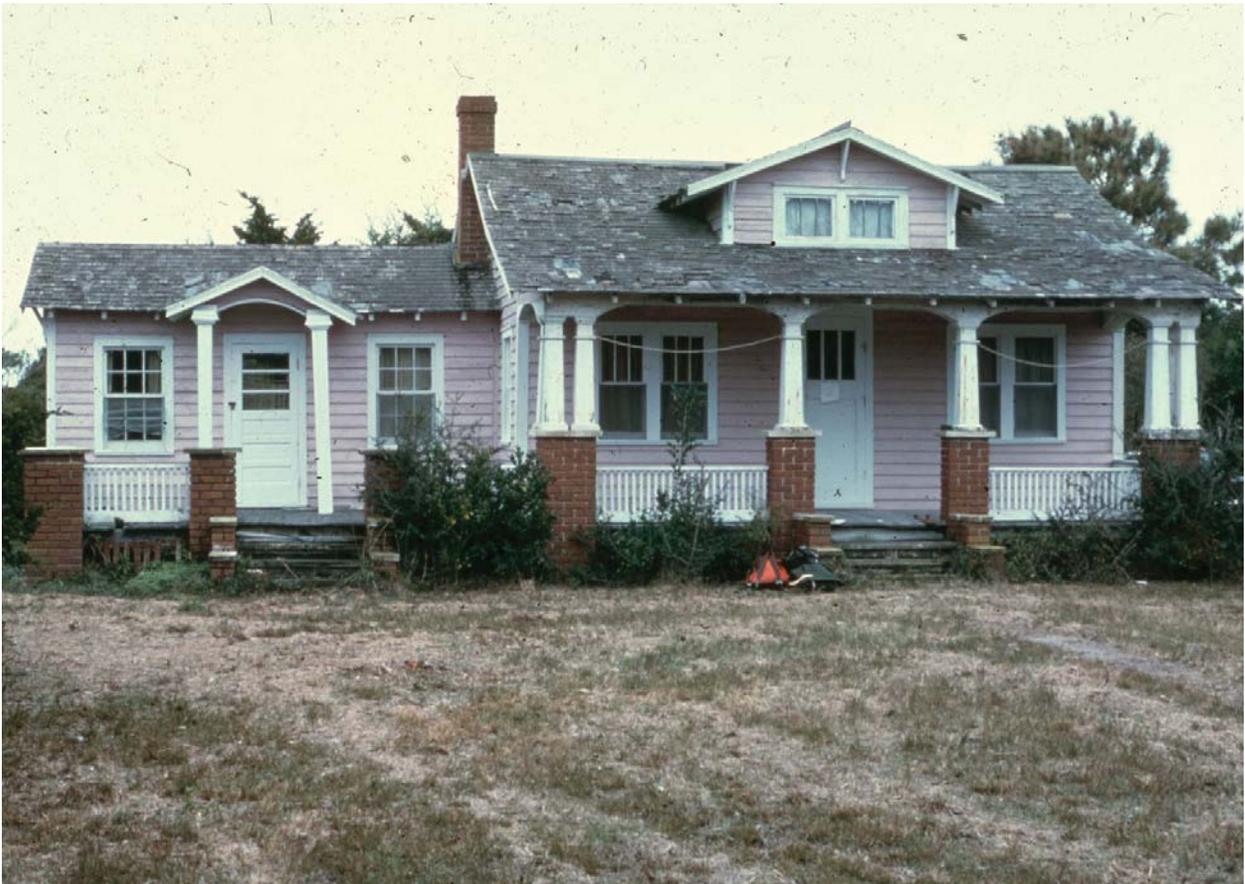
Figure 29. Condition of the house in 1977, also showing the 1960s replacement doors, the 1960s replacement six-over-six sash of the west wing, and the retained Craftsmen-style vertical-pane sash beneath the front porch. (CALO acc. 03355)

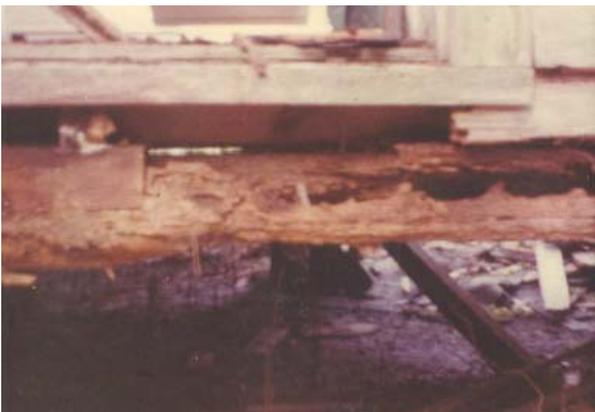
Work on the house began in 1979. An NPS album of Polaroid photographs shows the features and condition of the house at that time and some of the work underway. Like many in Portsmouth, the house suffered from severe termite damage (*Figs. 32-34*).

Figure 32. Termites in sill, 1979. (CALO Polaroid album)

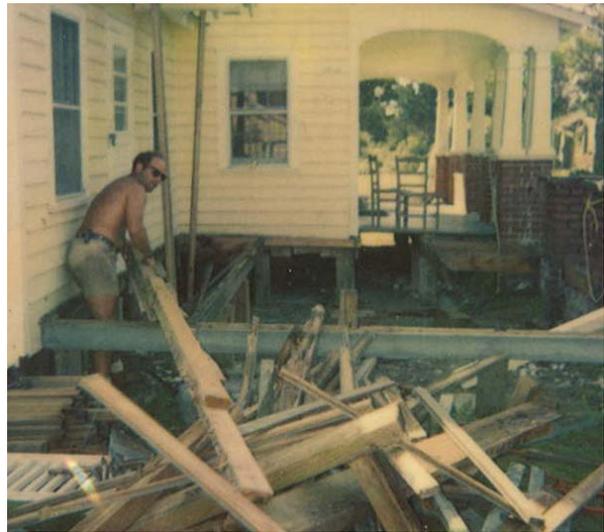
Figure 33. Preparing to replace kitchen deck, 1979. (blurry in CALO Polaroid album)

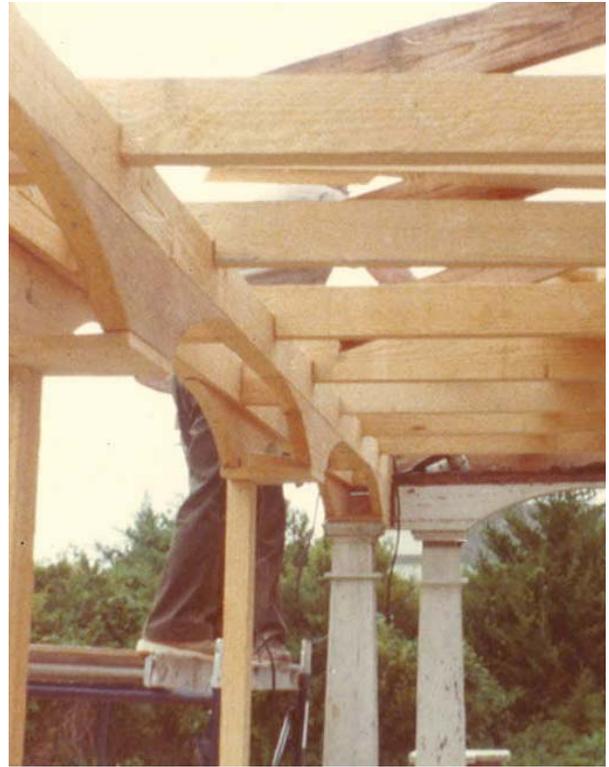
Figure 35. Replacing porch roof framing, 1979. (CALO Polaroid album)

In June and July, an NPS crew replaced most wood features of the porch and deck, which suffered from the more extensive rot and termite damage (*Figs. 32-36*). The subframe of both was replaced and new floorboards installed. The rafters of Harry Dixon's engaged roof extension were replaced, and a new ceiling installed. Also replaced were the two center box columns and all arches, which photographs show were severely damaged by termites. The 1928 tripled corner posts were able to be retained, and the posts and portions of the west portico were also replaced. Some railings were reused and most others replaced, and

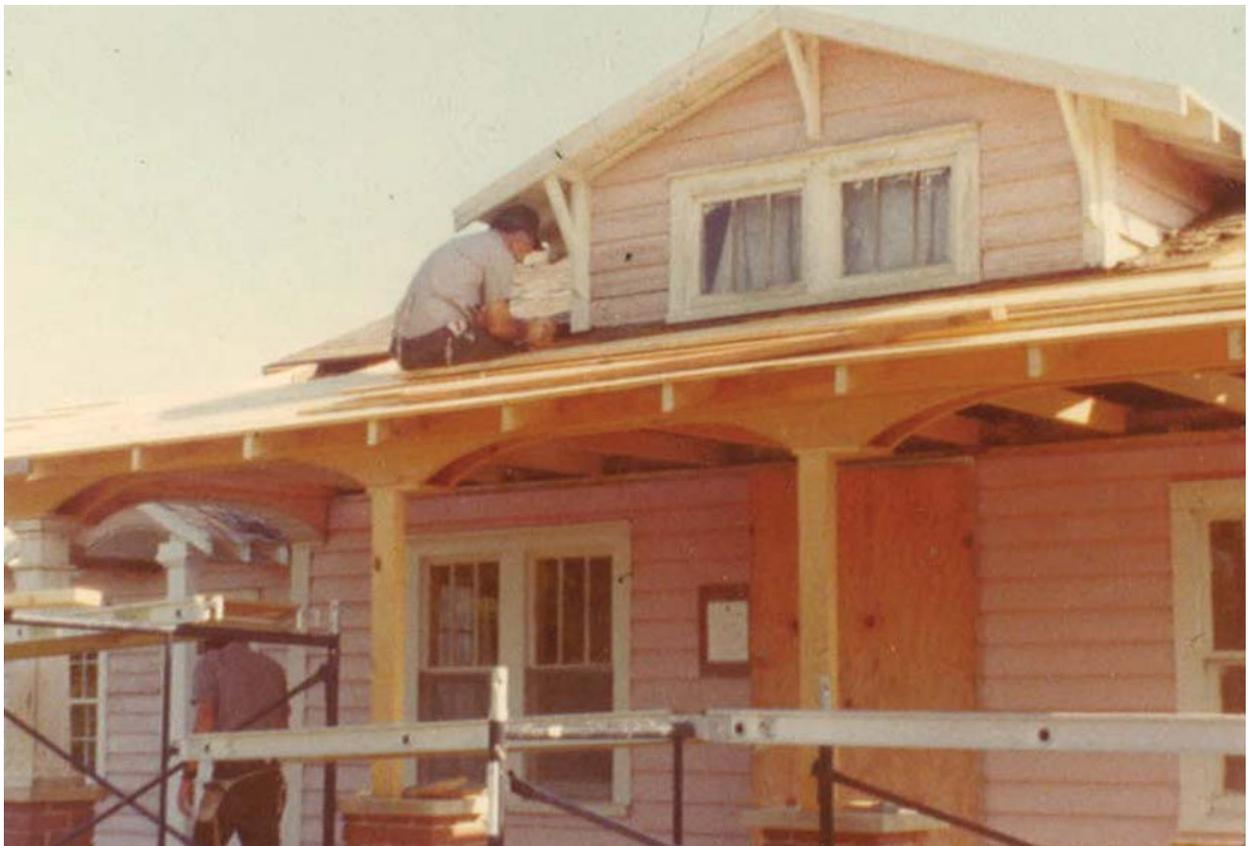
Figure 36. Replacing porch roof, arches, posts, 1979. (CALO Polaroid album)

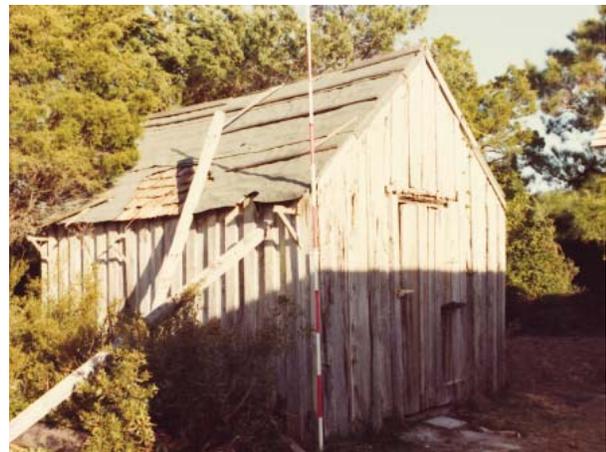
Figure 39. Front and west side of shed before work, 1979. (CALO coll. f289)

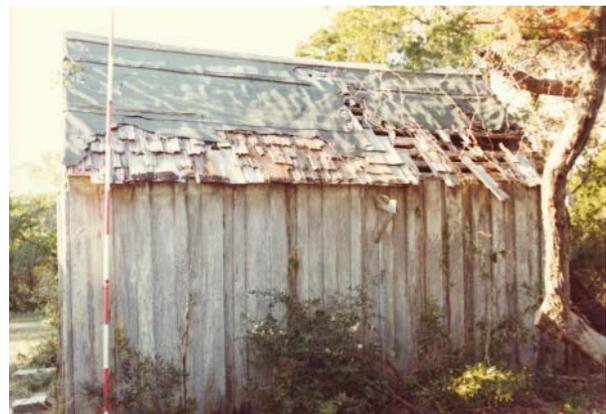
Figure 40. East side of shed before work, 1979. (CALO Coll. f290)

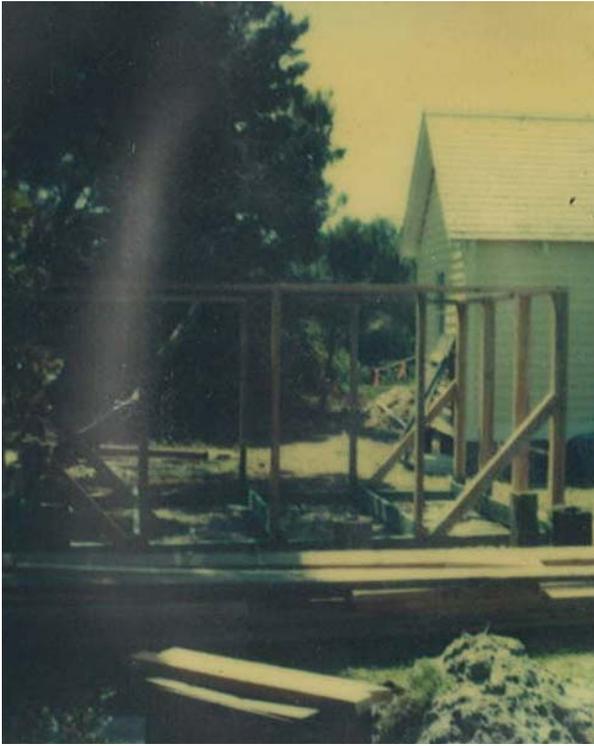
Figure 41. Reconstructed frame for rebuilt shed, 1980. (CALO Polaroid album)

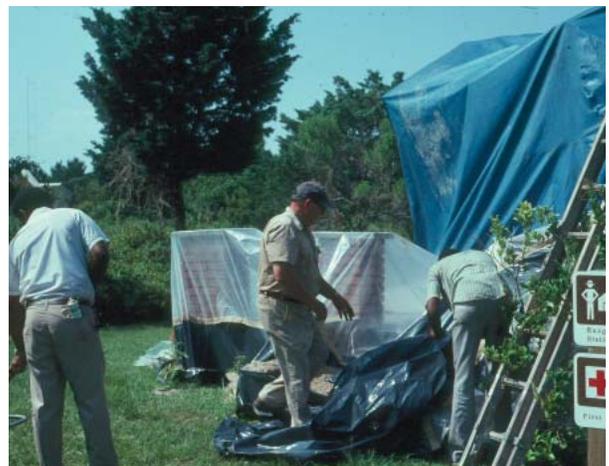
Figure 44. West wing and deck piers wrapped for fumigation project, July 1981. Ranger station sign in front of house. (CALO acc. 05537)

In 1981 the house was fully wrapped and fumigated to combat infestation of insects (Fig. 44).

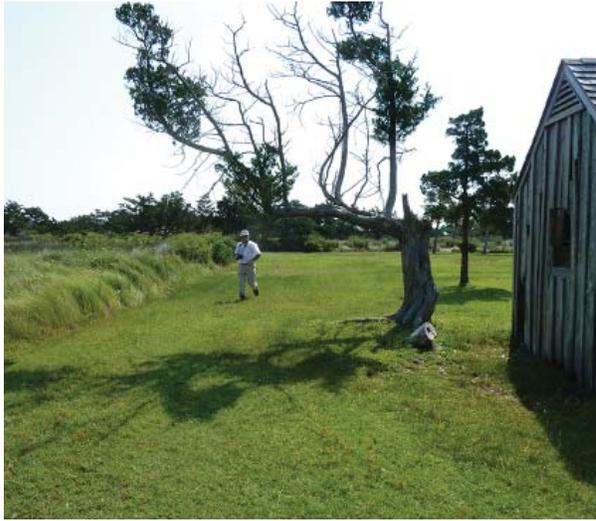
Figure 53. View in an easterly direction from the rear of the house.

almost uniformly level and poorly drained, with areas prone to standing water, including under the house and along the south and west sides. The site is covered with native grasses, which are kept mown, and a scattering of cedar, pine, and myrtle.

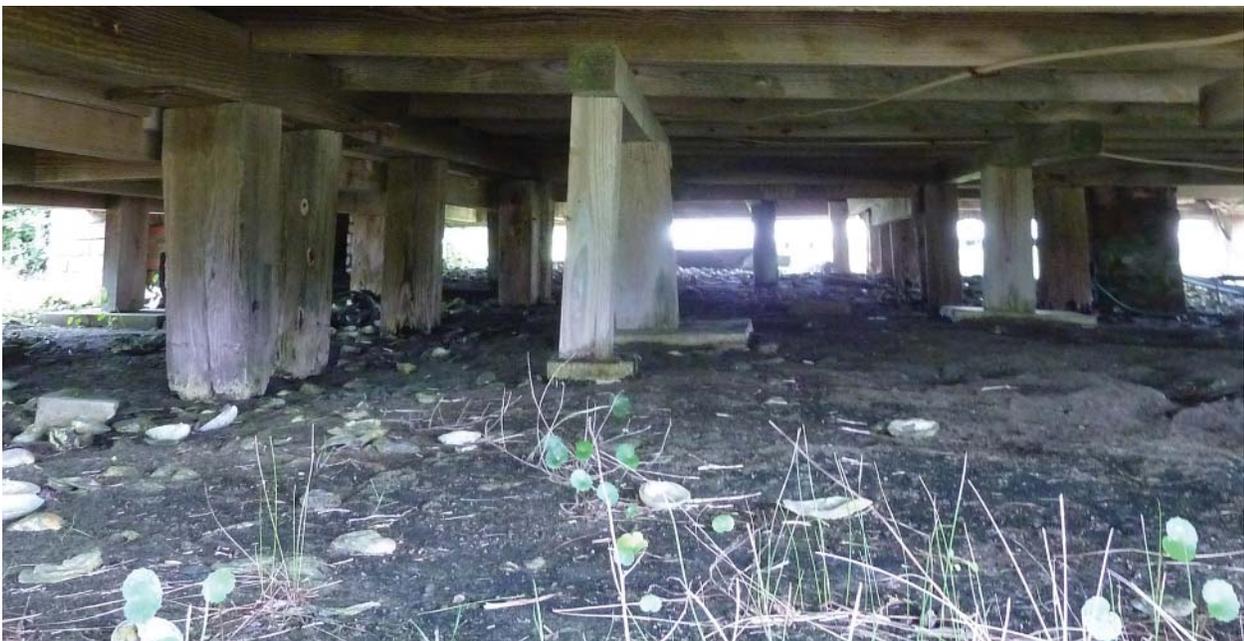
Figure 55. Looking north under west side of front porch and main block, showing historic wood posts at left.

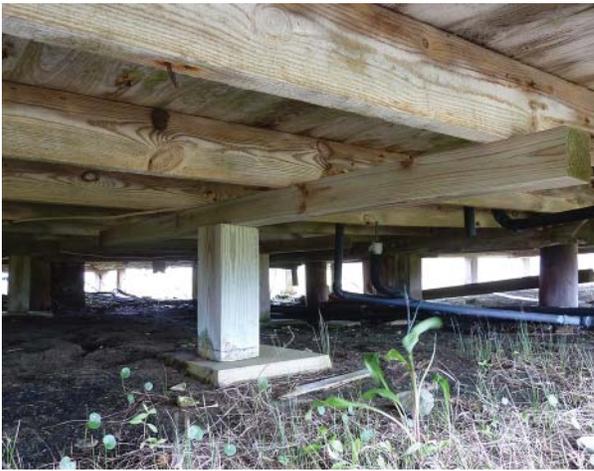
Figure 57. Added supports on west side of main block.

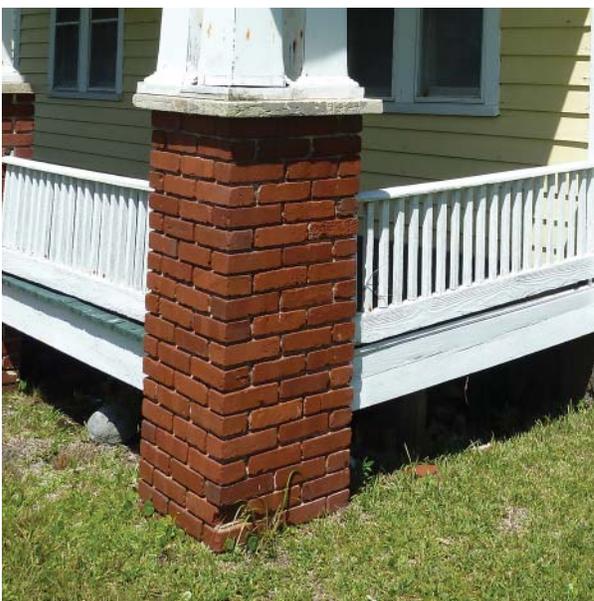
Figure 59. L-shaped pier at southeast corner of front porch.

At the corners of the front porch and at the outside corner of the deck, piers are L-shaped, generally 1'-9" by 1'-9" in plan. Square piers on each side of the two sets of front steps are 1'-5" by 1'-4" in plan.

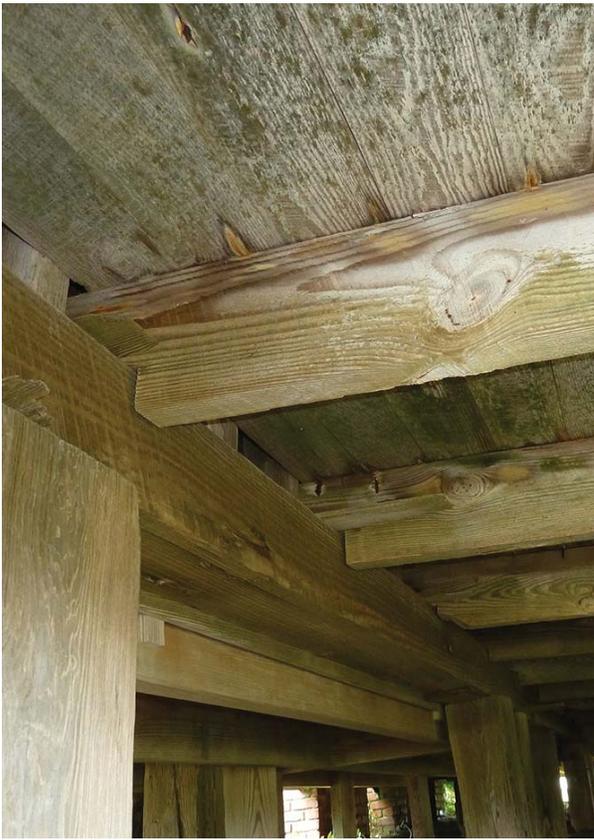
Dimensions of floor joists vary between the three sections of the house, but all are lapped over the sill without a rim joist. In the main block, joists are nominally 2" by 6" set on 24" centers, running north to south. In the west wing, joists are 4" by 4" on 28" centers. In the rear wing, joists are salvaged 3" by 10" and 2" by 8" set on centers 28" to 30" apart. Joists in the main block and north wing run east-west; those in the west wing run north-south.

Figure 63. Typical joist/stud/sill/post connections.

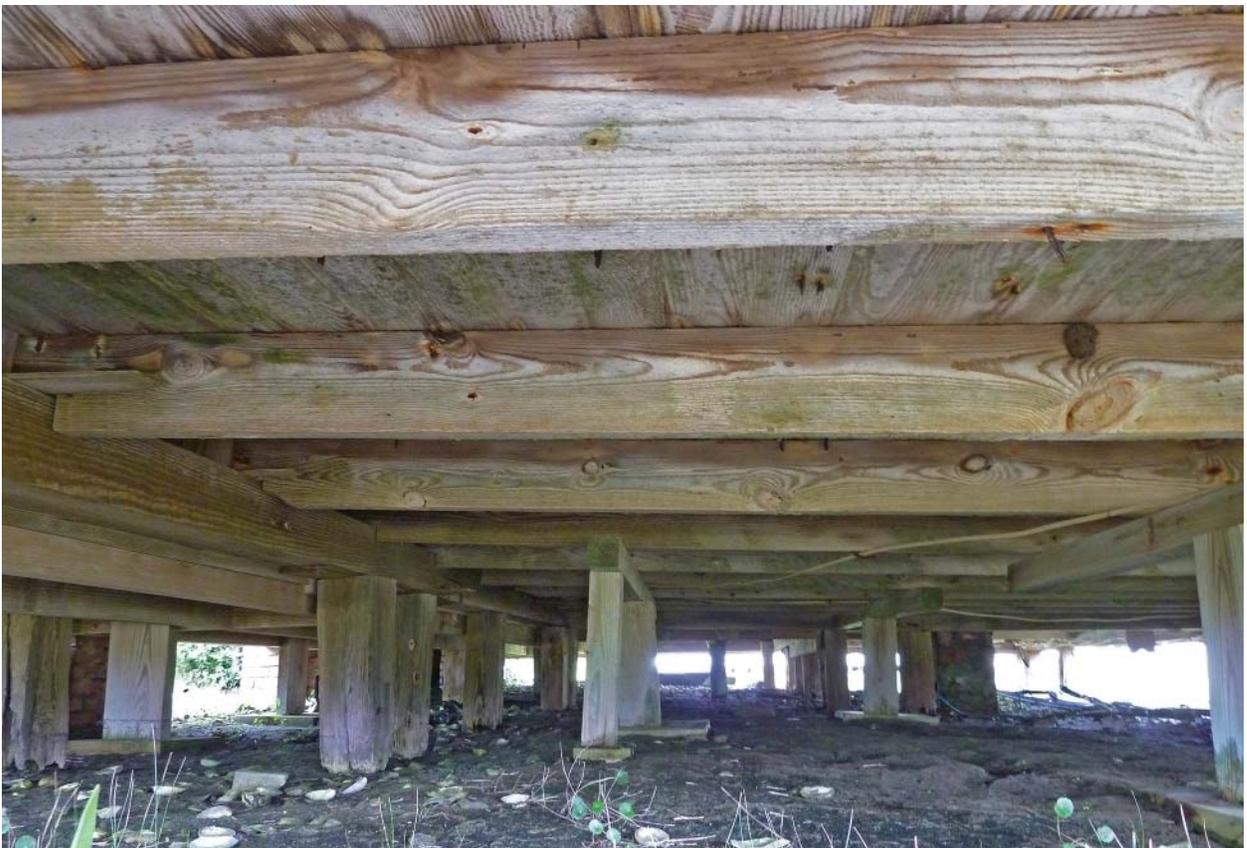
Figure 64. Looking north showing floor framing for the front porch in the foreground.

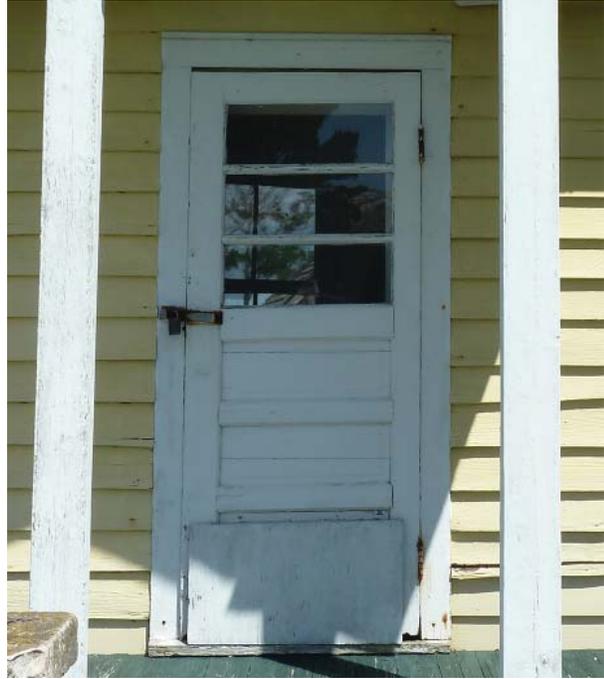
Figure 70. Front door to kitchen (west) wing.

The front door to Room 101 remains in generally good condition. The door to Room 106 is

deteriorated with severe damage to the bottom rail. The door to Room 104 is new but has no exterior hardware and no steps to the ground.

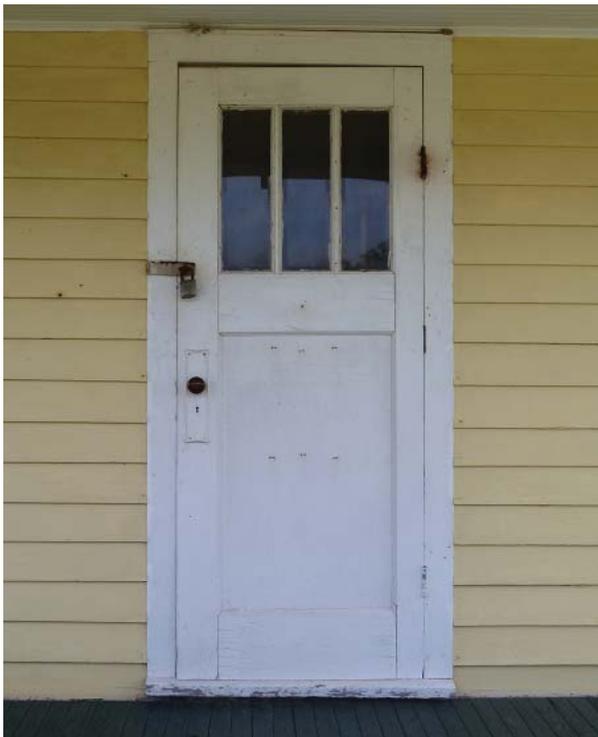
Figure 69. Front door, opening into Room 101.

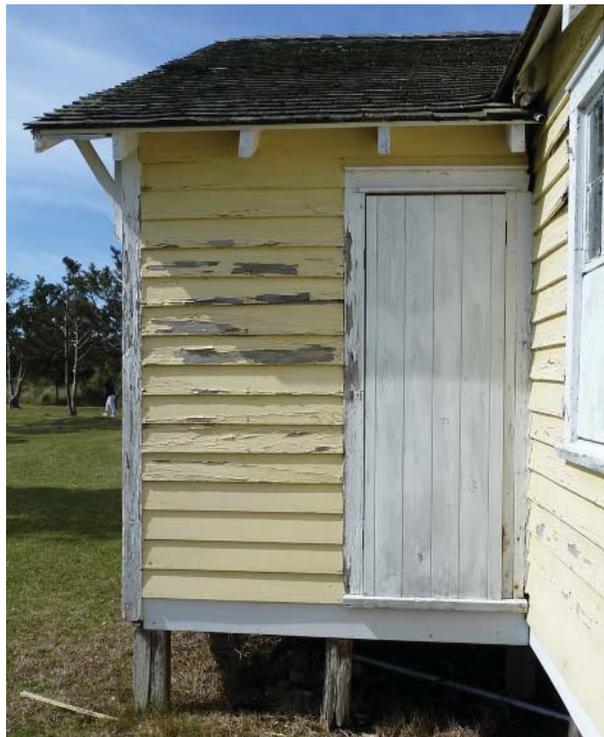
Figure 71. Back door, opening to Room 104.

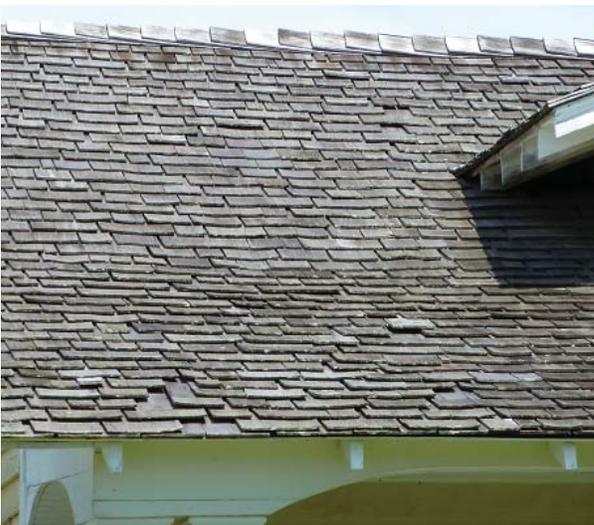
Figure 80. Typical roofing.

The roofing is in fair condition and there are no apparent leaks. A few shingles are missing or loose. As with most of the historic structures at Portsmouth, no gutters or french drains are present.

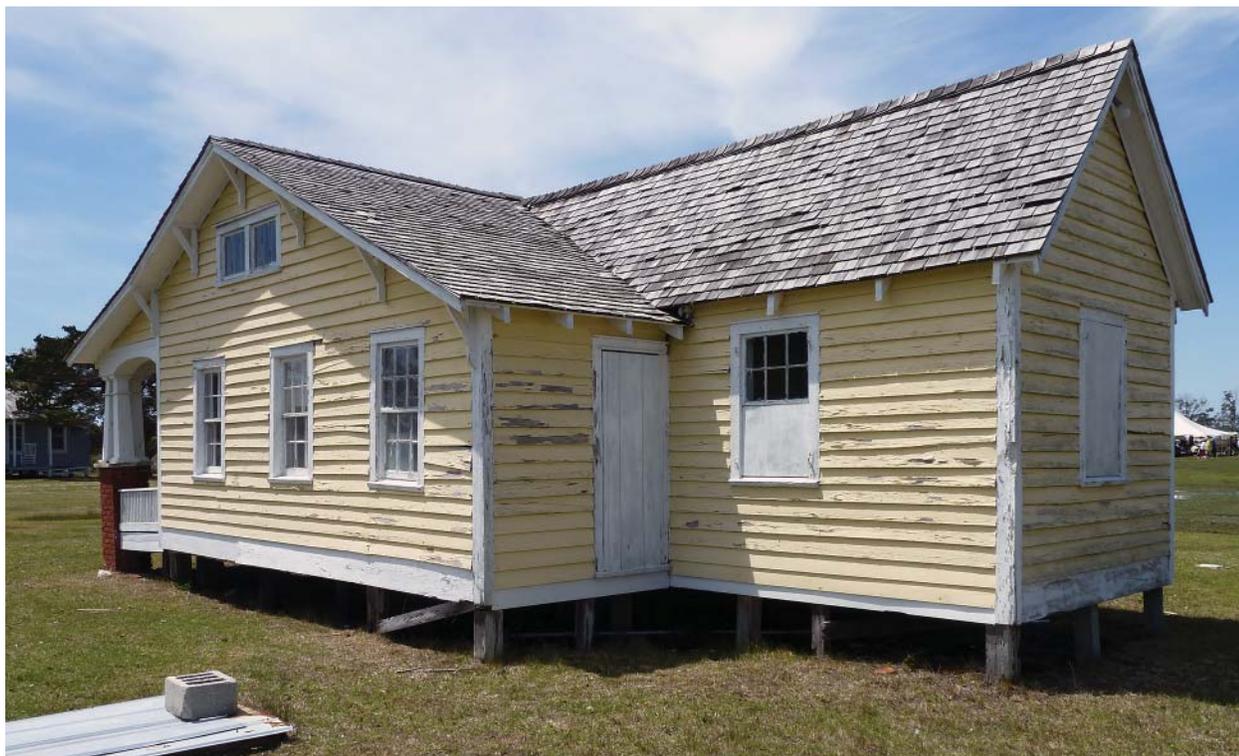
Most of the house's exterior woodwork is in fair condition. Painted finishes are peeling and bare

wood is being exposed at various locations all around the house. Some siding and most of the crown molding in the gables should be railed.

Figure 82. East side and north end of the house.

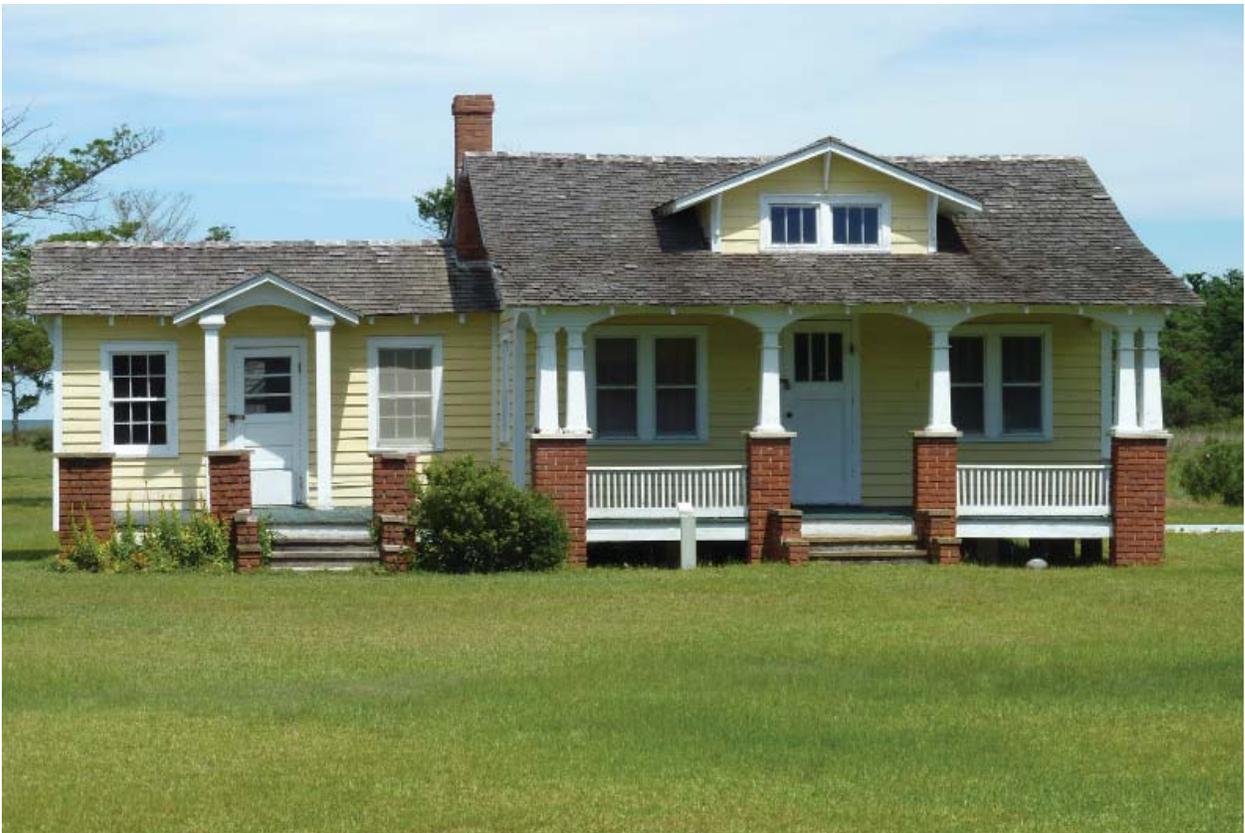
The porch is in mostly good condition, since all but the tripled columns at the corners was completely rebuilt in 1987. The lower parts of the box columns are now deteriorating along with the wooden plinths.

Figure 85. Front (south) elevation.

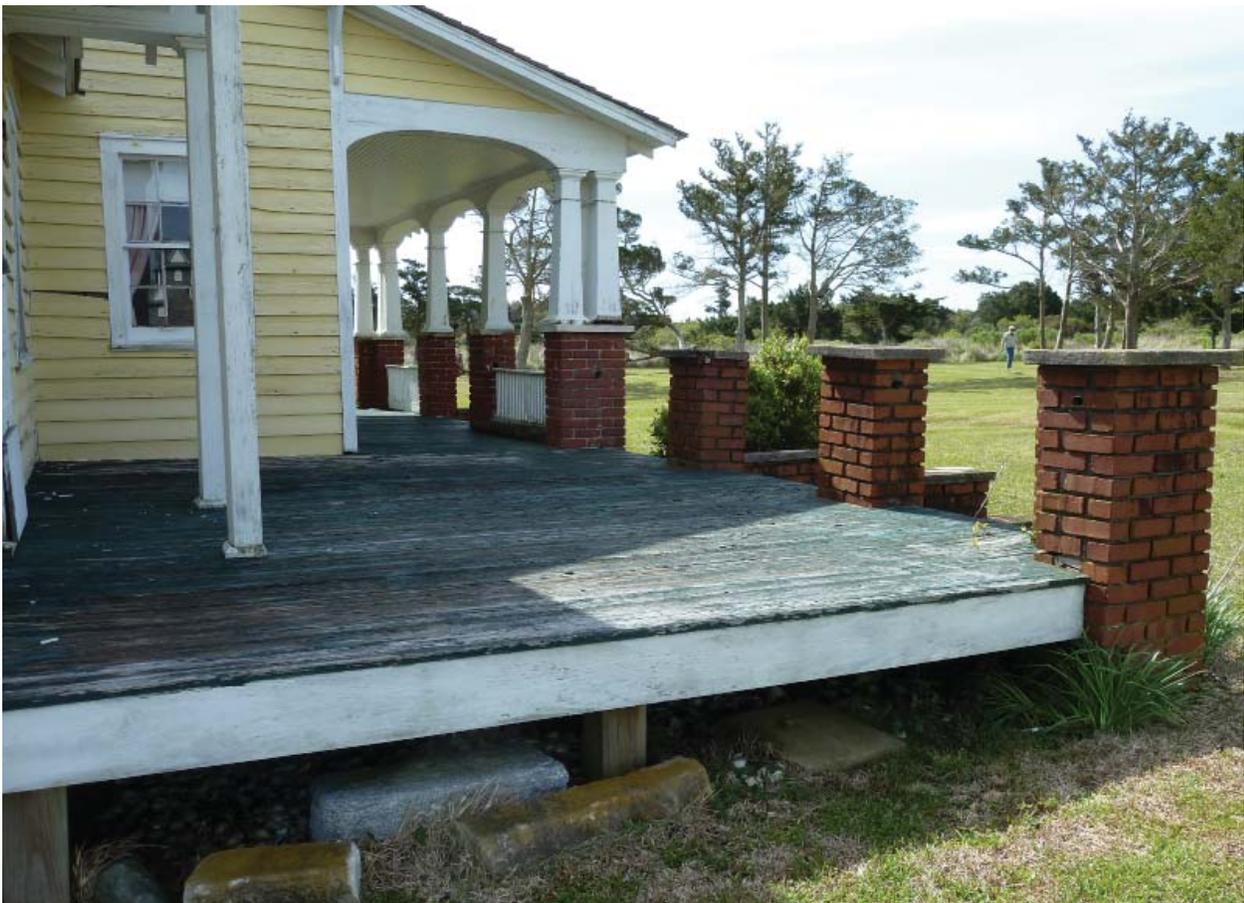
Figure 86. Deck and piers added by Harry Dixon along with the front porch ca. 1928.

The painted finish on the deck flooring is badly worn as is the paint on the plinths and lower half of the posts.

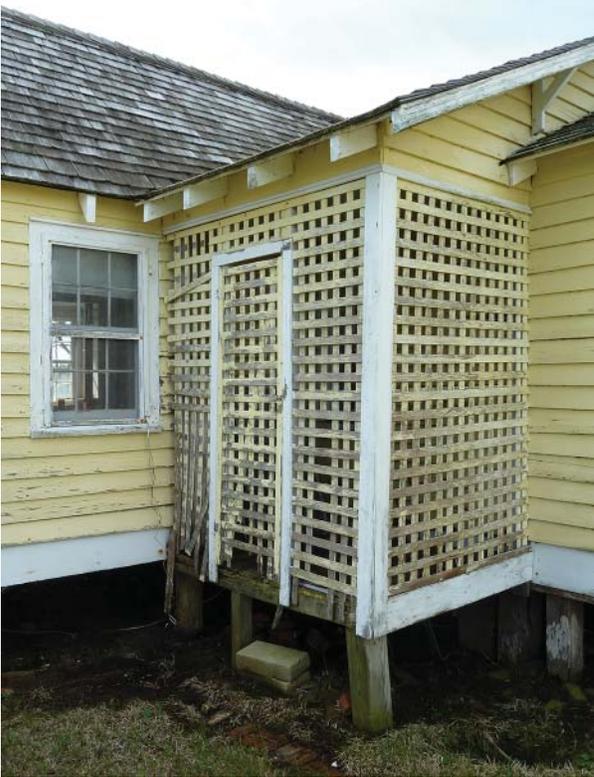
Figure 88. Lattice room at northwest corner.

The lattice on the lower portion of the north wall is badly damaged as is the painted finish on the entire porch. The door steps are missing entirely.

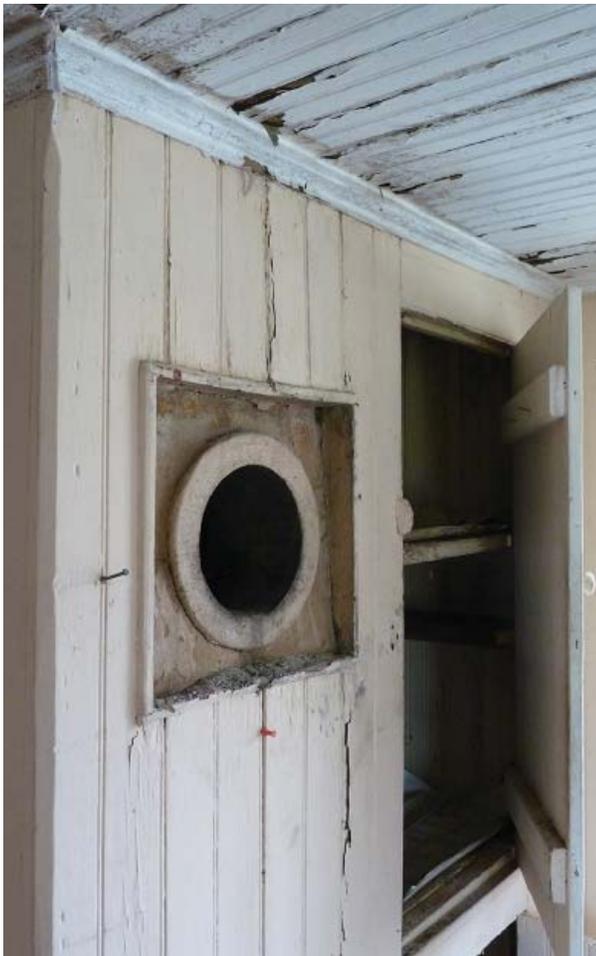
Figure 118. Stove flue and upper door of pantry closet.

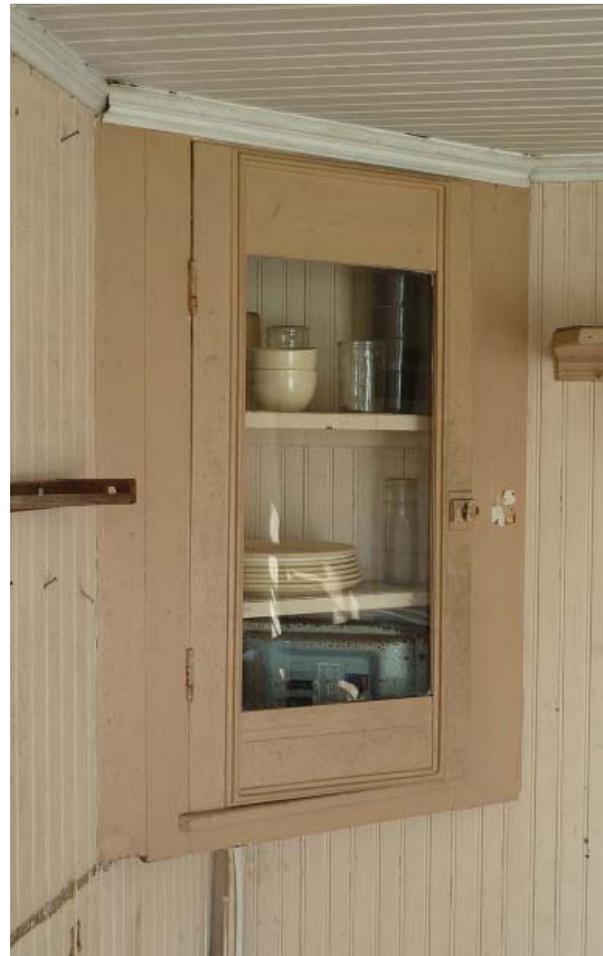
Figure 119. Northwest corner cupboard. The electrical circuit breaker is on the bottom shelf of this cabinet.

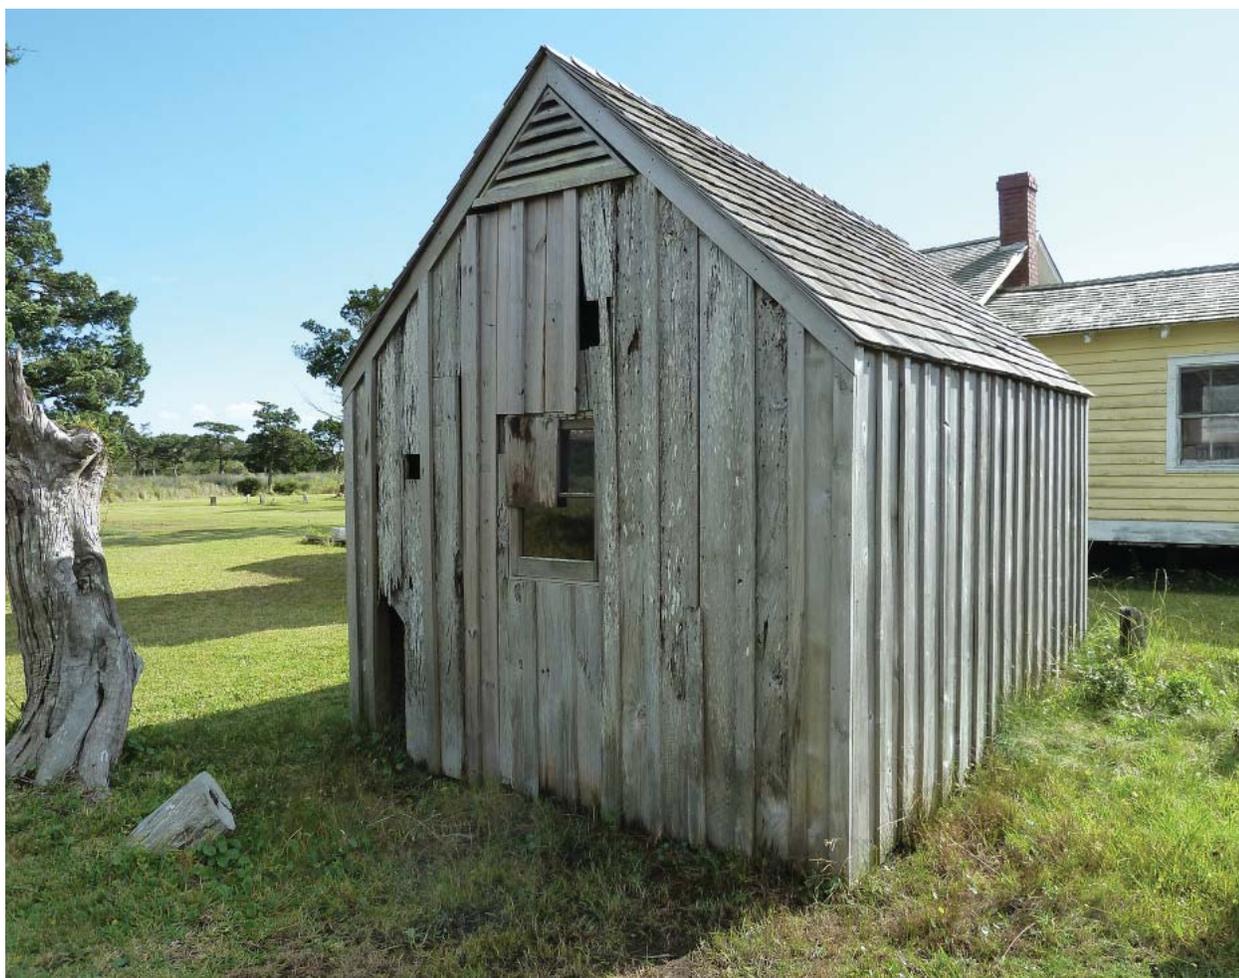
The parts of the shed that are visible are in good condition. Considering the building's proximity to the ground, deterioration of the sills and floor joists is probably ongoing.

Figure 123. Southeast oblique.

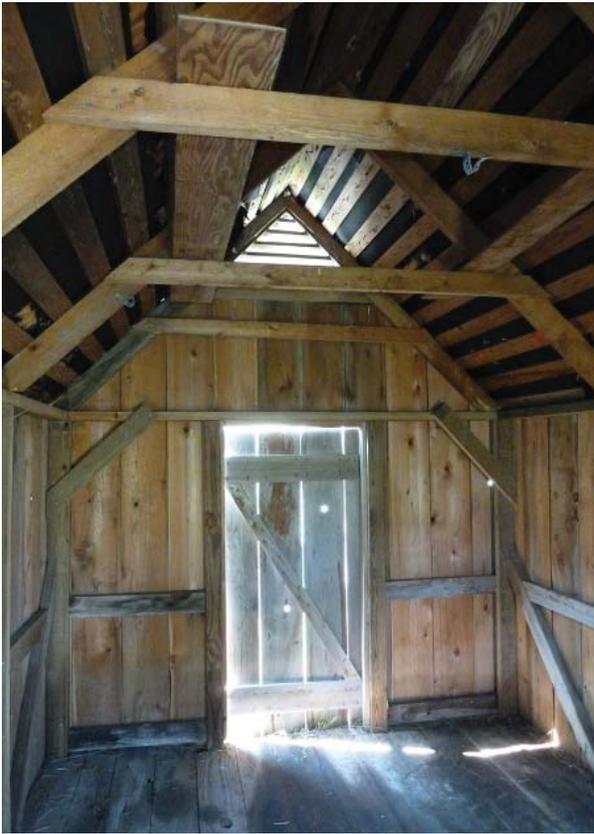
Figure 125. Looking south inside shed.

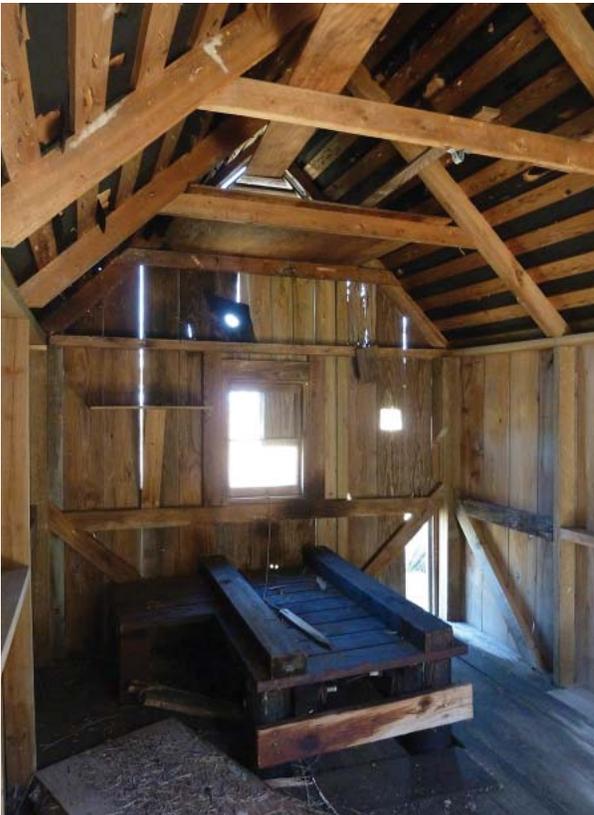
Figure 126. Looking north inside shed.
