**OFFICE OF SURFACE MINING**  
**REPORT ON OCTOBER 2000**  
**BREAKTHROUGH AT THE BIG BRANCH SLURRY IMPOUNDMENT**

**Martin County Coal Corporation**  
**Big Branch Slurry Impoundment**  
**Martin County, Kentucky**

**March 2002**

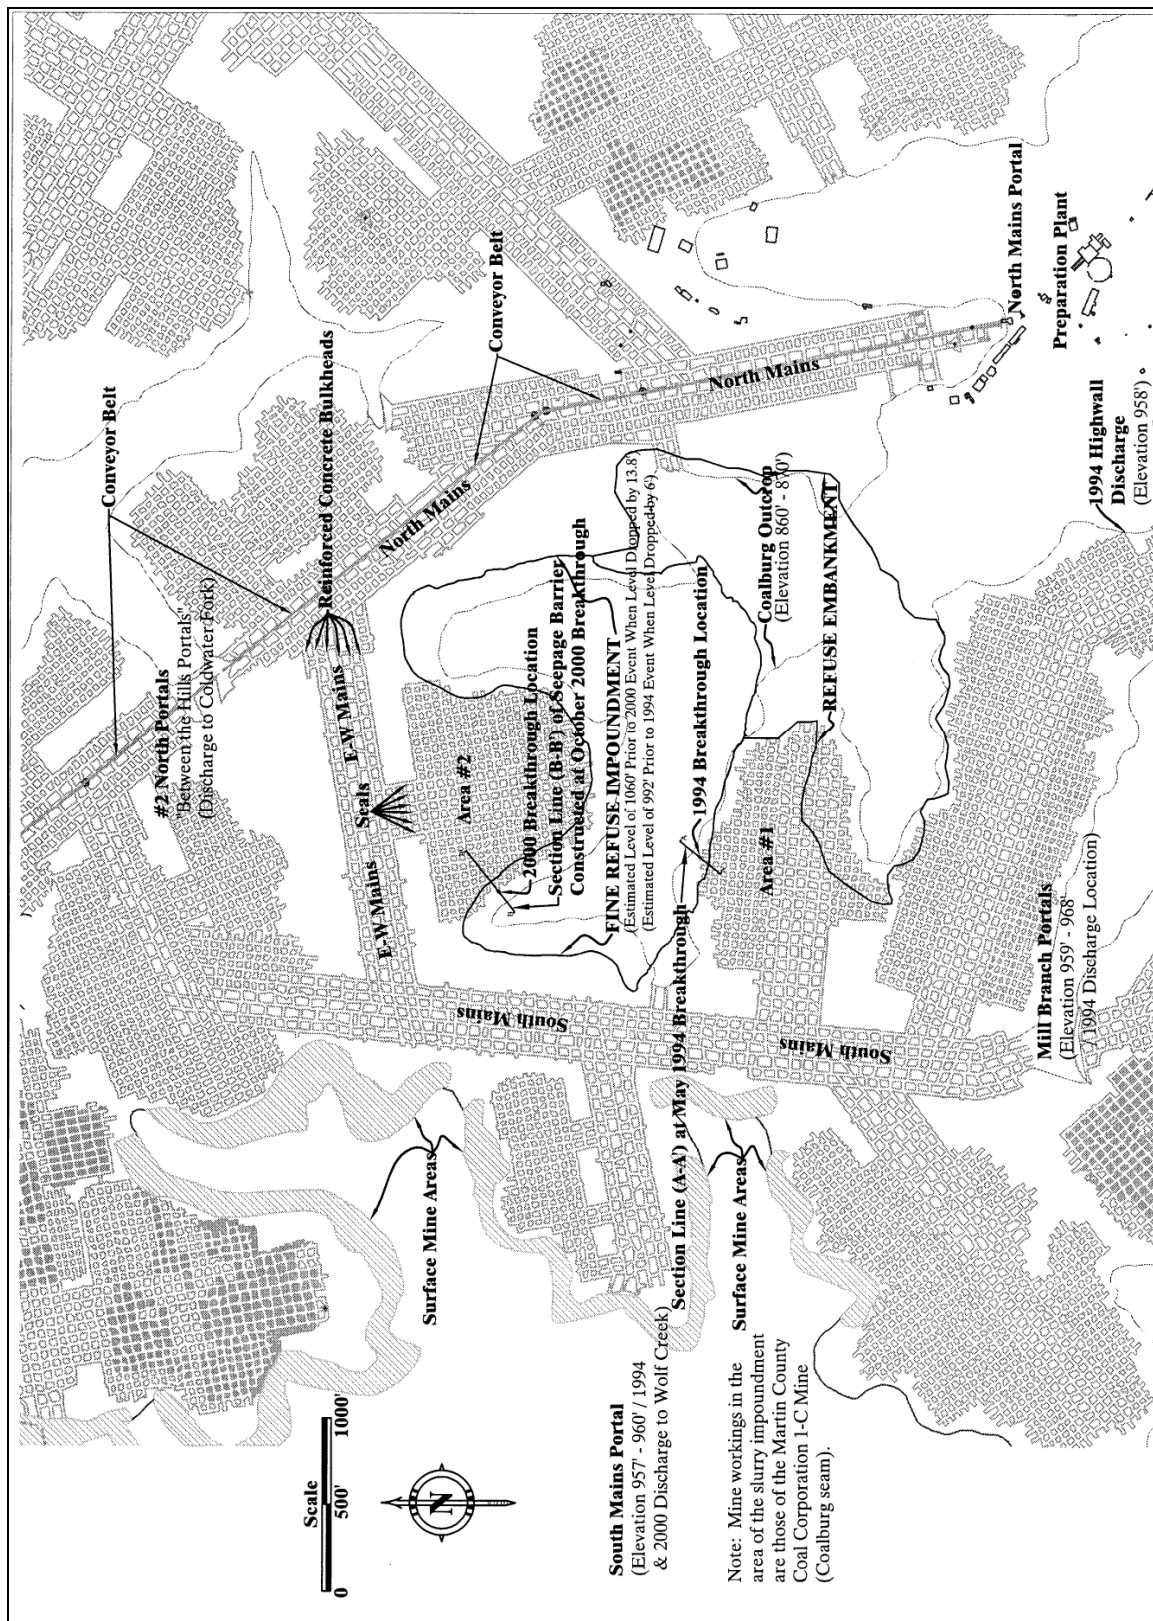
**Figure 2. Mine Map.**

On May 22, 1994, as the pool level reached 28 feet above the Coalburg coal seam, a major breakthrough into the underground mine occurred at the southwest side of the impoundment (Figures 2 and 3 [Pages 4 and 17] and Photo 1 [Page 3]). An unusual amount of water from the underground mine was observed in Big Branch at about 11:30 p.m. The exact location of the impoundment breakthrough was not discovered until about 2:55 a.m. on May 23, 1994. Emergency repairs were started at 3:30 a.m., and the flow was stopped at 6:30 a.m.

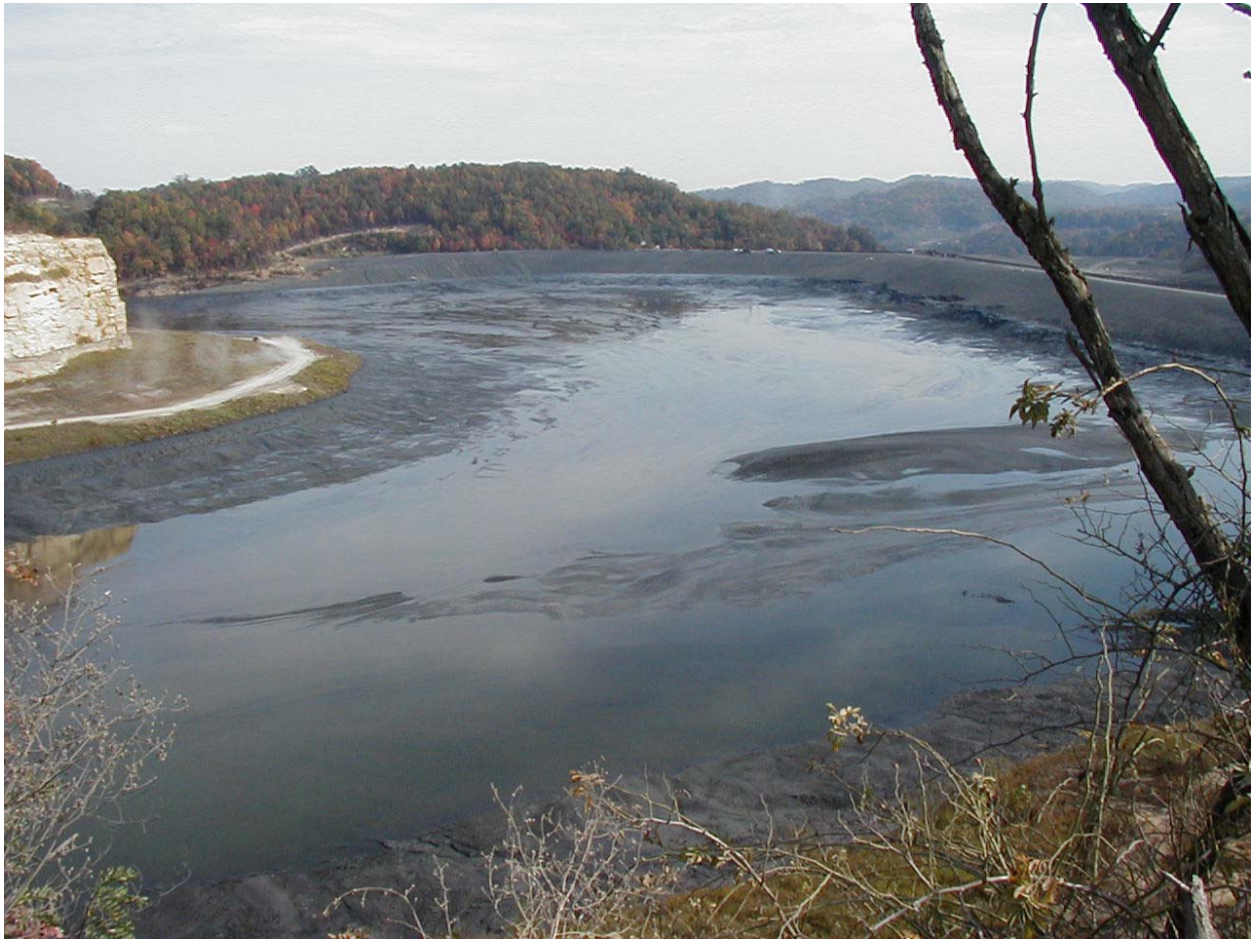
**Photo 3. General View of Impoundment and Embankment - October 16, 2000.**  
**Source: OSM. 2000 breakthrough area to left of photo, out of view.**

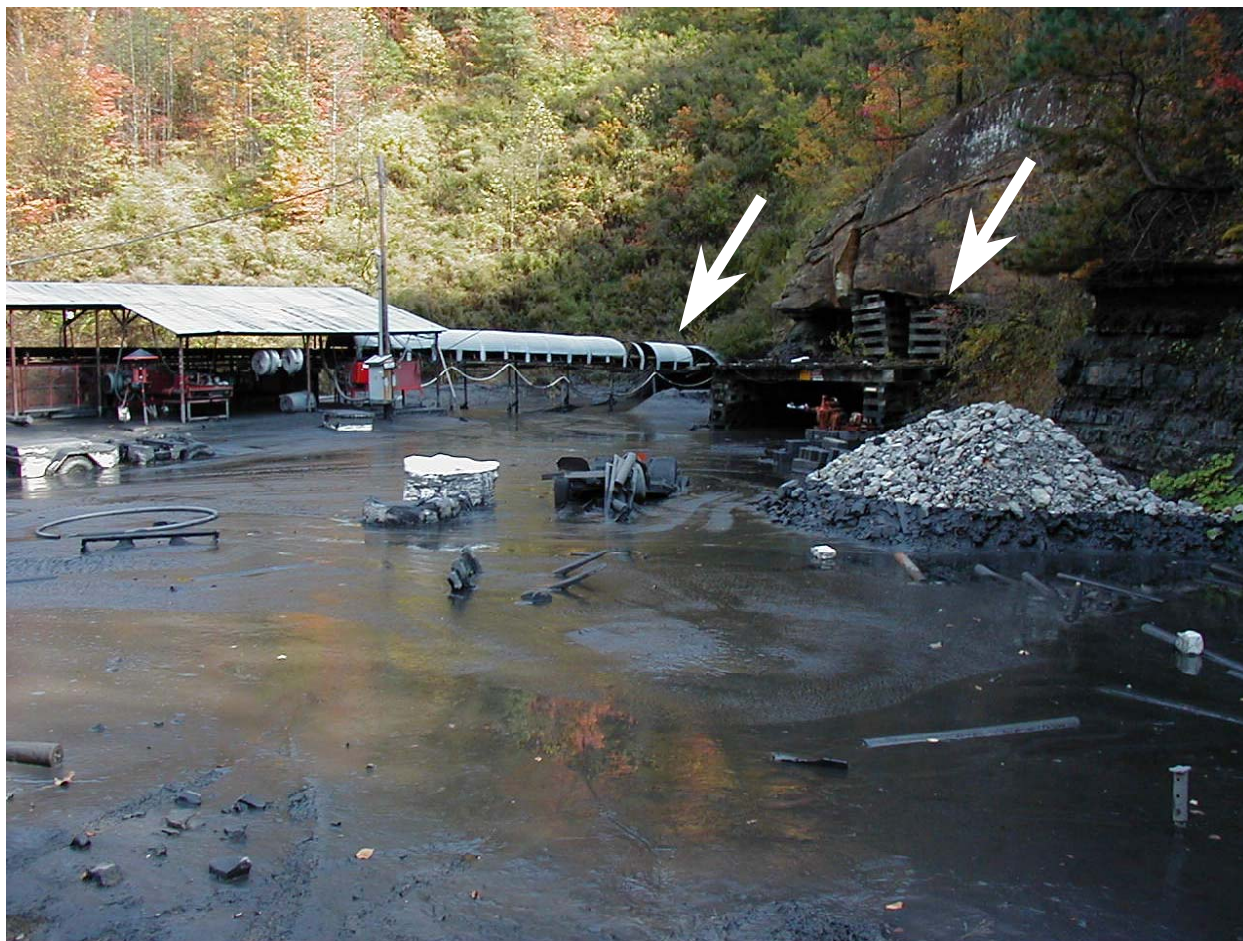
**Photo 4. Number 2 North Portals - October 16, 2000. Source: OSM.**

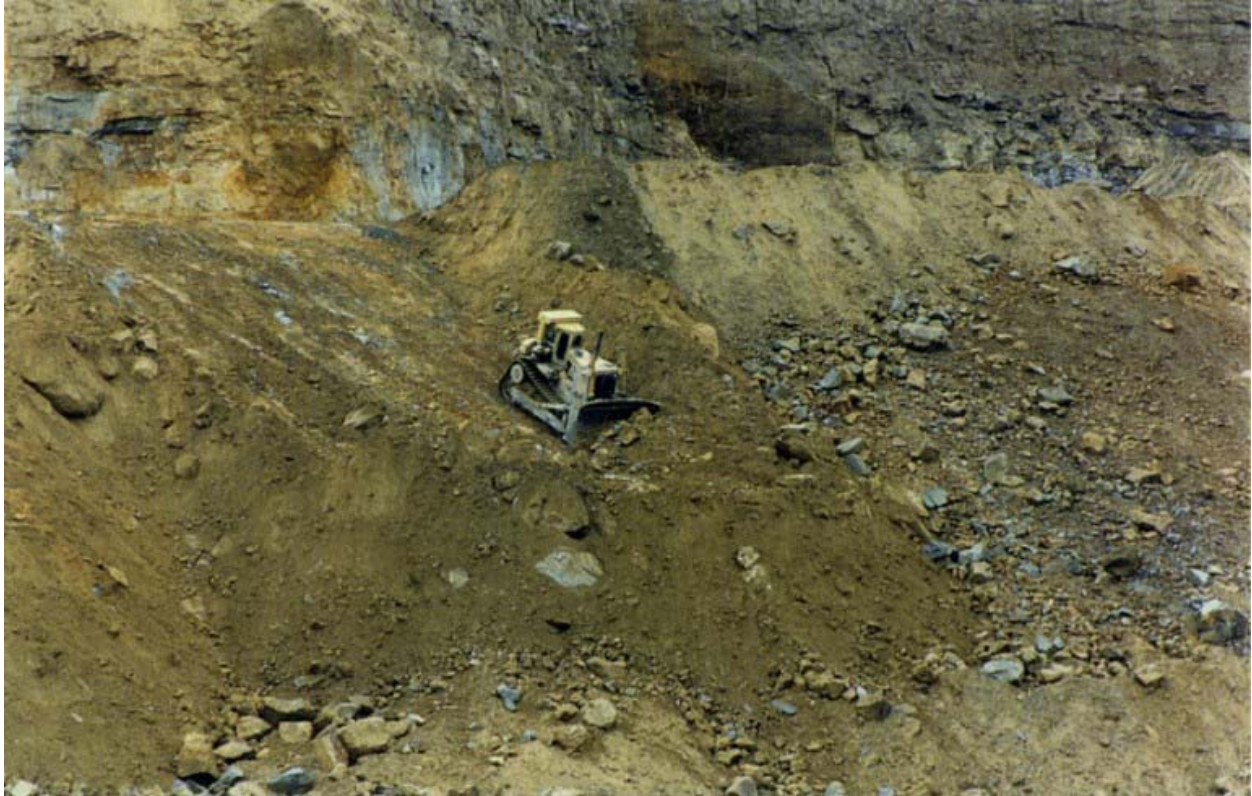
According to photographs (examples are provided in Photos 9 through 14 [Pages 36 through 41]) taken during the seepage barrier construction, the seepage barrier appears to have been constructed by dumping spoil downslope and dozing the material to final grade. Consequently, the spoil was placed as a single lift, at times greater than 30 feet thick measured perpendicular to the slope (Figure 4 [Page 18]). The photographs also confirmed that some gravity segregation occurred, potentially resulting in higher seepage barrier permeability at its base. The base of the seepage barrier is near the Coalburg coal seam outcrop.

**Photo 9. Construction of Seepage Barrier (Dozer Work) - March 6, 1995. Source: GAI.**  
The work is being conducted at the southwest side of the impoundment.

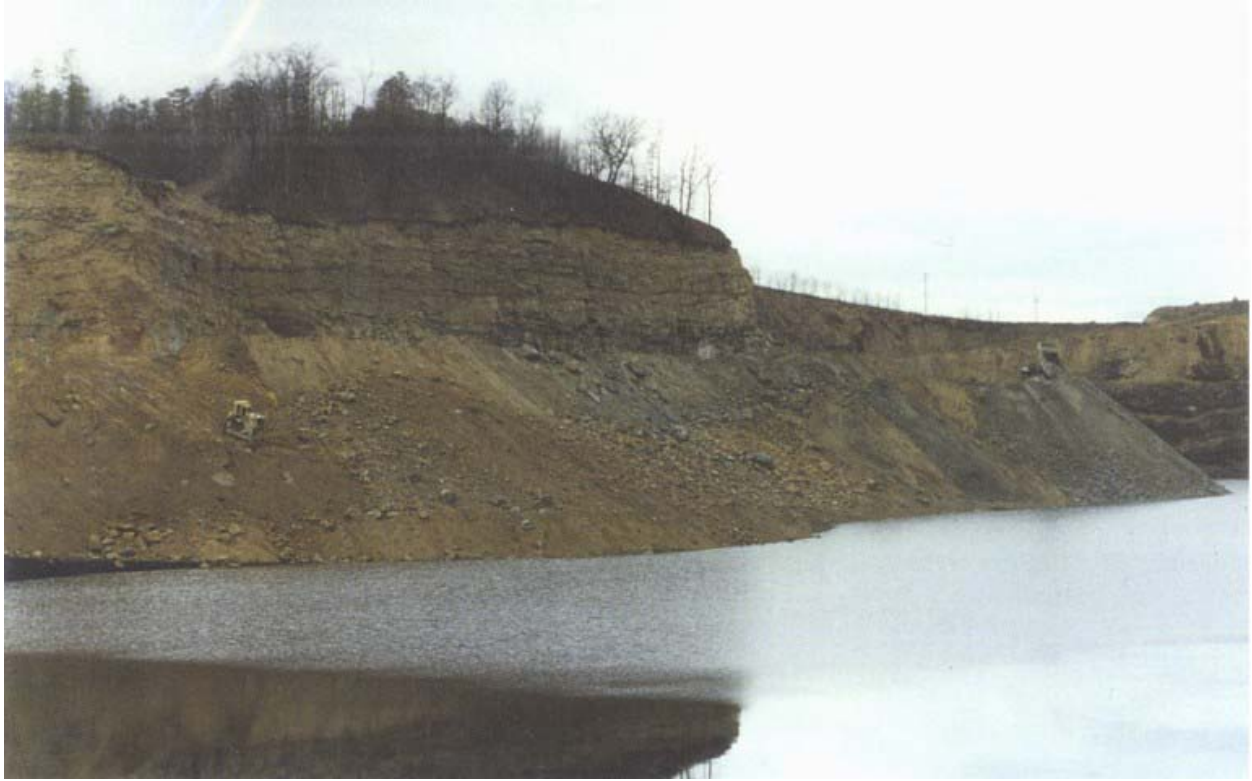
**Photo 11. Construction of Seepage Barrier (Long View of Dozer and Truck) - March 6, 1995. Source: GAI. The work is being conducted at the southwest side of the impoundment. Pool elevation 1,000 feet msl. Mine roof elevation 964 feet msl.**

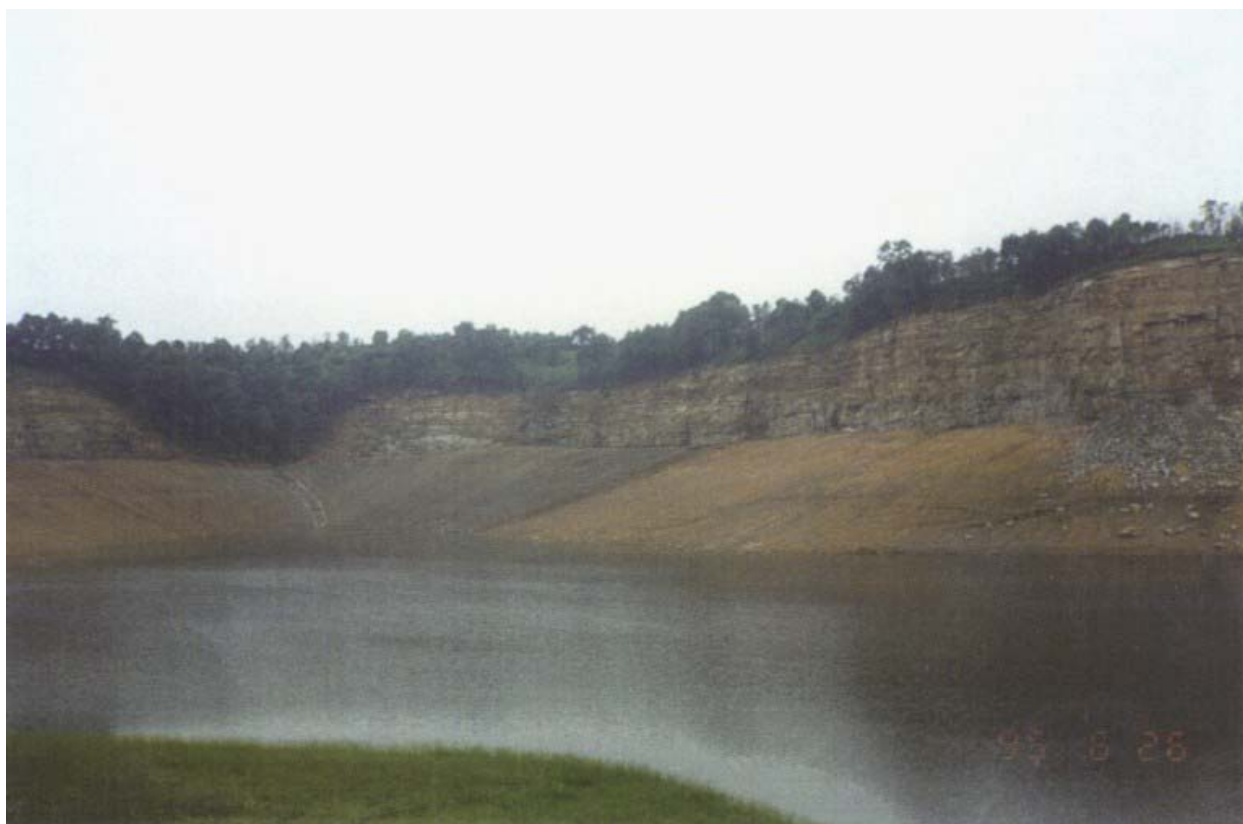
**Photo 14. Seepage Barrier by 2000 Breakthrough (After Construction) - June 26, 1995.**  
**Source: GAI. The 2000 breakthrough area is located at the left-center of the photo.**  
**Pool elevation 1,006 feet msl. Mine roof elevation 973 feet msl. Contour bench elevation 1,075 feet msl.**
