# Macondo

T H E G U L F O I L D I S A S T E R

Chief Counsel's Report | 2011

National Commission on the BP Deepwater Horizon Oil Spill and Offshore Drilling

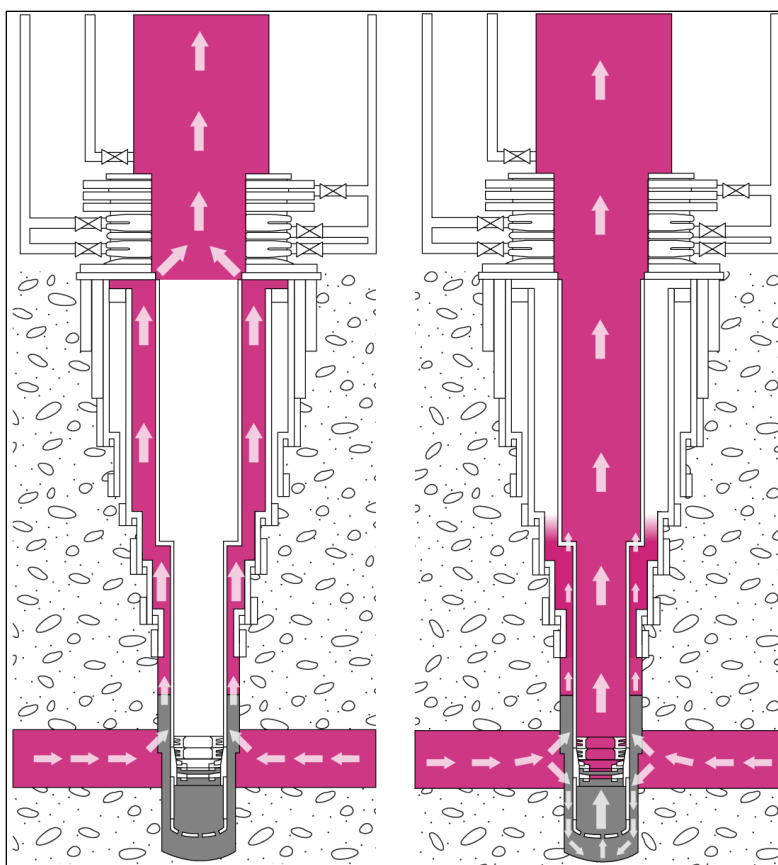
**Figure 4.1.1. Possible flow paths for hydrocarbons.**

Hydrocarbons can reach the surface by traveling up the annulus and through the seal assembly (left). Hydrocarbons can also enter and migrate up the inside of the production casing, through a number of possible flow paths (right).

The Chief Counsel's team finds that hydrocarbons came to the surface by traveling through the inside of the production casing, as seen on the right side of Figure 4.1.1. It is almost certain that hydrocarbons entered the production casing because of a failure of the shoe track cement. However, the Chief Counsel's team cannot entirely rule out the possibility that hydrocarbons may have entered the production casing from the annulus through a breach in the production casing somewhere near the bottom of the casing.

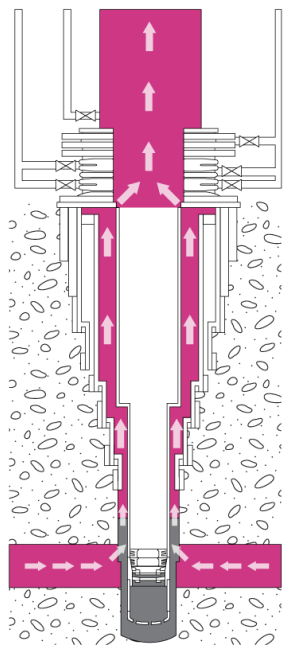
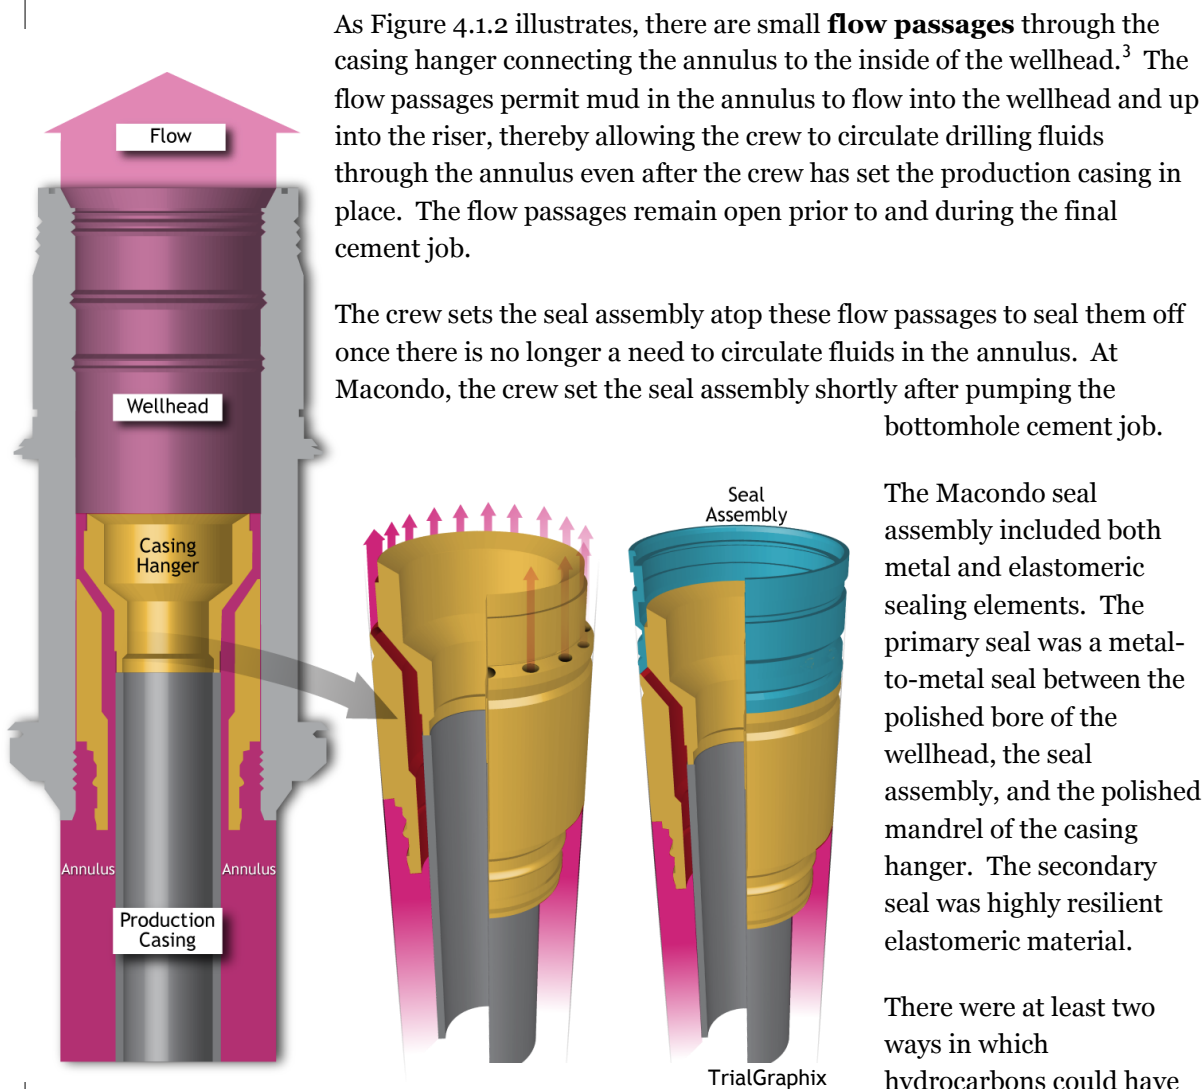
**Figure 4.1.2.**  
Flow through the seal assembly.

As Figure 4.1.2 illustrates, there are small **flow passages** through the casing hanger connecting the annulus to the inside of the wellhead.<sup>3</sup> The flow passages permit mud in the annulus to flow into the wellhead and up into the riser, thereby allowing the crew to circulate drilling fluids through the annulus even after the crew has set the production casing in place. The flow passages remain open prior to and during the final cement job.

First, there could have been a leak through the flow passages. This might have occurred because debris obstructed the seal area during the setting process, the seal failed to expand and set properly, or the seal dislodged after it was set.<sup>4</sup>

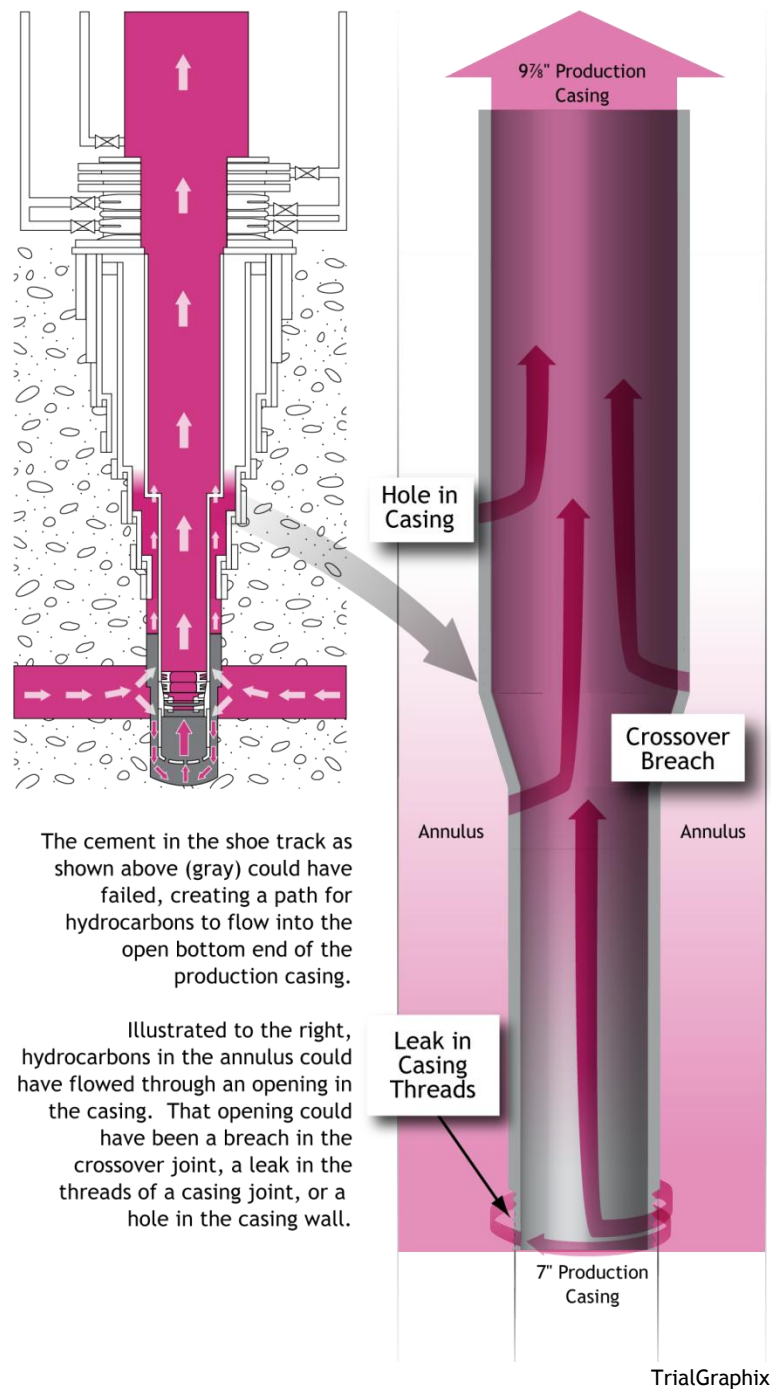
**Figure 4.1.3. Flow up the production casing.**

Second, hydrocarbons in the annulus could have flowed into the production casing through an opening in the casing. That opening could have been a breach in the 9<sup>7</sup>/<sub>8</sub>-inch × 7-inch tapered crossover joint,<sup>8</sup> a leak in the threads of a casing joint,<sup>9</sup> or a hole in the casing wall, as illustrated in Figure 4.1.3.

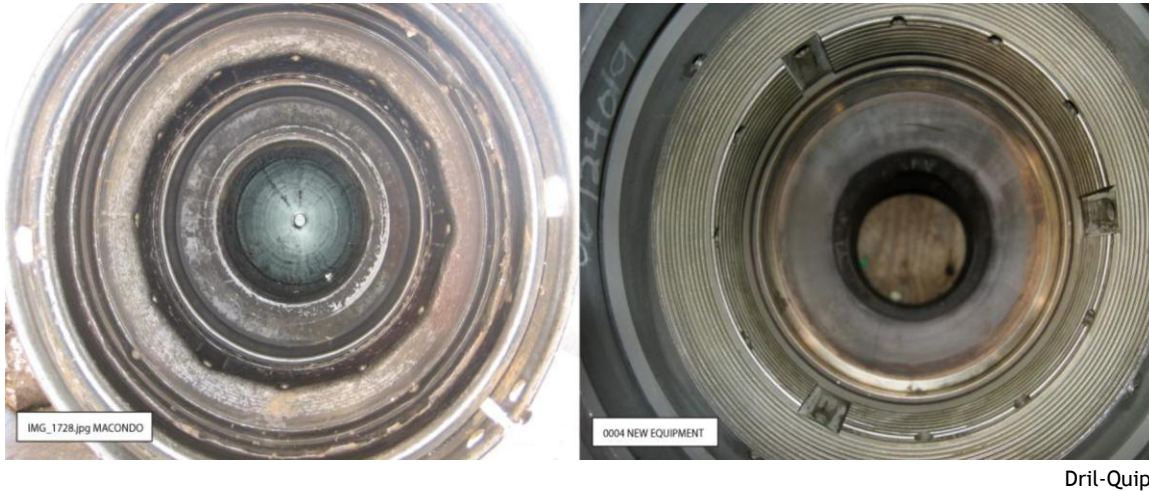
**Figure 4.1.5. Interior of the Macondo production casing hanger compared to new equipment.**

By contrast, the interior of the BOP<sup>46</sup> (through which hydrocarbons definitely flowed) showed serious erosion, as did the interior of the casing hanger, seen in Figure 4.1.5.<sup>47</sup>

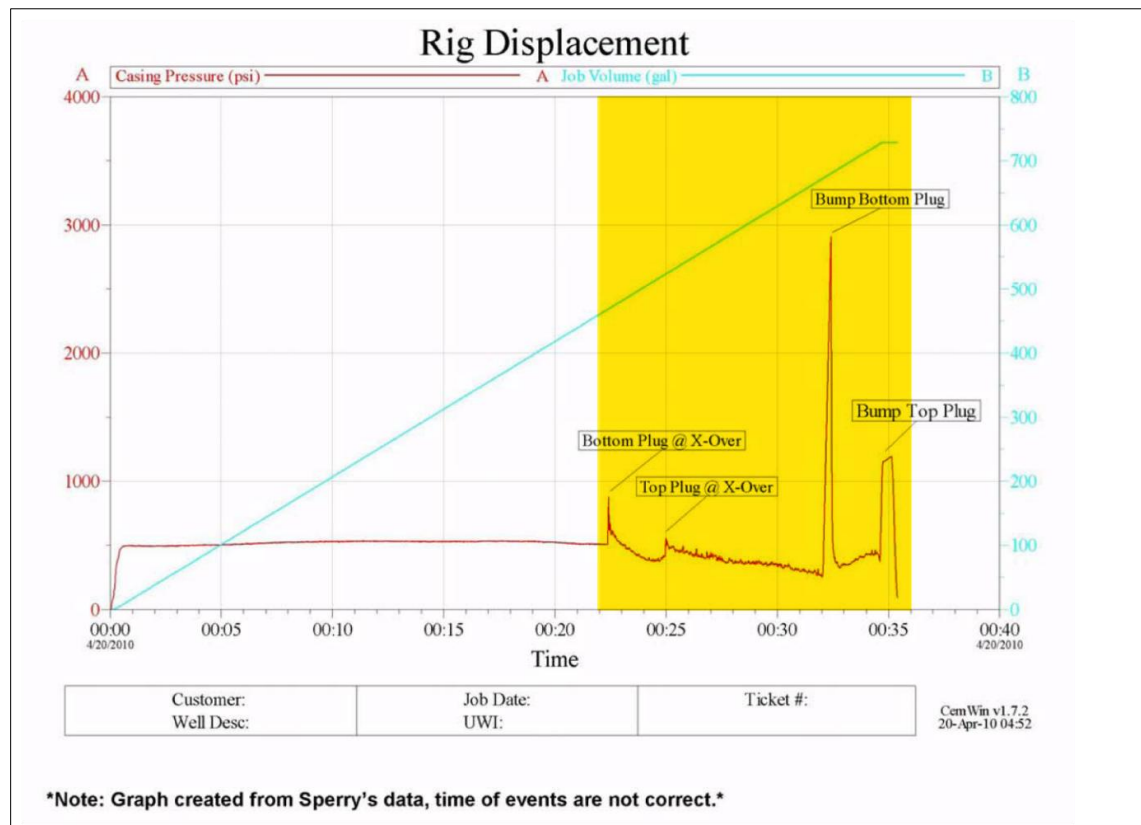
**Figure 4.1.7. Halliburton post-cement-job report.**

Finally, the cement job pressure readings cannot alone support a theory of annular flow (a point that Halliburton concedes<sup>67</sup>), and the other evidence discussed above is inconsistent with annular flow.

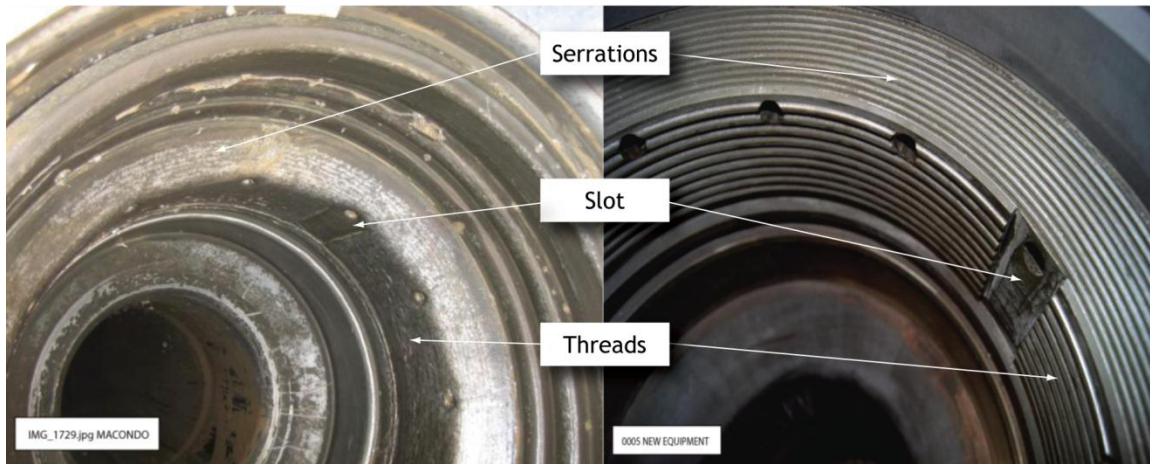
**Figure 4.1.8. Erosion of the inside of the casing hanger.**

Post-blowout inspection of the production casing hanger and seal assembly retrieved from the Macondo well shows severe erosion on the inside of the casing hanger (shown in the left-side photo in Figure 4.1.8). Serrations near the top of the casing hanger—normally 1/8-inch deep—are almost completely abraded away.<sup>68</sup> Threads that normally run around the inside of the casing hanger are flattened.<sup>69</sup> The slot that normally interrupts the threads—1/4-inch deep when new—appears as an almost nonexistent indentation.<sup>70</sup> These observations all suggest that hydrocarbons came up through the production casing.

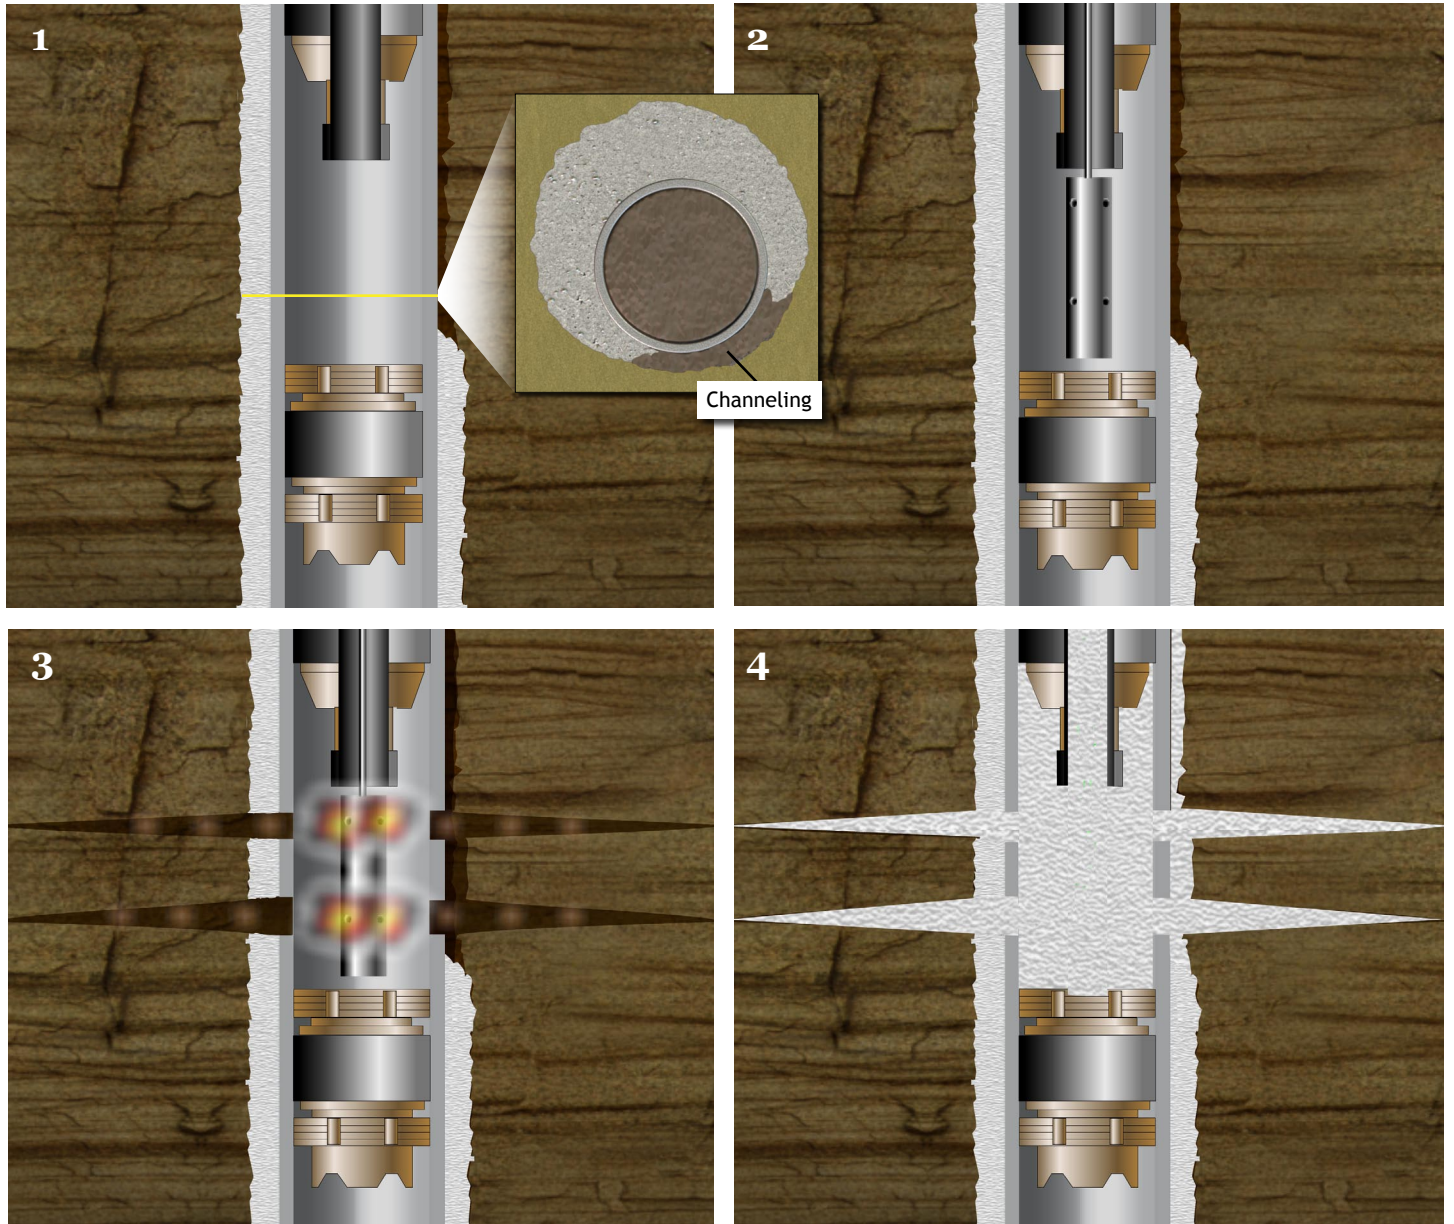
**Figure 4.3.12. Remedial cementing—squeeze job.**

From upper left: 1) Poor centralization has led to channeling; 2) a bridge plug is placed below the remediation area, and a packer is positioned above; 3) a perforation gun is lowered and fires shells through the casing and into the formation; 4) cement is pumped into the area, forced through the perforations, and into the formation, creating a seal.

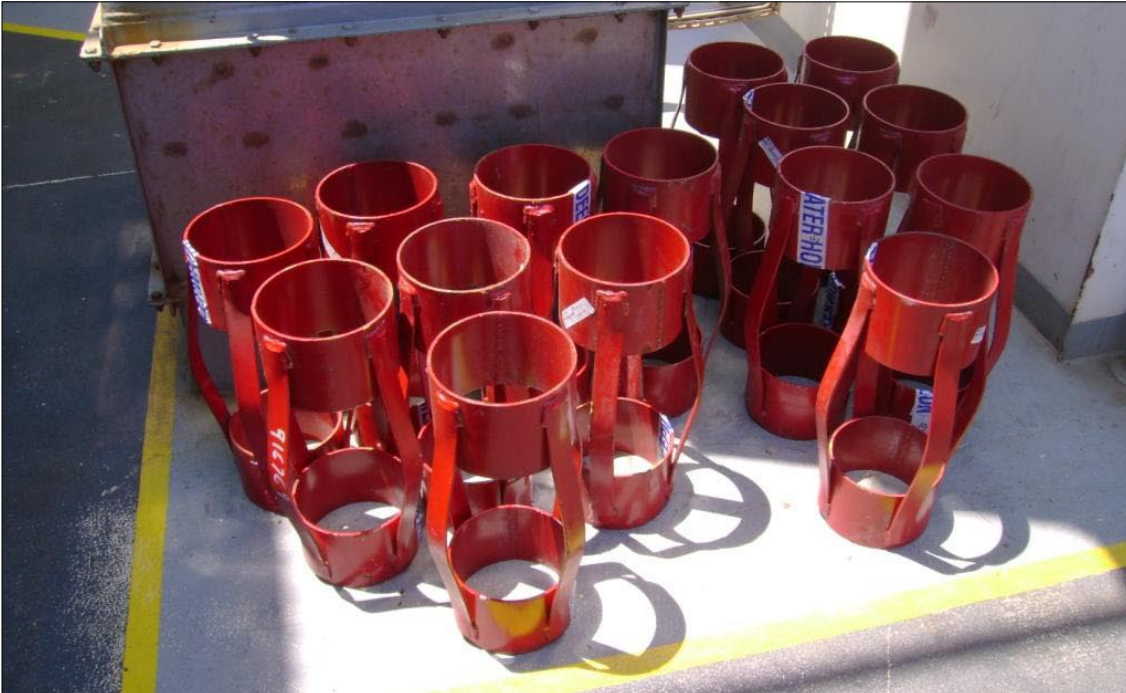
**Figure 4.3.15. Centralizers delivered to the *Deepwater Horizon* on April 16, 2010.**

Sometime after 5 a.m. on April 16, a helicopter arrived at the *Deepwater Horizon*, carrying the 15 additional centralizers and Weatherford service technician Daniel Oldfather.<sup>108</sup> The helicopter did not, however, carry the stop collars and accessories that would be needed to secure the centralizers on the casing. Those had been shipped by boat and were scheduled to arrive by 4 p.m. (before the casing would be run).<sup>109</sup> Oldfather explained this to the rig crew when he landed.<sup>110</sup>

Morel was still visiting the rig at the time the helicopter landed. He examined the centralizers when they arrived. Like the other BP engineers, he had expected that the centralizers would have integrated stop collars. He now recognized that this was not the case.<sup>111</sup> Morel called Guide and told him that these were not the “one-piece” centralizers that he was expecting. Guide agreed they were not what he had planned on using either.<sup>112</sup> Morel took digital pictures of the centralizers and emailed them to Guide, telling him that “the centralizers do not have the stop [collars] on them.”<sup>113</sup> However, Morel also told Guide that the centralizers could still be used because the boat carrying the collars would arrive in “plenty of time before needing them.”<sup>114</sup>

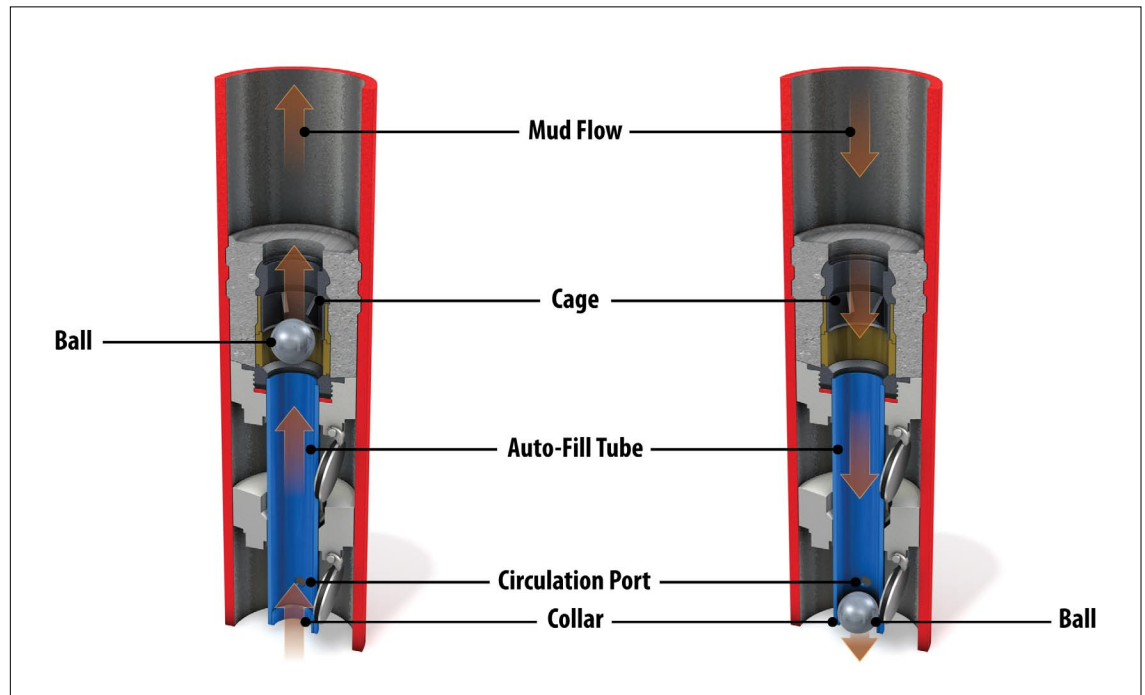
**Figure 4.3.17. Auto-fill float collar.**

The float collar's auto-fill tube contains a 2-inch weighted ball, which is free to move within the tube but not out of it. At the top of the float assembly is a plastic cage that prevents the ball from escaping but allows mud to flow through. At the bottom is a phenolic resin collar that is less than 2 inches in diameter, which also allows mud, but not the ball, to flow through. When casing is being run, mud flowing up through the tube pushes the ball against the inside of the cage. When the casing lands, the ball falls to and plugs the bottom of the tube, leaving two small holes on the side of the tube as the only path through the tube for mud circulated down through the well.<sup>145</sup>

Flow while casing is being lowered (left) and flow during conversion (right).

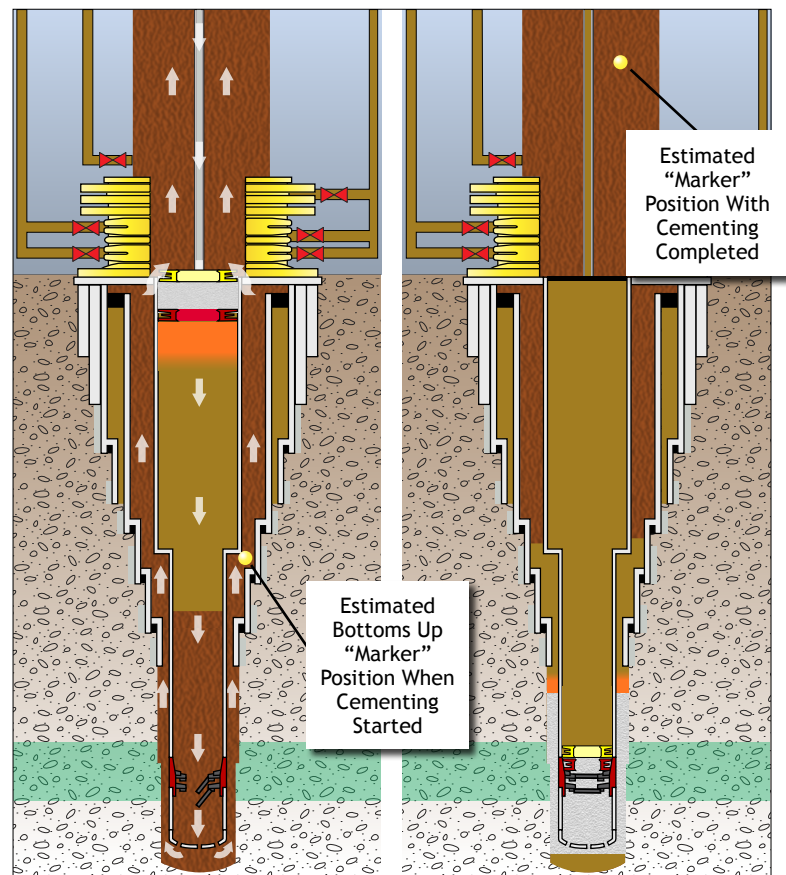
**Figure 4.3.18. BP's pre-cementing mud circulation.**

At approximately 4:18 p.m. on April 19, the rig crew re-established mud circulation after running the long string.<sup>199</sup> The rig crew then circulated a total of approximately 350 barrels of mud at rates up to 4 bpm before beginning the cementing process.<sup>200</sup> This figure exceeds the 261 bbl called for in the April 18 Halliburton cement job procedure<sup>201</sup> but is significantly lower than the 2,760 bbl required for a full bottoms up.<sup>202</sup>

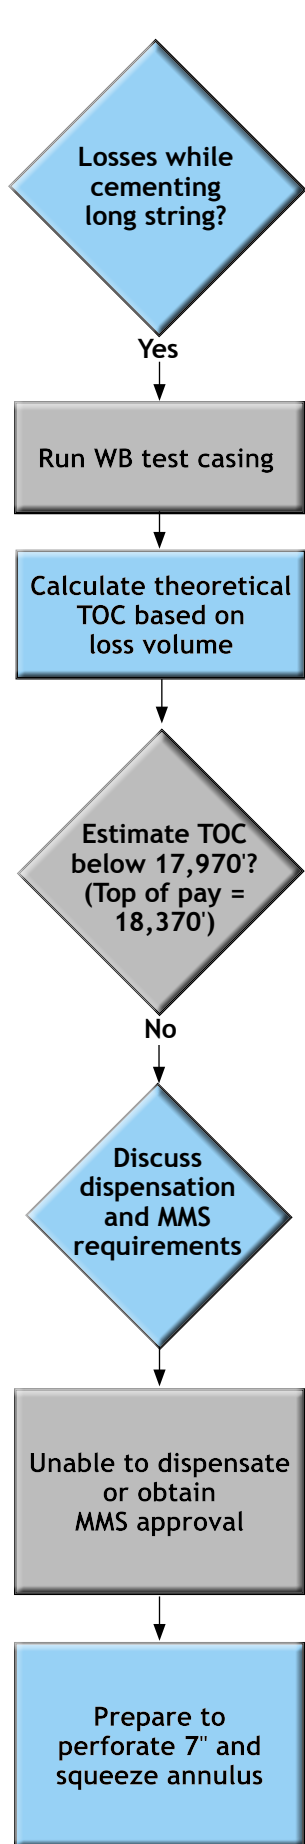
Figure 4.3.19. Decision tree.

After cementing was complete, rig personnel conducted a **float check** to ensure the float valves had closed properly. Rig personnel began by pressuring up the system after bumping the top wiper plug.<sup>238</sup> They then released the pressure and monitored the system for pressure differentials and flow back from the well.<sup>239</sup> BP well site leader trainee Lee Lambert and Halliburton cementer Vincent Tabler opened a valve at the cementing unit to see how much mud flowed out of the well when they released the pressure.<sup>240</sup> (Some modest flow back is expected due to the compressibility of fluids during the pumping of the cement job.) Models had predicted 5 or 6 bbl of flow back.<sup>241</sup> The two men observed 5.5 bbl of flow, which tapered off to a “finger

tip” trickle.<sup>242</sup> Tabler testified they watched flow “until it was probably what we call a pencil stream,” which stopped, started up again, and then stopped altogether.<sup>243</sup> The total flow at that point was close to the predicted flow,<sup>244</sup> and the two men concluded the float valves were holding.<sup>245</sup>

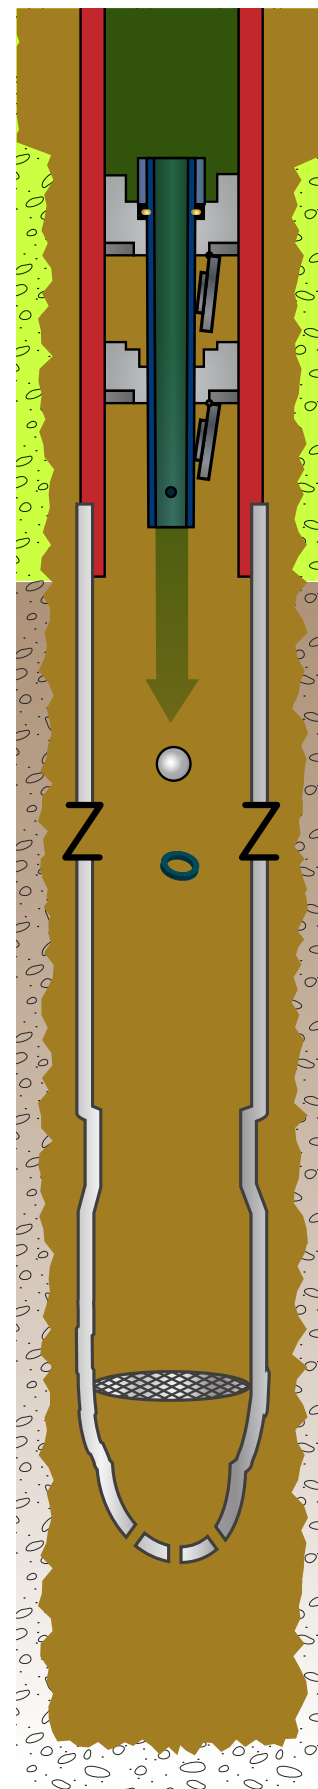
Figure 4.3.21. Ball forced through tube.

A second possibility, shown in Figure 4.3.21, is that the sudden pressure drop may have been caused when pump pressure forced the ball inside the auto-fill tube through the end of the auto-fill tube. The collar that would normally have retained the ball within the auto-fill tube was held in place with brass pins. It is possible those pins and the collar failed, allowing the ball to pass through.<sup>309</sup> This would have left the auto-fill tube in place between the float valves and created a path for flow in either direction.

If the ports in the bottom of the auto-fill tube were clogged, the rig pumps may have placed enough force on the collar to shear the brass pins instead of the pins holding the auto-fill tube in place. Clawson informed Morel on April 19 that it would only take 1,300 psi of pressure to force the ball through the collar without converting the float valves.<sup>310</sup> It is not apparent whether Morel considered or informed others of this possibility.<sup>311</sup>

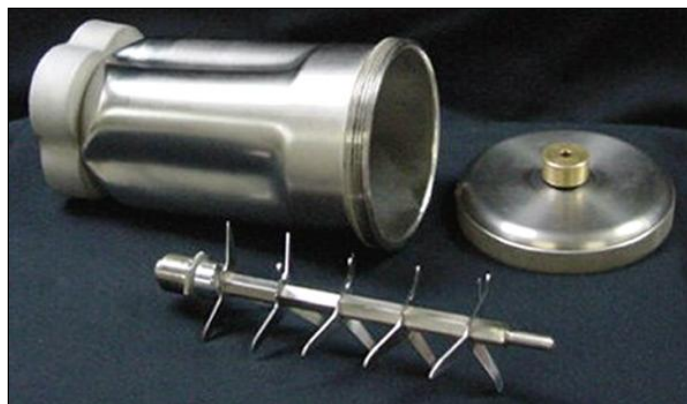
**Figure 4.4.1. Foam testing apparatus.**

Five-blade blender.

The technician mixes a volume of base cement slurry with air (not nitrogen) in a sealed blender to generate a foamed slurry of the same density that will be used in the field (see Figure 4.4.1). The laboratory may then conduct foam stability tests using one of two methods.

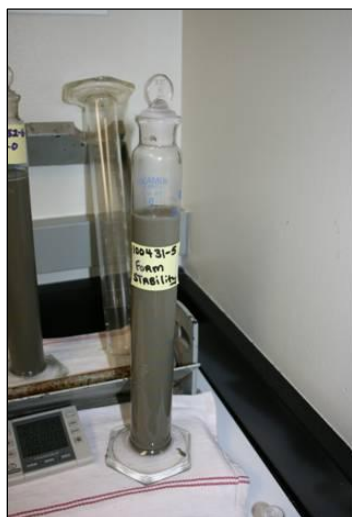
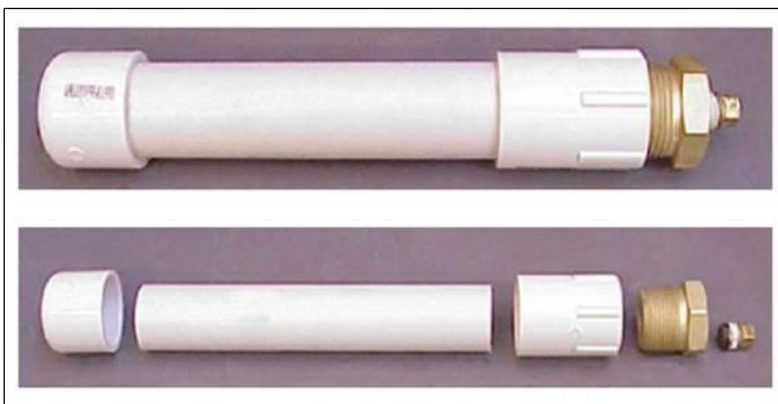
**Figures 4.4.2 and 4.4.3. Foam testing apparatus.**

The first method involves pouring a sample of the foamed cement into a graduated cylinder (see Figure 4.4.2). After two hours, the

The second method involves pouring the foamed cement into a plastic cylinder, sealing it, and then allowing it to cure and set (see Figure 4.4.3). The technician then removes the solid cement sample from the cylinder and measures the density of solid cement at the top, middle, and bottom of the sample. If there are density variations from top to bottom, or if the densities are equal to one another but significantly higher than the target density, the foamed cement is deemed unstable.

Left: Graduated cylinder for unset foam test. Above: Curing mold for set cement tests.

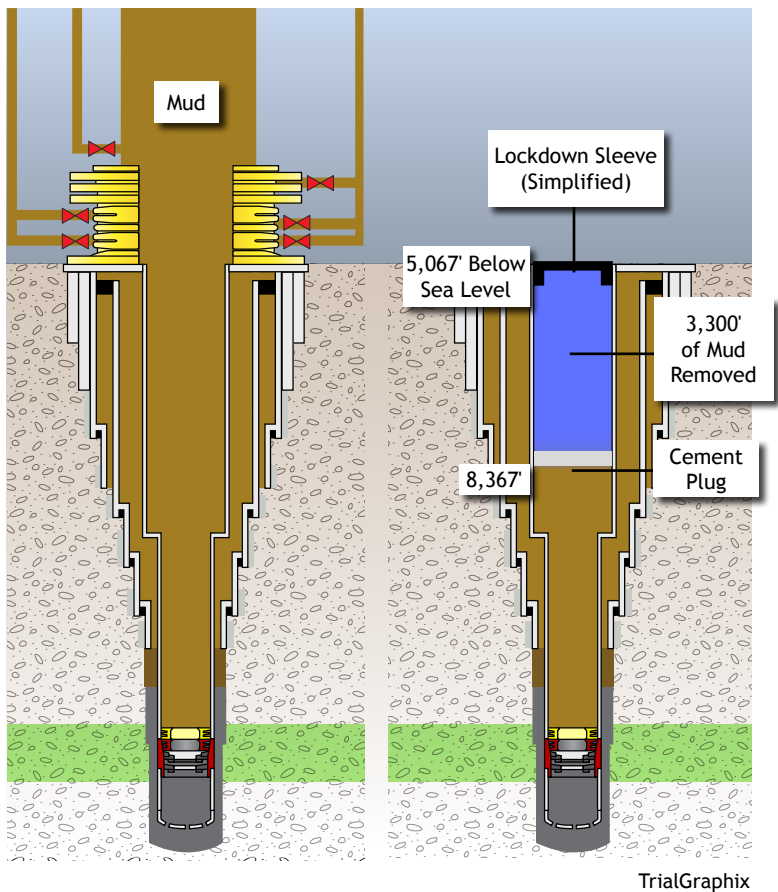
**Figure 4.5.1. Planned configuration after temporary abandonment.**

After finishing cementing the production casing (left), the rig crew began temporary abandonment procedures that would have allowed the *Deepwater Horizon* to remove its riser and BOP from the well and move on to another job (right). The blowout occurred before the rig crew set the cement plug and lockdown sleeve.

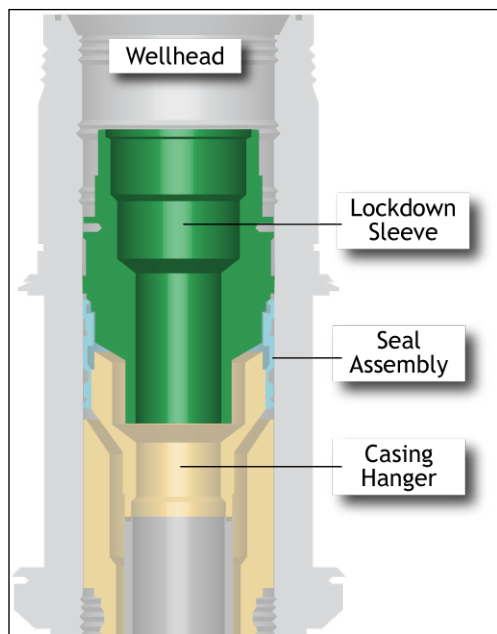
**Figure 4.5.2. Lockdown sleeve.**

BP's desire to set a lockdown sleeve during temporary abandonment drove the development of its temporary abandonment procedure. The lockdown sleeve locks down the casing hanger and seal assembly.

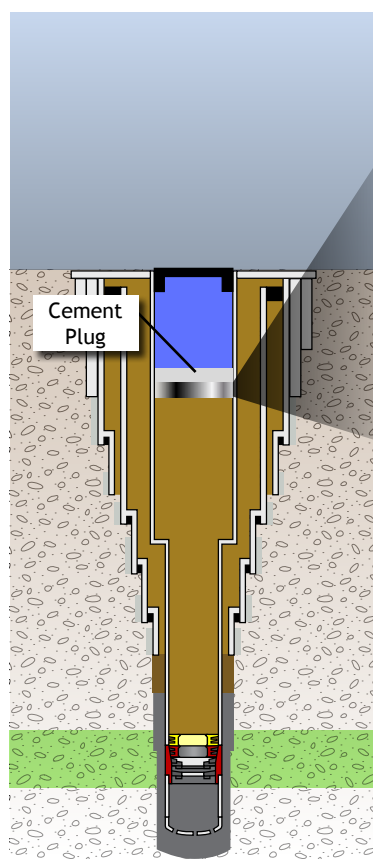
**Figure 4.5.5. Bridge plug.**

**BP could have used a mechanical plug in lieu of or in addition to a cement plug.**

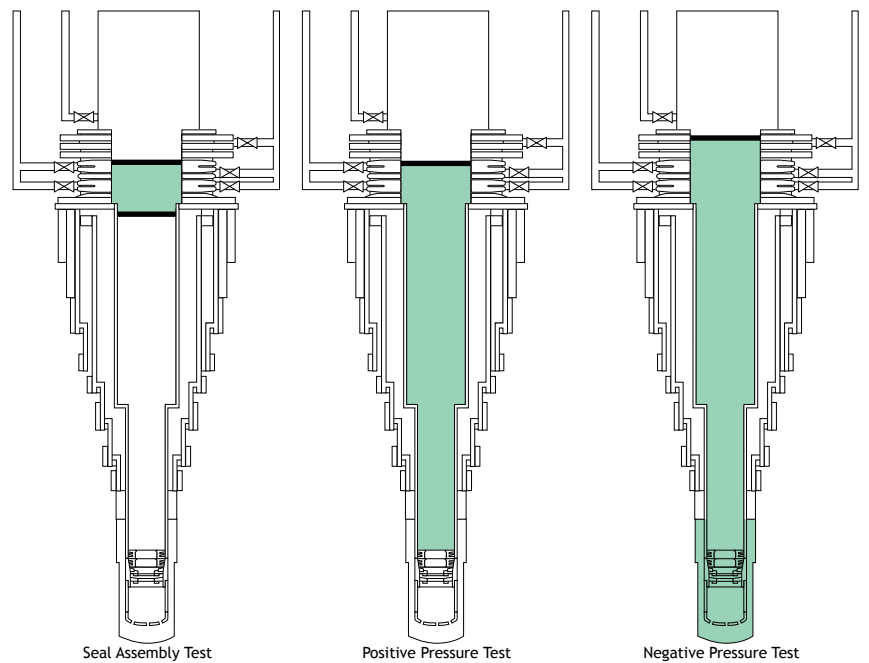
**Figure 4.6.1. Well integrity tests.**

The rig crew conducted three pressure tests as part of the temporary abandonment procedure to verify the integrity of the well. From left to right: the seal assembly test, the positive pressure test, and the negative pressure test. Test regions are shown in green.

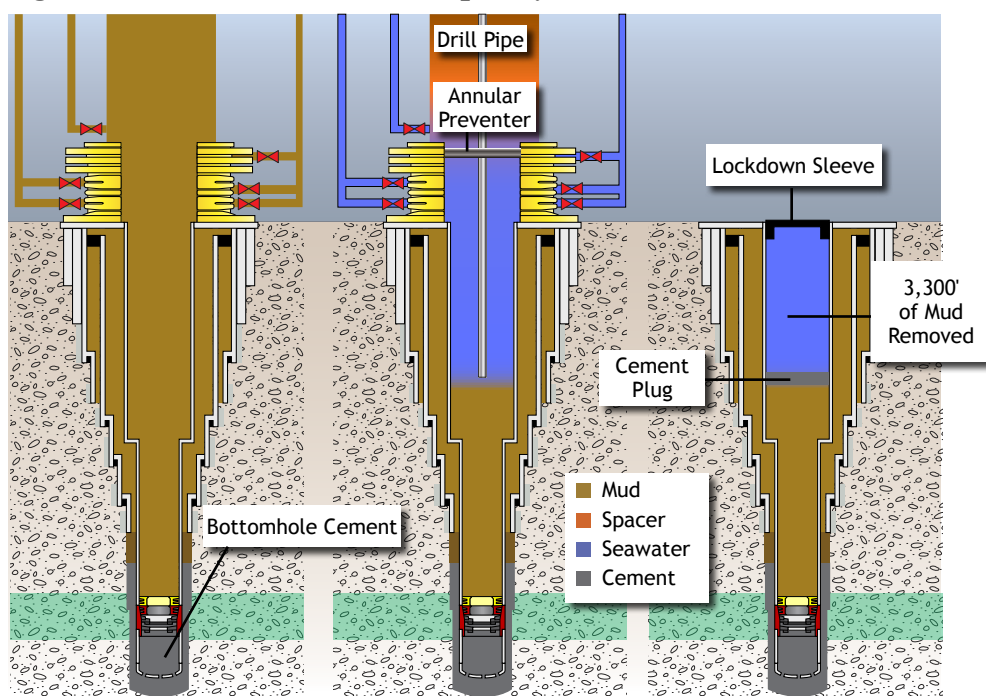
Figure 4.6.5. End of cement to temporary abandonment.

After the final casing string was cemented, heavy drilling mud filled the riser and the well (left). After the temporary abandonment planned for Macondo, the riser and its drilling mud would be removed. The drilling mud in the final casing string would be replaced with lighter seawater to a depth of over 8,000 feet below sea level (right). The removal of the hydrostatic pressure this drilling mud applied to the bottom of the well would increase the stress on the casing, seals, and cement. The negative pressure test simulated the conditions of temporary abandonment to confirm the integrity of the well in a controlled environment (middle).

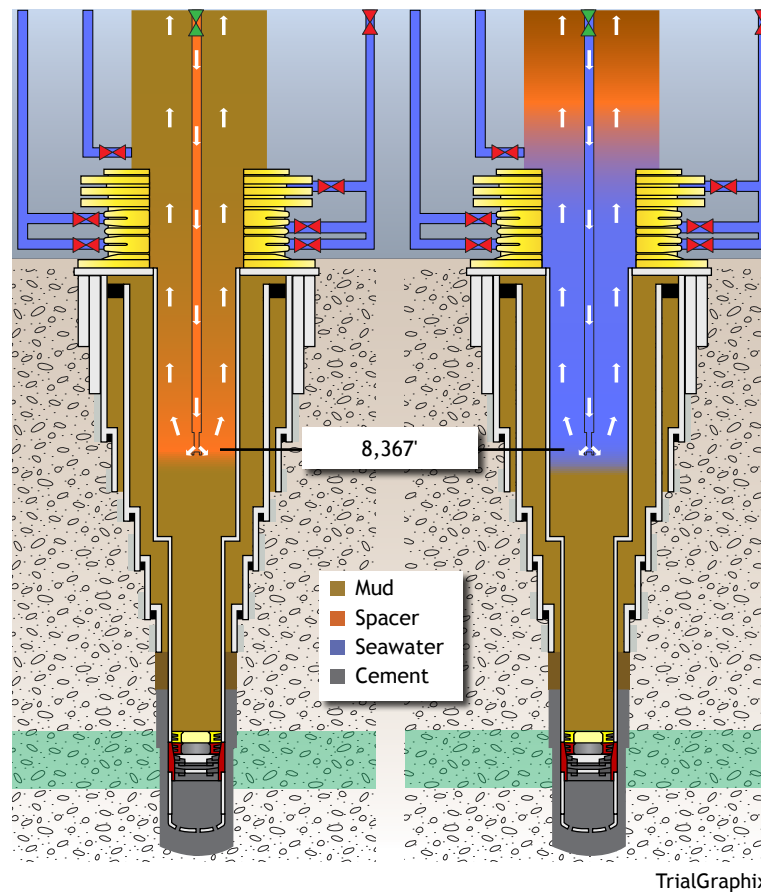
**Figure 4.6.6. Preparations for the negative pressure test.**

To prepare for the negative pressure test, the rig crew needed to displace the mud in the drill pipe and casing string from a depth of 8,367 feet to above the BOP. The crew did so by pumping spacer fluid (left) and then seawater (right) down the drill pipe until the mud was above the BOP.

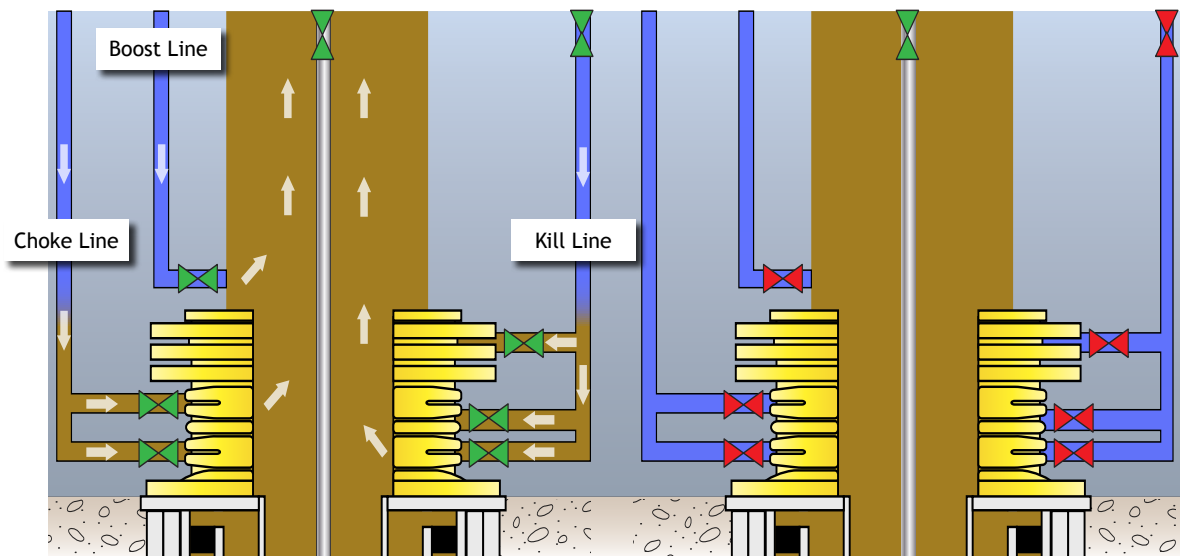
**Figure 4.6.9. Negative pressure test progress, 3 p.m. on April 20, 2010.**

To begin preparations for the negative pressure test, the rig crew displaced the boost, choke, and kill lines with seawater. Seawater was pumped into the lines on the rig, forcing mud into and up the riser (left). After the lines were displaced, the crew closed the valves connecting them to the riser and BOP (right).

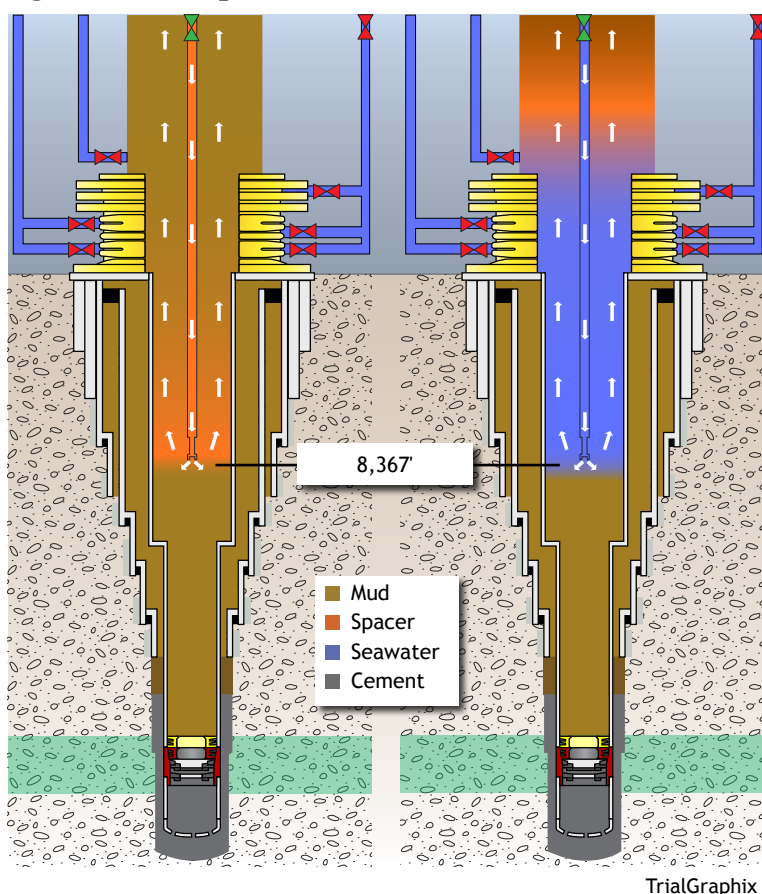
Figure 4.6.10. 4 p.m.

The crew displaced the mud in the drill pipe and in the casing from 8,367 feet to above the BOP. The crew first pumped a spacer fluid down the drill pipe, which forced the mud out and up the casing and the riser (left). Following the spacer, the crew pumped seawater into the drill pipe. This forced the spacer and the mud up the casing. The crew’s intent was to pump enough seawater to displace the spacer and mud above the BOP (right).

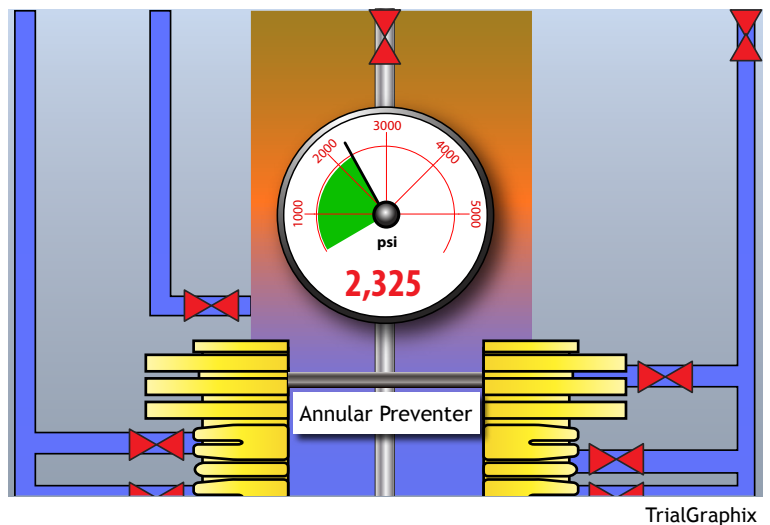
**Figure 4.6.11. 4:53 p.m.**

The crew closed the annular preventer around the drill pipe. The drill pipe pressure was approximately 700 psi higher than should have been expected, a sign that some spacer may have remained beneath the BOP.

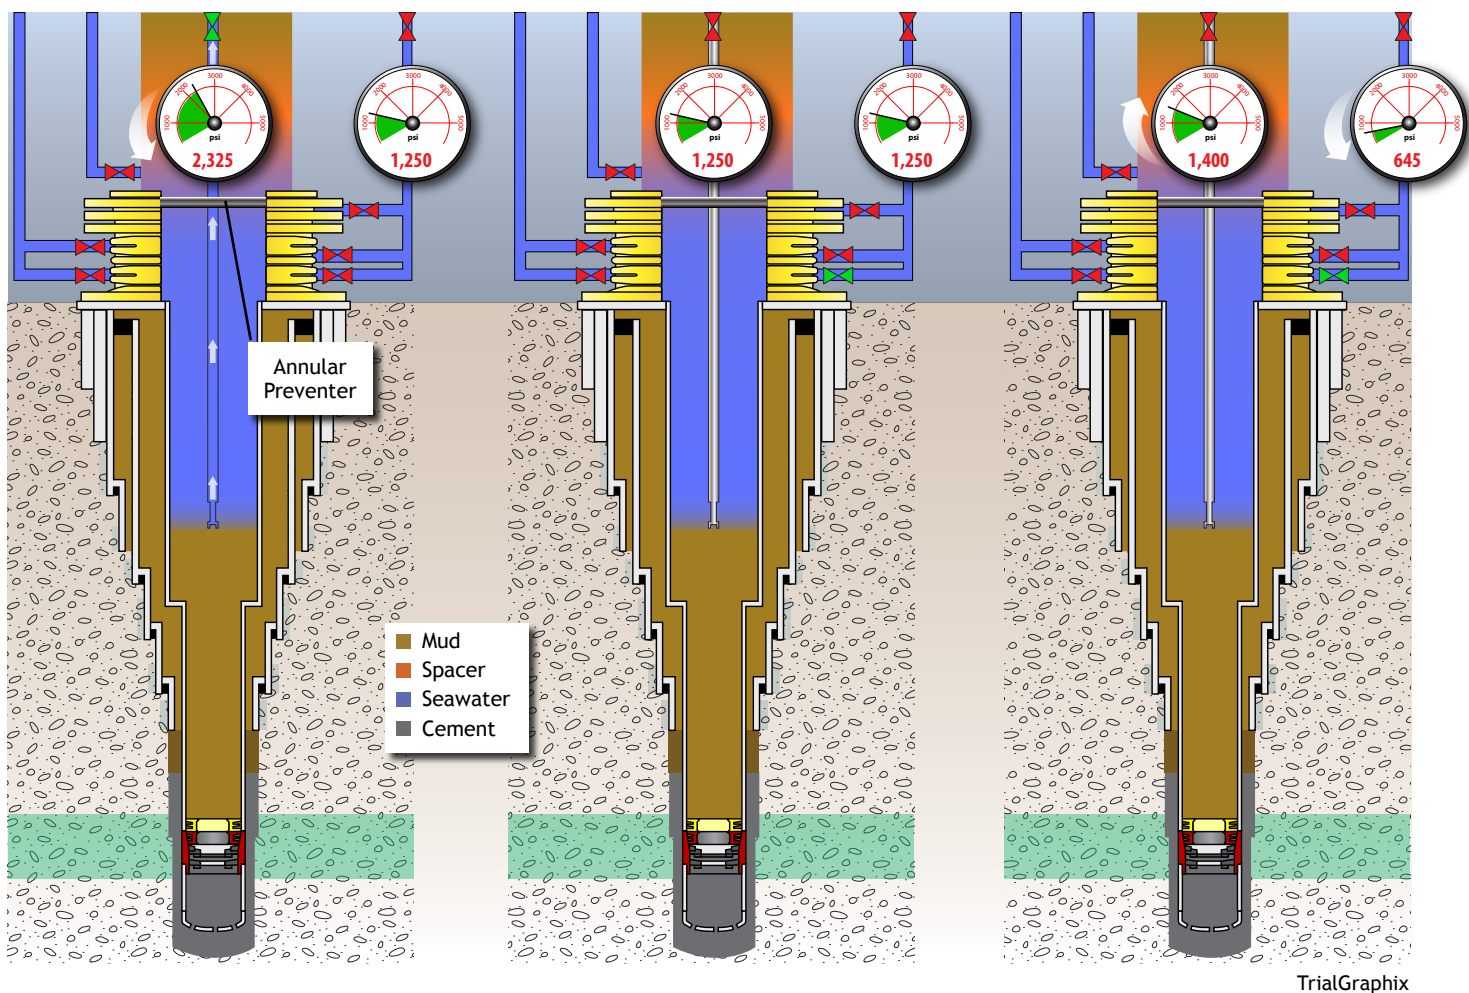
Figure 4.6.12. 4:55 p.m.

After the annular preventer was closed (left) the crew bled down the pressure in the drill pipe to equalize its pressure with the pressure in the kill line. Because both the drill pipe and the kill line go to the same vessel, when the valve connecting the kill line to the BOP is opened, the pressures should remain equal (middle). Instead, when the valve was opened, the pressures diverged (right).

The rig crew next bled the drill pipe to 1,250 psi, in an effort to equalize pressure on the drill pipe with pressure on the kill line (which was 1,250 psi at the time, as shown in Figure 4.6.12).<sup>30</sup> Once the crew had bled the drill pipe pressure down to 1,250 psi, it opened a valve on the kill line at the BOP so that both the drill pipe and kill line were open to the well. At this point, the drill pipe and kill line should have behaved like two straws in the same glass of water: The pressure in both should have been a steady 1,250 psi. Instead, when rig personnel opened the valve, the drill pipe pressure jumped, and the kill line pressure dropped.<sup>31</sup>
