# Macondo

T H E G U L F O I L D I S A S T E R

Chief Counsel's Report | 2011

National Commission on the BP Deepwater Horizon Oil Spill and Offshore Drilling

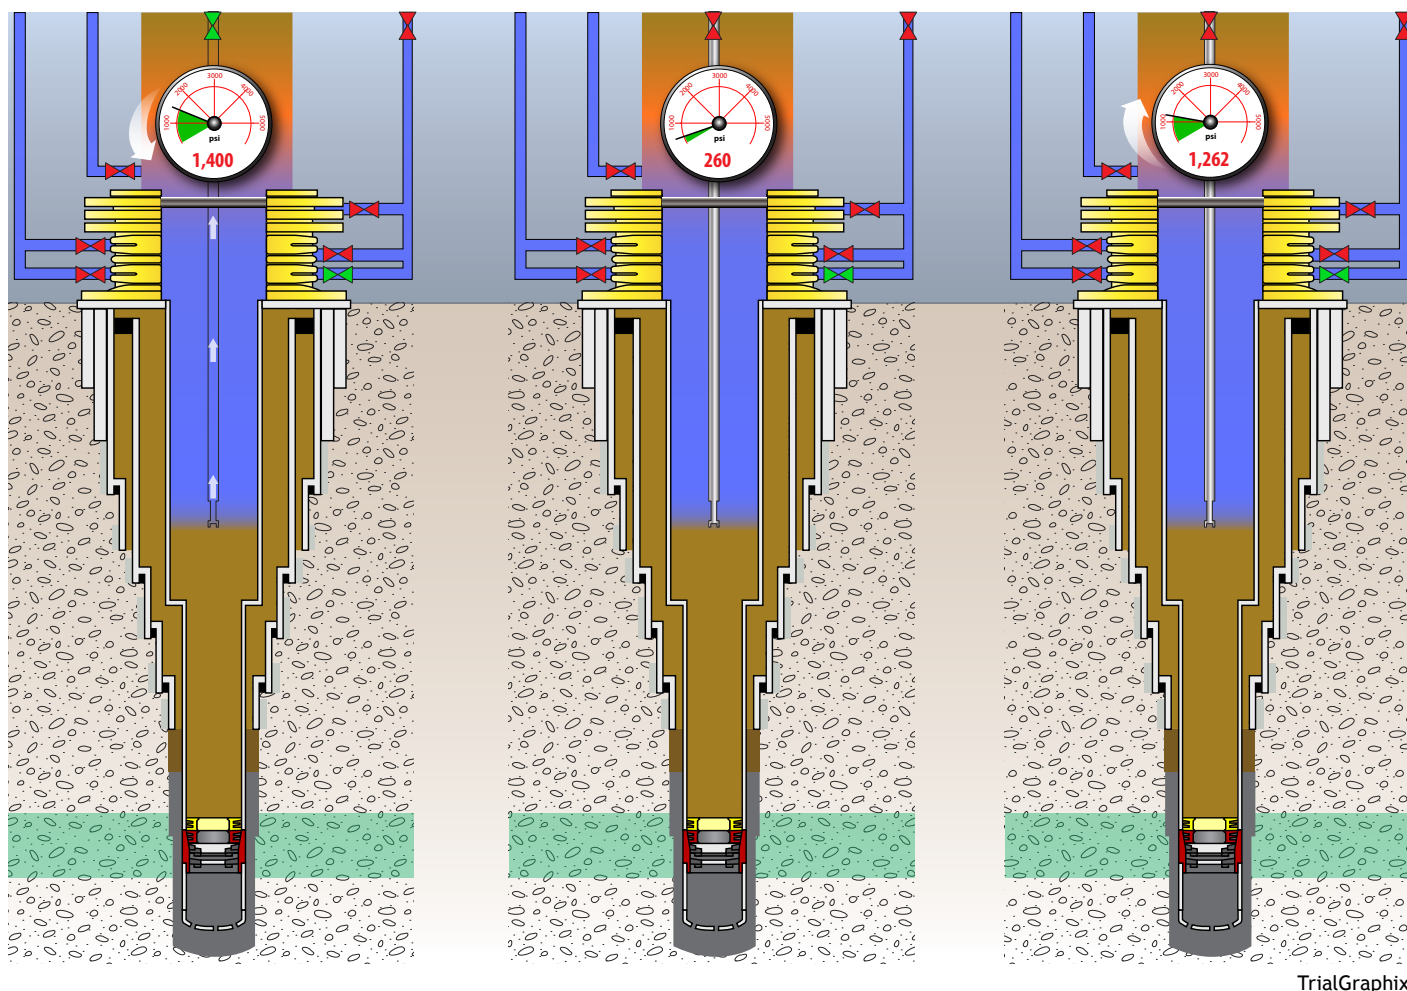
Figure 4.6.13. 4:58 p.m.

The crew began the negative pressure test by attempting to bleed the drill pipe pressure to 0 psi (left). However, the crew was unable to reduce pressure to below 260 psi (middle). This bleed returned an unknown amount of water to the rig. The crew shut in the drill pipe, and the pressure built up to 1,262 psi (right). In a successful negative pressure test, pressure does not build up.

The uncertainty over how much fluid flowed from the well during the bleed-off suggests that the well site leaders and crew failed to monitor the bleed-off volumes with requisite rigor. It does not appear that anyone had calculated ahead of time how many barrels should have flowed from the

well during the bleed, even though such calculations would have been relatively straightforward.<sup>37</sup> After failing to bleed the pressure down to 0 psi, the crew closed the valve on the drill pipe, and the pressure built back up to 1,262 psi.<sup>38</sup>

As one independent expert has pointed out, this series of events actually constituted a failed negative pressure test, although the crew did not recognize that fact.<sup>40</sup>

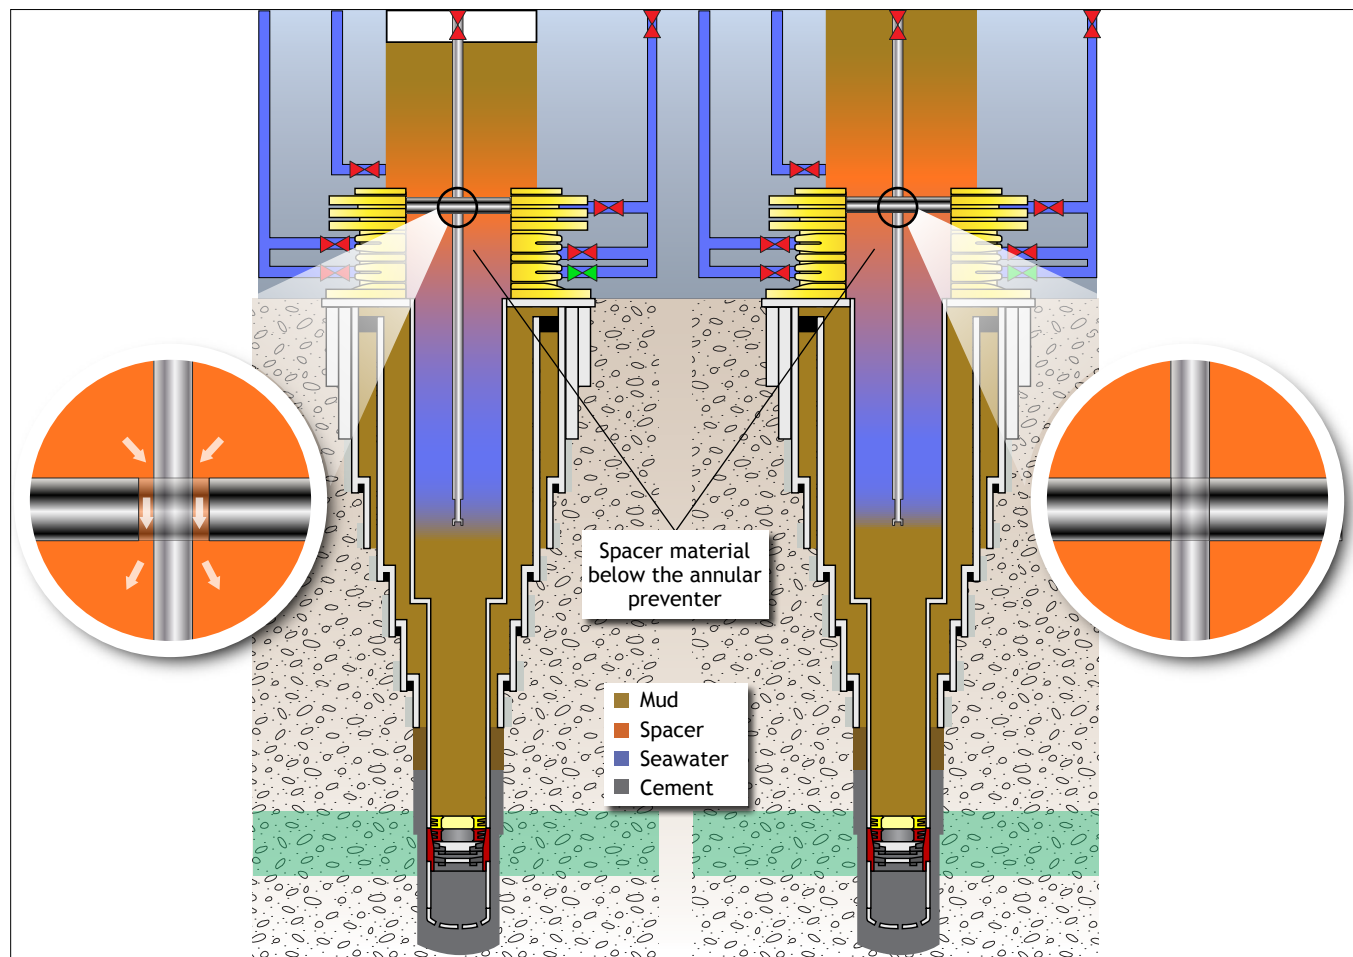
Figure 4.6.14. 5:10 p.m.

The rig crew noticed that the fluid level in the riser was falling. Because the annular preventer was not sufficiently tight around the drill pipe, spacer fell beneath the BOP (left). In response, the rig crew tightened the seal of the annular preventer and refilled the riser (right), but did not circulate the spacer back above the BOP.

At 5:10 p.m., the rig crew apparently noticed that the level of fluid in the riser was falling.<sup>41</sup> Spacer in the riser was leaking down through the annular preventer and into the well below the BOP.<sup>42</sup> Unlike many other indications, the crew could observe the fluid levels in the riser with their own eyes. When one rig crew member arrived on the rig floor, he saw others standing around the rotary table and using a flashlight to peer down into the riser to see how much fluid was missing.<sup>43</sup>

In response to the dropping levels of fluid in the riser, Harrell instructed the rig crew to tighten the seal of the annular preventer against the drill pipe as shown in Figure 4.6.14. Wyman Wheeler, the Transocean toolpusher on duty at the time, then topped off the riser with 20 to 25 barrels of mud, and the fluid level in the riser stayed steady.<sup>46</sup> The crew had thus identified and eliminated a leak in the well system that could have explained the anomalous pressure readings they had seen and their inability to bleed the drill pipe pressure to 0 psi.<sup>47</sup> By this time Kaluza returned to the rig floor.<sup>48</sup>

Despite clear evidence that spacer had probably leaked below the BOP, rig personnel again did nothing to ensure that they had fully displaced the spacer above the BOP and instead proceeded with the test.<sup>49</sup>

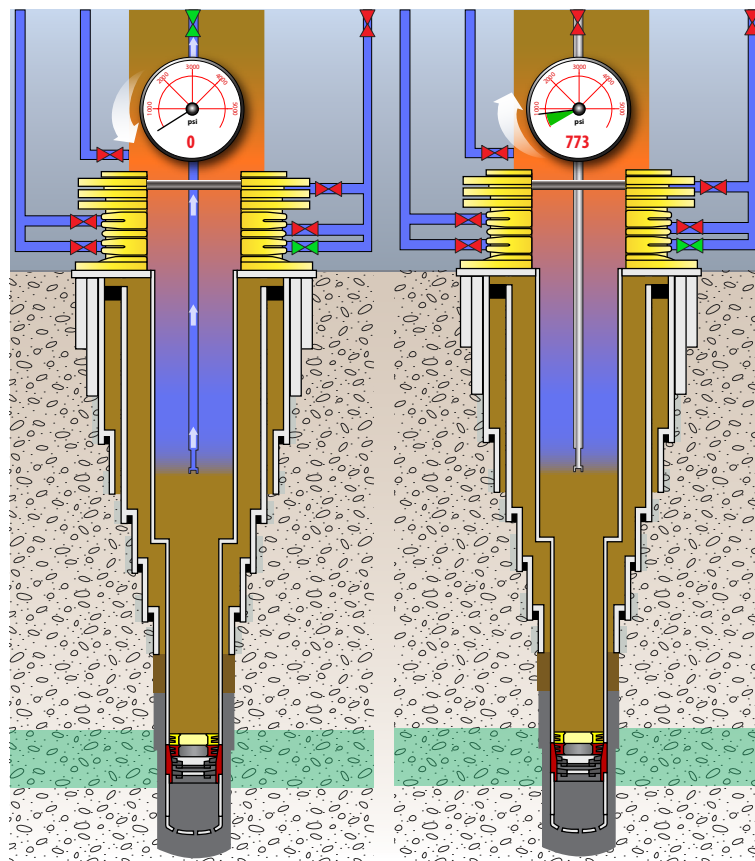
**Figure 4.6.15. 5:26 p.m.**

This second series of bleed-offs, excessive flows, and pressure buildups constituted another failed “negative pressure test” that the crew again did not recognize as such. With the annular preventer fully closed and sealed, the only explanation for the excessive returns and pressure increase would be that the primary cement job had failed to seal off the pay zone. Hydrocarbons were leaking from the formation into the well. Individuals involved in the test at this point should have recognized that the well lacked integrity.

**The rig crew attempted again, this time successfully, to bleed the drill pipe pressure down to 0 psi. Fifteen barrels of seawater were returned during this bleed (left). The drill pipe was shut in, but the drill pipe pressure rose to 773 psi. Fifteen barrels is a higher return than should have been expected, and the drill pipe pressure should not have built back up.**

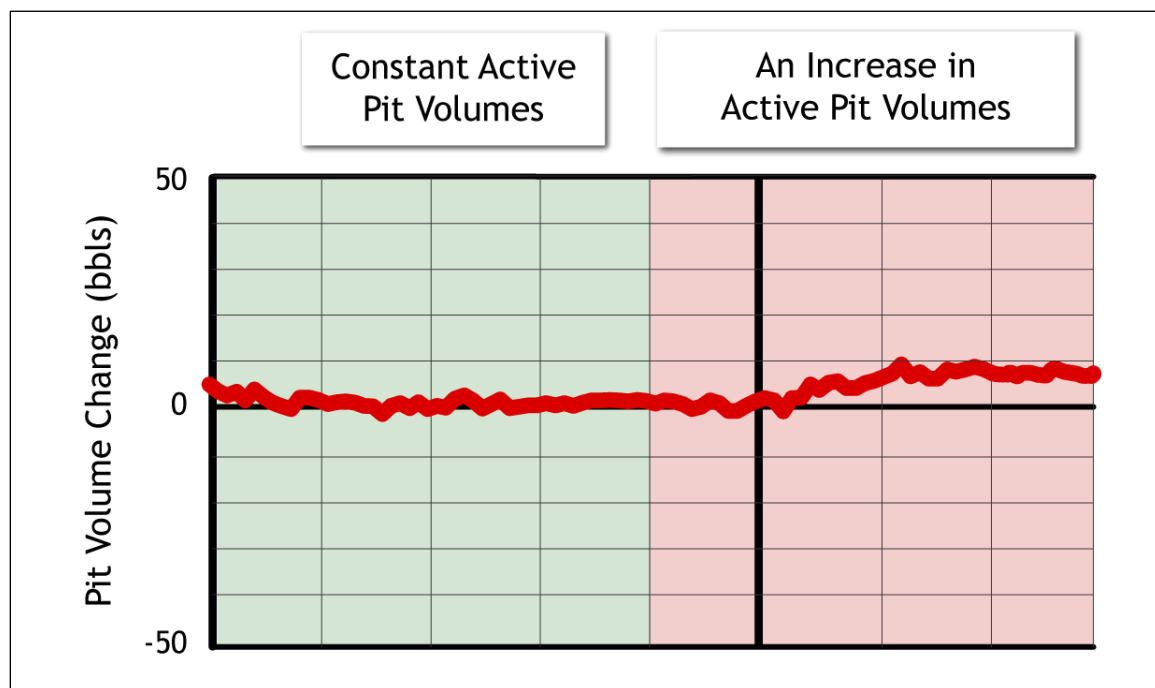
**Figure 4.7.1. Active pit volume in a closed-loop system.**

**In a closed-loop system, active pit volume will remain constant so long as the well is stable. An increase in active pit volume strongly indicates that a kick is under way.**

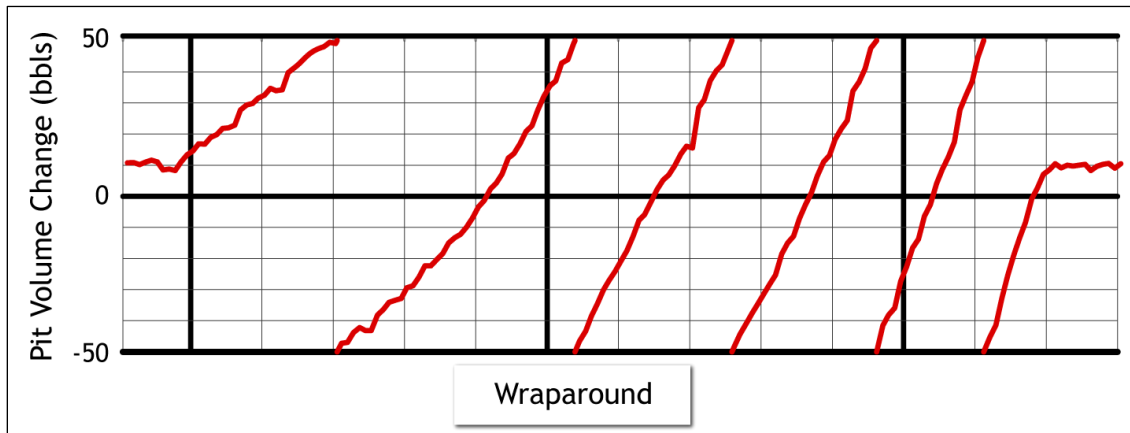
**Figure 4.7.2. Active pit volume in a non-closed-loop system.**

**In a non-closed-loop system, active pit volume will increase continuously regardless of the well's stability.**

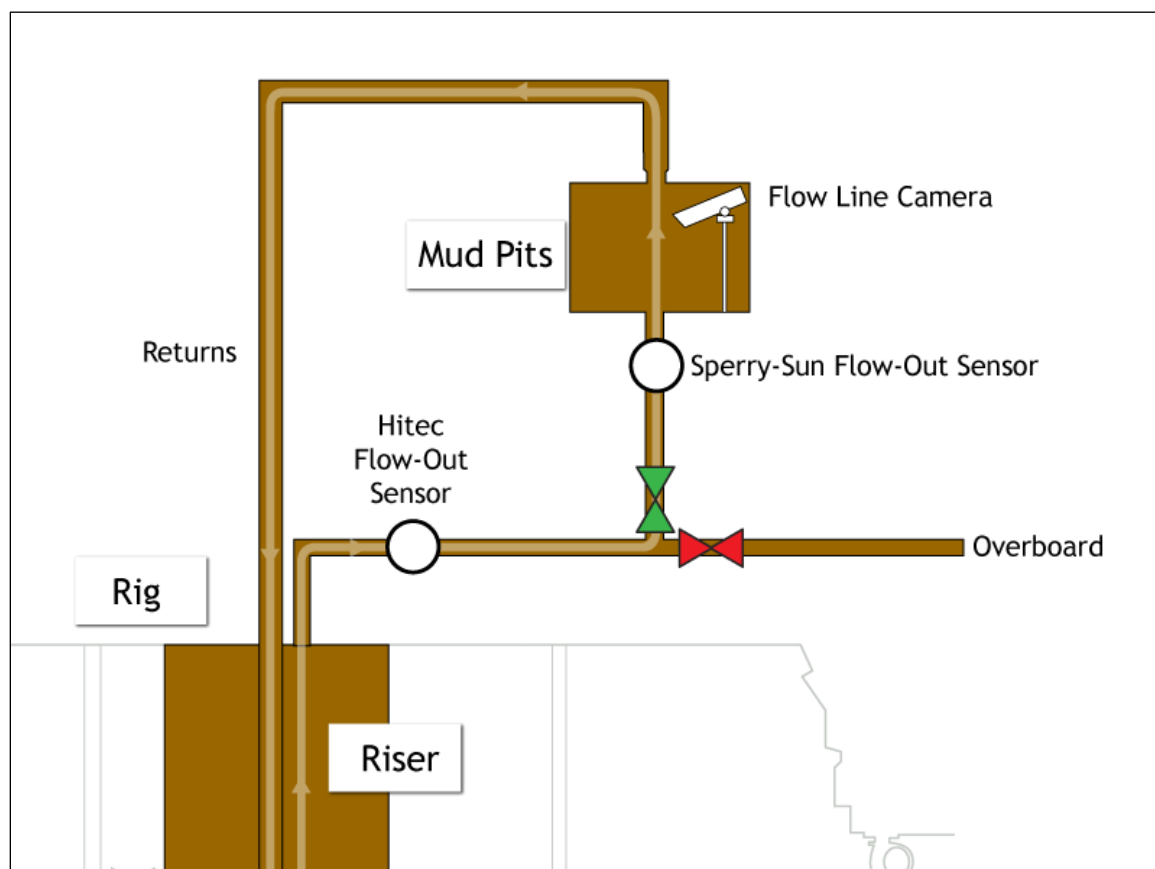
**Figure 4.7.5. Flow-out sensors and flow line camera.**

In addition to the data display systems, the rig also had video cameras that monitored key areas and components, including the rig floor and the flow line. The flow line camera (also illustrated in Figure 4.7.5) simply pointed at the flow line. Like the Sperry-Sun flow-out sensor, this camera was located after the fork; rig personnel could use it to observe flow returning to the pits but not flow that had been routed overboard.<sup>47</sup> When returns were sent overboard, rig personnel could still visually inspect for flow but could not do so using the video camera. They had to physically look behind the gumbo box (which was located before the fork).<sup>48</sup>

**The Sperry-Sun flow-out sensor and the rig's flow line camera could not register returns going overboard. The Hitec flow-out sensor could, but data from the Hitec flow-out sensor sank with the rig.**

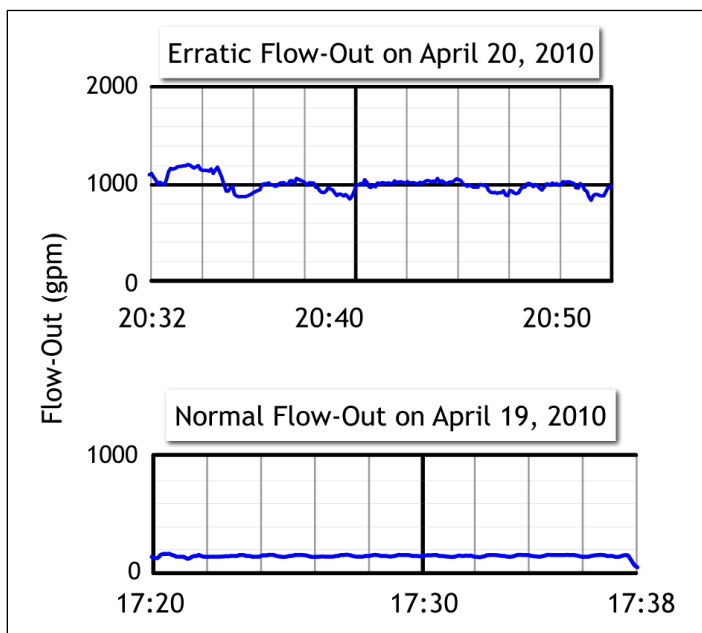
**Figure 4.7.8. Erratic vs. normal flow-out.**

This setup should not have impaired rig personnel's ability to monitor flow-out versus flow-in. However, the flow-out readings appear to have been more erratic than readings captured the previous day (seen in Figure 4.7.8). This may be because cranes were moving on the rig's deck, causing the rig to sway and thus affecting the level of fluids in the flow line.<sup>116</sup> Otherwise, flow-out appeared normal.<sup>117</sup>

**Flow-out readings appear to have been more erratic than normal during the final displacement, perhaps because crane operations were causing the rig to sway.**

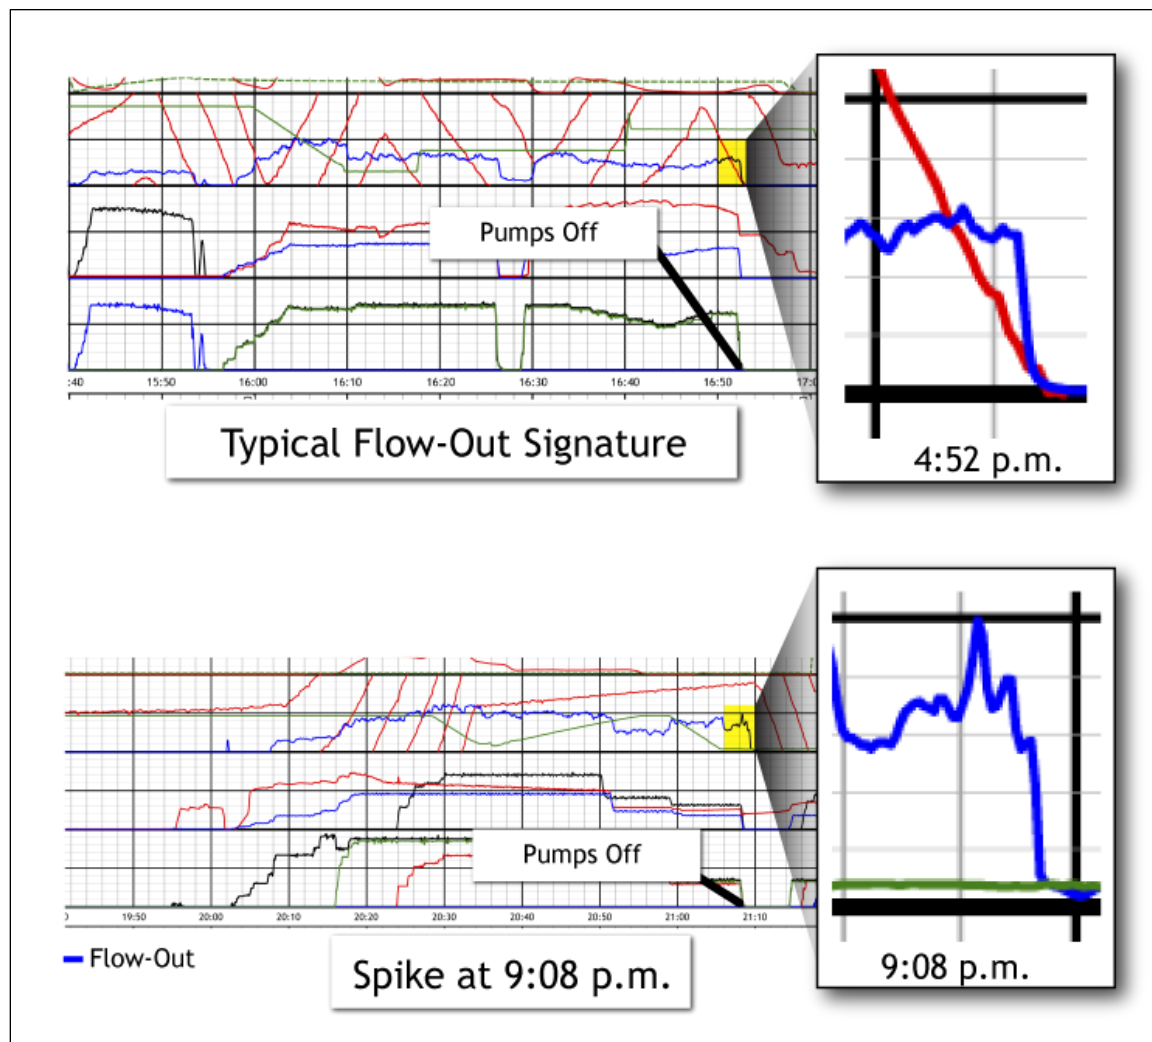
**Figure 4.7.9. Typical flow-out signature vs. spike at 9:08 p.m.**

Everything was not fine. For about a minute after the pumps stopped, flow-out continued beyond the *Horizon's* typical flow-out signature.<sup>142</sup> This was a kick indicator (Figure 4.7.9 depicts a typical flow-out signature at 4:52 p.m. and the 9:08 p.m. spike). A driller, assistant driller, or mudlogger watching the screen could have seen it.<sup>143</sup> Instead, they thought they had visual confirmation of no flow, based at least on Keith's observations.<sup>144</sup>

**For about a minute after the pumps stopped at 9:08 p.m., flow-out continued beyond the *Horizon's* typical flow-out signature.**

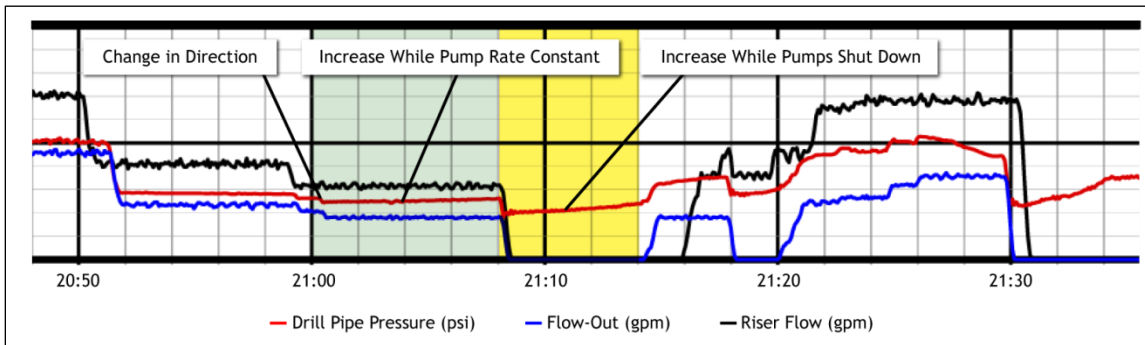
**Figure 4.7.10. Drill pipe pressure anomalies from 9:01 to 9:14 p.m.**

During the course of these activities, drill pipe pressure gradually increased. From 9:08 to 9:14 p.m., while the pumps were shut down, drill pipe pressure increased by approximately 250 psi (see Figure 4.7.10). This was a significant anomaly.<sup>152</sup> By 9:14 p.m., the increase would have been noticeable and a cause for concern.<sup>153</sup> The driller apparently missed this increase, perhaps because “having looked and seen 60 seconds of constant pressure...he may have then turned to do the next step in the process which was line up another mud pump to pump down the kill lines.”<sup>154</sup> It is unclear why the assistant driller and the mudlogger also missed the increase.<sup>155</sup>

At 9:01 p.m., drill pipe pressure changed direction. By 9:08 p.m., with the pump rates constant, drill pipe pressure had increased by approximately 100 psi. From 9:08 to 9:14 p.m., while the pumps were shut down, drill pipe pressure increased by approximately 250 psi. Each of these changes in drill pipe pressure was an anomaly that should have prompted rig personnel to stop and investigate, but the signs apparently went unnoticed.

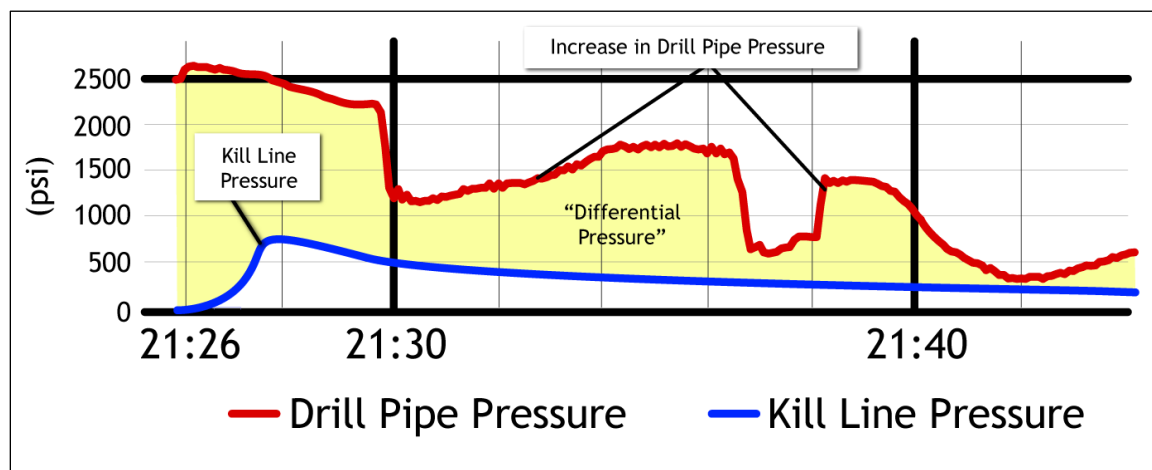
**Figure 4.7.11. Drill pipe pressure and kill line pressure anomalies from 9:27 to 9:40 p.m.**

From 9:30 to 9:35 p.m., drill pipe pressure increased by approximately 550 psi (see Figure 4.7.11). This was another significant anomaly: With the pumps shut off, there should have been no movement in the well.<sup>172</sup> (The increase might have reflected mud continuing to travel up the wellbore with oil and gas below.)<sup>173</sup> Revette and Anderson were intently watching the screens, but they did not shut in the well. Instead, Revette ordered Transocean floorhand Caleb Holloway to bleed off the drill pipe pressure<sup>174</sup>—apparently to eliminate the differential pressure. At 9:36 p.m., Holloway cranked open a valve on the stand pipe manifold to bleed down the pressure.<sup>175</sup> But it was taking longer than usual to bleed off.<sup>176</sup> Revette told Holloway, “Okay, close it back.”<sup>177</sup>

At 9:27 p.m., kill line pressure reached approximately 800 psi. From 9:30 to 9:35 p.m., while the pumps were shut down, drill pipe pressure increased by approximately 550 psi. After the crew attempted to bleed it down, drill pipe pressure again shot up, at 9:38 p.m., by approximately 600 psi. Each of these anomalies was a sign that fluids were moving in the well. Despite observing those signs, the crew did not yet shut in the well.

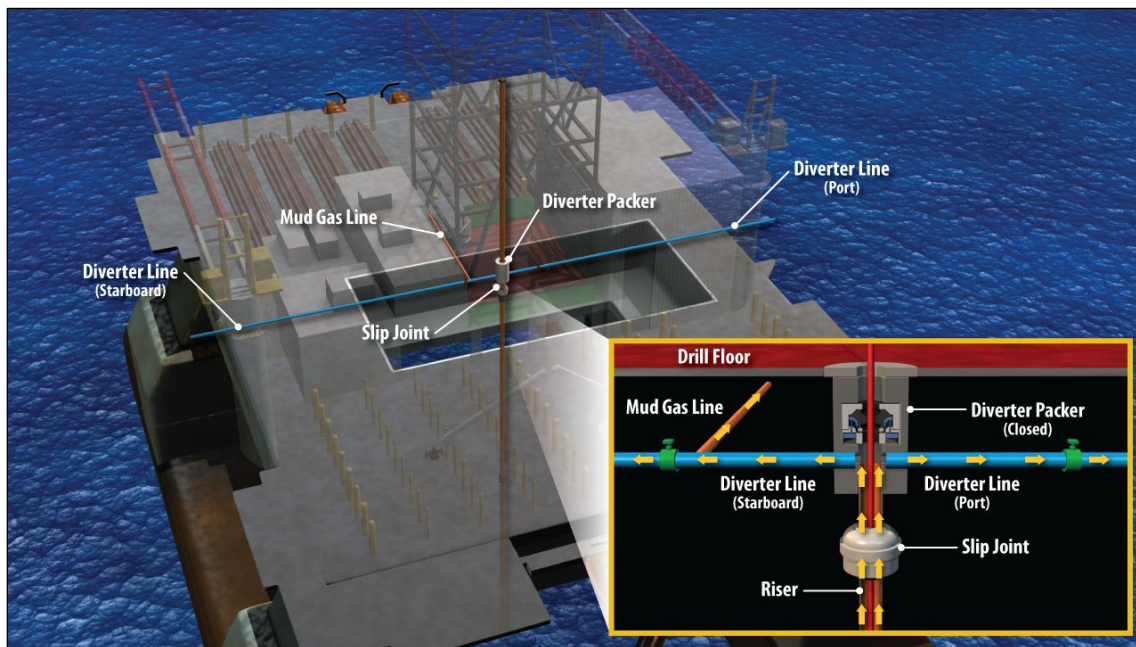
**Figure 4.8.1. Diverter system.**

On April 20, the rig crew diverted the influx to the mud gas separator rather than sending it overboard. That caused mud and gas to spray onto the rig from the derrick.

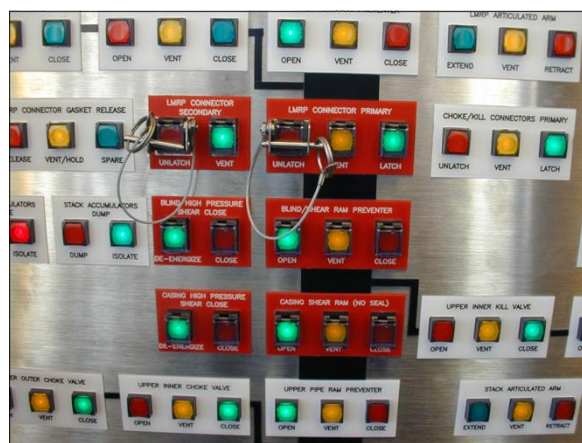
**Figures 4.8.2 and 4.8.3.**  
**BOP control panels on the rig floor and bridge.**

In addition to activating the annular preventers or pipe rams, the crew could have activated the blind shear ram to cut the drill pipe and shut in the well.<sup>54</sup> The blind shear ram can be activated directly by the rig crew from the control panels, seen in Figures 4.8.2 and 4.8.3.<sup>55</sup> There is no evidence the rig crew attempted to activate the blind shear ram prior to the explosion.<sup>56</sup>

**The blind shear ram can be activated from the BOP’s control panels on the rig floor and bridge.**

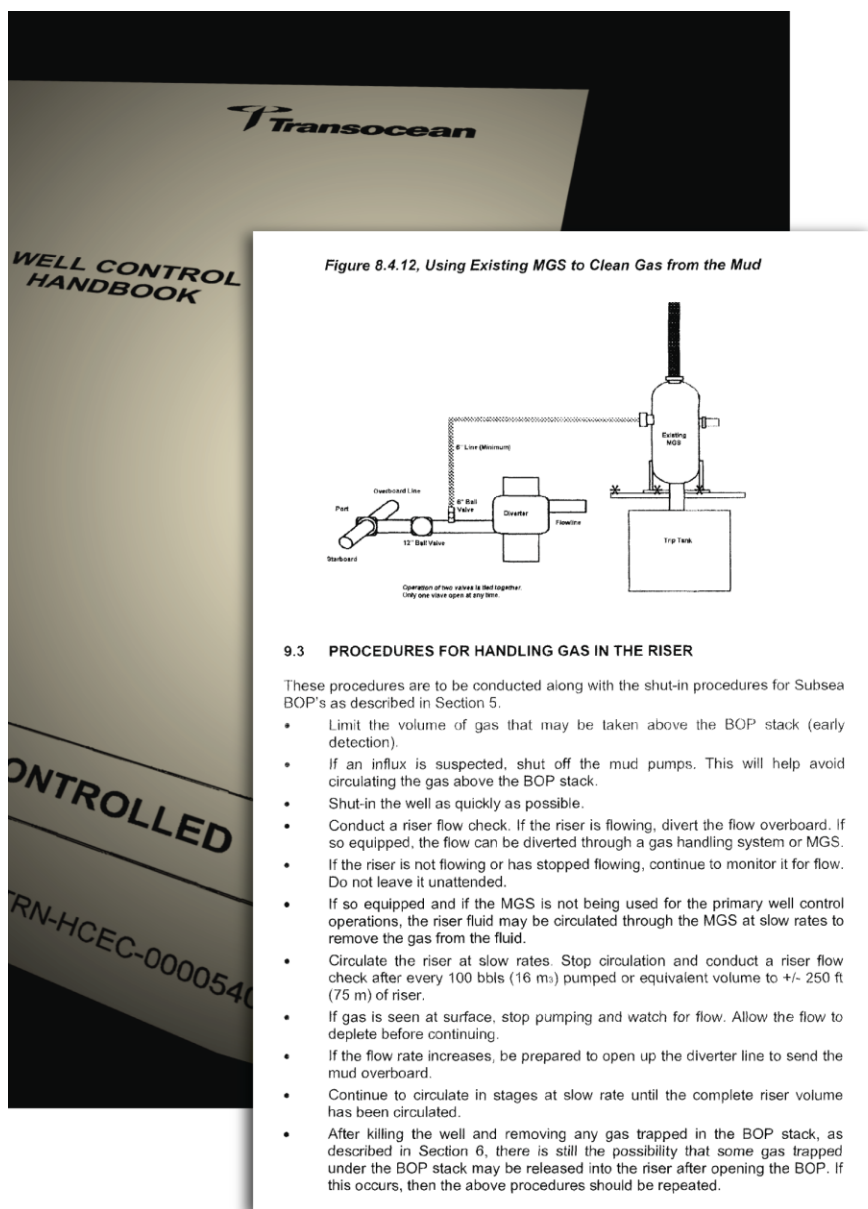
**Figure 4.8.4. Transocean's “procedures for handling gas in the riser.”**

Though Transocean's protocols provide that a severe influx should be sent overboard, the sequence of “procedures for handling gas in the riser”<sup>114</sup> (Transocean document shown in Figure 4.8.4) specifically recommends the overboard line—instead of the mud gas separator—only in the ninth step after actions such as monitoring for flow and circulating the riser. Here, there was *no time* to get to the ninth step.<sup>115</sup> In the future, well control training should include simulations and drills for low-probability, high-consequence emergency events and well-control protocols should specifically address such emergencies.<sup>116</sup> ♠

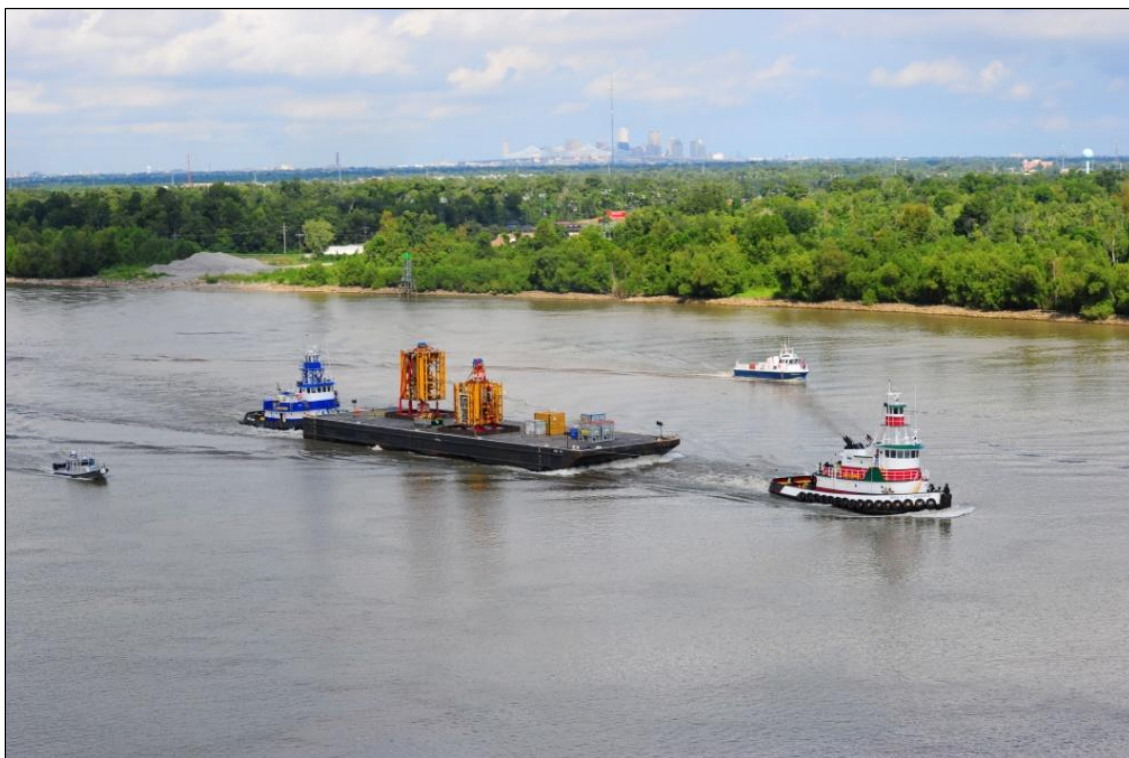
**Figure 4.9.1. Transporting the *Deepwater Horizon* BOP.**

The federal government has recovered the BOP from the blowout site, and forensic testing is ongoing. Until that testing is complete, a full examination of blowout preventer failure is impossible. In the meantime, the Chief Counsel’s team has made preliminary findings and identified certain technical faults that may have prevented the BOP system from activating and shutting in the well.

The *Deepwater Horizon*'s blowout preventer on the Mississippi River in transit to Michoud, Louisiana, to undergo forensic testing, September 11, 2010.

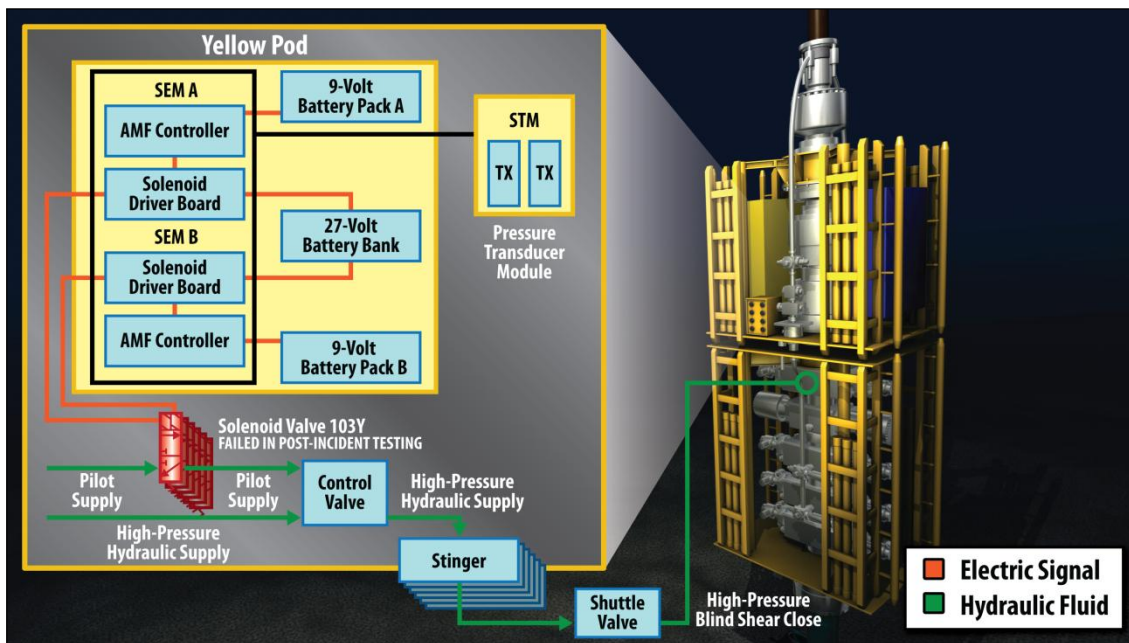
**Figure 4.9.8. BOP’s electrical schematic.**

Control pods also rely on functioning solenoid valves (diagrammed in Figure 4.9.8). The solenoid valves open and close in response to electrical signals and thereby send hydraulic pilot signals from the pods to the BOP elements.<sup>89</sup> The pilot signals in turn open hydraulic valves, which then deliver pressurized hydraulic fluid into BOP rams to close them.<sup>90</sup> Each solenoid activates when electric signals energize one of two redundant coils in the solenoid.<sup>91</sup>

Tests on the *Deepwater Horizon*’s yellow pod revealed that the solenoid valve used to close the blind shear ram was inoperable.
