National Transportation Safety Board

Railroad Accident Brief

Accident No: DCA-02-FR-013
Railroad: Norfolk Southern Railway
Train: Train 15T
Location: Farragut, Tennessee
Accident date and time: September 15, 2002, 11:20 a.m. eastern daylight time
Type of Accident: Derailment
Fatalities/Injuries: No fatalities or serious injuries
Property Damage: \$1.02 million

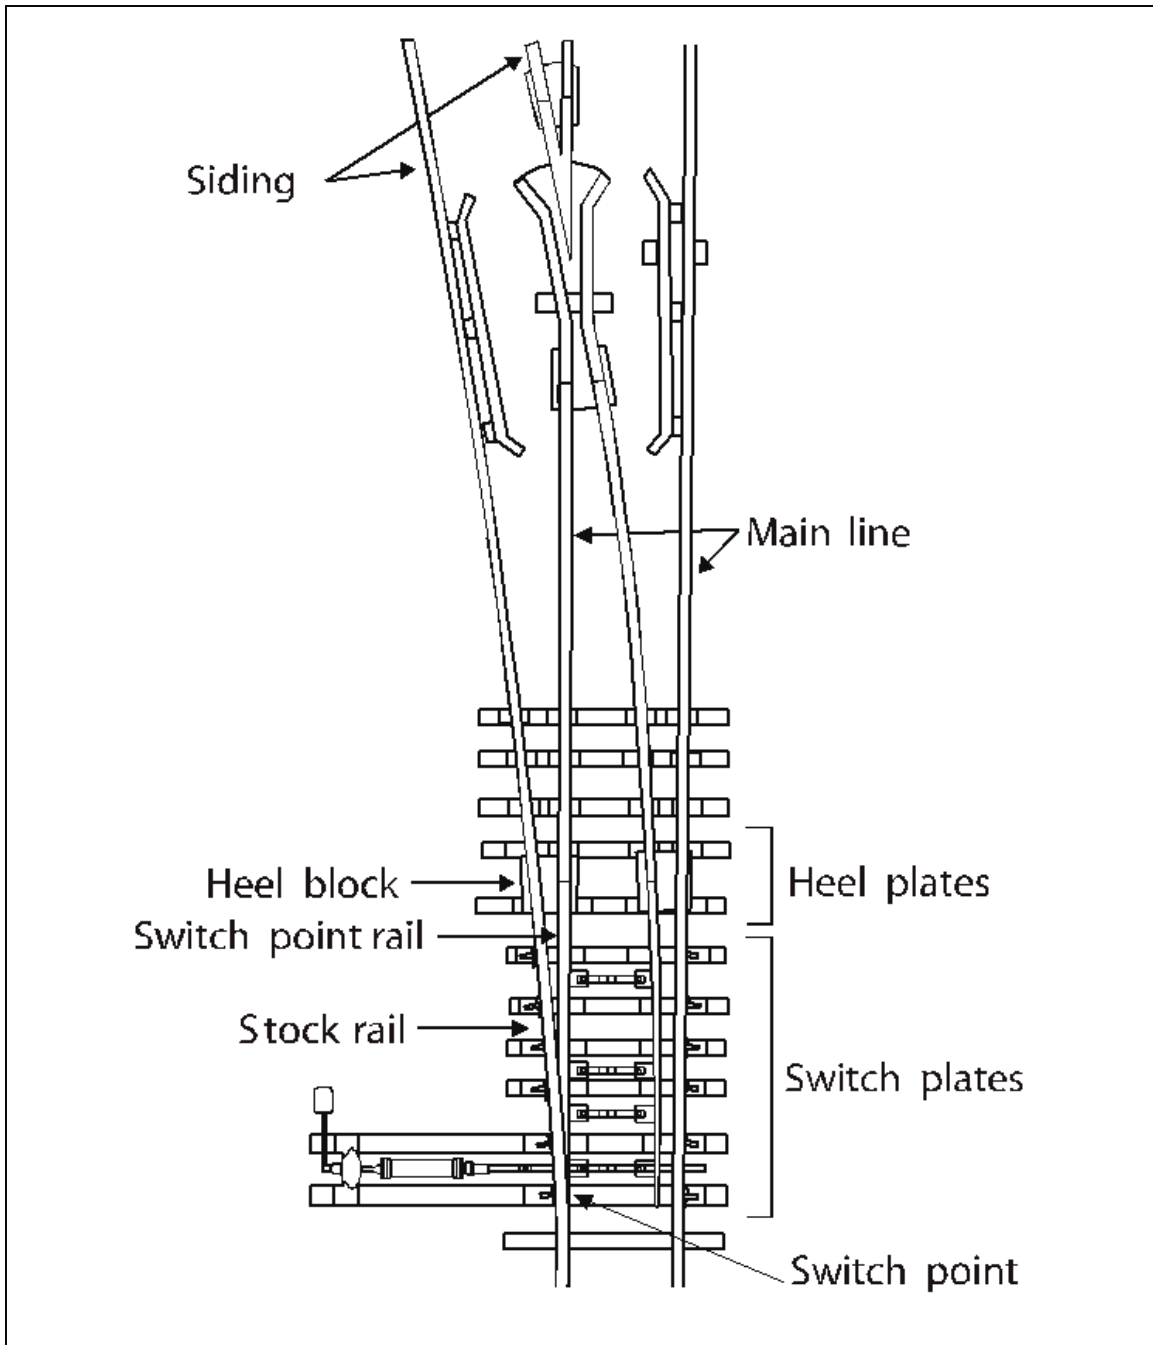
Figure 4. Diagram of a switch and turnout

The signal maintainer said that when he arrived at the switch, he noted that the points appeared to be properly positioned. He said that he visually inspected the switch and noticed that the switch plates,⁵ while not really dry, “looked like they could use a little oil.” He said that he put oil on each switch plate. He walked from the heel block to the switch point and did not see anything unusual. (See Figure 4.)
