Collision of Amtrak Passenger Train 371 and Norfolk
Southern Railway Company Freight Train 23M
Chicago, Illinois
November 30, 2007

Accident Report

NTSB/RAR-09/01
PB2009-916301

NTSB/RAR-09/01
PB2009-916301
Notation 7989A
Adopted March 31, 2009

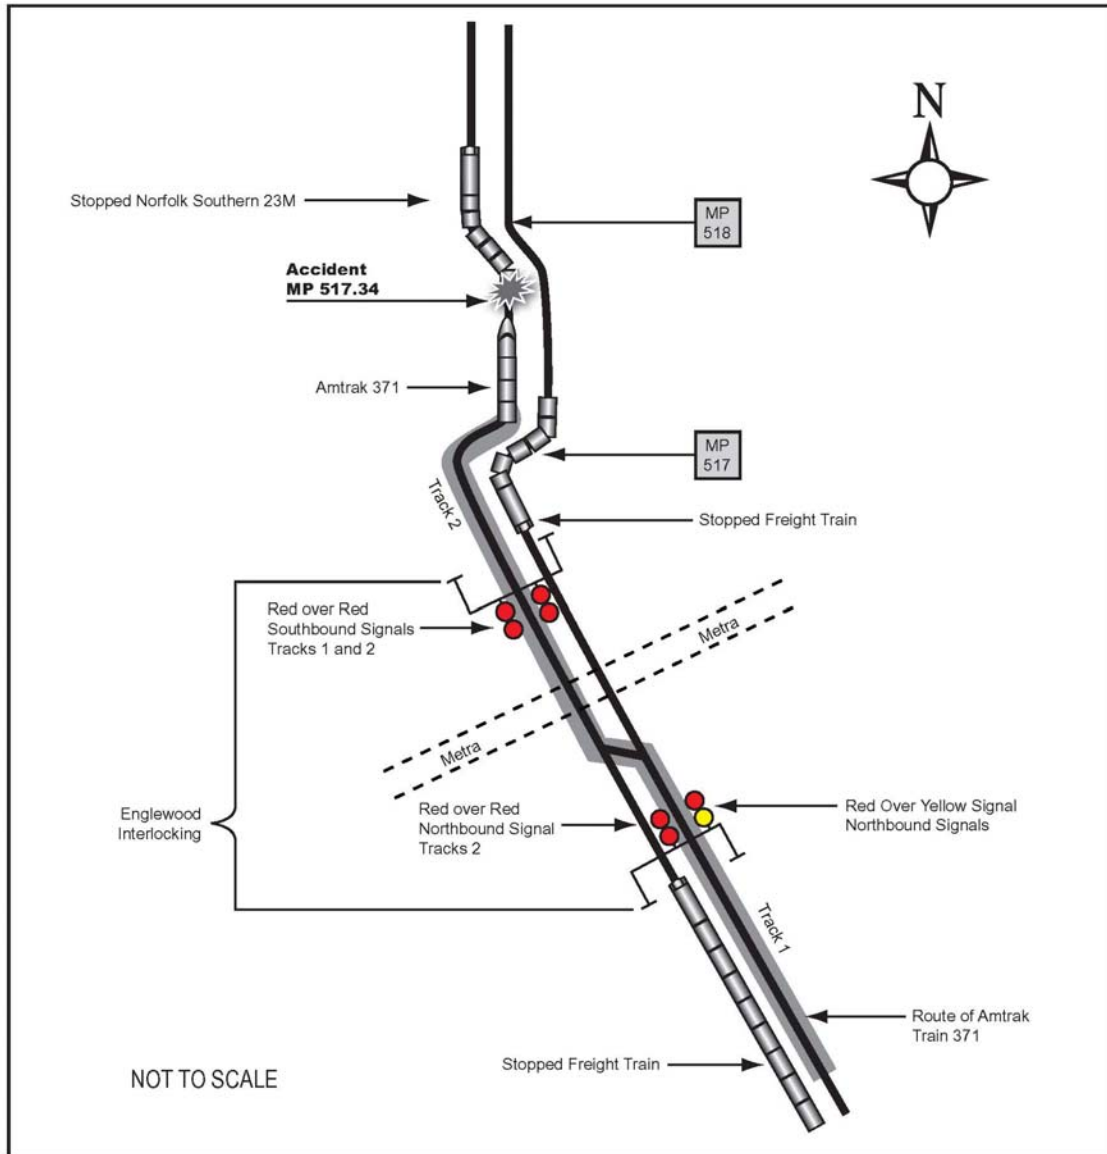
Figure 2. Path of accident train.

In the postaccident interview, the Amtrak relief engineer also said, "... [the] speed was still low while I was going through signals in my head." The locomotive's event recorder indicated that the engineer had slowed the train to 10 mph while traveling through the crossover switches from track 1 to track 2. When the train cleared on track 2, it accelerated to 25 mph until it cleared a permanent speed restriction (due to curved track) at MP 516.3. (See figure 2.)

Based on the event recorder data and the postaccident crew interviews, the rear of the standing Norfolk Southern freight train on track 2 came into view about a minute after the train was accelerated to 40 mph and while the crew was debating the last signal indication. The engineer reacted and started applying the brakes 8 seconds before the collision. The event

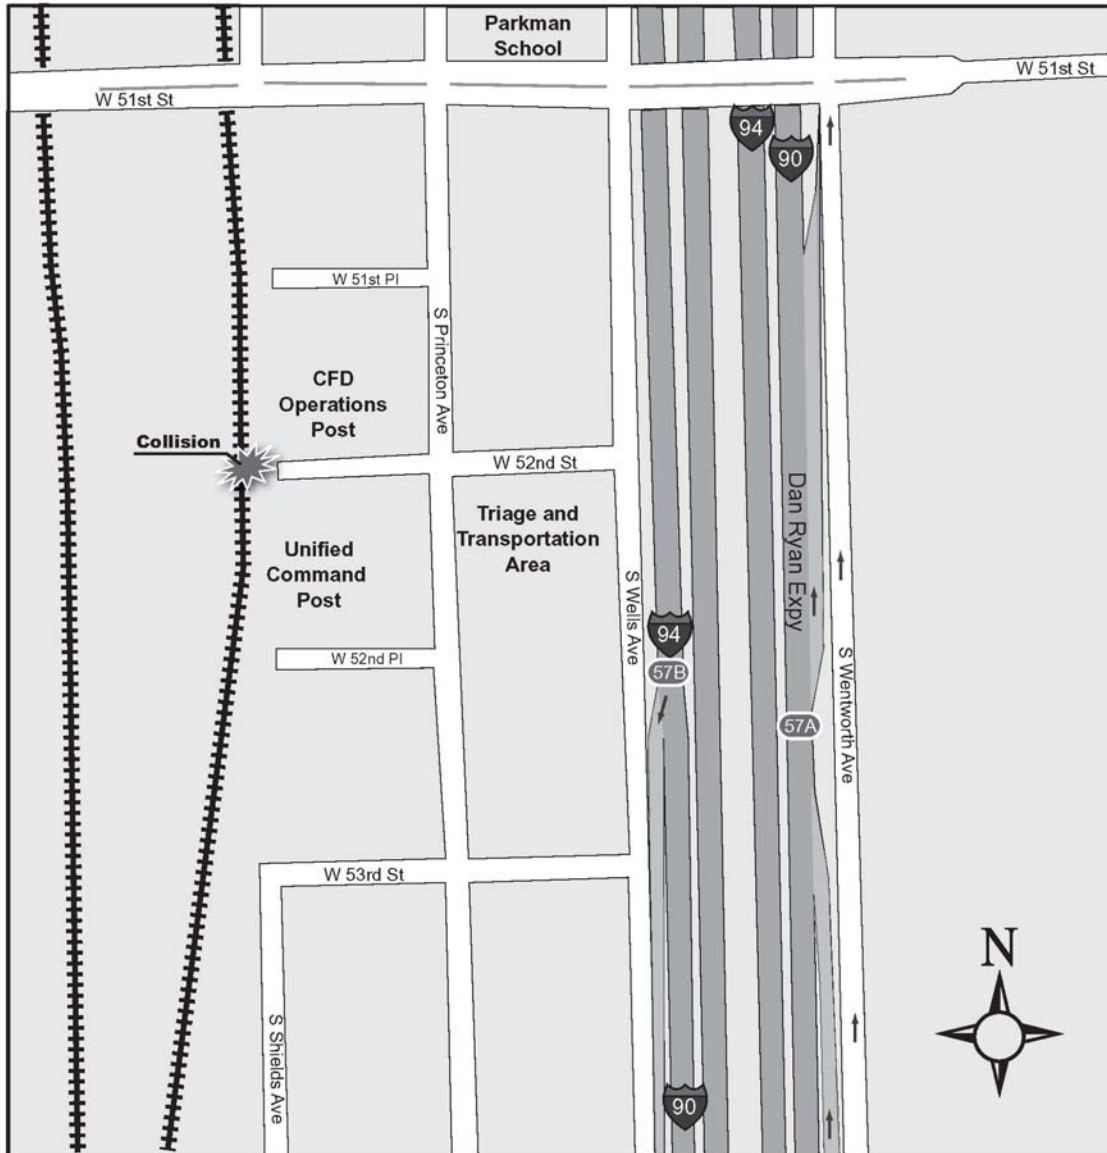
Figure 5. Emergency response locations.

A unified command post was established at 5220 South Shields Avenue. Representatives of the Chicago Fire Department, the Office of Emergency Management and Communications, Amtrak, the Red Cross, and the Chicago Police Department were at this location. The Chicago Police Department assisted with the evacuation of the passengers and provided security at the accident site and school. Norfolk Southern police and personnel also responded. (See figure 5.)

Passengers who were not taken by ambulance to hospitals were taken to Parkman School. After additional triage and treatment at this location, 24 passengers were transported by bus, accompanied by an advanced life support engine company, to Stroger Hospital at about 1:25 p.m. They were the last to be transported to hospitals. Additional buses were used to take uninjured passengers to the train’s final destination, Chicago’s Union Station. The scene was secured and released to the railroad at 1:30 p.m., a little more than 2 hours after the collision.
