Pacific Gas and Electric Company  
Natural Gas Transmission Pipeline Rupture and Fire  
San Bruno, California  
September 9, 2010

NTSB/PAR-11/01  
PB2011-916501

# Pipeline Accident Report

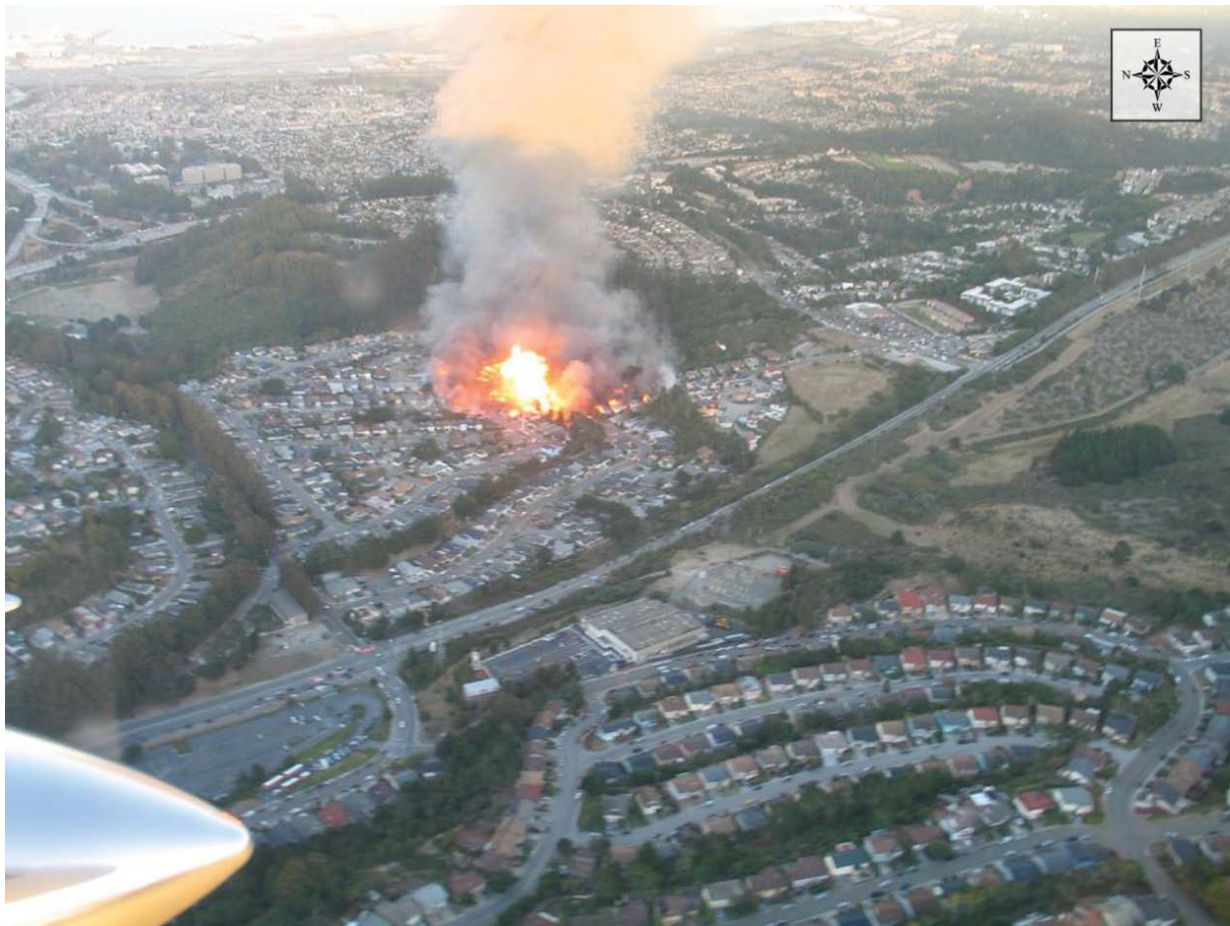
On September 9, 2010, about 6:11 p.m. Pacific daylight time,<sup>1</sup> a 30-inch-diameter segment of an intrastate natural gas transmission<sup>2</sup> pipeline known as Line 132, owned and operated by the Pacific Gas and Electric Company (PG&E), ruptured in a residential area in San Bruno, California. The rupture occurred at mile point (MP) 39.28 of Line 132,<sup>3</sup> at the intersection of Earl Avenue and Glenview Drive. The rupture produced a crater about 72 feet long by 26 feet wide. (See figure 1.) The section of pipe that ruptured, which was about 28 feet long, and weighed about 3,000 pounds, was found 100 feet south of the crater. (See figure 2.) PG&E estimated that 47.6 million standard cubic feet of natural gas was released. The released natural gas ignited, resulting in a fire that destroyed 38 homes and damaged 70. (See figure 3.) Eight people were killed, many were injured, and many more were evacuated from the area.

**Figure 3.** Aerial view of fire.

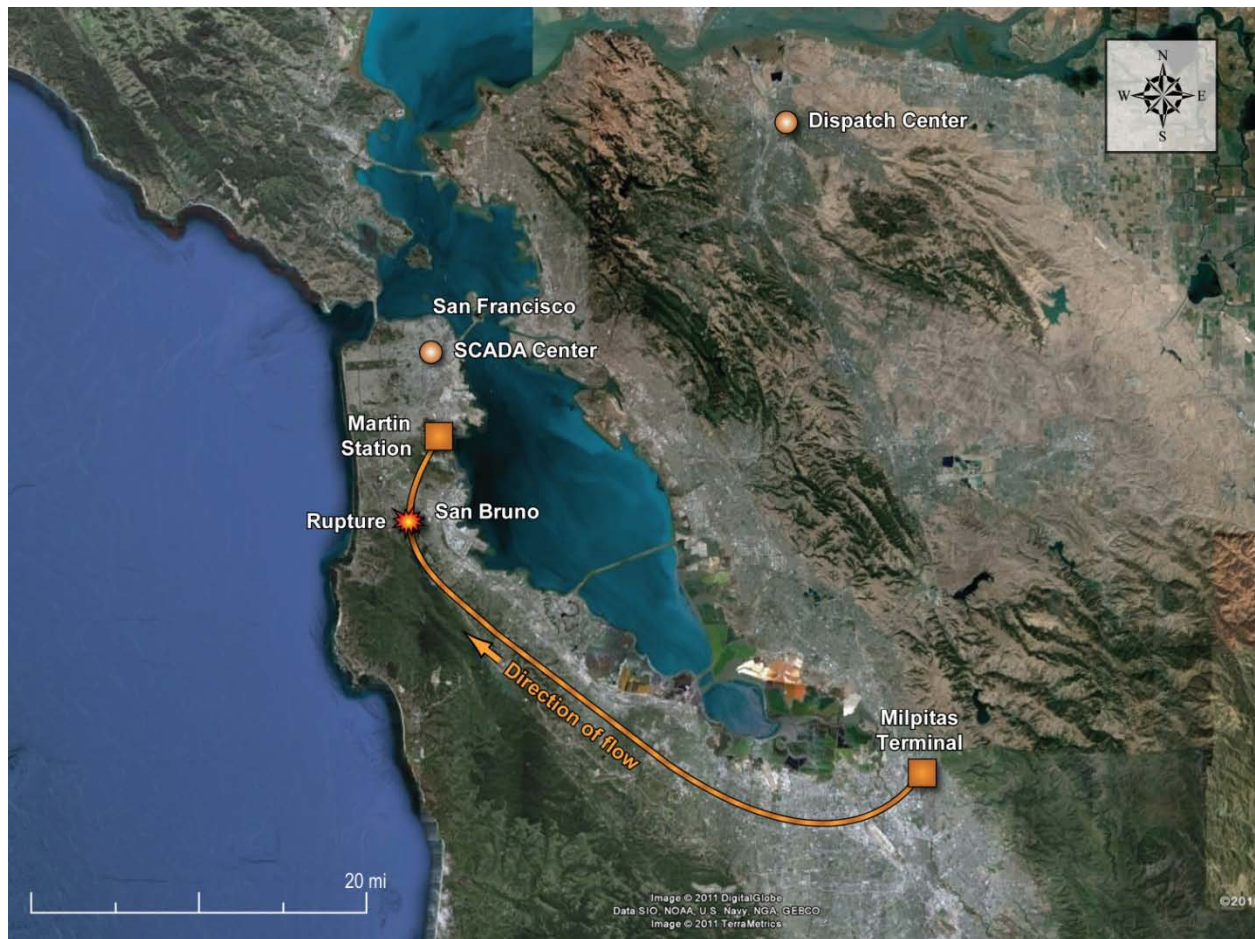
**Figure 4.** Overview of Line 132.

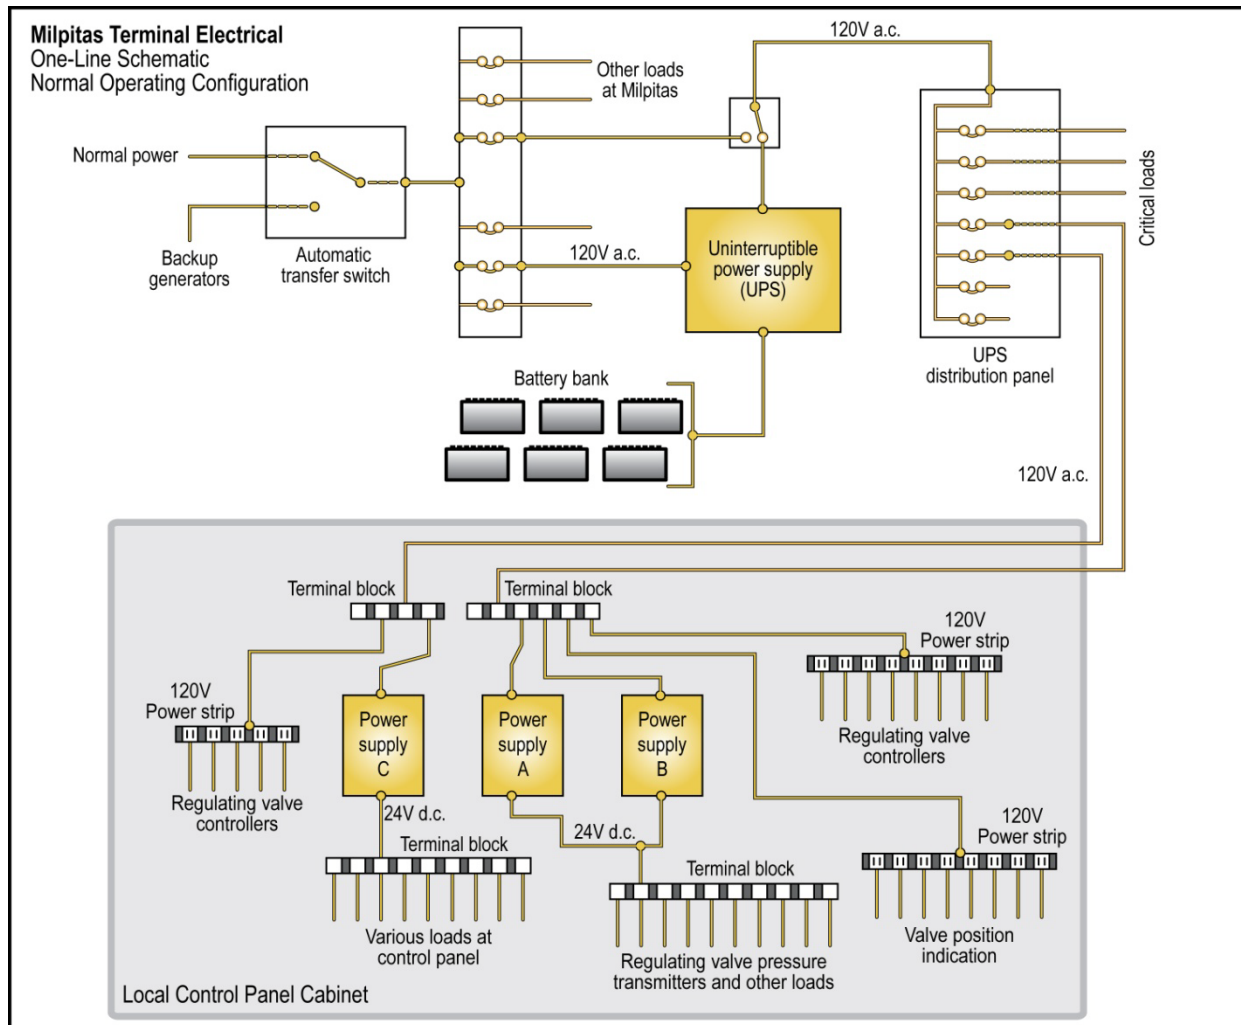
Following the transfer of critical loads from the UPS panel, workers at the Milpitas Terminal began to remove power from an unidentified breaker. During that work, the workers opened a circuit that resulted in a local control panel unexpectedly losing power. (See figure 5.) Rather than reenergizing the circuit, the workers pulled drawings and began investigating how to power the local control panel from an alternate source. One of the technicians stated in a postaccident interview that while measuring electrical currents with a clamp-on amp meter, the workers noticed some of the displays at the local control panel went blank. Subsequent troubleshooting showed this to be the result of erratic output voltages from two redundant 24-volt d.c. power supplies (power supplies A and B on figures 6a and 6b). These

**Figure 6a.** Normal electrical configuration at the Milpitas Terminal.

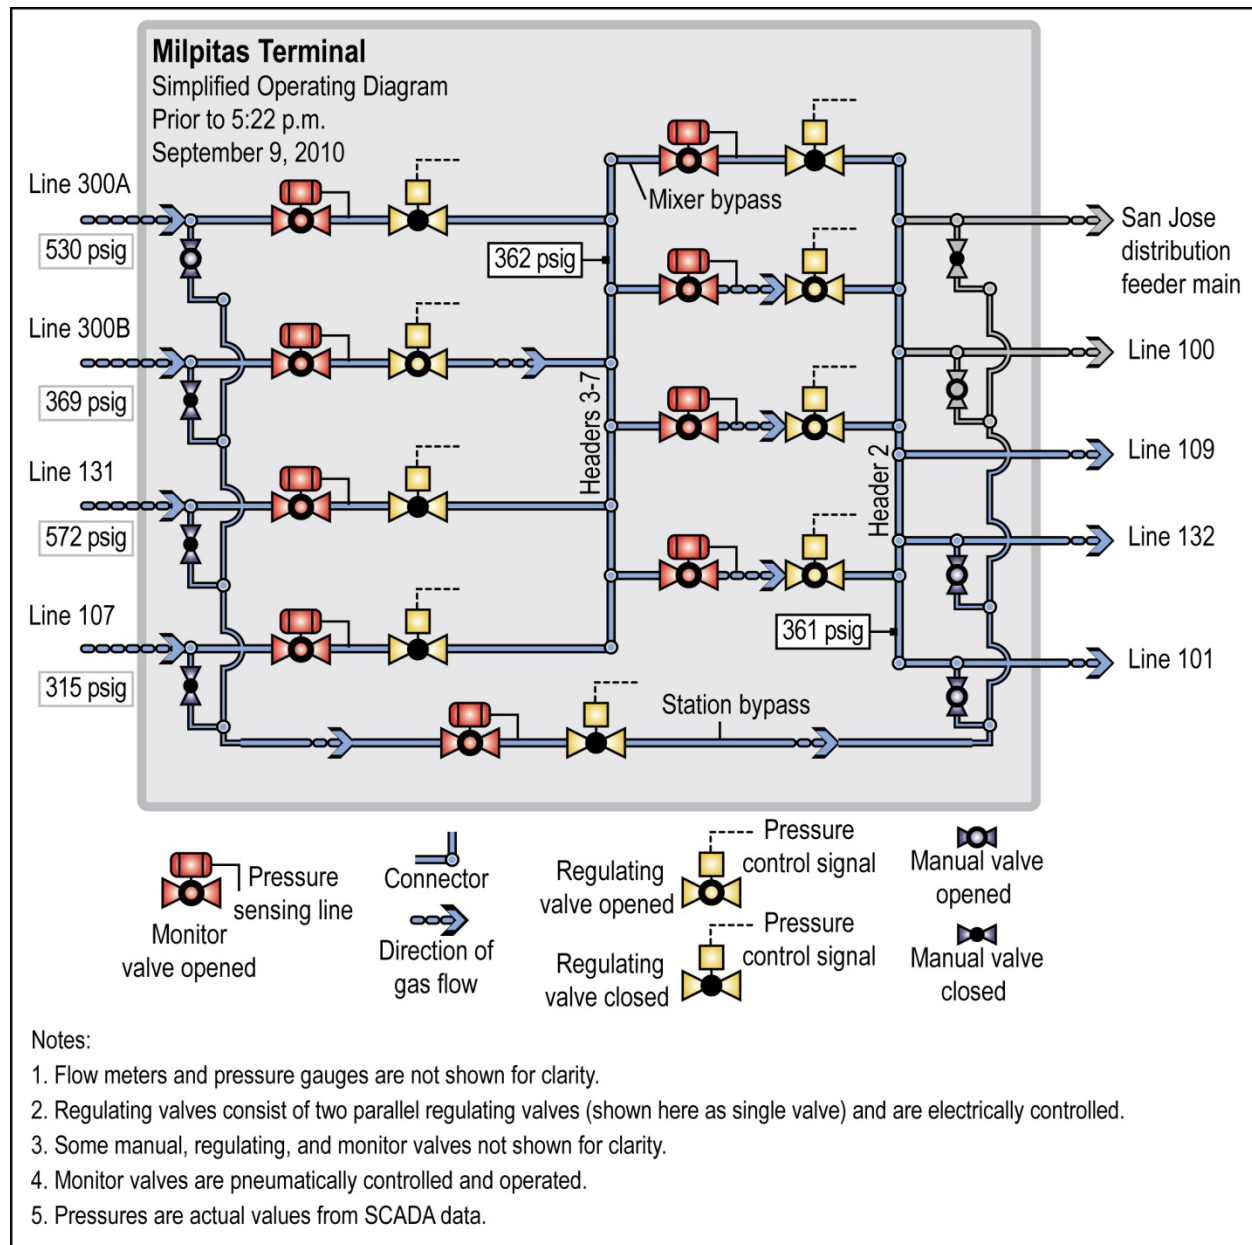
At 5:22 p.m., as a result of regulating valves fully opening and the erroneous signals caused by the erratic voltages, the SCADA center alarm console displayed over 60 alarms within a few seconds, including controller error alarms and high differential pressure and backflow alarms from the Milpitas Terminal. (See figure 8a.) These alarms were followed by high and high-high pressure alarms<sup>13</sup> on several lines leaving the Milpitas Terminal, including Line 132. At 5:25 p.m., SCADA operator C called the Milpitas technician to report the high pressure alarms, stating that they “look real.” During this conversation, the Milpitas technician realized that the pressure and regulating valve controller displays on the local control panel had lost all data. At the same time, the SCADA consoles displayed constant pressures<sup>14</sup> on the downstream lines and showed all regulating and a majority of monitor and incoming line valves<sup>15</sup> at the Milpitas Terminal as not open.<sup>16</sup> (See figure 8b.)

**Figure 8a.** Valve configuration at the Milpitas Terminal prior to 5:22 p.m.

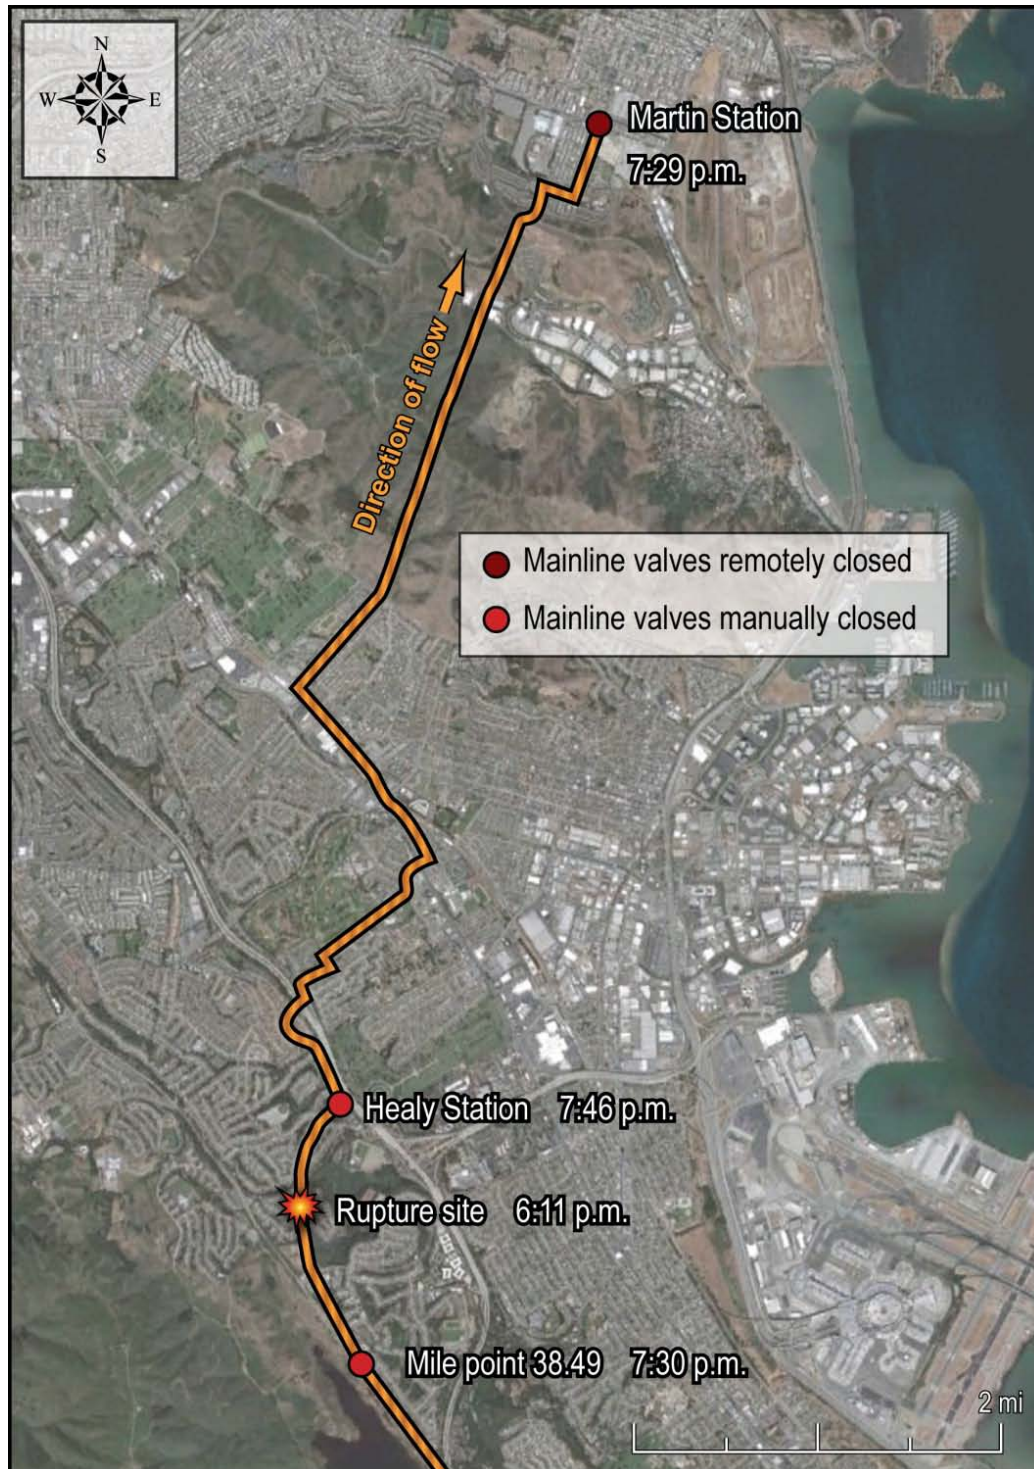
At 7:27 p.m., supervisor 6, who was with the two mechanics, requested that the SCADA center close two valves at the Martin Station. SCADA operator D remotely closed the valves downstream of the rupture by 7:29 p.m., which stopped the gas flow from north to south. (See figure 10.)

**Figure 10.** Location of valve closures.

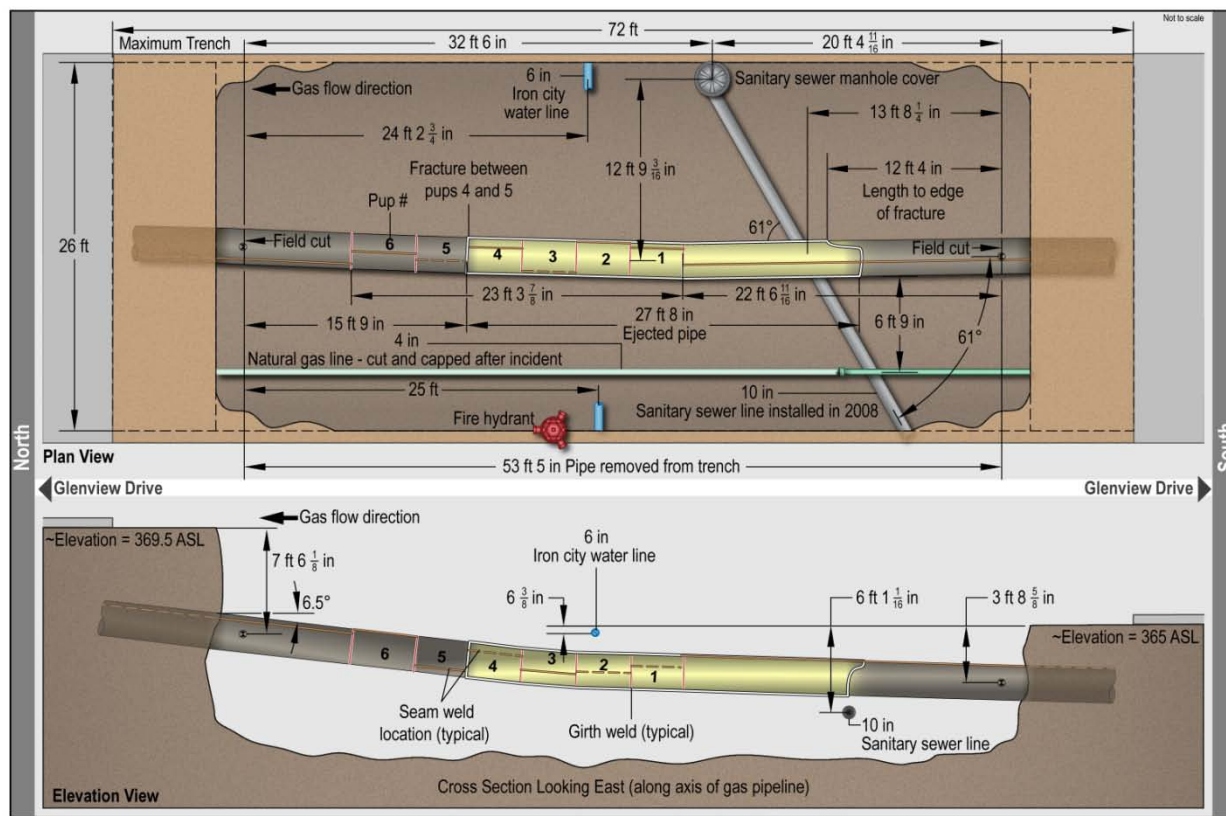
At the time of the accident, Line 132 was buried underground along the west side of Glenview Drive.<sup>45</sup> Other underground utilities at the accident site included a 6-inch-diameter water line, which crossed about 2.5 feet above Line 132 at the location of the rupture and was destroyed, resulting in the lack of functional fire hydrants near the accident scene. A 10-inch-diameter sanitary sewer line crossed below Line 132 about 108 inches south of pup 1. (The sewer line is discussed further below.) In addition, a 4-inch-diameter gas distribution line ran parallel to Line 132, about 6 feet 9 inches to the west. (See figure 16.) Farther below the buried utilities, at a depth of about 9 feet, was a drainage system with a catch basin running from west to east, which emptied into a canyon just east of the accident location.

**Figure 16.** Sketch of underground utilities environment.

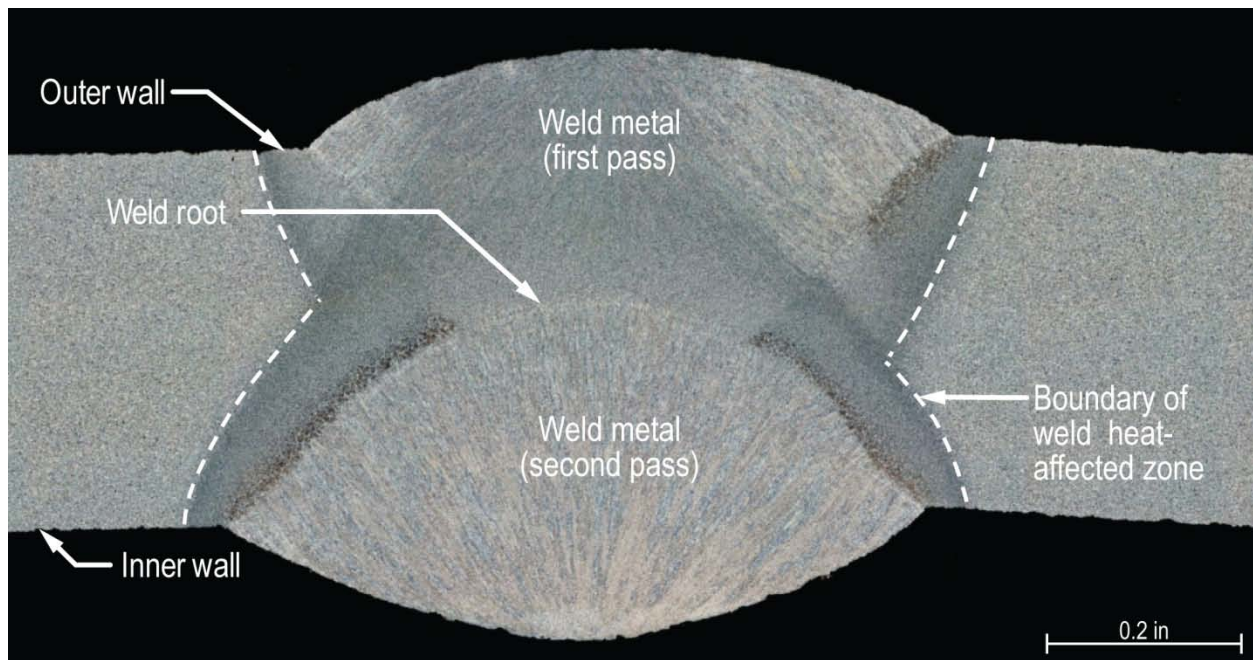
The south and north long joints, as well as pup 6, were standard factory-made DSAW pipe, made by a submerged arc welding<sup>65</sup> process on the outer- and inner-diameter surfaces. (See figure 19b.) The outer and inner weld passes overlapped, resulting in full penetration in the joint, and each weld exhibited a raised weld reinforcement with a smooth surface. No cracks or surface-connected defects were observed on the longitudinal seam welds of the DSAW pipe sections.

**Figure 19b.** Picture showing cross section of longitudinal seam in typical DSAW pipe.
