## Full-Scale Locomotive Dynamic Collision Testing and Correlations: Offset Collisions between a Locomotive and a Covered Hopper Car (Test 4)

| REPORT DOCUMENTATION PAGE | | | Form Approved<br>OMB No. 0704-0188 | |
|---|---|---|---|---|
| 4. TITLE AND SUBTITLE<br>Full-Scale Locomotive Dynamic Collision Testing and Correlations: Offset Collisions between a Locomotive and a Covered Hopper Car (Test 4) | | | 5. FUNDING NUMBERS | |
| 7. PERFORMING ORGANIZATION NAME(S) AND ADDRESS(ES)<br>Foster-Miller, Inc.<br>350 Second Avenue<br>Waltham, MA 02451-1196 | | | 8. PERFORMING ORGANIZATION<br>REPORT NUMBER<br>DFRA.040048 | |

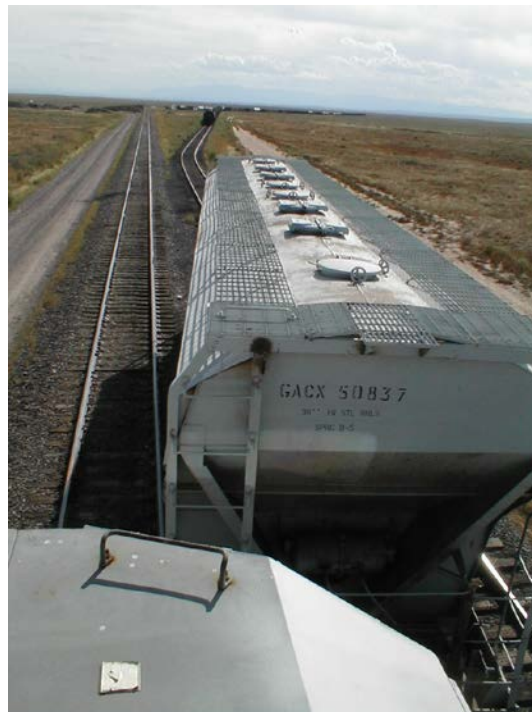
**Figure 8. Alignment of Locomotive and Covered Hopper Car at Point of Impact**

Figure 8 depicts the alignment of the locomotive and covered hopper car at the point of impact. The covered hopper car sits on a turnout connecting the locomotive's rail path to a parallel track, where it fouls the locomotive's right-of-way by approximately 36 inches (in). Figure 9 shows the engineer's view of the covered hopper car while the locomotive was parked during pretest activities.

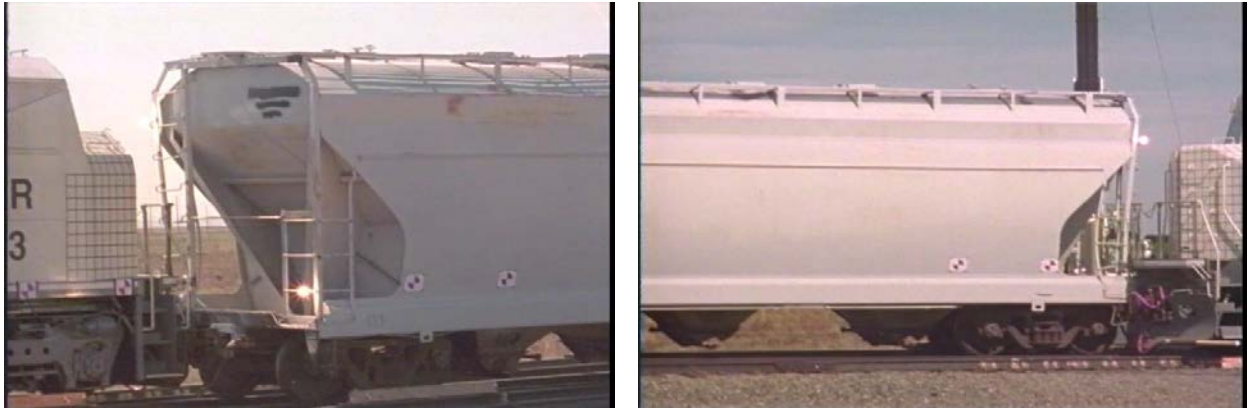
**Figure 10. Test at Moment of Impact**

- The first contact between the moving locomotive and the stationary covered hopper car occurred when the anticlimber touched and deformed the ladder at the corner of the hopper car (Figure 10). Soon thereafter, the locomotive plow made contact with the hopper side sill and was bent back toward the locomotive end plate. The hopper ladder and locomotive plow, being nonstructural elements, both immediately deformed.

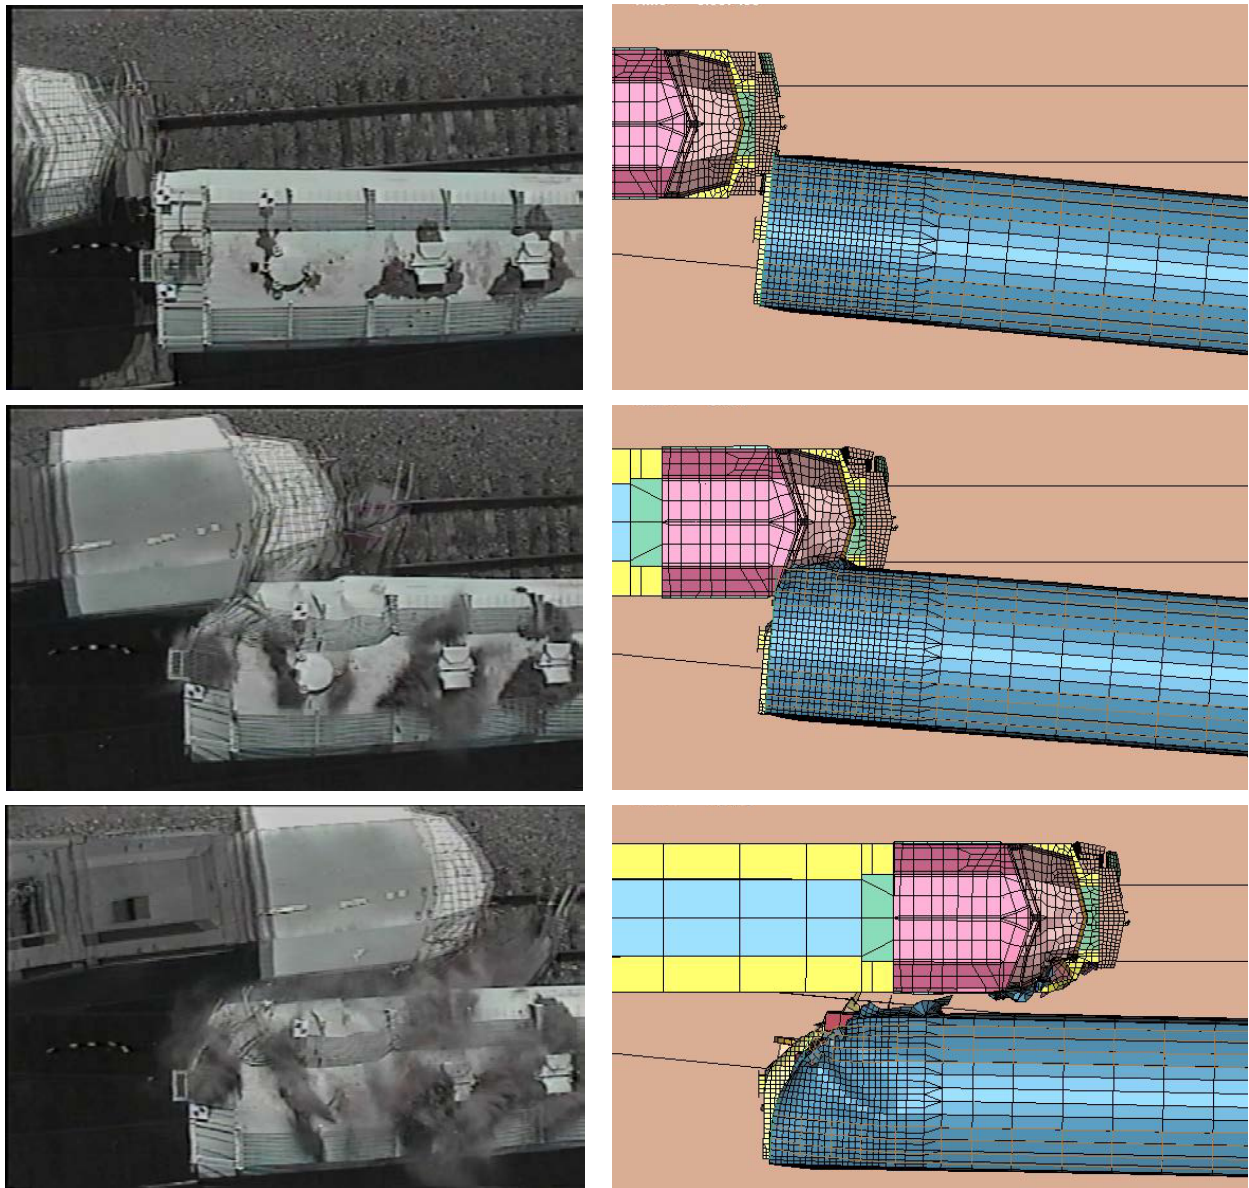
**Figure 24. Kinematic Comparison between Test and Simulation**

Figure 24 shows the dynamic sequence correlations between the test and the simulation captured at time equals 0.04, 0.225, and 0.64 s. The dynamic sequence as captured from the high-speed video seems to be in reasonable agreement with the simulations from the finite element analysis.

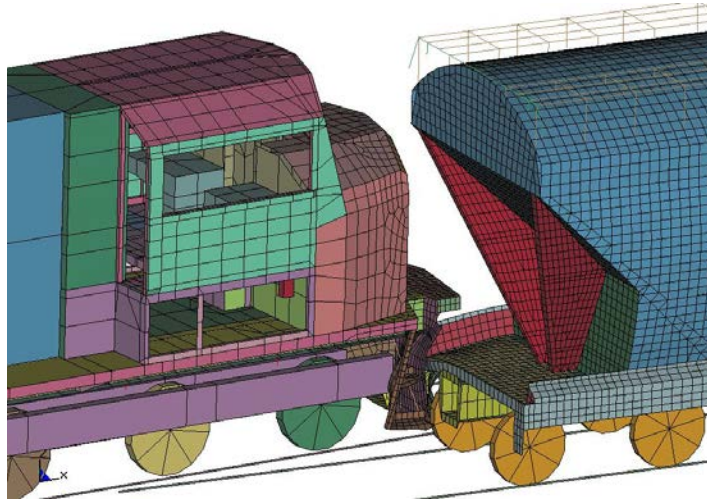
**Figure 25. Locomotive and Covered Hopper End Plates in Contact with the Truck**

- The locomotive plow and vertical end plate made contact with the covered hopper's side sill and horizontal end plate. The side sill and horizontal end plate were bent downward,

and the side sill torn open. Figure 25 shows that the left corner of the horizontal end plate was bent downward, making contact with the covered hopper's front truck.

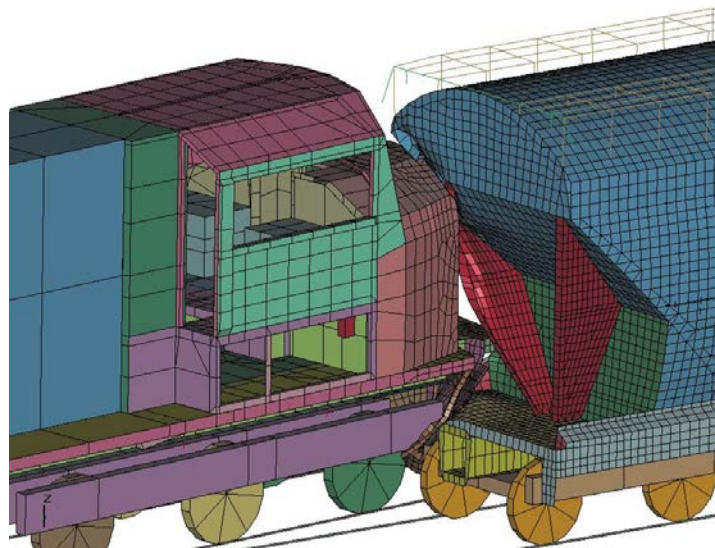
**Figure 26. Locomotive Hood in Contact with the Covered Hopper Car**

- The locomotive vertical end plate bent back underneath the underframe when it came in contact with the front truck. The locomotive plow was damaged but did not break free from the vertical end plate.
- The deformation and interaction of end plates and trucks on the two cars were sufficient to form a ramp that separated the two cars apart from each other; the locomotive moved to the left, whereas the covered hopper's front truck shifted to the right. Figure 26 shows that the impact end of the covered hopper shifted away from the locomotive as the hood of the locomotive interacted with the body of the covered hopper car.

- As the end-plate interaction occurred, the locomotive hood made contact with the sloped end of the covered hopper's body. The locomotive hood was significantly damaged with

plastic deformation at the side of the right collision post. Figure 27 shows that the hopper body side and roof were significantly damaged, exposing the ballast inside the hopper body.

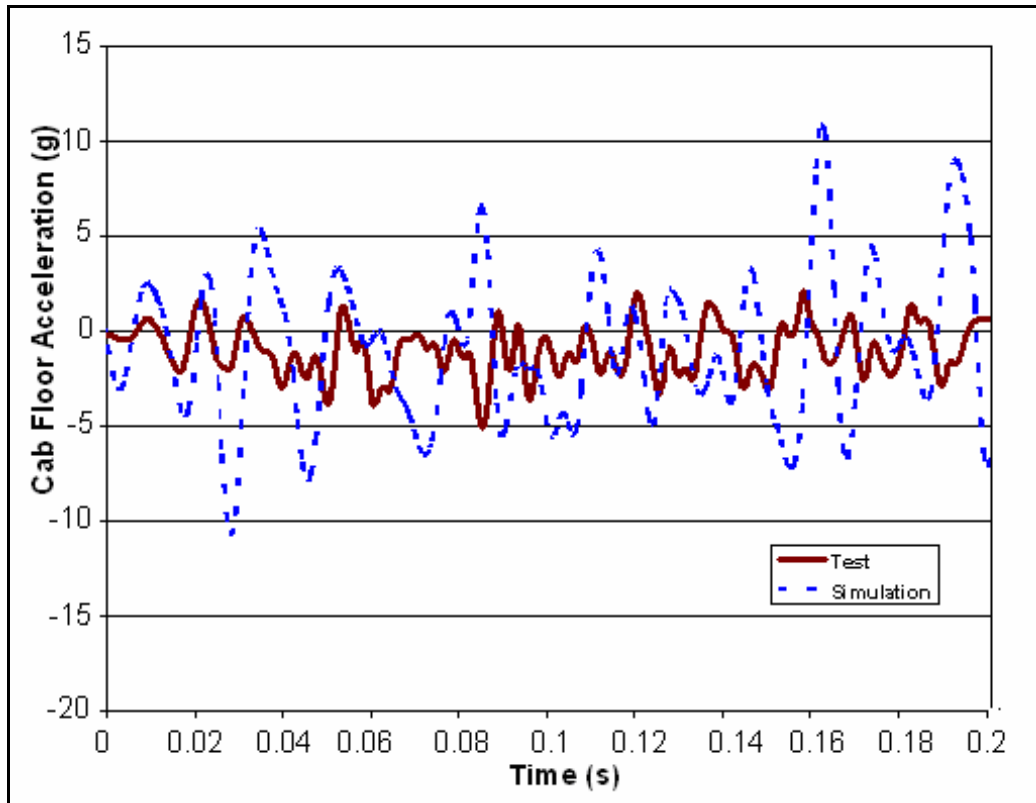
**Figure 30. Locomotive Cab Floor Longitudinal Acceleration Filtered at 60 Hz**

Figure 30 shows the acceleration correlations between the test vehicles and the finite element simulation. SAE J211 60-hertz filter was used for structural acceleration data. As shown in the figure, the simulation prediction for longitudinal acceleration of the locomotive cab floor varied from the test accelerations. In addition, the results show that the peak longitudinal accelerations for the cab floor were lower than the predicted values.

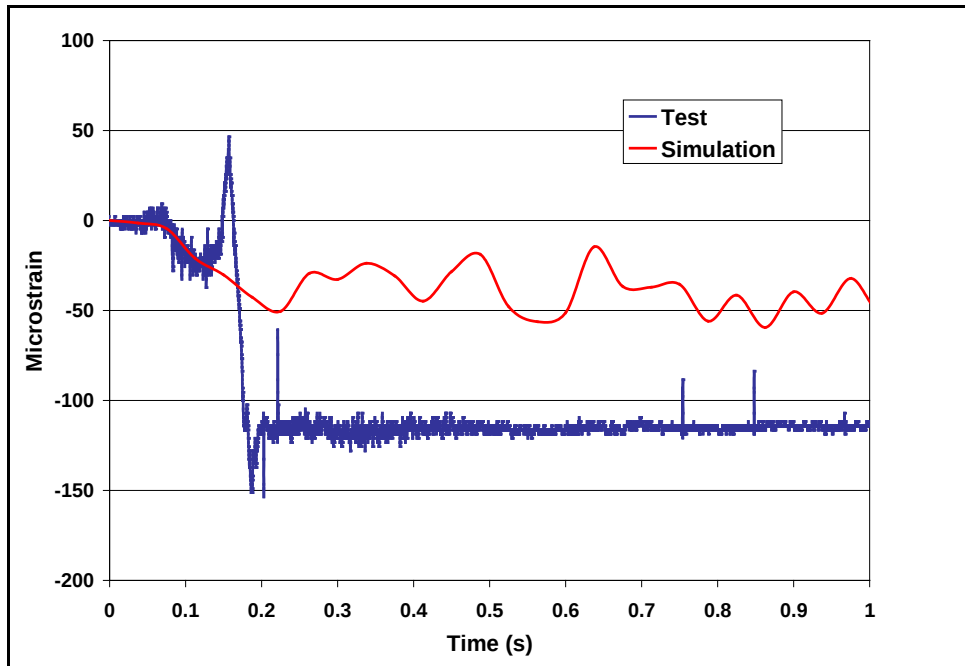
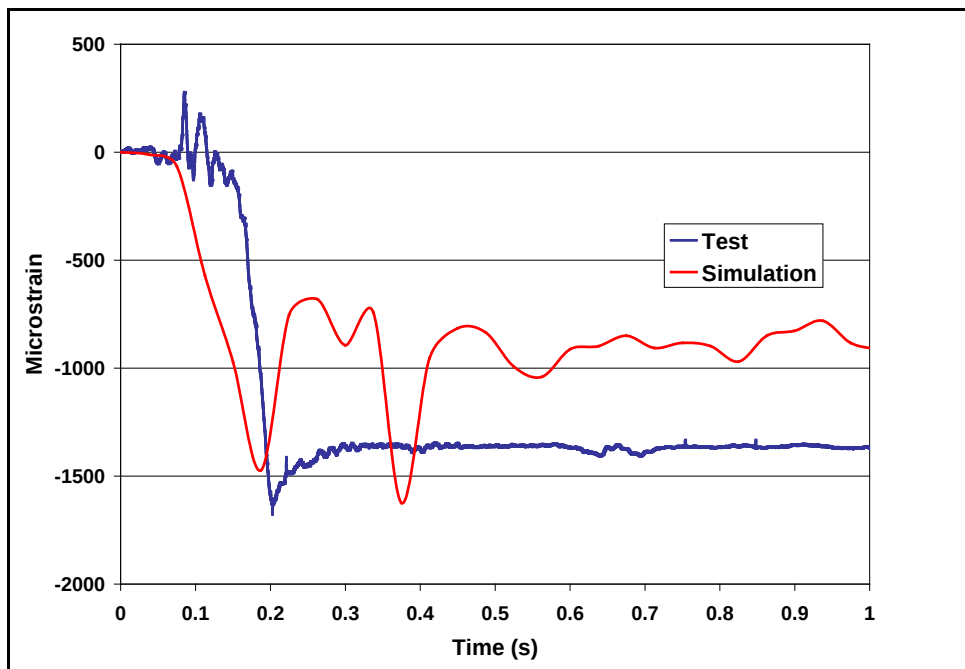
The above figures show that simulation results are in poor, mixed agreement with the test data on the right collision post for gauge location 1 during the first 0.1 s of the collision locations.

The largest strain on the collision post was 1,800 microstrain. TTCI measured this value on the longitudinal leg of the rosette gauge (location 10) located on the bottom front of the right collision post in the test. The simulation found the largest strain at the same location (location 10) on the right collision post with a value of 1,650 microstrain during the same time frame.

The strains at the top front of the collision posts caused permanent deformation at both collision post locations. The locomotive crashing into hopper cars in the simulation caused the plastic deformation.
