U.S. CHEMICAL SAFETY AND HAZARD INVESTIGATION BOARD

# **INVESTIGATION REPORT**

## **EXPLOSIVES MANUFACTURING INCIDENT**

### **SIERRA CHEMICAL COMPANY**

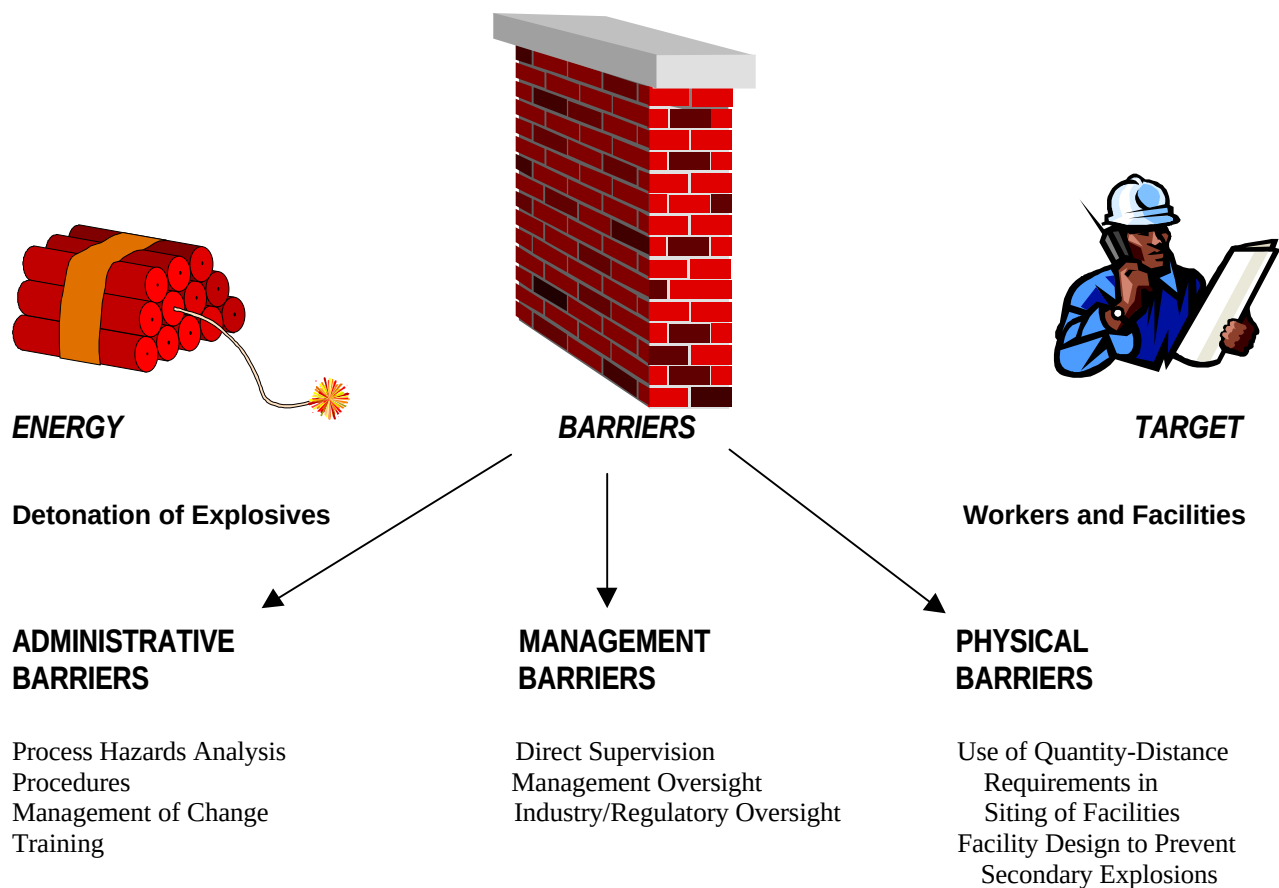
**Figure 13. Barrier Failure Analysis**

Barrier analysis is used to identify administrative, management, and physical barriers that could prevent, control, or reduce energy flows such as explosions to targets such as people or objects. This barrier analysis was concerned with those barriers that could have prevented or mitigated the impact of explosions but that either failed or were missing. The summary of this analysis, in Figure 13, shows barriers associated with all four credible initiating events.

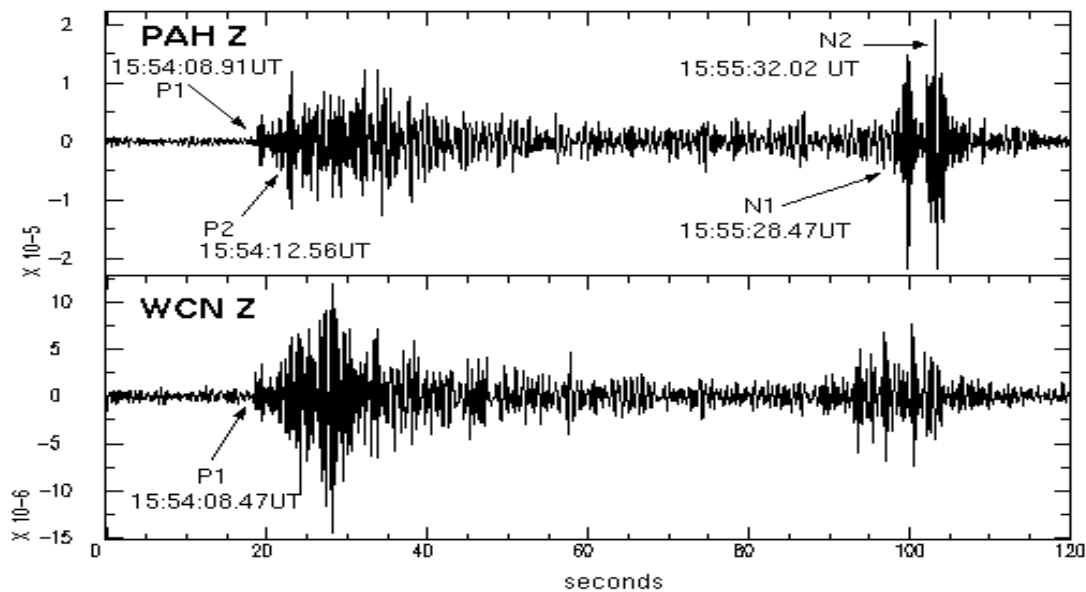
**Figure 2a.**

seismograms include two conspicuous P-wave arrivals, followed by an "N-wave" (*Kanamori et al., 1991*) that is created by the shock wave traveling in air. An examination of the seismograms (Figure 2) shows that there are two explosions separated in time by about 3.5 seconds. The phase that appears to be an S-wave in Figure 2 is the P-wave arrival from the second explosion, although there may be some amplitude contribution from an Lg phase. The station geometry relative to the source area is such that the P-wave arrival from the second source is nearly coincident with the expected Lg arrival from the initial event at both PAH and WCN. Evidence for the interpretation of these phase arrivals is based on the nearly same time separation observed in the air-wave arrivals at several stations. The larger amplitude of the P-wave and air-wave phases for the second event suggests that this was the larger of the two explosions, although the coupling of the explosion must also be taken into account in this interpretation.

Figure 2a. Vertical component seismograms from station PAH and WCN. The P1 and P2 labels indicate P-wave arrivals for explosion A and B. N1 and N2 labels indicate the N-wave (air wave) arrivals for explosion A and B.

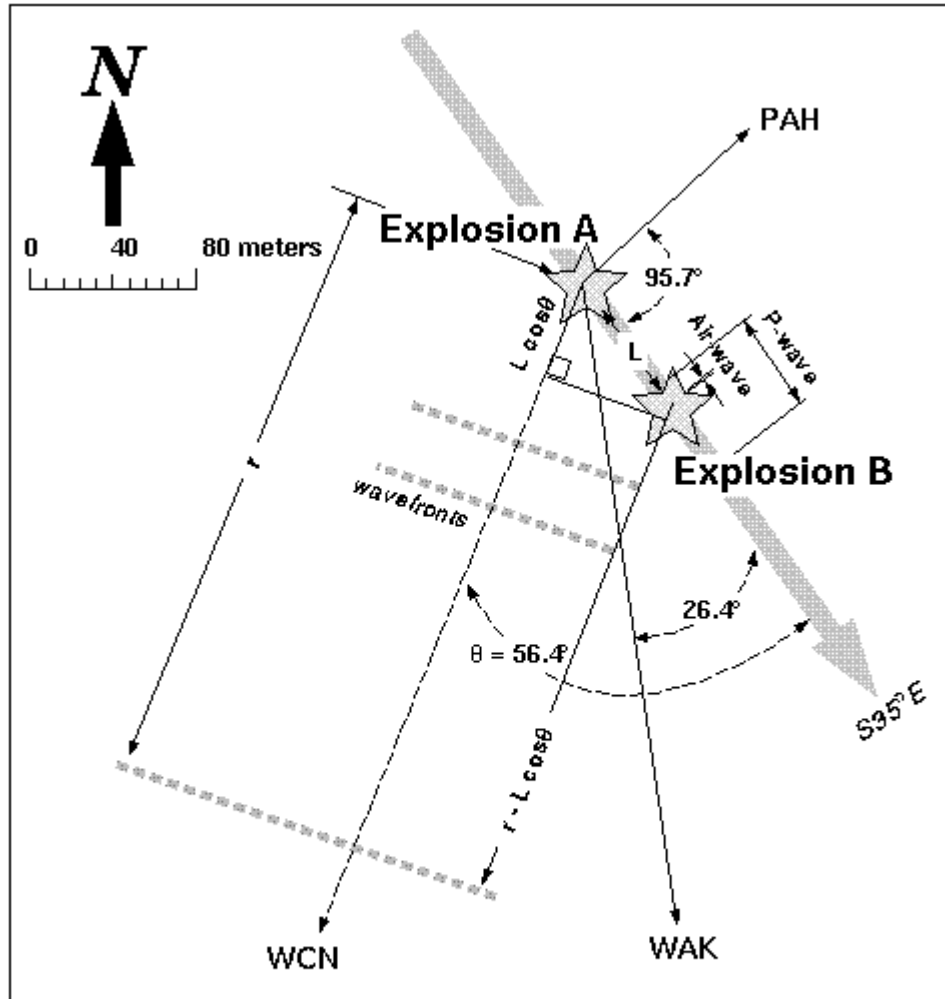
The relative locations based on the moveouts of these phases are, within error bars, consistent with the location of the second event based on the CSB investigation. The differences in separation between our estimate (73.2 meters) and the CSB estimate (76.2 meters) is small compared to the source dimensions, and the difference in azimuth between our estimate of  $S35^\circ$

E (145.1°) and the CSB estimate of S33°E (147°) is also within the range of angles that is allowed by the source sizes. The uncertainties in measuring  $\tau_s - \tau_r$ , shown in Table 3, corresponds to the standard deviation of  $\phi(\theta, f)$ . This standard deviation is considered as the maximum uncertainty of determining the slope using equation (1). There is always a  $2\pi n$  uncertainty in unwrapping the phase spectra but since an initial shift was performed, we expect  $n$  to equal around 1 and the maximum uncertainty in  $n$  to be less than  $2\pi$ . The uncertainties in determining the slope of the cross phase spectra are then propagated through equation (3) by fixing  $\theta$  and using the correct polarities of the  $\tau_s - \tau_r$  uncertainties. This gives the maximum uncertainty in source separation given only a pair of stations and their geometry. The importance in receiver geometry on uncertainty is shown by the difference in separation uncertainties, with  $\pm 7$  meters between PAH and WAK, which are almost along strike of the explosions, and  $\pm 21$  meters between WCN and WAK, which are relatively more perpendicular to the strike. The  $\tau_s - \tau_r$  uncertainties are not propagated through the simultaneous determination in L as a function of  $\theta$  because it is used to show the best combined estimates of these parameters.

**Figure 5.** A Schematic map of the explosion site with likely geometry of explosions marked as "stars" and the estimated relative separations shown as uncertainties along azimuth of S35°E. See equation (3) in text for variable definitions. The

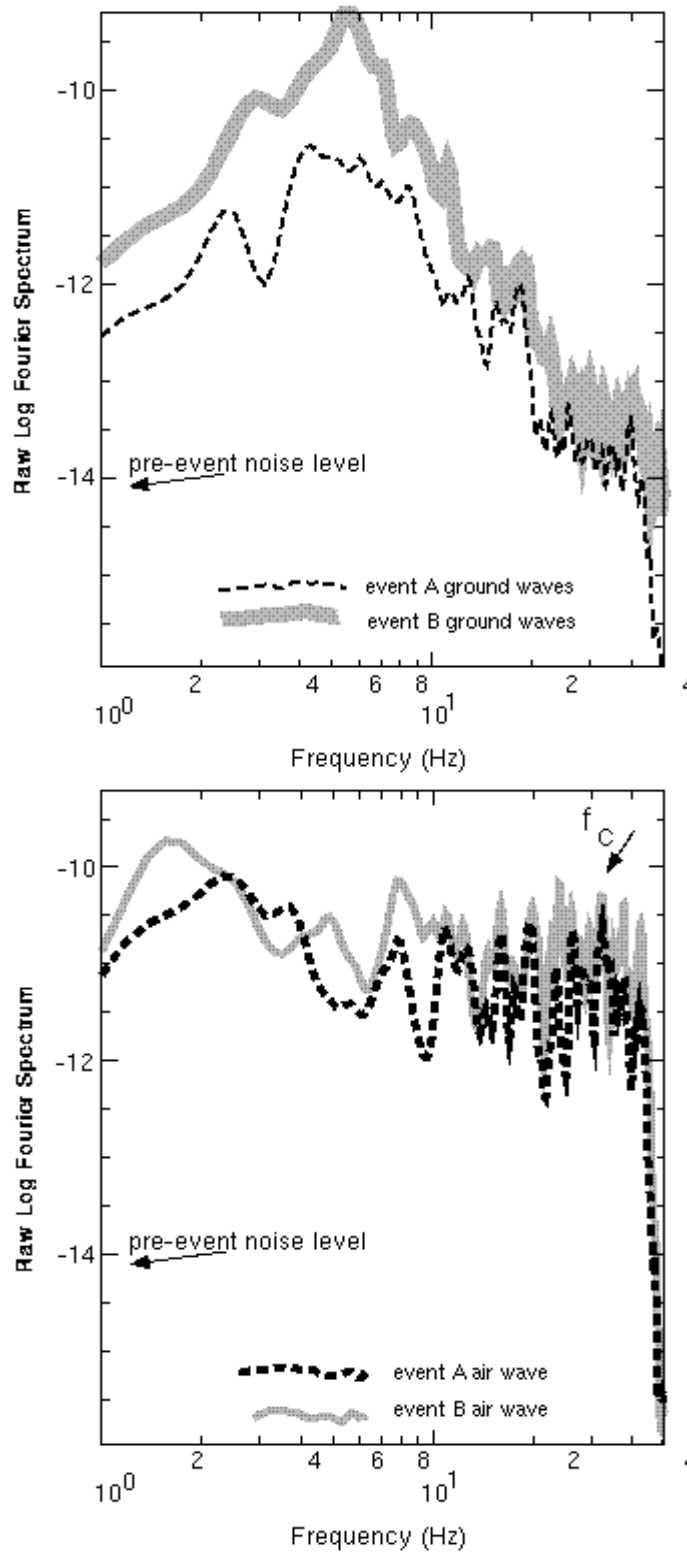
**Figure 6.** Uncorrected P-wave and air-wave

Figure 6 shows the uncorrected spectra of the P-wave and the air-wave from the two explosions at PAH (Guralp CMG-40 velocity sensor). The three components are log averaged and then smoothed. Based on the P-wave at PAH, explosion B was 3 to 4 times larger than explosion A, consistent with reports that the second site "B" contained more explosives. The spectrum of air-waves of explosion B is only a little larger than explosion A. This may suggest that explosion B was more coupled to the ground, allowing more energy to be partitioned into the ground than into the air. The CSB hypothesized that the second explosion was triggered when debris from the first explosion crashed through the ceiling or skylight at the second site. If so, we speculate that the second explosion may have been triggered at the top of the stockpile, resulting in downward directivity and a different partitioning of energy between the ground and the air.

The spectral curves are the smoothed log average of the three components of motion. The arrow points to peak spectral value of a noise window before explosion A.
