U.S. CHEMICAL SAFETY AND HAZARD INVESTIGATION BOARD

INVESTIGATION REPORT

Pesticide Chemical Runaway Reaction Pressure Vessel Explosion

Report No. 2008-08-I-WV
January 2011

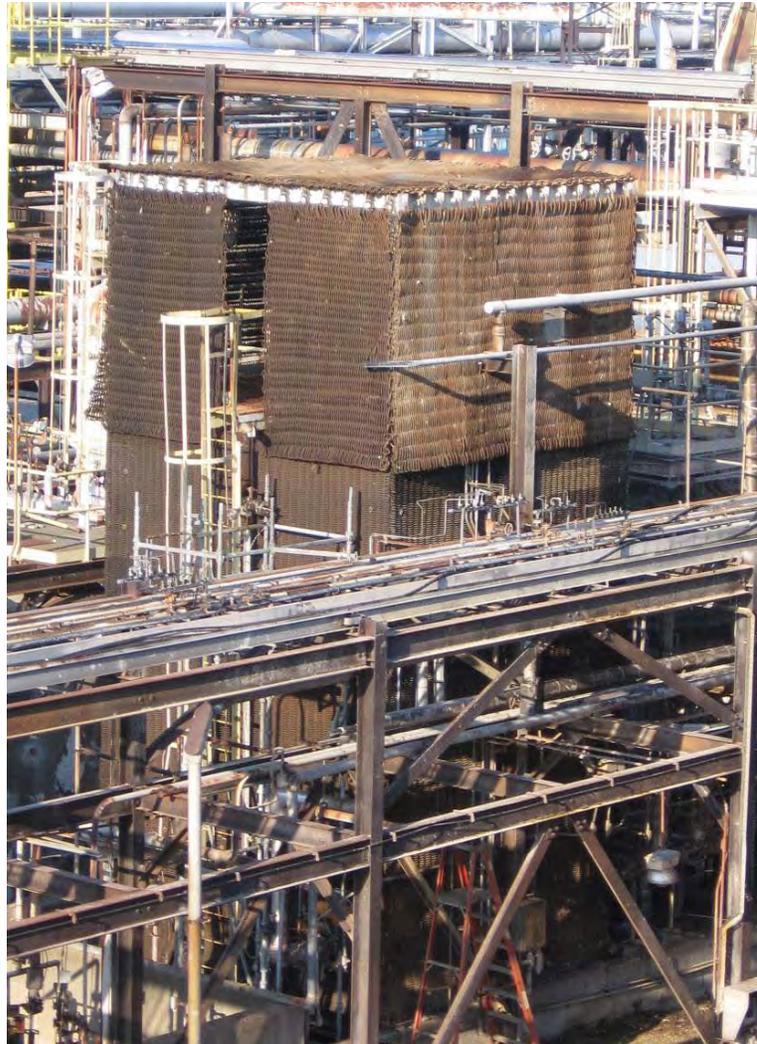
Figure 2. MIC day tank shield blanket structure

The control system contained redundant pressure, temperature, and flow instruments including high-pressure and high-temperature alarms and refrigeration system failure alarms. The area around the tank was equipped with air monitors to detect MIC. Firewater monitors (stationary spray nozzles) were located nearby to mitigate an MIC leak and suppress a fire that might threaten the tank. A wire rope blast blanket surrounded the entire tank and top piping connections (Figure 2) to stop debris from striking the day tank and to provide a thermal shield from radiant heat from a nearby fire.

The MIC day tank was adjacent to the methomyl-Larvin unit. A steel rope mesh ballistic shield (blast blanket), mounted on the sides of and on top of a structural frame, protected the tank in the event of an explosion in the unit or nearby equipment (see Figure 2). Flying debris from the residue treater explosion struck the blast blanket. The fires radiated intense heat on the blast blankets.

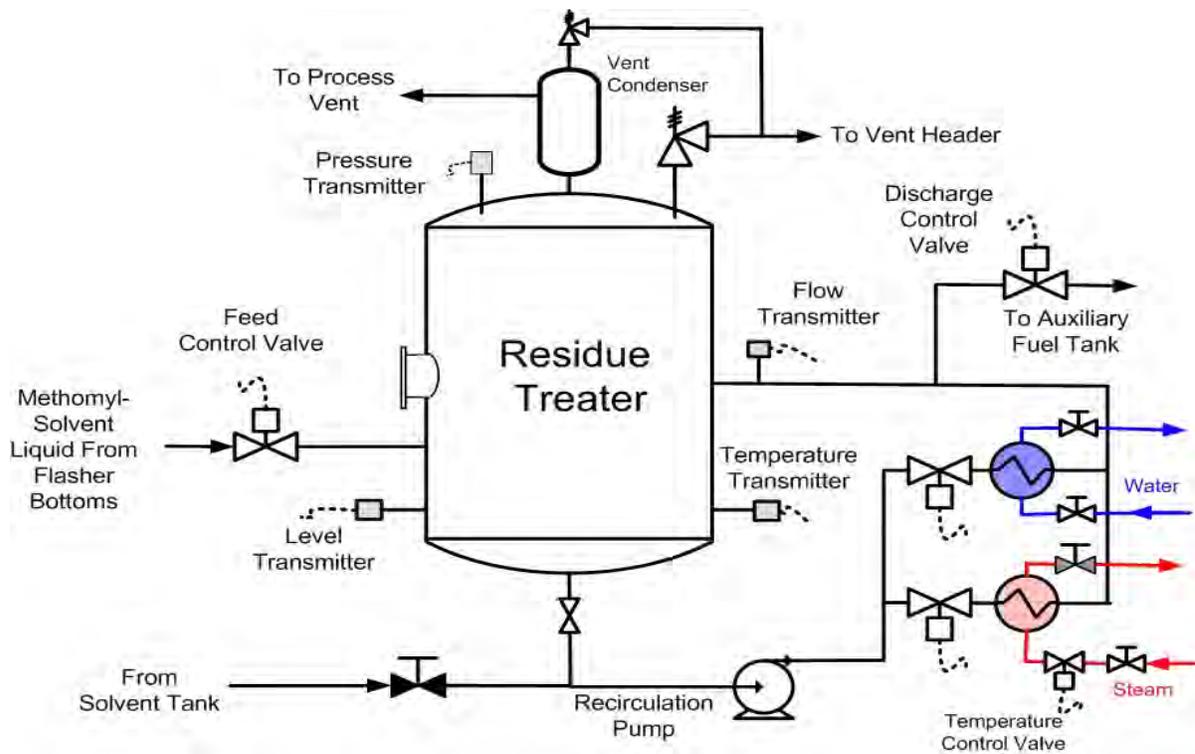
Figure 10. Residue treater piping system layout

The residue treater (Figure 10) had an automatic level control system to control the liquid level at about 50 percent. The residue treater recirculation system was used to heat the solvent at the beginning of a new production run, mix the incoming flasher bottoms into the partially filled vessel,

It was determined that the automatic temperature control system closed both the heater and cooler flow control valves (see Figure 10) at the same time when the recirculation temperature control transitioned from heating to cooling. Bayer examined the temperature controller and its investigation team concluded that

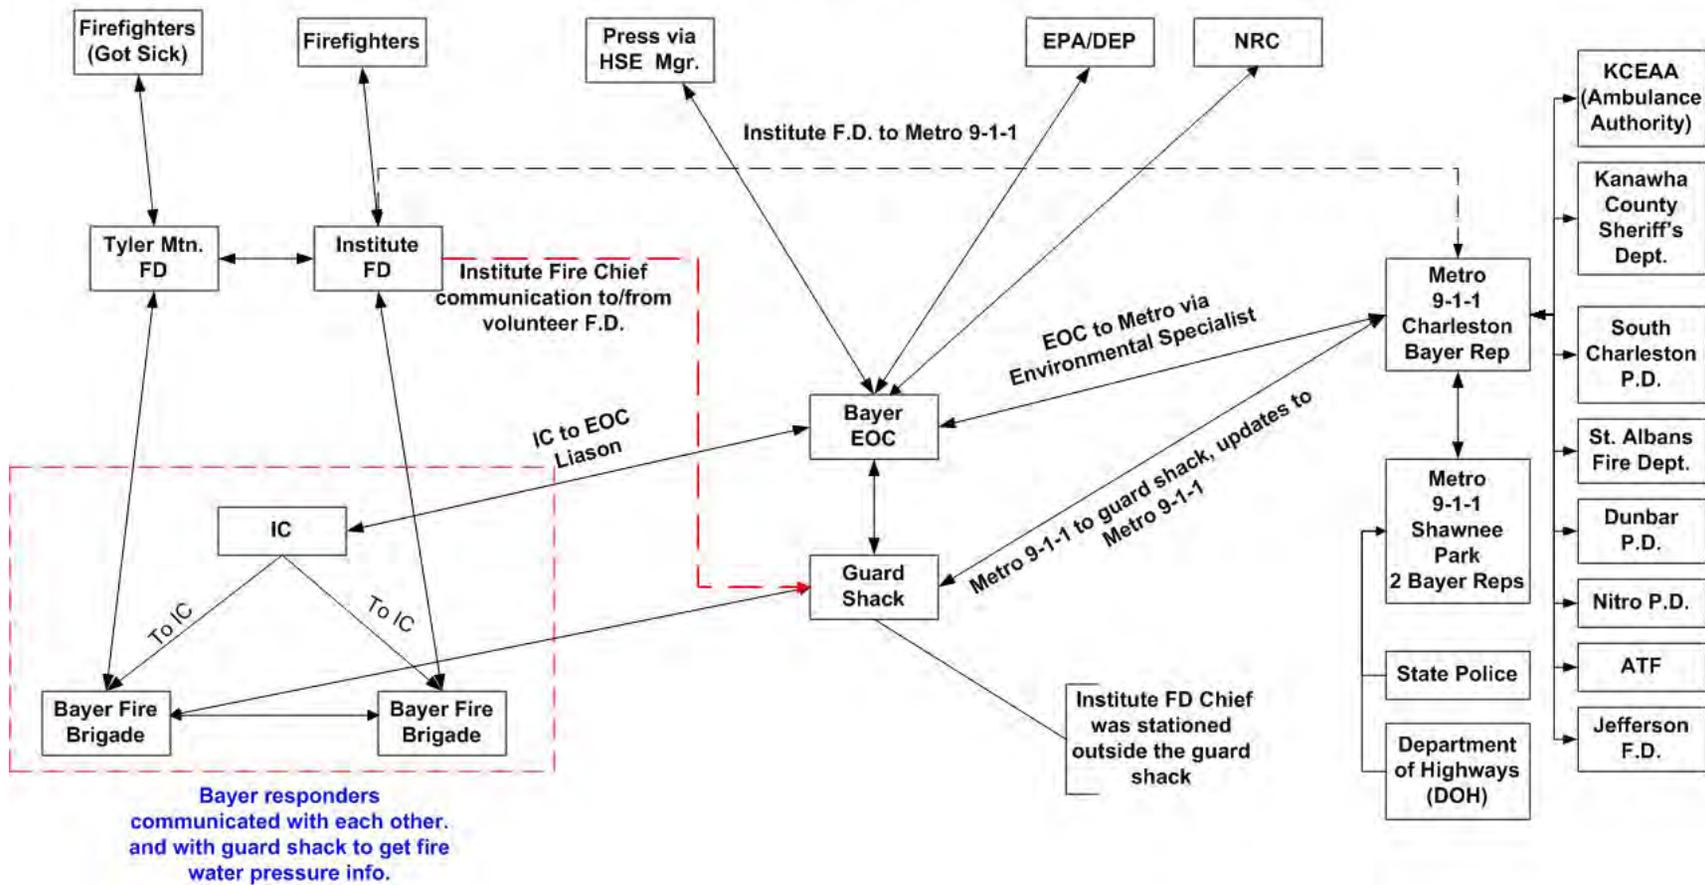
Figure 16. Methomyl unit explosion emergency communications diagram

The Kanawha County Sheriff heard a loud explosion at about 10:30 p.m. After hearing state and county radio traffic indicating that an explosion had occurred near the Bayer plant, he radioed Metro 9-1-1 while en route to the facility. He then requested that Metro Communications contact the Nitro and Dunbar Police Departments to arrange for roadblocks of Route 25 at the city limits to restrict traffic flow into the Institute area. The county EOC also routed information to and from the various responding municipal, state, and county agencies. Responding agencies included South Charleston, Nitro, and Dunbar Police Departments; the Jefferson and St. Albans Fire Departments; the Kanawha County Sheriff's Department; the State Fire Marshal's Office; the U.S. Bureau of Alcohol, Tobacco, and Firearms and Explosives, (ATF); and the KCEAA. All of these agencies routed their communications through the EOC during the emergency (Figure 16). As the night progressed, the Metro 9-1-1 call center received more than 2,700 phone calls, which overwhelmed the system.

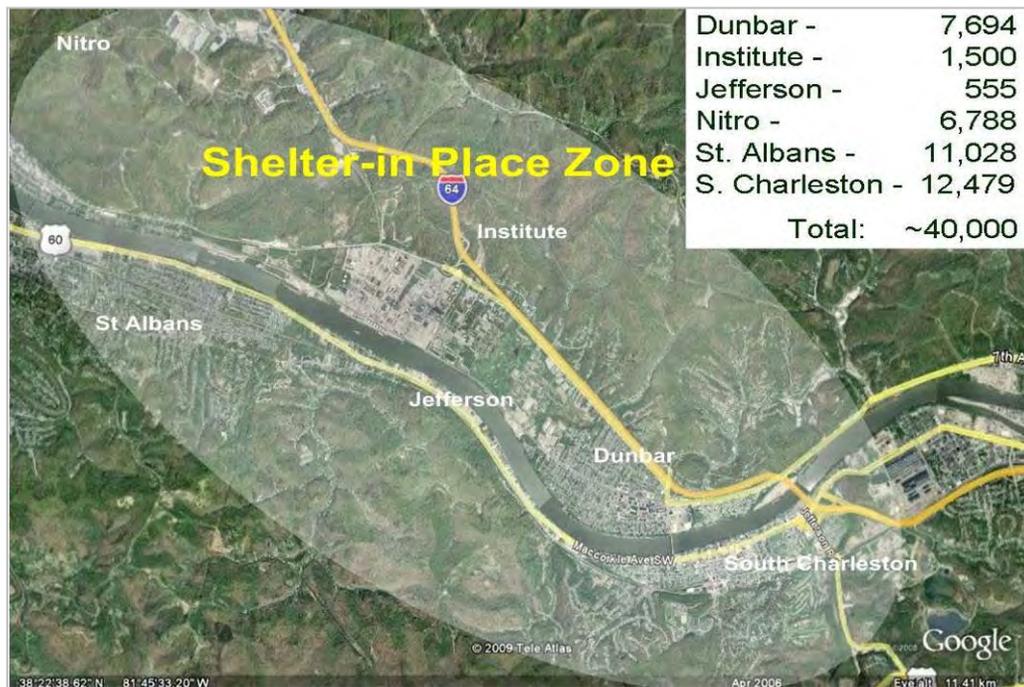
Figure 17. Areas and population affected by the shelter-in-place

At 11:19 p.m., Metro 9-1-1 announced a shelter-in-place for the immediate area surrounding the Bayer facility, and initiated a reverse ring-down notification³³ to the residents in the affected community. Five minutes later, Bayer recommended that Metro dispatchers issue a shelter-in-place for the St. Albans area. At about 11:34 p.m., the KPEPC activated the County Emergency Alert System, which in turn initiated a shelter-in-place for the areas west of Charleston to Putnam County line. The shelter-in-place affected about 40,000 residents (Figure 17).

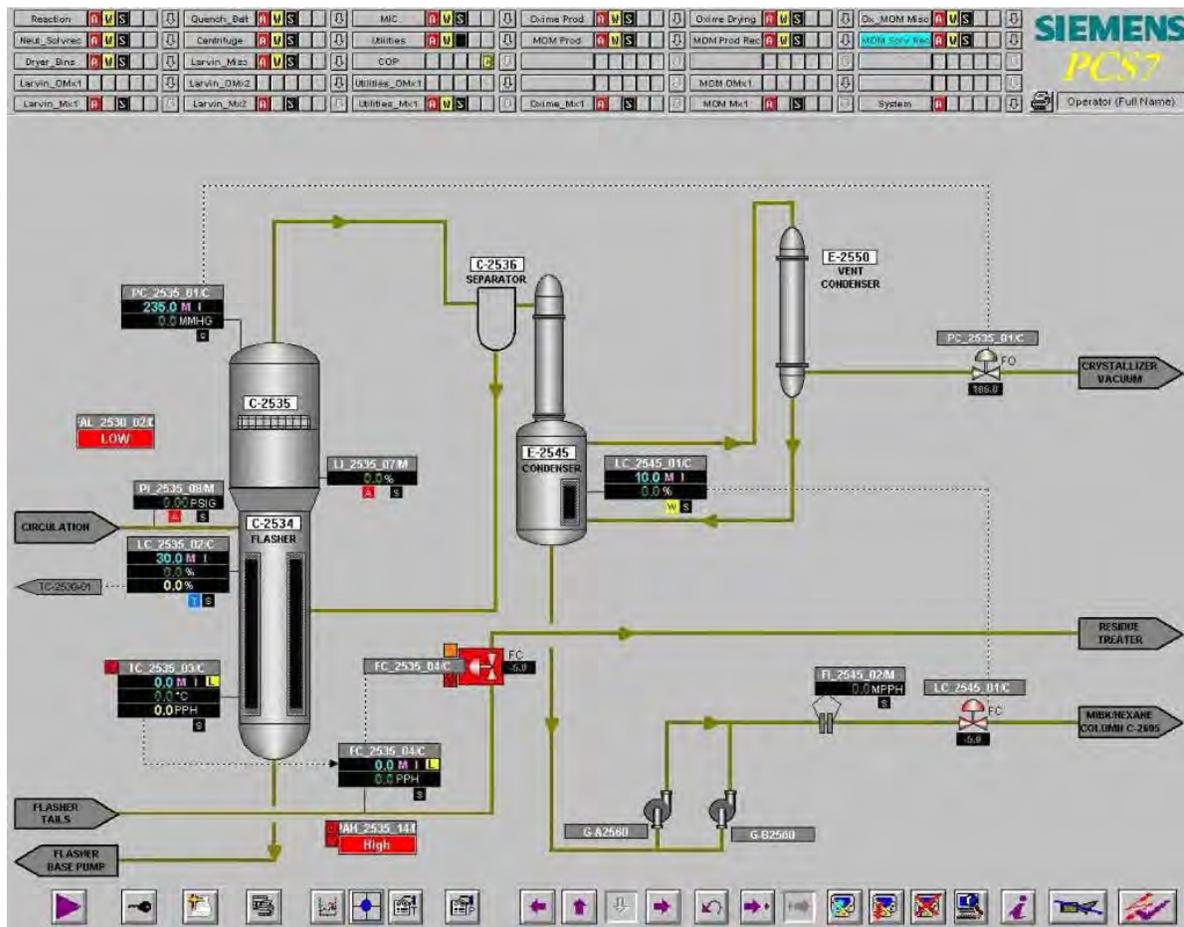
Figure 18. Typical Siemens work station screen display

The old system display and command entry was basically a spreadsheet, or line-item display. The new system used a graphical user interface (GUI) that displayed an illustrative likeness of the process and its various components (Figure 18). The board operator selected the device that needed to be changed. This made data entry clearer, but much slower. In the old system, board operators could change multiple process variables simultaneously, but they could select and change only one variable at a time in the Siemens system.

Prior to the methomyl startup, management provided operators time on the console during the DCS upgrade to practice using the new system. However, management did not require any methomyl operator to use this time to learn and practice operating the methomyl unit, and operators could decide for themselves how much time they needed to become familiar with the new DCS. Management also assumed that operators directly involved in designing the mimic displays, such as the one in Figure 18, and other customizable features would have had adequate exposure to the new system.

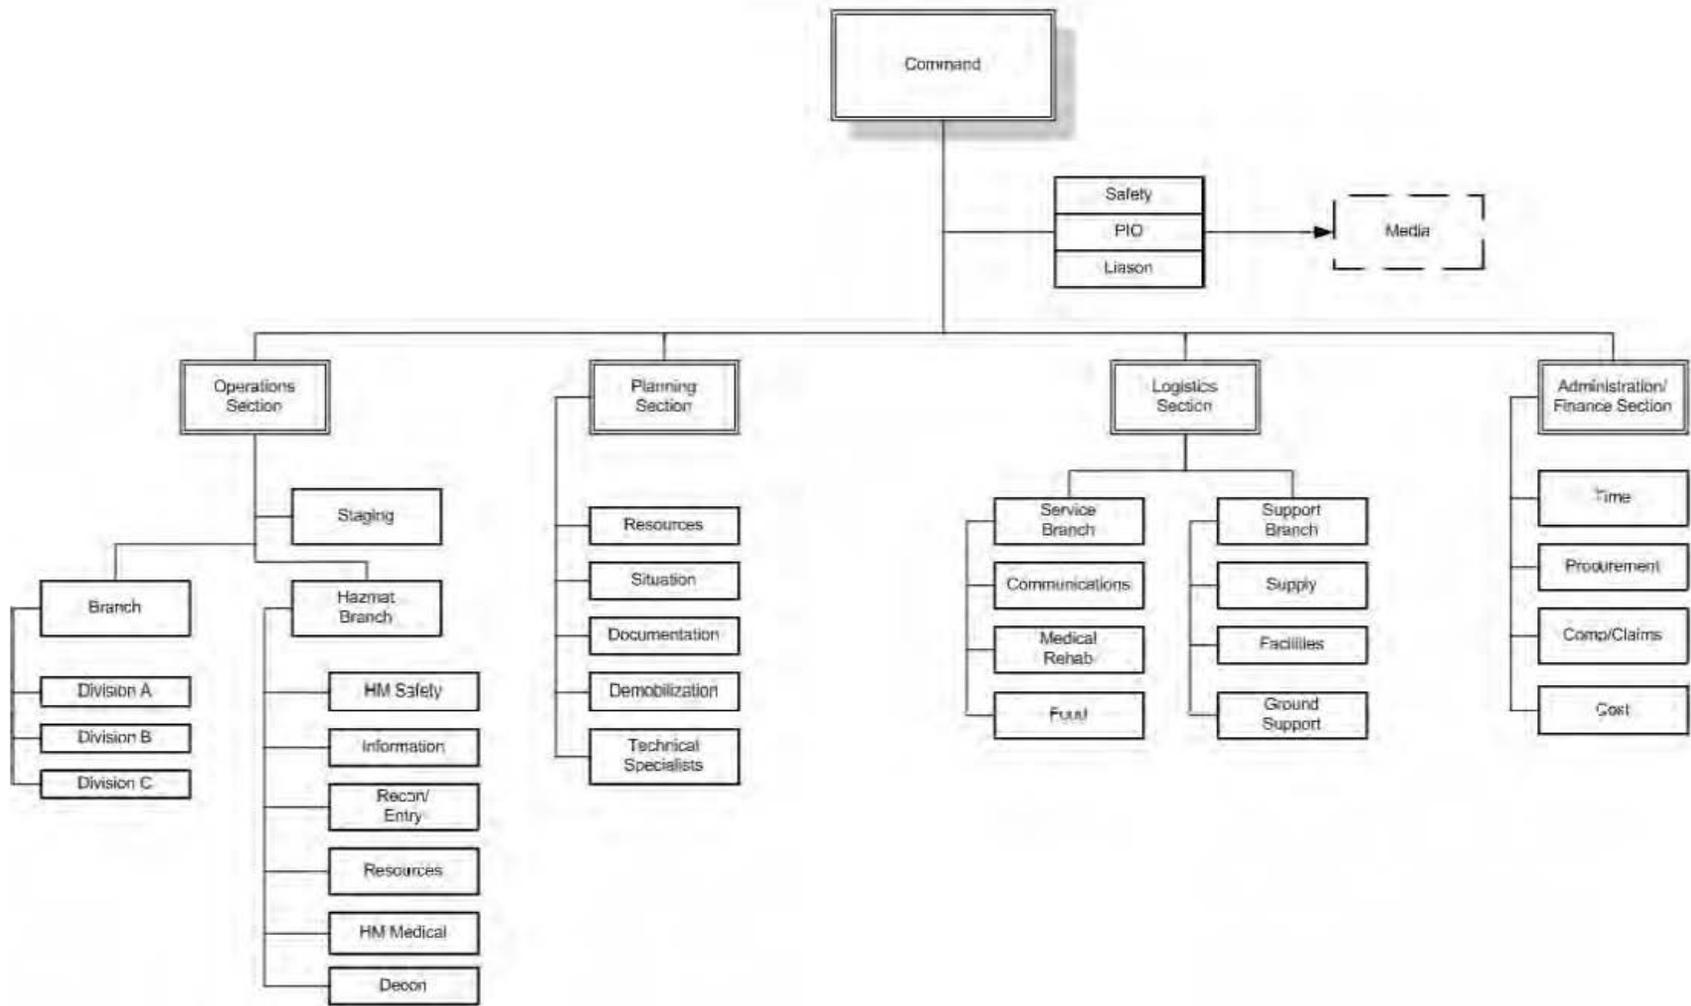
Figure 21. NIMS incident command structure

On the night of the incident, all of the responding outside agencies communicated via the Kanawha Putnam EOC. However, the Bayer EOC did not use a shared network to communicate with all responding agencies; thus, the responding agencies did not receive timely status updates. Important information updates about the continually changing conditions at the fire scene were not communicated to the other responding agencies (Knoll, 2005).

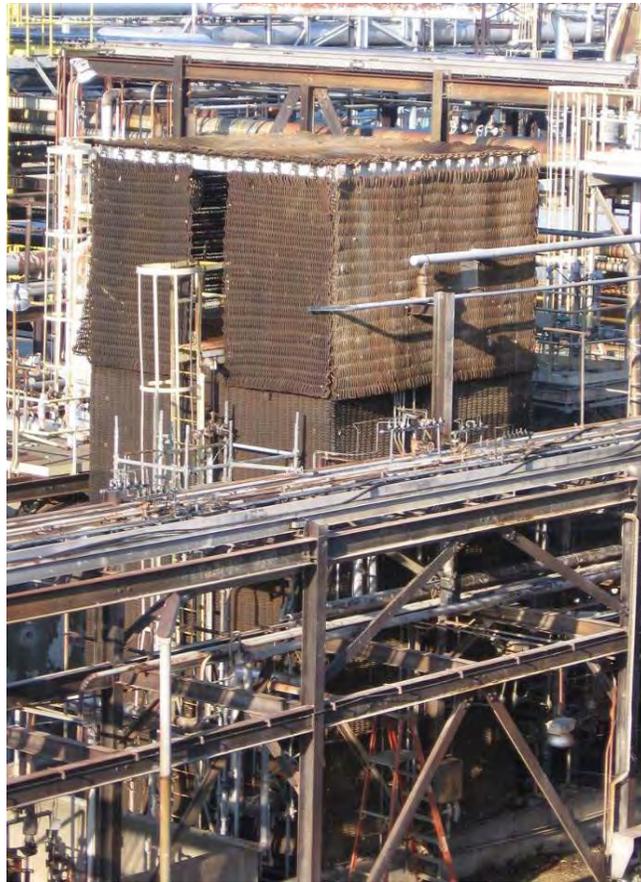
Figure C-2. MIC day tank shield structure

When the day tank was installed in 1983, a wire rope blast blanket system was installed to protect it from flying debris. The blast blankets also provide a radiant heat shield from nearby fires. In 1994, the structure was extended up to completely surround the entire tank and top piping connections (Figure C-2). The original frame design considered static (blast blanket weight) and wind loads only, and did not analyze the structure for dynamic side loading, one of the functional purposes of the assembly.
