U.S. CHEMICAL SAFETY AND HAZARD INVESTIGATION BOARD

Pesticide Chemical Runaway Reaction Pressure Vessel Explosion

BAYER CROPSCIENCE, LP

Report No. 2008-08-I-WV
January 2011

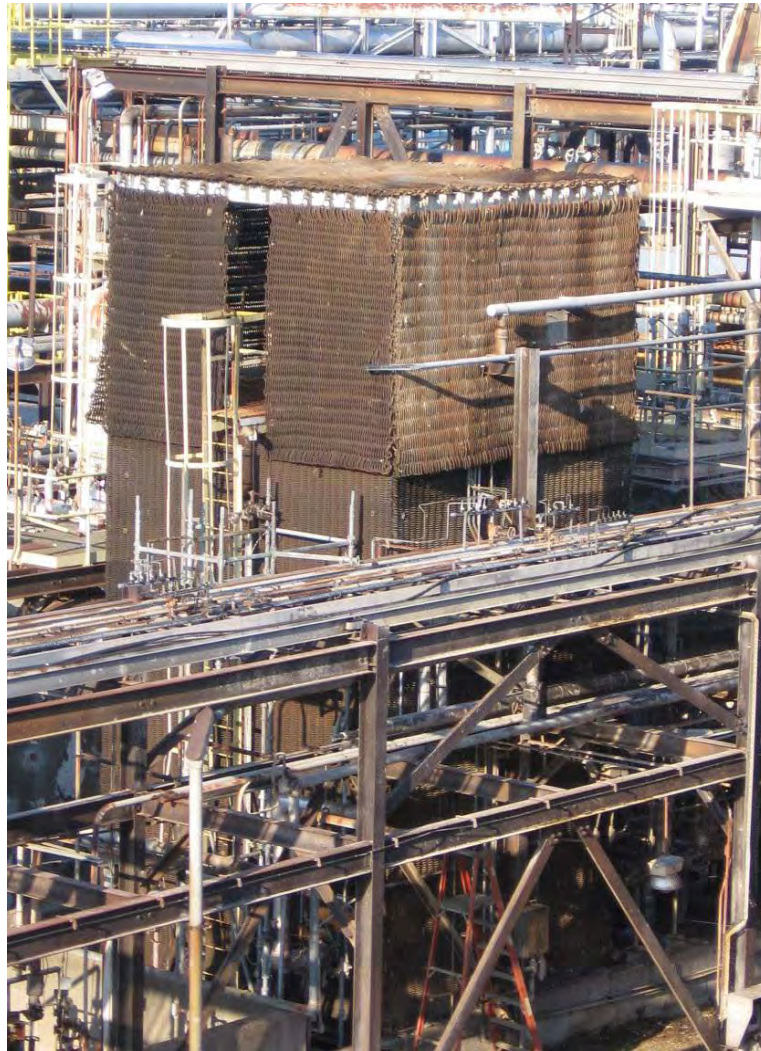
Figure 2. MIC day tank shield blanket structure

The MIC day tank was adjacent to the methomyl-Larvin unit. A steel rope mesh ballistic shield (blast blanket), mounted on the sides of and on top of a structural frame, protected the tank in the event of an explosion in the unit or nearby equipment (see Figure 2). Flying debris from the residue treater explosion struck the blast blanket. The fires radiated intense heat on the blast blankets.

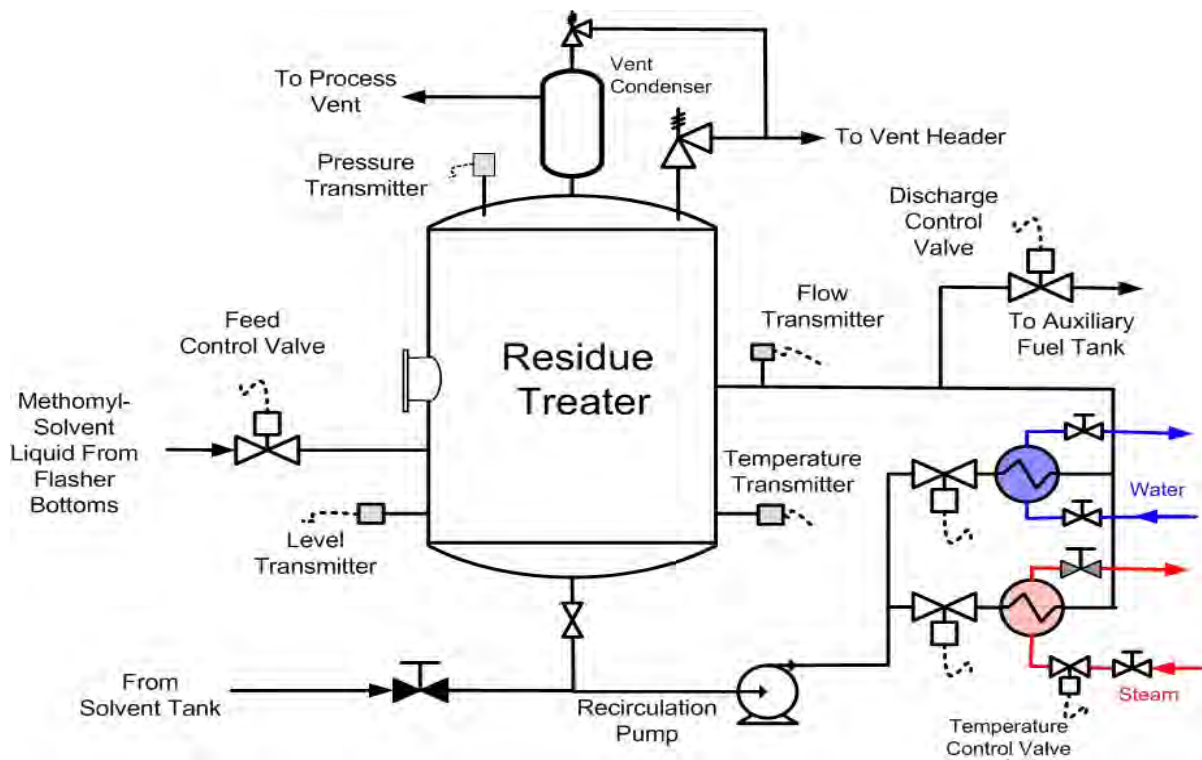
The residue treater (Figure 10) had an automatic level control system to control the liquid level at about 50 percent. The residue treater recirculation system was used to heat the solvent at the beginning of a new production run, mix the incoming flasher bottoms into the partially filled vessel,

Figure 10. Residue treater piping system layout

It was determined that the automatic temperature control system closed both the heater and cooler flow control valves (see Figure 10) at the same time when the recirculation temperature control transitioned from heating to cooling. Bayer examined the temperature controller and its investigation team concluded that

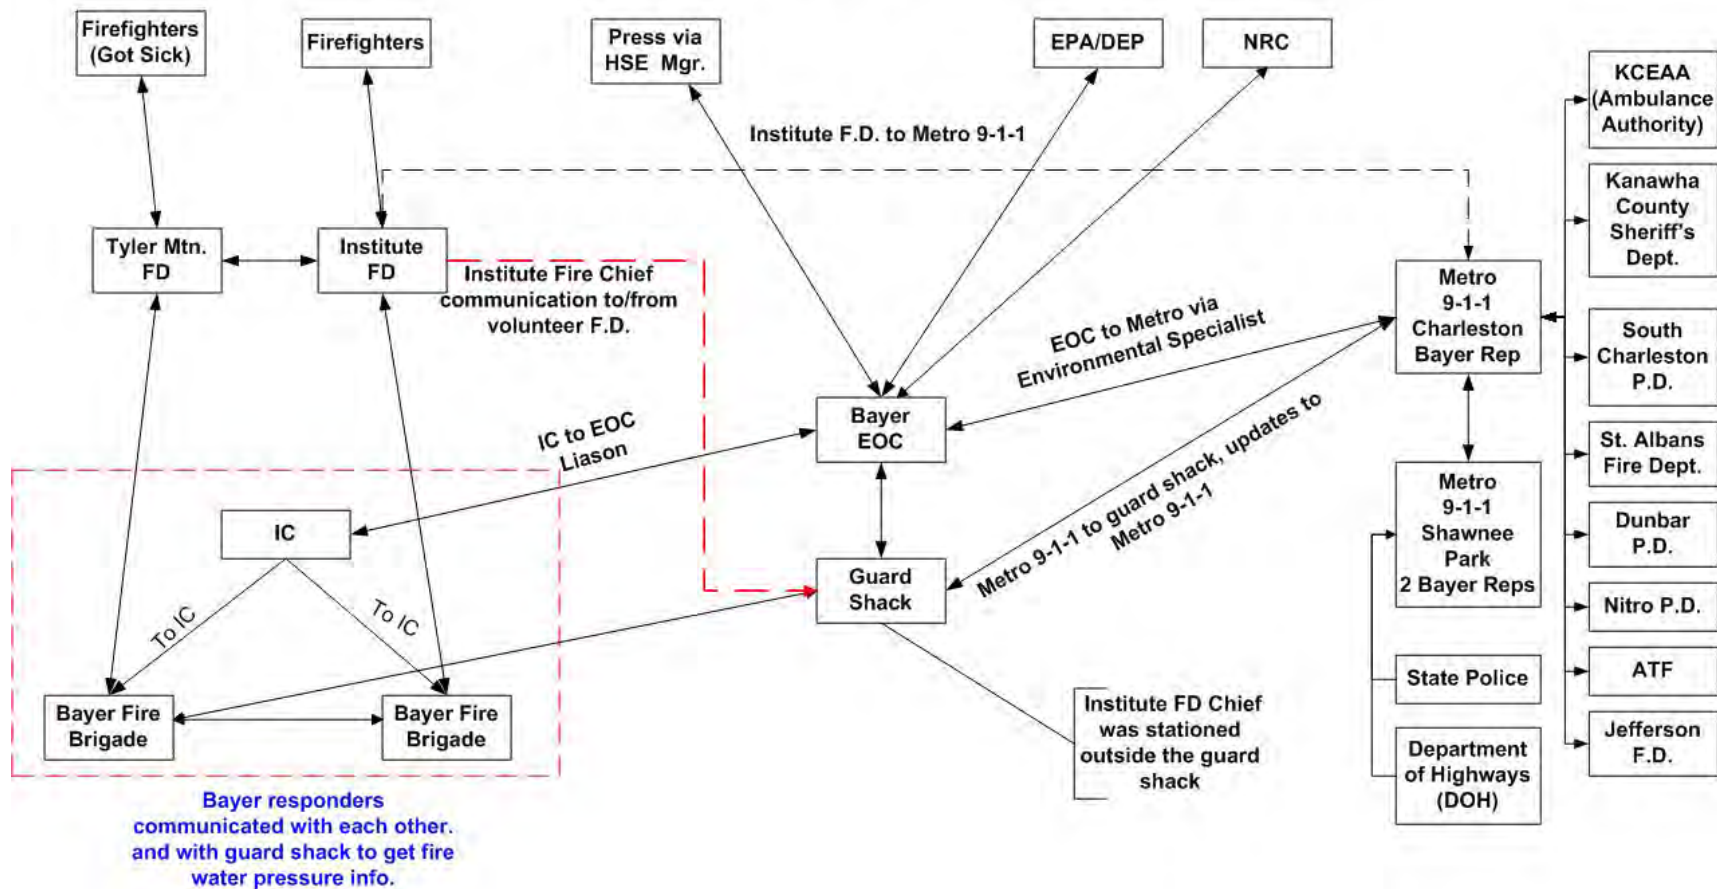
Figure 16. Methomyl unit explosion emergency communications diagram

On the night of the incident, all of the responding outside agencies communicated via the Kanawha Putnam EOC. However, the Bayer EOC did not use a shared network to communicate with all responding agencies; thus, the responding agencies did not receive timely status updates. Important information updates about the continually changing conditions at the fire scene were not communicated to the other responding agencies (Knoll, 2005).

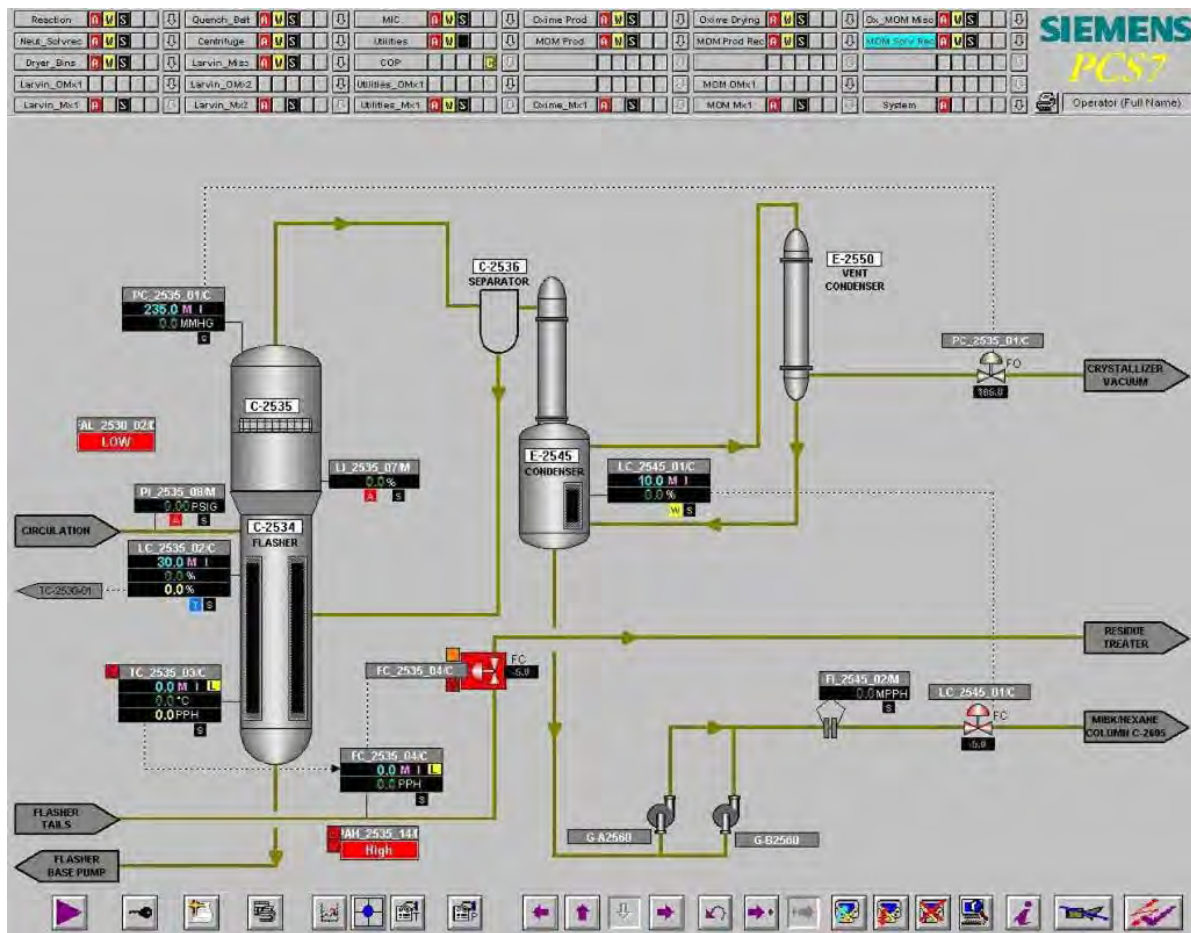
The old system display and command entry was basically a spreadsheet, or line-item display. The new system used a graphical user interface (GUI) that displayed an illustrative likeness of the process and its various components (Figure 18). The board operator selected the device that needed to be changed. This made data entry clearer, but much slower. In the old system, board operators could change multiple process variables simultaneously, but they could select and change only one variable at a time in the Siemens system.

Figure 18. Typical Siemens work station screen display

Prior to the methomyl startup, management provided operators time on the console during the DCS upgrade to practice using the new system. However, management did not require any methomyl operator to use this time to learn and practice operating the methomyl unit, and operators could decide for themselves how much time they needed to become familiar with the new DCS. Management also assumed that operators directly involved in designing the mimic displays, such as the one in Figure 18, and other customizable features would have had adequate exposure to the new system.

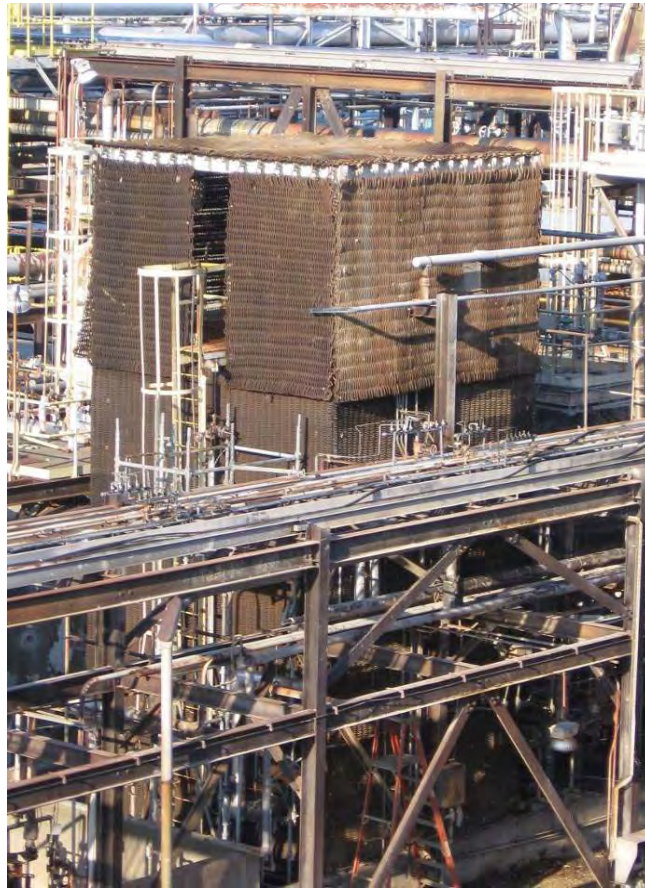
When the day tank was installed in 1983, a wire rope blast blanket system was installed to protect it from flying debris. The blast blankets also provide a radiant heat shield from nearby fires. In 1994, the structure was extended up to completely surround the entire tank and top piping connections (Figure C-2). The original frame design considered static (blast blanket weight) and wind loads only, and did not analyze the structure for dynamic side loading, one of the functional purposes of the assembly.

Figure C-2. MIC day tank shield structure
