U.S. Chemical Safety and Hazard Investigation Board

## Hoeganaes Corporation: Gallatin, TN Metal Dust Flash Fires and Hydrogen Explosion

January 31, 2011; March 29, 2011; May 27, 2011

No. 2011-4-I-TN

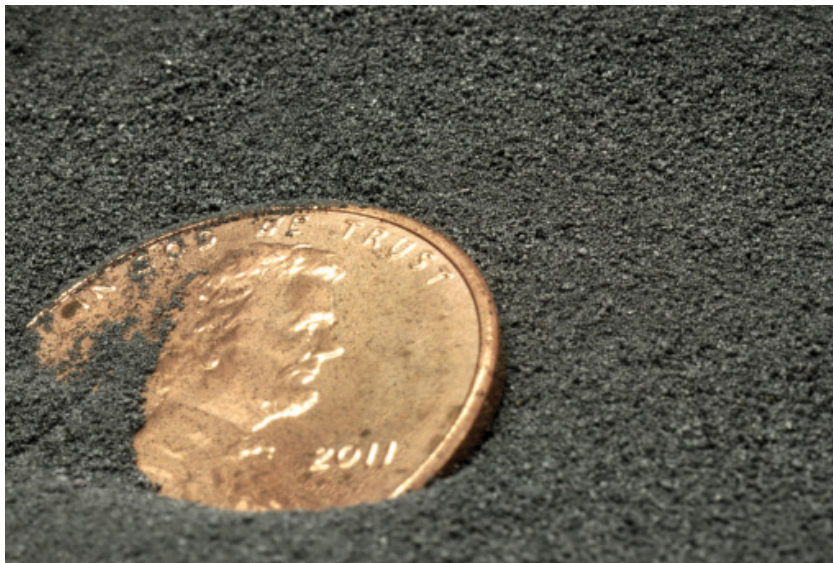
**FIGURE 2**

In the process of going through the furnace, the coarse powder becomes a thick sheet called “cake.” The cake is sent to a cake breaker and ultimately crushed into the fine PM product. The majority of the finished PM product has a particle diameter between 45-150 microns, or roughly the width of a human hair (Figure 2).

Fine PM collected from the Hoeganaes plant (penny shown for scale).

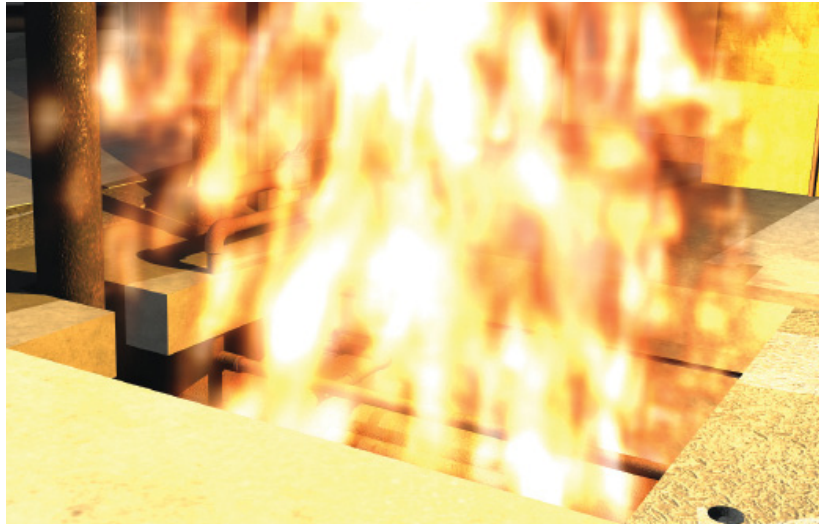
**FIGURE 11 (TOP LEFT)**

Interviews with eyewitnesses indicate that just as the first trench cover was wrenched from its position by the forklift, friction created sparks, followed by a powerful explosion. Several days after the explosion, CSB investigators observed a large hole (approximately 3 x 7 inches) in a corroded section of piping that carried hydrogen and ran through the trench (Figure 11).

Hole in 4-inch piping after the May 27, 2011, incident.
