**INVESTIGATION OF THE CHALLENGER
ACCIDENT**

**COMMITTEE ON
SCIENCE AND TECHNOLOGY
HOUSE OF REPRESENTATIVES**

**NINETY-NINTH CONGRESS
SECOND SESSION**

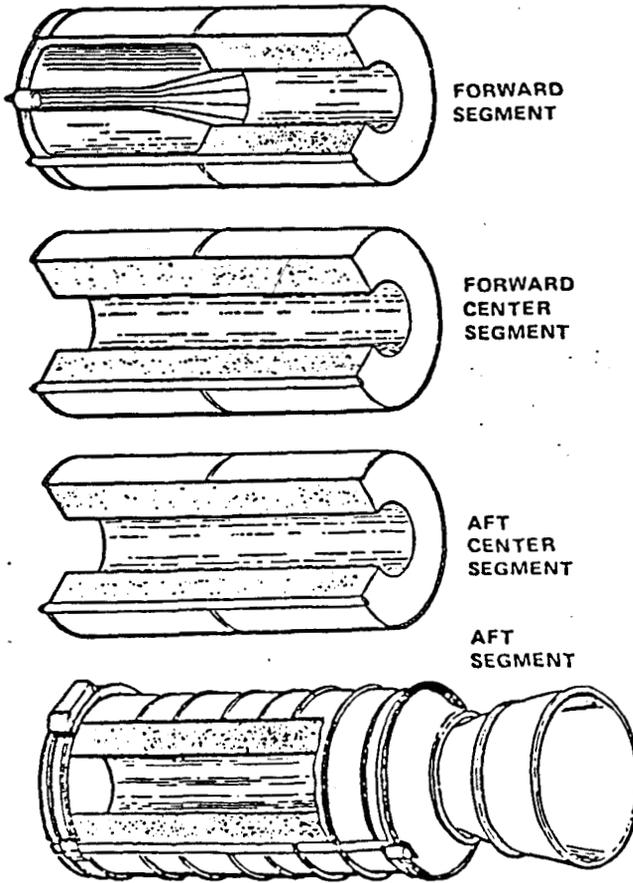
FIGURE V-3

Each motor case is made of 11 individual weld-free steel segments (Figure V-3). Averaging approximately 1.27 centimeters (0.5 inch) thick, the steel is a high-strength formulation. Each segment is heat-treated, hardened, and machined to the exact dimensions required. The 11 segments are held together by 177 high-strength steel pins at each case segment joint. The clevis-type joints are wrapped with reinforced fiberglass tape and sealed with a rubber seal band that is bonded to the case with adhesives.

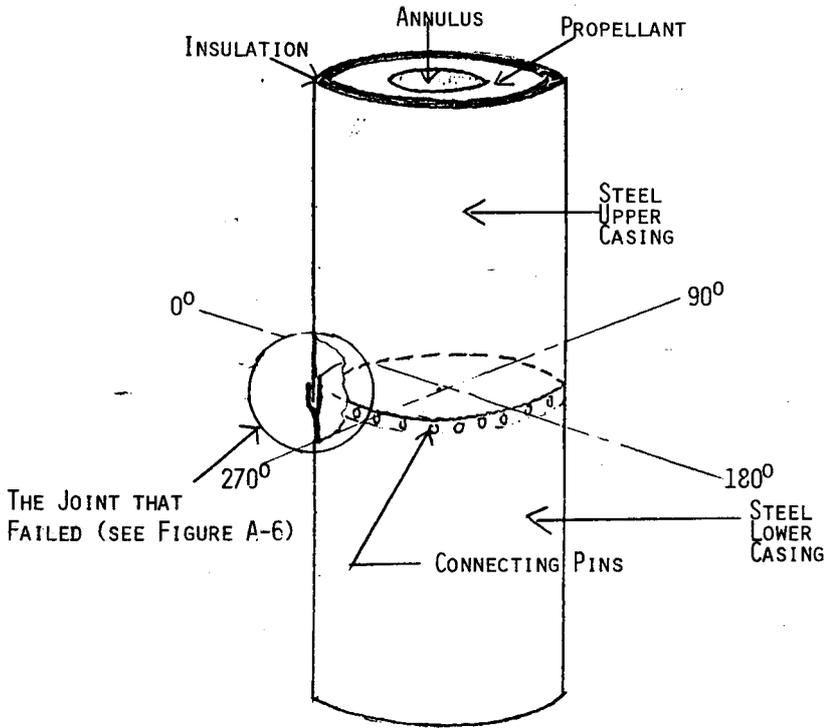
FIGURE V-5

Considerable reference will be made to the "joint design" throughout this section of the report. Consequently, the following description of the joint is provided. (See Figures V-5 thru V-7.)

A. JOINT IN NORMAL ALIGNMENT
(NO GAPS BETWEEN O-RINGS AND TANG)

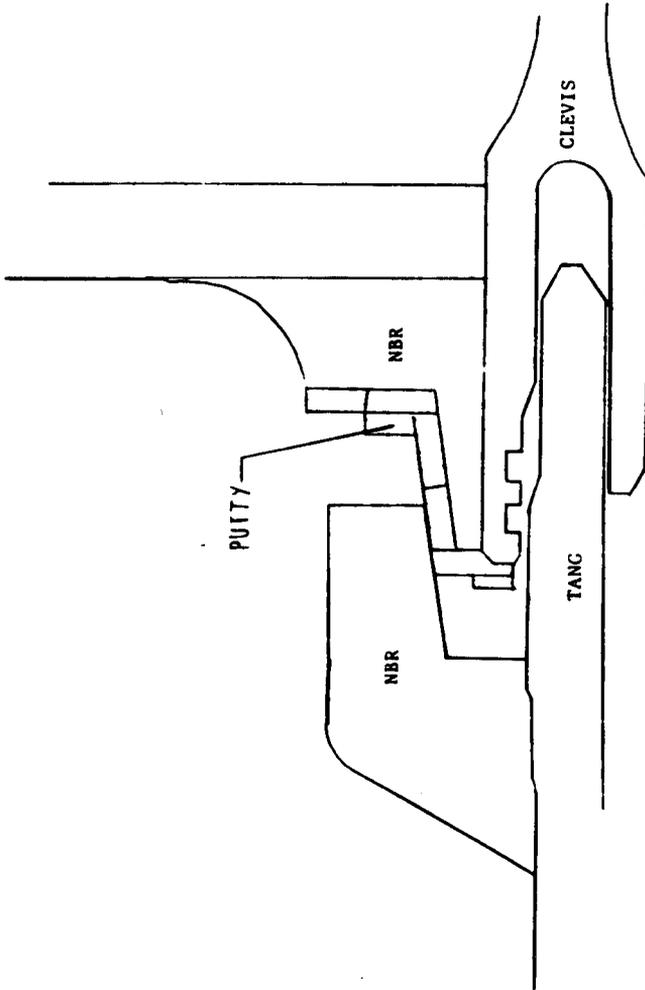
Figure 1

- (1) Putty layup tests using current layup design.
- (2) Putty layup tests using the attached figure 1 layup concept.
- (3) Putty layup tests using the attached figure 2 layup concept.
