§ 59.15-5 Stayed furnaces and combustion chambers.

§ 59.15-10 Bagged or blistered shell plates.

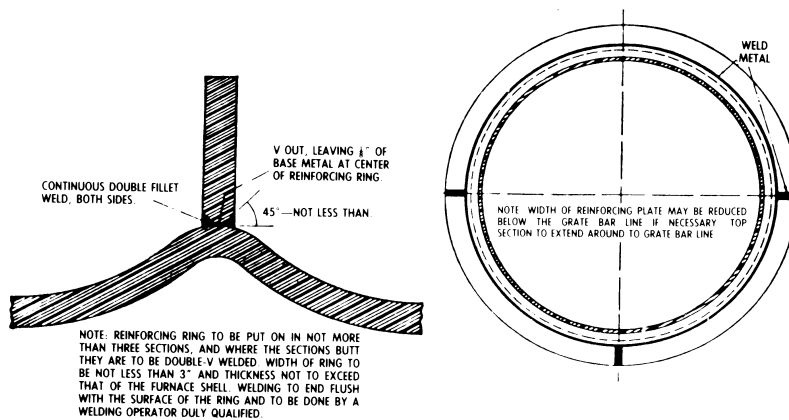
FIGURE 59.15-1—APPROVED METHOD OF REINFORCING FURNACES BY MEANS OF ARC OR GAS WELDING

this section, may be repaired by pumping back the distorted section to as nearly a true circle as possible and reinforcing the same by means of a ring, arc- or gas-welded to the distorted corrugation as shown in Figure 59.15-1, the welding to be done by welders and welding processors qualified in accordance with part 57 of this subchapter using acceptable welding electrodes in accordance with § 57.02-4 of this subchapter.
