IN THE UNITED STATES DISTRICT COURT
FOR THE EASTERN DISTRICT OF LOUISIANA

In re: Oil Spill by the Oil Rig "Deepwater Horizon" in the Gulf of Mexico, on April 20, 2010,	*	**MDL 2179**
	*	**SECTION J**
This Document Applies To:	*	
No. 10-2771, In re: The Complaint and Petition of Triton Asset Leasing GmbH, et al.	*	**JUDGE BARBIER**
and	*	**MAG. JUDGE SHUSHAN**
No. 10-4536, United States of America v. BP Exploration & Production, Inc., et al.	*

FINDINGS OF FACT AND CONCLUSIONS OF LAW

PHASE ONE TRIAL

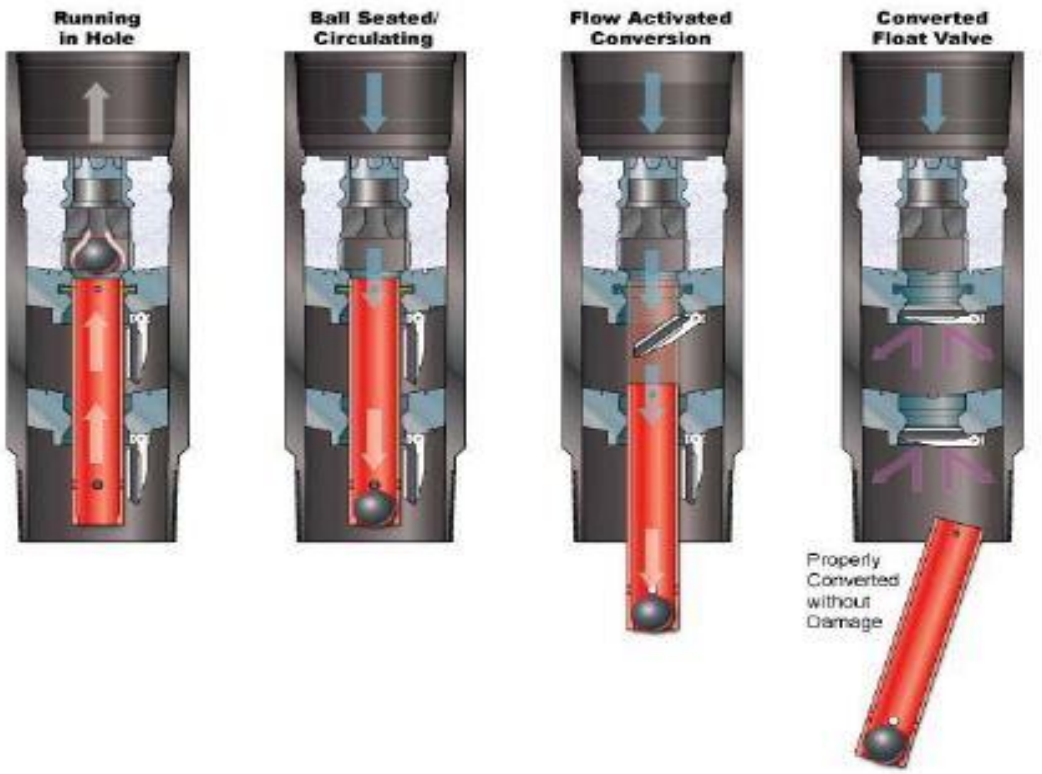
Figure 5 [38]

102. Figure 5 depicts a M45AP float collar being properly converted:

144. The Court finds that the float collar did not fully and properly convert on April 19, 2010, or anytime thereafter. On the ninth conversion attempt, the float collar experienced a mechanical failure. The most likely point of failure was the ball seat at the bottom of the auto-fill tube.

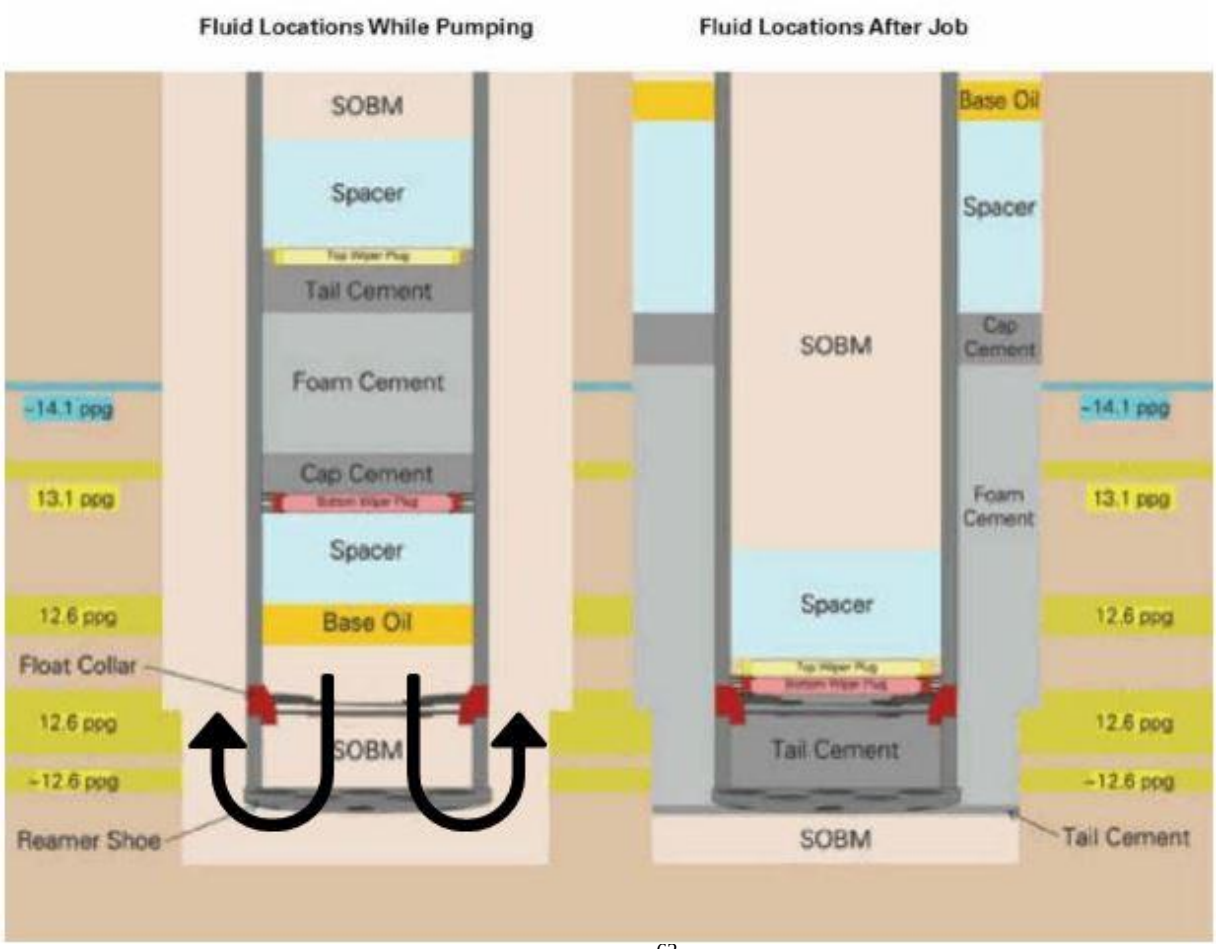
Figure 6 [63]

162. Figure 6 illustrates the ***intended*** placement of cement fluids in the annulus and shoe track and across hydrocarbon-bearing zones (yellow) and brine-bearing zones (blue):

164. Dr. Beck further testified that cement pumped through the rupture would immediately turn up the annulus; no cement would be placed below the rupture point. Dr. Beck also testified that a breach in the shoe track would prevent cement from being placed in the shoe track.

165. Dr. Beck believes that cement was pumped through the breach in the shoe track, rather than through the holes in the reamer shoe. Consequently, cement was not placed across the hydrocarbon-bearing sands below the rupture point. Therefore, the hydrocarbon-bearing sands below the breach in the shoe track were left exposed to the well and had unrestricted access into the casing through the breach in the shoe track.

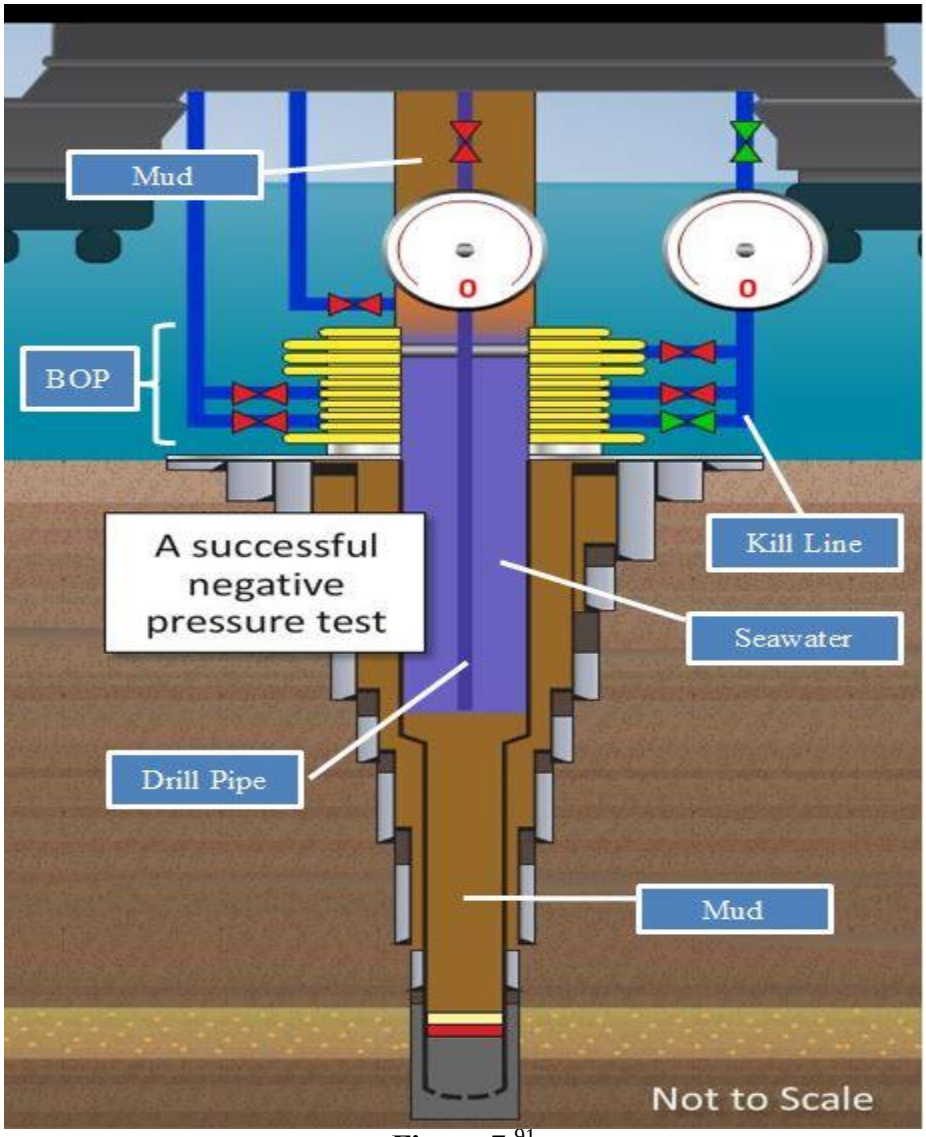
Figure 7 [91]

240. Figure 7 illustrates a ***successful*** negative pressure test using the pressure method. Note that the pressure gauges on the drill pipe and the kill line[90] indicate zero pressure.

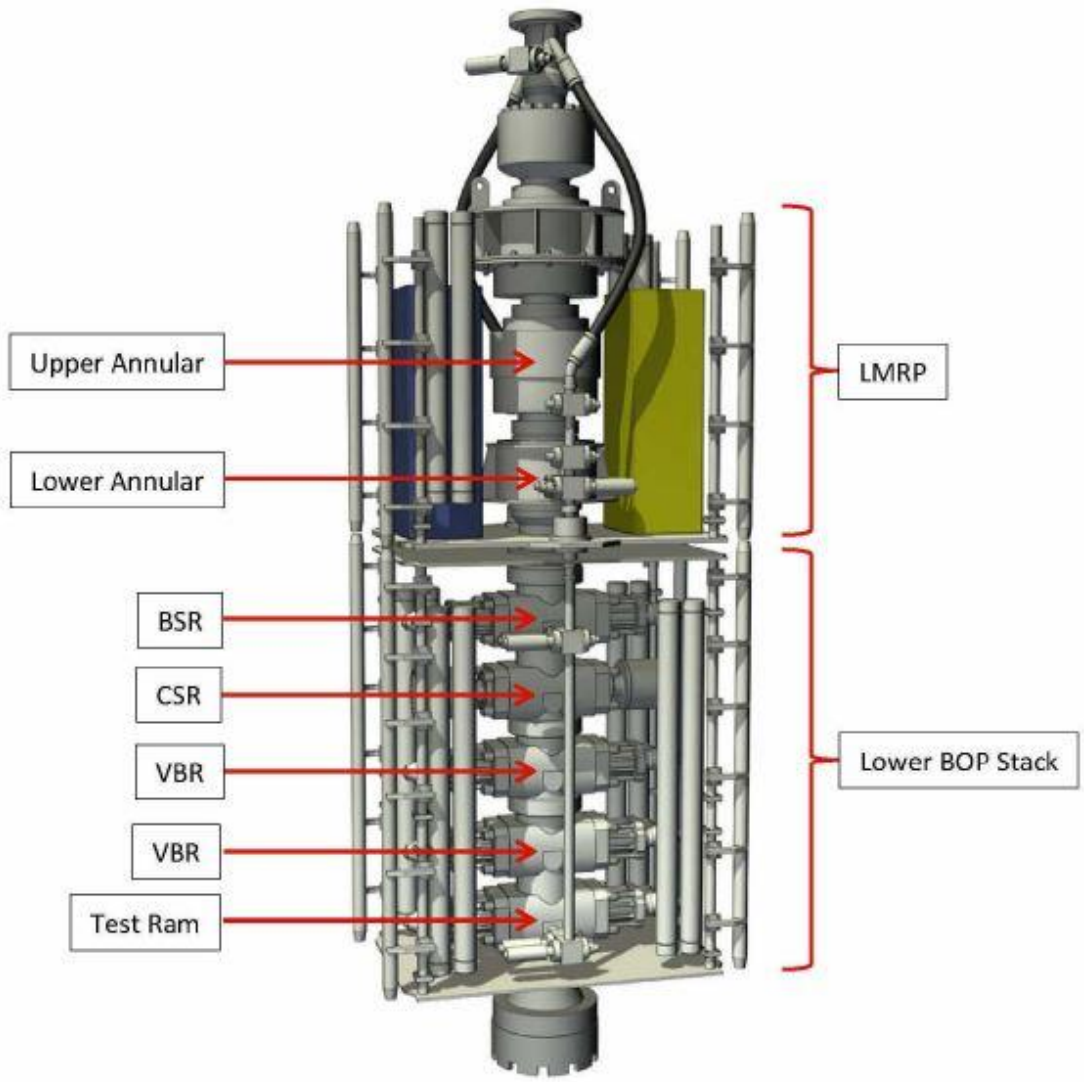
Figure 9 [135]

372. Figure 9 is an illustration of the HORIZON's BOP stack:

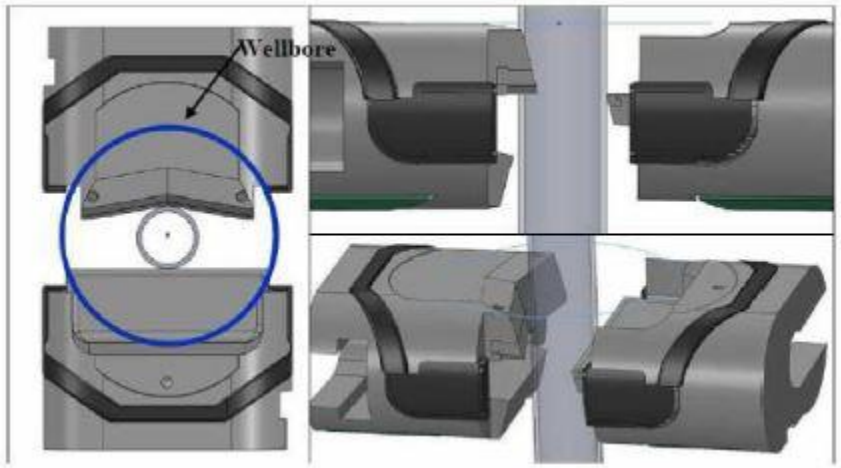
Figure 10 [137]

377. Figure 10 illustrates the BSRs used in the HORIZON's BOP and how they were intended to shear drill pipe.
