# PIERS 38/40 RE-USE PLAN

Philadelphia Regional Port Authority  
210 West Washington Square  
Philadelphia, Pennsylvania 19106

PIERS 38/40 RE-USE PLAN

DECEMBER 31, 1995

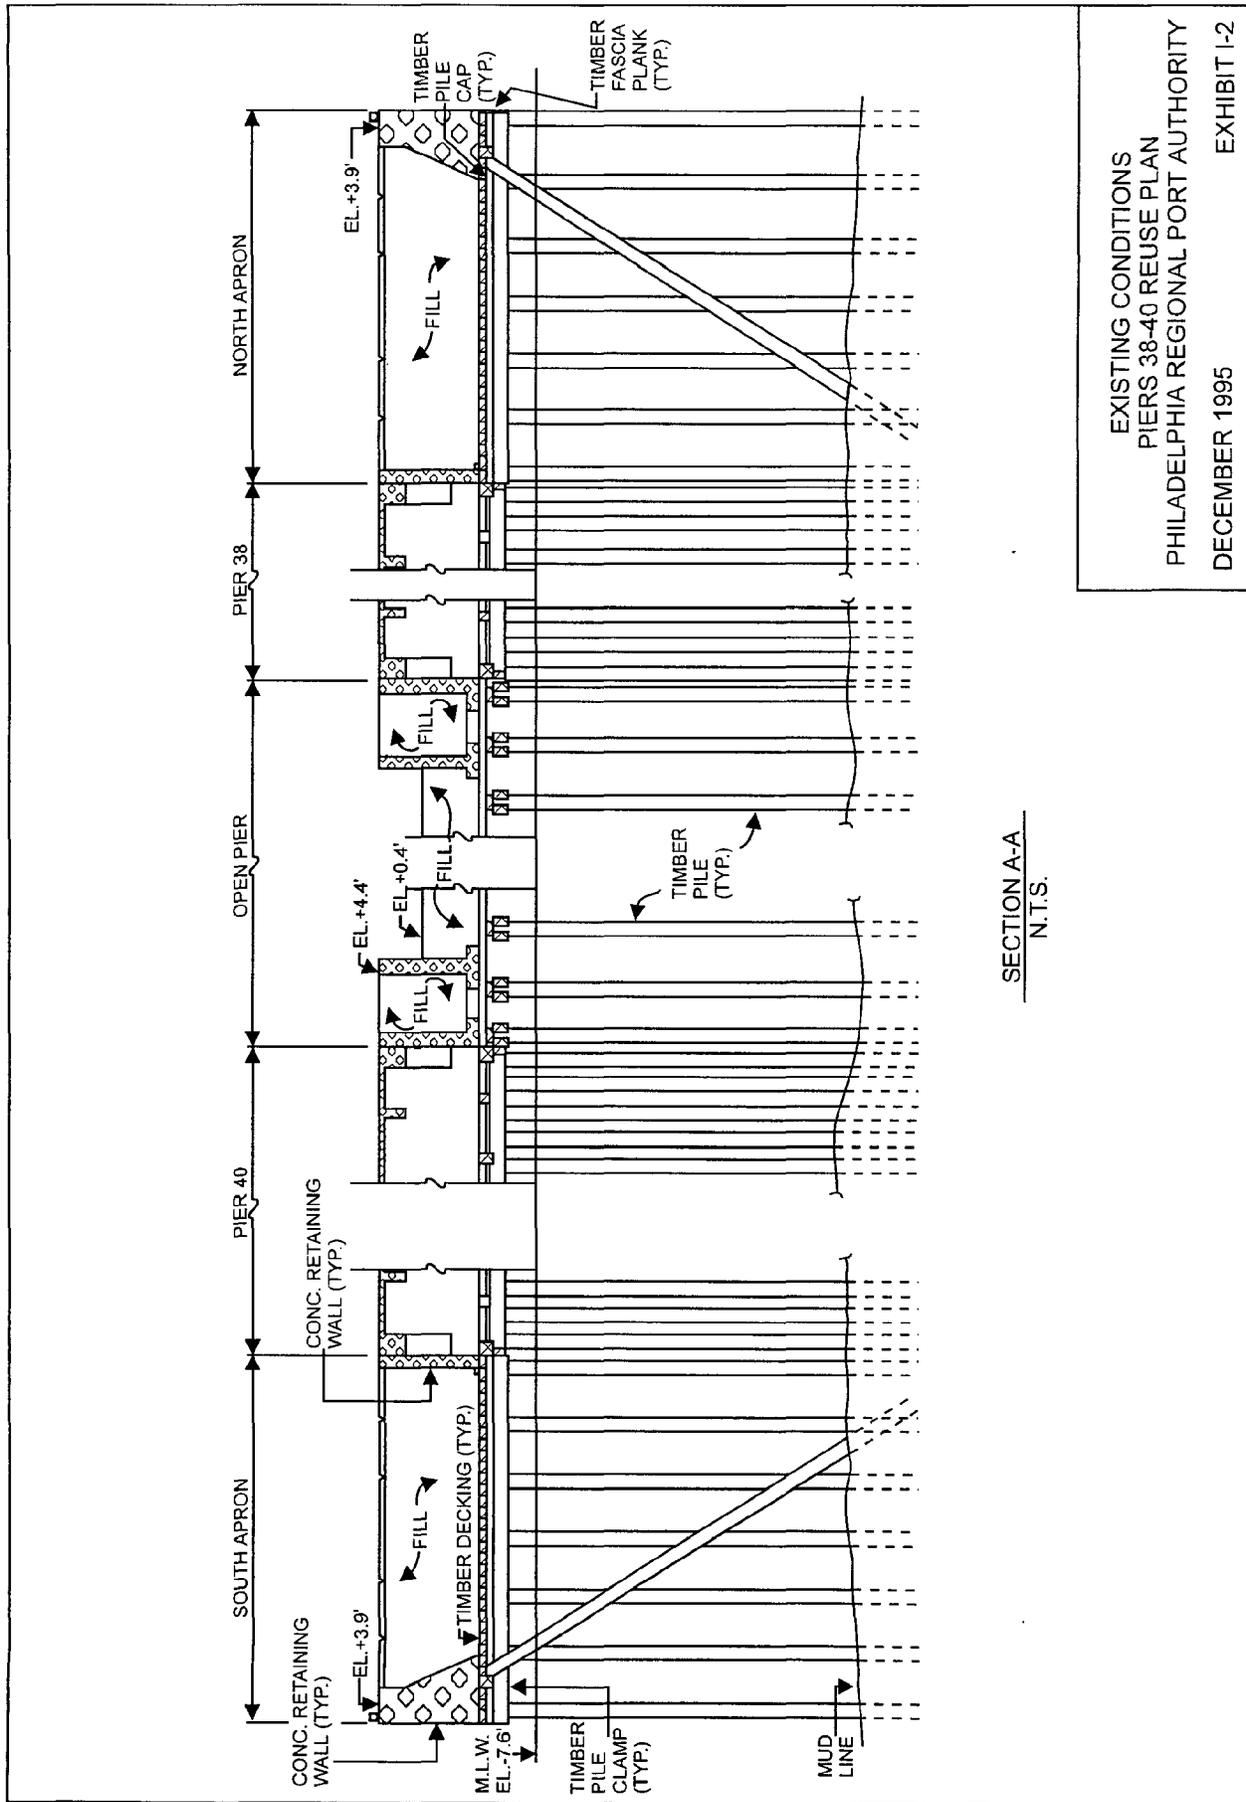
EXISTING CONDITIONS  
PIERS 38-40 REUSE PLAN  
PHILADELPHIA REGIONAL PORT AUTHORITY  
DECEMBER 1995 EXHIBIT I-2

SECTION A-A  
N.T.S.

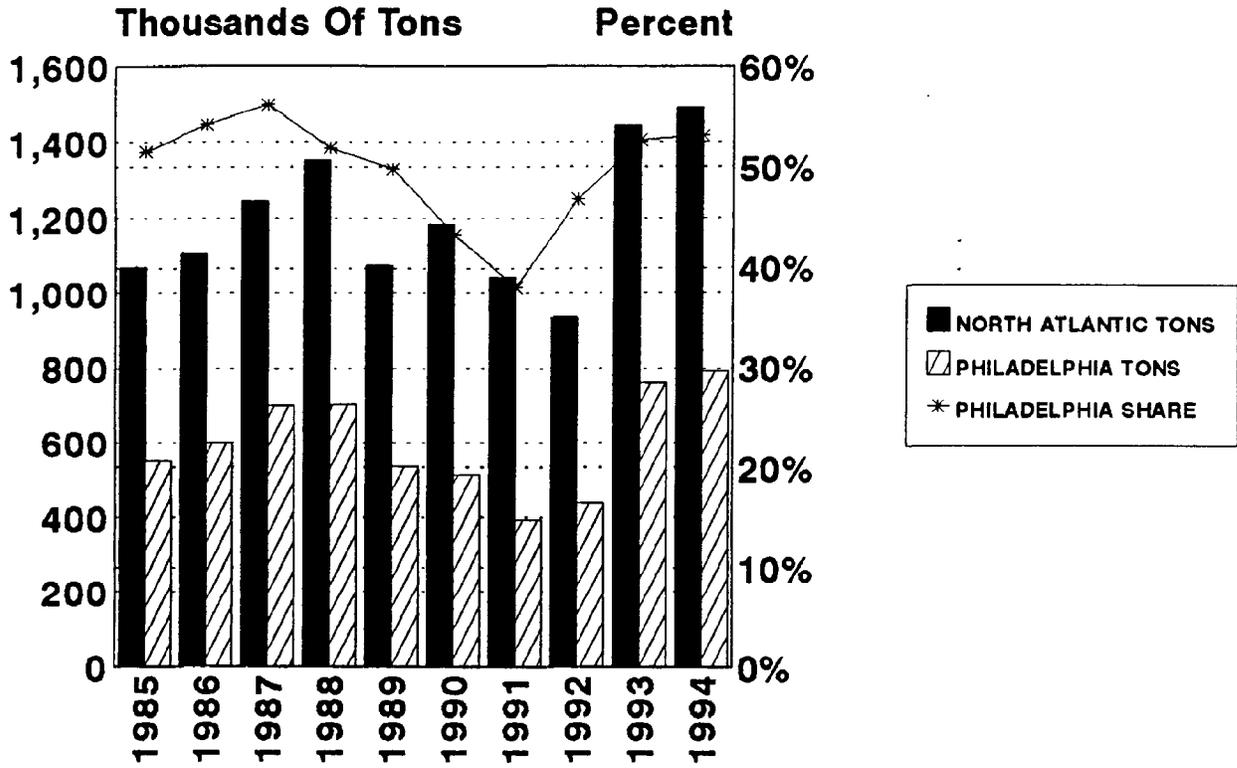
Exhibit II-1  
 Paper Imports at the Port of Philadelphia

In the near term, paper imports are projected to reach 950,000 tons, and assuming a 3% annual growth rate, paper import tonnage at the Port of Philadelphia will likely reach 1.1 million tons. These forecasts of paper import tonnage are consistent with the 970,000 tons projected by the PRPA in the Physical Plant and Paper Handling Operations Study<sup>1</sup>. Based on the analysis in this O'Donnell & Naccarato report, it would appear that the new paper warehouse planned at the Piers 78A and 80 complex will be adequate to handle this future tonnage, and, hence, Piers 38/40 will not be needed given the construction of a new warehouse.

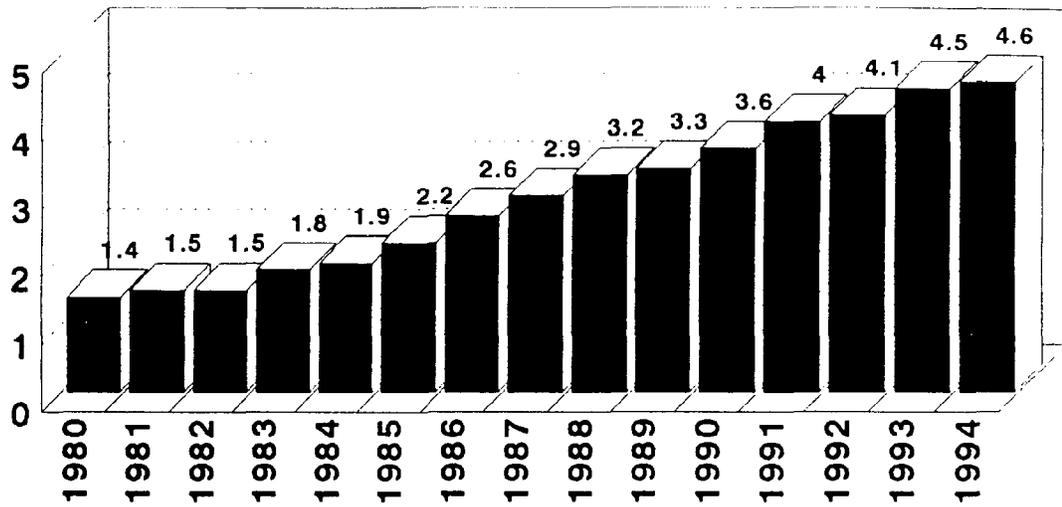
Exhibit II-4  
Annual Cruise Passengers  
(Embarkations)

**MILLIONS OF PASSENGERS (EMBARKATIONS)**

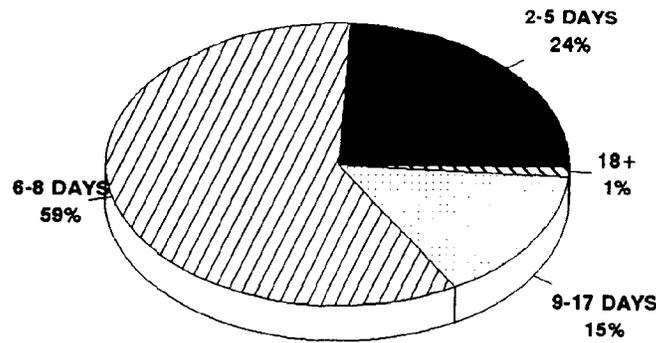
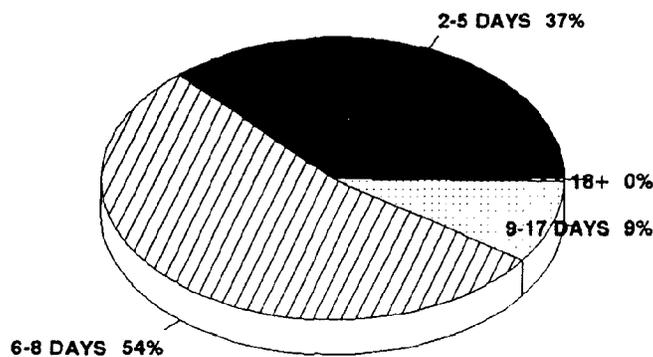
Exhibit II-5  
Share of North American Cruise Market by Length of Cruise

Caribbean market. Distance has become increasingly important as the demand for shorter cruises has increased over time. Exhibit II-5 shows the growth in the cruise passengers by length of cruise. As this exhibit shows, between 1980 and 1993, the major growth in cruise passengers has been in cruises of 2-5 days in length. The share of passengers on cruises of 9 to 17 days in length, which would be required for a Caribbean cruise from Philadelphia, has fallen from 15% in 1980 to 9% in 1993.

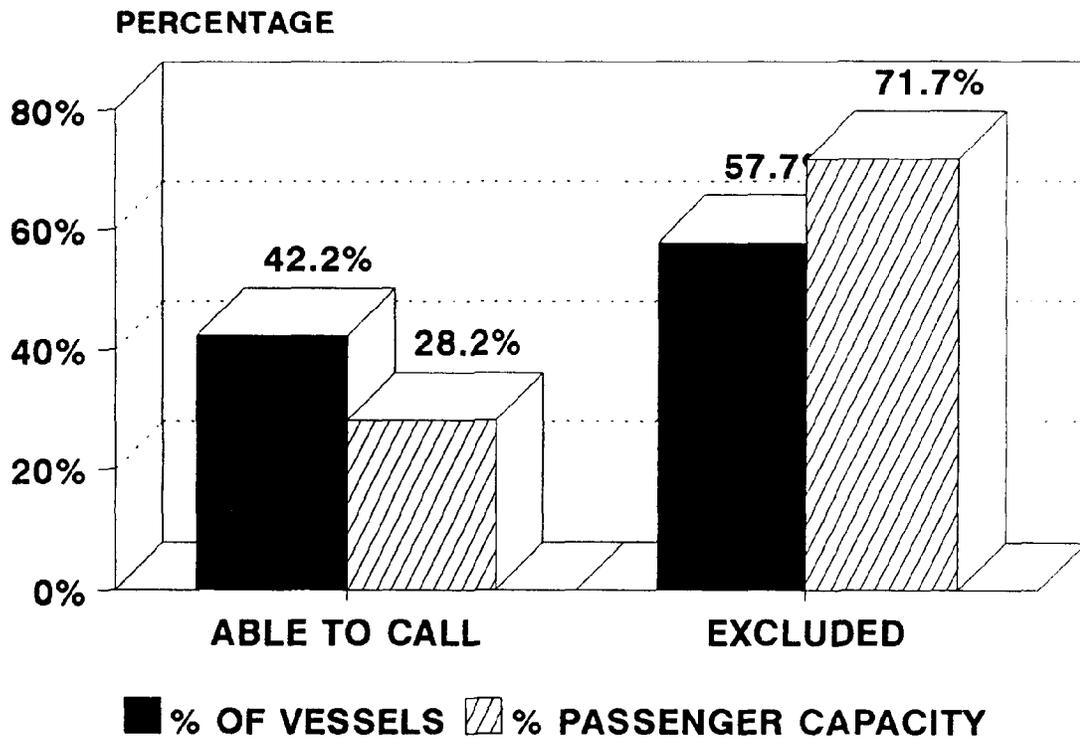
Exhibit II-6  
Cruise Vessels Excluded from Transitting Under the  
Walt Whitman Bridge  
Number of Vessels and Passenger Capacity

With respect to the use of Piers 38/40 as a cruise terminal, the height of the Walt Whitman Bridge may pose a problem for cruise ships. The Walt Whitman Bridge constrains the air draft of vessels to 150 feet. Martin Associates sampled the air draft of 45 cruise vessels deployed in the North American cruise markets. Exhibit II-6 shows that the 150 foot clearance of the bridge prohibits nearly 60% of the vessels from transitting under the Walt Whitman Bridge to call Piers 38/40, and more importantly, this bridge height restricts 72% of the North American cruise vessel passenger capacity.

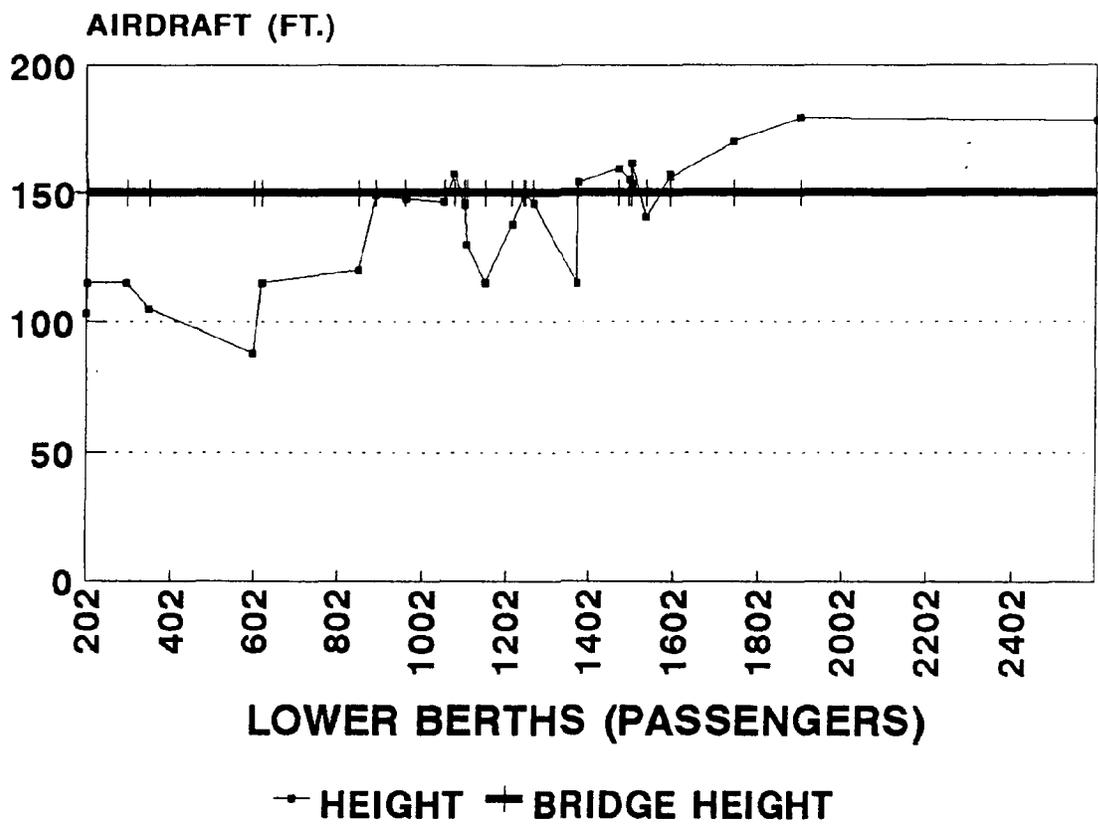
Exhibit II-7  
Air Draft Versus Lower Berth Capacity

While not the case for cargo vessels, there appears to be a relationship between size (measured in terms of lower berths) and air draft of cruise vessels. The larger the number of lower berths, the greater is the air draft of the vessel. Exhibit II-7 graphically depicts this relationship.

As this exhibit further demonstrates, the larger the cruise vessel in terms of passenger capacity, the greater will be the air draft. Exhibit II-8 shows the distribution of the cruise vessels on order. Given this relationship between passenger capacity and air draft, it is to be emphasized that the majority of new cruise vessels on order are over 1500 passengers in capacity, which appears, from the previous exhibit, to be in the range of the passenger capacity which is associated with a vessel air draft in excess of 150 feet. Therefore, since the majority of the new ships on order are not likely to be able to pass under the Walt Whitman Bridge, the market for cruise operations at Piers 38/40 is limited to an even greater extent (than just by the markets).

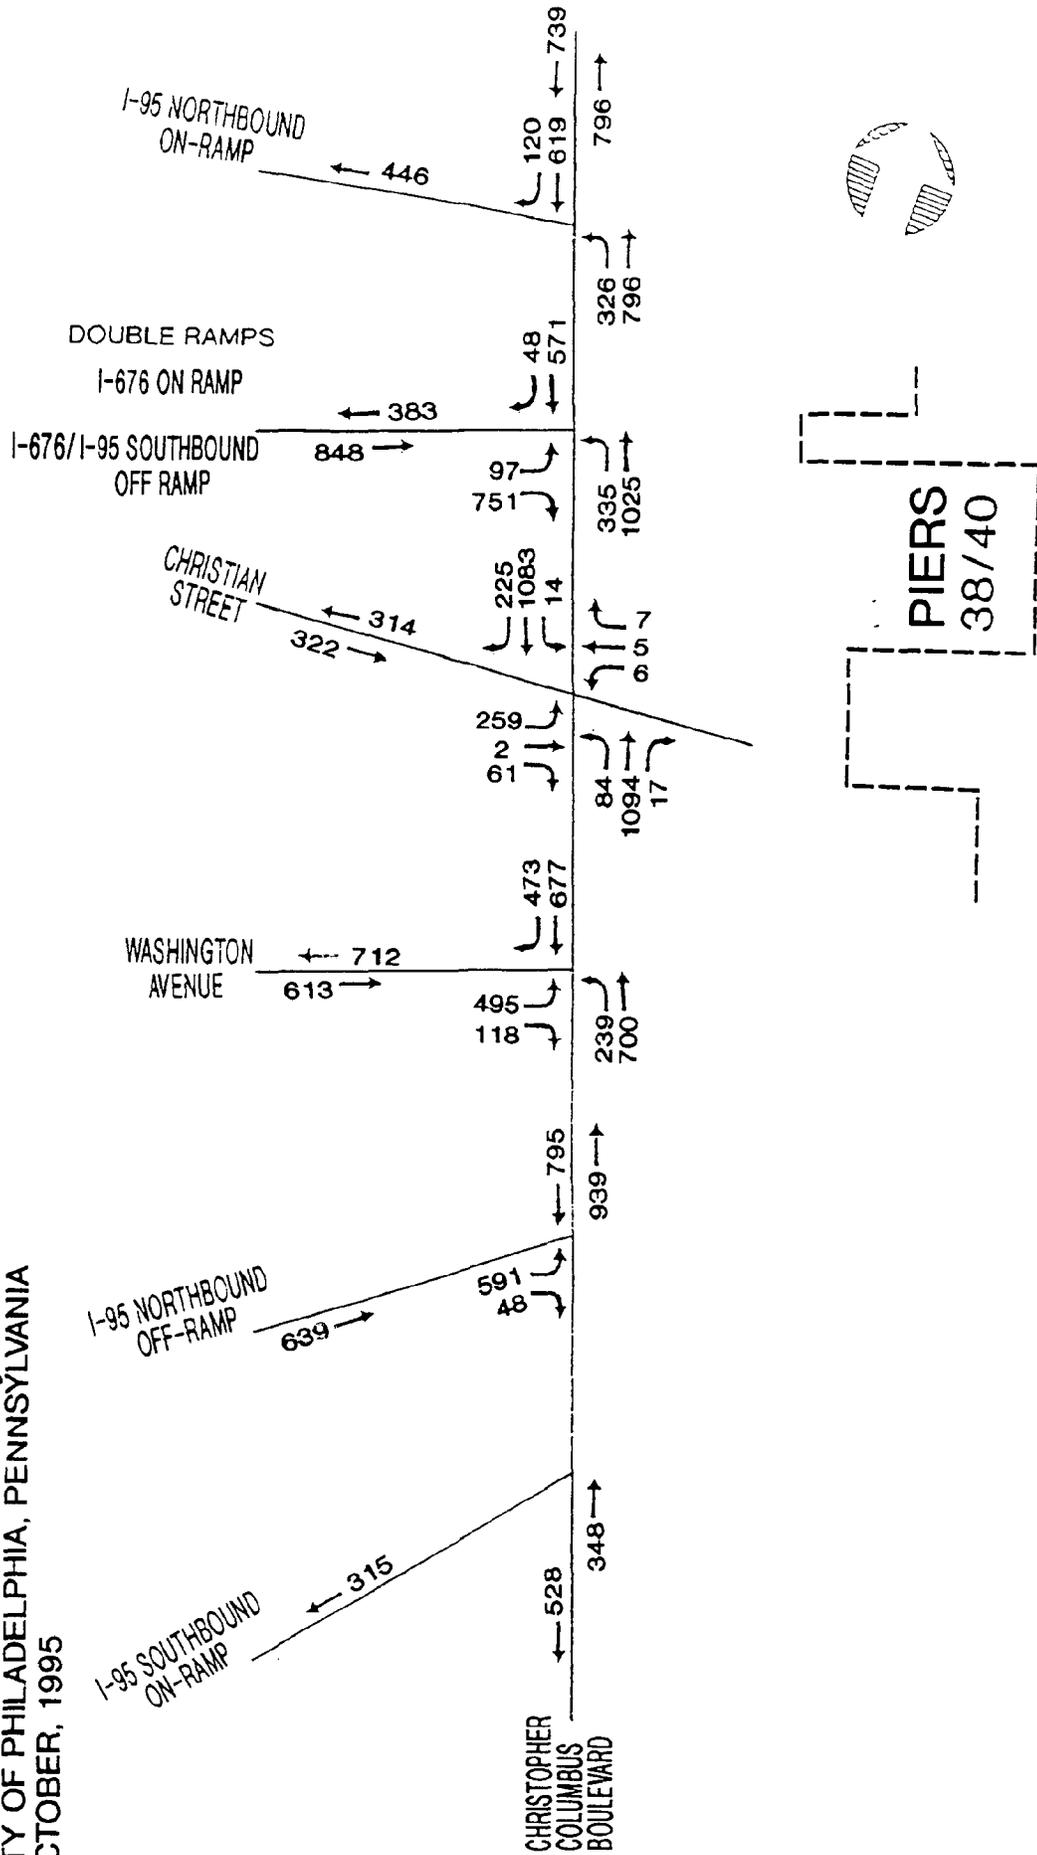
**Existing Morning Peak Hour Traffic Volumes- 7:30 to 8:30 AM**  
**Christopher Columbus Boulevard**  
**Piers 38/40 Reuse Study**  
 CITY OF PHILADELPHIA, PENNSYLVANIA  
 OCTOBER, 1995

Manual turning movement traffic counts were conducted in October 1995 during the morning and evening peak traffic periods at six intersections on Christopher Columbus Boulevard. They include:

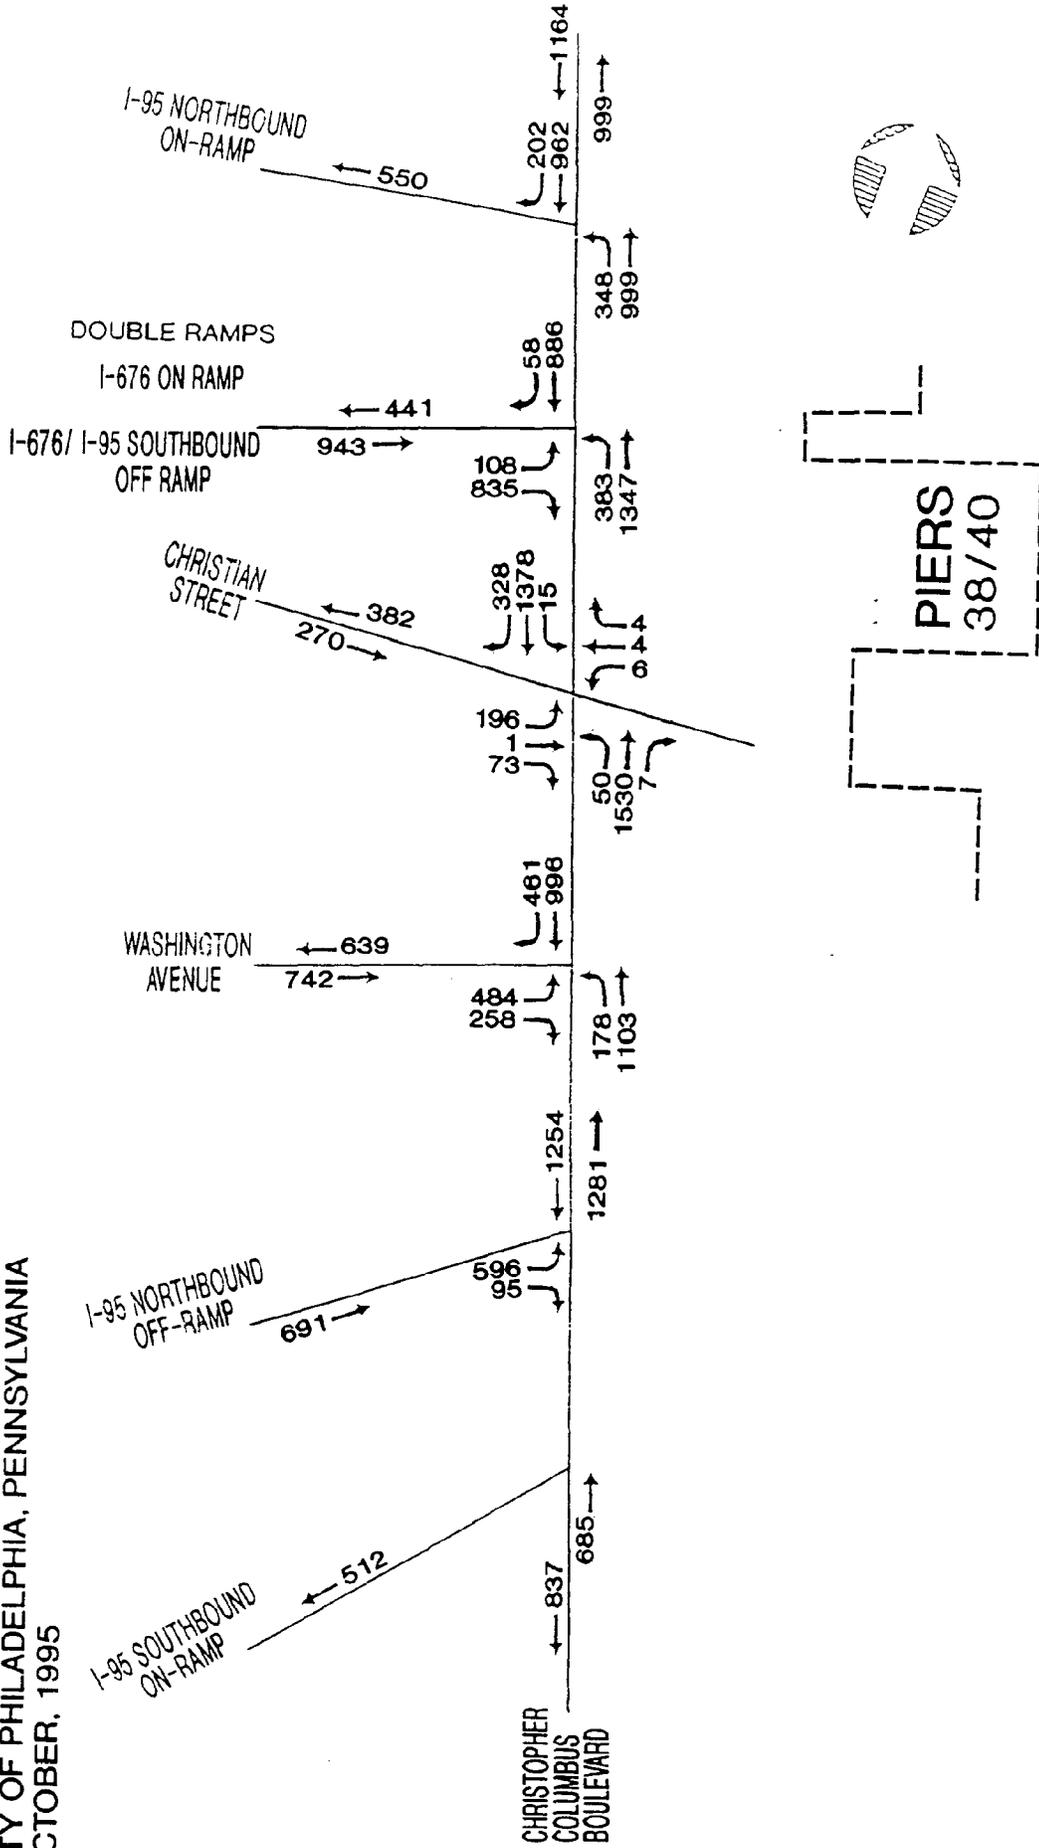
**Existing Evening Peak Hour Traffic Volumes- 4:30 to 5:30 PM**  
**Christopher Columbus Boulevard**  
**Piers 38/40 Reuse Study**  
 CITY OF PHILADELPHIA, PENNSYLVANIA  
 OCTOBER, 1995

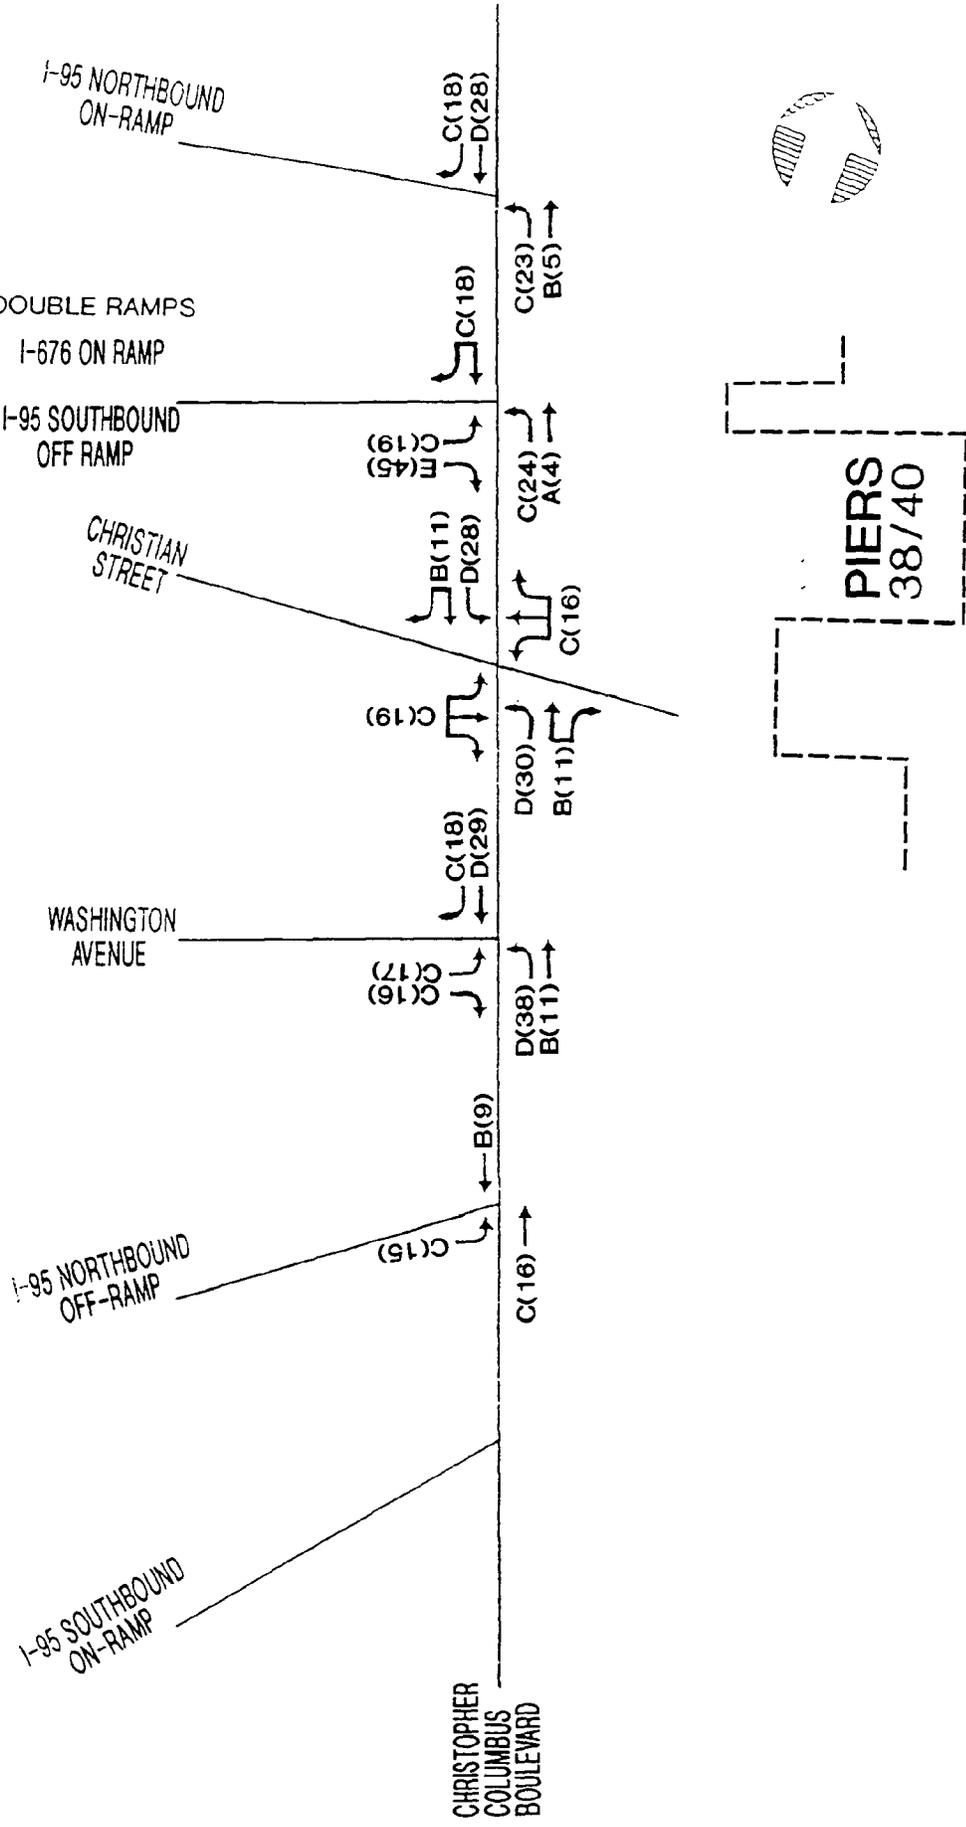
# Existing Evening Peak Hour Levels of Service Christopher Columbus Boulevard Piers 38/40 Reuse Study

Volume capacity analysis was performed for the six study intersections using the evening peak hour traffic volumes. It was assumed that roadway conditions and traffic signal operation will be in accordance with plans for the PennDOT Delaware Avenue improvement project. Resulting levels of service are shown in Exhibit III-4. As indicated, the existing roadway network operates generally at an acceptable level of service. The only location with an unsatisfactory level of service is the right turn exiting at the double ramp which is expected to operate at Level of Service 'E' during the evening peak hour.

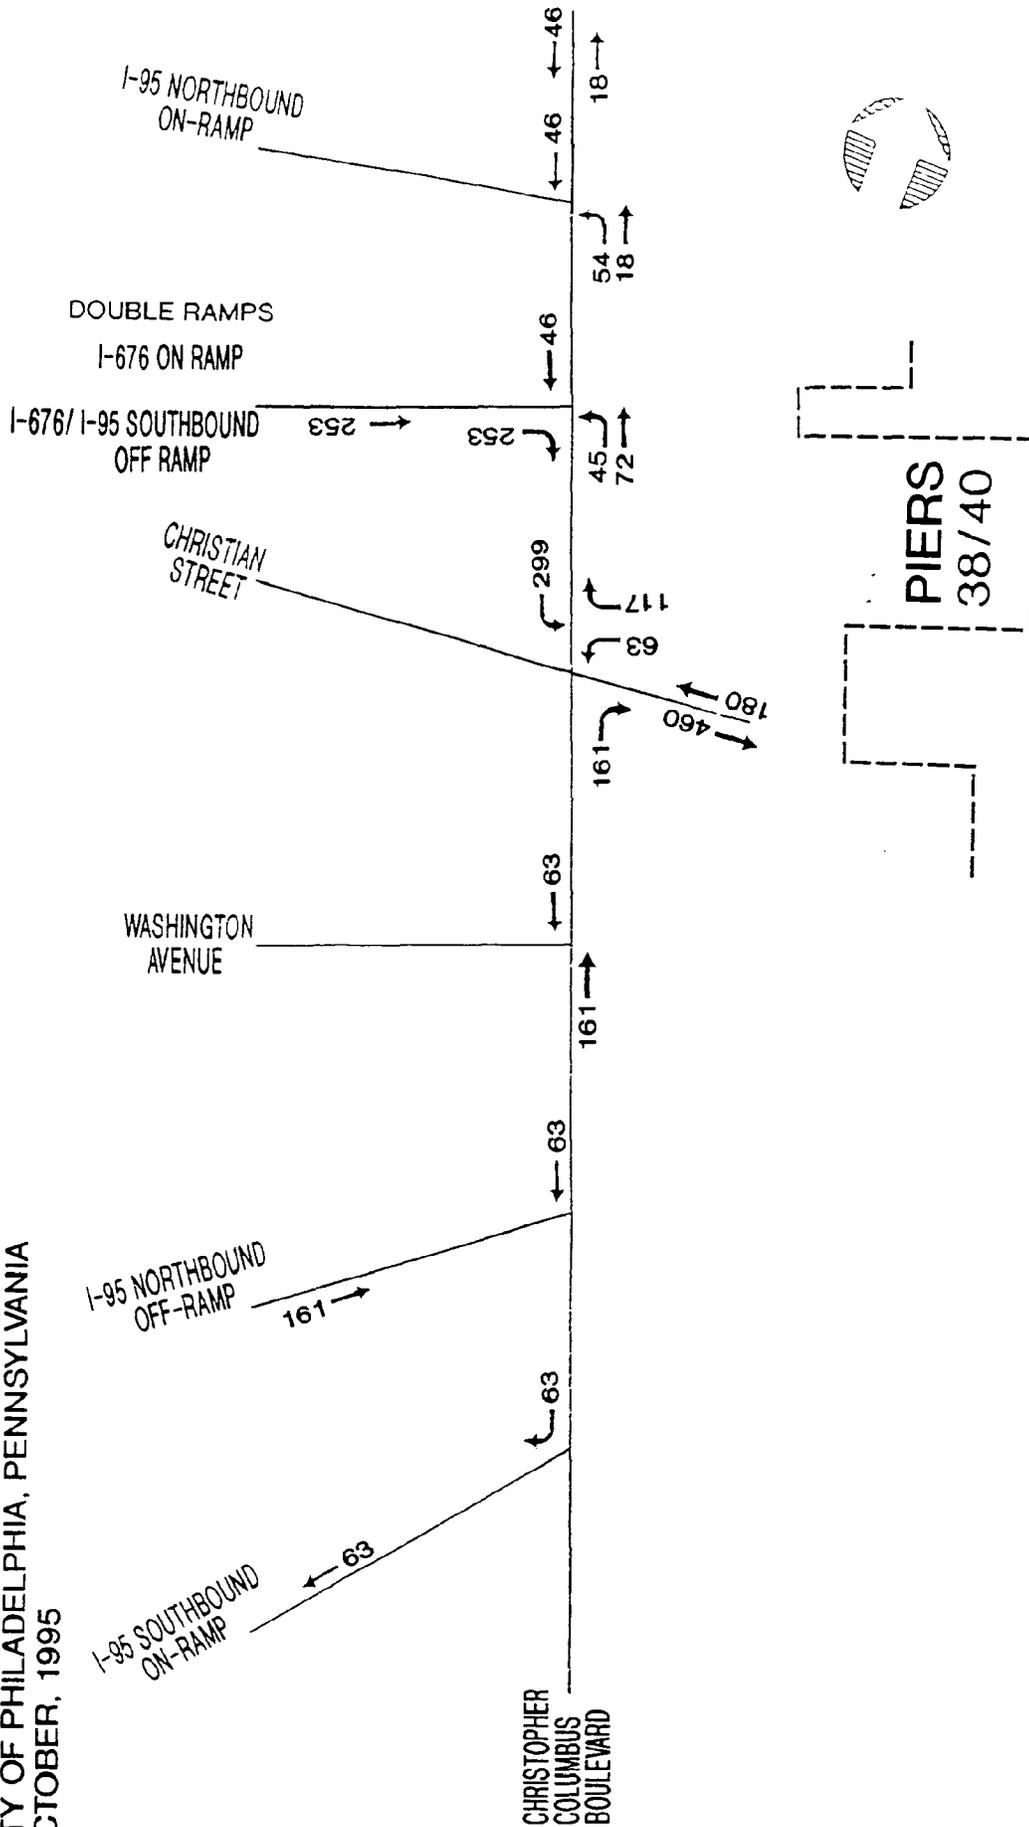
# Additional Peak Hour Traffic Volumes Generated by Cruise Terminal Christopher Columbus Boulevard Piers 38/40 Reuse Study

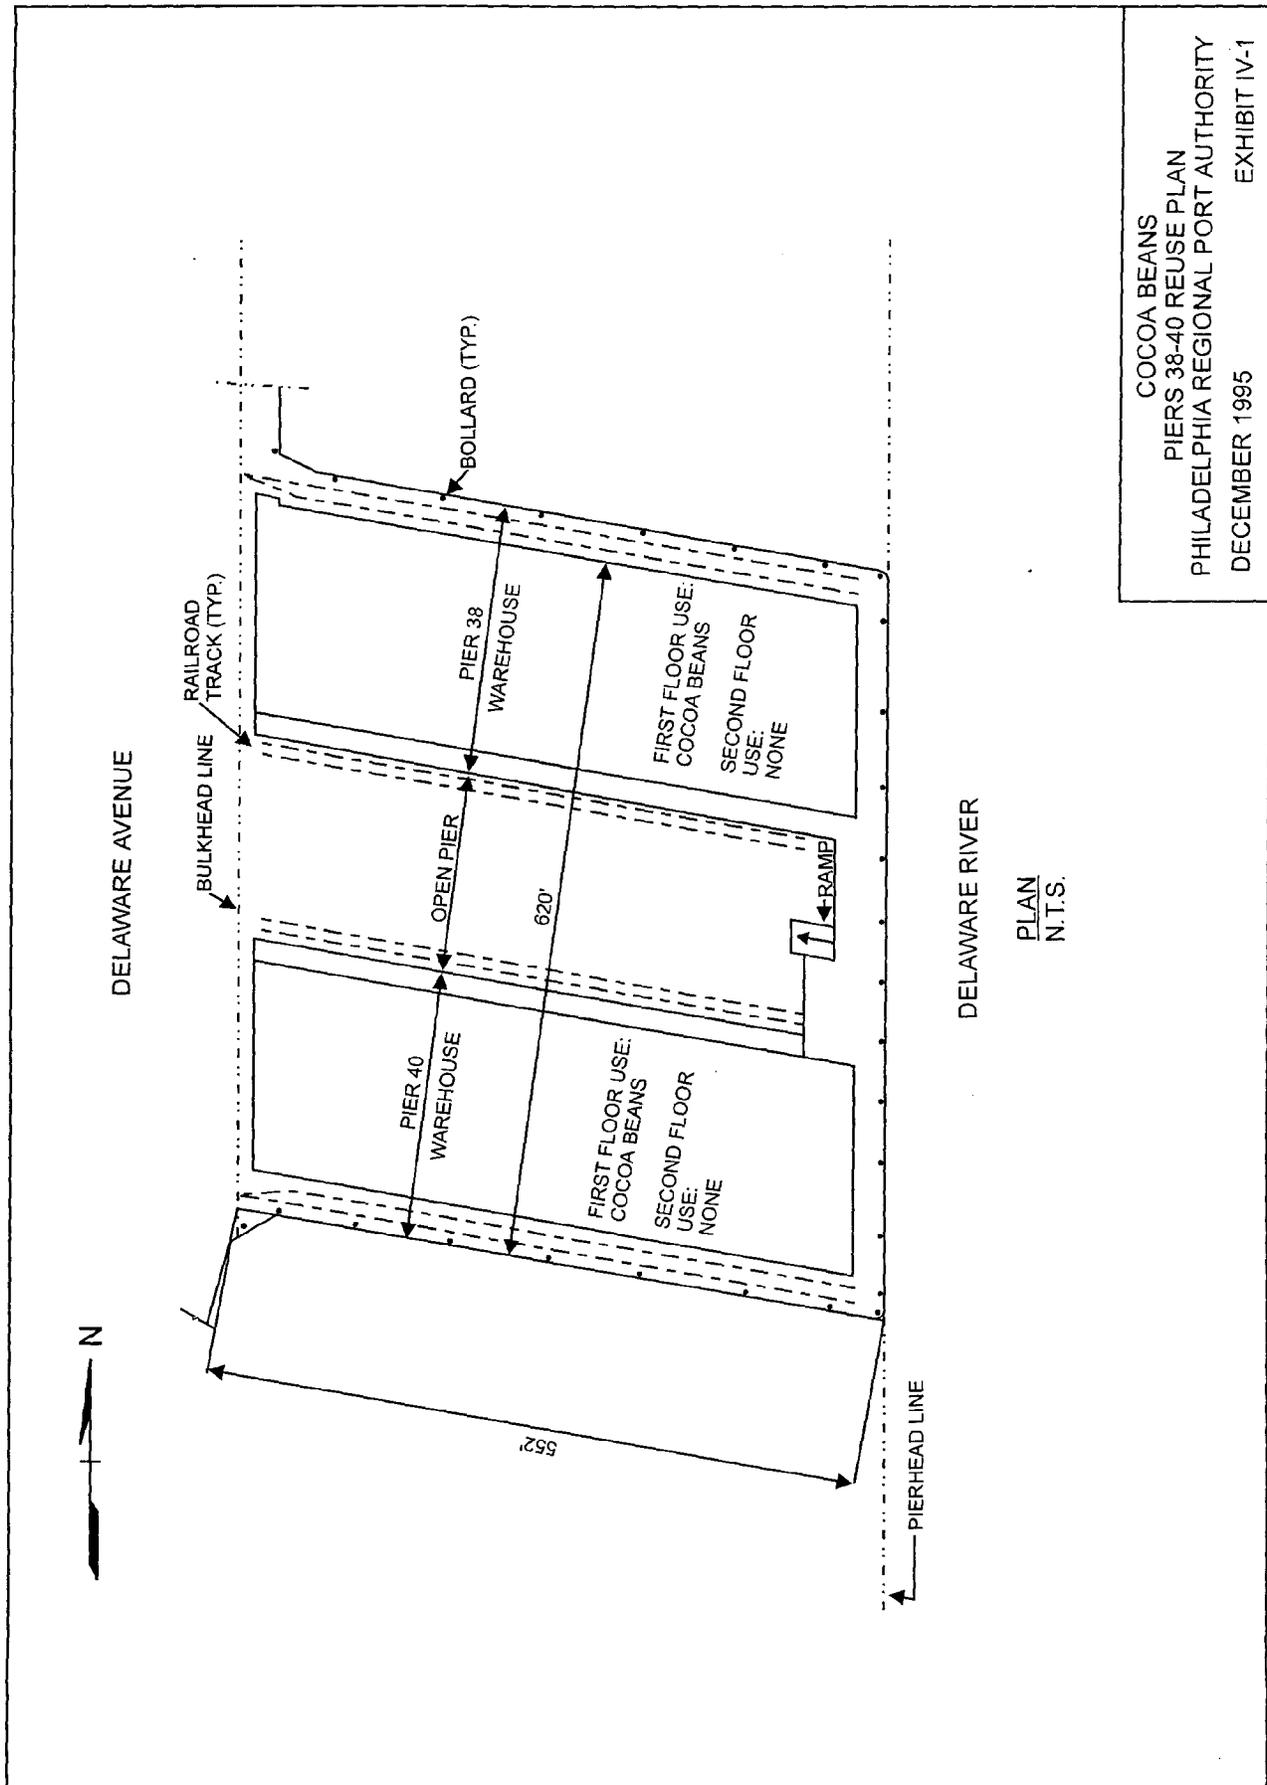
Cocoa beans are shipped in small cargo vessels and come packed in bags which are palletted with 25 bags per pallet. Each bag weighs about 140 pounds and the pallets are usually stacked 4 high. The footprint of a pallet is 6' x 4'6". The pallet weighs 1000 pounds. Therefore, the load is 140 lbs. x 25 bags x 4 high = 14,000 pounds plus 4 pallets at 1000 pounds per pallet, = 18,000 pounds per (6' x 4.5' = 27 sf) 27 square feet = 666.67 psf. This exceeds the design allowable live load of the first floor of the buildings on Piers 38 and 40 by 33%. Stacking the pallets only 3 high produces a load of 500 psf which is the design allowable live load of the first floor. It should be stressed that the live load capacity should be reevaluated based on a structural investigation of existing conditions before assuming that the design live load is appropriate for the structure in its current condition. Therefore, the user should be informed of the restriction that they may not stack the pallets more than 3 high if no limitations to the allowable loads are found in the structural analysis. The allowable live load should be posted inside the building to prevent overstressing the floor. The entire cocoa bean operation will be limited to the first floor of each pier structure. A plan of the proposed cocoa bean facility is shown in Exhibit IV-1.

Food quality upgrade of the facility will be required. Assuming this facility will be upgraded in a manner similar to that at Pier 84, the following amenities will be required: 1) a system of plastic strip partitions to segregate individual areas from each other; 2) an in-house fogging system to limit insect growth; 3) the interior steel must be painted (previous experience indicates that there will be the need for lead paint removal); 4) a active ventilation system which can be accommodated by installation of fans into replacement wall panels. (No roof ventilators were required for the Pier 84 renovations); and 5) seal and level the floor with a heavy duty epoxy.

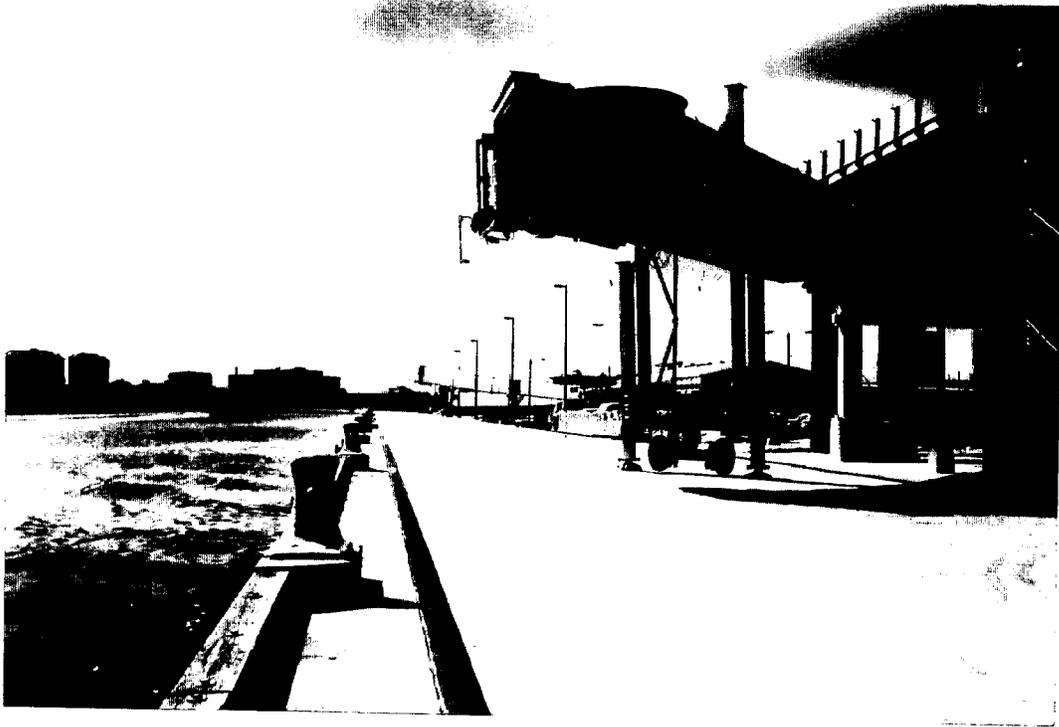
Typical Passenger Loading Bridge

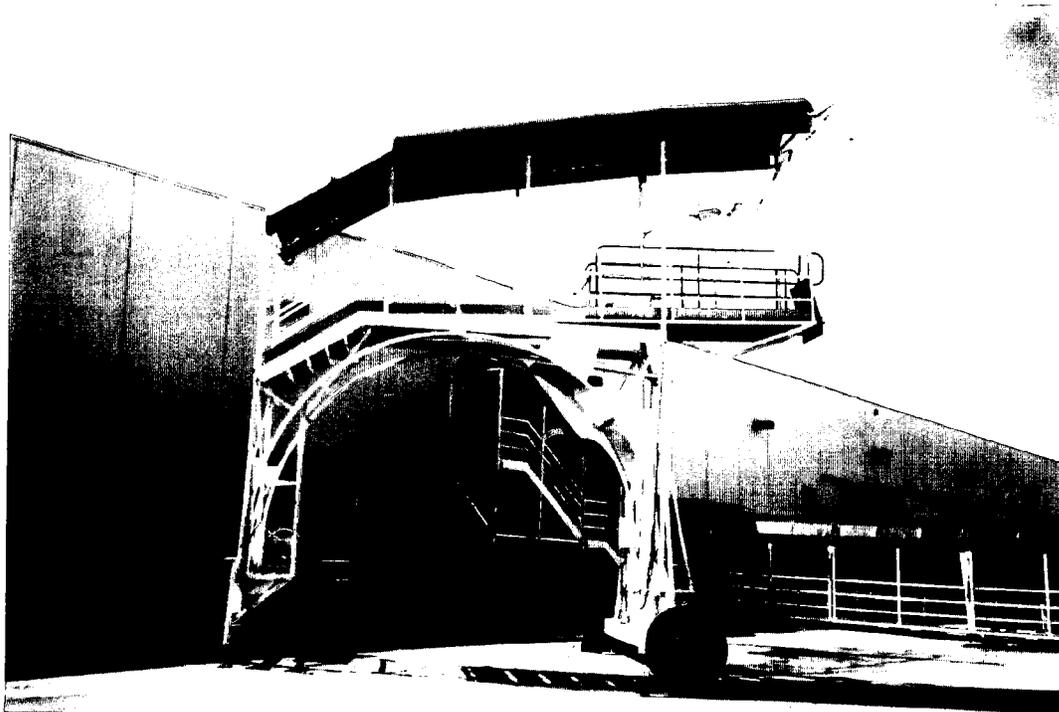
Typical Passenger Loading Bridge

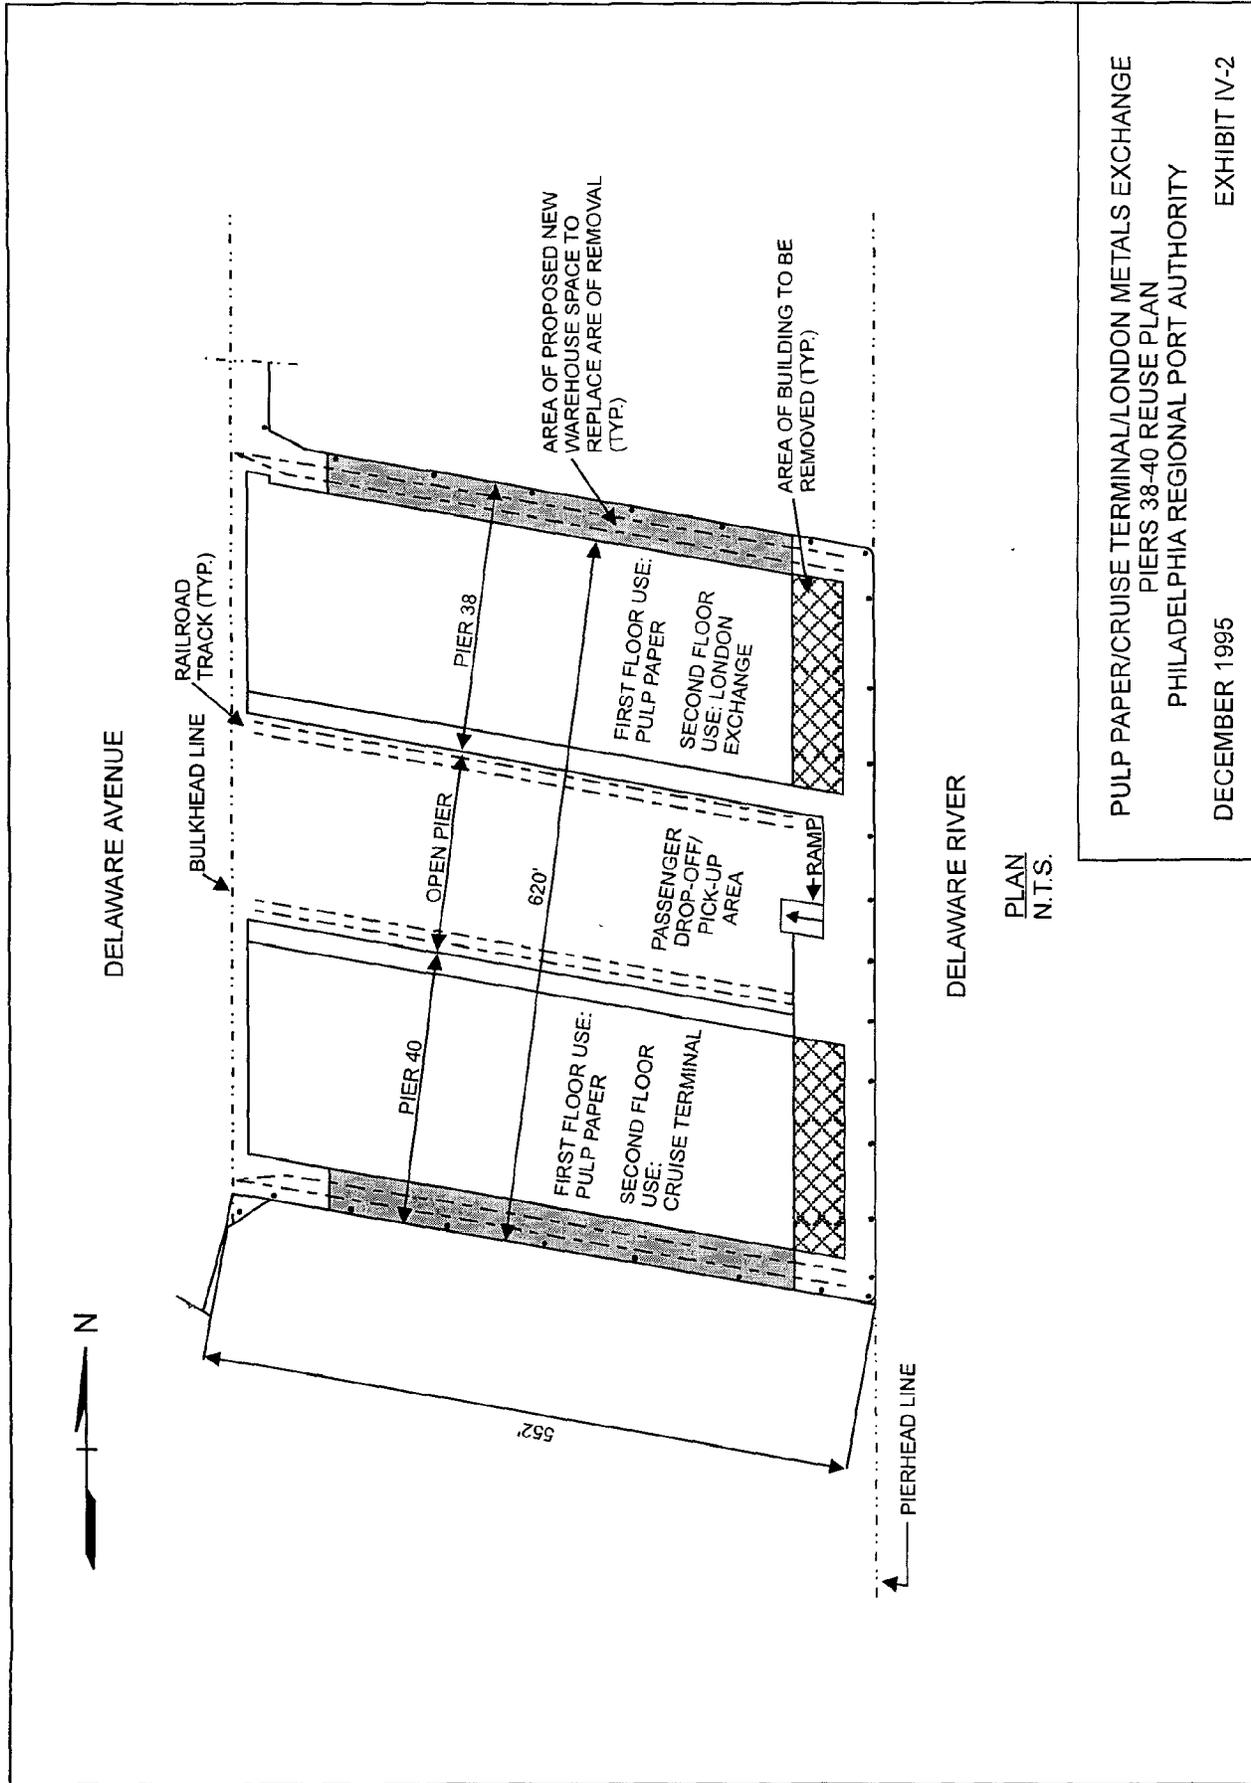
EXHIBIT IV-2

PULP PAPER/CRUISE TERMINAL/LONDON METALS EXCHANGE  
 PIERS 38-40 REUSE PLAN  
 PHILADELPHIA REGIONAL PORT AUTHORITY  
 DECEMBER 1995
