FEDERAL COMMUNICATIONS COMMISSION
47 CFR Part 73

Radio Broadcasting Services; Superior, WY

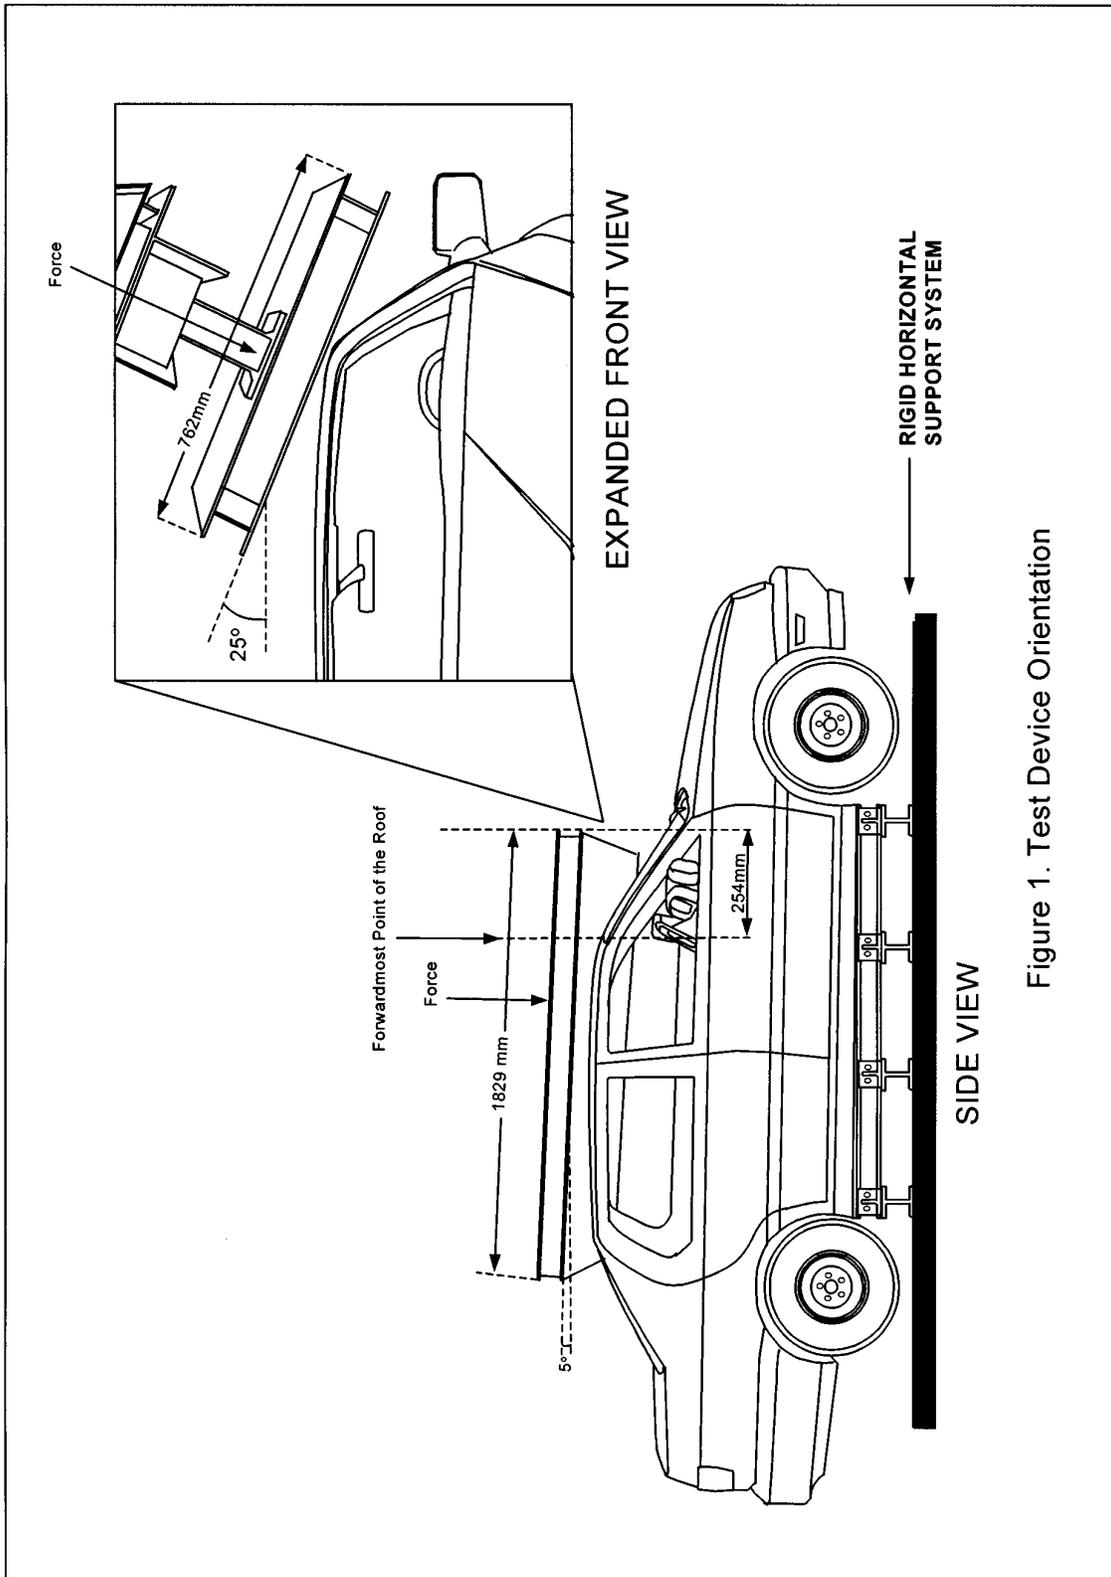
Figure 1 to §571.216

Figure 1. Test Device Orientation

Ford believes that the test procedures as applied to some vehicles are contradictory. S6.2 of the standard says to "[o]rient the test device as shown in Figure 1 * * *", which shows the test plate in contact with the front corner of the roof, inclined longitudinally at an angle of 5 degrees. At the same time, S6.2(d) of the rule specifies that the initial contact point be 254 mm (10 inches) from the front edge of the test plate. Since the initial contact point will not be located at the front corner of the roof for certain vehicles with rounded roofs, there is a conflict between the specifications in S6.2(d) and Figure 1 in the regulatory text.

Paragraph S7.2 has been rewritten to clarify, but not change, the process of orienting the test plate and lowering so that it makes initial contact with the vehicle being tested. In addition, the agency is making a number of clarifying minor changes to the regulatory text. In particular, a sentence was added to the test procedures to explicitly specify that non-structural components such as roof racks are removed prior to testing. This was already the agency's interpretation of the current test procedure. The word "accidents" in S2 is replaced with the word "crashes." Figure 1 is revised to

S7.2 Orient the test device as shown in Figure 1 of this section, so that—
