DEPARTMENT OF TRANSPORTATION**Federal Aviation Administration****14 CFR Part 39**

[Docket No. 99-NM-161-AD; Amendment 39-11749; AD 2000-11-01]

Airworthiness Directives; McDonnell Douglas Model DC-9-80 and MD-90-30 Series Airplanes, and Model MD-88 Airplanes

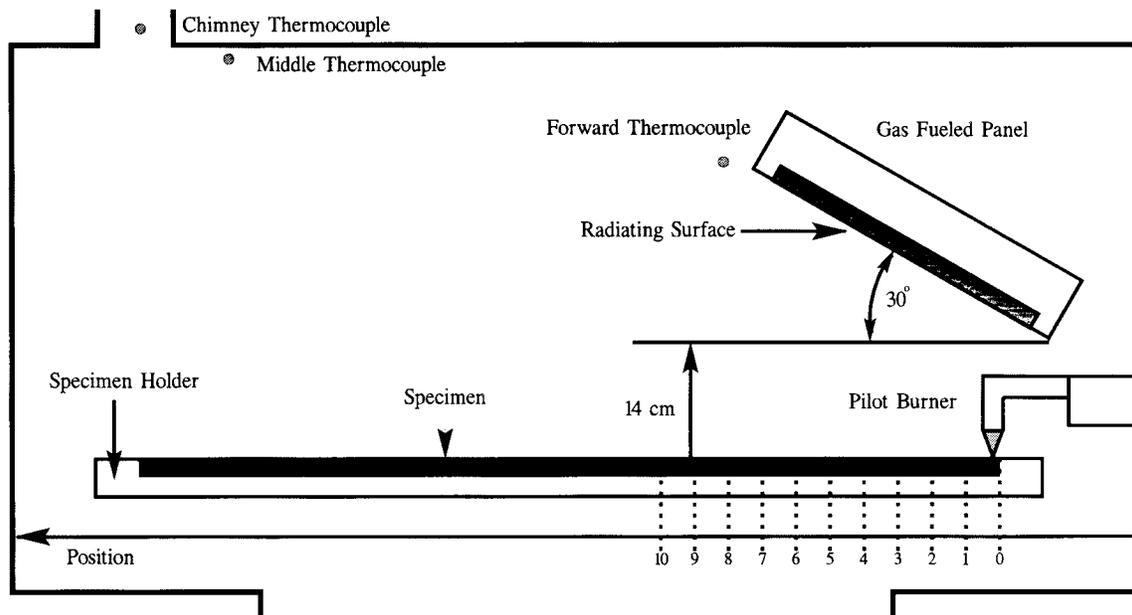
Figure 1.

(2) *Radiant Heat Source.* The radiant heat energy source will be a panel of porous refractory material mounted in a cast iron frame, with a radiation surface of 12 by 18 inches (305 by 457mm). It shall be capable of operating at temperatures up to 1500°F (816°C (Figure 1).

(ii) Radiant Panel Placement. The panel will be mounted in the chamber at 30 degrees to the horizontal specimen plane.

(b) *Test Apparatus* (as schematically shown in figure 1).

(1) During burner application, no flaming is allowed to propagate more than 2 inches (50.8mm) along the sample (to the left in figure 1) of the centerline of the flame.

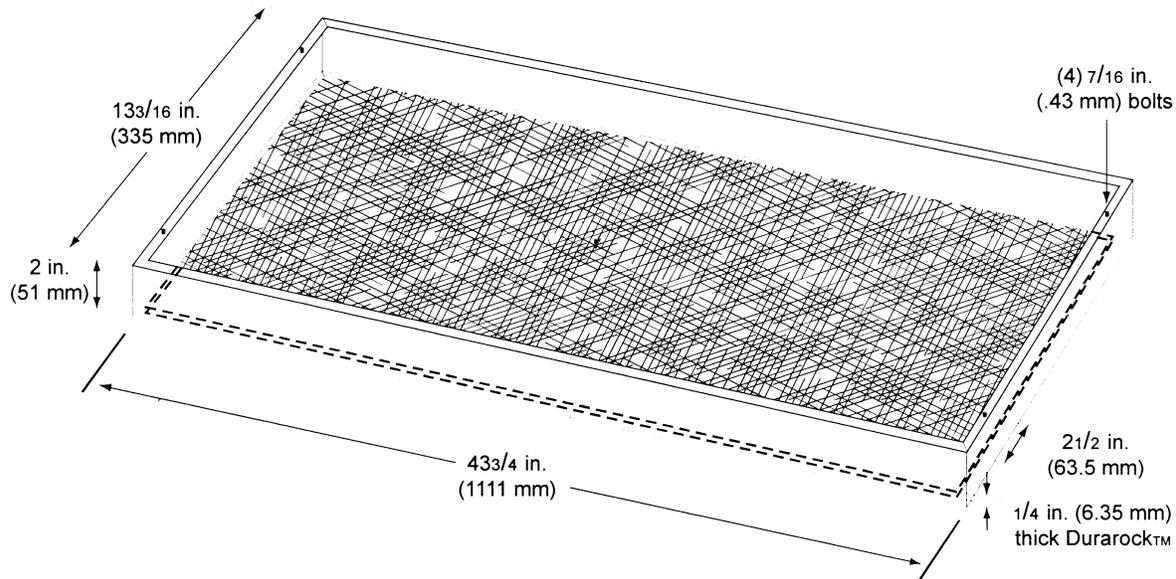
Figure 2: Sliding Platform

(19.1mm) lip that extends around the bottom of the platform base. It is suggested that the shortest piece be placed at the end furthest from the radiant panel (figure 2). A $\frac{1}{2}$ inch (13mm) piece of Kaowool™ board or other high temperature material measuring $41\frac{1}{2}$ by $8\frac{1}{4}$ inches (1054 by 210mm) will be attached to the back side of the platform. This board will serve as a heat retainer and will protect the test specimen from excessive preheating. The height of this board must not be too high such that it will impede the sliding platform movement (in and out) of the test chamber.

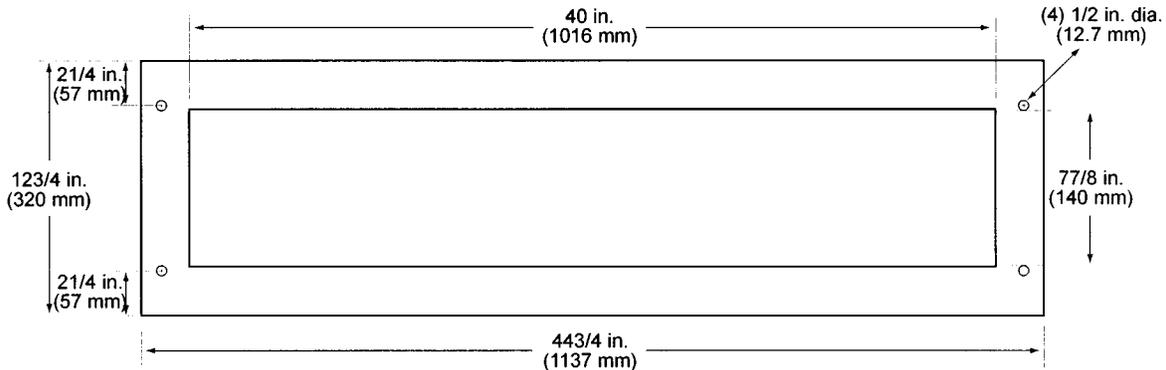
Figure 3: Stainless Steel Retaining Frame

(ii) The test specimen will be placed horizontally on the non-combustible base. A stainless steel retaining frame (AISI Type 300 UNA-NO8330), or equivalent, having a thickness of 0.078 inches (1.98mm) and

overall dimensions of $44\frac{3}{4}$ by $12\frac{3}{4}$ inches (1137 by 320mm) with a specimen opening of 40 by $7\frac{7}{8}$ (1016 by 140mm) will be placed on top of the test specimen. The retaining frame will have two $\frac{1}{2}$ inch (12.7mm) holes

drilled at each end for positioning the frame to the two stud bolts at each end of the sliding platform (figure 3).

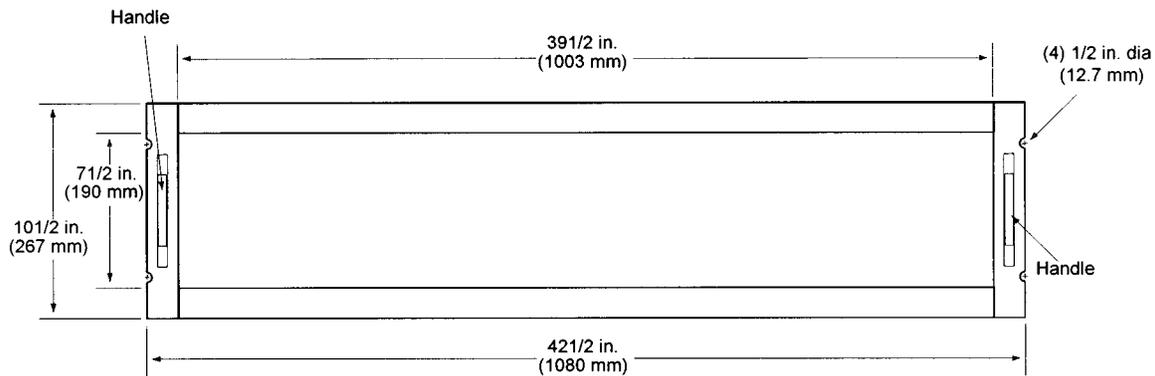
Figure 4: Angle Iron (1.5x1.5) Securing Frame
*NOTE: All Seams Welded

(iii) A securing frame (acting as a clamping mechanism) constructed of mild steel will be placed over the test specimen. The securing frame overall dimensions are $42\frac{1}{2}$ by $10\frac{1}{2}$ inches (1080 by 267mm) with a specimen opening of $39\frac{1}{2}$ by $7\frac{1}{2}$ inches (1003 by 190mm). Hence, the exposed area of test specimen exposed to the radiant panel is $39\frac{1}{4}$ by $7\frac{1}{4}$ inches (996 by 184mm). See figure 4. It is not necessary to physically fasten the securing frame over the test specimen due to the weight of the frame itself.

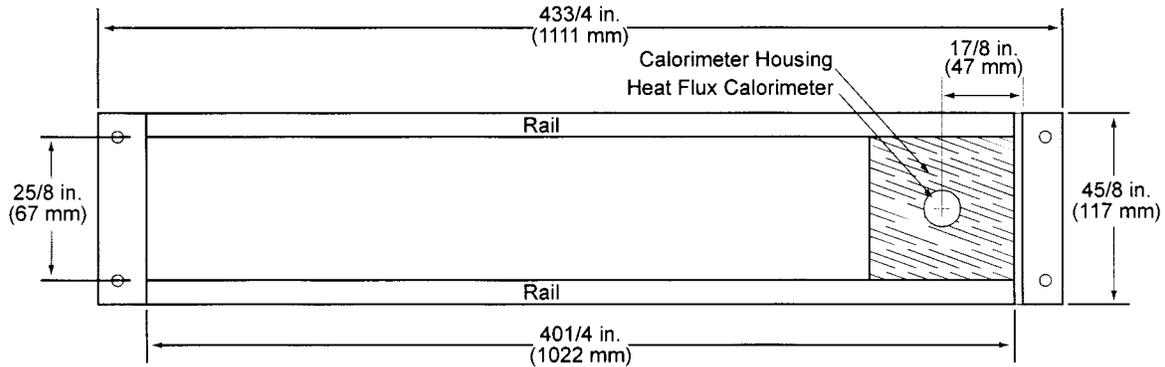
Figure 5: Calorimeter Rail

(8) *Calorimeter Fixture.* With the sliding platform pulled out of the chamber, install a 2-rail fixture that has a travel range of 40 1/4 inches (1022mm) over the sliding platform. The dimension between the 2 rails is 2 11/16 inches (68mm). The rail fixture is screwed into the sliding panel, such that it is always directly under the geometric center of the radiant panel (figure 4). Push the platform into the chamber and insert the calorimeter. The calorimeter, which is mounted in an insulated housing, fits in the rail opening but has enough clearance such that it may be moved along the rail for heat flux readings. The top surface of the calorimeter must be level with the rails.

(1) With the sliding platform out of the chamber, install the rail fixture. Push the platform back into the chamber, install the calorimeter (in its housing), and move the calorimeter to the "zero" position (figure 5). Close the bottom door located below the

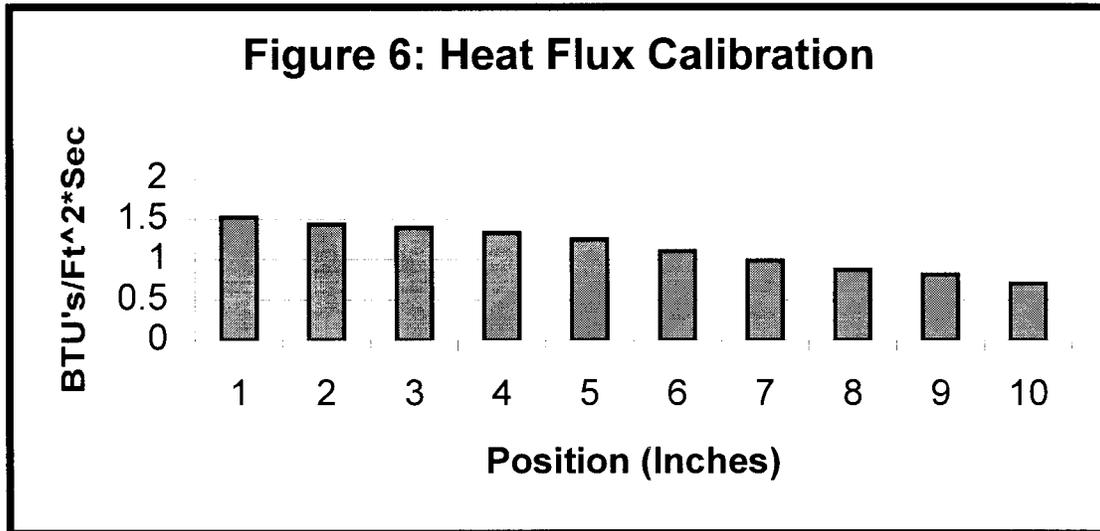
(3) After steady-state conditions have been reached, move the calorimeter 2 inches (51mm) from the "zero" position and record

the heat flux. Allow a minimum of 30 seconds at each position for the calorimeter

to stabilize. Record at least 10 positions. (Figure 6 depicts a calibration profile.)

(4) It is not necessary to run a full heat flux calibration (minimum of 10 positions) each time the chamber is powered on. It is required that a heat flux measurement be taken at the "zero" position at the start of the test period (e.g., each morning) to ensure that the 1.5 BTU/ft²-second (1.9 Watts/cm²) requirement be met. A full calibration should be run periodically.
