[Docket No. 99-NM-162-AD; Amendment 39-11750; AD 2000-11-02]

#### **Airworthiness Directives; McDonnell Douglas Model DC-10-10F, DC-10-15, DC-10-30, DC-10-30F, and DC-10-40 Series Airplanes, and Model MD-11 and -11F Series Airplanes**

**ACTION:** Final rule.

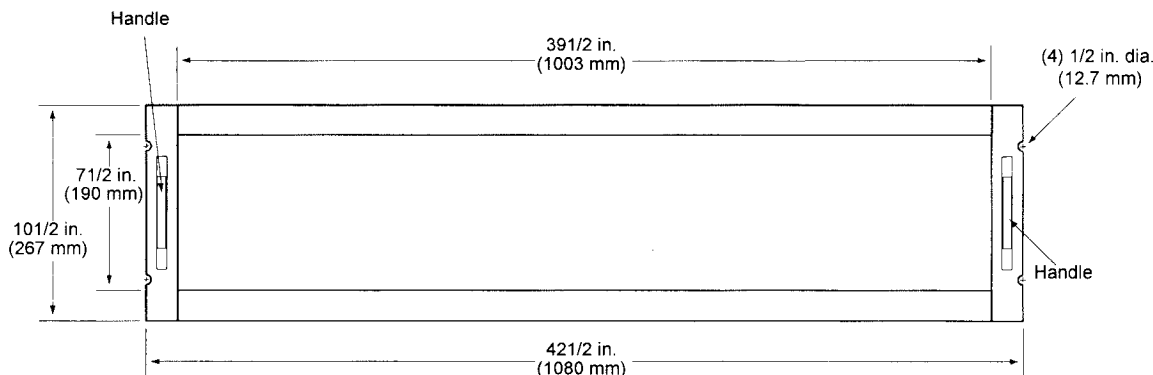
Figure 4: Angle Iron (1.5x1.5) Securing Frame  
\*NOTE: All Seams Welded

(iii) A securing frame (acting as a clamping mechanism) constructed of mild steel will be placed over the test specimen. The securing frame overall dimensions are  $42\frac{1}{2}$  by  $10\frac{1}{2}$  inches (1080 by 267mm) with a specimen opening of  $39\frac{1}{2}$  by  $7\frac{1}{2}$  inches (1003 by 190mm). Hence, the exposed area of test specimen exposed to the radiant panel is  $39\frac{1}{4}$  by  $7\frac{1}{4}$  inches (996 by 184mm). See figure 4. It is not necessary to physically fasten the securing frame over the test specimen due to the weight of the frame itself.
