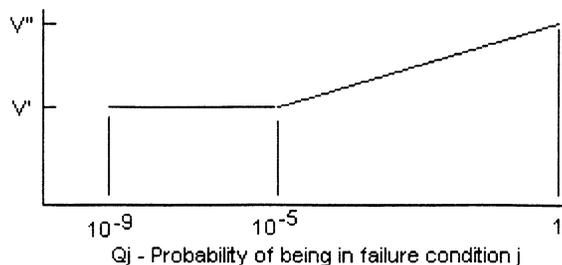
Figure 3
Clearance speed

VI = Clearance speed as defined by § 25.629(b)(2).

VII = Clearance speed as defined by § 25.629(b)(1).

$Q_j = (T_j)(P_j)$ where:

T_j = Average time spent in failure condition j (in hours).

P_j = Probability of occurrence of failure mode j (per hour).

Note: If P_j is greater than 10^{-3} per flight hour, then the flutter clearance speed must not be less than VII.

(v) Freedom from aeroelastic instability must be shown up to a speed determined from Figure 3. Flutter clearance speeds VI and VII may be based on the speed limitation specified for the remainder of the flight using the margins defined by § 25.629(b).

(vi) Freedom from aeroelastic instability must also be shown up to VI in Figure 3 above for any probable system failure condition combined with any damage required or selected for investigation by § 25.571(b).

d. Dispatch with known failure conditions. If the airplane is to be dispatched in a known system failure condition that affects structural performance, or affects the reliability of the remaining system to maintain structural performance, then the provisions of these special conditions must be met for the dispatched condition and for subsequent failures. Flight limitations and expected operational limitations may be taken into account in establishing Q_j as the combined probability of being in the dispatched failure condition and the subsequent failure condition for the safety margins in Figures 2 and 3. These limitations must be such that the
