Unsafe Condition

(d) This AD results from our determination that the surface eddy current inspection method should be used in place of the dye penetrant inspection method currently required in AD 62-24-01. We are issuing this AD to prevent failure of the front and/or rear horizontal stabilizer spars caused by fatigue cracks. This failure could result in stabilizer separation and loss of control of the airplane.

Purpose: This procedure is to be used to detect cracks in the inner and outer spars of the front and rear spar assemblies of Raytheon Aircraft Company Beech Models 45 (YT-34), A45 (T-34A, B-45), and D45 (T-34B) airplane stabilizers outside of the steel bushings in the attach holes.

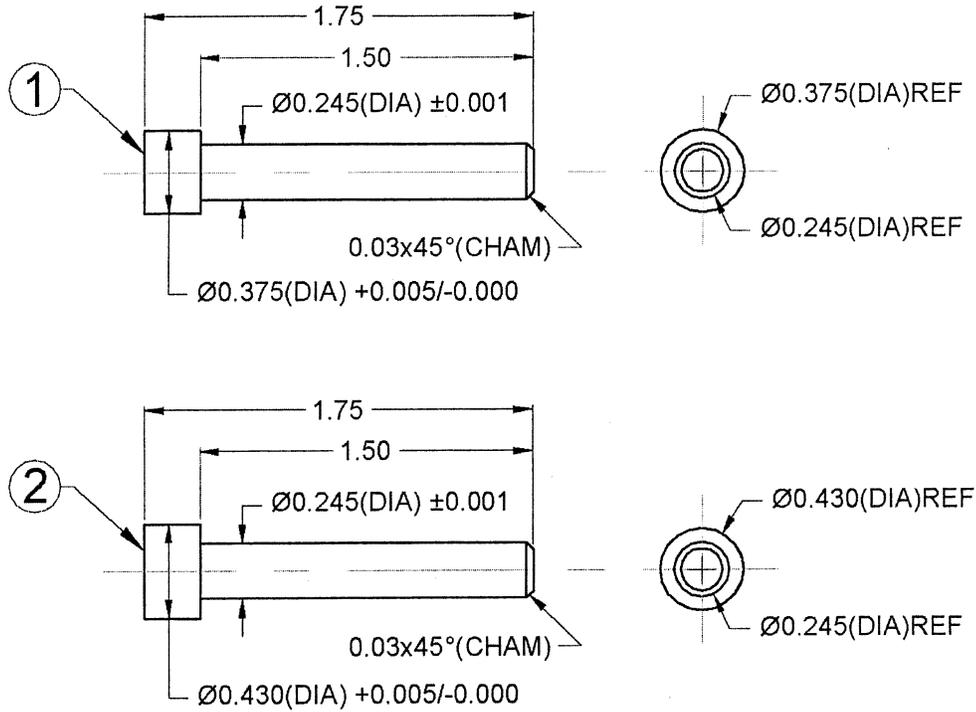
SIZE	DWG. NO.	REV
A	45-127	A
SCALE	CAD FILE	SHEET
1.5=1	45-127 REVA.DWG	1 OF 1

2	45-127-2	BUSHING TOOL	Ø0.44(DIA) x1.75	ALUMINUM		BREAK ALL SHARP EDGES
1	45-127-1	BUSHING TOOL	Ø0.38(DIA) x1.75	ALUMINUM		BREAK ALL SHARP EDGES
KEY	PART NO.	DESCRIPTION	SIZE	MATERIAL SPEC.	HEAT TREAT	NOTES
